**Badin Inn Stream Restoration
Stanly County, NC**

**Mitigation Plan and As-built Baseline Report
DRAFT**

**EEP Project Number 92666
SCO Project Number D06125-E
Data Collection Period: April-July, 2009
Submission Date: August, 2009**

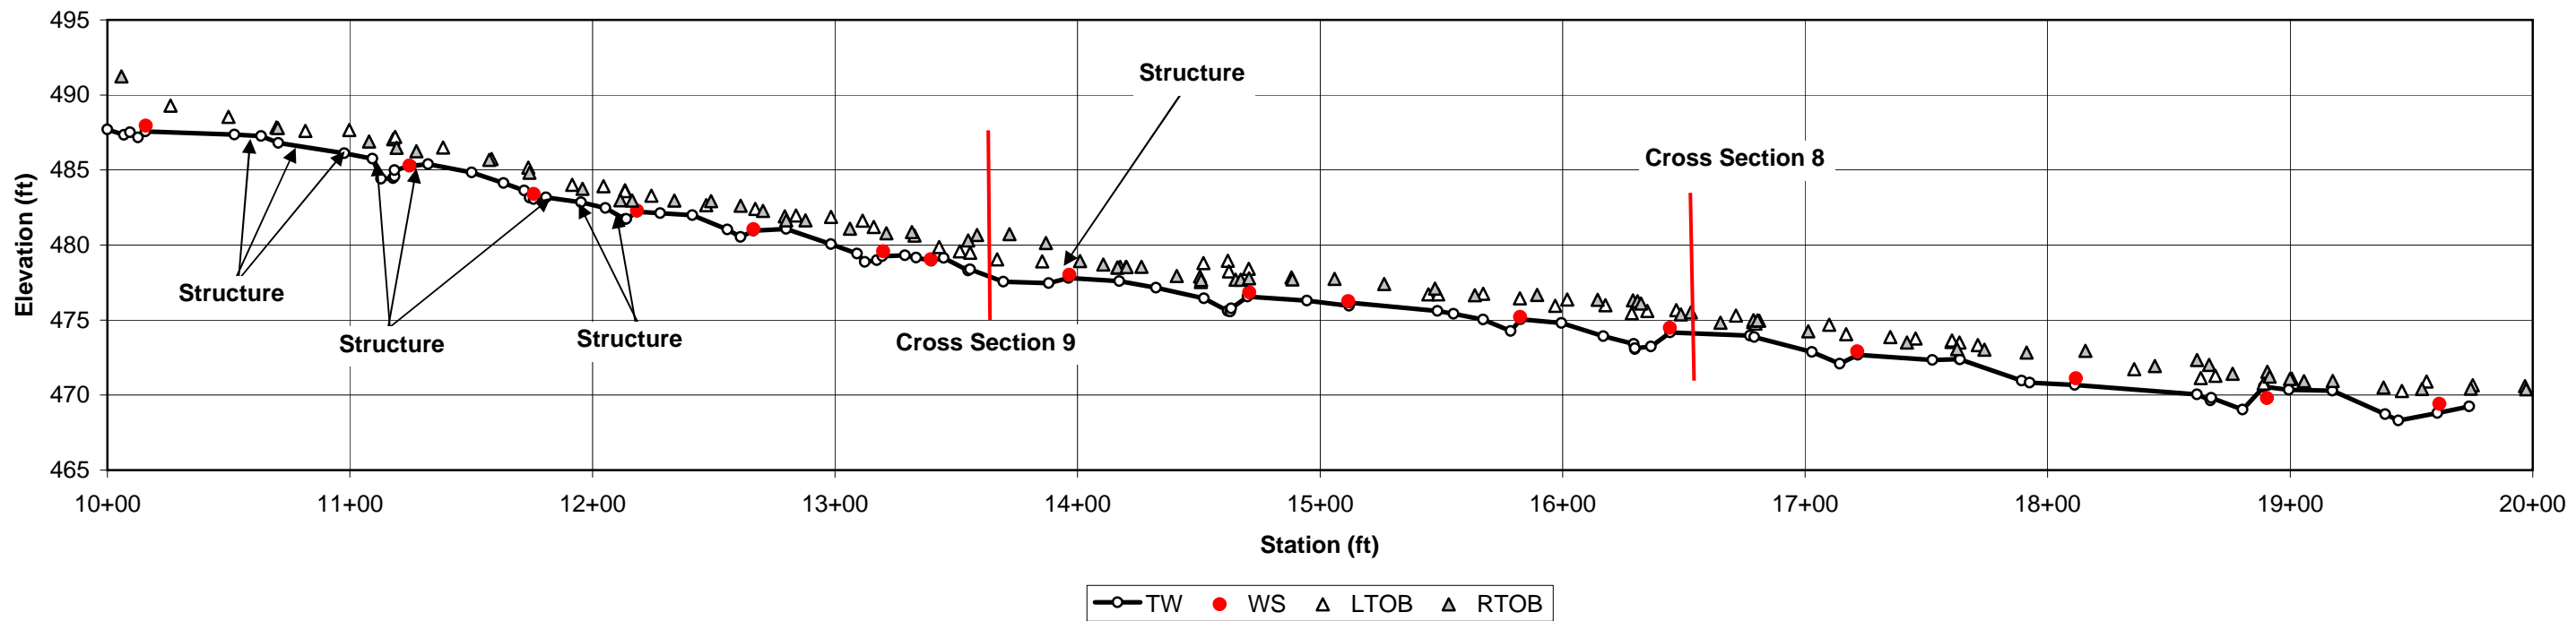
UT to Little Mountain Creek Long Profile

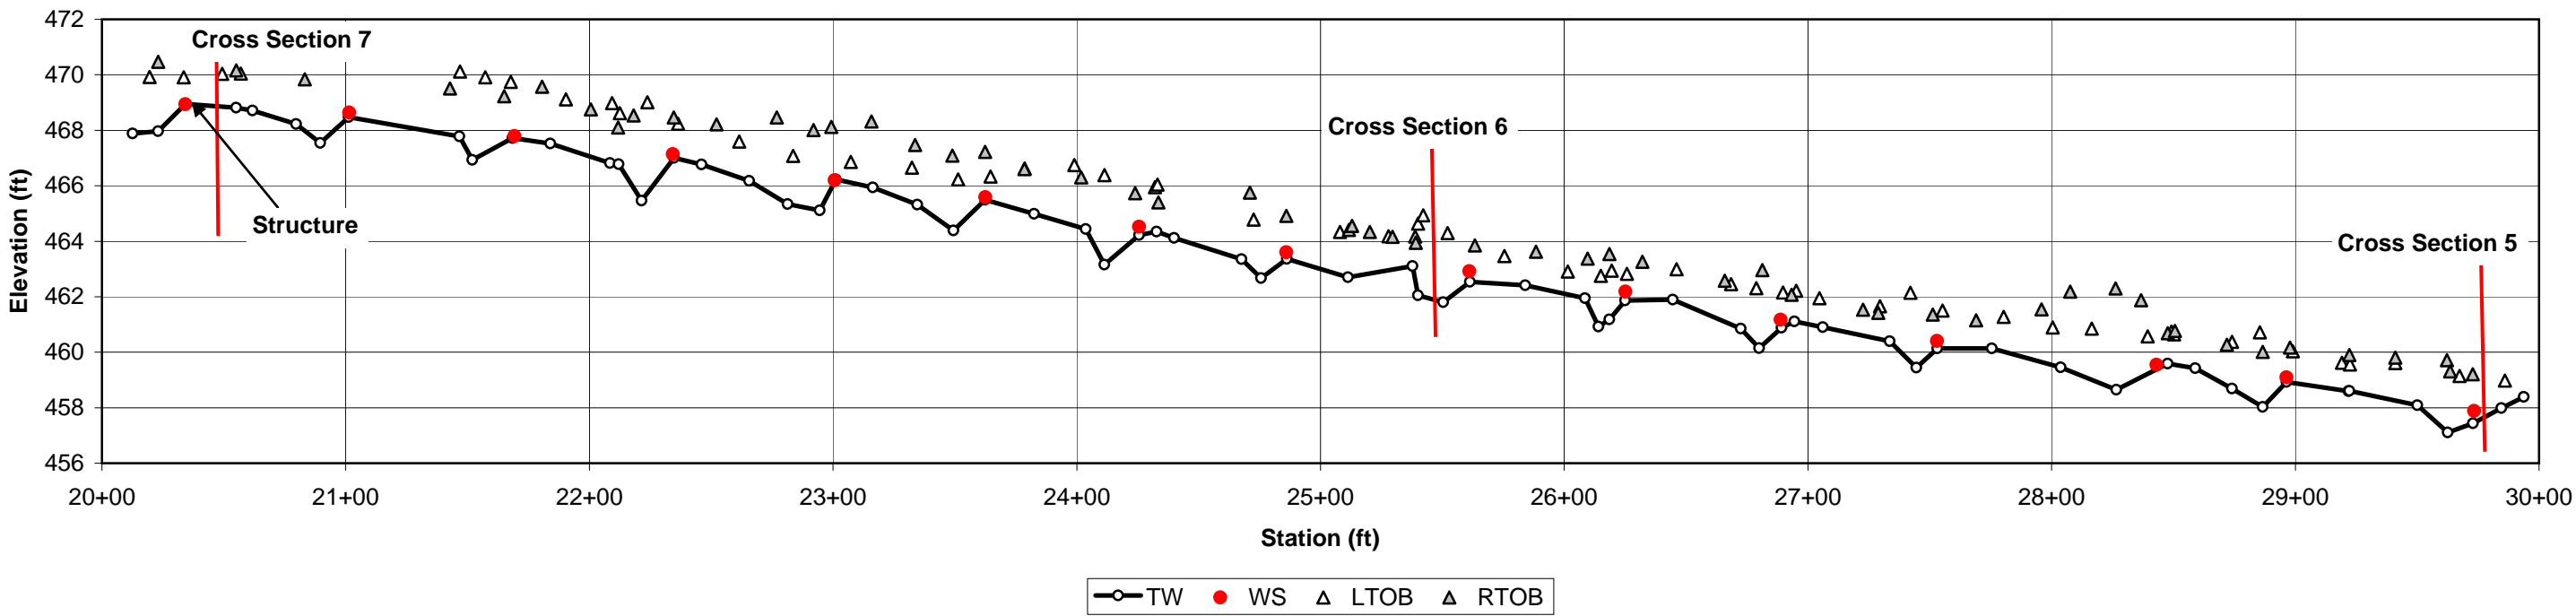
UT to Little Mountain Creek Long Profile

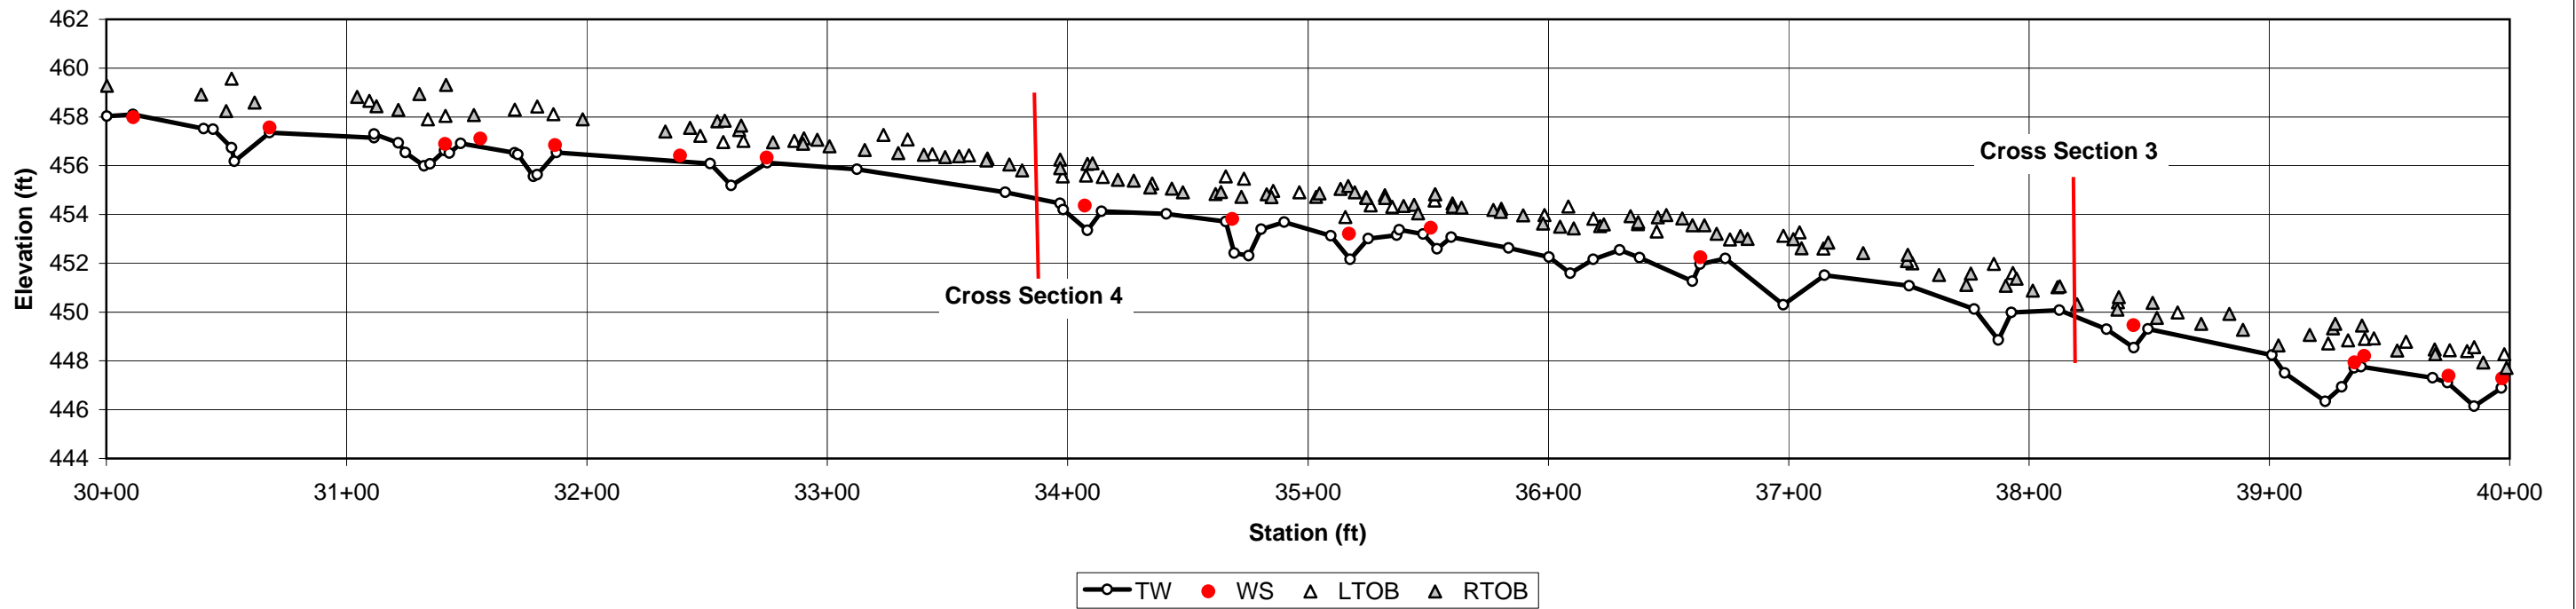
UT to Little Mountain Creek Long Profile

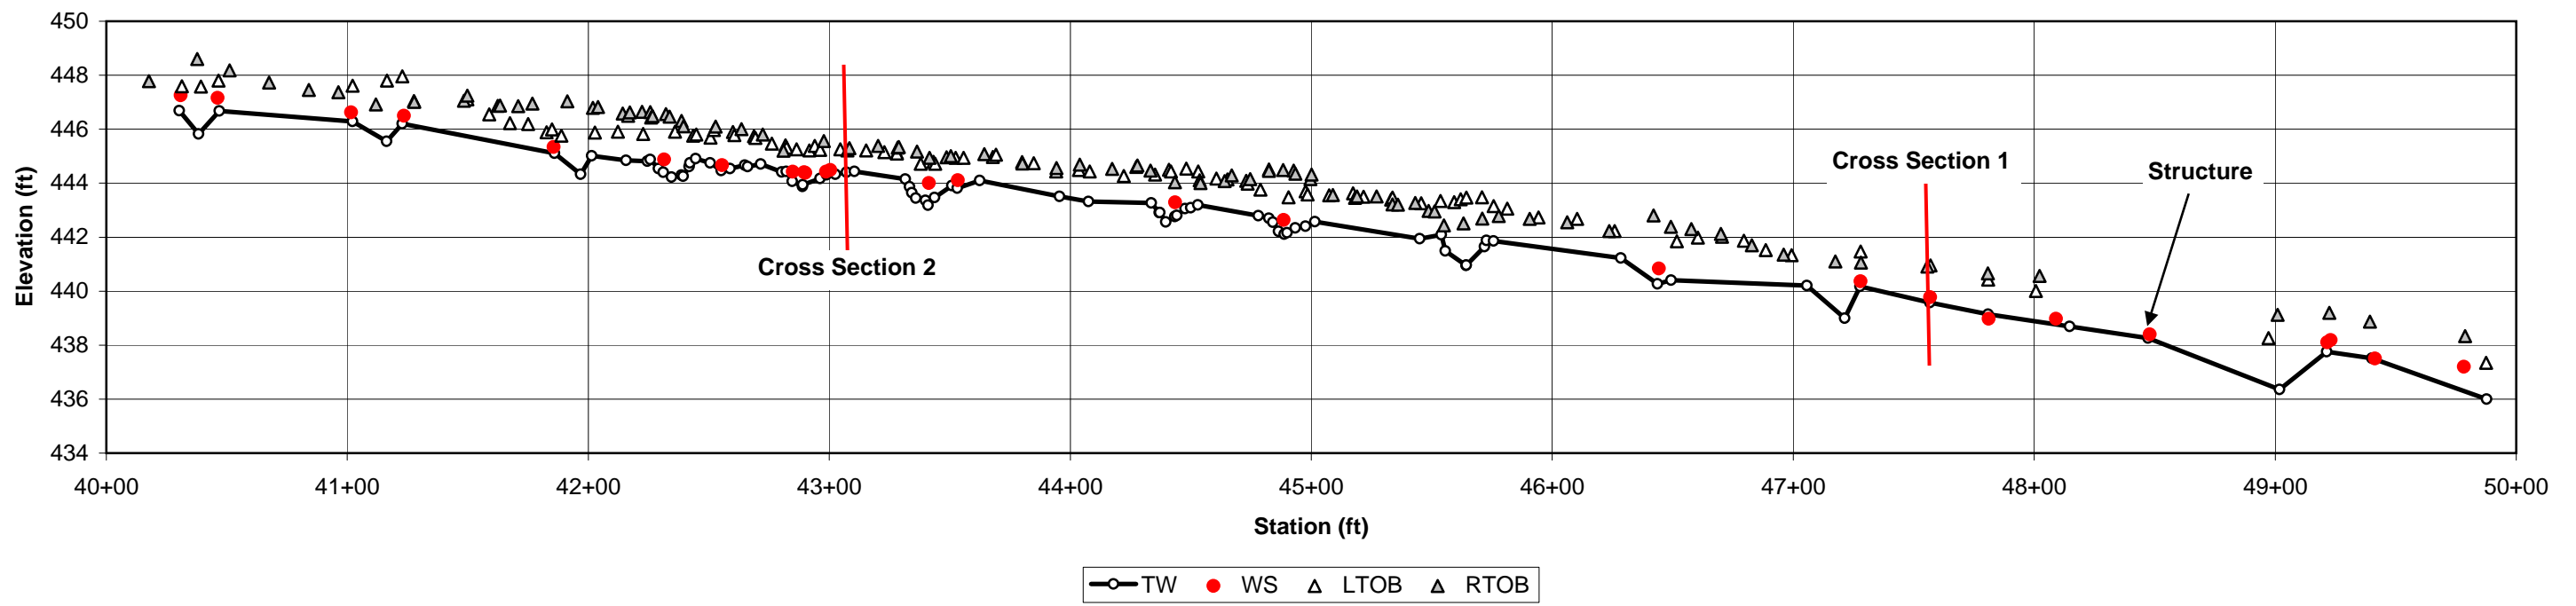
UT to Little Mountain Creek Long Profile

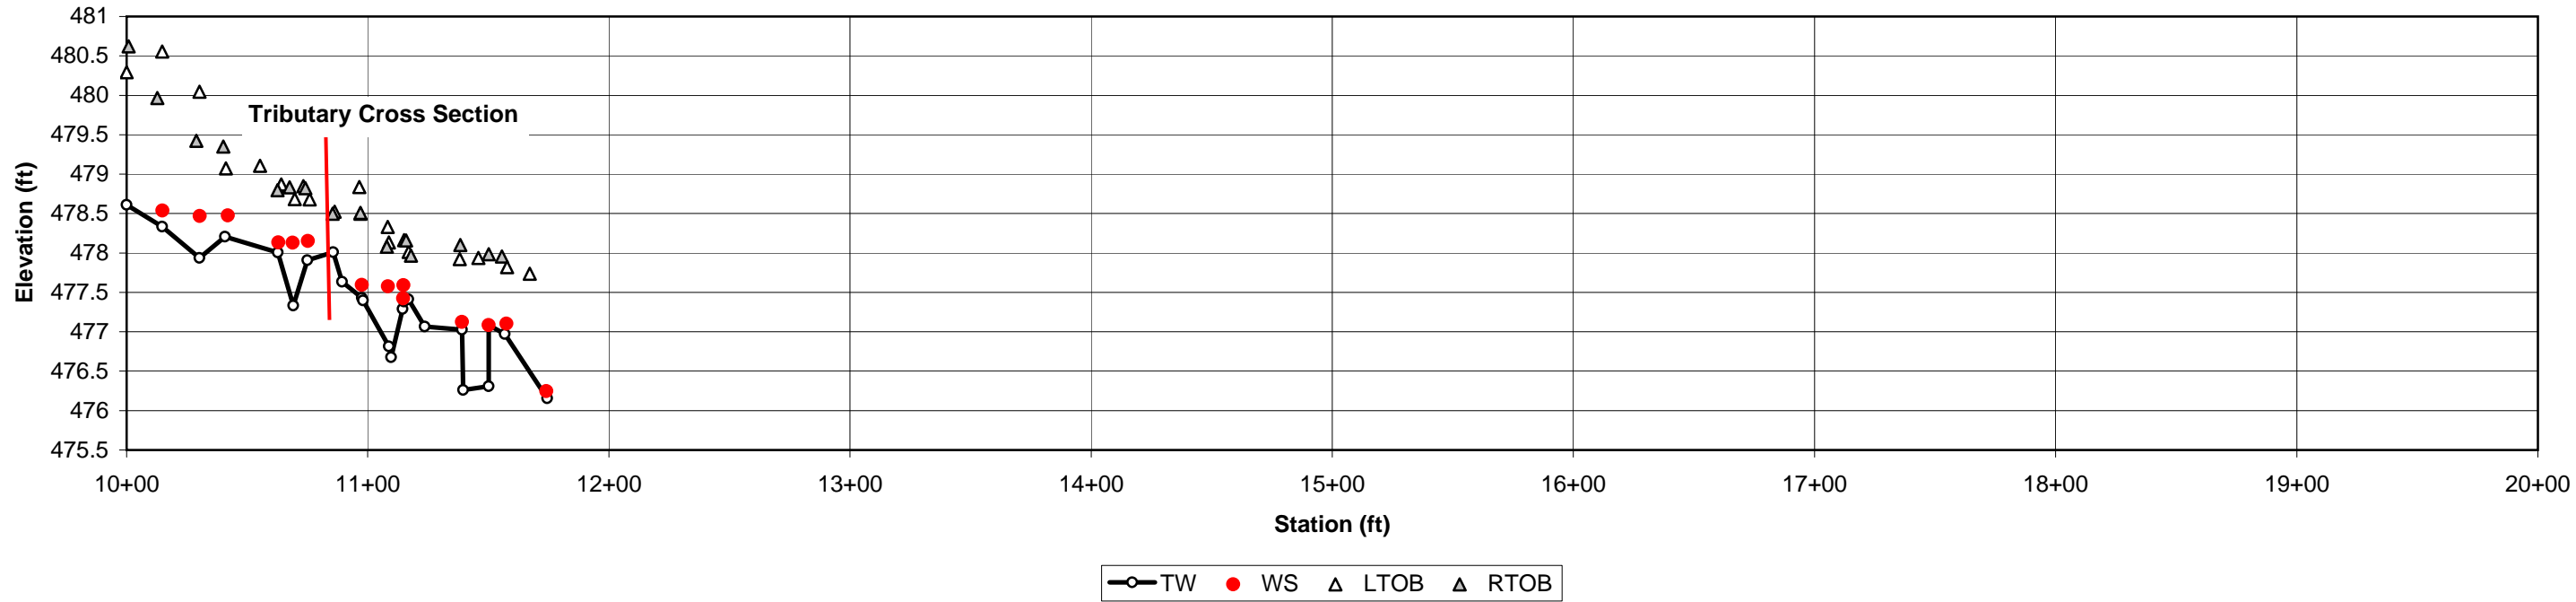
UT to Little Mountain Creek-Tributary Long Profile

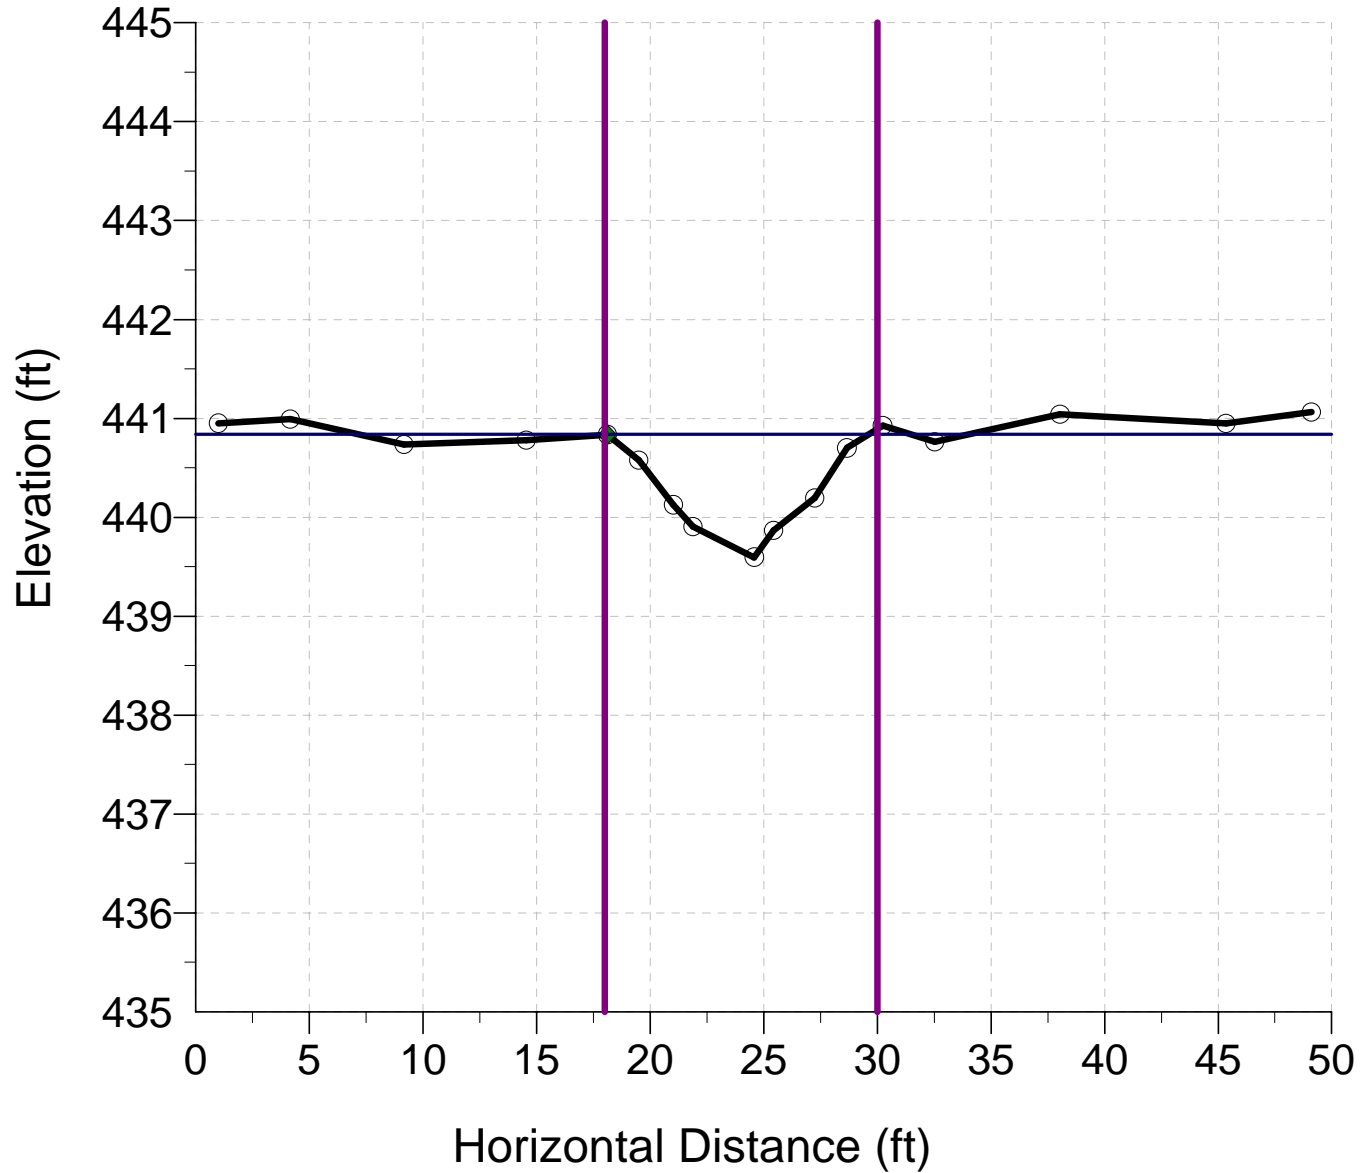
Cross Section 1 Riffle

Wbkf = 11.6 Dbkf = .65 Abkf = 7.62

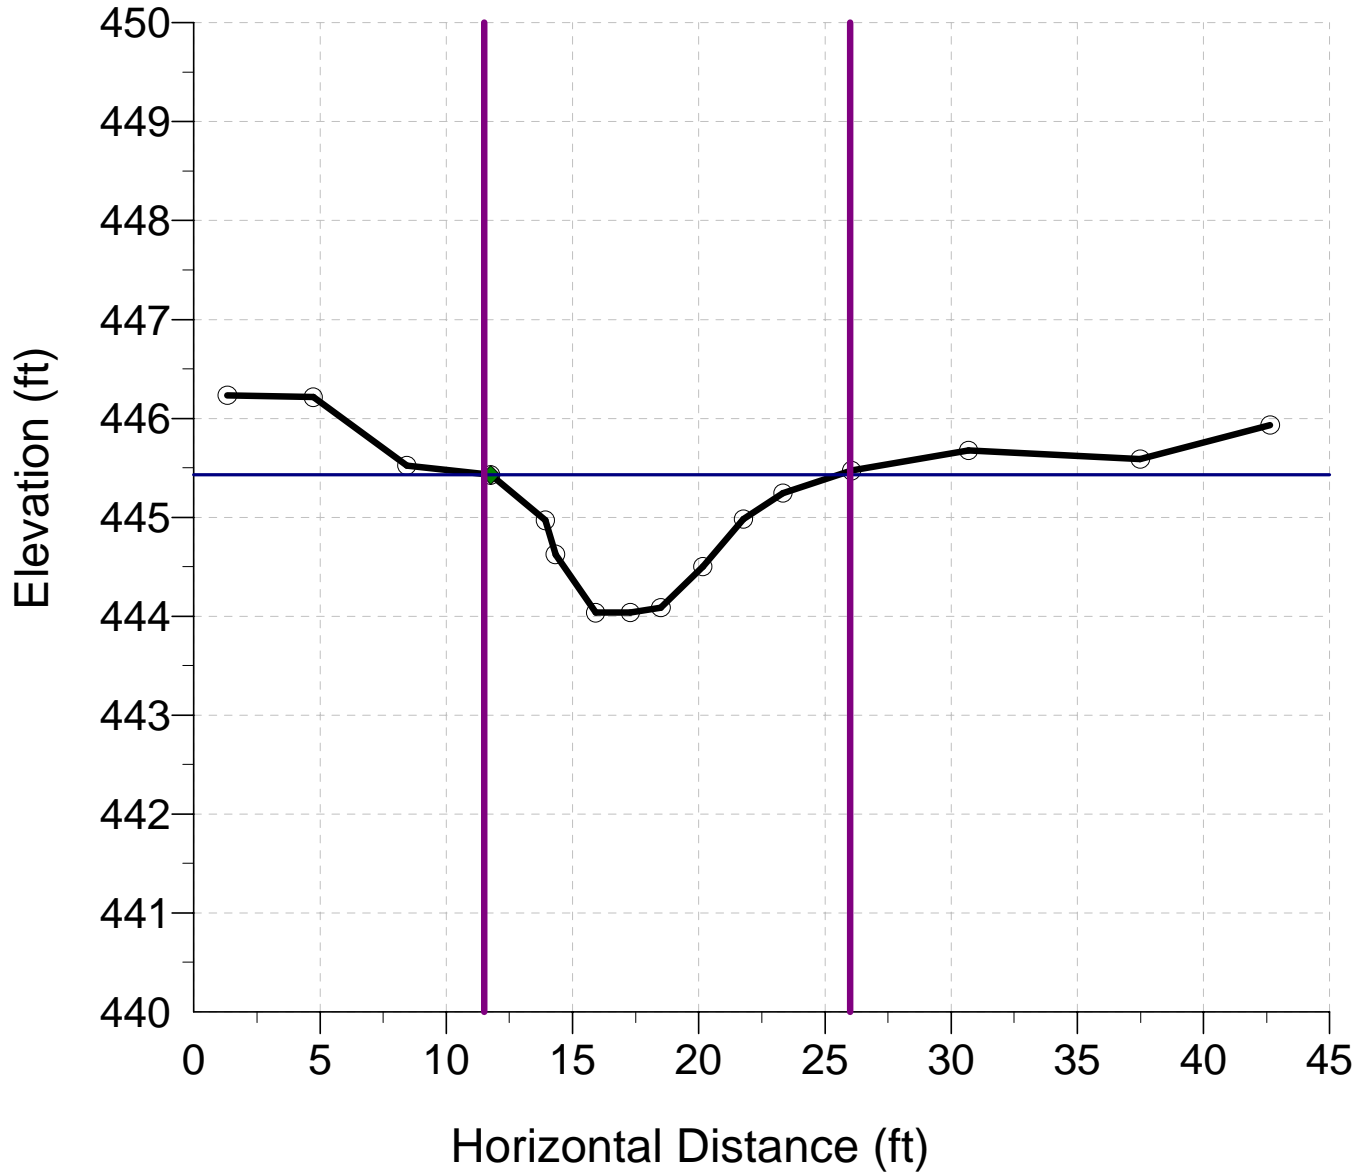
Cross Section 2 Pool

Dbkf = .7

Abkf = 9.78

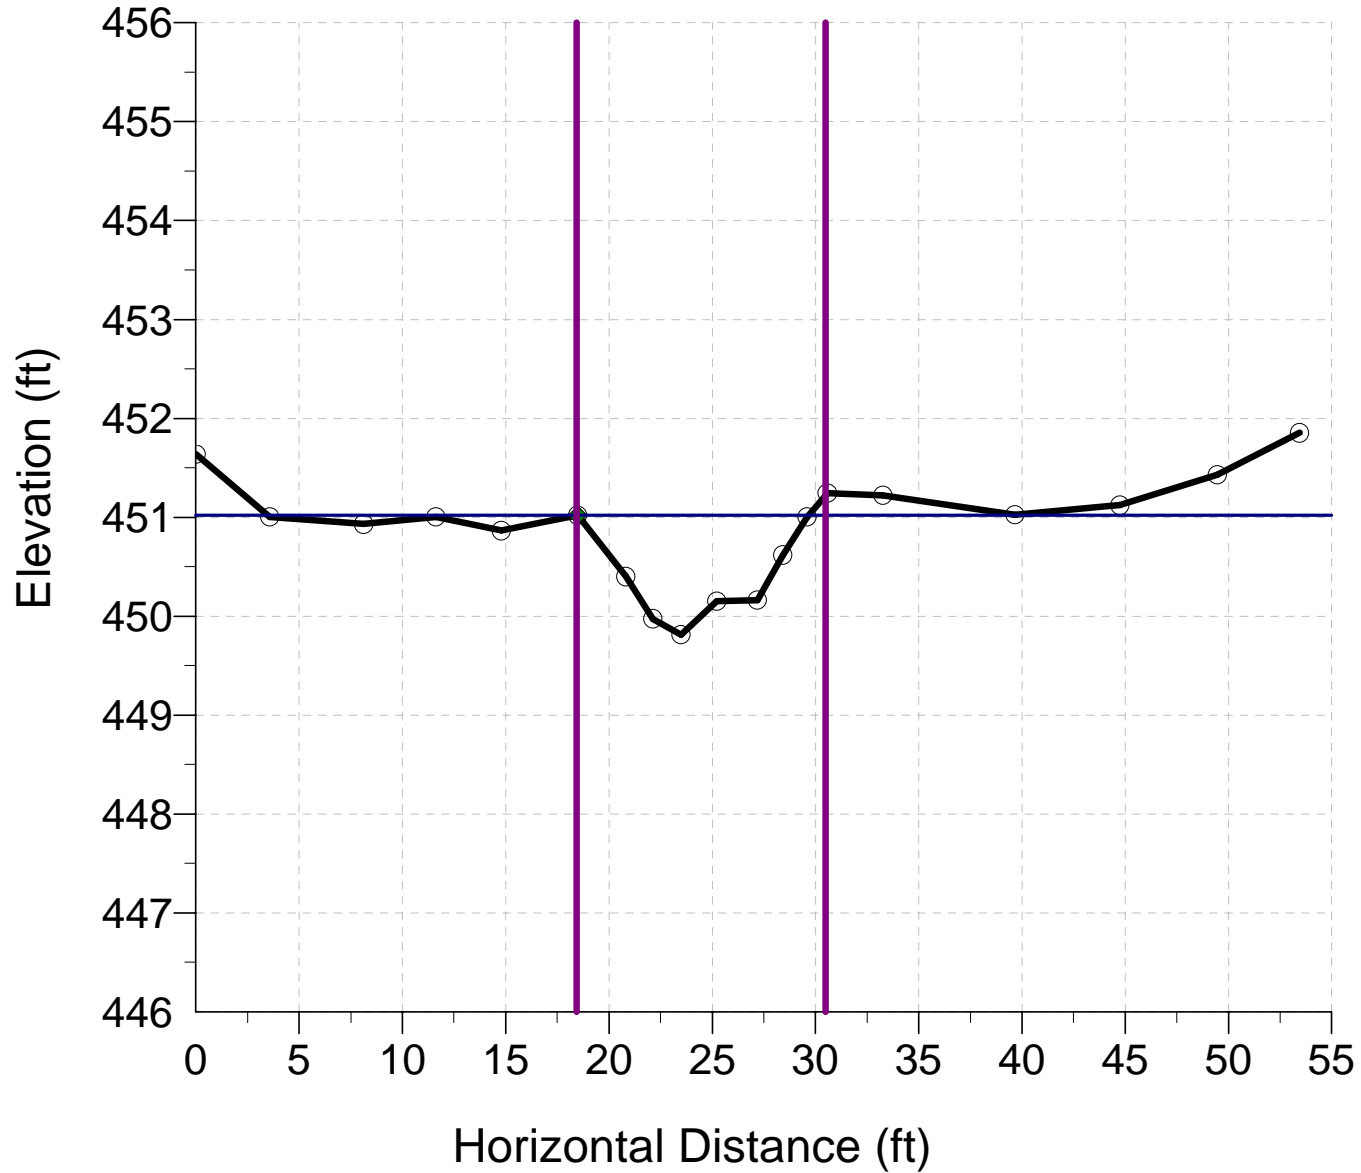
Cross Section 3 Riffle

Dbkf = .7

Abkf = 7.87

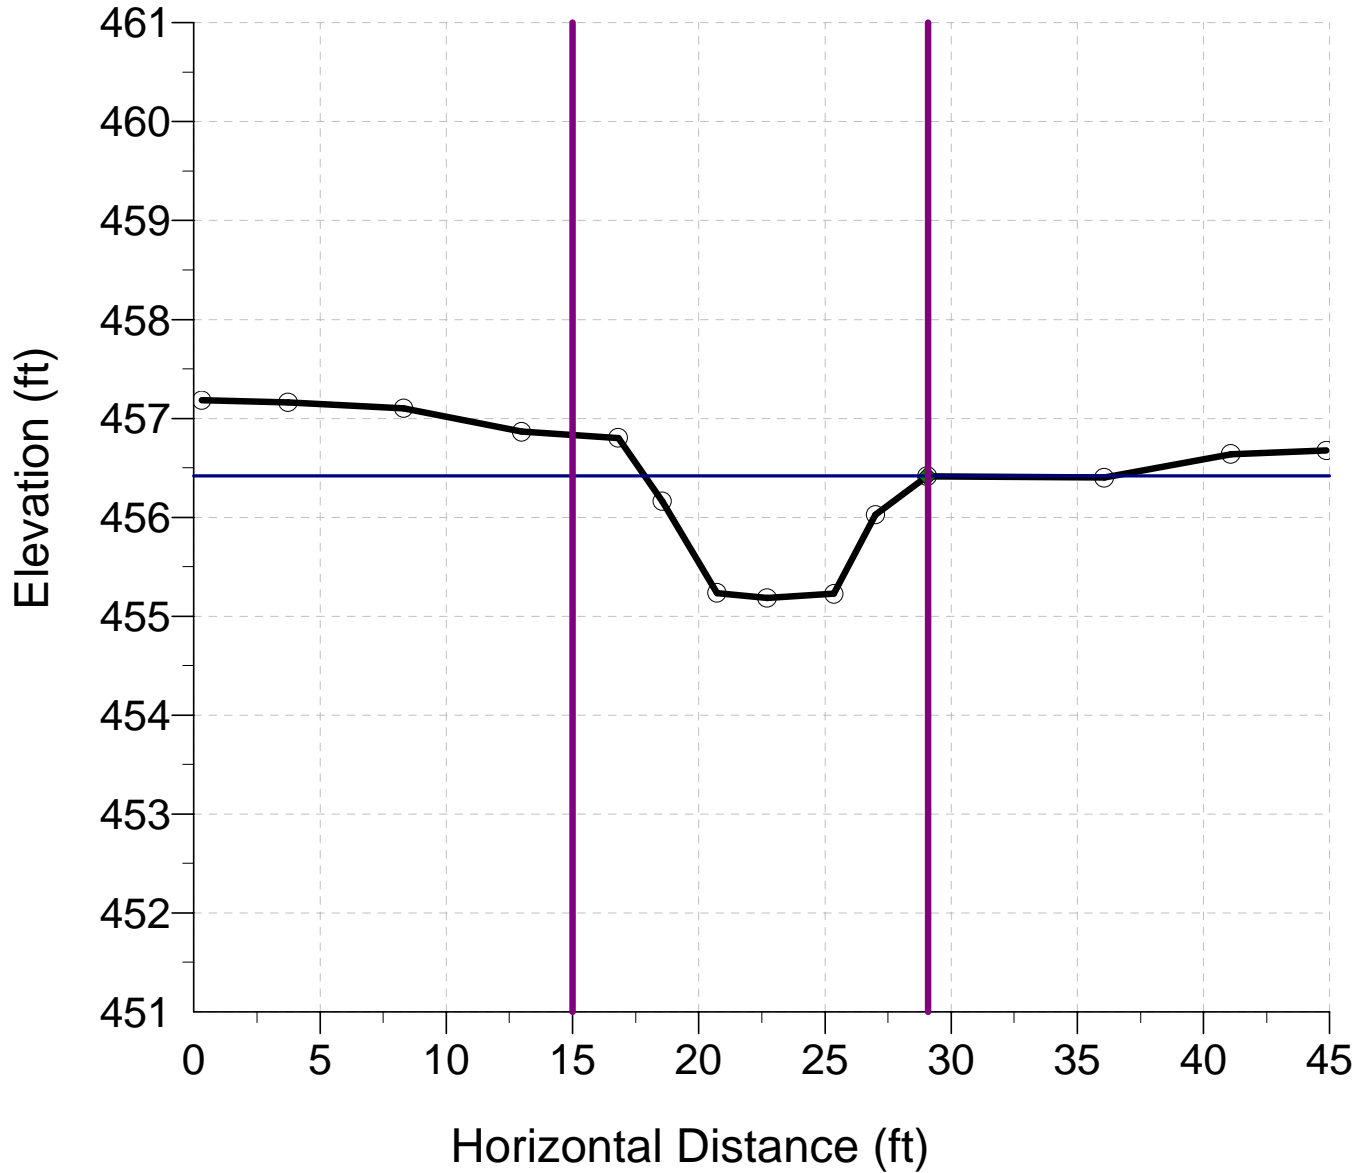
Cross Section 4 Riffle

Dbkf = .8

Abkf = 9

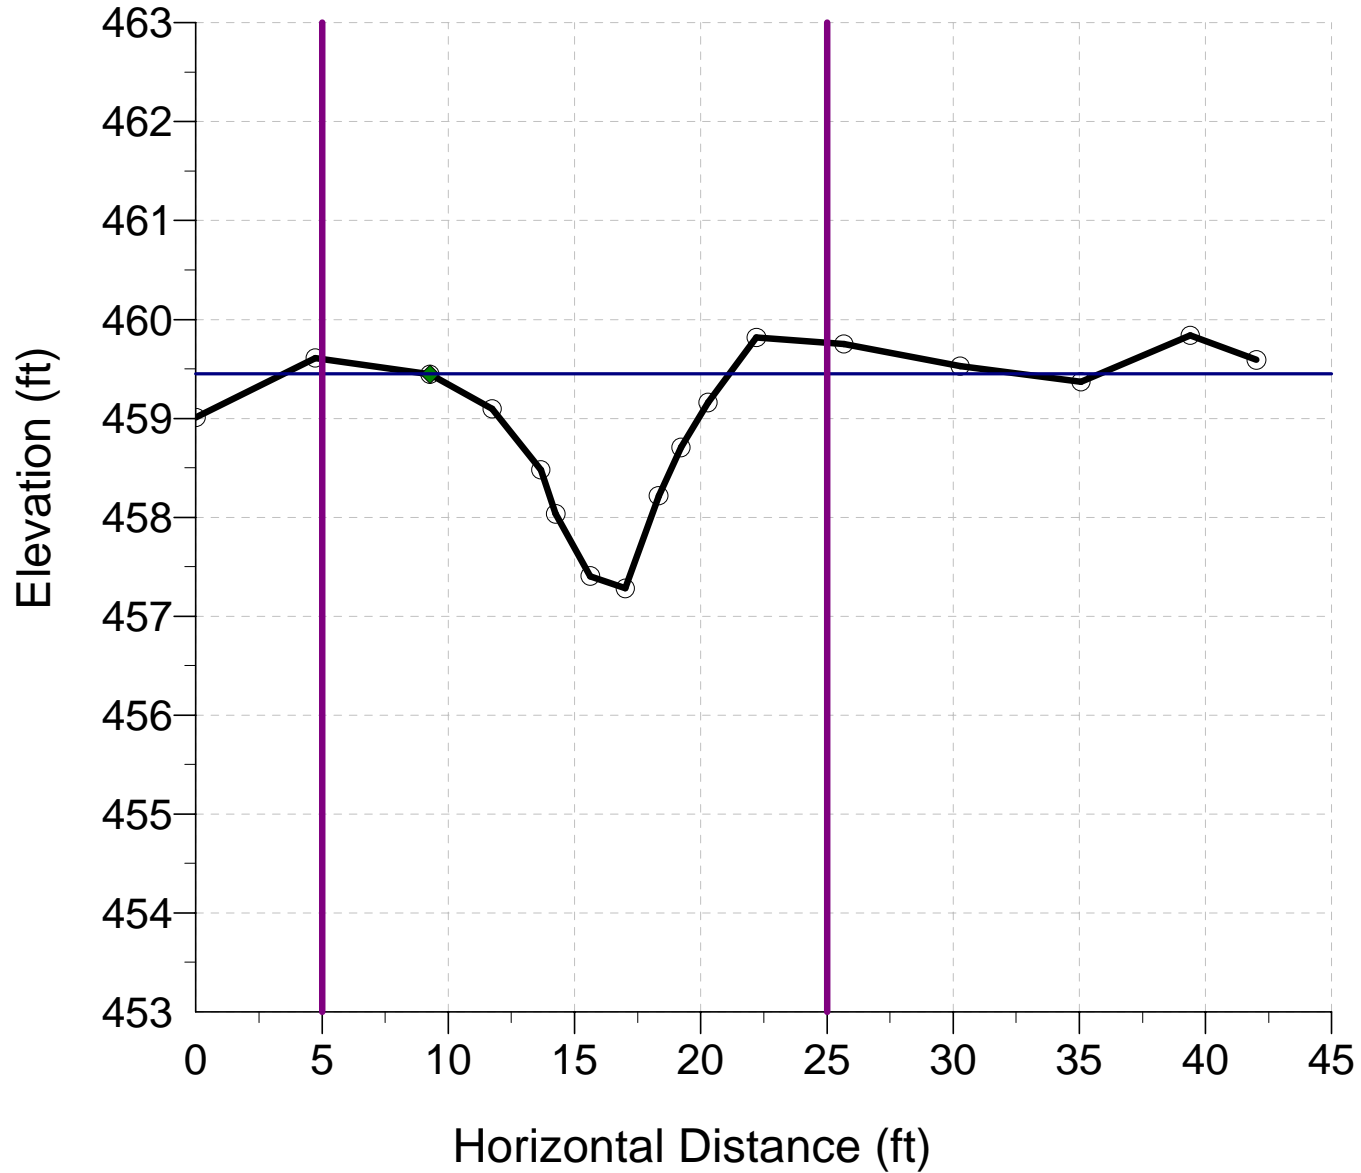
Cross Section 5 Pool

Dbkf = .96

Abkf = 11.5

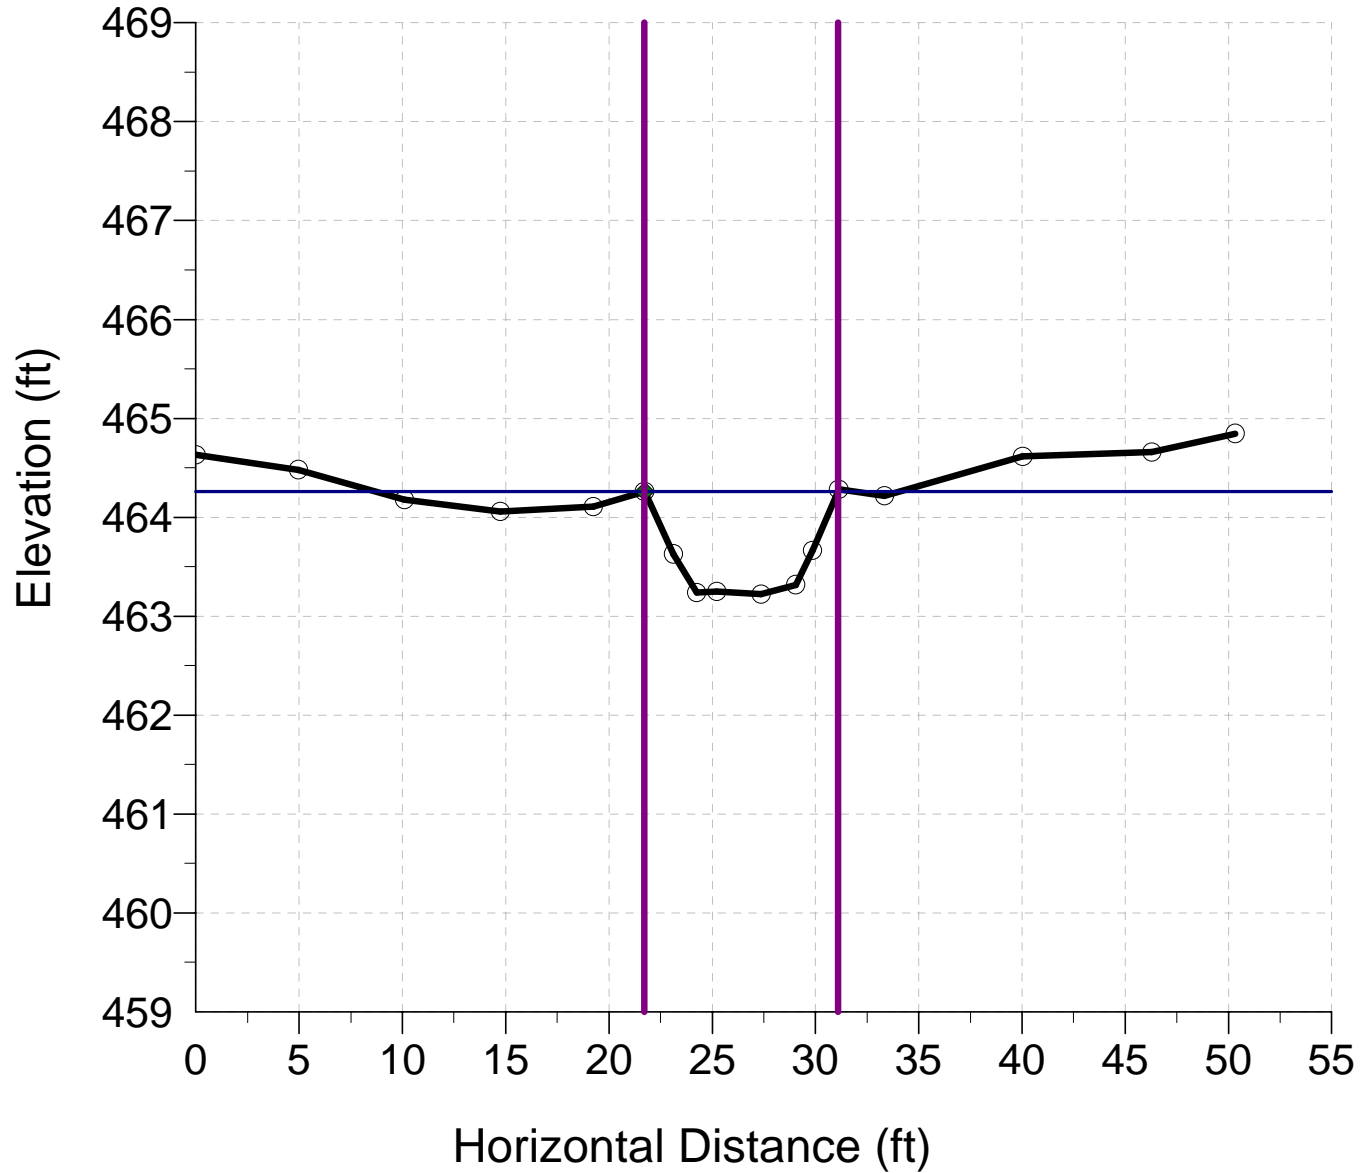
Cross Section 6 Riffle

Dbkf = .77

Abkf = 7.21

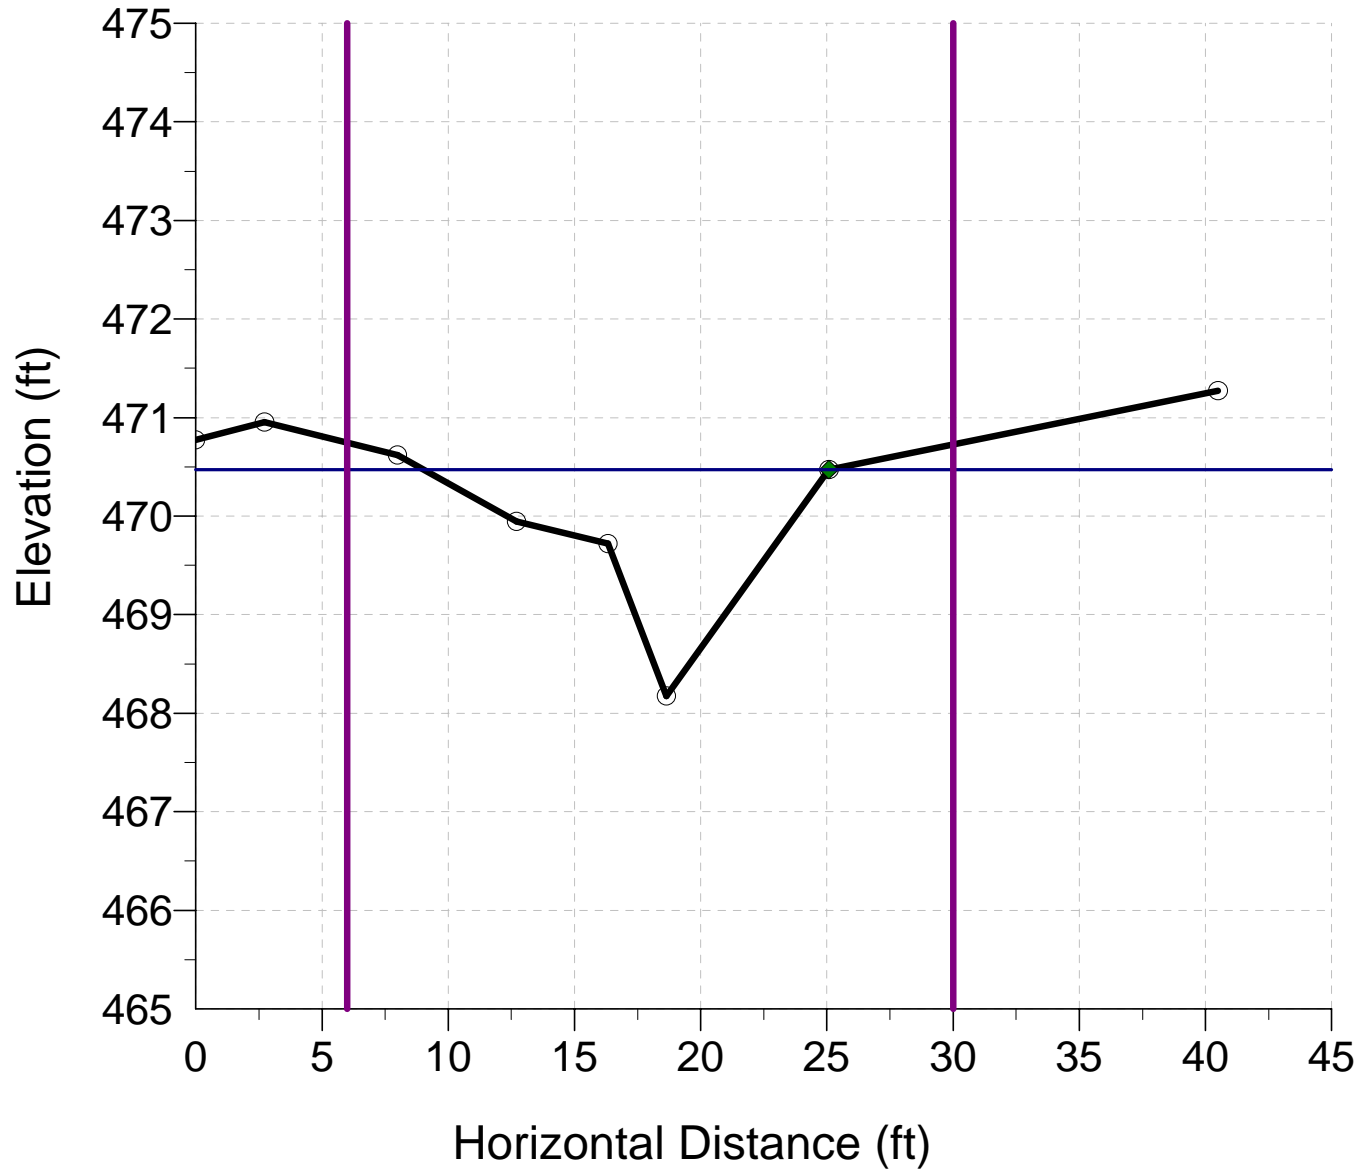
Cross Section 7 Pool

Wbkf = 16.1 Dbkf = .88 Abkf = 14.2

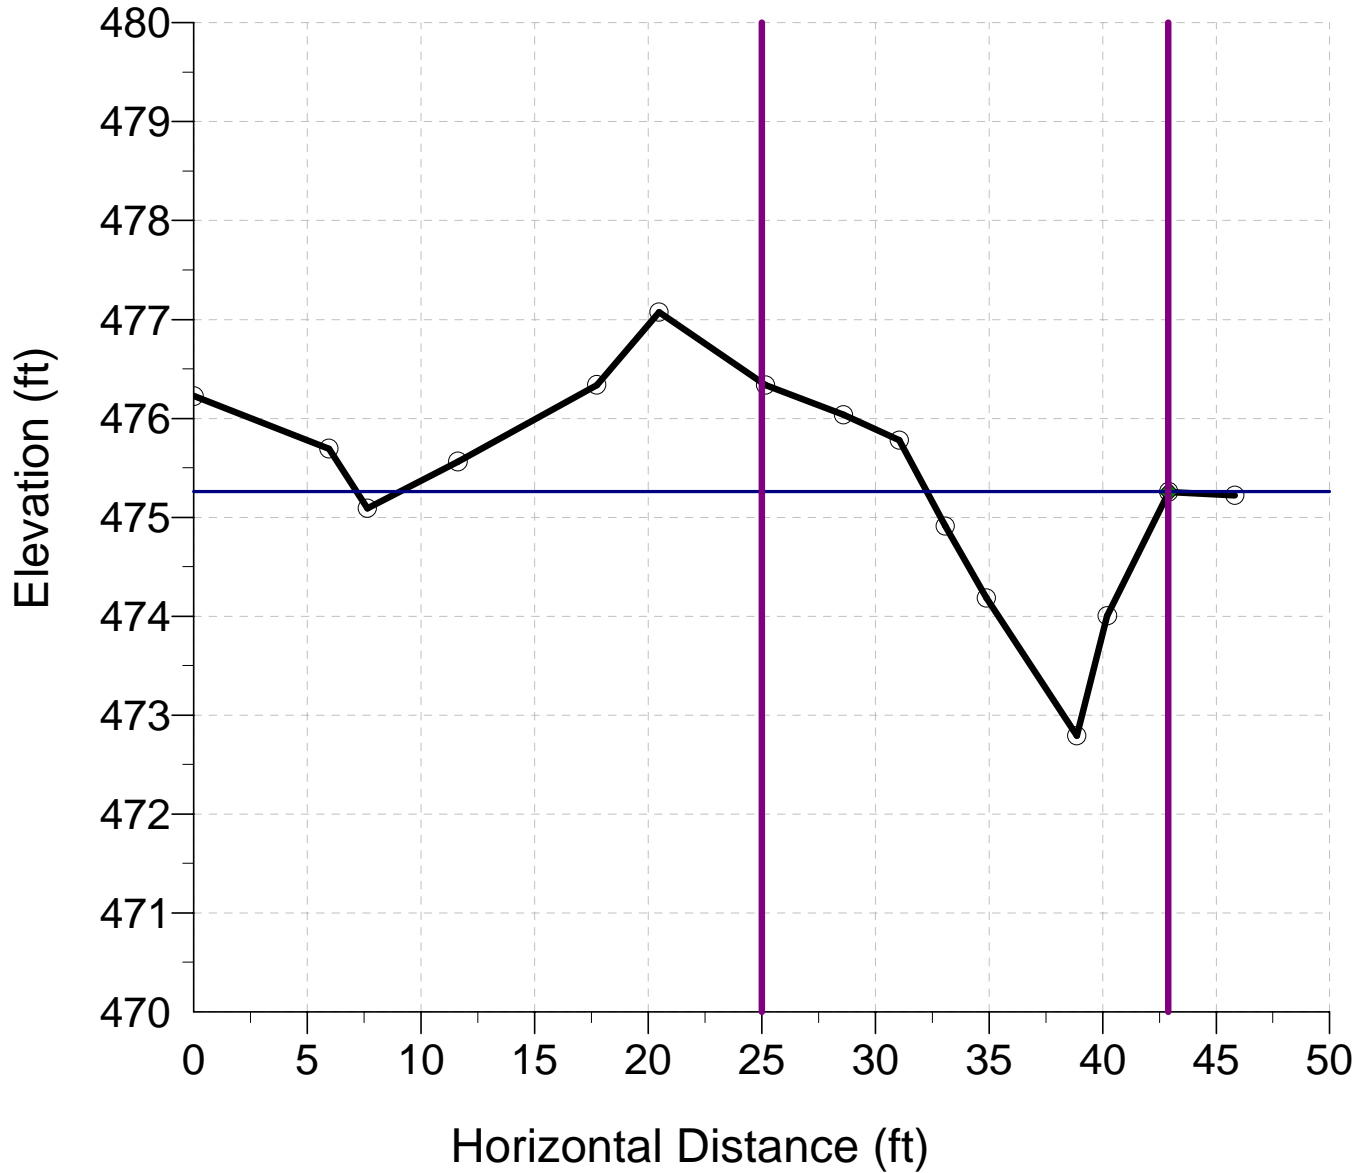
Cross Section 8 Pool

Wbkf = 10.6 Dbkf = 1.19 Abkf = 12.7

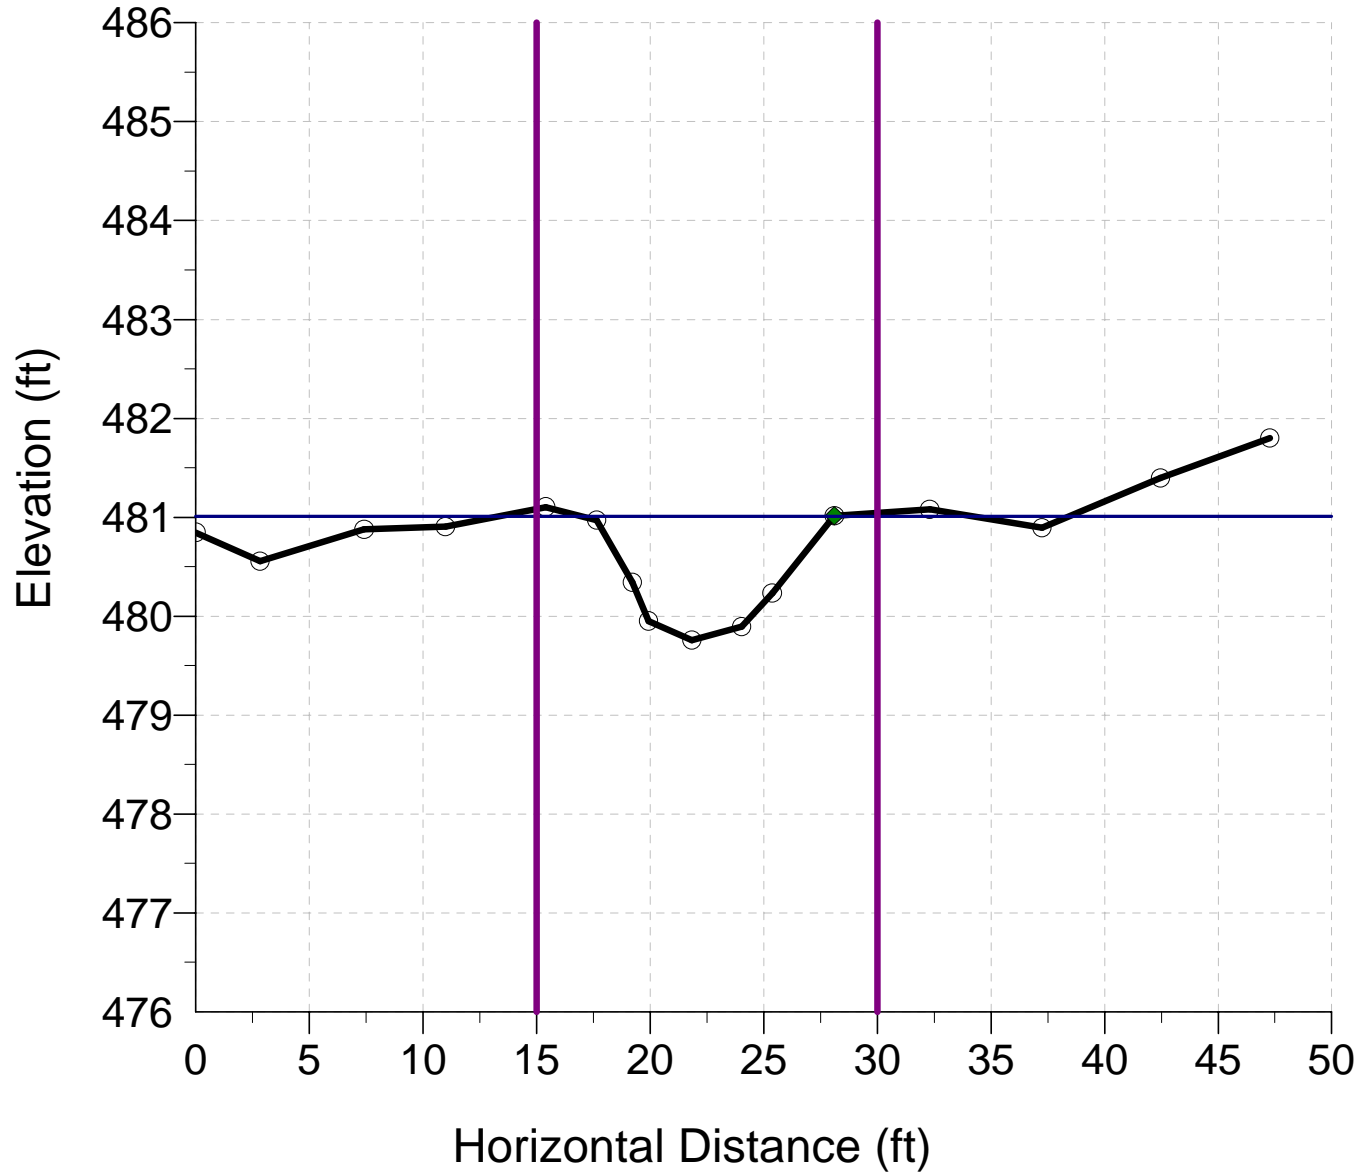
Cross Section 9 Riffle

Wbkf = 11.1 Dbkf = .75 Abkf = 8.32
