**Badin Inn Stream Restoration
Stanly County, NC**

**Mitigation Plan and As-built Baseline Report
DRAFT**

**EEP Project Number 92666
SCO Project Number D06125-E
Data Collection Period: April-July, 2009
Submission Date: August, 2009**

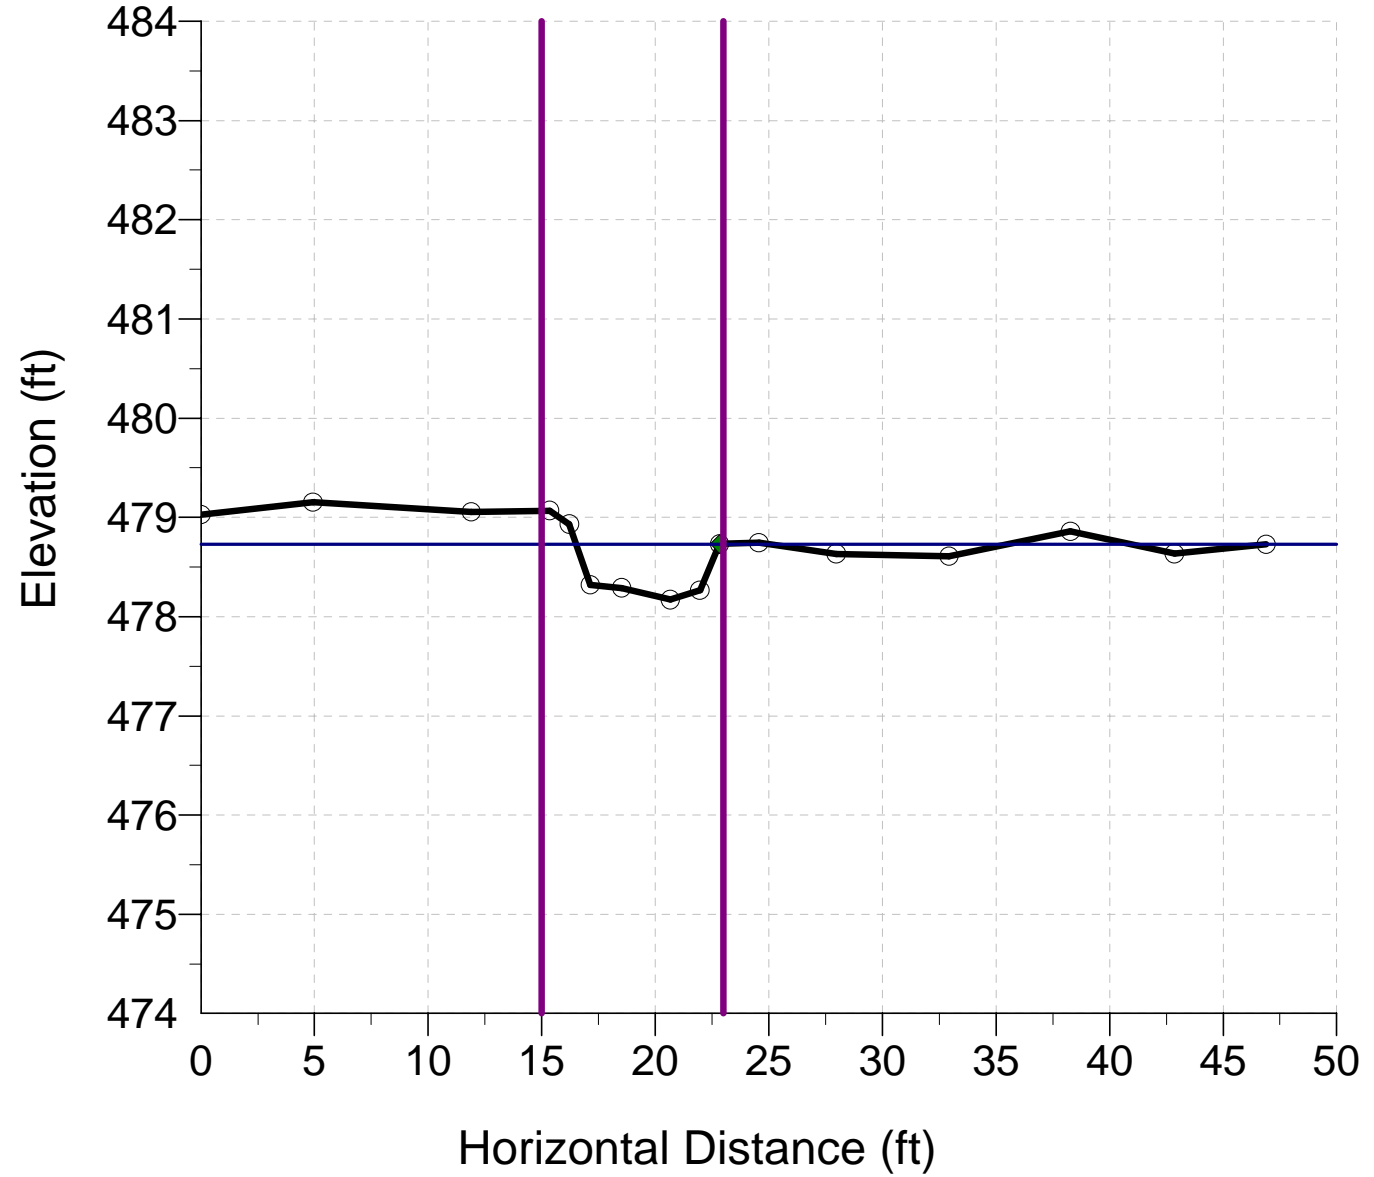
Tributary Cross Section Riffle

Wbkf = 6.29 Dbkf = .42 Abkf = 2.64

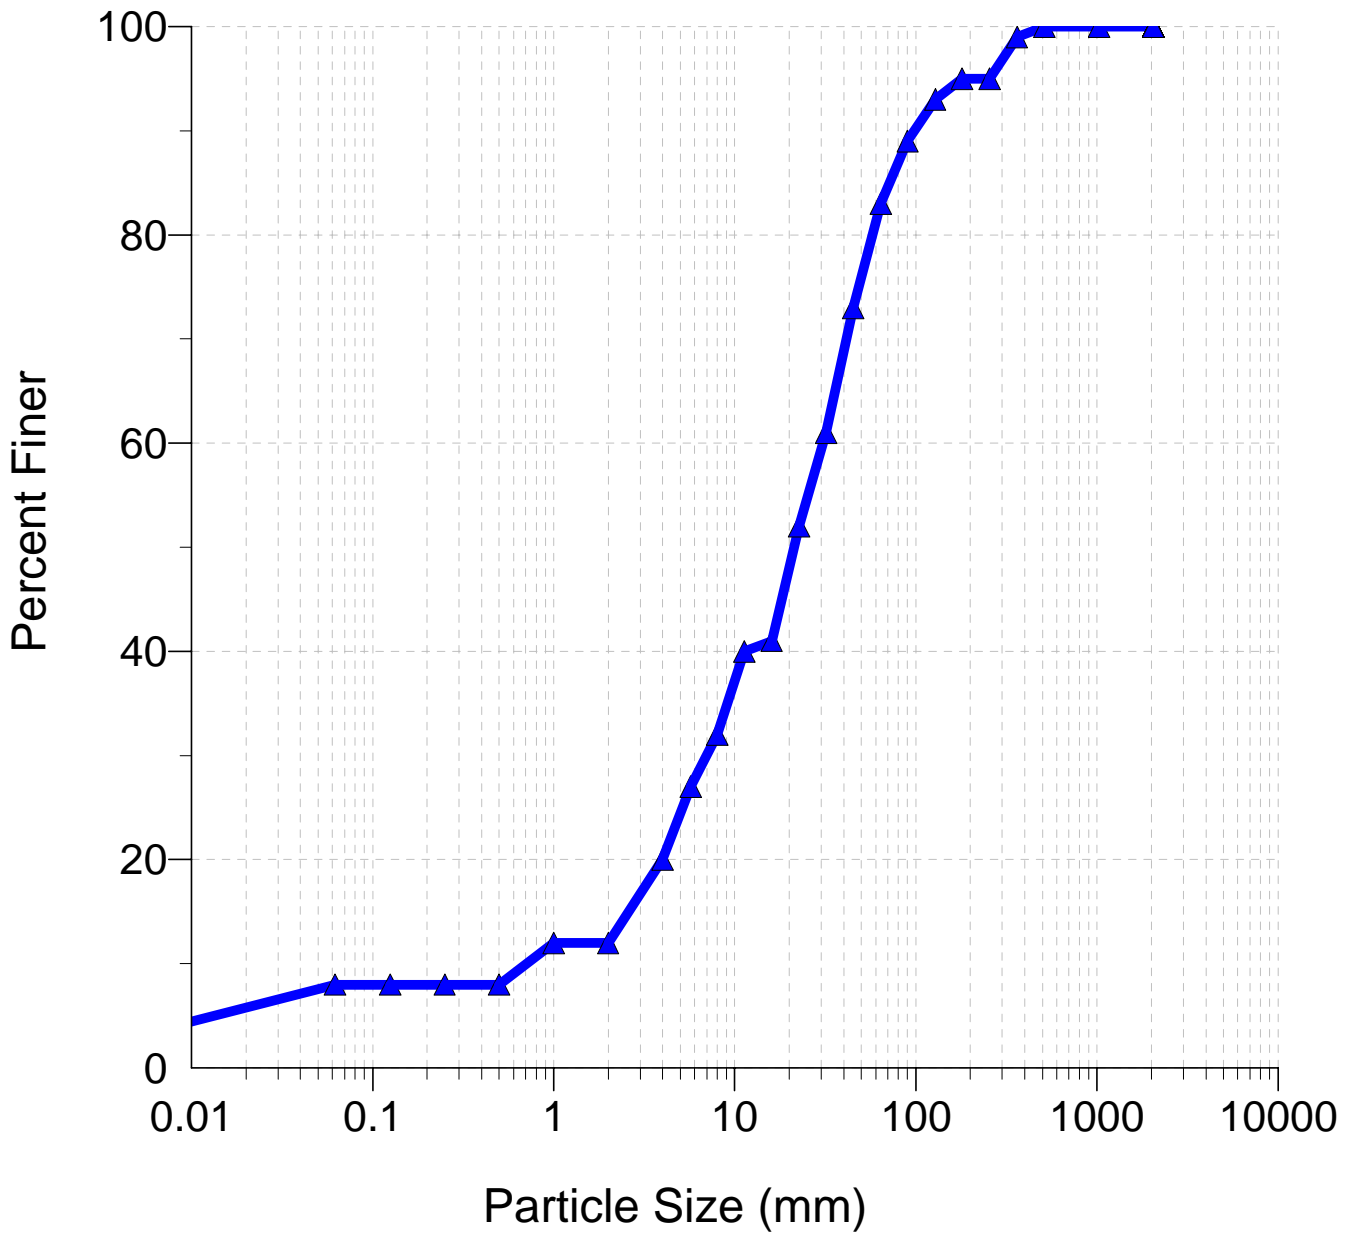
Pebble Count 1 Riffle

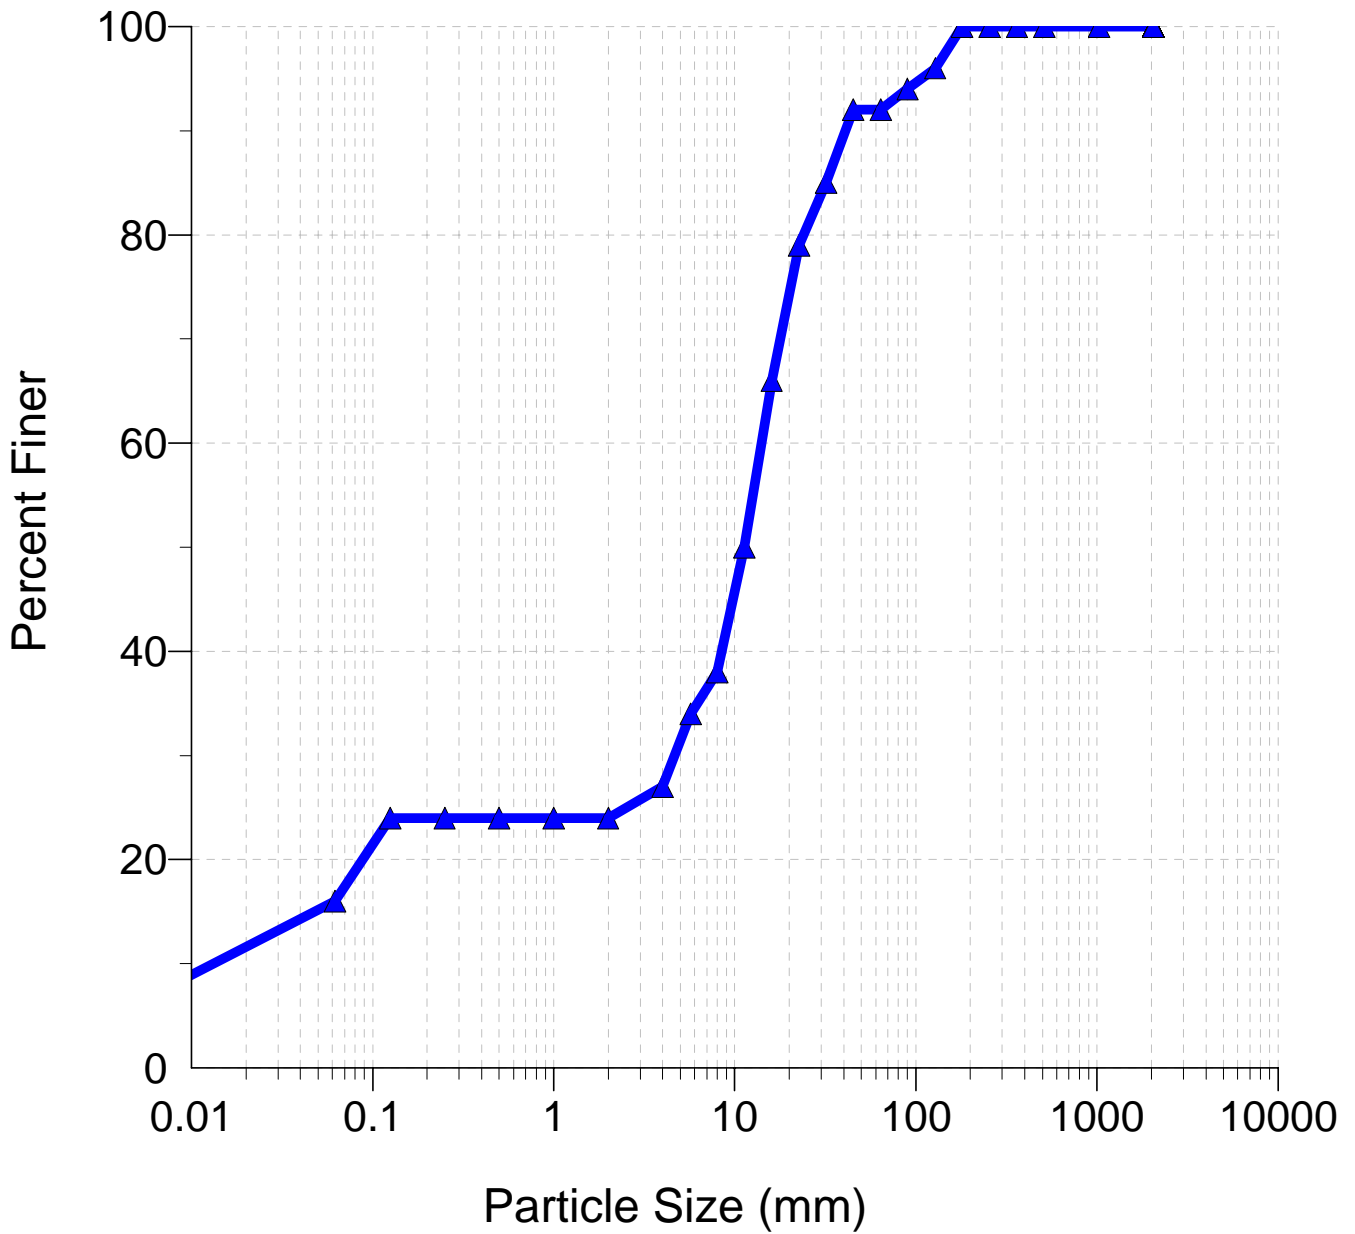
Pebble Count 2 Pool

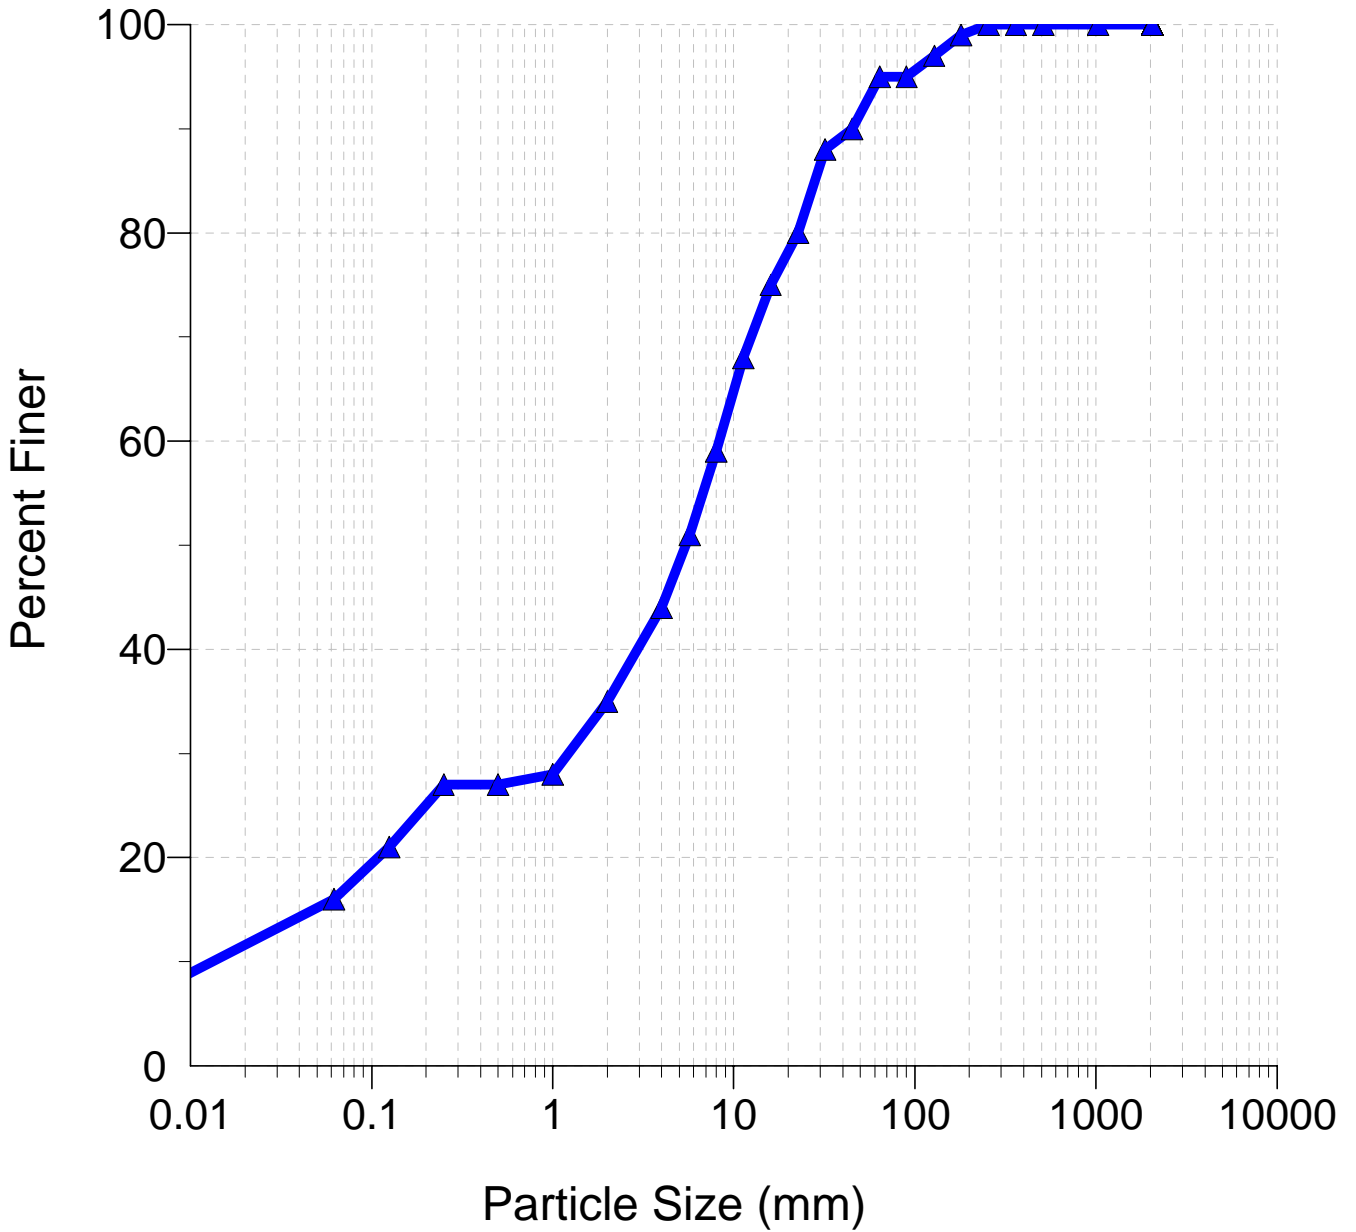
Pebble Count 3 Riffle

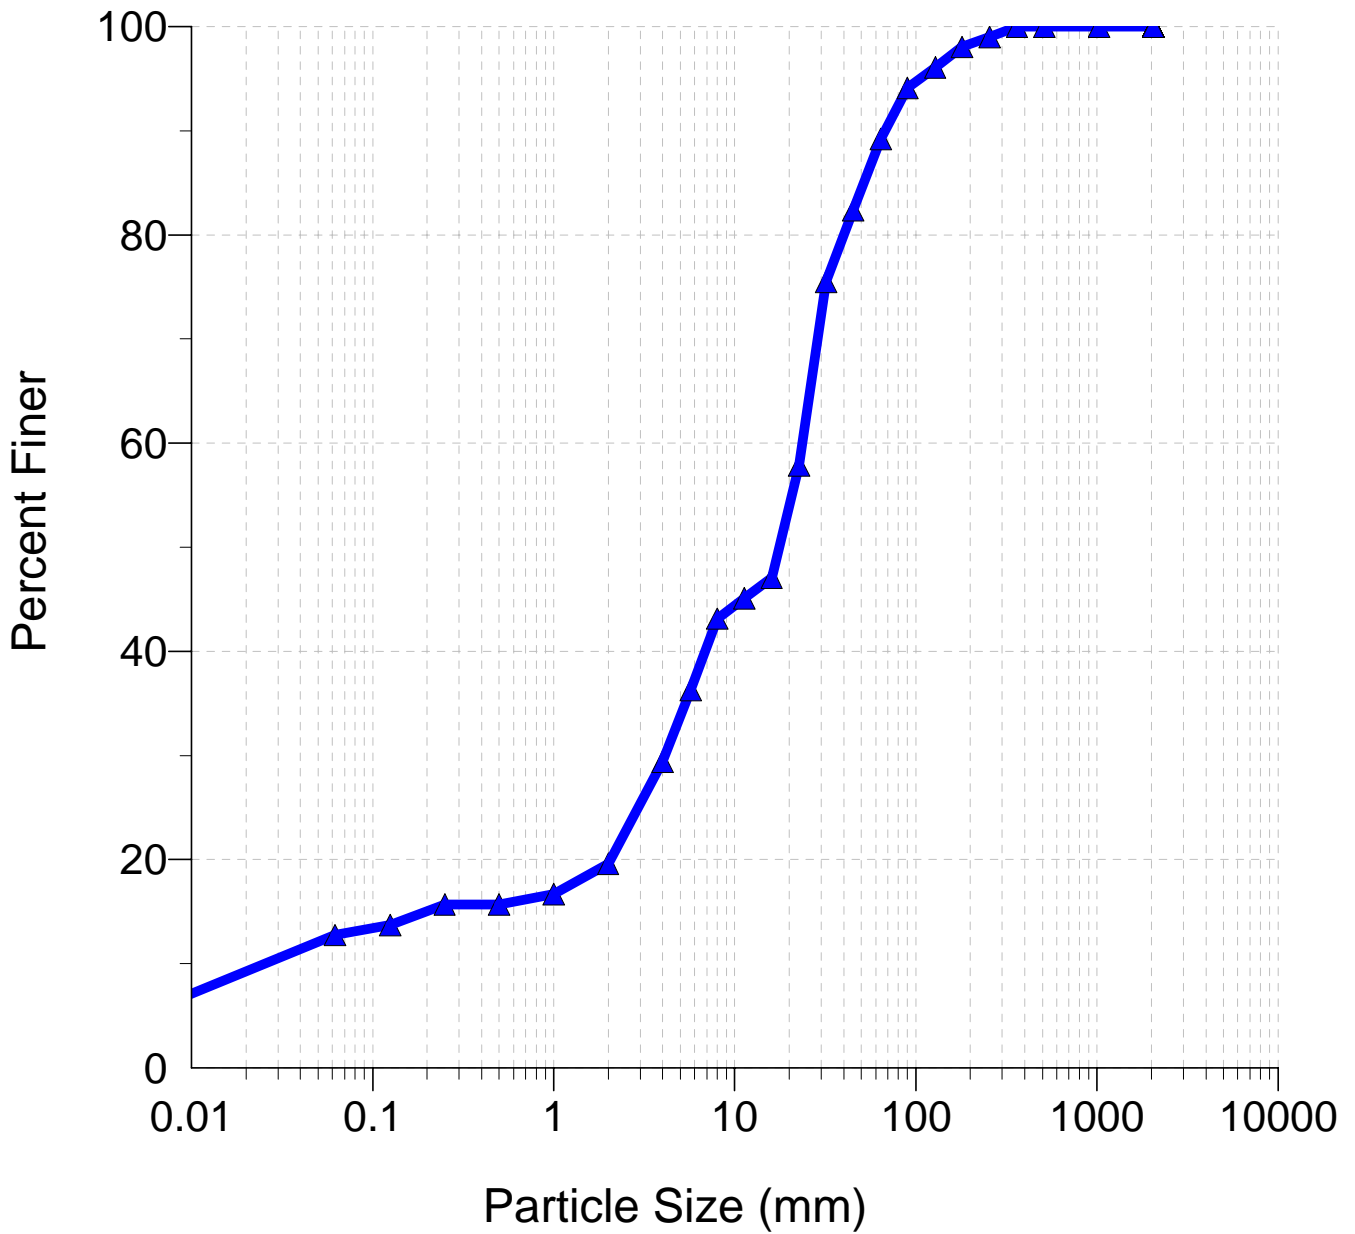
Pebble Count 4 Riffle

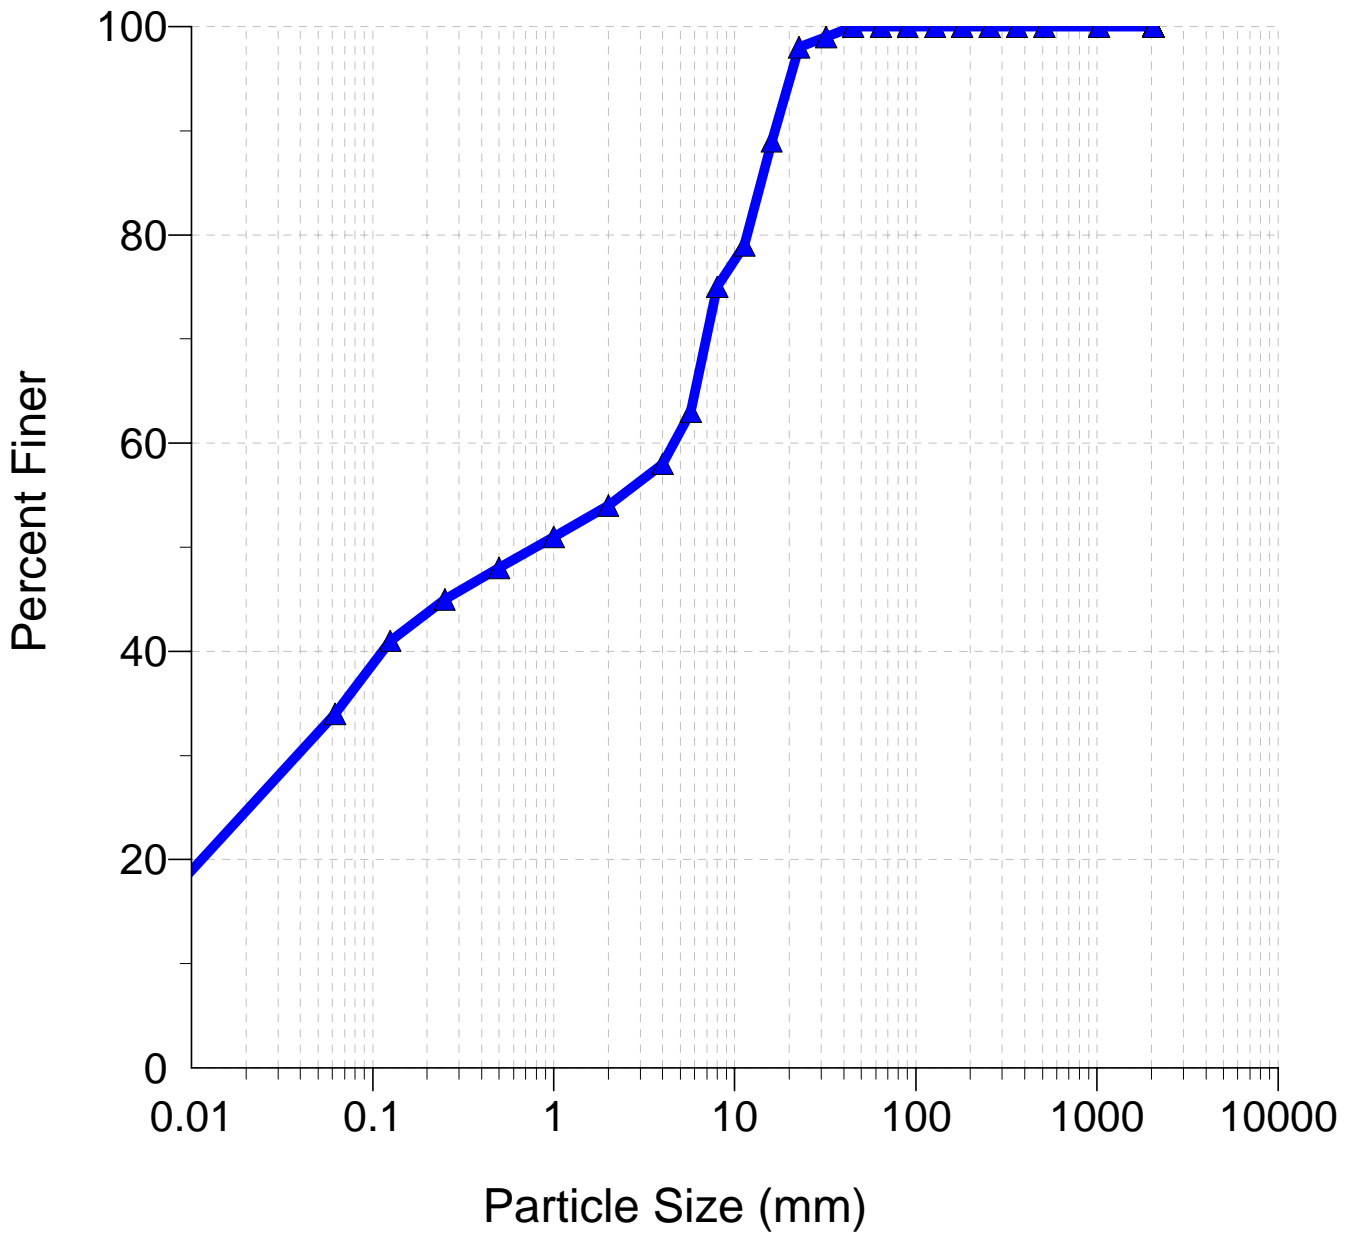
Pebble Count 5 Pool

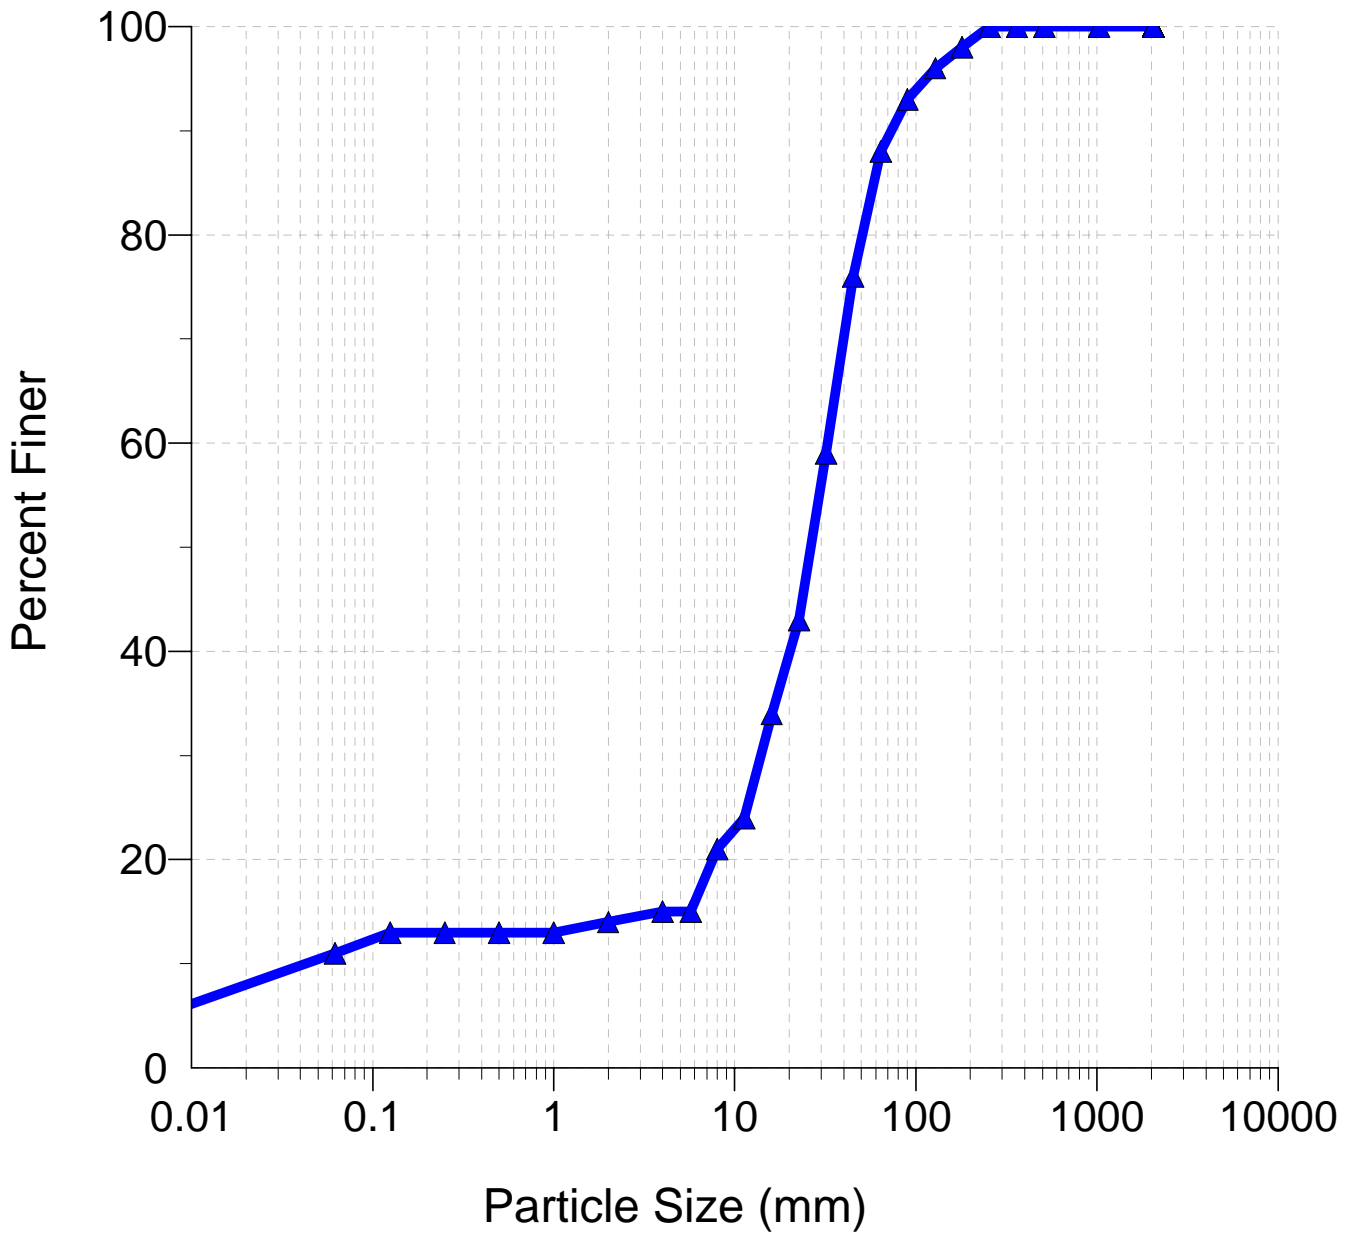
Pebble Count 6 Riffle

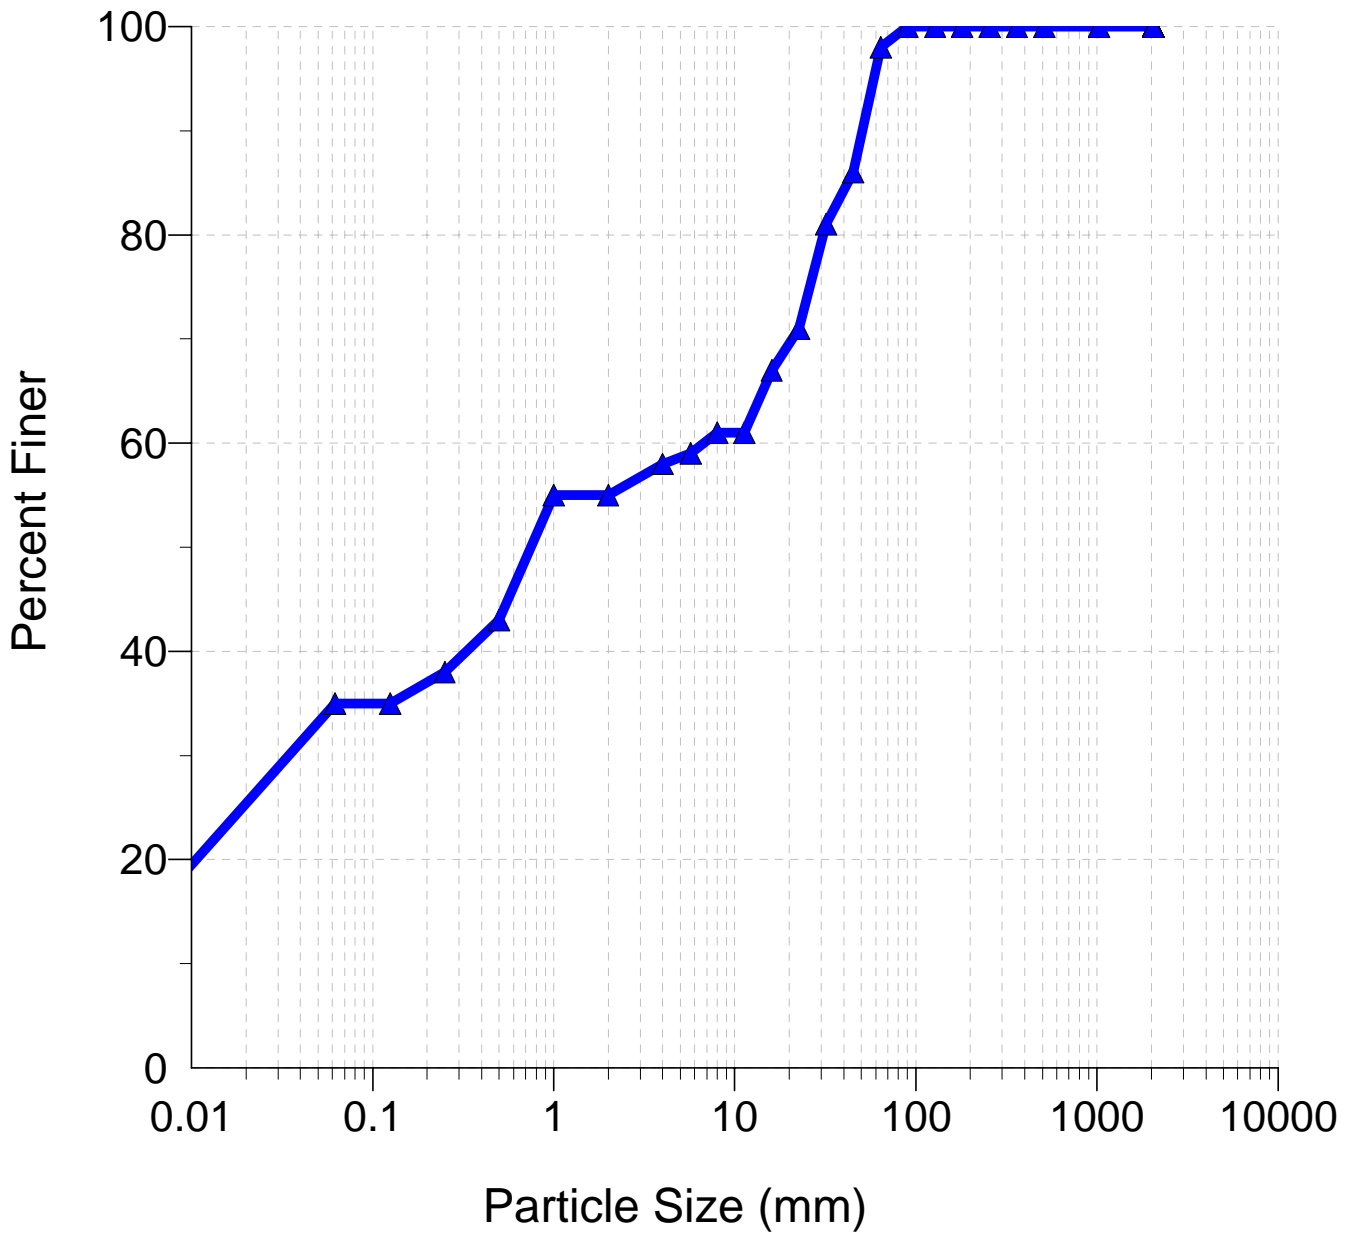
Pebble Count 7 Pool

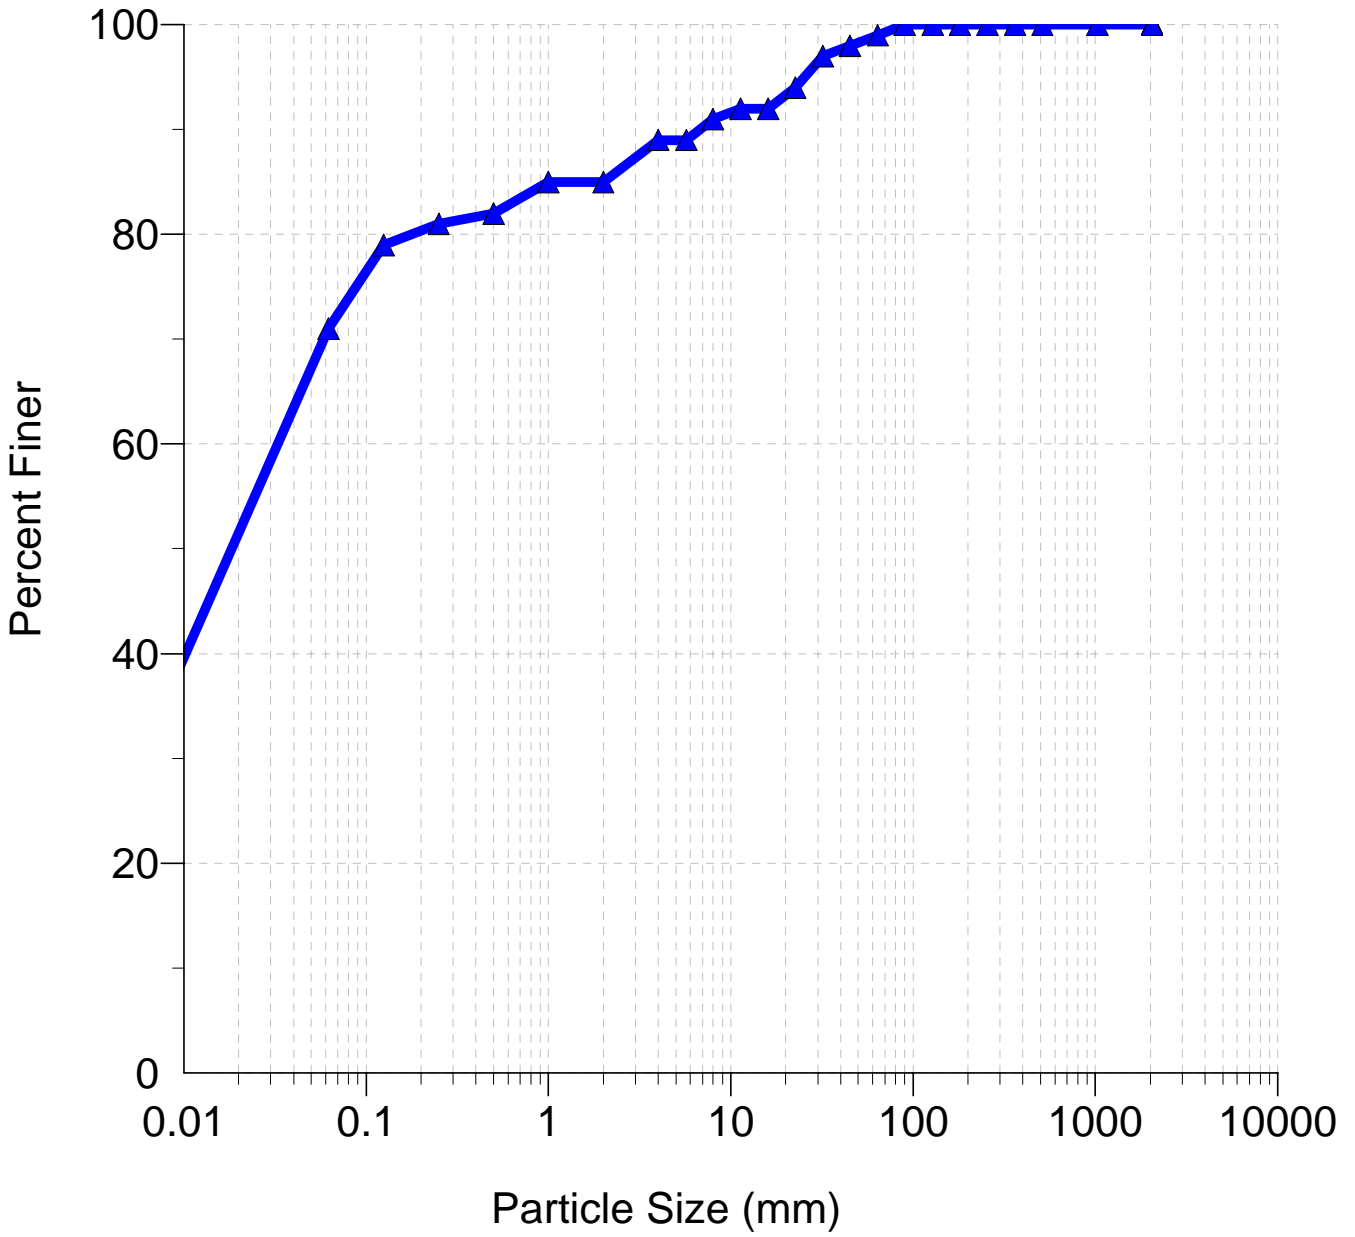
Pebble Count 8 Pool

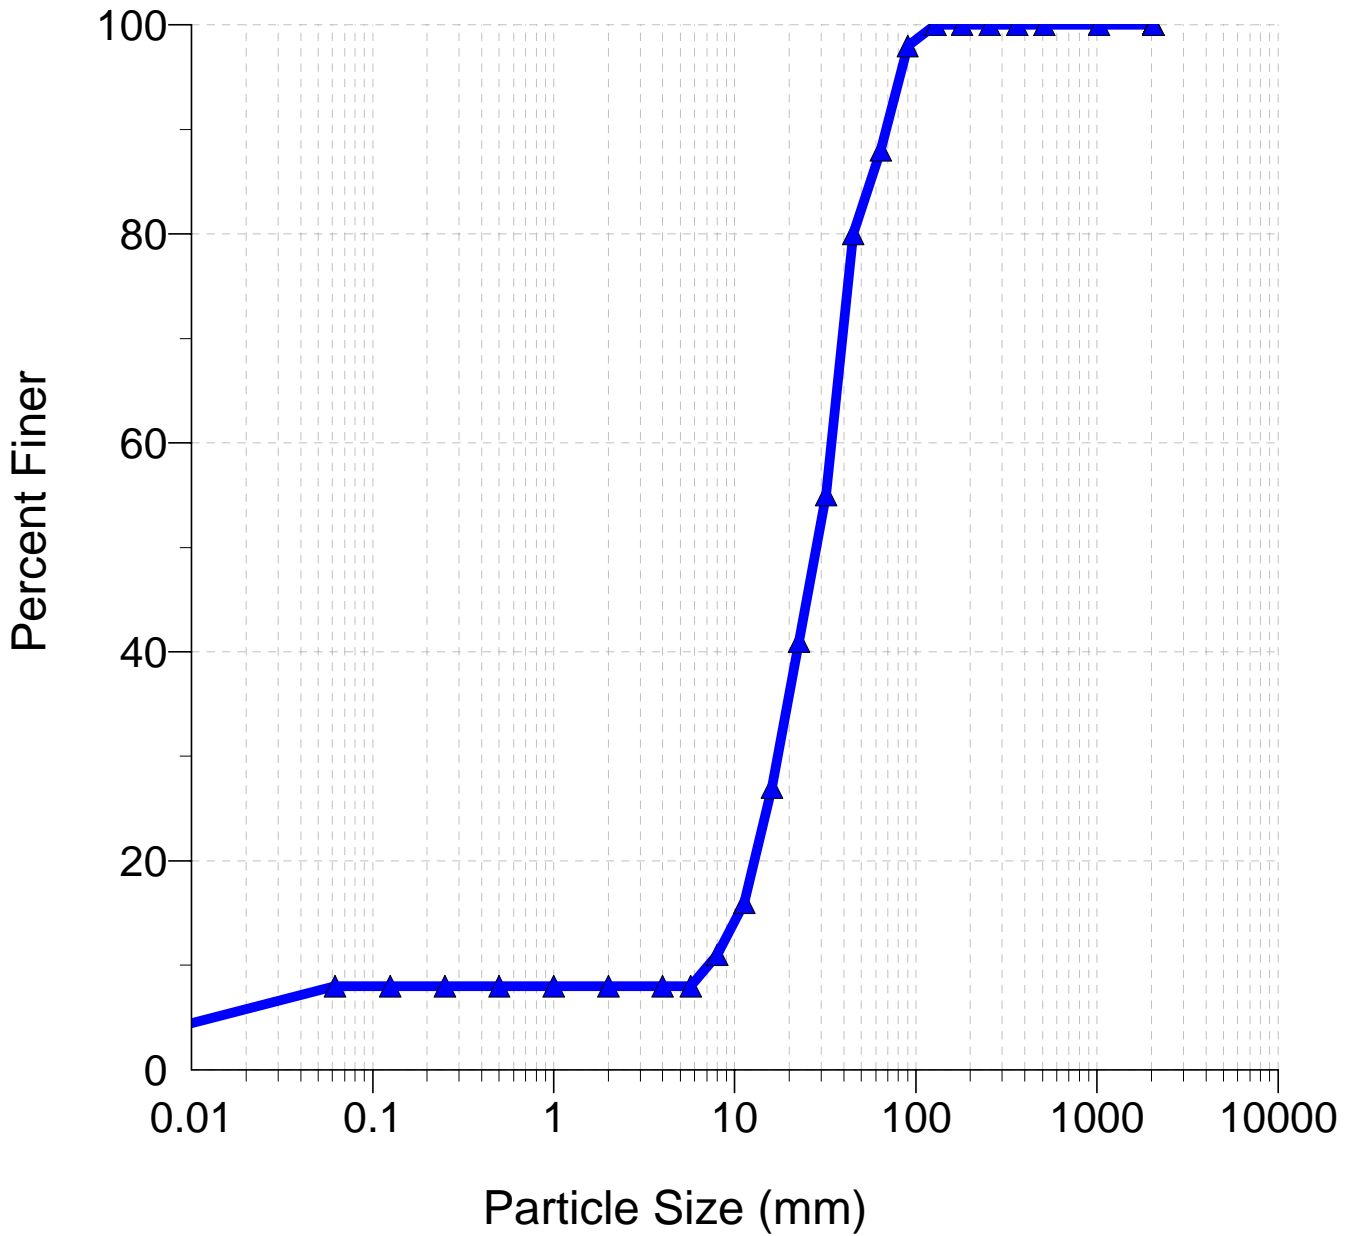
Pebble Count 9 Riffle

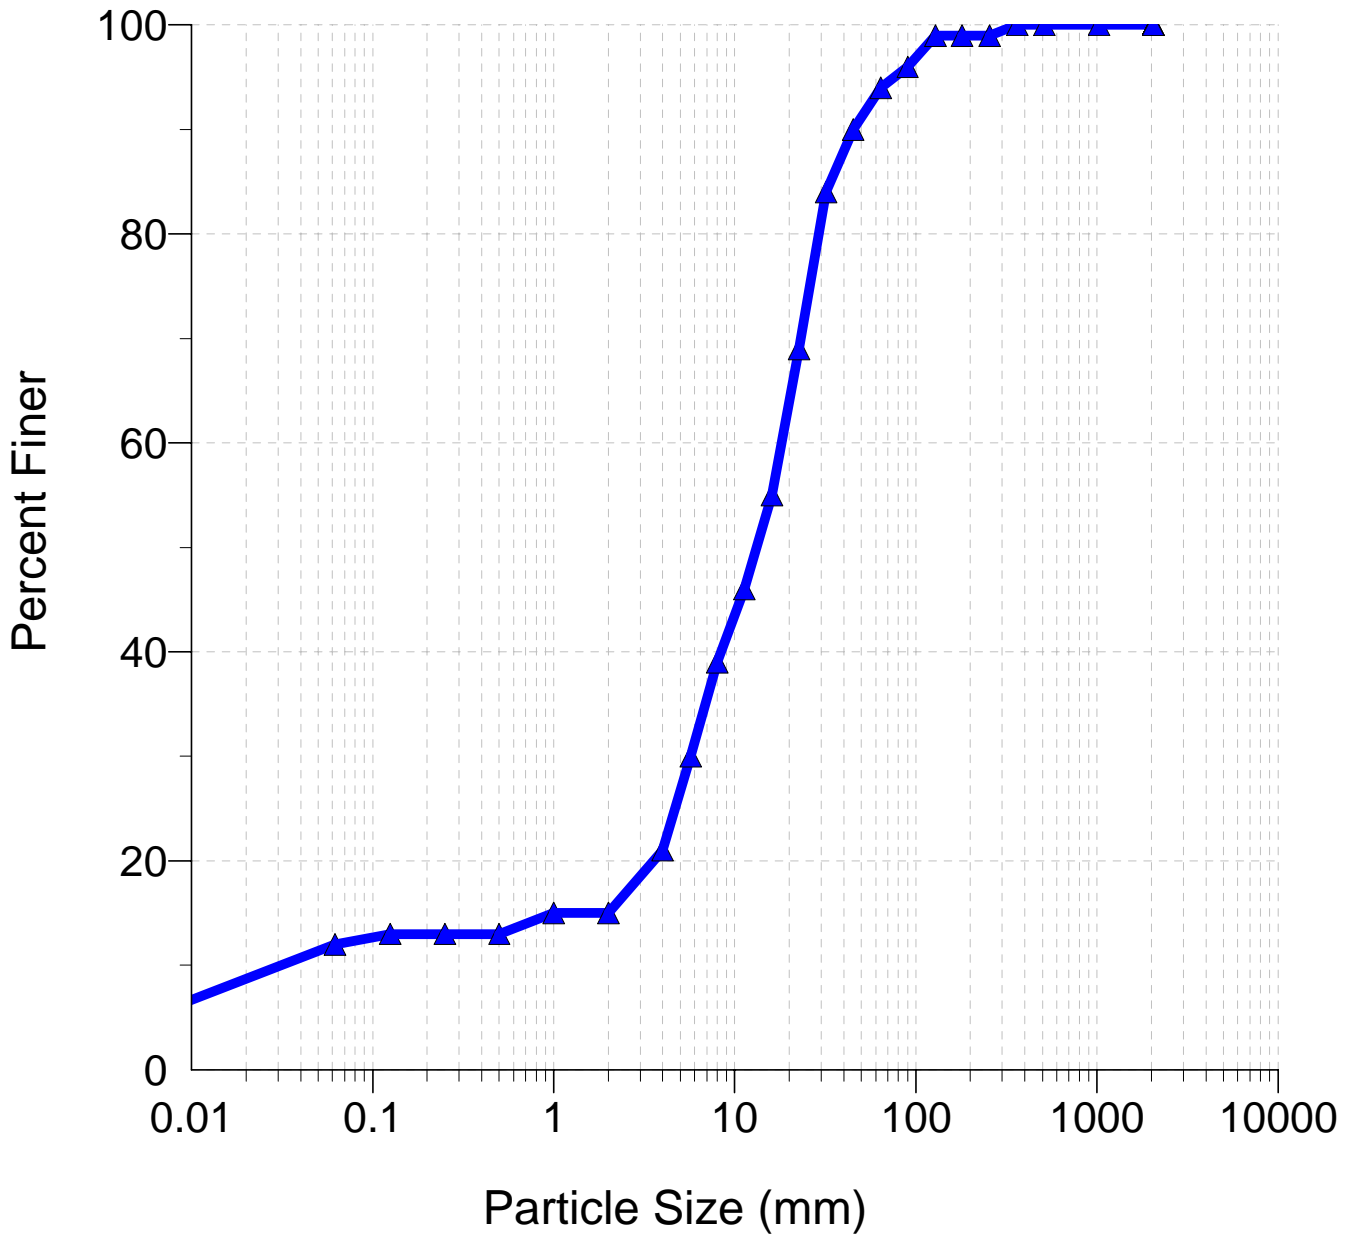
Tributary Pebble Count Riffle

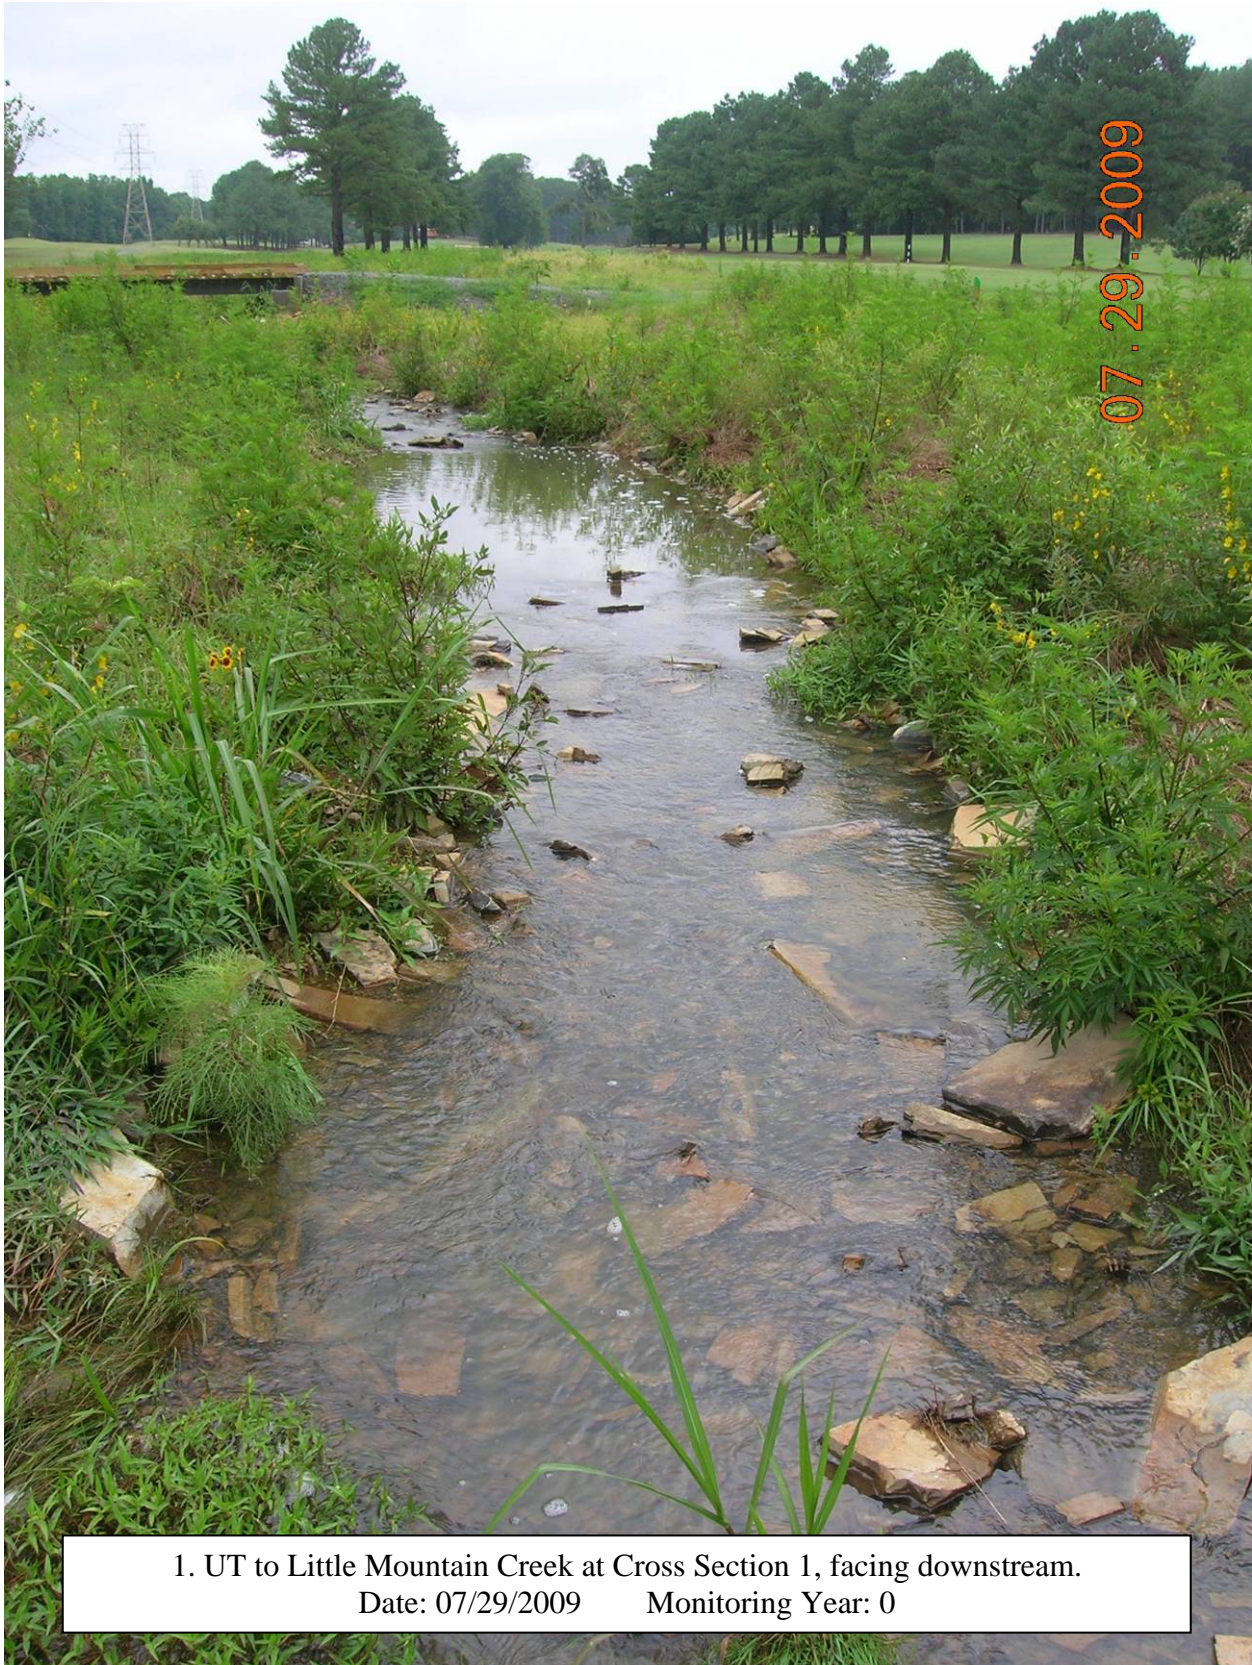
1. UT to Little Mountain Creek at Cross Section 1, facing downstream.

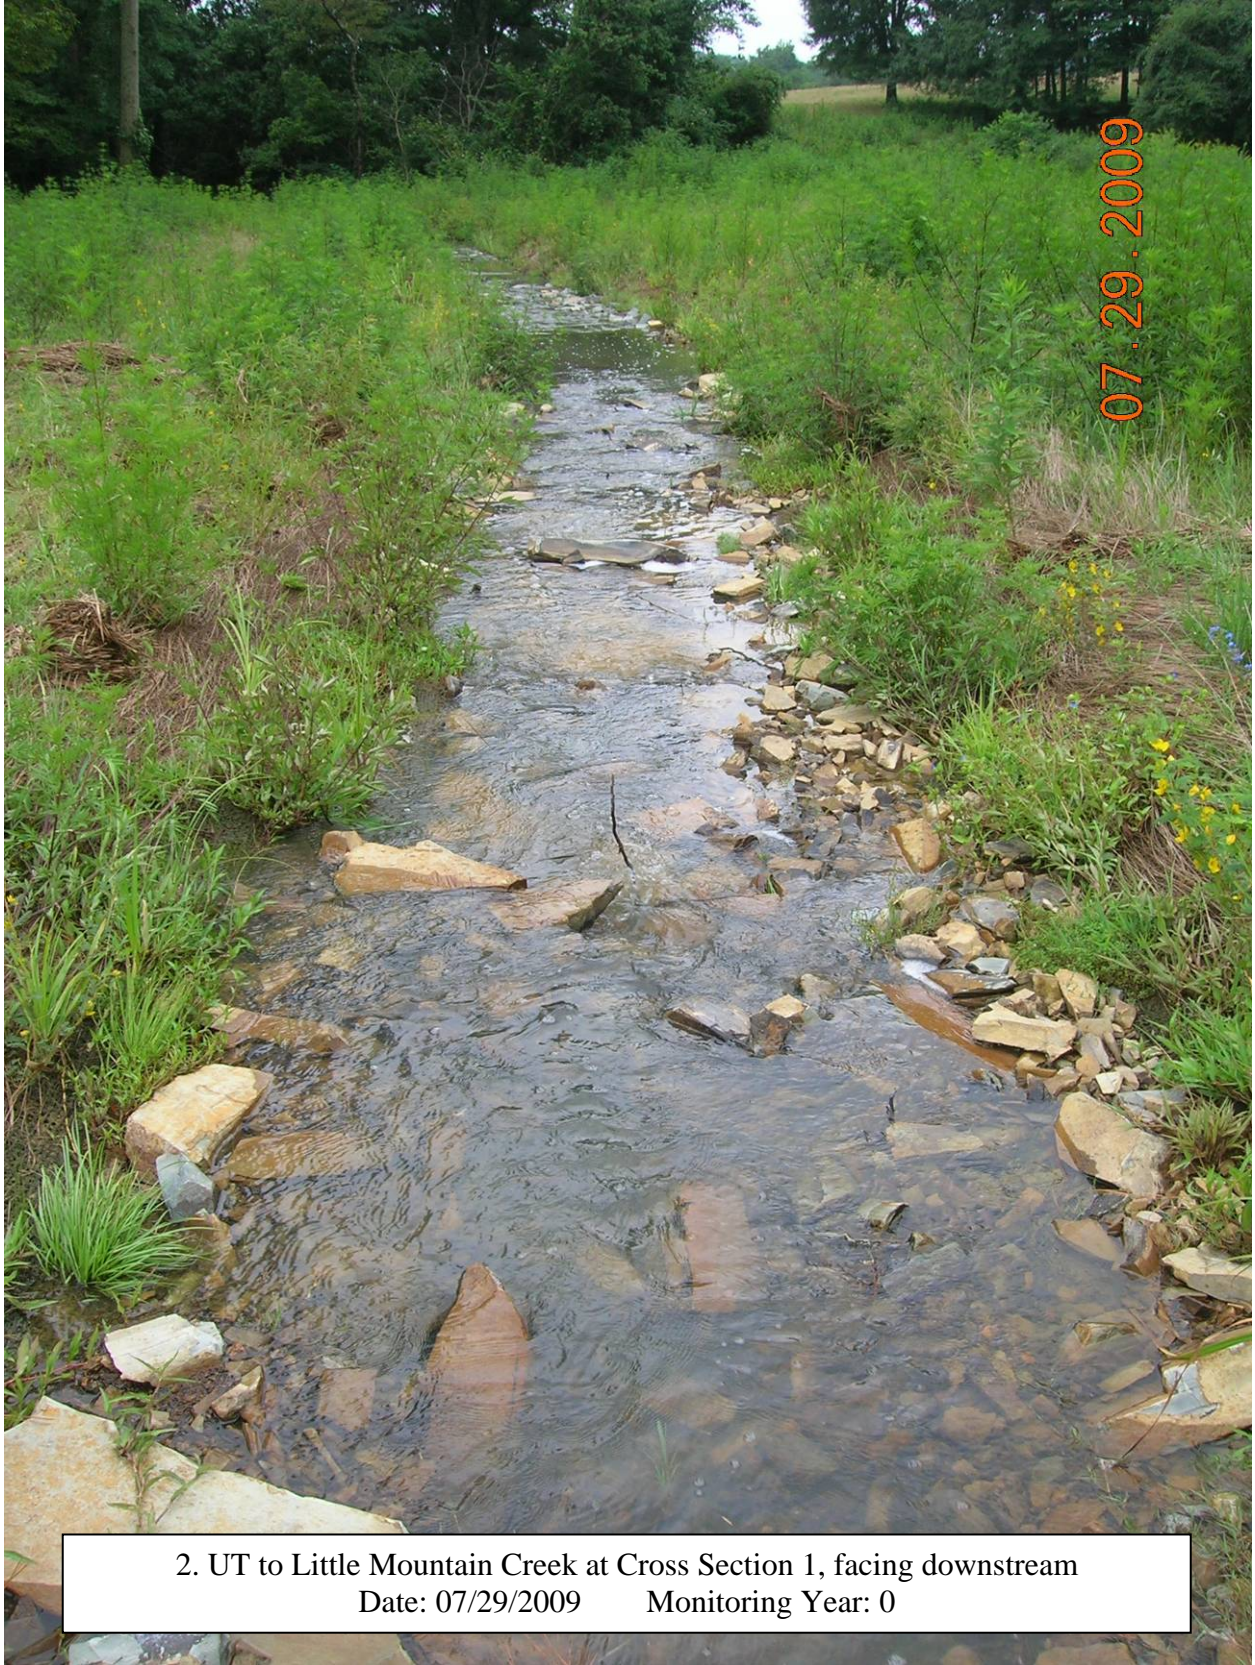
2. UT to Little Mountain Creek at Cross Section 1, facing downstream
Date: 07/29/2009 Monitoring Year: 0
