**Badin Inn Stream Restoration
Stanly County, NC**

**Mitigation Plan and As-built Baseline Report
DRAFT**

**EEP Project Number 92666
SCO Project Number D06125-E
Data Collection Period: April-July, 2009
Submission Date: August, 2009**

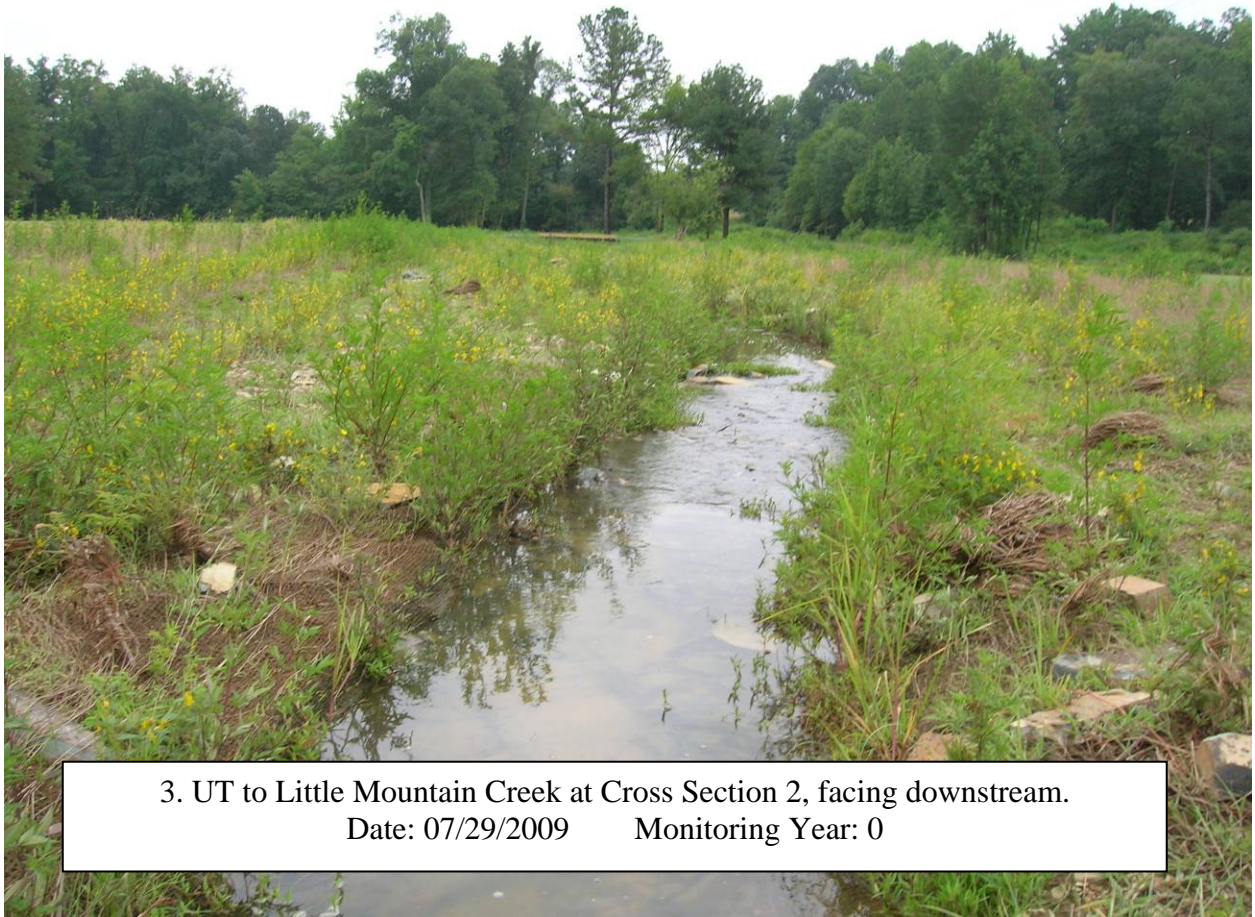
3. UT to Little Mountain Creek at Cross Section 2, facing downstream.
Date: 07/29/2009 Monitoring Year: 0

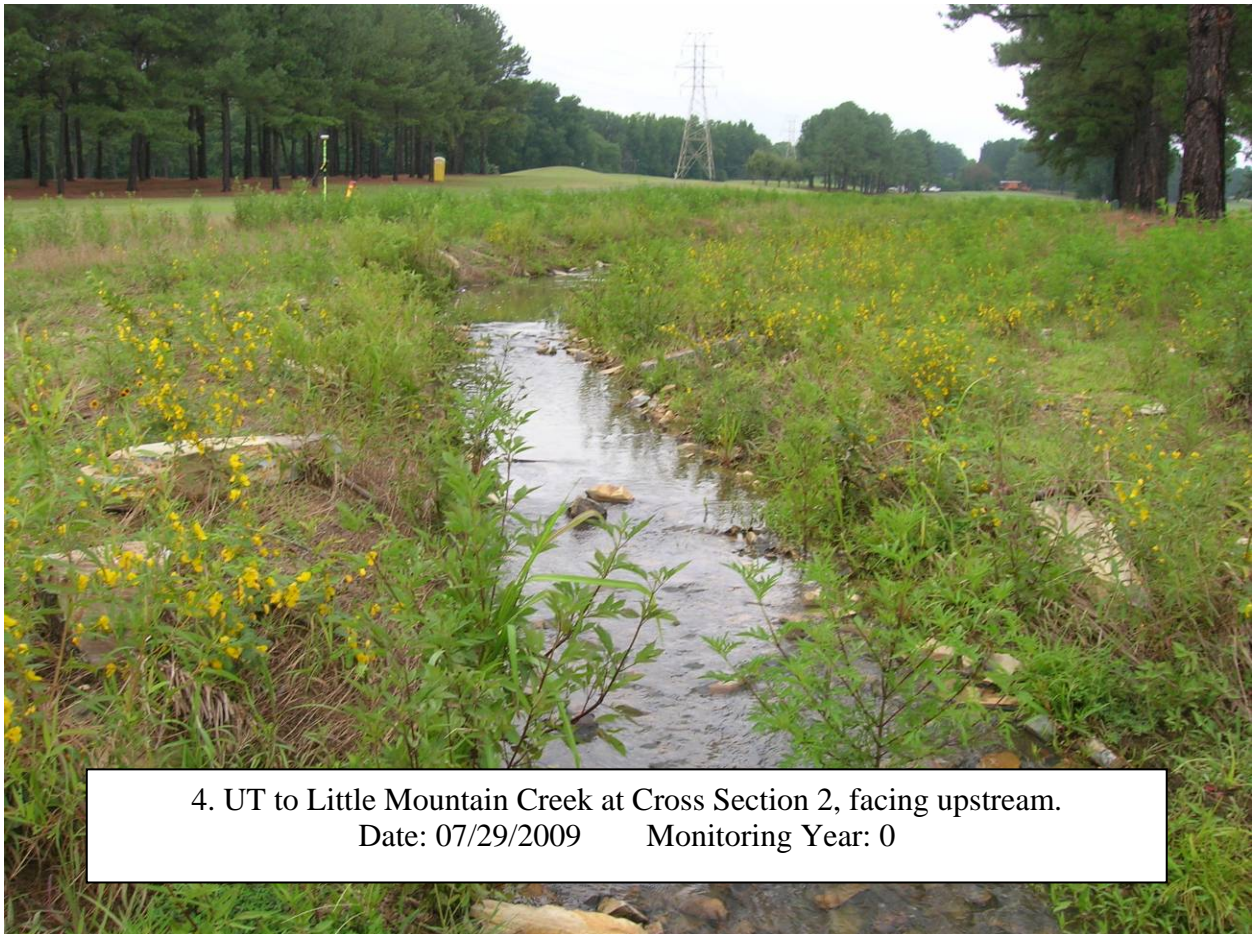
4. UT to Little Mountain Creek at Cross Section 2, facing upstream.
Date: 07/29/2009 Monitoring Year: 0

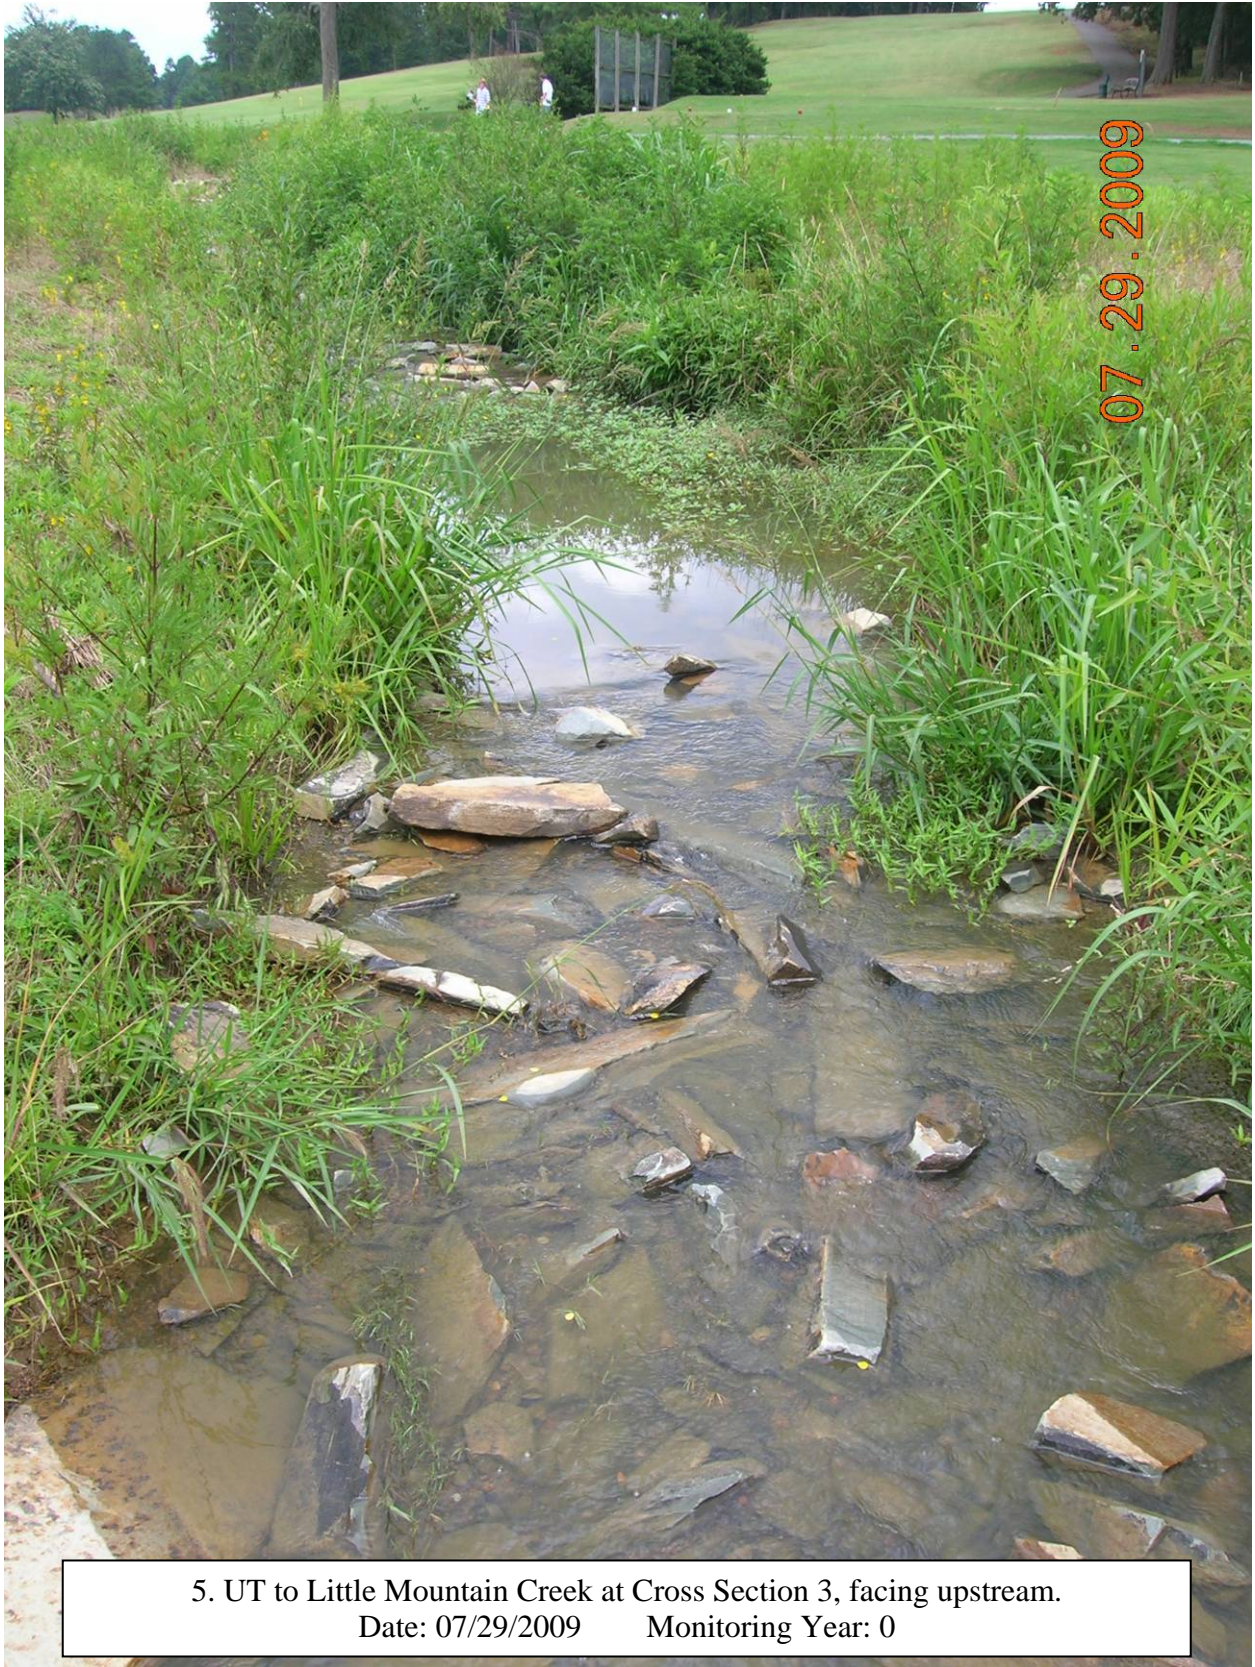
5. UT to Little Mountain Creek at Cross Section 3, facing upstream.

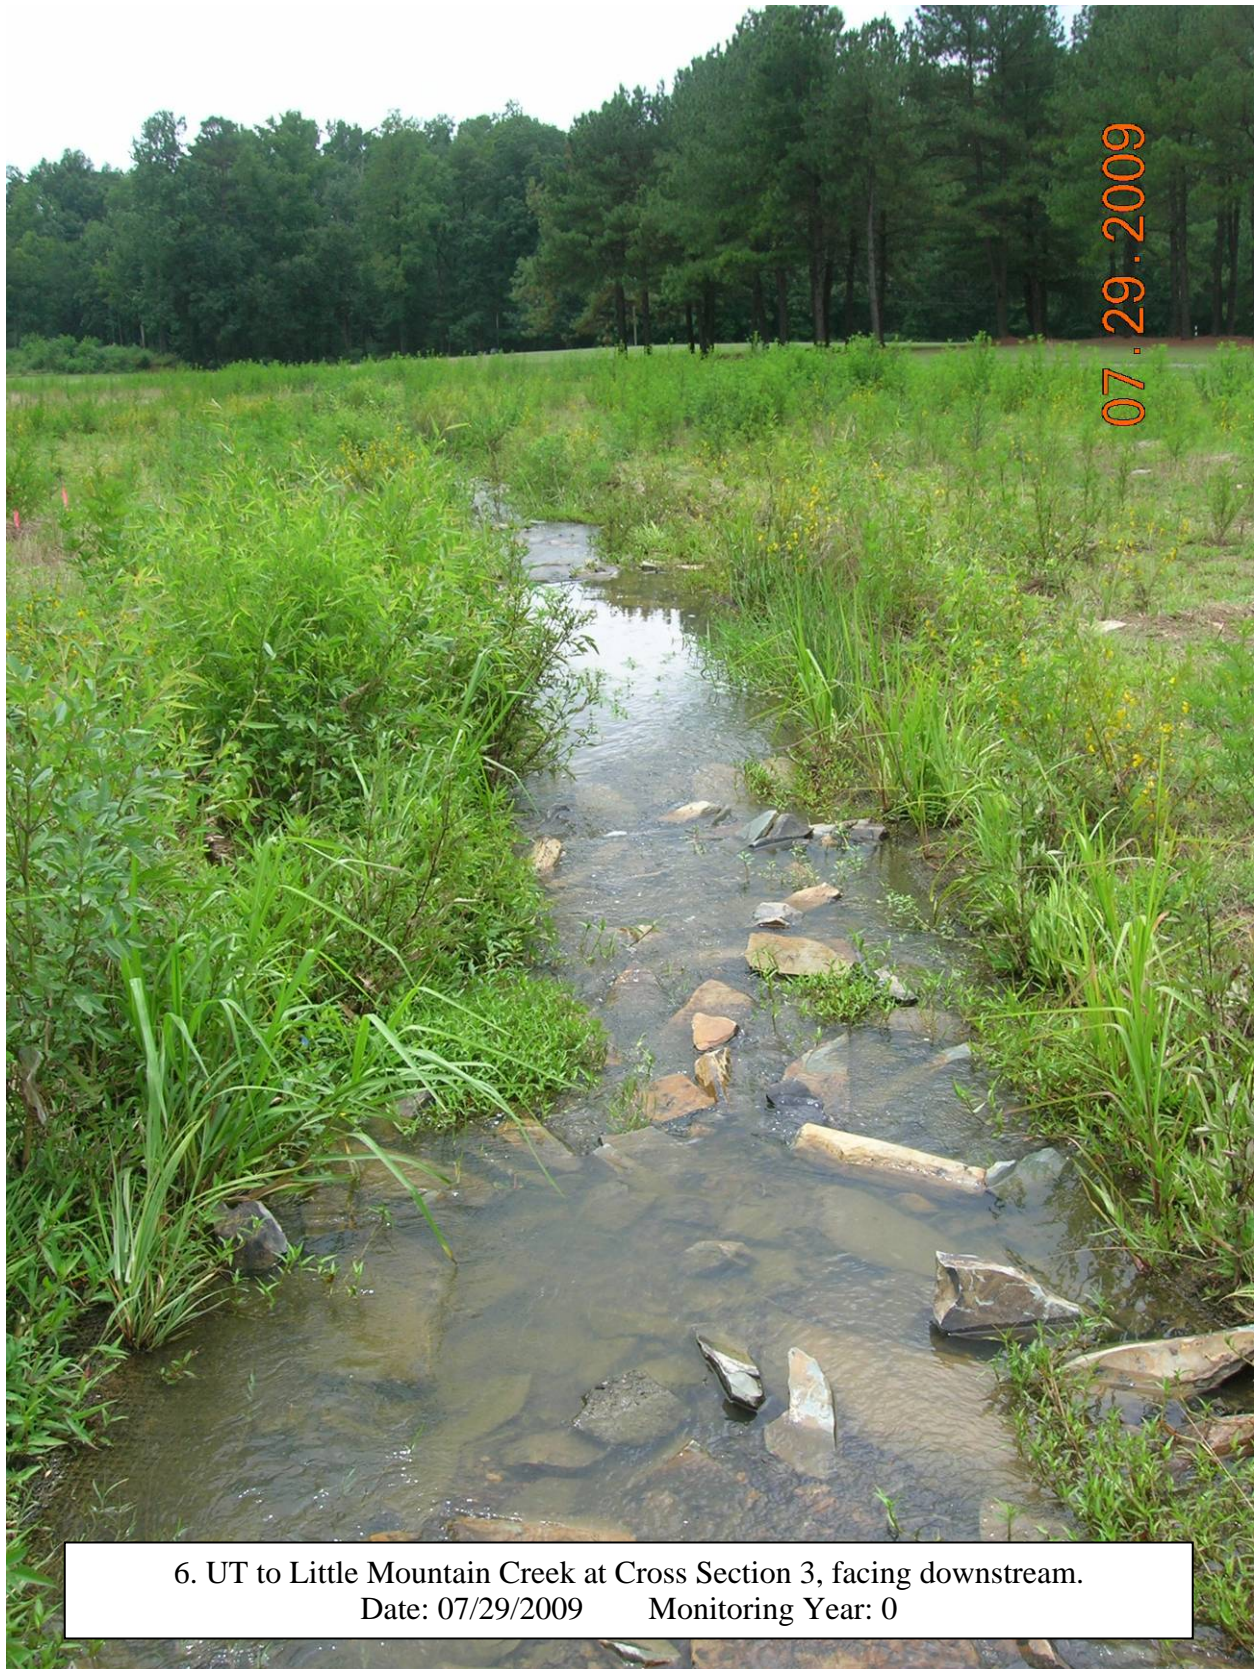
6. UT to Little Mountain Creek at Cross Section 3, facing downstream.
Date: 07/29/2009 Monitoring Year: 0

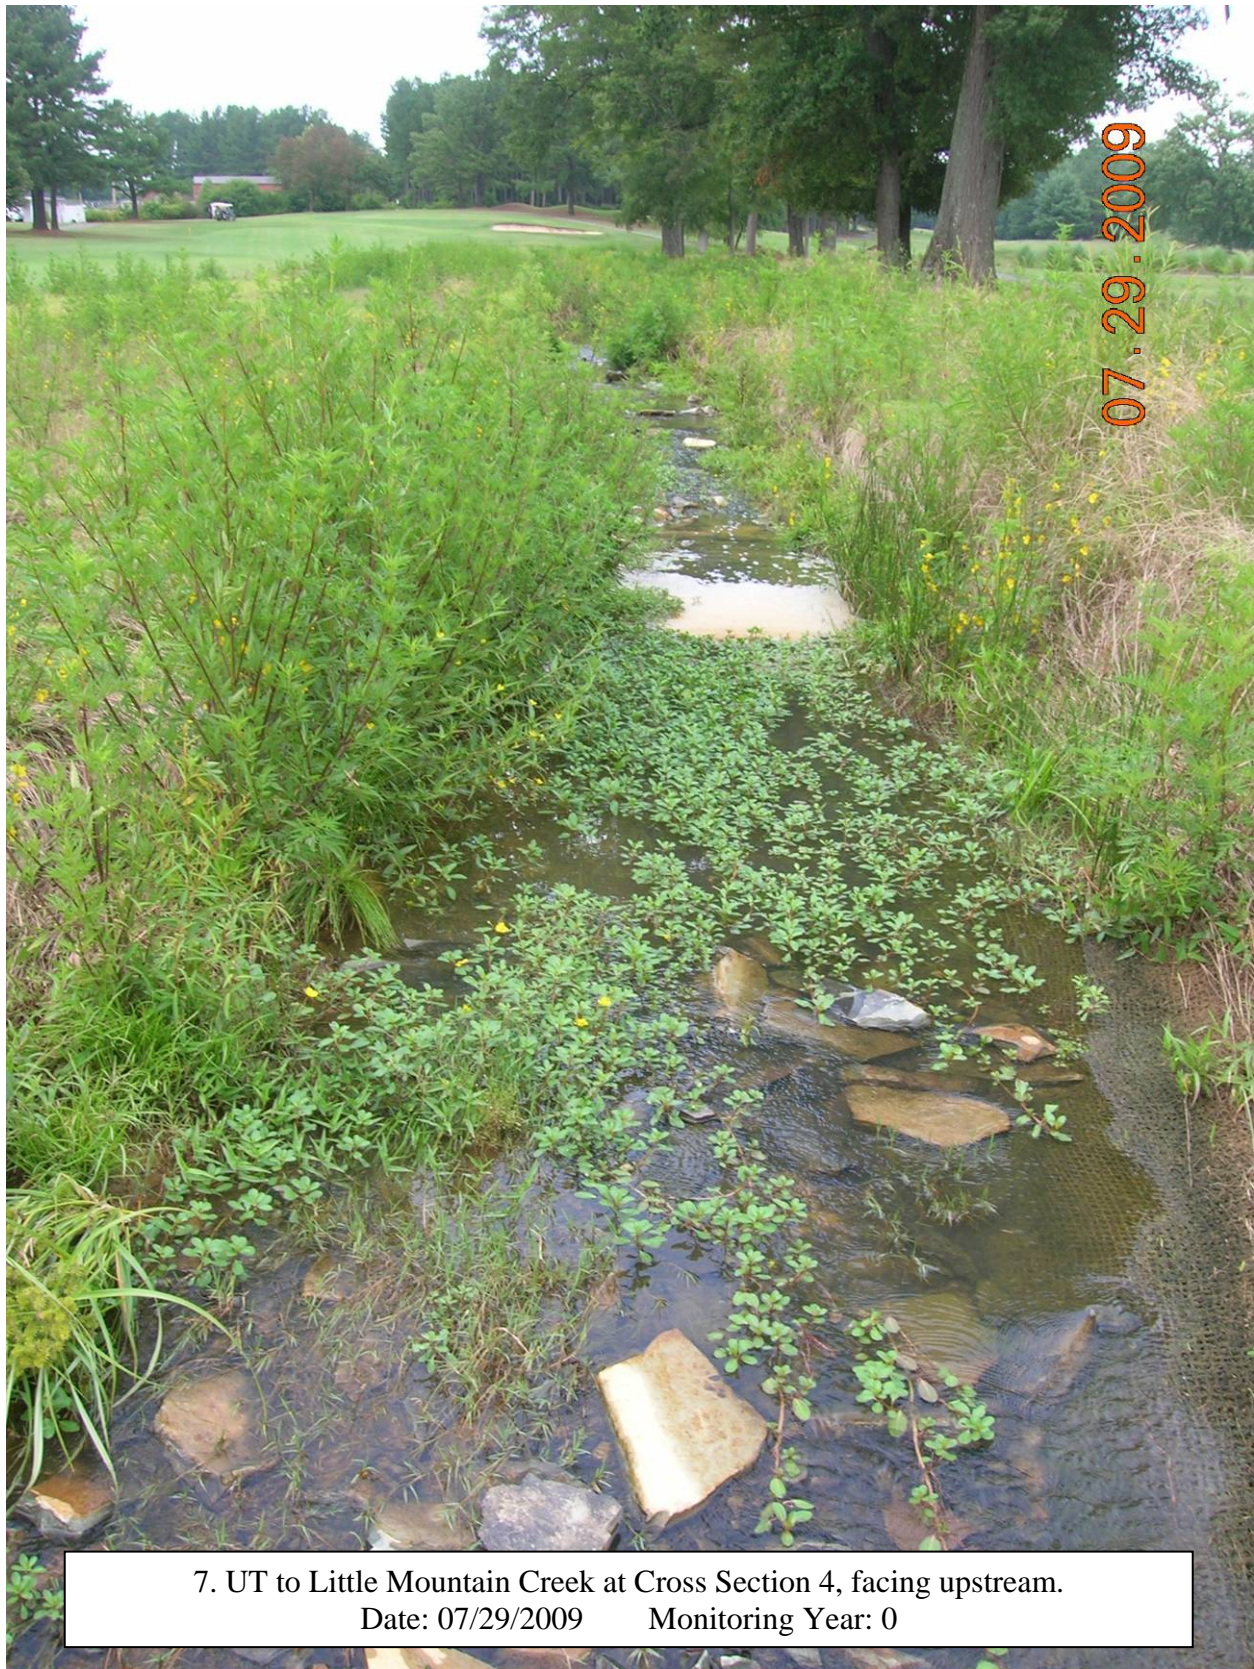
7. UT to Little Mountain Creek at Cross Section 4, facing upstream.
Date: 07/29/2009 Monitoring Year: 0

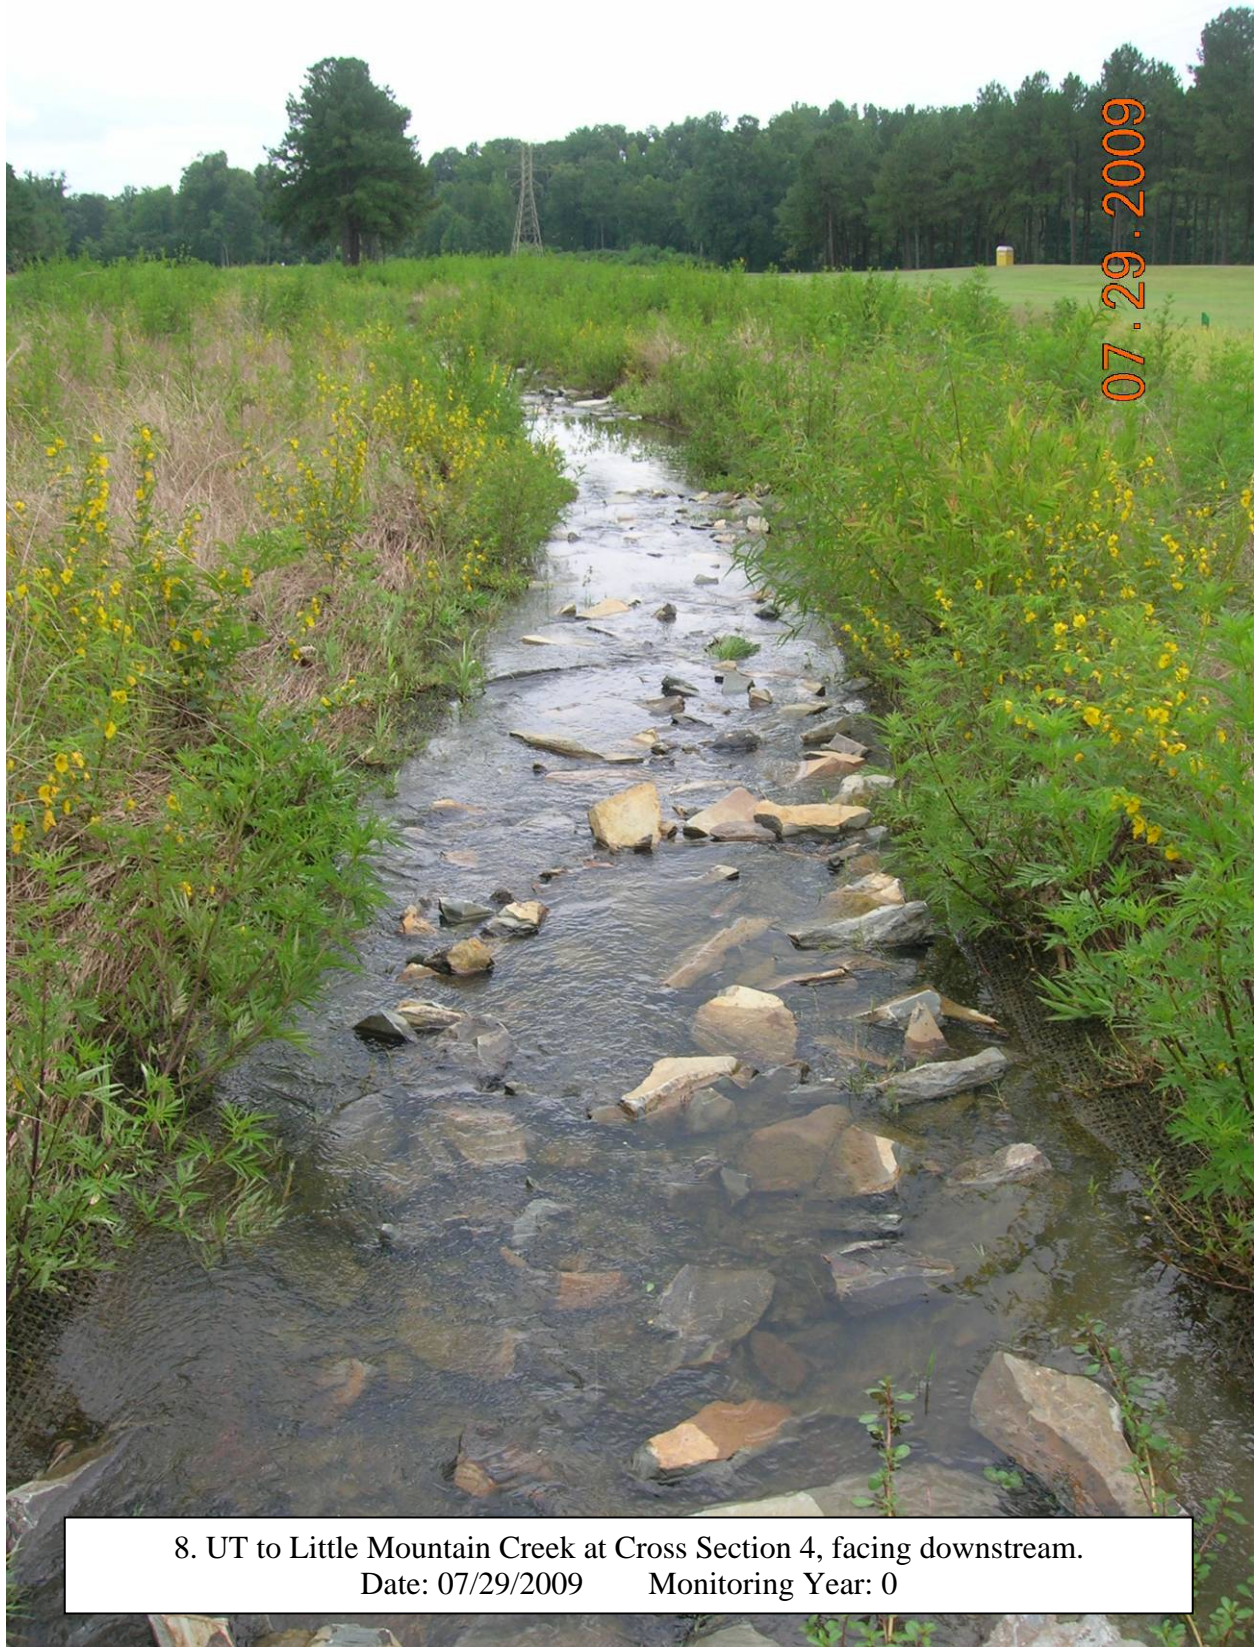
8. UT to Little Mountain Creek at Cross Section 4, facing downstream.
Date: 07/29/2009 Monitoring Year: 0

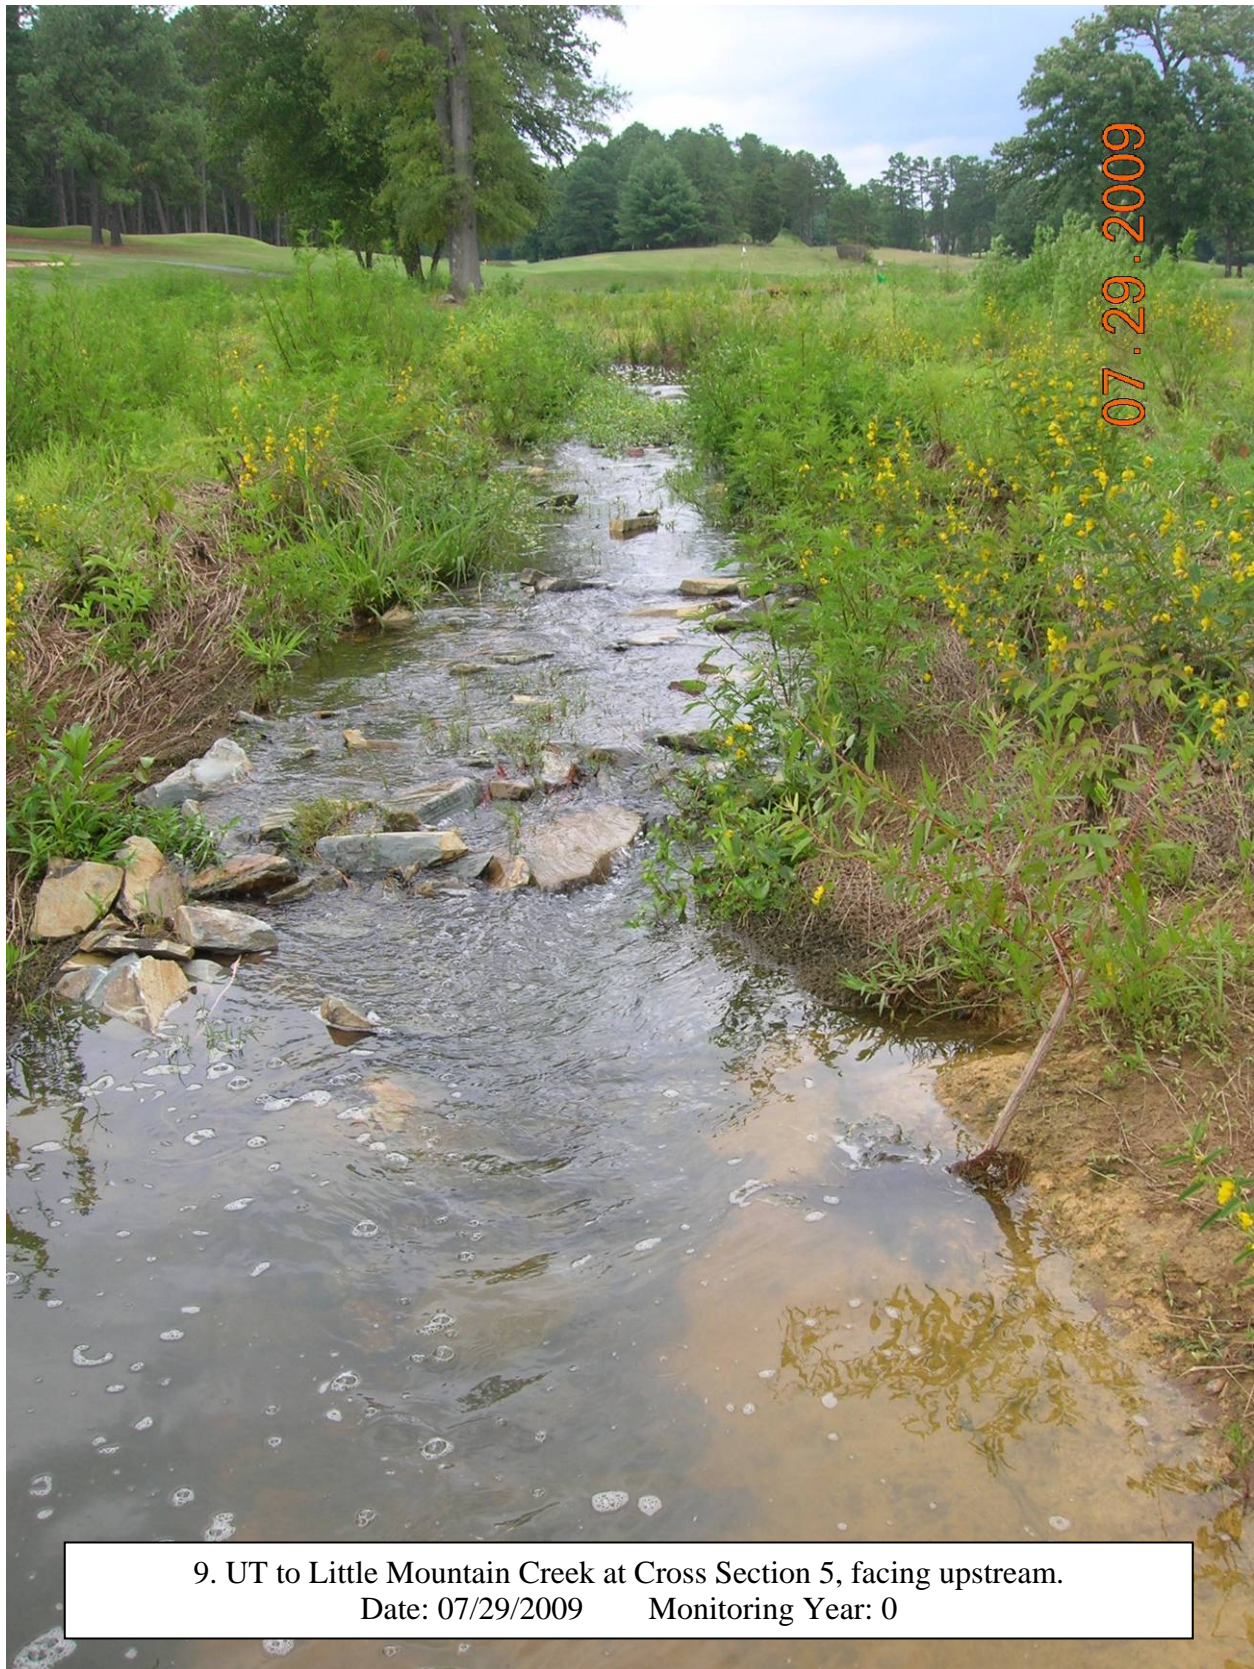
9. UT to Little Mountain Creek at Cross Section 5, facing upstream.
Date: 07/29/2009 Monitoring Year: 0

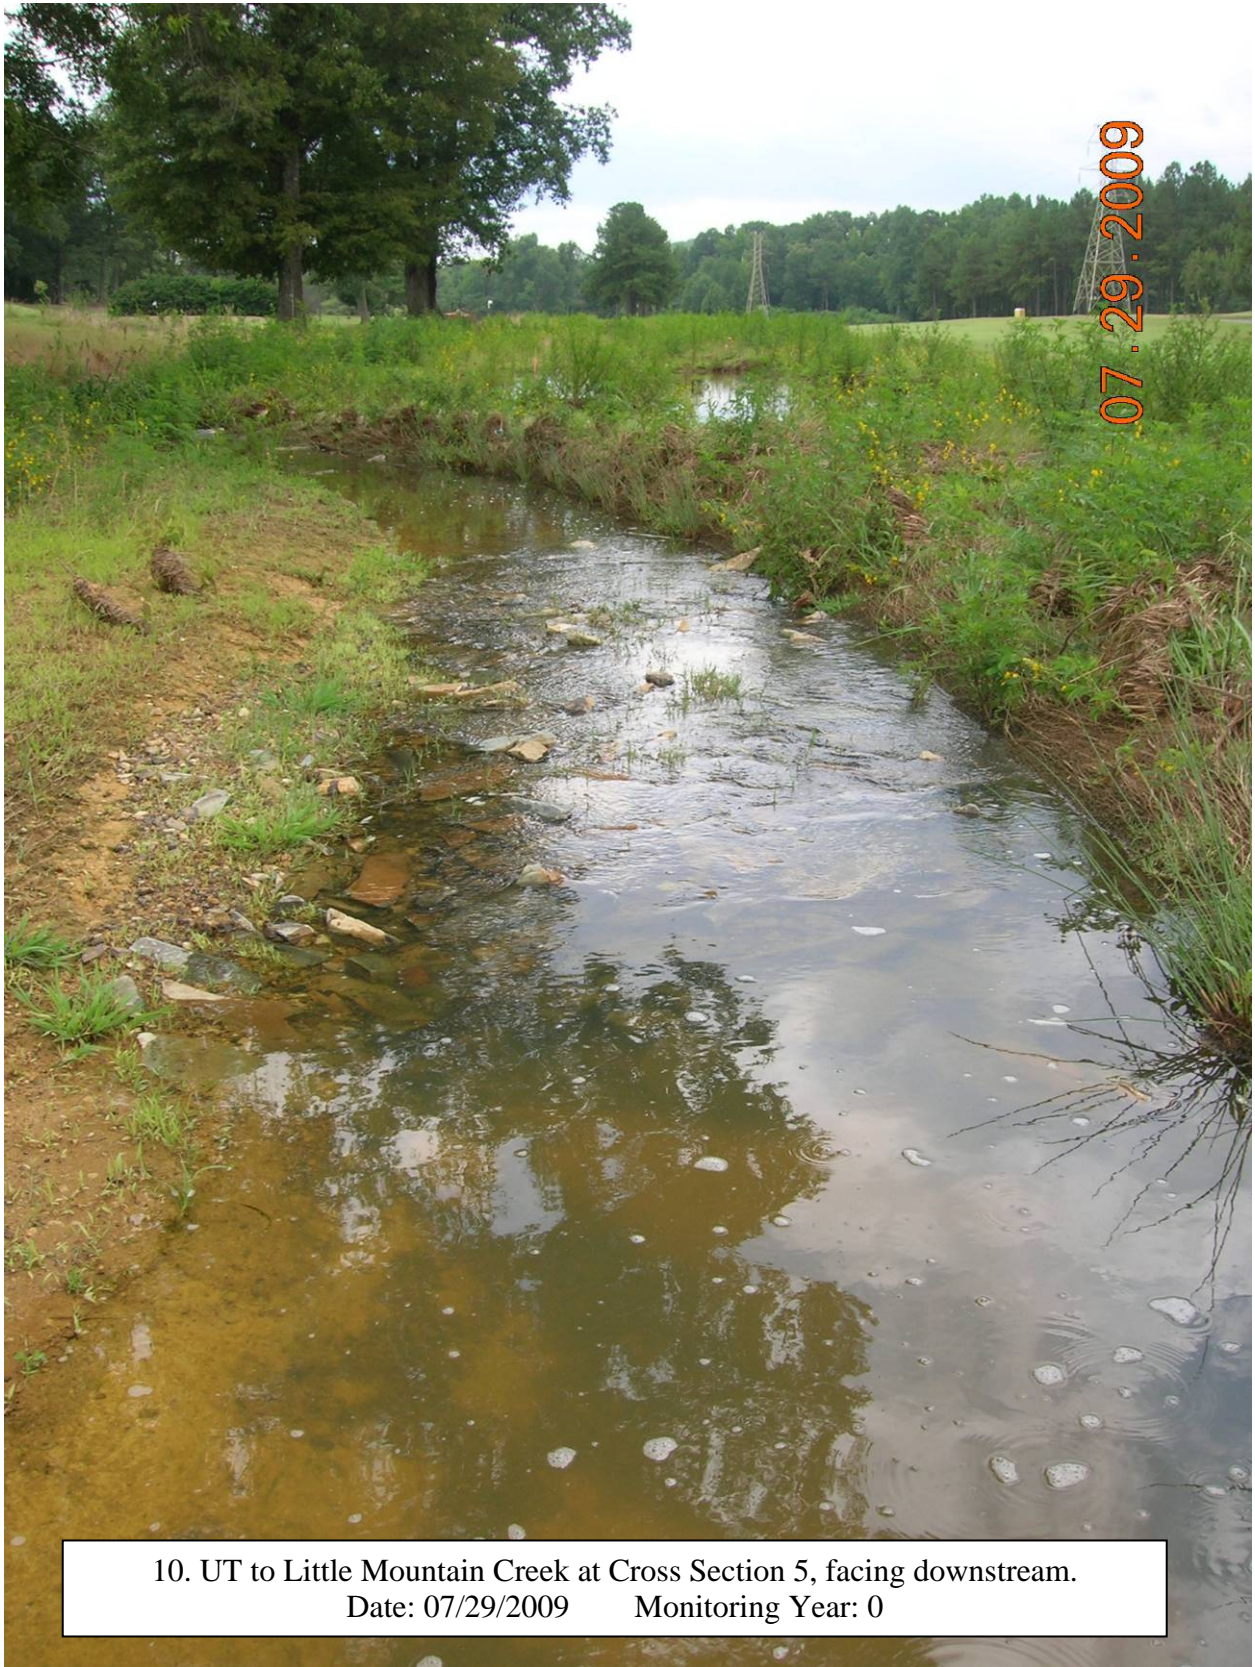
10. UT to Little Mountain Creek at Cross Section 5, facing downstream.
Date: 07/29/2009 Monitoring Year: 0

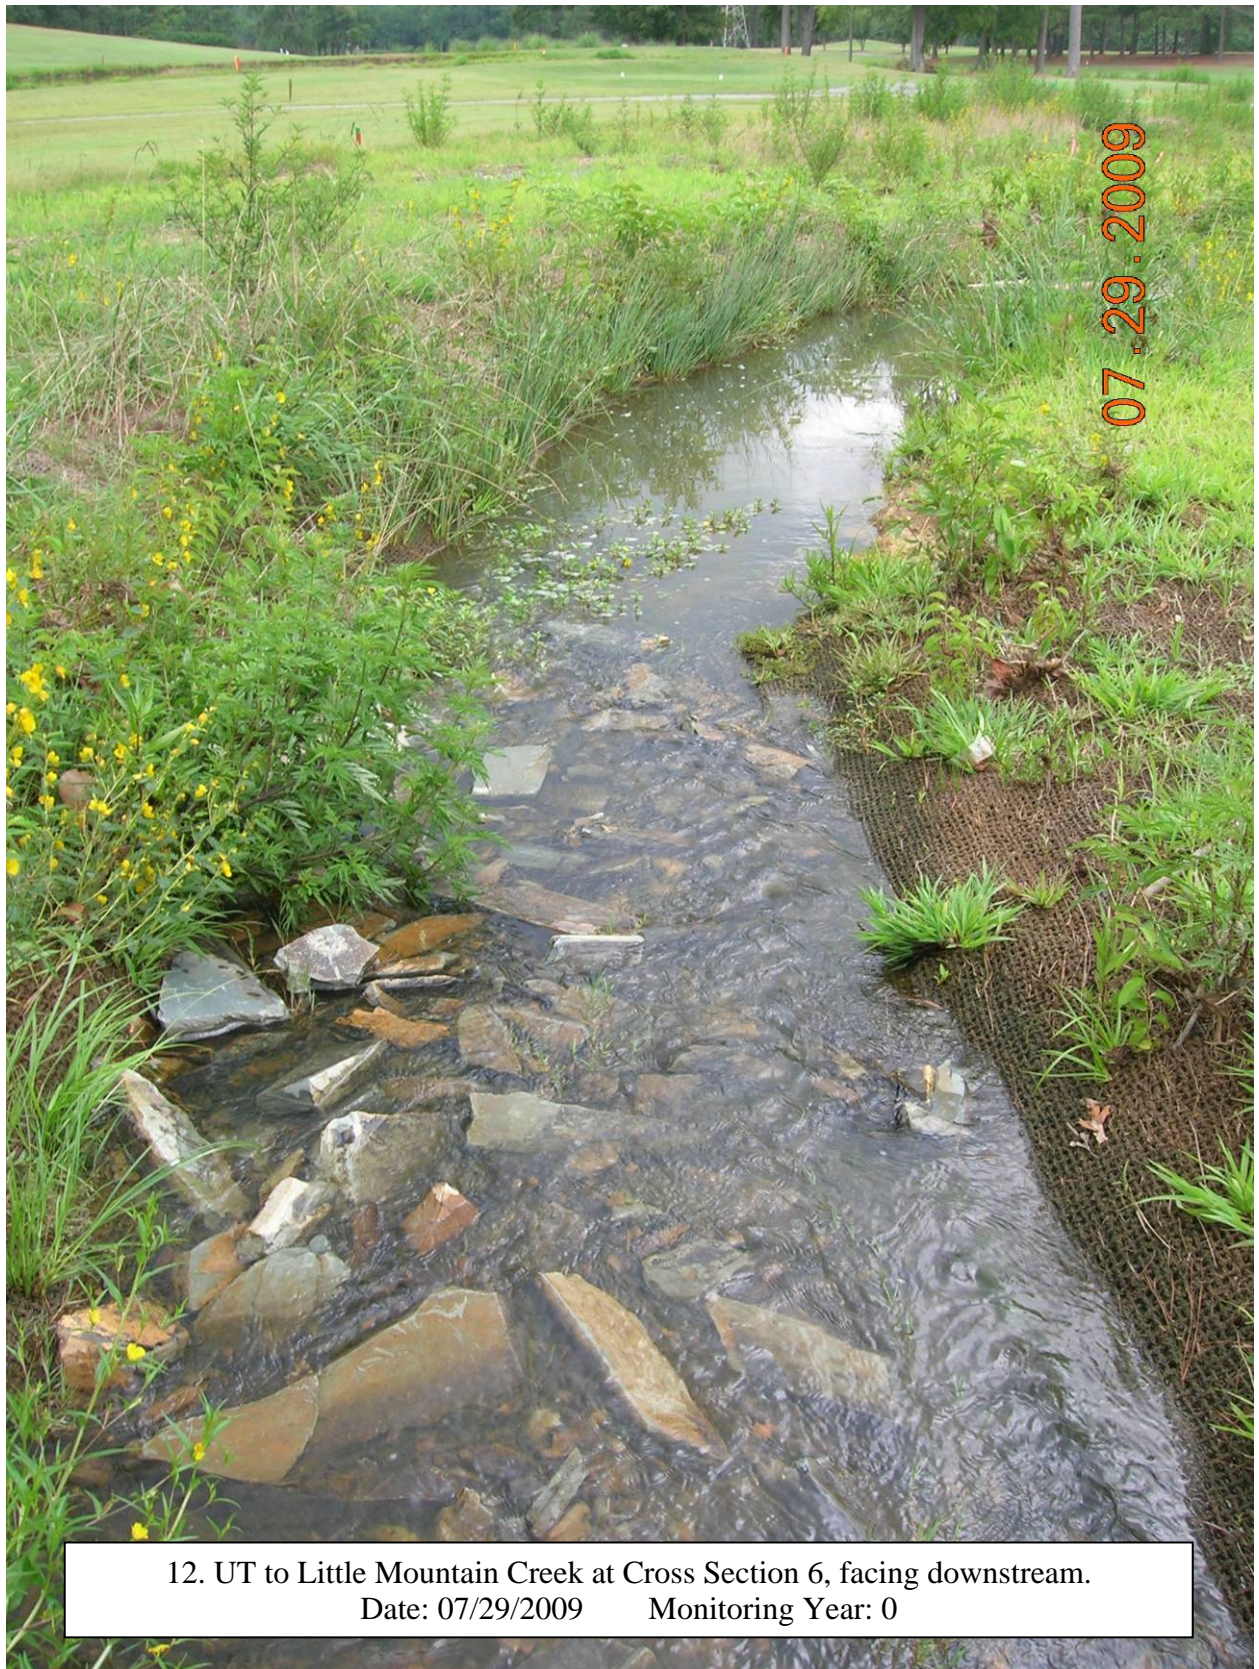
11. UT to Little Mountain Creek at Cross Section 6, facing upstream.
Date: 07/29/2009 Monitoring Year: 0

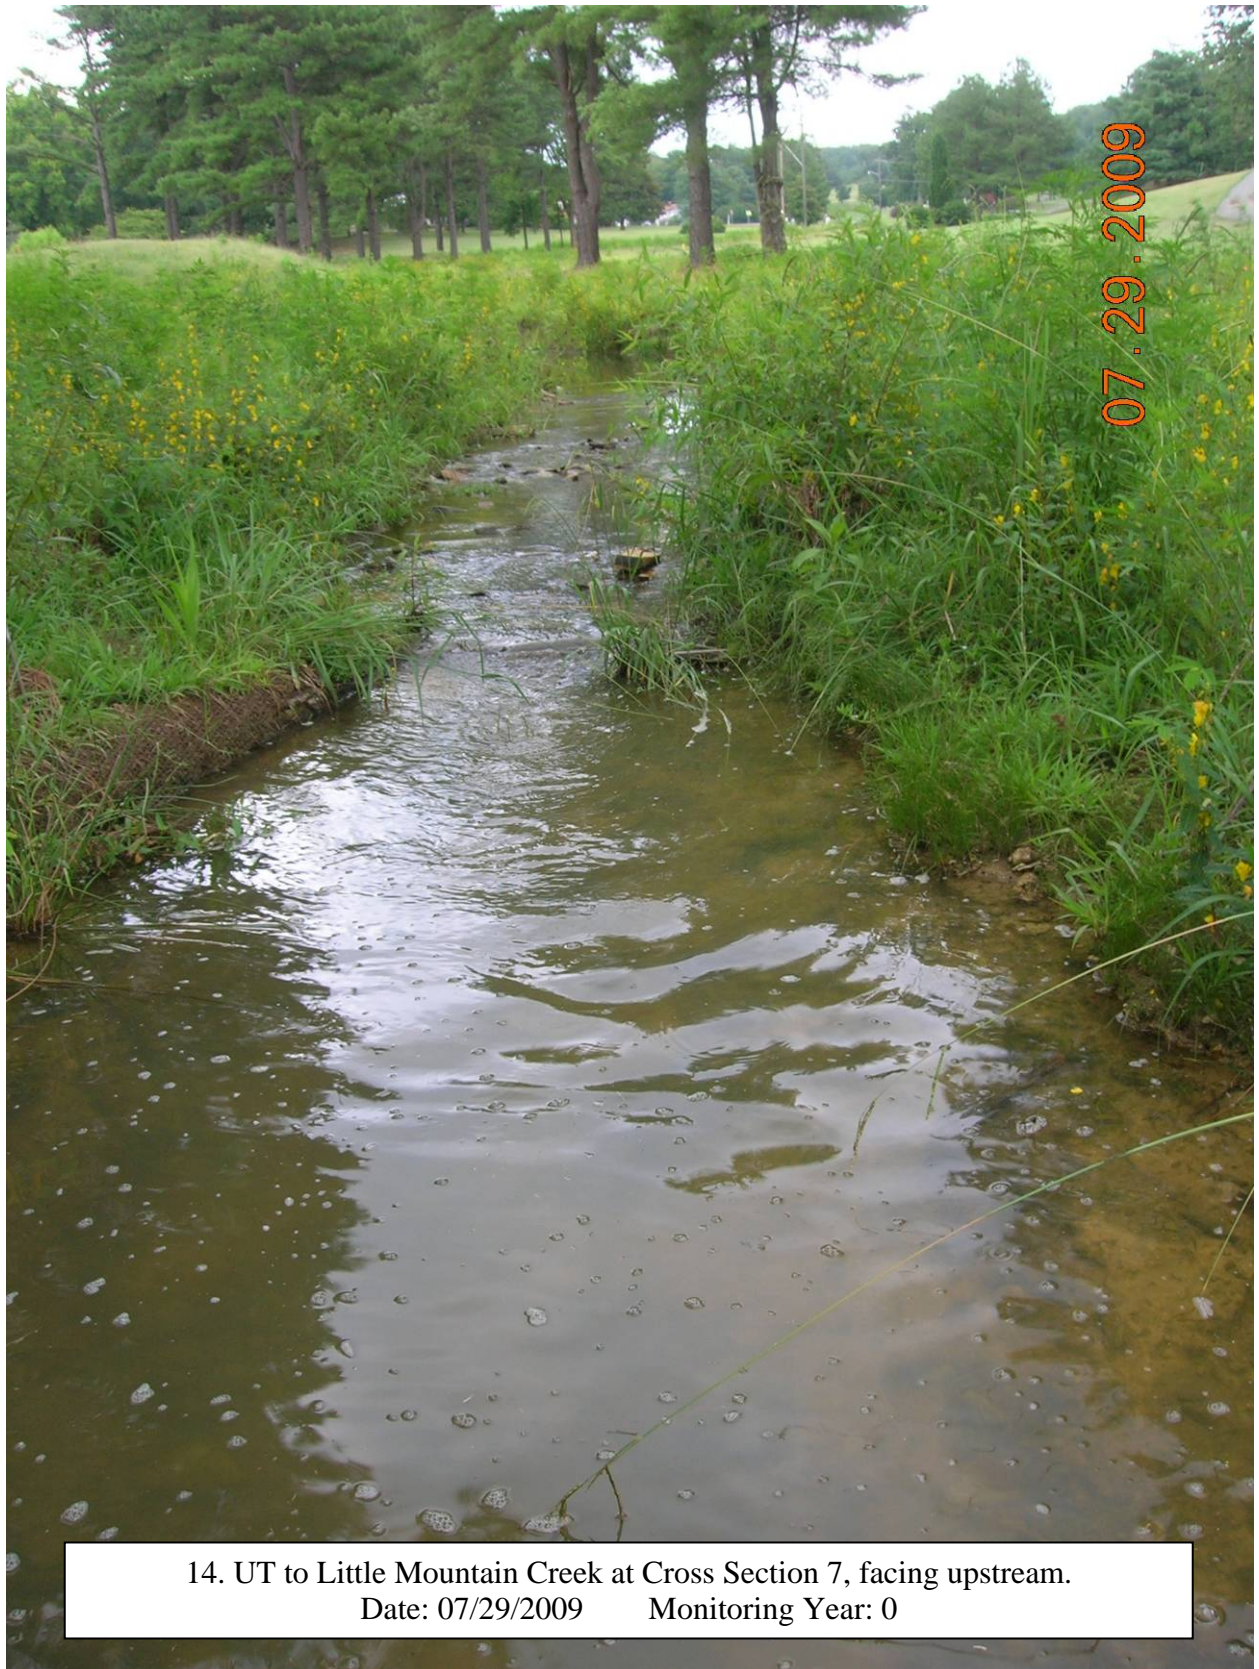
12. UT to Little Mountain Creek at Cross Section 6, facing downstream.
Date: 07/29/2009 Monitoring Year: 0

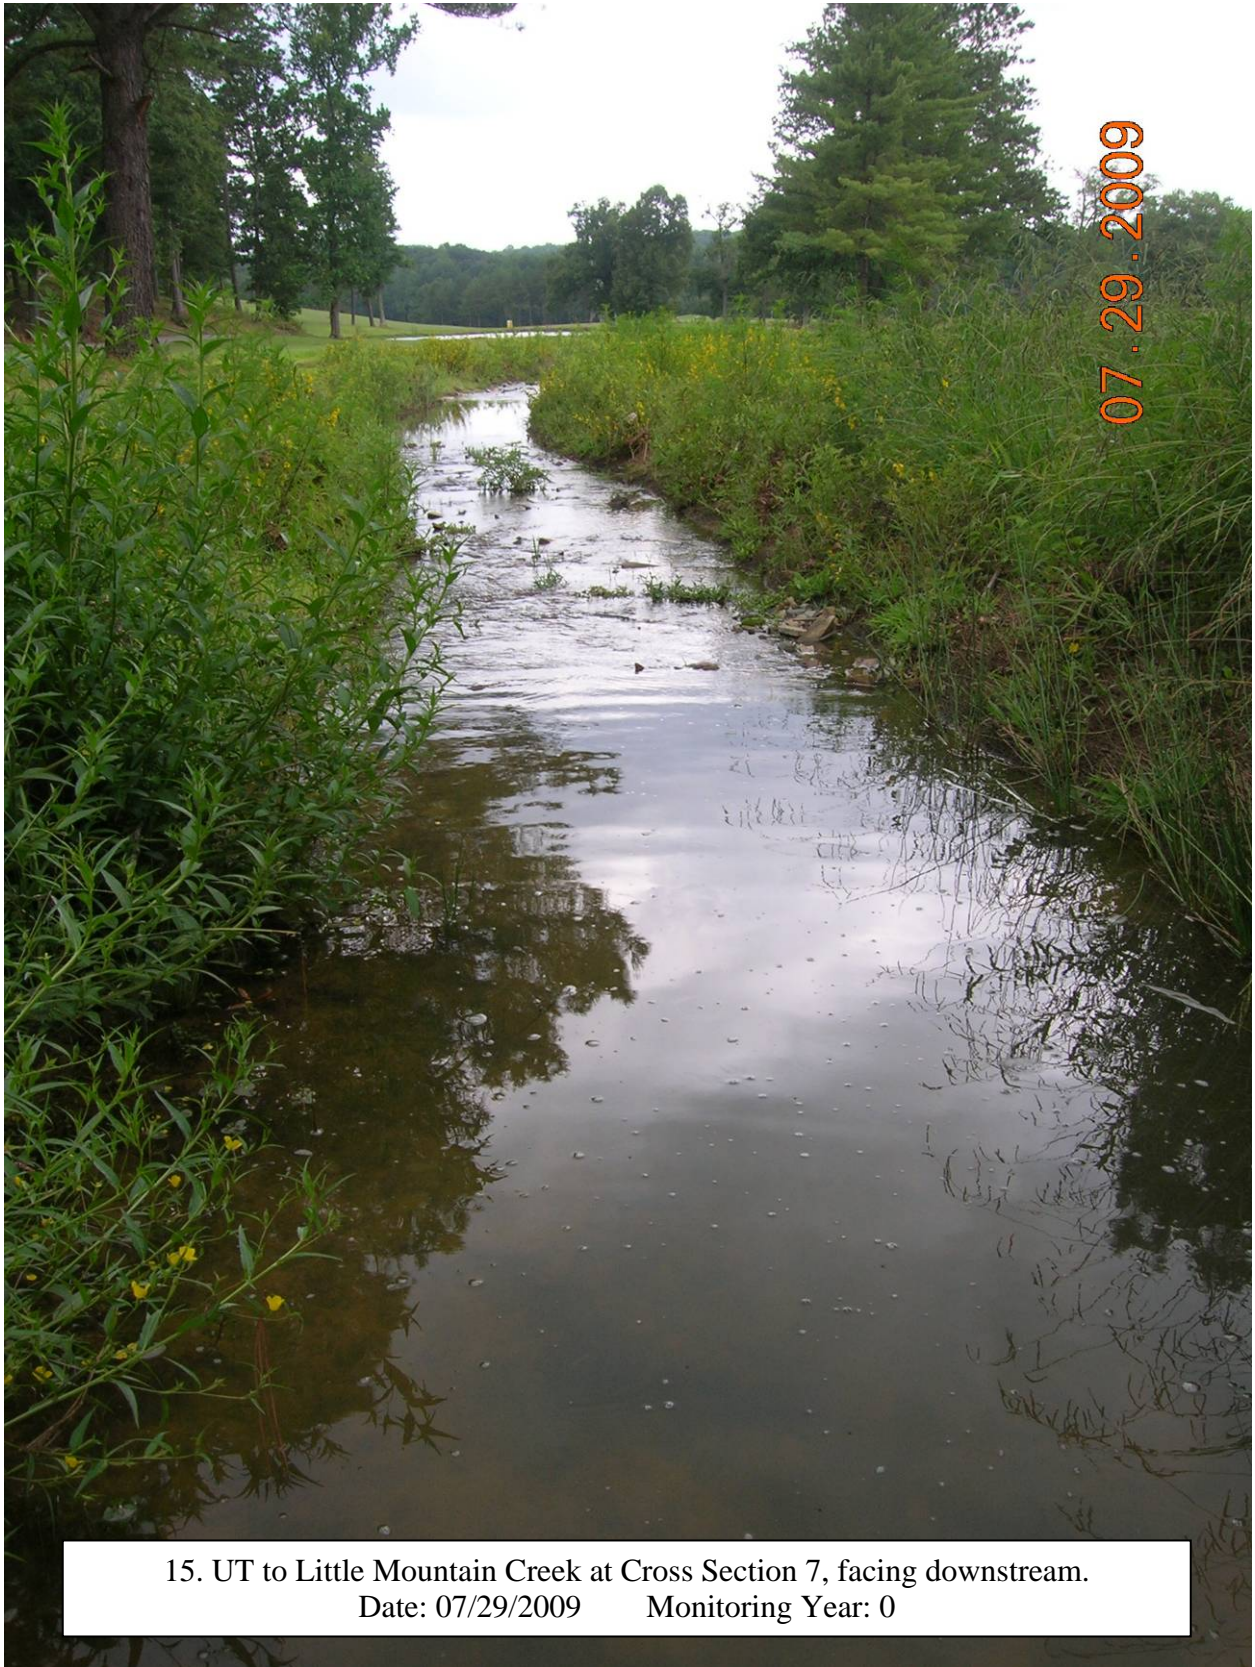
14. UT to Little Mountain Creek at Cross Section 7, facing upstream.
Date: 07/29/2009 Monitoring Year: 0
