**Badin Inn Stream Restoration
Stanly County, NC**

**Mitigation Plan and As-built Baseline Report
DRAFT**

**EEP Project Number 92666
SCO Project Number D06125-E
Data Collection Period: April-July, 2009
Submission Date: August, 2009**

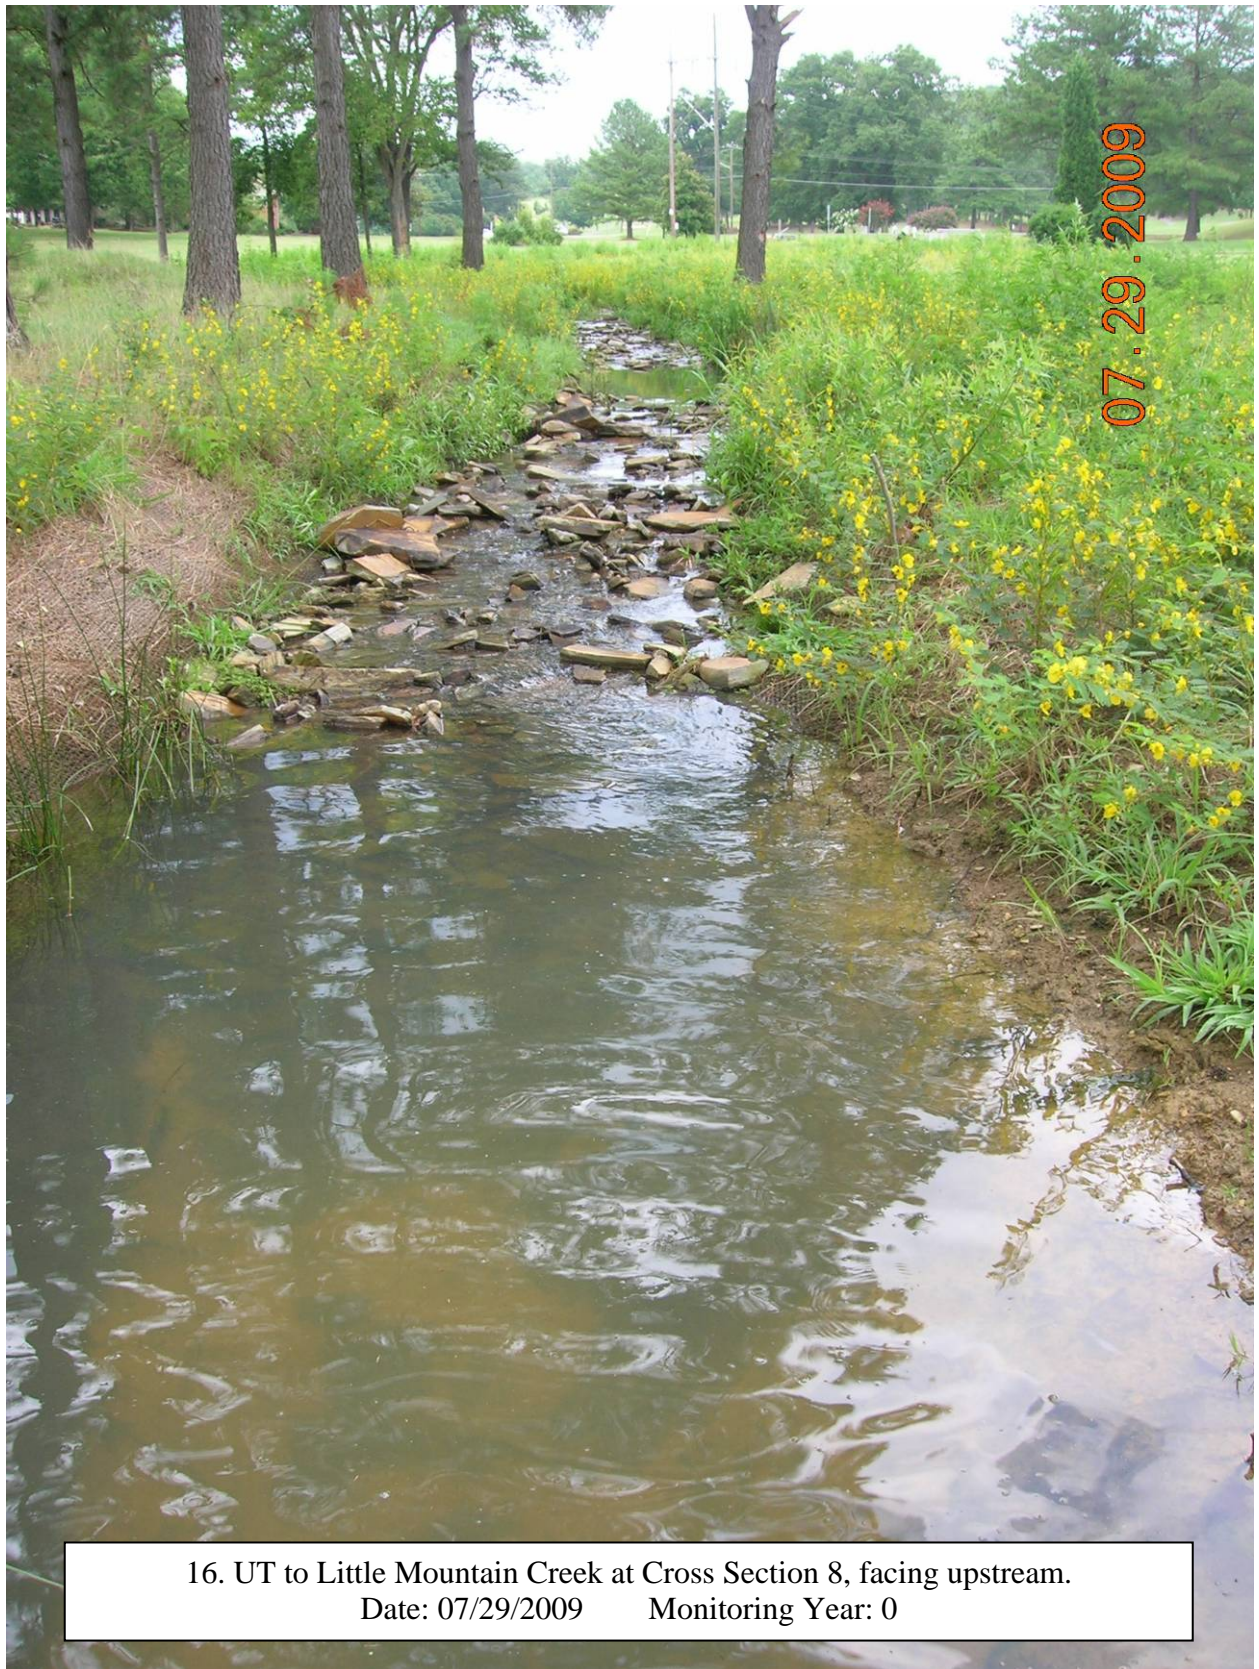
15. UT to Little Mountain Creek at Cross Section 7, facing downstream.
Date: 07/29/2009 Monitoring Year: 0

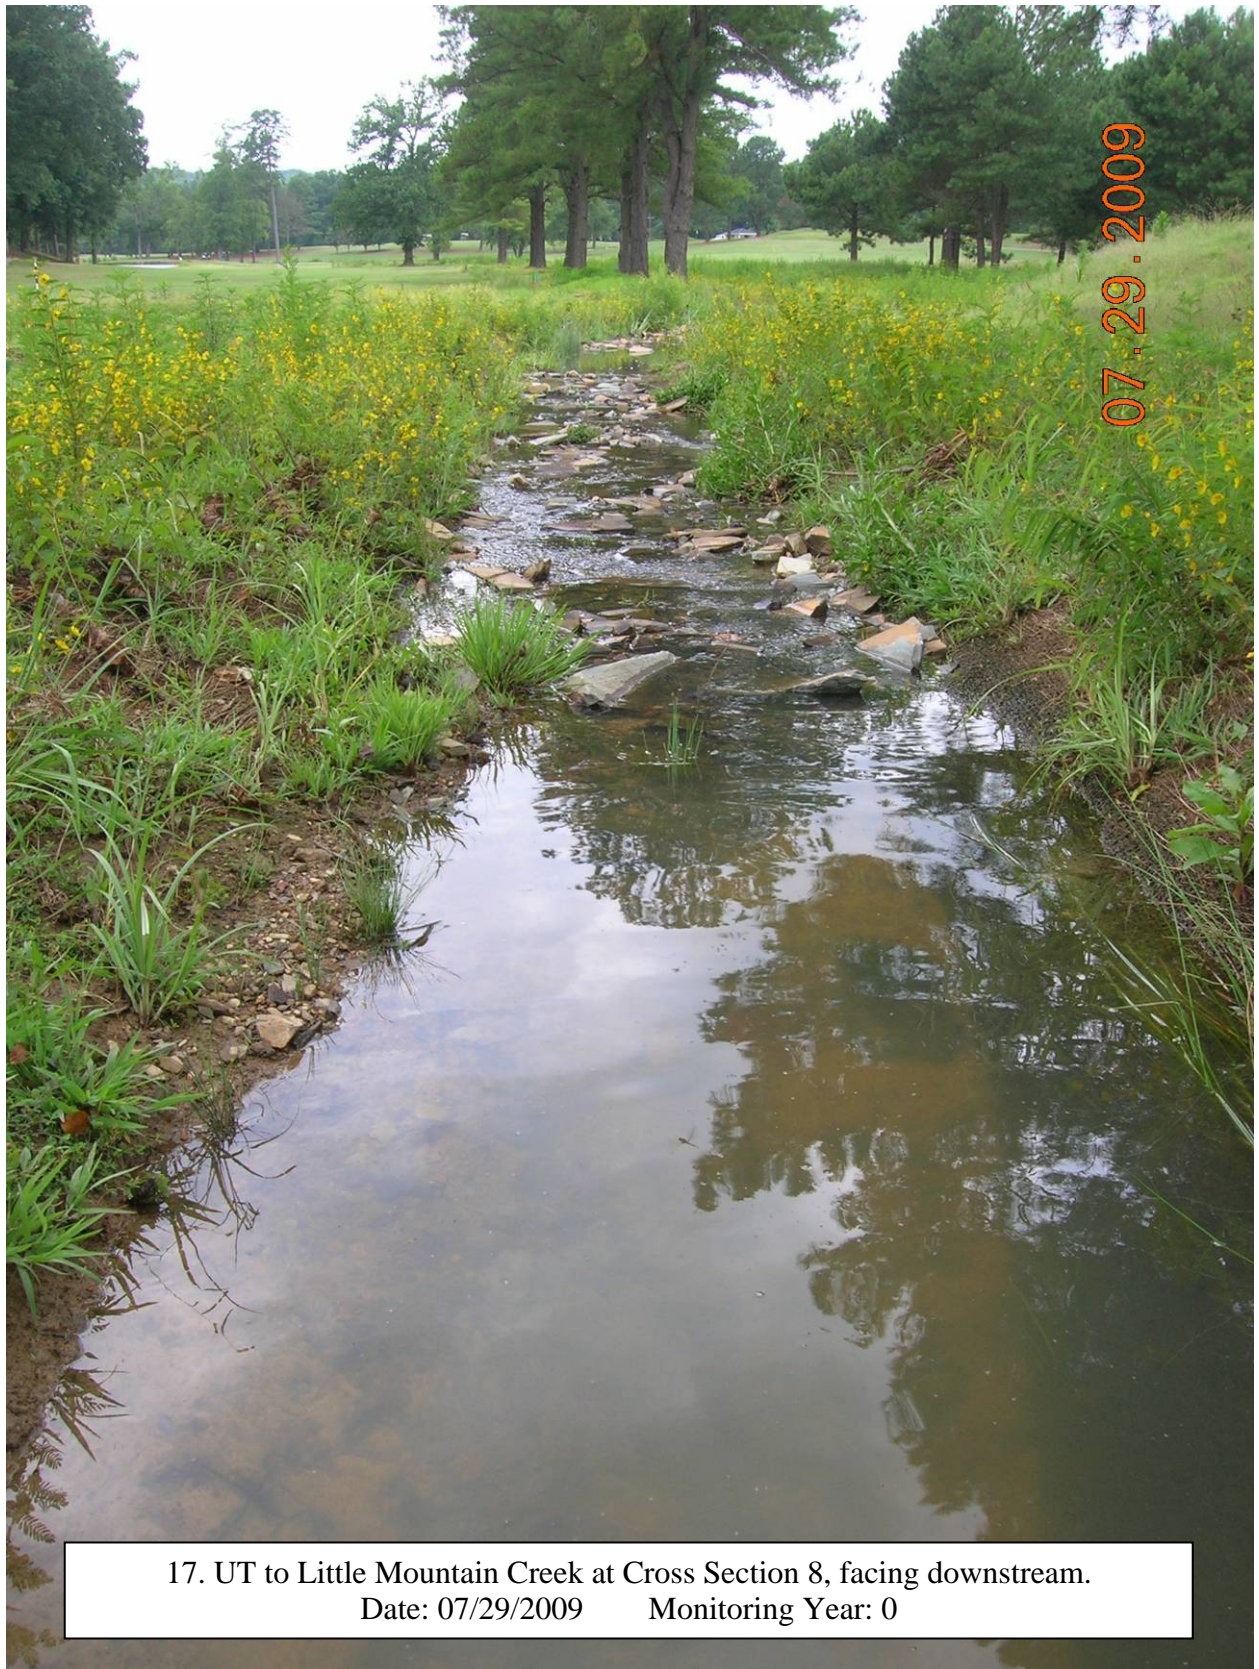
16. UT to Little Mountain Creek at Cross Section 8, facing upstream.
Date: 07/29/2009 Monitoring Year: 0

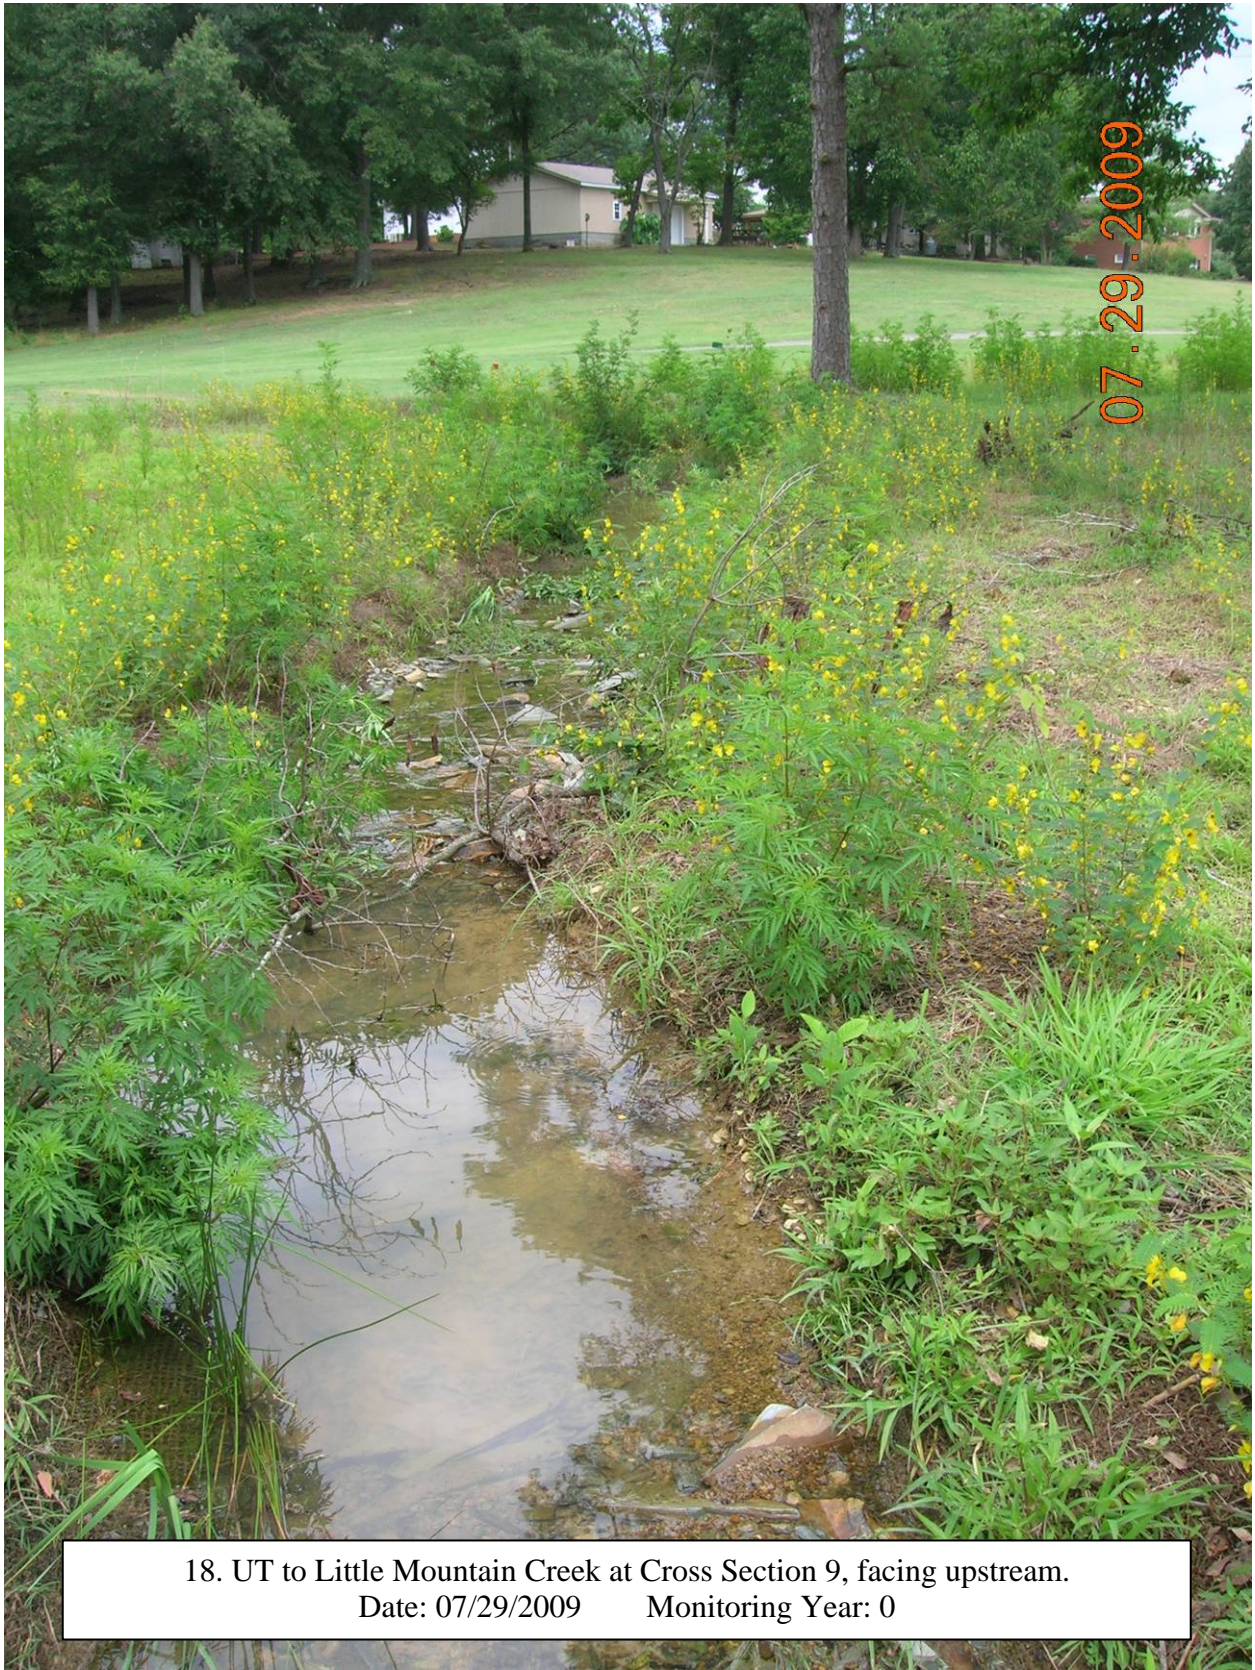
17. UT to Little Mountain Creek at Cross Section 8, facing downstream.
Date: 07/29/2009 Monitoring Year: 0

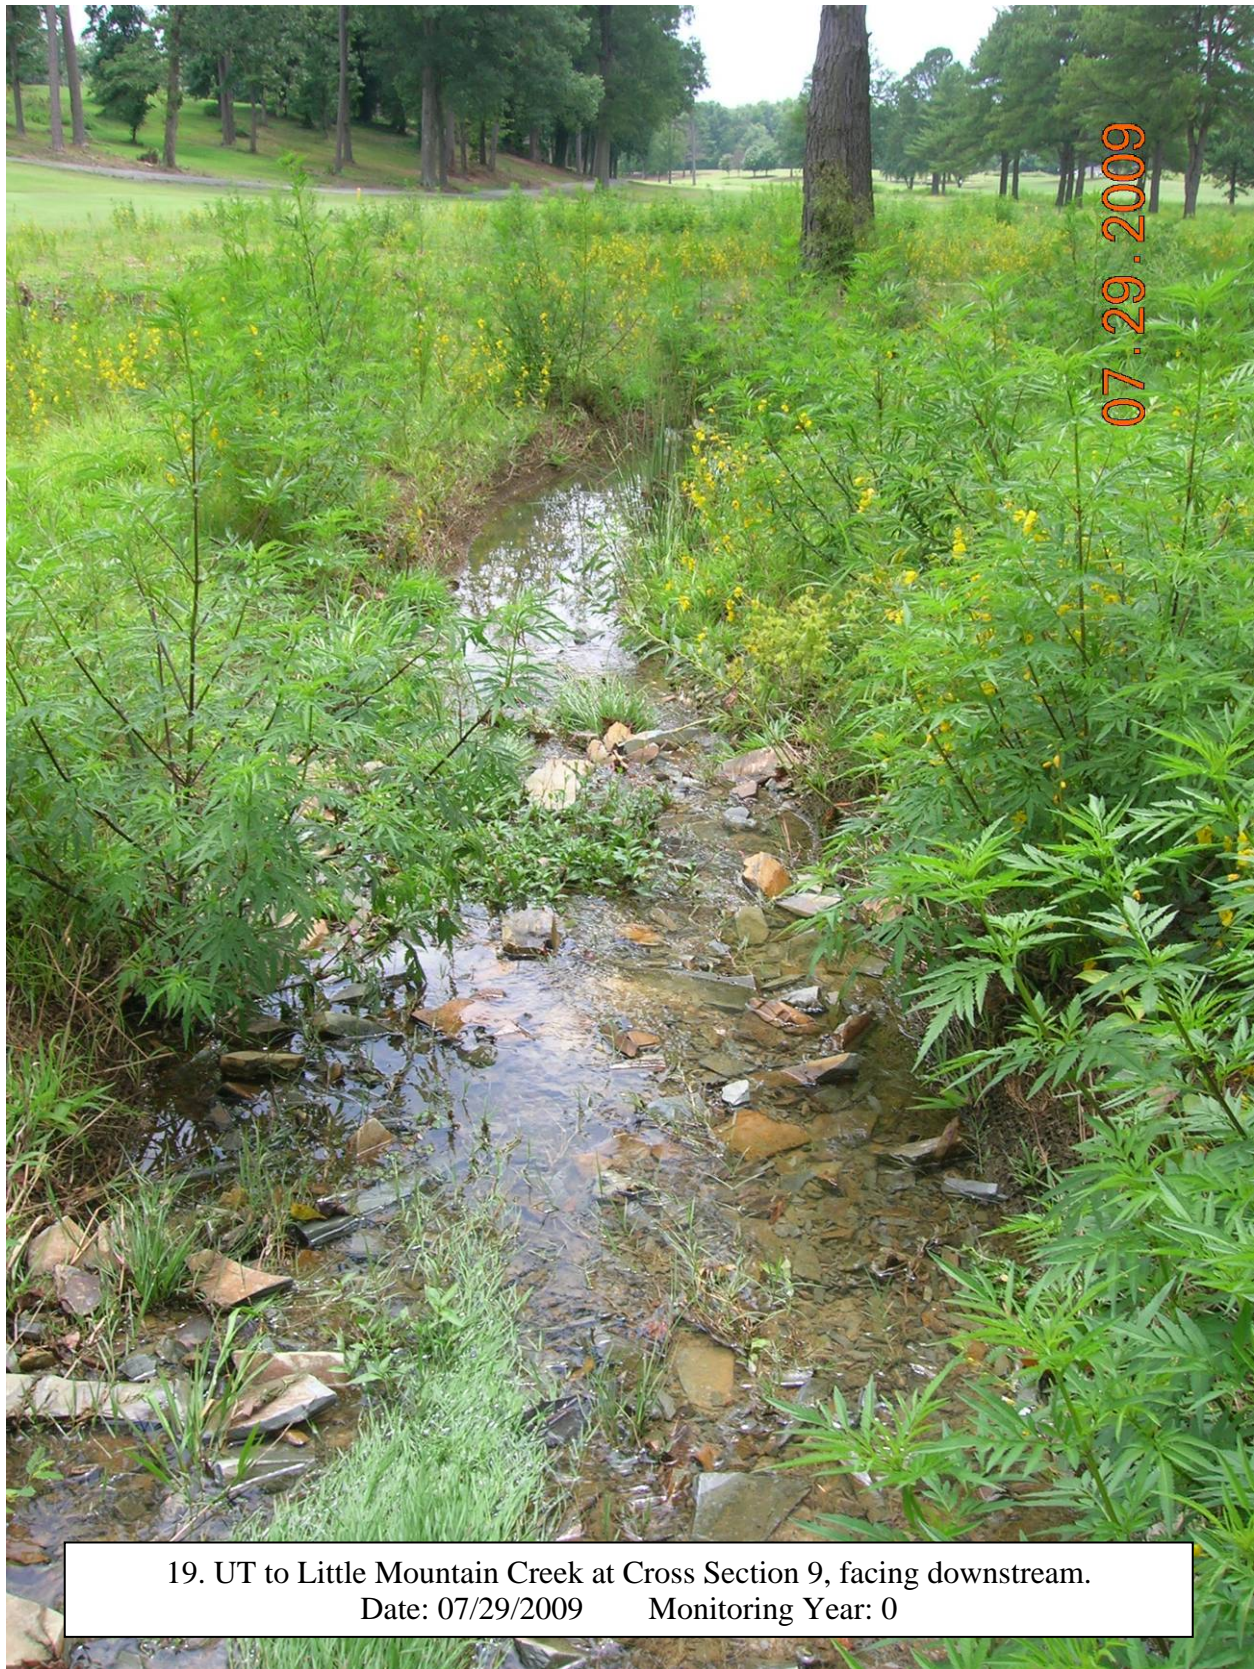
18. UT to Little Mountain Creek at Cross Section 9, facing upstream.
Date: 07/29/2009 Monitoring Year: 0

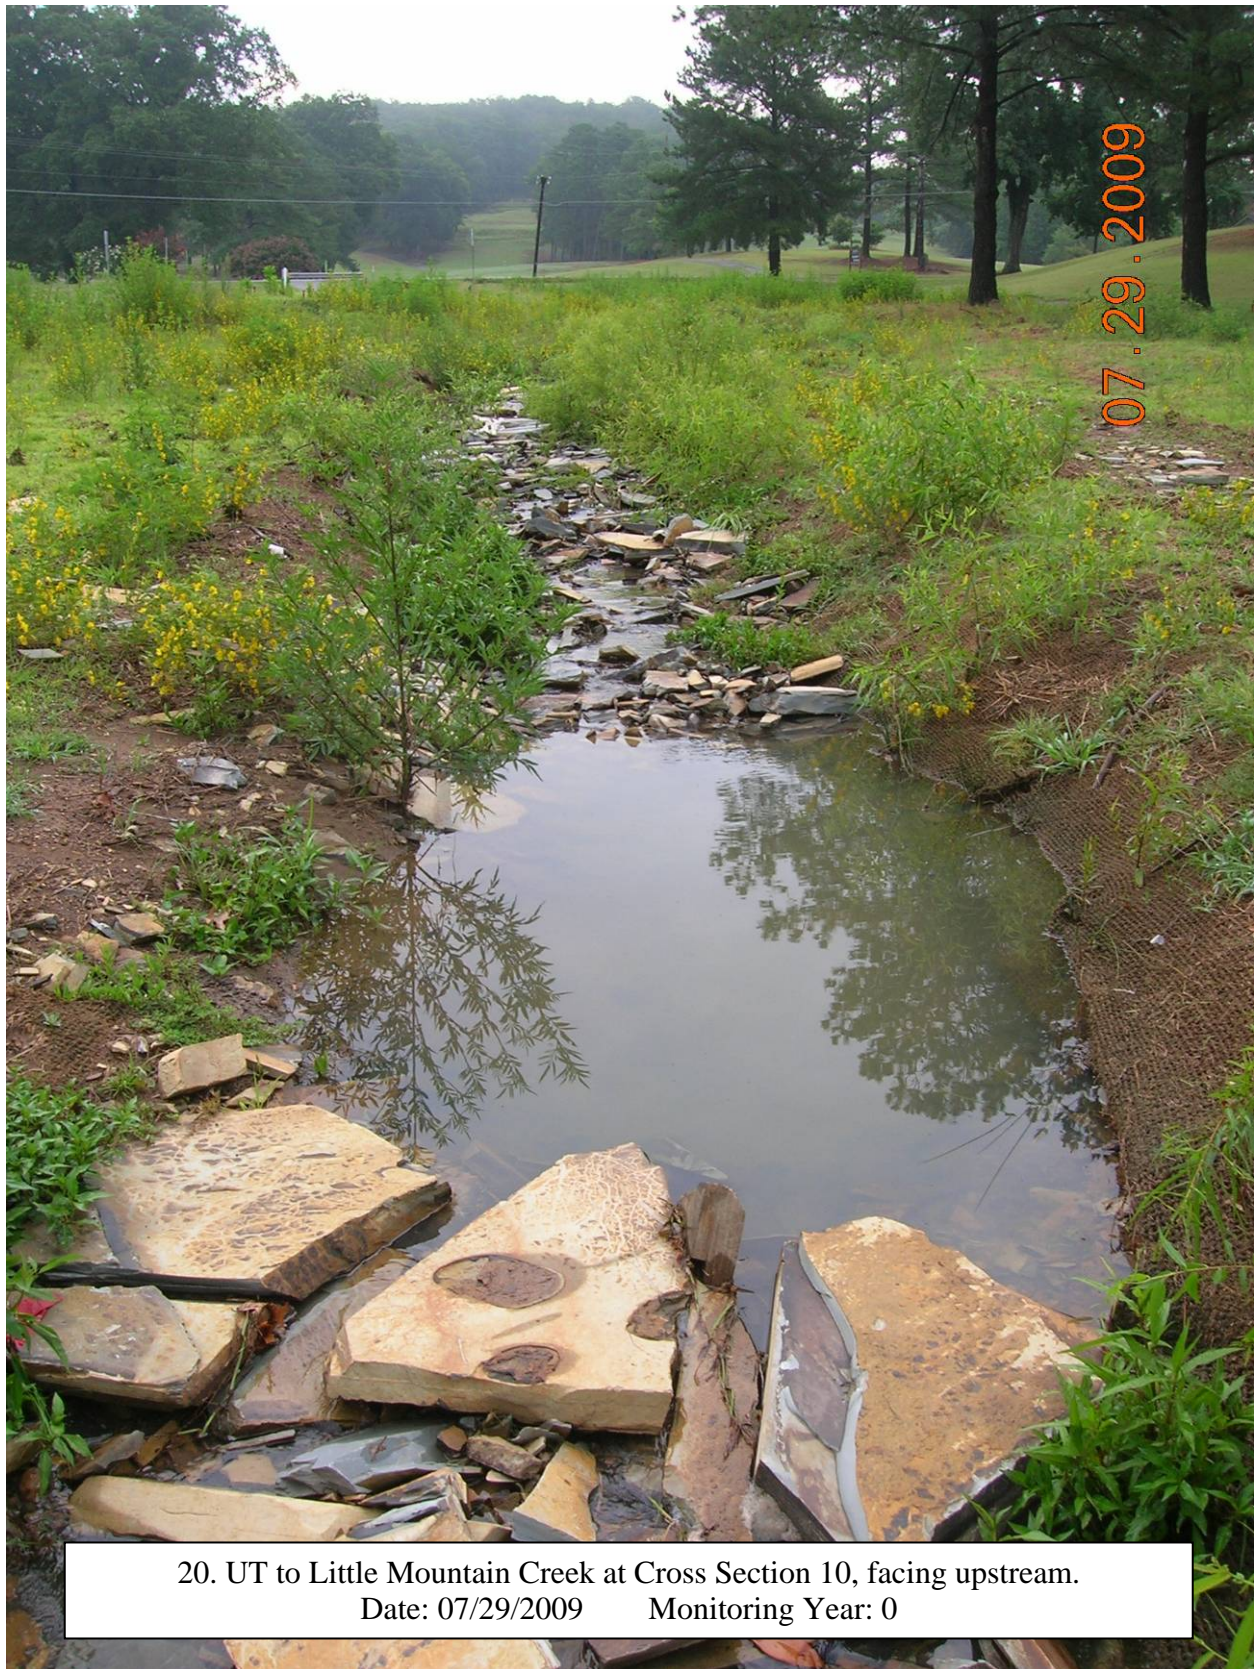
19. UT to Little Mountain Creek at Cross Section 9, facing downstream.
Date: 07/29/2009 Monitoring Year: 0

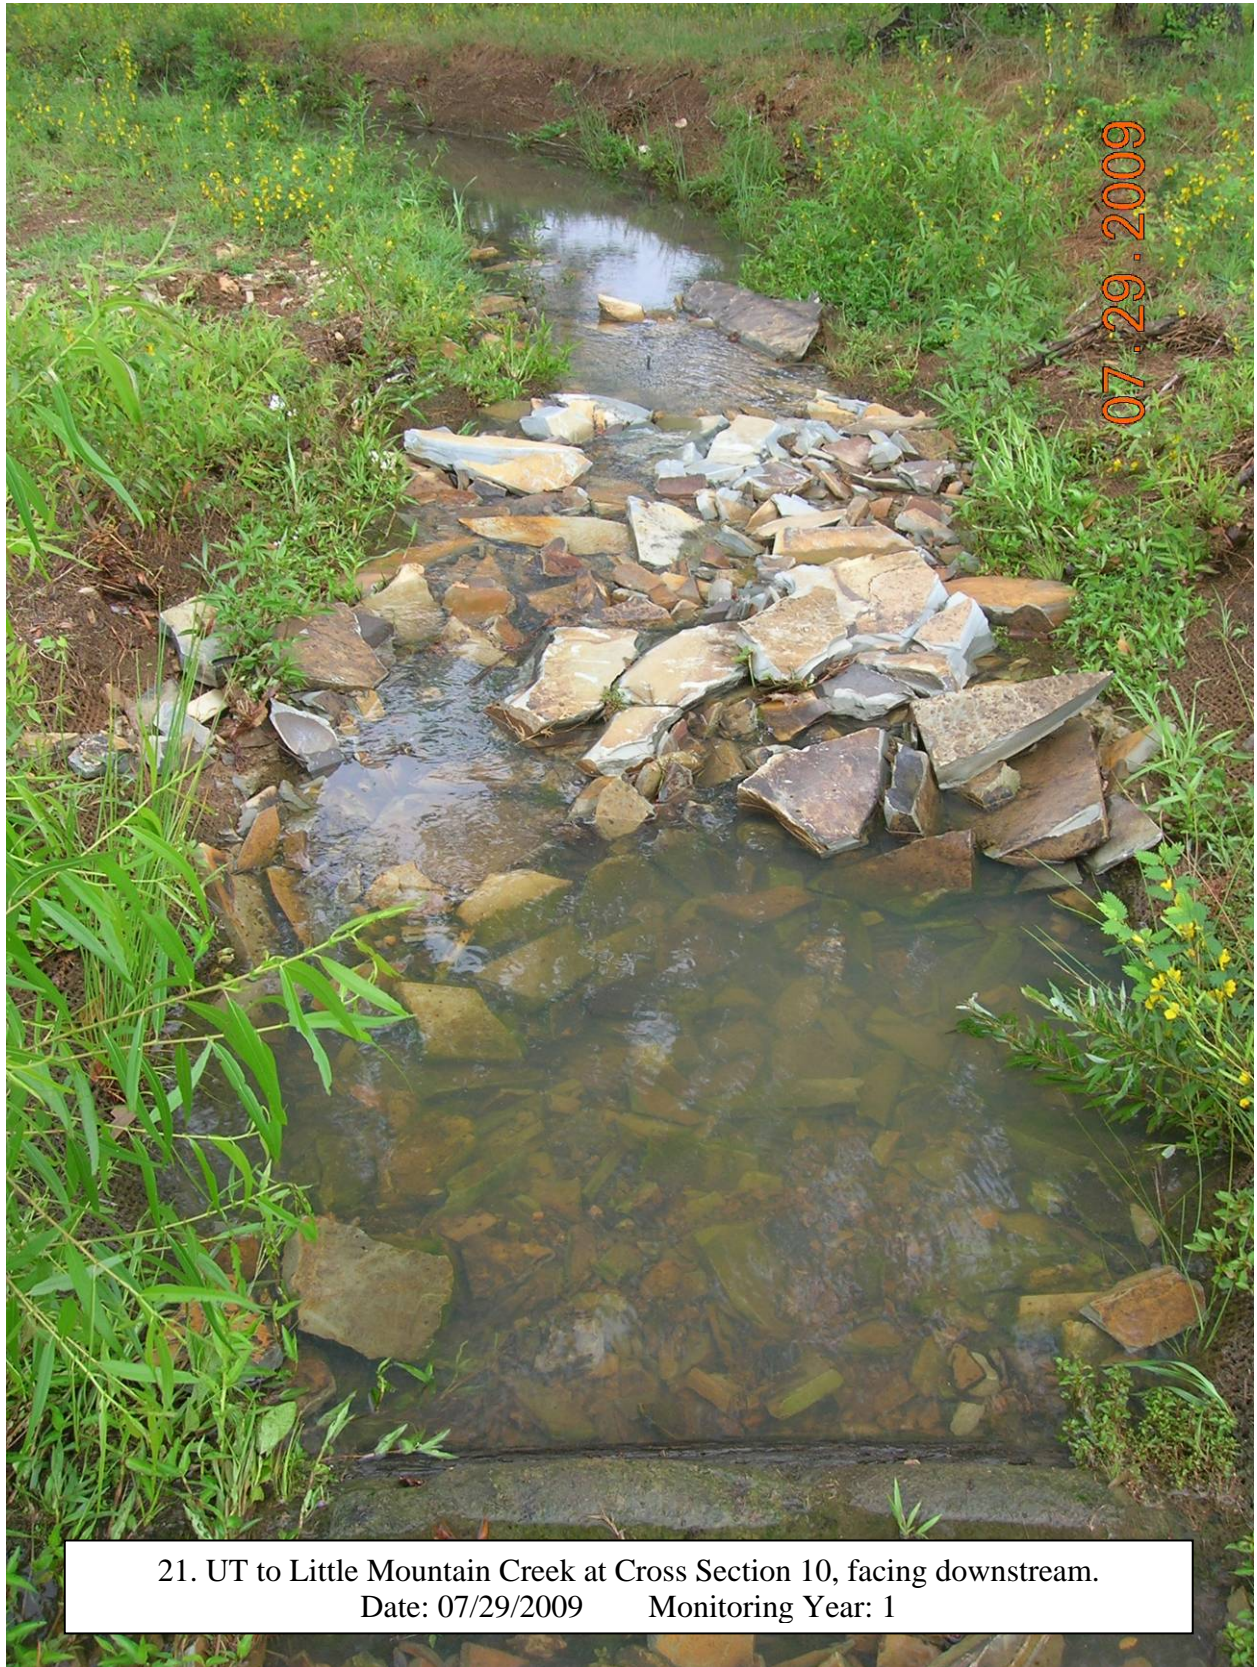
20. UT to Little Mountain Creek at Cross Section 10, facing upstream.
Date: 07/29/2009 Monitoring Year: 0

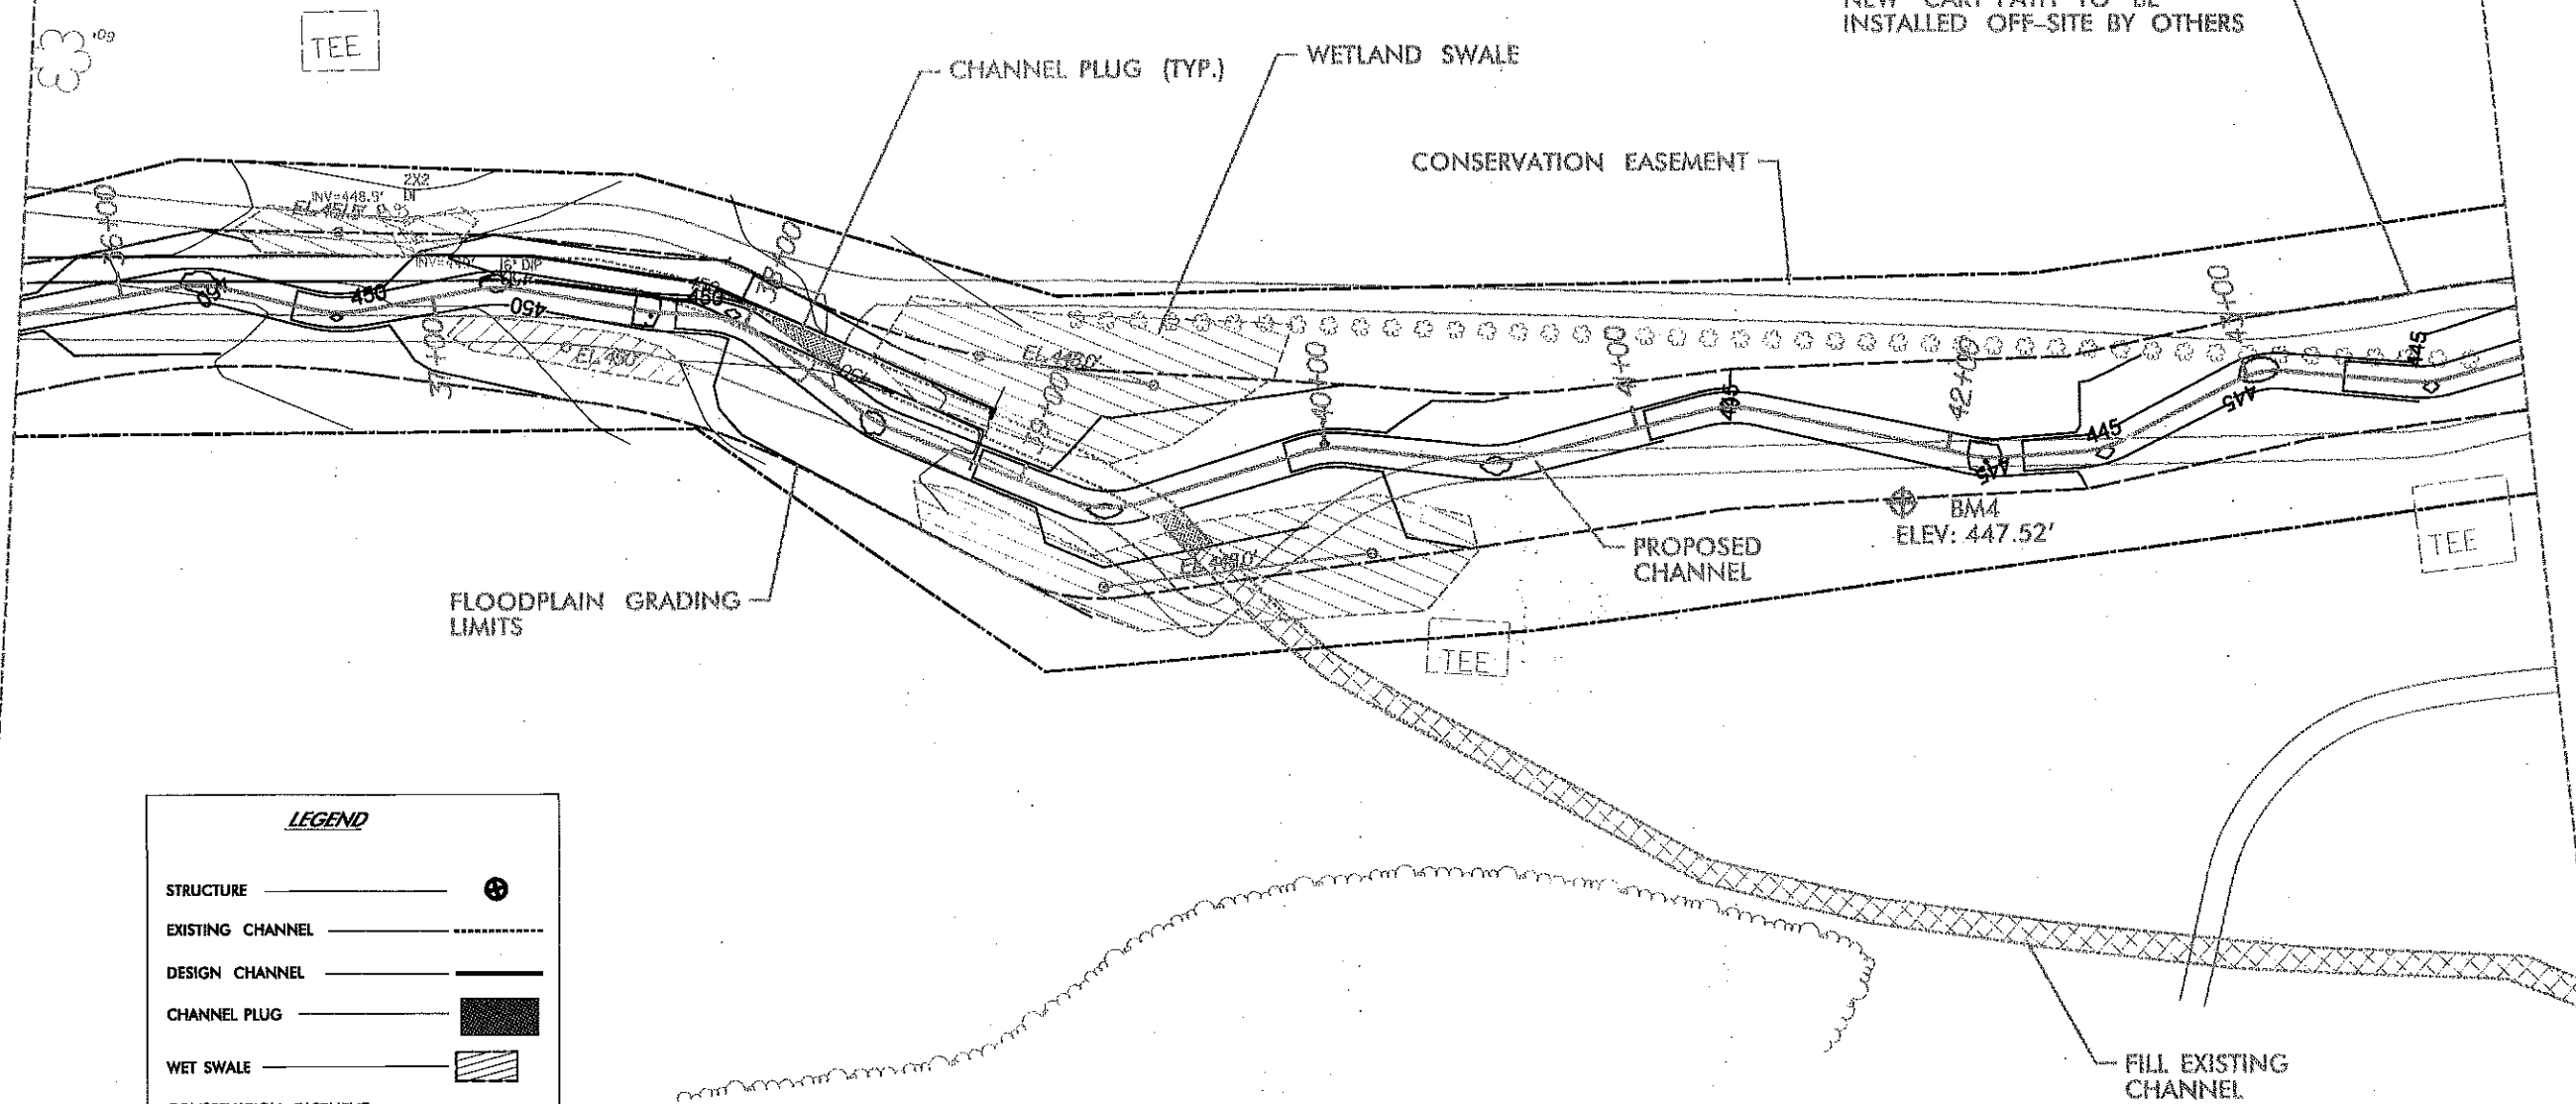
REMOVE EXISTING
CART PATH
NEW CART PATH TO BE
INSTALLED OFF-SITE BY OTHERS

END CONSTRUCTION
 -SREV- STA 50+22
 N: 599169.39
 E: 1666742.68

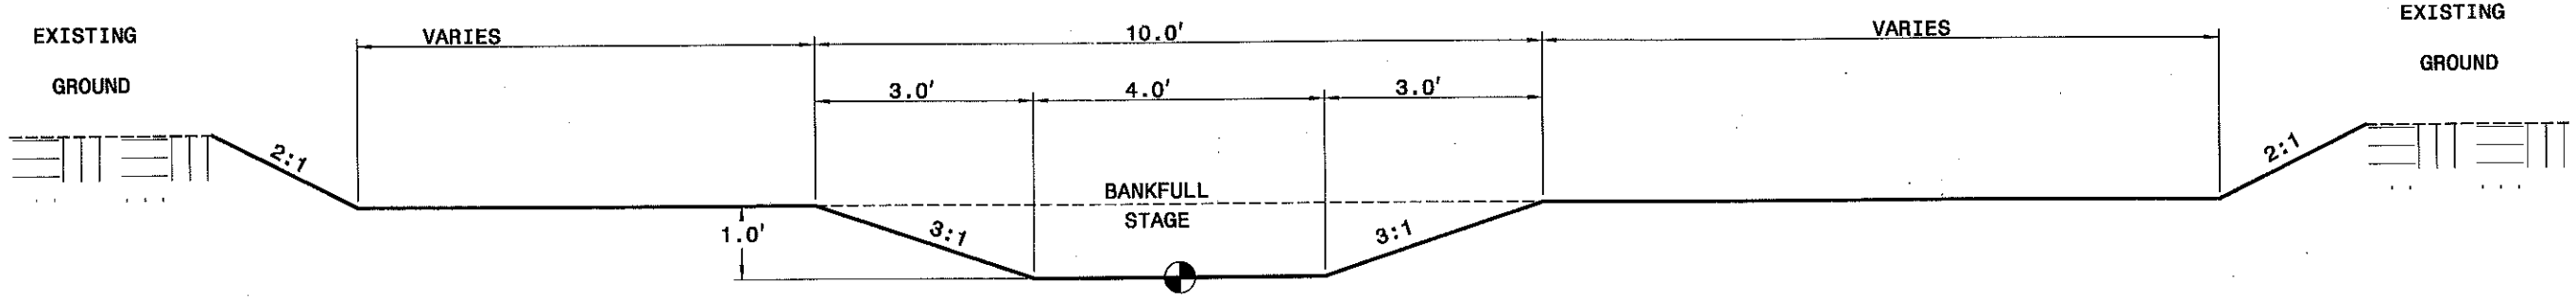
TYPICAL SECTION -SREV-

☉ = THALWEG LOCATION

RIFFLE

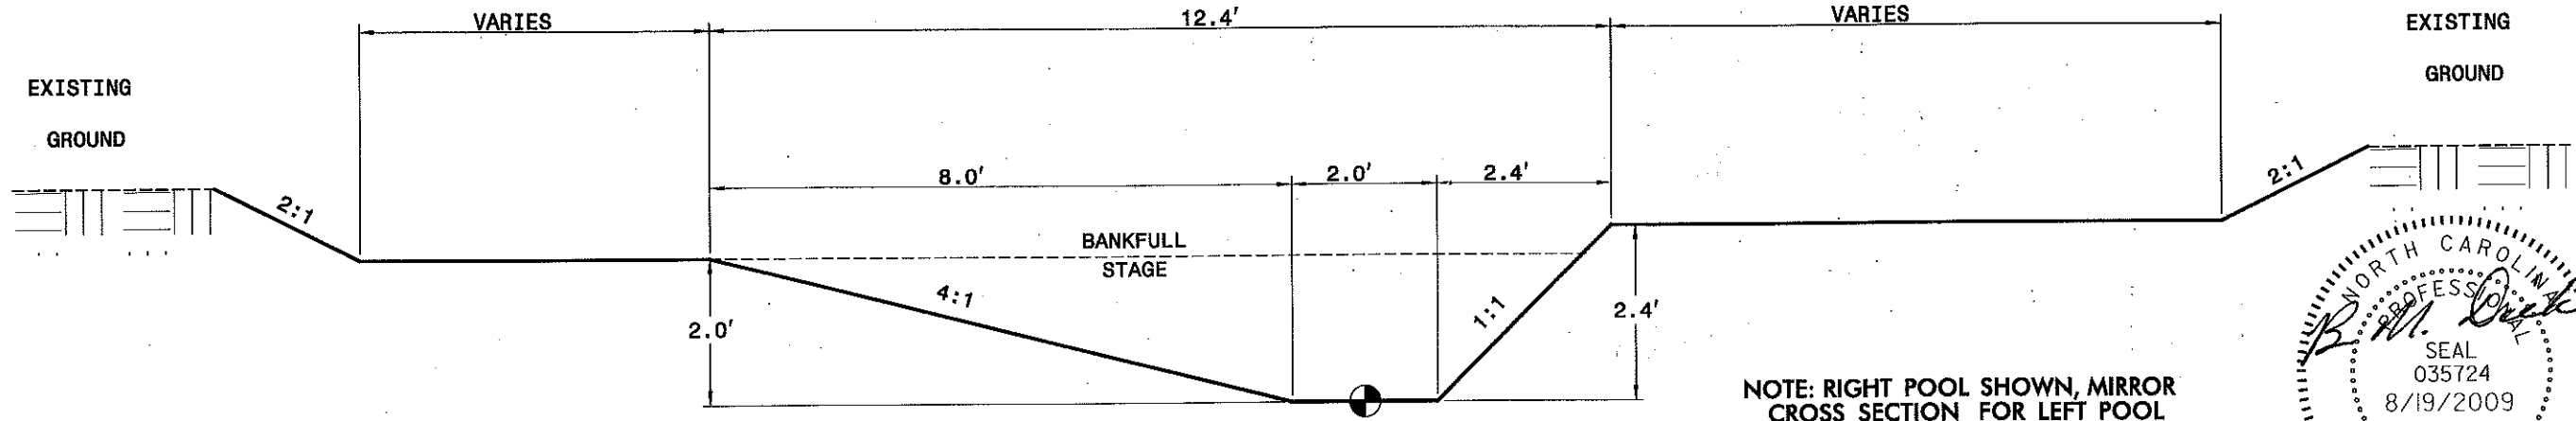
TYPICAL SECTION -SREV-

POOL

NOTE: RIGHT POOL SHOWN, MIRROR CROSS SECTION FOR LEFT POOL

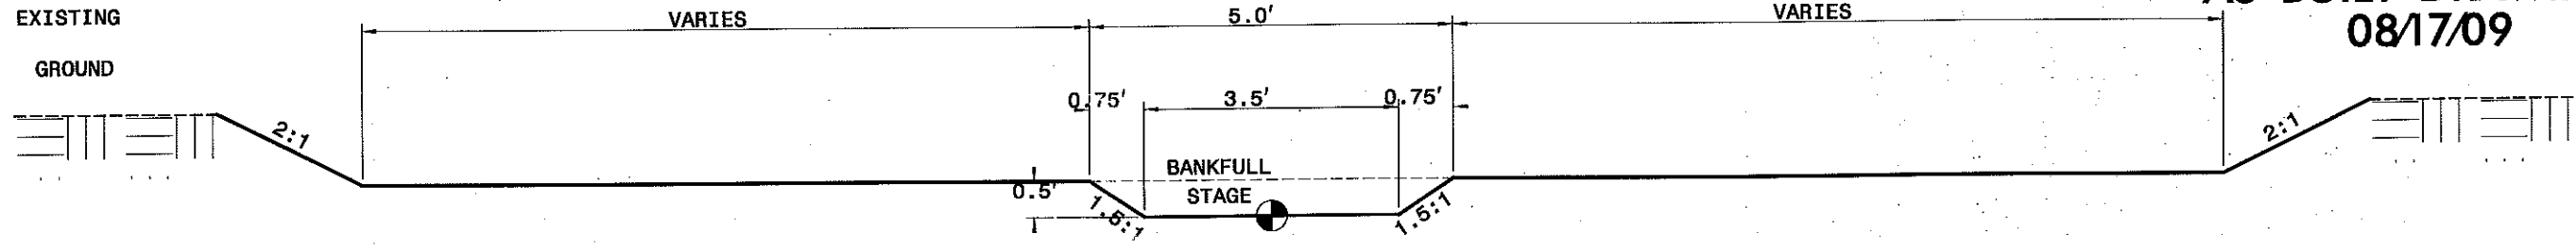
TYPICAL SECTION -TRIB-

RIFFLE

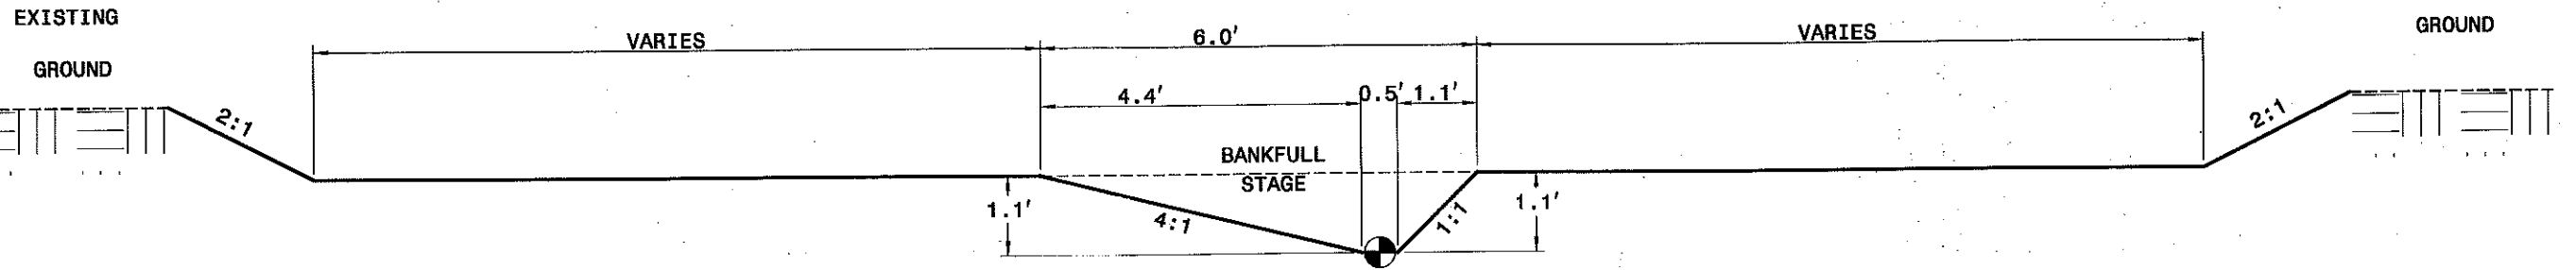
TYPICAL SECTION -TRIB-

POOL

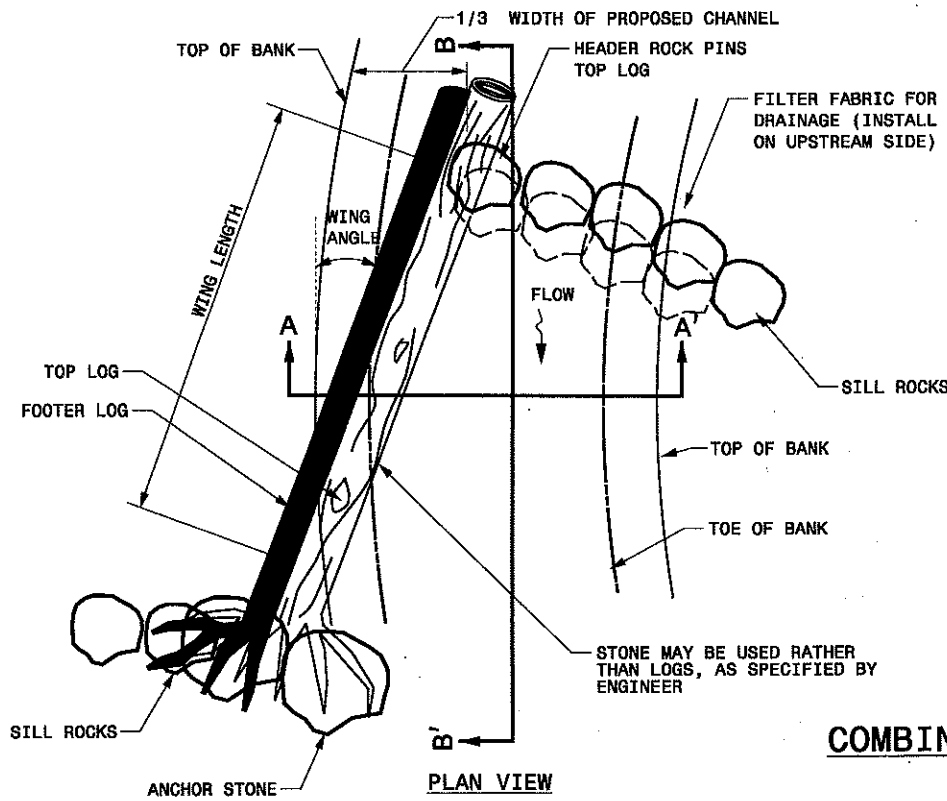
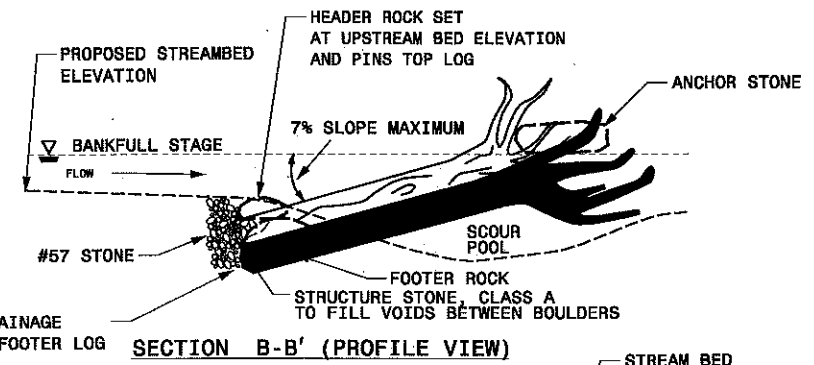
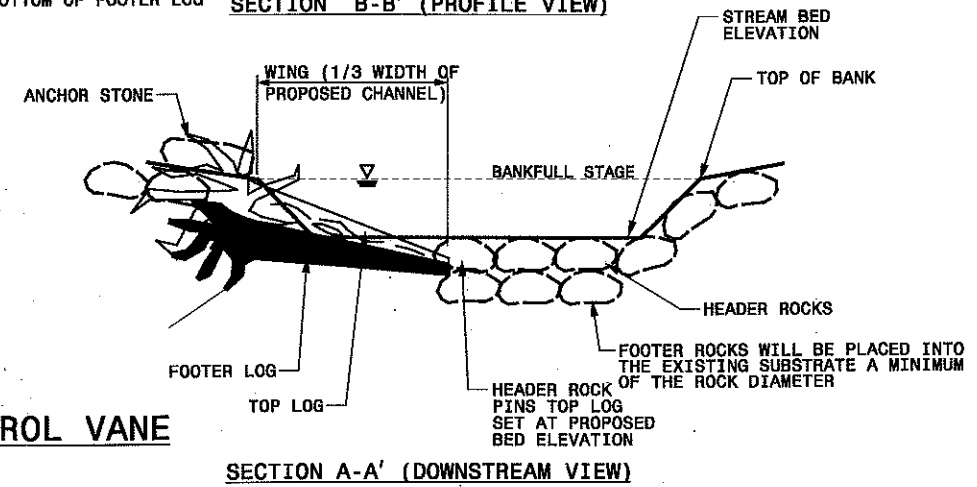
COMBINATION GRADE CONTROL VANE/ ROCK GRADE CONTROL VANE

WING LENGTH	-SREV-
APPROXIMATE LENGTH ALONG CENTERLINE	
WING ANGLE

NOTES:
 HEADER, FOOTER, AND SILL ROCKS TO BE STRUCTURE STONE, 18" - 30".
 AT THE DISCRETION OF THE ENGINEER, SURGE STONE MAY BE USED IN LIEU OF #57 STONE AND CLASS 'A' USED TO FILL VOIDS.

NOTE:
 VANE PARAMETERS WILL BE DETERMINED IN FINAL DESIGN

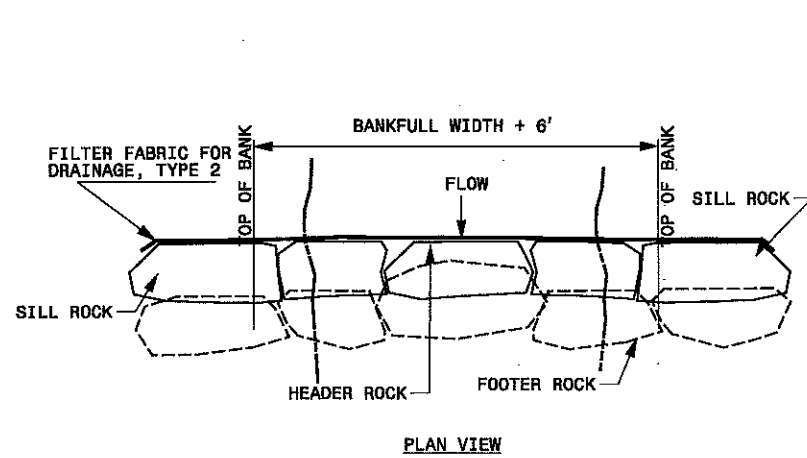
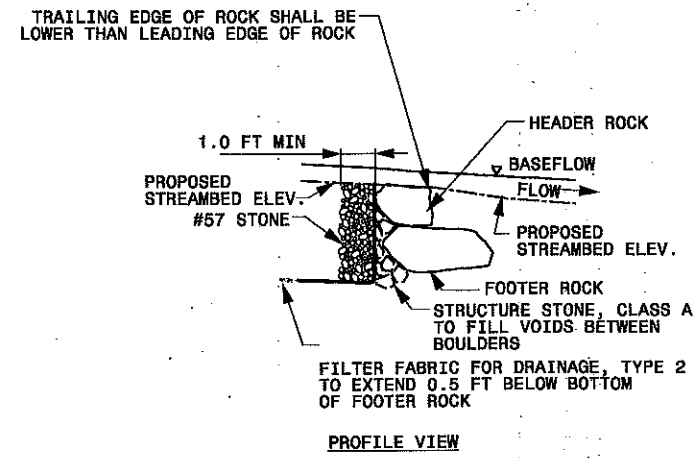
ROCK SILL

NOTES:
 HEADER, FOOTER, AND SILL ROCKS TO BE STRUCTURE STONE, CLASS BOULDER
 HEADER ROCK IS PLACED LOWER THAN TOE ROCKS

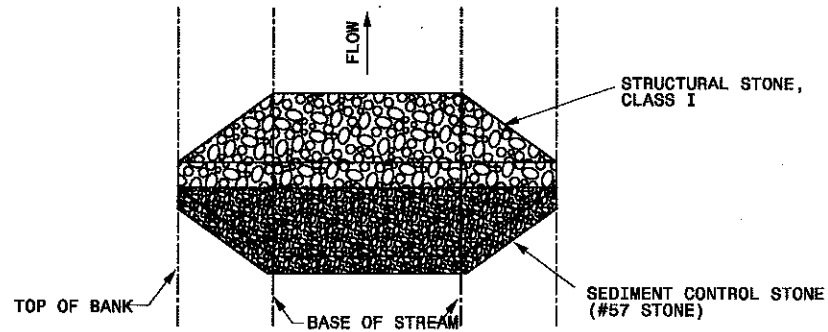
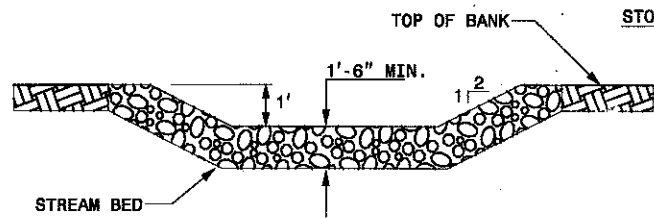
STONE IMPERVIOUS DIKE
CROSS SECTION

- NOTES:
1. THE STRUCTURE SHALL BE USED FOR DIVERTING AND PUMPING ONLY. THE STRUCTURE SHALL BE RELOCATED OR REMOVED ONCE PUMPING/DIVERTING IS COMPLETE.
 2. EITHER TYPE OF IMPERVIOUS DIKE (SANDBAG OR STONE) MAY BE USED.

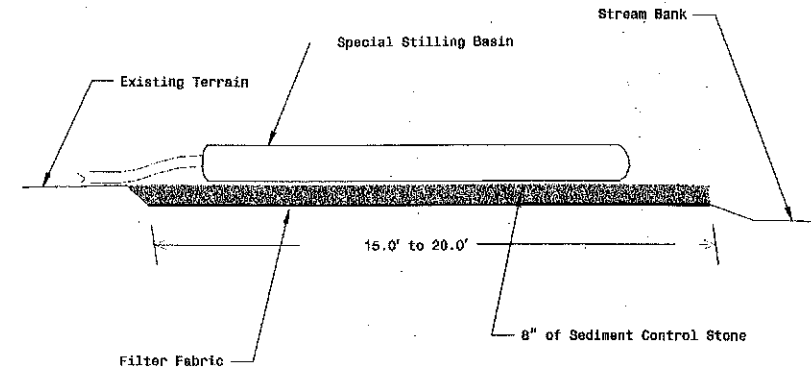
SPECIAL STILLING BASIN

Note: Provide Stabilized Outlet to Streambank
Not To Scale

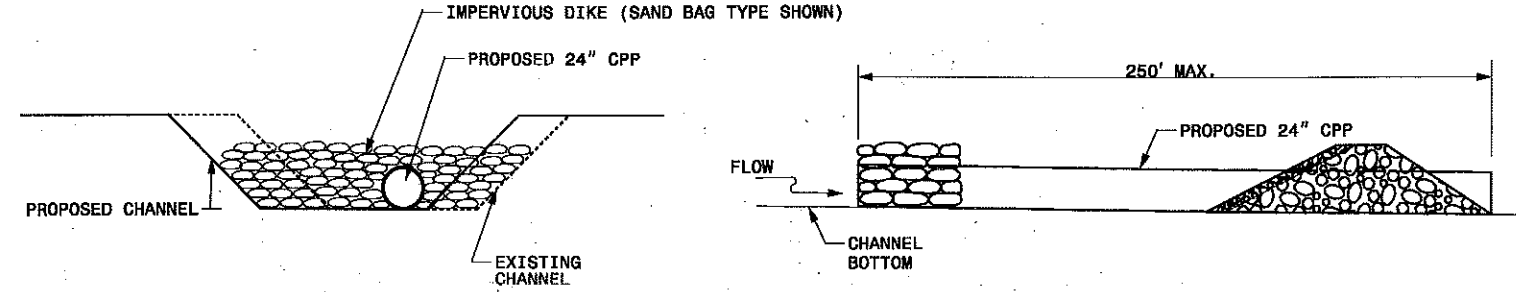
DIVERSION CROSS SECTION

DIVERSION PROFILE

NOTE:
PIPE MUST HAVE POSITIVE DRAINAGE WHEN USING DIVERSION (0.3% TO 2.0% PIPE SLOPE IS RECOMMENDED)
