**Badin Inn Stream Restoration
Stanly County, NC**

**Mitigation Plan and As-built Baseline Report
DRAFT**

**EEP Project Number 92666
SCO Project Number D06125-E
Data Collection Period: April-July, 2009
Submission Date: August, 2009**

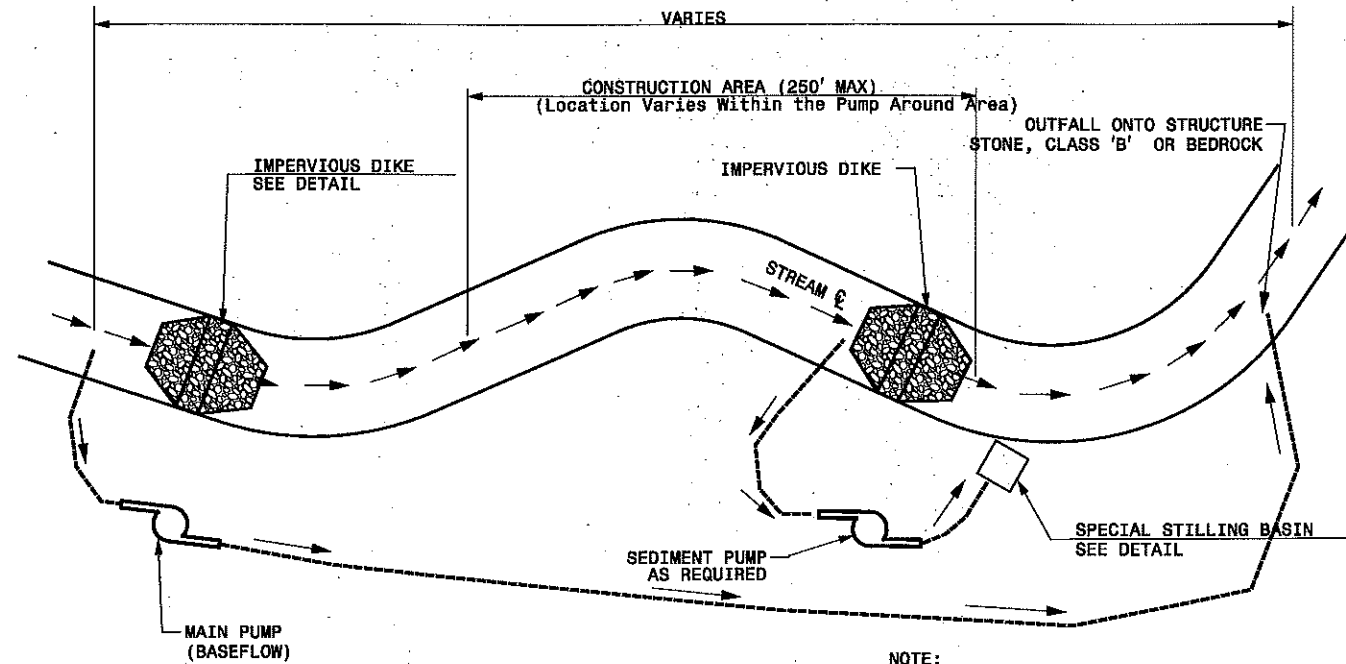
PUMP-AROUND/PIPE DIVERSION

NOTE:
CHANNEL SHALL BE MATTED WITH COIR FIBER MATTING (SEE DETAIL) PRIOR TO THE CLOSE OF EACH WORK DAY.

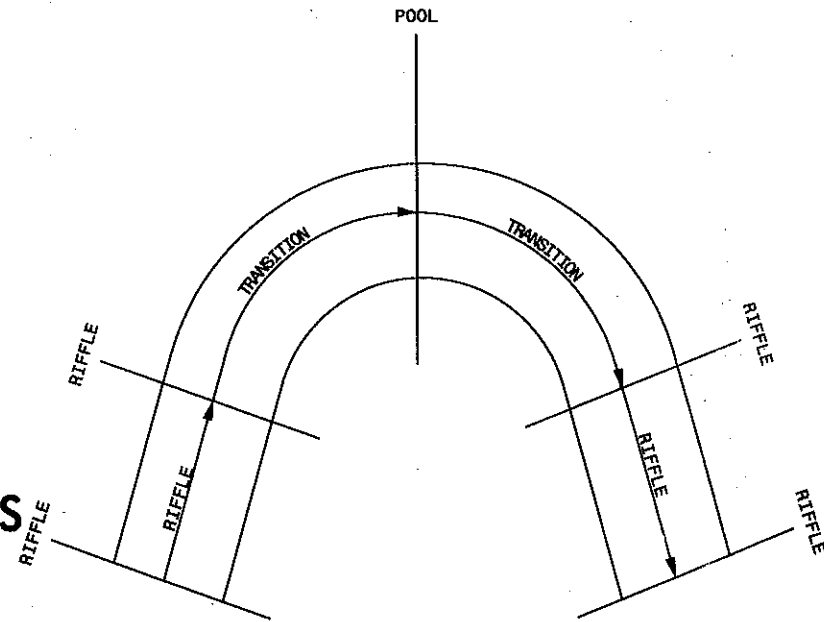
CROSS SECTION TRANSITION LOCATIONS

1. AREAS IN BETWEEN LABELED FEATURES ARE TRANSITION AREAS.
2. SEE TYPICALS AND STATIONING FOR MORE DETAIL.
3. THE AREA BETWEEN THE CONCURRENT RIFFLE CROSS-SECTIONS ARE CONSIDERED THE RIFFLE SECTION.
4. THE AREA BETWEEN THE DOWNSTREAM RIFFLE AND RUN CROSS-SECTION IS CONSIDERED THE RUN SECTION.
5. THE AREA BETWEEN THE RUN AND GLIDE CROSS-SECTION IS CONSIDERED THE POOL SECTION.
6. THE AREA BETWEEN THE GLIDE AND THE UPSTREAM RIFFLE CROSS-SECTION IS CONSIDERED THE GLIDE SECTION.

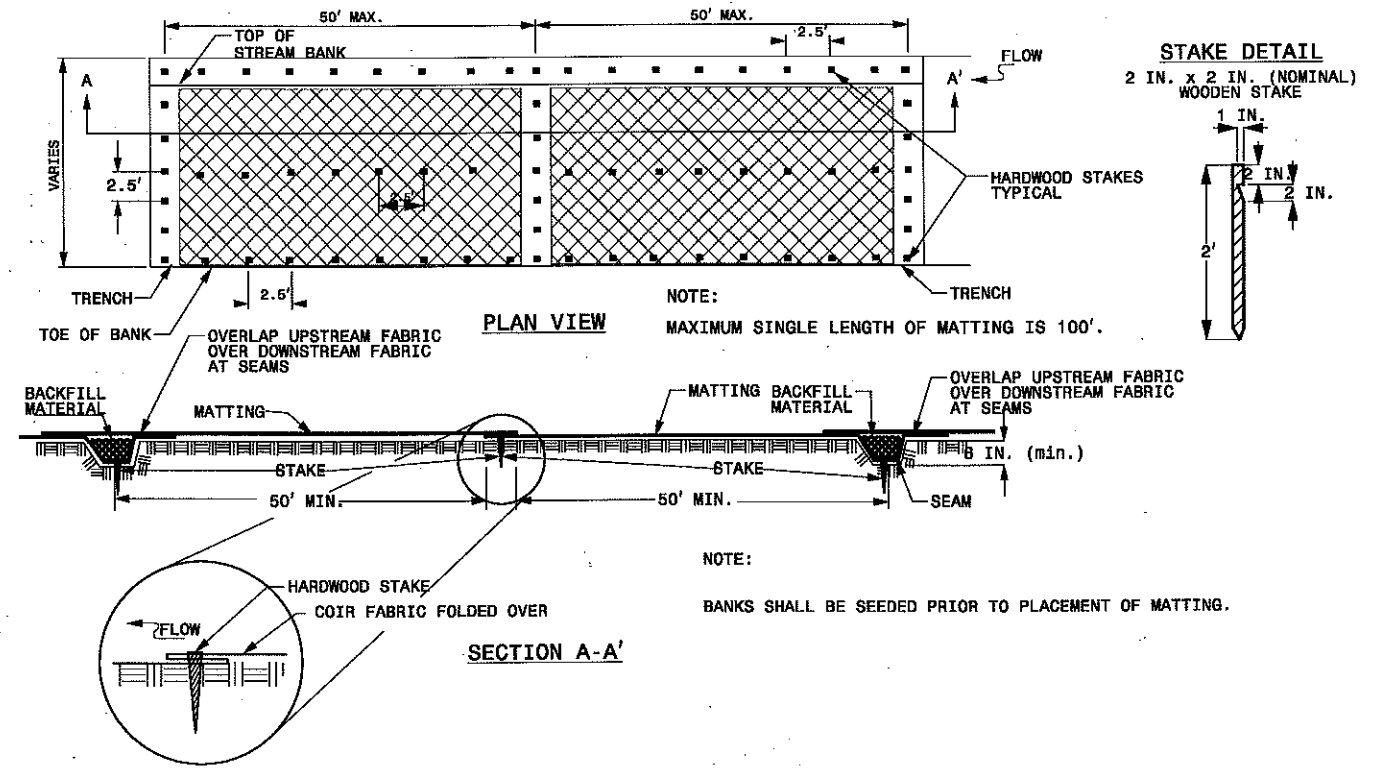
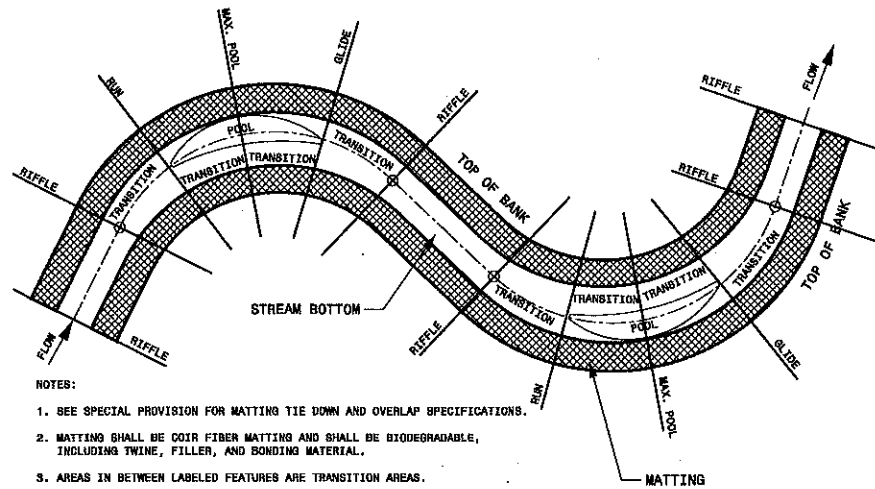
COIR FABRIC

1. SEE SPECIAL PROVISION FOR MATTING TIE DOWN AND OVERLAP SPECIFICATIONS.
2. MATTING SHALL BE COIR FIBER MATTING AND SHALL BE BIODEGRADABLE, INCLUDING TWINE, FILLER, AND BONDING MATERIAL.
3. AREAS IN BETWEEN LABELED FEATURES ARE TRANSITION AREAS.
4. THE AREA BETWEEN THE CONCURRENT RIFFLE CROSS-SECTIONS ARE CONSIDERED THE RIFFLE SECTION.
5. THE AREA BETWEEN THE DOWNSTREAM RIFFLE AND RUN CROSS-SECTION IS CONSIDERED THE RUN SECTION.
6. THE AREA BETWEEN THE RUN AND GLIDE CROSS-SECTION IS CONSIDERED THE POOL SECTION.
7. THE AREA BETWEEN THE GLIDE AND THE UPSTREAM RIFFLE CROSS-SECTION IS CONSIDERED THE GLIDE SECTION.

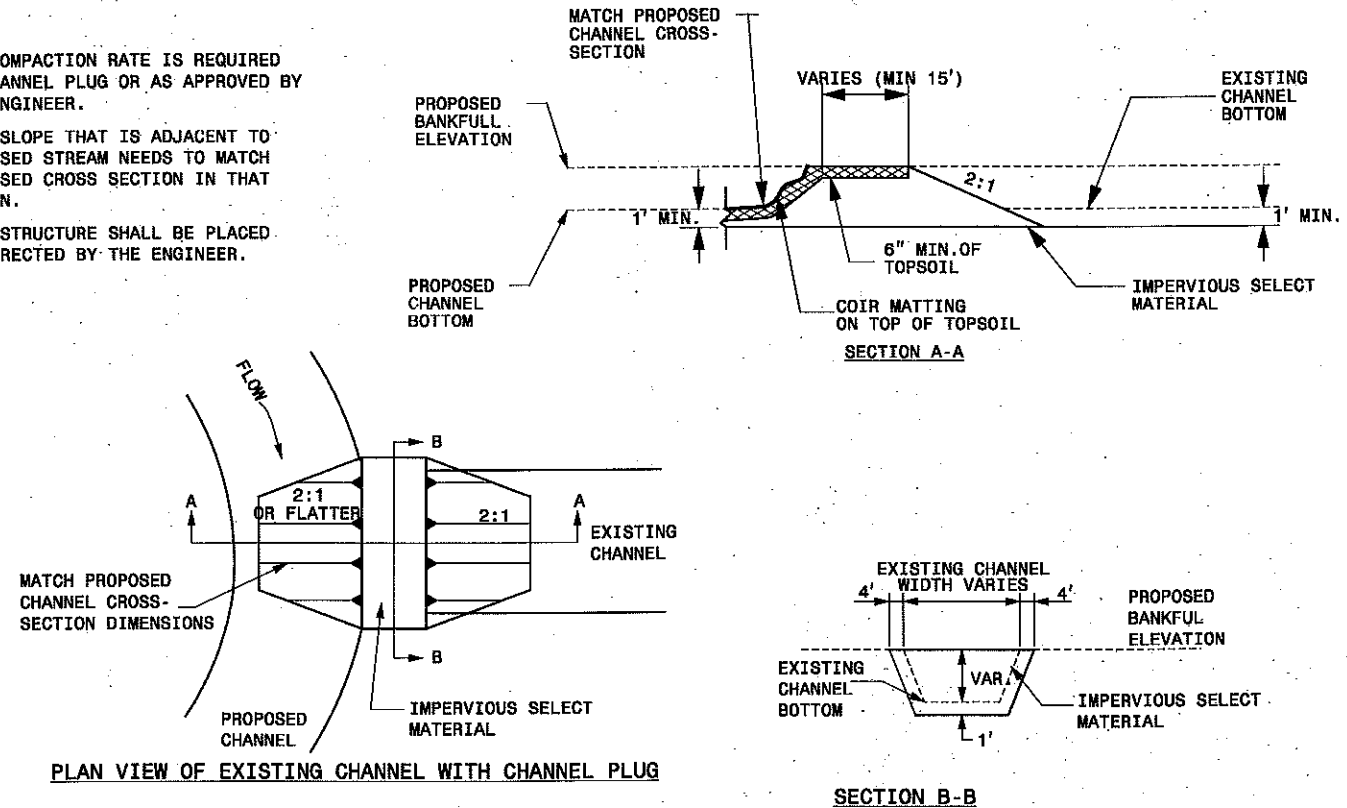
1. 90% COMPACTION RATE IS REQUIRED ON CHANNEL PLUG OR AS APPROVED BY THE ENGINEER.
2. SIDE SLOPE THAT IS ADJACENT TO PROPOSED STREAM NEEDS TO MATCH PROPOSED CROSS SECTION IN THAT REGION.
3. THIS STRUCTURE SHALL BE PLACED AS DIRECTED BY THE ENGINEER.

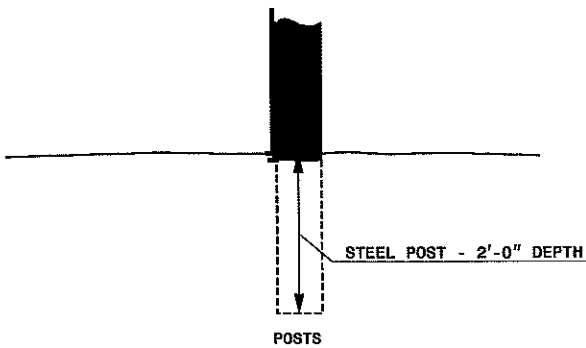
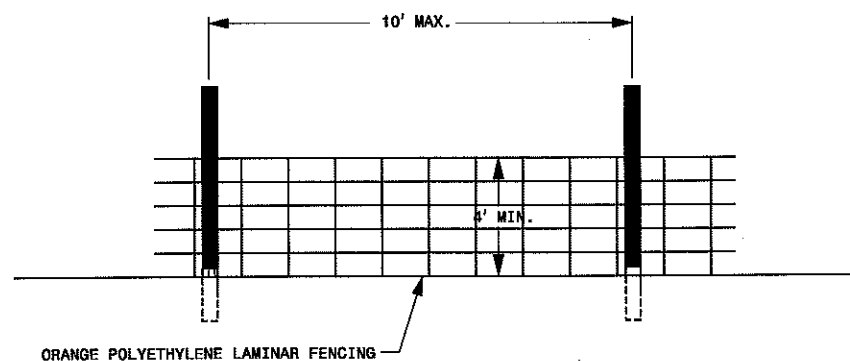
SAFETY FENCE/TREE PROTECTION FENCE

- NOTES:
1. STEEL POSTS SHALL BE 5'-0" IN HEIGHT AND BE OF THE SELF-FASTENER ANGLE STEEL TYPE.
 2. WOOD POST SHALL BE 6'-0" IN HEIGHT AND 3" MINIMUM IN DIAMETER.

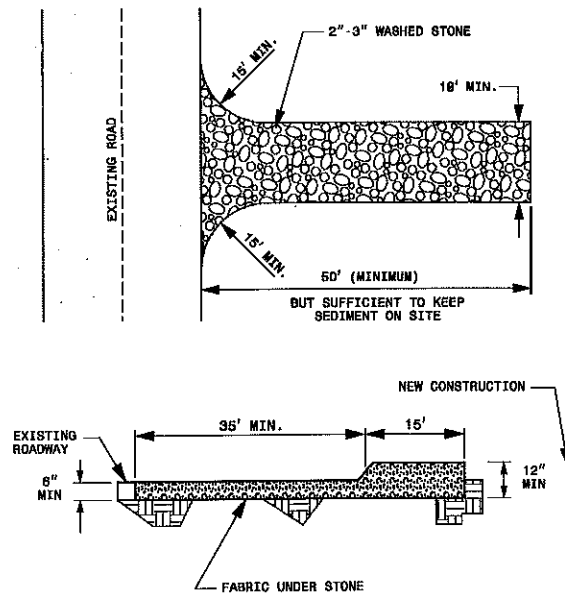
TEMPORARY CONSTRUCTION ENTRANCE

3. THE ENTRANCE SHALL BE MAINTAINED IN A CONDITION WHICH WILL PREVENT TRACKING OR FLOWING OF SEDIMENT ONTO PUBLIC STREETS OR EXISTING PAVEMENT. THIS MAY REQUIRE PERIODIC TOP DRESSING WITH ADDITIONAL STONE AS CONDITIONS DEMAND AND REPAIR AND/OR CLEAR OUT OF ANY MEASURES USED TO TRAP SEDIMENT.

4. ALL SEDIMENT SPILLED, DROPPED, WASHED, OR TRACKED ONTO PUBLIC STREETS MUST BE REMOVED IMMEDIATELY.
 5. IF CONSTRUCTION ON THE SITES ARE SUCH THAT THE MUD IS NOT REMOVED BY THE VEHICLE TRAVELING OVER THE STONE, THEN THE TIRES OF THE VEHICLES MUST BE WASHED BEFORE ENTERING THE PUBLIC ROAD. WHEN WASHING IS REQUIRED, IT SHALL BE DONE ON AN AREA STABILIZED WITH CRUSHED STONE WHICH DRAINS INTO AN APPROVED SEDIMENT BASIN.

6. ADDITIONAL GRADING SHALL BE REQUIRED TO CONNECT THE STONE ENTRANCE TO THE EXISTING GROUND. UPON COMPLETION OF THE PROJECT, THE ROAD SHALL BE RETURNED TO A CONDITION THAT MEETS OR EXCEEDS THE PRE-EXISTING CONDITIONS.

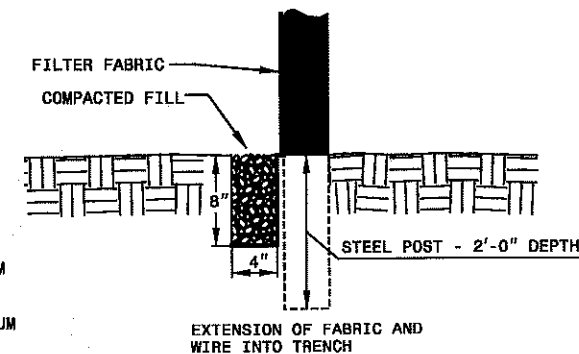
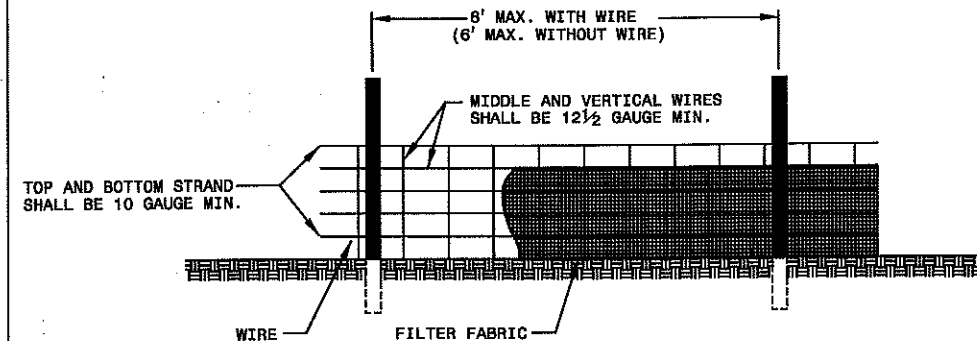
TEMPORARY SILT FENCE (HIGH VISIBILITY)

- NOTES
- WIRE SHALL BE A MINIMUM OF 32" IN WIDTH AND SHALL HAVE A MINIMUM OF 6 LINE WIRES WITH 12" STAY SPACING.
- FILTER FABRIC SHALL BE A MINIMUM OF 36" IN WIDTH AND SHALL BE FASTENED ADEQUATELY TO THE WIRE AS DIRECTED BY THE ENGINEER.
- STEEL POST SHALL BE 5'-0" IN HEIGHT AND BE OF THE SELF-FASTENER ANGLE STEEL TYPE.

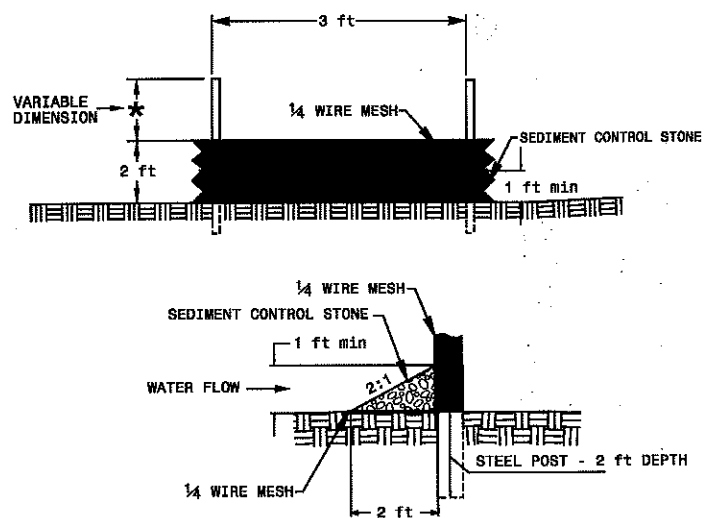
SPECIAL SEDIMENT CONTROL FENCE

SEDIMENT CONTROL STONE SHALL BE NO. 5 OR NO. 57 AND SHALL BE PAID FOR AT THE CONTRACT UNIT PRICE PER TON "SEDIMENT CONTROL STONE."

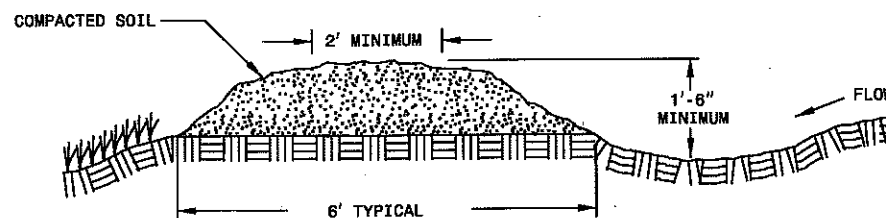
TEMPORARY DIVERSION

CROSS SECTIONAL VIEW

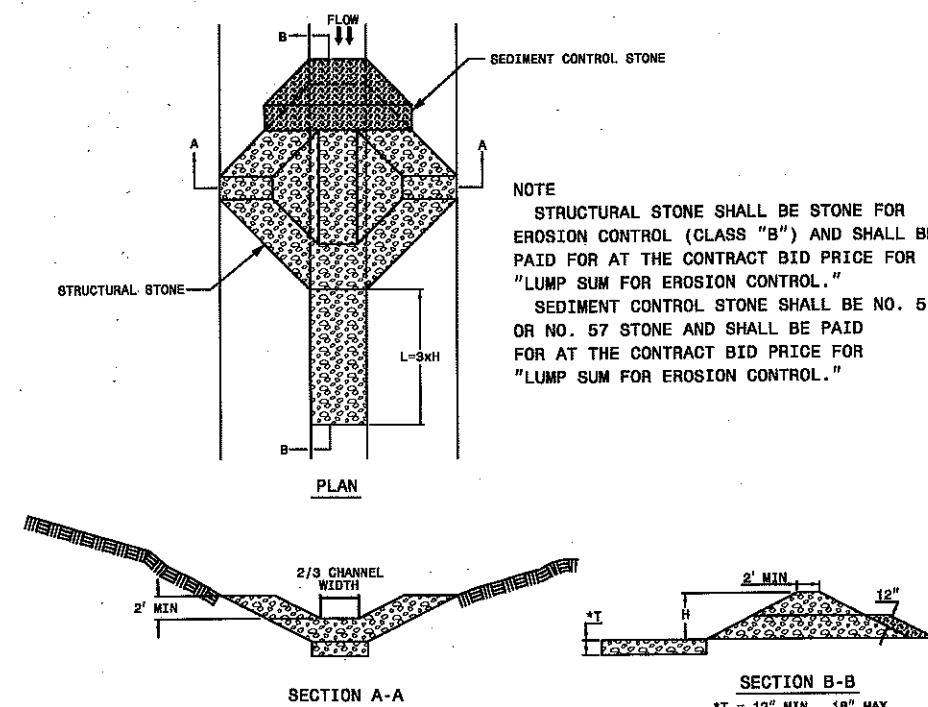
TEMPORARY ROCK SILT CHECK TYPE 'A'

- NOTE
- STRUCTURAL STONE SHALL BE STONE FOR EROSION CONTROL (CLASS "B") AND SHALL BE PAID FOR AT THE CONTRACT BID PRICE FOR "LUMP SUM FOR EROSION CONTROL."
- SEDIMENT CONTROL STONE SHALL BE NO. 5 OR NO. 57 STONE AND SHALL BE PAID FOR AT THE CONTRACT BID PRICE FOR "LUMP SUM FOR EROSION CONTROL."

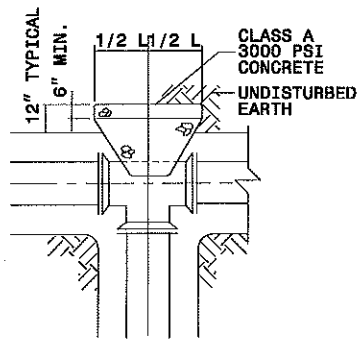
PLAN - TEE

THRUST BLOCKING
SCALE: NTS

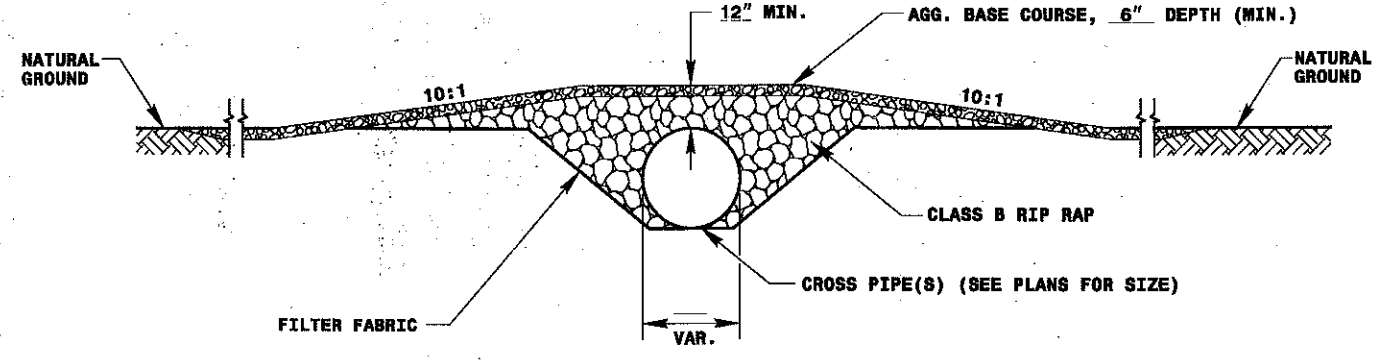
TEMPORARY STREAM CROSSING
SCALE: NTS

SECTION A-A
NOT TO SCALE

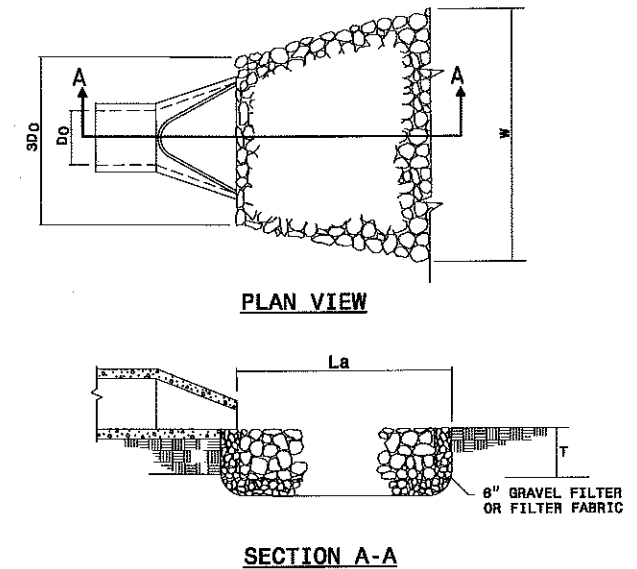
- La IS THE LENGTH OF THE RIPRAP APRON.
- THE DOWNSTREAM WIDTH OF THE APRON IS EQUAL TO $D_0 + 0.4L_a$
- A FILTER BLANKET OR FILTER FABRIC SHOULD BE INSTALLED BETWEEN THE RIPRAP AND SOIL FOUNDATION.
- IN A WELL DEFINED CHANNEL EXTEND THE APRON UP THE CHANNEL BANKS TO AN ELEVATION OF 6" ABOVE THE MAXIMUM TAILWATER DEPTH OR TO THE TOP OF THE BANK, WHICHEVER IS LESS.

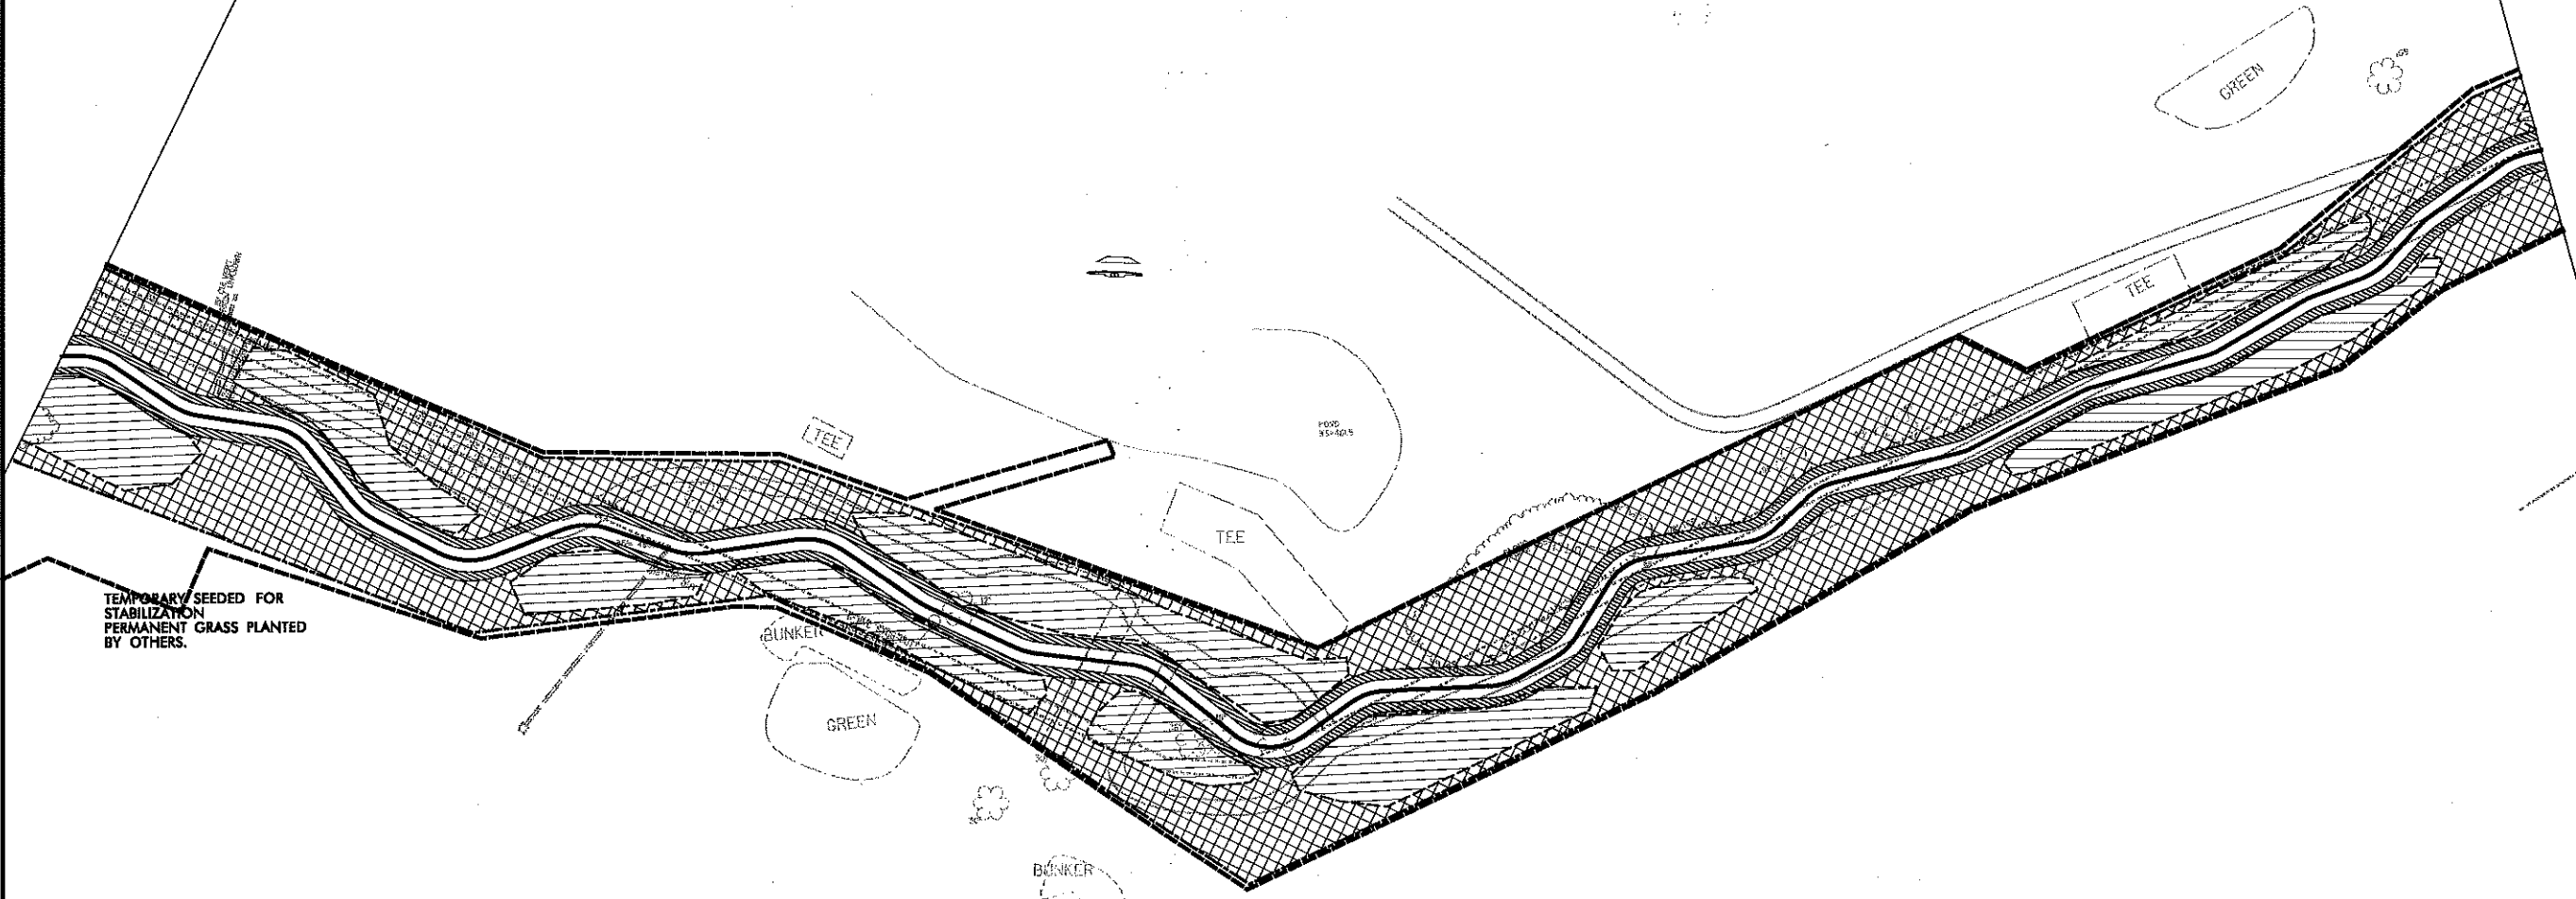
DATE	8/19/2009
PROJECT NO	99255
FILENAME	
SHEET NO	L-2
DRAWN BY	CHKD BY
ICJ	BMD

TEMPORARY SEEDED FOR
STABILIZATION
PERMANENT GRASS PLANTED
BY OTHERS.

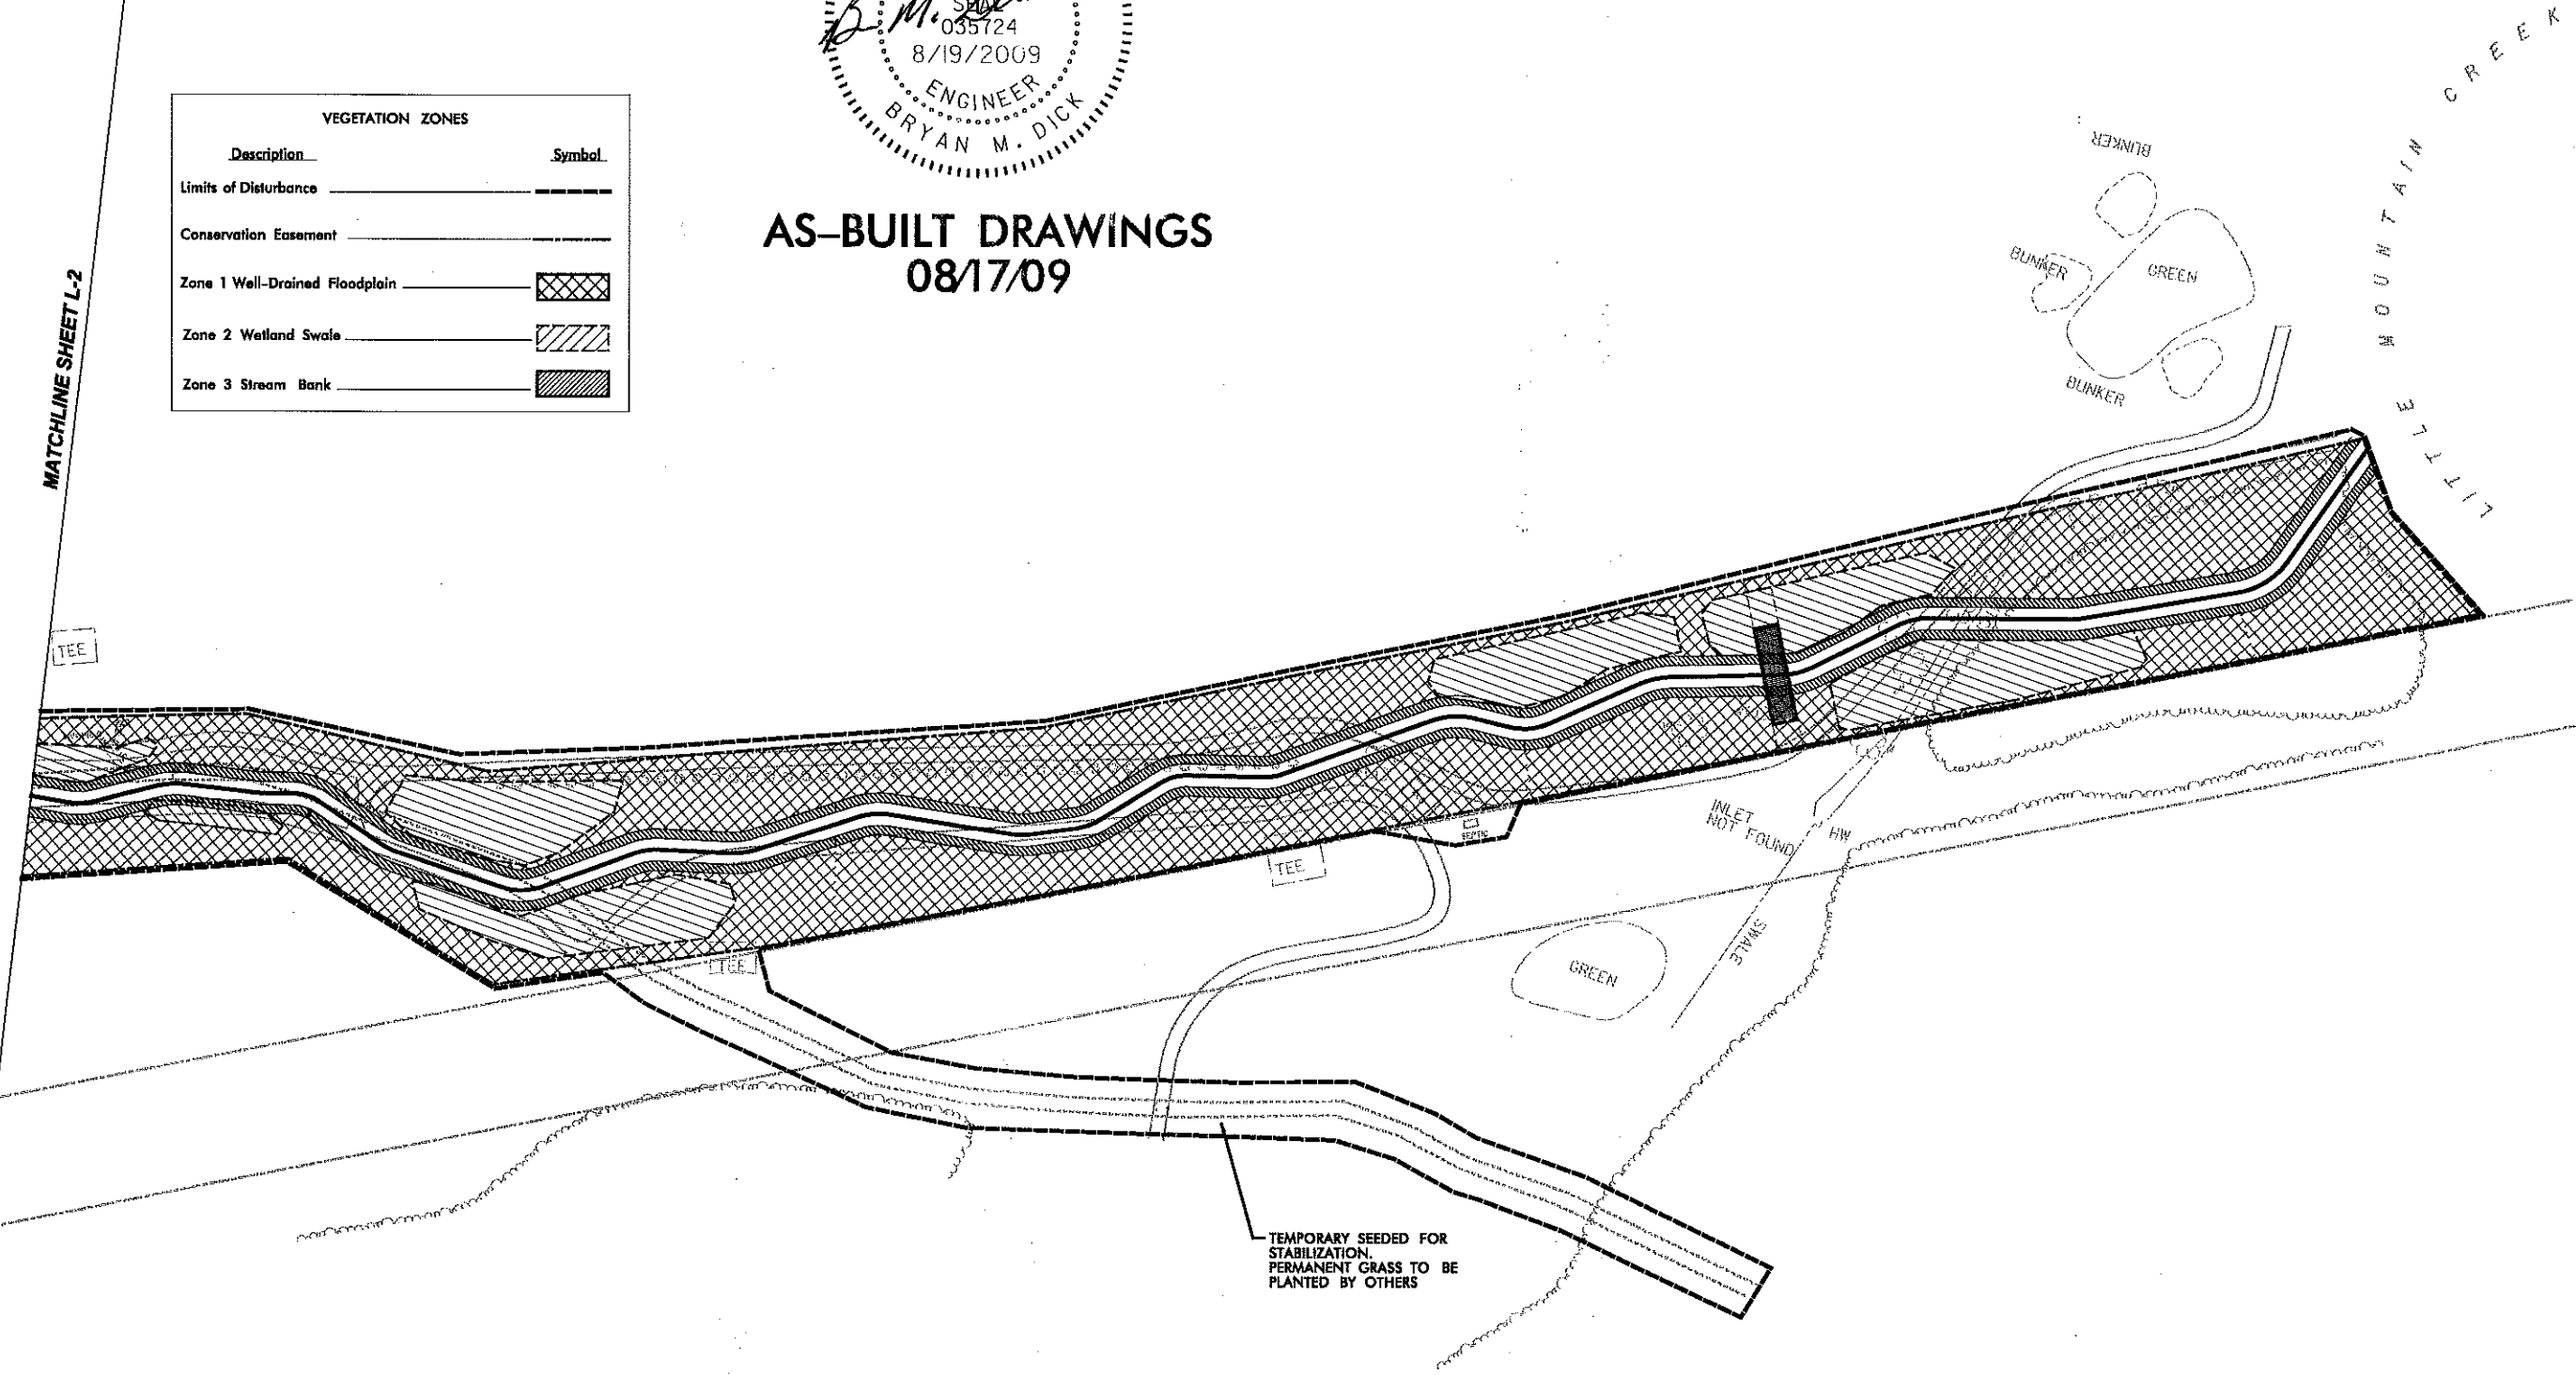
DATE	8/19/2009
PROJECT NO	99255
FILENAME	
SHEET NO	L-3
DRAWN BY	CHKD BY
ICJ	BMD

TEMPORARY SEEDED FOR STABILIZATION. PERMANENT GRASS TO BE PLANTED BY OTHERS

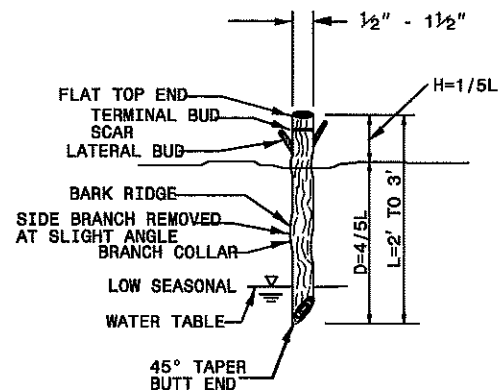
1. ALL LATERAL BRANCHES SHALL BE TRIMMED TO AVOID DAMAGE TO THE BARK RIDGE AND BRANCH COLLAR.
2. A MINIMUM OF TWO BUDS (ONE LATERAL PLUS ONE TERMINAL OR TWO TERMINAL) SHALL BE ABOVE THE PLANTING DEPTH.

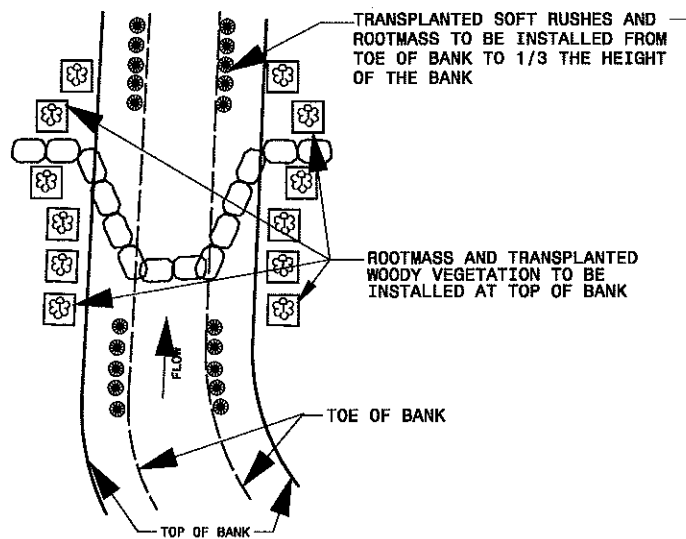
CROSS VANE/GRADE CONTROL VANE

TRANSPLANT PLACEMENT BY STRUCTURE TYPE

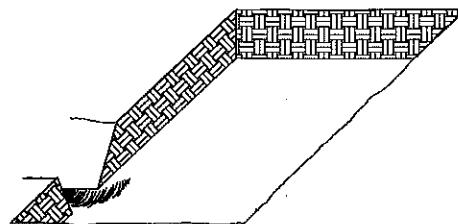
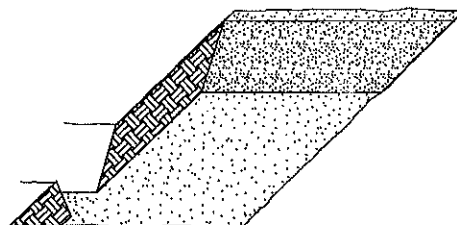
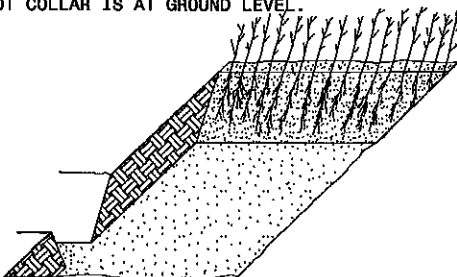
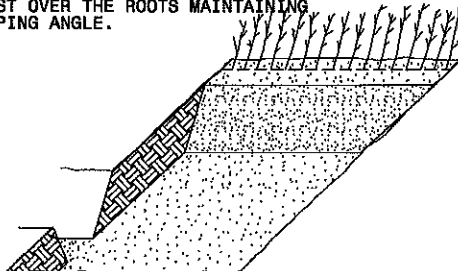
HEALING IN

1. LOCATE A HEALING-IN SITE IN A SHADY, WELL PROTECTED AREA.
2. EXCAVATE A FLAT BOTTOM TRENCH 300 MM DEEP AND PROVIDE DRAINAGE.

3. BACKFILL THE TRENCH WITH 50 MM OF WELL ROTTED SAWDUST. PLACE A 50 MM LAYER OF WELL ROTTED SAWDUST AT A SLOPING ANGLE AT ONE END OF THE TRENCH.

4. PLACE A SINGLE LAYER OF PLANTS AGAINST THE SLOPING END SO THAT THE ROOT COLLAR IS AT GROUND LEVEL.

5. PLACE A 50 MM LAYER OF WELL ROTTED SAWDUST OVER THE ROOTS MAINTAINING A SLOPING ANGLE.

6. REPEAT LAYERS OF PLANTS AND SAWDUST AS NECESSARY AND WATER THOROUGHLY.

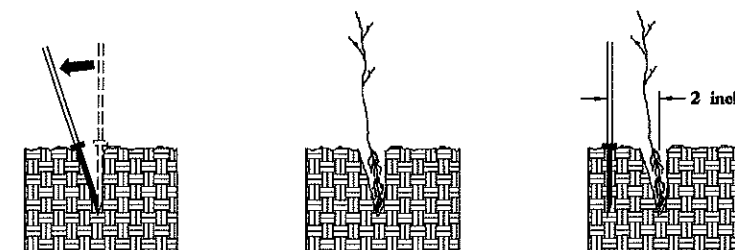
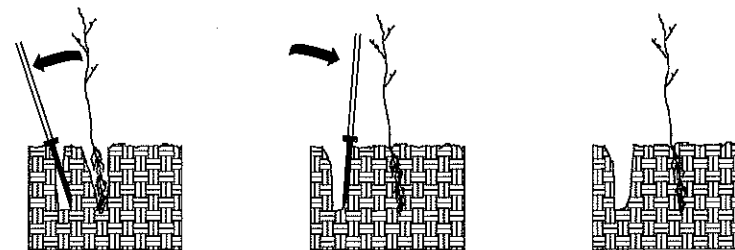
DIBBLE PLANTING METHOD USING THE KBC PLANTING BAR

1. INSERT PLANTING BAR AS SHOWN AND PULL HANDLE TOWARD PLANTER.
2. REMOVE PLANTING BAR AND PLACE SEEDLING AT CORRECT DEPTH.
3. INSERT PLANTING BAR 50 MM TOWARD PLANTER FROM SEEDLING.

4. PULL HANDLE OF BAR TOWARD PLANTER, FIRING SOIL AT BOTTOM.
5. PUSH HANDLE FORWARD FIRING SOIL AT TOP.
6. LEAVE COMPACTION HOLE OPEN. WATER THOROUGHLY.

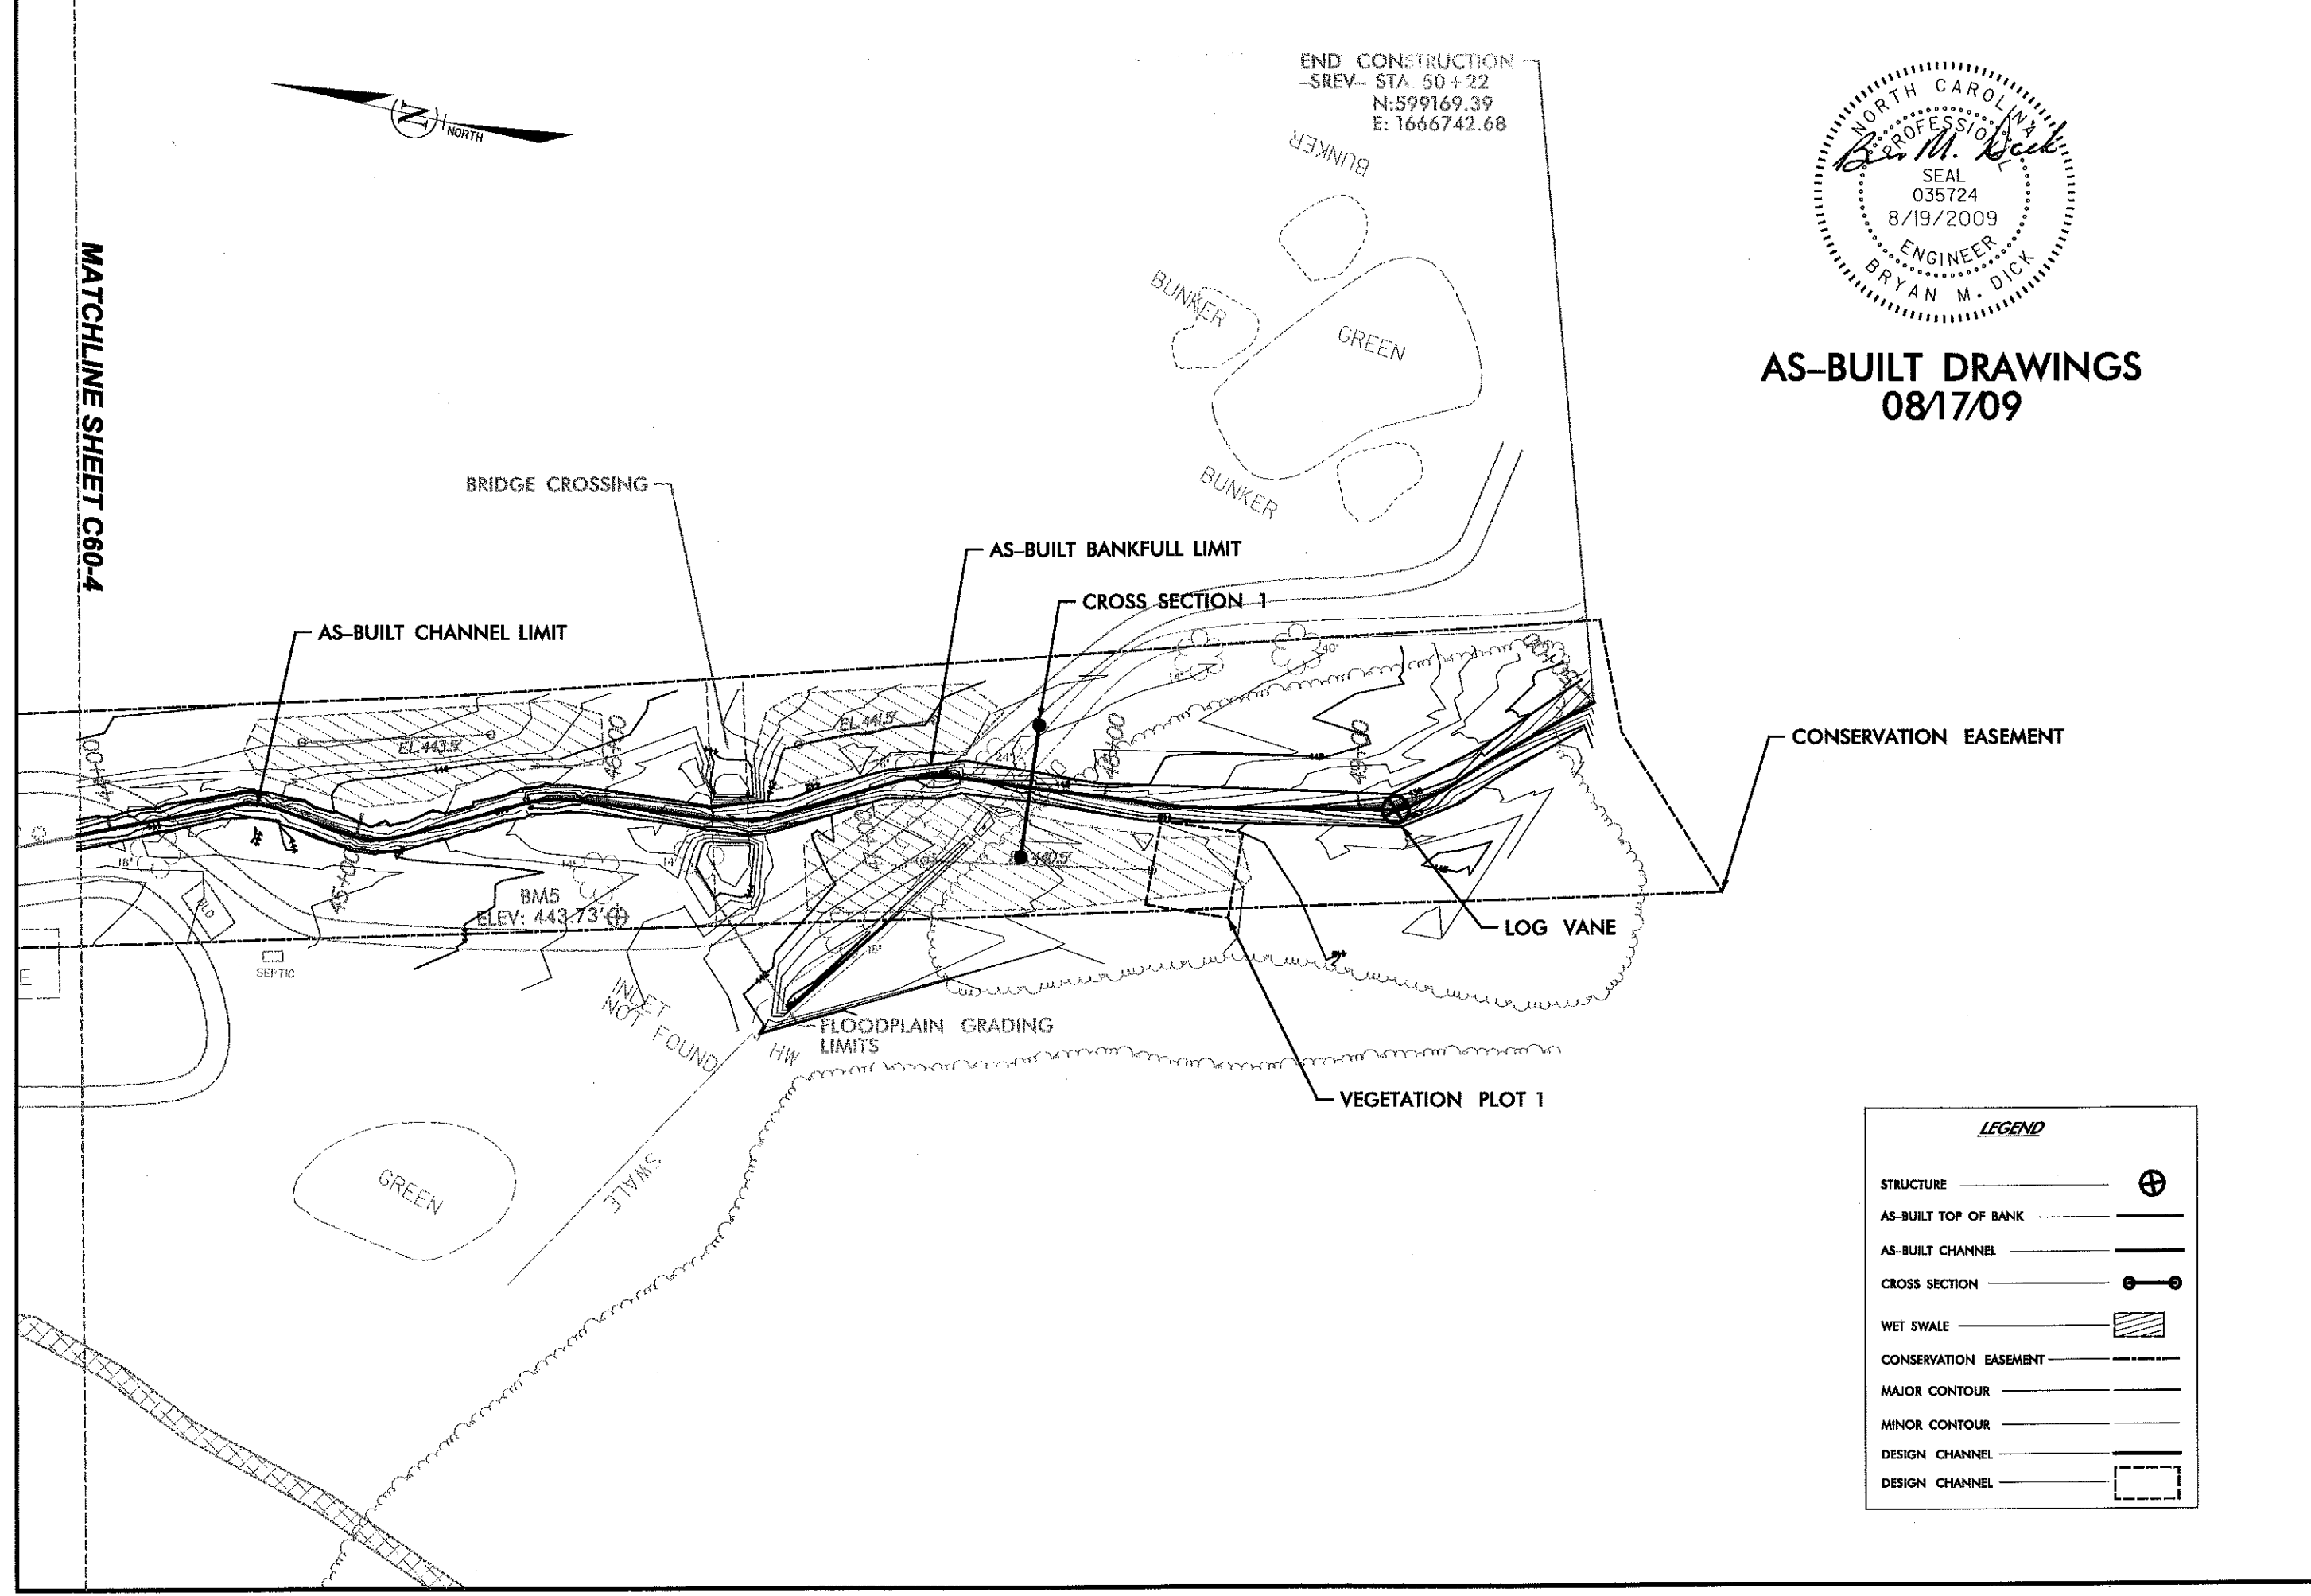
END CONSTRUCTION
 -SREV- STA. 50+22
 N: 599169.39
 E: 1666742.68
