**Badin Inn Stream Restoration
Stanly County, NC**

**Mitigation Plan and As-built Baseline Report
DRAFT**

**EEP Project Number 92666
SCO Project Number D06125-E
Data Collection Period: April-July, 2009
Submission Date: August, 2009**

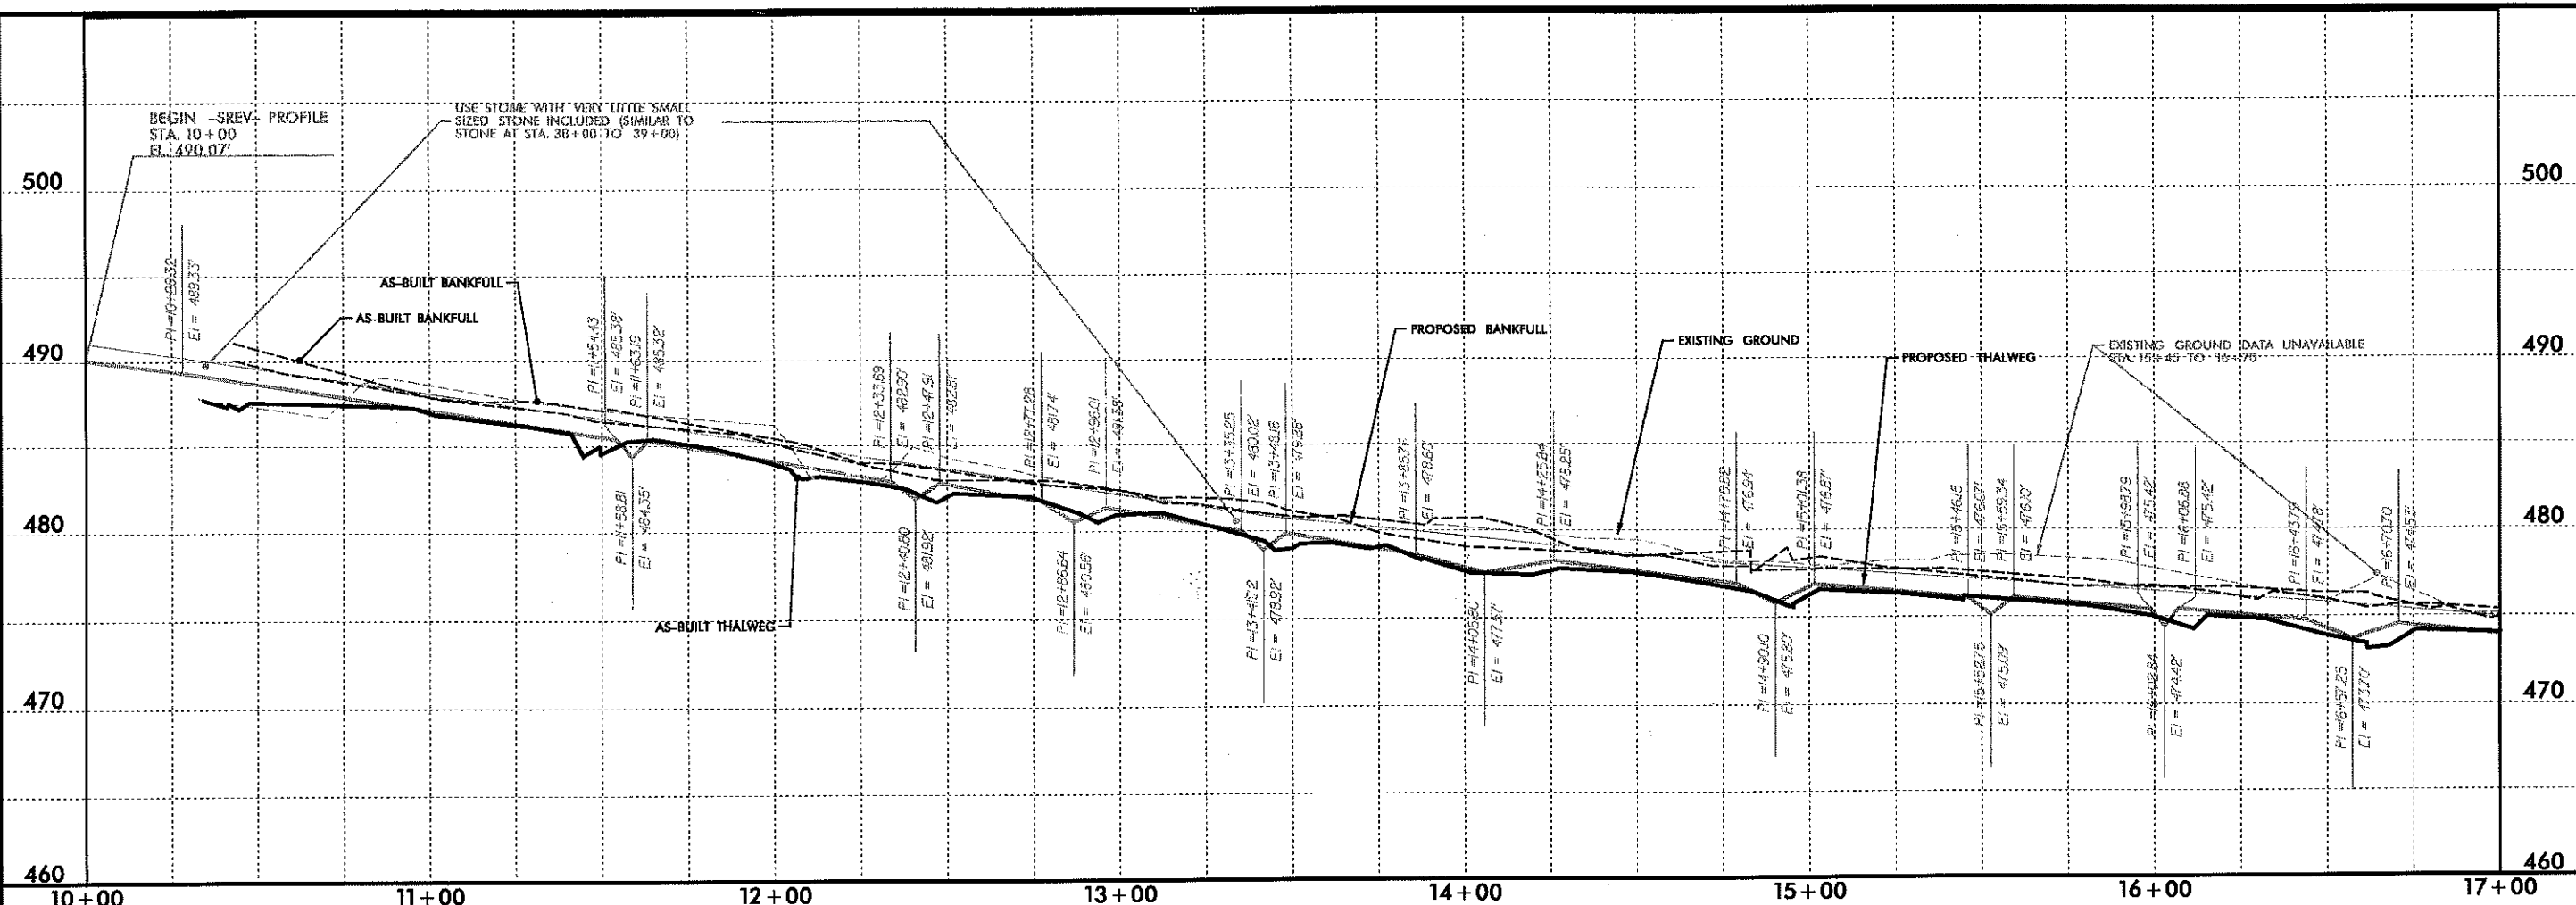
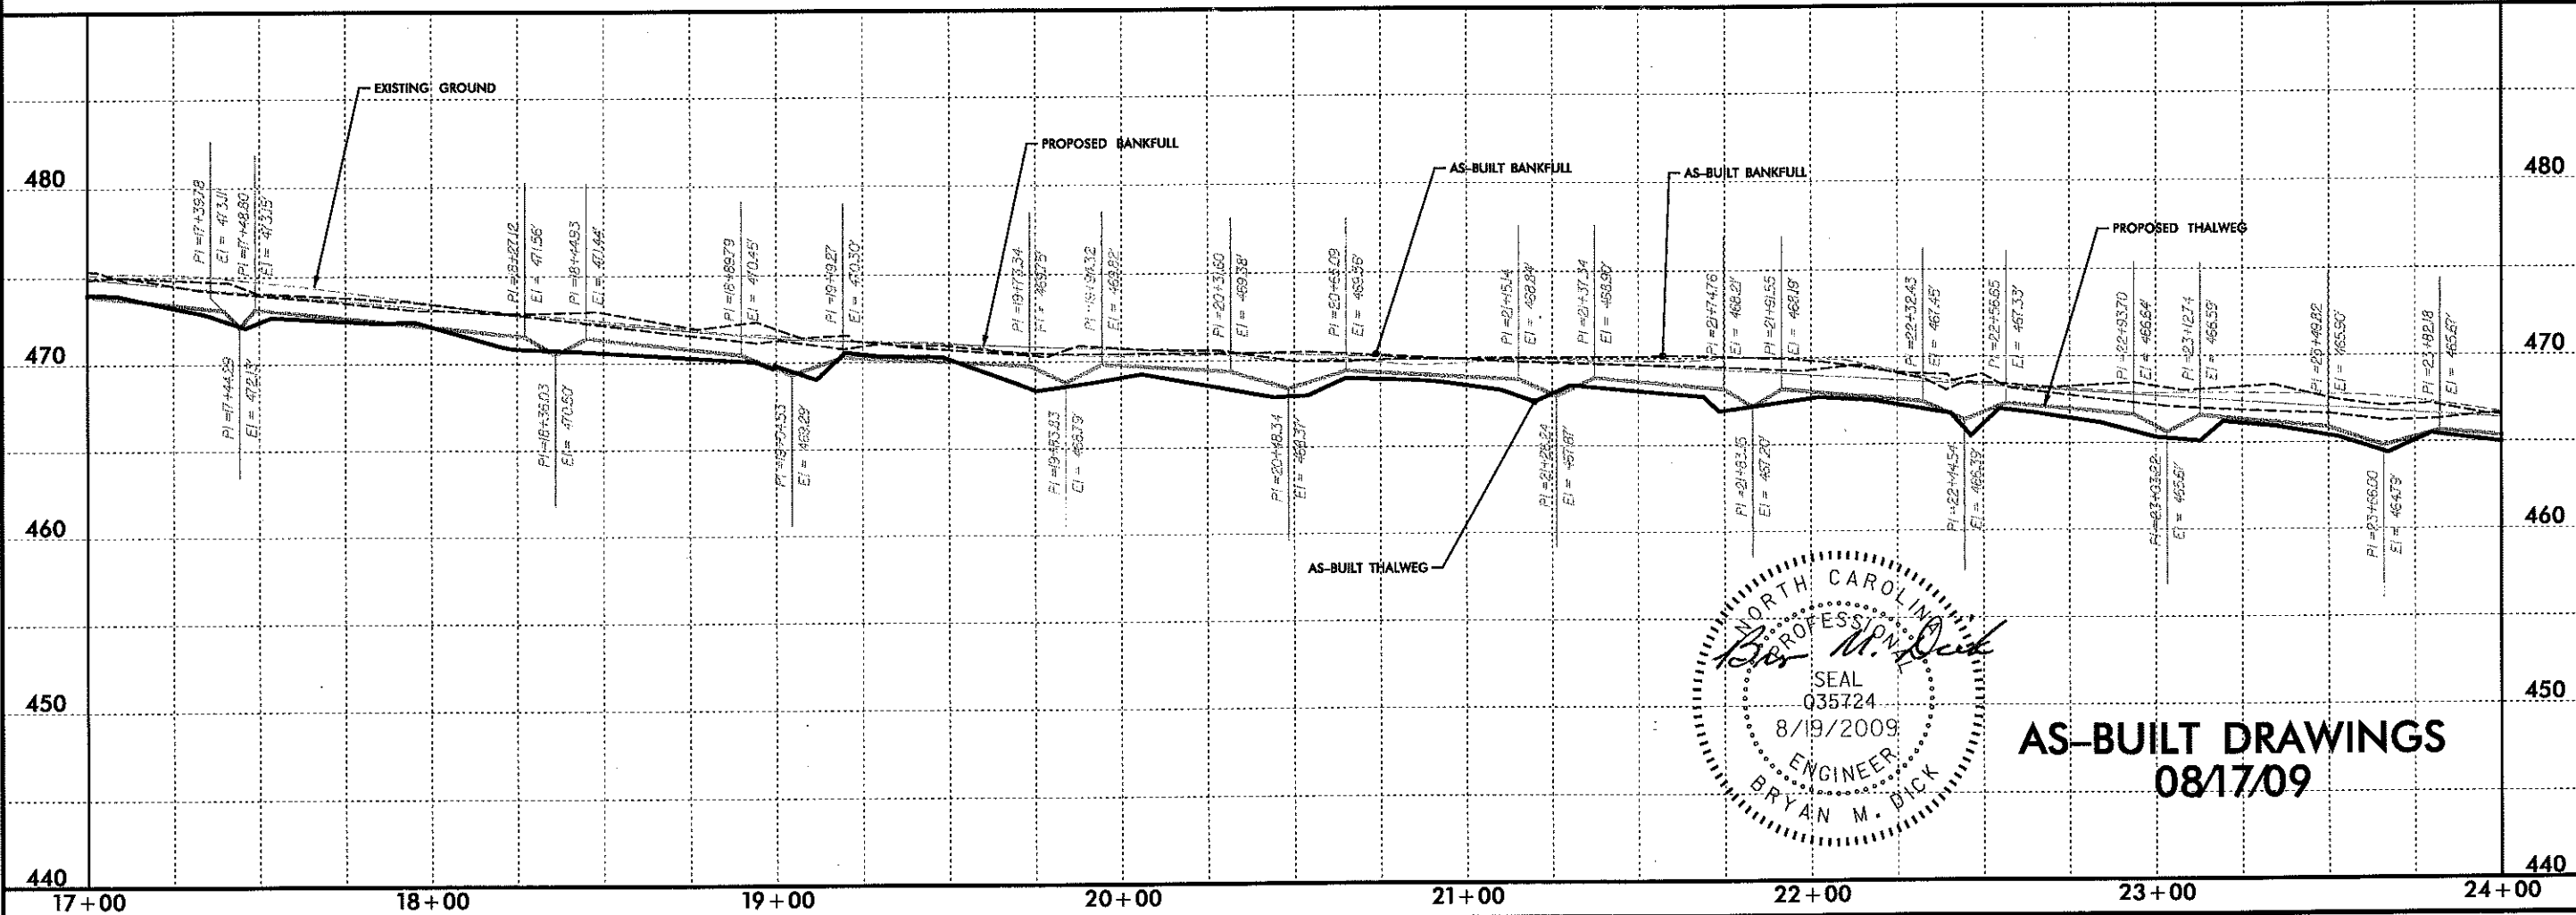
BADIN INN STREAM RESTORATION	
AS-BUILT CHANNEL PROFILE	
EARTH TECH AECOM	
701 CORPORATE CENTER DRIVE, SUITE 415, RALEIGH, NC 27603 919-854-6000 919-854-6029 (fax)	
DATE	8/19/2009
PROJECT NO	99255
FILENAME	
SHEET NO	C-24
DRAWN BY	ABW
CHKD BY	BMD

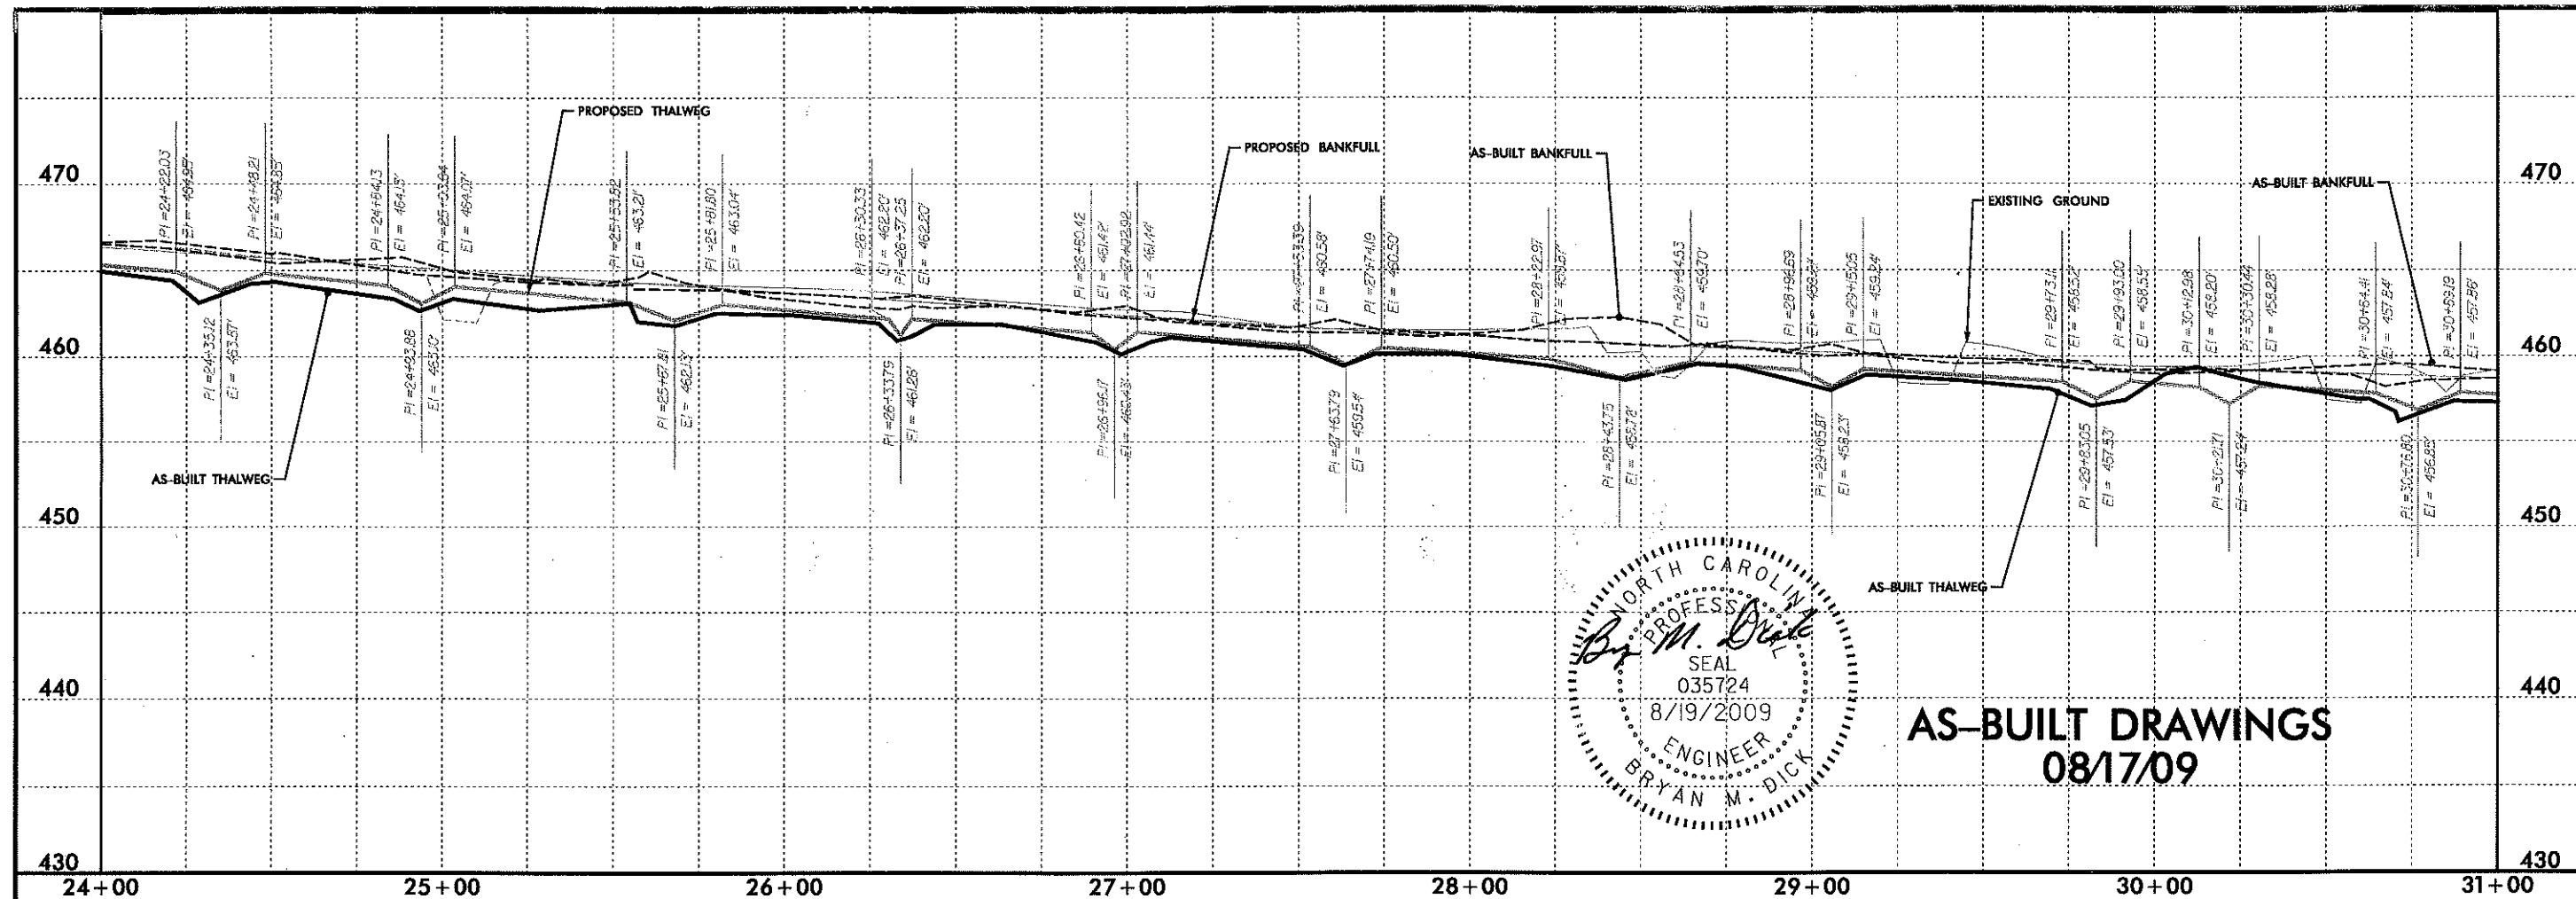
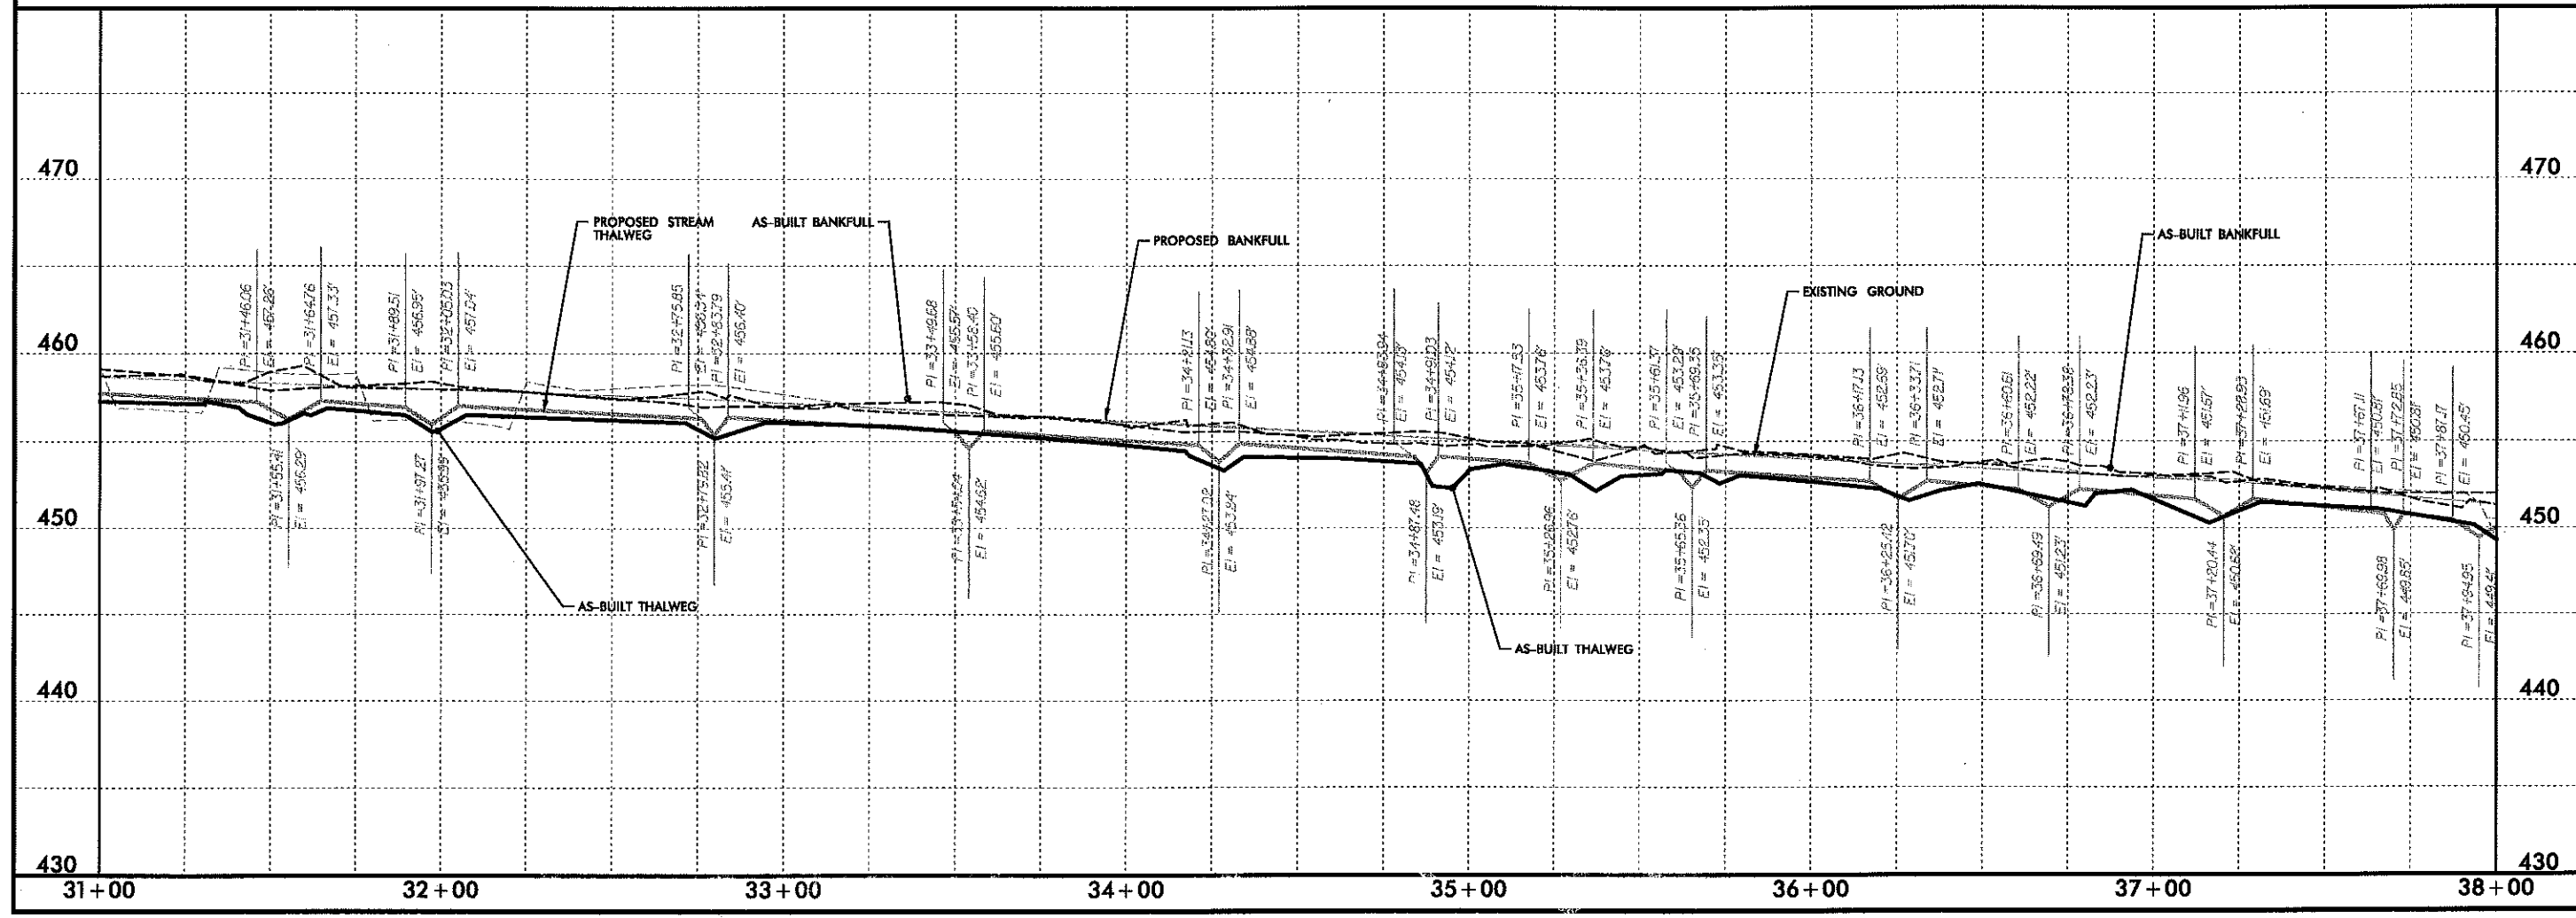
BADIN INN STREAM RESTORATION	
AS-BUILT CHANNEL PROFILE	
EARTH TECH AECOM	
TO: CORPORATE CENTER DRIVE, SUITE 475, HALLMARK, NC 27607 315-564-6622 315-564-6625 (FAX)	
DATE	8/19/2009
PROJECT NO	99255
FILENAME	
SHEET NO	C-25
DRAWN BY	ABW
CHKD BY	BMD

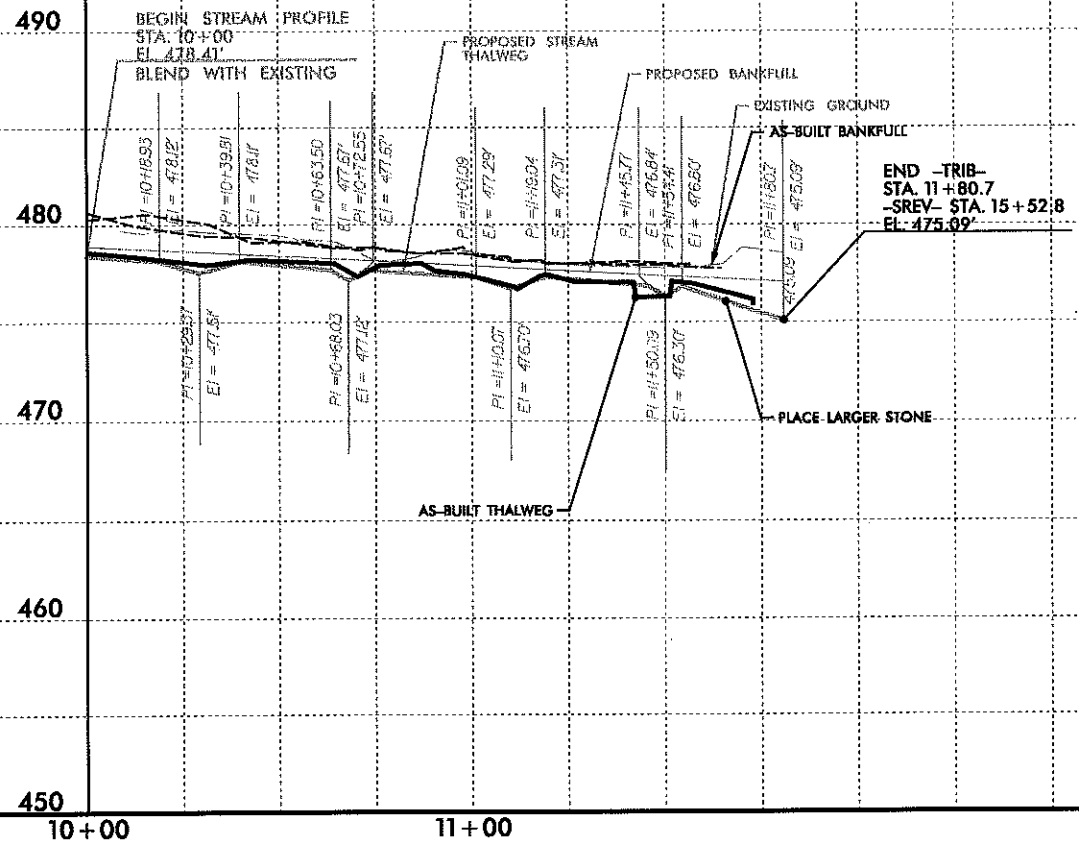
BADIN INN STREAM RESTORATION	
AS-BUILT CHANNEL PROFILE	
EARTH TECH AECOM	
701 CORPORATE CENTER DRIVE, SUITE 475, HALESBURN, NC 27607 <small>919-854-6200 919-854-6259 (fax)</small>	
DATE	8/19/2009
PROJECT NO	99255
FILENAME	
SHEET NO	C-27
DRAWN BY	ABW
CHKD BY	BMD

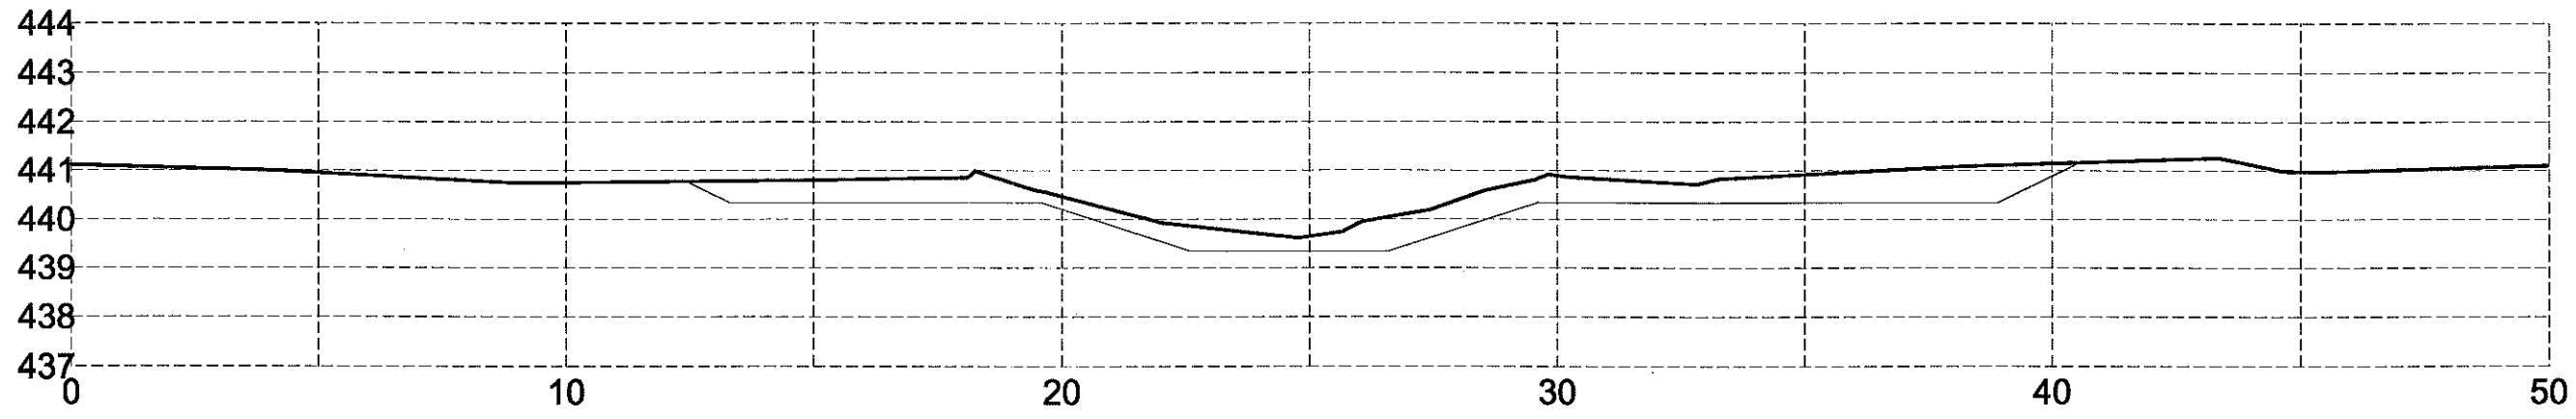
CROSS SECTION 1 - RIFFLE
 STA. 47+67

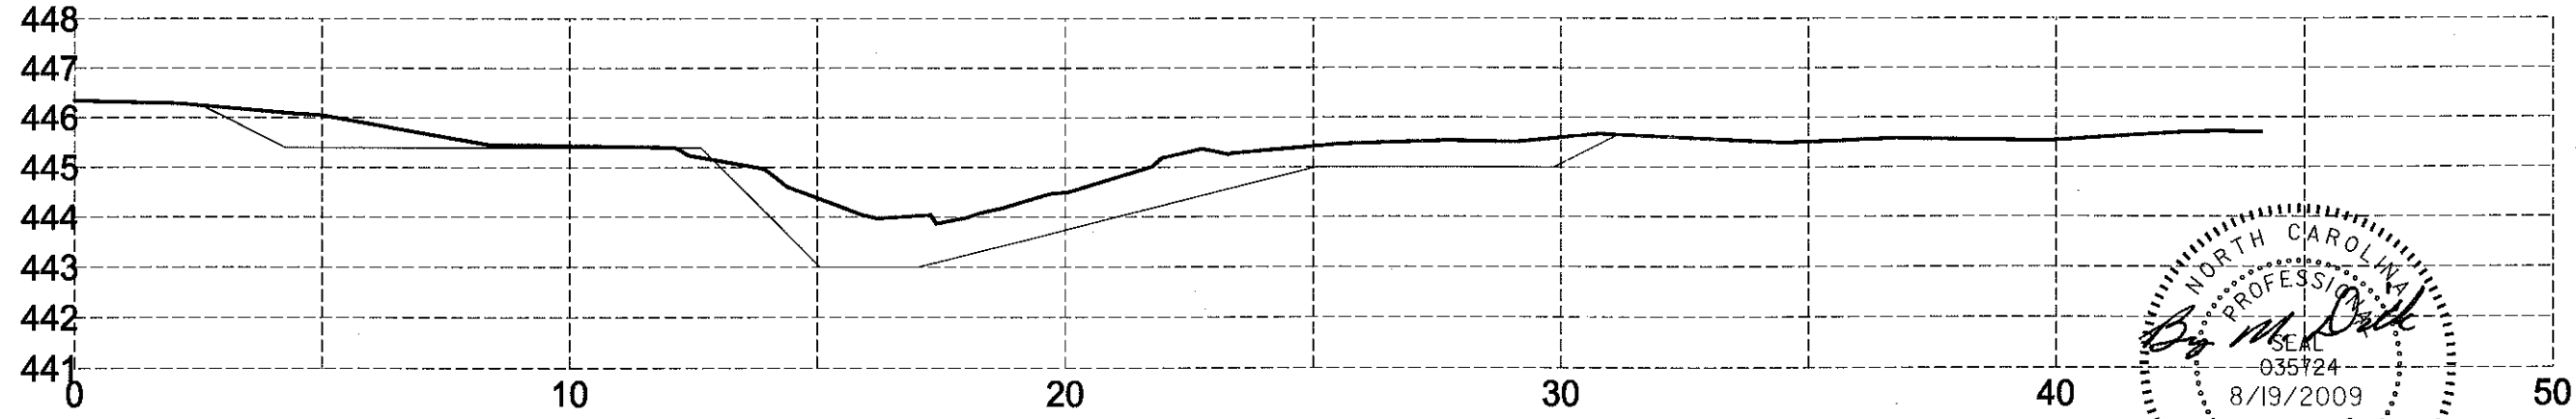
CROSS SECTION 2 - POOL
 STA. 43+05

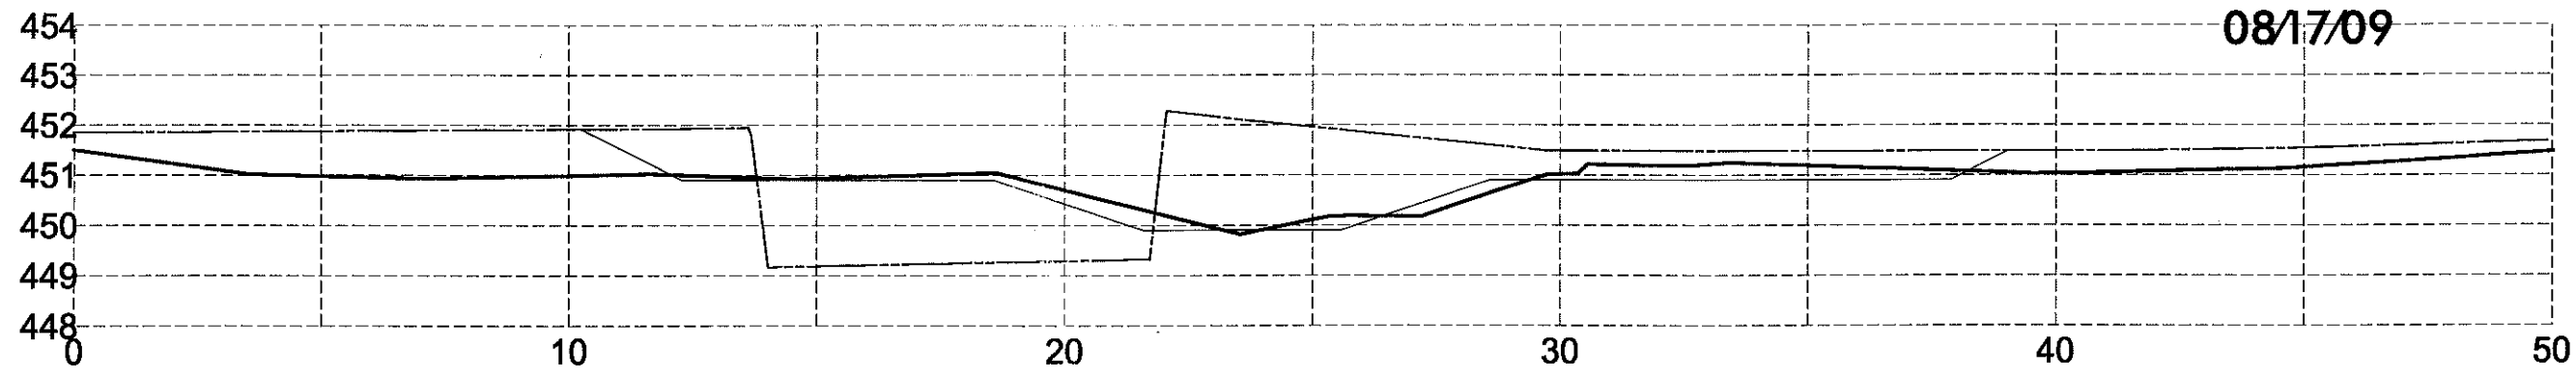
CROSS SECTION 3 - RIFFLE
 STA. 38+26

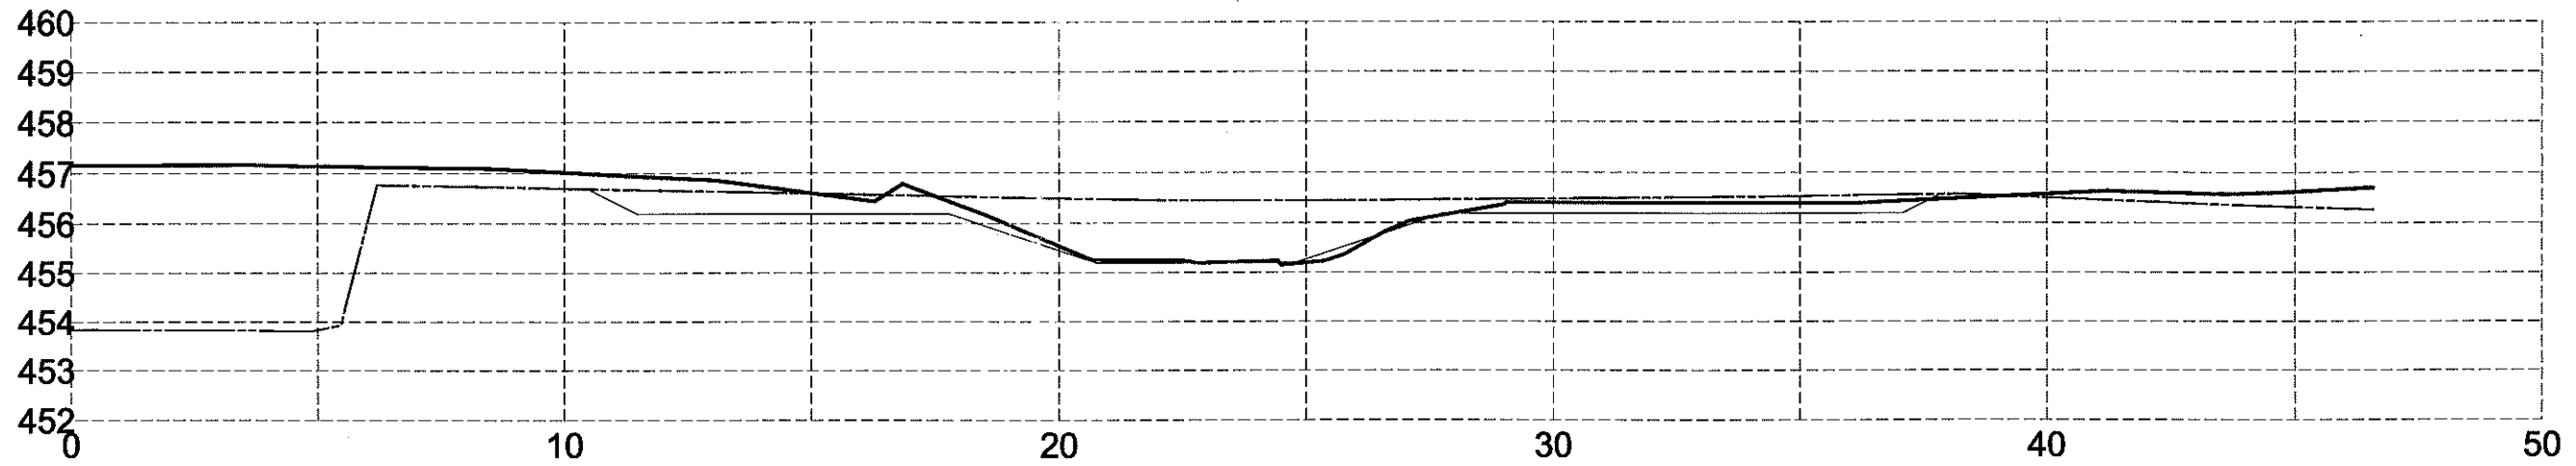
CROSS SECTION 4 - RIFFLE
STA. 33+72

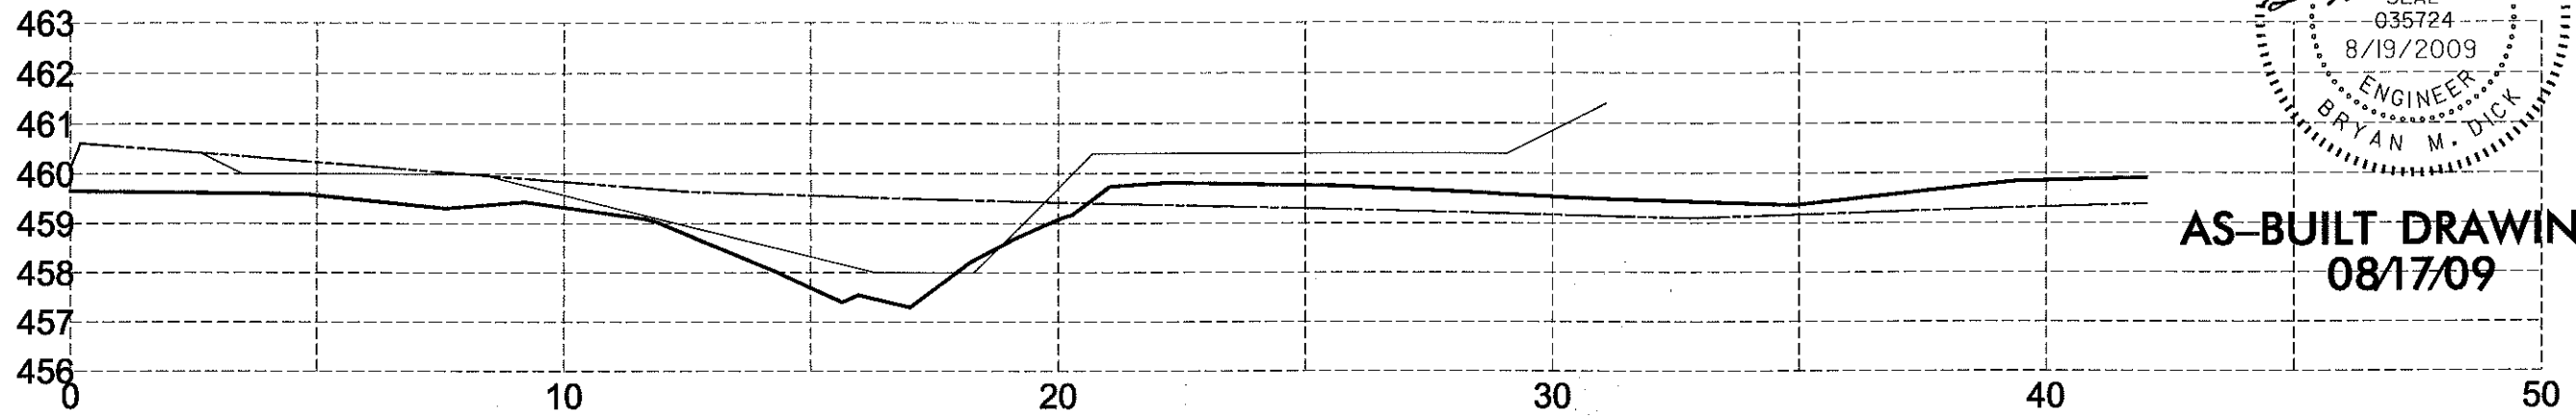
CROSS SECTION 5 - POOL
STA. 29+78

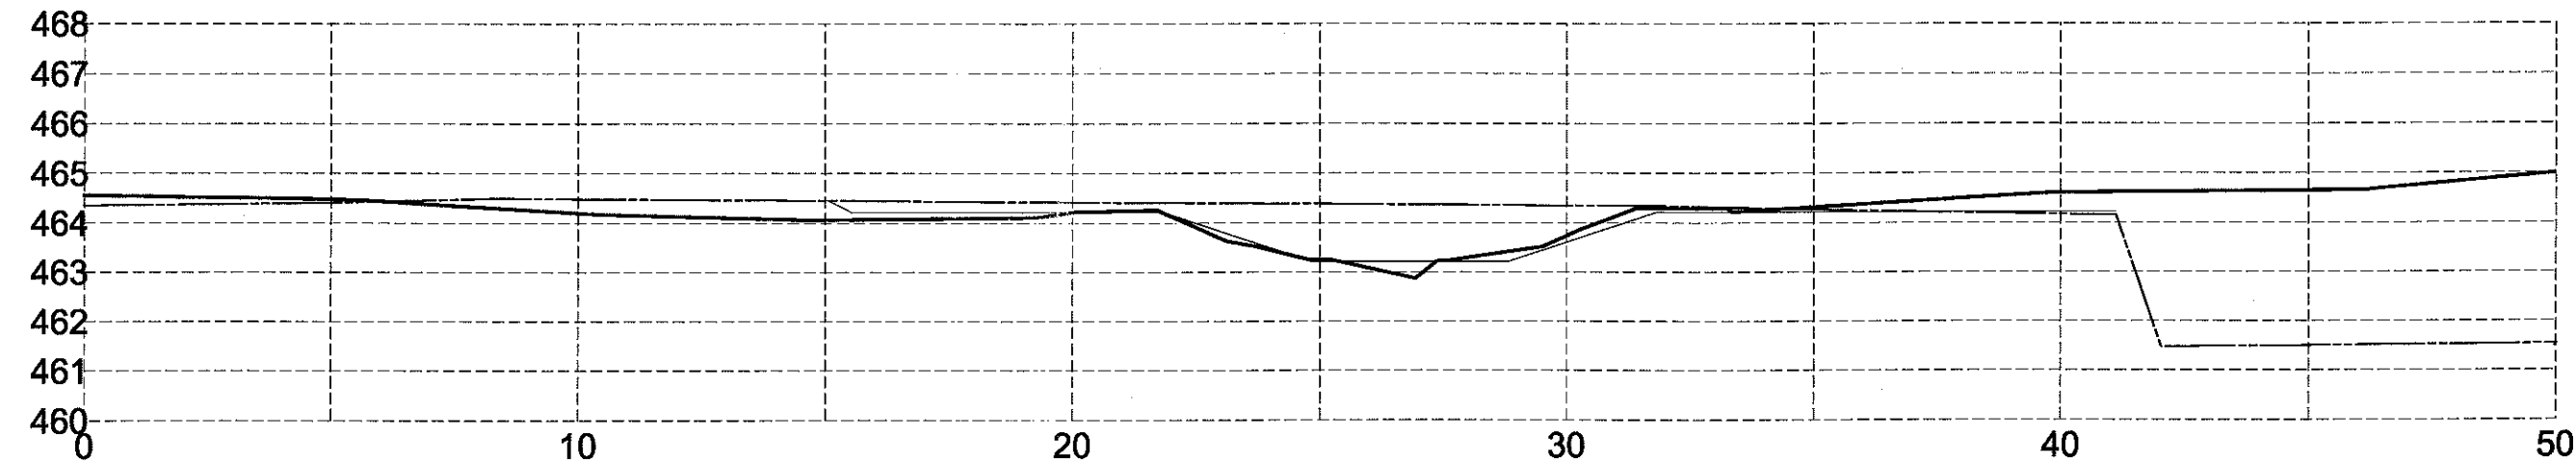
CROSS SECTION 6 - RIFFLE
STA. 25+39

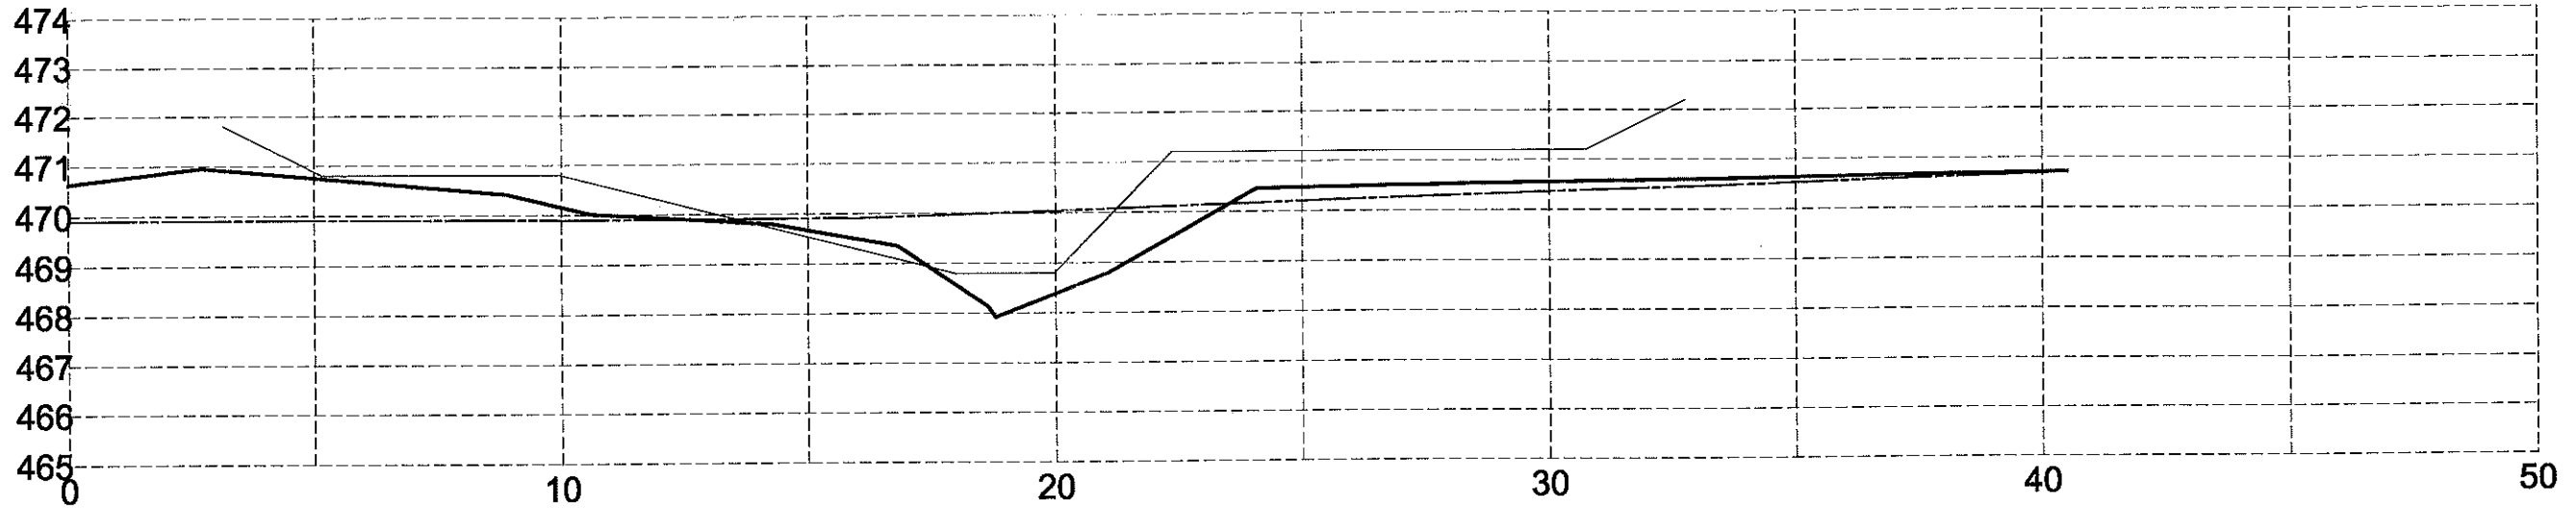
CROSS SECTION 7 - POOL
STA. 20+45

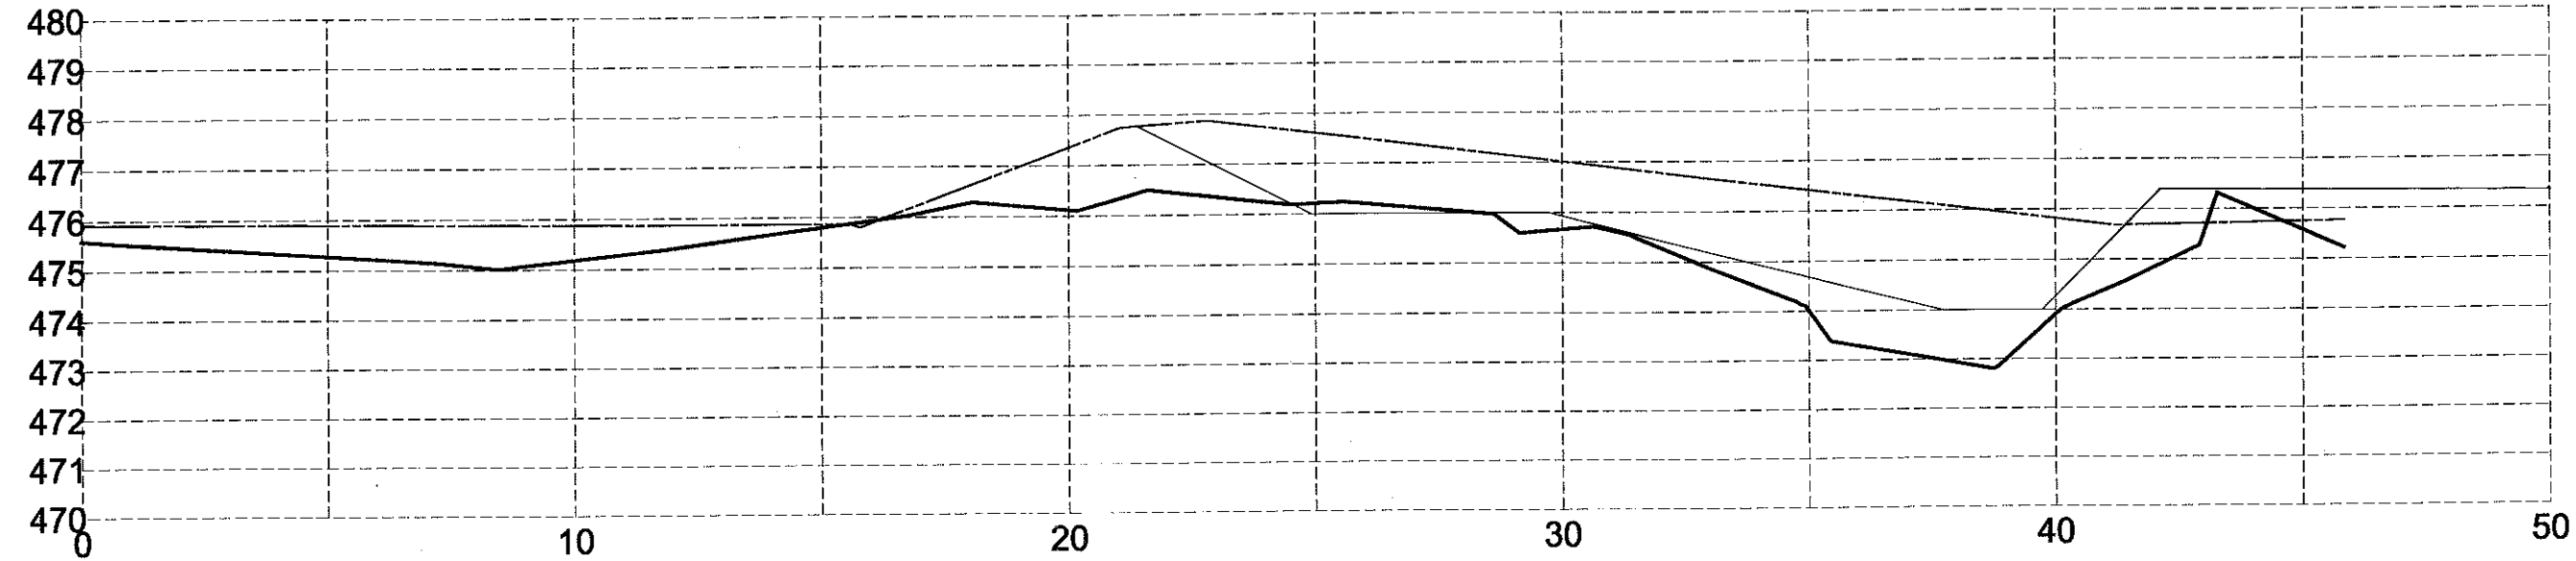
CROSS SECTION 8 - POOL
STA. 16+50

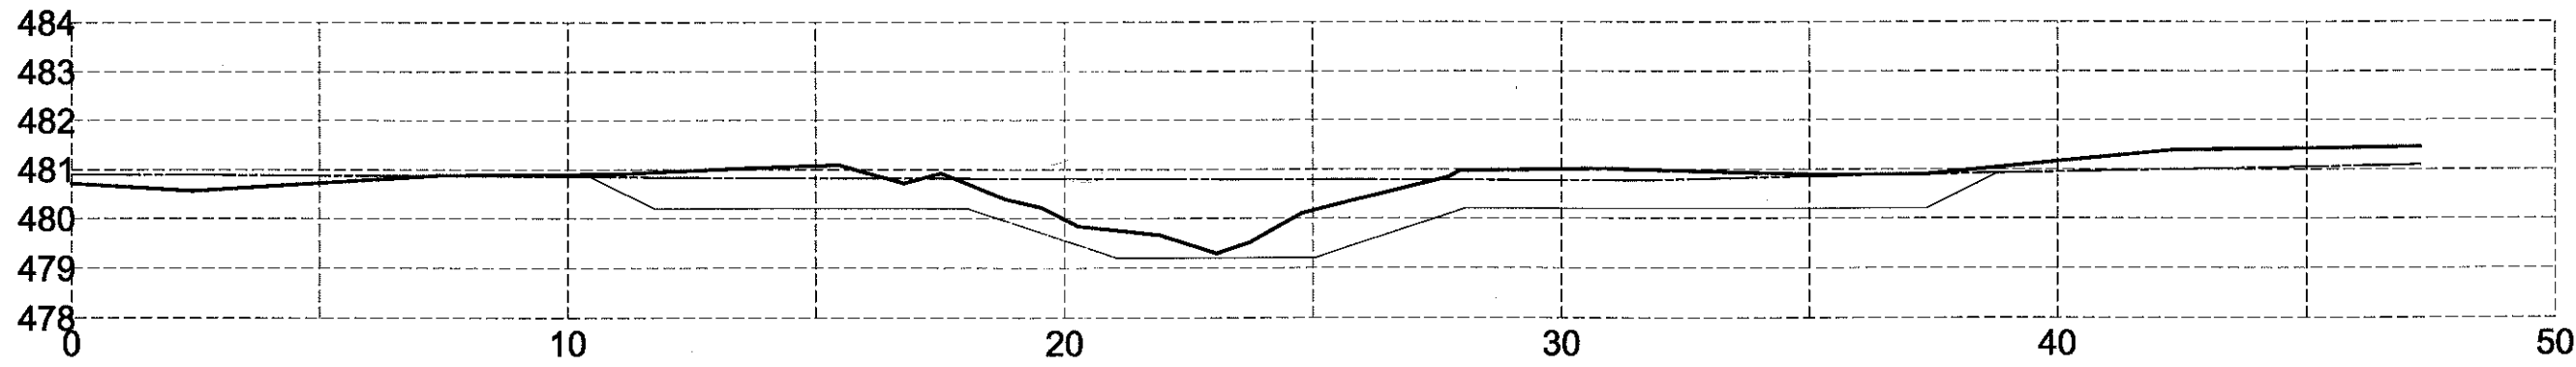
CROSS SECTION 9 - RIFFLE

STA. 13+61

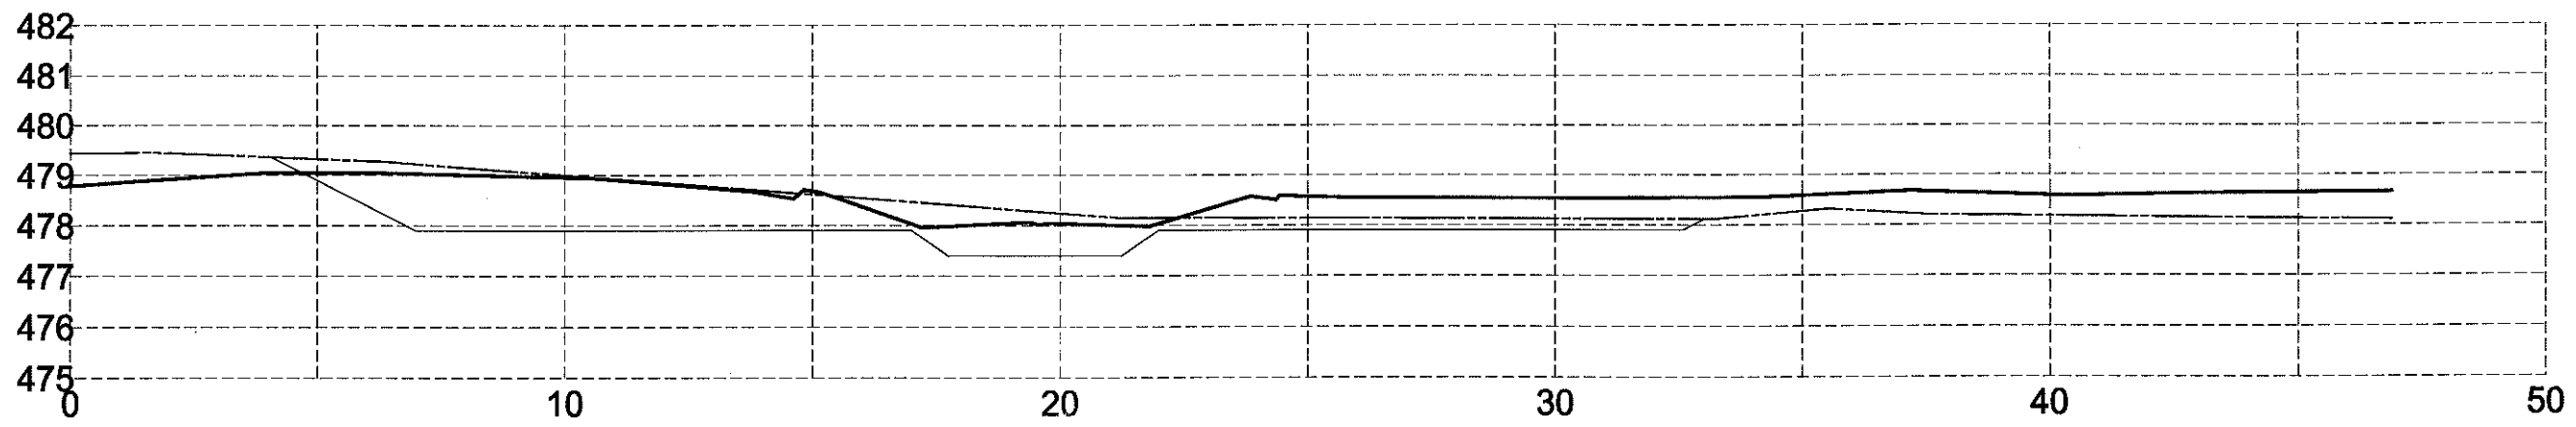
TRIBUTARY CROSS SECTION - RIFFLE

STA. 10+85

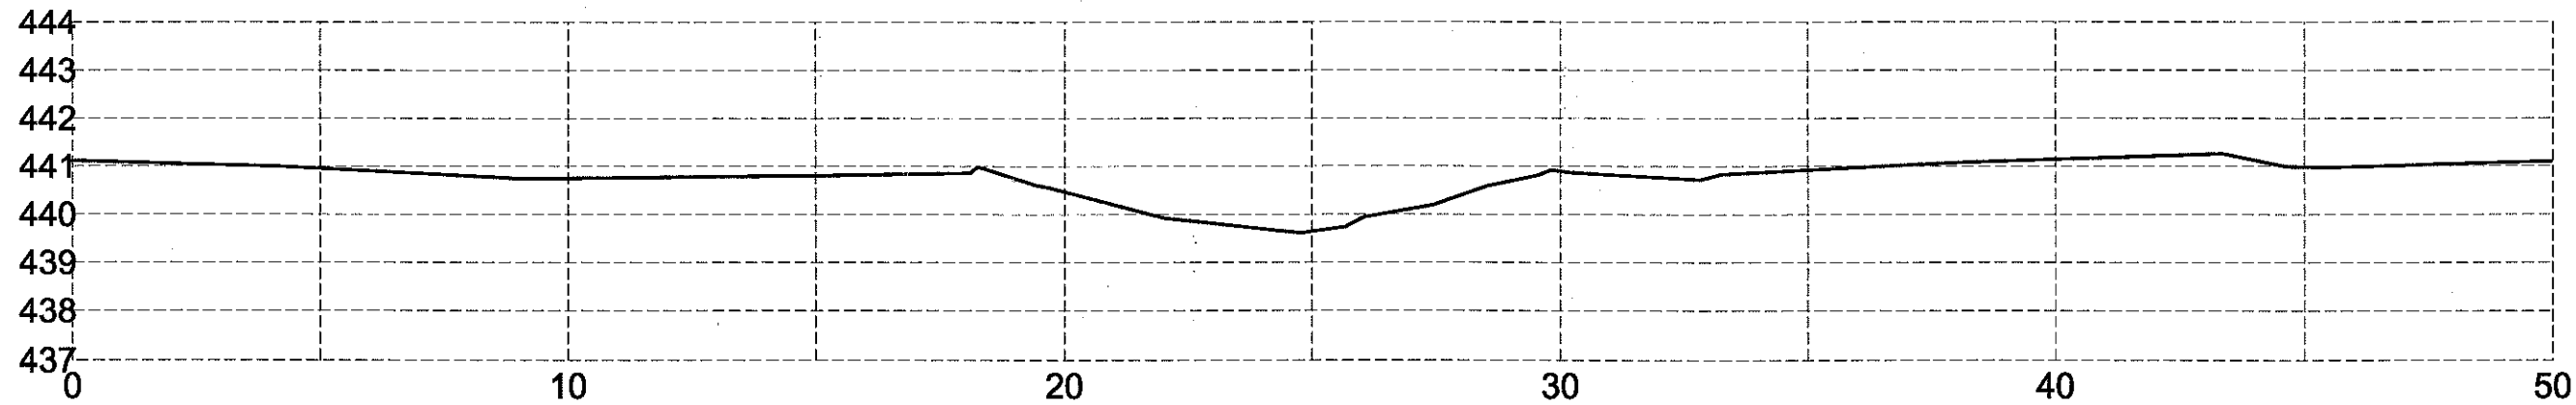
CROSS SECTION 1 - RIFFLE
STA. 47+67
