**Badin Inn Stream Restoration
Stanly County, NC**

**Mitigation Plan and As-built Baseline Report
DRAFT**

**EEP Project Number 92666
SCO Project Number D06125-E
Data Collection Period: April-July, 2009
Submission Date: August, 2009**

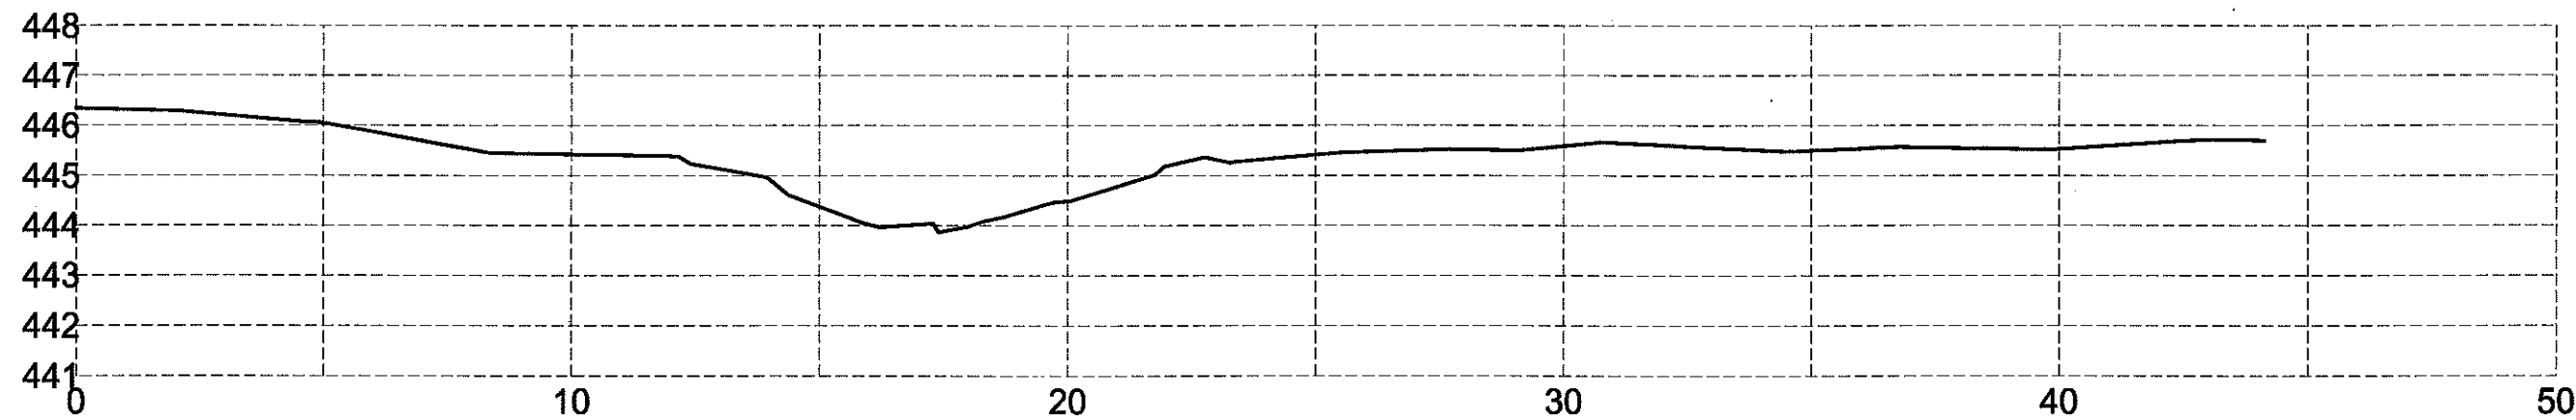
CROSS SECTION 2 - POOL
STA. 43+05

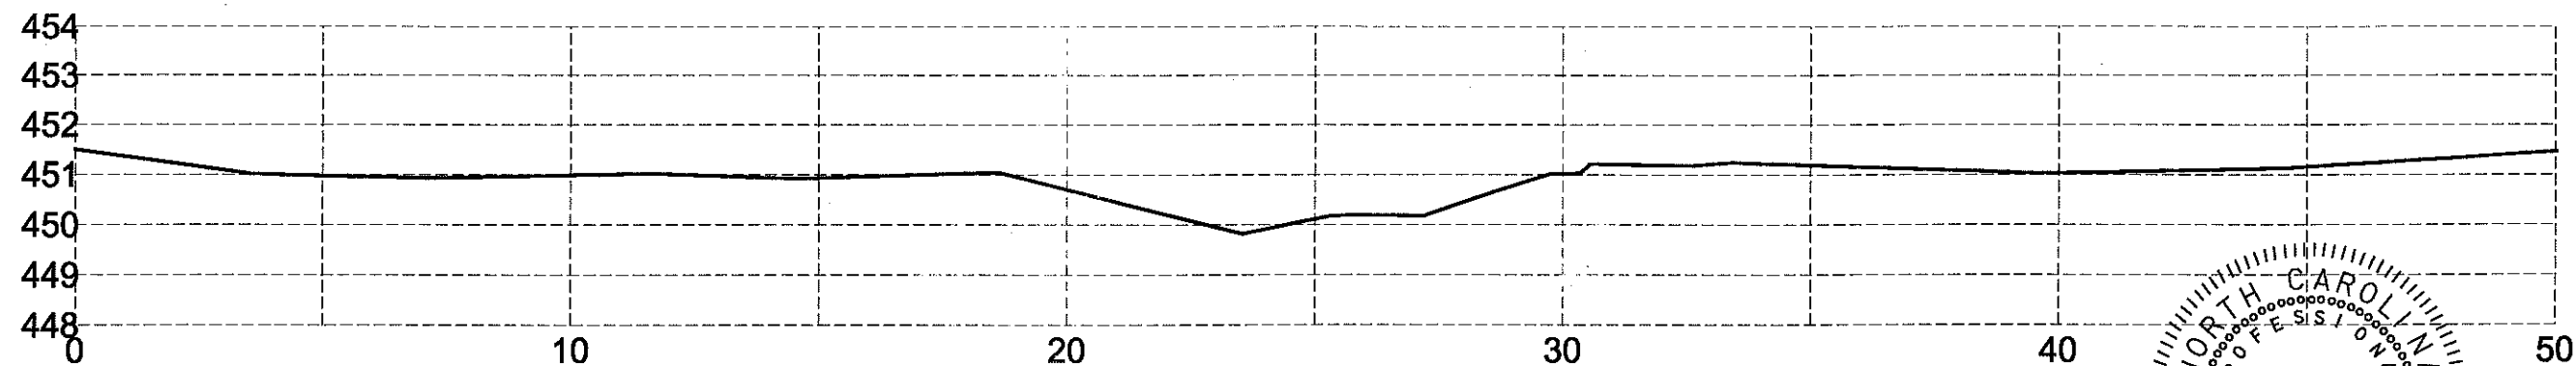
CROSS SECTION 3 - RIFFLE
STA. 38+26

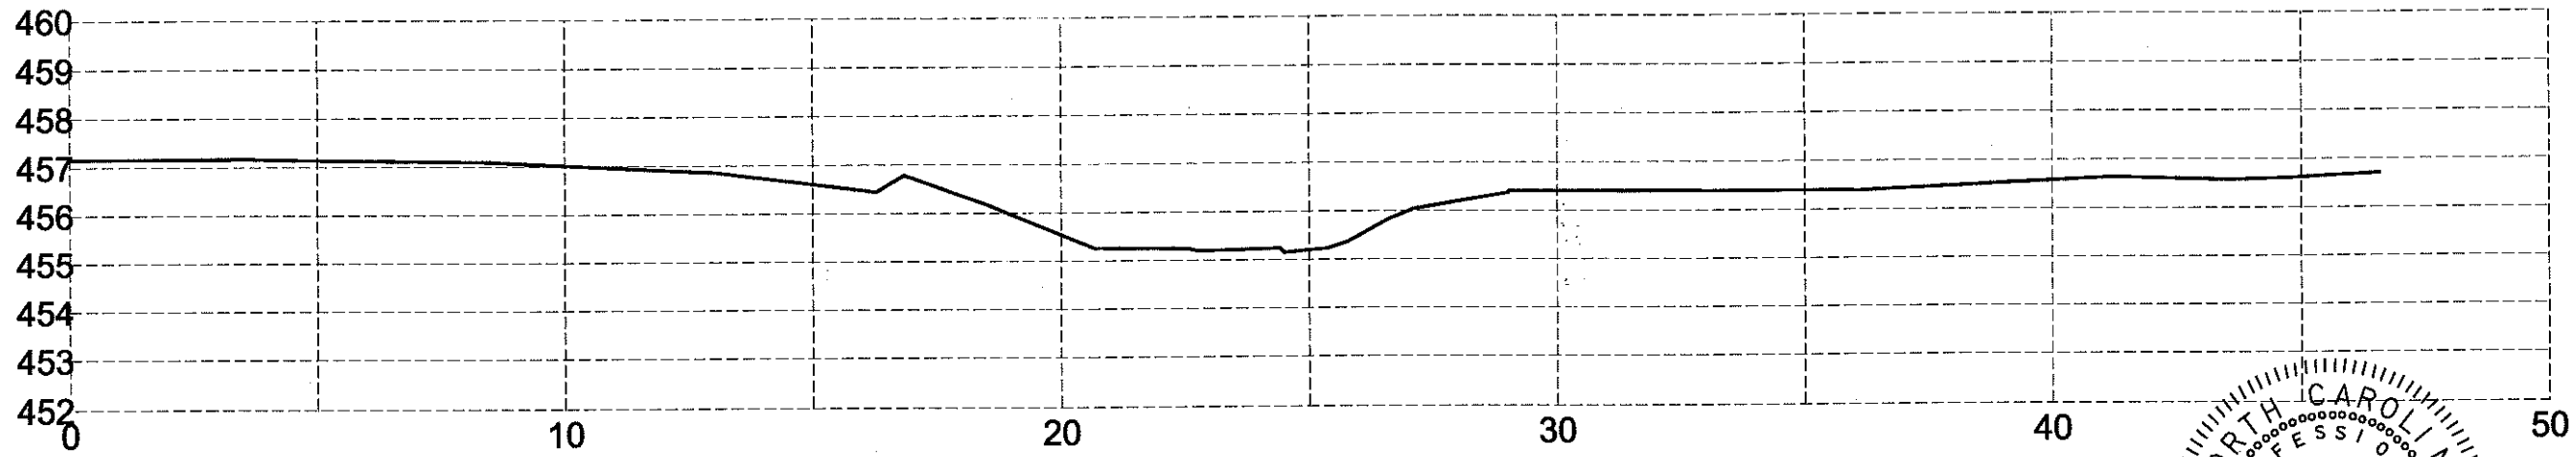
CROSS SECTION 4 - RIFFLE
 STA. 33+72

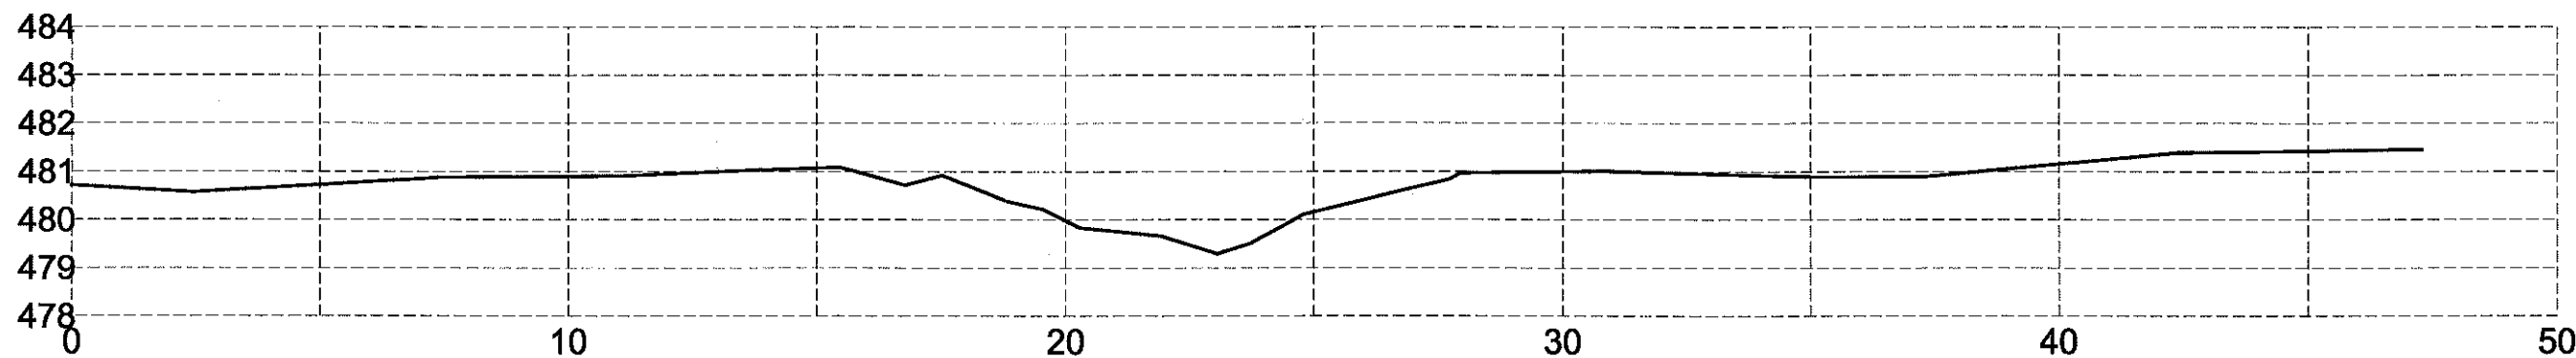
CROSS SECTION 9 - RIFFLE

STA. 13+61

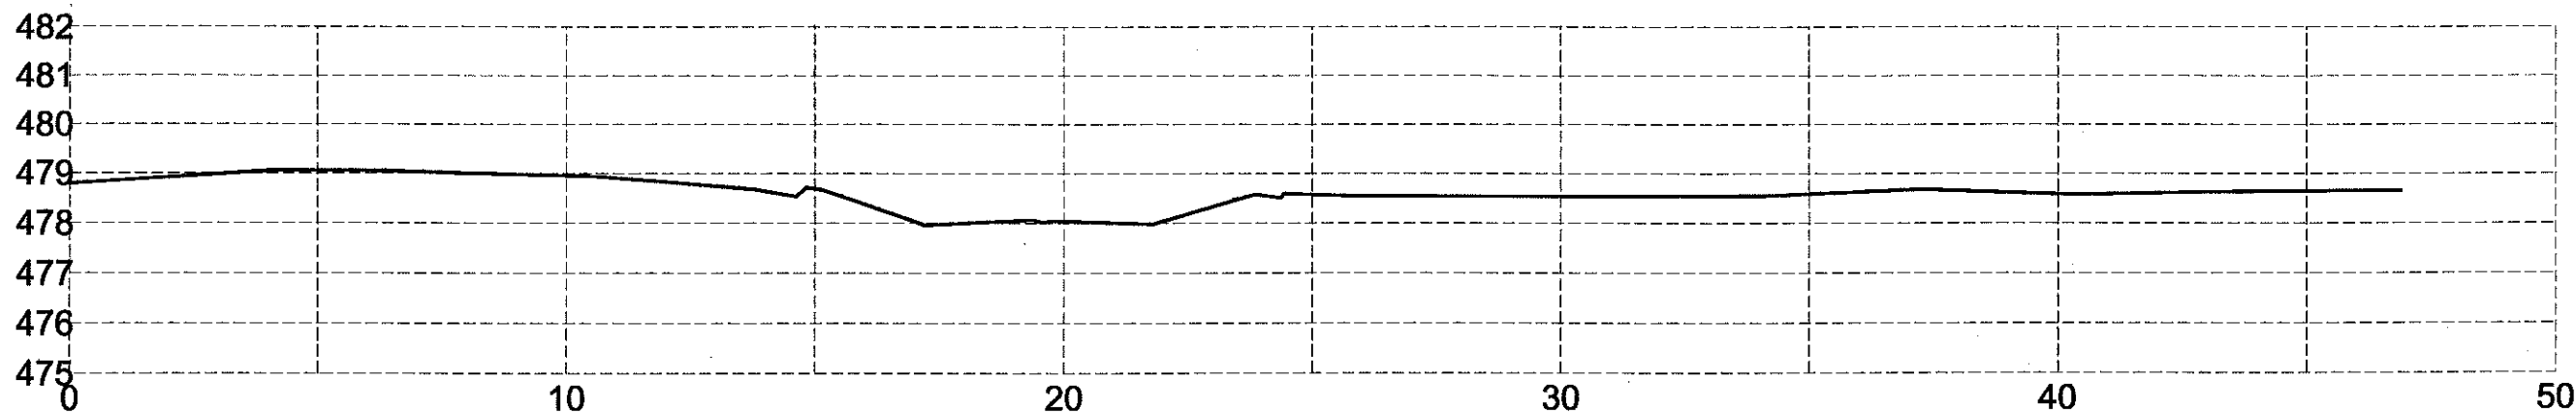
TRIBUTARY CROSS SECTION - RIFFLE

STA. 10+85
