**BEAVERDAM CREEK  
STREAM RESTORATION PROJECT**  
ANNUAL MONITORING REPORT FOR 2006-2007 (YEAR 1)

**Project Number: D05016-1**

Prepared by: Baker Engineering

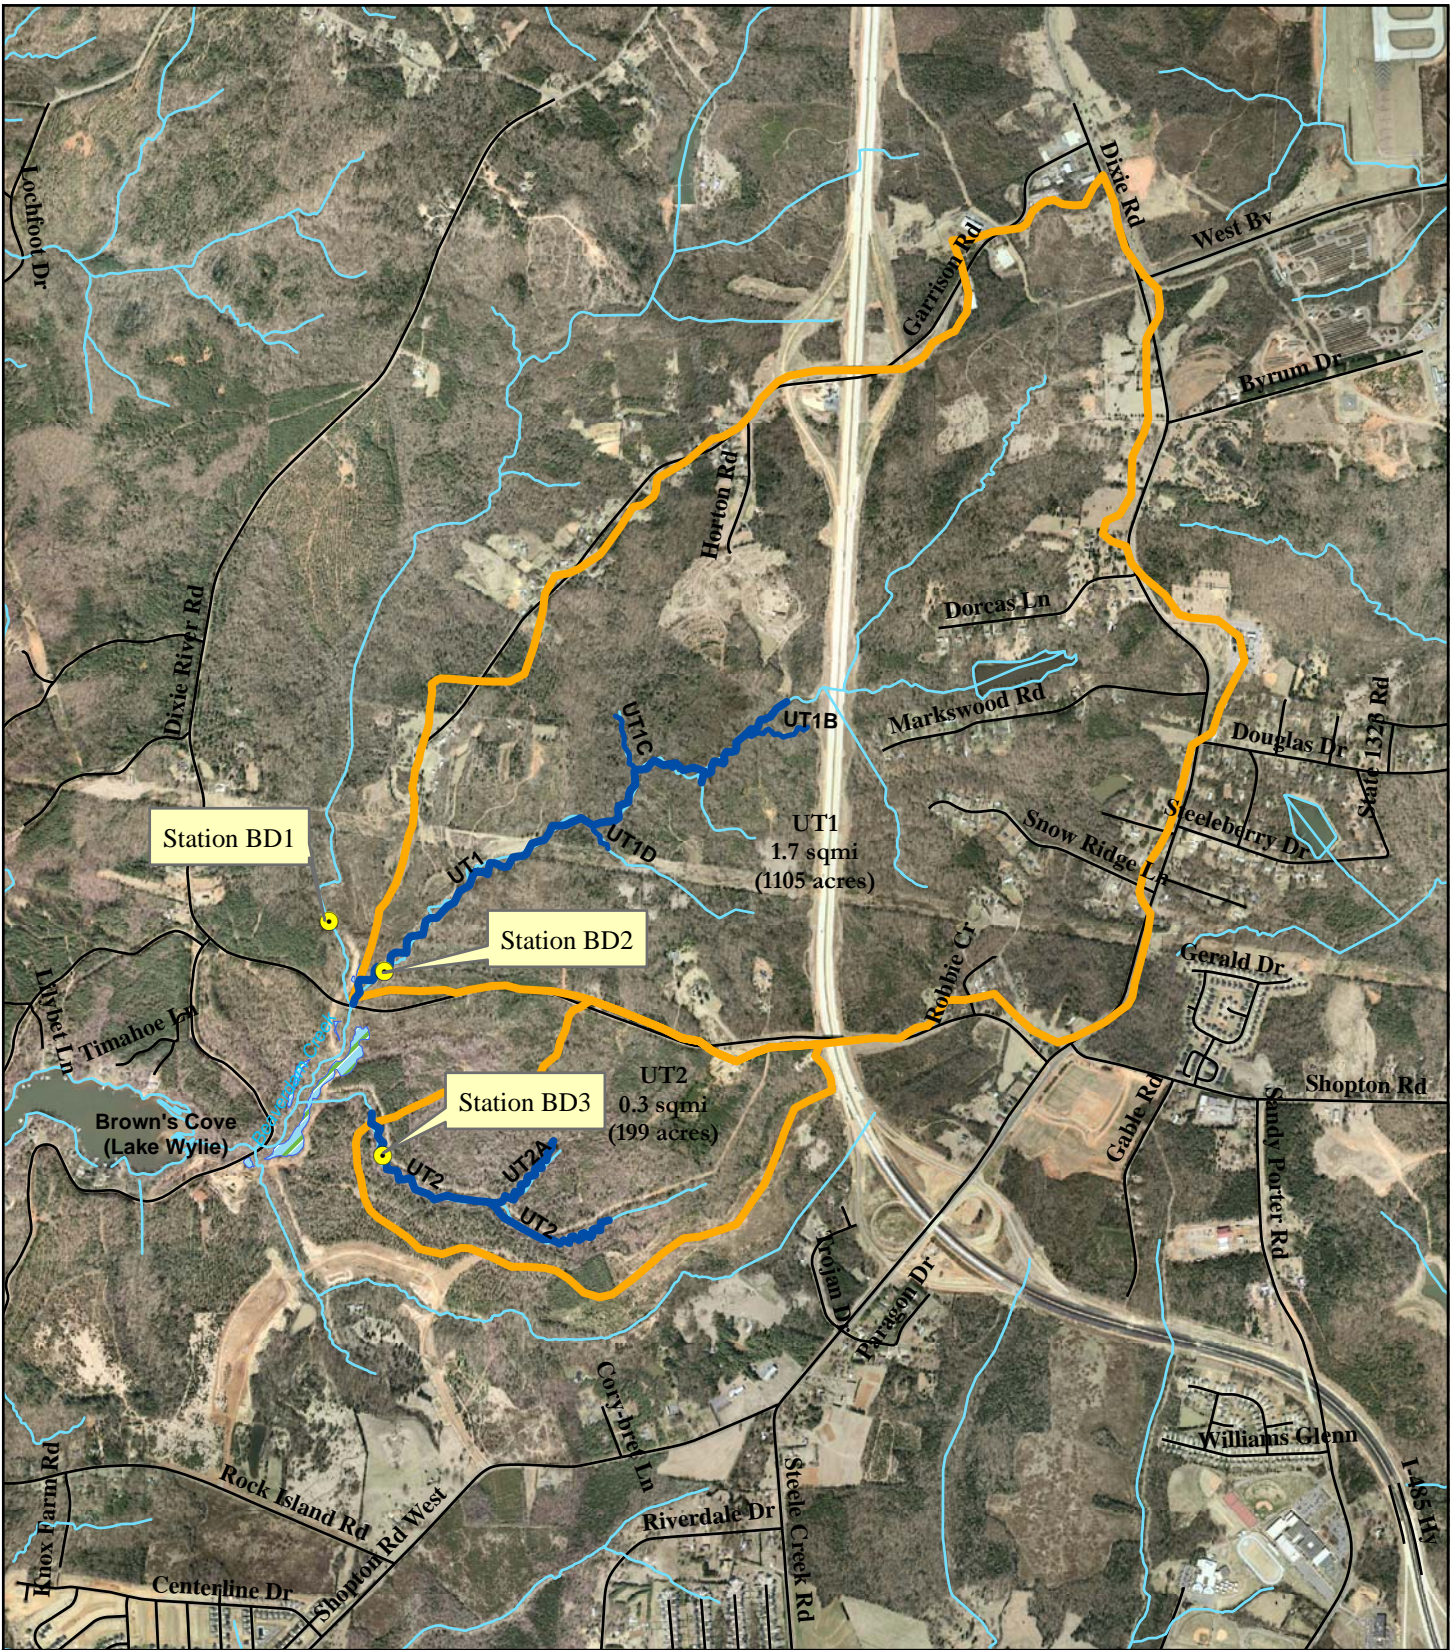
**LEGEND**

- Crest Gauges
- As-built Alignments
- Project Watershed Boundary
- Creeks
- Roads

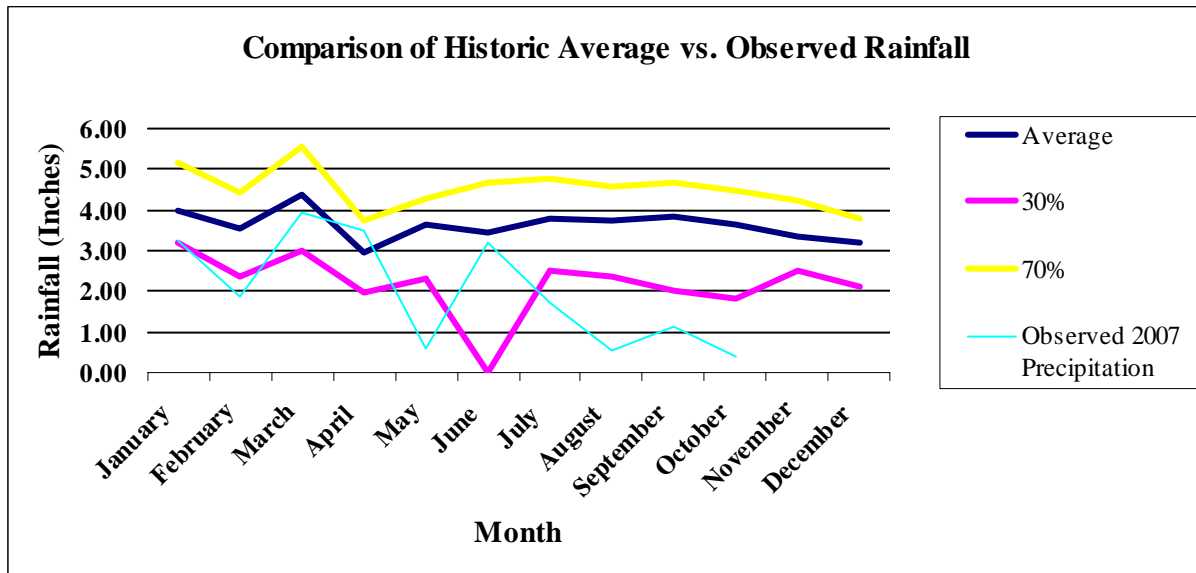
**Figure 5. Historic Average vs. Observed Rainfall**

Rainfall data were collected to document the hydrologic conditions throughout the project area in the 2007 growing season. Since no rain gauges were installed within the project boundaries, monthly rainfall totals were calculated from data downloaded from the Withers Cove USGS gauge 35090308100454 in Mecklenburg County, NC. Historical rainfall data were collected from the Charlotte WSO AP WETS Station in Mecklenburg County (NC 1690) using NRCS National Water and Climate Data Center website. Hydrologic monitoring results are shown in Table 10 and Figure 5.

\*Total Observed Rainfall does not include data from October 23 – 31, November, nor December of 2007.

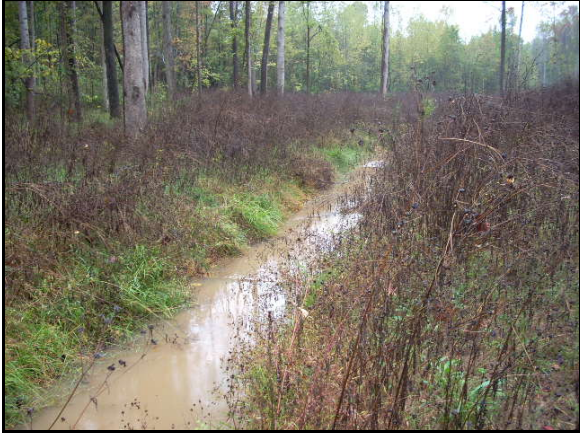
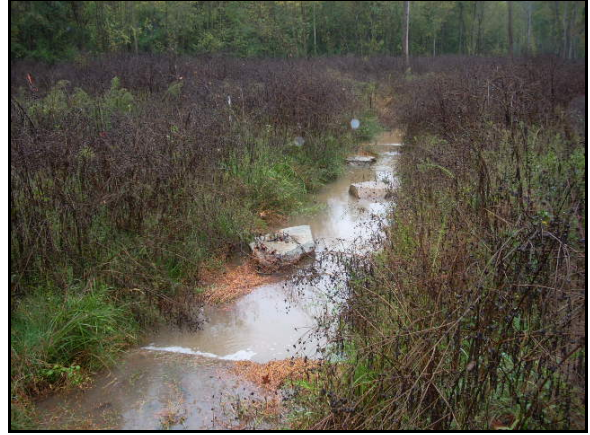
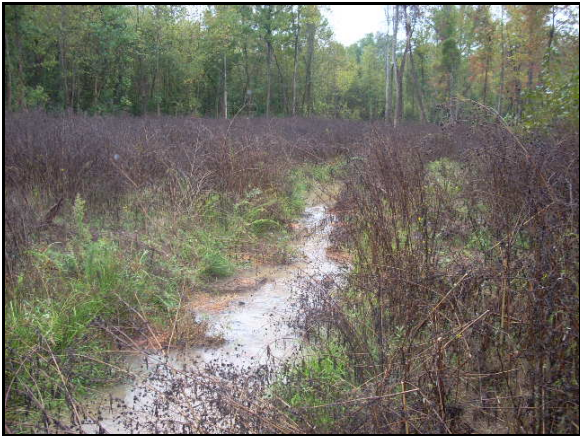
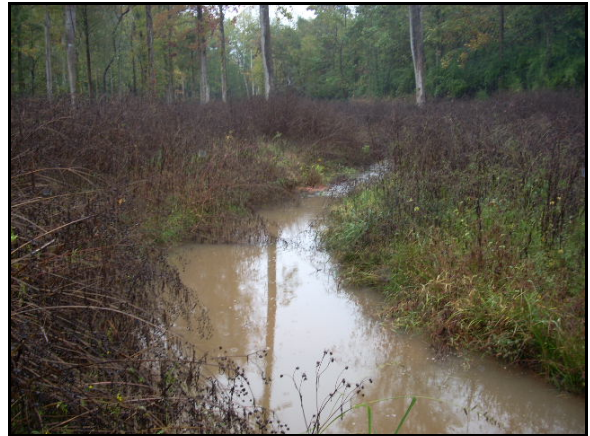
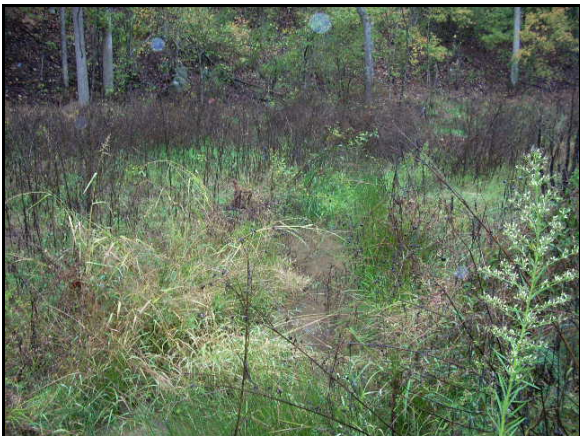
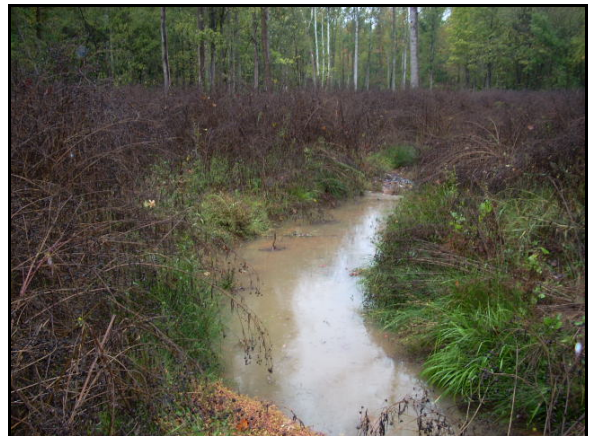
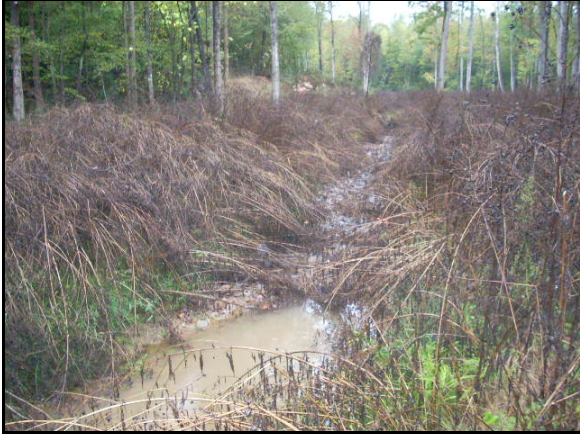
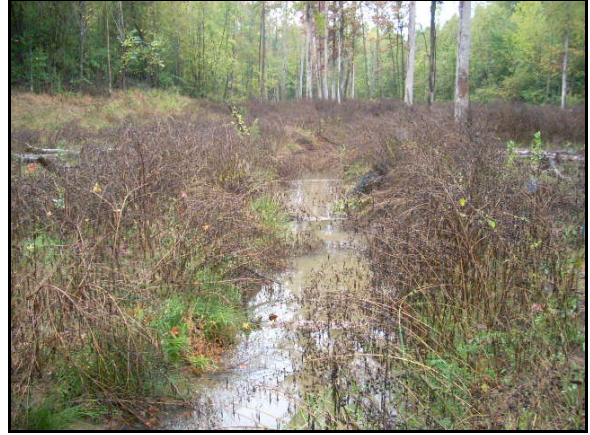
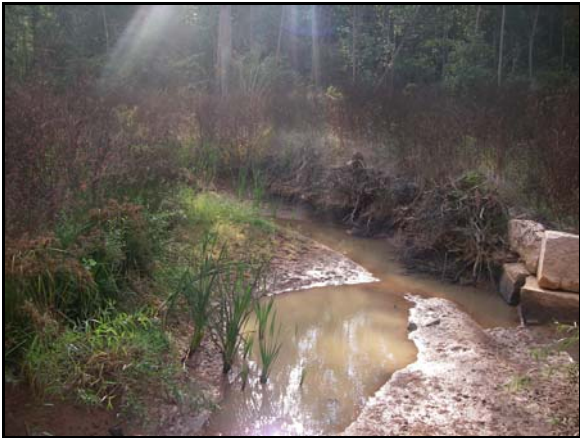
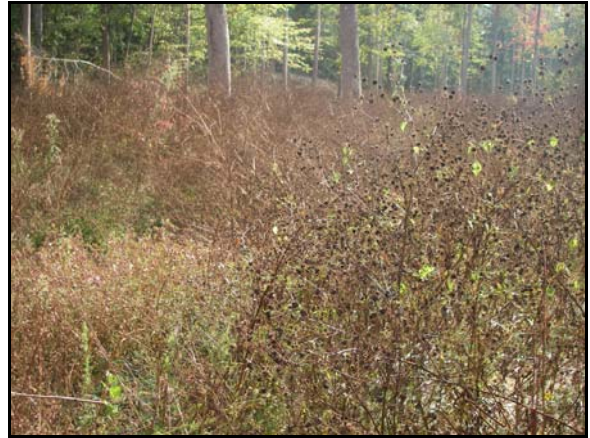
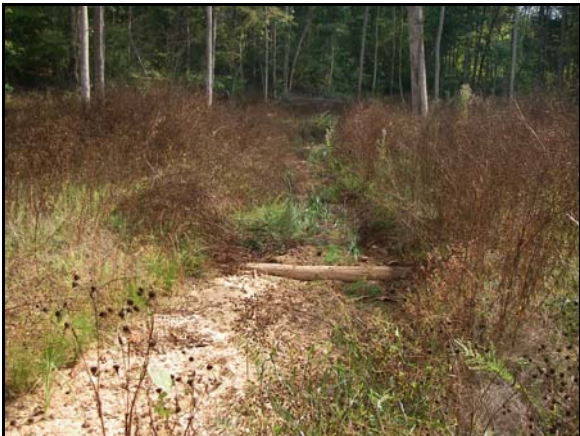
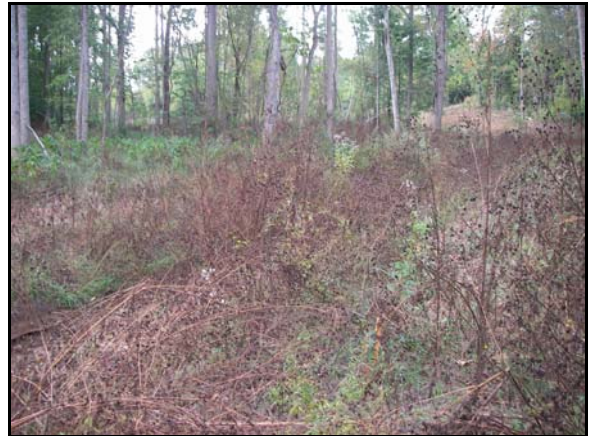
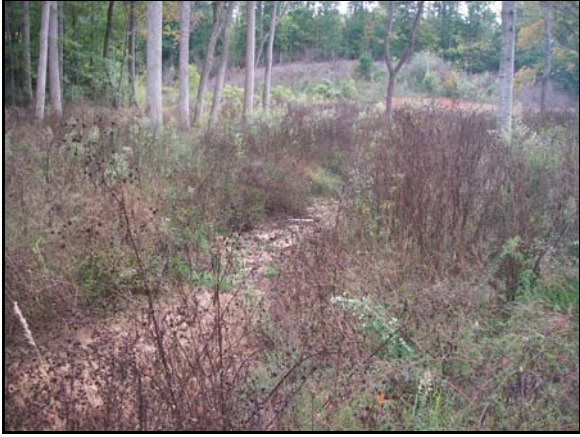
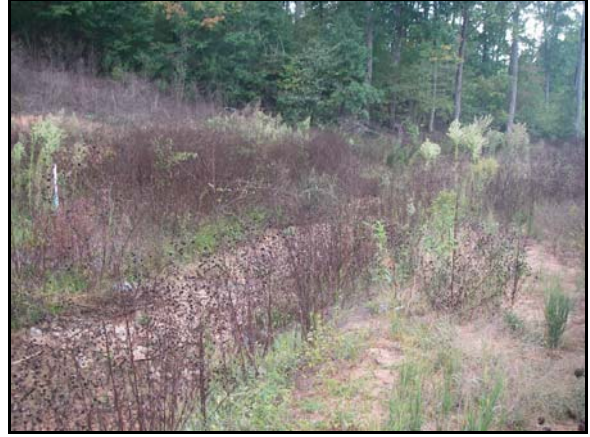
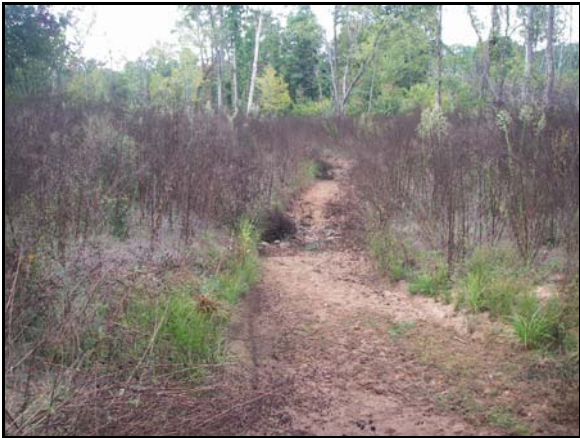
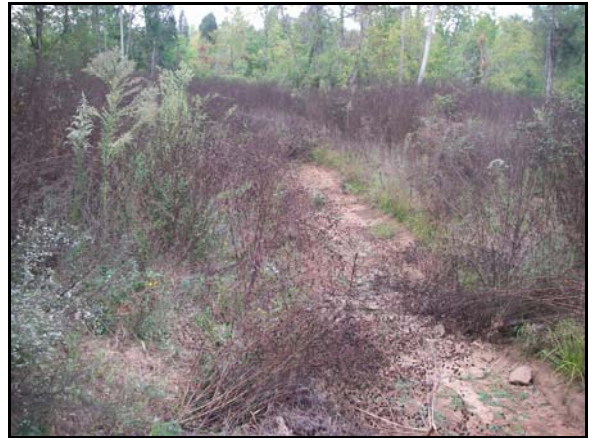
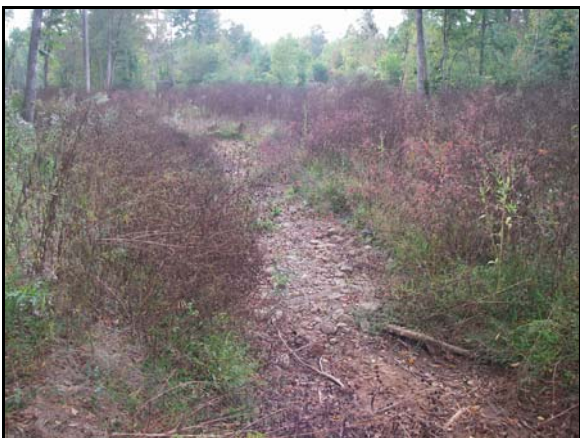
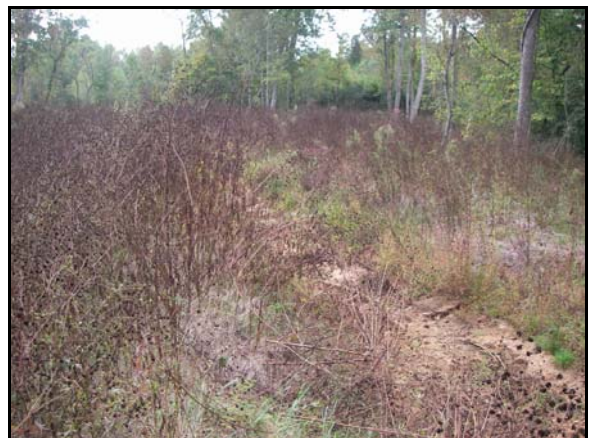
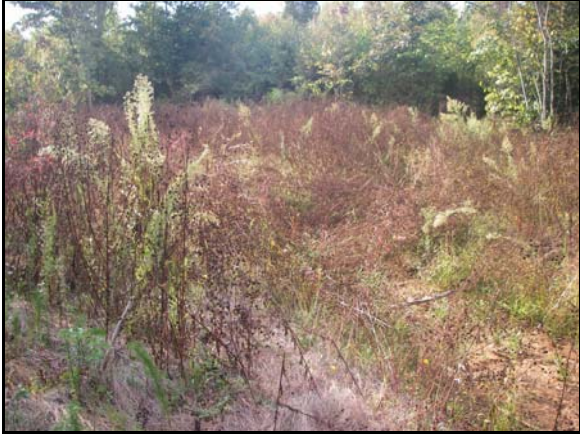
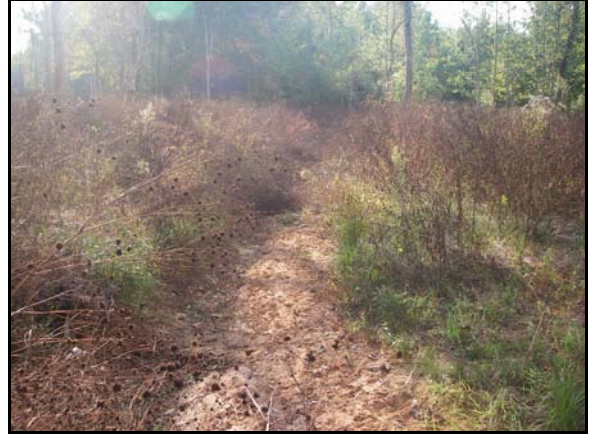
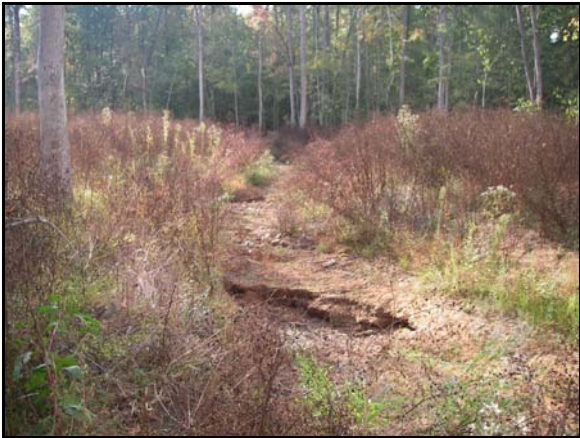
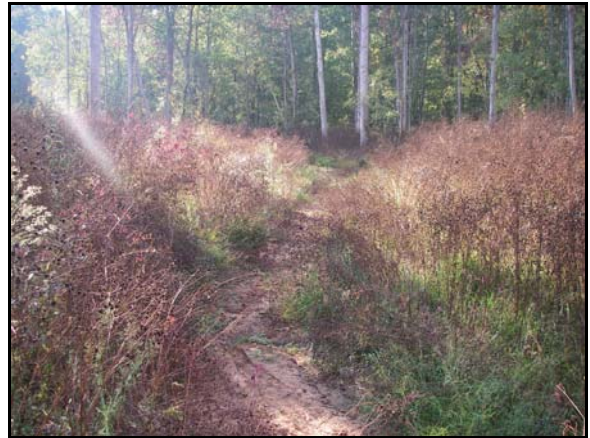
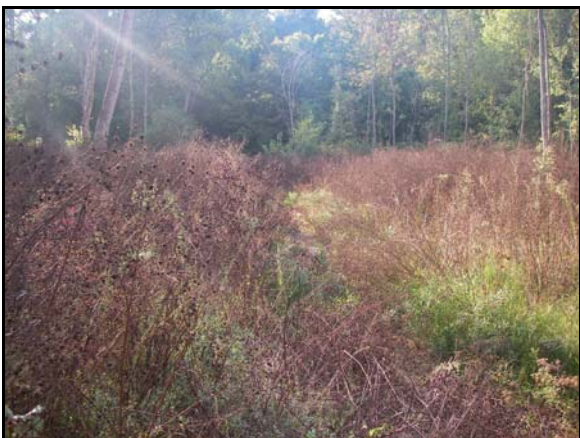
## PHOTO LOG – UT1

*Photo Reference Stations:* Photographs were used to visually document restoration success. Fifty-one (51) reference stations were established to document conditions at the constructed grade control structures across the Site. These photos are provided in Appendix A. The GPS coordinates of each photo station were noted as additional reference to ensure the same photo location was used throughout the monitoring period. These stations are included in the As-built Plan Sheets in Appendix C. Reference photos were taken once per year.

During the Year 1 Monitoring site visit the stream-side vegetation was noted as being successfully reestablished. In addition, the annual herbaceous plant *Bidens frondosa* (*tickseed sunflower*) intended as a nurse crop, to discourage aggressive weeds while the permanent seedlings become established, has been successful throughout the Site (USDA, 2007). See Project ID photos in Appendix A.

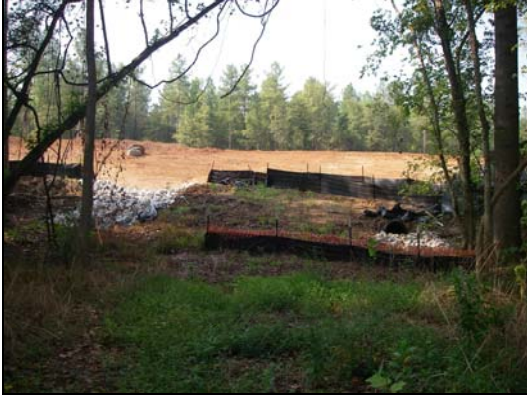
**Detention Pond – Adjacent  
to UT2 at STA 20+00**

Currently, none of the BMPs are causing any significant degradation of the restored channels; however, discharge from the BMP adjacent to Station 20+00 along UT2 has caused some minor headcutting below the riffle at the log sill. See Appendix A for photo documentation of the BMP structure and the in-stream impact.

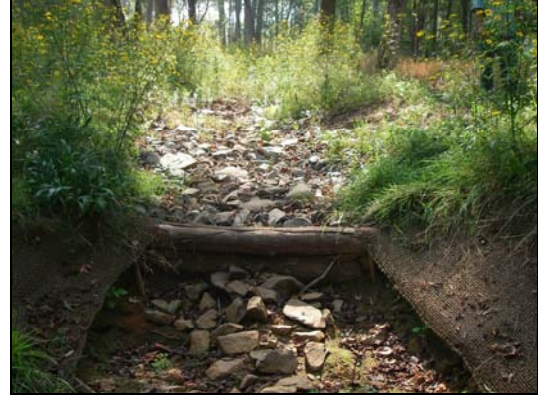
**Beginning headcut below  
riffle at STA 20+00 on UT2**

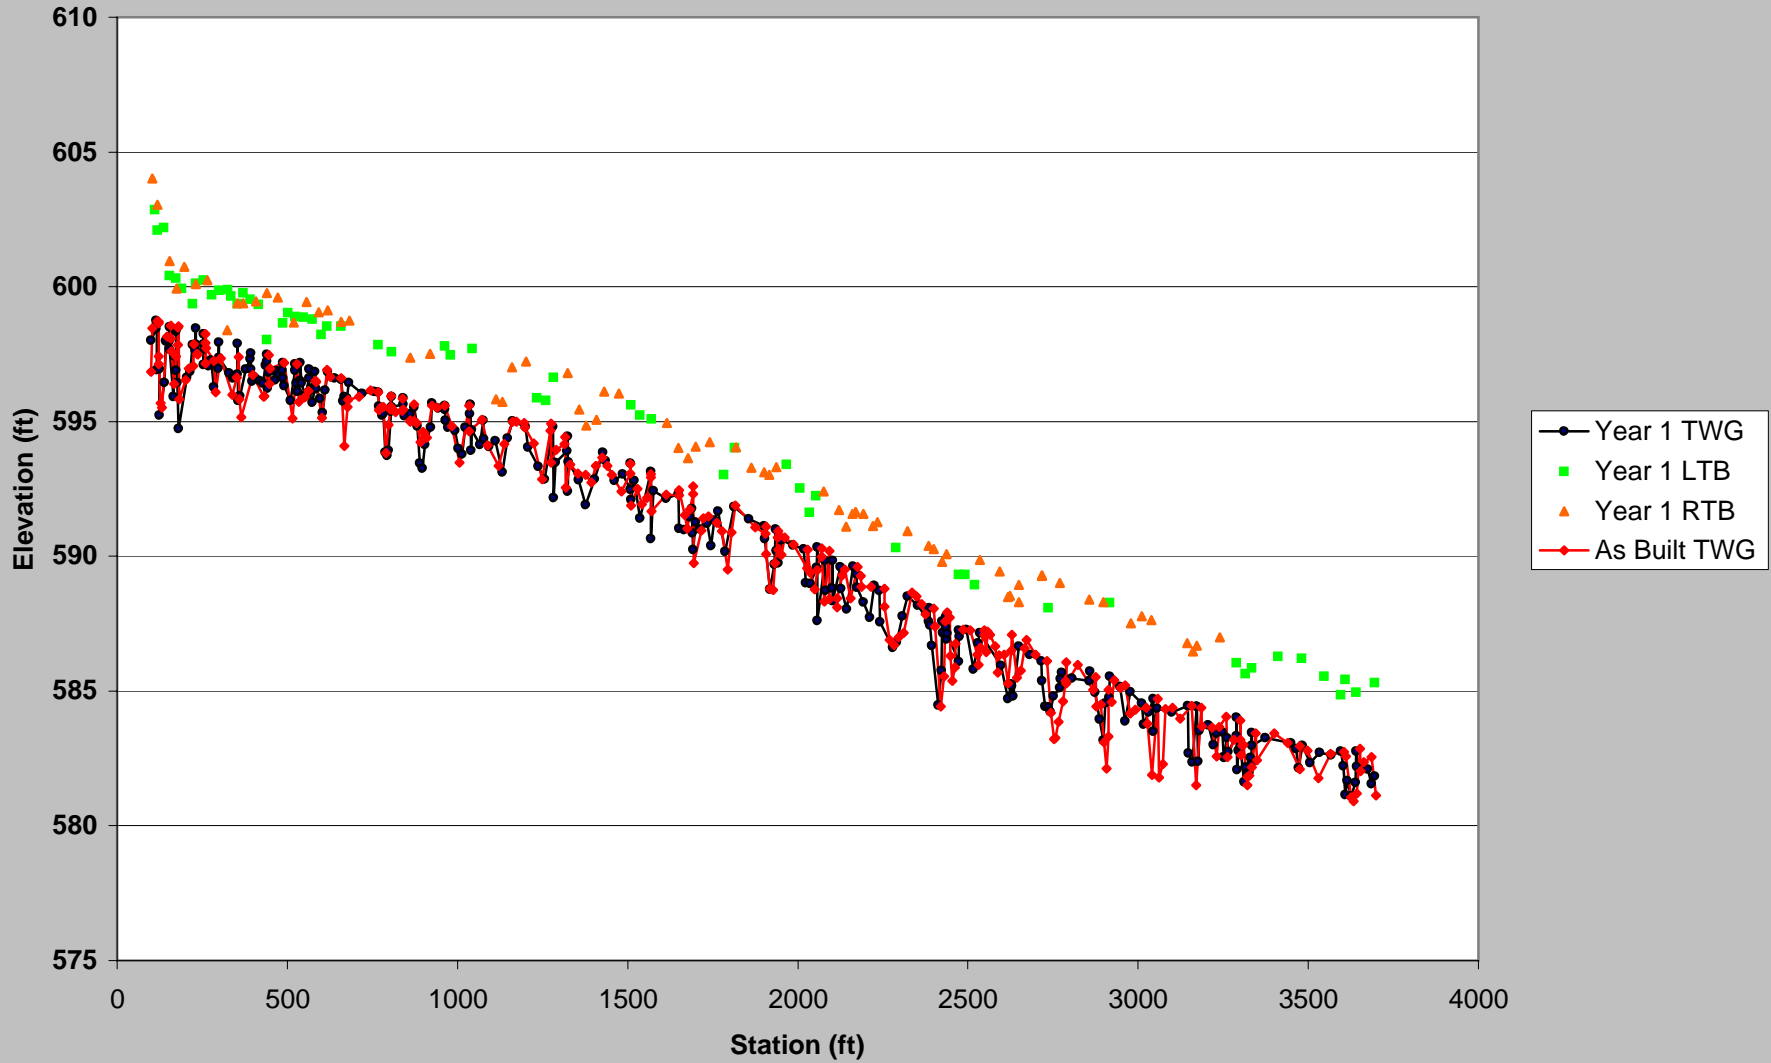
### UT1 Mainstem Profile (2007 Monitoring)

The representative longitudinal profiles along the restored channels were resurveyed to document stream profile at the end of monitoring Year 1. Drought conditions resulted in little to no water within the restored channels and therefore profile data such as riffle slopes and pool-to-pool spacing could not be calculated. Sinuosity for all restored reaches has remained the same and there's been no measurable change in stream pattern. Though there was some minor areas of bed scour, as mentioned in Section 3.5 of this report, none of the areas need to be addressed, at this time, nor should result any future problems. Inspections of these areas will be performed in subsequent monitoring periods.

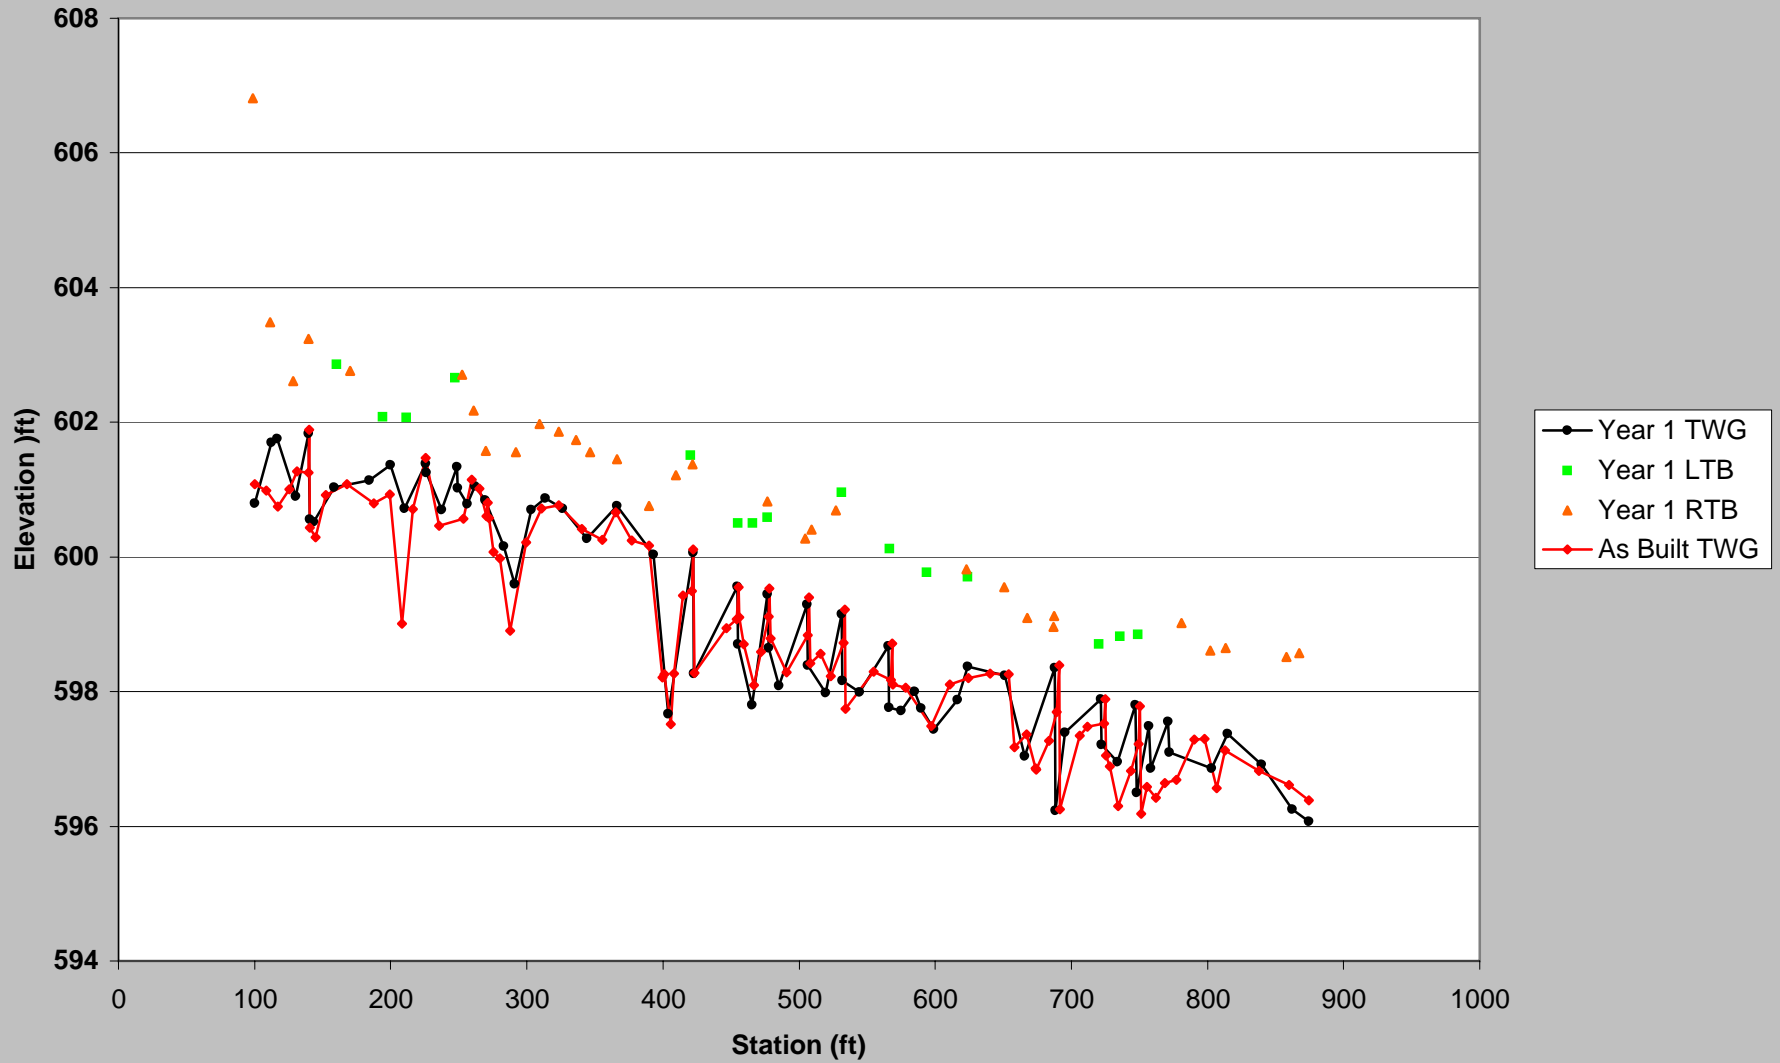
### UT1B Profile (2007 Monitoring)

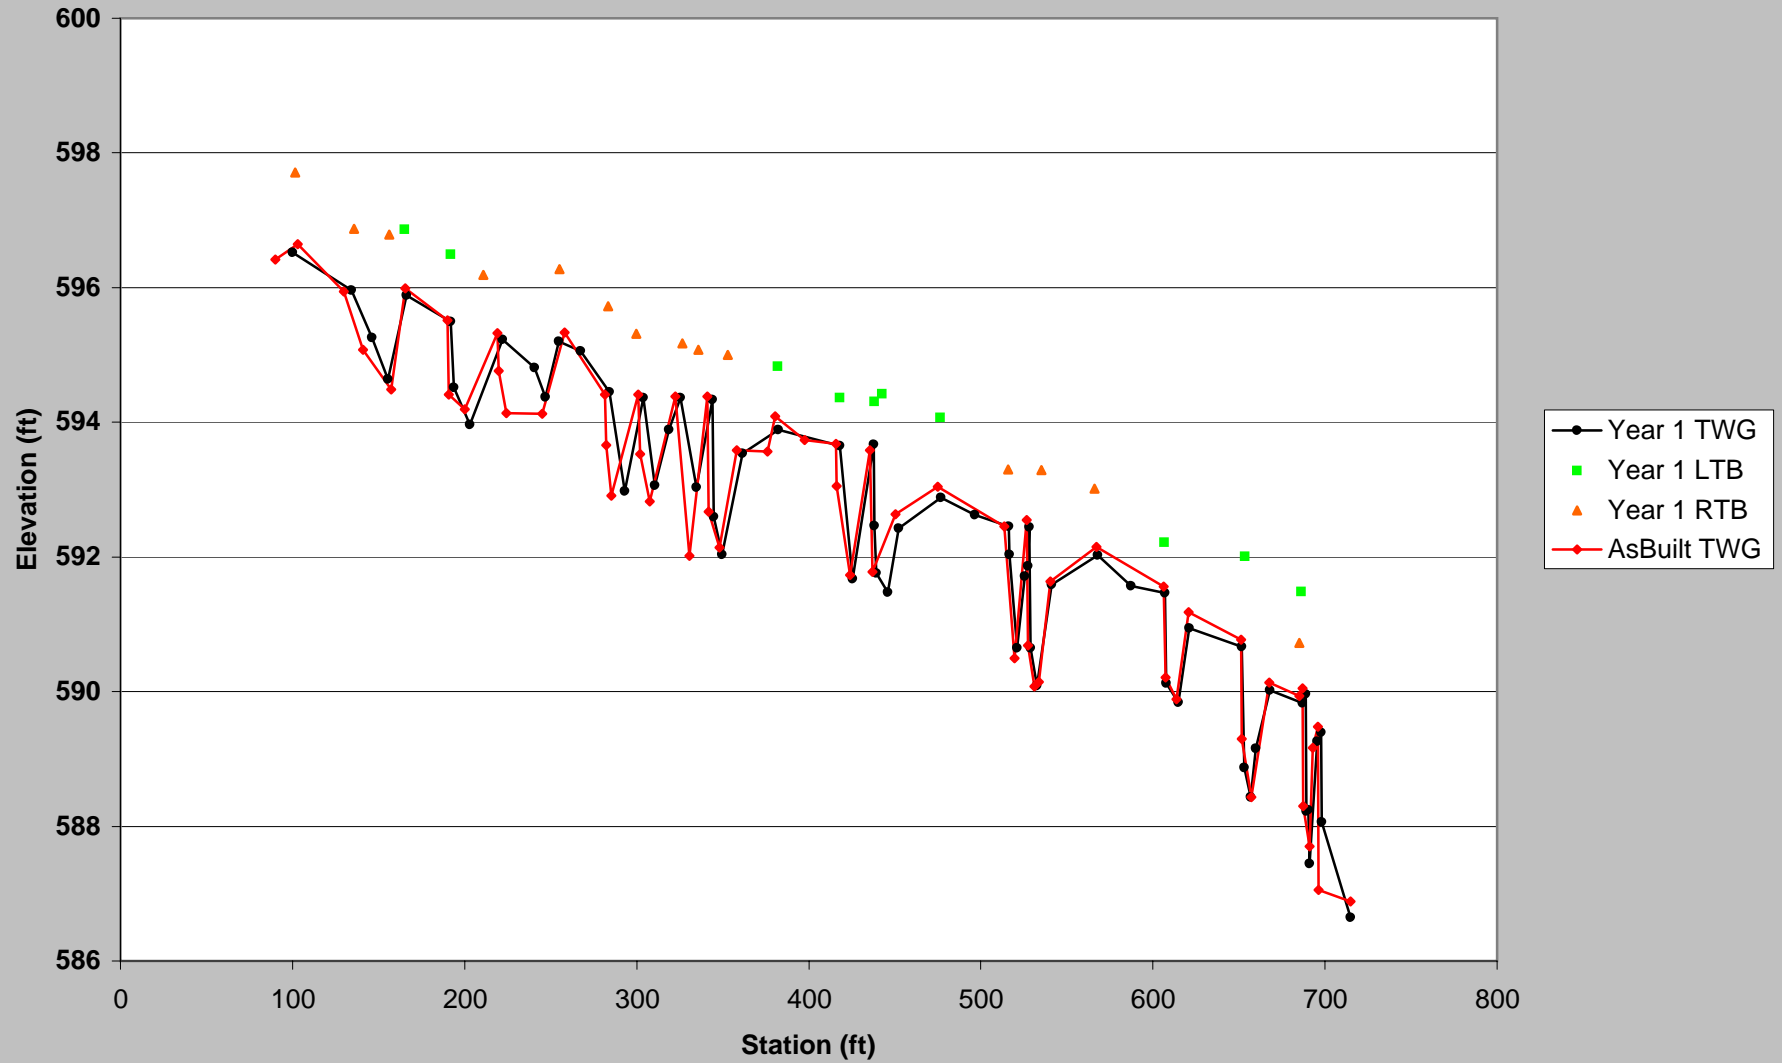
UT1C Profile (2007 Monitoring)

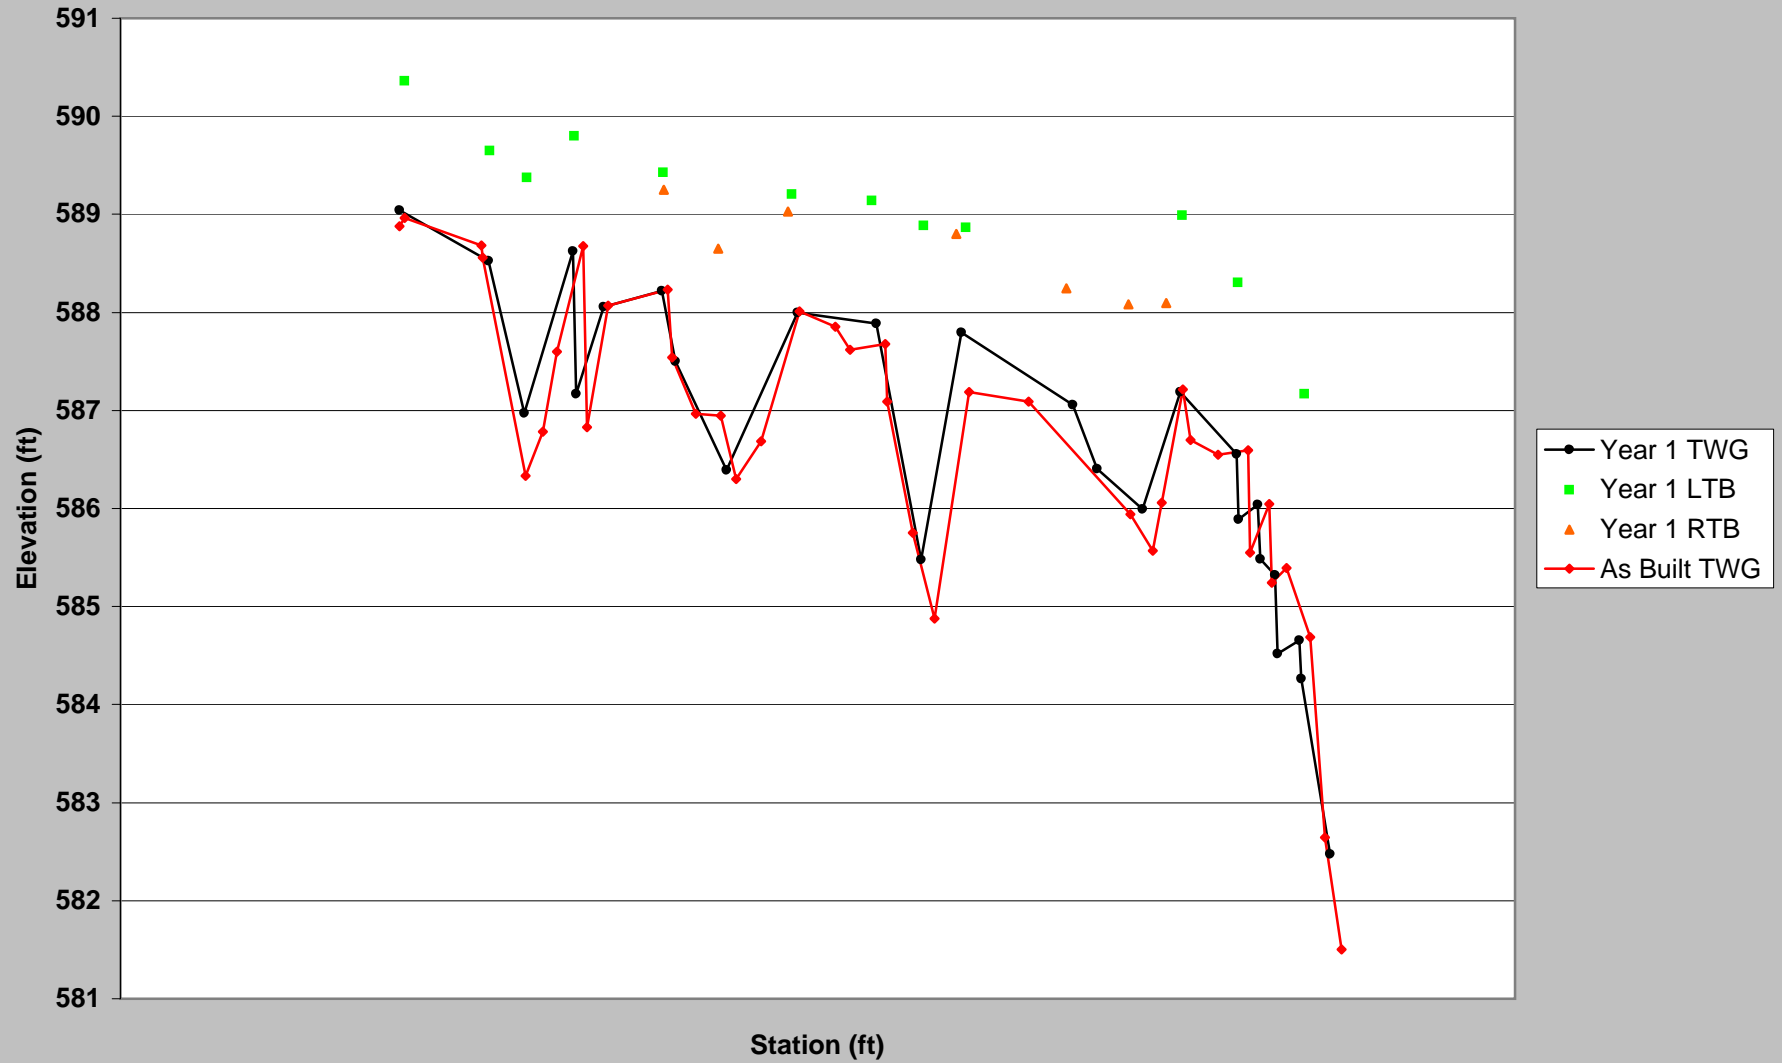
### UT1C Profile (2007 Monitoring)

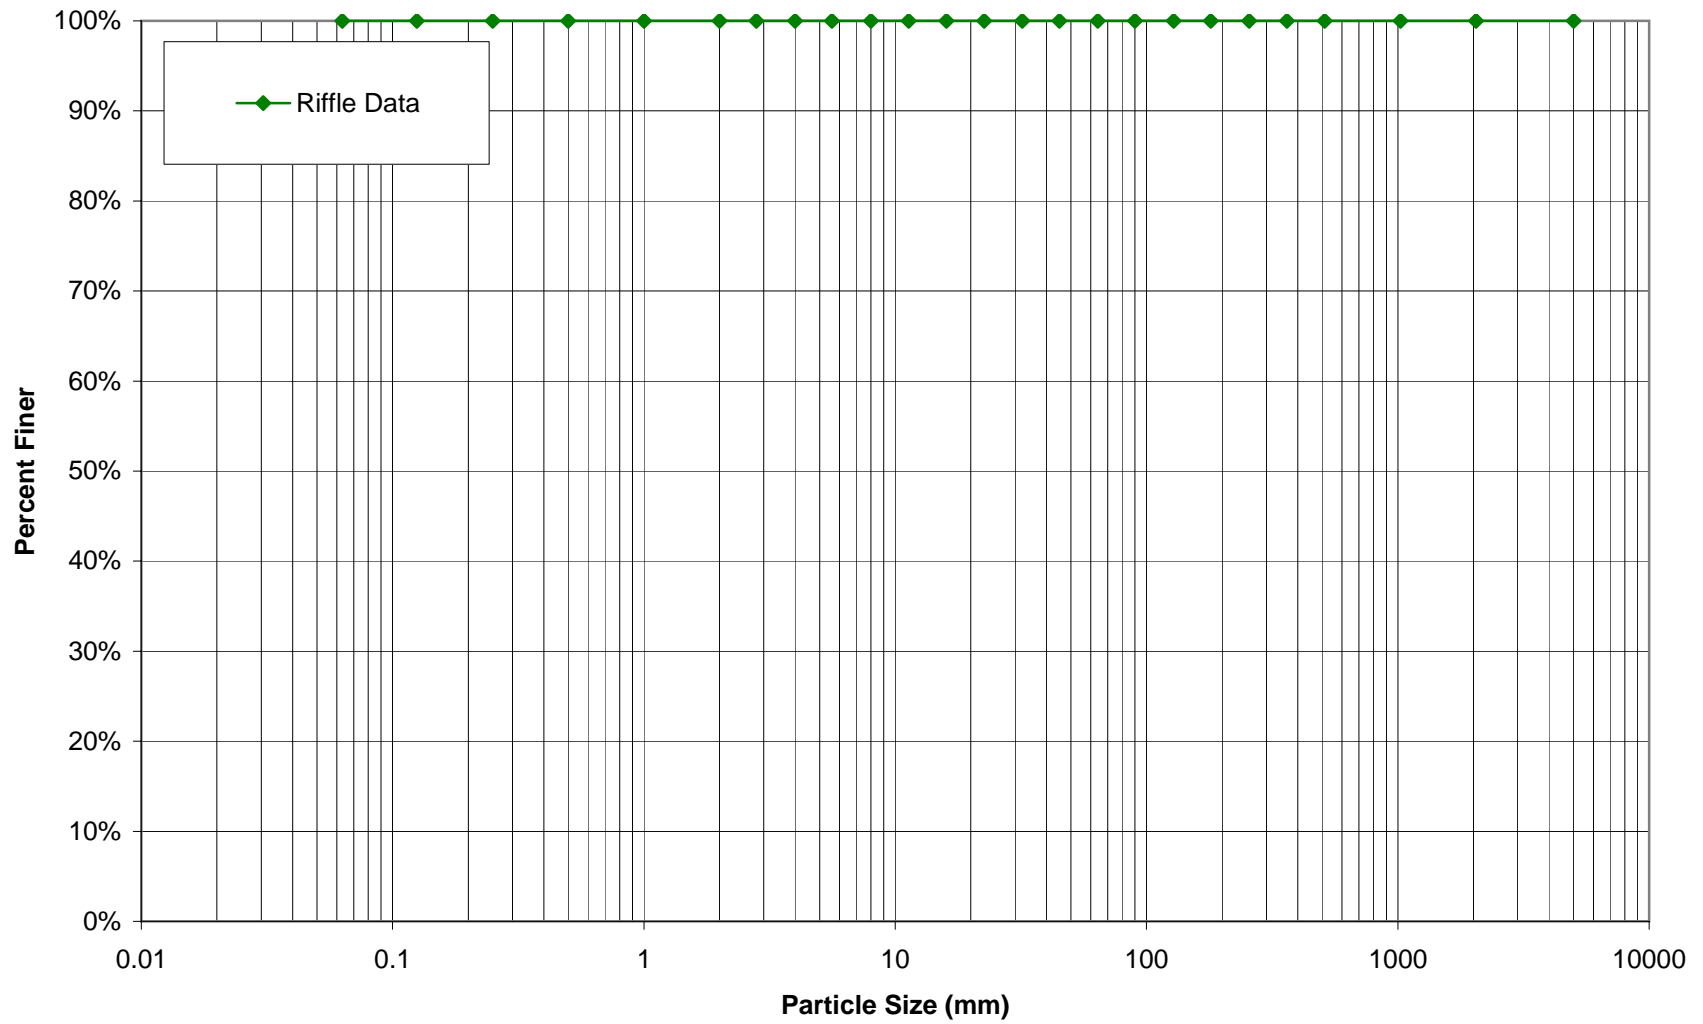
Beaverdam Creek UT1 (Reach 1)  
X1 Pool  
Pebble Count Particle Size Distribution

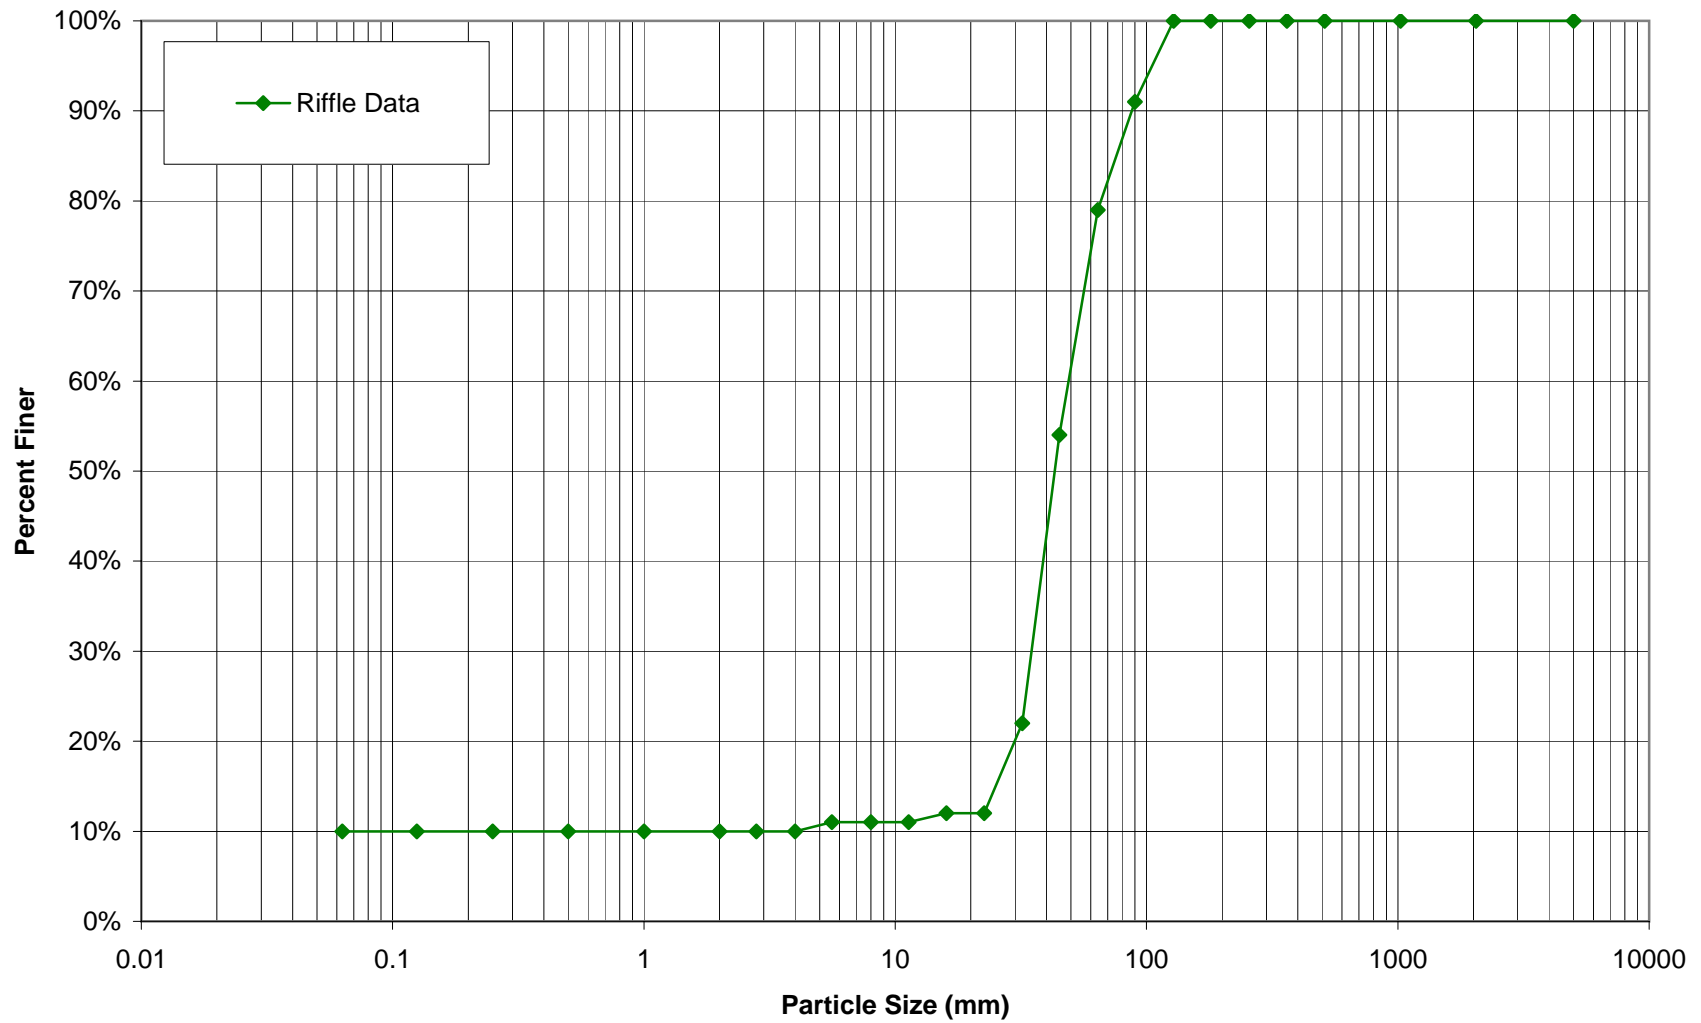
Beaverdam Creek UT1 (Reach 1)  
X2 Riffle  
Pebble Count Particle Size Distribution

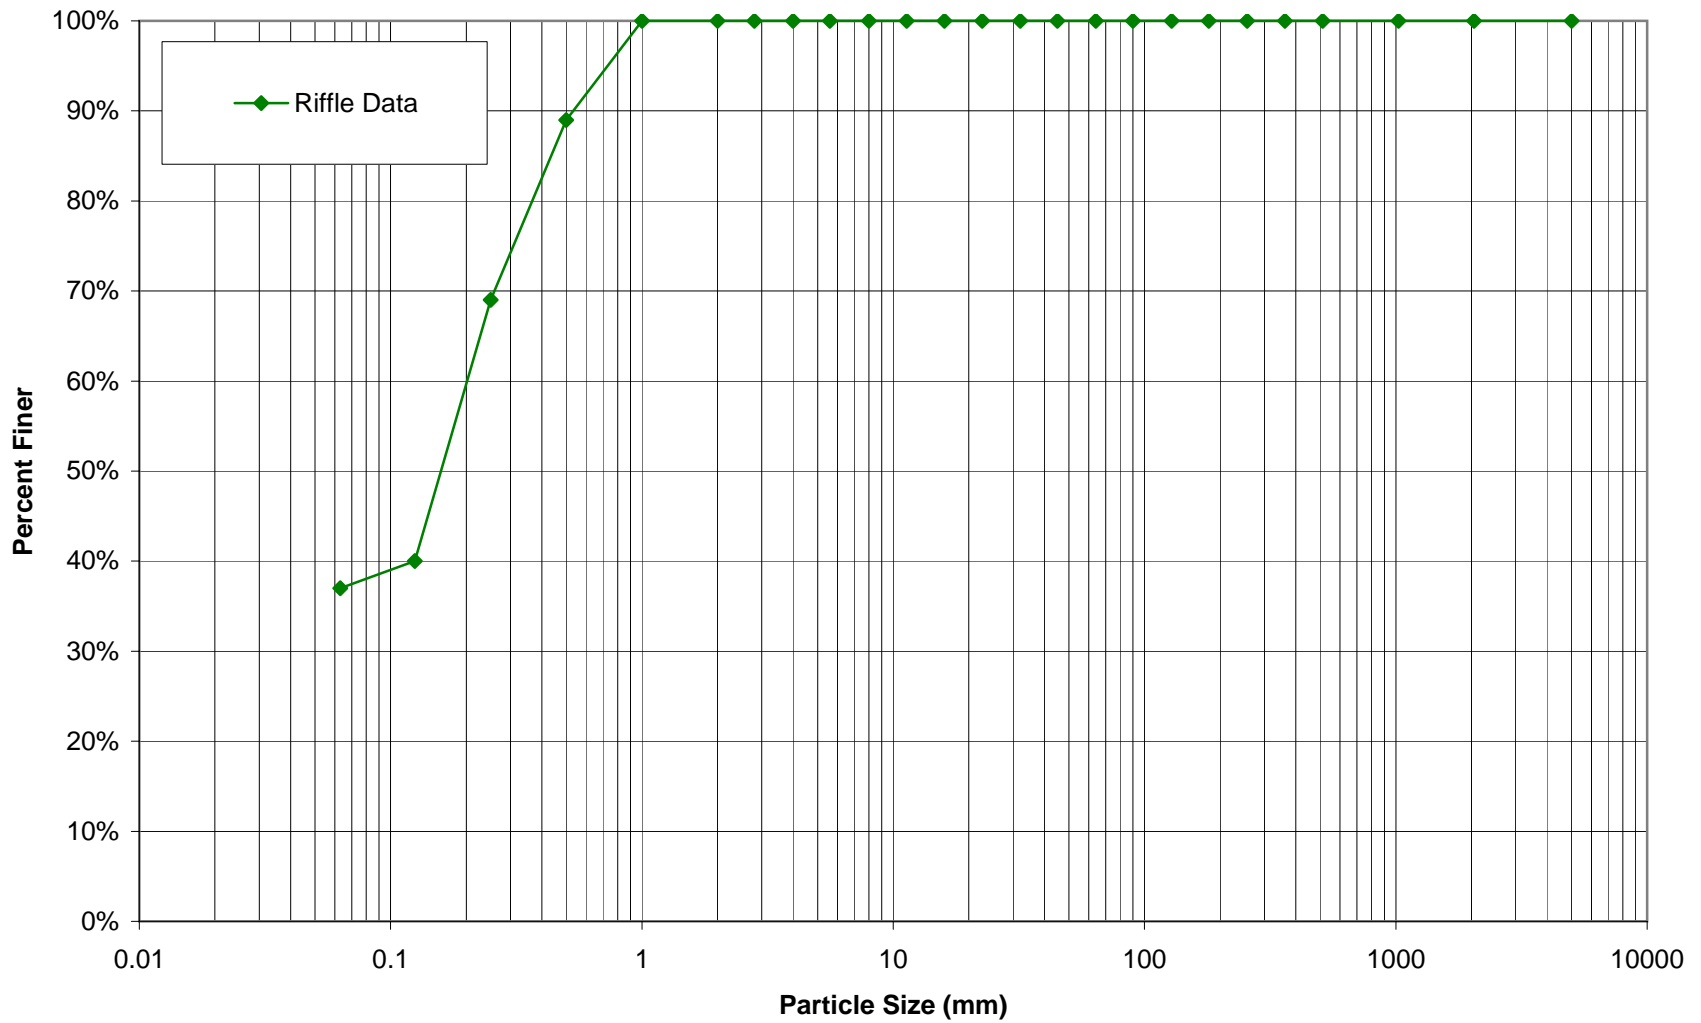
Beaverdam Creek UT1B  
X3 Pool  
Pebble Count Particle Size Distribution
