**BEAVERDAM CREEK  
STREAM RESTORATION PROJECT**  
ANNUAL MONITORING REPORT FOR 2006-2007 (YEAR 1)

**Project Number: D05016-1**

Prepared by: Baker Engineering

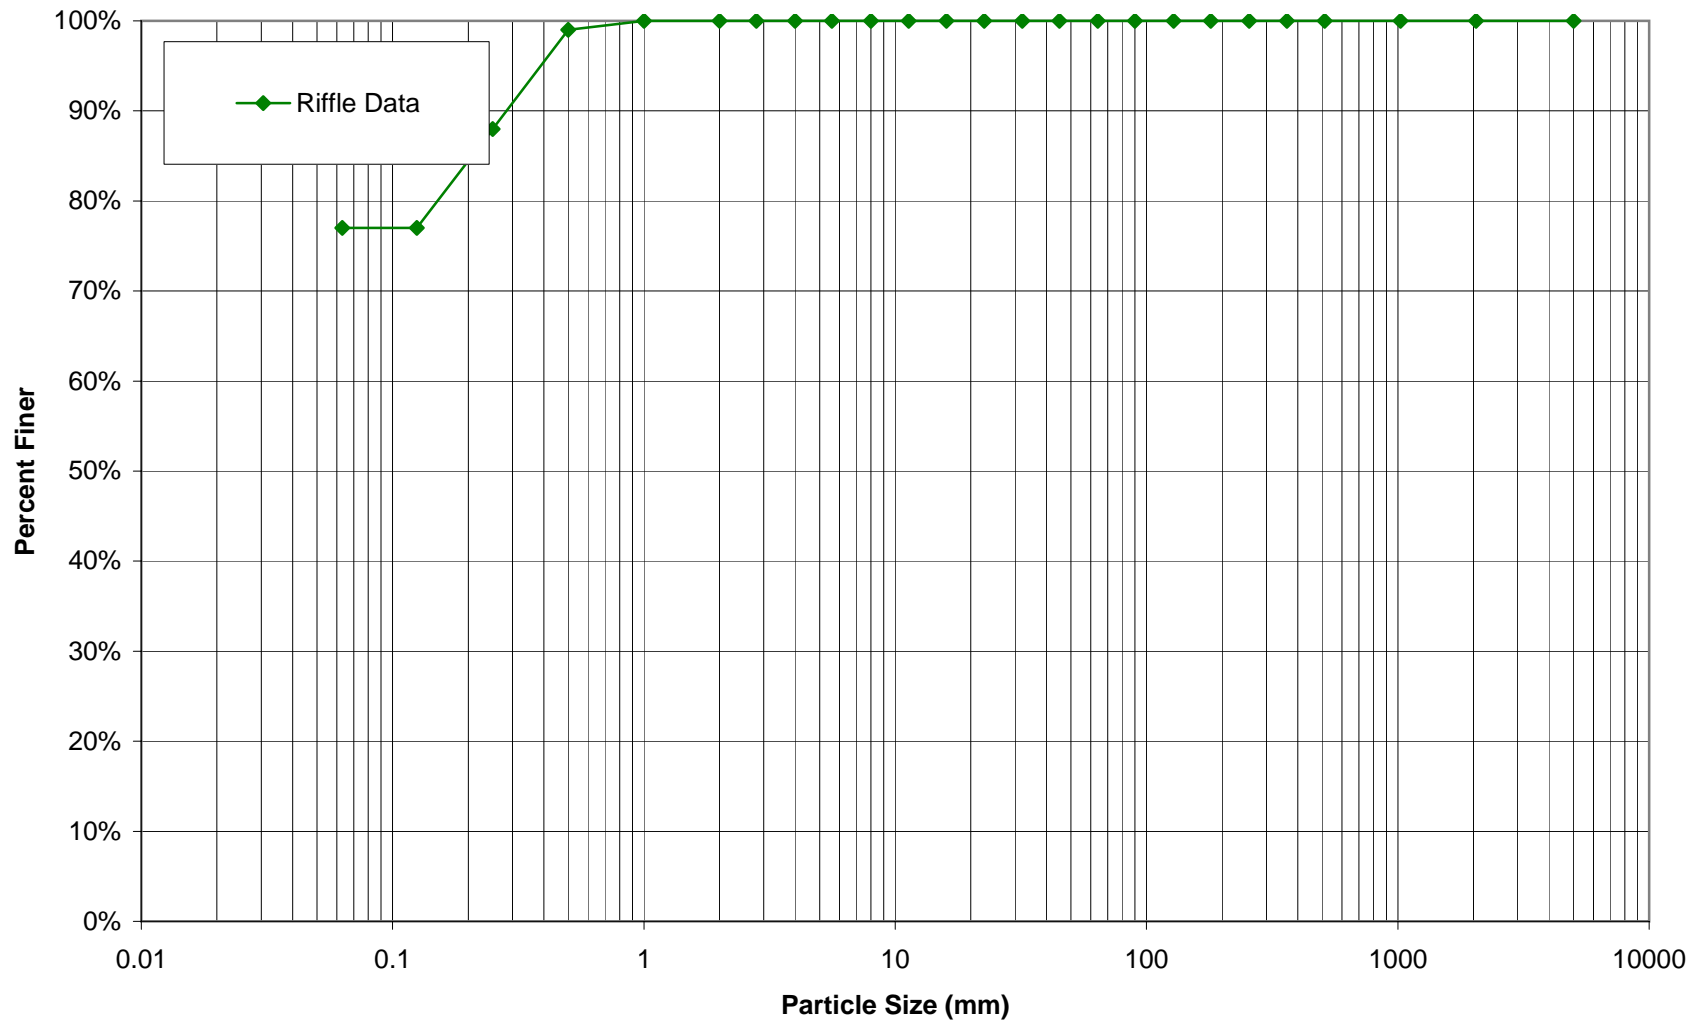
Beaverdam Creek UT1B  
X4 Riffle  
Pebble Count Particle Size Distribution

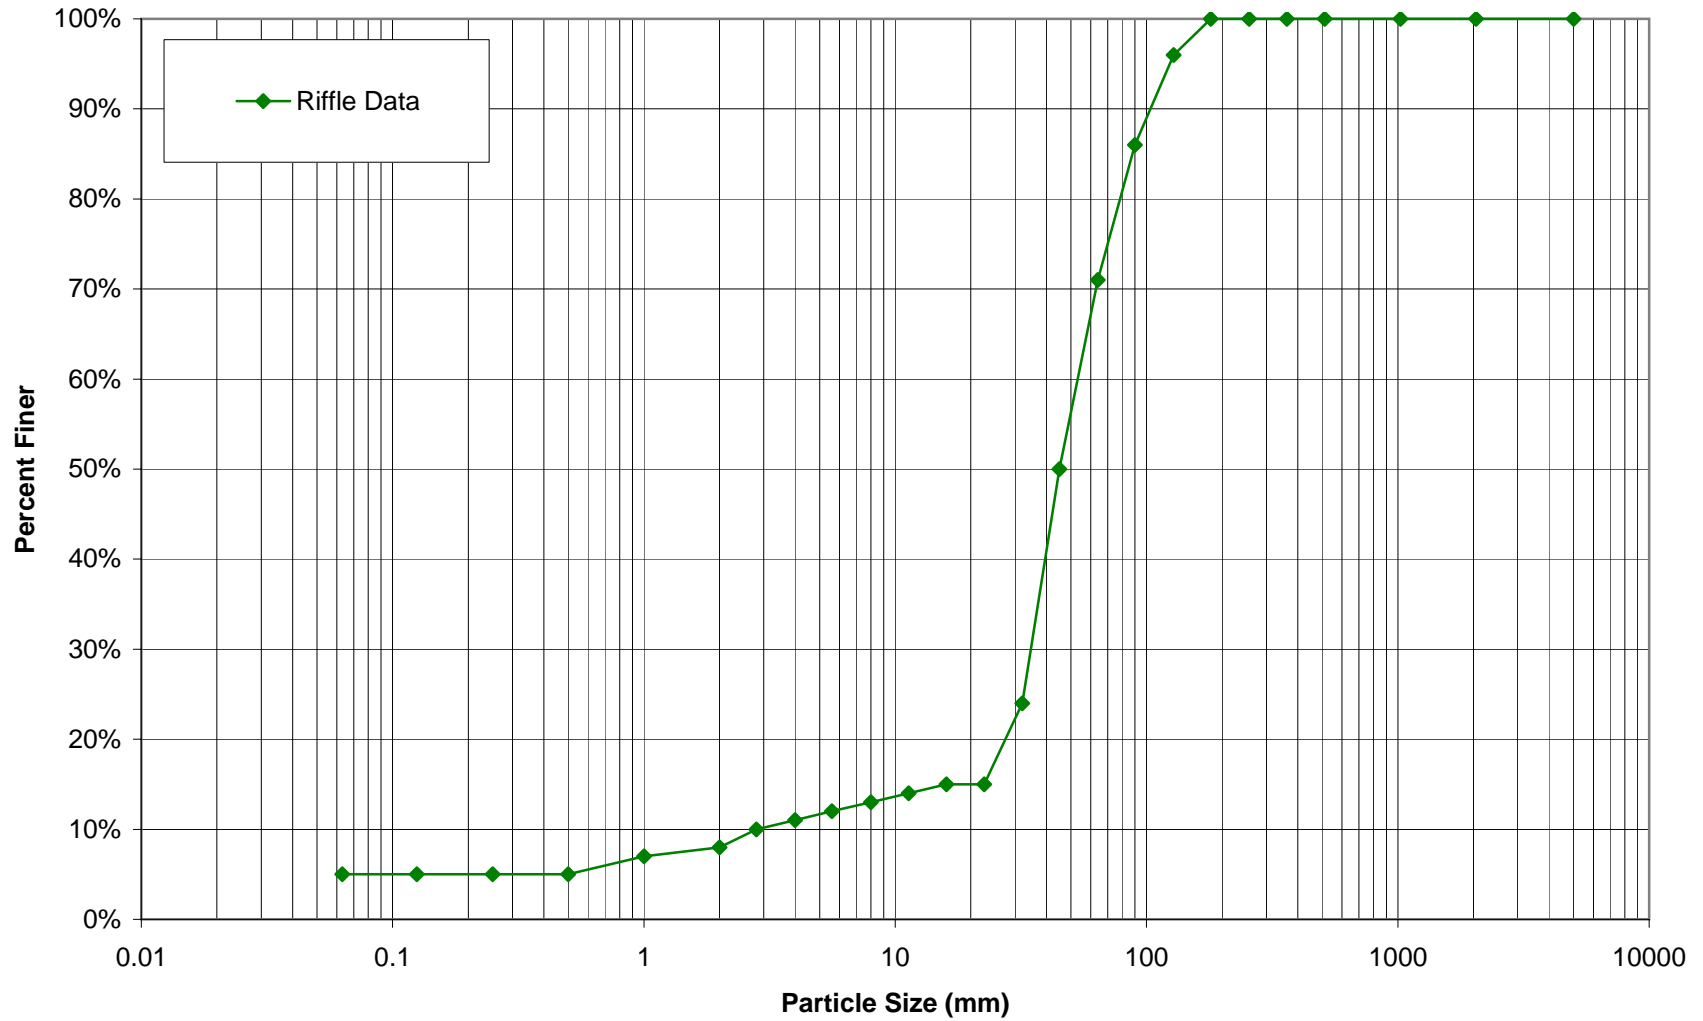
**Beaverdam Creek UT1 (Reaches 2-5)  
X5 Riffle  
Pebble Count Particle Size Distribution**

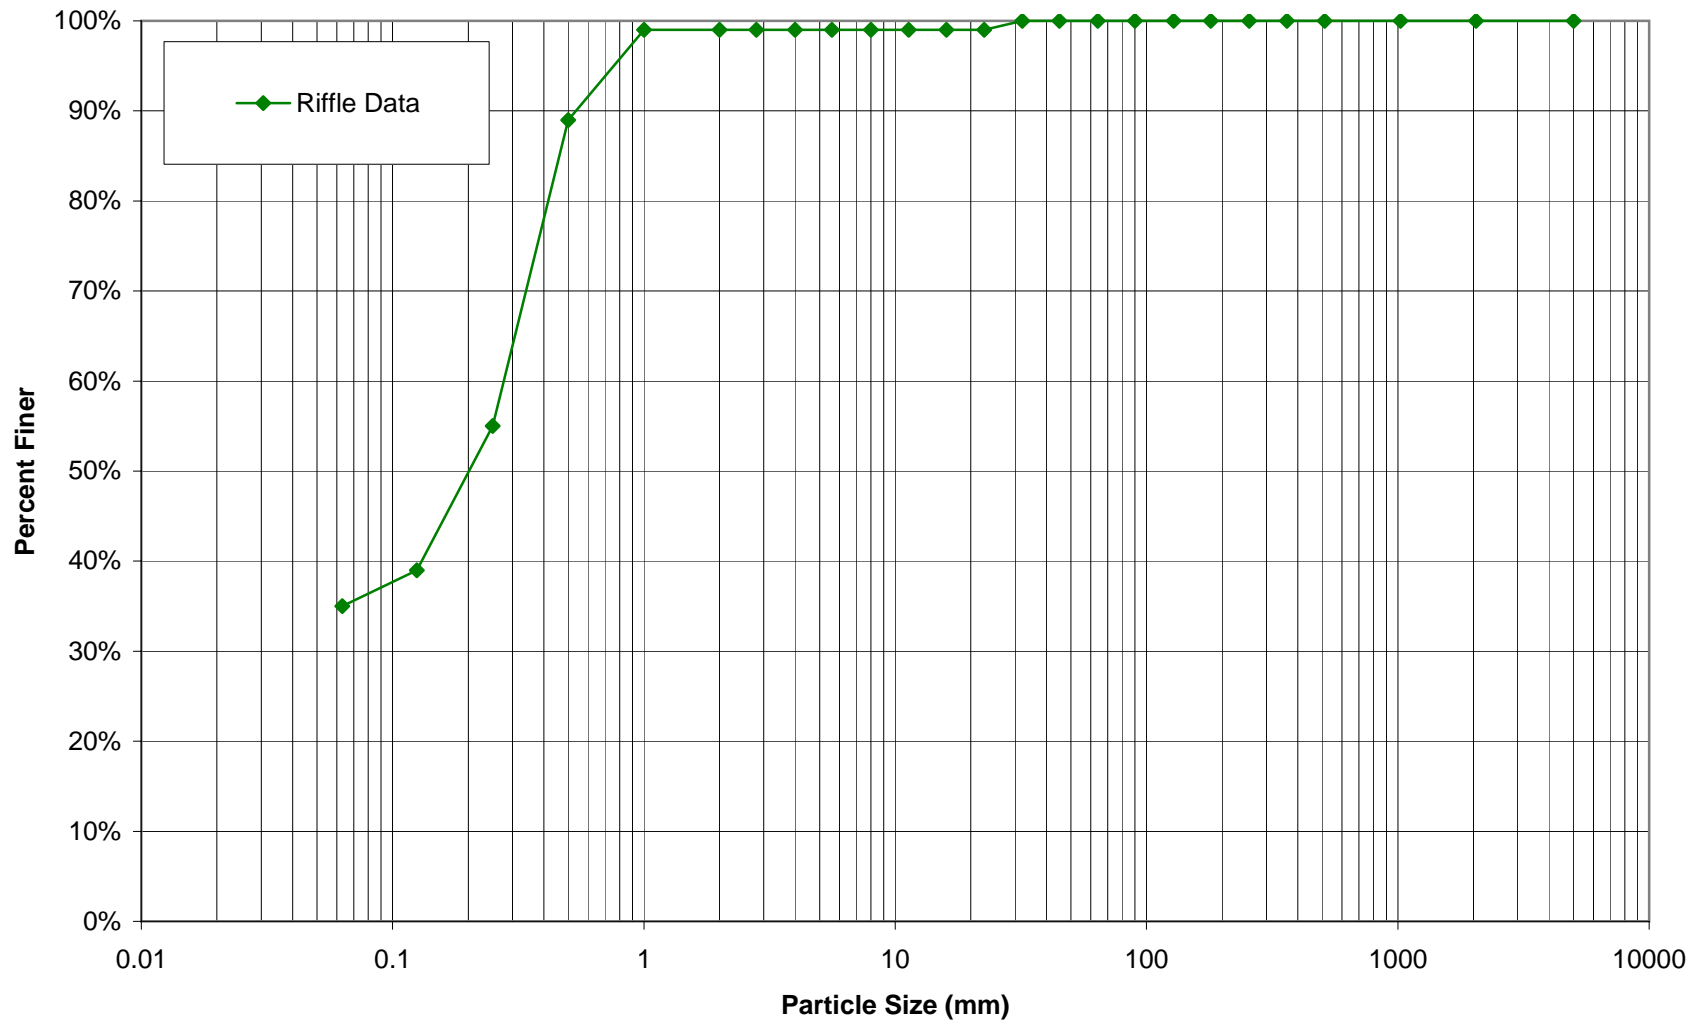
Beaverdam Creek UT1 (Reaches 2-5)  
X6 Pool  
Pebble Count Particle Size Distribution

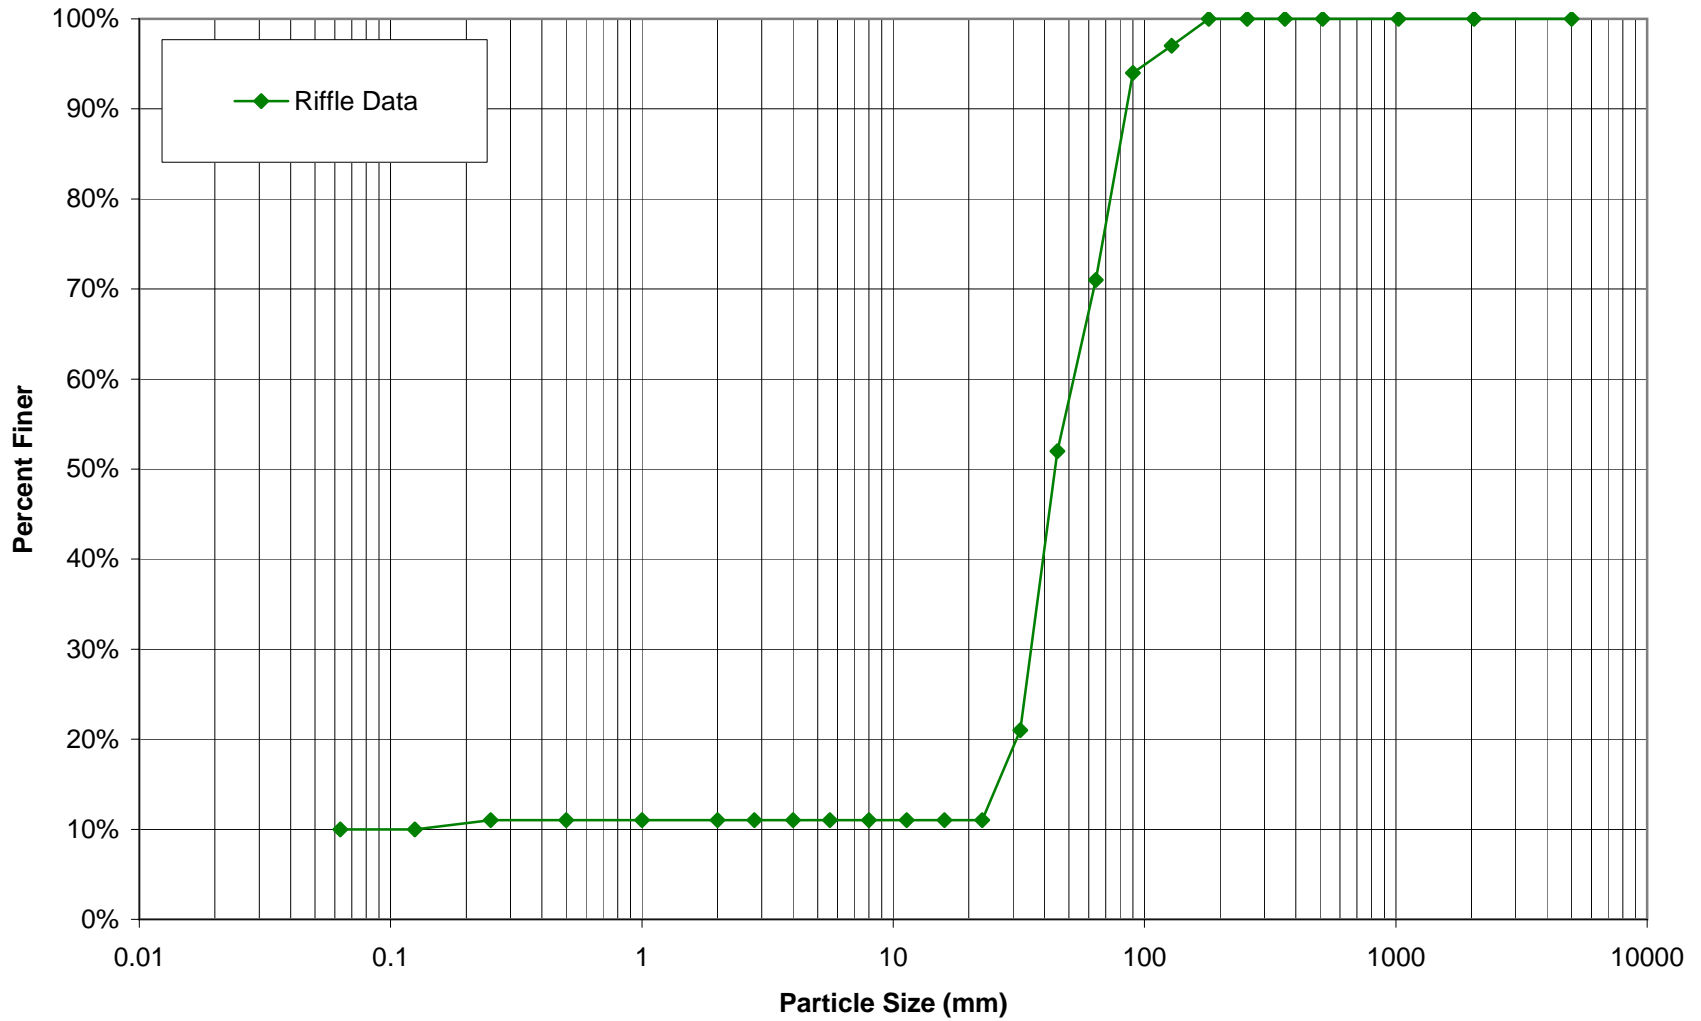
Beaverdam Creek UT1C  
X7 Riffle  
Pebble Count Particle Size Distribution

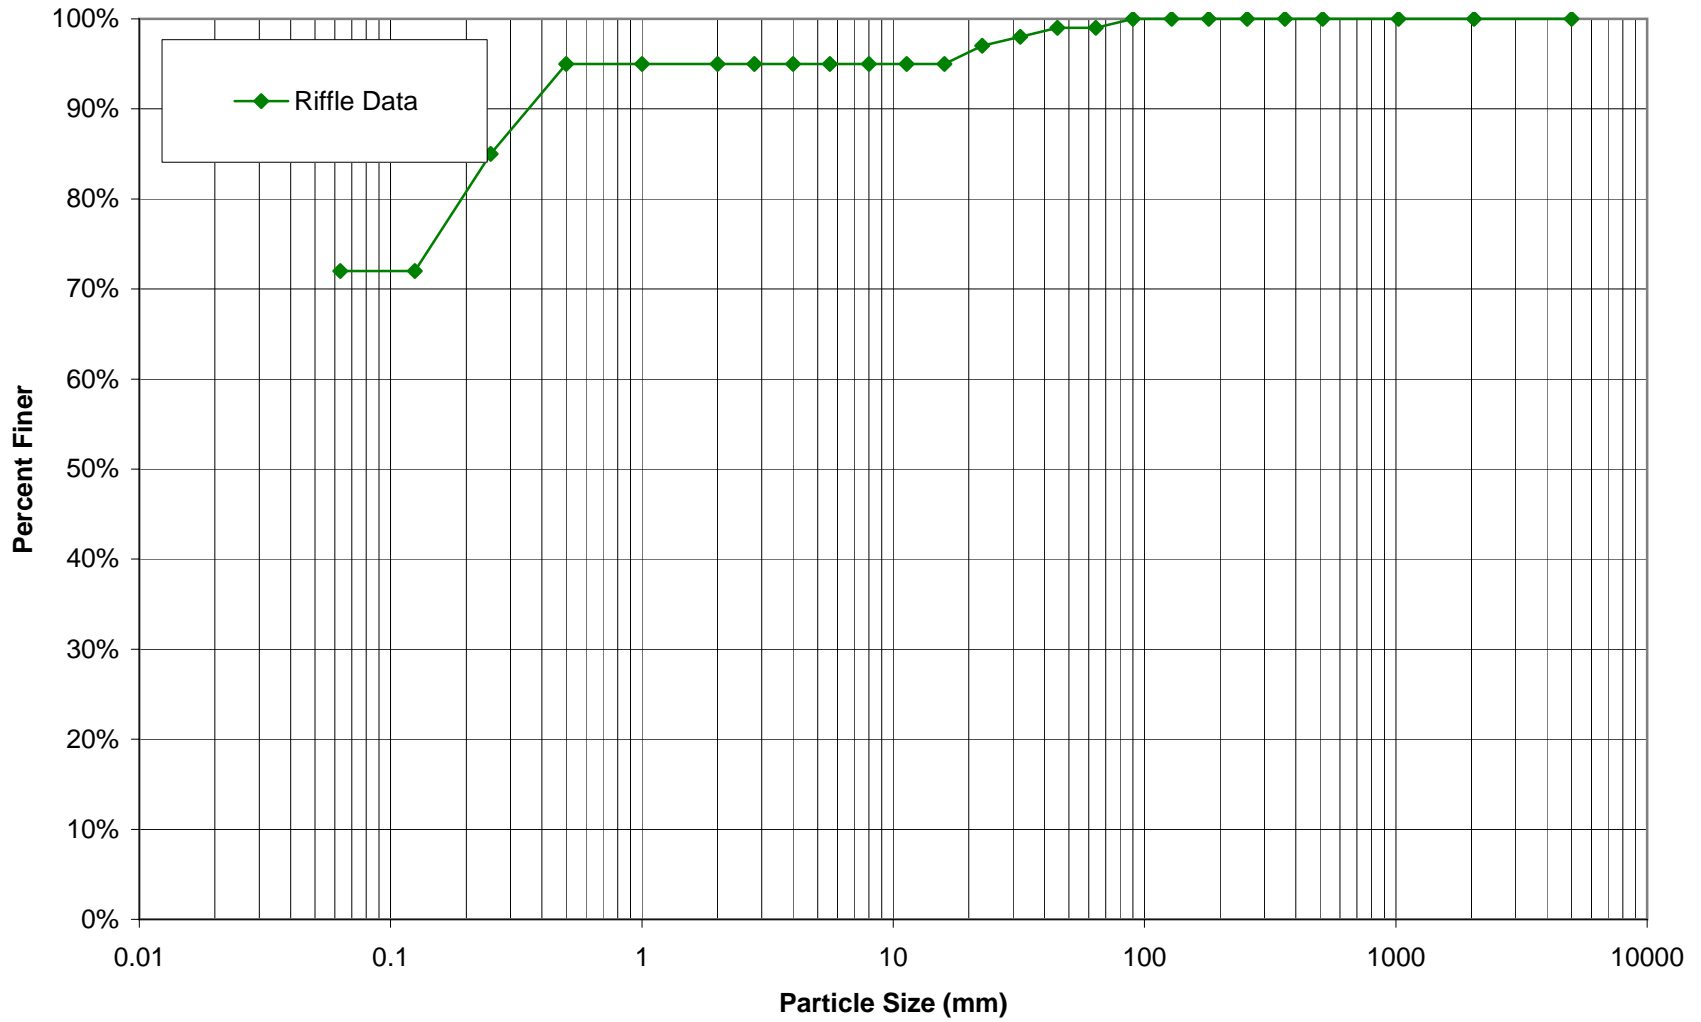
Beaverdam Creek UT1C  
X8 Pool  
Pebble Count Particle Size Distribution

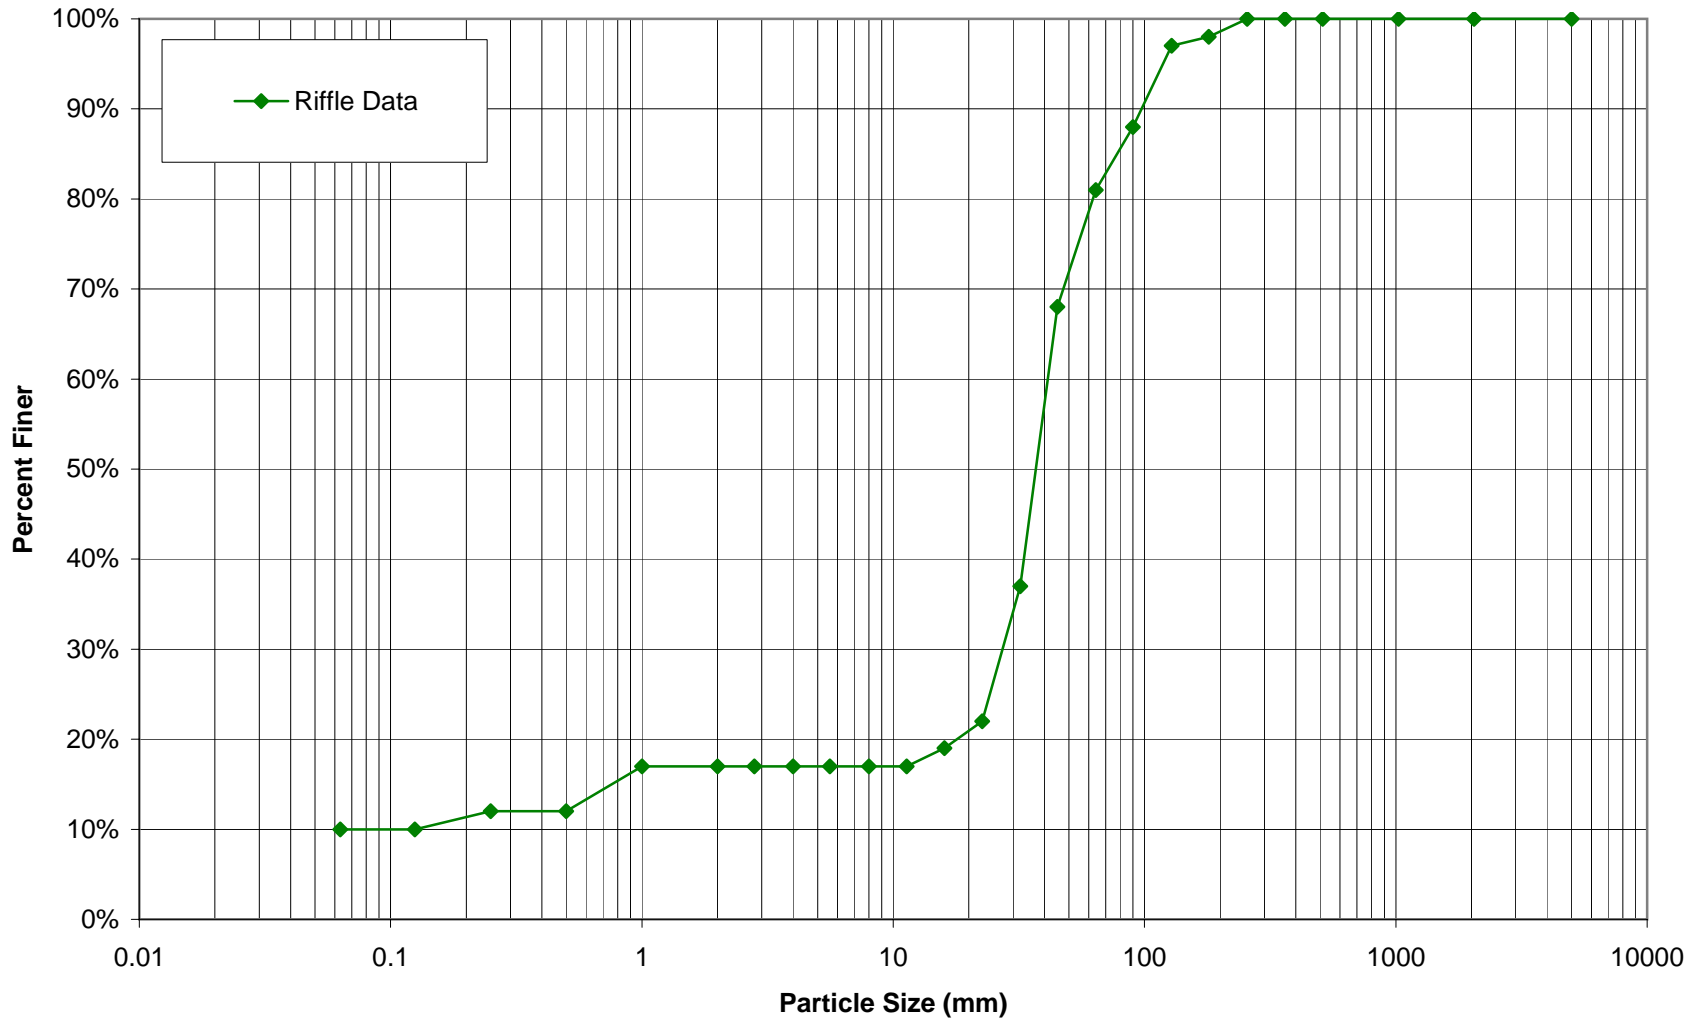
**Beaverdam Creek UT1 (Reaches 2-5)  
X9 Riffle  
Pebble Count Particle Size Distribution**

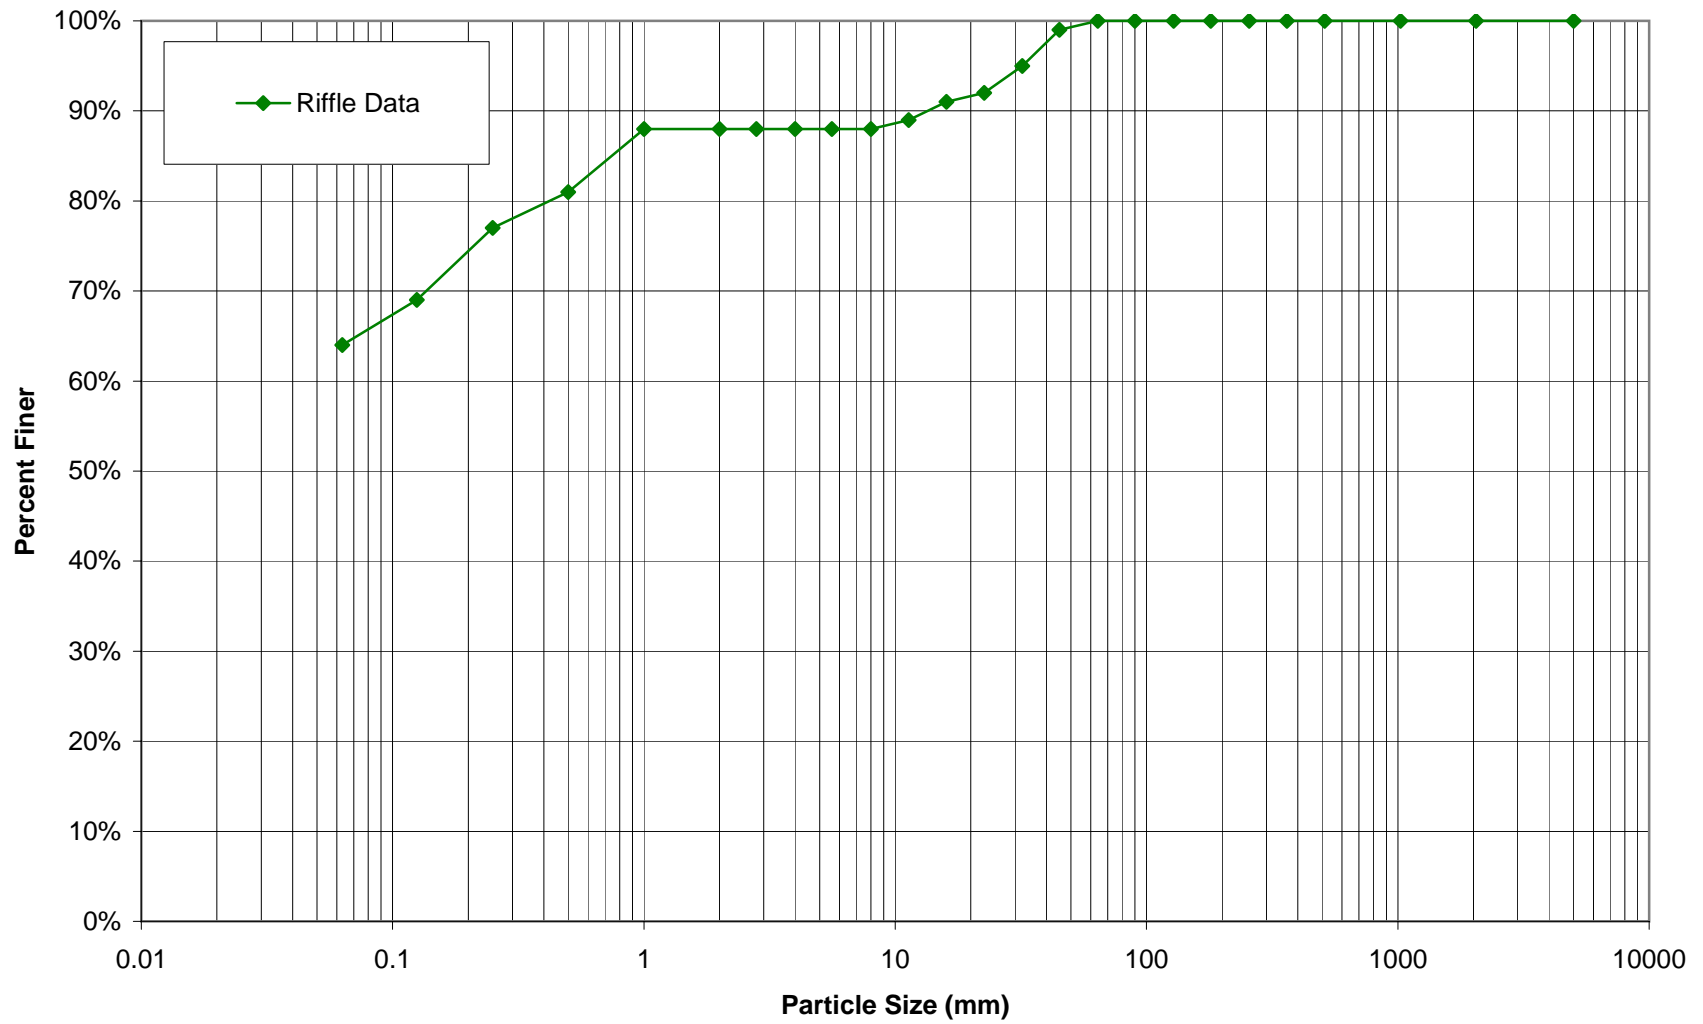
**Beaverdam Creek UT1 (Reaches 2-5)  
X10 Pool  
Pebble Count Particle Size Distribution**

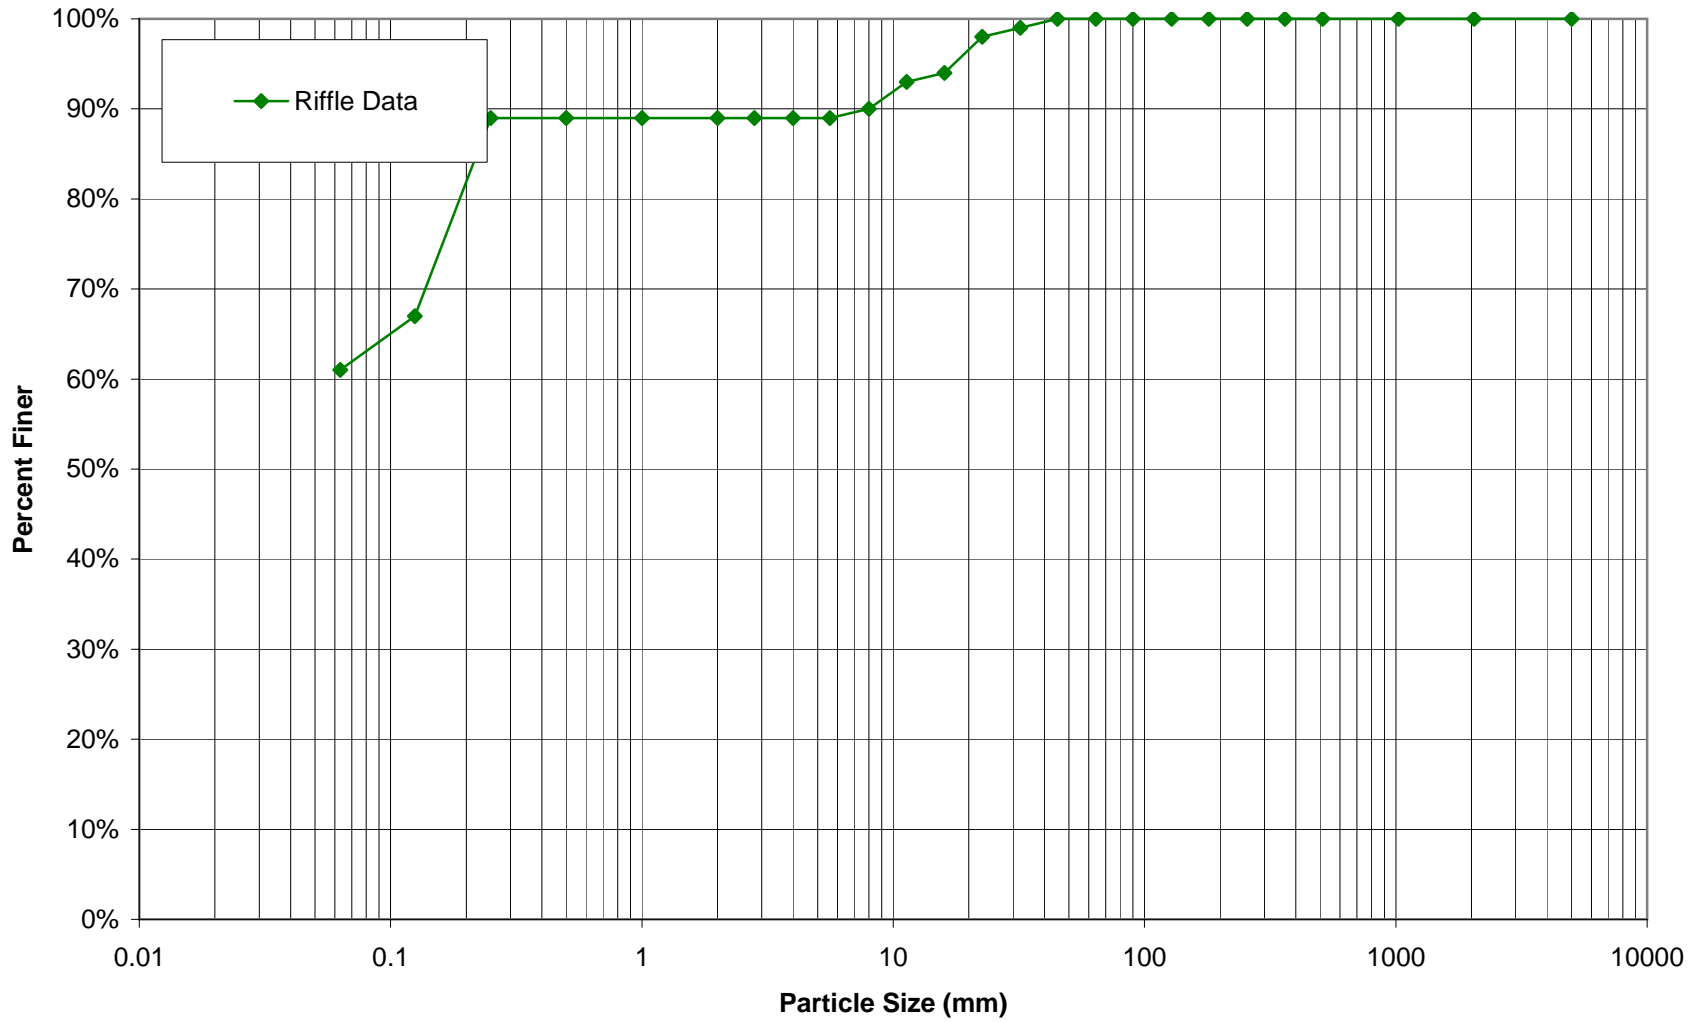
Beaverdam Creek UT1D  
X11 Pool  
Pebble Count Particle Size Distribution

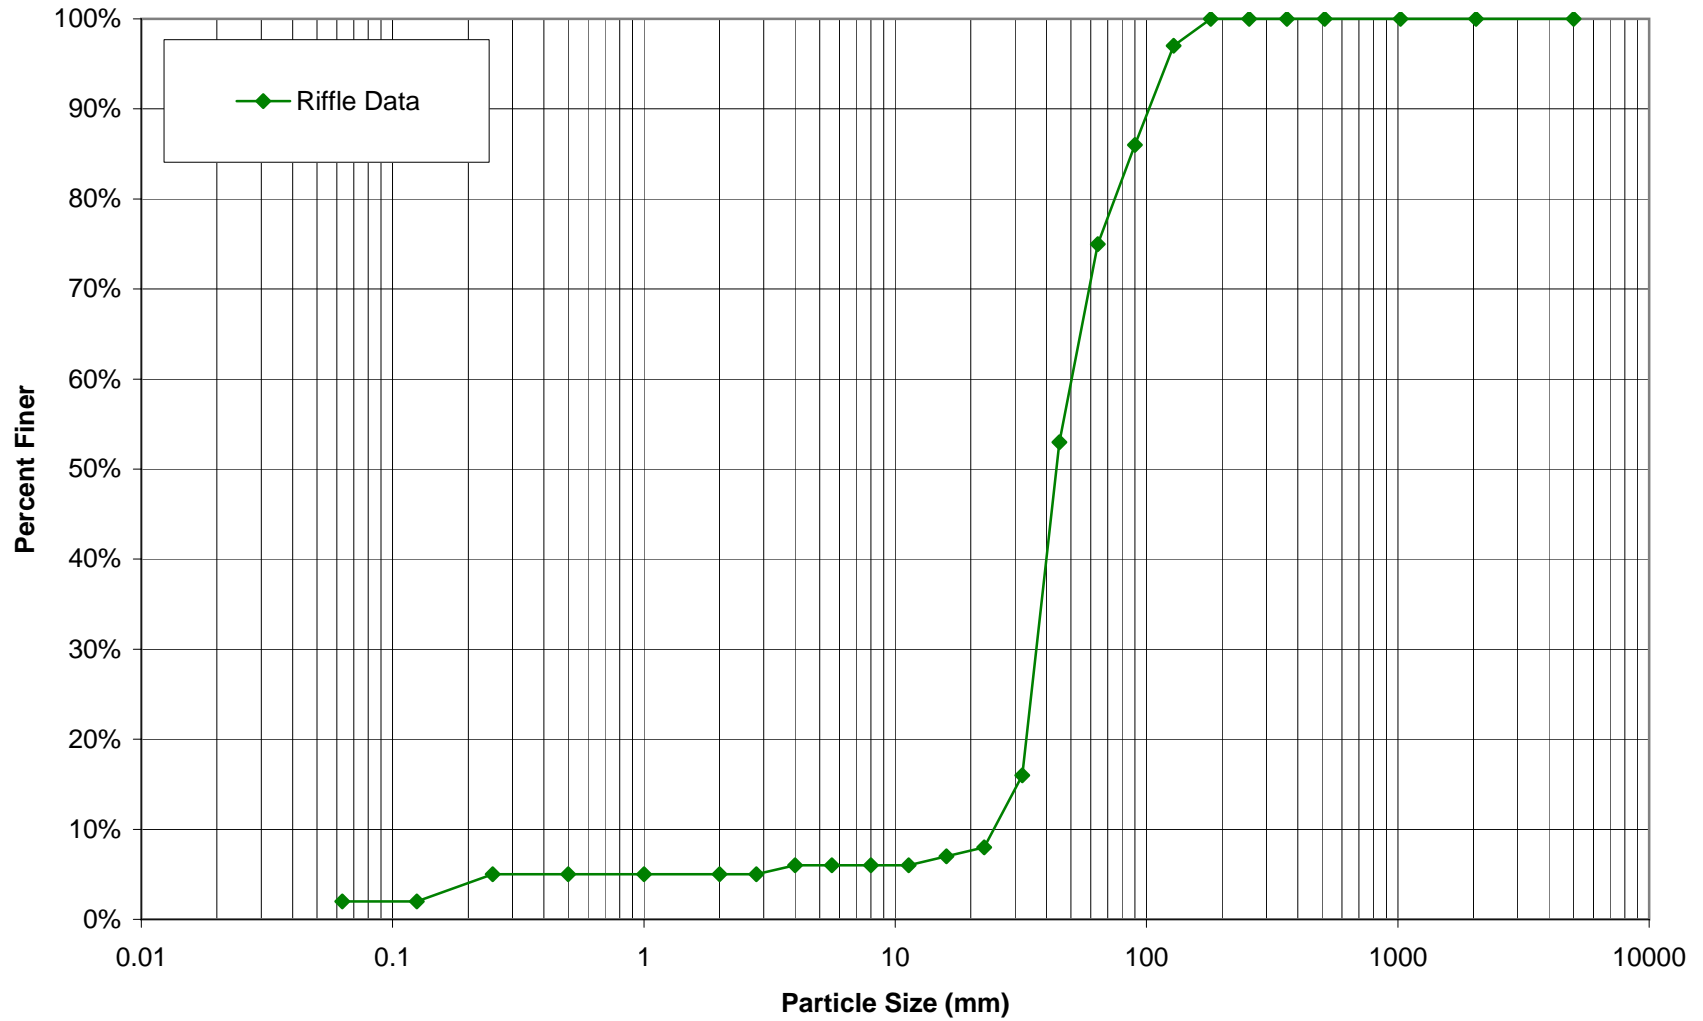
Beaverdam Creek UT1D  
X12 Riffle  
Pebble Count Particle Size Distribution

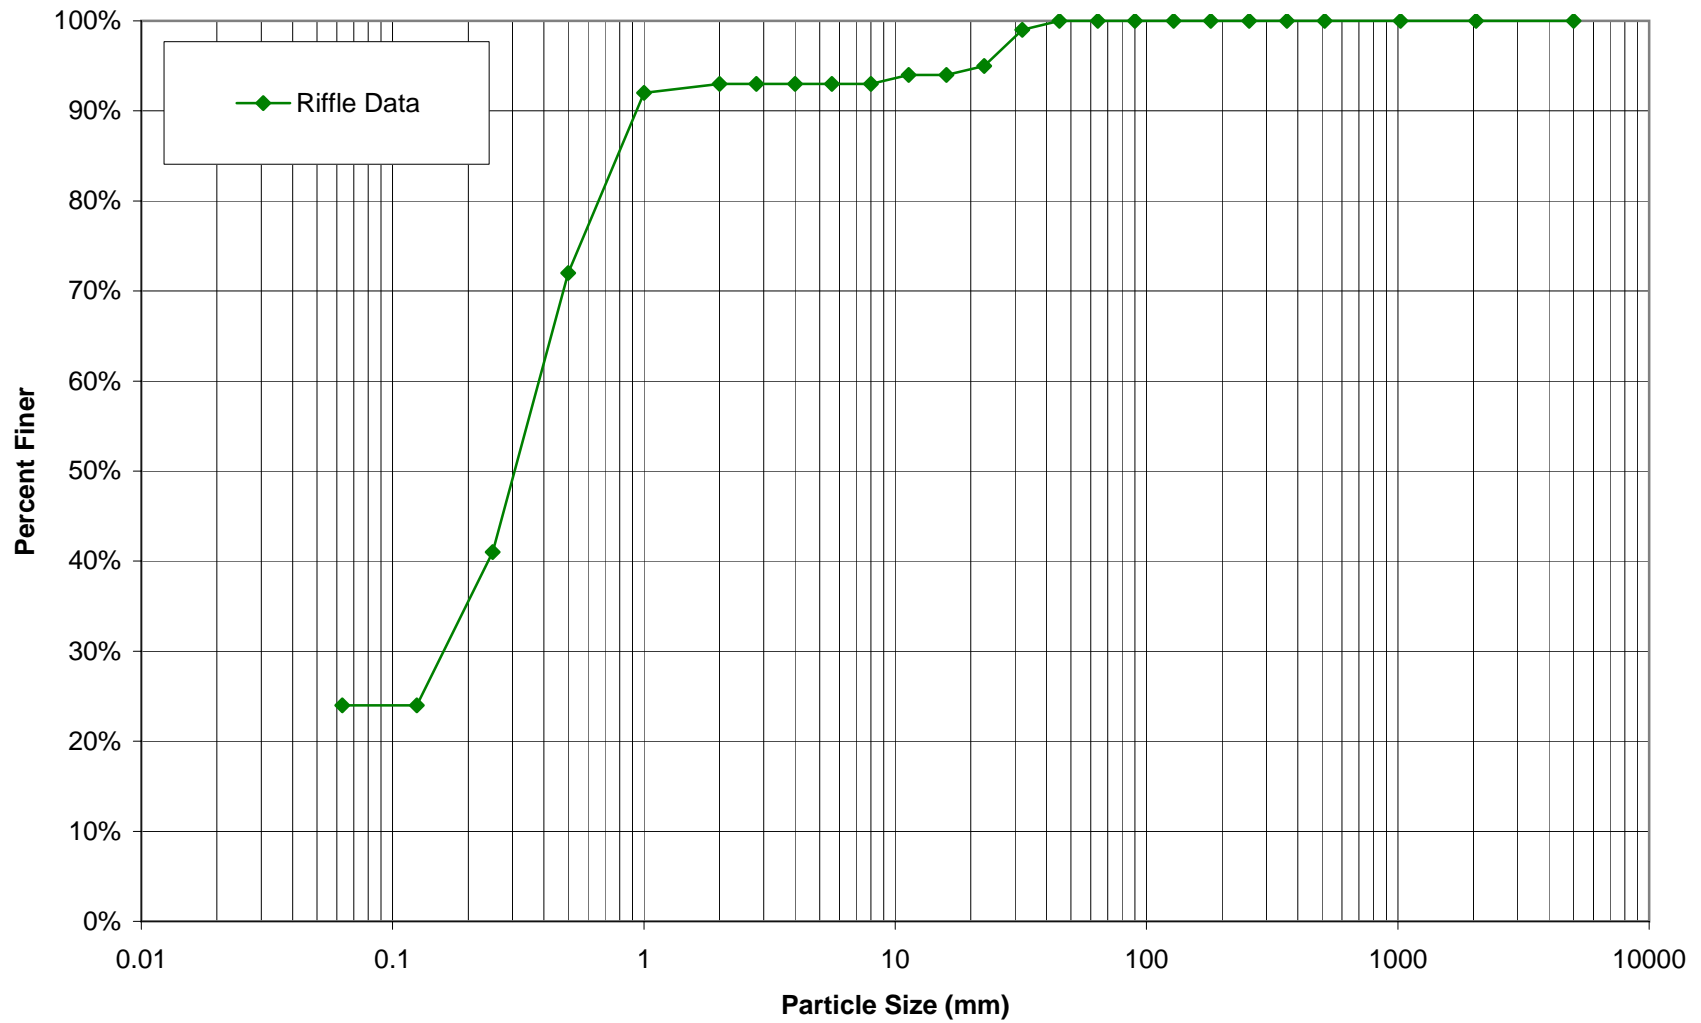
**Beaverdam Creek UT1 (Reaches 2-5)  
X13 Pool  
Pebble Count Particle Size Distribution**

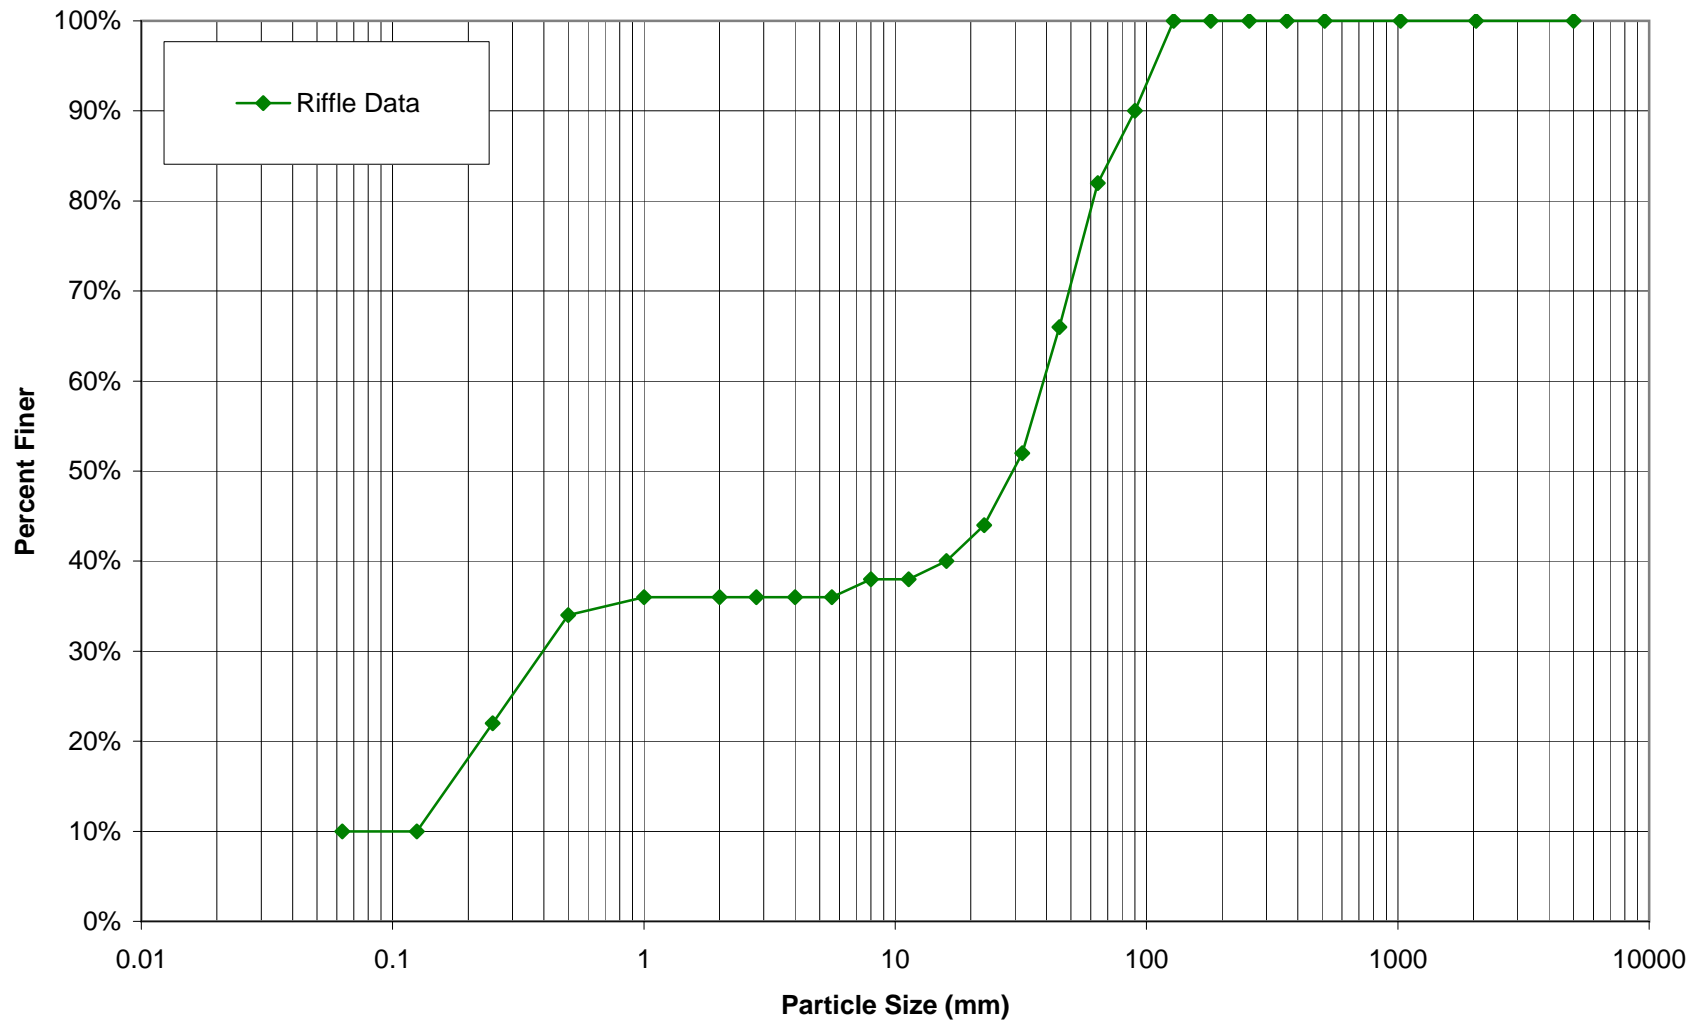
Beaverdam Creek UT1 (Reaches 2-5)  
X14 Riffle  
Pebble Count Particle Size Distribution

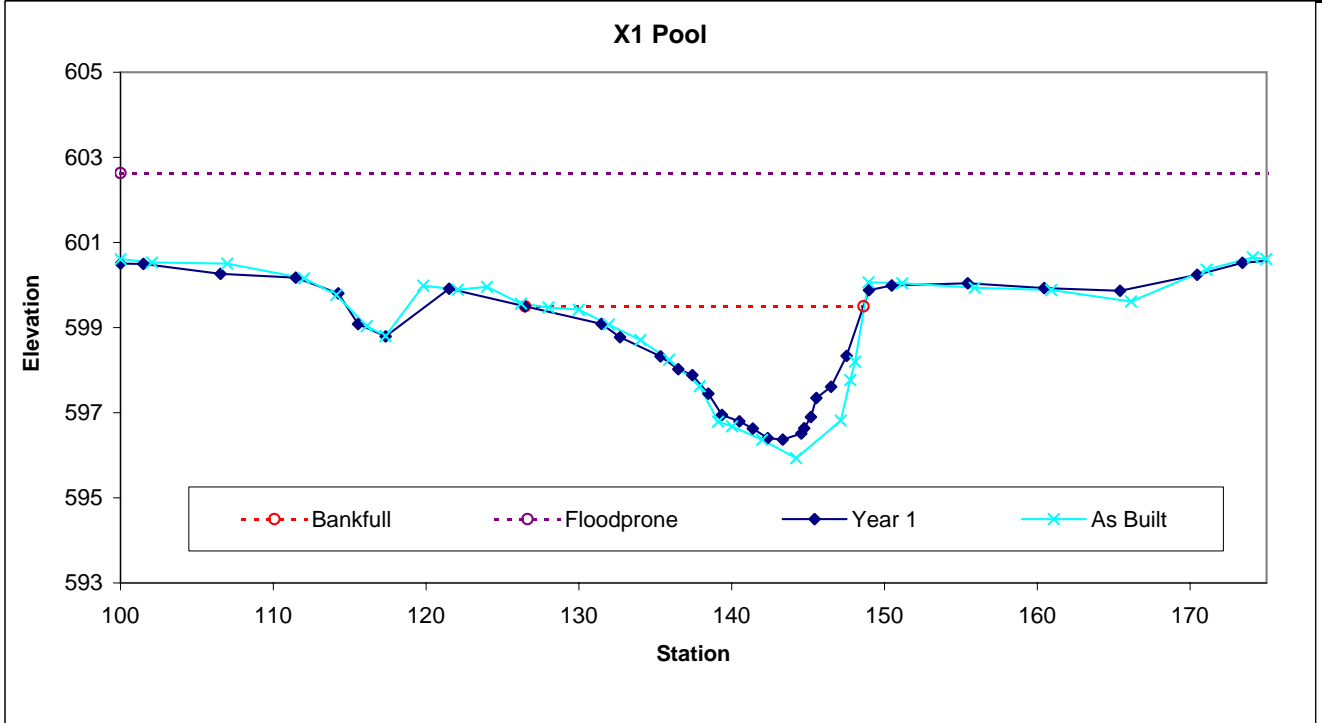
**UT1 Permanent Cross Section X1**  
 (Year 1 Monitoring Data - collected October 2007)

Feature	Stream Type	BKF Area	BKF Width	BKF Depth	Max BKF Depth	W/D	BH Ratio	ER	BKF Elev	TOB Elev
Pool		33.1	22.14	1.49	3.13	14.82	1	3.4	599.5	599.5

Year 1 cross-section monitoring data for stream stability was collected during October 2007 and compared to as-built conditions (collected March 2007).

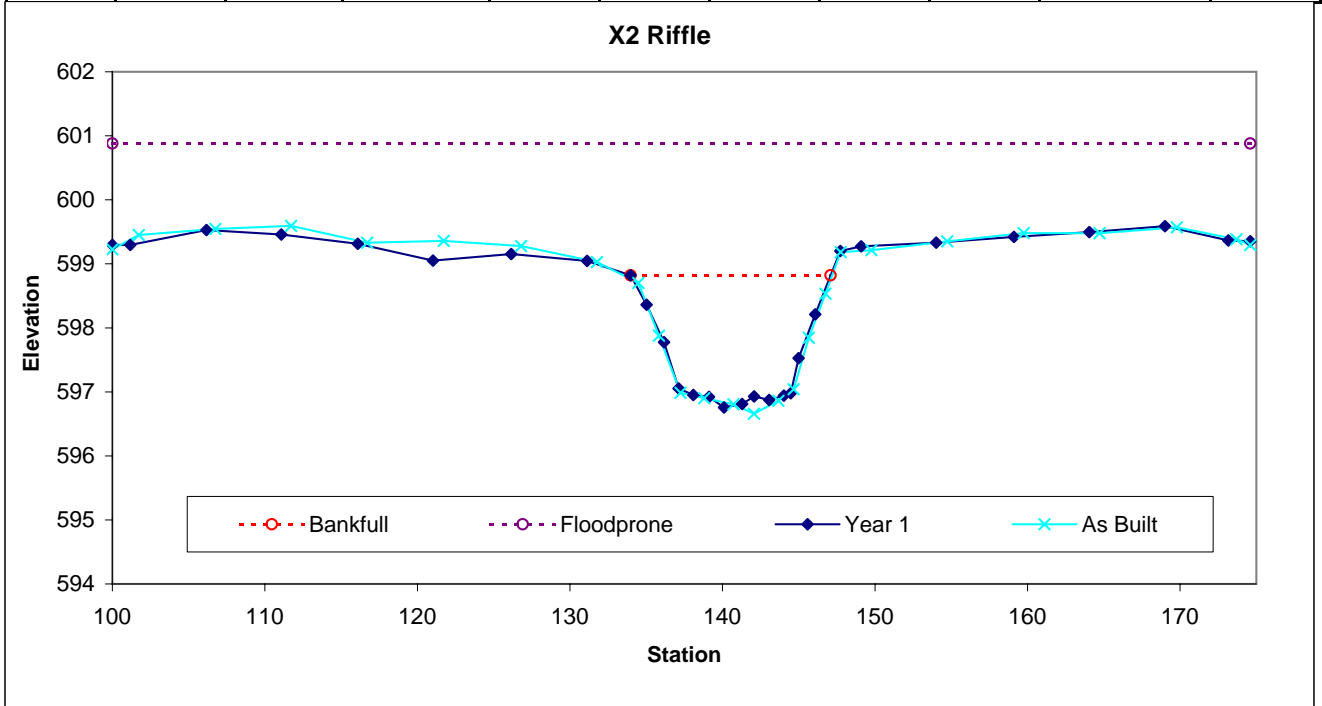
**UT1 Permanent Cross Section X2**  
 (Year 1 Monitoring Data - collected October 2007)

Feature	Stream Type	BKF Area	BKF Width	BKF Depth	Max BKF Depth	W/D	BH Ratio	ER	BKF Elev	TOB Elev
Riffle	C/E	18.8	13.12	1.43	2.06	9.17	1	5.7	598.82	598.82

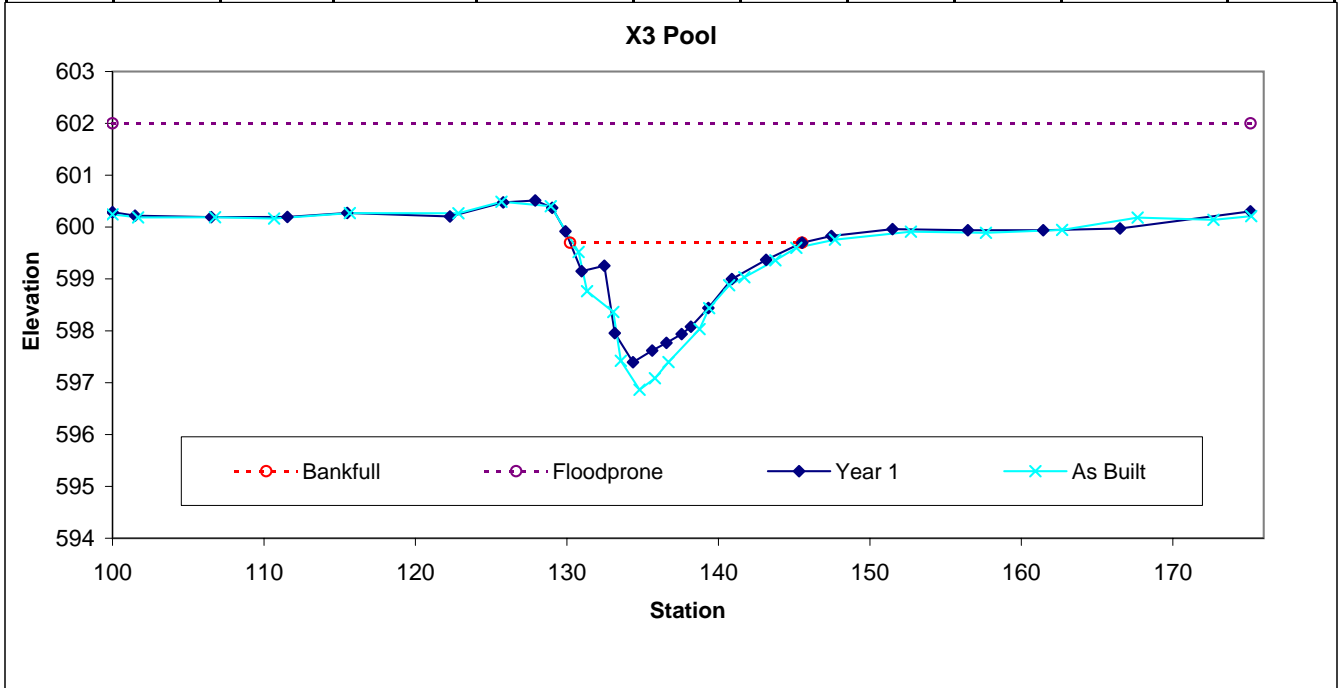
**UT1 Permanent Cross Section X3**  
 (Year 1 Monitoring Data - collected October 2007)

Feature	Stream Type	BKF Area	BKF Width	BKF Depth	Max BKF Depth	W/D	BH Ratio	ER	BKF Elev	TOB Elev
Pool		16.4	15.32	1.07	2.31	14.29	1	4.9	599.7	599.7

A few cross-sections show point bar formation along UT1 and include cross-sections 3, 10, 11, and 13, which are located across pools found at the apex of a meander bend. Flow through a meander bend possesses higher conveyance velocity along its boundary with the outer bank of the bend, and lower flow velocity along its boundary with the bend's inner bank. As flow reduces, its sediment transport capacity also reduces, causing flow to drop some of its transported sediment as it slows down. Point bar formation along the inside of a meander bend indicates flow velocity vectors occurring as designed, and is therefore expected. Cross-section 10 has slightly aggraded along the outside bank of a meander. This channel geometry reflects a plug of sediment deposited during the large storm event that occurred shortly after construction was completed. Drought conditions haven't allowed flow to correct channel geometry in this meander bend.
