**BEAVERDAM CREEK  
STREAM RESTORATION PROJECT**  
ANNUAL MONITORING REPORT FOR 2006-2007 (YEAR 1)

**Project Number: D05016-1**

Prepared by: Baker Engineering

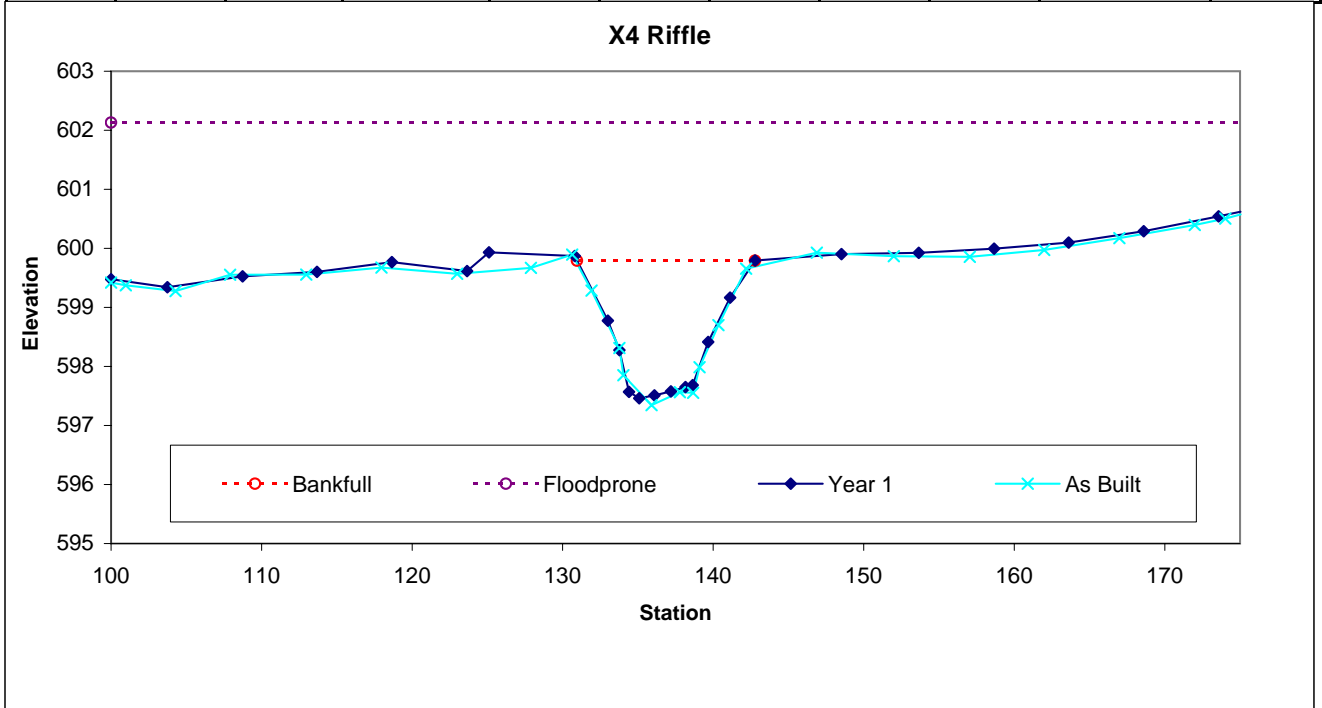
**UT1 Permanent Cross Section X4**  
 (Year 1 Monitoring Data - collected October 2007)

Feature	Stream Type	BKF Area	BKF Width	BKF Depth	Max BKF Depth	W/D	BH Ratio	ER	BKF Elev	TOB Elev
Riffle	C/E	16.5	11.83	1.39	2.33	8.5	1	6.3	599.79	599.79

Year 1 cross-section monitoring data for stream stability was collected during October 2007 and compared to as-built conditions (collected March 2007).

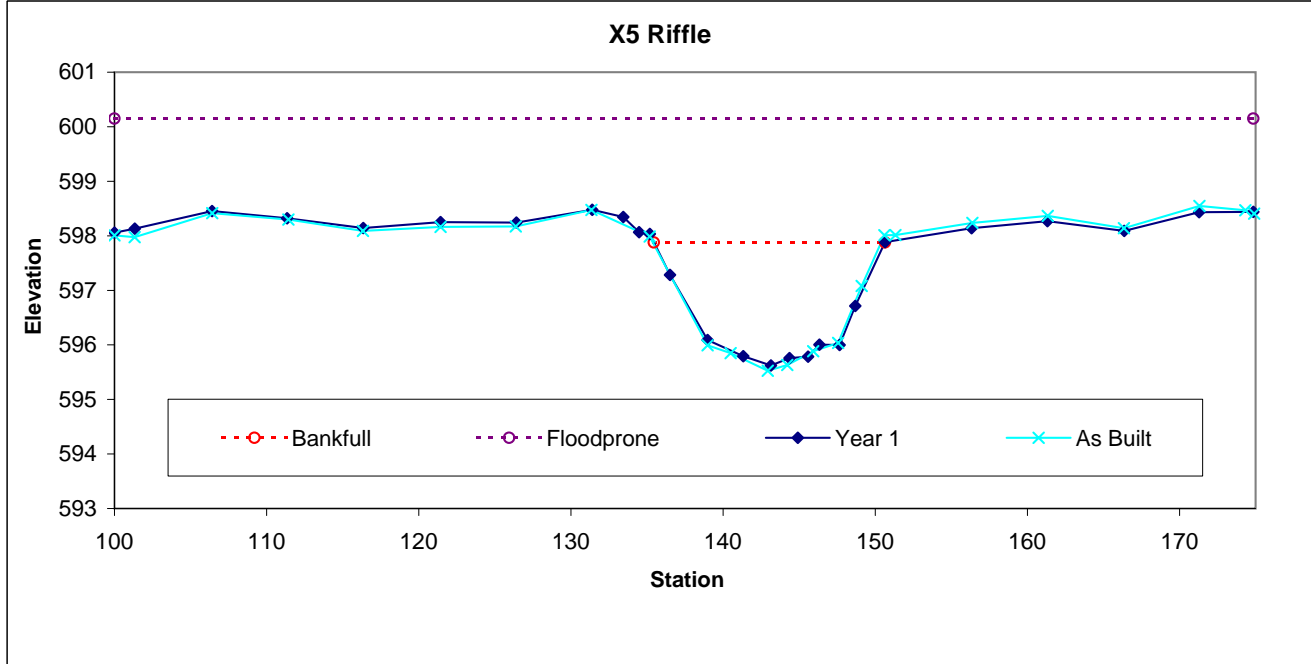
**UT1 Permanent Cross Section X5**  
 (Year 1 Monitoring Data - collected October 2007)

Feature	Stream Type	BKF Area	BKF Width	BKF Depth	Max BKF Depth	W/D	BH Ratio	ER	BKF Elev	TOB Elev
Riffle	C/E	23.7	15.19	1.56	2.26	9.72	1	4.9	597.88	597.88

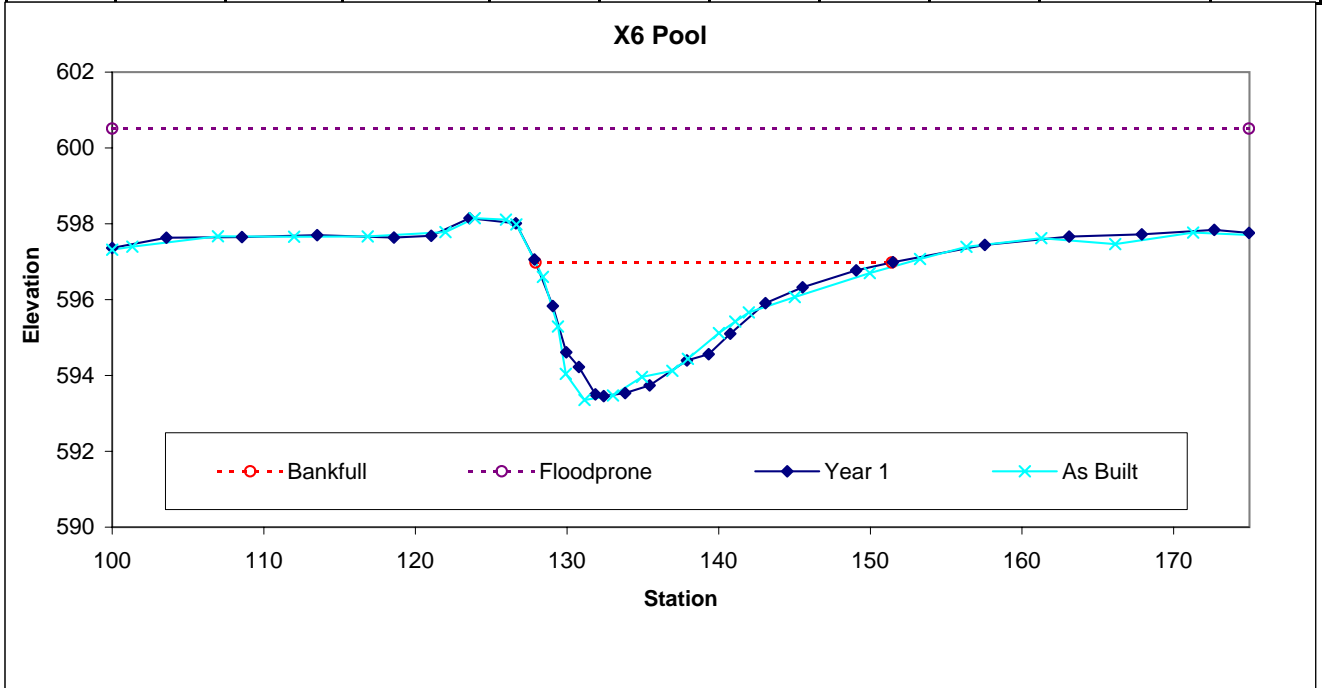
**UT1 Permanent Cross Section X6**  
 (Year 1 Monitoring Data - collected October 2007)

Feature	Stream Type	BKF Area	BKF Width	BKF Depth	Max BKF Depth	W/D	BH Ratio	ER	BKF Elev	TOB Elev
Pool		41.1	23.5	1.75	3.53	13.43	1	3.2	596.98	596.99

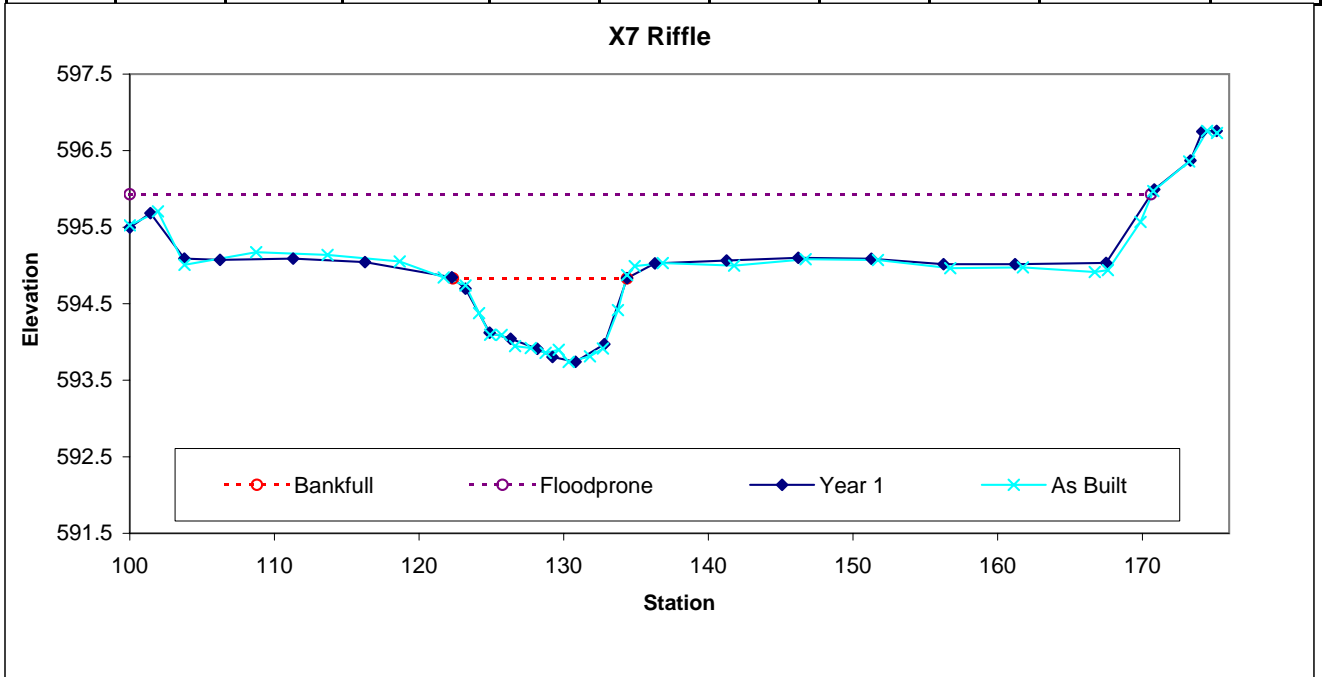
Feature	Stream Type	BKF Area	BKF Width	BKF Depth	Max BKF Depth	W/D	BH Ratio	ER	BKF Elev	TOB Elev
Riffle	B	8.8	12.04	0.73	1.09	16.49	1	5.9	594.83	594.83

**UT1 Permanent Cross Section X8**  
 (Year 1 Monitoring Data - collected October 2007)

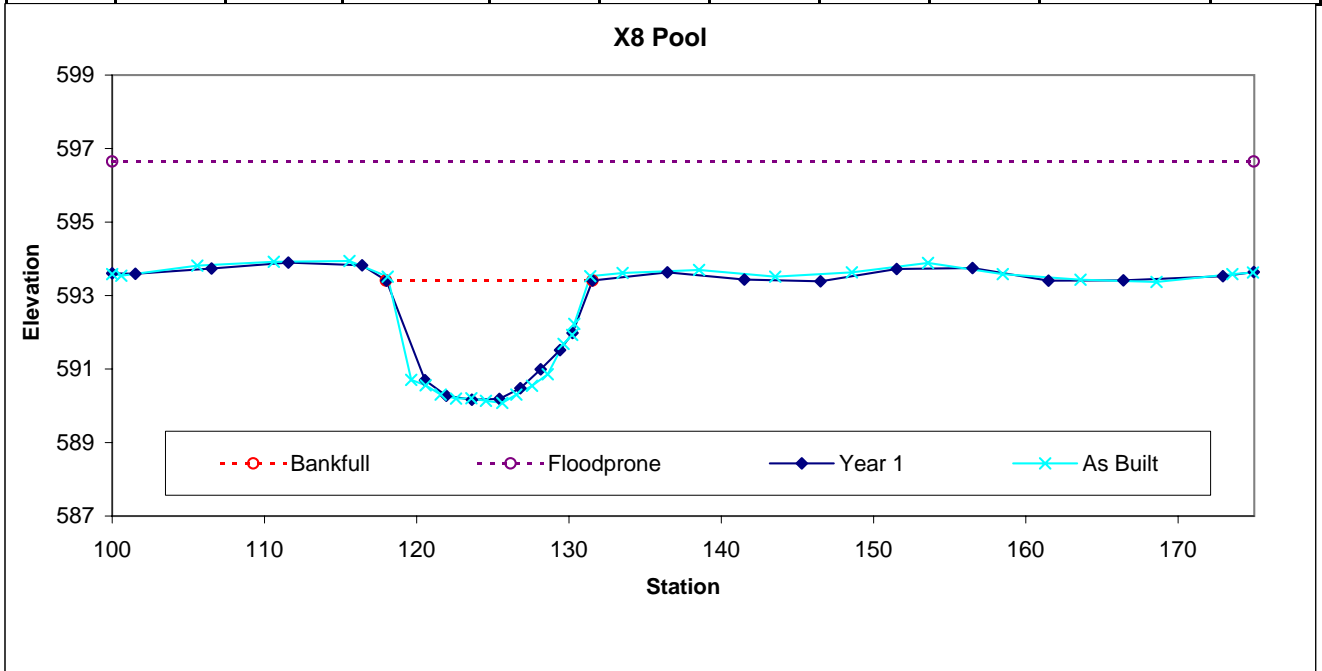
Feature	Stream Type	BKF Area	BKF Width	BKF Depth	Max BKF Depth	W/D	BH Ratio	ER	BKF Elev	TOB Elev
Pool		31.6	13.56	2.33	3.24	5.82	1	5.5	593.41	593.41

**UT1 Permanent Cross Section X9**  
 (Year 1 Monitoring Data - collected October 2007)

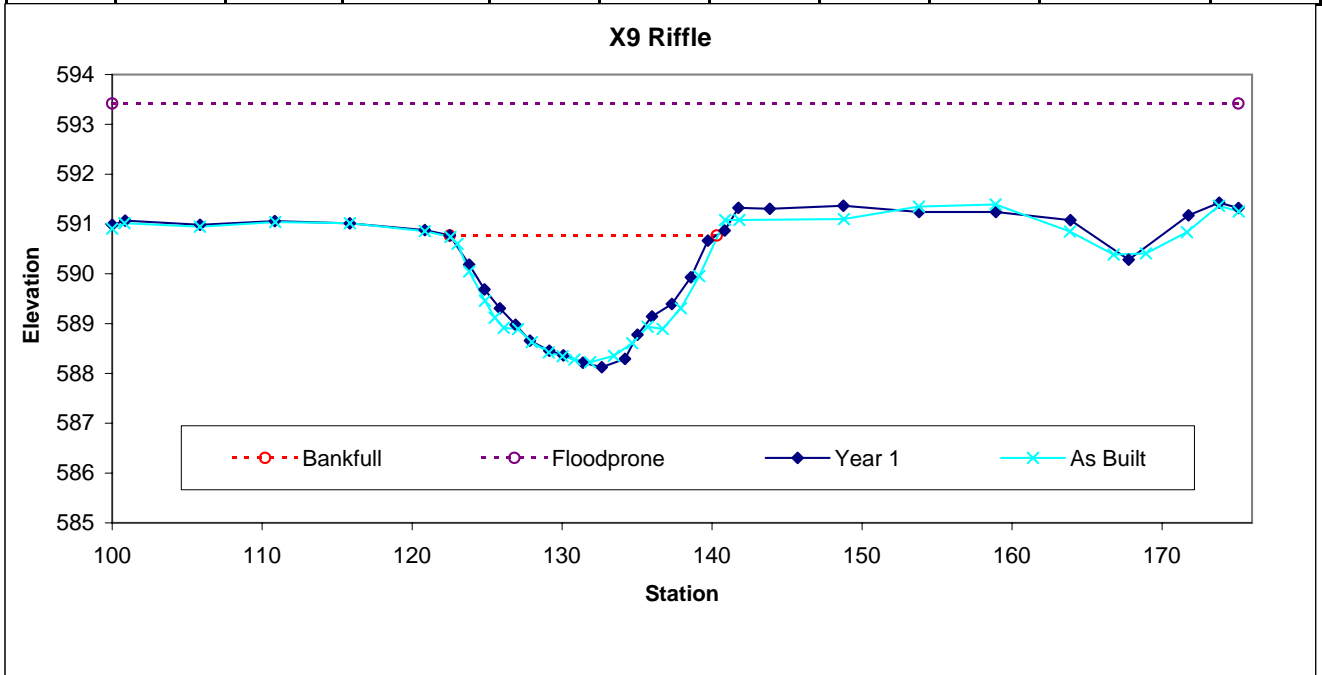
Feature	Stream Type	BKF Area	BKF Width	BKF Depth	Max BKF Depth	W/D	BH Ratio	ER	BKF Elev	TOB Elev
Riffle	C/E	29.3	17.8	1.64	2.65	10.83	1	4.2	590.77	590.77

**UT1 Permanent Cross Section X10**  
 (Year 1 Monitoring Data - collected October 2007)

A few cross-sections show point bar formation along UT1 and include cross-sections 3, 10, 11, and 13, which are located across pools found at the apex of a meander bend. Flow through a meander bend possesses higher conveyance velocity along its boundary with the outer bank of the bend, and lower flow velocity along its boundary with the bend's inner bank. As flow reduces, its sediment transport capacity also reduces, causing flow to drop some of its transported sediment as it slows down. Point bar formation along the inside of a meander bend indicates flow velocity vectors occurring as designed, and is therefore expected. Cross-section 10 has slightly aggraded along the outside bank of a meander. This channel geometry reflects a plug of sediment deposited during the large storm event that occurred shortly after construction was completed. Drought conditions haven't allowed flow to correct channel geometry in this meander bend.

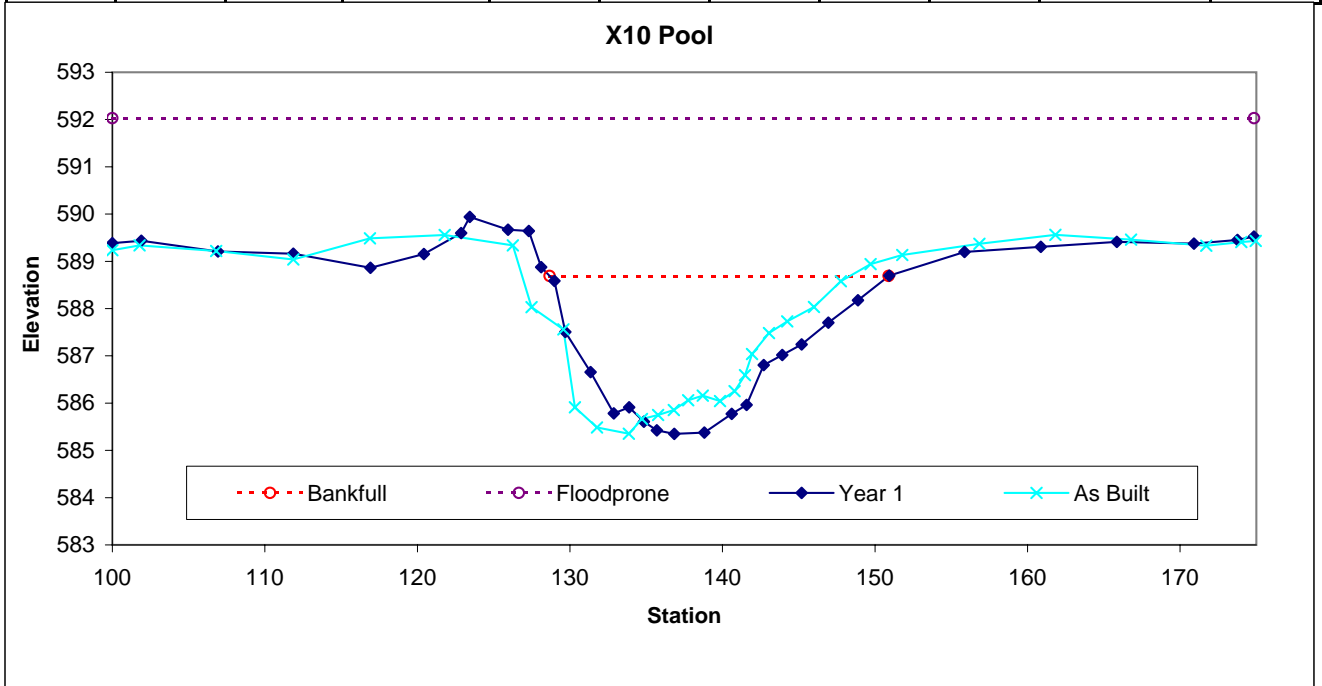
Feature	Stream Type	BKF Area	BKF Width	BKF Depth	Max BKF Depth	W/D	BH Ratio	ER	BKF Elev	TOB Elev
Pool		44.8	22.23	2.02	3.34	11.03	1	3.4	588.69	588.7

**UT1 Permanent Cross Section X11**  
 (Year 1 Monitoring Data - collected October 2007)

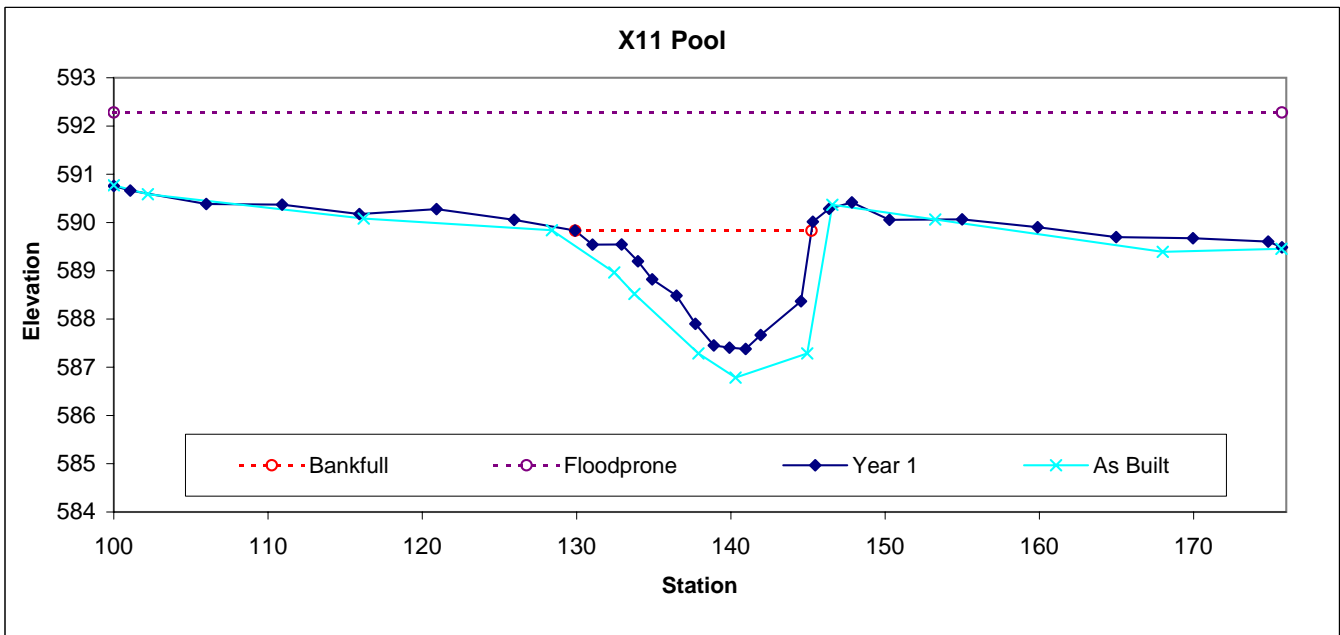
Feature	Stream Type	BKF Area	BKF Width	BKF Depth	Max BKF Depth	W/D	BH Ratio	ER	BKF Elev	TOB Elev
Pool		20.9	15.32	1.36	2.45	11.25	1	4.9	589.83	589.83

**UT1 Permanent Cross Section X12**  
 (Year 1 Monitoring Data - collected October 2007)

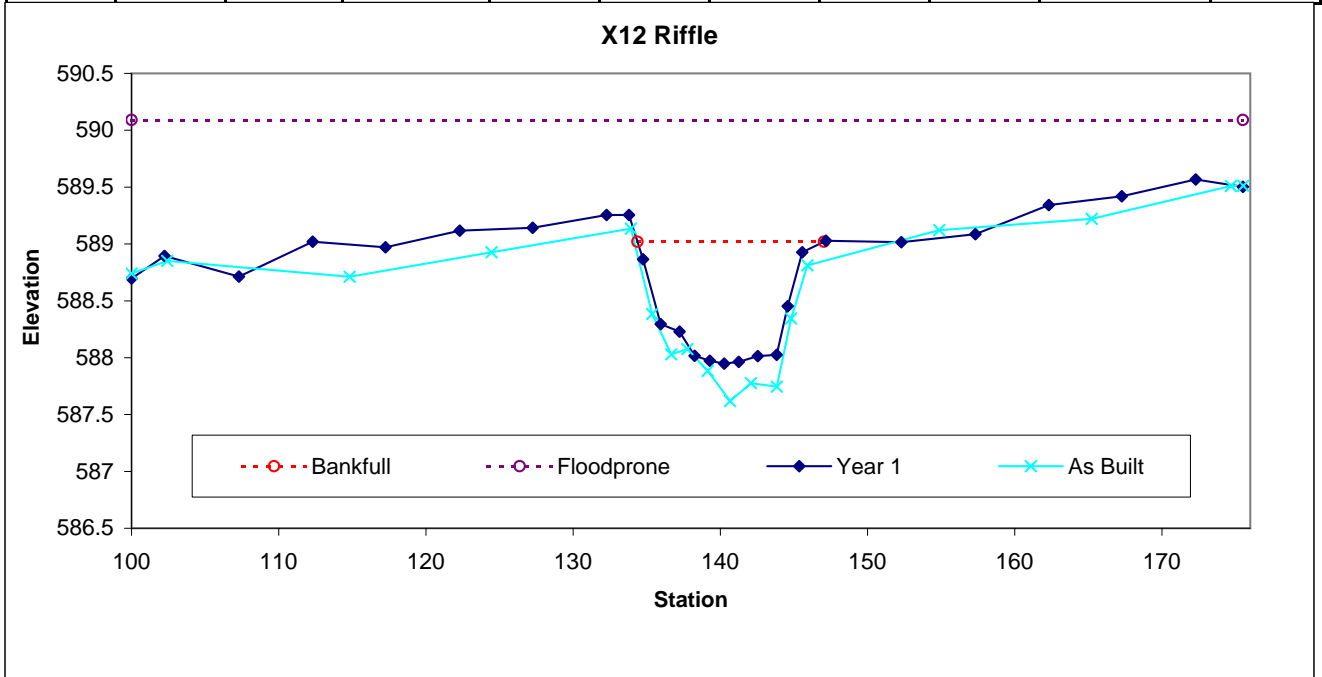
Feature	Stream Type	BKF Area	BKF Width	BKF Depth	Max BKF Depth	W/D	BH Ratio	ER	BKF Elev	TOB Elev
Riffle	C/E	9.2	12.67	0.73	1.07	17.46	1	6	589.02	589.03

**UT1 Permanent Cross Section X13**  
 (Year 1 Monitoring Data - collected October 2007)

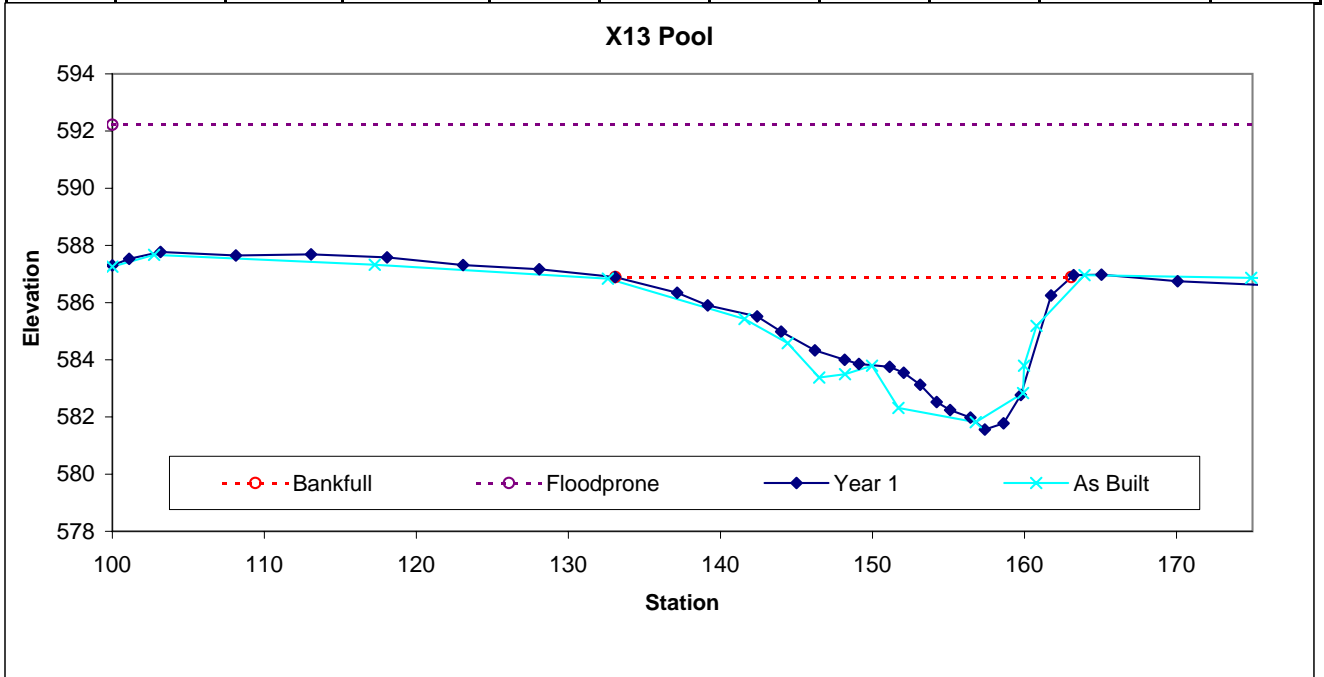
Feature	Stream Type	BKF Area	BKF Width	BKF Depth	Max BKF Depth	W/D	BH Ratio	ER	BKF Elev	TOB Elev
Pool		71.7	29.99	2.39	5.33	12.55	1	3	586.89	586.89

**UT1 Permanent Cross Section X14**  
 (Year 1 Monitoring Data - collected October 2007)

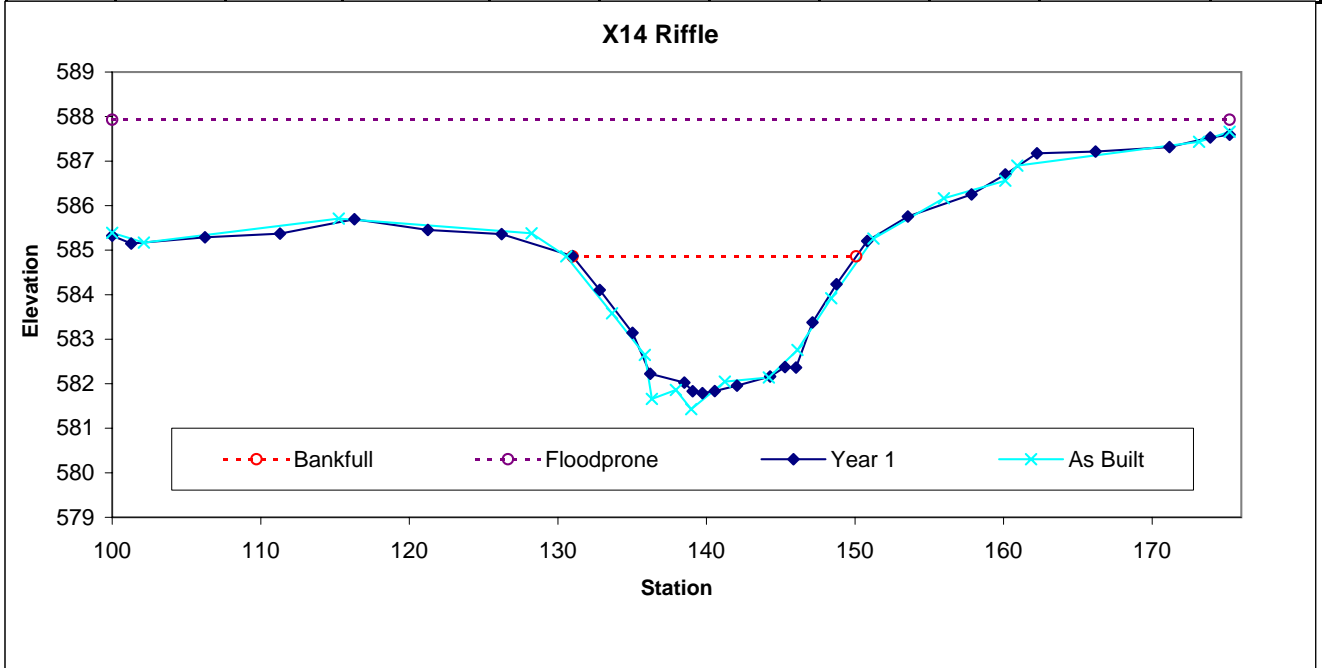
Feature	Stream Type	BKF Area	BKF Width	BKF Depth	Max BKF Depth	W/D	BH Ratio	ER	BKF Elev	TOB Elev
Riffle	C/E	37.9	19.09	1.99	3.07	9.61	1	3.9	584.86	584.87

**UT1 Permanent Cross Section X15**  
 (Year 1 Monitoring Data - collected October 2007)

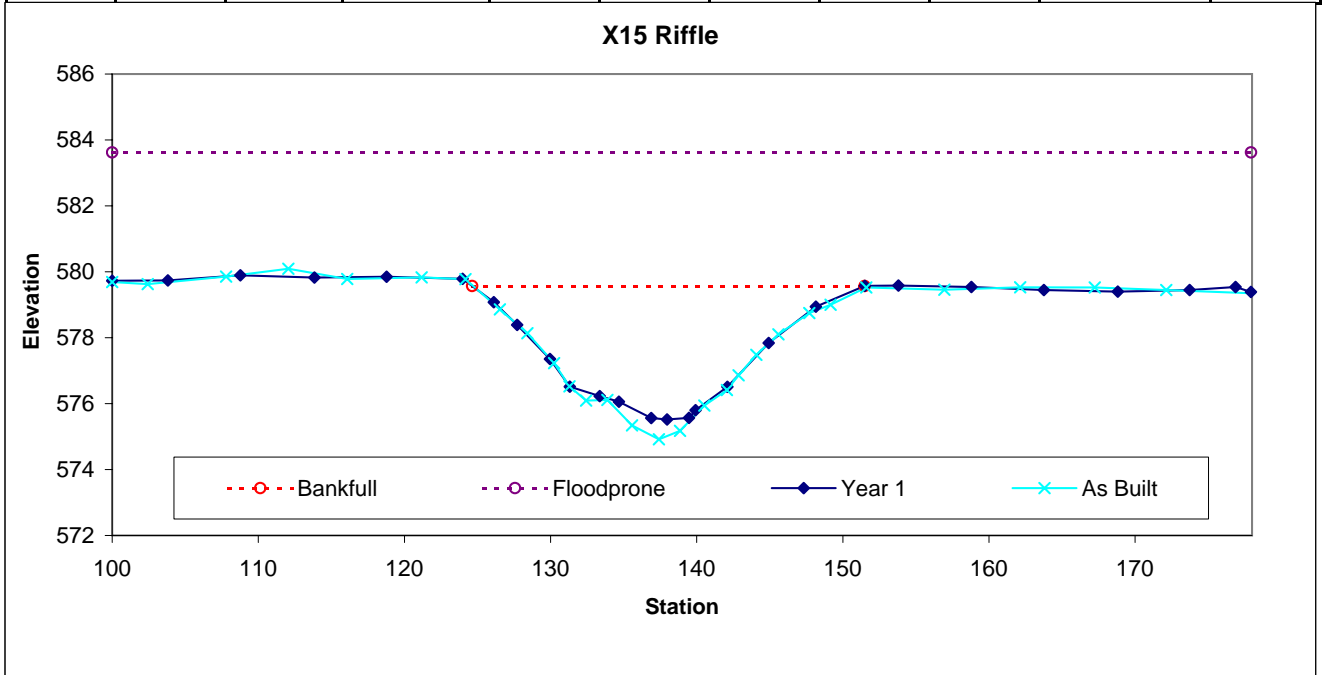
Feature	Stream Type	BKF Area	BKF Width	BKF Depth	Max BKF Depth	W/D	BH Ratio	ER	BKF Elev	TOB Elev
Riffle	C/E	59.7	26.86	2.22	4.05	12.1	1	2.9	579.57	579.57

**UT1 Permanent Cross Section X16**  
 (Year 1 Monitoring Data - collected October 2007)

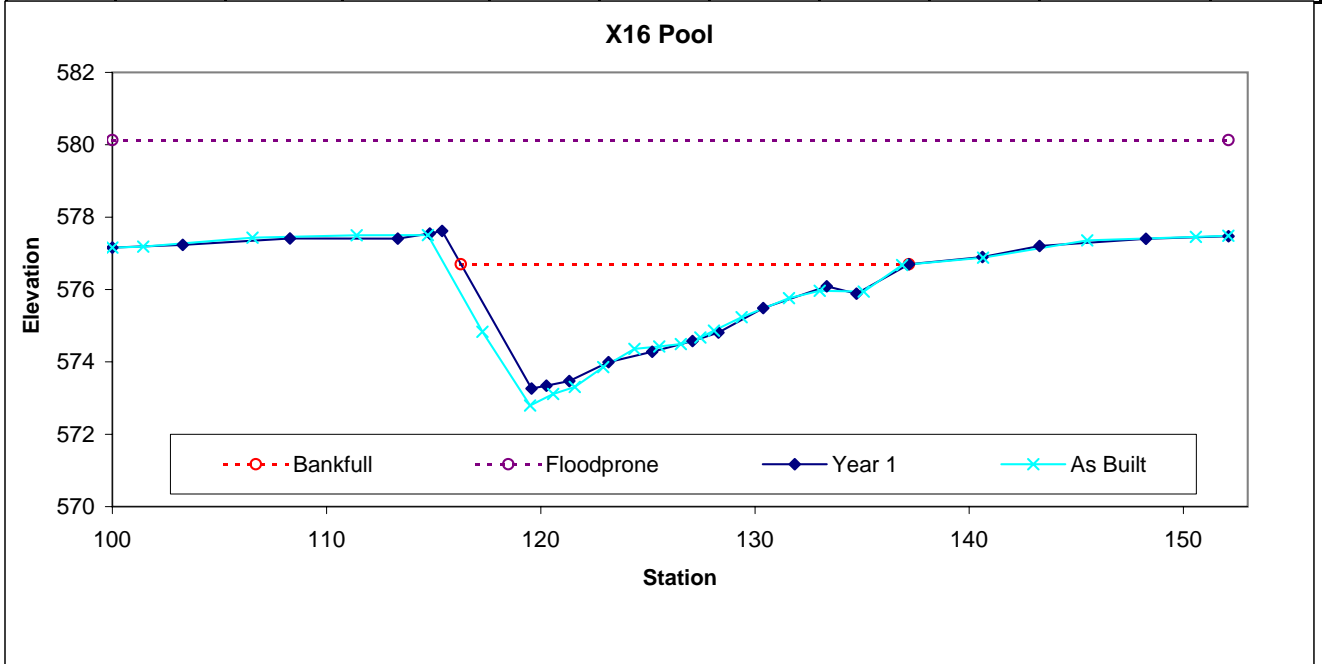
Feature	Stream Type	BKF Area	BKF Width	BKF Depth	Max BKF Depth	W/D	BH Ratio	ER	BKF Elev	TOB Elev
Pool		36.8	20.92	1.76	3.44	11.88	1	2.5	576.7	576.7

**UT1 Permanent Cross Section X17**  
 (Year 1 Monitoring Data - collected October 2007)

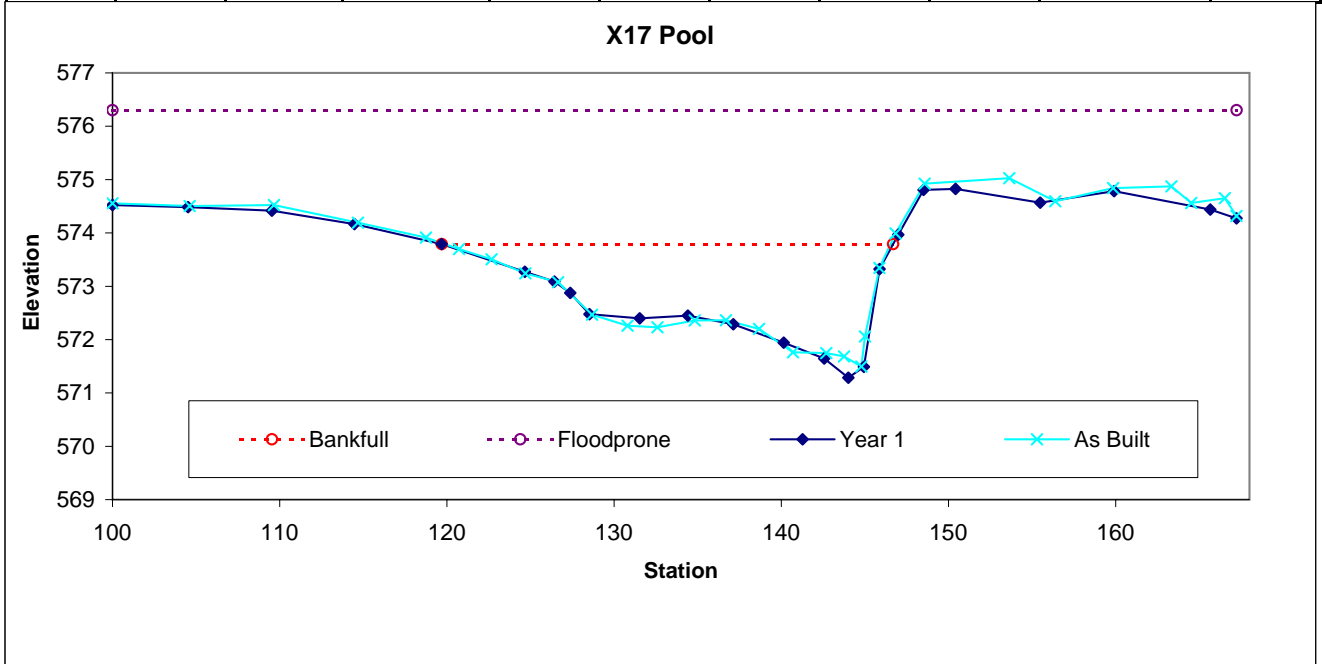
Feature	Stream Type	BKF Area	BKF Width	BKF Depth	Max BKF Depth	W/D	BH Ratio	ER	BKF Elev	TOB Elev
Pool		33.2	27	1.23	2.51	21.94	1	2.5	573.79	573.79

**UT1 Permanent Cross Section X18**  
 (Year 1 Monitoring Data - collected October 2007)

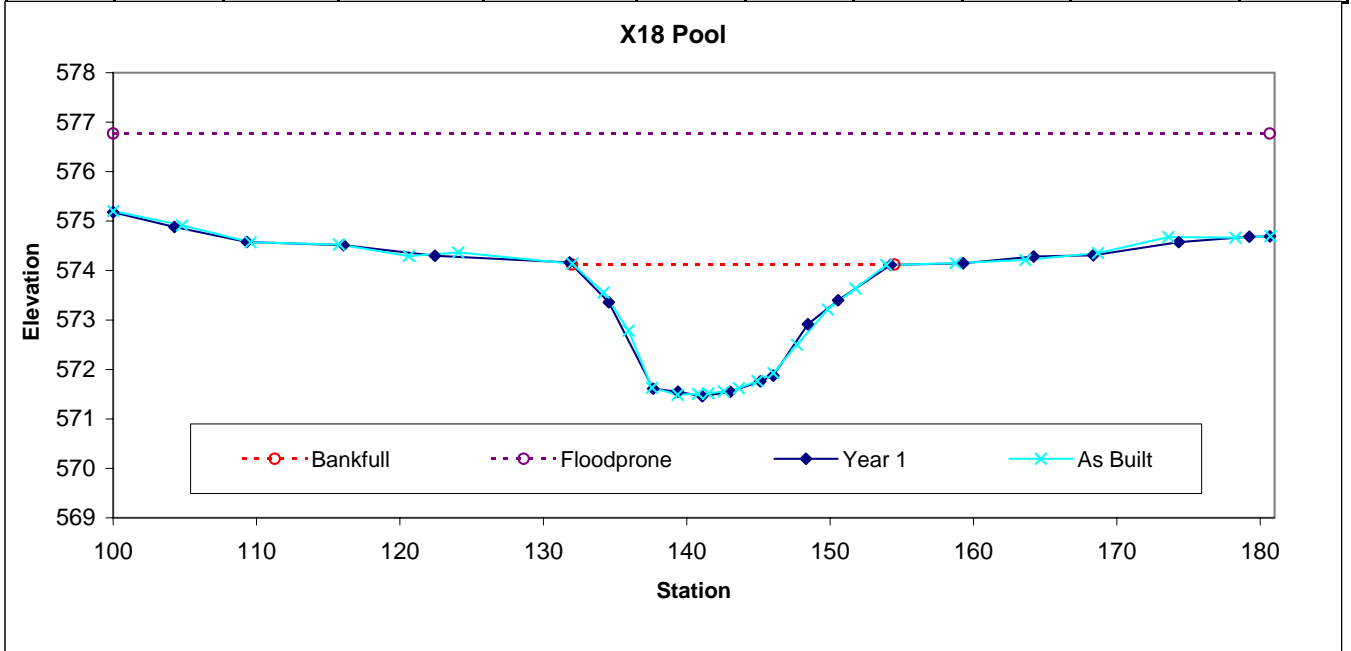
Feature	Stream Type	BKF Area	BKF Width	BKF Depth	Max BKF Depth	W/D	BH Ratio	ER	BKF Elev	TOB Elev
Riffle	C/E	34.7	22.49	1.54	2.66	14.59	1	3.6	574.12	574.11

### UT2 Mainstem Profile (2007 Monitoring)

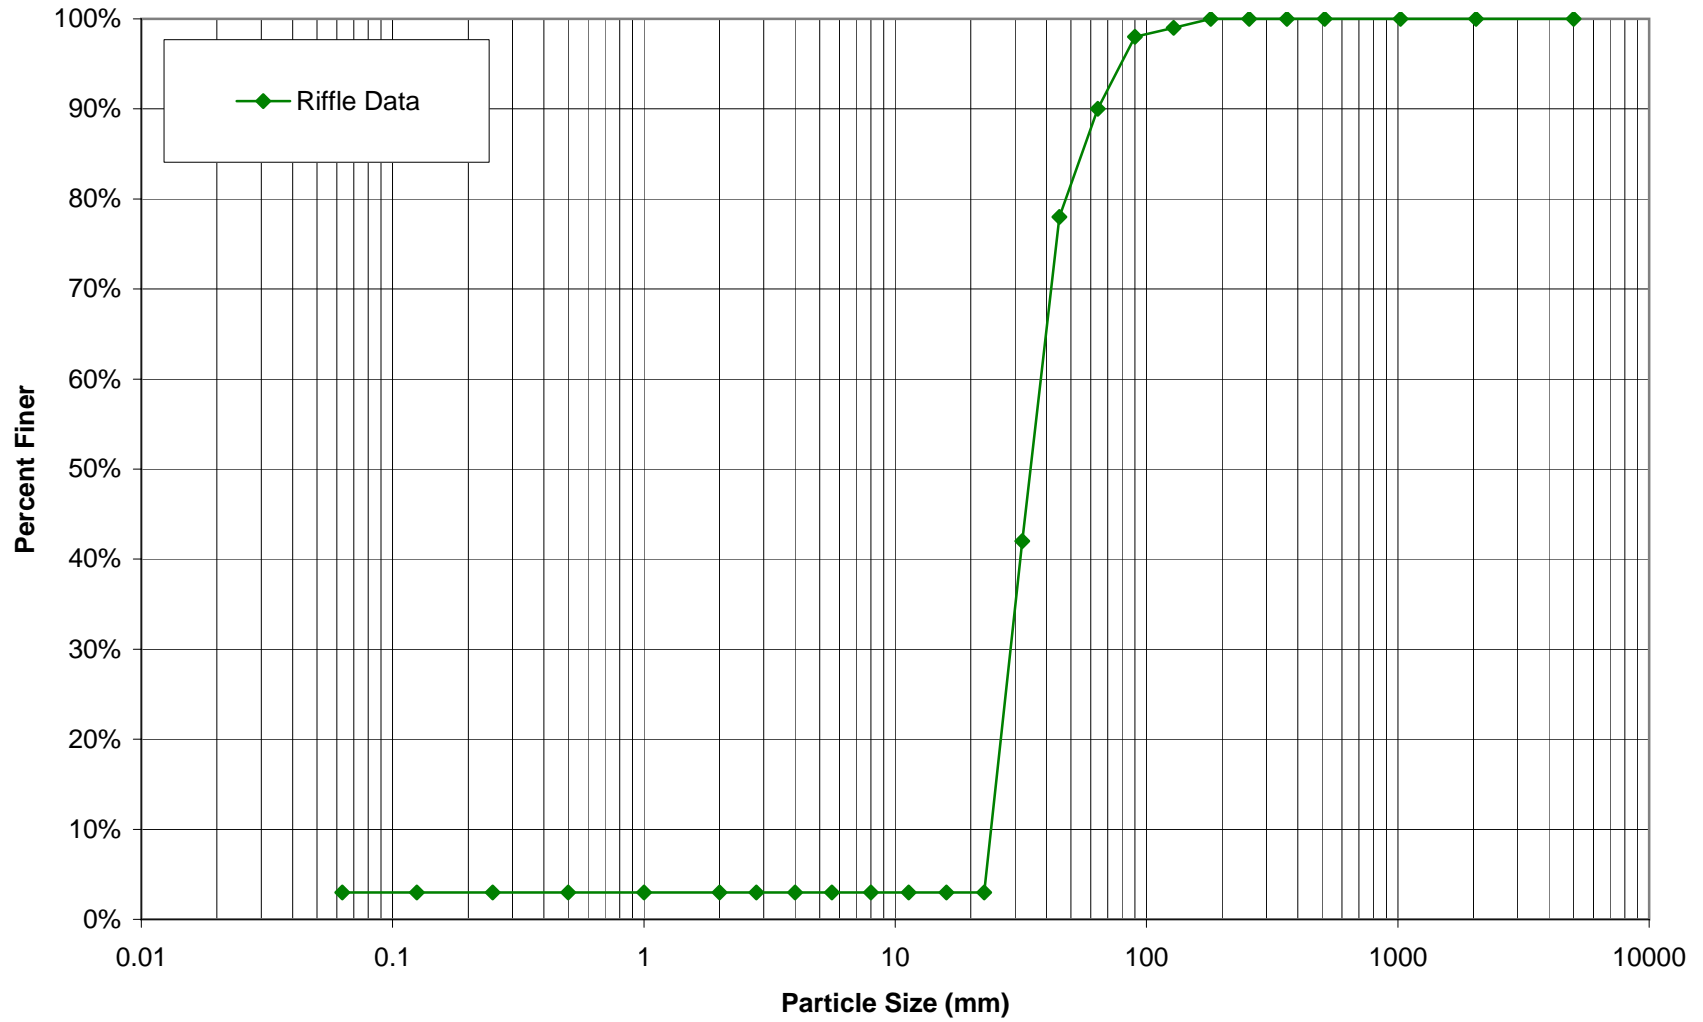
Beaverdam Creek UT2A  
X1 Riffle  
Pebble Count Particle Size Distribution

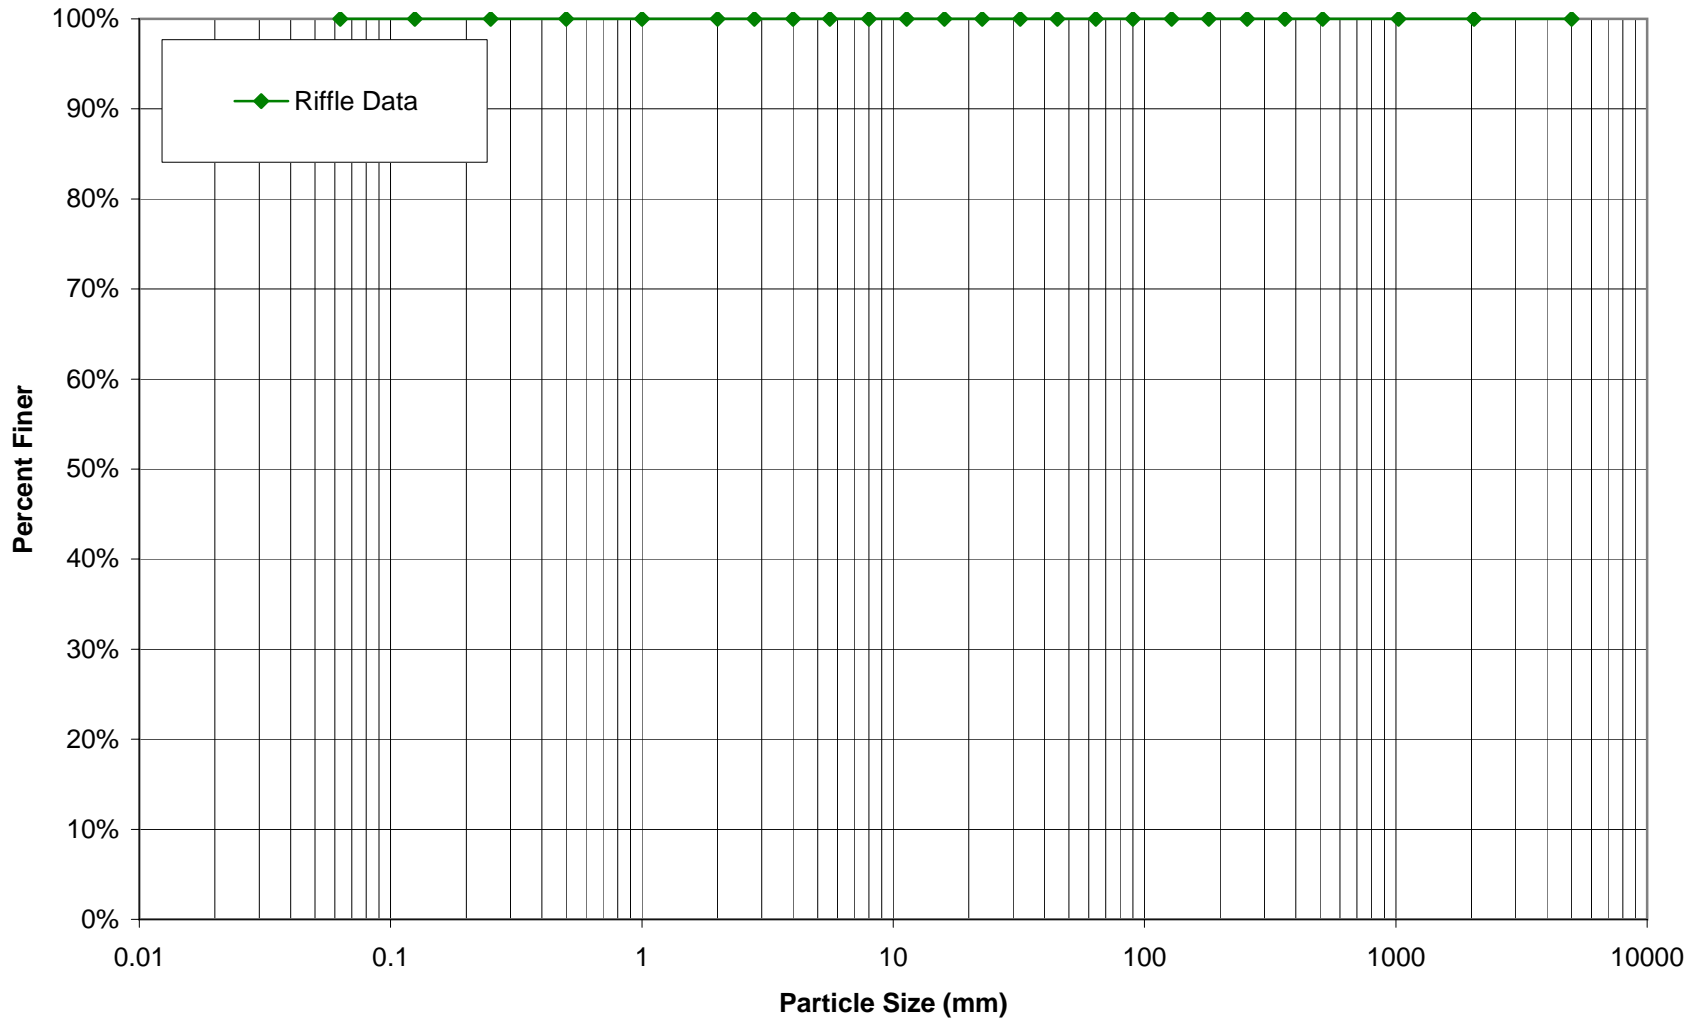
Beaverdam Creek UT2A  
X2 Pool  
Pebble Count Particle Size Distribution

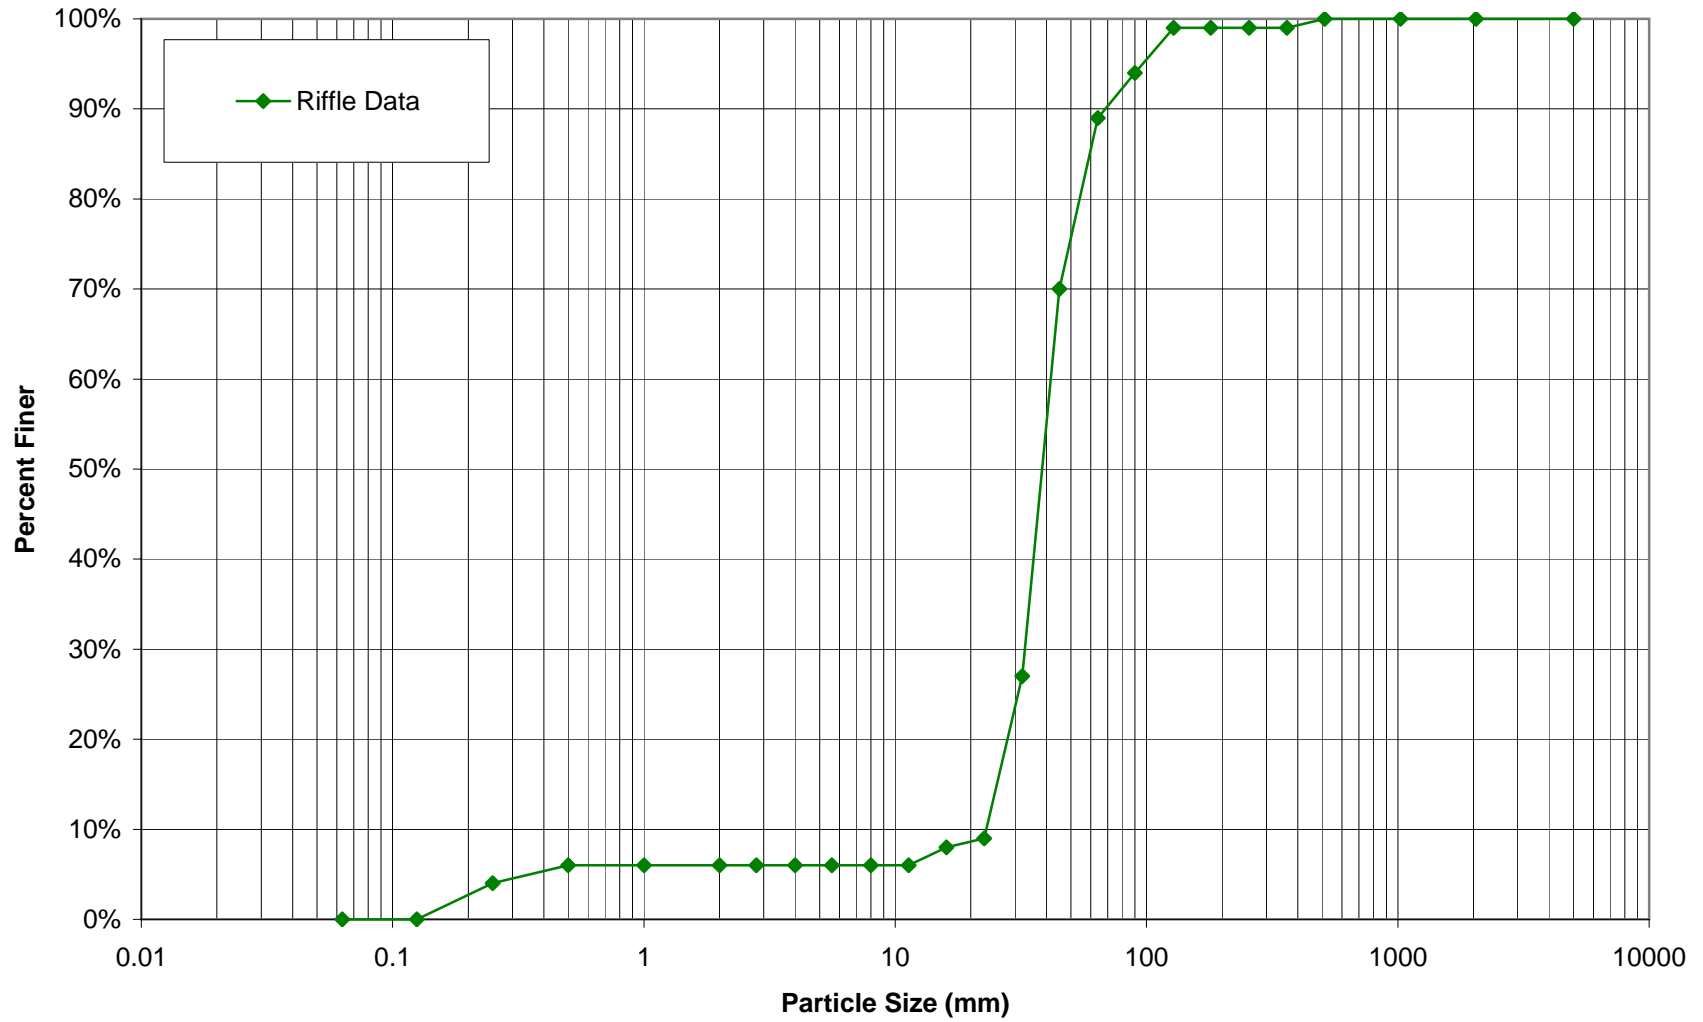
Beaverdam Creek UT2  
X3 Riffle  
Pebble Count Particle Size Distribution

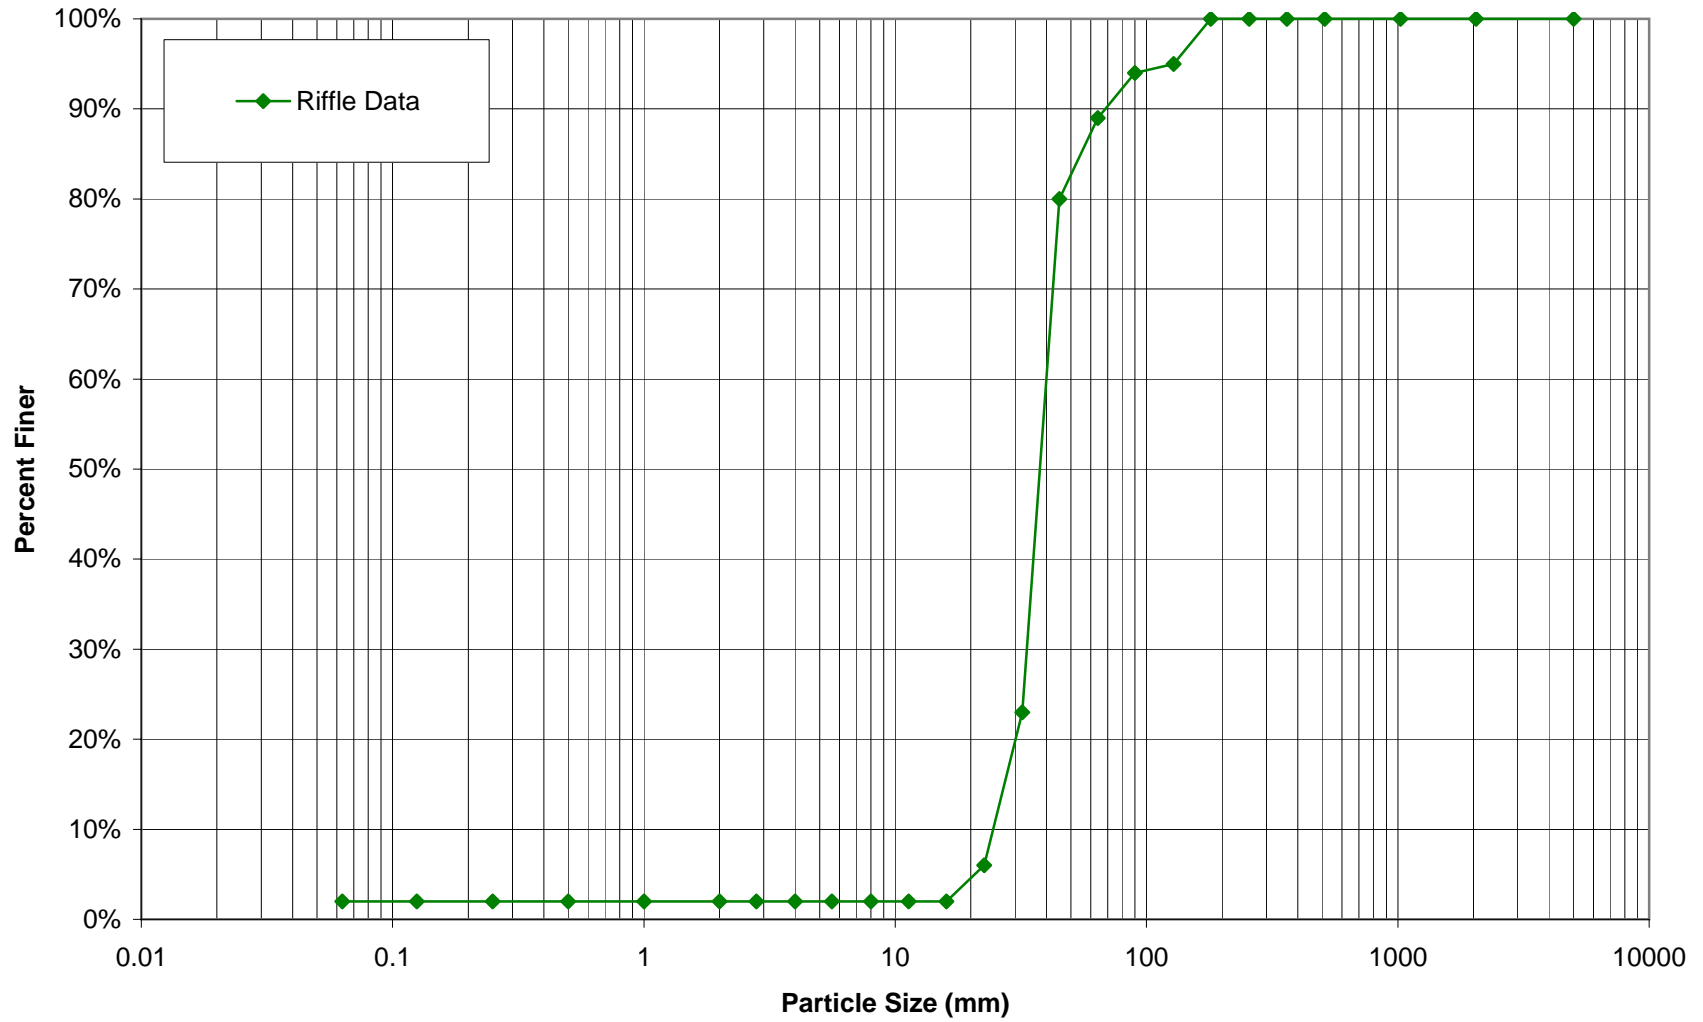
Beaverdam Creek UT2  
X5 Riffle  
Pebble Count Particle Size Distribution

<b>BAKER PROJECT NO.</b>		108528
SITE OR PROJECT:	Beaverdam Creek 1st Year Monitoring	
REACH/LOCATION:	UT2 X5-Riffle	
DATE COLLECTED:	10/15/2007	
FIELD COLLECTION BY:	RR/IE	
DATA ENTRY BY:	IE

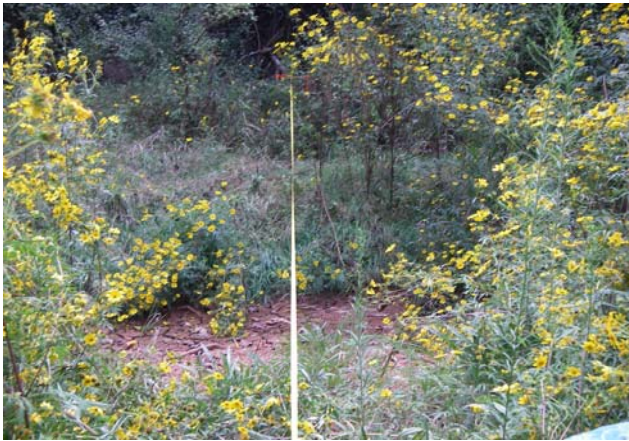
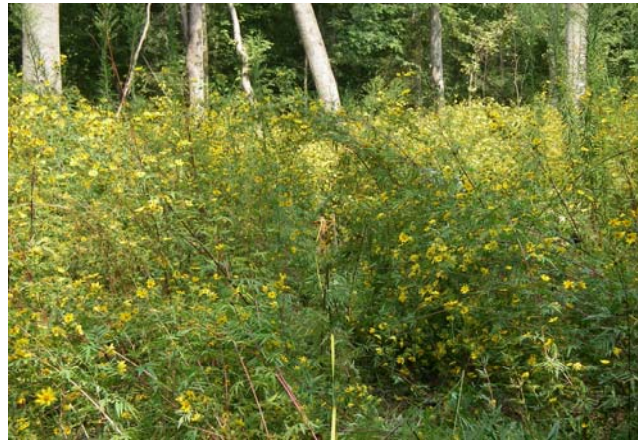
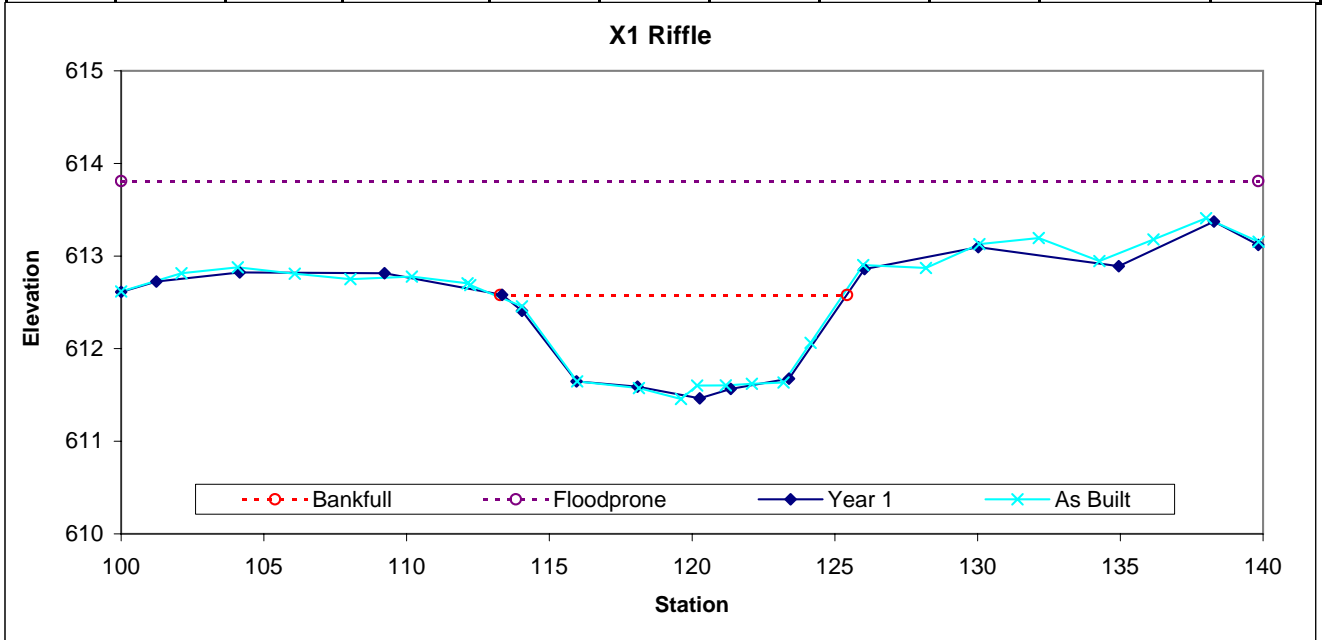
**UT2 Permanent Cross Section X1**  
 (Year 1 Monitoring Data - collected October 2007)

**Looking at the Left Bank**

**Looking at the Right Bank**

Feature	Stream Type	BKF Area	BKF Width	BKF Depth	Max BKF Depth	W/D	BH Ratio	ER	BKF Elev	TOB Elev
Riffle	C	9.6	12.15	0.79	1.12	15.45	1	3.3	612.58	612.58
