**BEAVERDAM CREEK  
STREAM RESTORATION PROJECT**  
ANNUAL MONITORING REPORT FOR 2006-2007 (YEAR 1)

**Project Number: D05016-1**

Prepared by: Baker Engineering

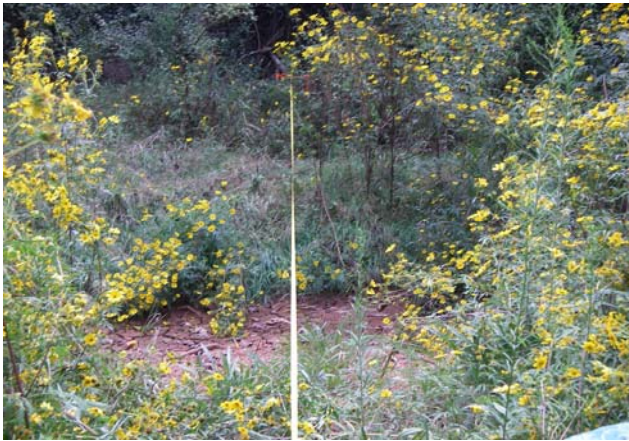
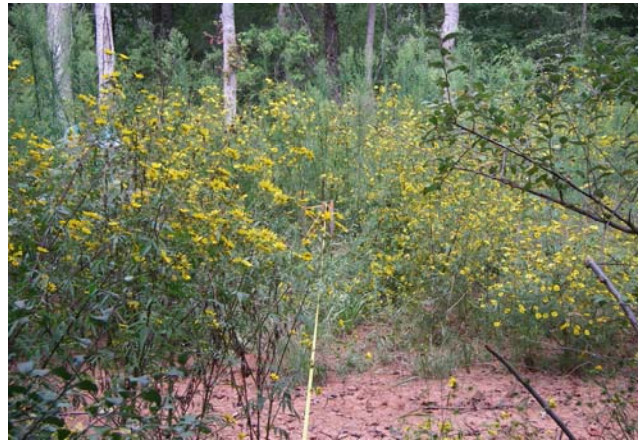
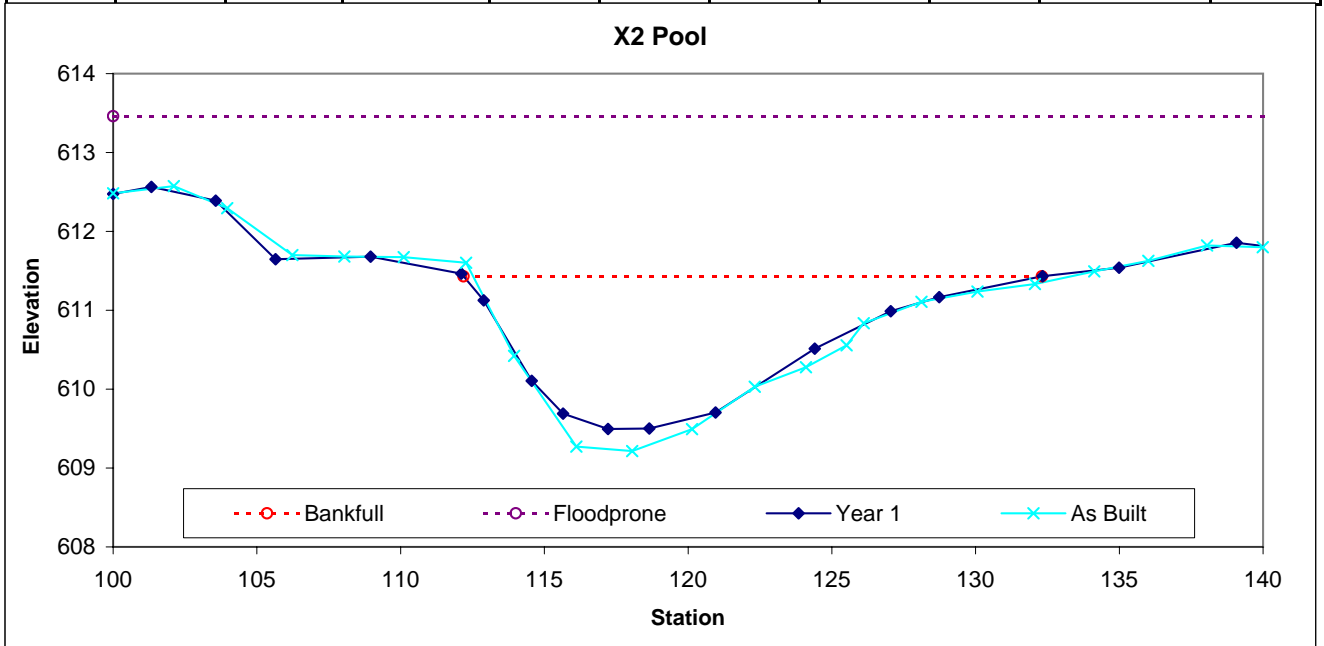
**UT2 Permanent Cross Section X2**  
 (Year 1 Monitoring Data - collected October 2007)

Looking at the Left Bank

Looking at the Right Bank

Feature	Stream Type	BKF Area	BKF Width	BKF Depth	Max BKF Depth	W/D	BH Ratio	ER	BKF Elev	TOB Elev
Pool		20.4	20.12	1.01	1.93	19.83	1	2	611.43	611.43

Year 1 cross-section monitoring data for stream stability was collected during October 2007 and compared to as-built conditions (collected March 2007).

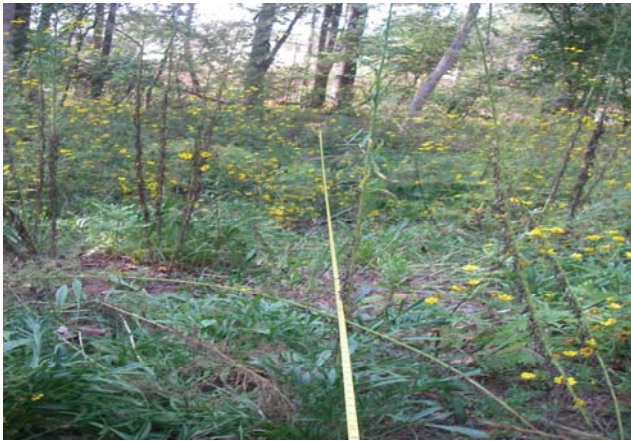
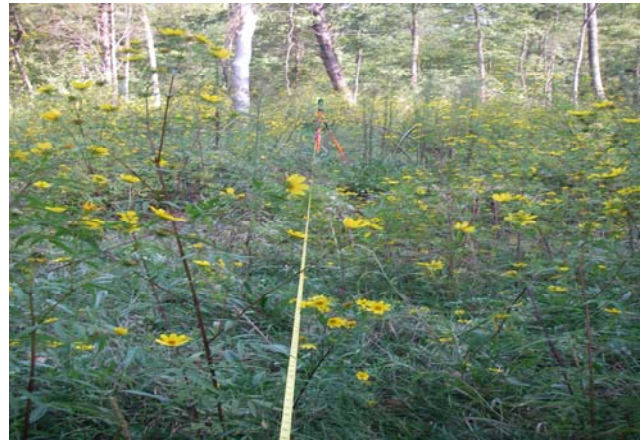
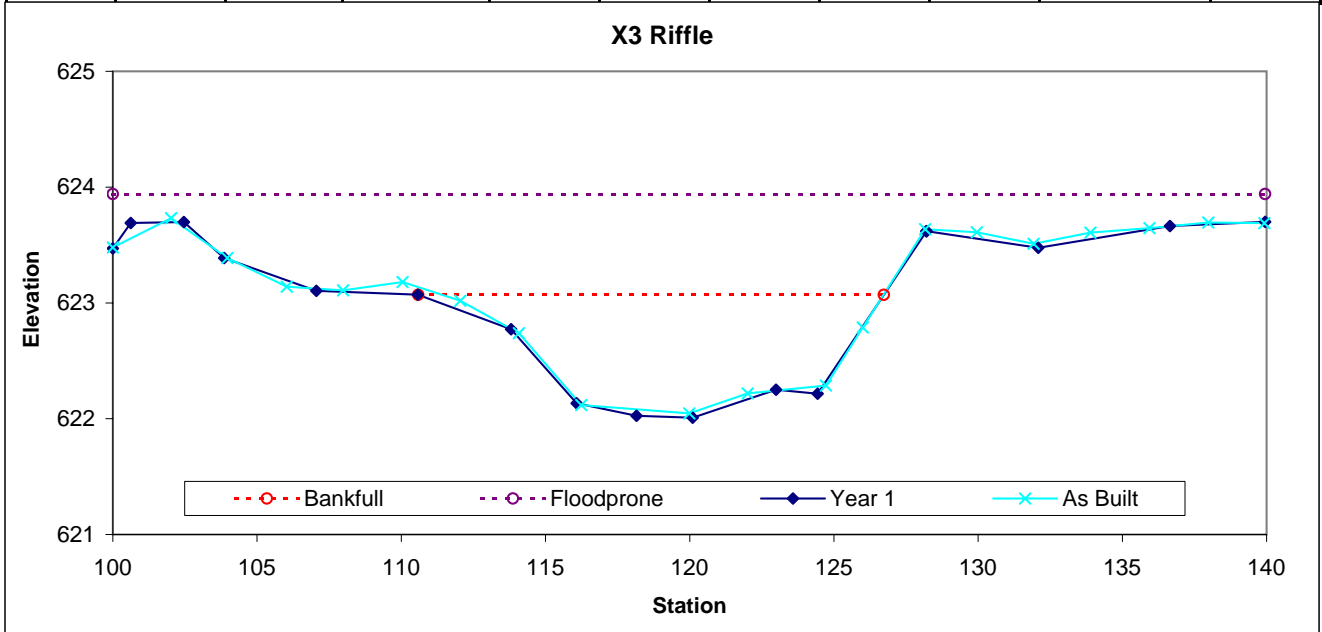
**UT2 Permanent Cross Section X3**  
 (Year 1 Monitoring Data - collected October 2007)

Looking at the Left Bank

Looking at the Right Bank

Feature	Stream Type	BKF Area	BKF Width	BKF Depth	Max BKF Depth	W/D	BH Ratio	ER	BKF Elev	TOB Elev
Riffle	C	10.9	16.14	0.67	1.06	23.92	1	2.5	623.07	623.07

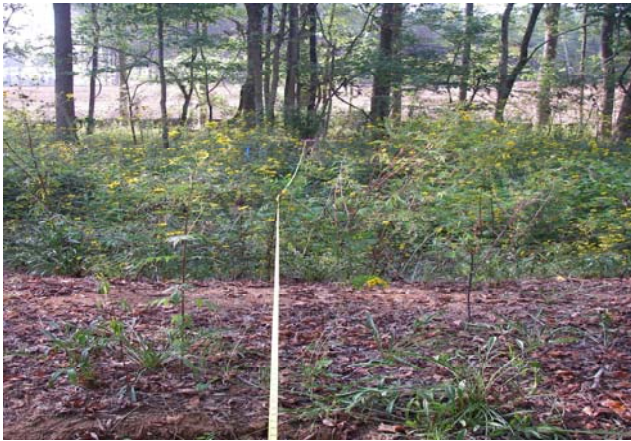
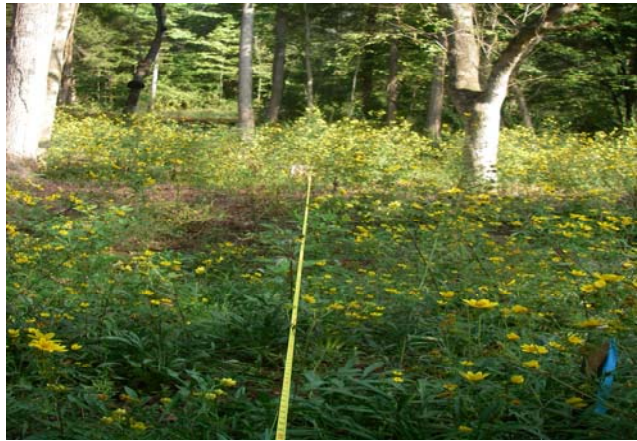
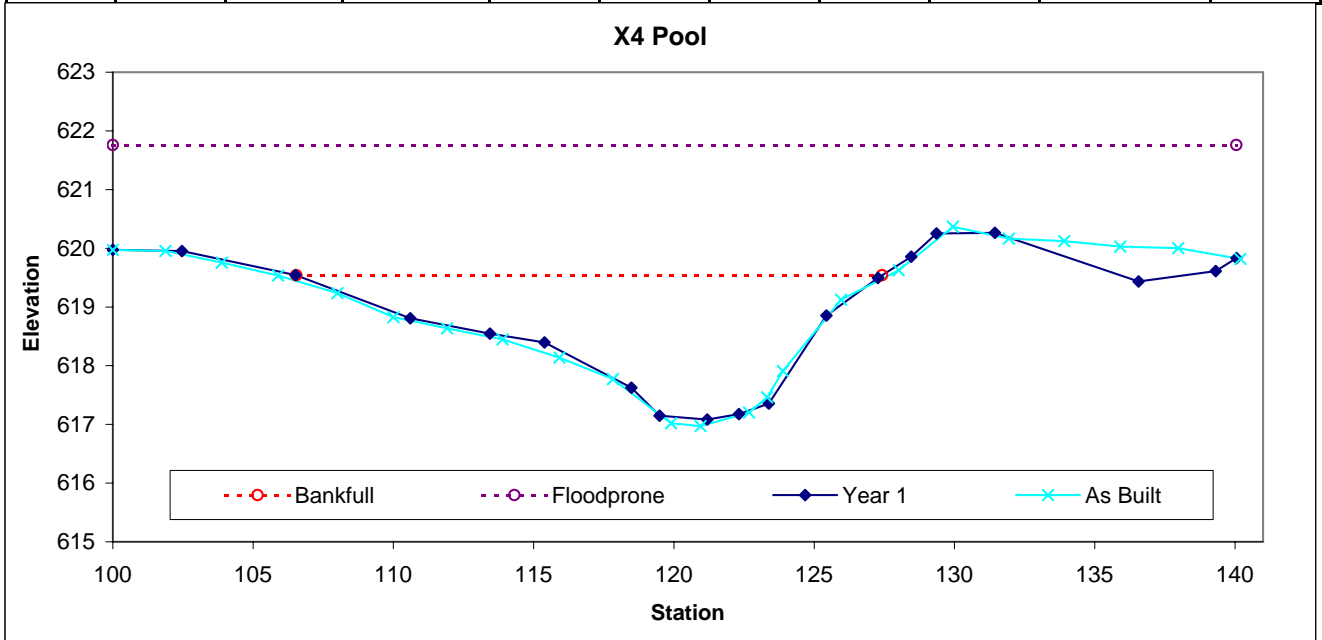
**UT2 Permanent Cross Section X4**  
 (Year 1 Monitoring Data - collected October 2007)

Looking at the Left Bank

Looking at the Right Bank

Feature	Stream Type	BKF Area	BKF Width	BKF Depth	Max BKF Depth	W/D	BH Ratio	ER	BKF Elev	TOB Elev
Pool		25.8	20.88	1.24	2.46	16.9	1	1.9	619.54	619.3

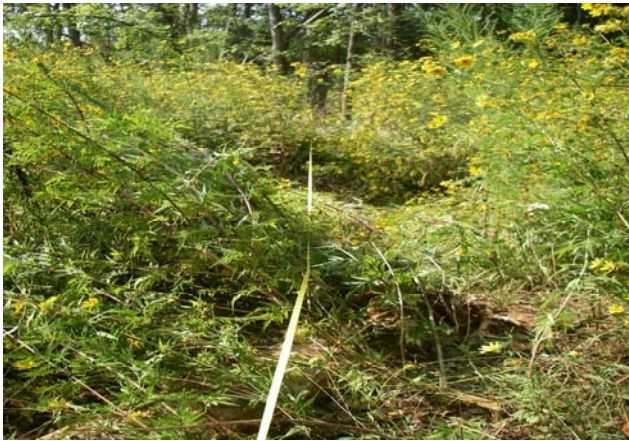
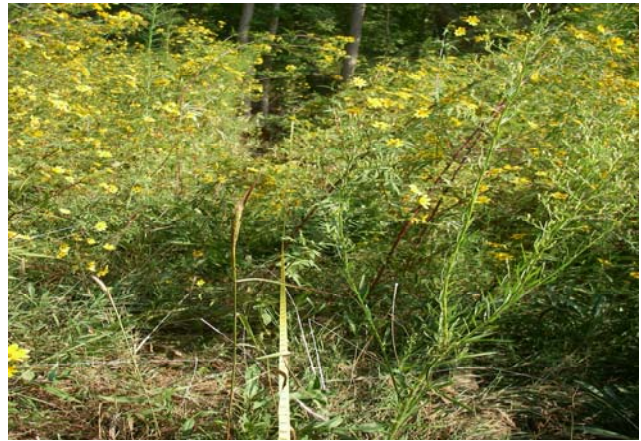
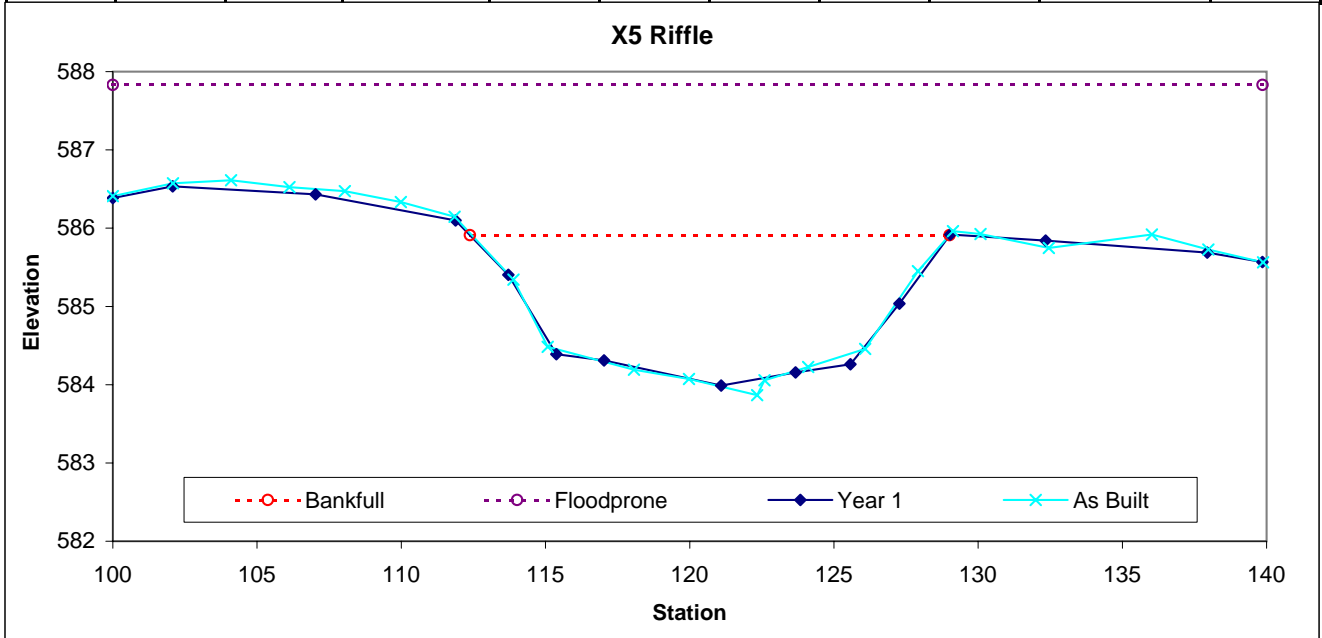
**UT2 Permanent Cross Section X5**  
 (Year 1 Monitoring Data - collected October 2007)

Looking at the Left Bank

Looking at the Right Bank

Feature	Stream Type	BKF Area	BKF Width	BKF Depth	Max BKF Depth	W/D	BH Ratio	ER	BKF Elev	TOB Elev
Riffle	C	22.6	16.63	1.36	1.92	12.23	1	2.4	585.91	585.92

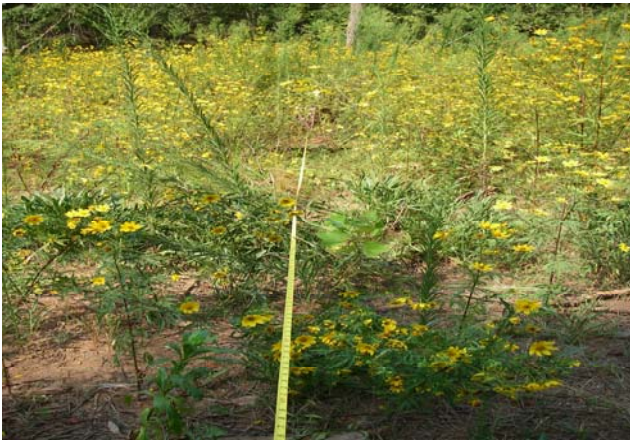
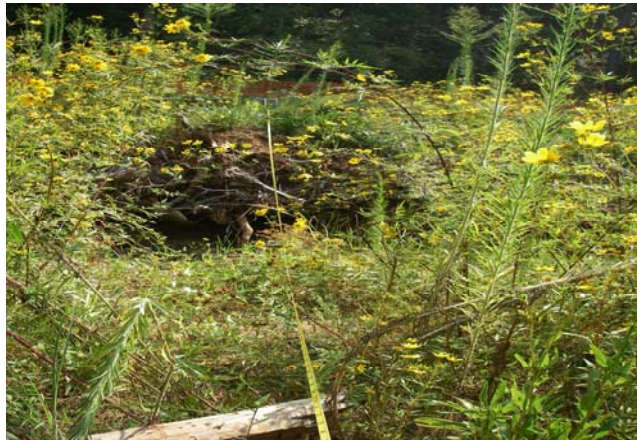
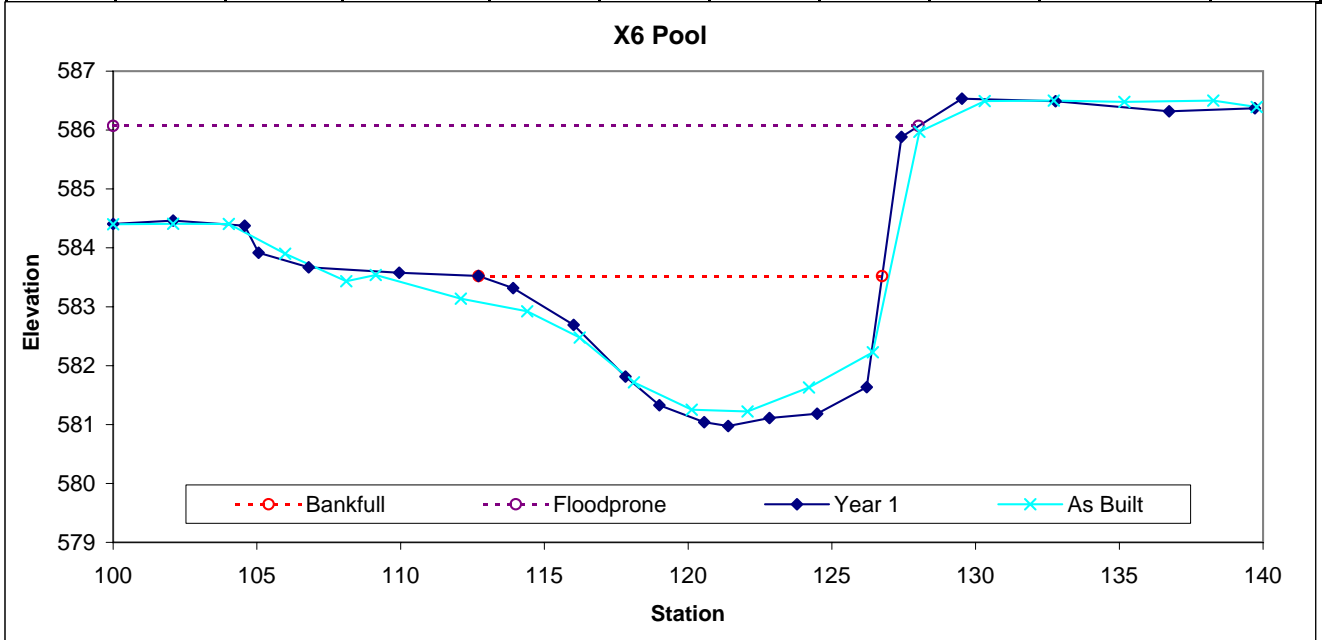
**UT2 Permanent Cross Section X6**  
 (Year 1 Monitoring Data - collected October 2007)

Looking at the Left Bank

Looking at the Right Bank

Feature	Stream Type	BKF Area	BKF Width	BKF Depth	Max BKF Depth	W/D	BH Ratio	ER	BKF Elev	TOB Elev
Pool		23.2	14.04	1.65	2.55	8.5	1	2	583.52	583.52

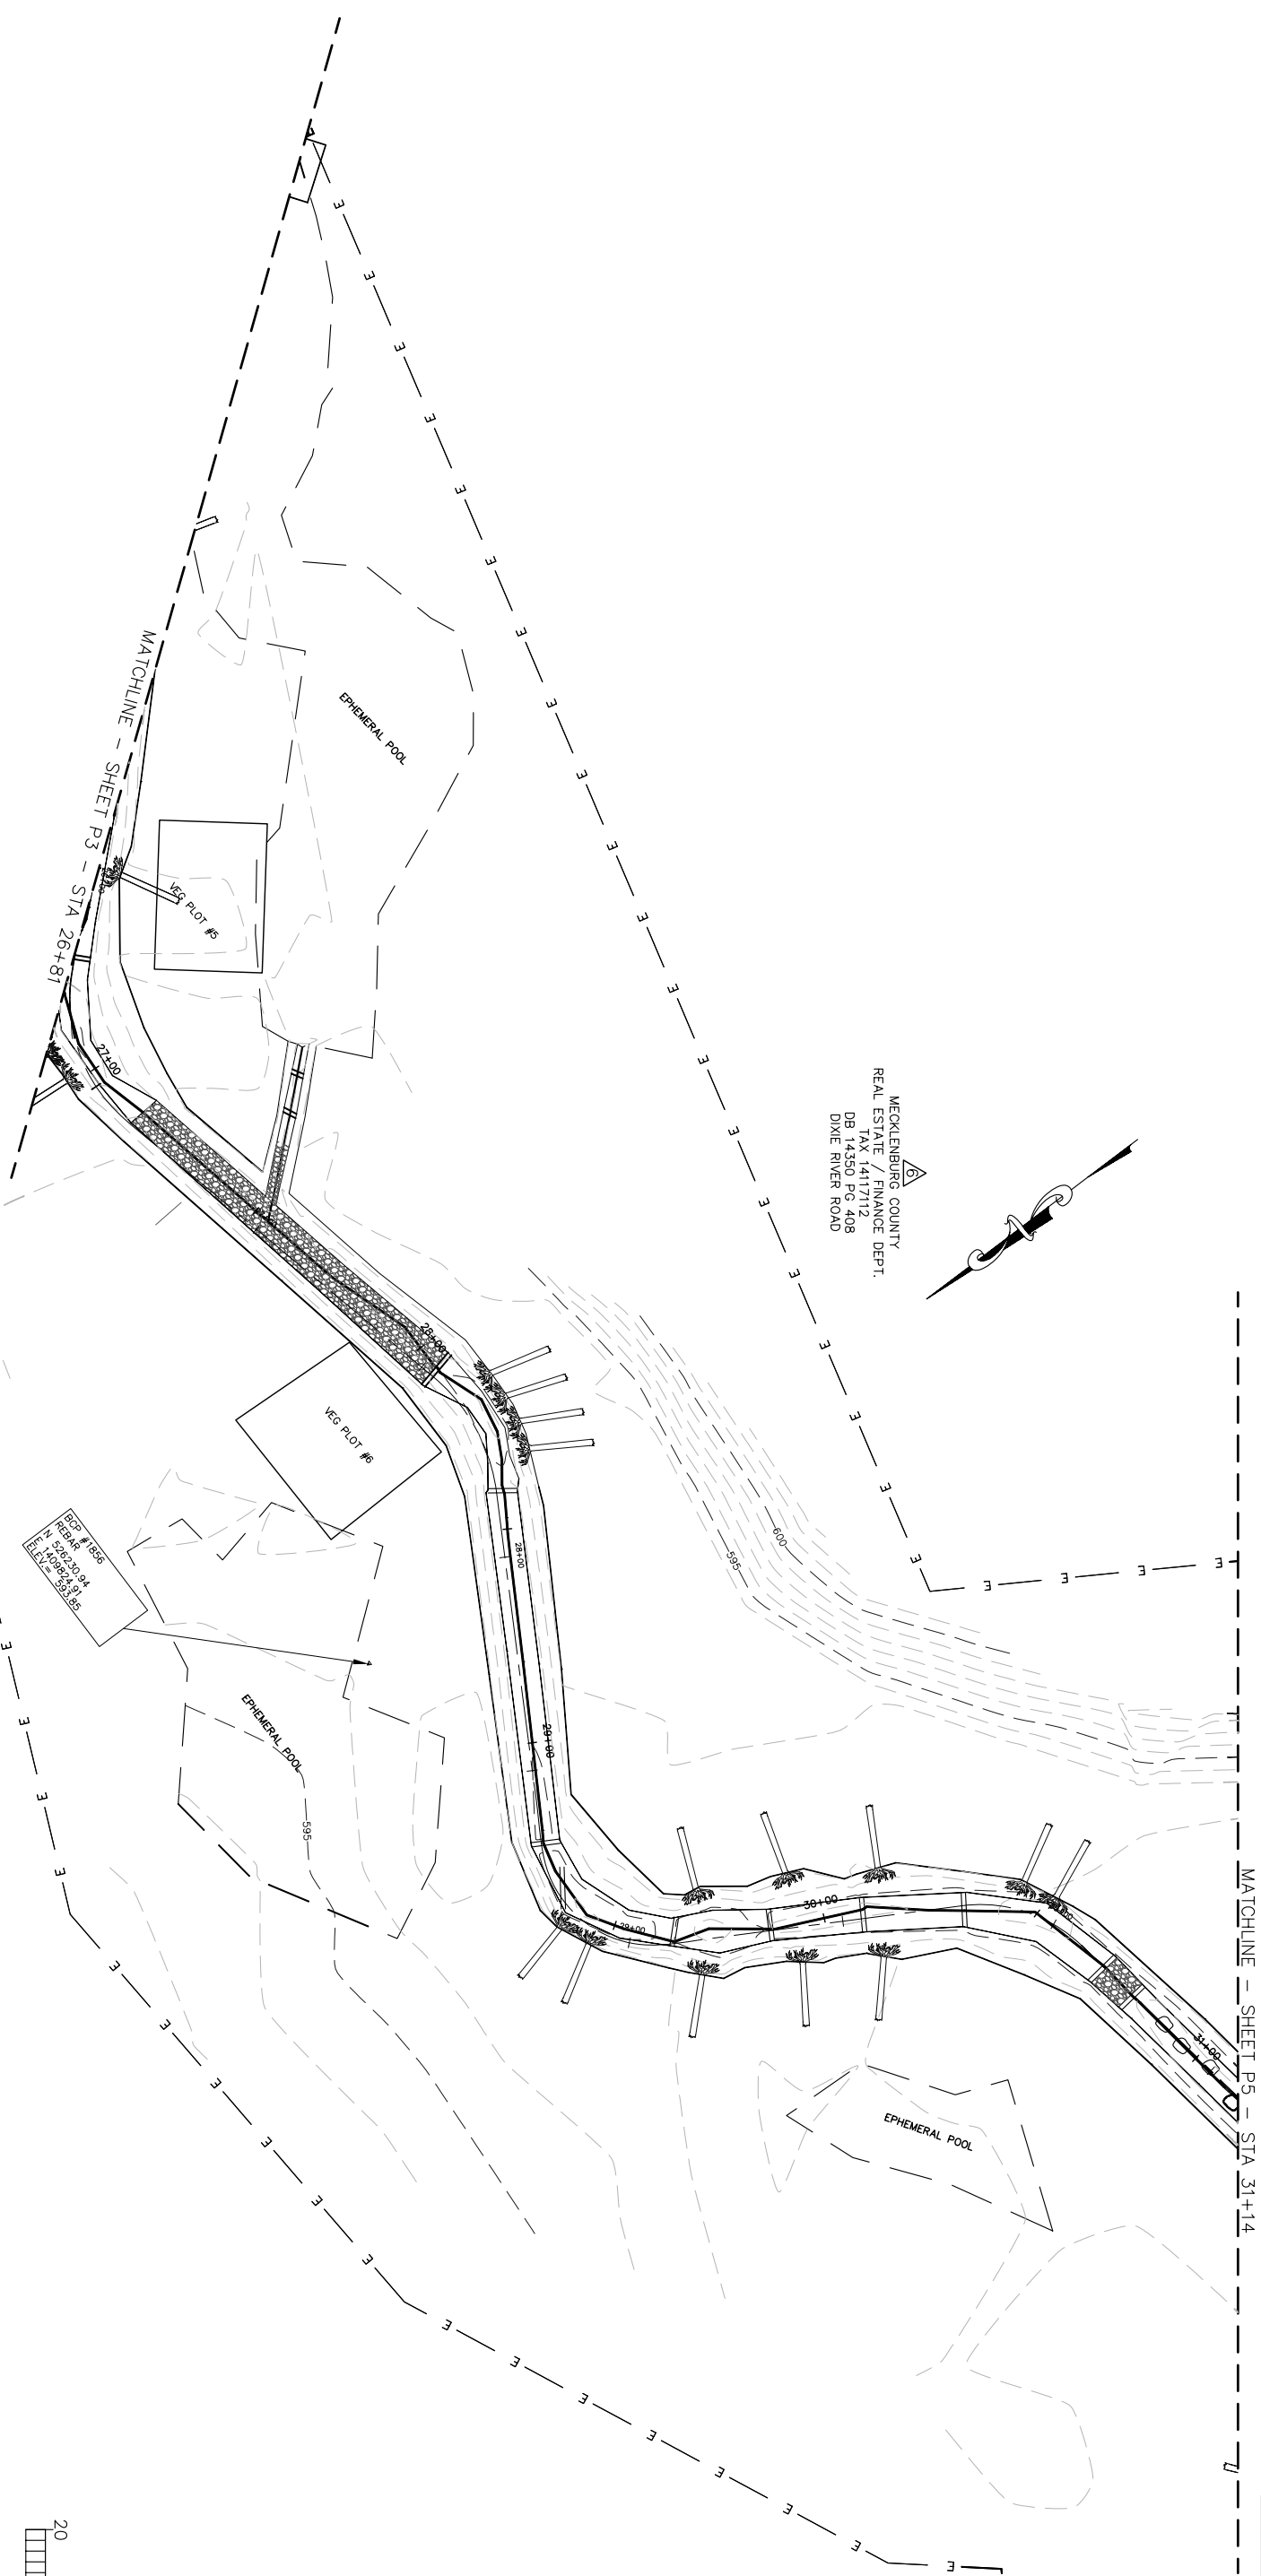
PROJECT REFERENCE NO. 108528  
SHEET NO. P5

BEAVERDAM CREEK  
 AS-BUILT WITH BMPS  
 UT1 SITE PLAN

Adjacent to the Site's property boundaries are new residential developments under construction. During Year 1 Monitoring, several Best Management Practices (BMPs) were noted as areas of concern within and immediately outside the conservation easement along UT2 and UT2A of the Restoration Project. The BMPs consist of both temporary and permanent detention ponds which are discharging stormwater into the Project Site, and a retaining wall. Locations of the BMPs are shown on the as-built plans included in Appendix C.

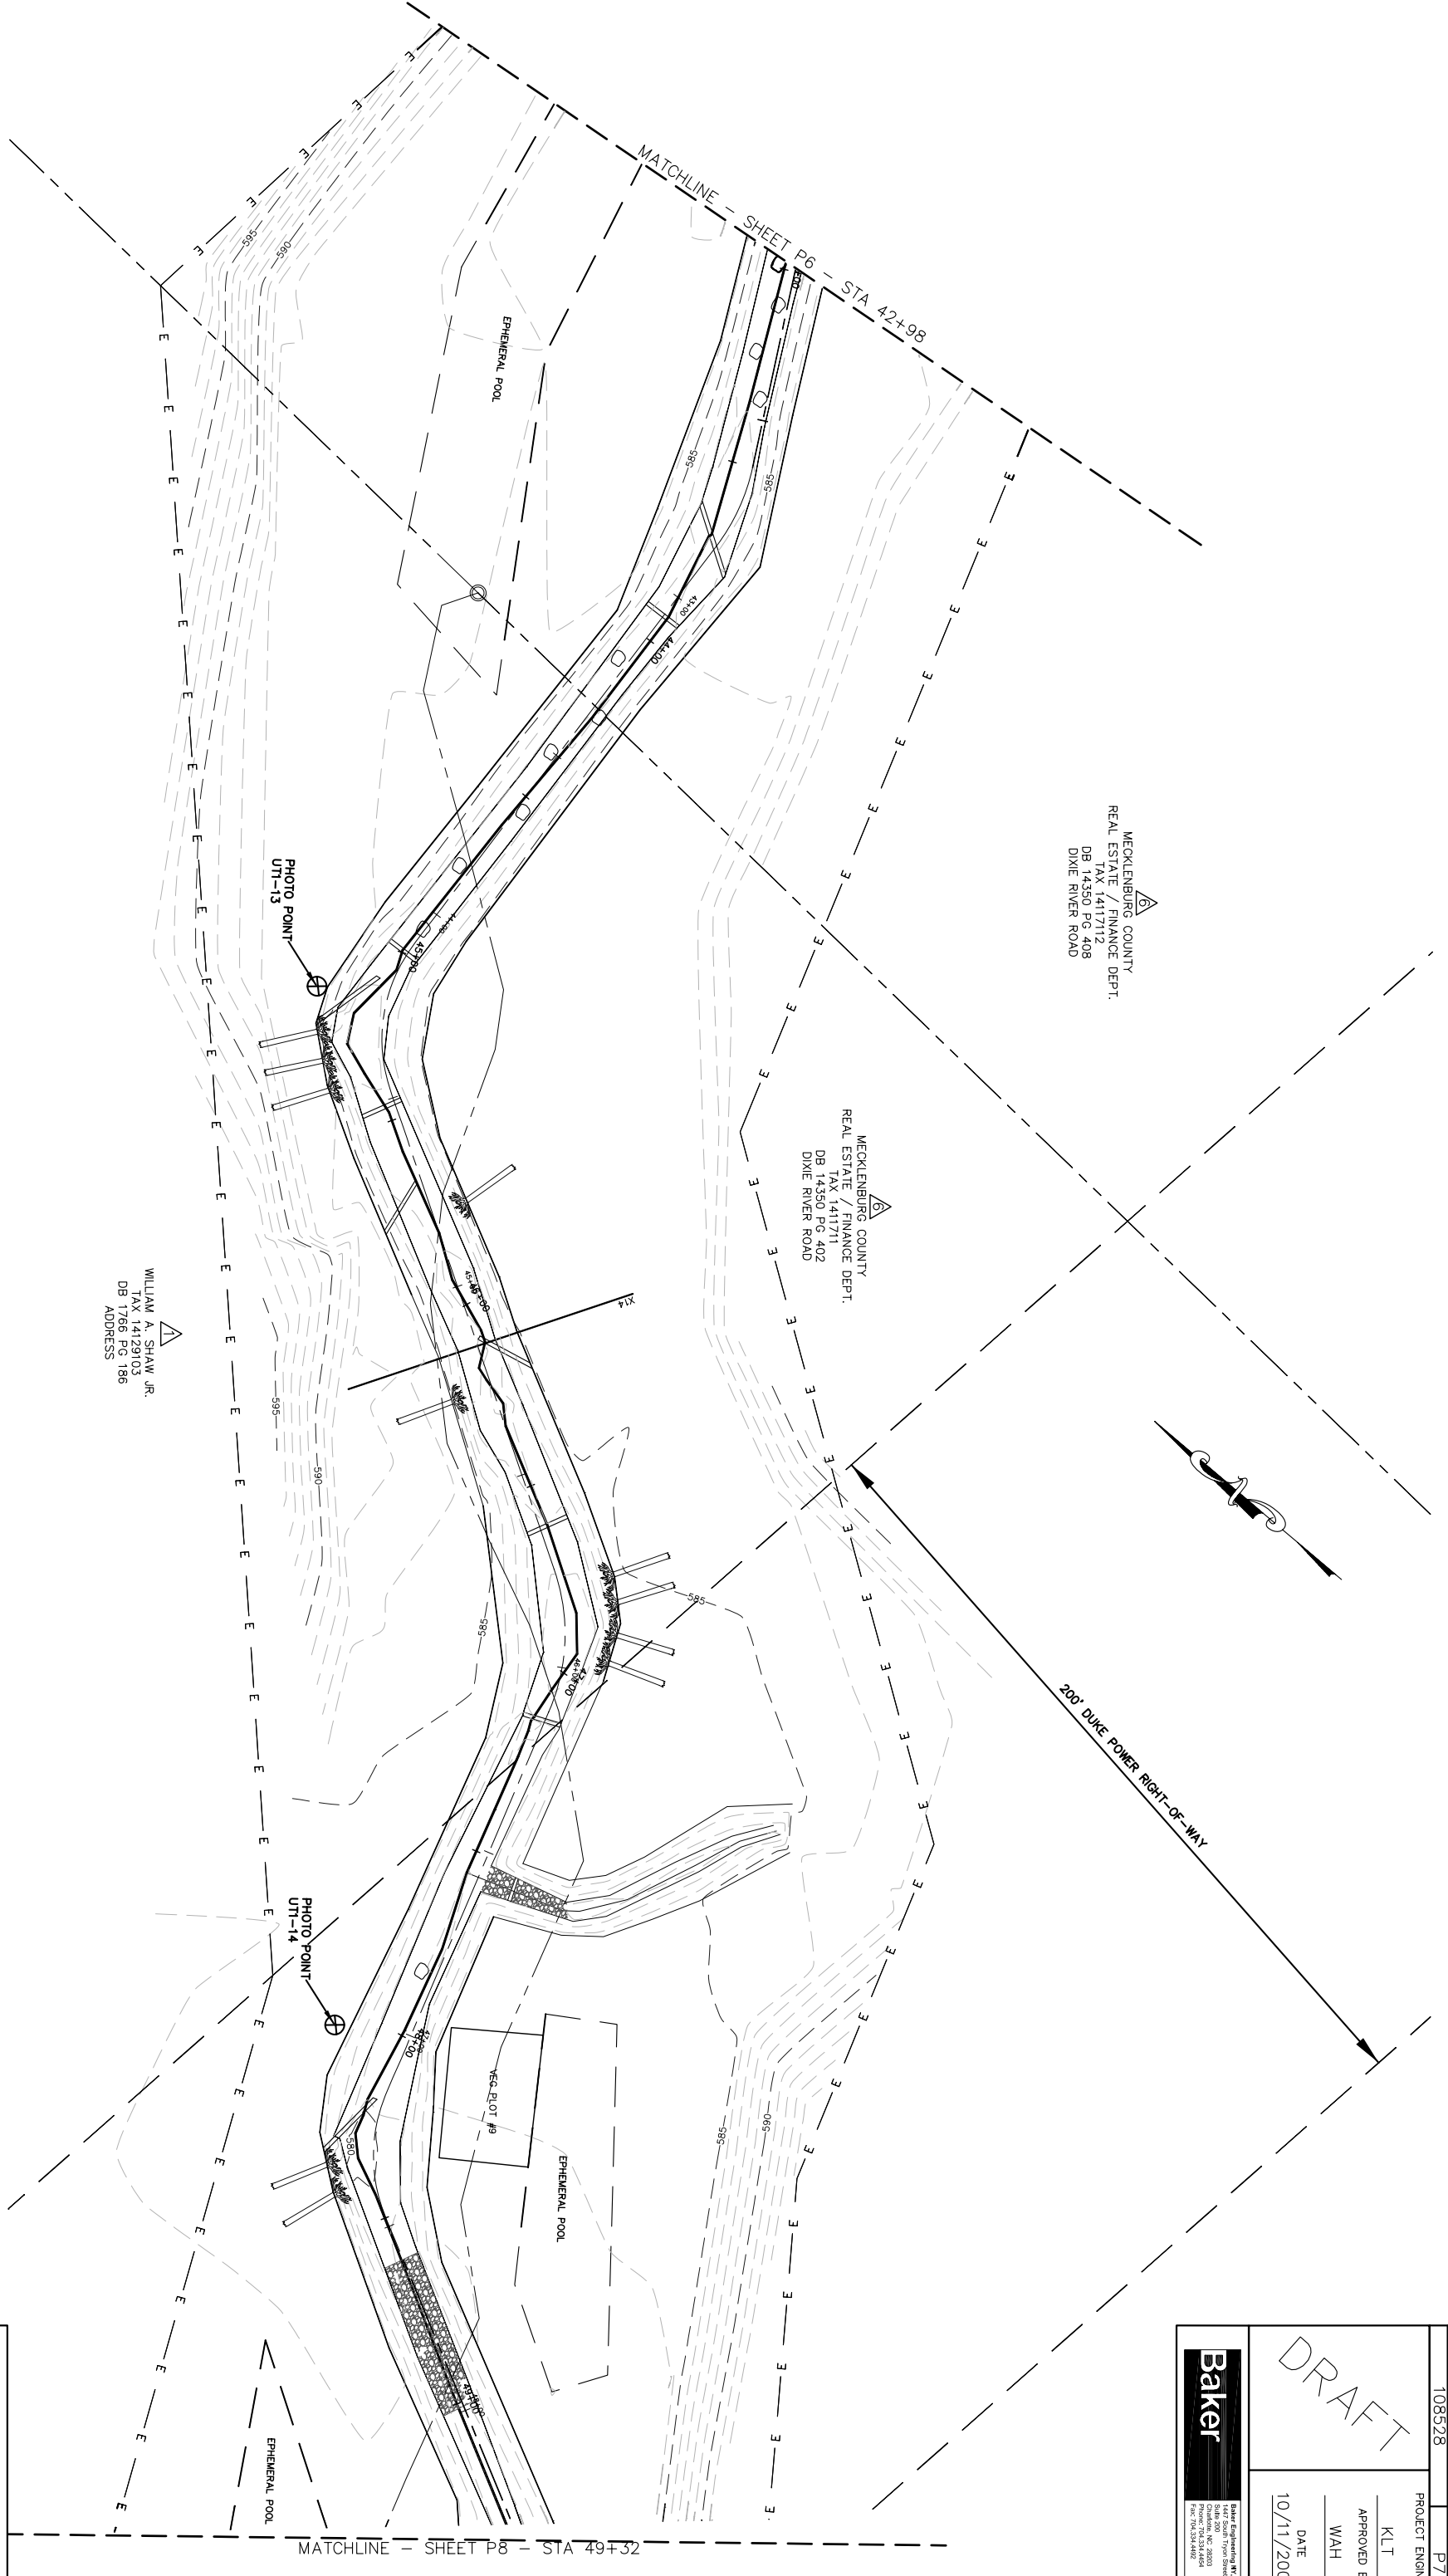
PROJECT REFERENCE NO. 108528 SHEET NO. P8

BEAVERDAM CREEK  
 AS-BUILT WITH BMPs  
 UT1 SITE PLAN

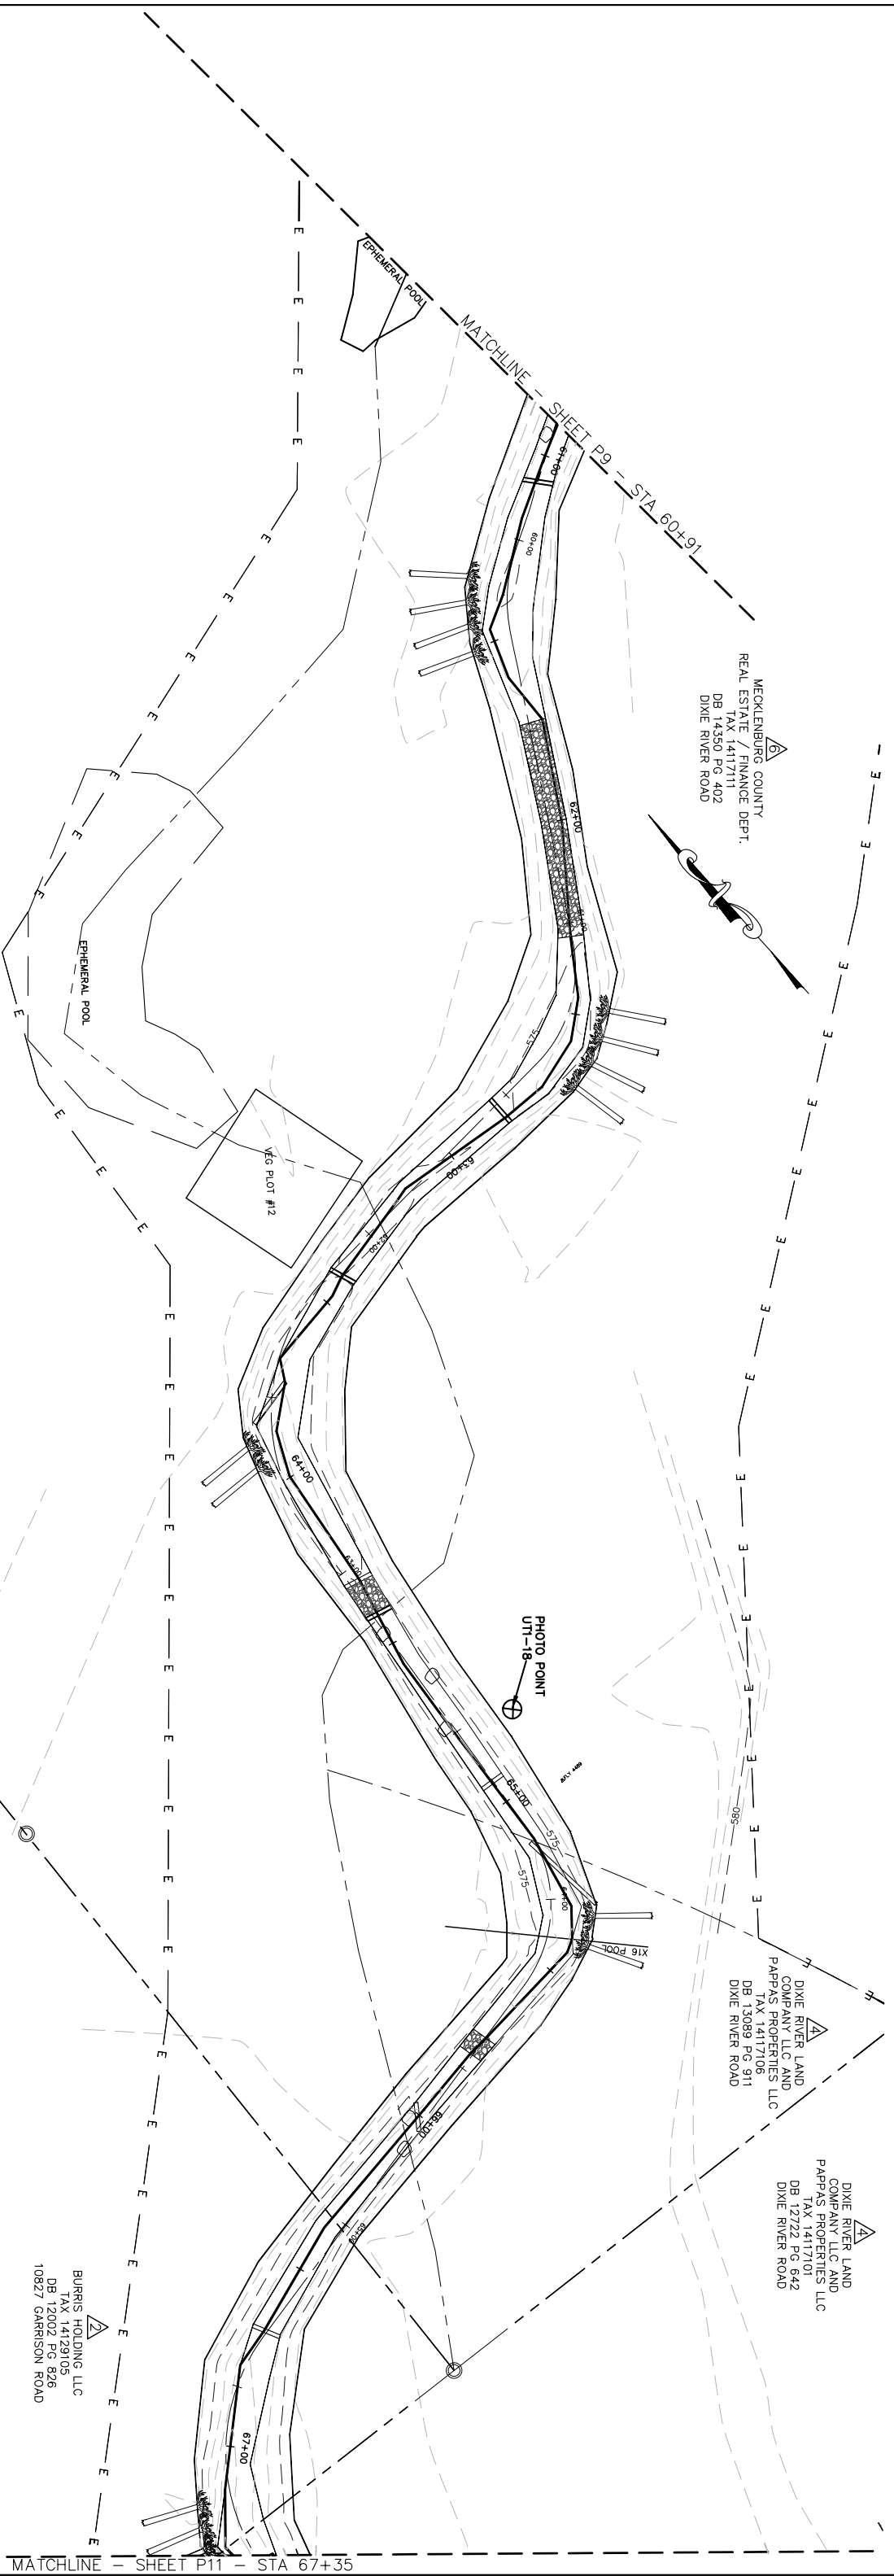
PROJECT REFERENCE NO. 108528  
SHEET NO. P11

BEAVERDAM CREEK  
 AS-BUILT WITH BMPS  
 UT1 SITE PLAN

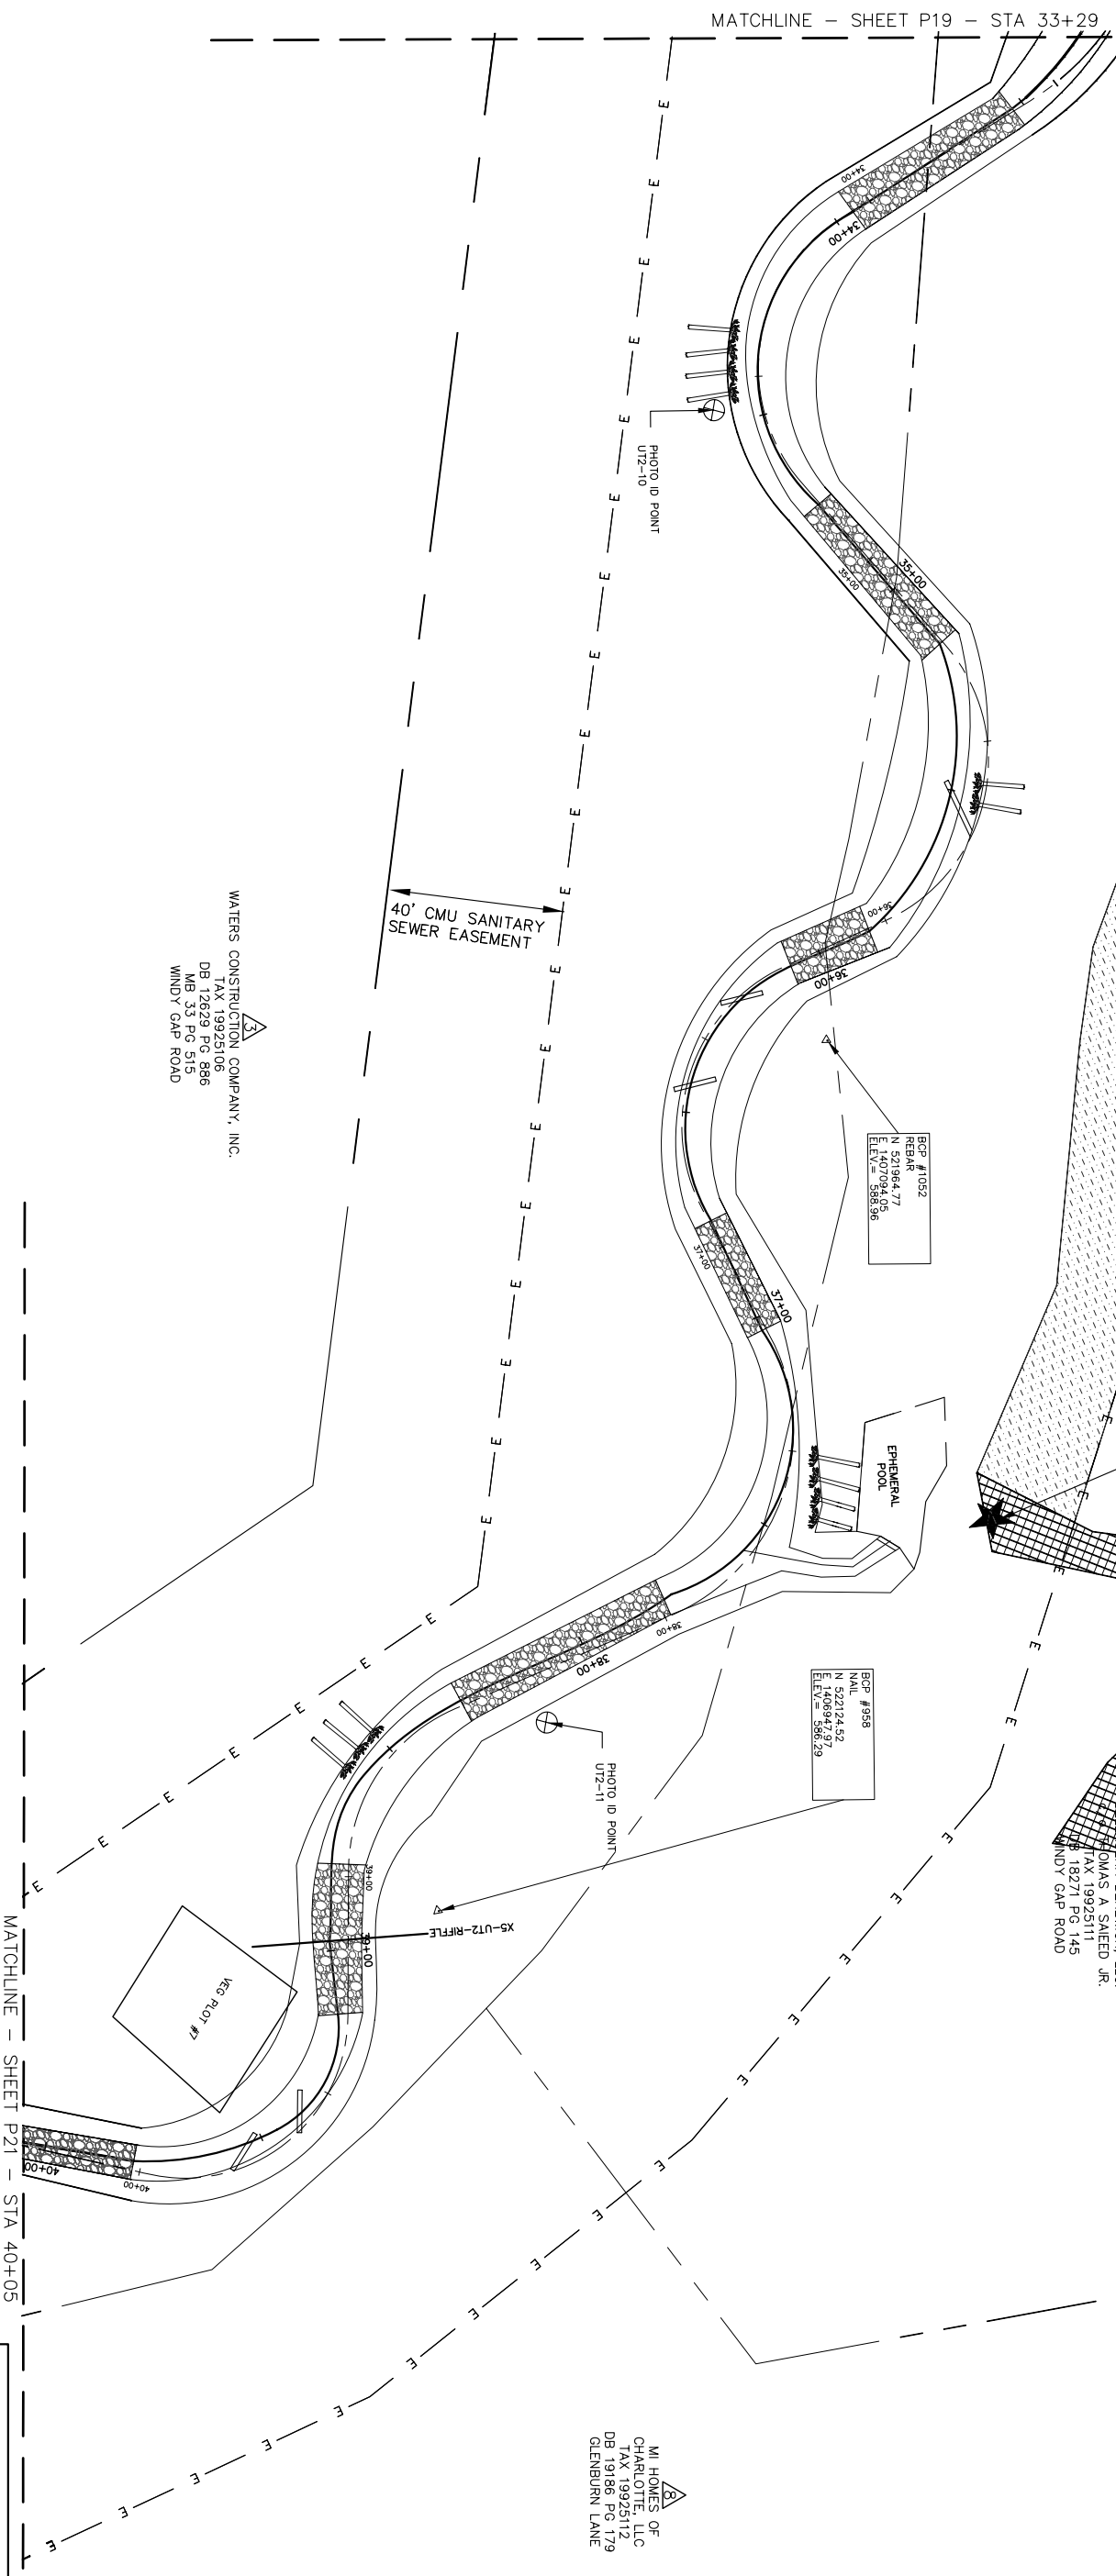
BEAVERDAM CREEK  
AS-BUILT WITH BMPs  
UT2 SITE PLAN

PROJECT REFERENCE NO. 108528 SHEET NO. P21
