# Beaverdam Creek and Unnamed Tributaries Restoration Plan

Union County, North Carolina  
SCO # D06054-C

**Submitted:** January 16, 2008

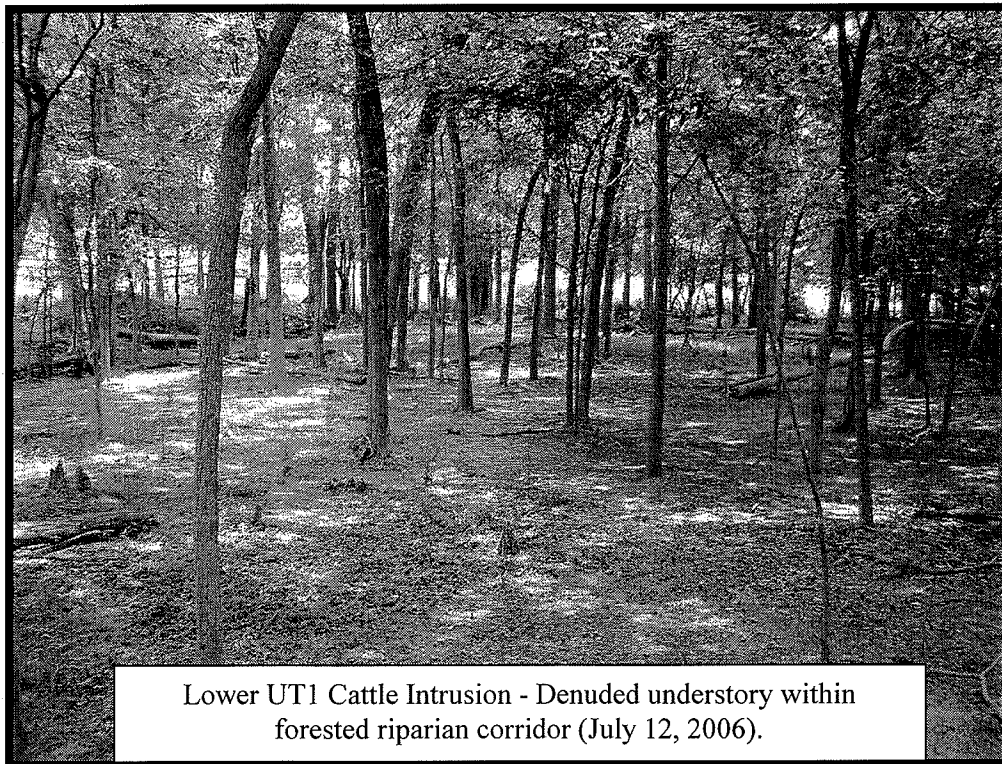
Lower UT1 Cattle Intrusion - Denuded understory within forested riparian corridor (July 12, 2006).

The land surrounding the restoration project is cattle pasture land. Cattle have direct access to the project stream reaches for drinking water, and in areas where established riparian canopy corridors exist, cattle access the project reaches for shade. Presently, the cattle access the stream randomly and, in doing so, have denuded and destabilized the channel banks due to grazing, browsing and hoof shear. The unstable streambanks contribute significant quantities of sediment to the project stream reaches. Sediment eroded from the unstable streambanks is transported downstream and off site into the larger Beaverdam Creek watershed. Runoff from cattle intrusion along the project corridors provides direct nutrient pathways into the streams. Currently, the upper reach of UT1 and the entire UT2 reach have sparse riparian vegetation along their stream corridors. Vegetation along the existing stream corridors is nonfunctional with respect to bank stabilization, nutrient uptake and sediment removal from overland flow (i.e., non-point source pollutants). The approximate lower third of UT1 and Beaverdam Creek mainstem reaches have established hardwood forested riparian corridors. However, cattle intrusion has denuded herbaceous groundcover, and adversely impaired shrub and mid-story canopy vegetation. Cattle intrusion is the primary cause of stream instability on site. The photographs on the following page show the adverse effects of browsing and grazing of shrub and herbaceous vegetation, hoof shear, and resulting nutrient loading, streambank destabilization and erosion, respectively.

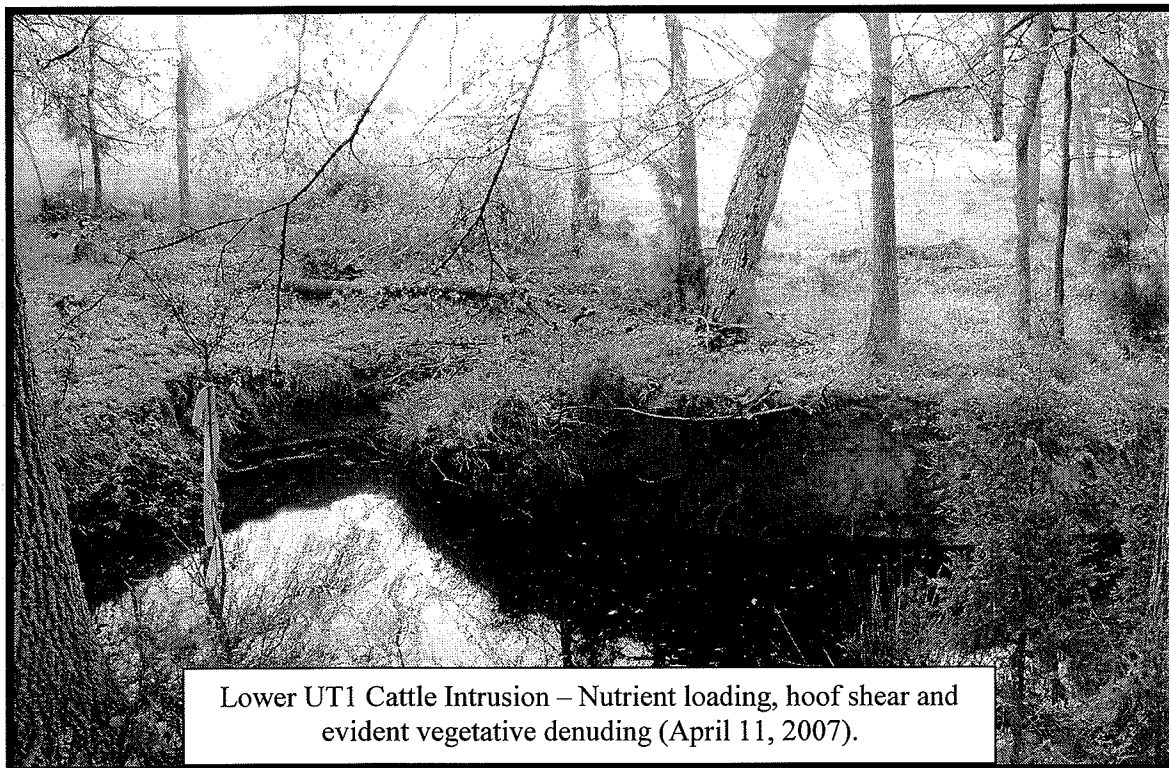
Lower UT1 Cattle Intrusion – Nutrient loading, hoof shear and evident vegetative denuding (April 11, 2007).

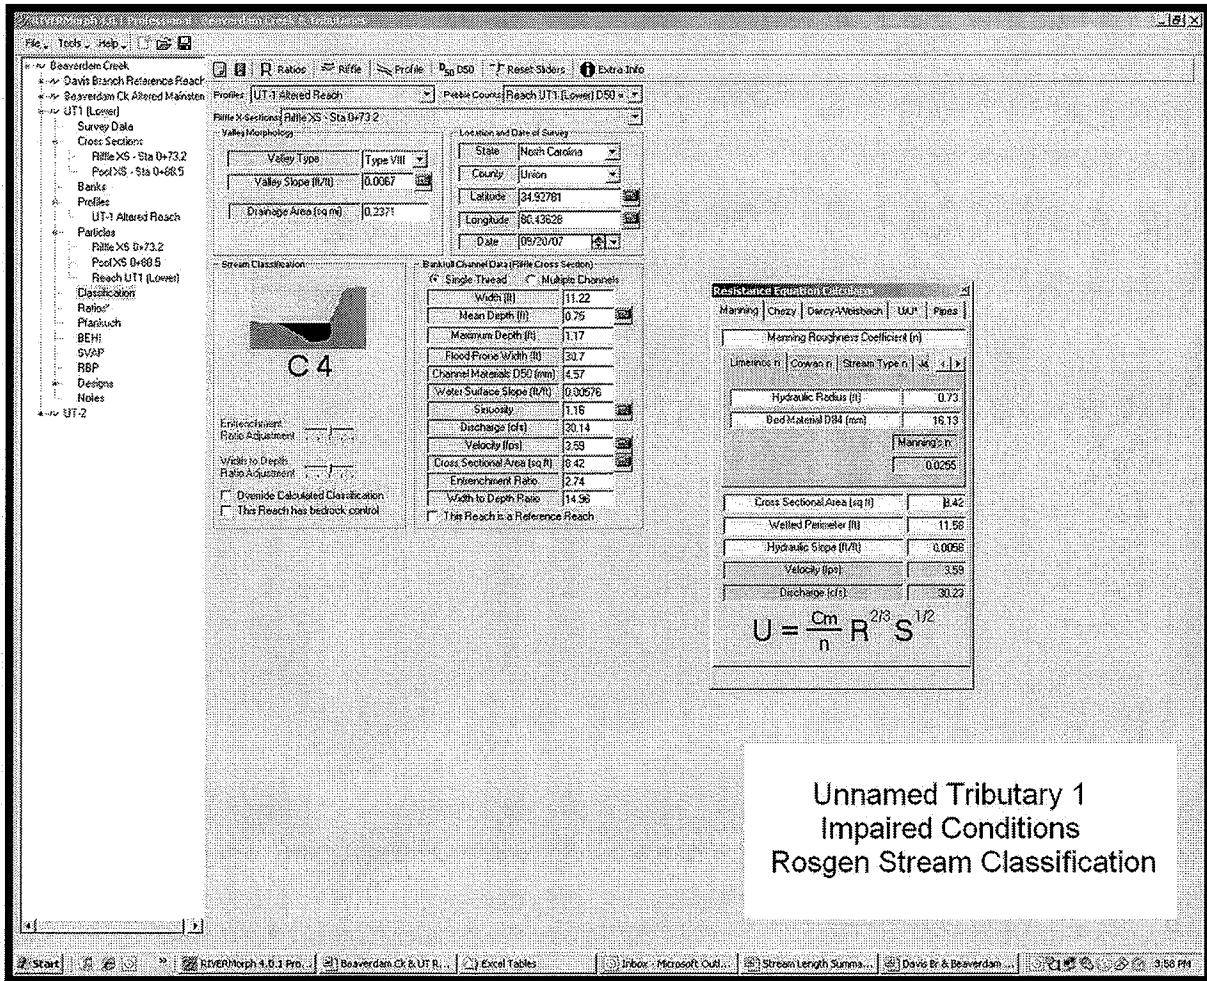
In its existing impaired state, UT1, along its final 300 feet reach, has C4 channel morphology, based on dimensions measured at the selected impaired reach riffle cross-section, albeit under incised conditions. **Tables 4c – 4d** provide baseline morphologic and hydraulic summary of reference, existing and proposed channel dimension, pattern and profile, along with addition reach parameters. The preceding screenshot from RiverMorph v. 4.0.1, shows impaired project reach Rosgen stream channel classification, dominant substrate materials, morphologic and hydraulic conditions for UT1.

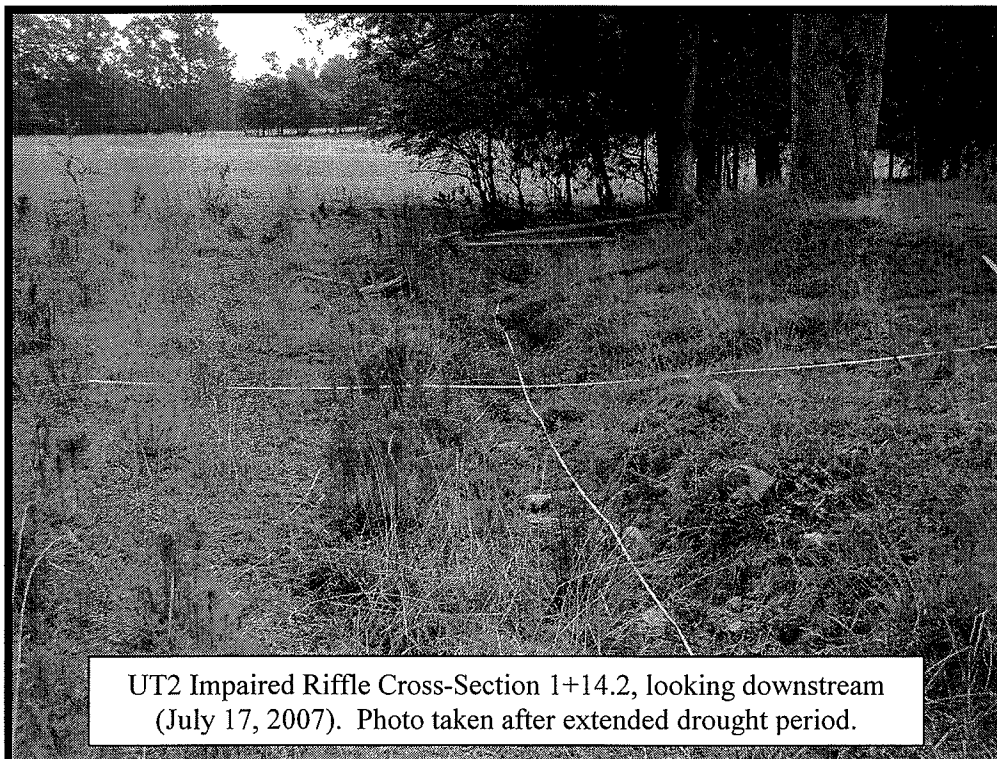
UT2 Impaired Riffle Cross-Section 1+14.2, looking downstream (July 17, 2007). Photo taken after extended drought period.

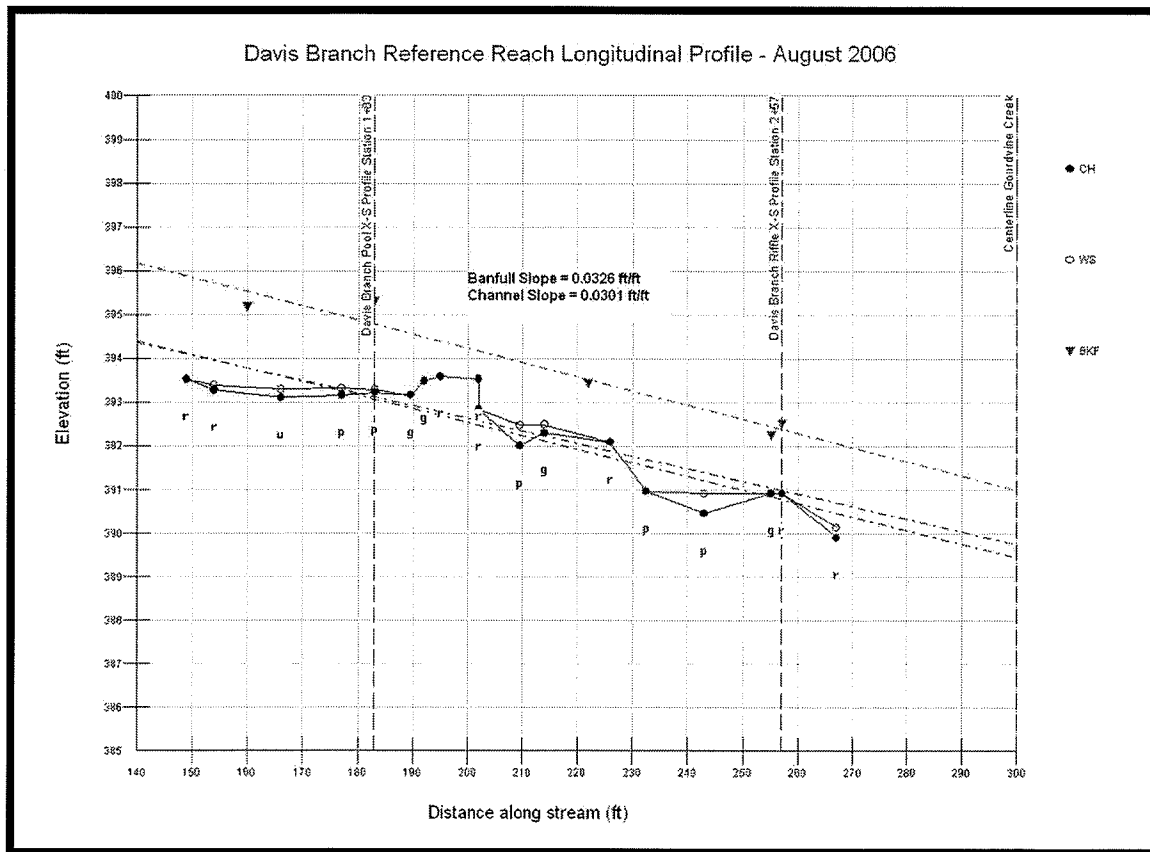
For Beaverdam Creek, bankfull discharge was determined through a quantitative assessment and analysis of reference reach boundary conditions and comparison of predicted bankfull discharge through a stable riffle cross-section located on Davis Branch 43 feet upstream from its confluence with Gourdvine Creek. The reference reach is a Rosgen Valley Type VIII, E3/1b stream type (i.e., E channel morphology, large cobble substrate with strong bedrock control, profile gradient greater than 2 percent). The reference reach is located within a healthy, deciduous hardwood forested riparian corridor. A complete Rosgen Level III watershed assessment and analysis of the reference reach conditions was conducted during August 8 and 9, 2006. The longitudinal profile that follows, analyzed using RiverMorph<sup>®</sup> version 4.0.1, shows the best fit trend lines of the streambed, water surface and bankfull indicators:

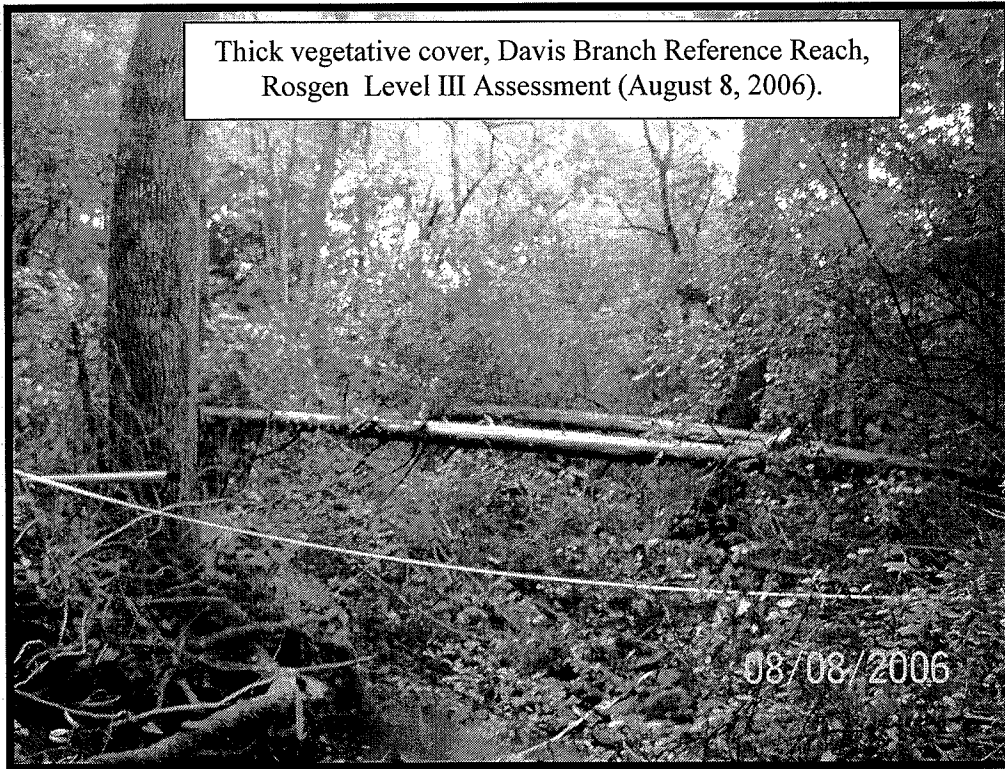
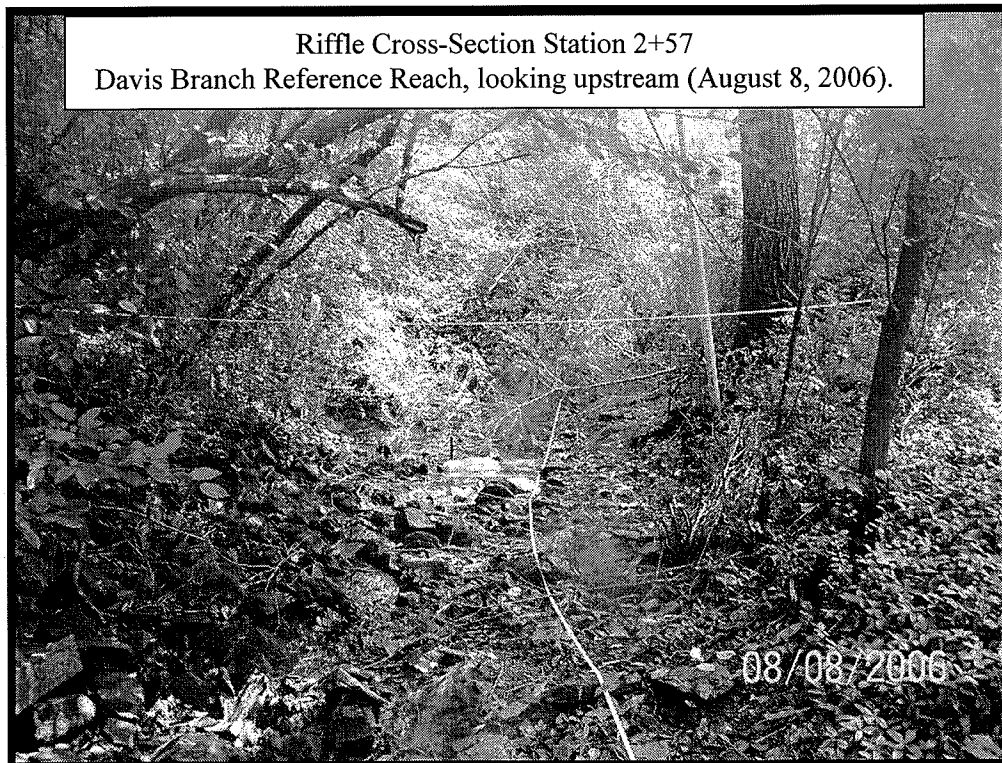
The healthy, robust vegetation and root mass along the reference reach riparian corridor, extending overbank into the channel, is extremely stable and resistant to streambank erosion. The streambed is stable due to hard bedrock control. Large cobble deposited on top of the bedrock is a secondary substrate, resulting from physical weathering of the highly fractured, steeply dipping, thick- to thin-bedded slate bedrock (dominant bedding plane orientation strikes N65°E, with a mean dip angle of 55° to the northwest, average protrusion height 0.57 feet or 174 mm based on field measurements). Due to extremely thick riparian vegetation during August 2006, it was possible to collect profile and cross-section data along a relatively short length of the stable reach. The following photographs

depict field conditions at the time of the field survey and reference reach Rosgen Level III assessment.

EMH&T staff were able to clear line of site 151 feet deep into the overgrown Davis Branch Reference Reach, accessing the stream from its confluence with Gourdvine Creek. Due to backwater from Gourdvine Creek at the mouth of Davis Branch, 118 linear feet of profile, capturing three pool and four riffle sequences, with one representative riffle and pool cross-section being surveyed in the field. Geologic structural controls and lithology, fluvial geomorphologic processes, depositional materials, climatic influence, riparian vegetation, deposition pattern, debris occurrence, meander pattern, channel stability rating, sediment supply, streambed stability and width/depth ratio state were evaluated following Rosgen Level III stream assessment protocols. Visibility was limited in the field to dense vegetative cover along the Davis Branch Reference Reach; therefore, Union County orthoimagery (2/2004) was used to verify stream pattern. The high-resolution (1 pixel = 6 inches) orthoimagery is included on **Figures 3A** and **7**. A total of 1129 linear feet of the reach was assessed for each Level III stream state and condition parameter consistent with a Rosgen Level III methodologies. The assessment included GPS data spatial analysis to evaluate channel pattern upstream from the surveyed reach, beyond the point where additional differential level surveying was impracticable and channel pattern could not be discerned from recent aerial imagery.

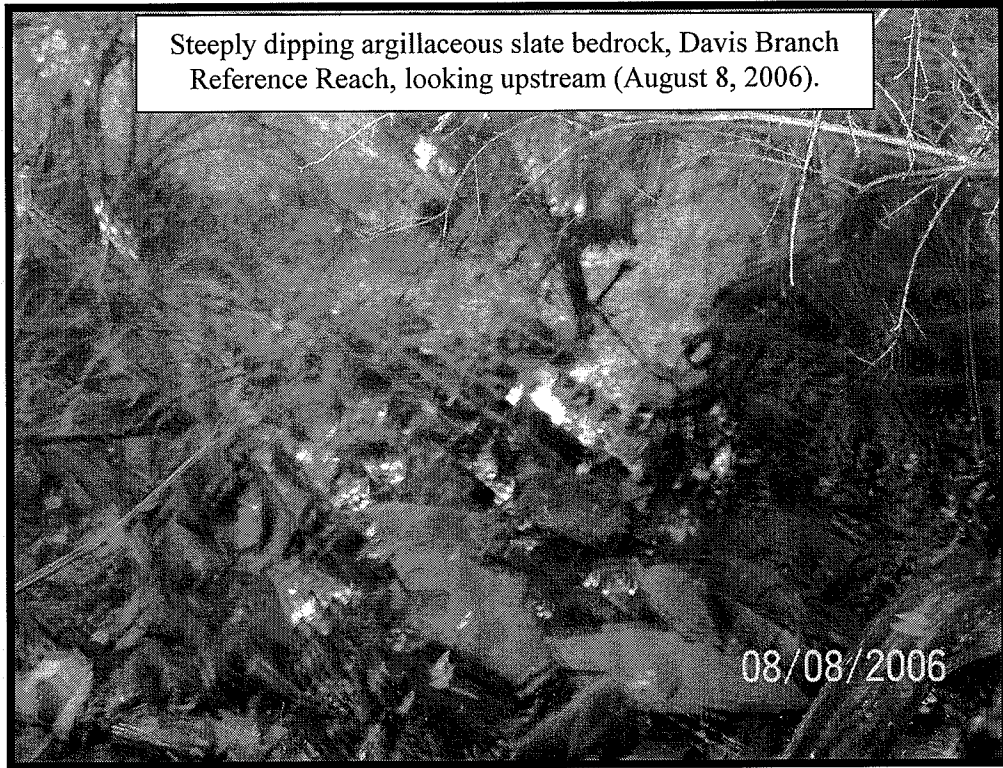
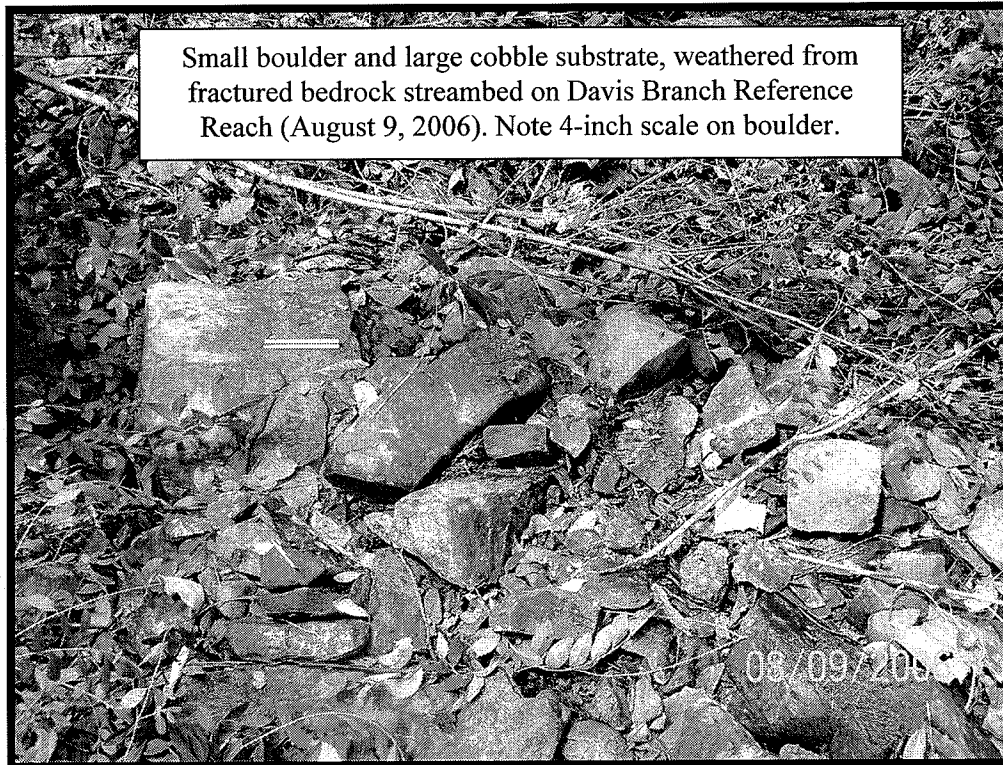
Calculated bankfull discharge for the surveyed reference reach riffle cross-section, was computed using hydraulic radius, wetted perimeter, channel slope and a relative roughness ( $u/u^*$ ) method based on the average protrusion height of the steeply dipping bedrock (Rosgen, 1998). Additionally, a particle distribution was collected from the large angular cobble deposited along the reference reach riffle bed. Based on an average protrusion height of 0.57 feet (or 174 mm), bankfull discharge is quantified at 77.6 cfs. The D84 particle size from the stable riffle particle distribution is 140.1 mm and is consistent with the observed bed thickness and axial splitting planes and observed joint sets in the folded and deformed slate bedrock, as shown on the photographs that follow.

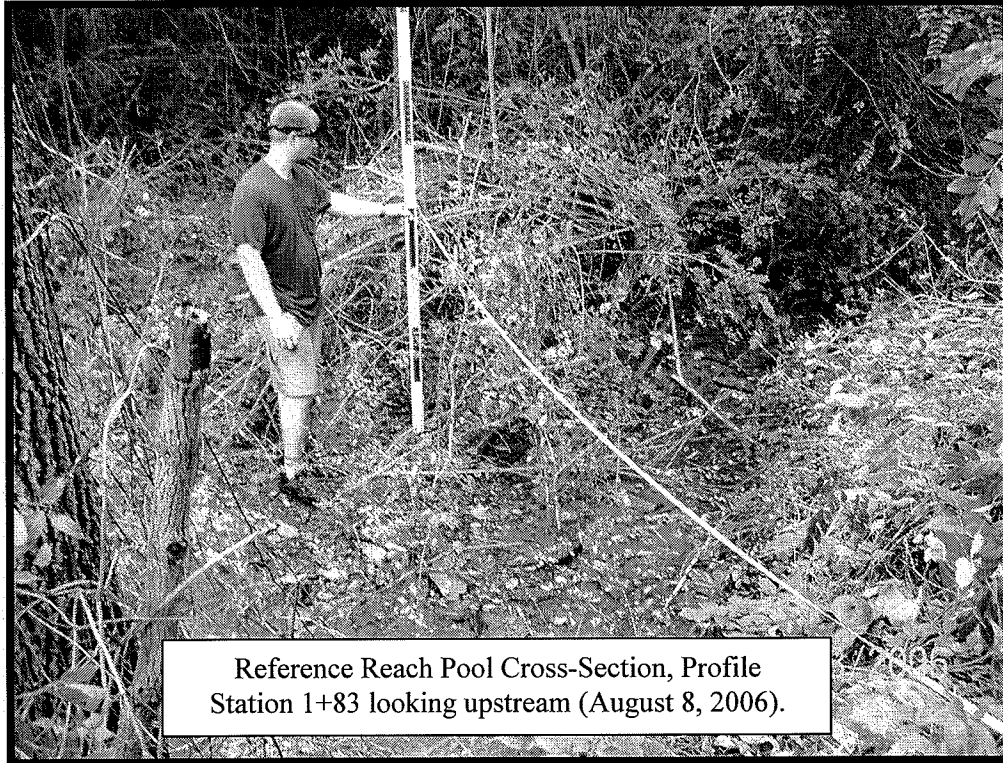
Reference Reach Pool Cross-Section, Profile Station 1+83 looking upstream (August 8, 2006).

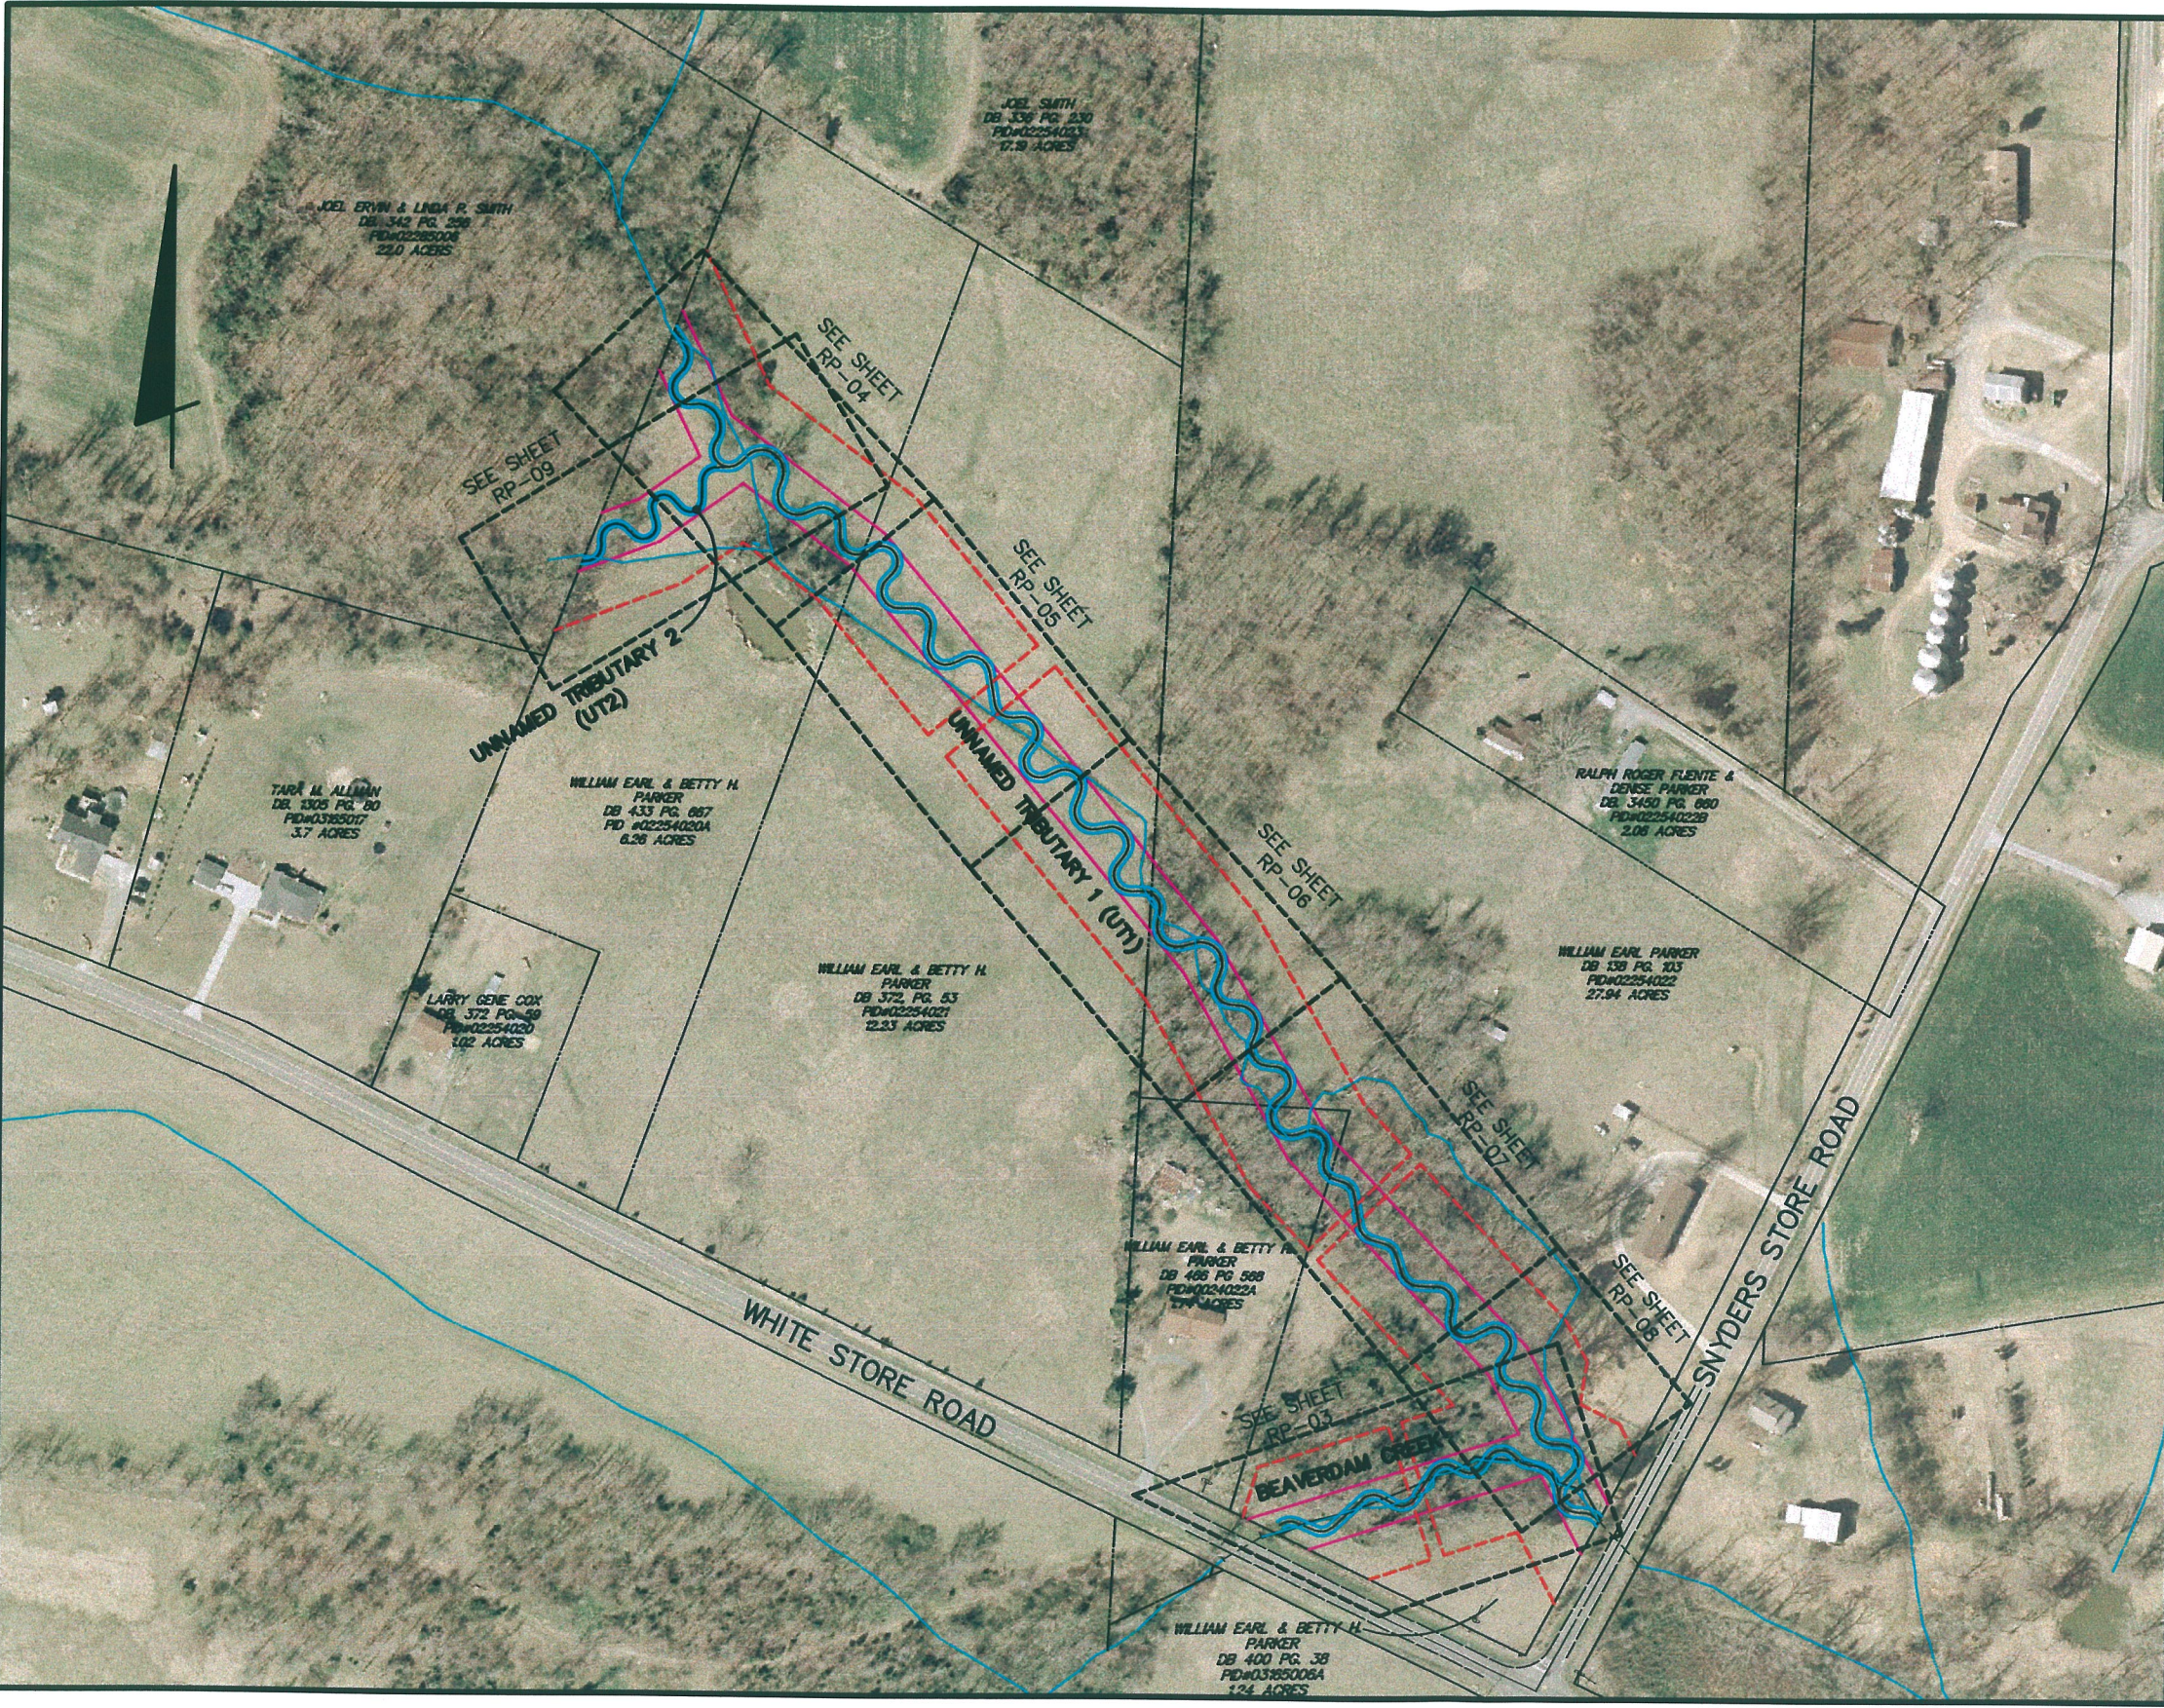
**INDEX MAP**  
Scale: 1" = 200'

Job No.	2006-1399	Date	January, 2008	Scale	As Noted
Sheet	RP-02/18	UNION COUNTY, NORTH CAROLINA STREAM RESTORATION PLAN FOR <b>BEAVERDAM CREEK AND UNNAMED TRIBUTARIES</b> STREAM RESTORATION PROJECT INDEX MAP			
<b>EMHNT</b> <small>Evans, Mechwart, Hambleton &amp; Tilton, Inc.          500 West 4th Street, Suite 200, Raleigh, NC 27601          Phone: 919.733.4000 Fax: 919.733.4800</small>					
REVISIONS					
MARK	DATE	DESCRIPTION

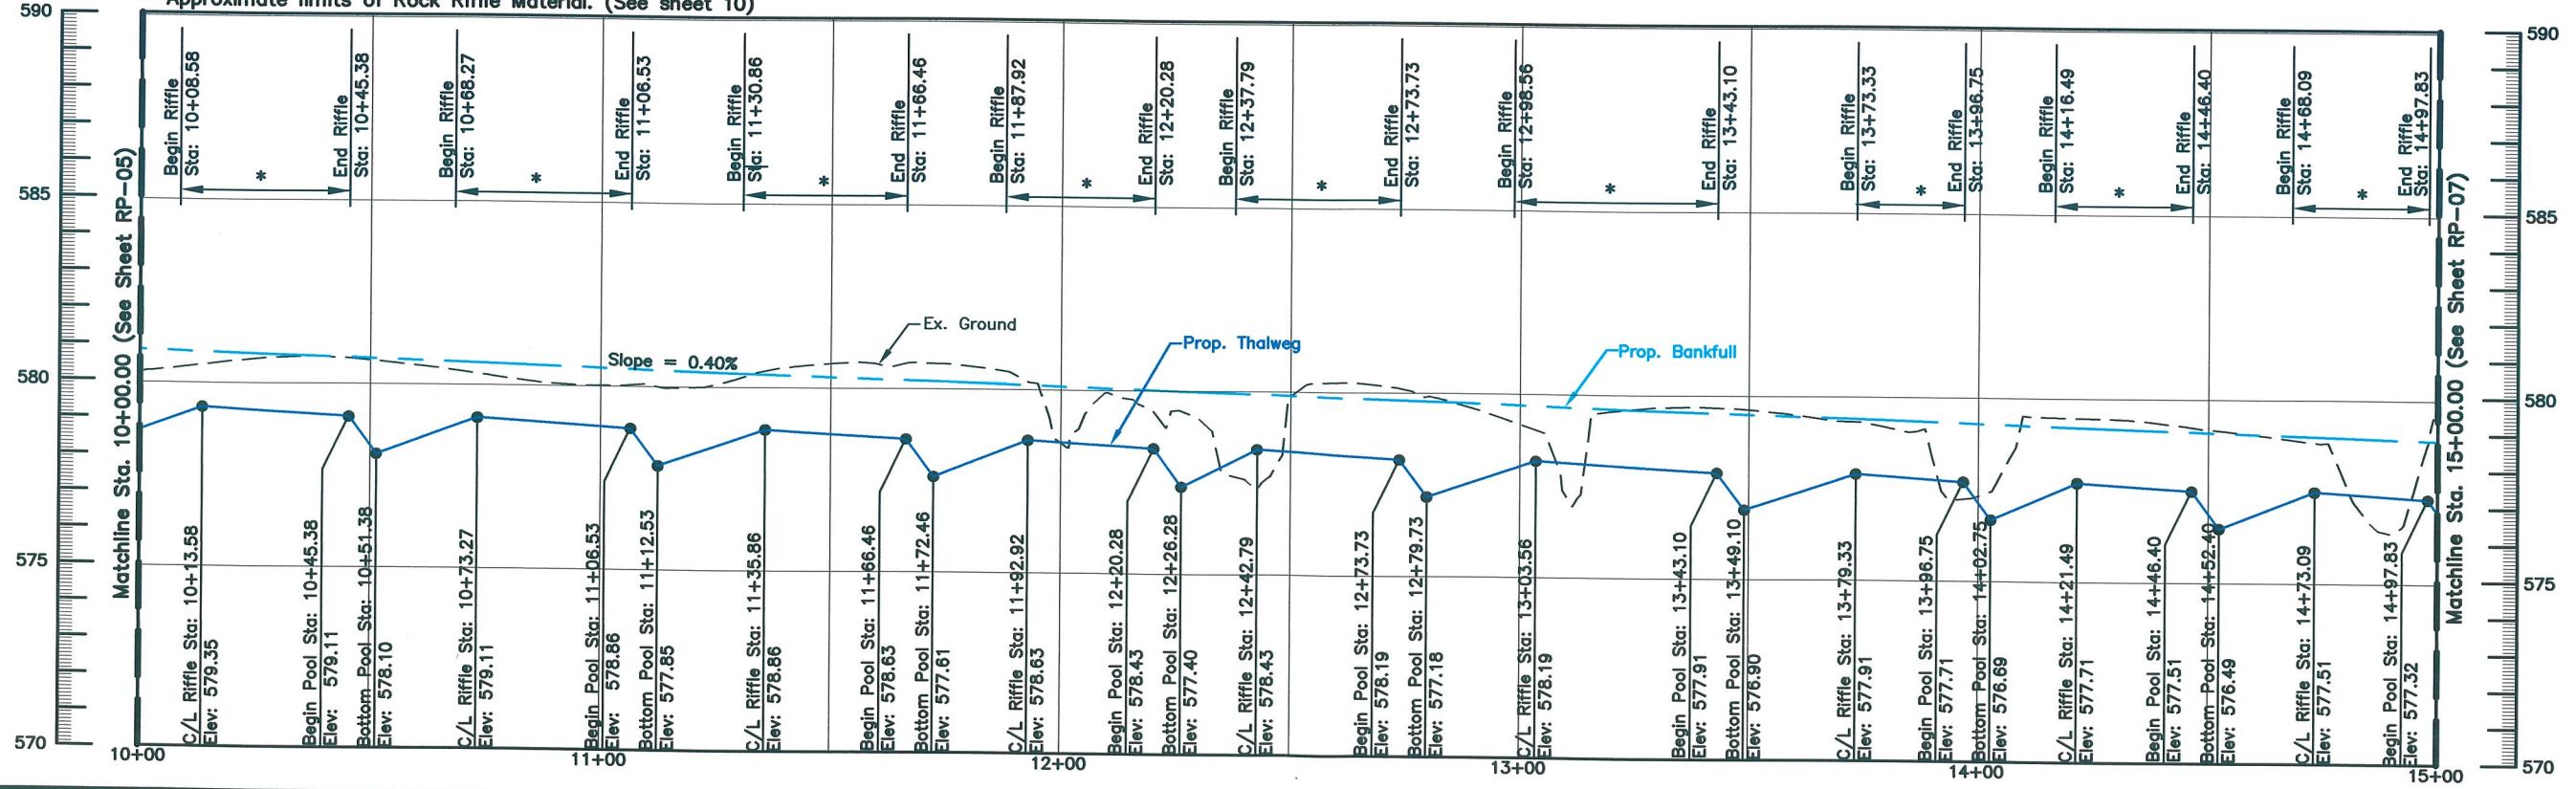
UNION COUNTY, NORTH CAROLINA  
 STREAM RESTORATION PLAN  
 FOR  
**BEAVERDAM CREEK  
 AND UNNAMED TRIBUTARIES**  
 STREAM RESTORATION PROJECT  
 PLAN & PROFILE (PT 1)

**Notes:**  
 See sheets 10-11 for In-Stream Structures.  
 See sheets 12-16 for Erosion Control notes, plan and details.  
 \*\* Channel Reinforcement shall begin 5 feet above the end of the upstream riffle and extend 3 feet below the beginning of the downstream riffle. Refer to riffle stations on profile.  
 See sheet 10 for channel dimensions.

\* Approximate limits of Rock Riffle Material. (See sheet 10)

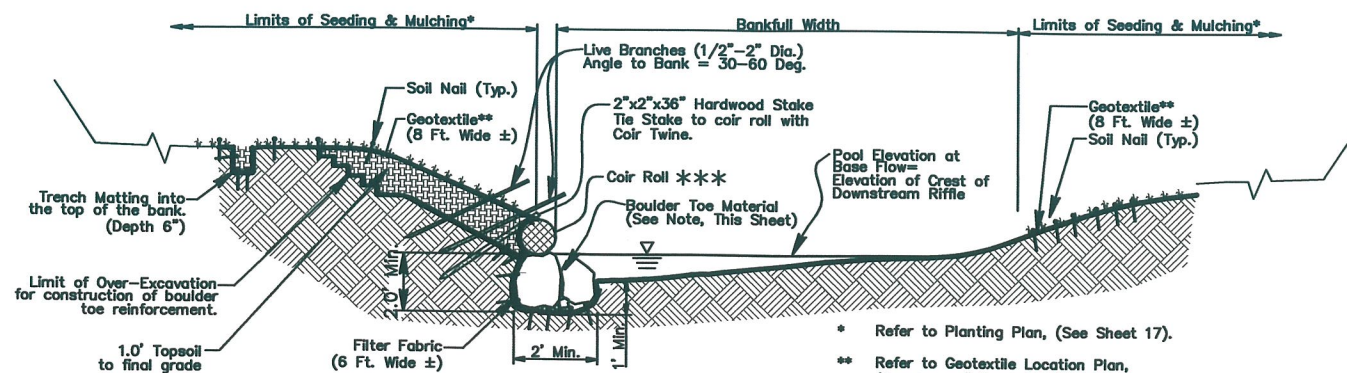
CHANNEL REINFORCEMENT DETAIL - DETAIL 'C'

Rolls shall consist of biodegradable material 12-inches in diameter with a density of 7 lbs./cu.ft. The coir roll outer netting shall consist of a biodegradable twine 0.24 inches in diameter with the breaking strength of 90 lbs. Hardwood stakes to anchor the coir rolls shall be 2"x2"x36" in size. The specified length is a minimum and may need to be adjusted to allow for sufficient anchoring.

- \* Refer to Planting Plan, (See Sheet 17).
- \*\* Refer to Geotextile Location Plan, (See Detail 'A', This Sheet).
- \*\*\* Coir Rolls may be eliminated and replaced with additional Boulder Toe material.

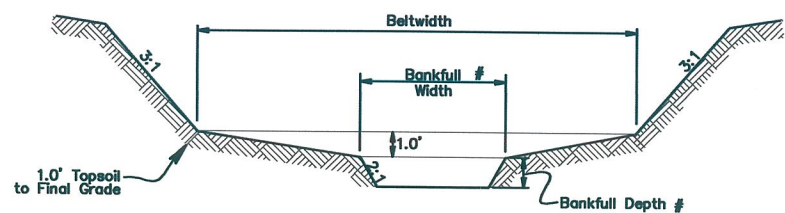
TYPICAL RIFFLE SECTION (See Detail 'B')

CHANNEL DIMENSION TABLE				
	BEAVERDAM CREEK (Upper)	BEAVERDAM CREEK (Lower)	UNNAMED TRIB. 1 (Upper)	UNNAMED TRIB. 1 (Lower)	UNNAMED TRIB. 2
From Station	0+00	4+02	0+00	2+07	0+00
To Station	4+02	4+62	2+07	23+27	2+82
Bankfull max depth - Riffle	1.5	1.8	1.2	1.5	1.0
Bankfull max depth - Pool	2.6	3.1	2.0	2.6	1.7
Bankfull width - Riffle	9.0	11.2	7.2	9.0	6.3
Bankfull width - Pool	10.1	12.5	8.1	10.1	7.1

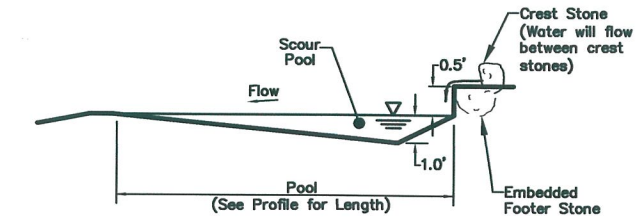
**SECTION C-C**  
Not to Scale

**CROSS VANE DETAIL - BEAVERDAM AND UNNAMED TRIBUTARY**  
Not to Scale

3. Dimension slopes and deflection angles of structures may be adjusted by designer based on field conditions during construction.
4. Footer stone and crest stone shall be native stone or shot rock, cubical or rectangular in shape with a minimum diameter of 2.0 feet.

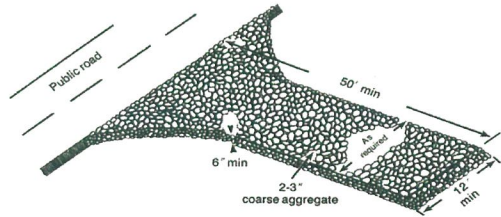
**TEMPORARY GRAVEL CONSTRUCTION ENTRANCE/EXIT**

- Construction Specifications**
1. Clear the entrance and exit area of all vegetation, roots, and other objectionable material and properly grade it.
  2. Place the gravel to the specific grade and dimensions shown on the plans, and smooth it.
  3. Provide drainage to carry water to a sediment trap or other suitable outlet.
  4. Use geotextile fabrics because they improve stability of the foundation in locations subject to seepage or high water table.
- Maintenance**
- Maintain the gravel pad in a condition to prevent mud or sediment from leaving the construction site. This may require periodic topdressing with 2-inch stone. After each rainfall, inspect any structure used to trap sediment and clean it out as necessary. Immediately remove all objectionable materials spilled, washed, or tracked onto public roadways.

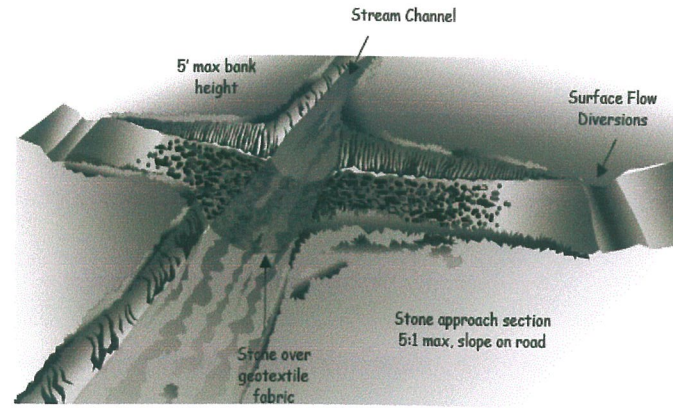
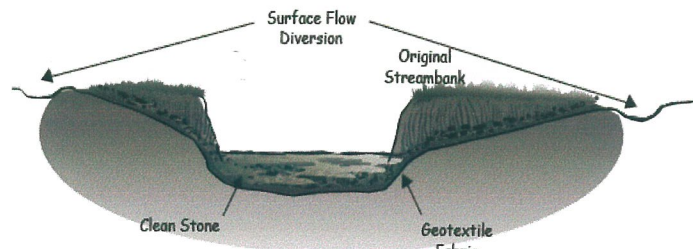
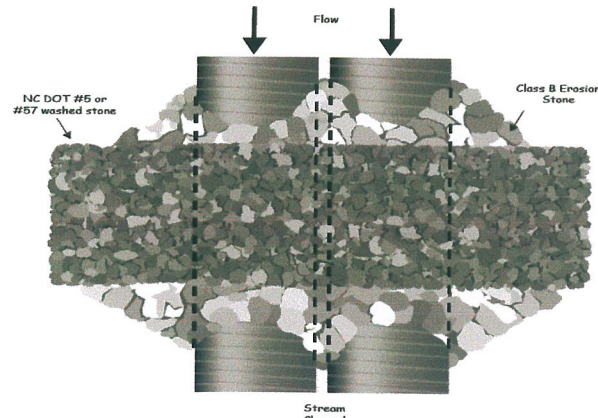
**TEMPORARY STREAM CROSSING**

- Construction Specifications**
1. Keep clearing and excavation of the stream banks and bed and approach sections to a minimum.
  2. Divert all surface water from the construction site onto undisturbed areas adjoining the stream.

3. Keep stream crossings at right angles to the stream flow.
  4. Align road approaches with the center line of the crossing for a minimum distance of 30 feet. Raise bridge abutments and culvert fills a minimum of 1 foot above the adjoining approach sections to prevent erosion from surface runoff and to allow flood flows to pass around the structure.

8. Any in-stream sediment control measures must be removed upon stabilization of the area.
- Maintenance**
- Inspect temporary stream crossings after runoff-producing rains to check for blockage in channel, erosion of abutments, channel scour, riprap displacement, or piping. Make all repairs immediately to prevent further damage to the installation.

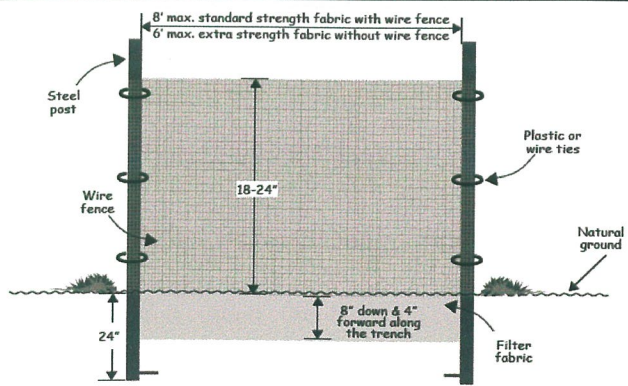
**SEDIMENT FENCE**

**MATERIALS**  
 1. Use a synthetic filter fabric of at least 95% by weight of polyethylene or polyester, which is certified by the manufacturer or supplier as conforming to the requirements in ASTM D 6461, which is shown in part in Table 6.62b.  
 Synthetic filter fabric should contain ultraviolet ray inhibitors and stabilizers to provide a minimum of 6 months of expected usable construction life at a temperature range of 0 to 120° F.  
 2. Ensure that posts for sediment fences are 1.33 lb/linear ft steel with a minimum length of 5 feet. Make sure that steel posts have projections to facilitate fastening the fabric.  
 3. For reinforcement of standard strength filter fabric, use wire fence with a minimum 14 gauge and a maximum mesh spacing of 6 inches.

1. Construct the sediment barrier of standard strength or extra strength synthetic filter fabrics.
2. Ensure that the height of the sediment fence does not exceed 24 inches above the ground surface. (Higher fences may impound volumes of water sufficient to cause failure of the structure.)

Inspect sediment fences at least once a week and after each rainfall. Make any required repairs immediately. Should the fabric of a sediment fence collapse, tear, decompose or become ineffective, replace it promptly. Remove sediment deposits as necessary to provide adequate storage volume for the next rain and to reduce pressure on the fence. Take care to avoid undermining the fence during cleanout. Remove all fencing materials and unstable sediment deposits and bring the area to grade and stabilize it after the contributing drainage area has been properly stabilized.

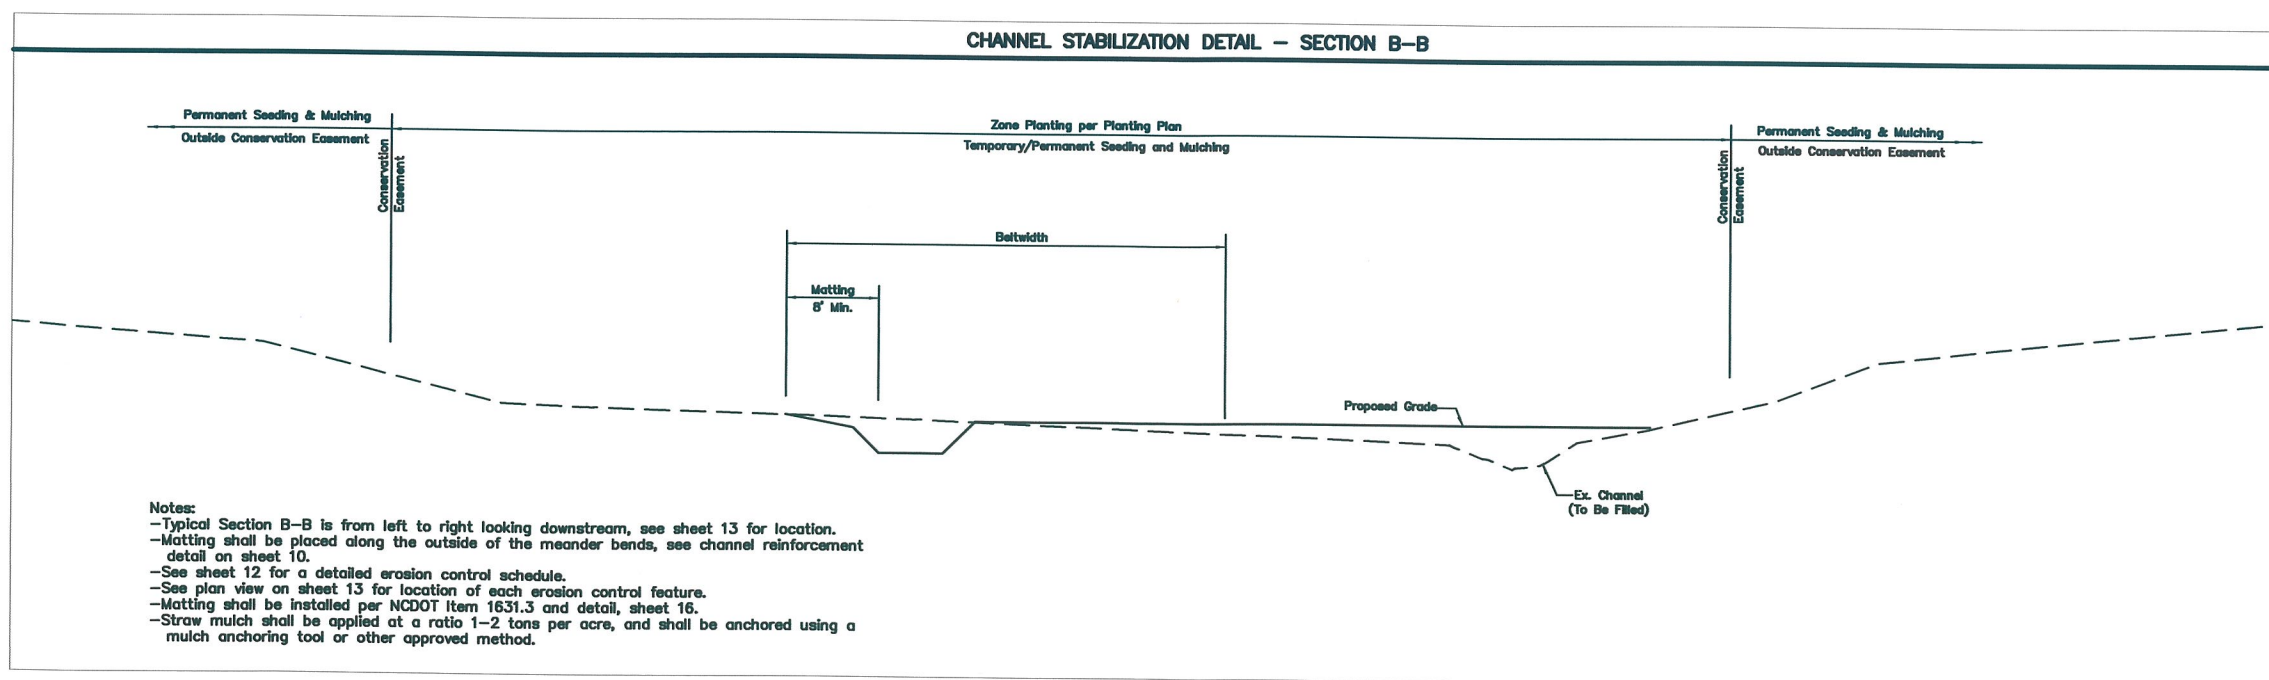
- Notes:**
- Typical Section B-B is from left to right looking downstream, see sheet 13 for location.
  - Matting shall be placed along the outside of the meander bends, see channel reinforcement detail on sheet 10.
  - See sheet 12 for a detailed erosion control schedule.
  - See plan view on sheet 13 for location of each erosion control feature.
  - Matting shall be installed per NCDOT Item 1631.3 and detail, sheet 16.
  - Straw mulch shall be applied at a ratio 1-2 tons per acre, and shall be anchored using a mulch anchoring tool or other approved method.
