# Beaverdam Creek and Unnamed Tributaries Restoration Plan

Union County, North Carolina  
SCO # D06054-C

**Submitted:** January 16, 2008

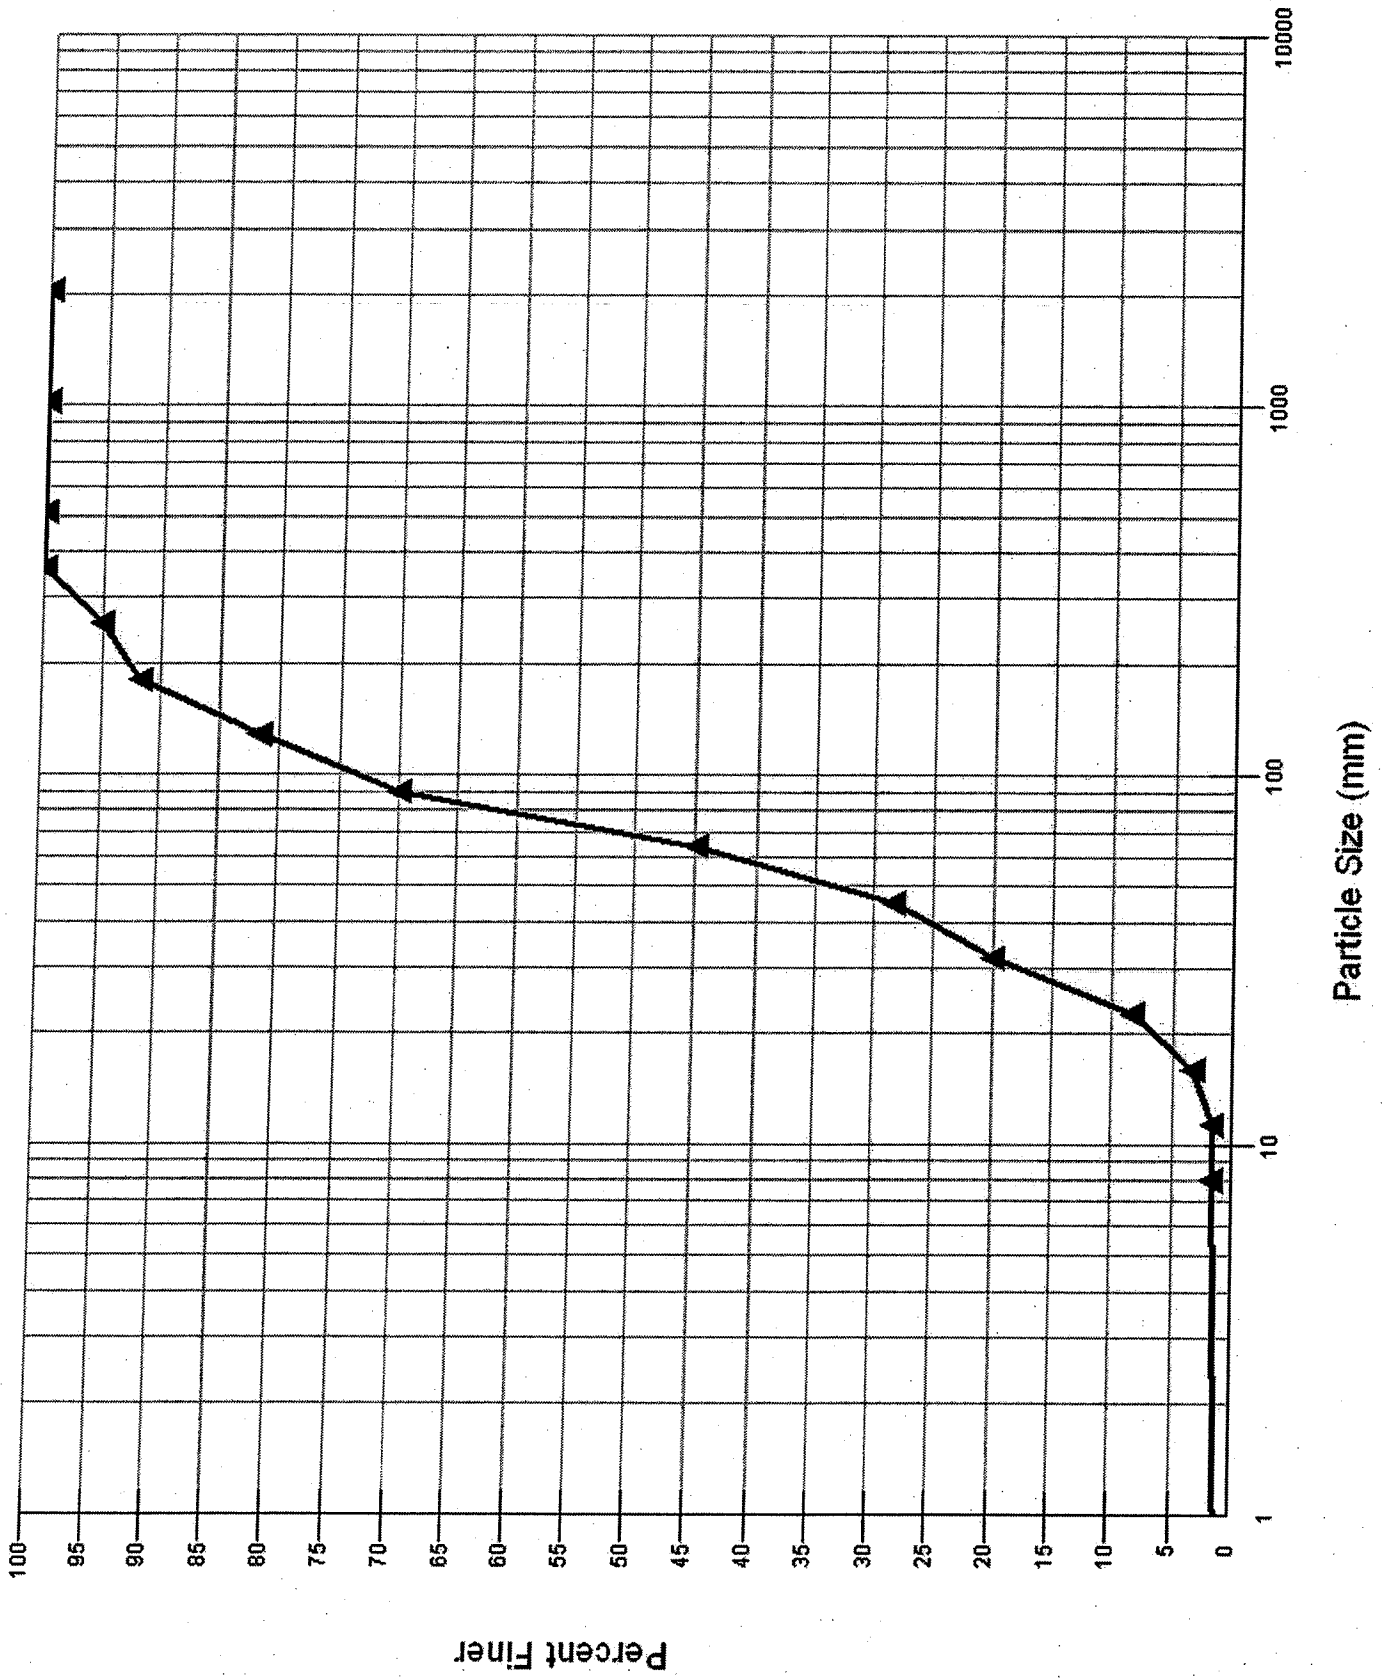
# Davis Branch Reference Reach - Riffle Bed Sample

RIVERMORPH PARTICLE SUMMARY

River Name: Beaverdam Creek  
 Reach Name: Davis Branch Reference Reach  
 Sample Name: Riffle Bed Sample  
 Survey Date: 08/08/06

Total Particles = 60.

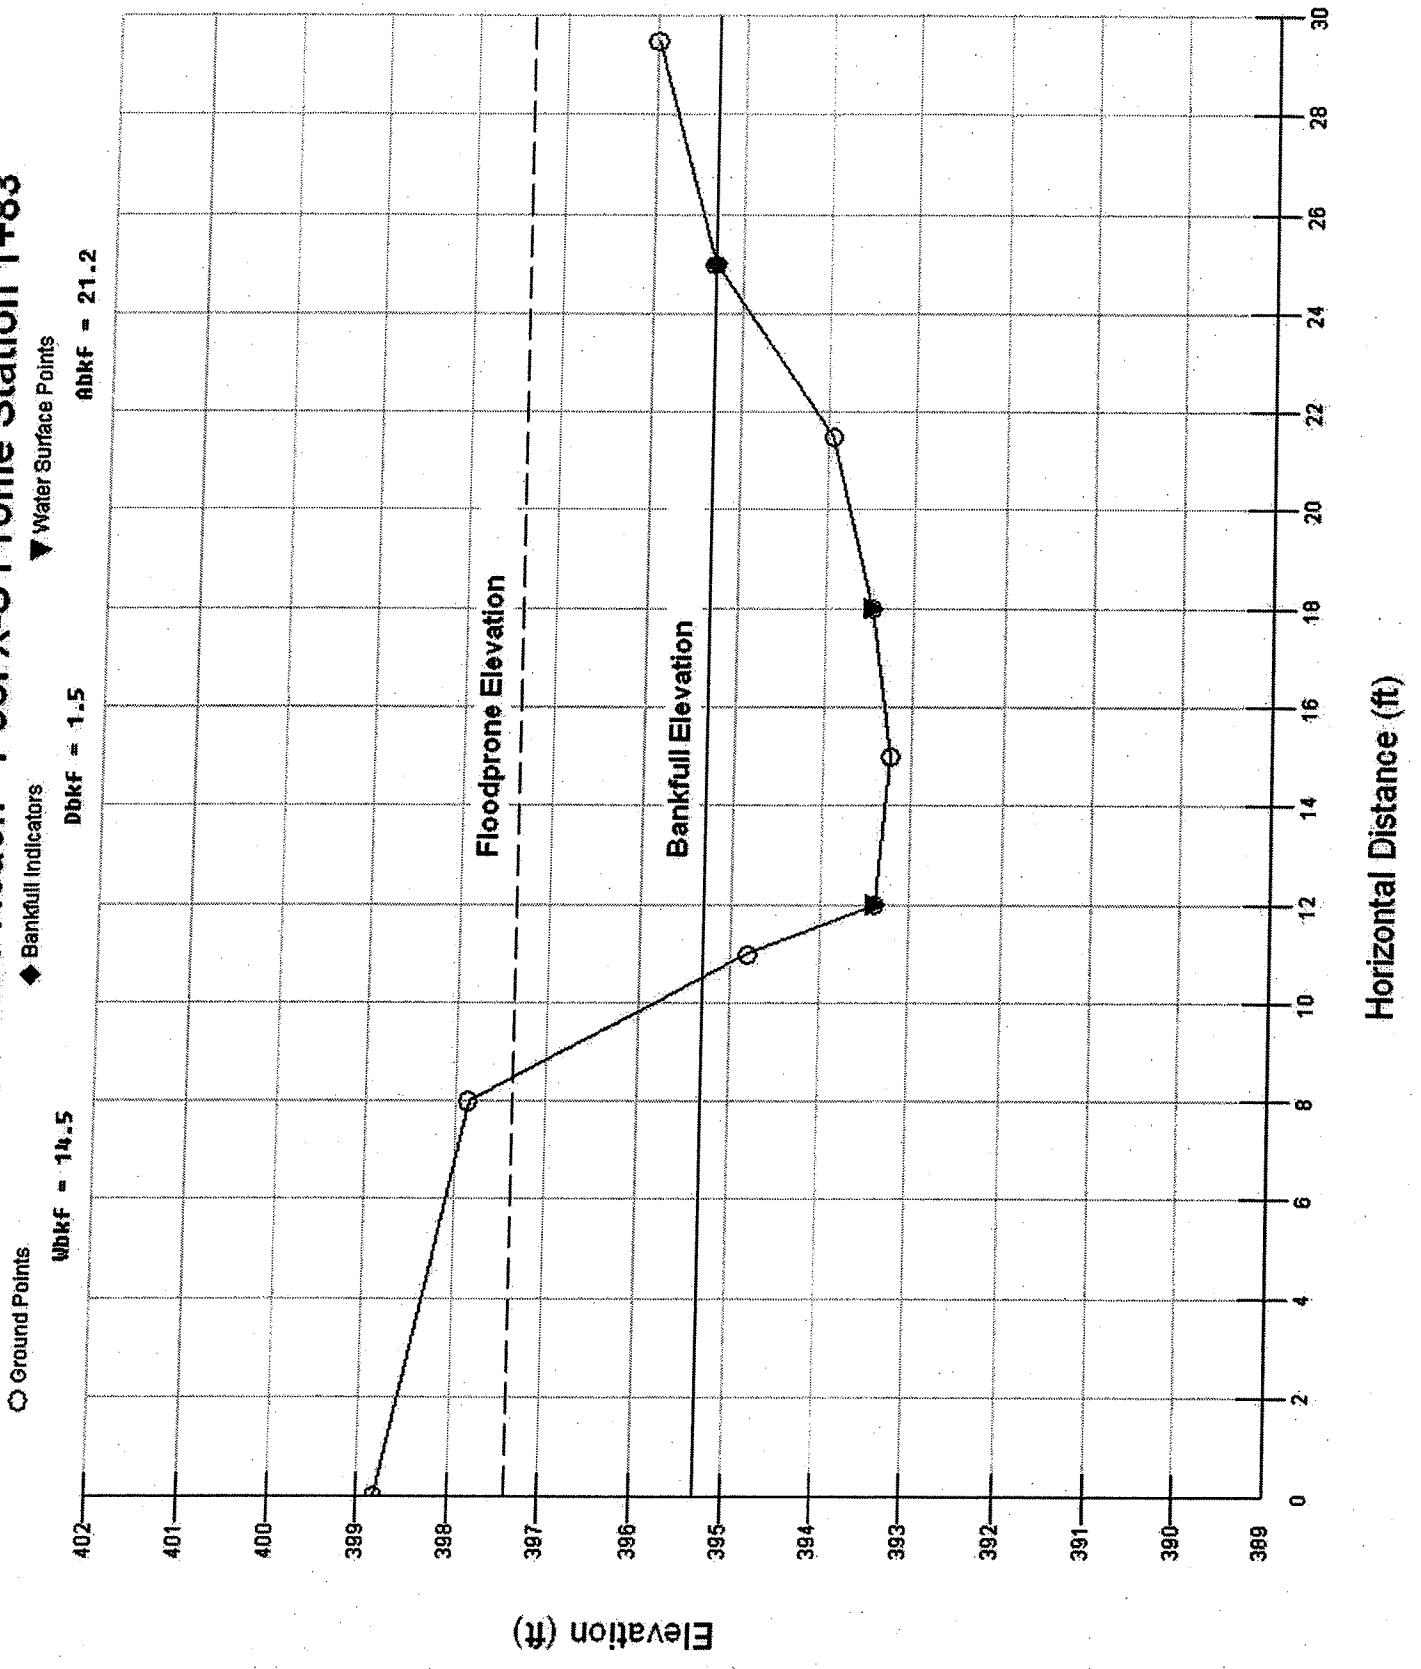
# Davis Branch Reference Reach - Pool X-S Profile Station 1+83

RIVERMORPH CROSS SECTION SUMMARY

River Name: Beaverdam Creek  
 Reach Name: Davis Branch Reference Reach  
 Cross Section Name: Davis Branch Pool X-S Profile Station 1+83  
 Survey Date: 08/08/06

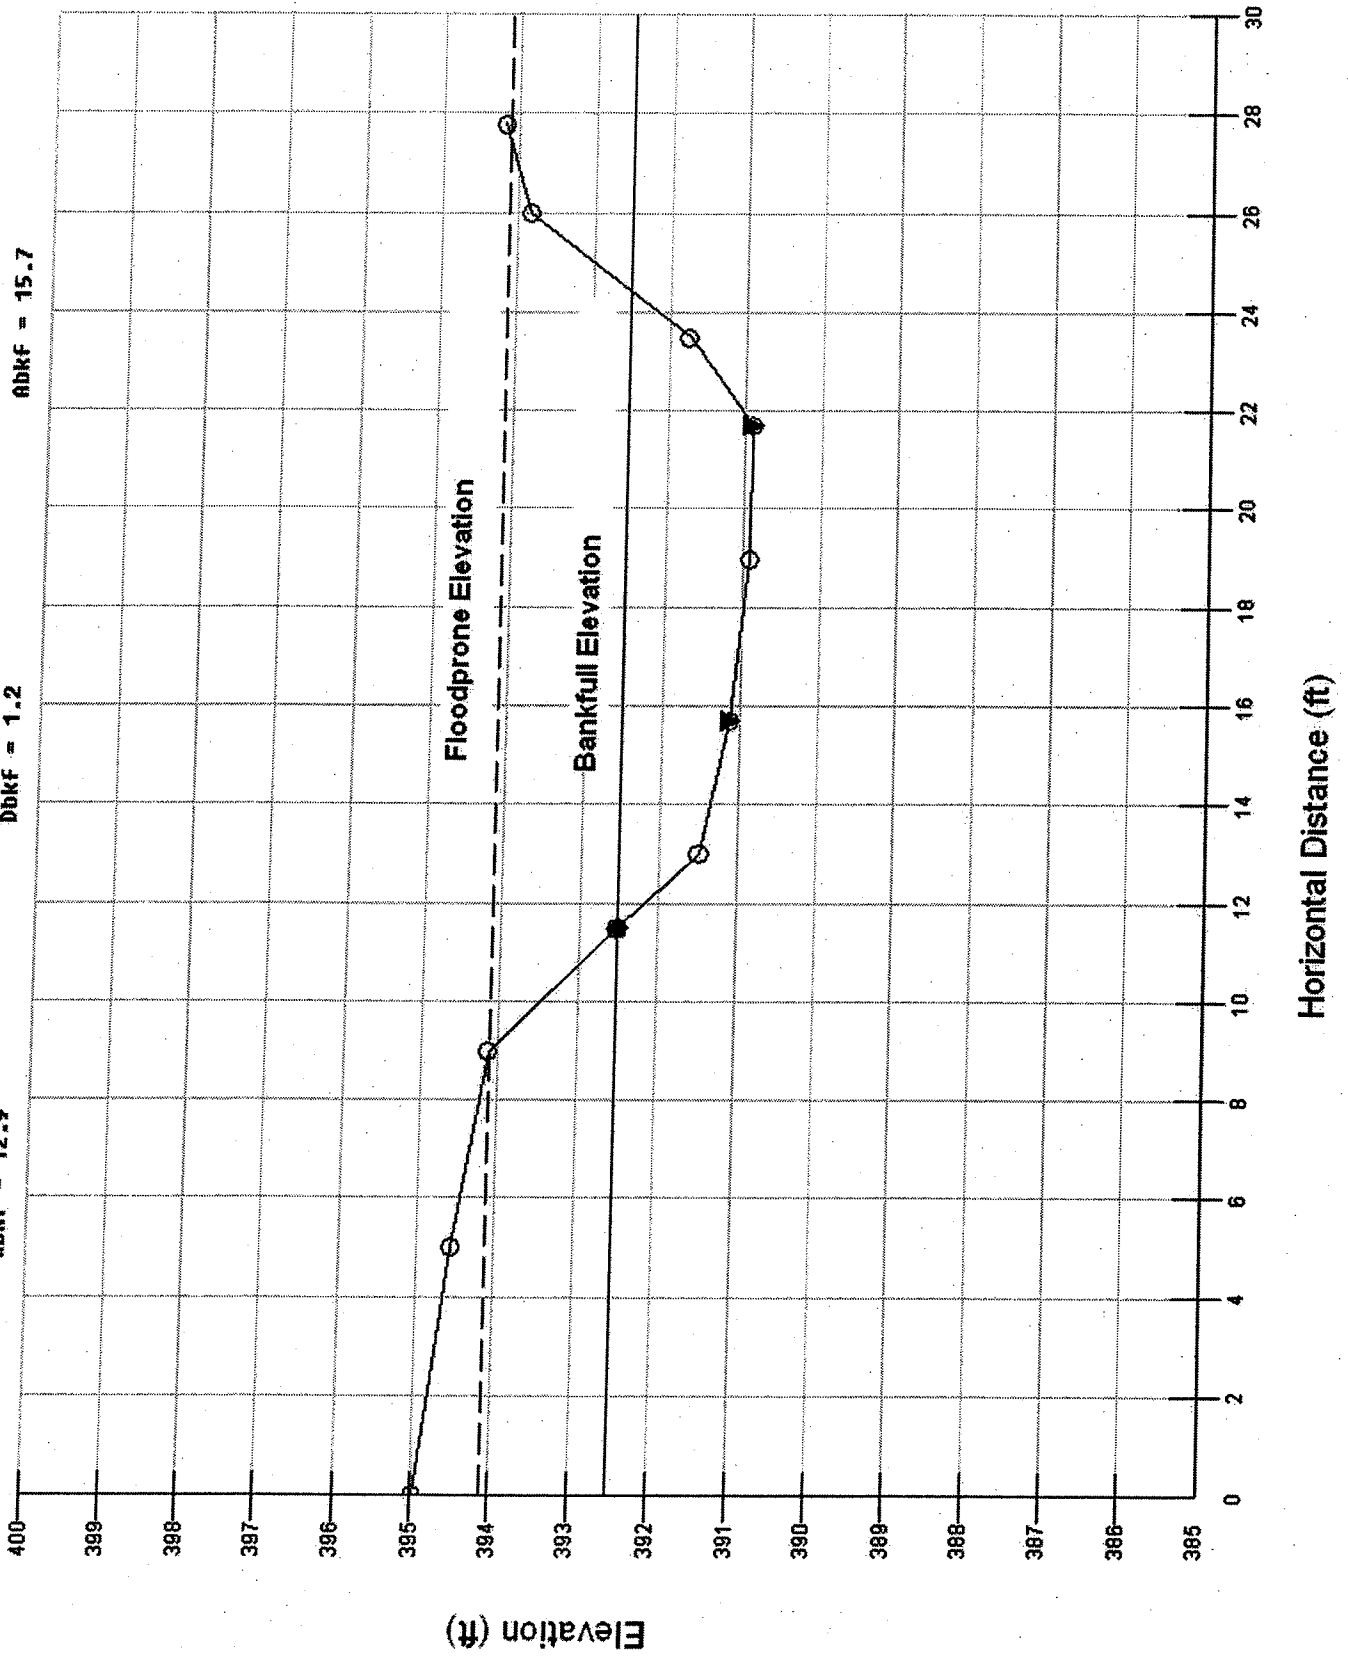
# Davis Branch Reference Reach - Riffle X-S Profile Station 2+57

○ Ground Points      WDKF = 12.9      ◆ Bankfull Indicators      DBKF = 1.2      ▼ Water Surface Points      ABKF = 15.7

RIVERMORPH CROSS SECTION SUMMARY

-----  
 River Name: Beaverdam Creek  
 Reach Name: Davis Branch Reference Reach  
 Cross Section Name: Davis Branch Riffle X-S Profile Station 2+57  
 Survey Date: 08/08/06  
 -----

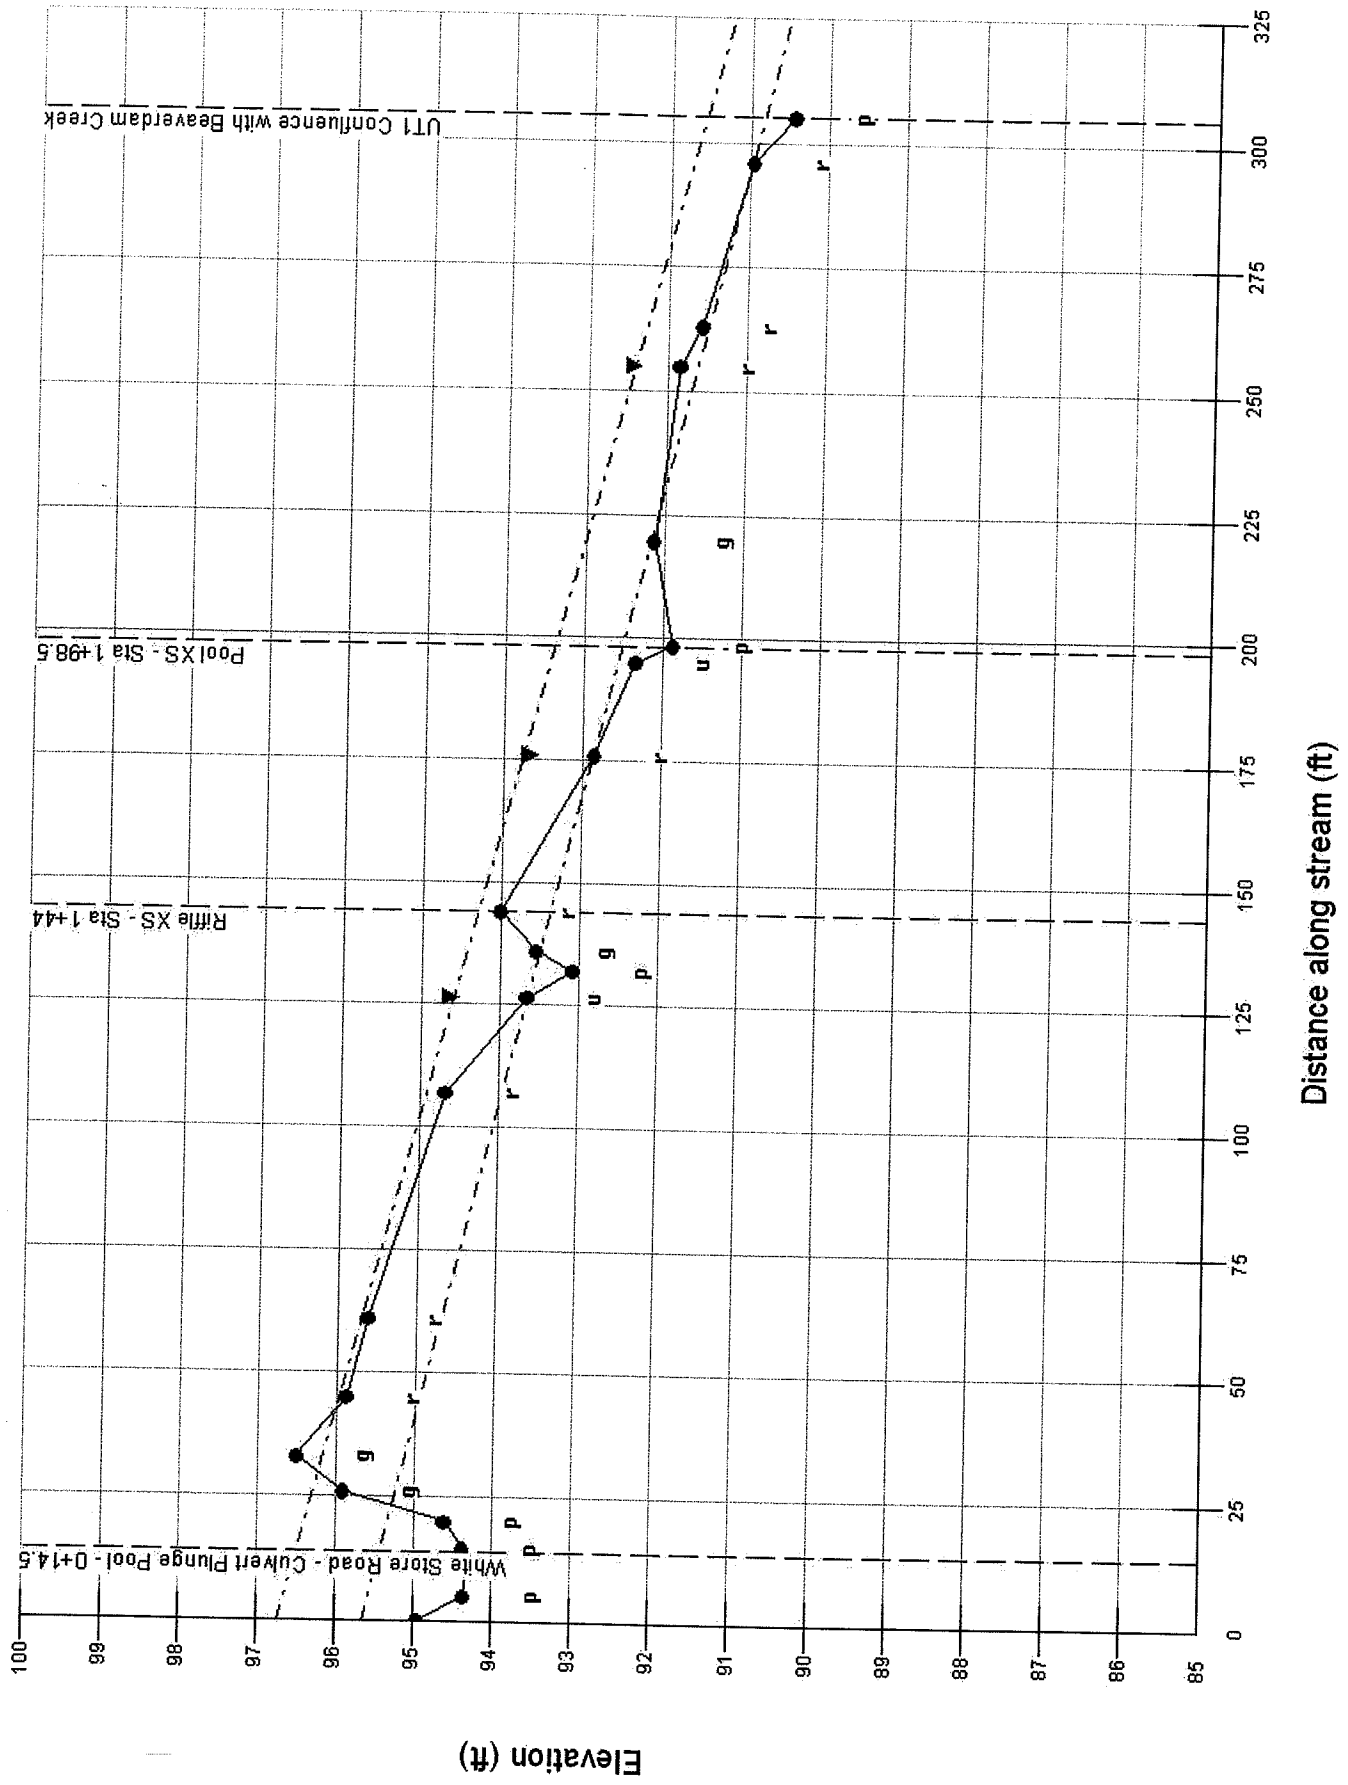
# Beaverdam Creek (Upper) Impaired Mainstem Longitudinal Profile 07/17/07

Distance along stream (ft)

Elevation (ft)

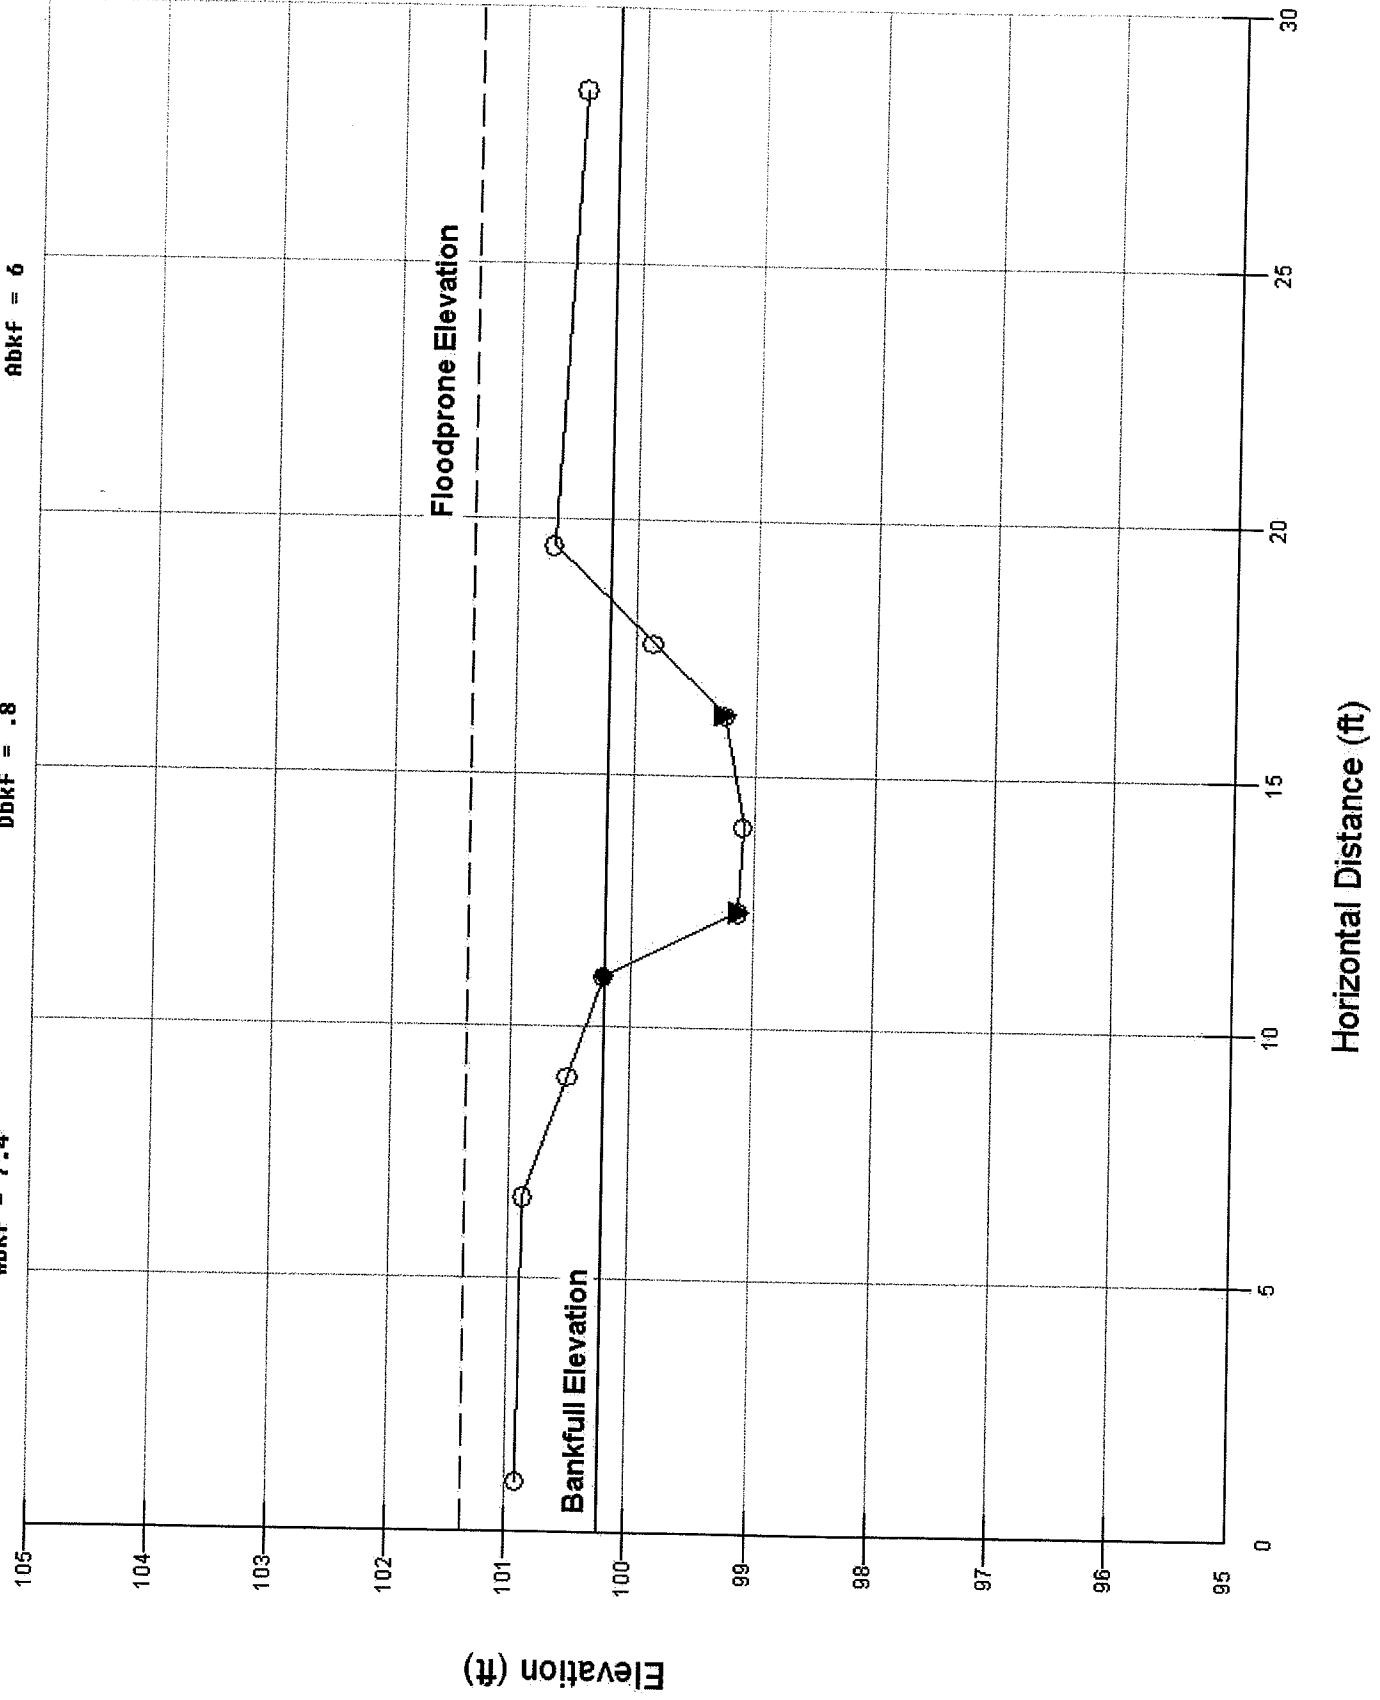
RIVERMORPH CROSS SECTION SUMMARY

River Name: Beaverdam Creek  
 Reach Name: Beaverdam Ck Impaired Mainstem  
 Cross Section Name: Pool XS - Sta 1+98.5  
 Survey Date: 07/17/07

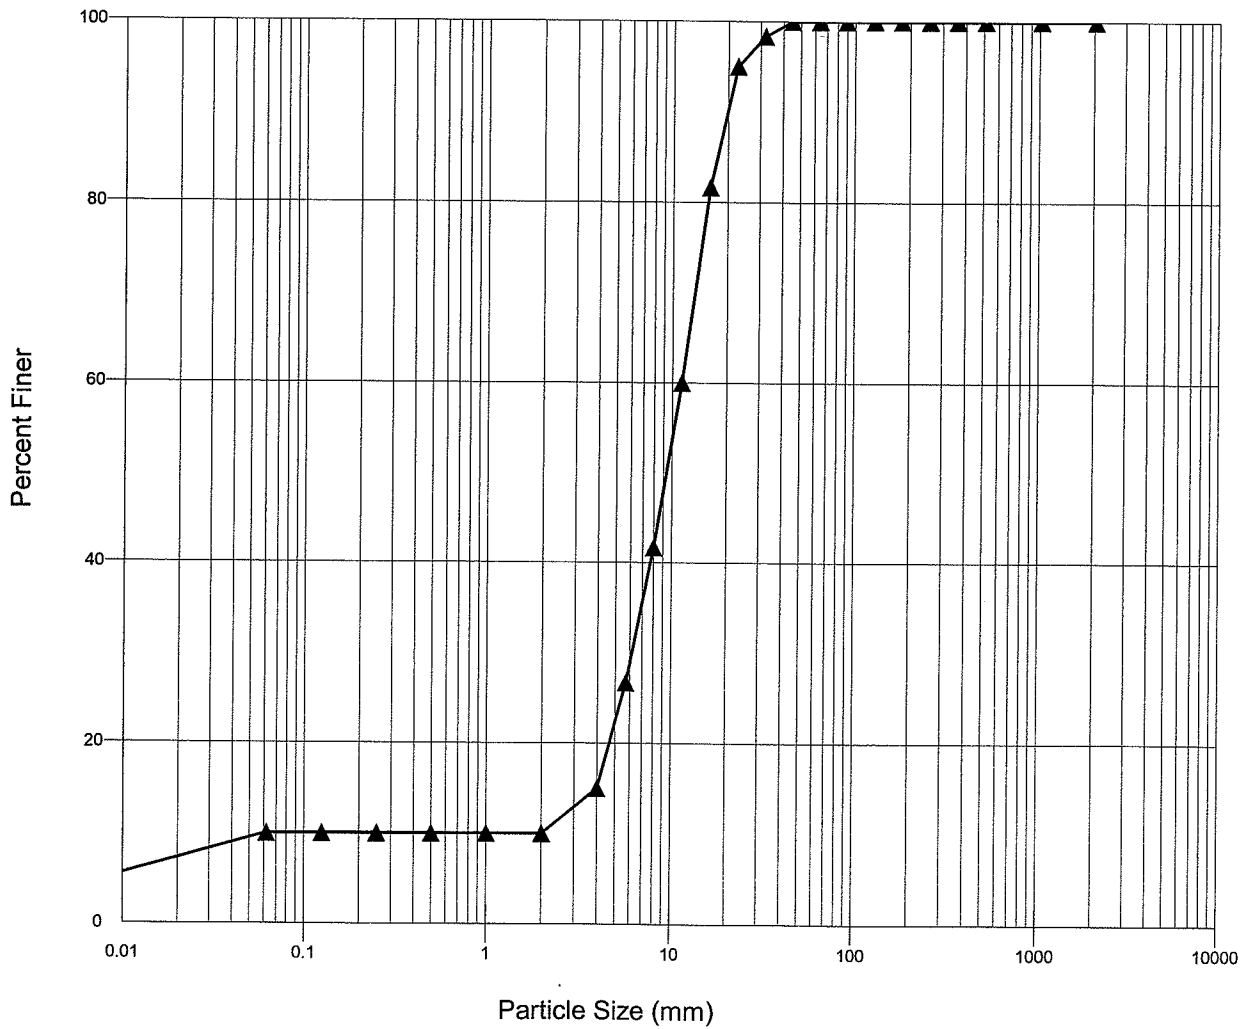
RIVERMORPH PARTICLE SUMMARY

River Name: Beaverdam Creek  
 Reach Name: Beaverdam Ck Impaired Mainstem  
 Sample Name: Pool XS - Sta 1+98.5  
 Survey Date: 07/17/07

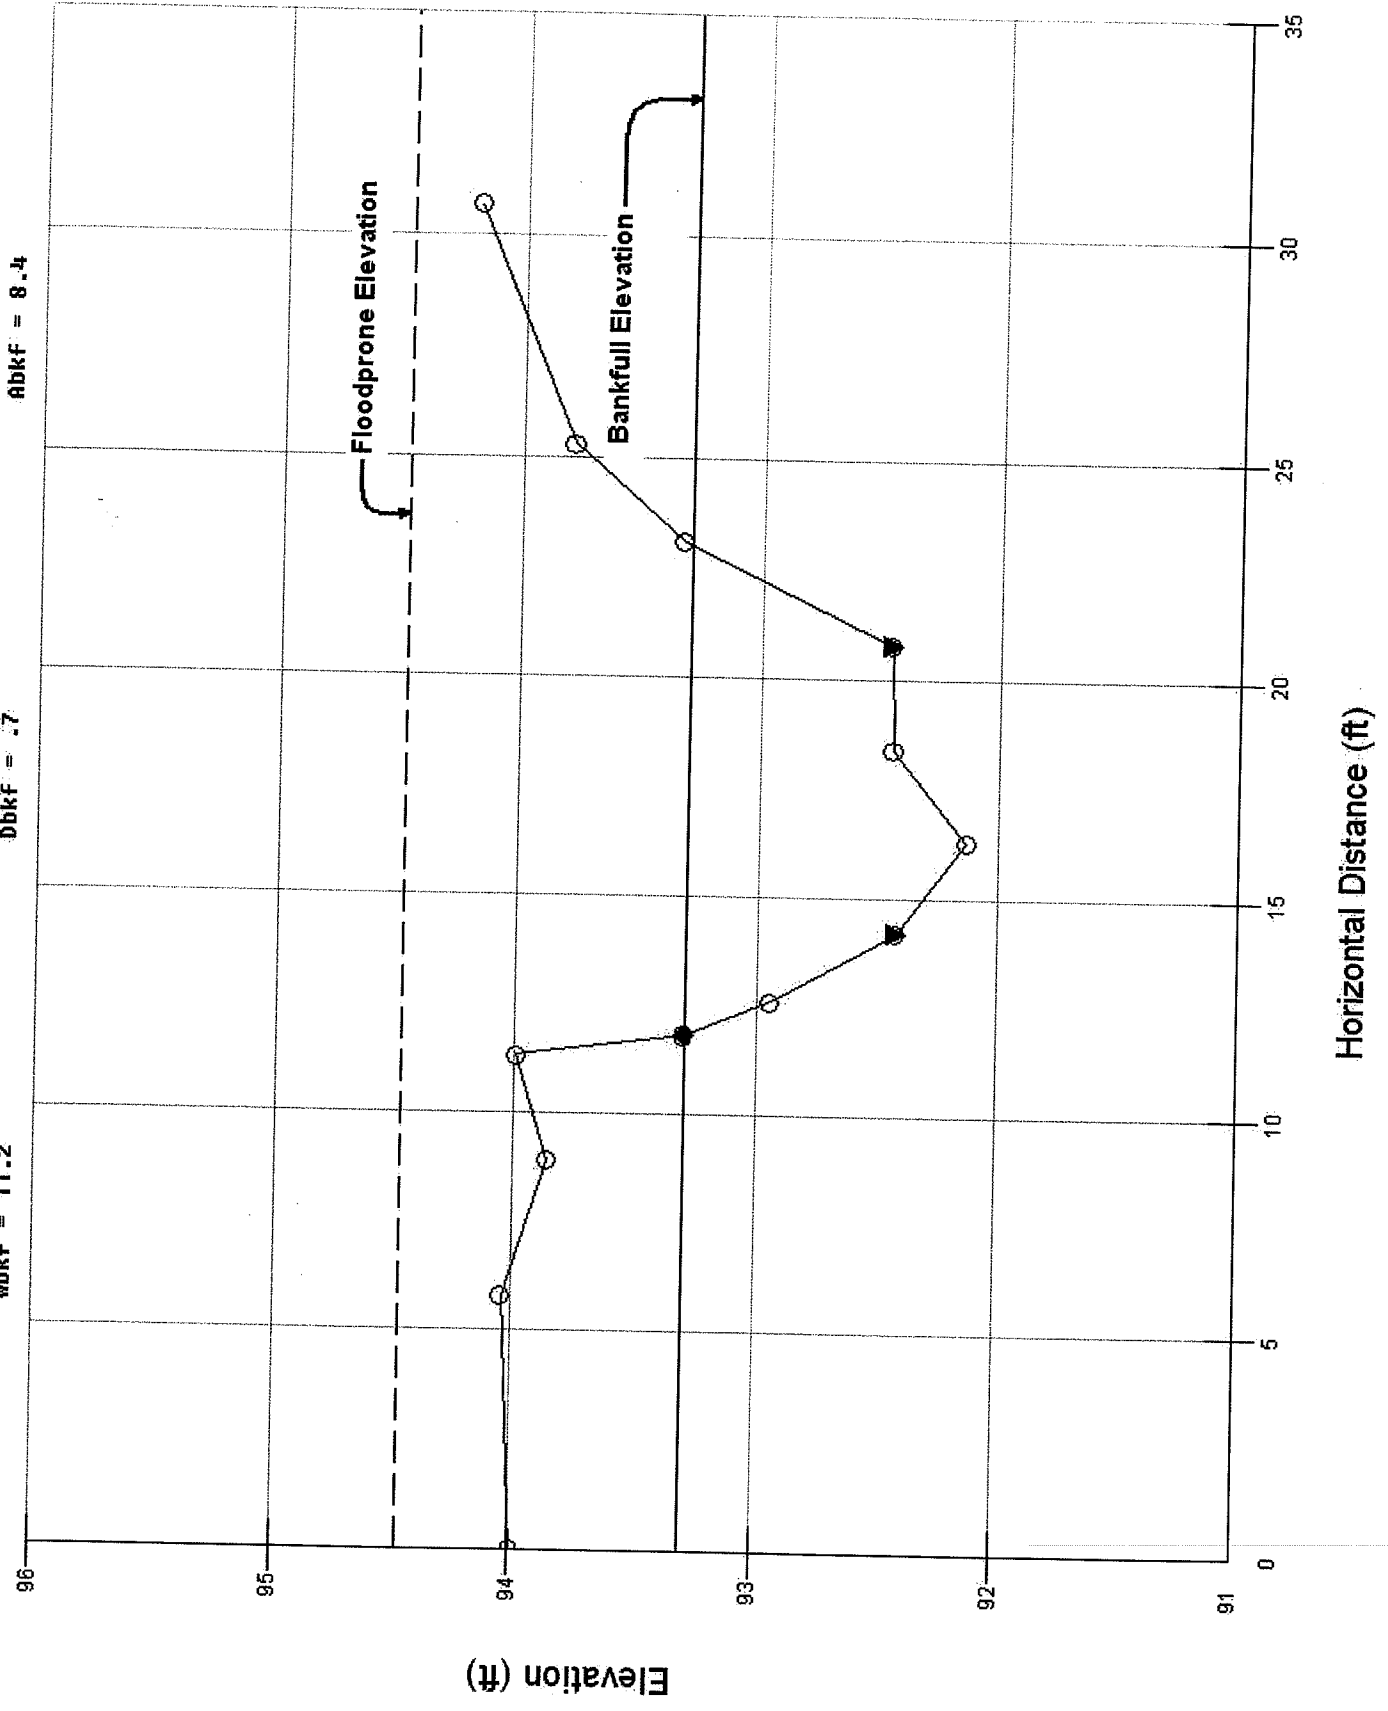
# UT1 - Impaired Conditions - Riffle XS - Sta 0+73.2

○ Ground Points      Wbkf = 11.2      Dbkf = .7      Abkf = 8.4  
◆ Bankfull Indicators      ▼ Water Surface Points

RIVERMORPH CROSS SECTION SUMMARY

River Name: Beaverdam Creek  
 Reach Name: UT1 (Lower) Impaired  
 Cross Section Name: Riffle XS - Sta 0+73.2  
 Survey Date: 07/17/07

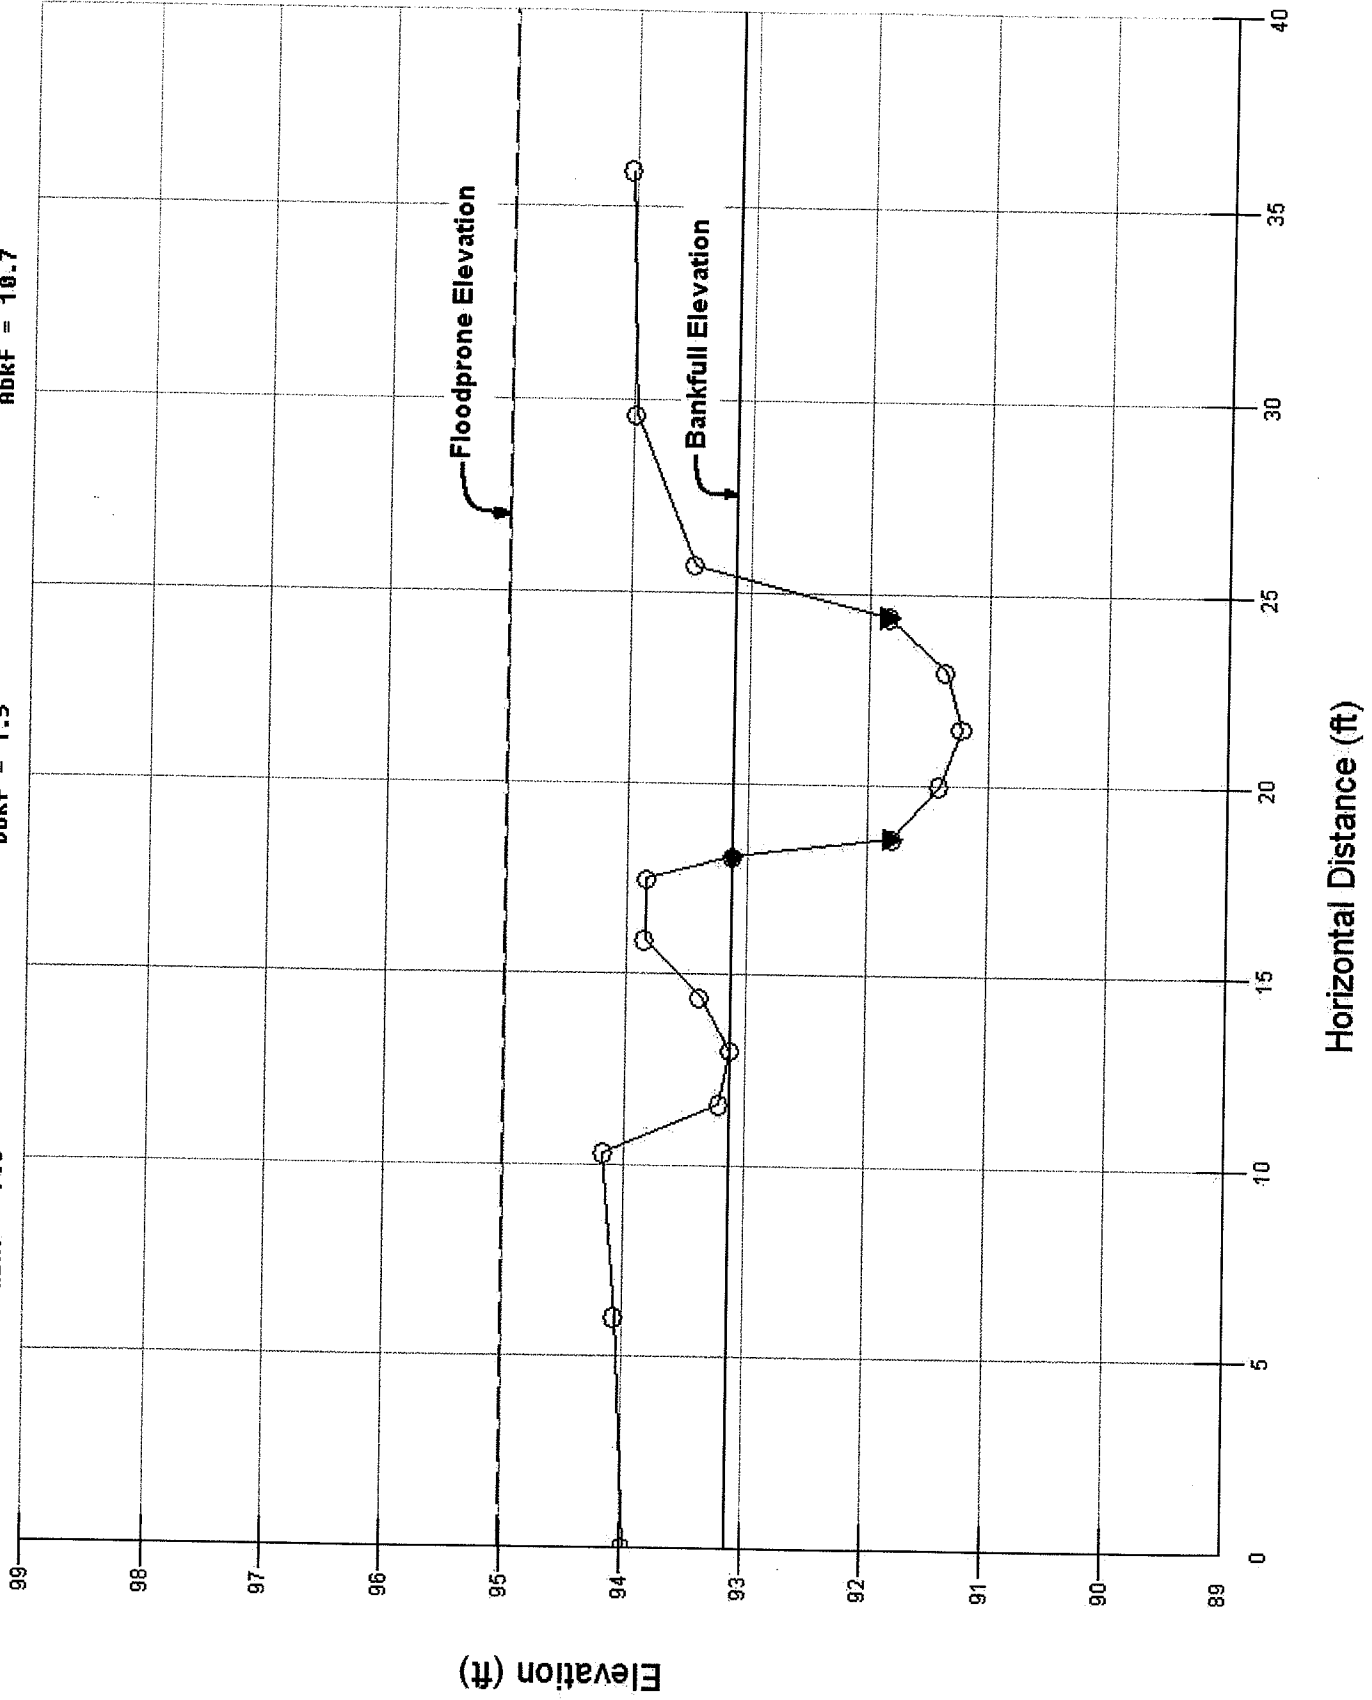
# UT1 - Impaired Condition Pool XS - Sta. 0+88.5

Dbkf = 1.5

Abkf = 18.7

RIVERMORPH CROSS SECTION SUMMARY

River Name: Beaverdam Creek  
 Reach Name: UT1 (Lower) Impaired  
 Cross Section Name: Pool XS - Sta 0+88.5  
 Survey Date: 07/17/07

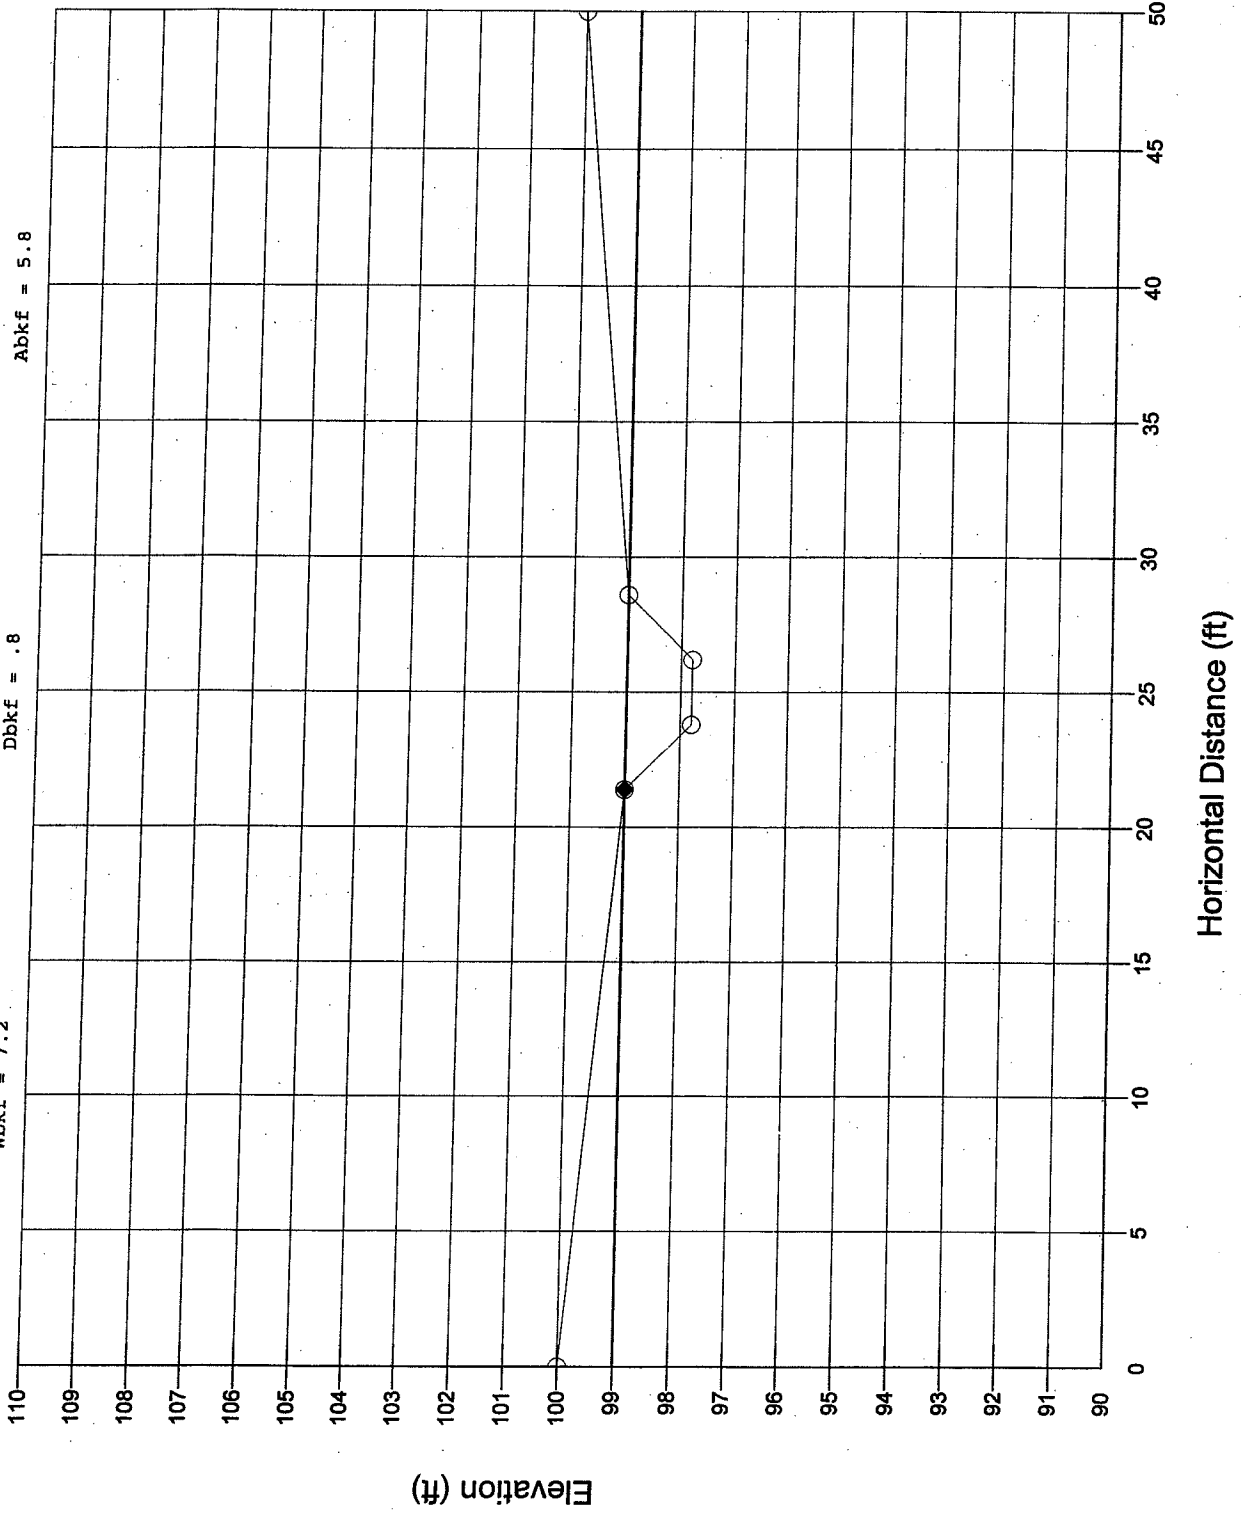
RIVERMORPH CROSS SECTION SUMMARY

River Name: Beaverdam Creek  
 Reach Name: UT1 (Lower) Impaired  
 Cross Section Name: UT1 (Upper) Design Riffle XS  
 Survey Date: 09/24/07

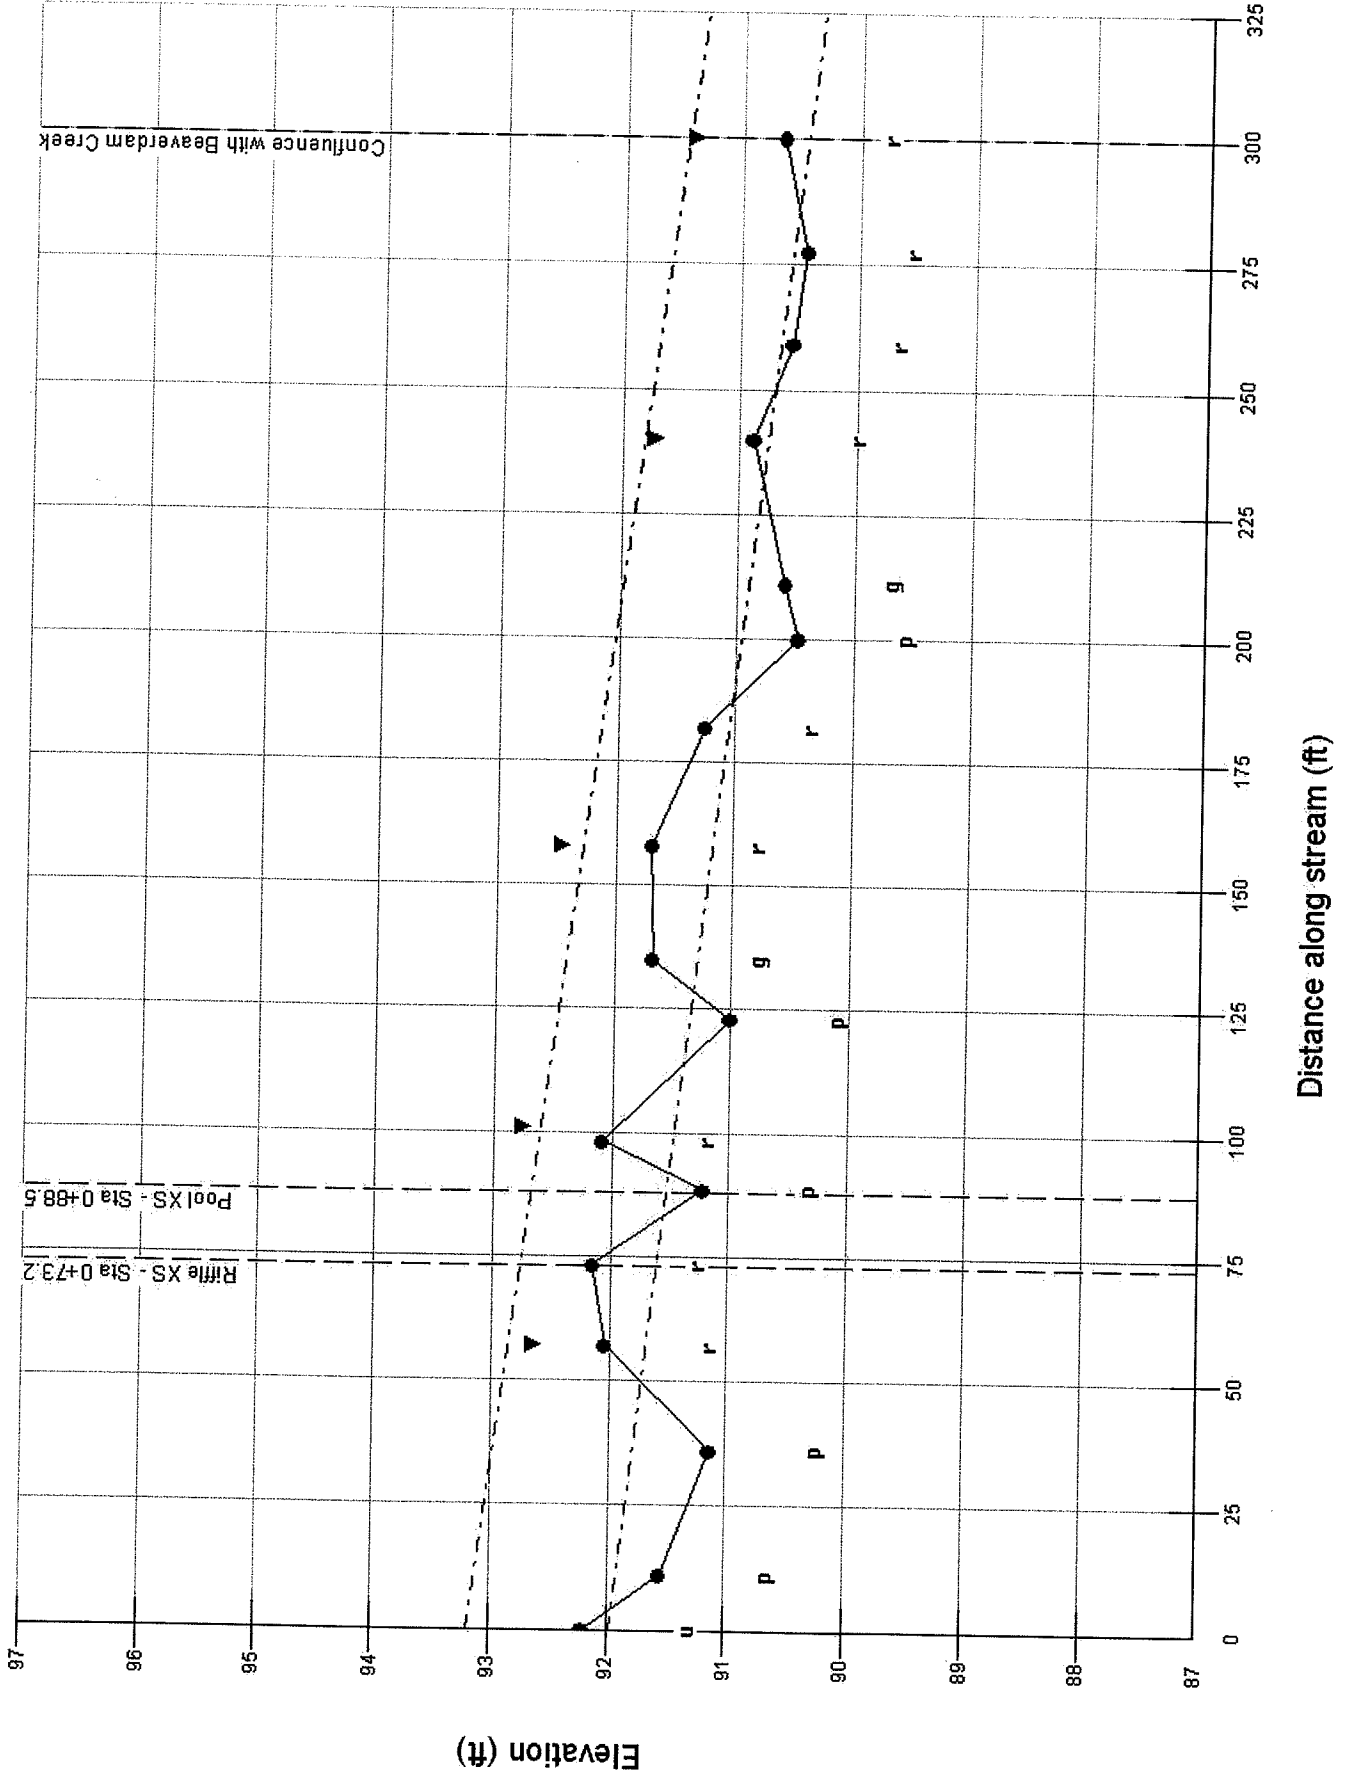
# Beaverdam Creek - UT1 (Lower) Impaired Reach - 07/17/07

RIVERMORPH PROFILE SUMMARY

River Name: Beaverdam Creek  
 Reach Name: UT1 (Lower) Impaired  
 Profile Name: UT1 Impaired Reach  
 Survey Date: 07/24/07

DIST	Note
0	U
11	P
36	P
57	R
73.2	Riffle @ XS
88.5	Pool @ XS
98.2	R
101	BKF
123	P
135	G
158	R
182	R
200	P
211	G
240	R
259	R
277.5	R
300	Riffle @ Conf w BDC
