# Beaverdam Creek and Unnamed Tributaries Restoration Plan

Union County, North Carolina  
SCO # D06054-C

**Submitted:** January 16, 2008

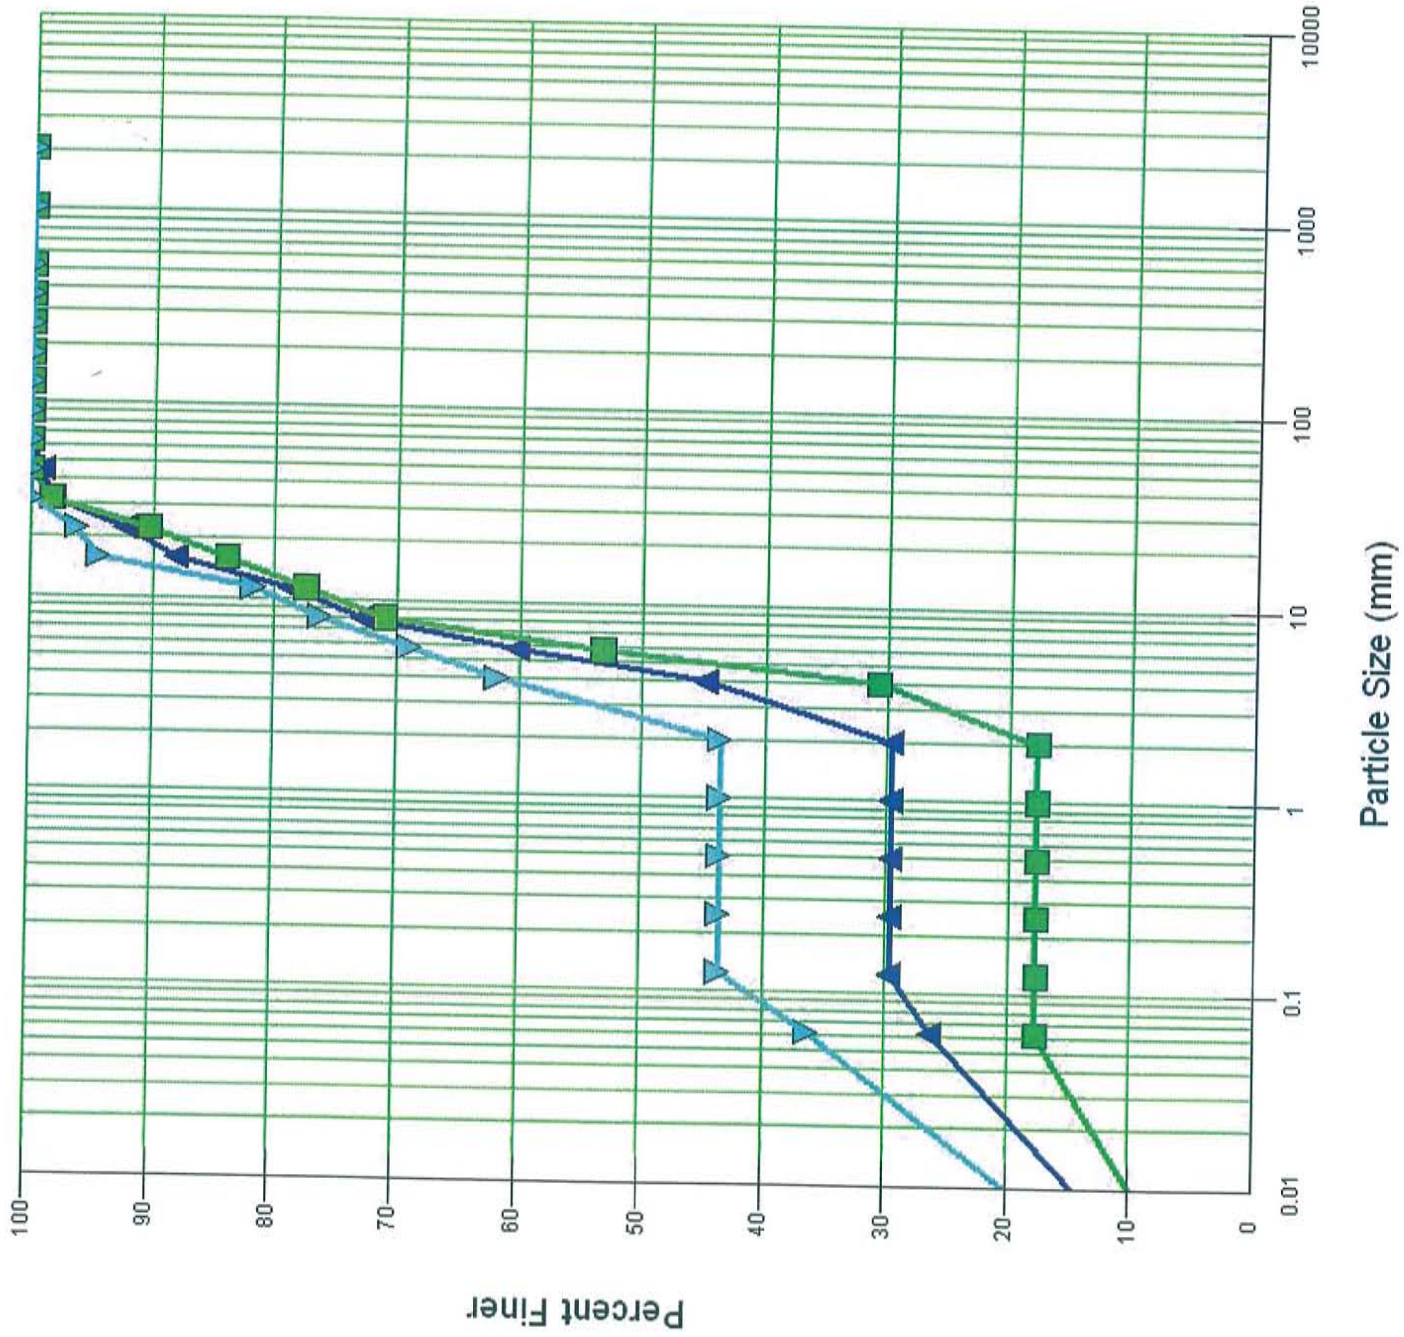
# Reach Particle Distribution - UT1 (Lower) Altered Conditions 7/17/07

RIVERMORPH PARTICLE SUMMARY

River Name: Beaverdam Creek  
 Reach Name: UT1 (Lower) Impaired  
 Sample Name: Riffle XS 0+73.2  
 Survey Date: 07/17/07

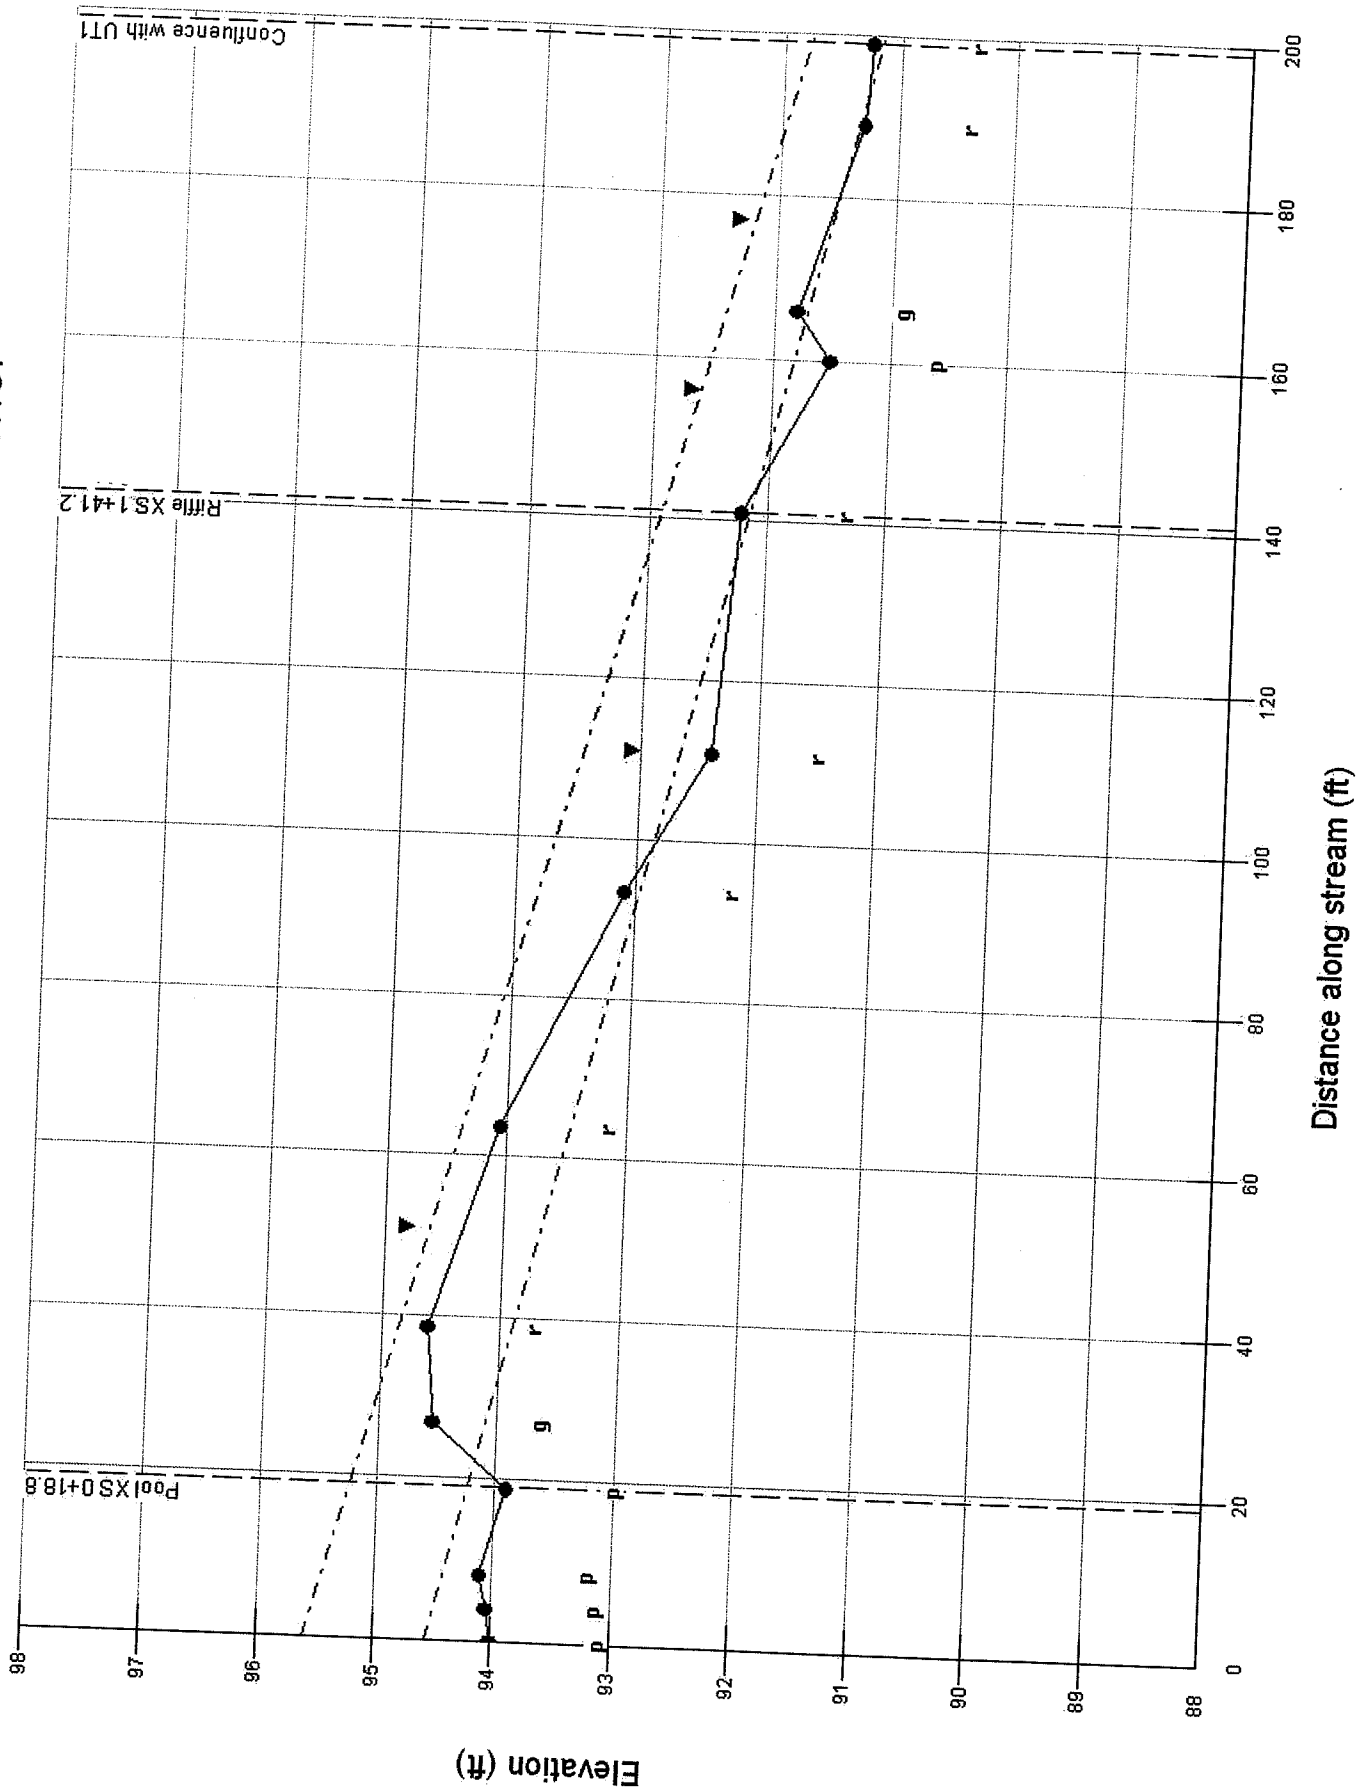
# UT2 Impaired Conditions Longitudinal Profile - 7/17/07

RIVERMORPH PROFILE SUMMARY

River Name: Beaverdam Creek  
 Reach Name: UT2 Impaired  
 Profile Name: UT2 Impaired Conditions Profile  
 Survey Date: 09/20/07

DIST	Note
0	P
4	P
8.2	P
18.8	Pool @ XS
26.9	G
38.7	R
51	BKF
63.8	R
93.5	R
111	R
141	Riffle @ XS
156	BKF
160	P
166	G
177	BKF
189	R
199	Riffle Confluence w UT1

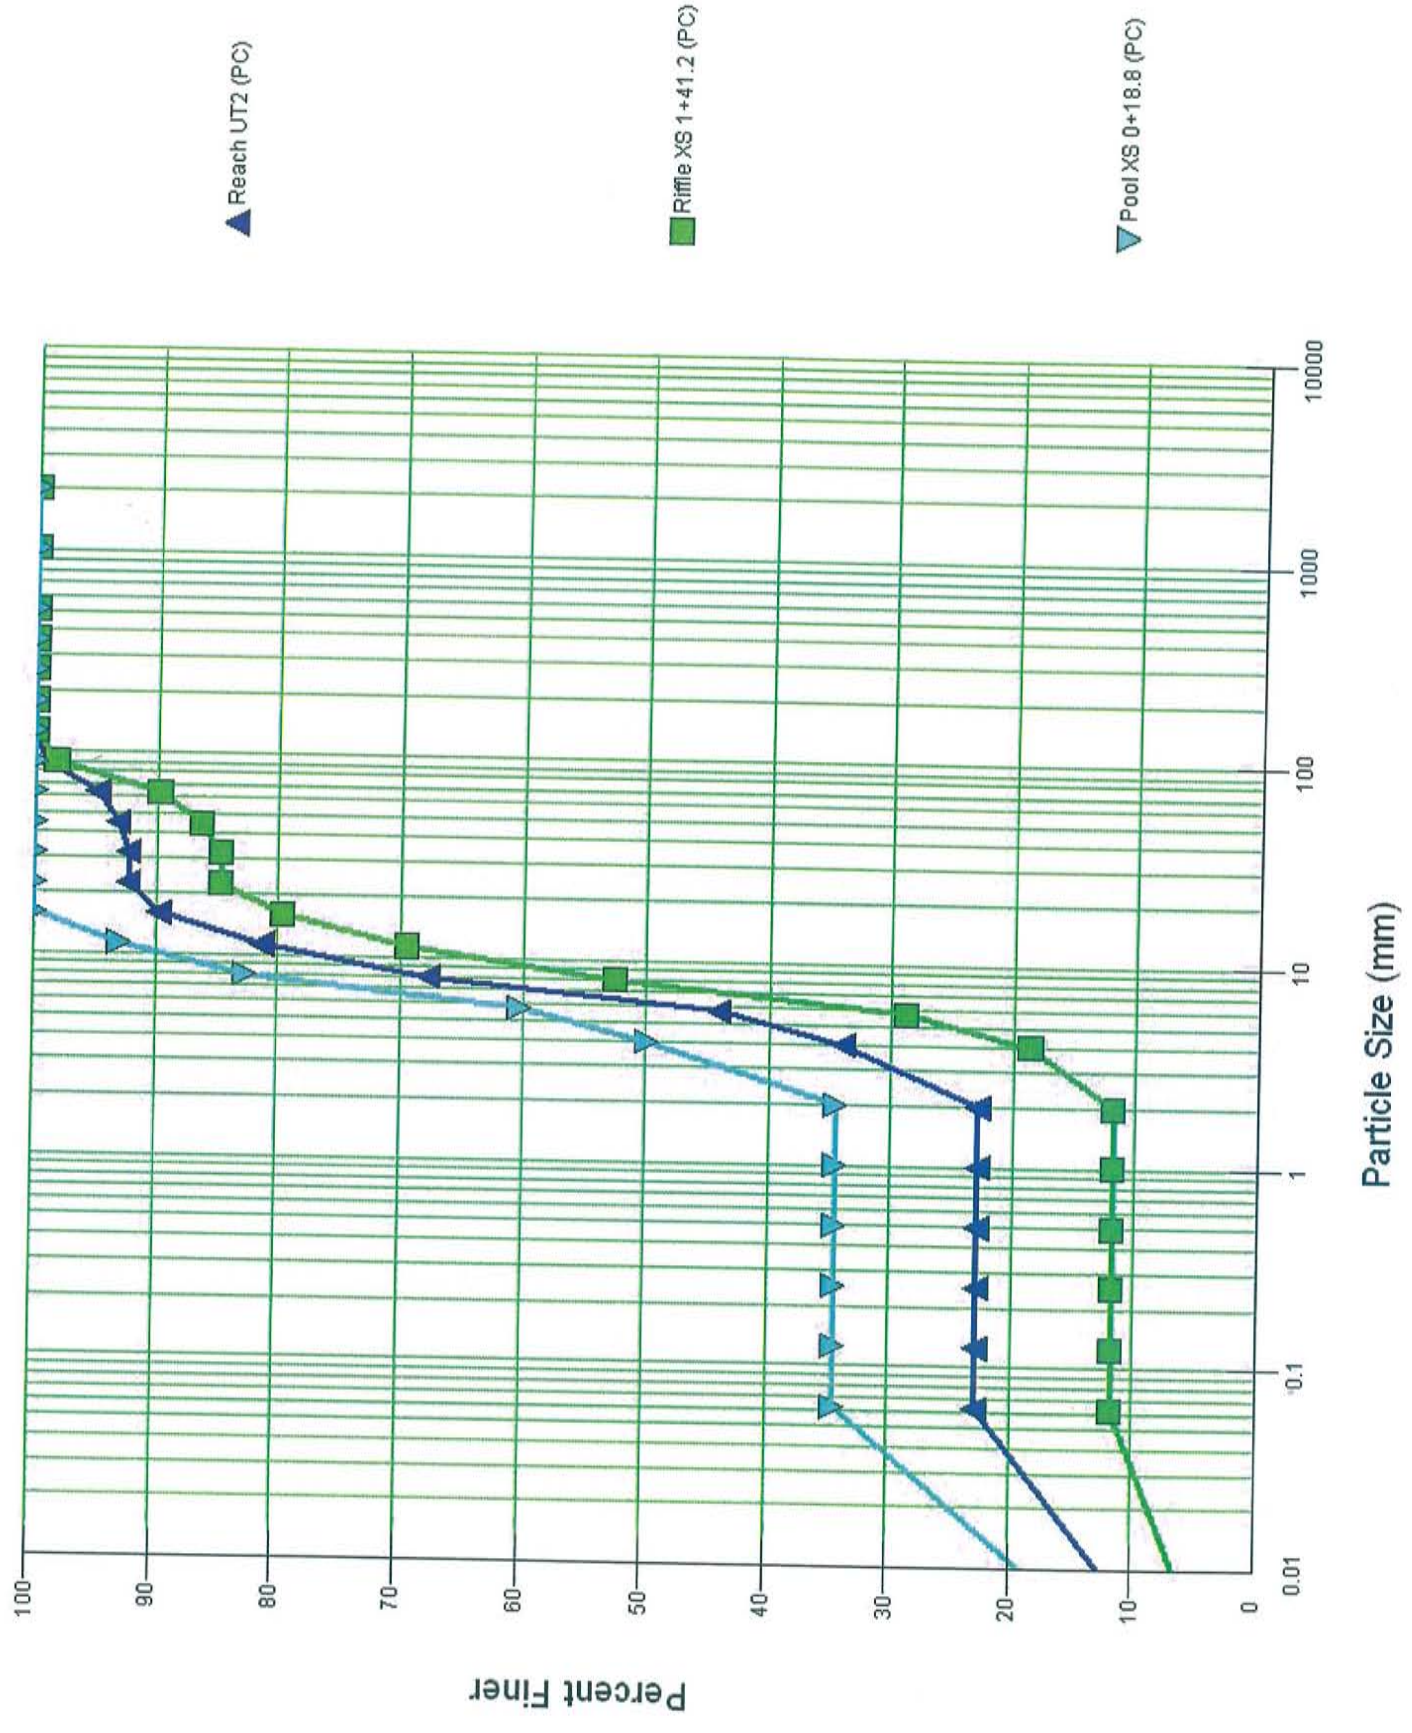
# Reach UT2 Particle Distributi... - Altered Conditions 7/17/07

RIVERMORPH PARTICLE SUMMARY

-----  
 River Name: Beaverdam Creek  
 Reach Name: UT2 Impaired  
 Sample Name: Reach UT2  
 Survey Date: 07/17/07  
 -----

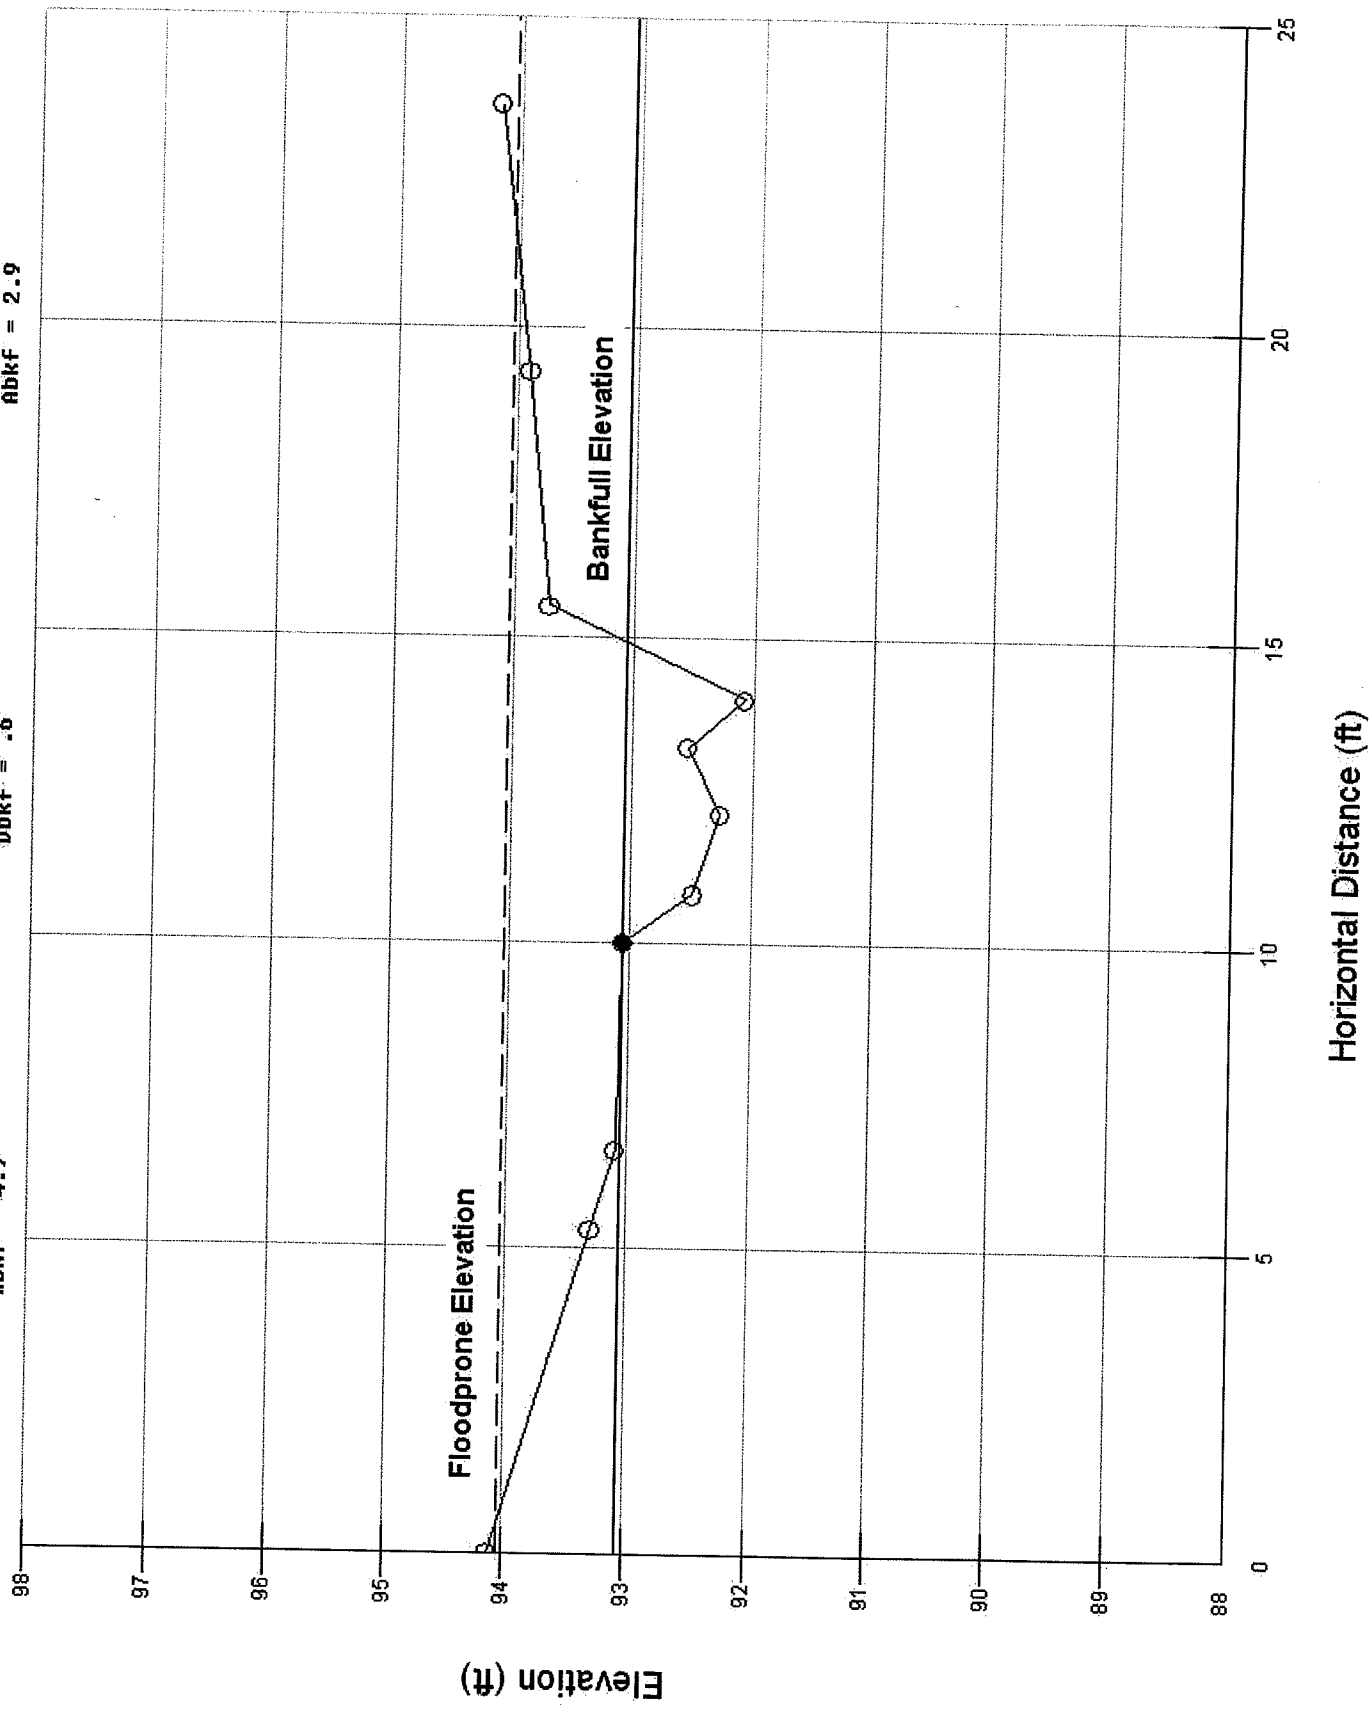
# UT2 Impaired Conditions Profile XS 1+41.2 - 7/17/07

○ Ground Points      Wbkf = 4.9      ▽ Water Surface Points      Abkf = 2.9  
◆ Bankfull Indicators      Dbkf = .6

RIVERMORPH CROSS SECTION SUMMARY

River Name: Beaverdam Creek  
 Reach Name: UT2 Impaired  
 Cross Section Name: Riffle XS 1+41.2  
 Survey Date: 09/19/07

Channel	Left side	Right side
Slope	0.01924	0	0
Shear Stress (lb/sq ft)	0.61		
Movable Particle (mm)	106.0

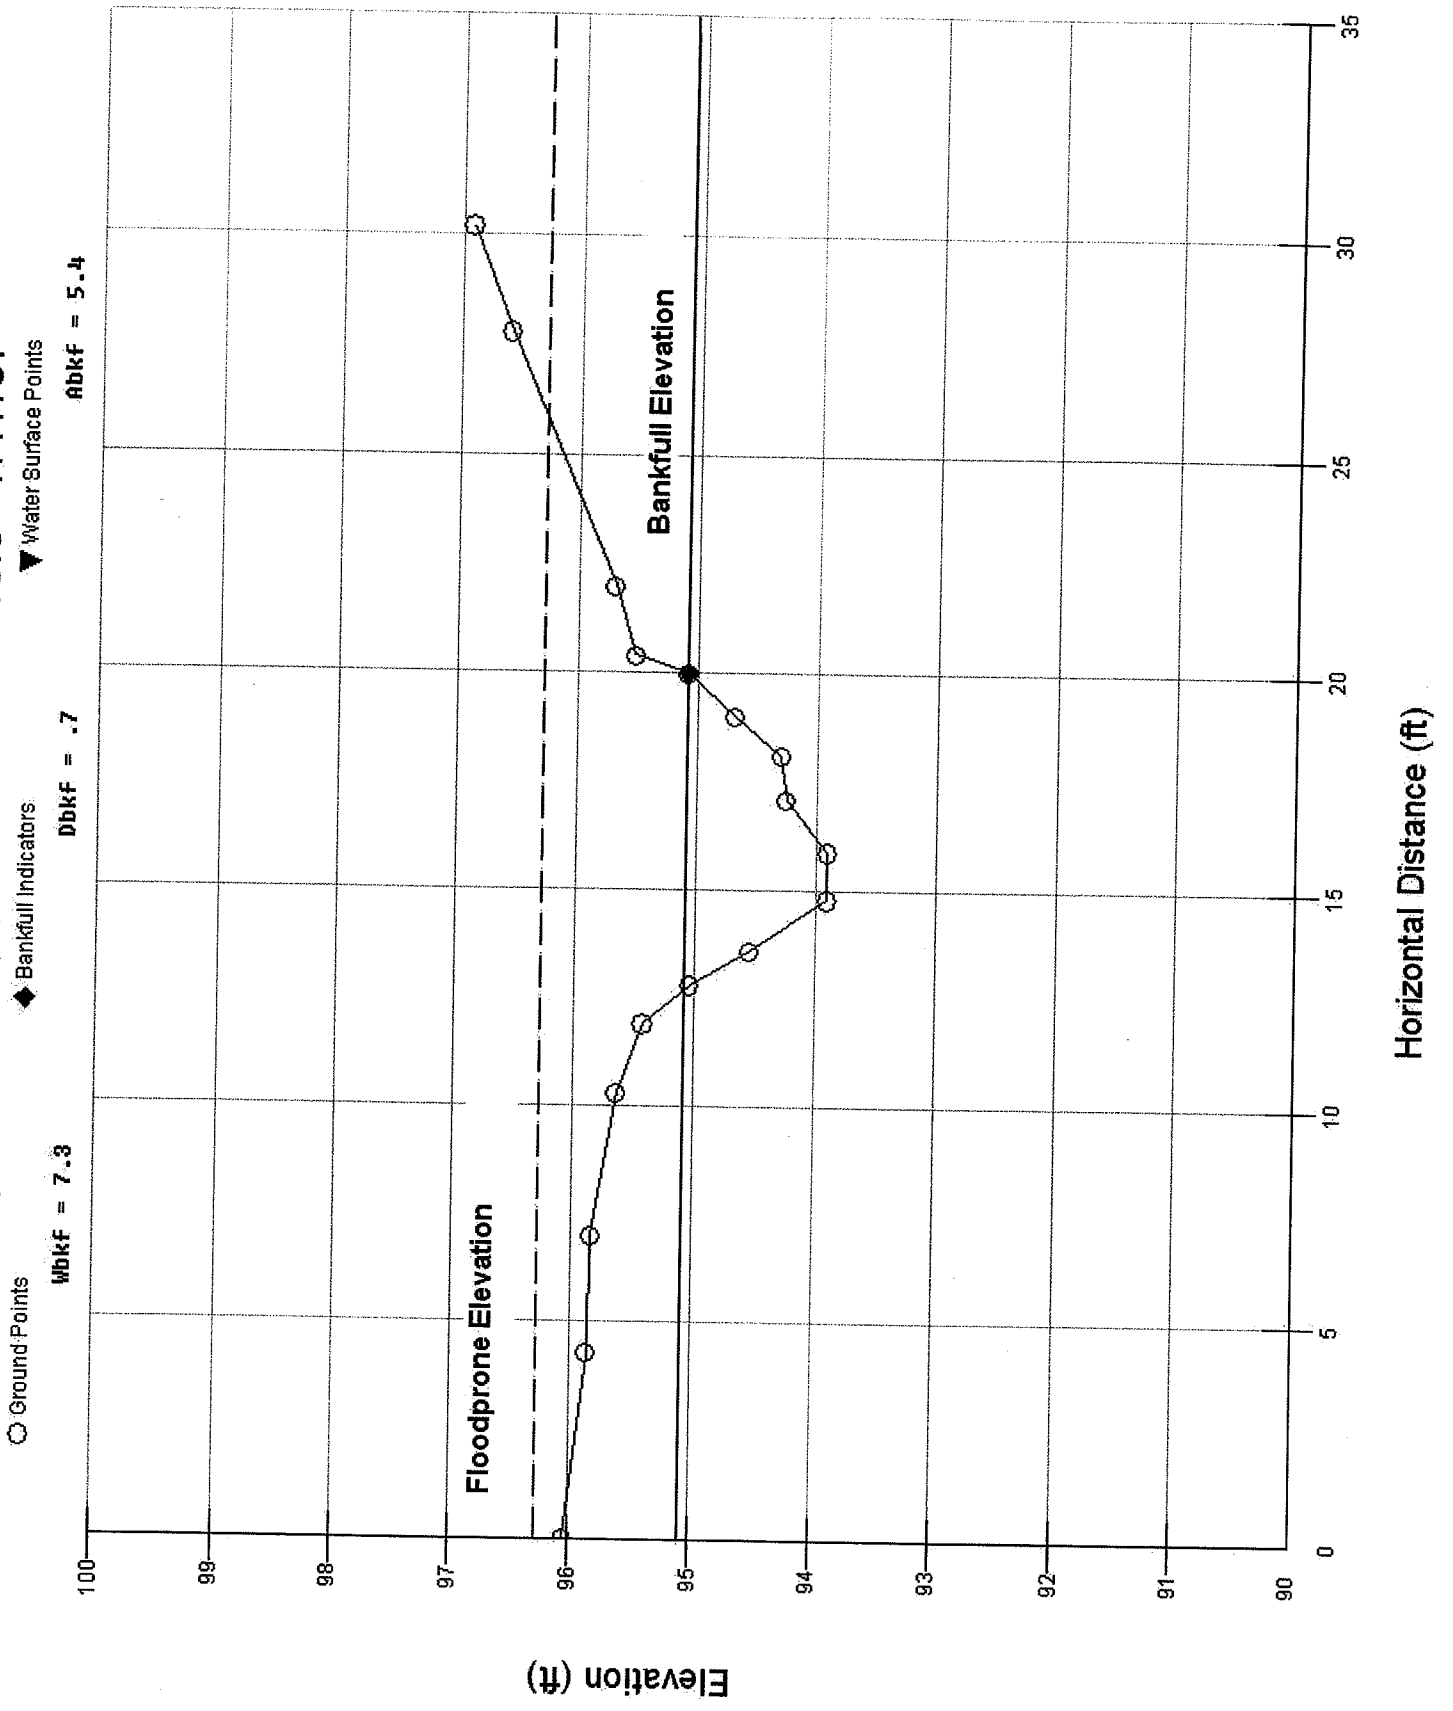
# UT2 Impaired Conditions Vol XS 0+18.8 - 7/17/07

RIVERMORPH CROSS SECTION SUMMARY

River Name: Beaverdam Creek  
 Reach Name: UT2 Impaired  
 Cross Section Name: Pool XS 0+18.8  
 Survey Date: 09/19/07
