**Benbow Park
Stream Restoration Monitoring Report
EEP Project # 29
Monitoring Year – 05
2009**

December 2009

1.0 EXECUTIVE SUMMARY / PROJECT ABSTRACT

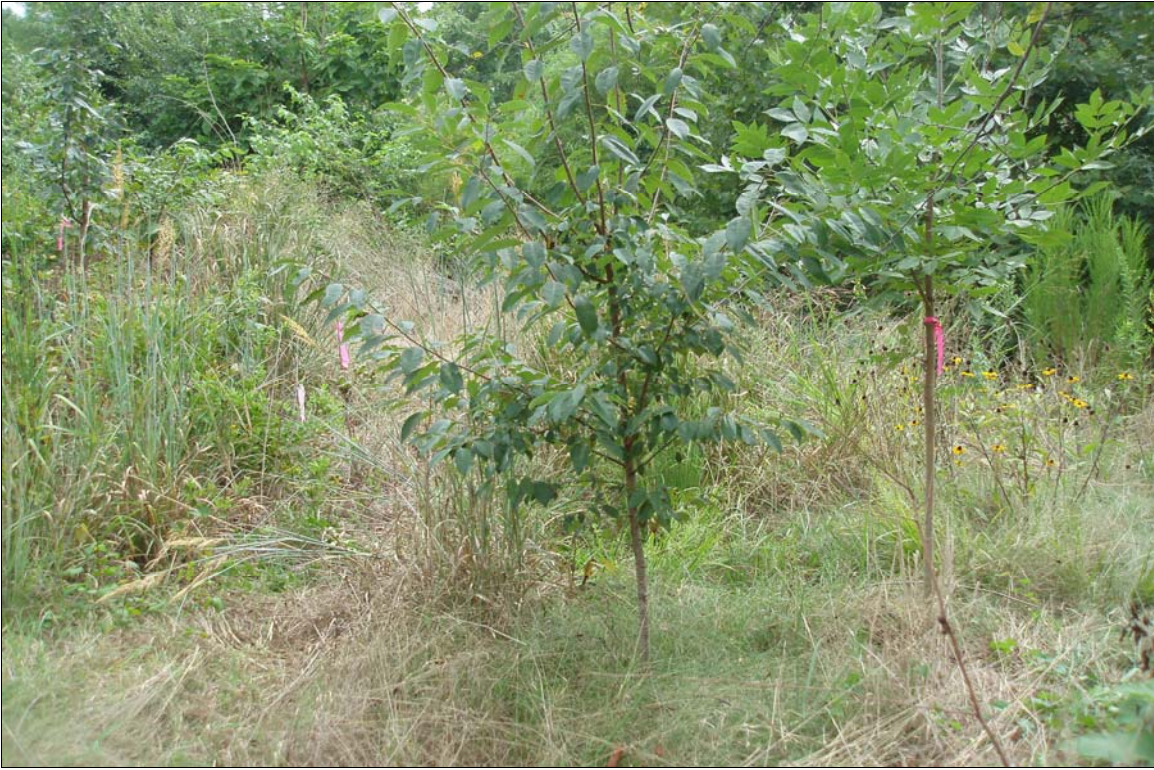
Plot 1 Photo – Taken looking south from the northern corner. 8/13/09 - MY 05

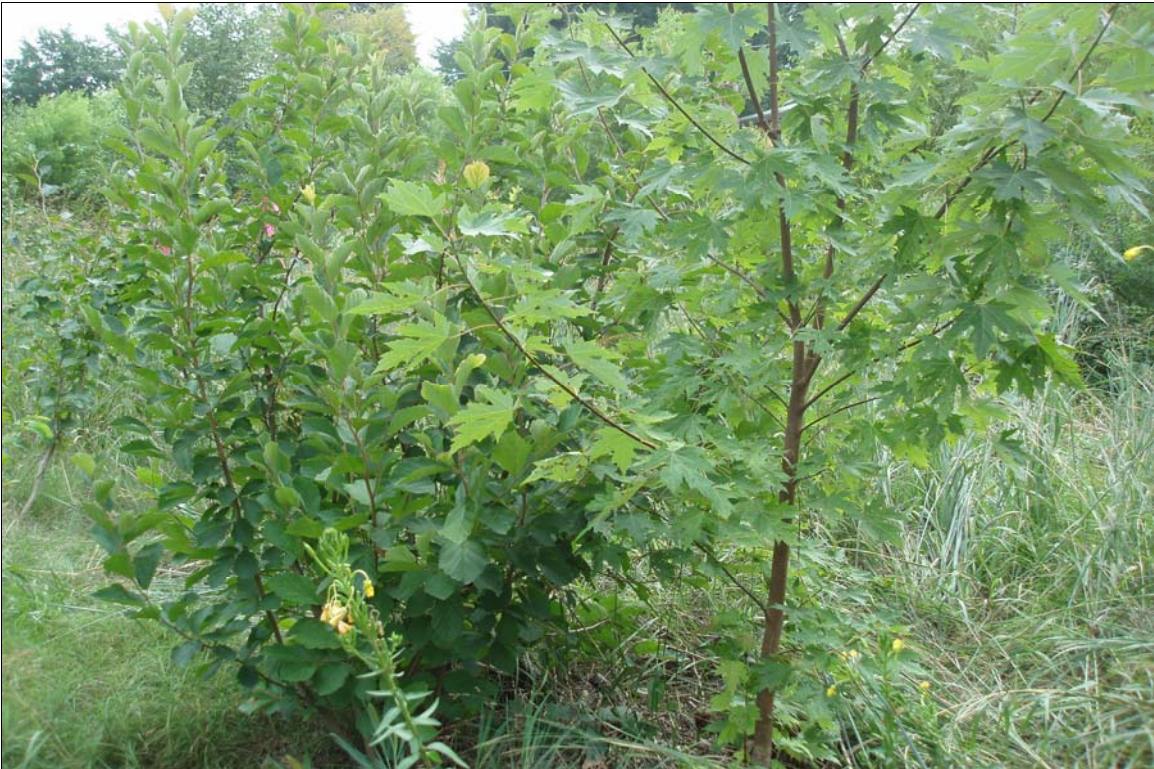
Plot 2 Photo – Taken looking south from the northern corner. 8/13/09 - MY 05

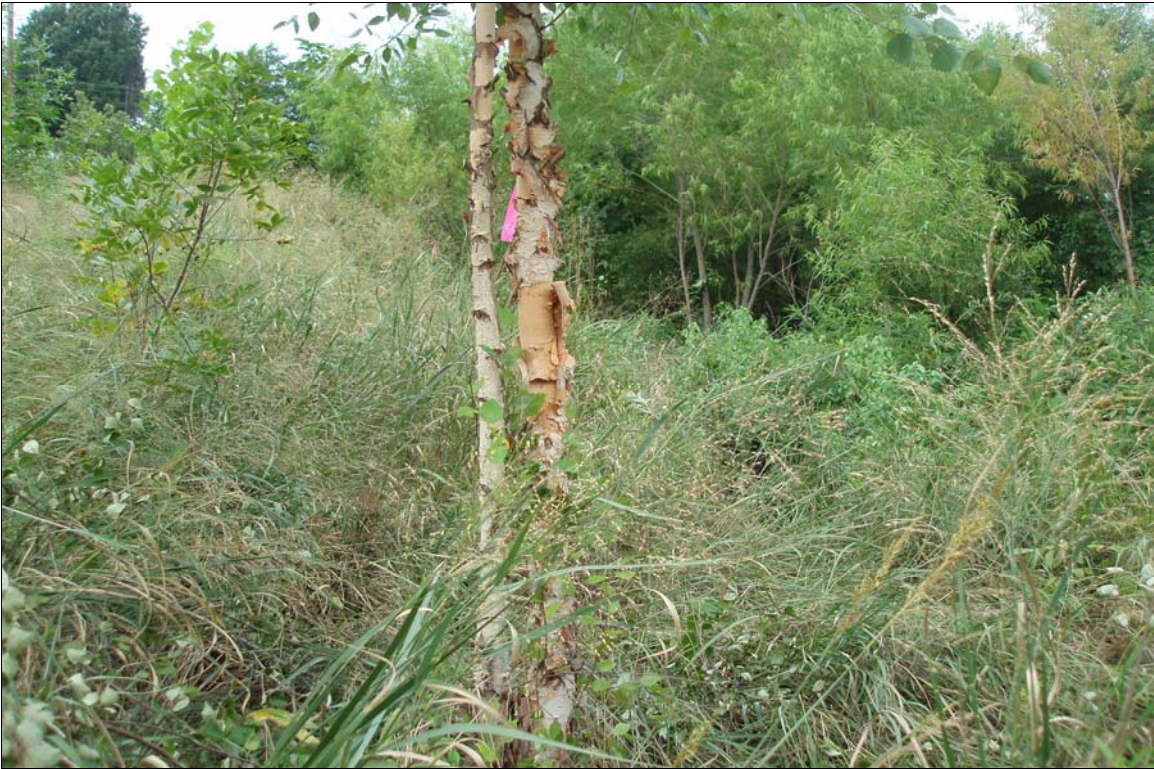
Plot 3 Photo – Taken looking north from the southern corner. 8/13/09 - MY 05

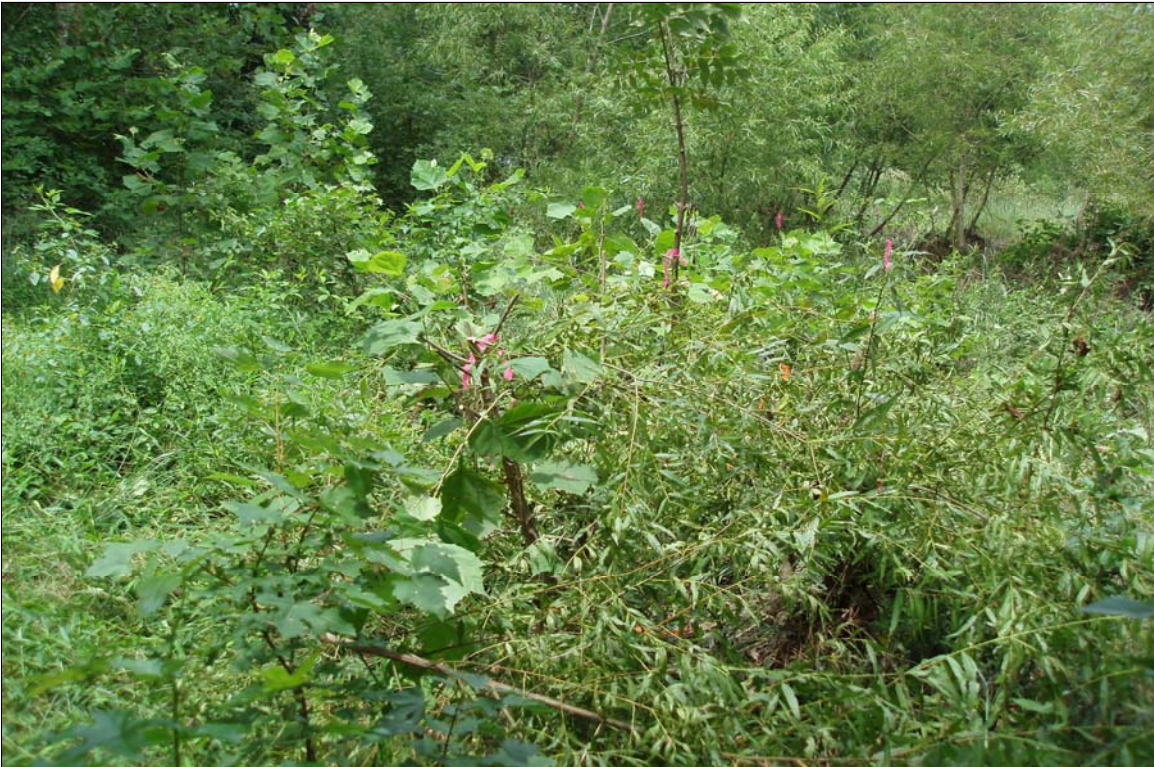
Plot 4 Photo – Taken looking northwest from the southeastern corner. 8/13/09 - MY 05

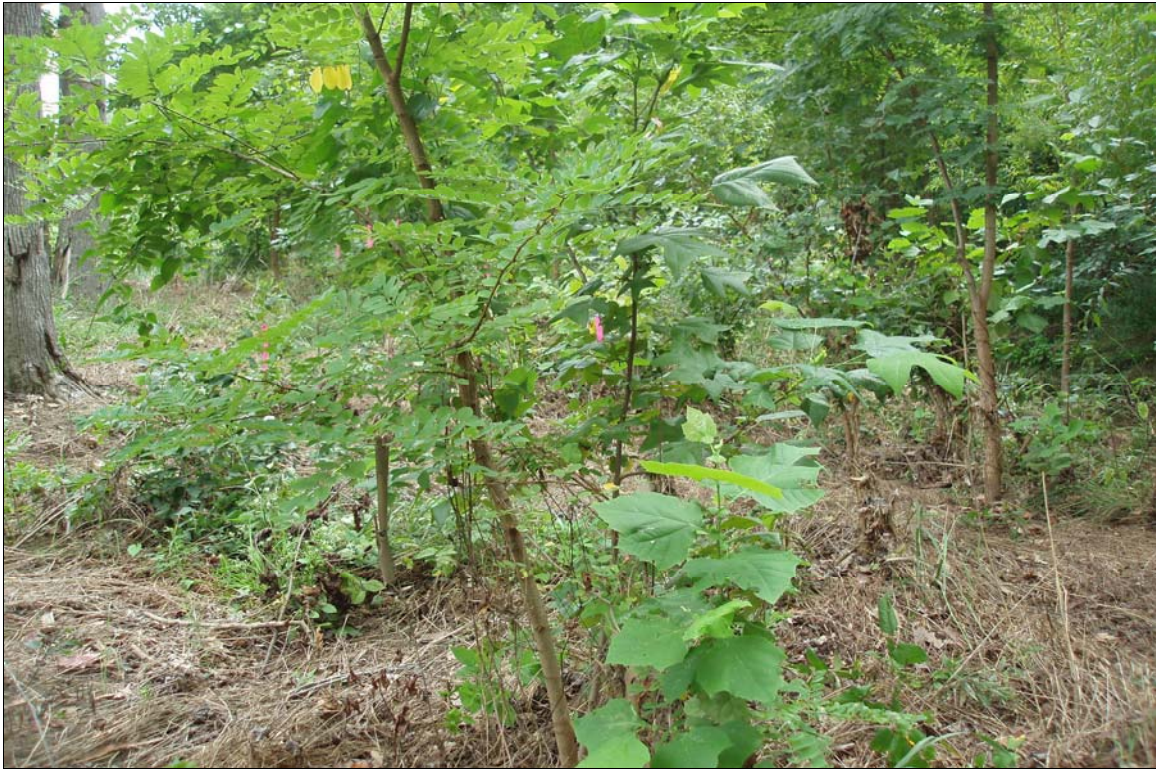
Plot 5 Photo – Taken looking east from the western corner. 8/13/09 - MY 05

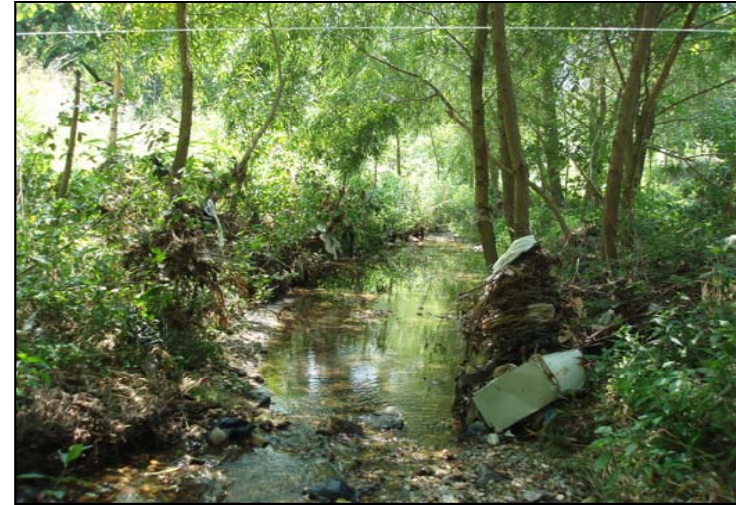
Cape Fear River Basin, Benbow Park, MY05, XS - 1, Riffle

River Basin:	Cape Fear
Watershed:	Benbow Park, MY05
XS ID	XS - 1, Riffle
Drainage Area (sq mi):	0.7
Date:	8/11/2009
Field Crew:	B. Roberts, C. Carter

Station	Elevation
0.0	736.62
4.1	736.28
6.0	735.97
8.6	735.29
13.4	733.43
17.3	733.02
19.9	732.70
21.1	732.37
24.6	730.70
25.9	730.57
26.3	730.33
27.0	730.28
27.9	730.03
28.4	730.21
29.2	730.28
29.4	730.19
30.2	730.36
31.4	730.41
31.6	730.95
32.8	731.20
33.9	732.14
34.9	733.06
36.5	733.41
38.0	733.38
40.2	733.10
51.2	735.77
64.7	739.22
68.9	740.34
70.6	740.41

SUMMARY DATA	
Bankfull Elevation:	732.3
Bankfull Cross-Sectional Area:	18.5
Bankfull Width:	12.8
Flood Prone Area Elevation:	734.5
Flood Prone Width:	36
Max Depth at Bankfull:	2.2
Mean Depth at Bankfull:	1.4
W / D Ratio:	8.9
Entrenchment Ratio:	2.8
Bank Height Ratio:	1.0

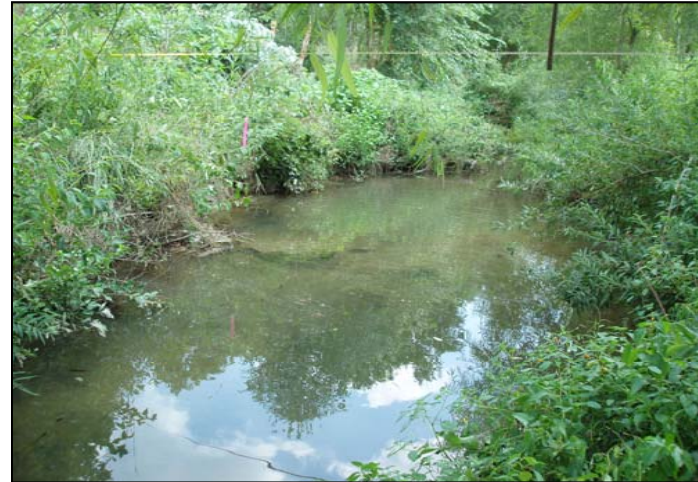
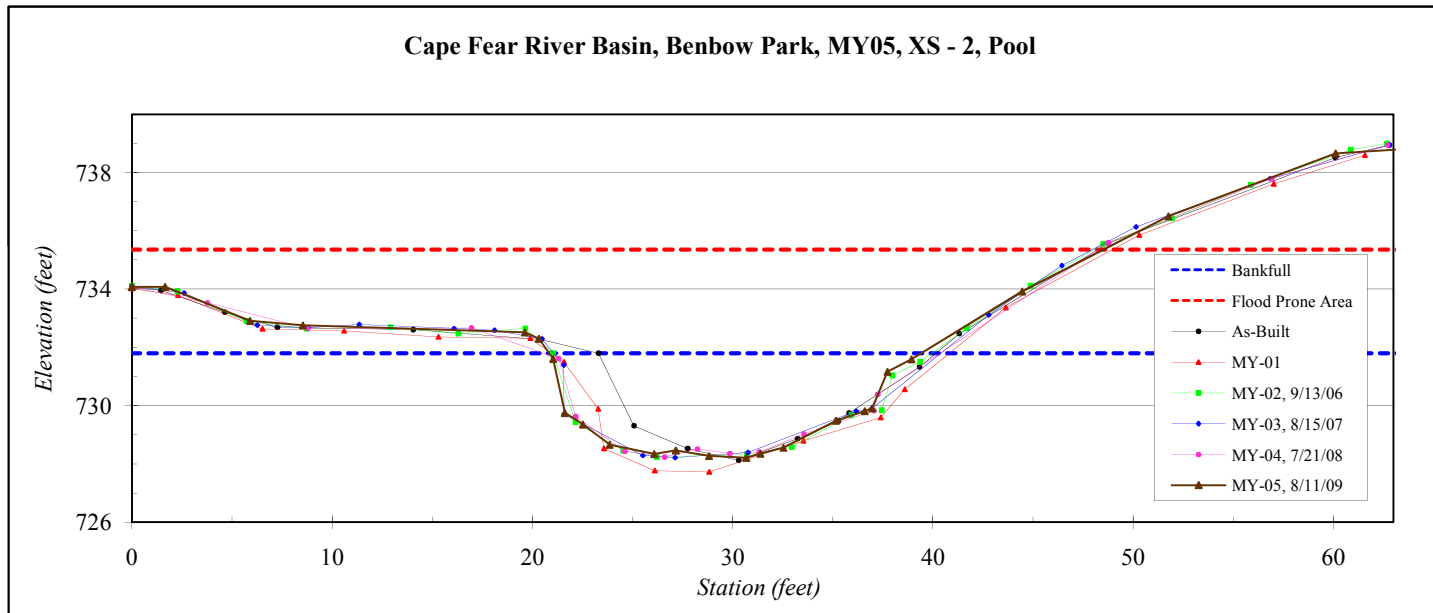
Cape Fear River Basin, Benbow Park, MY05, XS - 2, Pool

River Basin:	Cape Fear
Watershed:	Benbow Park, MY05
XS ID	XS - 2, Pool
Drainage Area (sq mi):	0.7
Date:	8/11/2009
Field Crew:	B. Roberts, C. Carter

Station	Elevation
0.0	734.08
1.7	734.08
5.9	732.92
8.5	732.76
19.6	732.52
20.3	732.30
21.0	731.61
21.6	729.75
22.5	729.36
23.9	728.66
26.1	728.34
27.2	728.47
28.8	728.27
30.7	728.21
31.4	728.36
32.5	728.56
35.2	729.49
36.6	729.81
37.0	729.91
37.7	731.16
38.9	731.60
44.5	733.92
51.8	736.51
60.1	738.66
66.7	738.95

SUMMARY DATA	
Bankfull Elevation:	731.8
Bankfull Cross-Sectional Area:	48.7
Bankfull Width:	18.6
Flood Prone Area Elevation:	735.4
Flood Prone Width:	>50
Max Depth at Bankfull:	3.6
Mean Depth at Bankfull:	2.6
W / D Ratio:	7.1
Entrenchment Ratio:	>2.5
Bank Height Ratio:	1.2

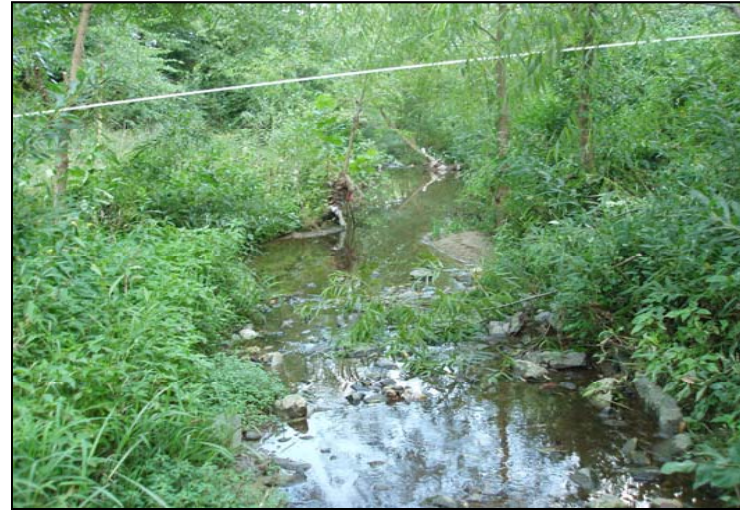
Cape Fear River Basin, Benbow Park, MY05, XS - 3, Riffle

River Basin:	Cape Fear
Watershed:	Benbow Park, MY05
XS ID	XS - 3, Riffle
Drainage Area (sq mi):	0.7
Date:	8/11/2009
Field Crew:	B. Roberts, C. Carter

Station	Elevation
0.0	733.50
1.9	733.24
5.4	731.92
15.1	731.60
16.0	731.79
18.4	731.66
21.0	731.17
22.5	730.72
24.6	730.36
25.2	729.75
25.8	729.68
27.5	729.63
28.7	729.31
30.2	729.72
31.6	729.72
31.9	729.82
32.1	730.22
34.7	731.51
36.7	731.91
38.1	732.15
45.7	735.14
51.6	737.60
53.5	737.87

SUMMARY DATA	
Bankfull Elevation:	731.4
Bankfull Cross-Sectional Area:	17.7
Bankfull Width:	14.9
Flood Prone Area Elevation:	733.6
Flood Prone Width:	40
Max Depth at Bankfull:	2.1
Mean Depth at Bankfull:	1.2
W / D Ratio:	12.5
Entrenchment Ratio:	2.7
Bank Height Ratio:	1.0

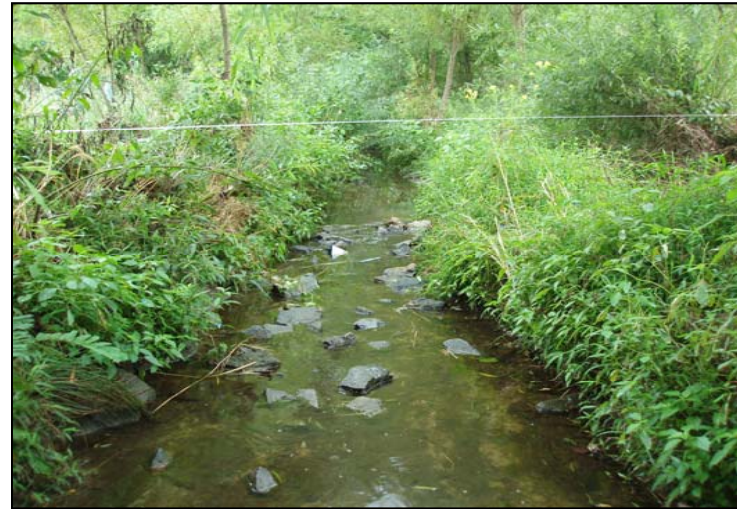
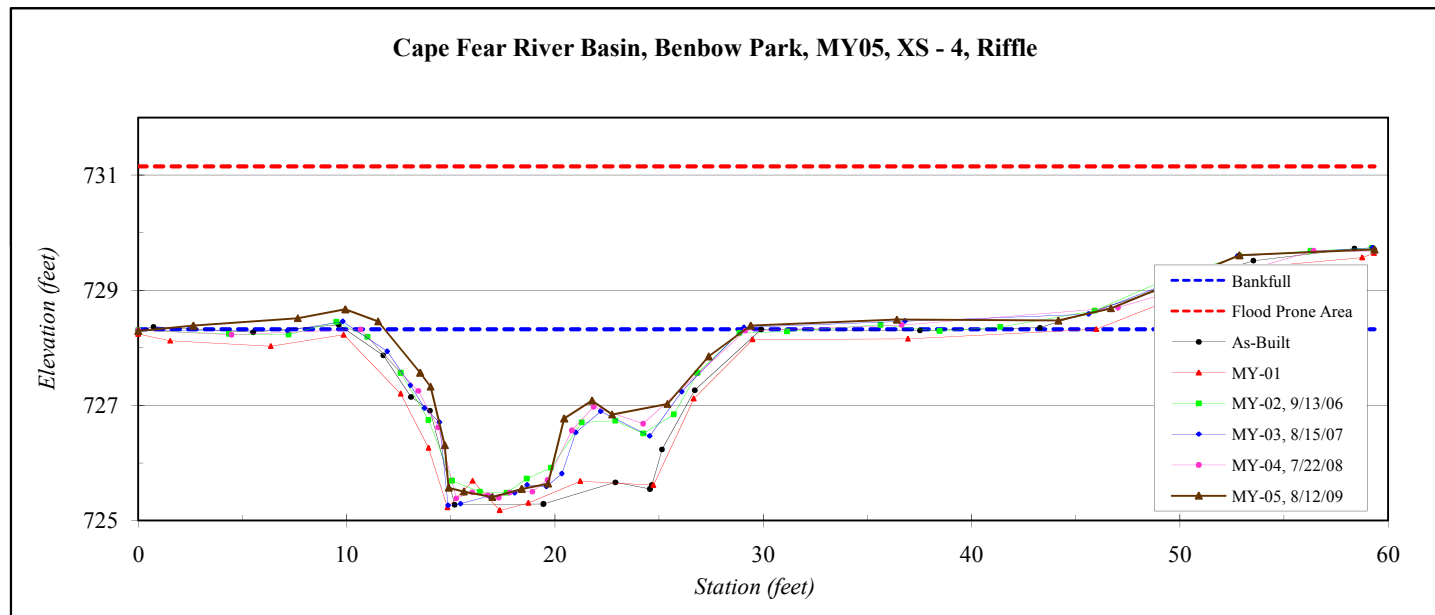
River Basin:	Cape Fear
Watershed:	Benbow Park, MY05
XS ID	XS - 4, Riffle
Drainage Area (sq mi):	0.7
Date:	8/12/2009
Field Crew:	B. Roberts, C. Carter

Station	Elevation
0.0	728.29
2.6	728.38
7.7	728.51
9.9	728.67
11.5	728.46
13.5	727.57
14.0	727.33
14.7	726.31
14.9	725.57
15.6	725.51
17.0	725.41
18.4	725.55
19.7	725.64
20.4	726.77
21.8	727.08
22.7	726.84
25.4	727.03
27.4	727.85
29.4	728.38
36.4	728.49
44.2	728.47
46.7	728.69
52.9	729.61
59.3	729.71

SUMMARY DATA	
Bankfull Elevation:	728.3
Bankfull Cross-Sectional Area:	26.6
Bankfull Width:	17.3
Flood Prone Area Elevation:	731.2
Flood Prone Width:	>60
Max Depth at Bankfull:	2.9
Mean Depth at Bankfull:	1.5
W / D Ratio:	11.3
Entrenchment Ratio:	>3.4
Bank Height Ratio:	1.0

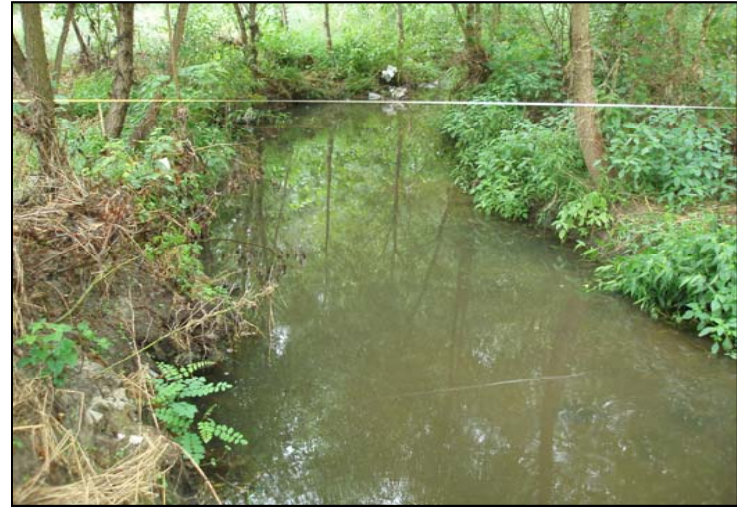
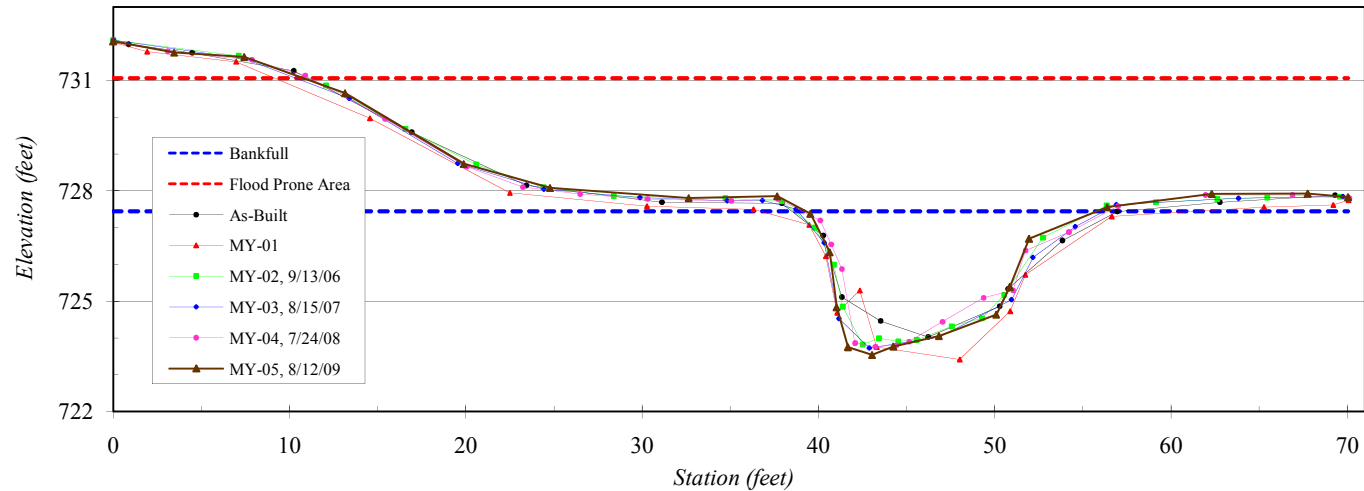
Cape Fear River Basin, Benbow Park, MY05, XS - 5, Pool

River Basin:	Cape Fear
Watershed:	Benbow Park, MY05
XS ID	XS - 5, Pool
Drainage Area (sq mi):	0.7
Date:	8/12/2009
Field Crew:	B. Roberts, C. Carter

Station	Elevation
0.0	732.07
3.5	731.76
7.4	731.64
13.1	730.66
19.9	728.73
24.8	728.08
32.6	727.81
37.7	727.85
39.5	727.38
40.6	726.33
41.0	724.84
41.7	723.76
43.0	723.54
44.3	723.77
46.8	724.06
50.1	724.64
50.9	725.39
52.0	726.70
56.4	727.56
62.3	727.92
67.8	727.93
70.0	727.83

SUMMARY DATA	
Bankfull Elevation:	727.4
Bankfull Cross-Sectional Area:	37.1
Bankfull Width:	16.5
Flood Prone Area Elevation:	731.1
Flood Prone Width:	>60
Max Depth at Bankfull:	3.9
Mean Depth at Bankfull:	2.2
W / D Ratio:	7.3
Entrenchment Ratio:	>3.6
Bank Height Ratio:	1.0

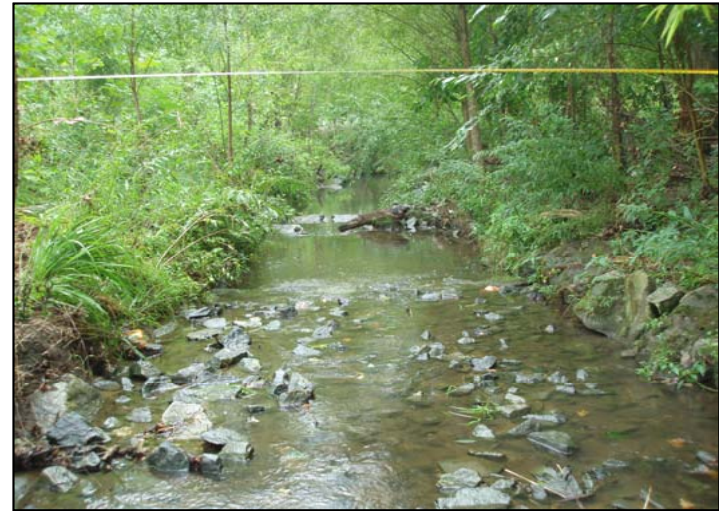
Cape Fear River Basin, Benbow Park, MY05, XS - 6, Riffle

River Basin:	Cape Fear
Watershed:	Benbow Park, MY05
XS ID	XS - 6, Riffle
Drainage Area (sq mi):	0.7
Date:	8/12/2009
Field Crew:	B. Roberts, C. Carter

Station	Elevation
0.0	727.84
3.2	727.77
8.5	727.39
12.1	727.21
14.4	726.96
15.4	727.23
16.3	727.14
17.6	726.57
18.6	726.24
19.7	724.90
20.1	724.75
24.0	724.64
26.5	724.87
28.0	724.79
29.8	724.57
30.4	726.17
32.5	726.53
34.2	727.21
35.7	728.06
40.1	728.45
46.3	728.97
48.5	728.94

SUMMARY DATA	
Bankfull Elevation:	727.3
Bankfull Cross-Sectional Area:	32.8
Bankfull Width:	18.9
Flood Prone Area Elevation:	729.9
Flood Prone Width:	>50
Max Depth at Bankfull:	2.7
Mean Depth at Bankfull:	1.7
W / D Ratio:	10.9
Entrenchment Ratio:	>2.5
Bank Height Ratio:	1.0

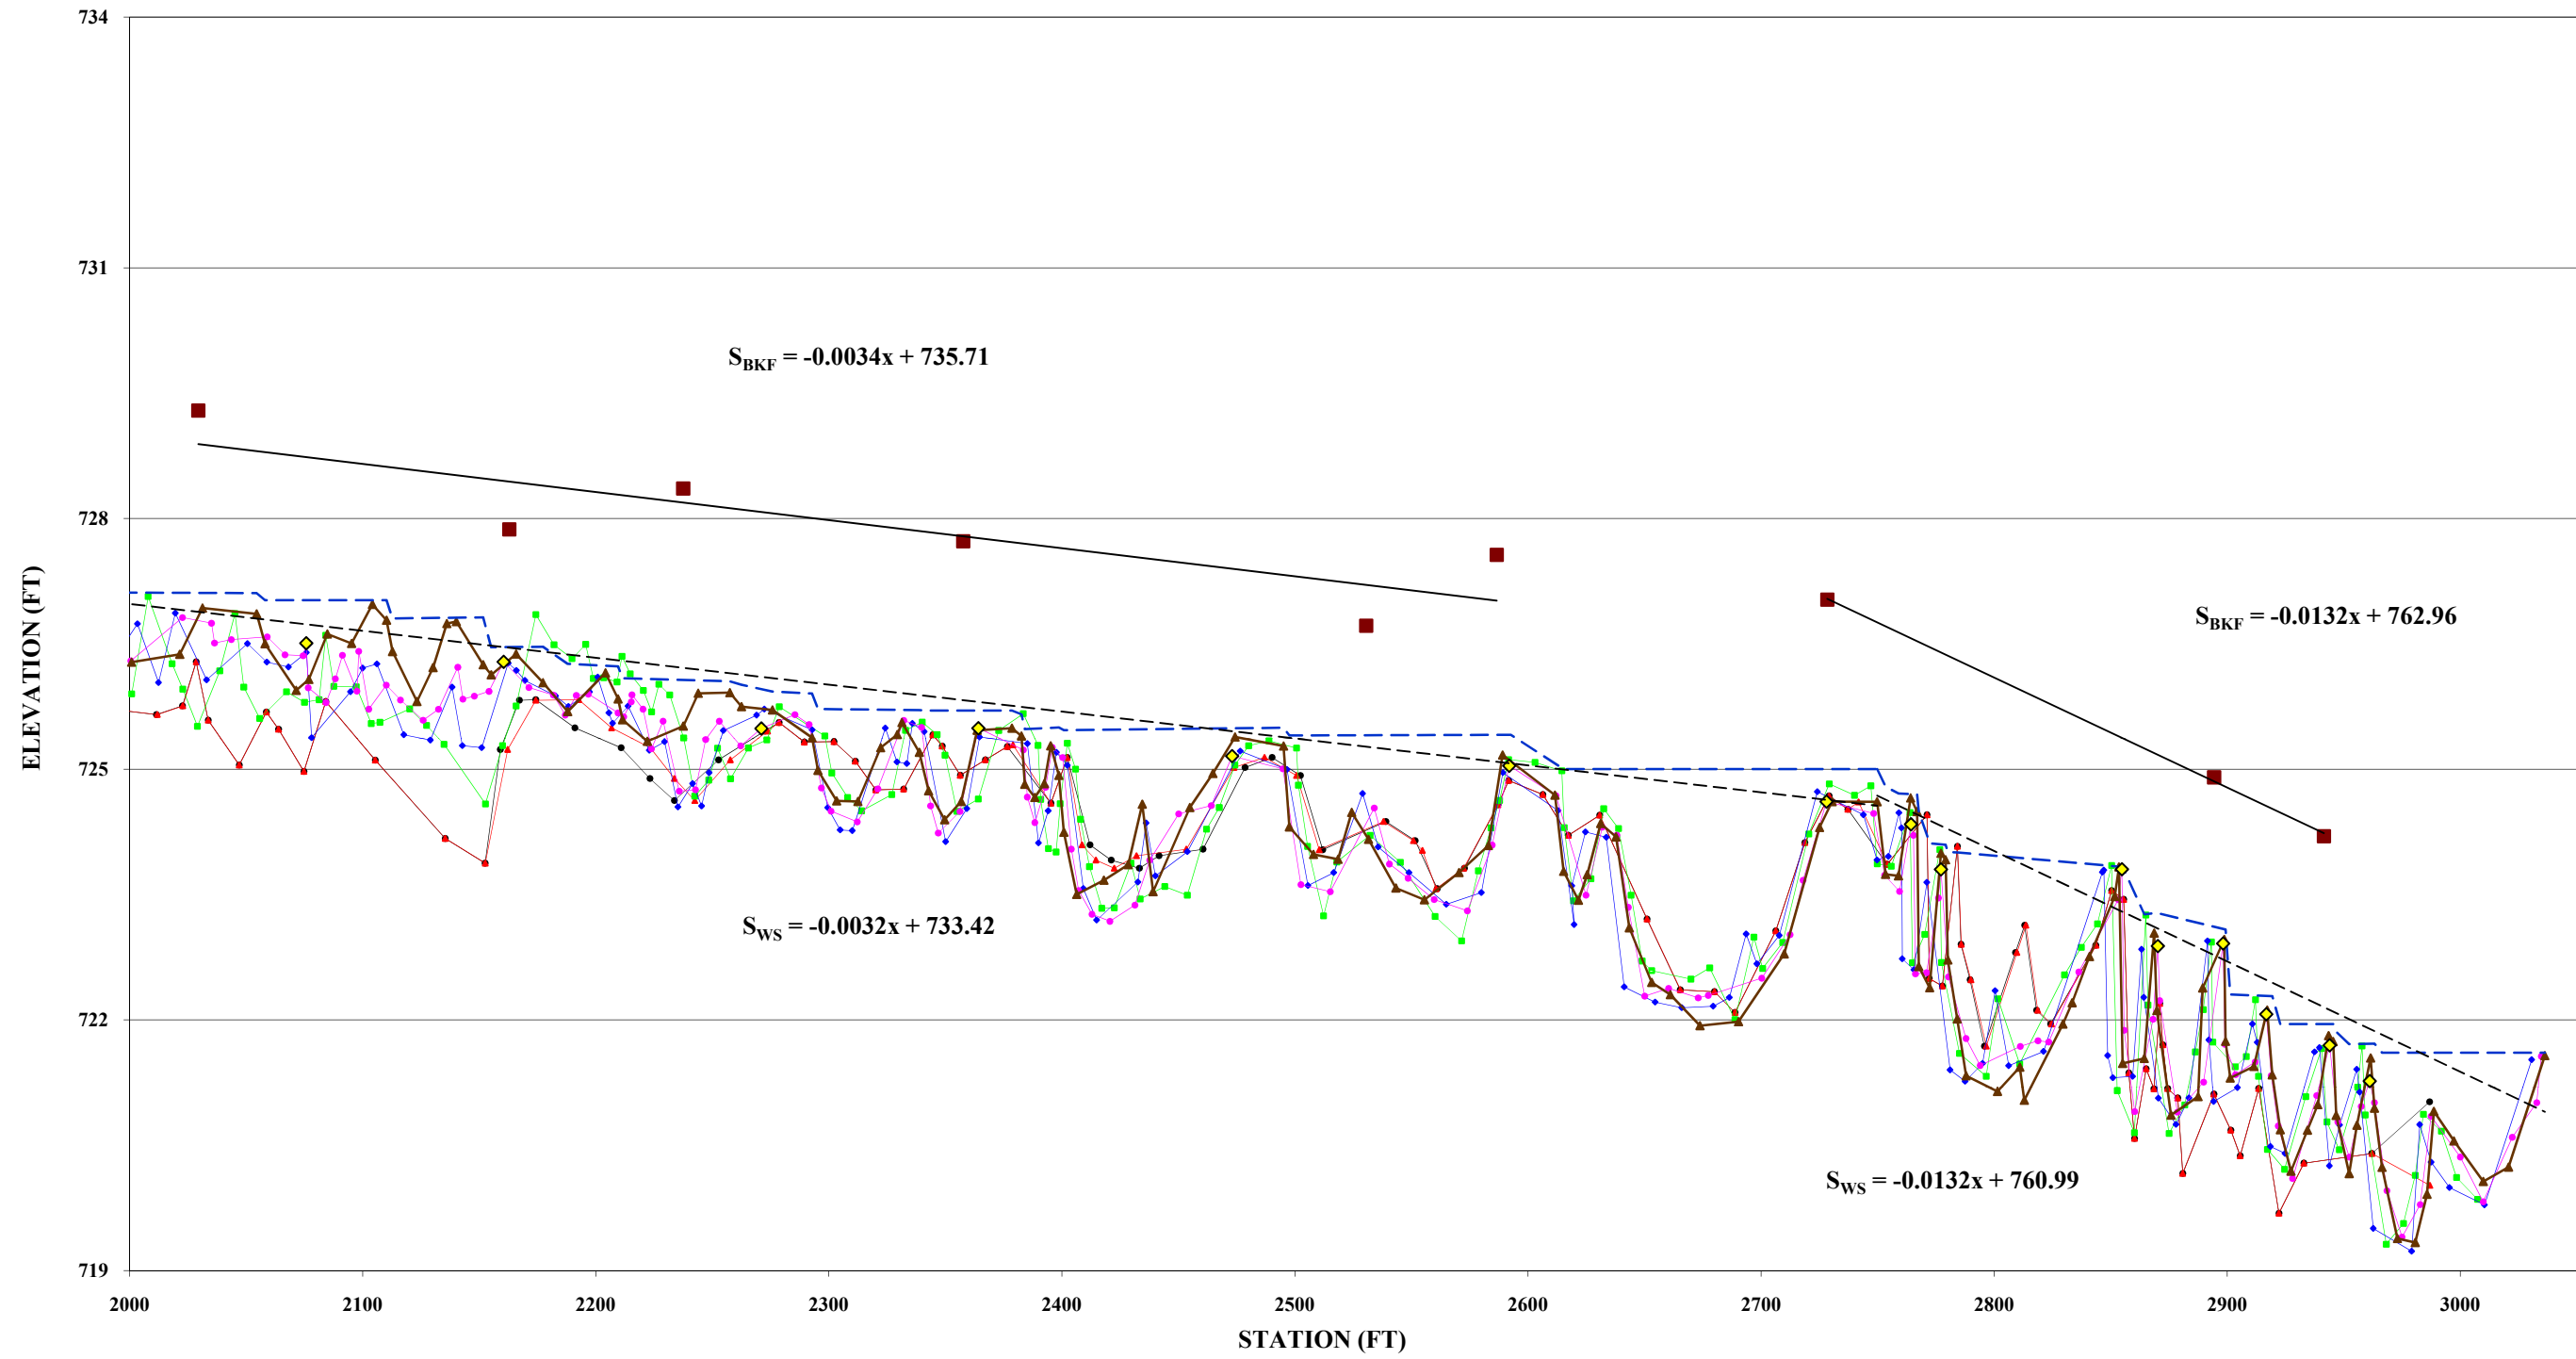
**Longitudinal Profile
Benbow Park
EEP Project Number 29 - MY05
Stations 20+00 - 30+50**

| —●— As-Built | —▲— MY-01 | —■— MY-02, 9/13/06 | —◆— MY-03, 8/15/07 | —●— MY-04, 7/24/08 | —▲— MY-05, 8/13/09 | ■ Bankfull | — — — Water Surface | ◆ In-stream Structures | — BKF Slope | — — — WS Slope |

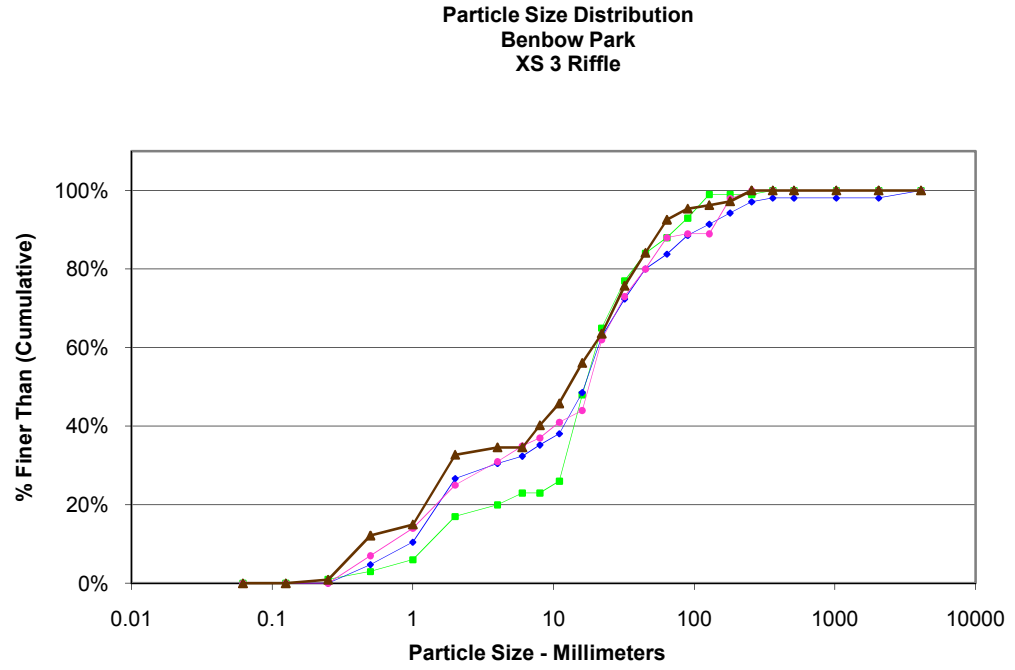
Cross-Section 3 Riffle - MY05			
Particle	Millimeter		Count
Silt/Clay	< 0.062	S/C	
Very Fine	.062 - .125	S	
Fine	.125 - .25	A	1
Medium	.25 - .50	N	12
Coarse	.50 - 1	D	3
Very Coarse	1 - 2	S	19
Very Fine	2 - 4		2
Fine	4 - 5.7	G	
Fine	5.7 - 8	R	6
Medium	8 - 11.3	A	6
Medium	11.3 - 16	V	11
Coarse	16 - 22.6	E	8
Coarse	22.6 - 32	L	13
Very Coarse	32 - 45	S	9
Very Coarse	45 - 64		9
Small	64 - 90	C	3
Small	90 - 128	O	1
Large	128 - 180	B	1
Large	180 - 256	L	3
Small	256 - 362	B	
Small	362 - 512	L	
Medium	512 - 1024	D	
Lrg- Very Lrg	1024 - 2048	R	
Bedrock	>2048	BDRK	
		Total	107
Note:

Size (mm)	Count
D16	1
D35	6.1
D50	13
D65	23
D84	45
D95	86

Size Distribution	
mean	6.7
dispersion	8.2
skewness	-0.22

Type	
silt/clay	0%
sand	33%
gravel	60%
cobble	7%
boulder	0%
bedrock	
hardpan	
wood/det	
artificial

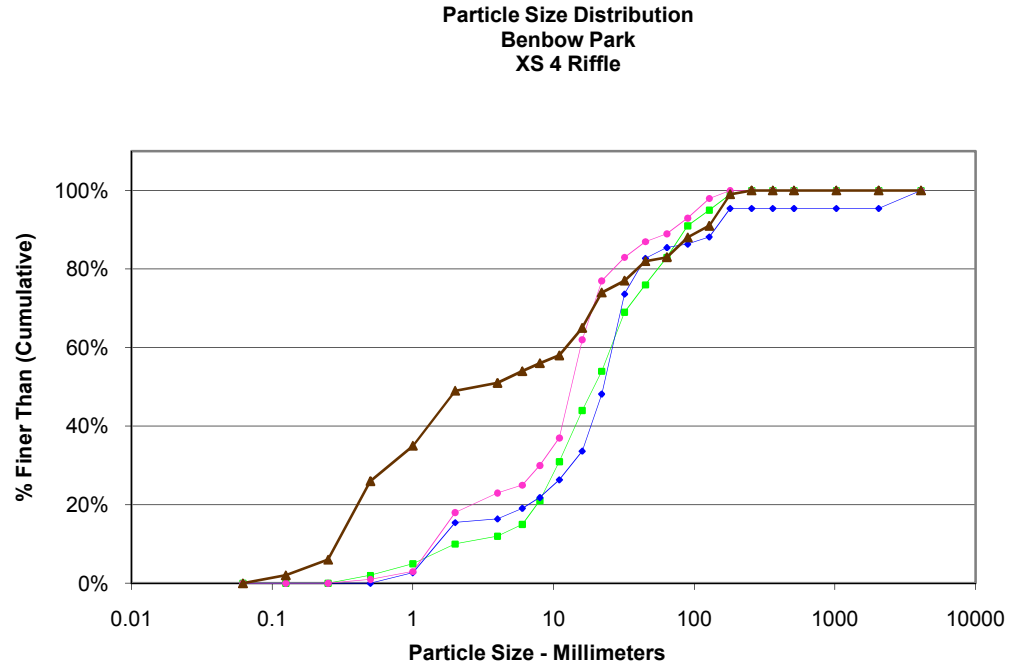
Cross-Section 4 Riffle - MY05			
Particle	Millimeter		Count
Silt/Clay	< 0.062	S/C	
Very Fine	.062 - .125	S	2
Fine	.125 - .25	A	4
Medium	.25 - .50	N	20
Coarse	.50 - 1	D	9
Very Coarse	1 - 2	S	14
Very Fine	2 - 4		2
Fine	4 - 5.7	G	3
Fine	5.7 - 8	R	2
Medium	8 - 11.3	A	2
Medium	11.3 - 16	V	7
Coarse	16 - 22.6	E	9
Coarse	22.6 - 32	L	3
Very Coarse	32 - 45	S	5
Very Coarse	45 - 64		1
Small	64 - 90	C	5
Small	90 - 128	O	3
Large	128 - 180	B	8
Large	180 - 256	L	1
Small	256 - 362	B	
Small	362 - 512	L	
Medium	512 - 1024	D	
Lrg- Very Lrg	1024 - 2048	R	
Bedrock	>2048	BDRK	
		Total	100
Note:

Size (mm)	
D16	0.35
D35	1
D50	2.8
D65	16
D84	69
D95	150

Size Distribution	
mean	4.9
dispersion	16.3
skewness	0.16

Type	
silt/clay	0%
sand	49%
gravel	34%
cobble	17%
boulder	0%
bedrock	
hardpan	
wood/det	
artificial
