# **BILLY'S CREEK STREAM RESTORATION PLAN**

**AUGUST 11, 2003**

# **URS**

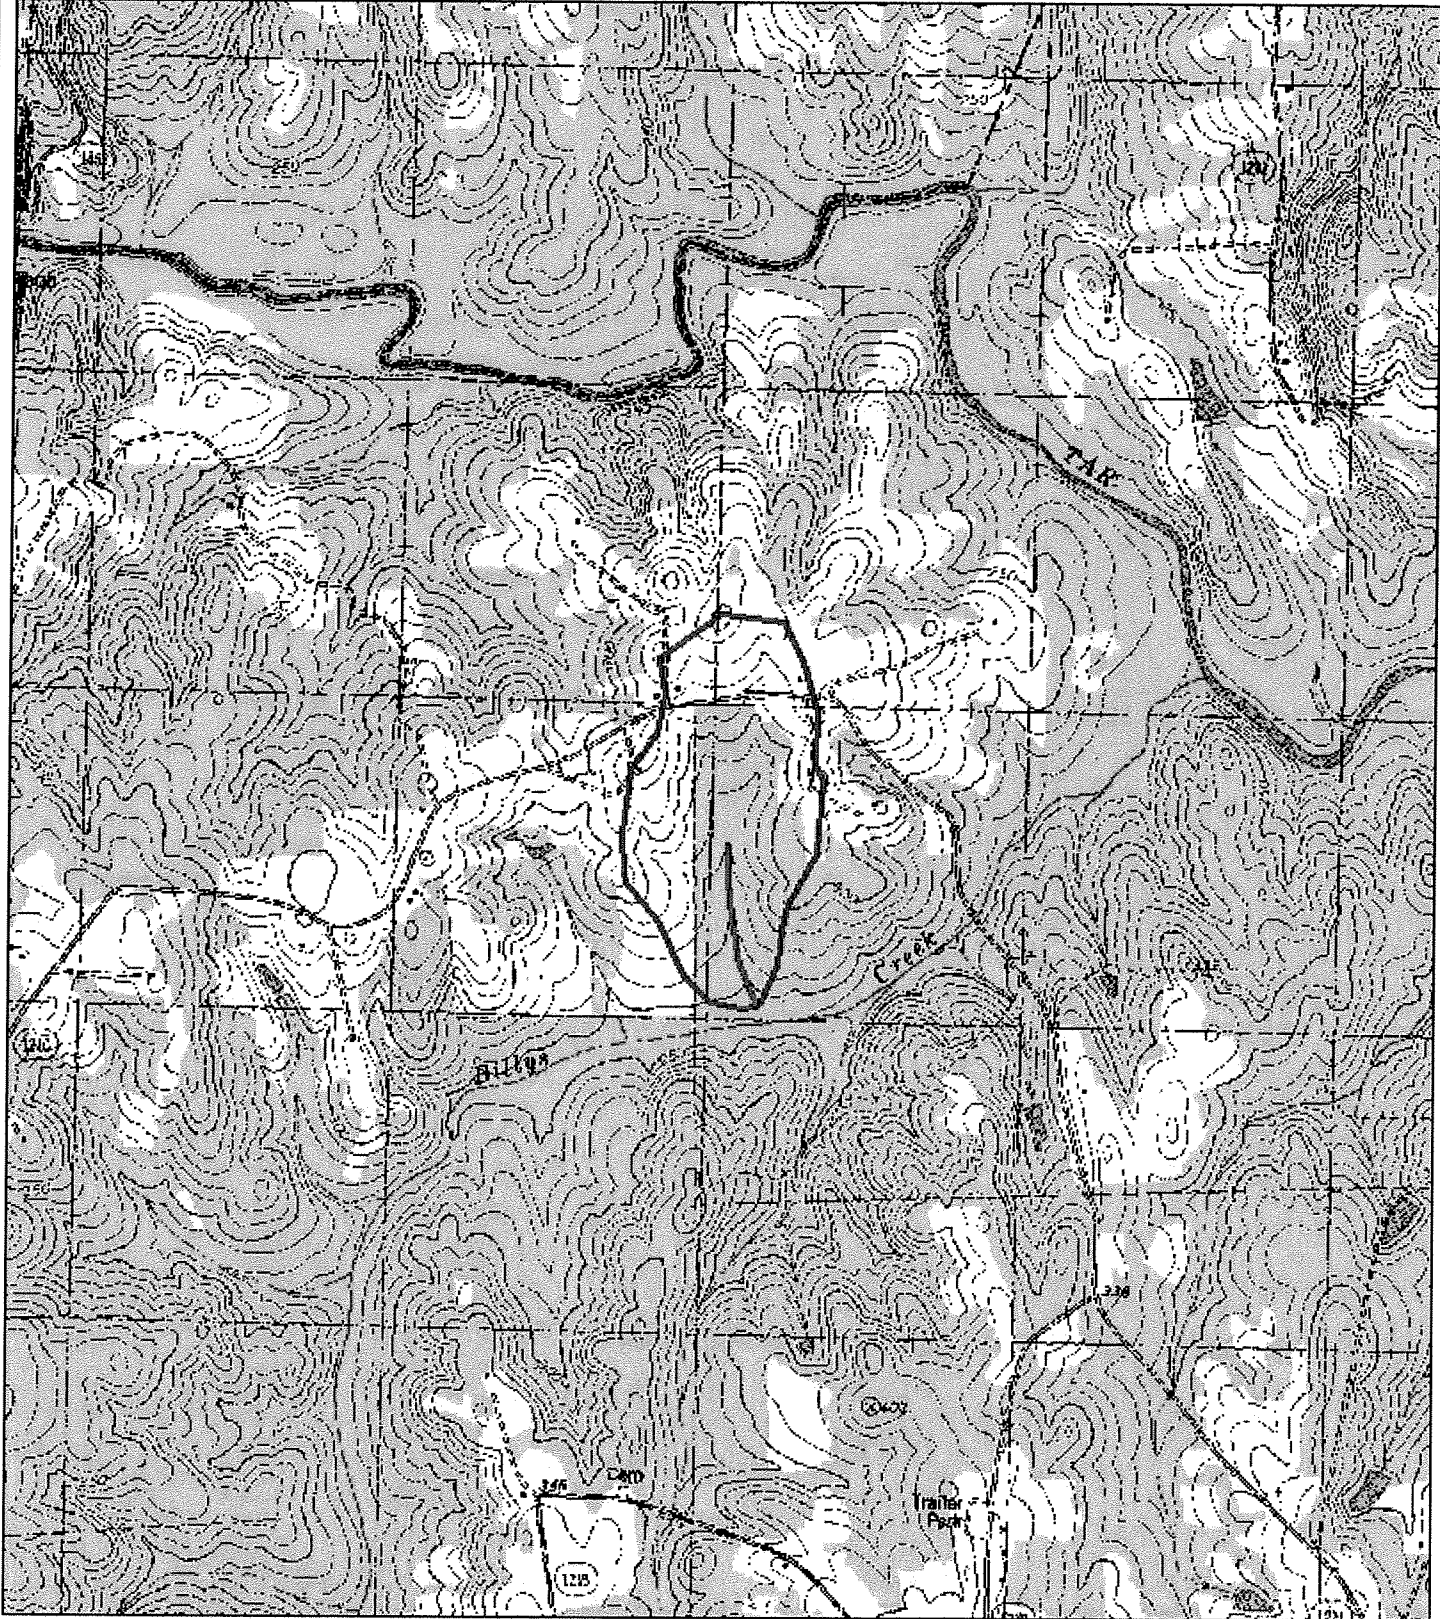
Figure 2 - Watershed Area  
Billy's Creek Stream Restoration Project

The drainage area for the tributary to Billy's Creek is approximately 143 acres or 0.22 square miles (Figure 2). A ridge approximately 800 feet north of Montgomery Road forms the north boundary of the project watershed. Montgomery Road (SR 1210) runs east-west through the northern third of the watershed. The watershed can be roughly divided in half by the unpaved

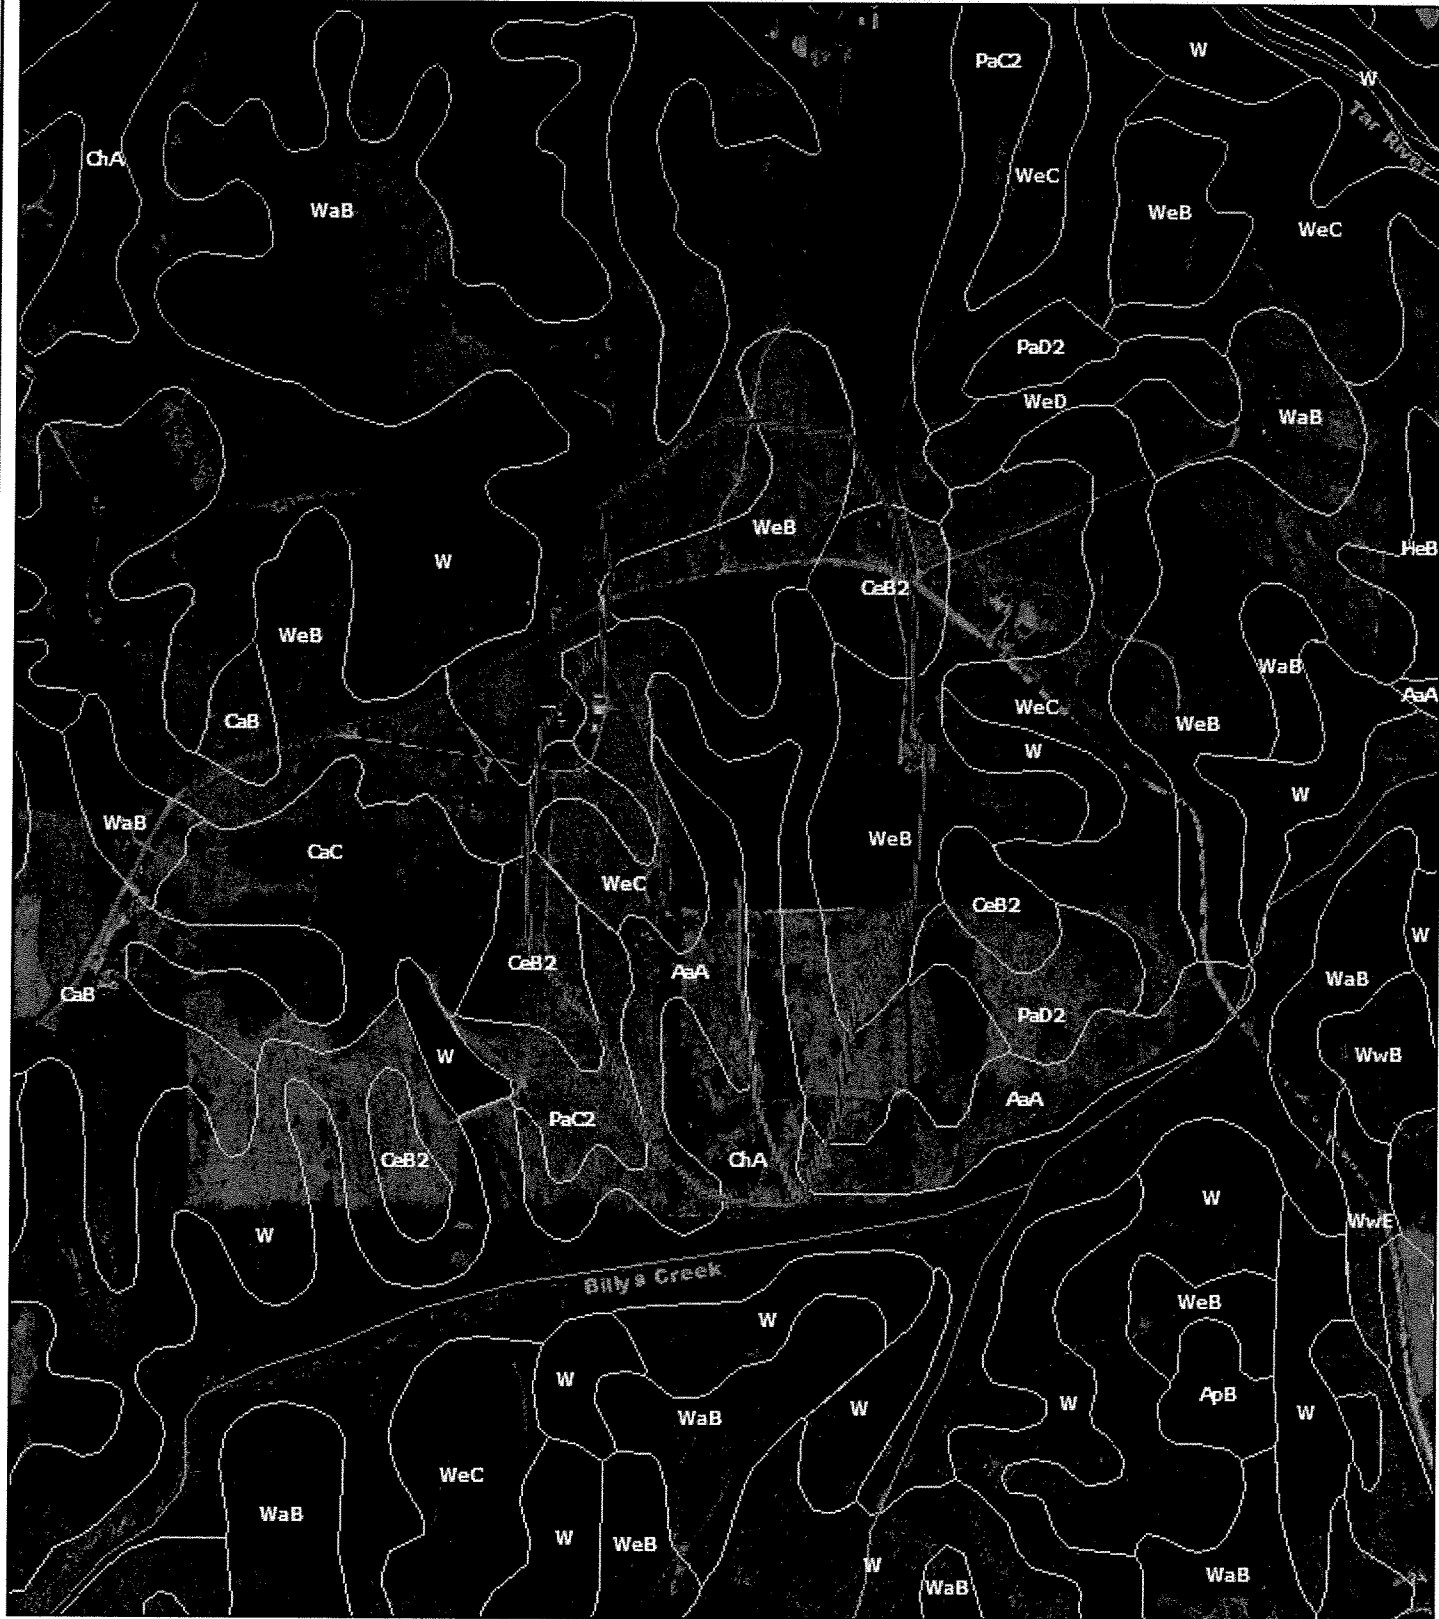
Figure 3 - Soils of the Watershed  
Billy's Creek Stream Restoration Project

Soil	
PaC2	Pacolet
PaD2	Pacolet
W	Water
WaB	Wake
WeB	Wedowee
WeC	Wedowee
WeD	Wedowee
WwB	Winnboro
WwE	Winnboro
AaA	Altavista
ApB	Appling
CaB	Cecil
CaC	Cecil
CeB2	Cecil
ChA	Chewacha
HeB	Helena

According to the *United States Department of Agriculture Natural Resources Conservation Service, Soil Survey of Franklin County, North Carolina*, Wedowee is the primary soil unit that is dominant within the watershed (1998) (Figure 3). The Wedowee unit consists of well-drained, yellowish-brown to brownish yellow loamy soils found on uplands. The major soil types found in the tributary to Billy's Creek watershed include:

The *United States Department of Agriculture-Natural Resources Conservation Service, Soil Survey of Franklin County, North Carolina (1998)*, indicated soils present along the tributary to Billy's Creek are exclusively Chewacla and Wehadkee (see Figure 3). The Chewacla series consists of nearly level, somewhat poorly drained soils of stream floodplains. The Wehadkee series consists of poorly drained soils on nearly level to slightly concave slopes. These soils are alluvium from soils that formed in residuum derived from metamorphic or igneous rock.

The soil underlying these wetland areas was identified from the soil survey as Chewacla and Wehadkee (Figure 3). The Chewacla series consists of nearly level, somewhat poorly drained soils of stream floodplains. The Wehadkee series consists of poorly drained soils on nearly level to slightly concave slopes. Both soil units are recognized by the NRCS as either hydric soils or potentially containing inclusions of hydric soils (NRCS, 1995). Standing water was apparent in all wetland areas. These areas were delineated by the three parameter method (Environmental Laboratories, 1987) in the spring of 2003, however jurisdictional concurrence has not been granted by United States Army Corps of Engineers.

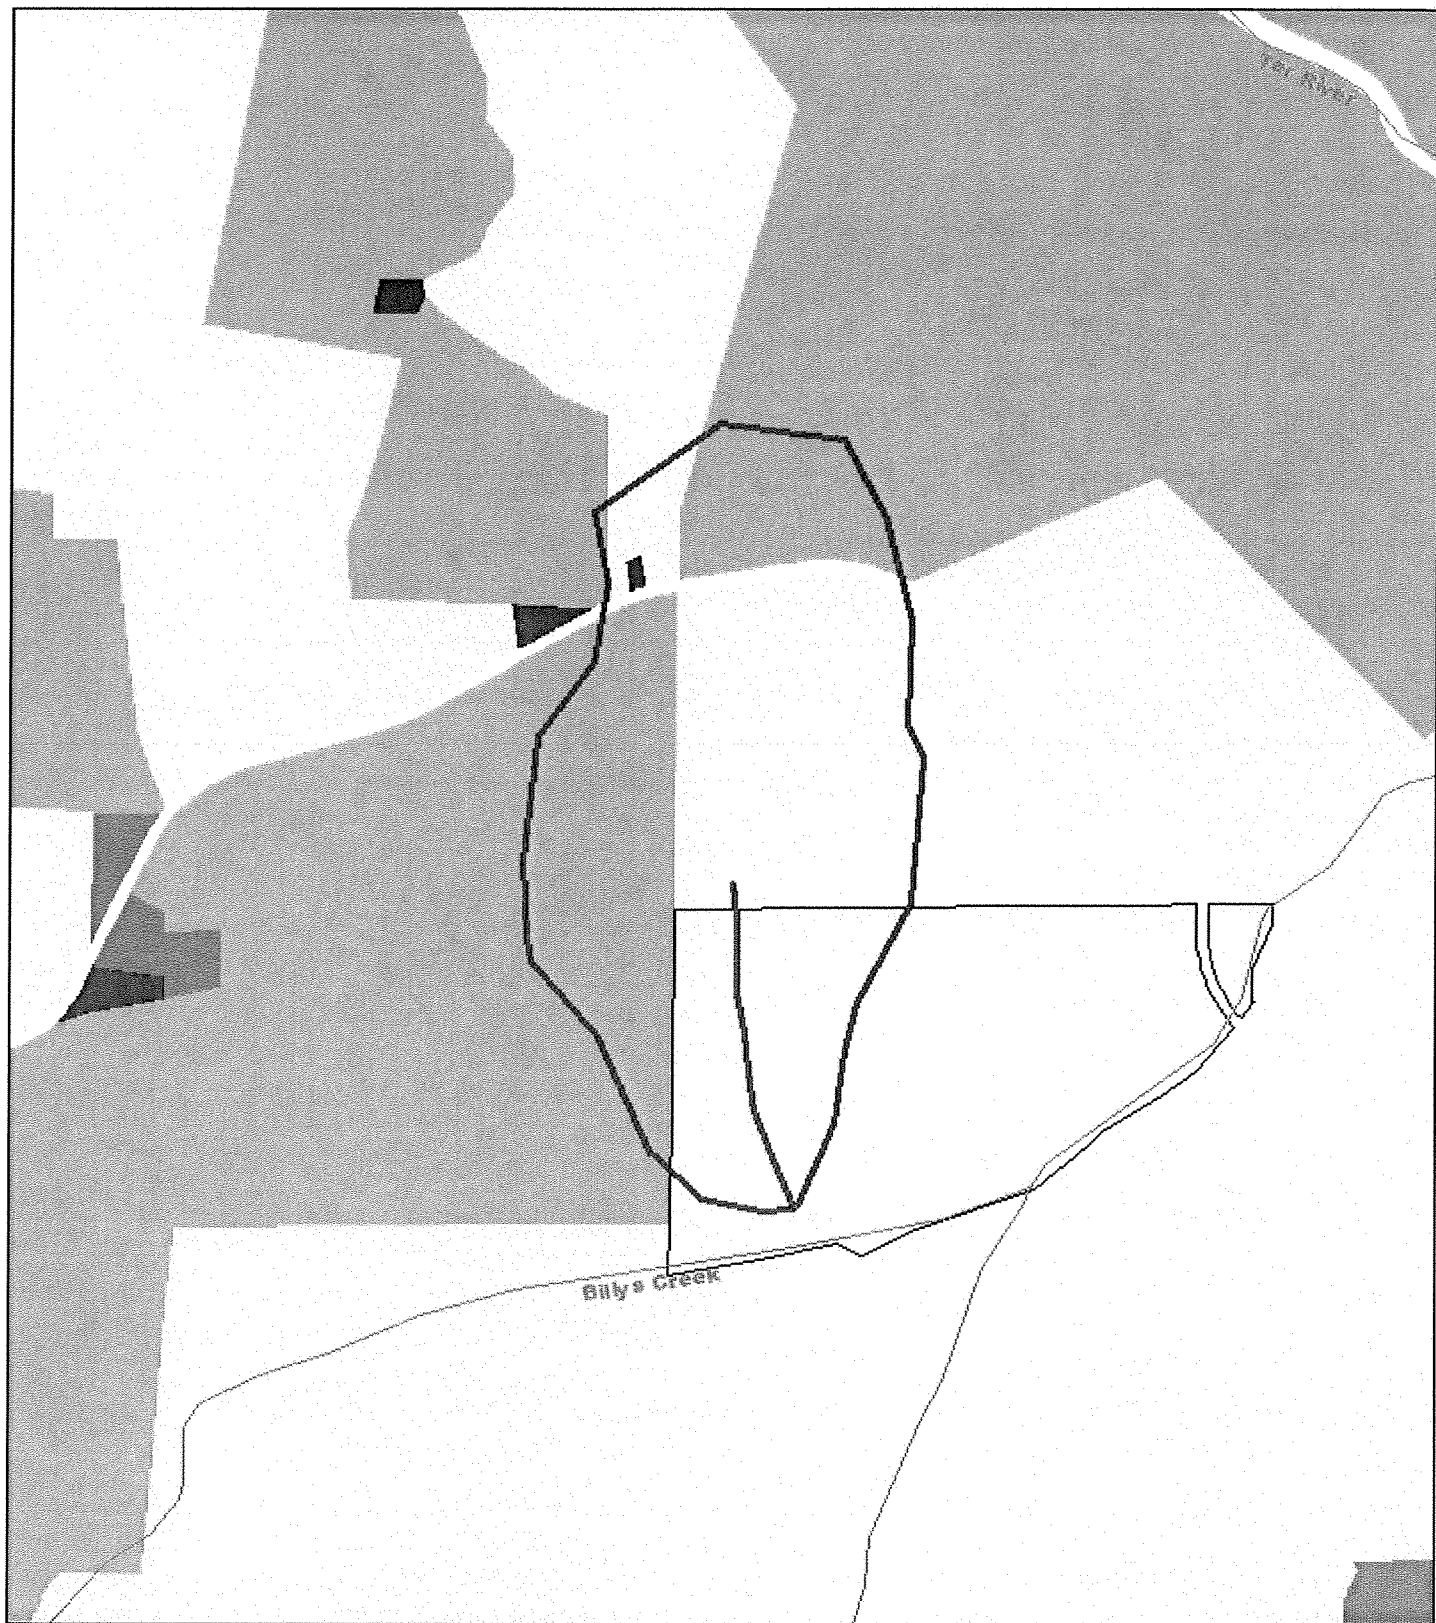
Figure 4 - Land Use within the Watershed  
Billy's Creek Stream Restoration Project

Agriculture and open space and agriculture and residential comprises almost the entirety of land use within the project area watershed, with a small area of roadway and high density residential (Figure 4, Table 1). Most of the agricultural land is in cattle pasture; however a substantial portion is forested. There are two residences and several farm buildings within the watershed. All of the project area is zoned as an Agricultural-Residential District. This zoning designation permits a mixture of agricultural, forestry, conservation, and very low-density residential uses with few public services (Franklin County, 2003).

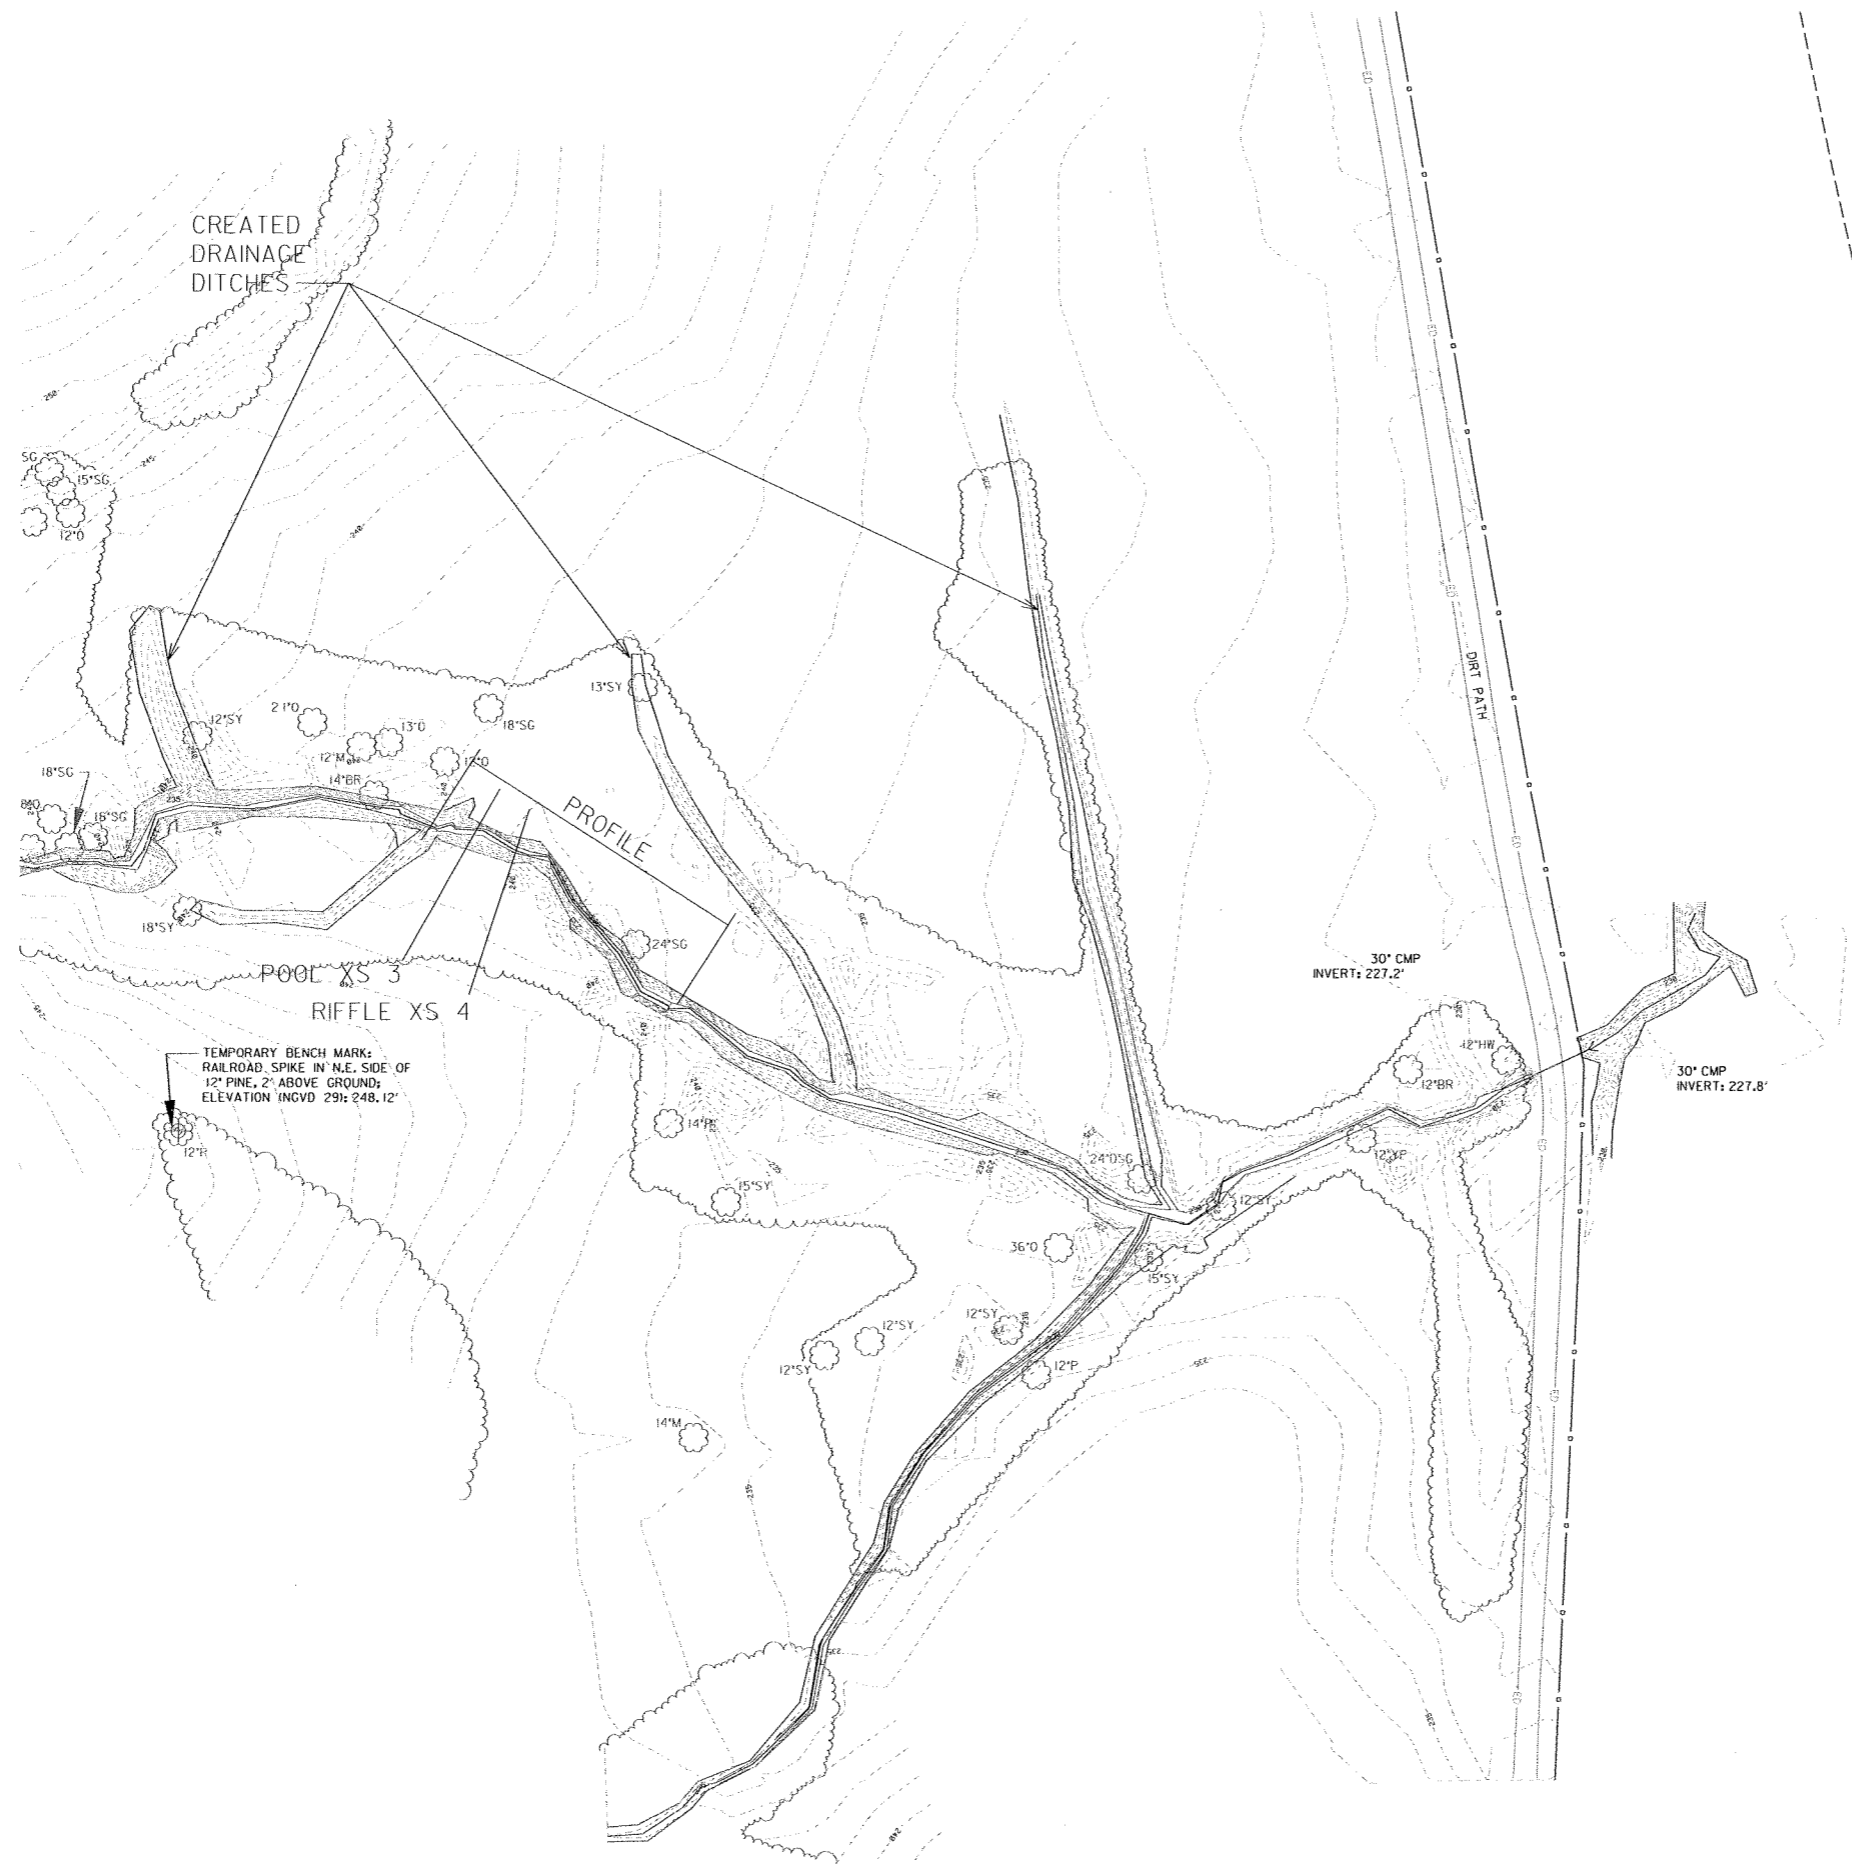
FIGURE: FIGURE 5-2  
 PROJECT: PROJECT REACH  
 TITLE: EXISTING CONDITIONS

30' CMP  
 T: 254.7'

The project reach of the un-named tributary to Billy's Creek is a 1800-foot long section of a perennial, degraded stream that occupies the lower portion of a 0.22 square mile drainage area (Figure 5 and Appendix A). The project reach is framed by 30-inch diameter culverts under unpaved farm roads at the north and south ends and pastured slopes to the east and west. There is at least one intermittent and four or more ephemeral tributary channels that flow into the project channel segment. The ephemeral channels were created to provide drainage within the floodplain. Approximately 600 feet south of the northern end of the project, the stream runs through an area of fairly active floodplain. Here, wetlands have developed in the relict channels and floodplain adjacent to the main channel of the stream. Downstream from this area, severe incision in the stream channel becomes apparent following a major grade control point. It appears that several trees and their root systems are providing the grade control at this location. The soil downstream of the trees is actively eroding and threatening the root system of these trees.

The cross sectional area within the project reach was measured at two riffle cross sections (see Figure 5 and Appendix B). The first cross section in the flat sinuous section of the tributary. The cross sectional area was approximately 7.3 square feet. This cross sectional area is just below the Rural NC regional curve. The regional curve does not include data for drainage areas of this size. The equation was used to extrapolate the curve for the project site. A pool cross section was also taken in this section. The cross sectional area was 10.3 square feet. The second set of cross sections was taken in the impacted reach. The bankfull cross sectional area of the riffle was 8.2 square feet. This cross sectional area is very close to the 8 square feet calculated for the Rural Piedmont Regional Curve. The pool had a cross sectional area of 15 square feet.

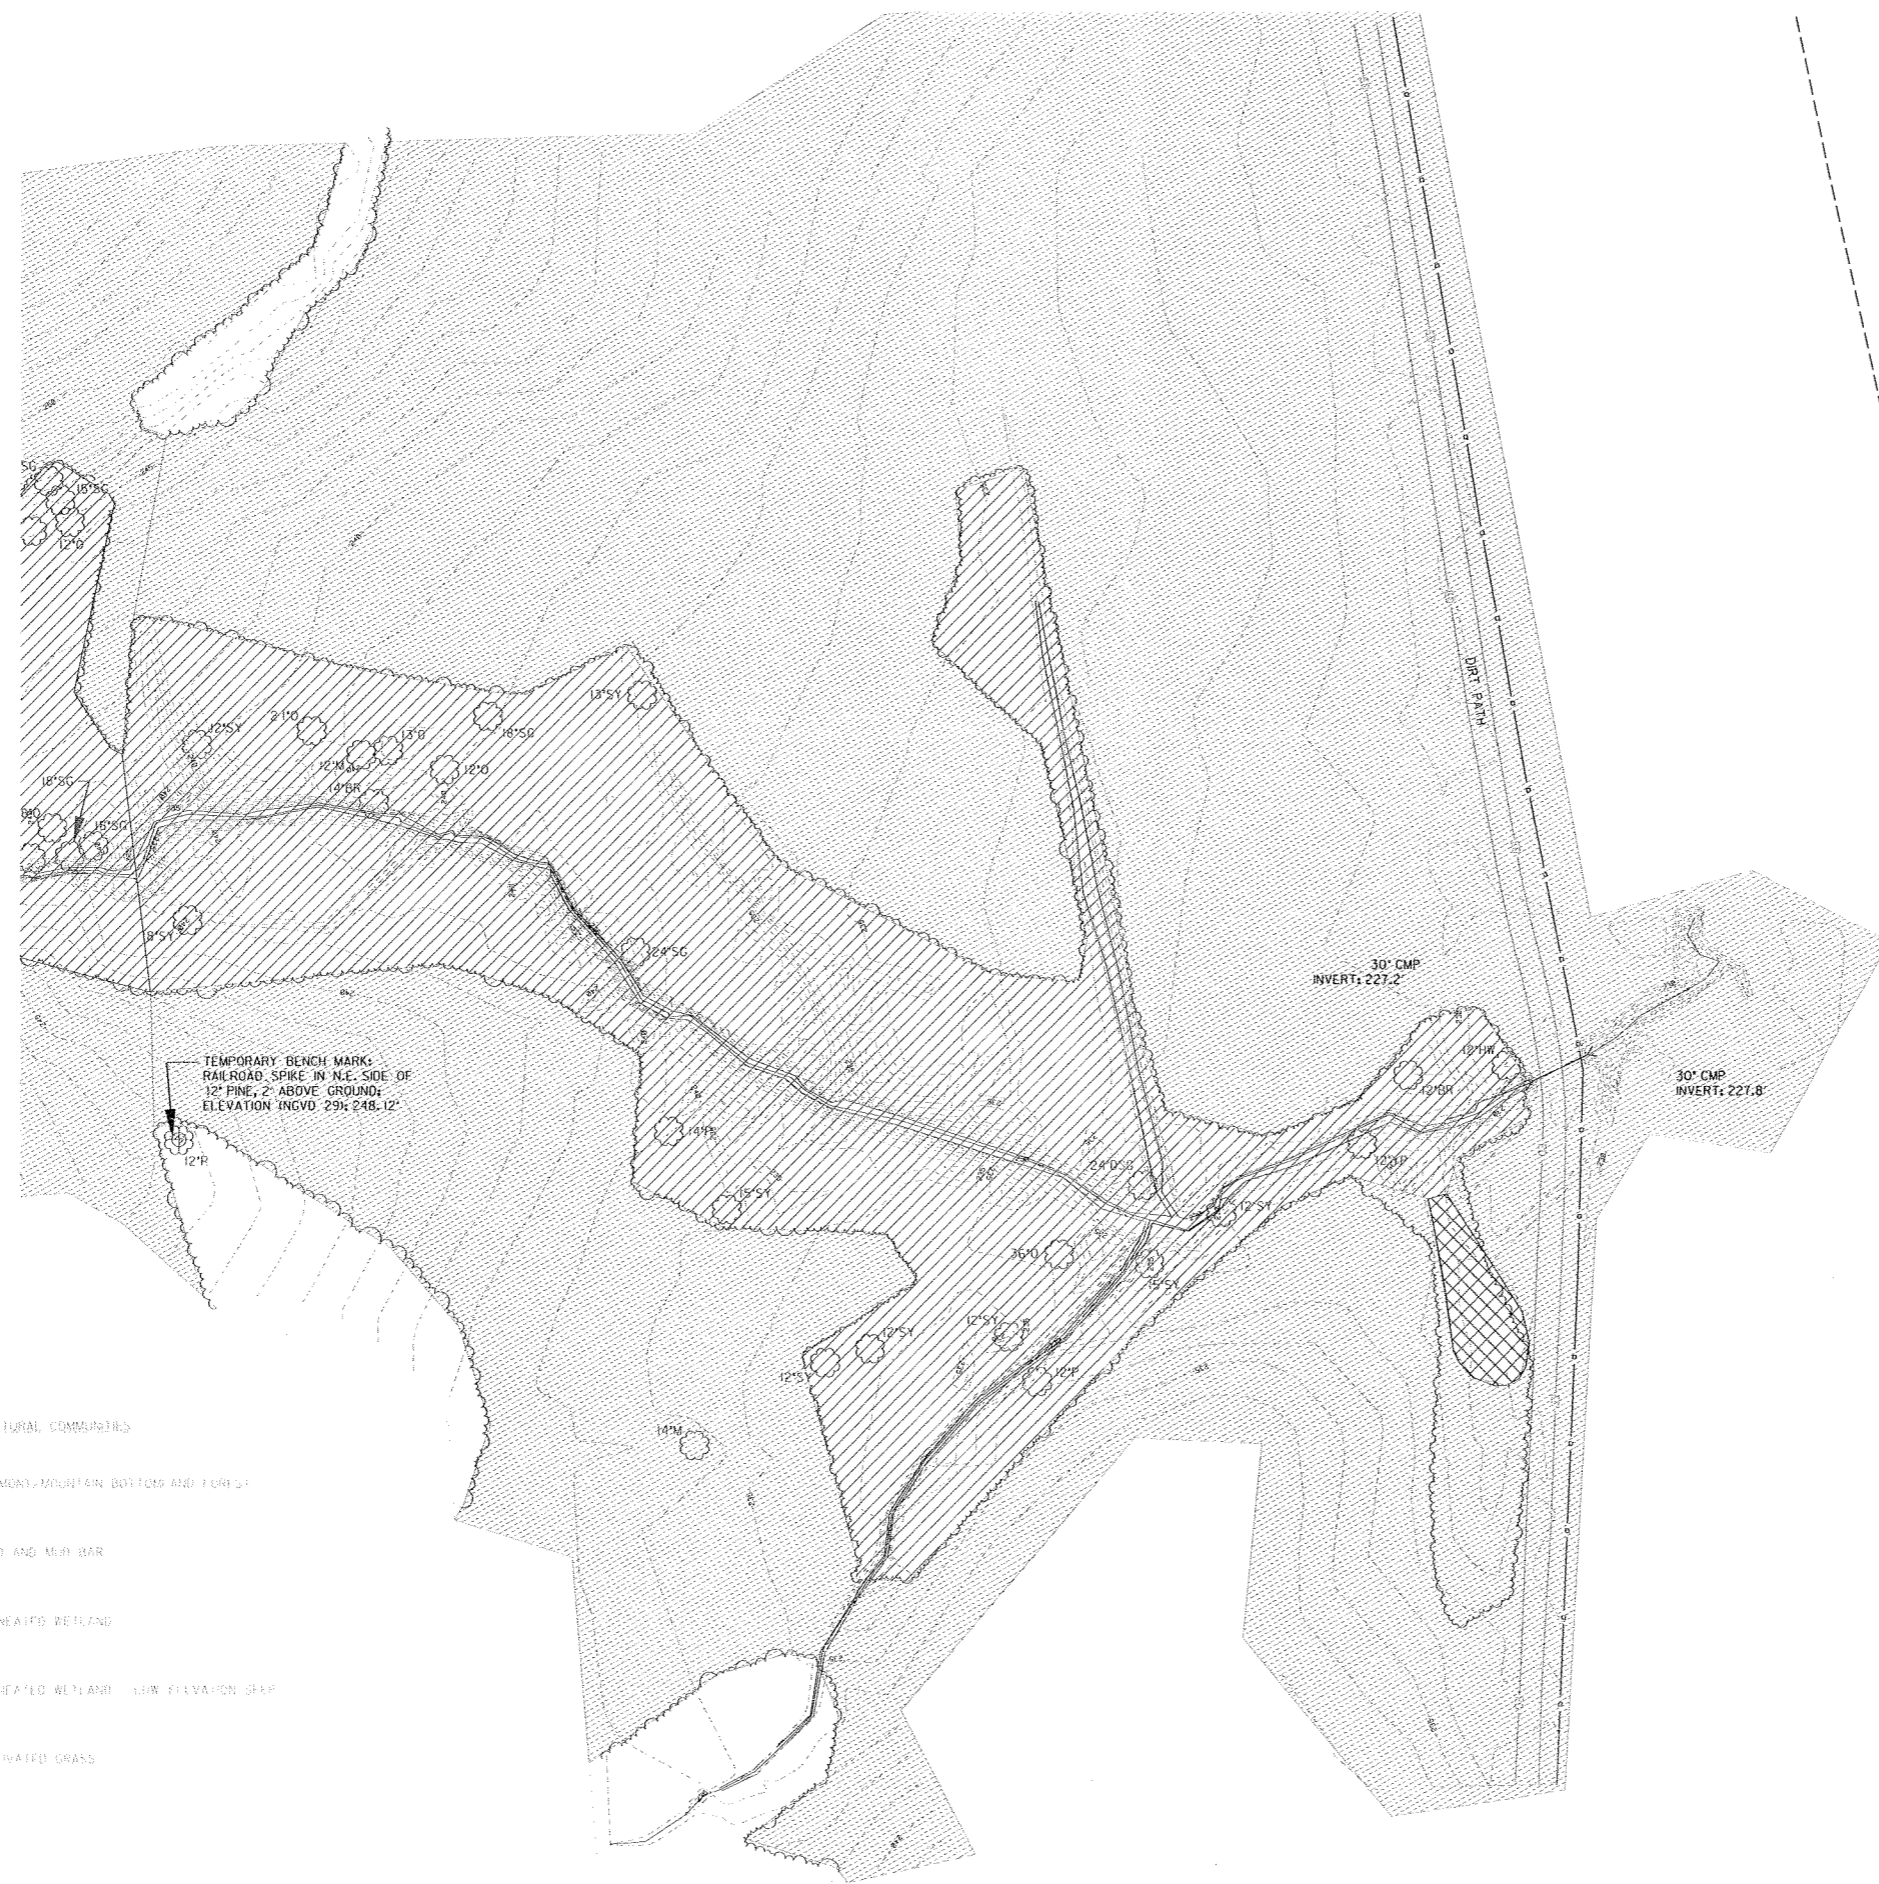
- EXISTING NATURAL COMMUNITIES
- PIEDMONT MOUNTAIN BOTTOMS AND FOREST
  - SAND AND MUD BAR
  - OPEN BAY WETLAND
  - RESTORED WETLAND - LOW FLOODPLAIN ZONE
  - RESTORED GRASS

There are four distinct vegetative communities adjacent to the project reach of the unnamed tributary to Billy's Creek (Figure 6). Three of these community types are described by Schafale and Weakley (1990).

- **Sand and Mud Bar.** This community was located centered on the stream channel within the bottomland forest matrix. It appears to cover around 12,000 square feet at the approximate halfway point on the project reach. The Sand and Mud Bar community appears to experience frequent flooding and accumulations of alluvial deposits typical of this community type were noted. The upper canopy in this community was not closed and was dominated by black willow, sweetgum, and red maple. Scattered individual American elms were also present. The shrub layer was very sparse and was composed of scattered saplings of the canopy tree species and some small Chinese privet. The herb layer was also very sparse and contained

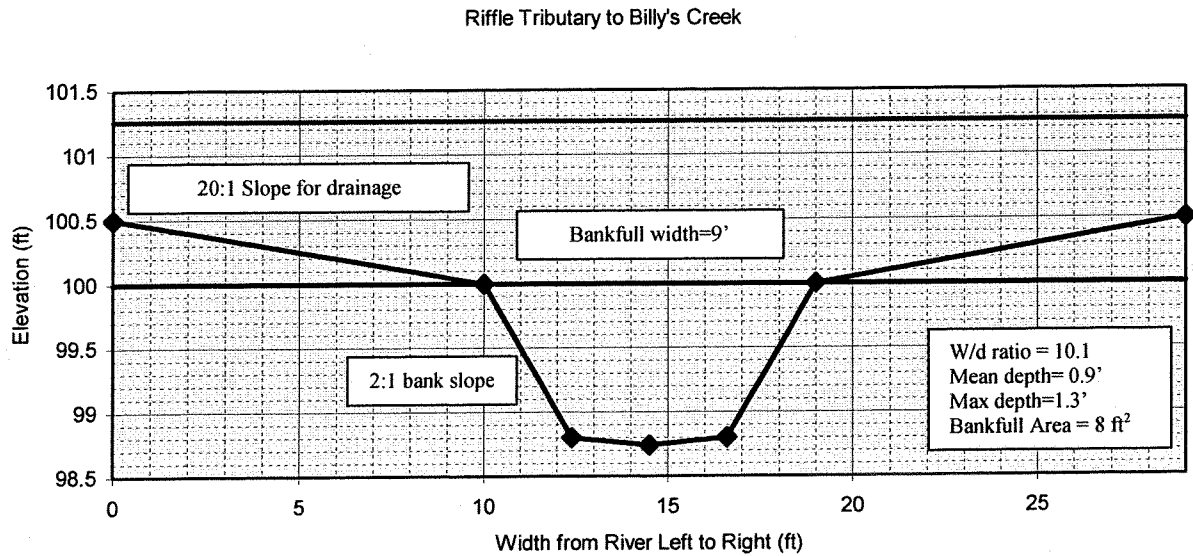
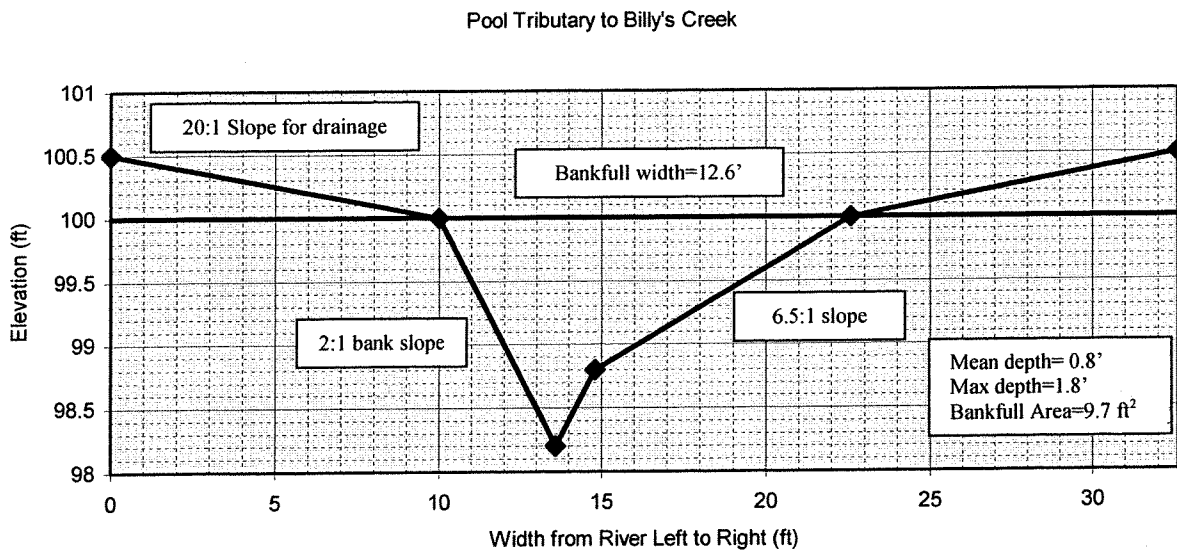
**Figure 9. Proposed Cross Sections.**

The cross sectional area proposed has an area of approximately 8 square feet, which was field verified in the existing condition survey and by the Piedmont Rural Regional Curve. The width to depth ratio in the proposed stream is 10.1. While this is higher than the width to depth ratio of the reference reaches, this will allow for a constructible stream with no more than 2 to 1 side slopes. A lower width to depth ratio channel is very difficult to build and stabilize. A bankfull bench has been included in the cross section and will only be used where necessary. In most cases the floodplain will be the same as the existing ground surface. Where necessary the bench will be at least 20 feet wide.

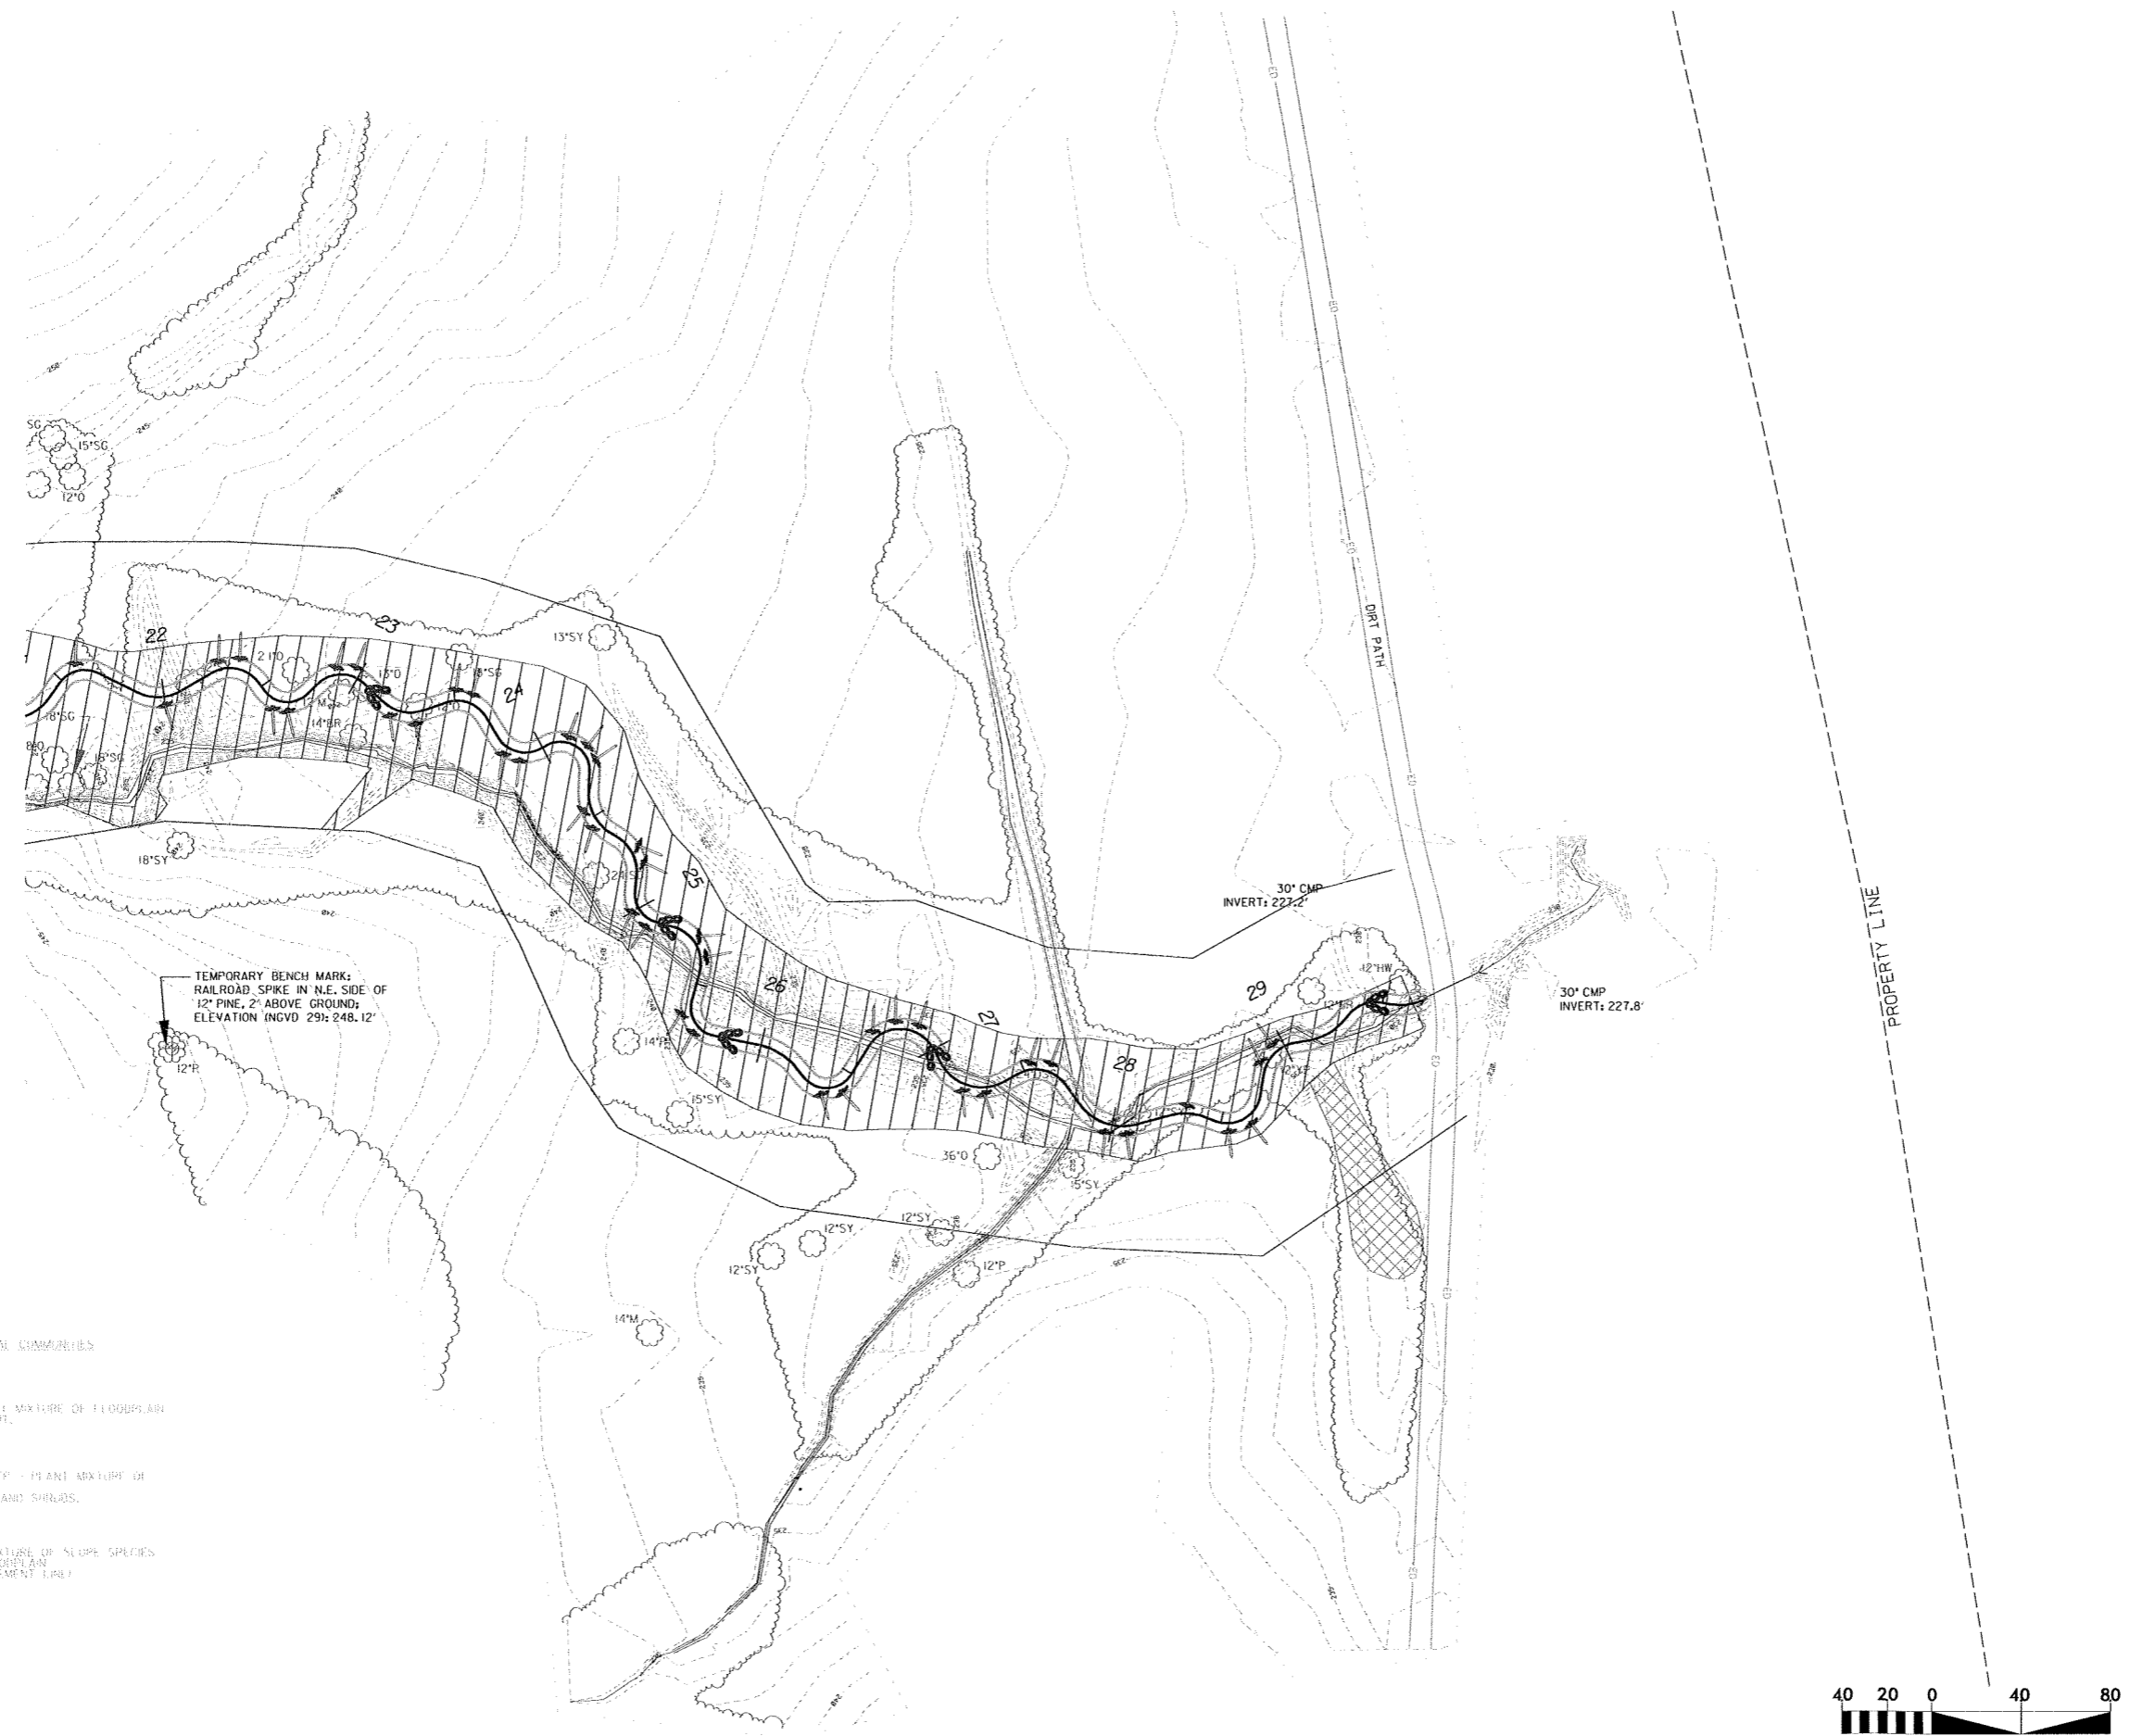
- PROPOSED NATURAL COMMUNITIES
-

The proposed plantings will cover the constructed stream banks, floodplain, and slopes between the floodplain and existing ground level (Figure 10). Generally, throughout the project, the target natural community to be created is a Piedmont Bottomland Forest. Alteration of the vegetative makeup of Sand and Mud Bar community will be limited to the removal of the non-native species currently identified in this area and promotion of existing species.

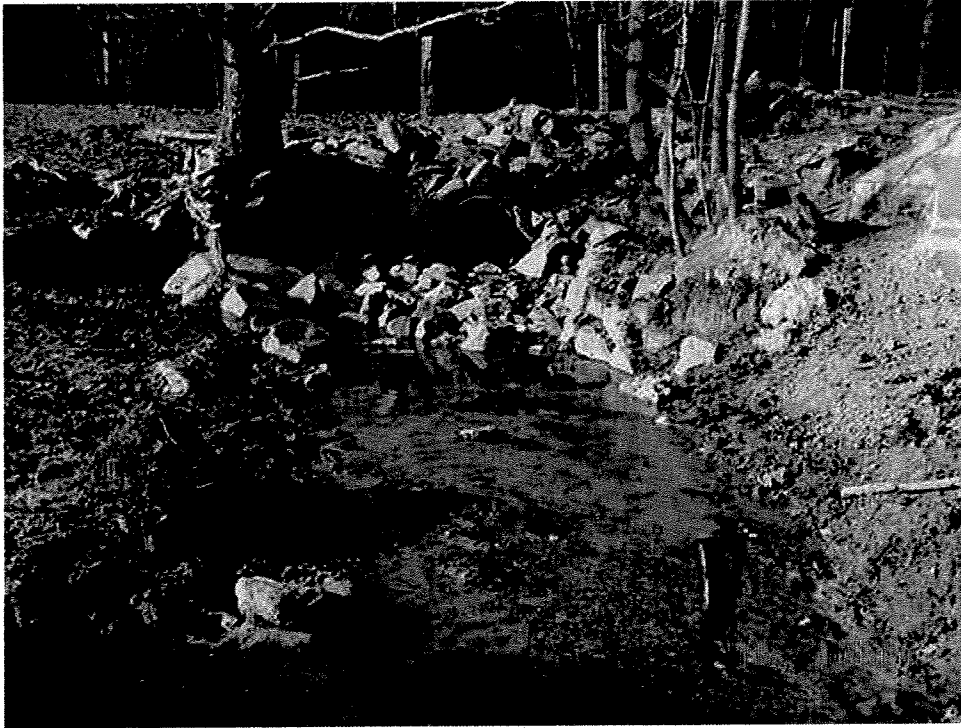
Picture 1. Culvert under farm road at north end of project reach, looking upstream.

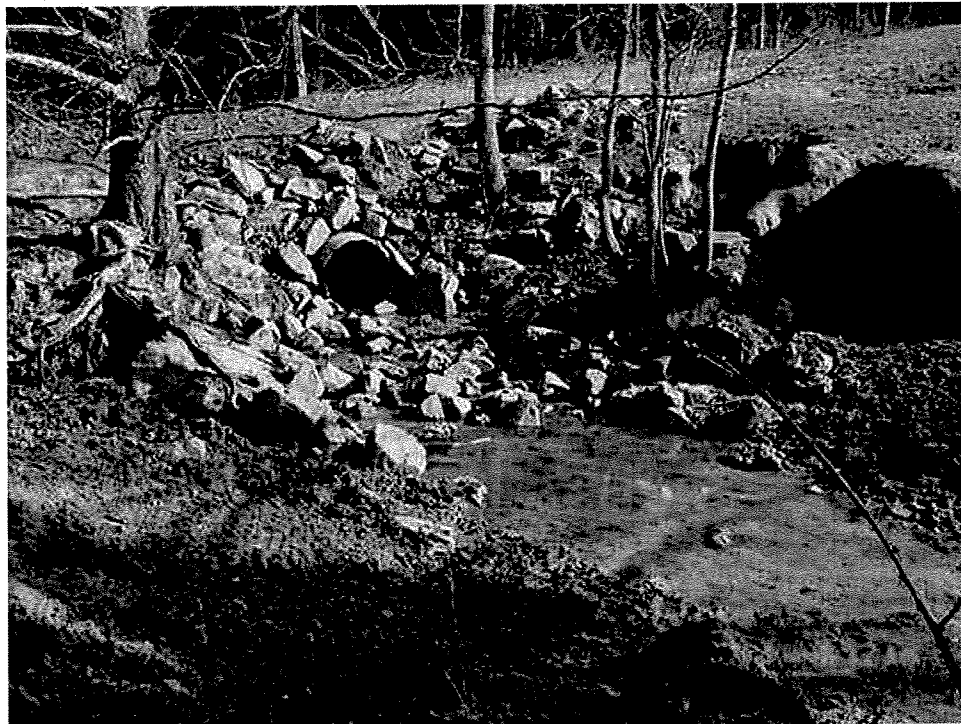
Picture 2. Culvert under farm road at north end of project reach, looking upstream from west bank.
