# **BILLY'S CREEK STREAM RESTORATION PLAN**

**AUGUST 11, 2003**

# **URS**

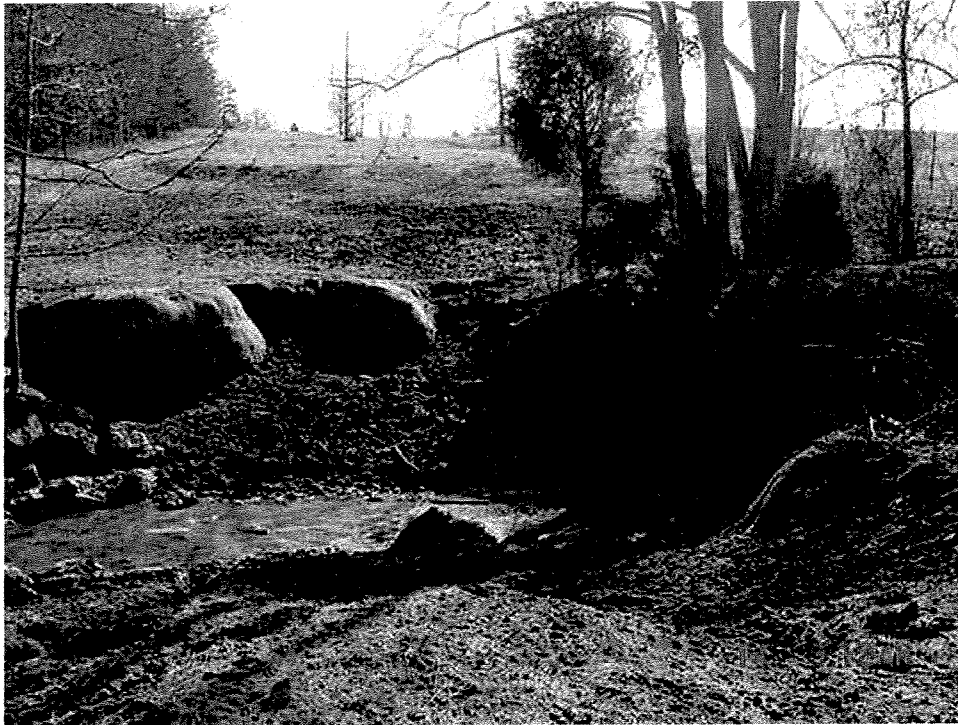
Picture 3. View of highly eroded east bank approximately 20 feet downstream from the north end of the project reach.

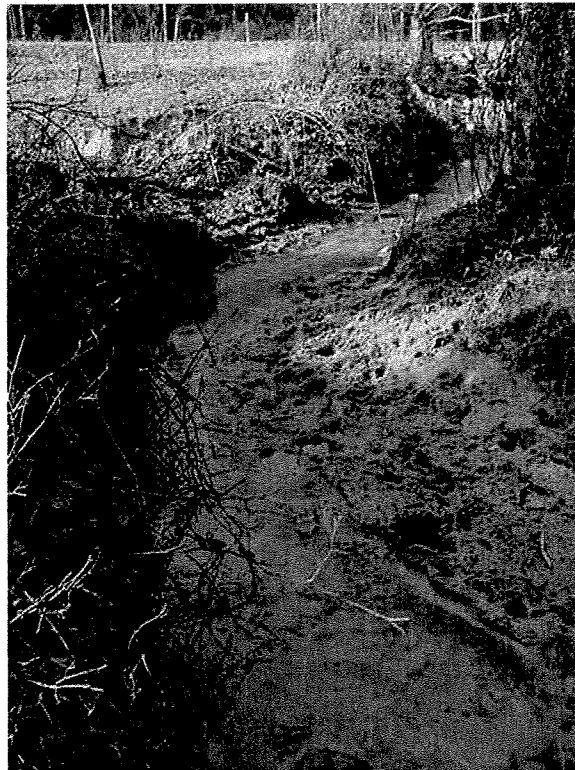
Picture 4. View of west bank of eroded area shown in Picture 3 from downstream.

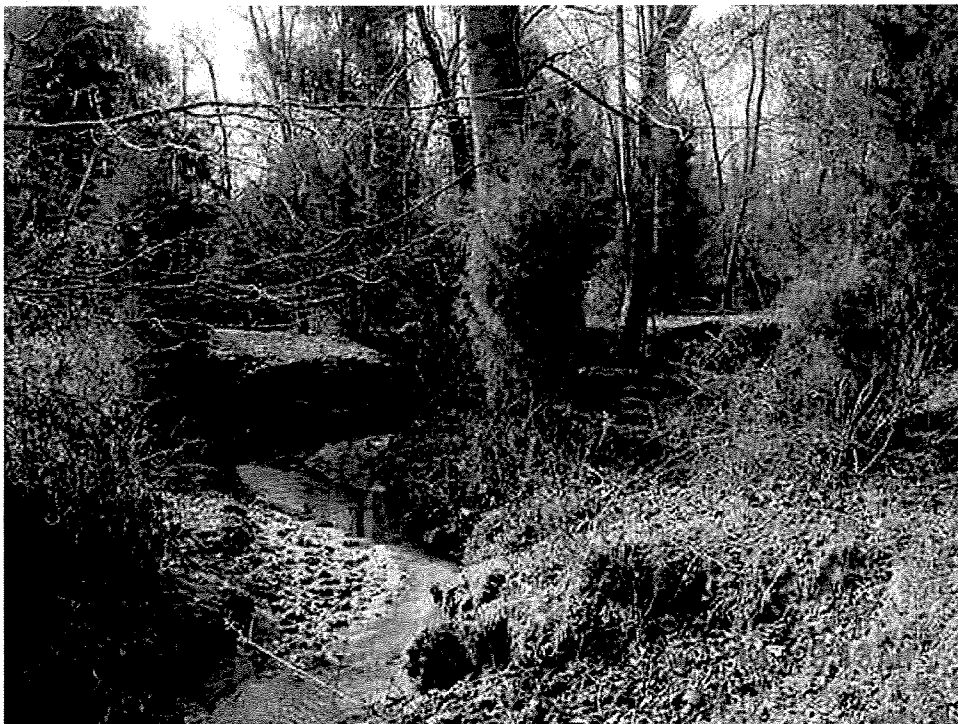
Picture 6. Area impacted by livestock crossing. View looking downstream.

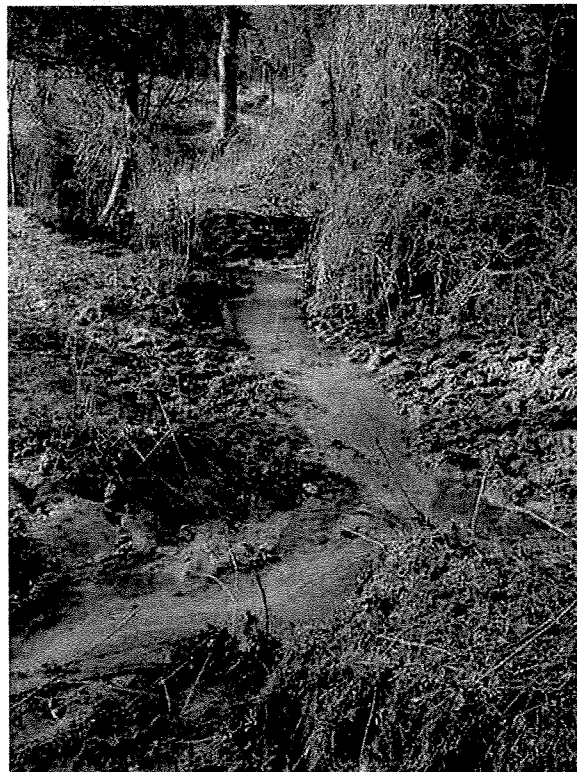
Picture 8. Area impacted by livestock crossing. View looking upstream.

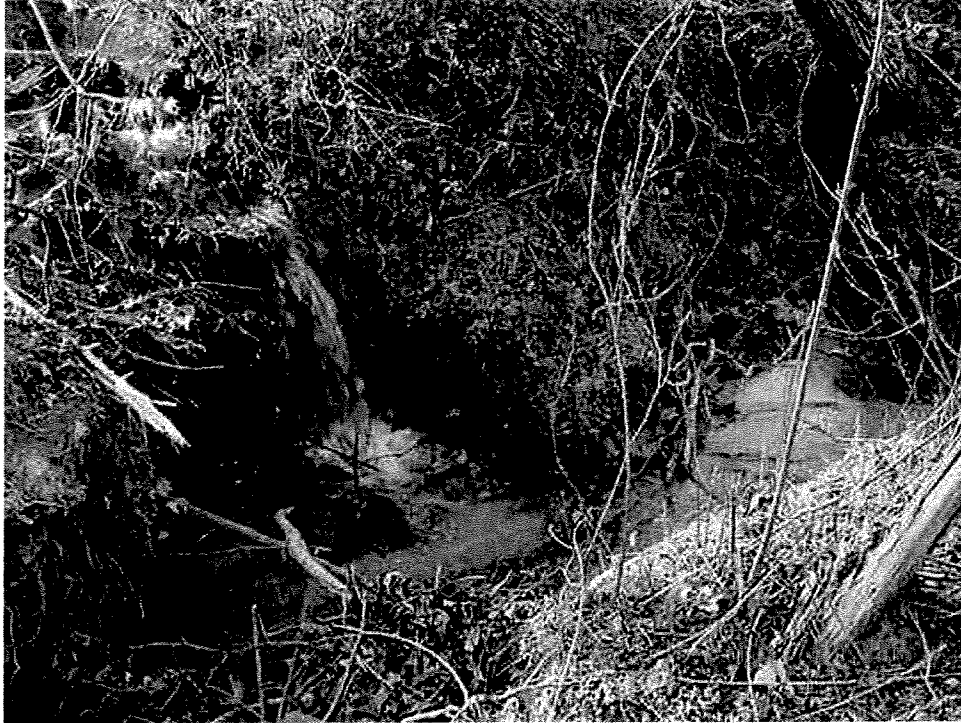
Picture 13. Grade Control Point.

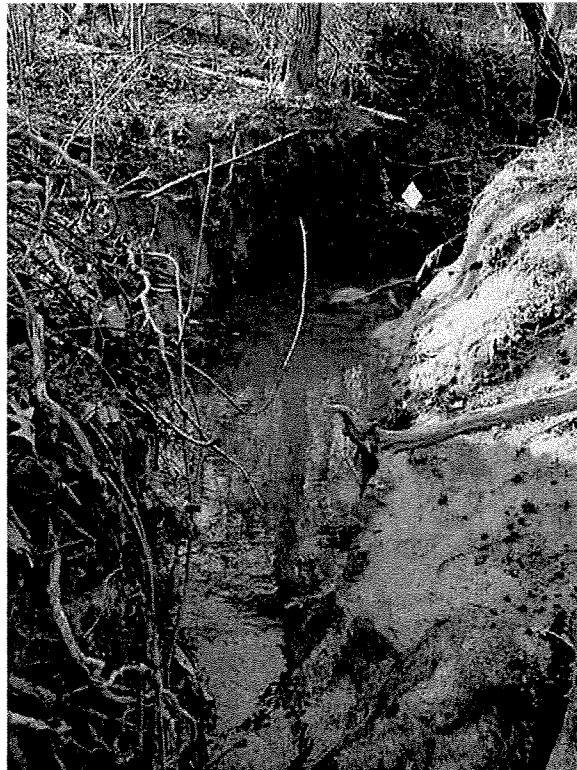
Picture 14. Downstream of Grade Control. Note highly incised stream banks on both sides.

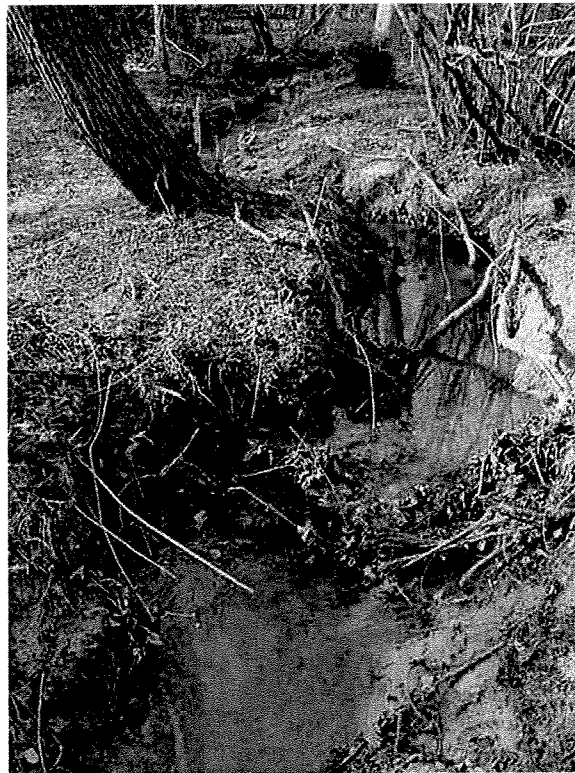
Picture 15. Eroded stream bank and alluvial deposit in meander.

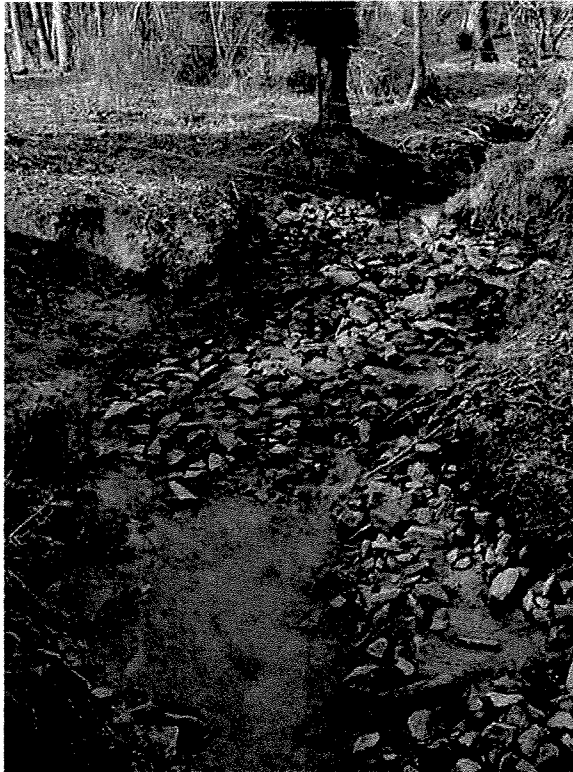
Picture 16. Grade control and undercutting in bank.

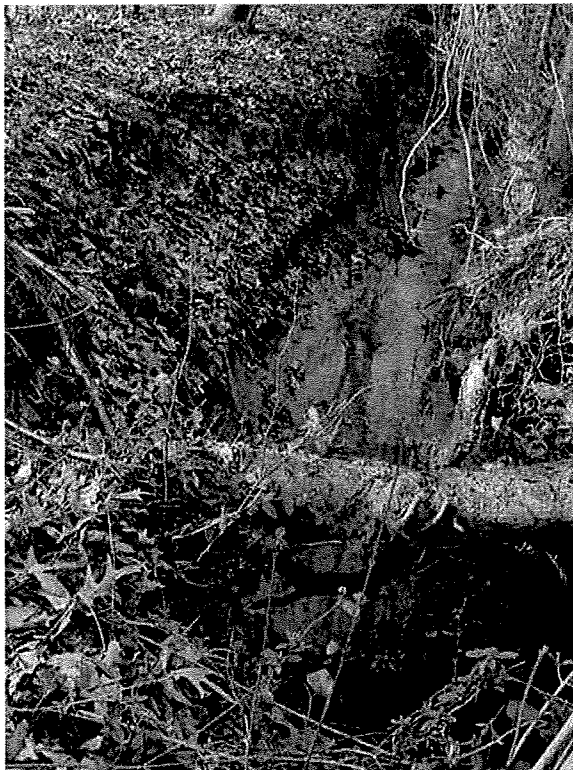
Picture 17. Impact from livestock crossing and stone added to stabilize banks at fence line.

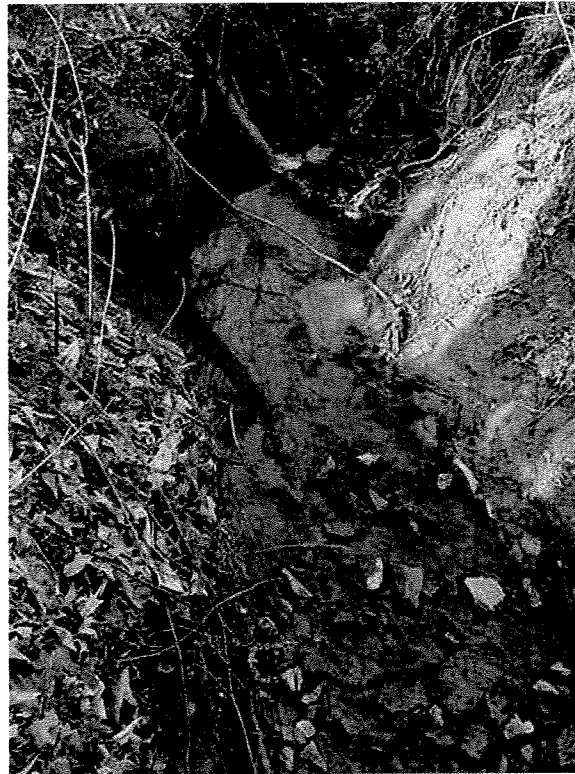
Picture 18. Highly incised banks downstream from fence line shown in Picture 17.

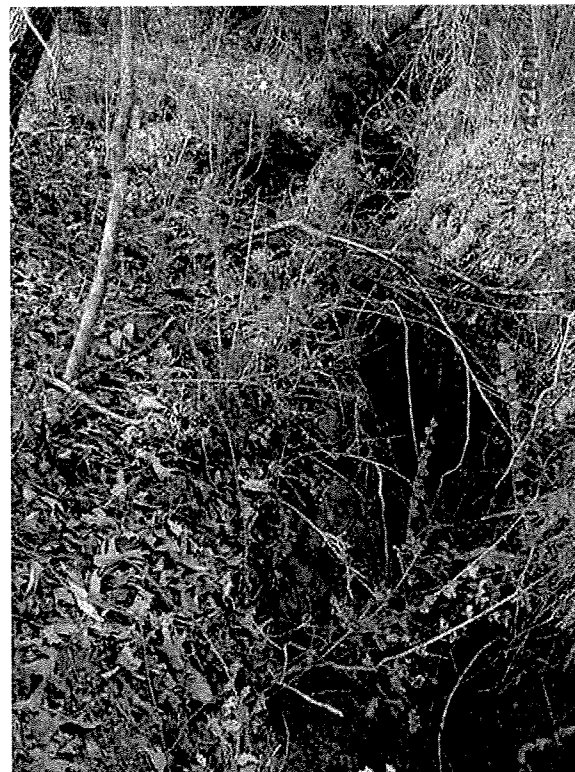
Picture 19. Highly incised and collapsing stream banks.

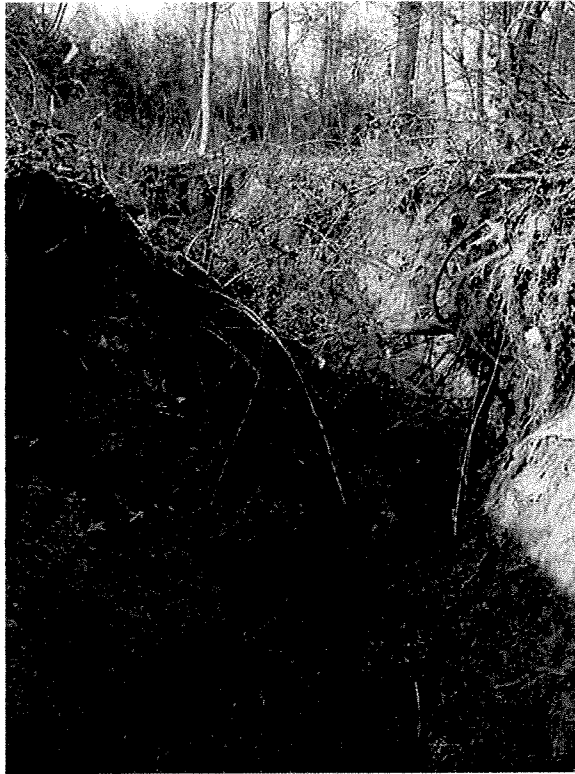
Picture 20. Highly incised stream banks.

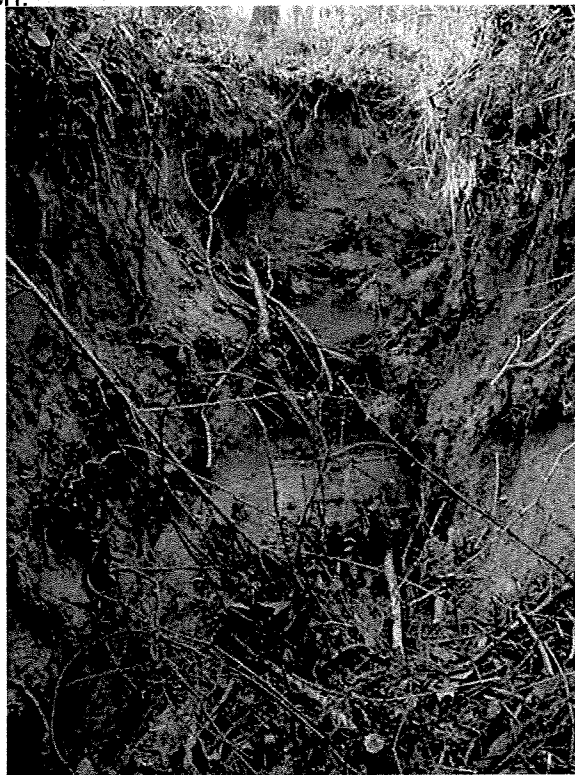
Picture 21. Highly incised and eroded stream banks south of center of project reach.

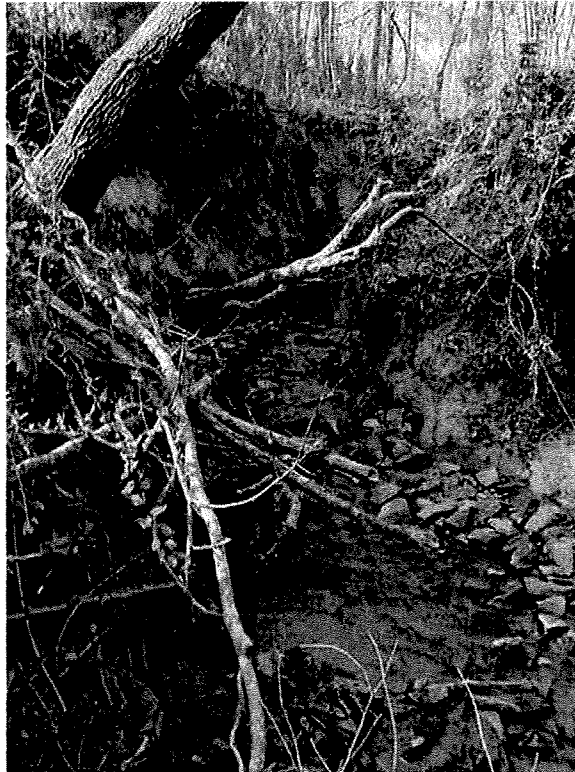
Picture 22. Highly incised and eroded stream banks downstream from Picture 21.

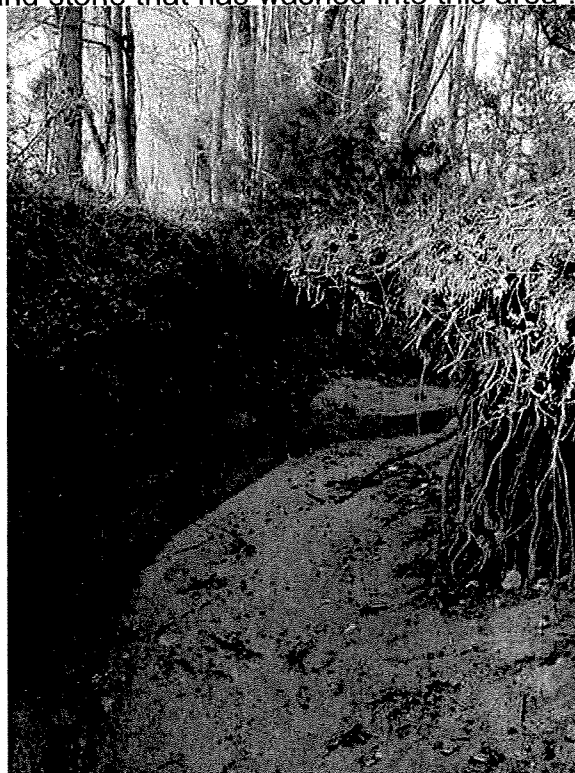
Picture 23. Highly incised and eroded stream banks. Note undercutting and stone that has washed into this area.

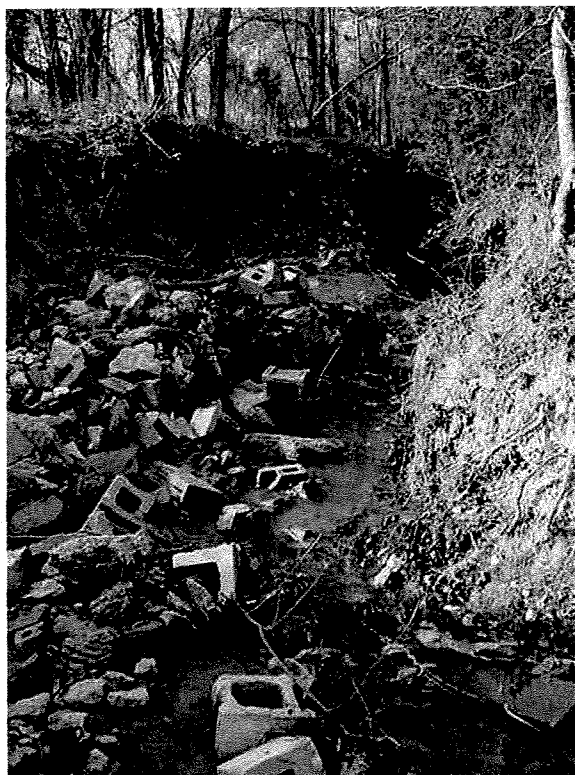
Picture 24. Highly incised and eroded stream banks. Note alluvial deposition and exposed root mass on inside of bend.

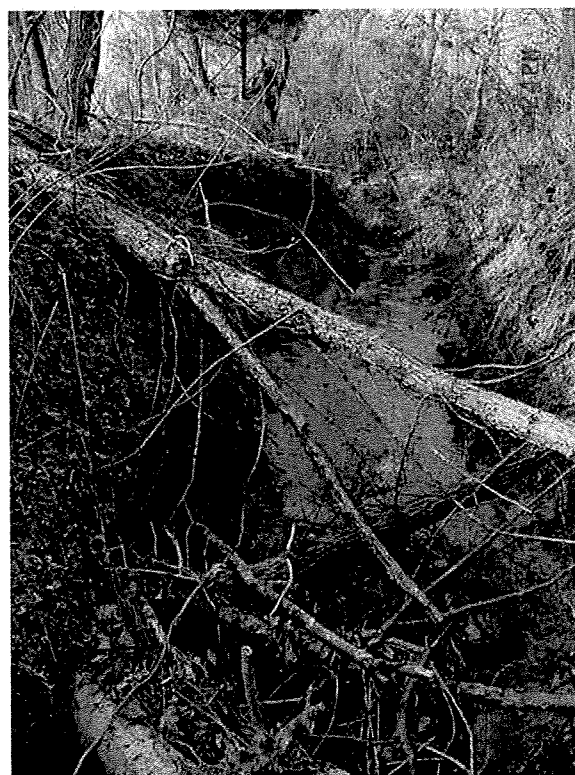
Picture 25. Highly incised and eroded stream banks. Debris added to stabilize channel.

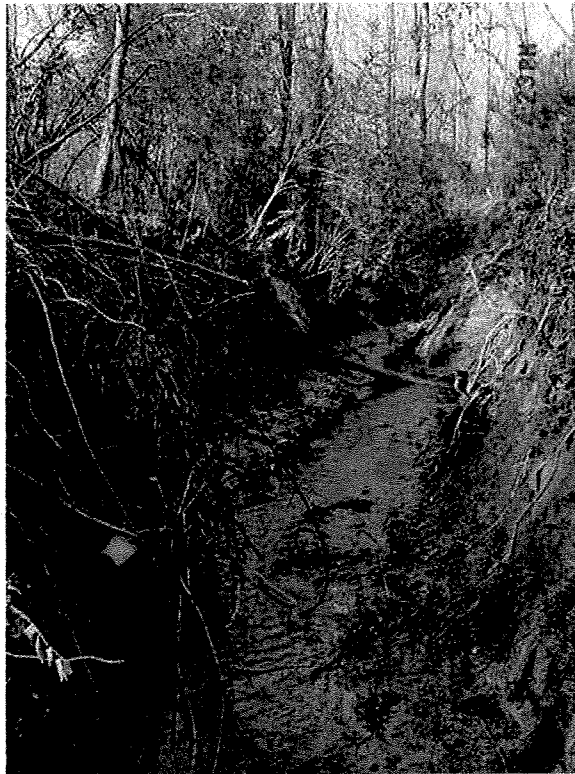
Picture 26. Highly incised eroded stream banks. Note woody debris collected in channel.

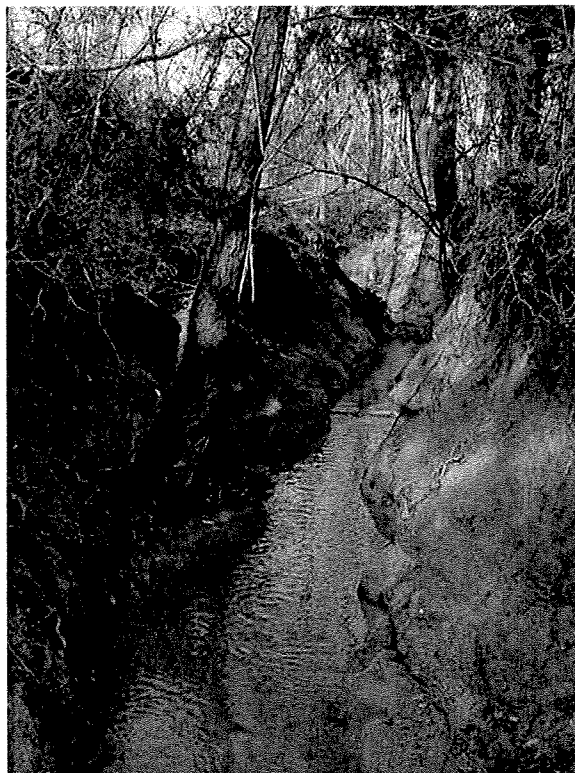
Picture 27. Highly incised channel. Pink flag indicates location of bankfull bench.

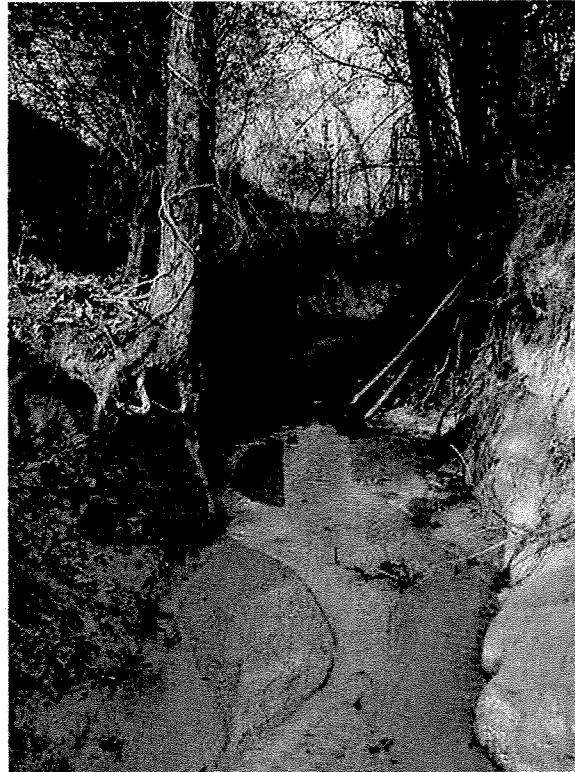
Picture 28. Highly incised and eroded stream banks. Note undercutting.

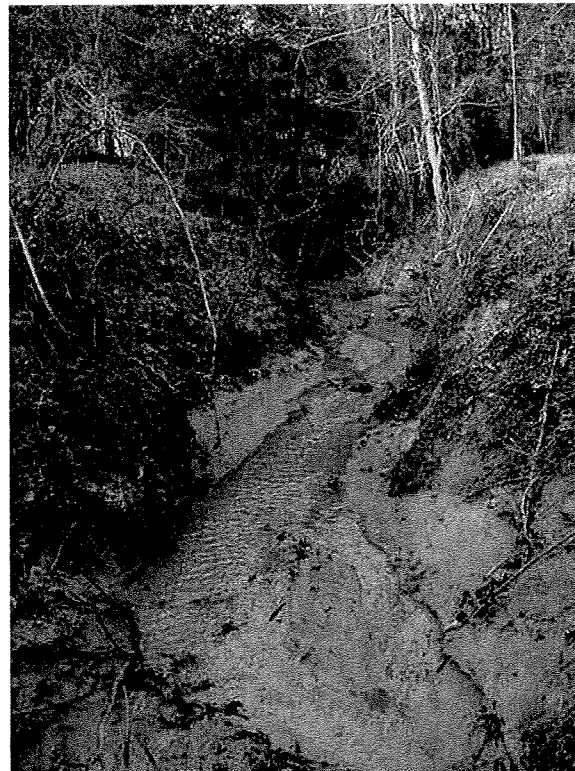
Picture 29. Highly incised and eroded stream banks.

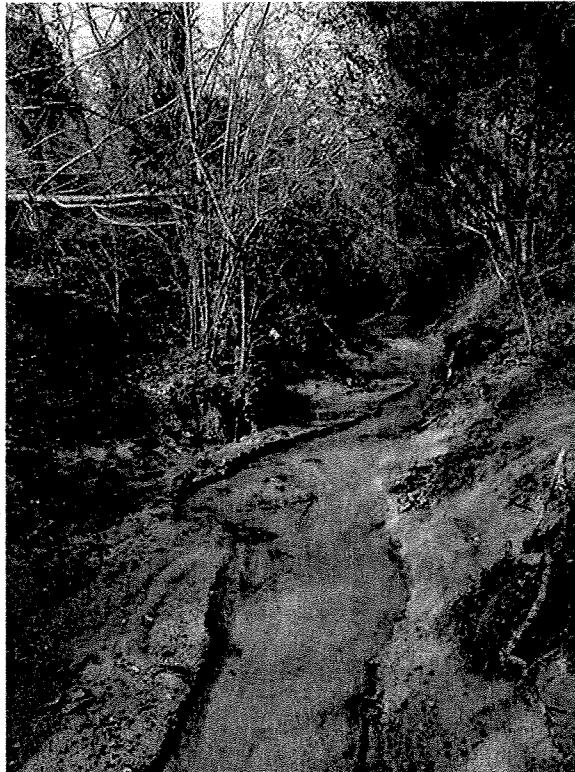
Picture 30. Highly incised and eroded stream banks.

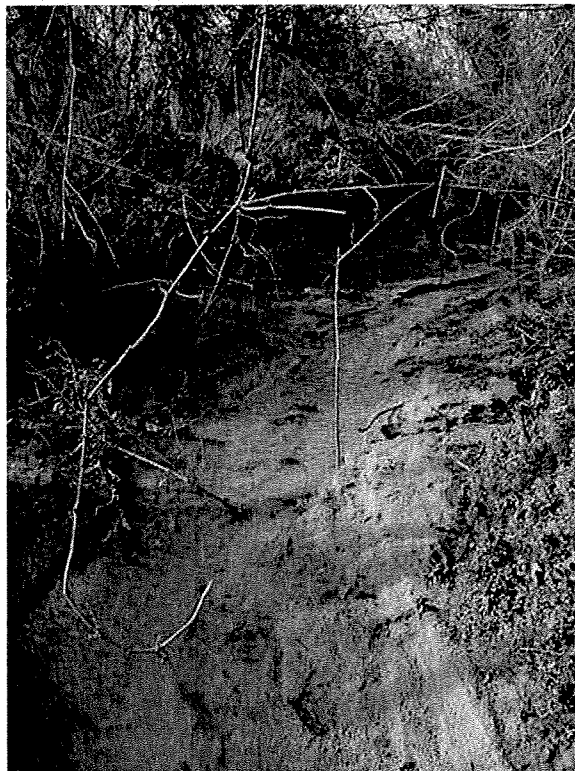
Picture 31. Alluvial deposits south of highly incised section.

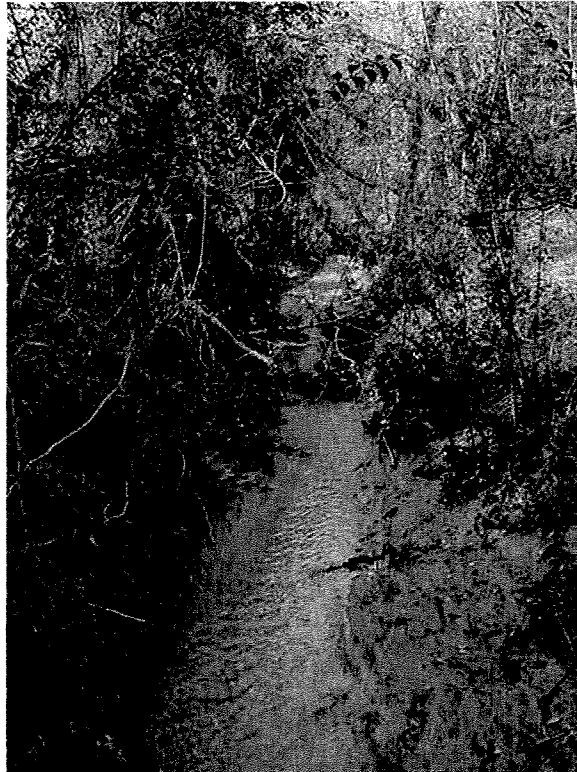
Picture 32. Widening channel at south end of project looking upstream. Tributary entering on the left.

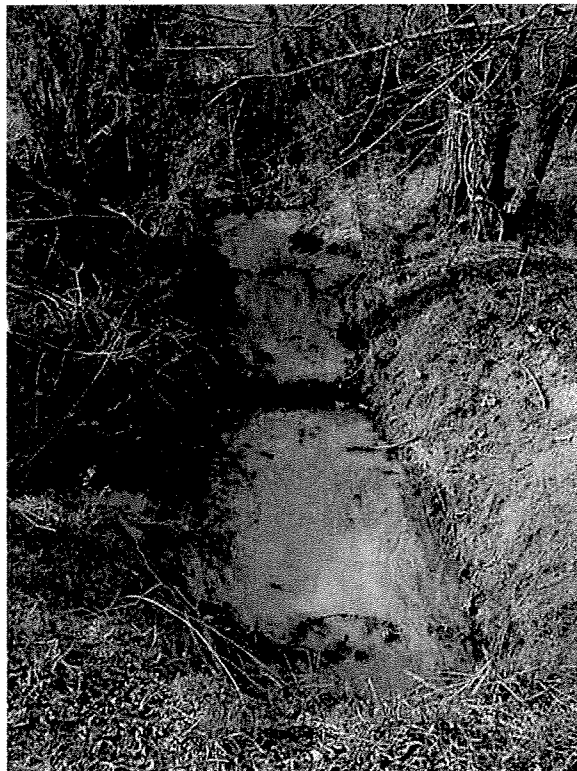
Picture 33. View looking north and upstream near southern end of project reach. Note invasive Chinese privet on west bank.

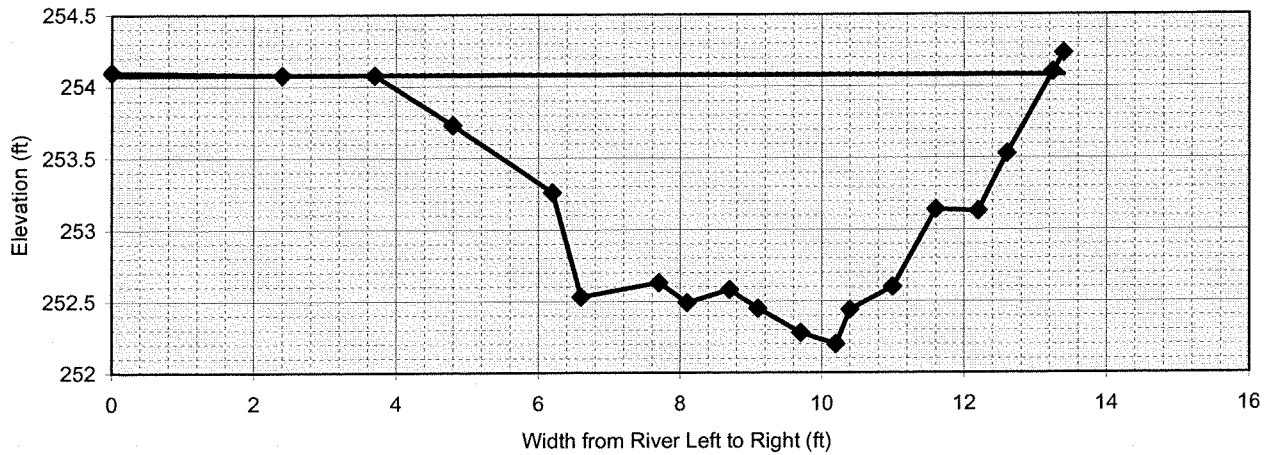
section: Cross Section 2

Pool  
Tributary to Billy's Creek  
---

check from channel material			
4	measured D84 (mm)		
79.9	relative roughness	13.7	fric. factor
0.000	Manning's n from channel material

The cross sectional area within the project reach was measured at two riffle cross sections (see Figure 5 and Appendix B). The first cross section in the flat sinuous section of the tributary. The cross sectional area was approximately 7.3 square feet. This cross sectional area is just below the Rural NC regional curve. The regional curve does not include data for drainage areas of this size. The equation was used to extrapolate the curve for the project site. A pool cross section was also taken in this section. The cross sectional area was 10.3 square feet. The second set of cross sections was taken in the impacted reach. The bankfull cross sectional area of the riffle was 8.2 square feet. This cross sectional area is very close to the 8 square feet calculated for the Rural Piedmont Regional Curve. The pool had a cross sectional area of 15 square feet.

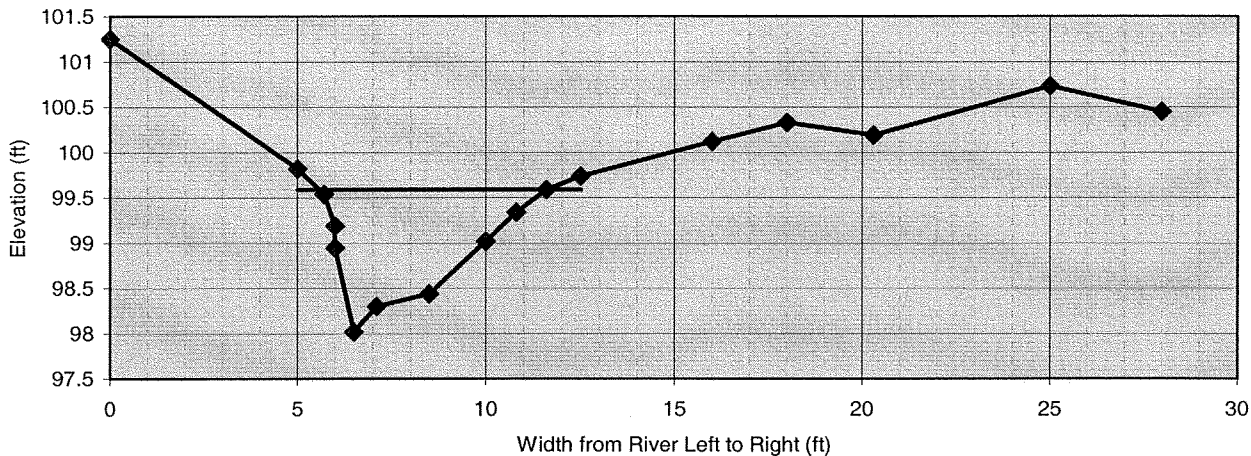
0+09 Pool Unnamed Tributary to UT

section: **0+09**

Pool  
Unnamed Tributary to UT  
Billy's Creek

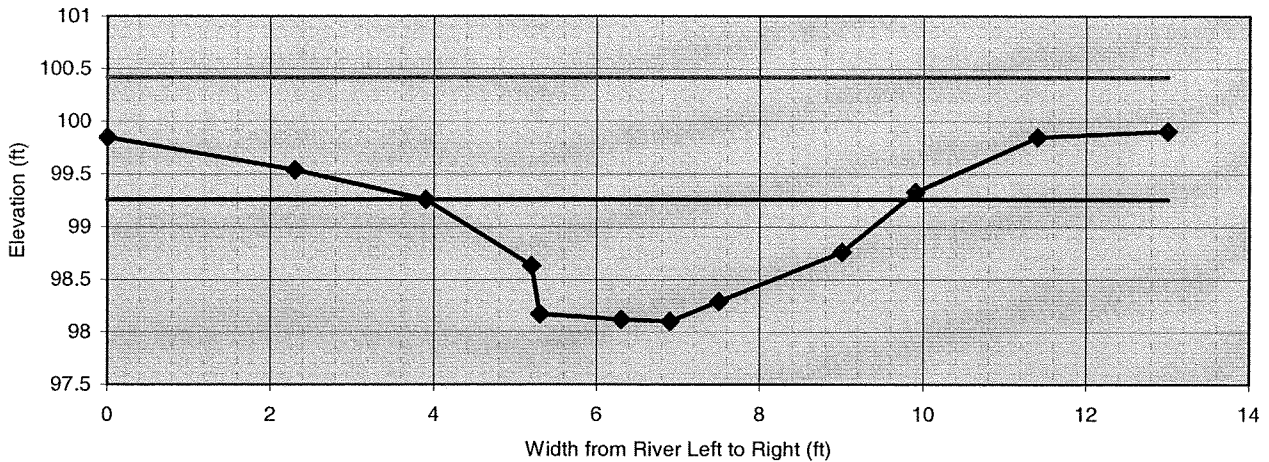
section: 0+15

Glide  
Unnamed Tributary to UT  
Billy's Creek

hydraulics	
0.0	velocity (ft/sec)
0.0	discharge rate, Q (cfs)
0.00	shear stress ((lbs/ft sq)
0.00	shear velocity (ft/sec)
0.000	unit stream power (lbs/ft/sec)
0.00	Froude number
0.0	friction factor u/u*
0.0	threshold grain size (mm)

check from channel material			
3	measured D84 (mm)		
72.7	relative roughness	13.4	fric. factor
0.000	Manning's n from channel material

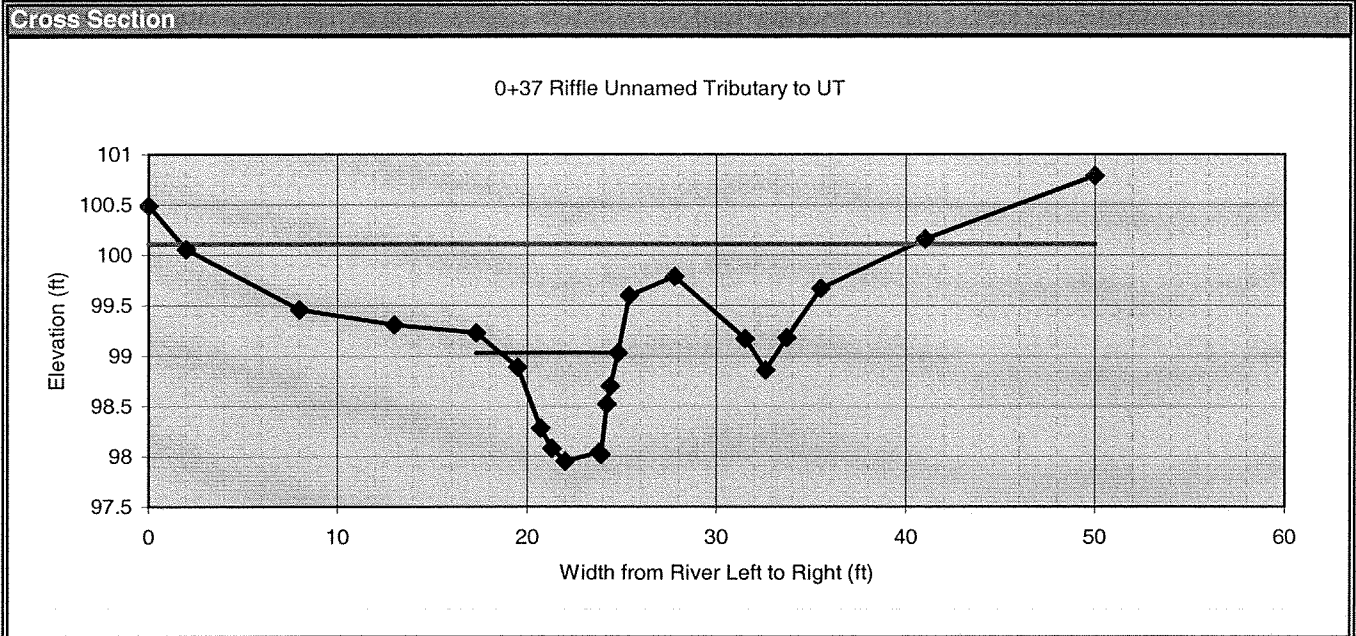
section: **0+37**

Riffle  
 Unnamed Tributary to UT  
 Billy's Creek

check from channel material

3	measured D84 (mm)		
67.7	relative roughness	13.3	fric. factor
0.018	Manning's n from channel material

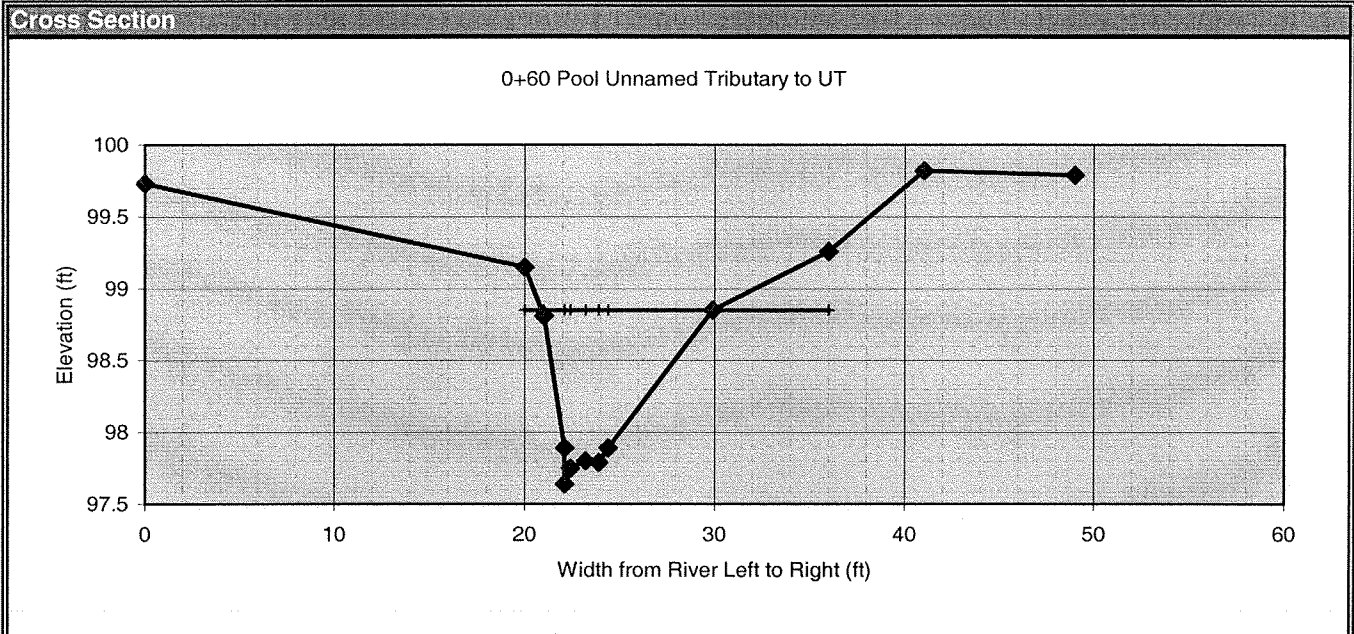
section: **0+60**  
 Pool  
 Unnamed Tributary to UT  
 Billy's Creek

description:  
 height of instrument (ft): **105.65**

hydraulics	
0.0	velocity (ft/sec)
0.0	discharge rate, Q (cfs)
0.00	shear stress ((lbs/ft sq)
0.00	shear velocity (ft/sec)
0.000	unit stream power (lbs/ft/sec)
0.00	Froude number
0.0	friction factor u/u*
0.0	threshold grain size (mm)

check from channel material			
3	measured D84 (mm)		
63.2	relative roughness	13.1	fric. factor
0.000	Manning's n from channel material

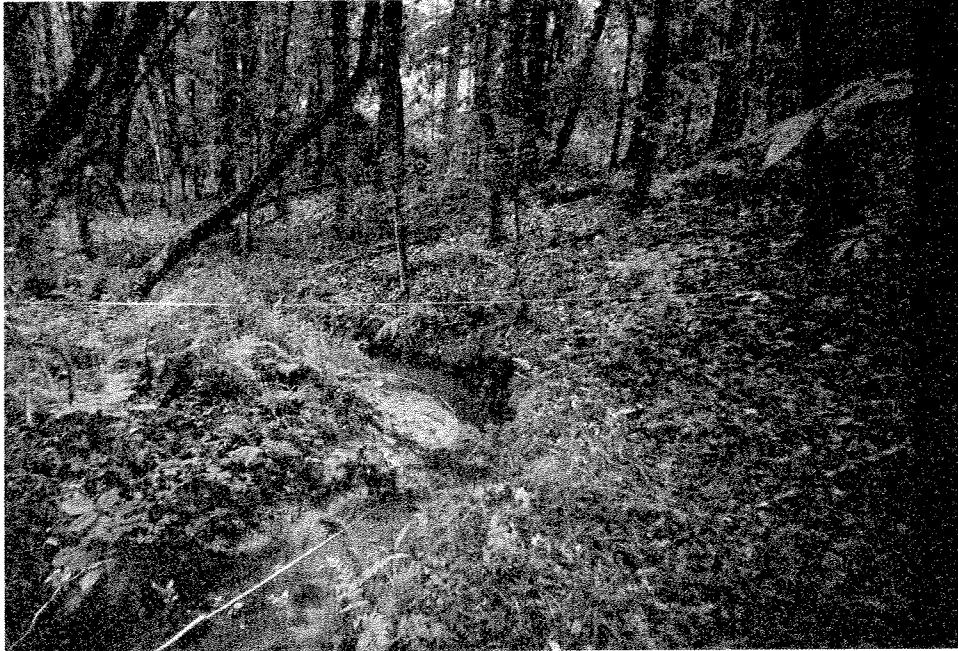
Picture 1. Outside meander bend where first pool section was taken.

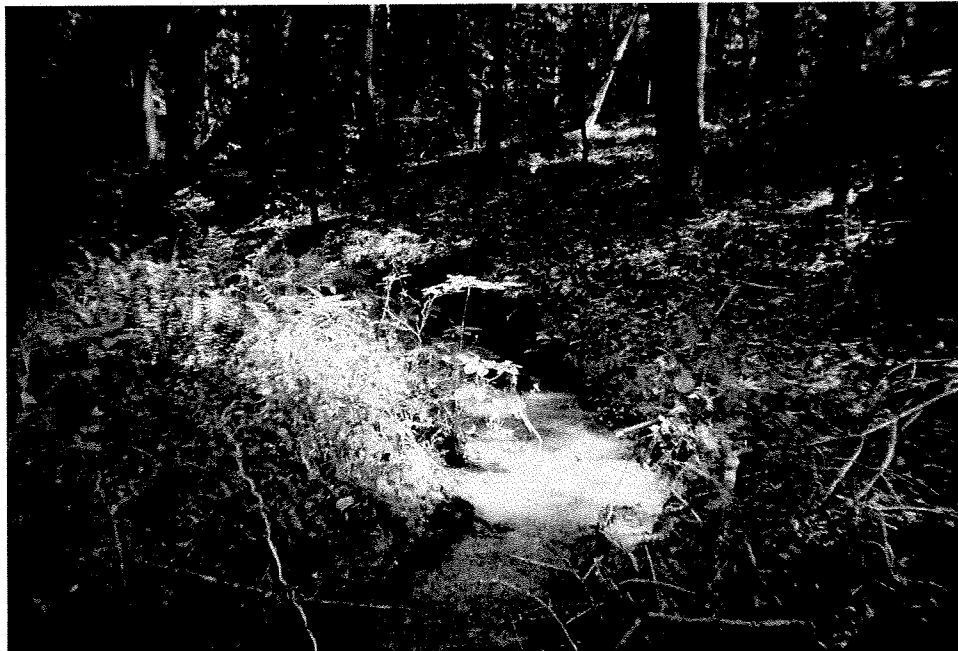
Picture 2. View of pool and glide.

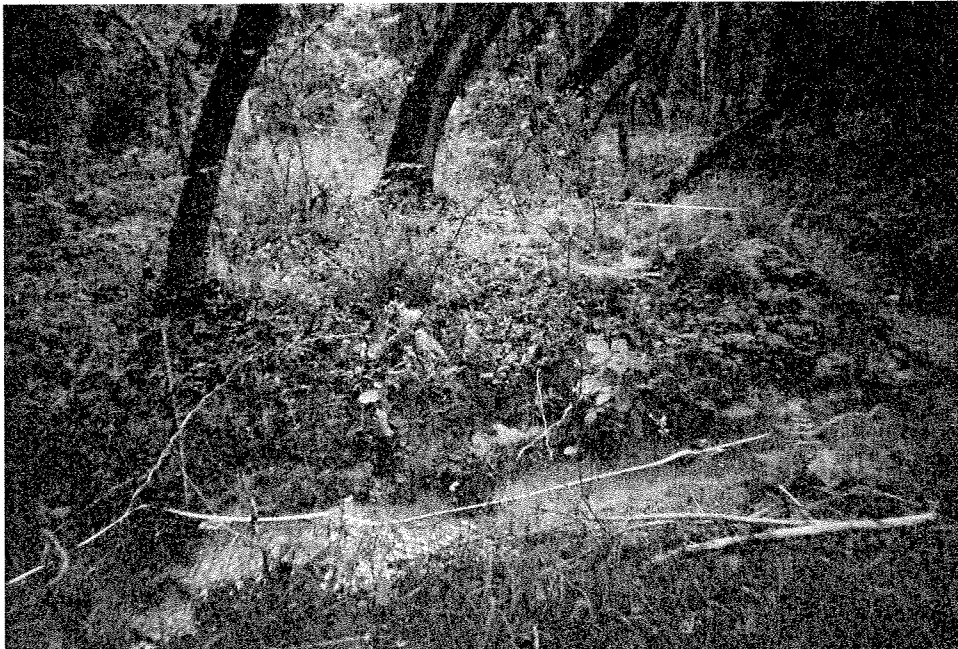
Picture 4. Riffle cross section taken in this area, looking across the channel. Note vegetation on banks.

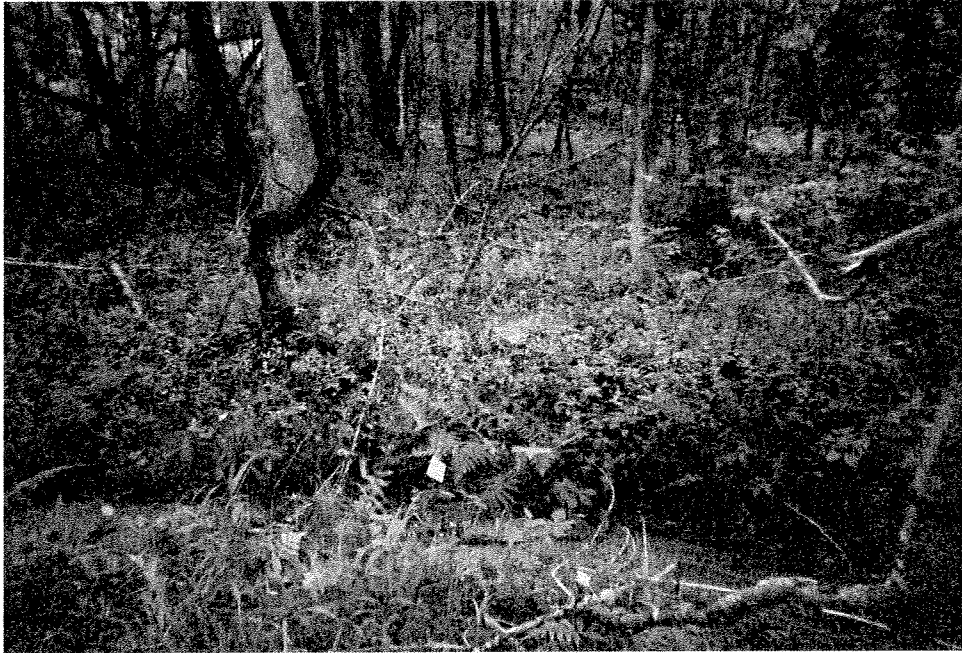
Picture 5. Second riffle cross section.

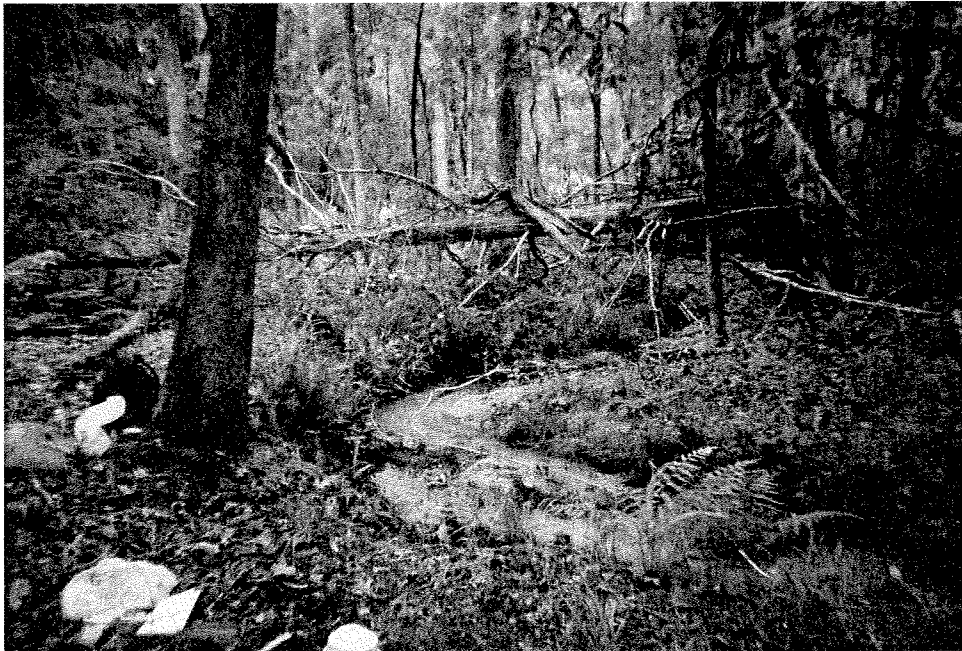
Picture 6. Large meander bend looking downstream.

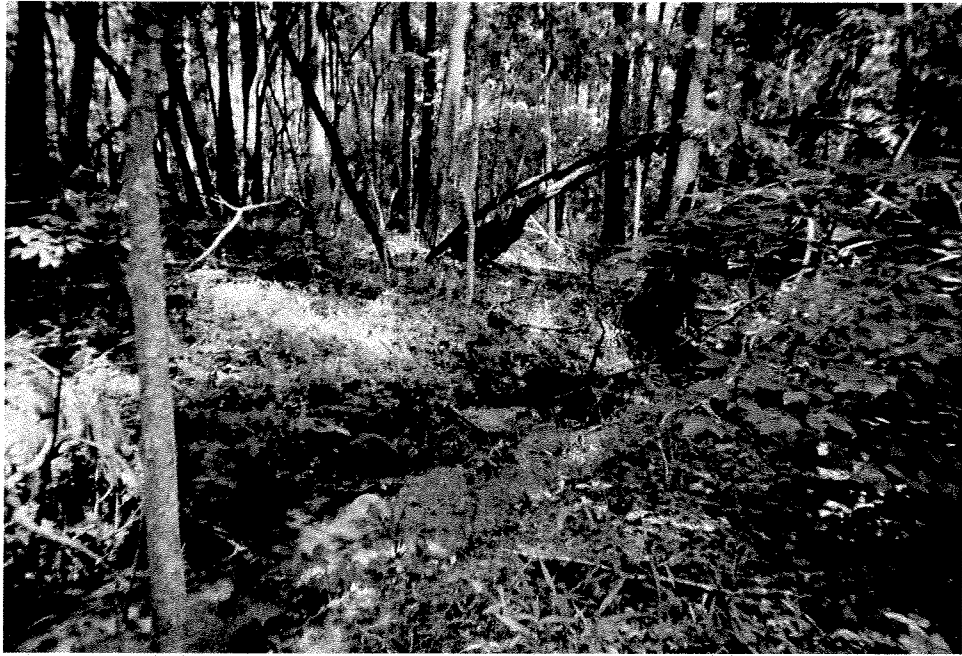
Picture 7. Looking upstream below woody debris.

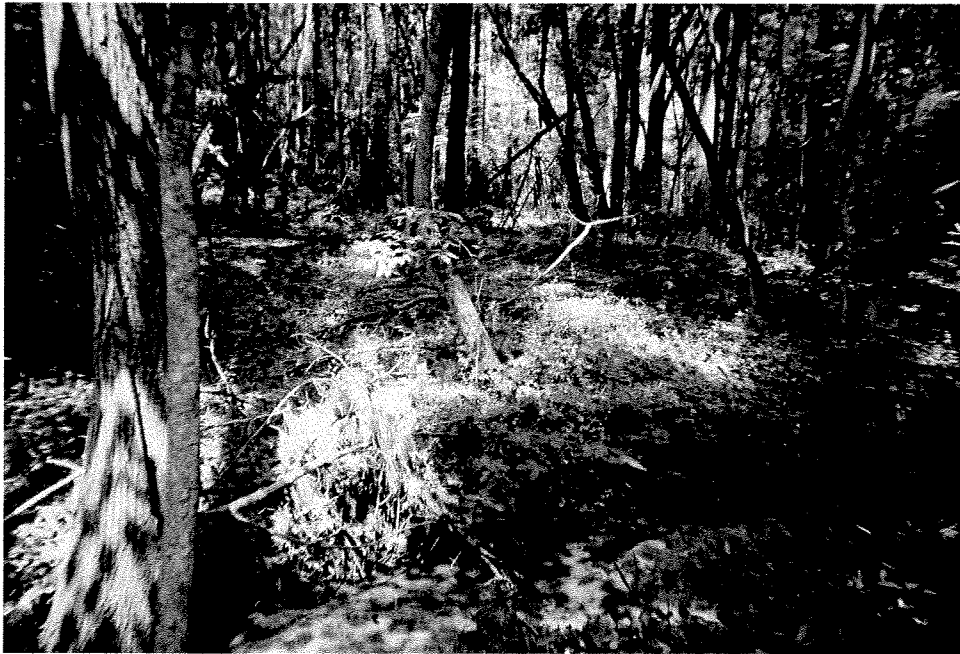
Picture 8. Looking across the channel downstream of woody debris.

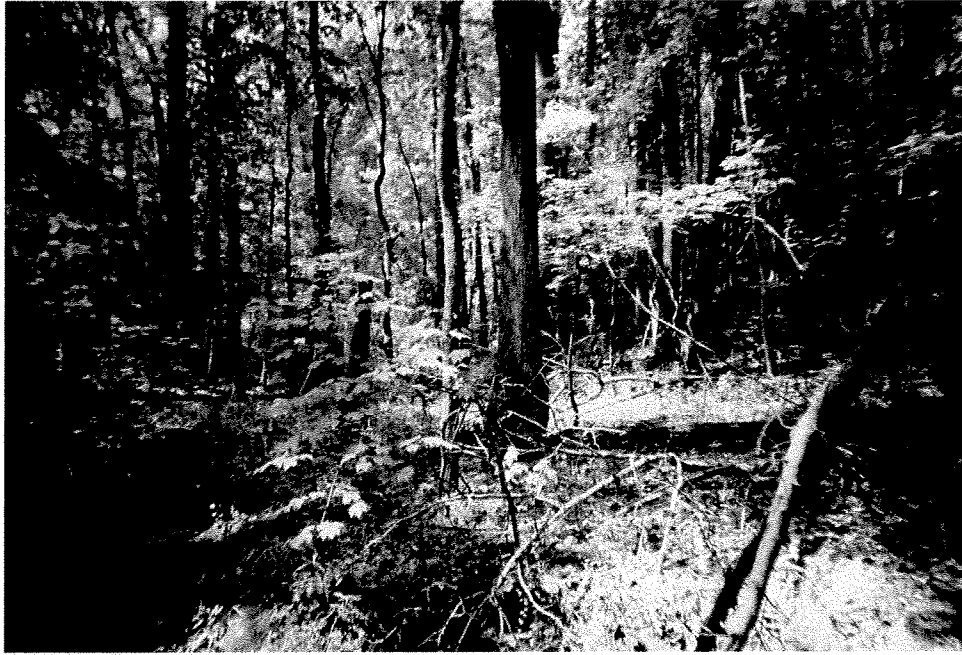
Picture 9. Stream side woody vegetation.

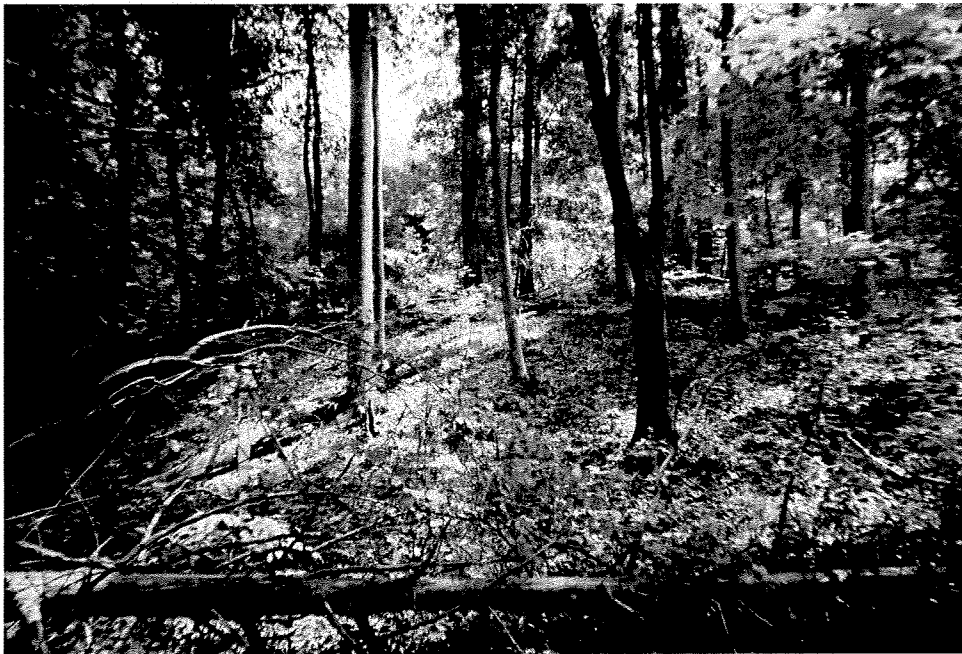
Picture 10. Slope vegetation.

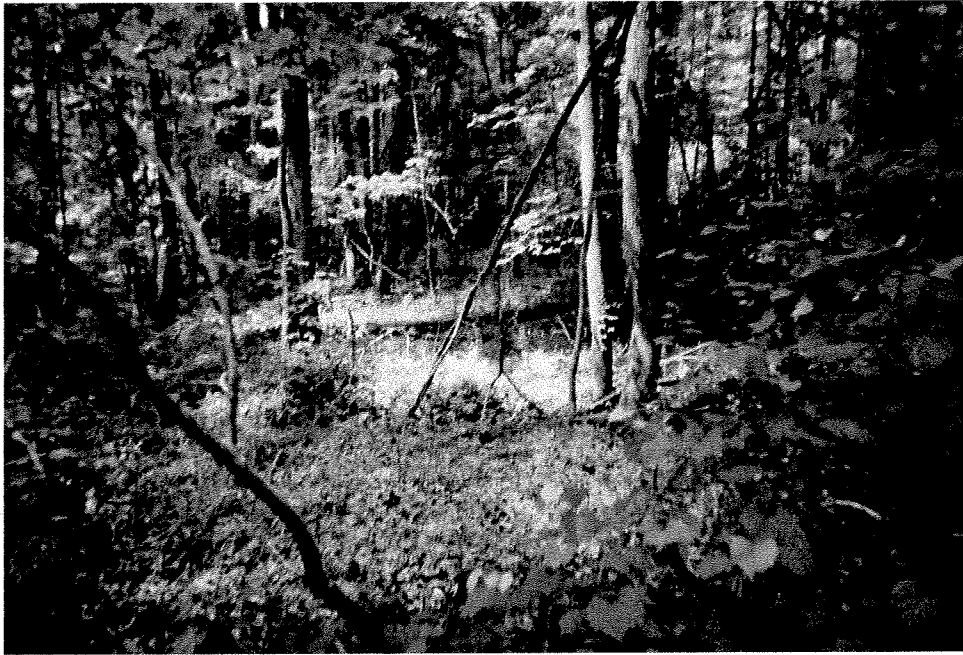
Picture 11. Floodplain vegetation.
