# **BILLY'S CREEK STREAM RESTORATION PLAN**

**AUGUST 11, 2003**

# **URS**

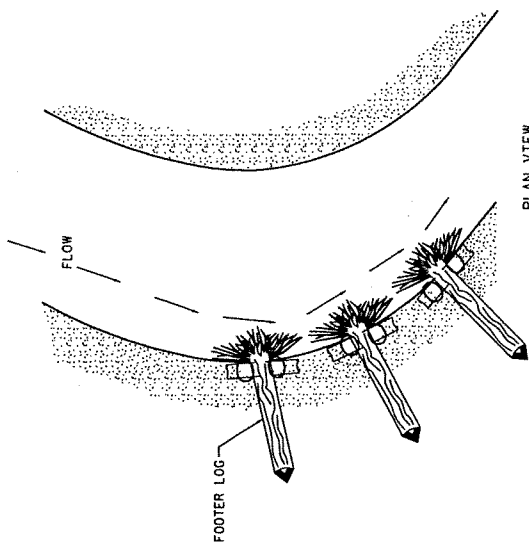
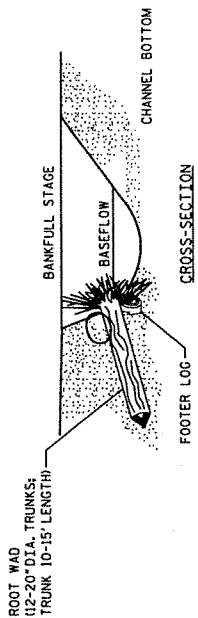
## ROOT WAD

PLAN VIEW

ROOT WADS SHOULD BE INSTALLED ON THE OUTSIDE OF MEANDER BENDS. THEY SHOULD BE ANGLED UPSTREAM TO DEFLECT THE STREAM FLOW AWAY FROM THE BANK.

CROSS-SECTION

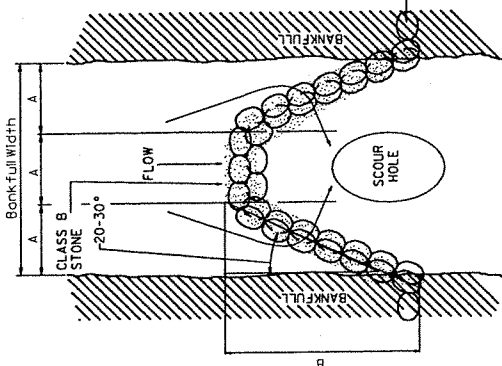
PLAN VIEW

PLACE KEY-IN STONE WITH 6" OF SOIL ABOVE TO ALLOW FOR VEGETATION TO ROOT.
