Blockhouse Creek Restoration Project

Mitigation Plan and As-built Baseline Report

Polk County, North Carolina

Date Submitted: November 2008

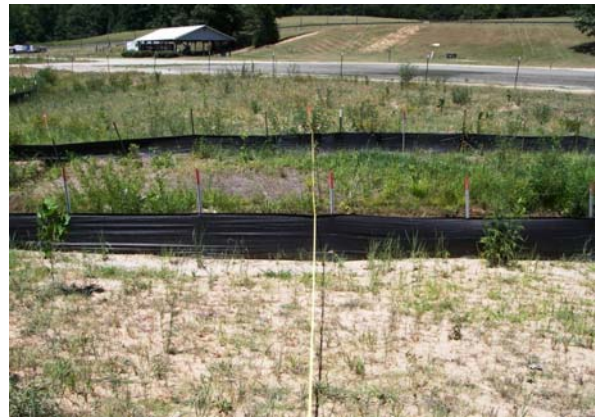
Photo 7: XS-4 facing right bank

Photo 8: XS-4 facing left bank

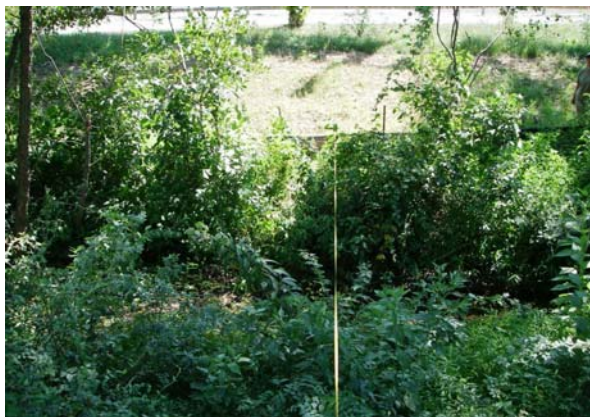
Photo 11: XS-5 facing right bank

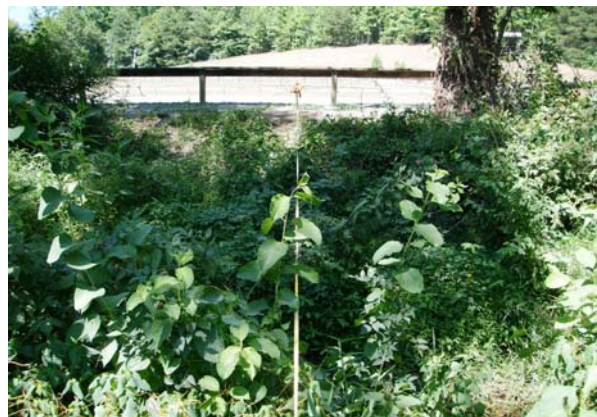
Photo 12: XS-5 facing left bank

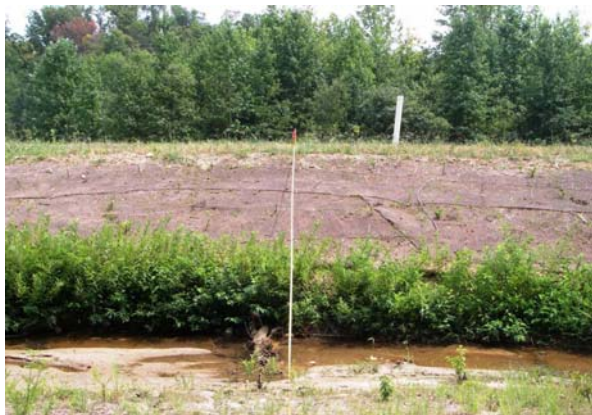
Photo 11: XS-6 facing right bank

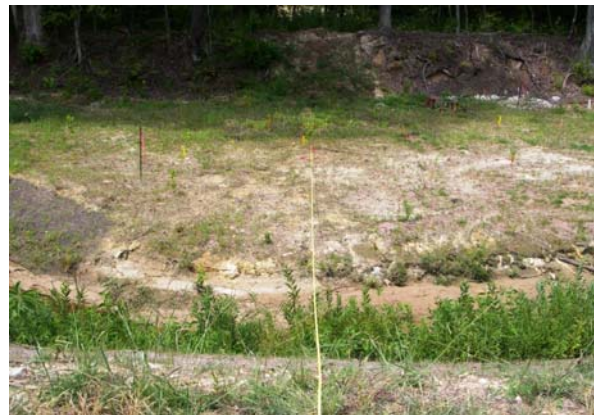
Photo 12: XS-6 facing left bank

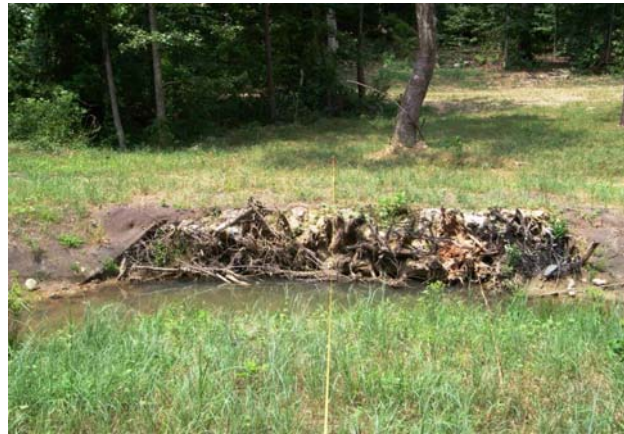
Photo 16: XS-8 facing left bank

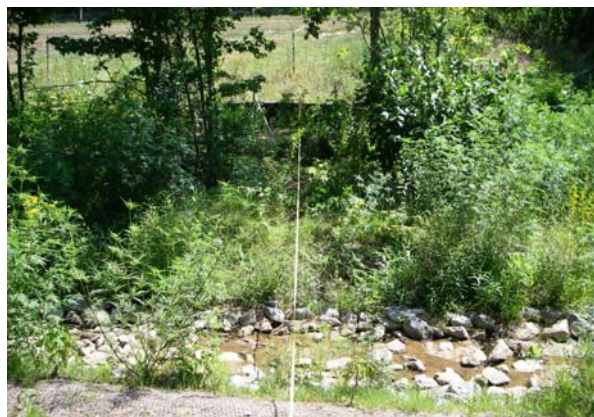
Photo 19: XS-10 facing right bank

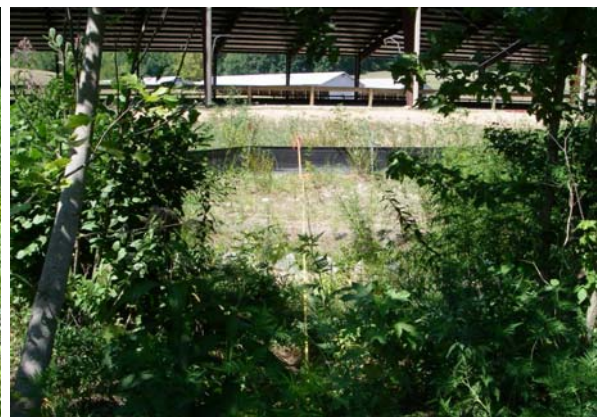
Photo 20: XS-10 facing left bank

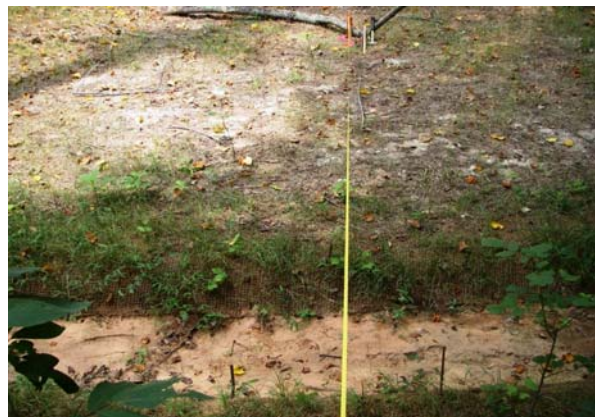
Photo 26: XS-13 facing left bank

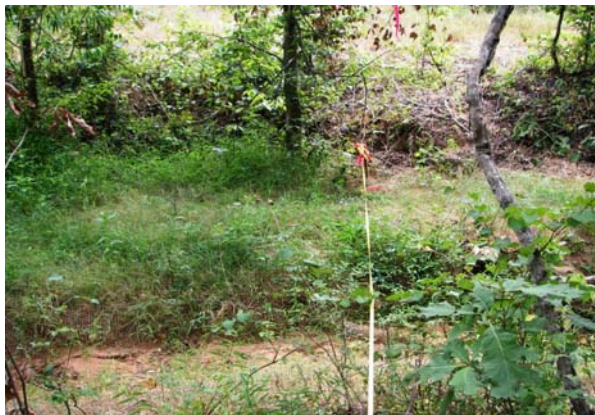
Photo 27: XS-14 facing right bank

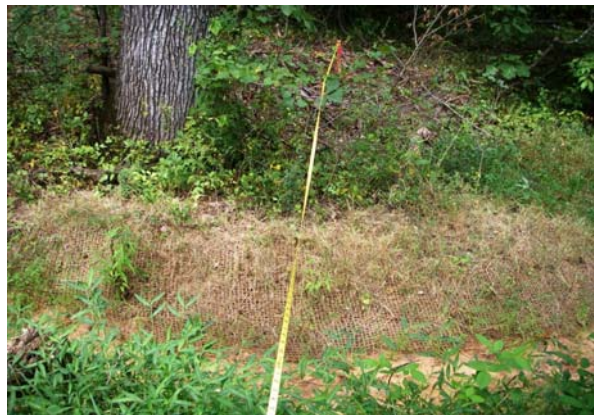
Photo 28: XS-14 facing left bank

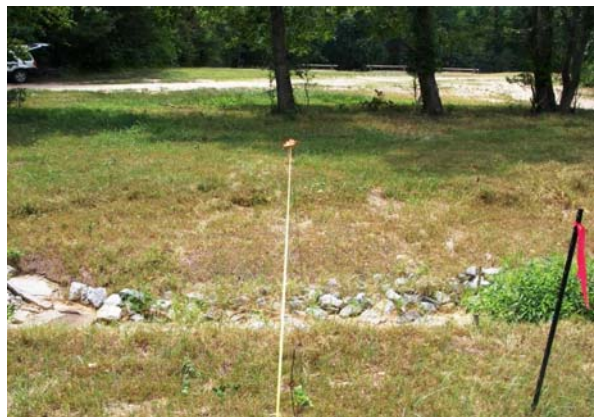
Photo 29: XS-15 facing right bank

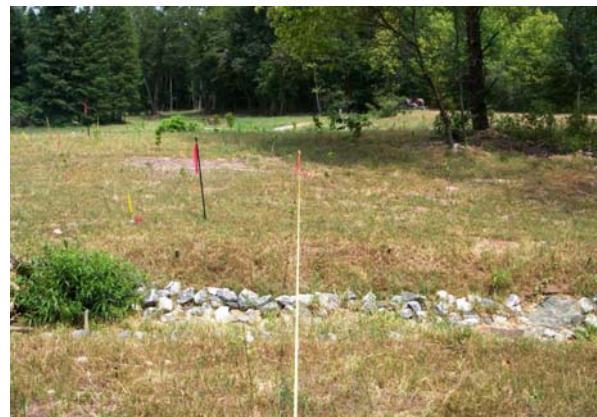
Photo 30: XS-15 facing left bank

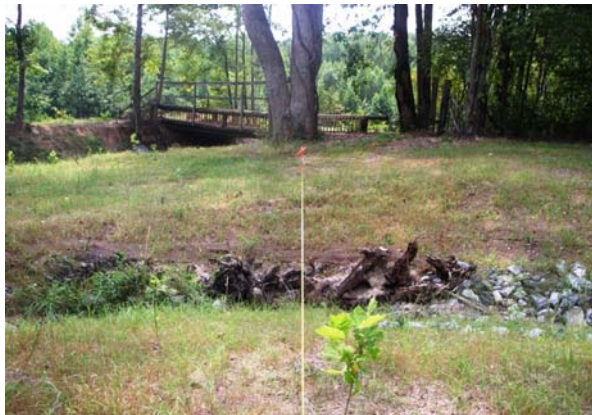
Photo 31: XS-16 facing right bank

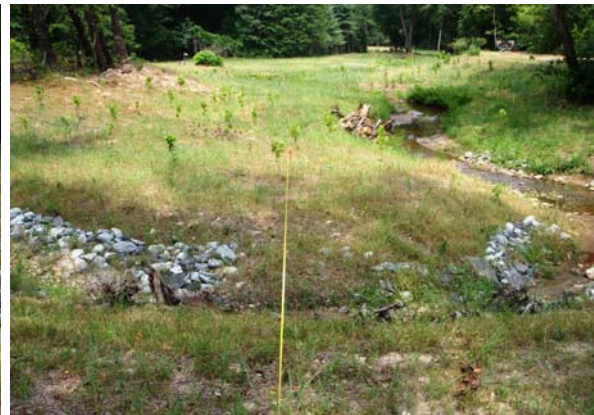
Photo 32: XS-16 facing left bank
