FINAL
AS-BUILT BASELINE
MONITORING REPORT

BOBS CREEK
STREAM MITIGATION SITE

NCDMS Project No. 92879
Contract No. D09023S
USACE Action ID No. SAW-2009-917 & NCDWR Project No. 10-0122
SCO No. 08-07308-01
McDowell County, North Carolina

Data Collection: April 2016
Submission: July 2016

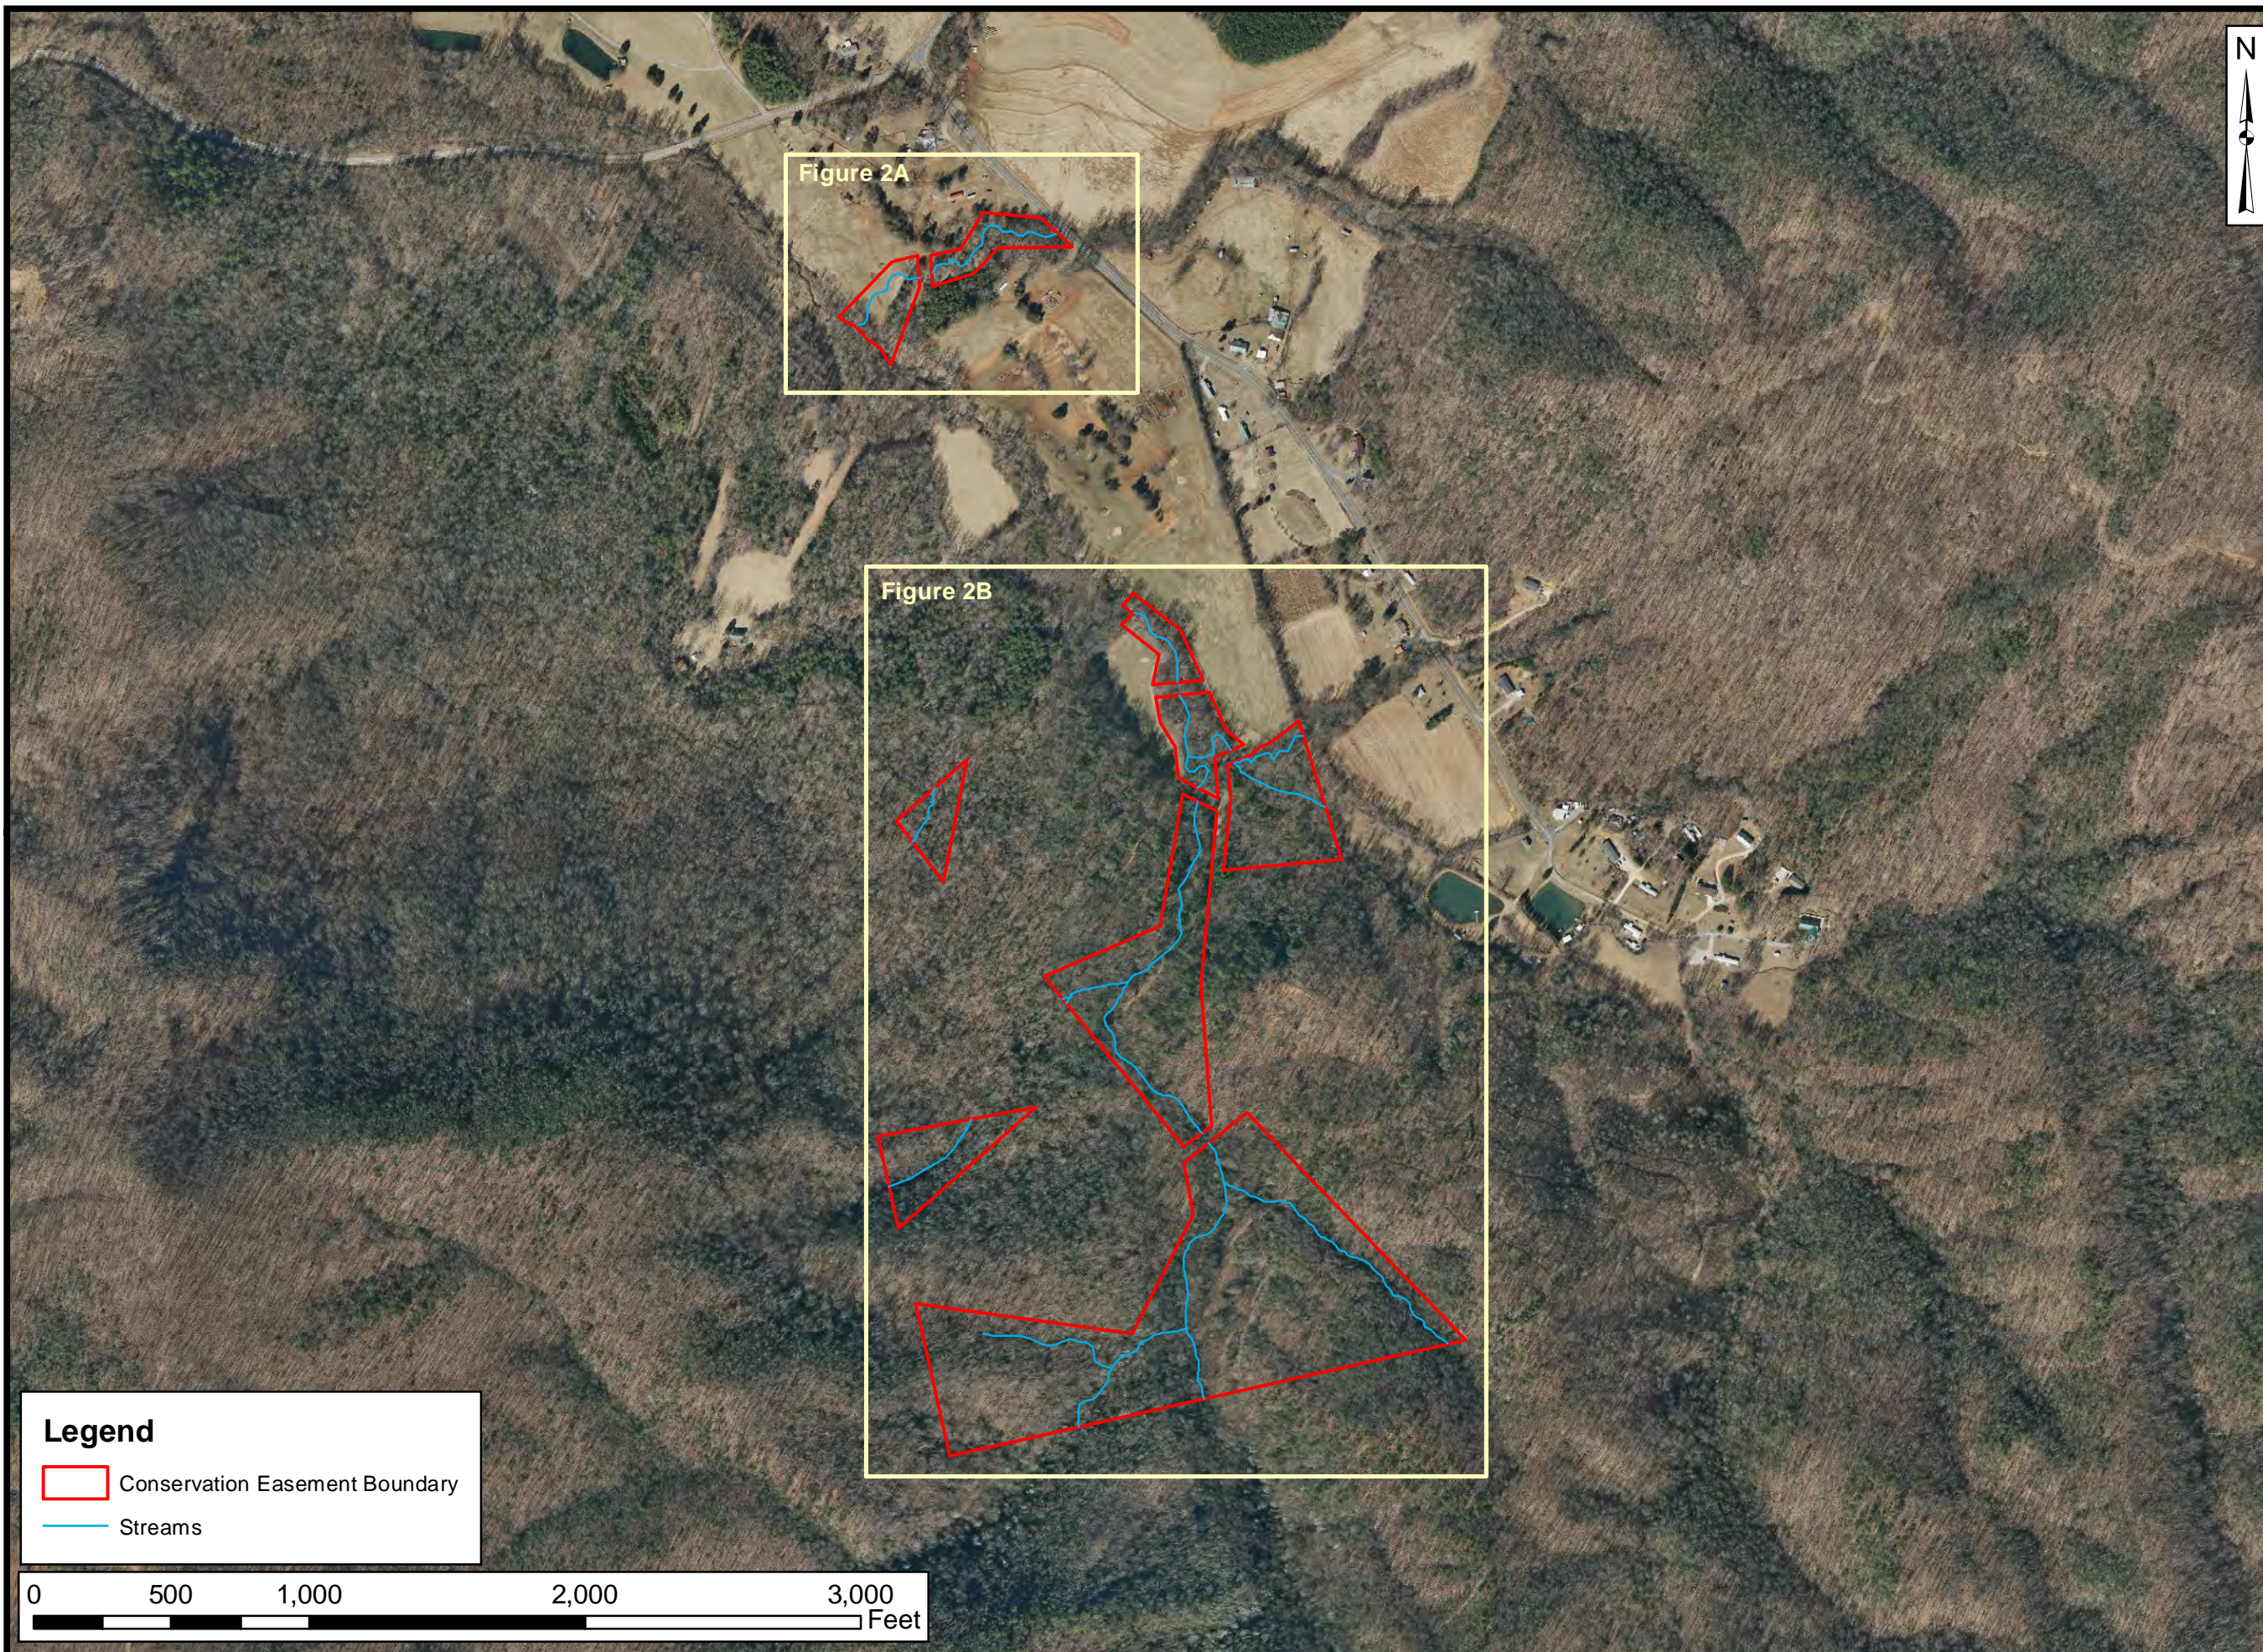
FIGURE
2

Title:
**Current Conditions
 Plan View**

Monitoring of restoration efforts will be performed for five years or until success criteria are fulfilled. Monitoring is proposed for the stream channel and vegetation. In general, the restoration success criteria, and required remediation actions, are based on the *Stream Mitigation Guidelines* (USACE et al. 2003). Monitoring features are described below and are depicted on Figure 2 (Appendix B).

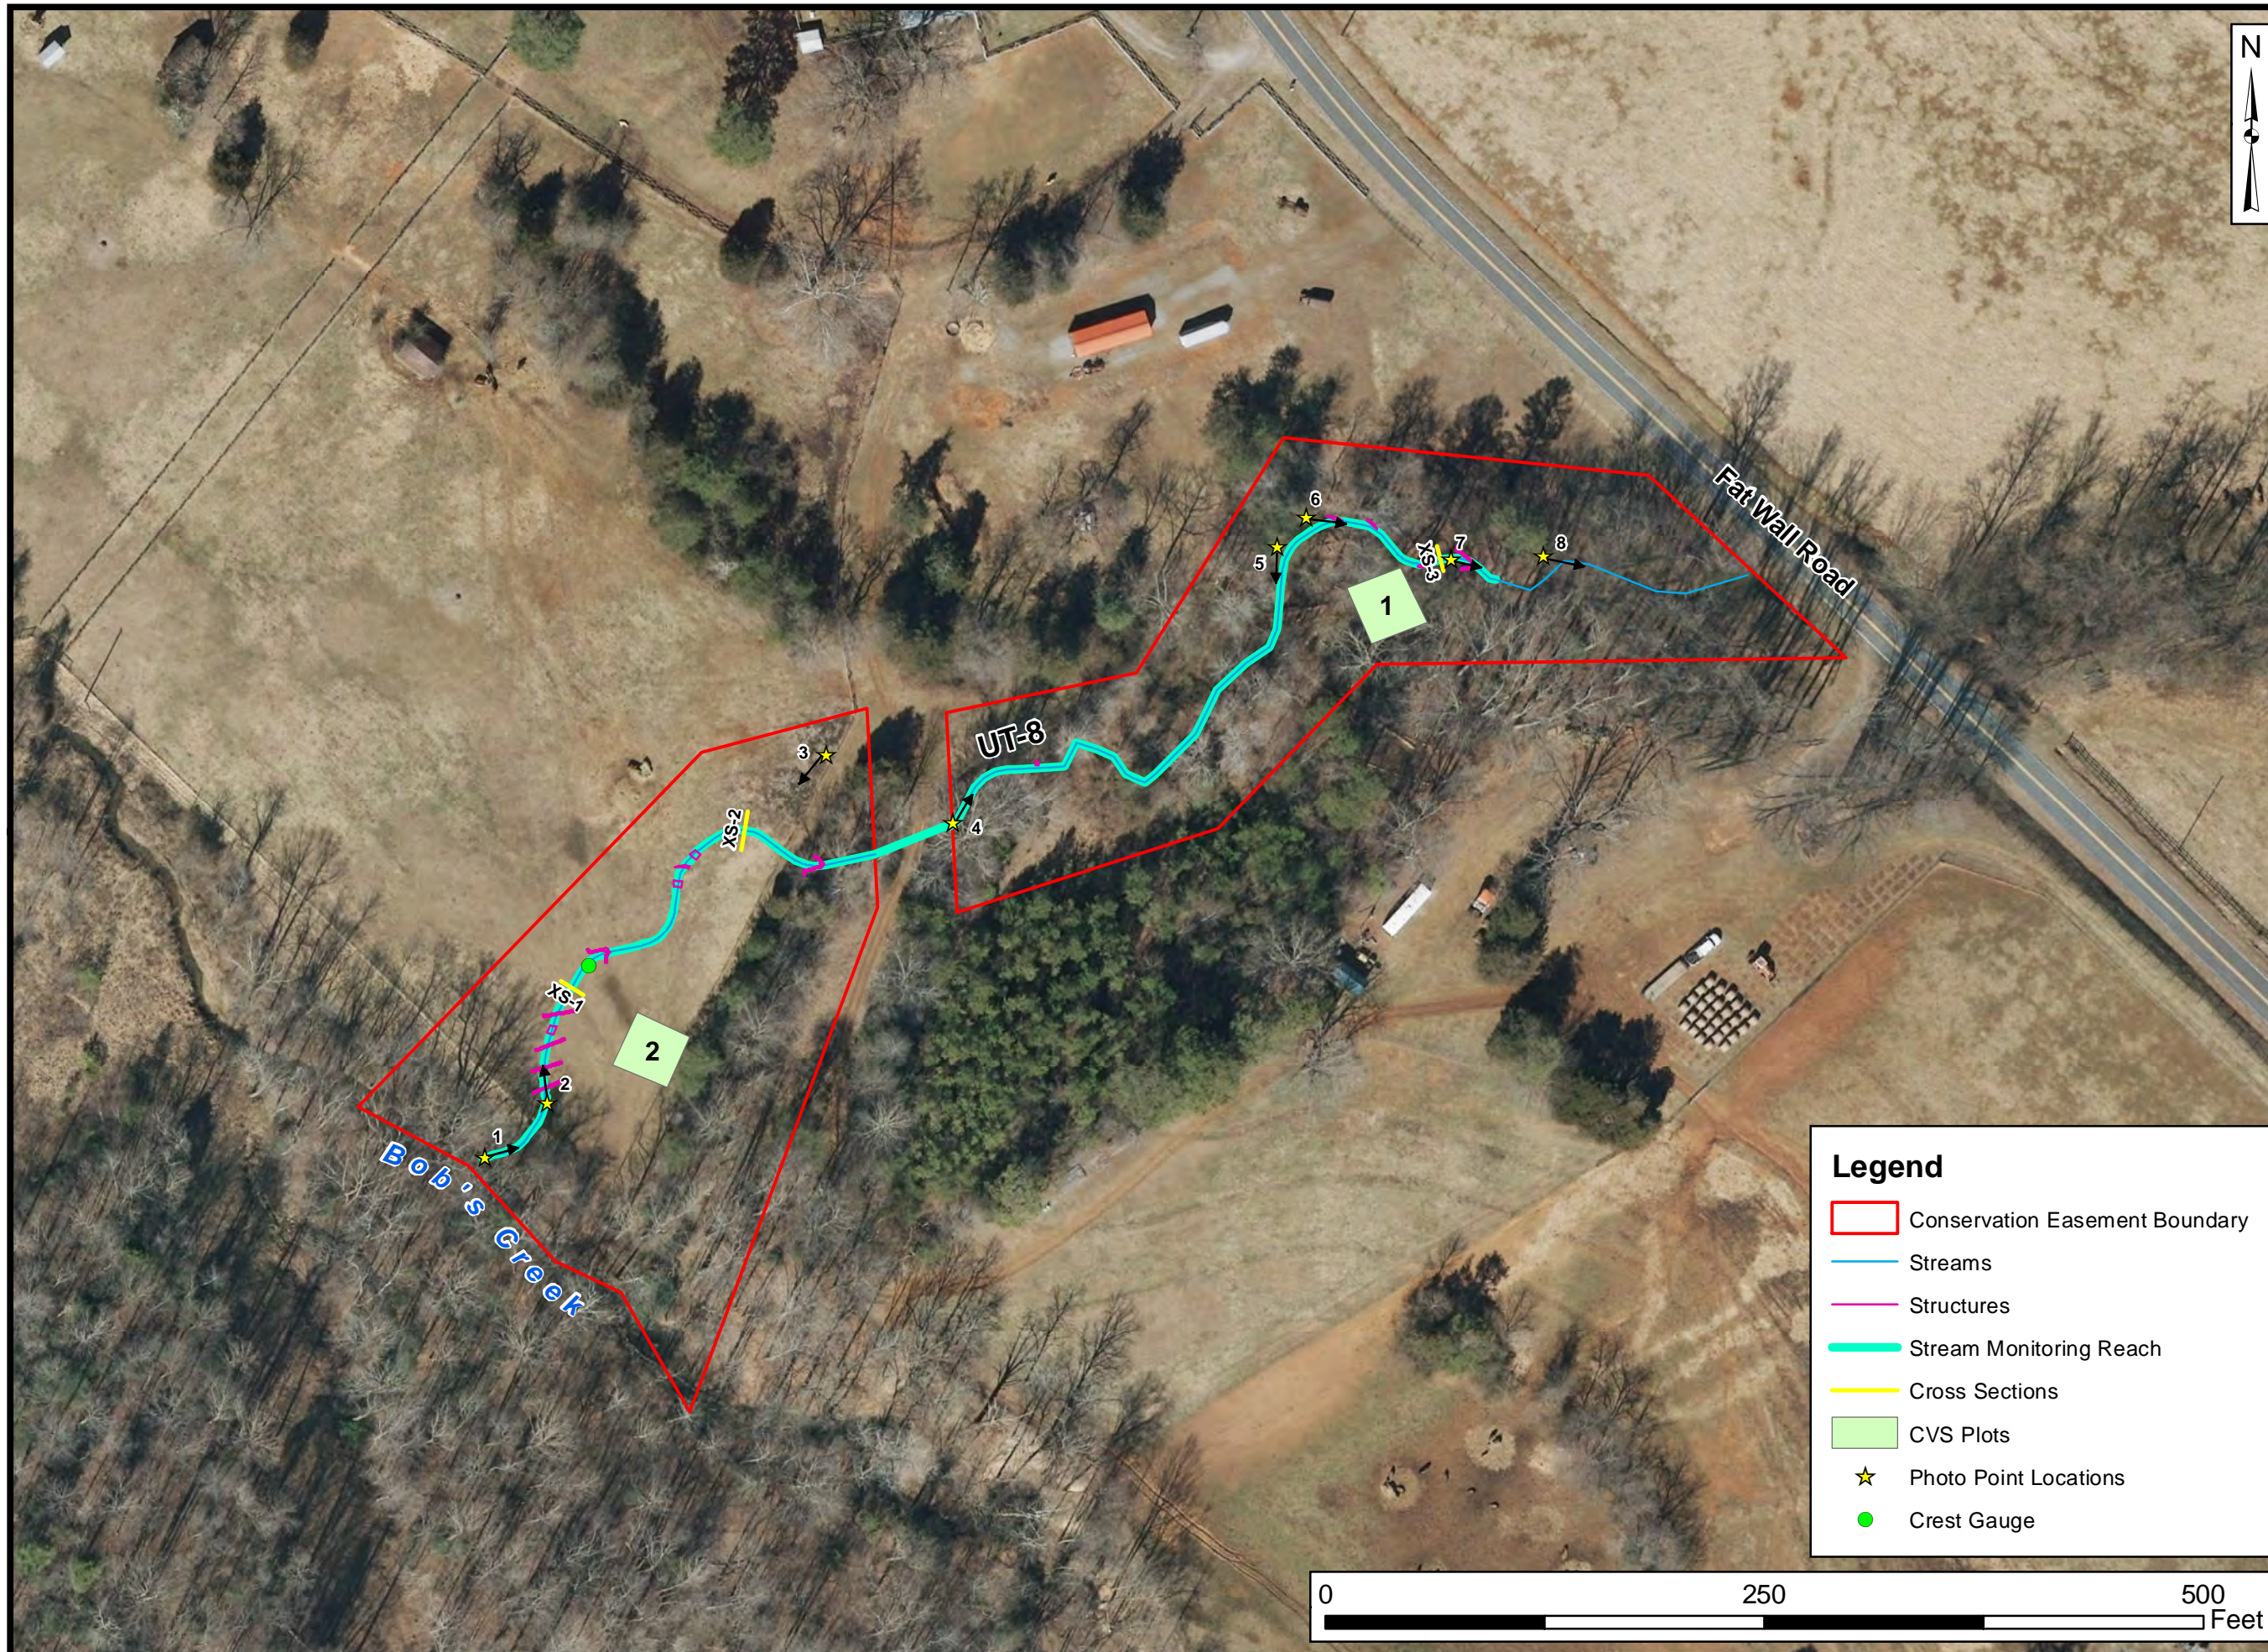
FIGURE
2A

Title:
Current Conditions Plan View

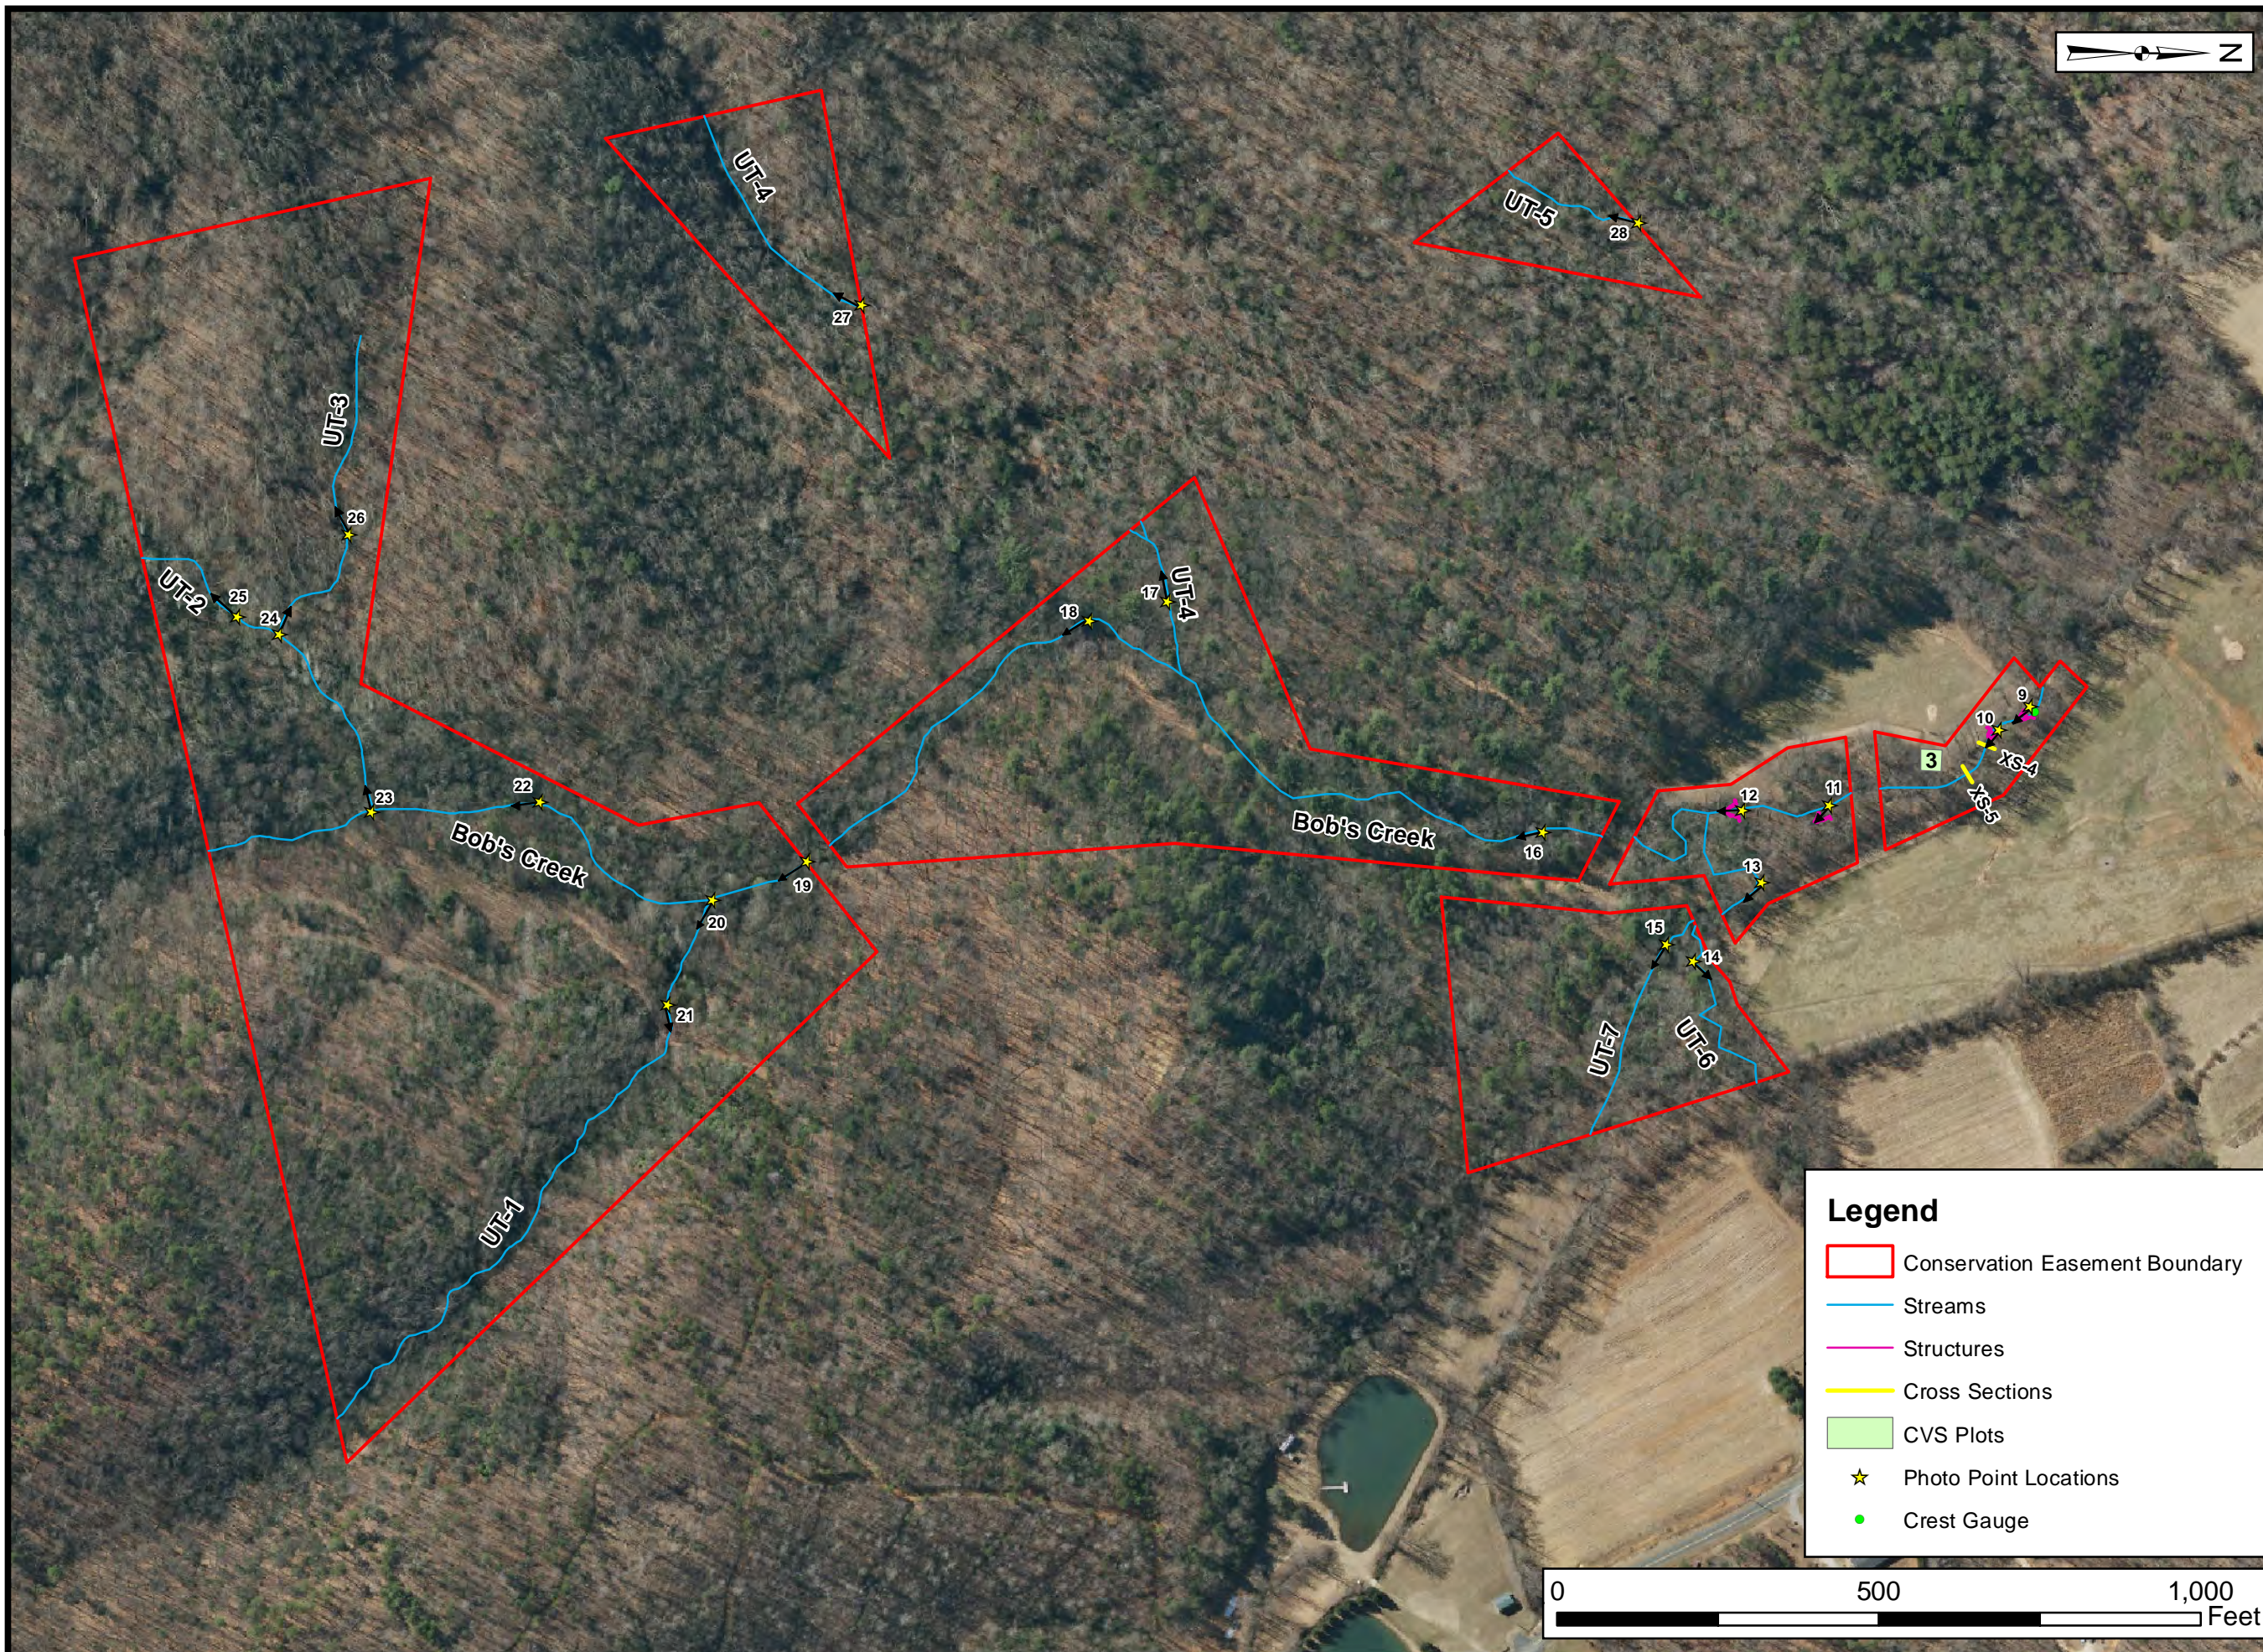
FIGURE
2B

Title:
Current Conditions Plan View

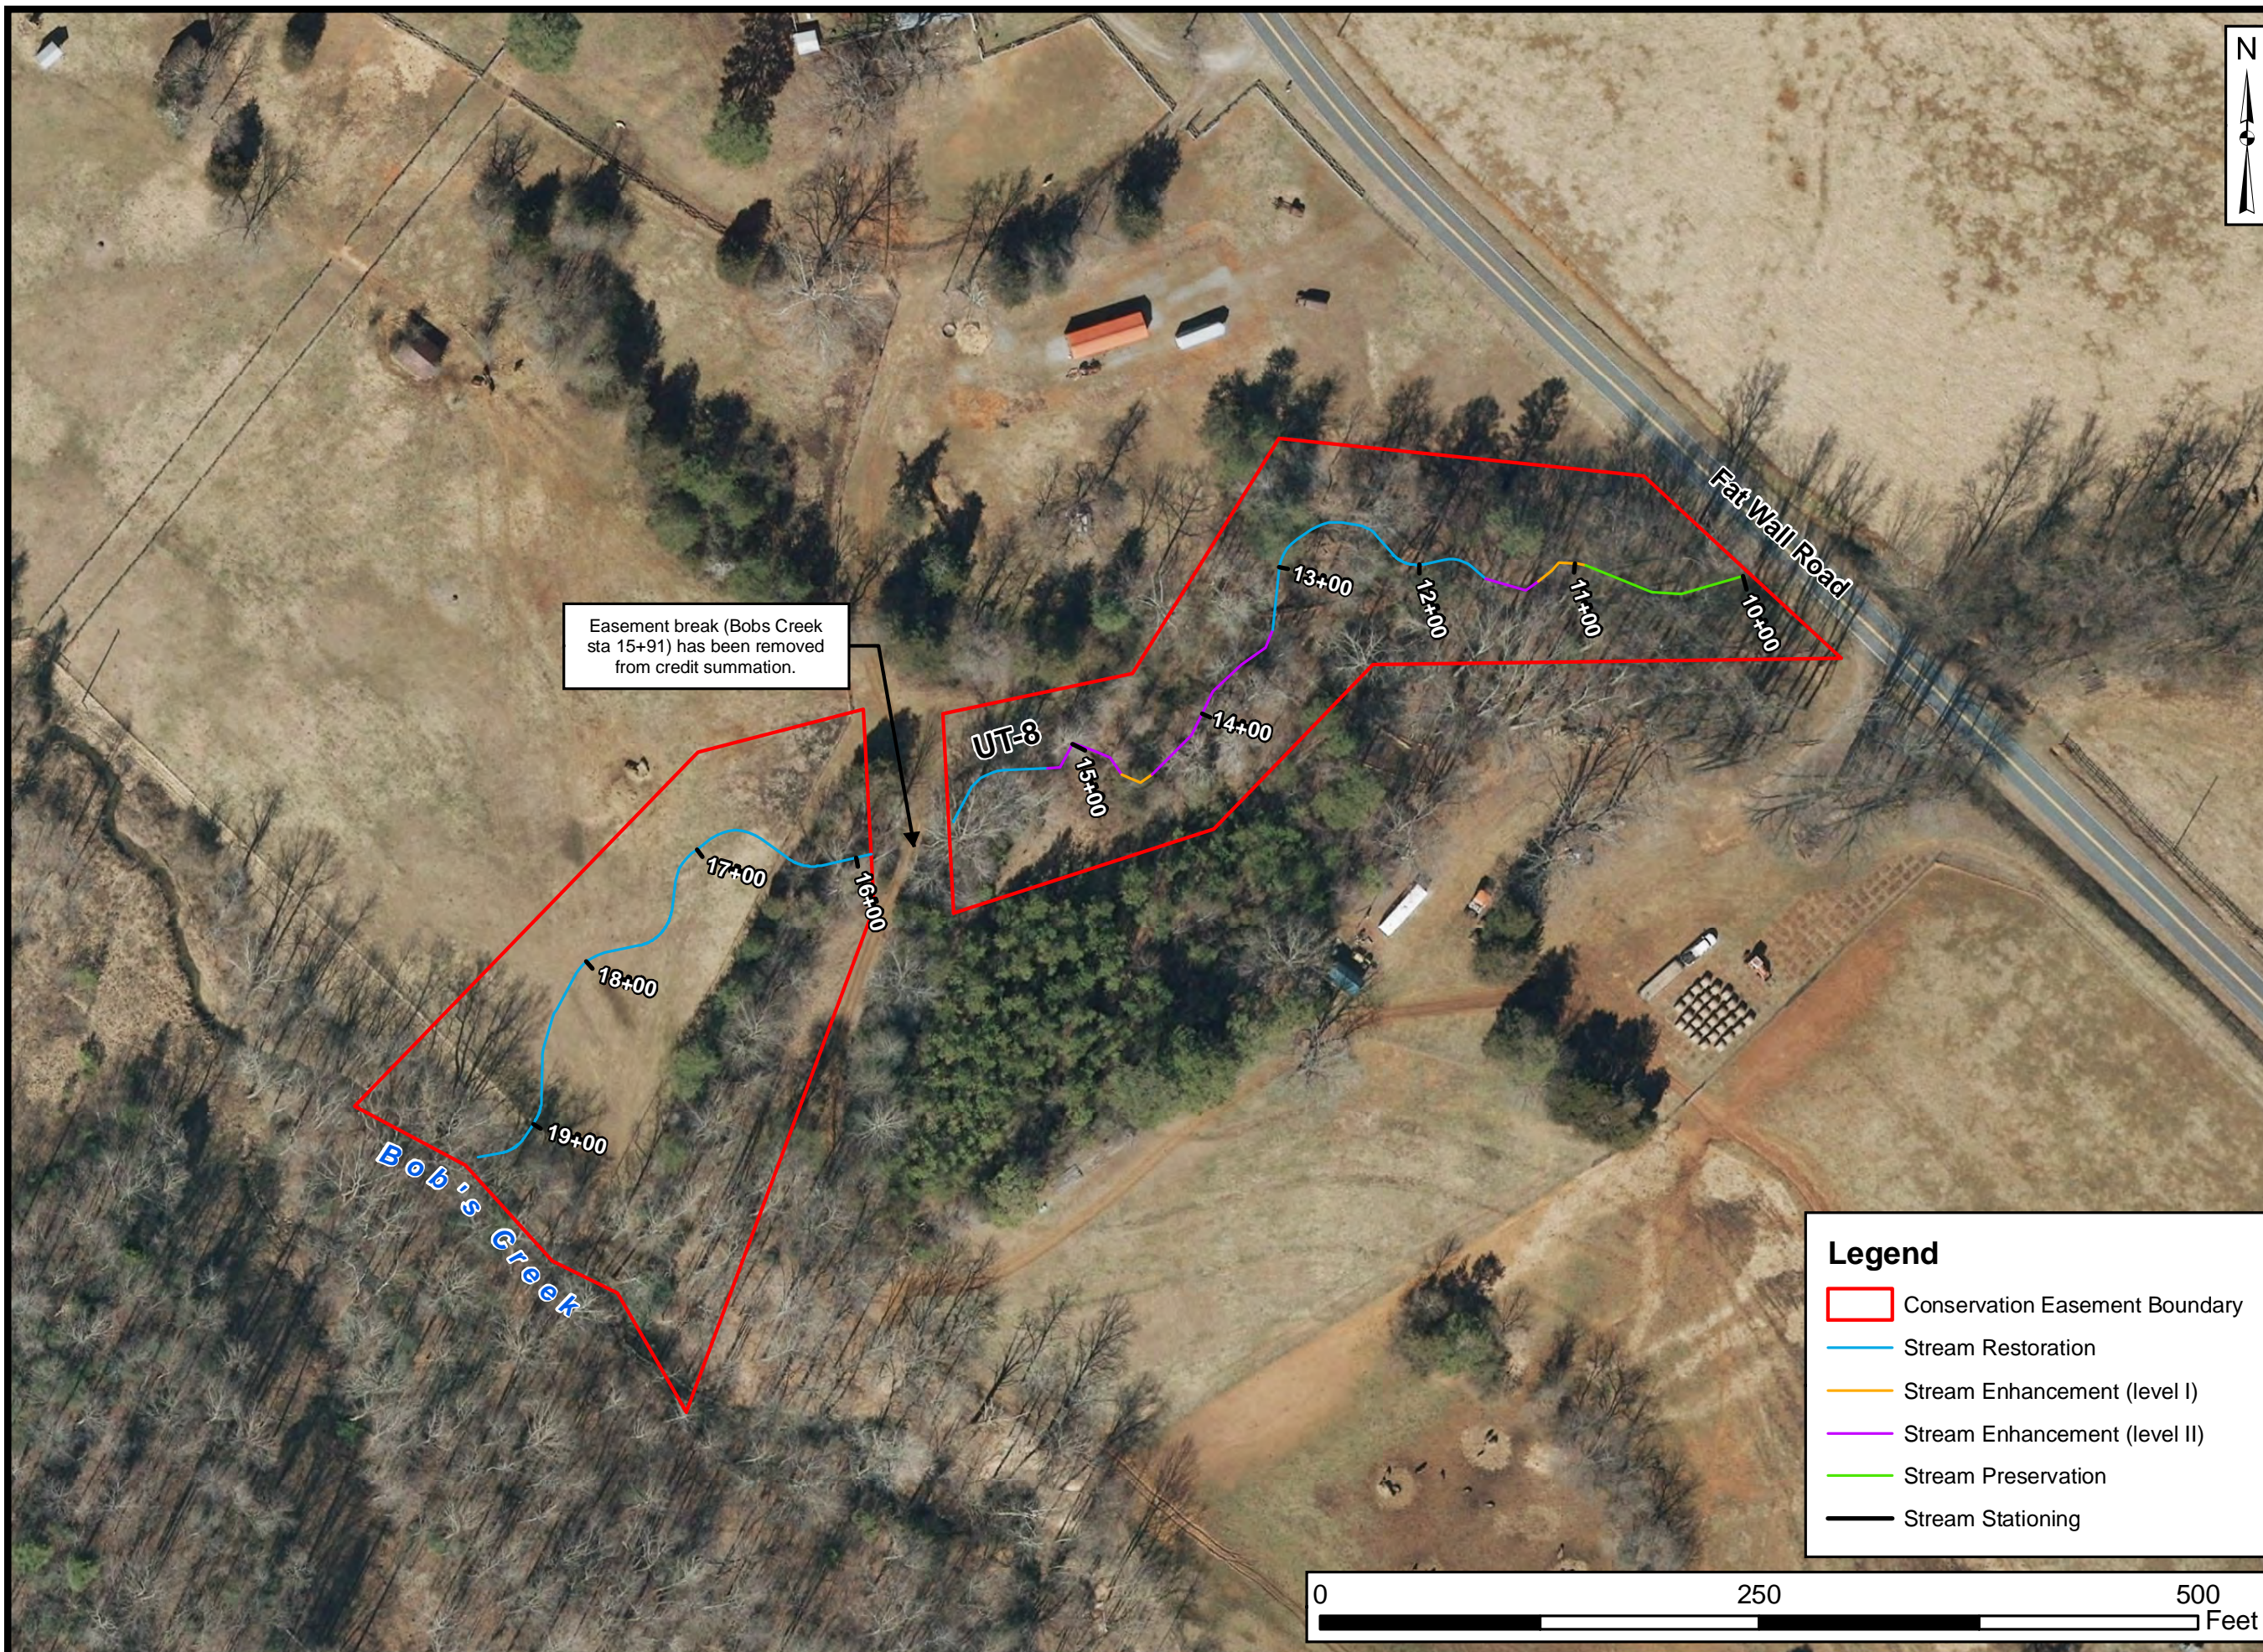
FIGURE
3A

Easement break (Bobs Creek sta 15+91) has been removed from credit summation.

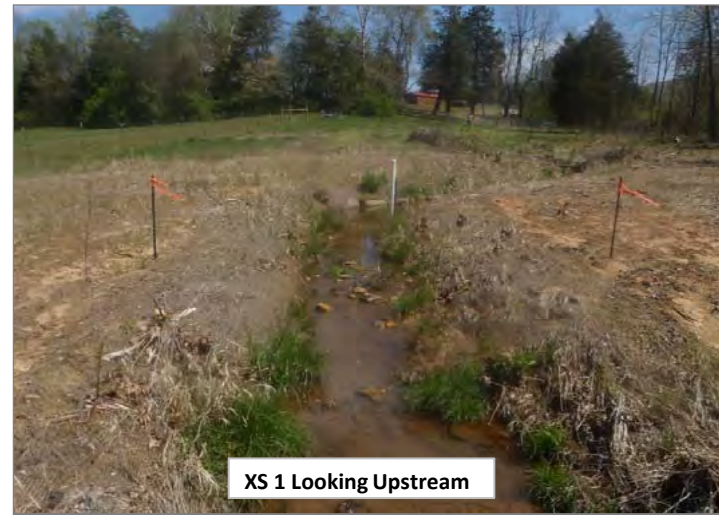
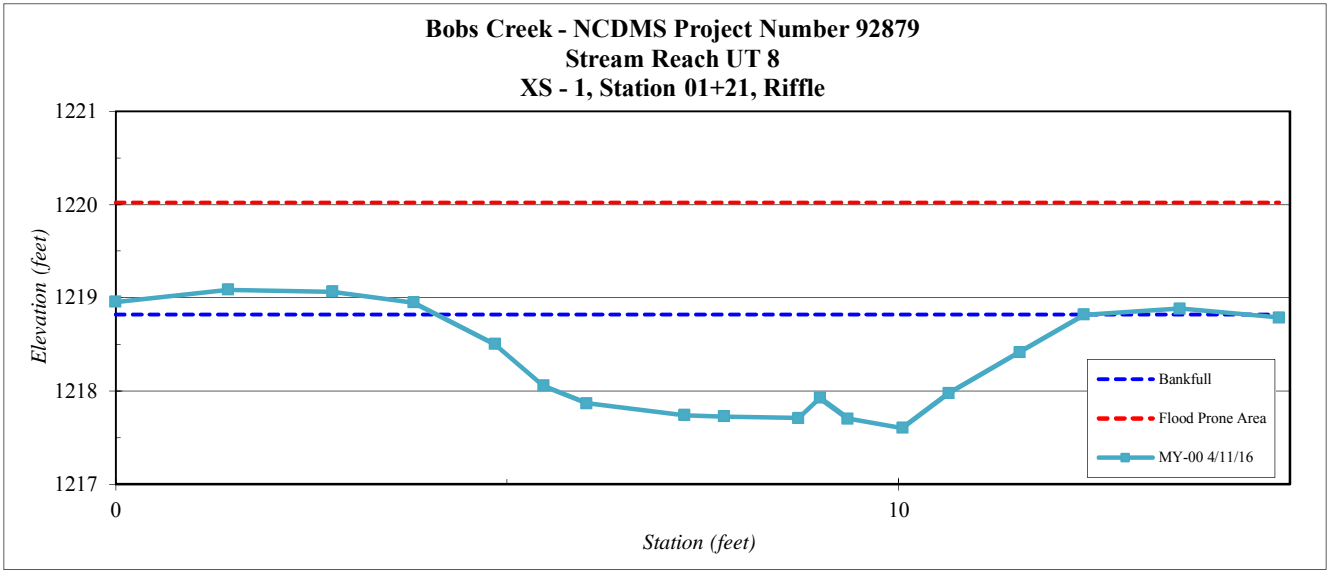
| XS ID | XS - 1, Riffle |

| Stream Type | E |

| SUMMARY DATA | |
|---|---|
| Bankfull Elevation: | 1218.8 |
| Bankfull Cross-Sectional Area: | 6.6 |
| Bankfull Width: | 8.3 |
| W / D Ratio: | 10.4 |
| Entrenchment Ratio: | 12.0 |
| Bank Height Ratio: | 1.0 |

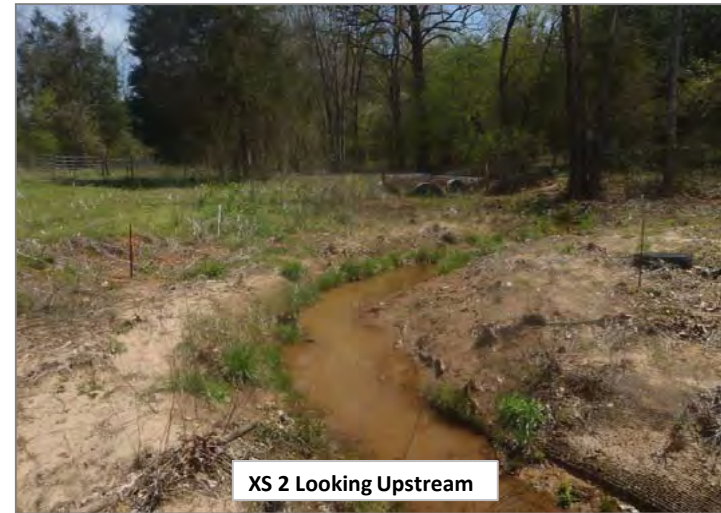
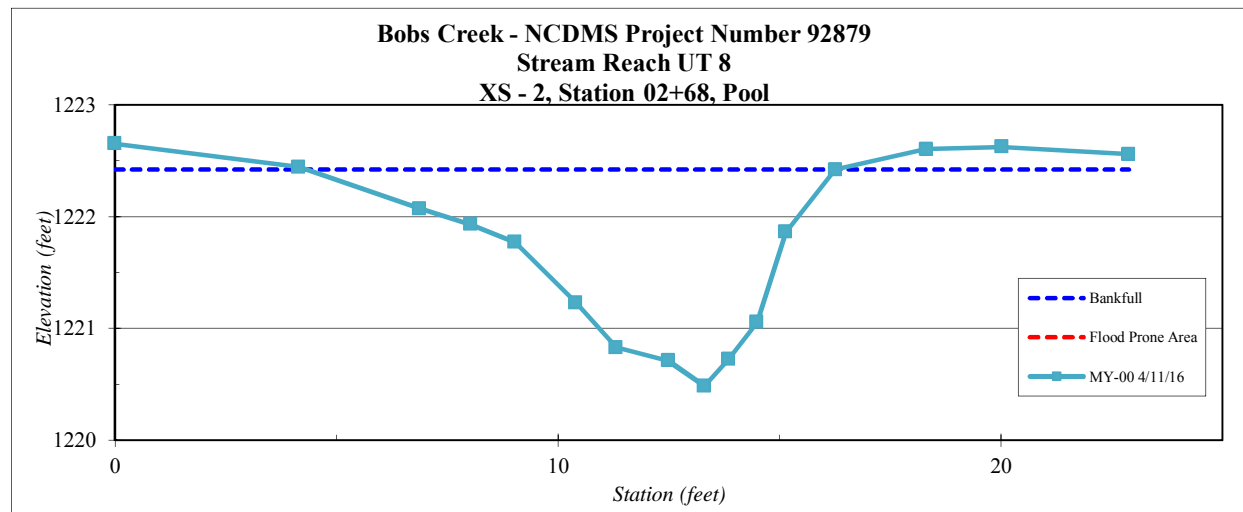
| XS ID | XS - 2, Pool |

| SUMMARY DATA | |
|---|---|
| Bankfull Elevation: | 1222.4 |
| Bankfull Cross-Sectional Area: | 10.4 |
| Bankfull Width: | 11.9 |
| Max Depth at Bankfull: | 1.9 |
| Bank Height Ratio: | 1.0 |

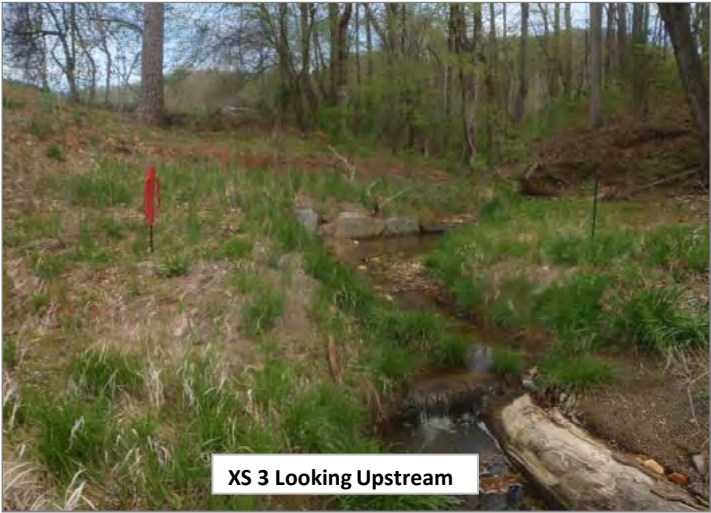
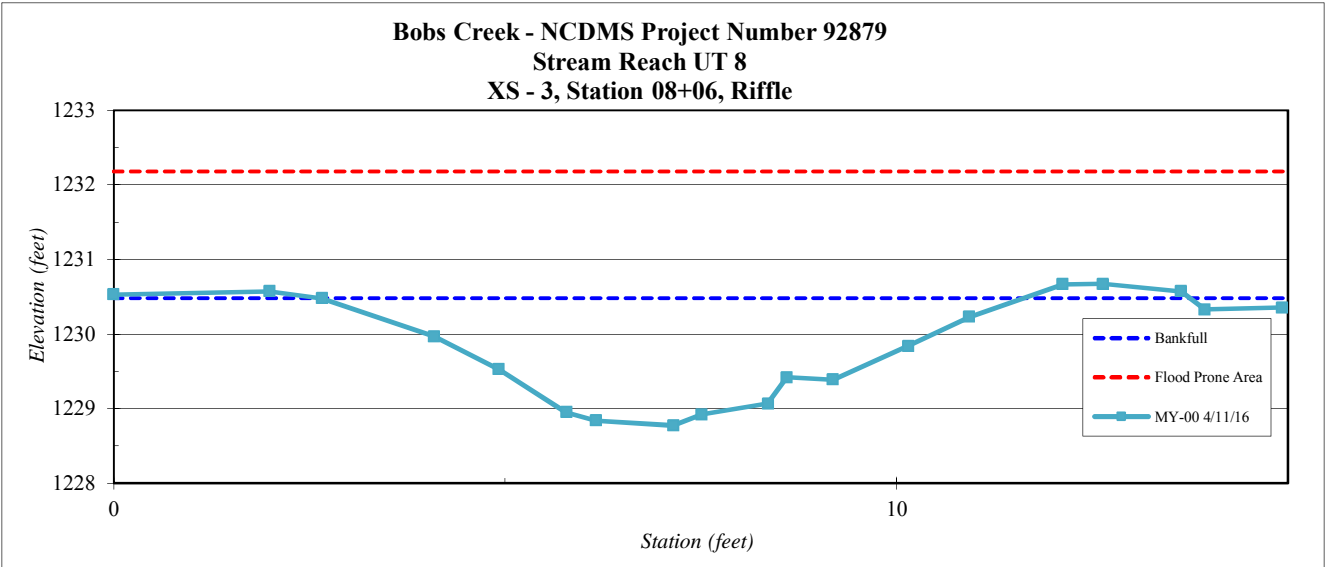
| XS ID | XS - 3, Riffle |

| Stream Type | E |

| SUMMARY DATA | |
|---|---|
| Bankfull Elevation: | 1230.5 |
| Bankfull Cross-Sectional Area: | 8.3 |
| Bankfull Width: | 9.0 |

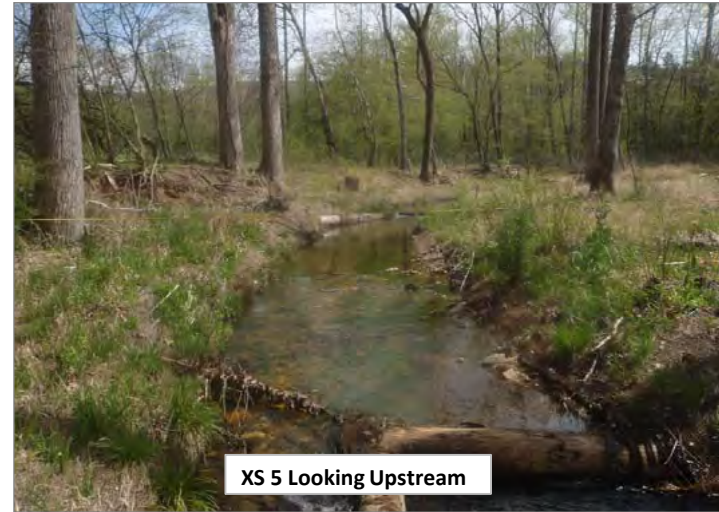
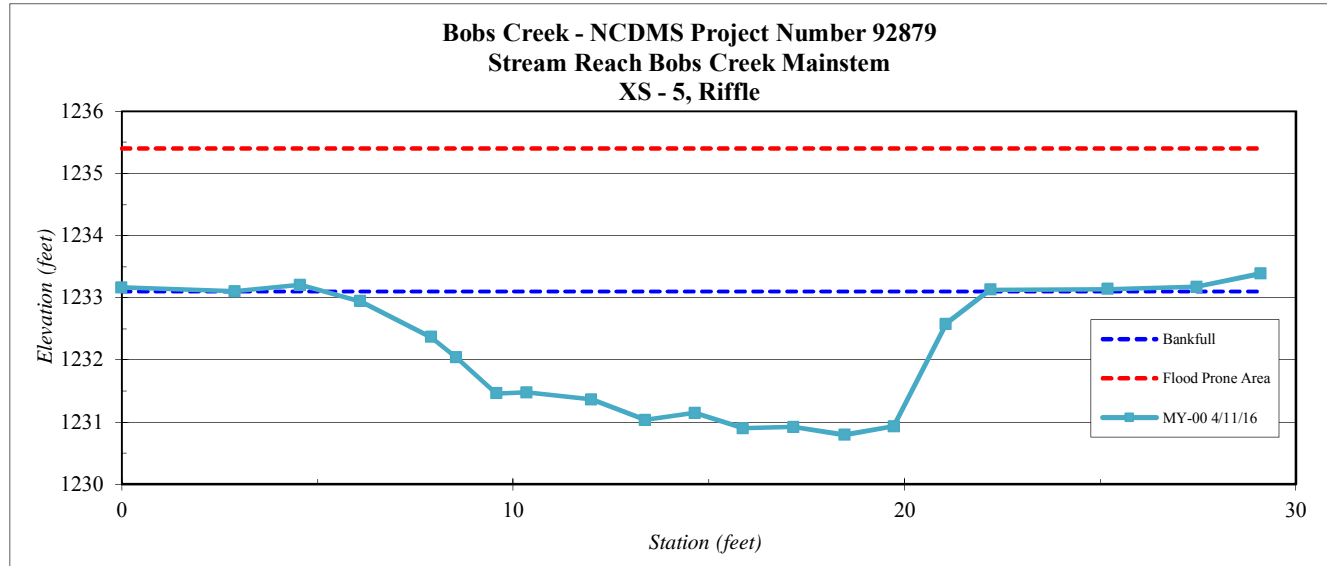
XS 5 Looking Upstream

| Stream Type | E |

| SUMMARY DATA | |
|---|---|
| Entrenchment Ratio: | 8.8 |
| Bank Height Ratio: | 1.0 |

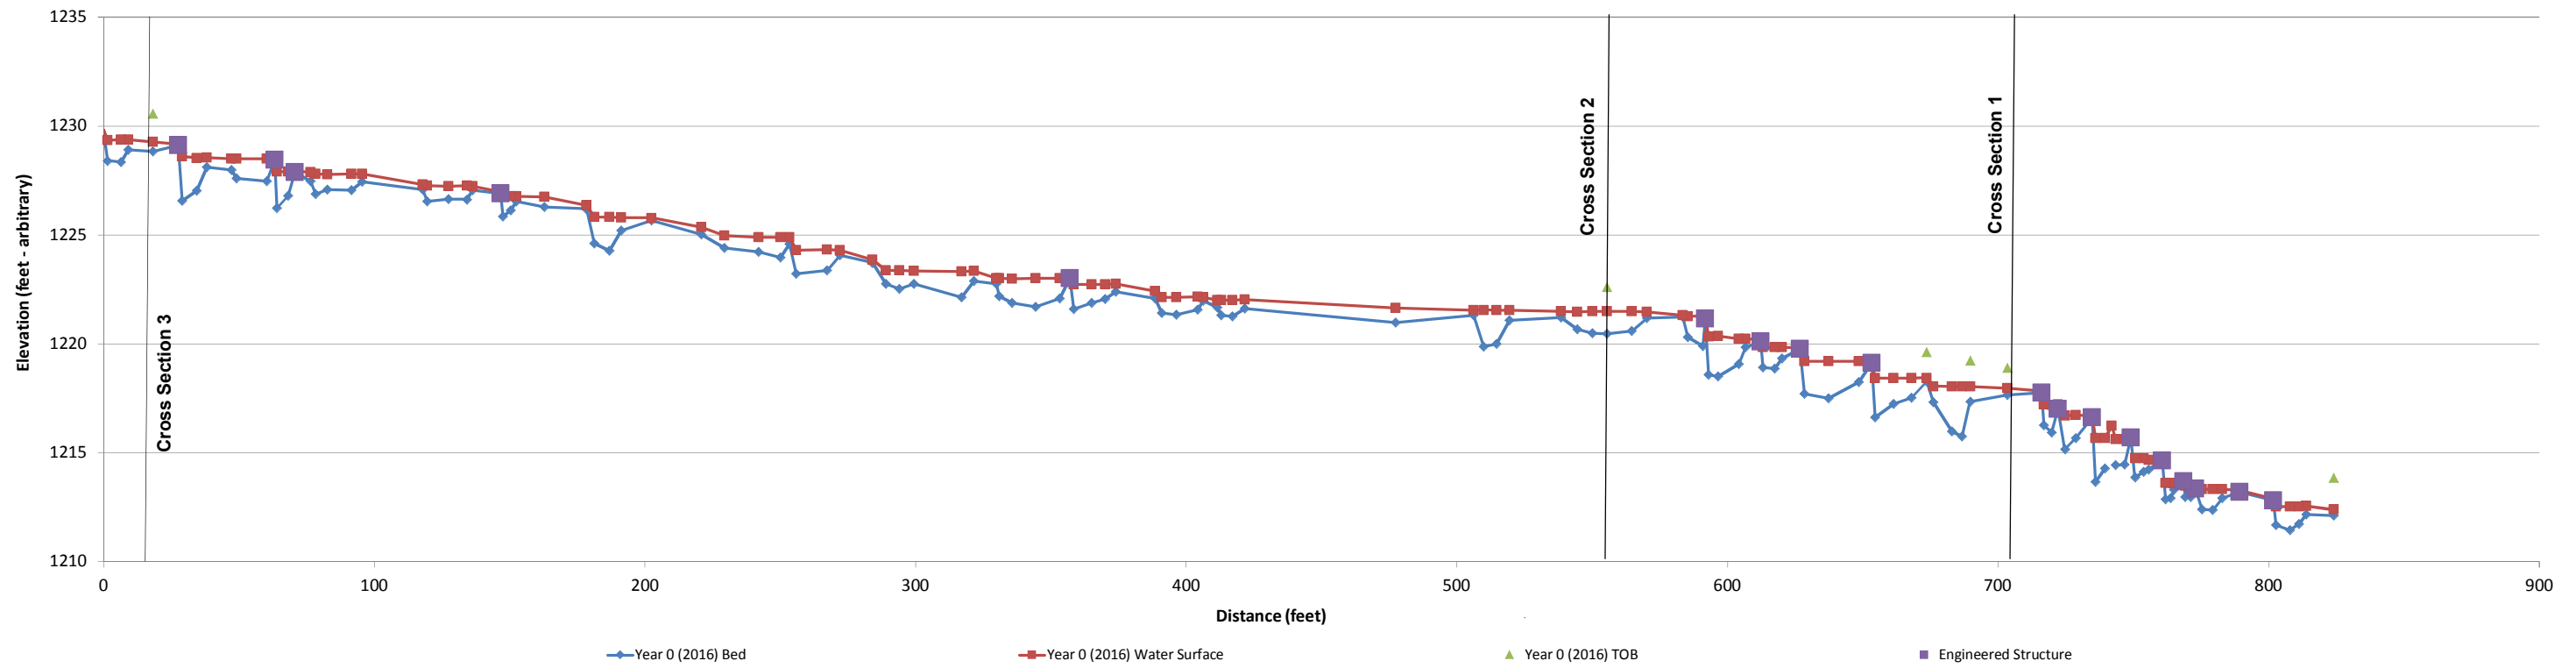
Bobs Creek Year 0 (2016) Profile - Tributary 8 Station 00+00 to 09+00

Project Name Bobs Creek - Profile
Reach UT 8 Station 00+00 - 09+00
Feature Profile
Date 4/11/16
Crew Perkinson, Jernigan

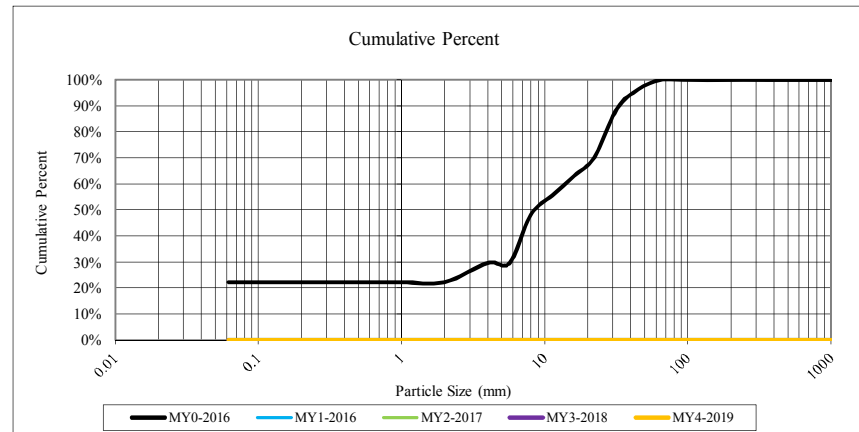
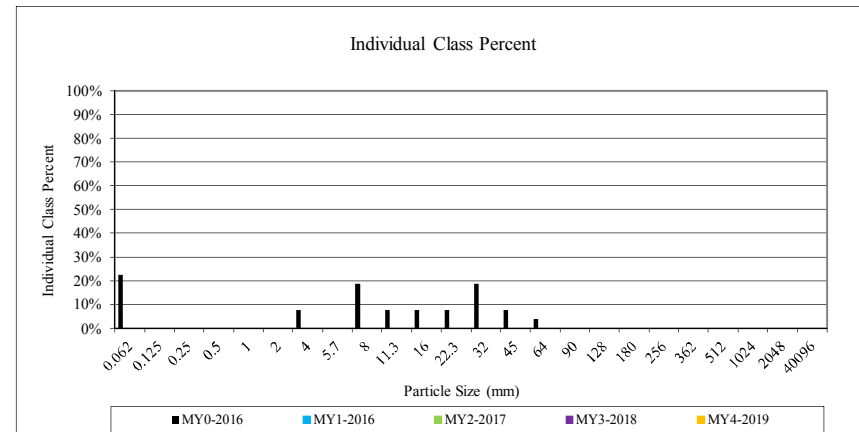
| Project Name: Bobs Creek - UT 8 | | | | | |
|---|---|---|---|---|---|
| Cross-Section: 1 | | | | | |

| Summary Data | |
|---|---|
| D84 | 29 |
| D95 | 42 |

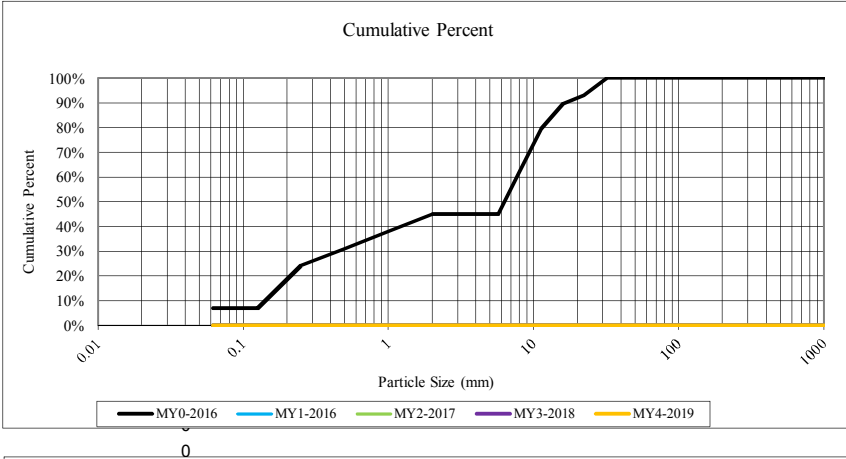
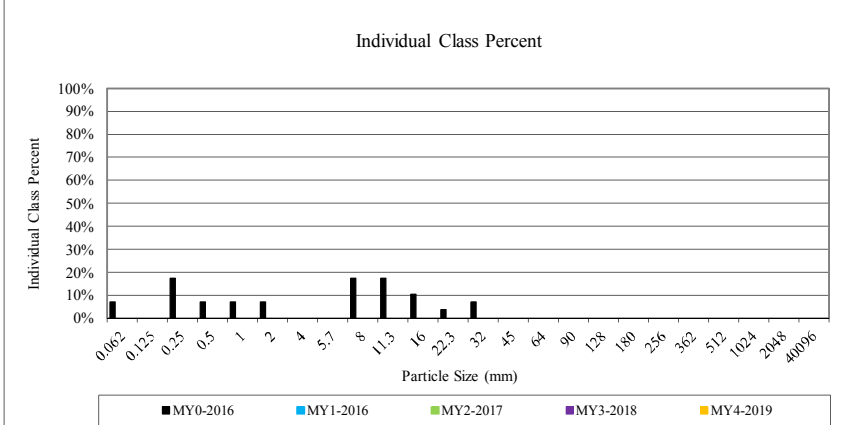
| Project Name: Bobs Creek - UT 8 | | | | | |
|---|---|---|---|---|---|
| Cross-Section: 3 | | | | | |

| Project Name: Bobs Creek - UT 8 | | | | | |
|---|---|---|---|---|---|
| D84 | 13 | | | | |
| D95 | 24 | | | | |
