FINAL
AS-BUILT BASELINE
MONITORING REPORT

BOBS CREEK
STREAM MITIGATION SITE

NCDMS Project No. 92879
Contract No. D09023S
USACE Action ID No. SAW-2009-917 & NCDWR Project No. 10-0122
SCO No. 08-07308-01
McDowell County, North Carolina

Data Collection: April 2016
Submission: July 2016

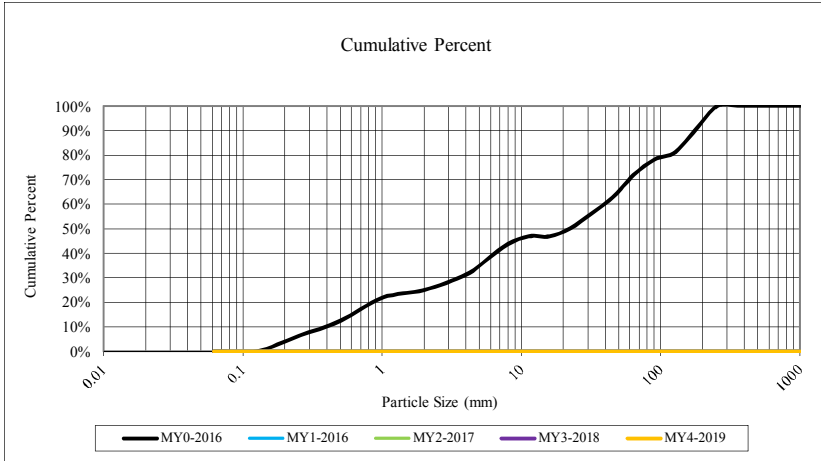
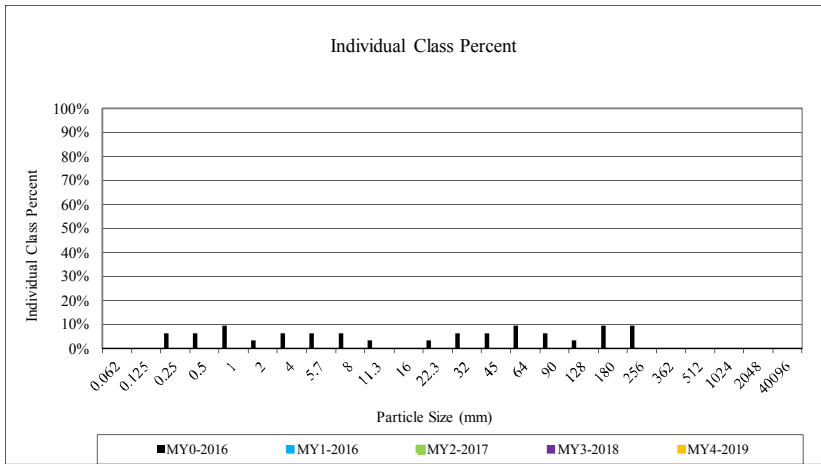
| Project Name: Bobs Creek | | | | | |
|---|---|---|---|---|---|
| Cross-Section: 4 | | | | | |

| Project Name: Bobs Creek | | | | | |
|---|---|---|---|---|---|
| D84 | 141 | | | | |
| D95 | 212 | | | | |

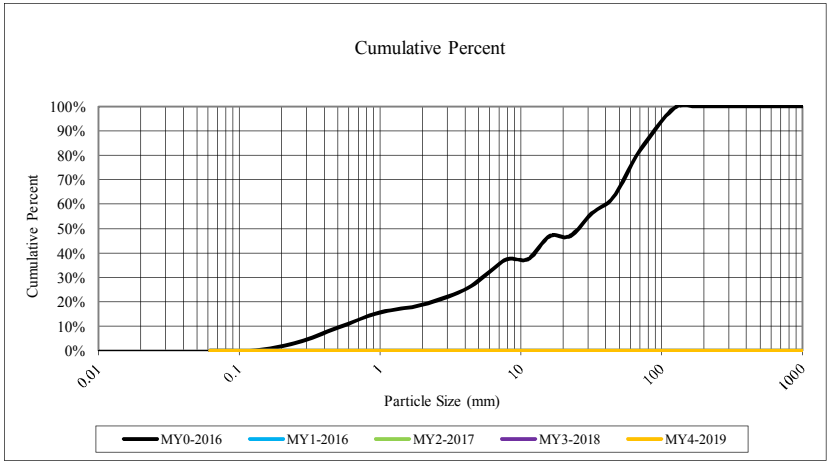
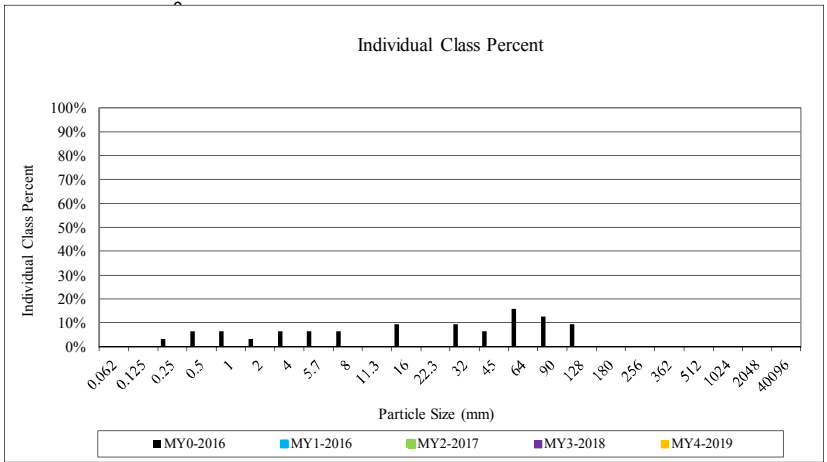
| Project Name: Bobs Creek | | | | | |
|---|---|---|---|---|---|
| Cross-Section: 5 | | | | | |

| Summary Data | |
|---|---|
| D84 | 75 |
| D95 | 106 |

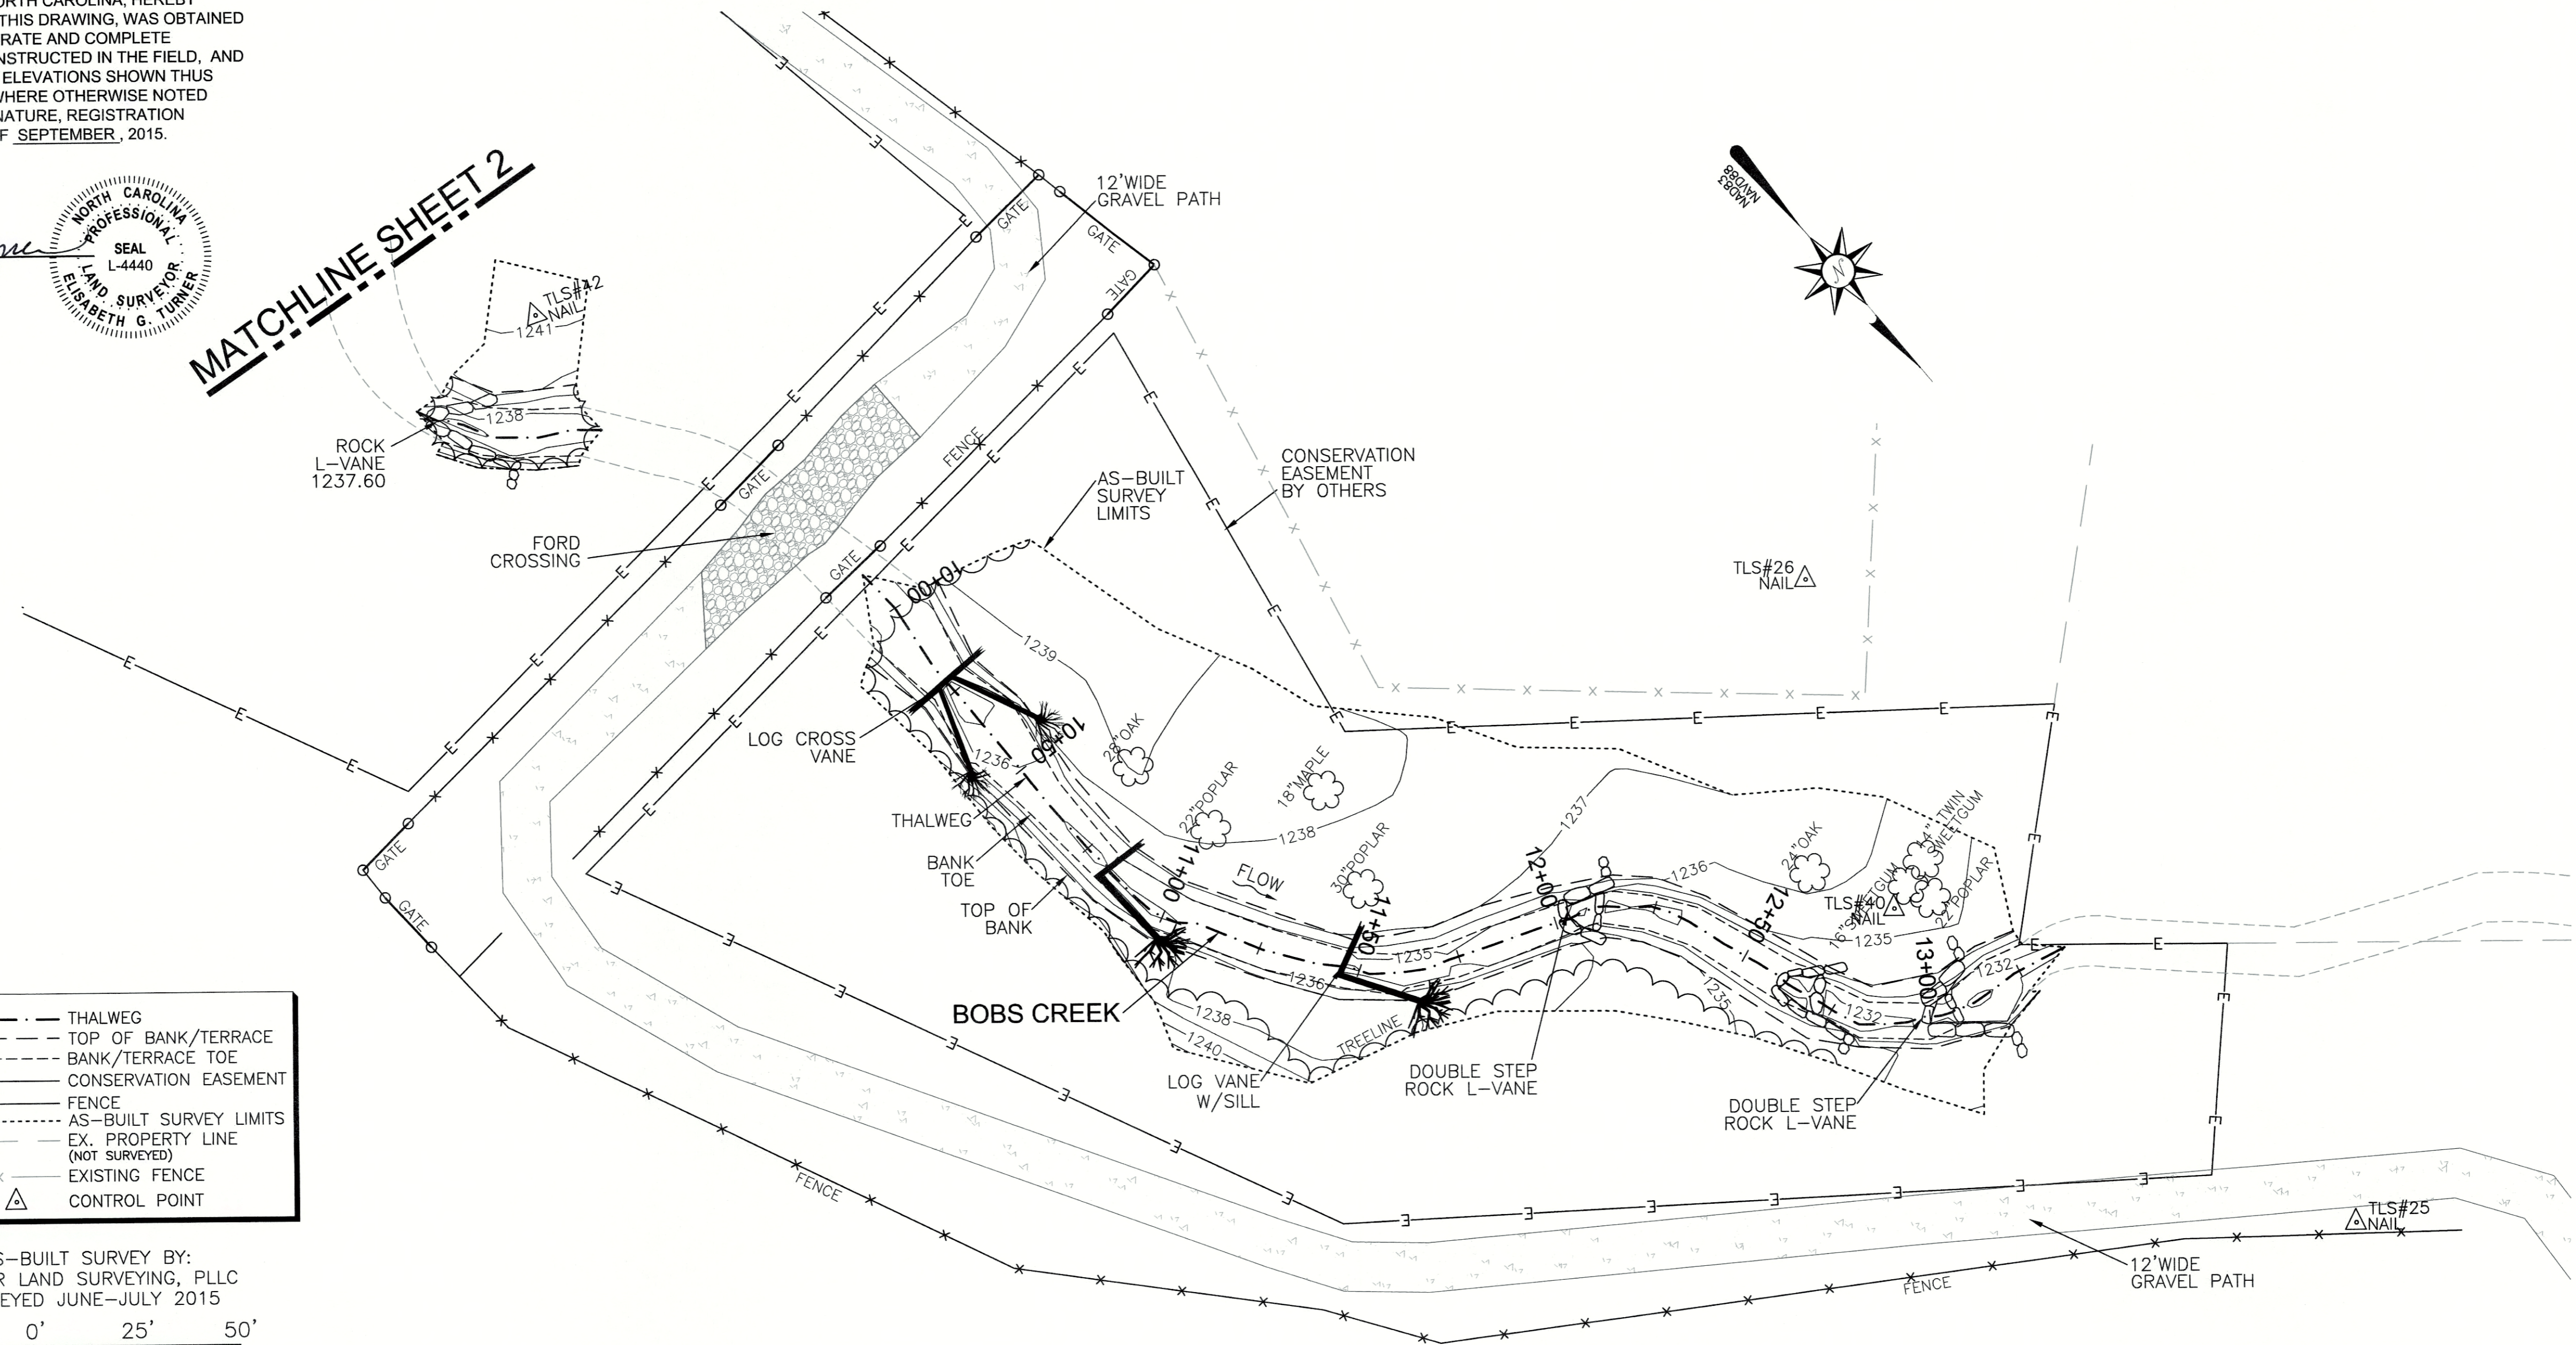
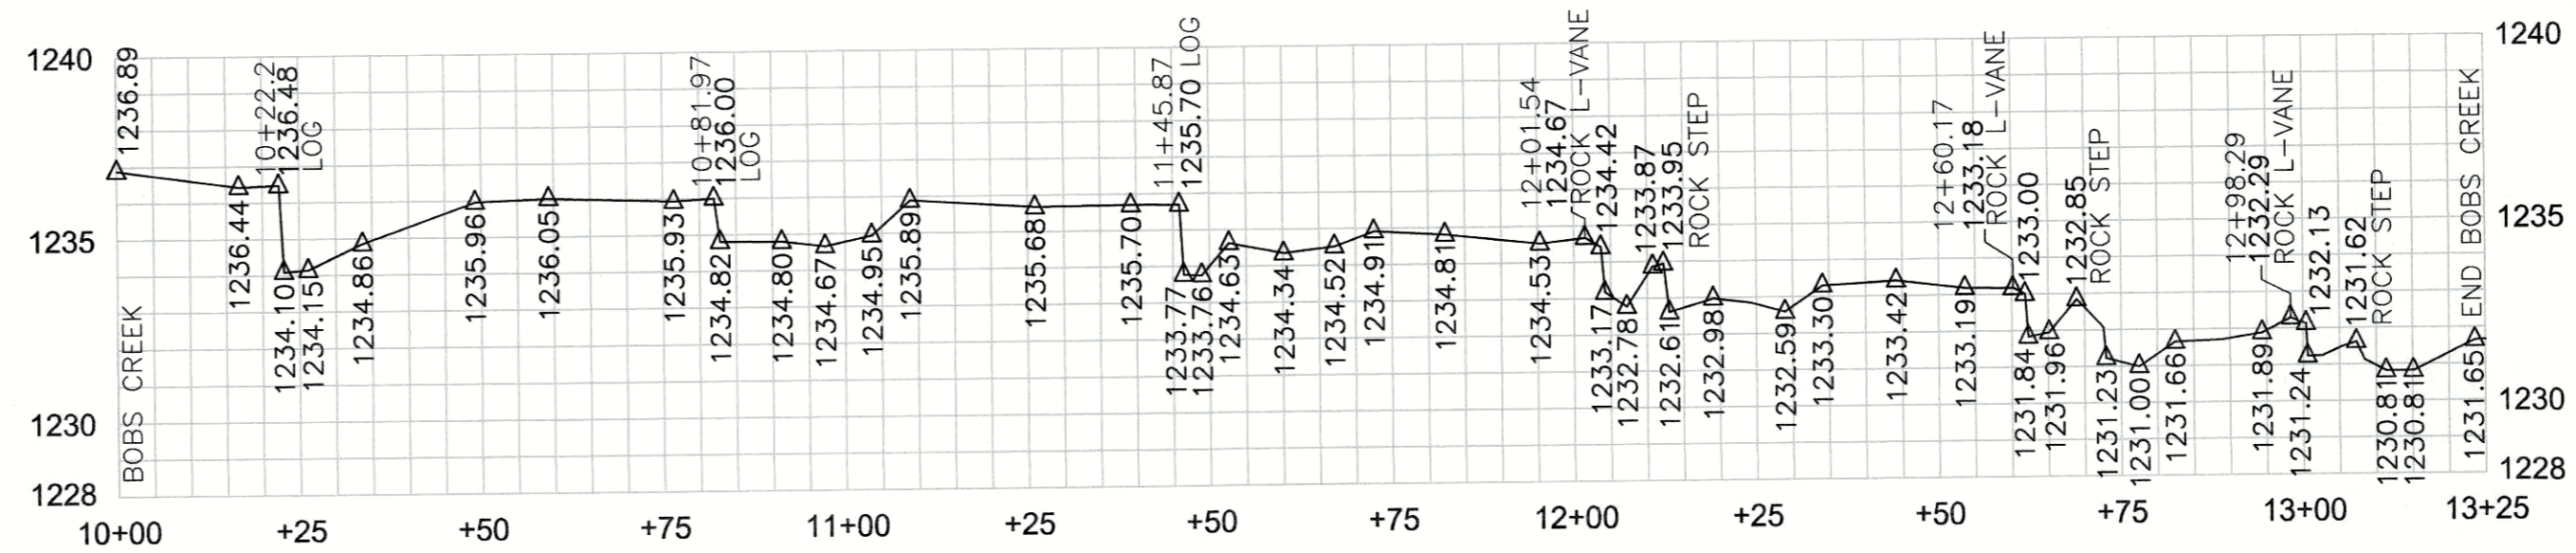
BOBS CREEK PLAN & PROFILE
BOBS CREEK STREAM RESTORATION PROJECT
 NCEEP PROJECT # 92879

**AS-BUILT PROFILE
 BOBS CREEK
 STA 10+00 TO 13+25**

PROFILE SCALE
 HORIZONTAL: 1"=25'(22x34)
 1"=50'(11x17)
 VERTICAL: 1"=5'(22x34)
 1"=10'(11x17)

SHEET INDEX
 SHEET 1- TITLE, VICINITY MAP, & SHEET INDEX
 SHEET 2- UT 7 & BOBS CREEK PLAN VIEW
 SHEET 3- BOBS CREEK PLAN & PROFILE
 SHEET 4- UT 8 UPSTREAM PLAN & PROFILE
 SHEET 5- UT 8 DOWNSTREAM PLAN & PROFILE

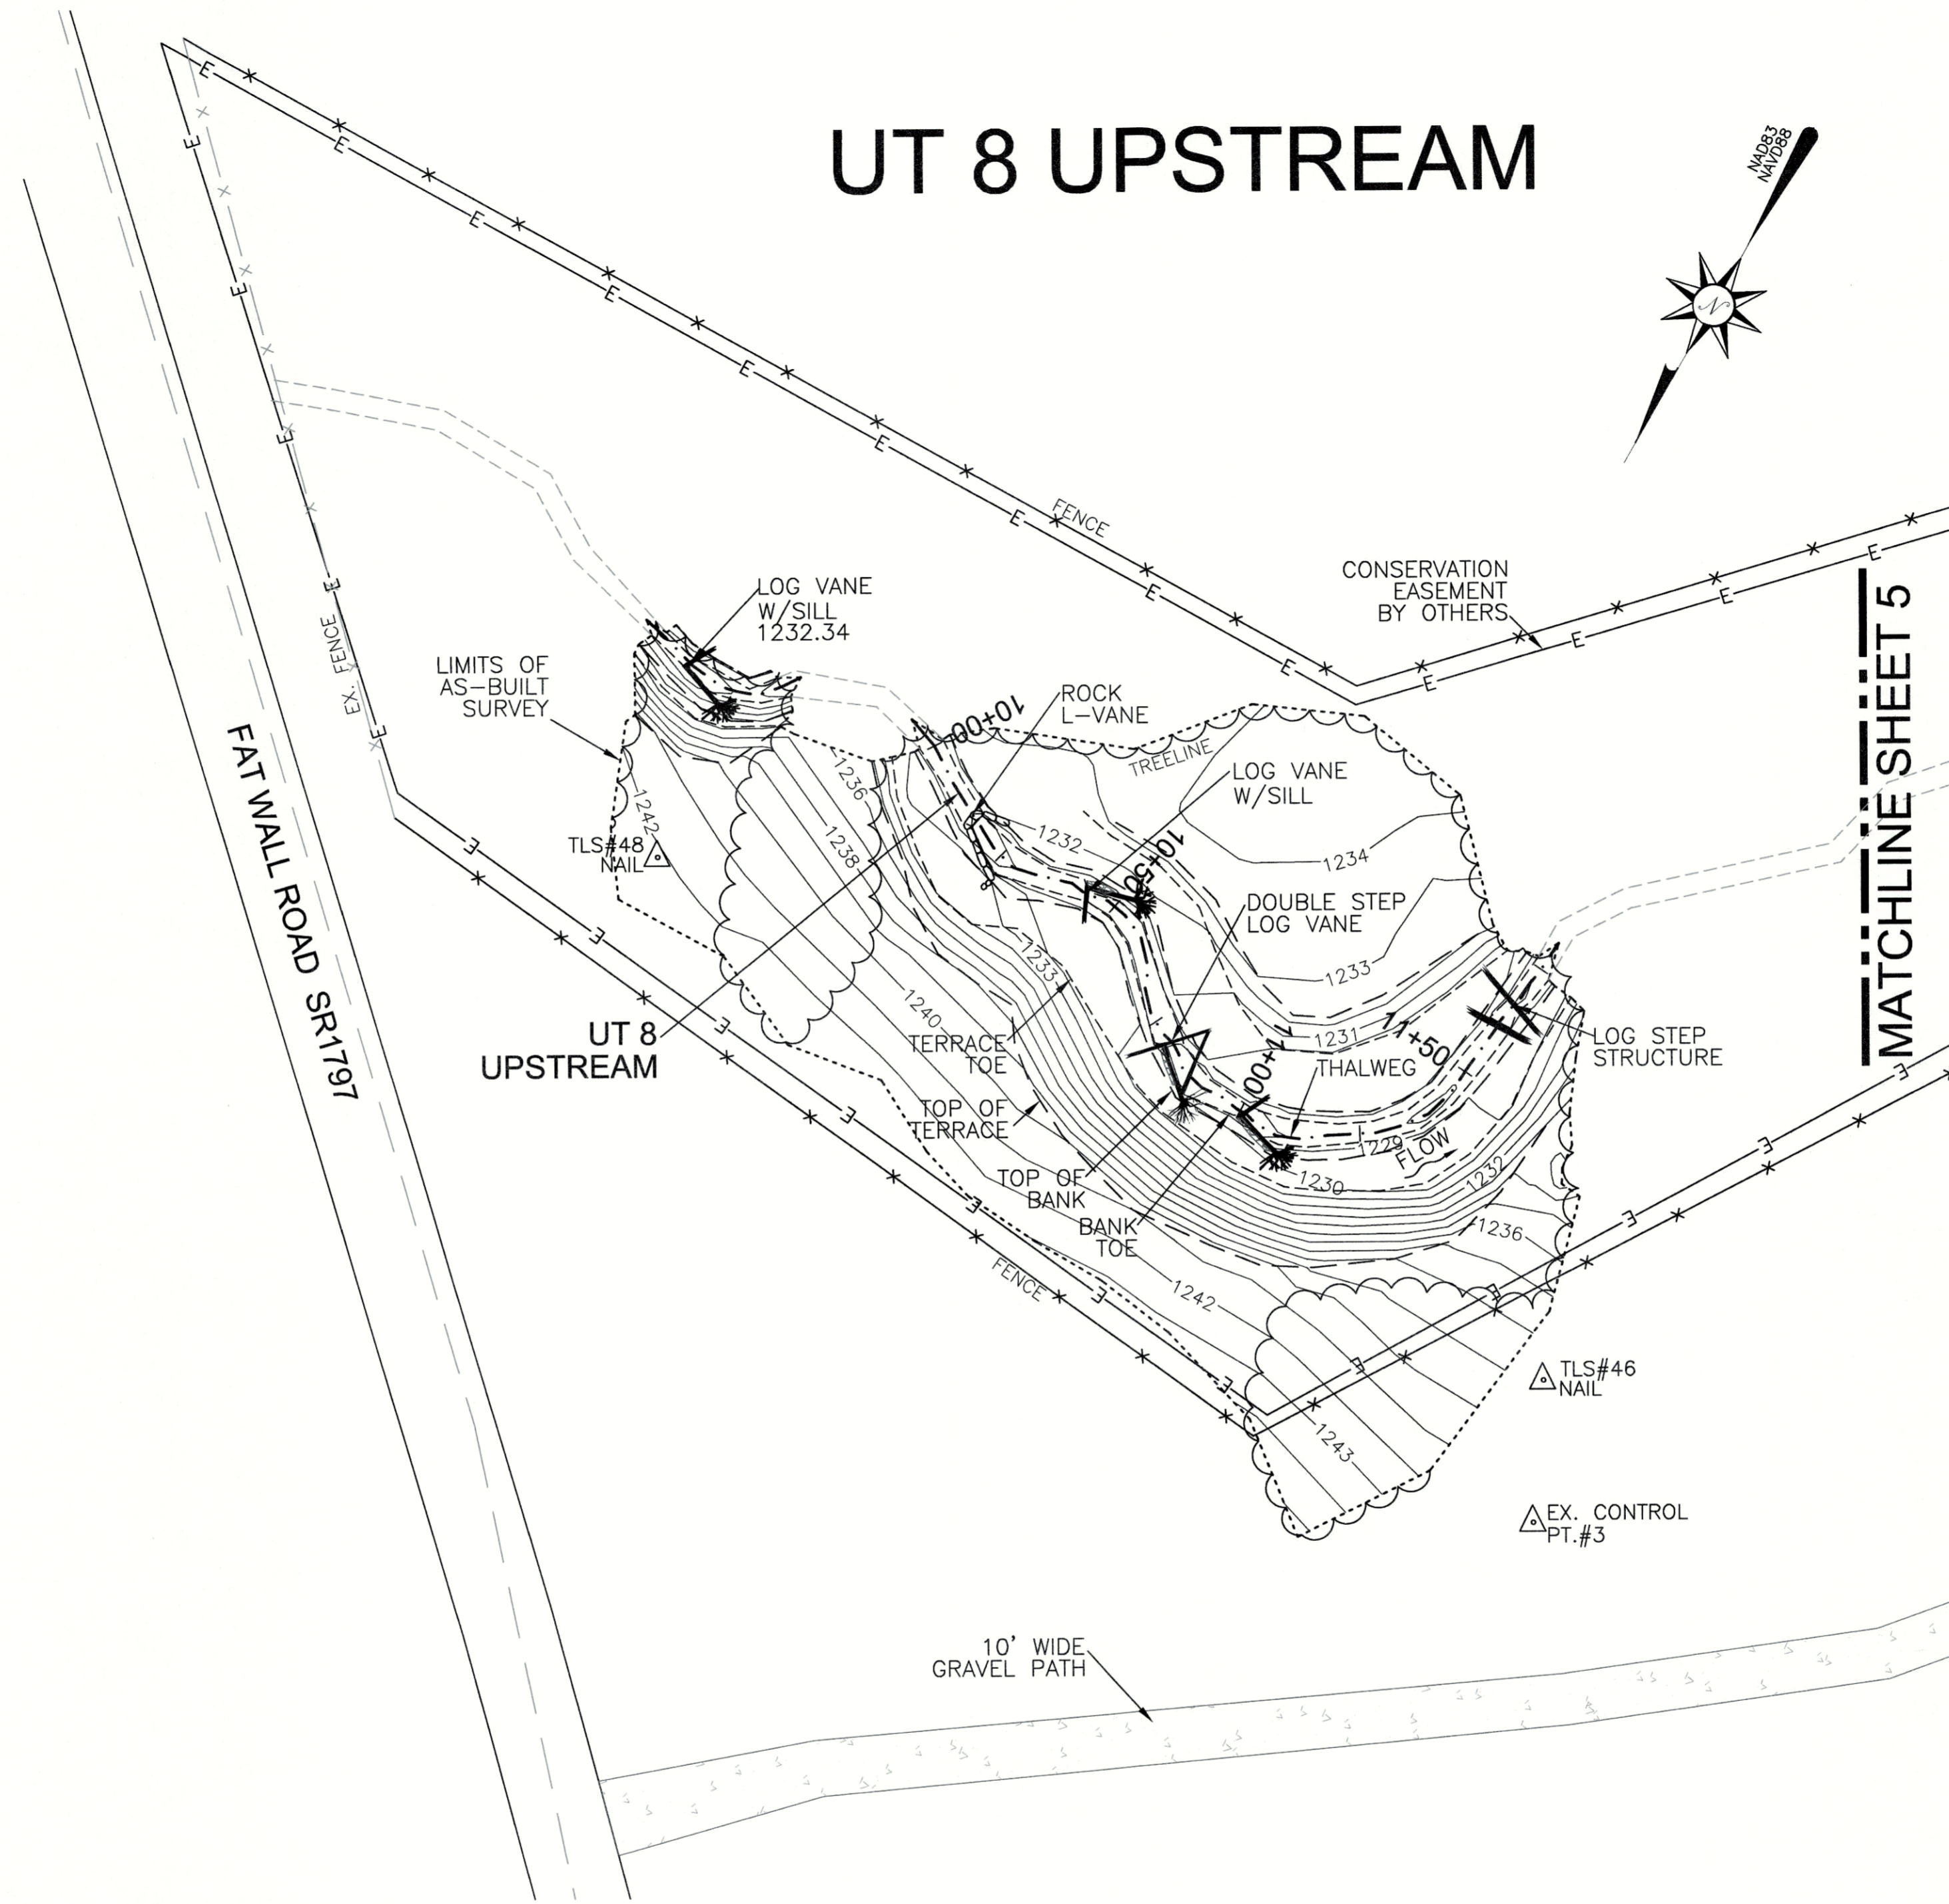
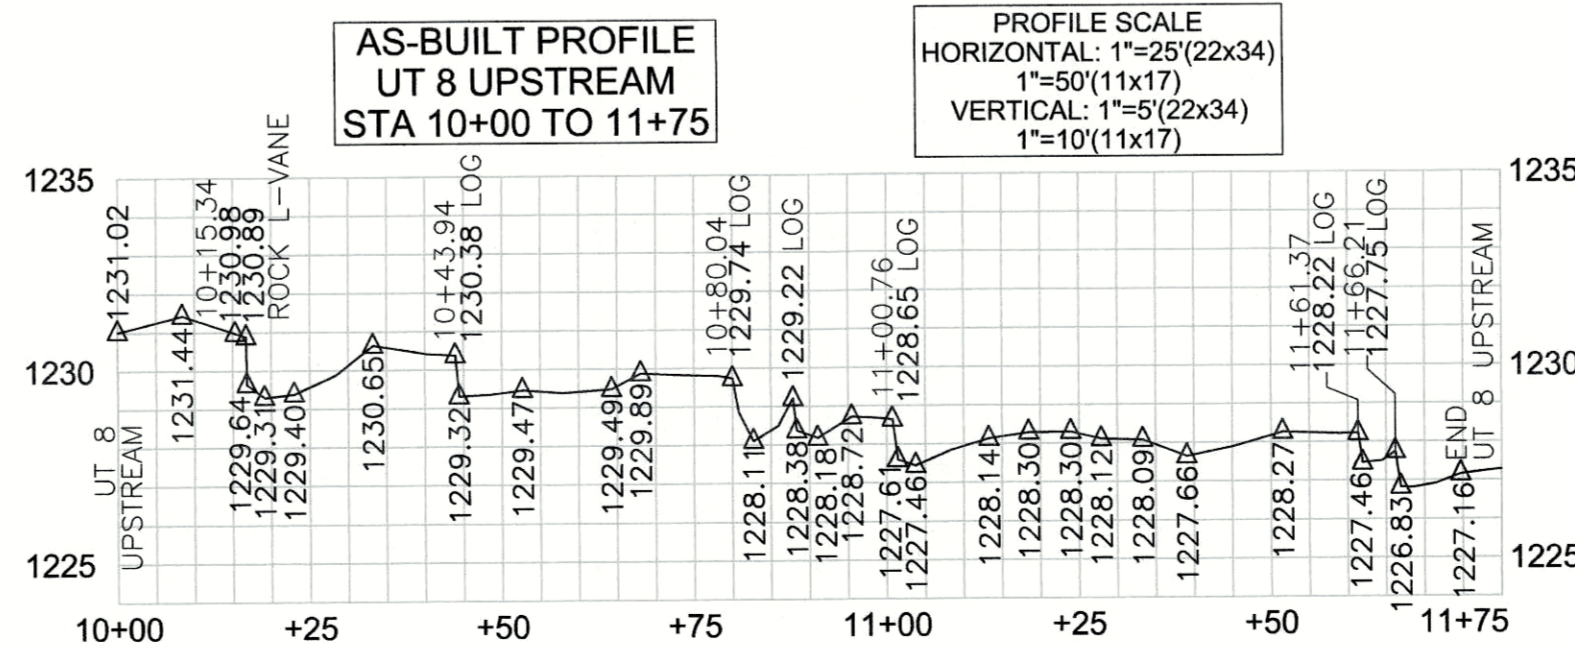
UT 8 UPSTREAM PLAN & PROFILE

SCALE: 1"=25' (22x34)
 1"=50' (11x17)
 CONTOUR INTERVAL = 1'
