**FINAL**  
**YEAR 2 (2017) ANNUAL**  
**MONITORING REPORT**

**BOBS CREEK**  
**STREAM MITIGATION SITE**

NCDMS Project No. 92879  
Contract No. D09023S  
USACE Action ID No. SAW-2009-917 & NCDWR Project No. 10-0122  
SCO No. 08-07308-01  
McDowell County, North Carolina

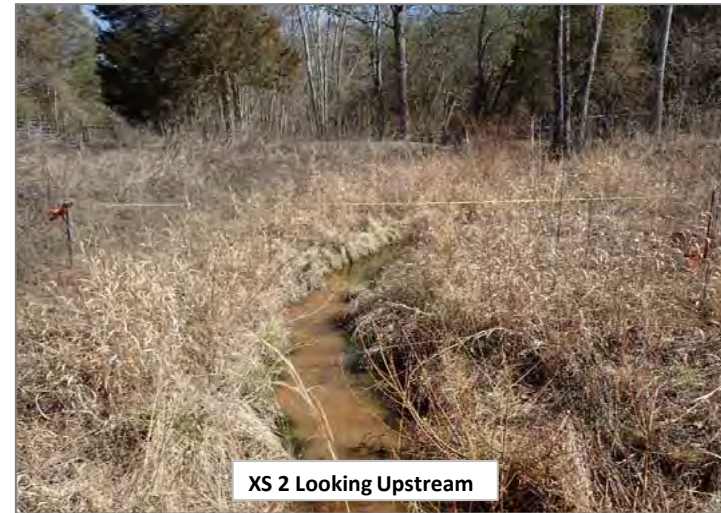
Station	Elevation
0.0	1222.6
3.1	1222.5
5.5	1222.4
7.4	1222.0
8.4	1221.9
9.3	1221.4
10.1	1221.4
10.7	1221.1
11.3	1220.9
12.0	1220.8
12.8	1220.7
13.5	1220.6
13.9	1220.9
14.6	1221.7
15.2	1222.0
16.0	1222.4
17.2	1222.5
19.2	1222.6
21.1	1222.6
22.6	1222.6

SUMMARY DATA	
<b>Bankfull Elevation:</b>	1222.4
<b>Bankfull Cross-Sectional Area:</b>	9.5
<b>Bankfull Width:</b>	11.0
<b>Flood Prone Area Elevation:</b>	NA
<b>Flood Prone Width:</b>	NA
<b>Max Depth at Bankfull:</b>	1.8
<b>Mean Depth at Bankfull:</b>	0.9
<b>W / D Ratio:</b>	NA
<b>Entrenchment Ratio:</b>	NA
<b>Bank Height Ratio:</b>	1.0

<b>Stream Type</b>	E
--------------------	---

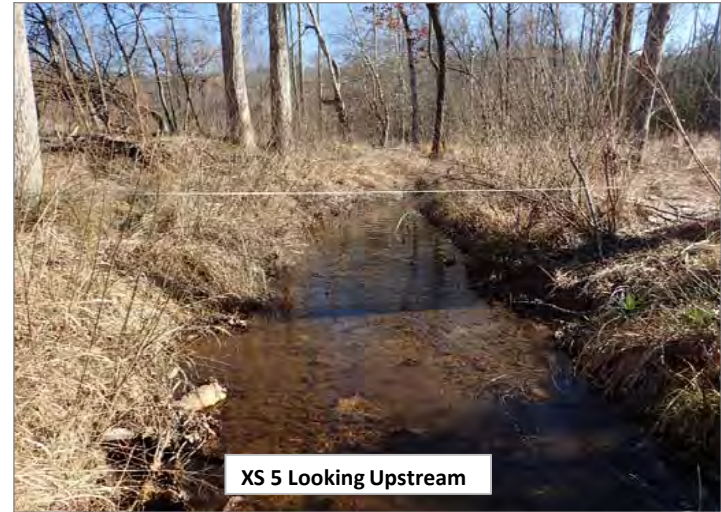
<b>Site</b>	Bobs Creek
<b>Project Number:</b>	92879
<b>XS ID</b>	XS - 5, Riffle
<b>Reach</b>	Bobs Creek
<b>Date:</b>	2/20/2017
<b>Field Crew:</b>	Perkinson, Jernigan

<b>Stream Type</b>	E
--------------------	---

SUMMARY DATA	
<b>Bankfull Elevation:</b>	1233.0
<b>Bankfull Cross-Sectional Area:</b>	25.2
<b>Bankfull Width:</b>	17.4
<b>Flood Prone Area Elevation:</b>	1235.2
<b>Flood Prone Width:</b>	150.0
<b>Max Depth at Bankfull:</b>	2.2
<b>Mean Depth at Bankfull:</b>	1.4
<b>W / D Ratio:</b>	12.0
<b>Entrenchment Ratio:</b>	8.6
<b>Bank Height Ratio:</b>	1.0

Station	Elevation
0.00	1232.97
2.93	1233.02
5.01	1232.98
6.50	1232.55
8.44	1231.91
9.65	1231.57
10.35	1231.24
12.25	1231.00
13.65	1230.93
15.18	1230.94
16.89	1230.86
16.91	1230.83
17.97	1231.00
18.70	1231.26
19.87	1230.99
20.6	1231.65
21.2	1232.51
22.5	1233.02
26.0	1233.08
29.0	1233.39

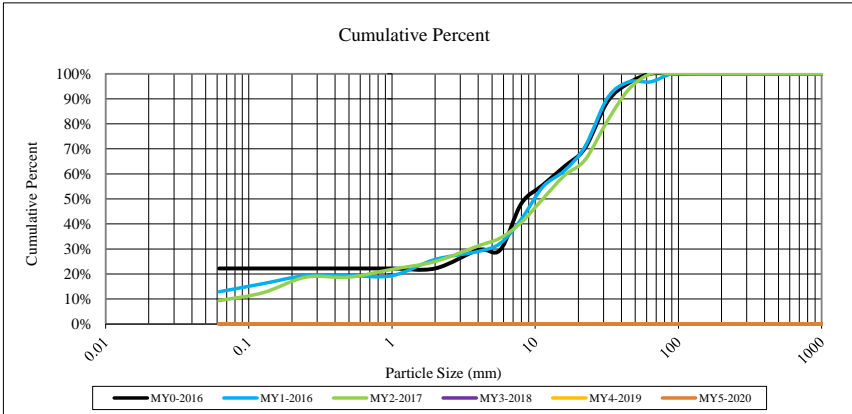
Project Name: Bobs Creek - UT 8					
Cross-Section: 1					
Feature: Riffle					
2017					
Description	Material	Size (mm)	Total #	Item %	Cum %
Silt/Clay	silt/clay	0.062	3	9%	36%
	very fine sand	0.125	1	3%	44%
Sand	fine sand	0.250	2	6%	48%
	medium sand	0.50	0	0%	48%
	coarse sand	1.00	1	3%	56%
	very coarse sand	2.0	1	3%	60%
Gravel	very fine gravel	4.0	2	6%	68%
	fine gravel	5.7	1	3%	72%
	fine gravel	8.0	2	6%	84%
	medium gravel	11.3	3	9%	92%
	medium gravel	16.0	3	9%	92%
	course gravel	22.3	2	6%	96%
	course gravel	32.0	5	16%	96%
	very coarse gravel	45	4	13%	96%
Cobble	very coarse gravel	64	2	6%	100%
	small cobble	90	0	0%	100%
	medium cobble	128	0	0%	100%
	large cobble	180	0	0%	100%
Boulder	very large cobble	256	0	0%	100%
	small boulder	362	0	0%	100%
	small boulder	512	0	0%	100%
Boulder	medium boulder	1024	0	0%	100%
	large boulder	2048	0	0%	100%
Bedrock	bedrock	40096	0	0%	100%
<b>TOTAL % of whole count</b>			32	100%	100%
Summary Data

D50	11				
D84	34				
D95	48

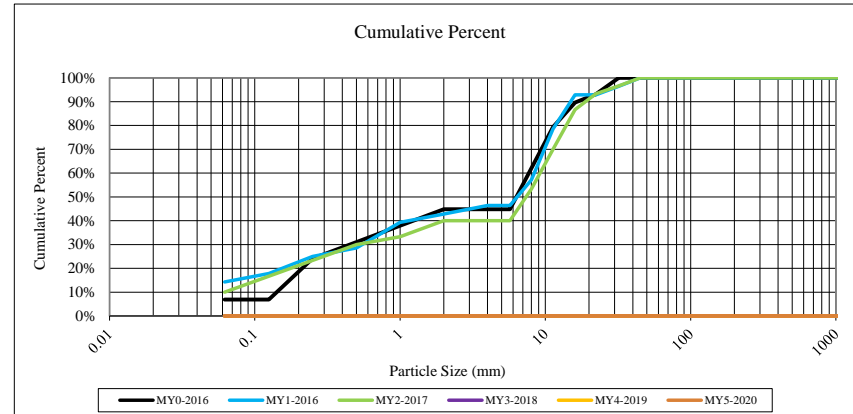
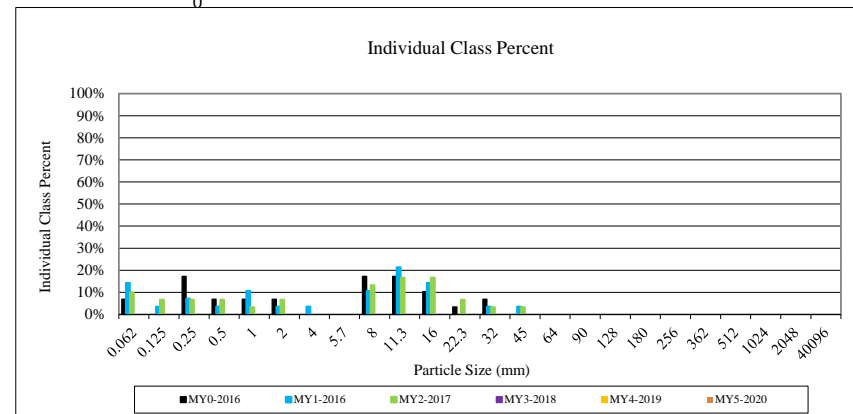
Project Name: Bobs Creek - UT 8					
Cross-Section: 3					
Feature: Riffle					
			2017		
Description	Material	Size (mm)	Total #	Item %	Cum %
Silt/Clay	silt/clay	0.062	3	10%	33%
	very fine sand	0.125	2	7%	43%
Sand	fine sand	0.250	2	7%	48%
	medium sand	0.50	2	7%	52%
	coarse sand	1.00	1	3%	62%
	very coarse sand	2.0	2	7%	67%
	very fine gravel	4.0	0	0%	67%
Gravel	fine gravel	5.7	0	0%	67%
	fine gravel	8.0	4	13%	71%
	medium gravel	11.3	5	17%	76%
	medium gravel	16.0	5	17%	86%
	course gravel	22.3	2	7%	90%
	course gravel	32.0	1	3%	95%
	very coarse gravel	45	1	3%	95%
	very coarse gravel	64	0	0%	95%
Cobble	small cobble	90	0	0%	100%
	medium cobble	128	0	0%	100%
	large cobble	180	0	0%	100%
	very large cobble	256	0	0%	100%
	Boulder	small boulder	362	0	0%
small boulder		512	0	0%	100%
medium boulder		1024	0	0%	100%
large boulder		2048	0	0%	100%
Bedrock	bedrock	40096	0	0%	100%
<b>TOTAL % of whole count</b>			30	100%	100%

Summary Data	
D50	7.4
D84	15
D95	27

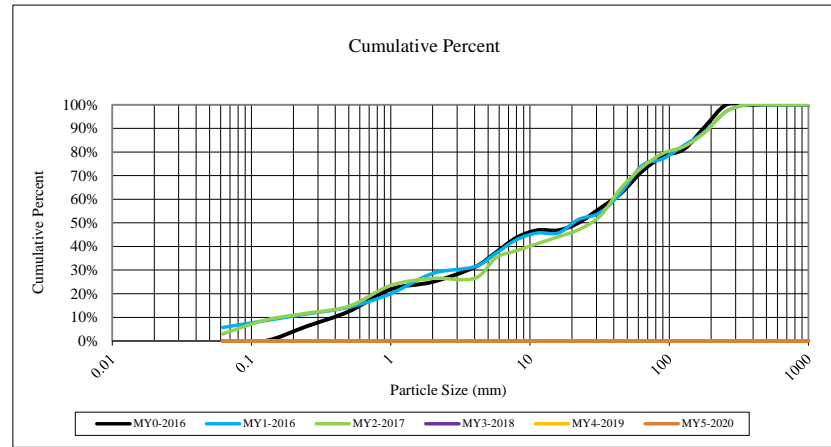
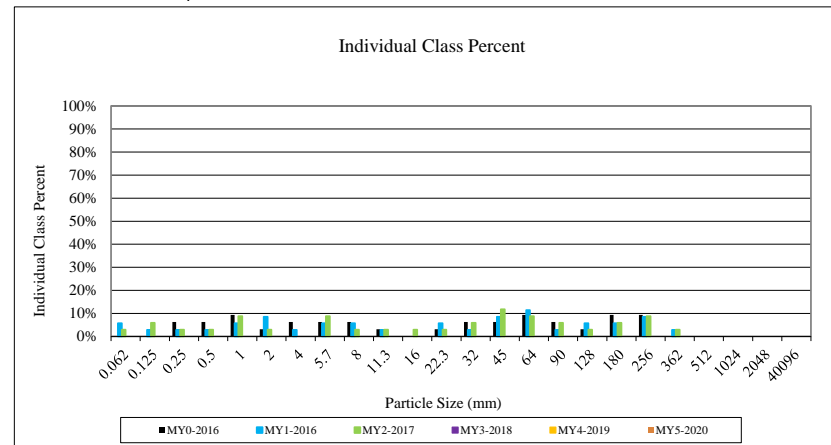
Project Name: Bobs Creek					
Cross-Section: 4					
Feature: Riffle					
			2017		
Description	Material	Size (mm)	Total #	Item %	Cum %
Silt/Clay	silt/clay	0.062	1	3%	24%
	very fine sand	0.125	2	6%	32%
Sand	fine sand	0.250	1	3%	44%
	medium sand	0.50	1	3%	48%
	coarse sand	1.00	3	9%	56%
	very coarse sand	2.0	1	3%	60%
	very fine gravel	4.0	0	0%	68%
Gravel	fine gravel	5.7	3	9%	72%
	fine gravel	8.0	1	3%	80%
	medium gravel	11.3	1	3%	80%
	medium gravel	16.0	1	3%	84%
	course gravel	22.3	1	3%	96%
	course gravel	32.0	2	6%	96%
	very coarse gravel	45	4	12%	96%
	very coarse gravel	64	3	9%	100%
	small cobble	90	2	6%	100%
Cobble	medium cobble	128	1	3%	100%
	large cobble	180	2	6%	100%
	very large cobble	256	3	9%	100%
	small boulder	362	1	3%	100%
Boulder	small boulder	512	0	0%	100%
	medium boulder	1024	0	0%	100%
	large boulder	2048	0	0%	100%
	bedrock	bedrock	40096	0	0%
<b>TOTAL % of whole count</b>			34	100%	100%

Summary Data	
D50	26.5
D84	141
D95	236
