**Bold Run Stream/Buffer Restoration
Mitigation Plan
EEP Project # 439
2007**

June 2007

JUNE 2007	
SUBMITTED WITH MITIGATION PLAN	
REVISIONS	
ENGINEERS • PLANNERS • SCIENTISTS 4601 SIX FORKS ROAD RALEIGH, NORTH CAROLINA 27609	
BOLD RUN CREEK STREAM / BUFFER RESTORATION WAKE FOREST, WAKE COUNTY, NORTH CAROLINA EEP PROJECT NUMBER 439 - MY 00 STATION 10+00 TO STATION 16+77	
DATE:	06/01/2007
SCALE:	SEE SHEET
MONITORING PLAN VIEW	
SHEET	1 OF 6

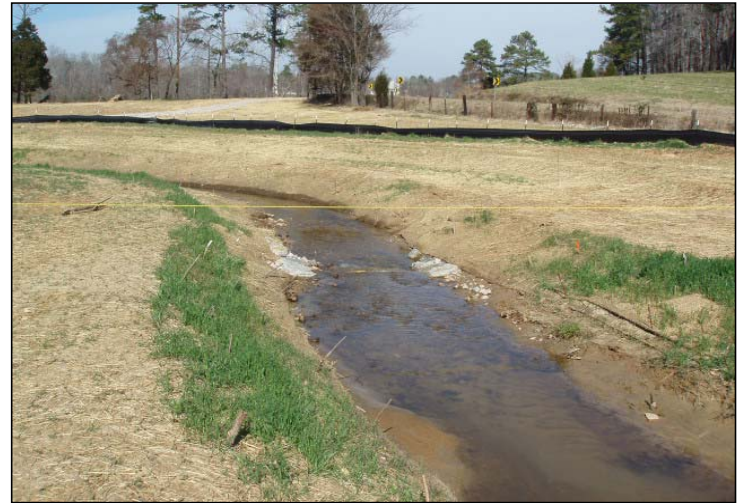
River Basin:	Neuse
Watershed:	Bold Run, As-Built
XS ID	XS - 1, Riffle
Drainage Area (sq mi):	12
Date:	3/6/2007
Field Crew:	A. Spiller, B. Roberts, H. Miller

Station	Elevation
0.00	280.1
6.17	280.4
9.43	280.5
12.92	280.2
15.92	279.9
21.37	278.5
23.23	278.4
26.06	278.5
29.73	278.5
31.76	278.7
33.69	278.3
35.88	277.1
36.67	276.7
37.50	276.3
37.70	275.9
38.40	275.6
39.94	275.6
41.30	275.6
42.86	275.7
44.25	275.8
46.13	276.0
47.13	276.7
47.91	276.8
50.44	277.9
52.03	278.2
58.11	278.2
62.38	278.4
66.56	279.8
70.41	279.4
72.85	279.6
81.44	279.6

SUMMARY DATA	
Bankfull Elevation:	278.2
Bankfull Cross-Sectional Area:	29.6
Bankfull Width:	18.1
Flood Prone Area Elevation:	280.8
Flood Prone Width:	>80
Max Depth at Bankfull:	2.6
Mean Depth at Bankfull:	1.6
W / D Ratio:	11.1
Entrenchment Ratio:	>5
Bank Height Ratio:	1.0
Slope:	0.0069
Discharge:	116

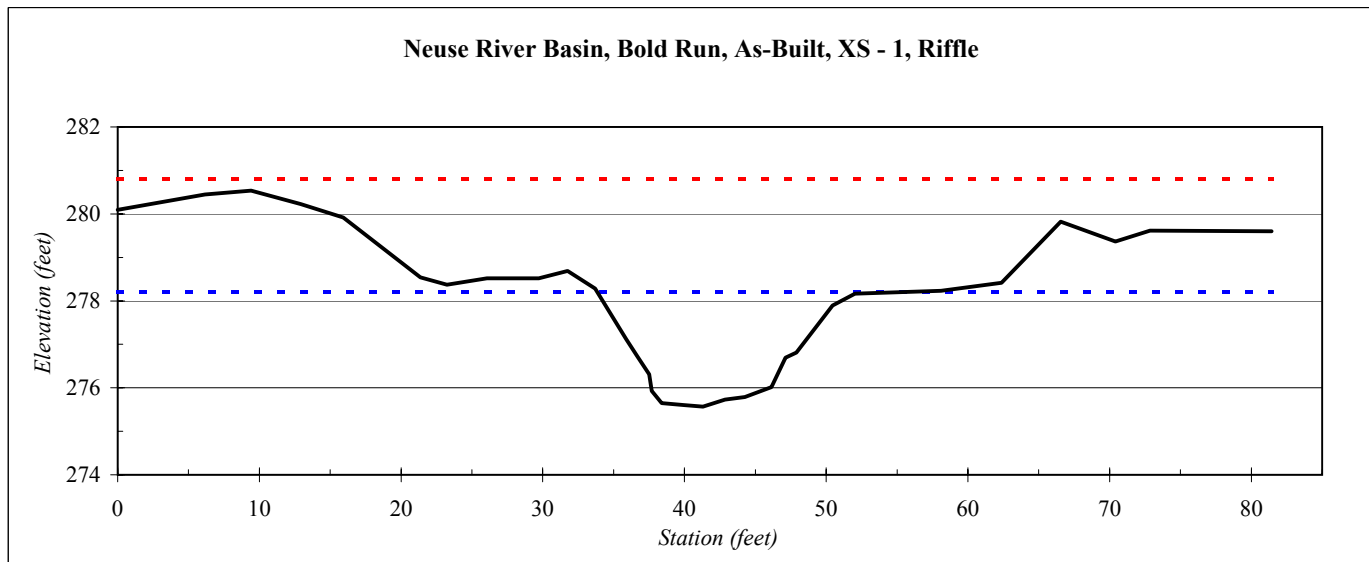
Neuse River Basin, Bold Run, As-Built, XS - 1, Riffle

Riffle		
Material	Size Range (mm)	Count
silt/clay	0 - 0.062	10
very fine sand	0.062 - 0.125	11
fine sand	0.125 - 0.25	1
medium sand	0.25 - 0.5	
coarse sand	0.5 - 1	1
very coarse sand	1 - 2	1
very fine gravel	2 - 4	2
fine gravel	4 - 6	
fine gravel	6 - 8	1
medium gravel	8 - 11	3
medium gravel	11 - 16	13
coarse gravel	16 - 22	11
coarse gravel	22 - 32	5
very coarse gravel	32 - 45	3
very coarse gravel	45 - 64	12
small cobble	64 - 90	19
medium cobble	90 - 128	7
large cobble	128 - 180	
very large cobble	180 - 256	
small boulder	256 - 362	
small boulder	362 - 512	
medium boulder	512 - 1024	
large boulder	1024 - 2048	
very large boulder	2048 - 4096	
total particle count:		100
bedrock -----		
clay hardpan -----		
detritus/wood -----		
artificial -----		
total count:		100
Note: XS-1 Riffle

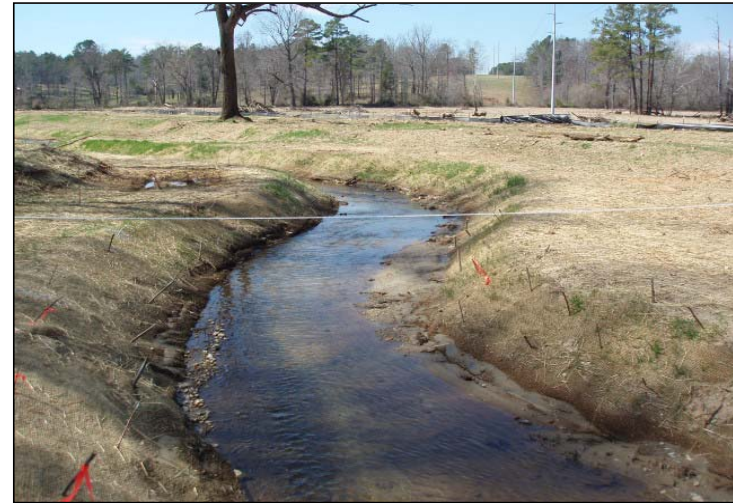
River Basin:	Neuse
Watershed:	Bold Run, As-Built
XS ID	XS - 2, Pool
Drainage Area (sq mi):	12
Date:	3/6/2007
Field Crew:	A. Spiller, B. Roberts, H. Miller

Station	Elevation
0.00	278.4
3.92	278.4
7.66	276.9
9.52	276.5
15.33	276.5
18.49	276.5
22.70	274.2
23.15	274.0
24.20	273.8
25.34	273.4
27.51	273.6
28.58	273.9
30.08	274.0
30.87	274.3
34.59	276.0
38.00	276.4
43.25	276.6
46.33	276.7
48.86	277.4
52.49	278.9
57.82	278.5
60.84	278.6

SUMMARY DATA	
Bankfull Elevation:	276.4
Bankfull Cross-Sectional Area:	30.8
Bankfull Width:	18.9
Flood Prone Area Elevation:	-
Flood Prone Width:	-
Max Depth at Bankfull:	3.0
Mean Depth at Bankfull:	1.6
W / D Ratio:	-
Entrenchment Ratio:	-
Bank Height Ratio:	-
Slope:	-
Discharge:	-

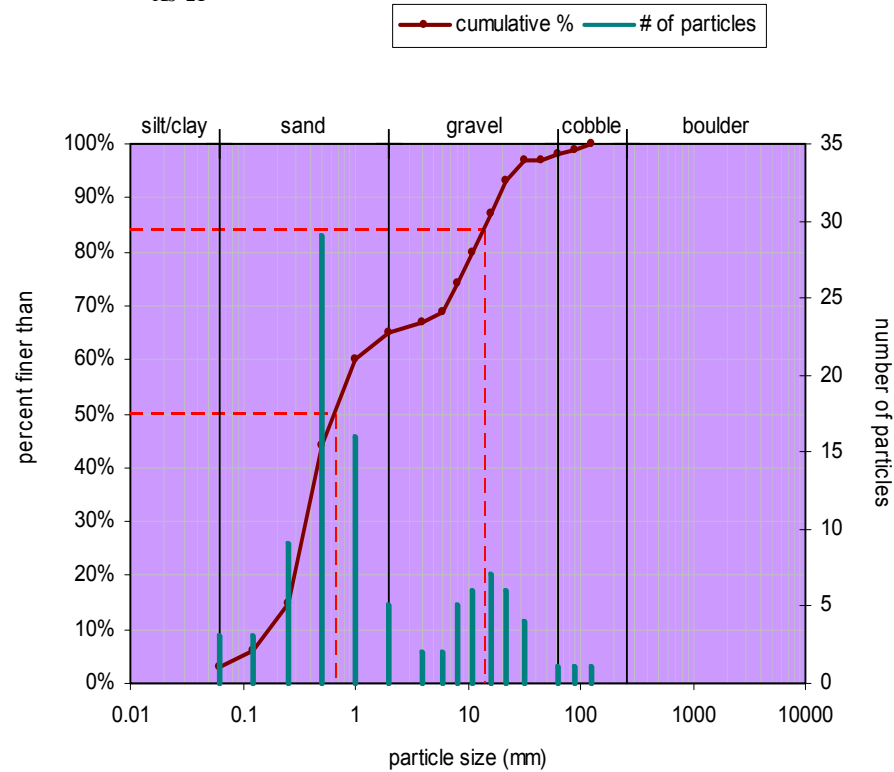
**Bold Run, As Built
XS-2P**

Pool			
Material	Size Range (mm)	Count	
silt/clay	0 - 0.062	3	
very fine sand	0.062 - 0.125	3	
fine sand	0.125 - 0.25	9	
medium sand	0.25 - 0.5	29	
coarse sand	0.5 - 1	16	
very coarse sand	1 - 2	5	
very fine gravel	2 - 4	2	
fine gravel	4 - 6	2	
fine gravel	6 - 8	5	
medium gravel	8 - 11	6	
medium gravel	11 - 16	7	
coarse gravel	16 - 22	6	
coarse gravel	22 - 32	4	
very coarse gravel	32 - 45		
very coarse gravel	45 - 64	1	
small cobble	64 - 90	1	
medium cobble	90 - 128	1	
large cobble	128 - 180		
very large cobble	180 - 256		
small boulder	256 - 362		
small boulder	362 - 512		
medium boulder	512 - 1024		
large boulder	1024 - 2048		
very large boulder	2048 - 4096		
total particle count:		100	
bedrock	-----		
clay hardpan	-----		
detritus/wood	-----		
artificial	-----		
total count:		100	
Note:	XS-2 Pool

Size (mm)	Size Distribution	Type
D16 0.26	3.4 mean 1.9	silt/clay 3%
D35 0.4	12 dispersion 12.0	sand 62%
D50 0.65	17 skewness 0.36	gravel 33%
D65 2	20	cobble 2%
D84 14	29	boulder 0%
D95 27	39

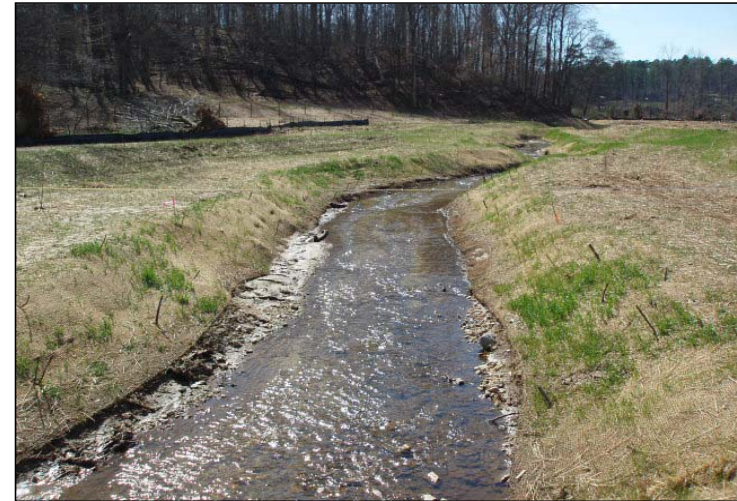
River Basin:	Neuse
Watershed:	Bold Run, As-Built
XS ID	XS - 3, Riffle
Drainage Area (sq mi):	12
Date:	3/6/2006
Field Crew:	A. Spiller, B. Roberts, H. Miller

Station	Elevation
0.00	276.8
4.43	276.7
7.19	276.6
9.45	276.9
11.63	276.7
16.04	275.0
19.82	274.8
24.76	274.7
26.08	274.8
27.15	274.7
30.90	272.2
32.58	272.0
33.54	271.8
34.43	271.9
36.63	271.7
37.56	271.7
39.18	272.1
40.17	272.4
43.14	274.3
45.39	274.6
47.27	274.8
54.06	274.7
56.12	275.0
61.72	276.8
66.91	276.9
73.6	276.9

SUMMARY DATA	
Bankfull Elevation:	274.7
Bankfull Cross-Sectional Area:	34.1
Bankfull Width:	18.9
Flood Prone Area Elevation:	277.9
Flood Prone Width:	>74
Max Depth at Bankfull:	2.9
Mean Depth at Bankfull:	1.8
W / D Ratio:	10.4
Entrenchment Ratio:	>2
Bank Height Ratio:	1.1
Slope:	0.007
Discharge:	150

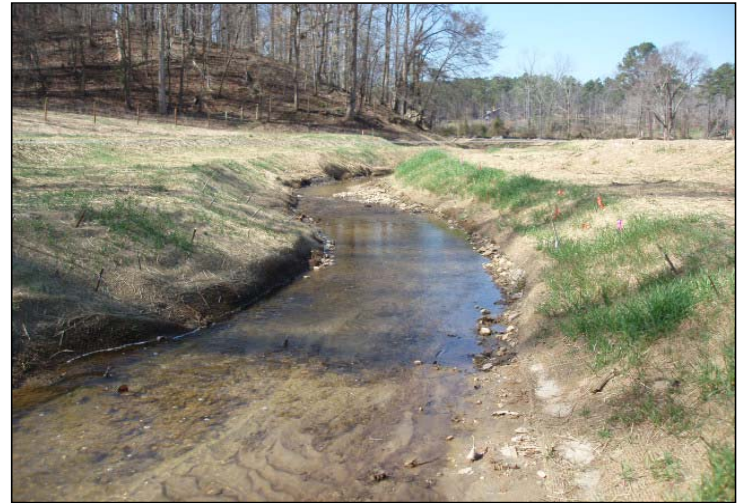
Station	Elevation
0.0	275.37
3.4	275.54
8.4	275.30
10.7	274.91
13.1	273.87
17.9	273.59
23.9	273.77
27.6	271.77
28.5	271.43
28.8	271.02
29.1	270.97
31.4	270.76
33.3	270.88
34.5	270.97
35.5	270.86
36.9	271.10
37.5	272.10
40.9	273.63
42.1	273.50
47.0	273.70
51.8	273.57
53.1	273.77
58.3	275.79
64.3	275.86
69.5	275.83

SUMMARY DATA	
Bankfull Elevation:	273.6
Bankfull Cross-Sectional Area:	31.6
Bankfull Width:	18.5
Flood Prone Area Elevation:	276.4
Flood Prone Width:	>70
Max Depth at Bankfull:	2.9
Mean Depth at Bankfull:	1.7
W / D Ratio:	10.8
Entrenchment Ratio:	>3
Bank Height Ratio:	1.0
Slope:	0.0073
Discharge:	123

Stream Type	C4
--------------------	----

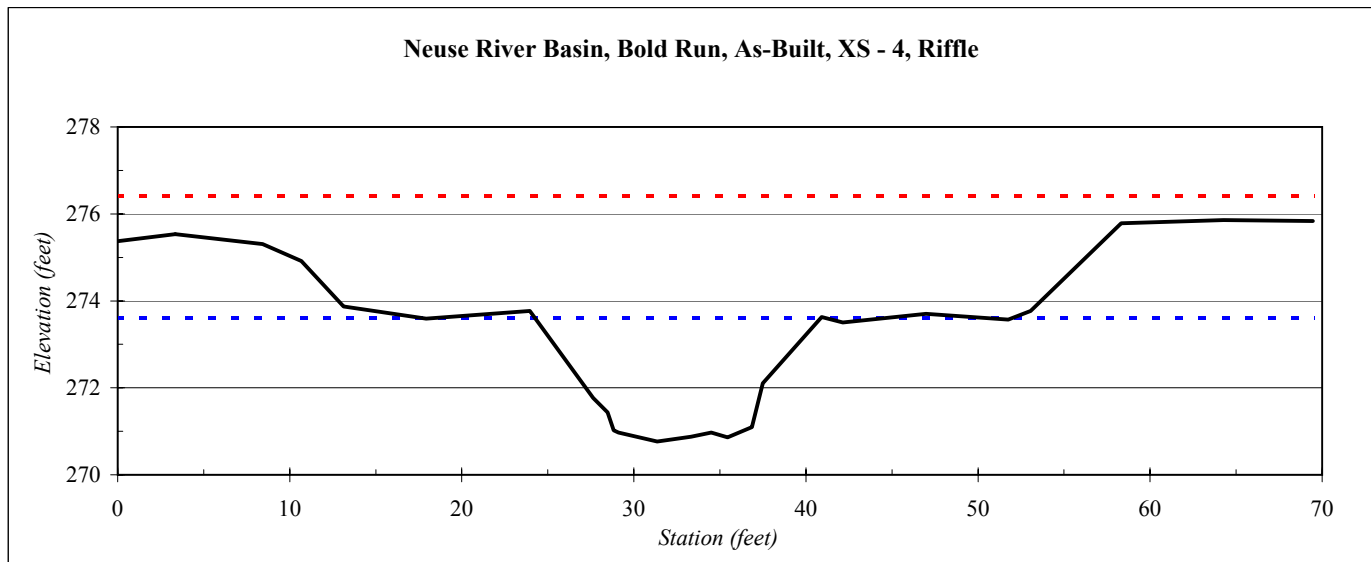
Riffle		
Material	Size Range (mm)	Count
silt/clay	0 - 0.062	11
very fine sand	0.062 - 0.125	9
fine sand	0.125 - 0.25	7
medium sand	0.25 - 0.5	13
coarse sand	0.5 - 1	5
very coarse sand	1 - 2	2
very fine gravel	2 - 4	2
fine gravel	4 - 6	5
fine gravel	6 - 8	5
medium gravel	8 - 11	4
medium gravel	11 - 16	4
coarse gravel	16 - 22	7
coarse gravel	22 - 32	11
very coarse gravel	32 - 45	6
very coarse gravel	45 - 64	8
small cobble	64 - 90	4
medium cobble	90 - 128	1
large cobble	128 - 180	
very large cobble	180 - 256	1
small boulder	256 - 362	
small boulder	362 - 512	
medium boulder	512 - 1024	
large boulder	1024 - 2048	
very large boulder	2048 - 4096	
total particle count:		100
bedrock	-----	
clay hardpan	-----	
detritus/wood	-----	
artificial	-----	
total count:		100
Note:	XS-4 Riffle

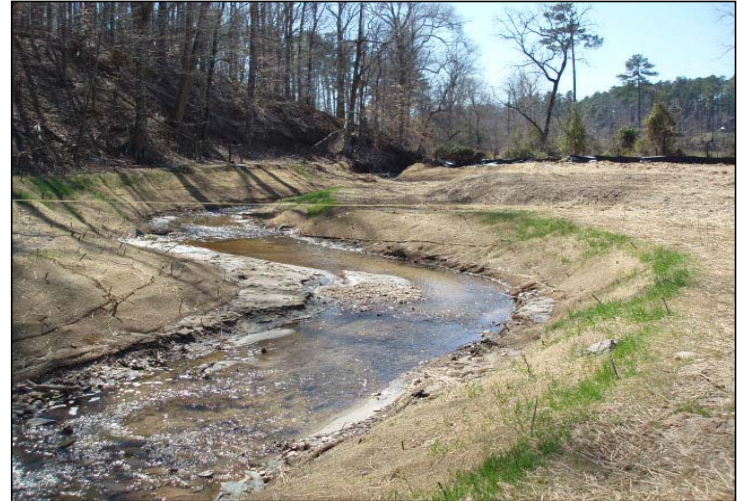
Neuse River Basin, Bold Run, As-Built, XS - 5, Pool

River Basin:	Neuse
Watershed:	Bold Run, As-Built
XS ID	XS - 5, Pool
Drainage Area (sq mi):	12
Date:	3/7/2007
Field Crew:	A. Spiller, K. Knight, B. Roberts

Stream Type	C4
--------------------	----

Station	Elevation
0.0	274.5
3.1	274.5
4.5	274.3
6.5	273.7
9.2	272.9
10.8	272.5
12.7	271.7
15.4	271.5
19.1	271.7
22.2	271.0
24.9	270.1
28.5	268.9
30.5	268.8
32.3	268.7
32.9	268.3
36.0	268.5
37.9	268.3
39.0	268.3
39.9	268.1
40.8	268.0
41.7	267.9
42.8	268.1
43.7	268.1
44.3	268.3
46.4	269.4
48.7	270.5
50.7	271.4
56.6	271.3
60.8	271.3
62.2	271.5
65.9	273.2
69.1	273.4
72.4	273.5

SUMMARY DATA	
Bankfull Elevation:	271.4
Bankfull Cross-Sectional Area:	65.5
Bankfull Width:	30.1
Flood Prone Area Elevation:	-
Flood Prone Width:	-
Max Depth at Bankfull:	3.5
Mean Depth at Bankfull:	2.2
W / D Ratio:	-
Entrenchment Ratio:	-
Bank Height Ratio:	-
Slope:	-
Discharge:	-
