**Briles Stream Restoration
Mitigation Plan / As-Built Report
EEP Project # 47
2008**

June 2008

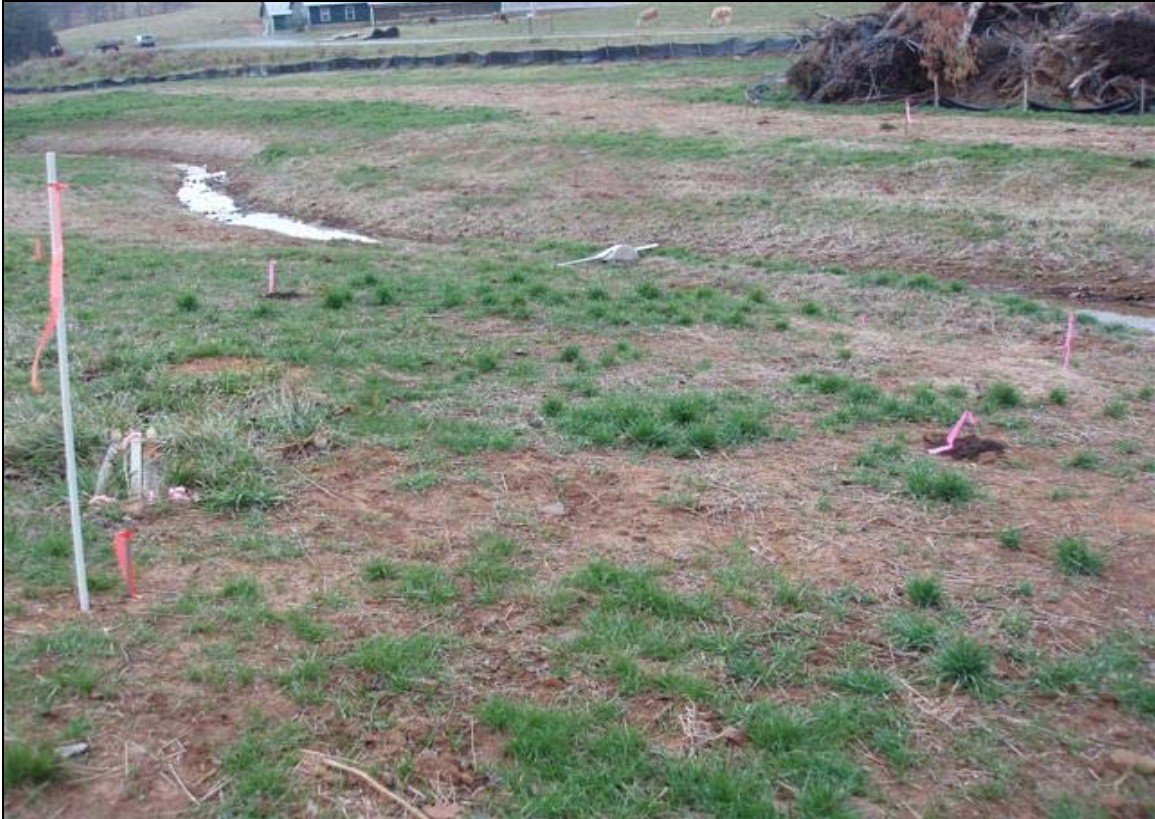
Vegetation Plot 1: 1/9/08 – As-Built

Baseline vegetation monitoring data were collected in January 2008. A total of eight vegetation monitoring plots were established. Five of the eight plots include live stakes. Plot photos can be found in Appendix B.

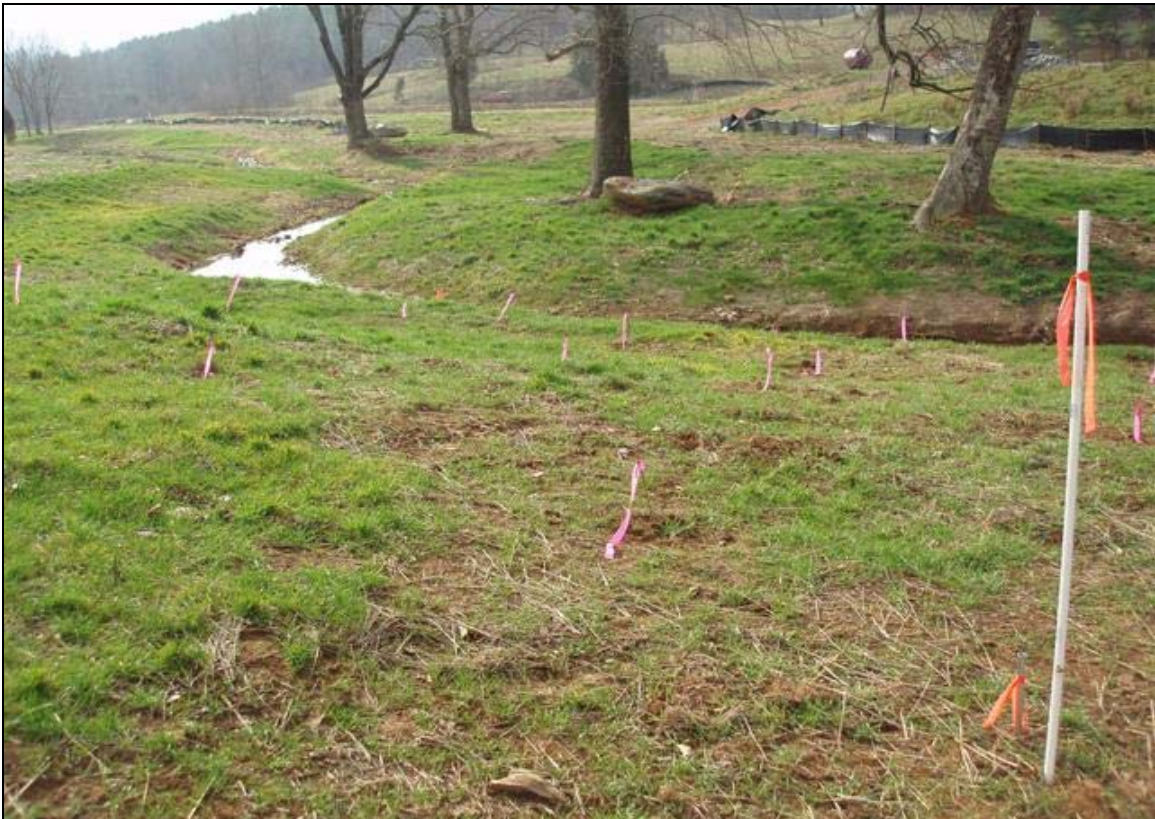
Vegetation Plot 2: 1/9/08 – As-Built

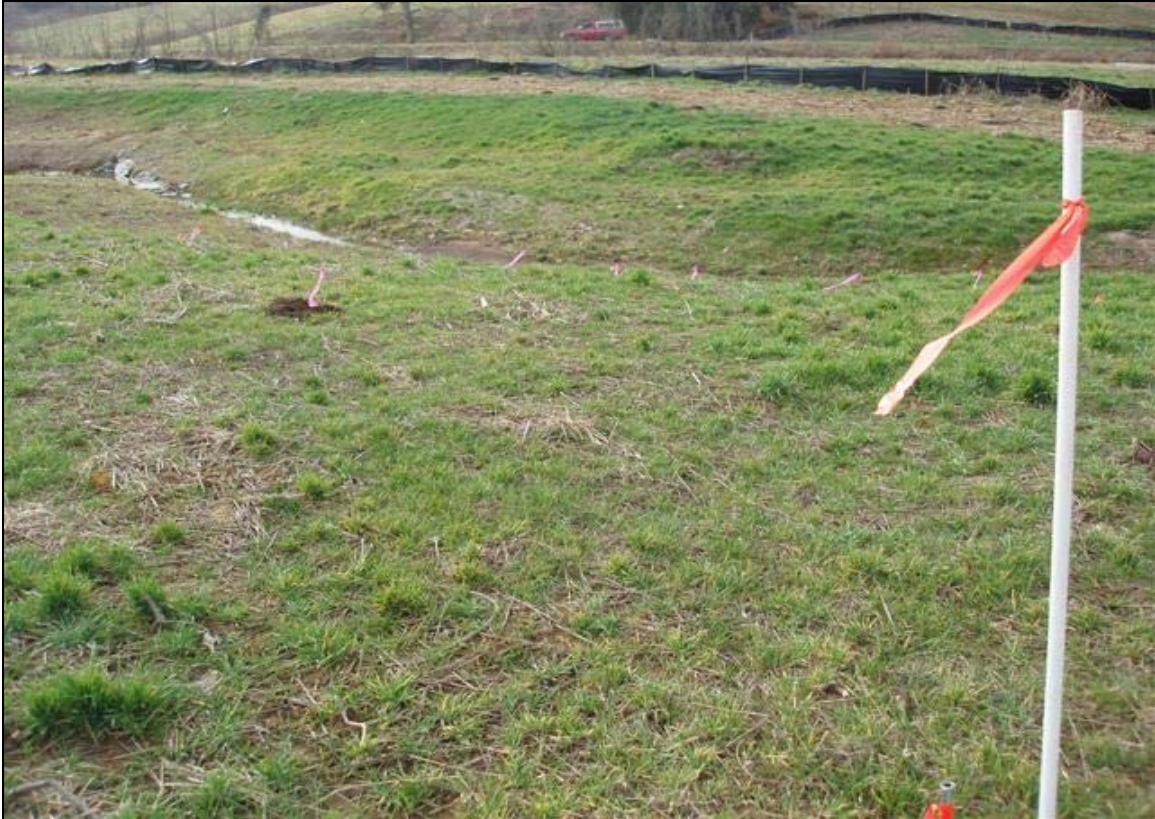
Vegetation Plot 3: 1/9/08 – As-Built

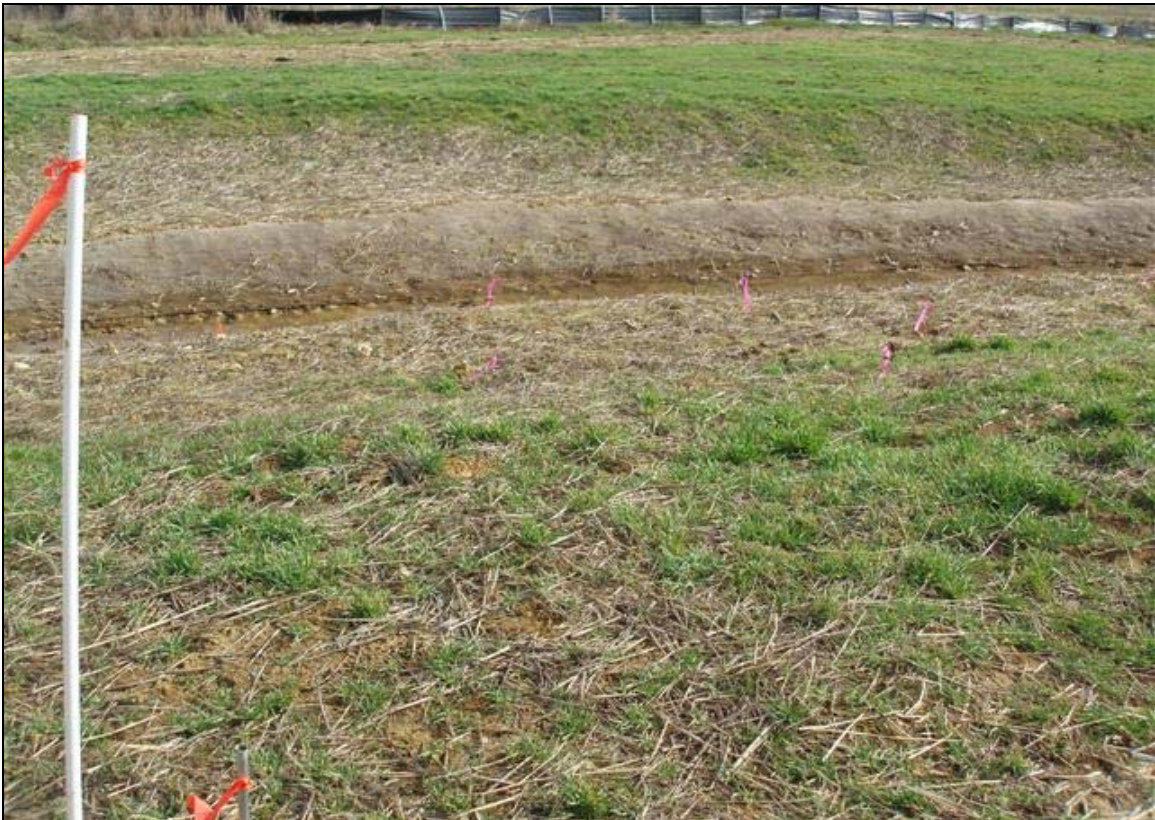
Vegetation Plot 4: 1/9/08 – As-Built

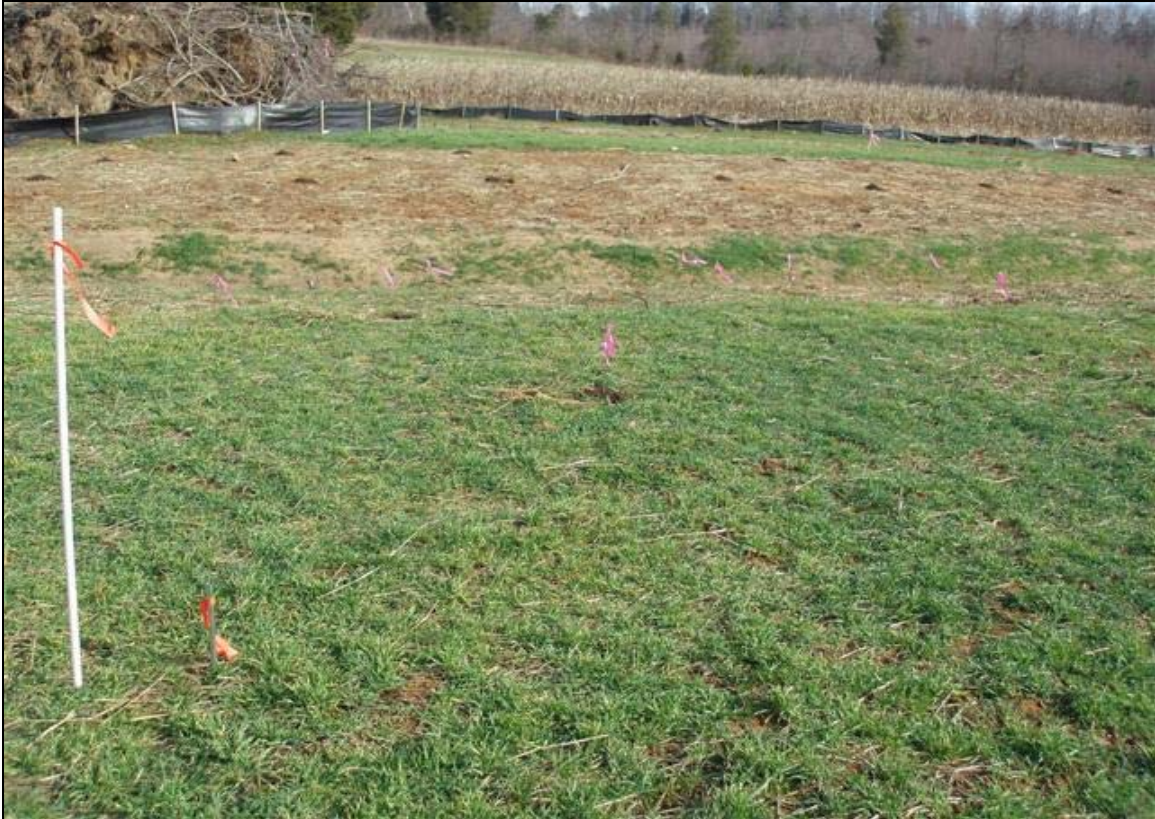
Vegetation Plot 5: 1/9/08 – As-Built

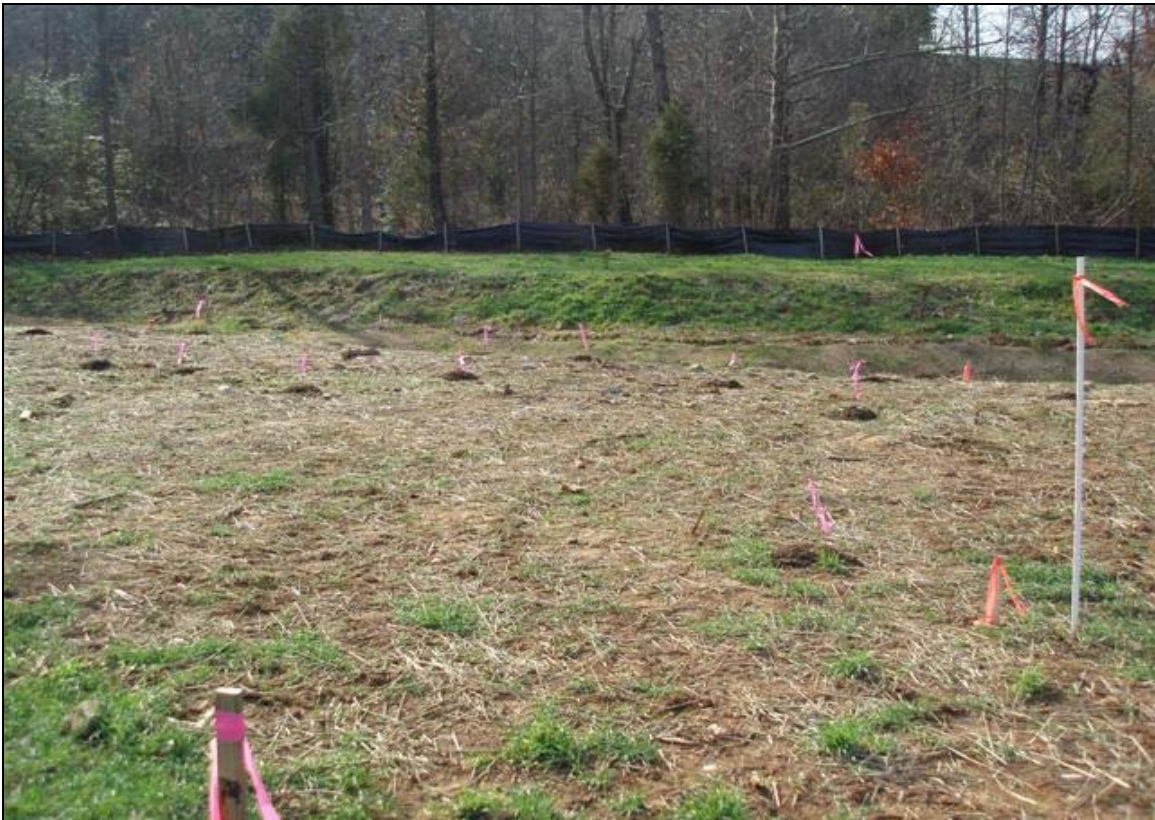
Vegetation Plot 6: 1/9/08 – As-Built

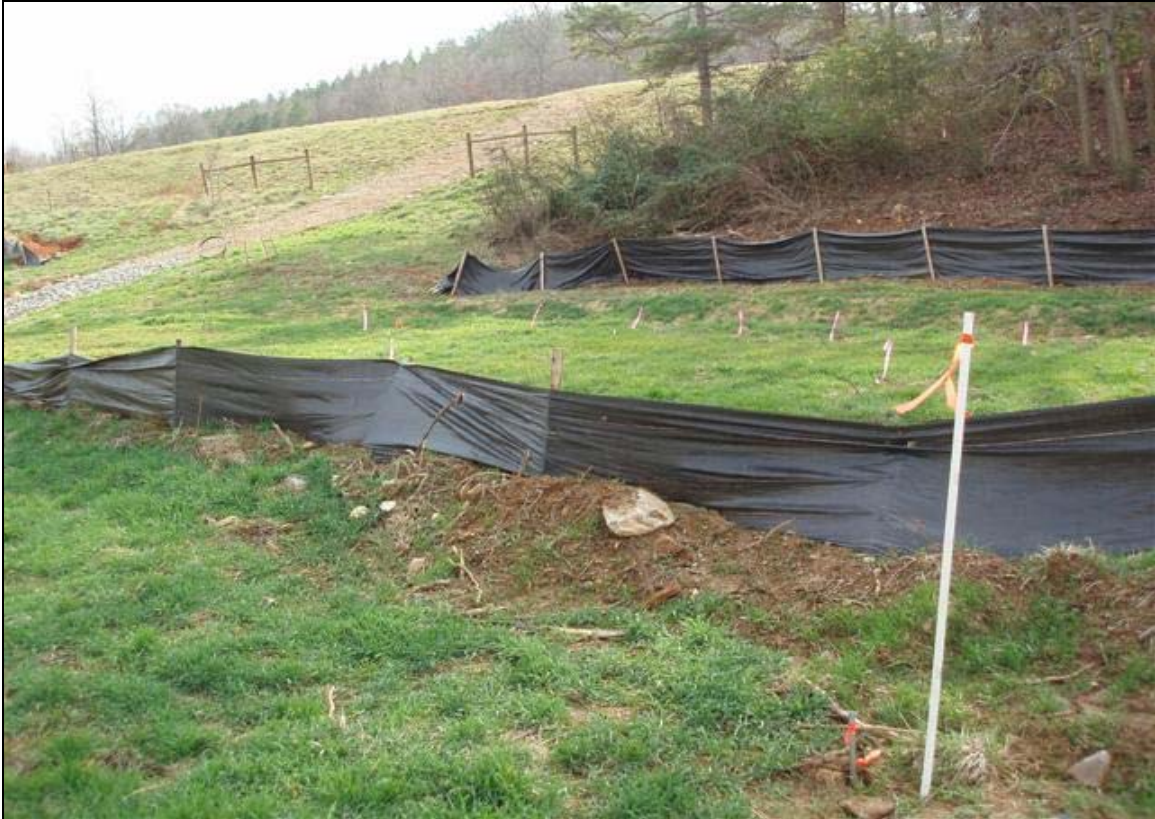
Vegetation Plot 7: 1/9/08 – As-Built

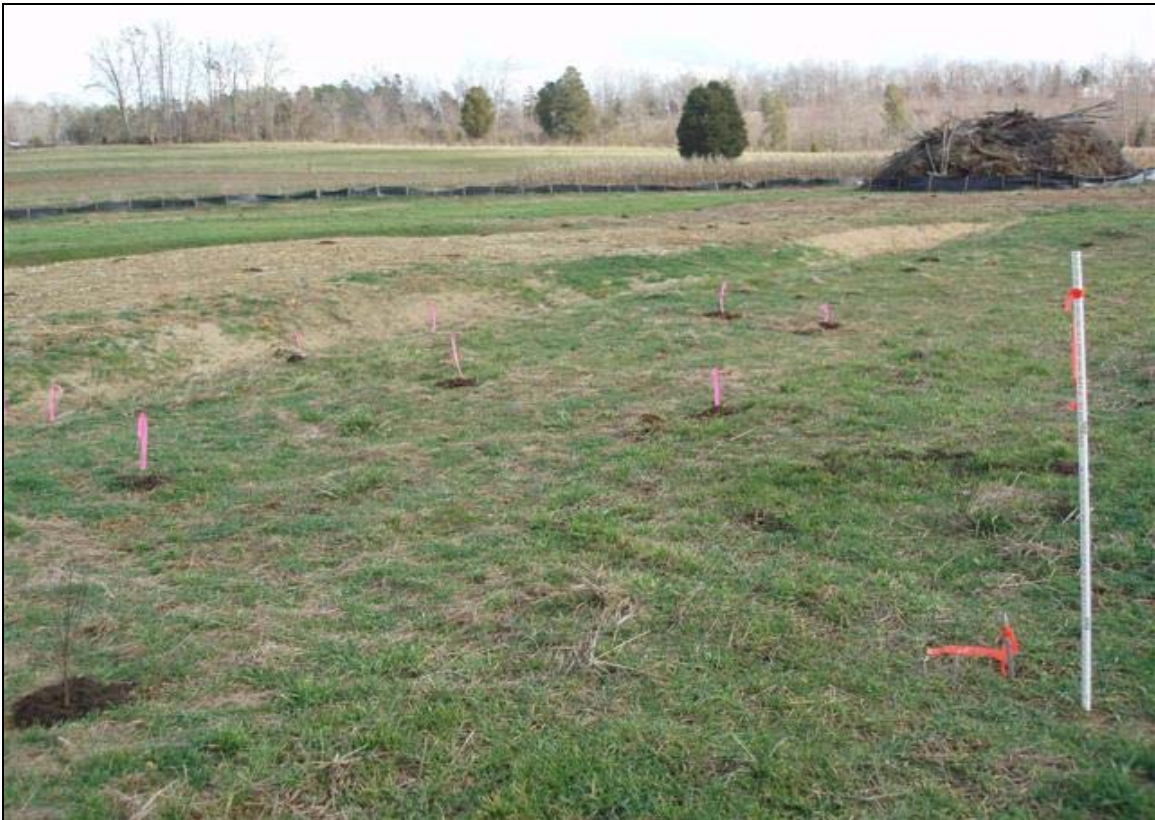
Vegetation Plot 8: 1/9/08 – As-Built

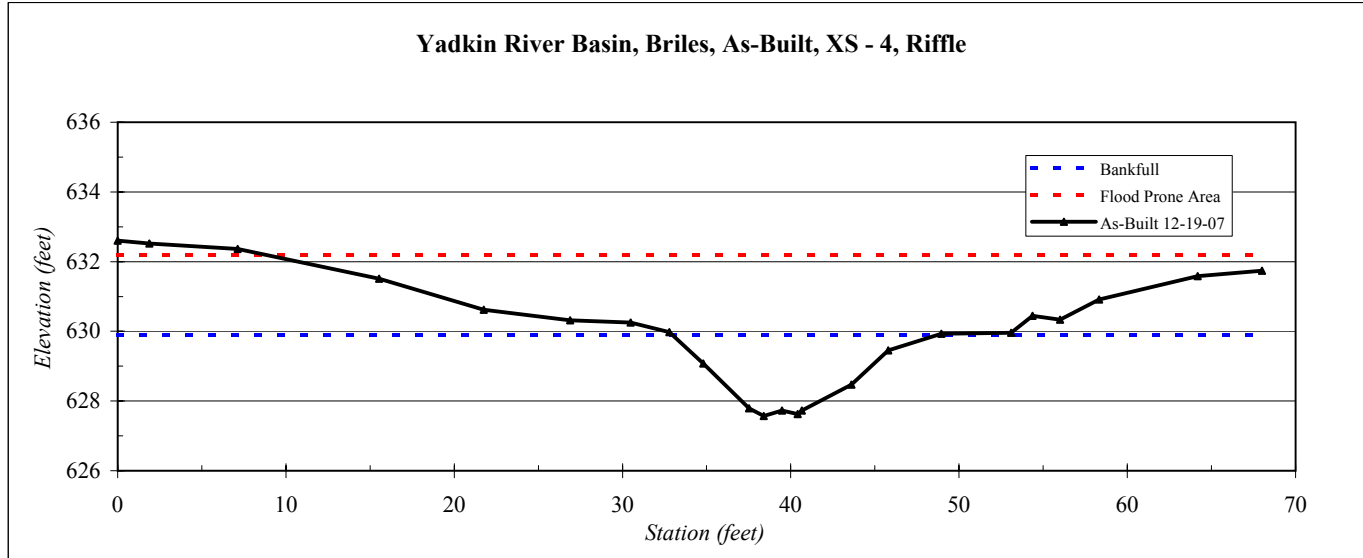
Yadkin River Basin, Briles, As-Built, XS - 4, Riffle

Cross-section measurements should show little or no change from the as-built cross-sections. If changes do occur, they will be evaluated to determine whether they are minor adjustments associated with settling and increasing stability or whether they indicate movement toward an unstable condition. Annual measurements of the longitudinal profile should indicate stable bedform features with little change from the as-built survey. The pools should maintain their depth with lower water surface slopes, while the riffles should remain shallower with steeper water surface slopes. Sediment transport should remain relatively unchanged with respect to aggradation and deposition of sediments. Visual monitoring of Reach 3 should indicate minimal changes between monitoring years and should not show any visual indicators of instability.

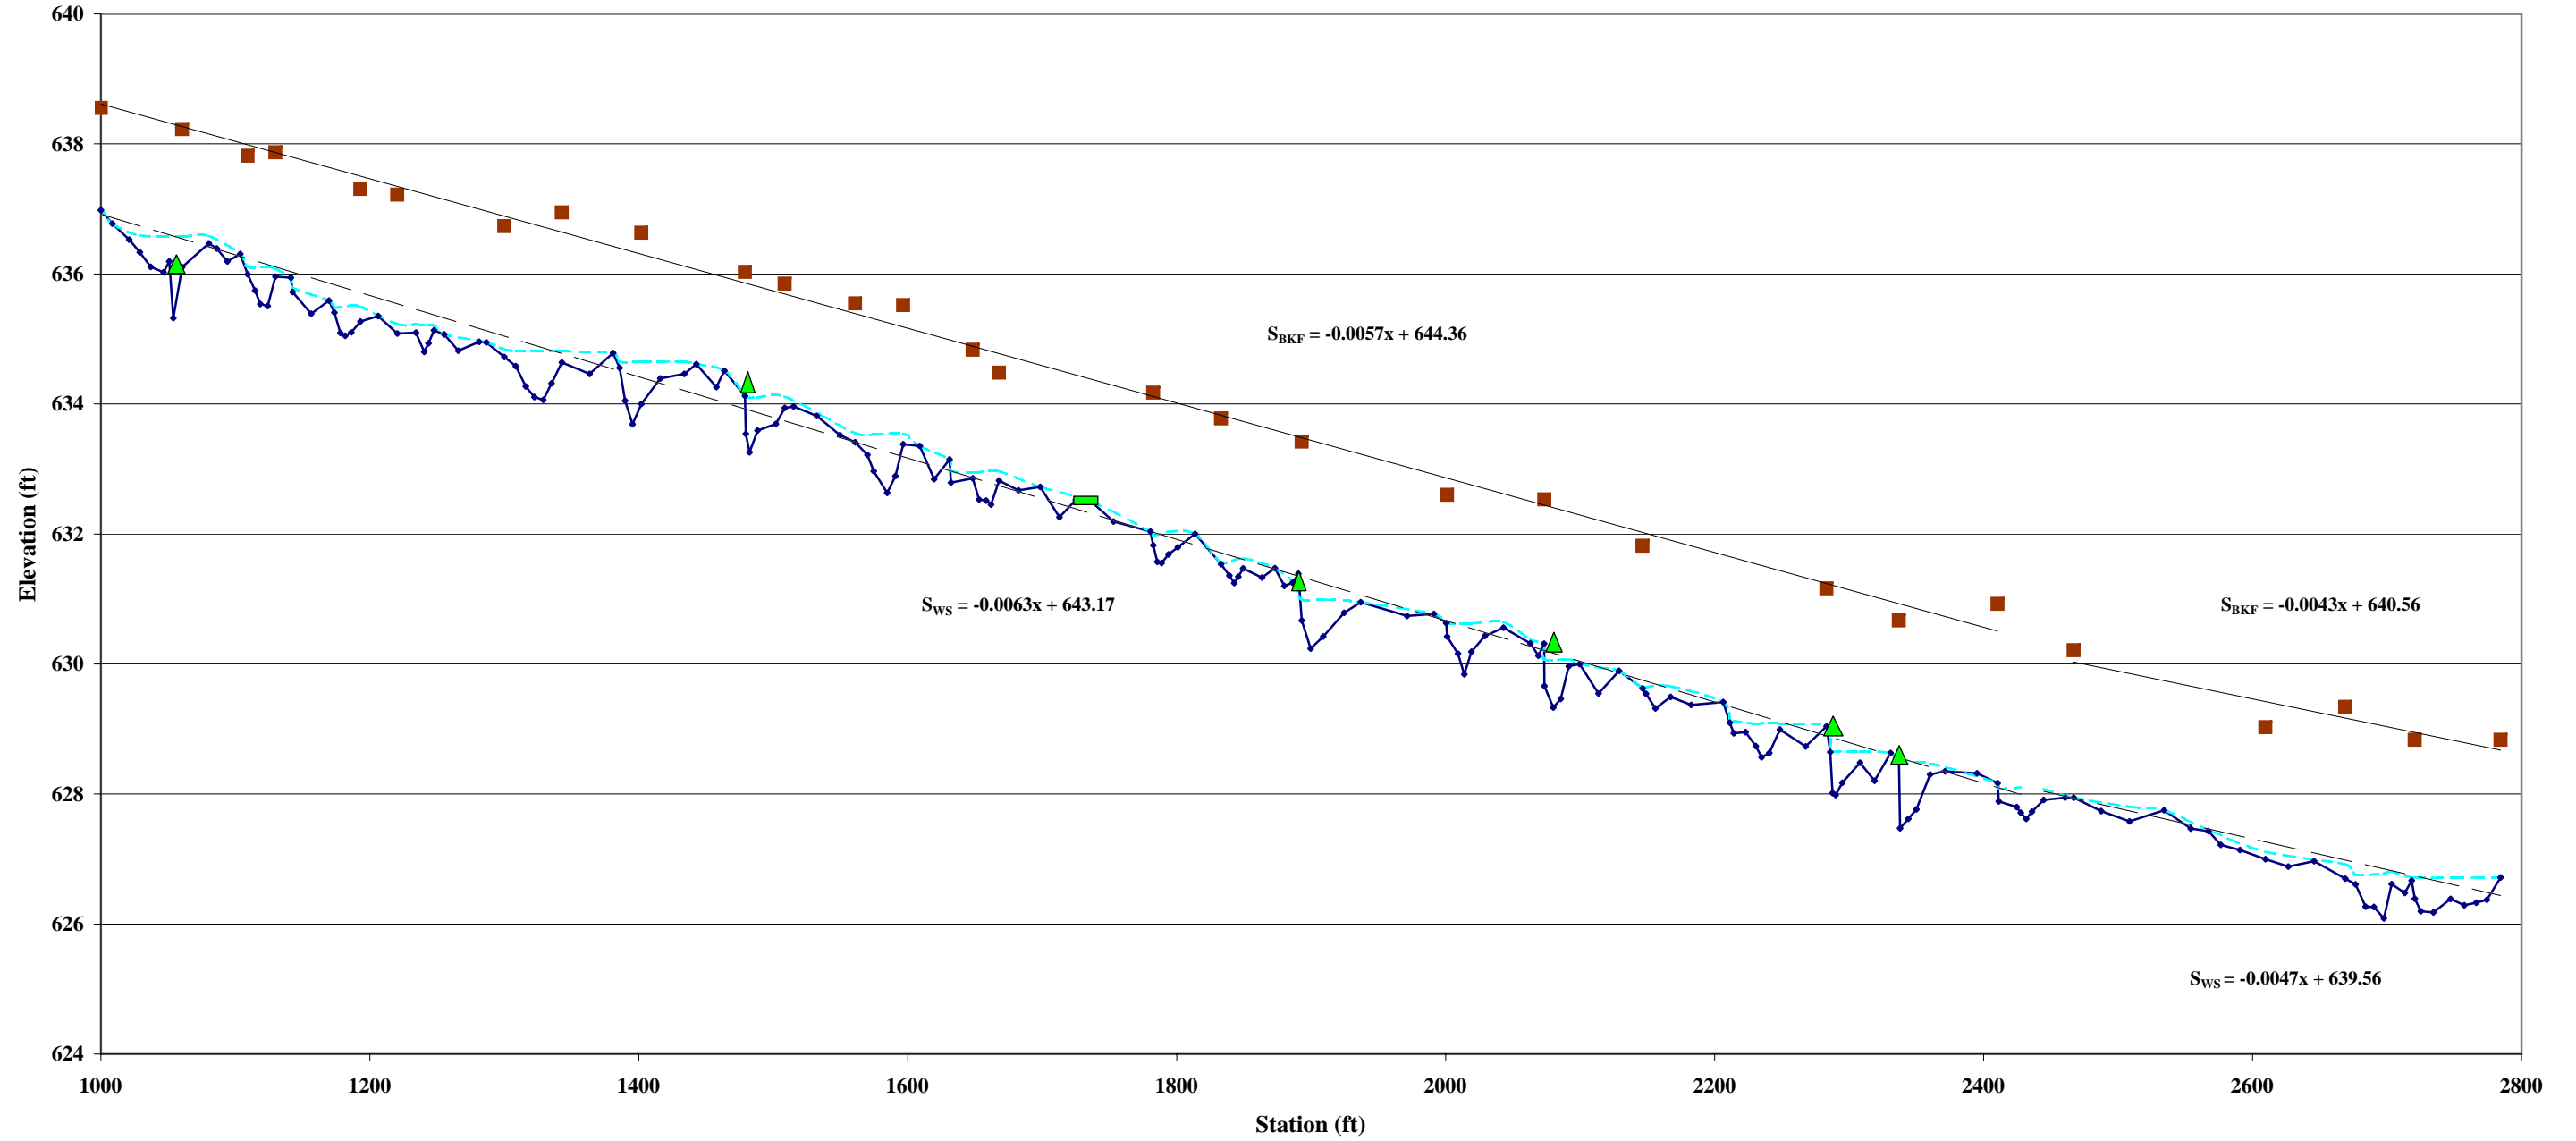
Longitudinal Profile
Briles - Unnamed Tributary to Jackson Creek
EEP Project Number - 47
Station 10+00-28+00

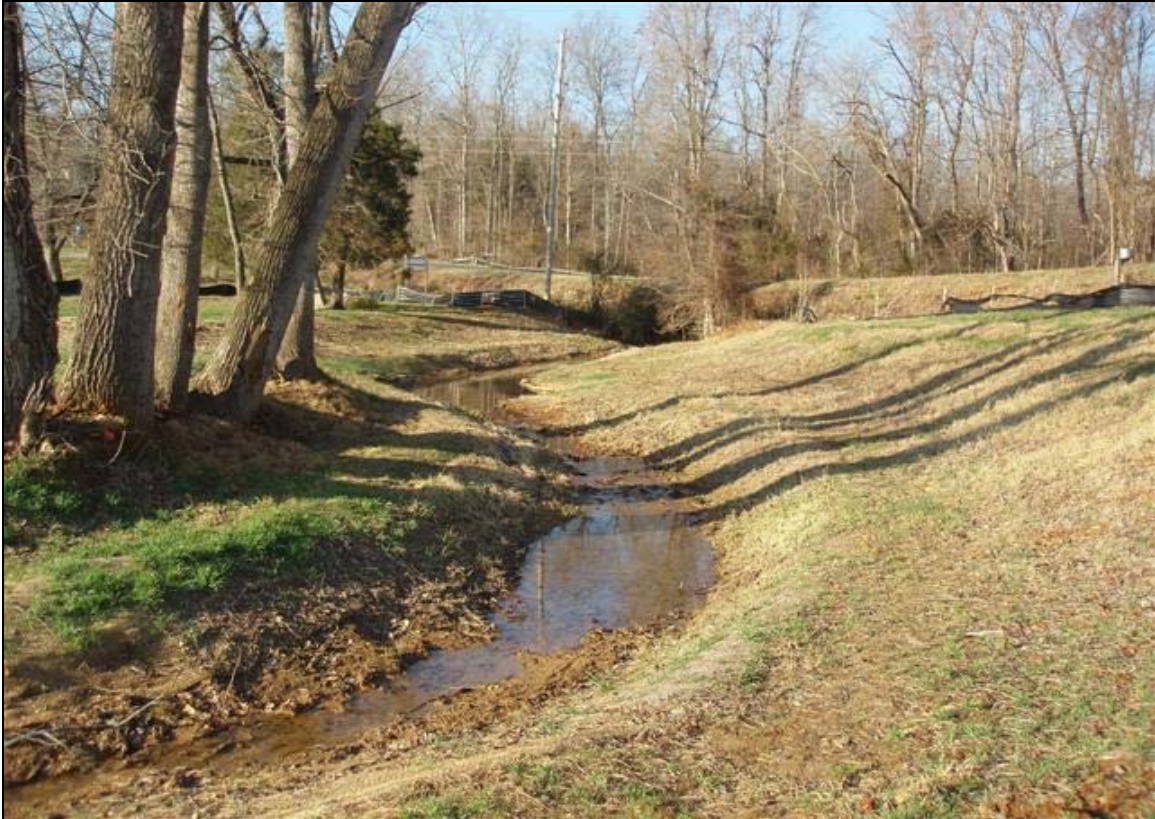
Photo Point 1a: View looking upstream towards the beginning of the project. 12/19/07 – As-Built

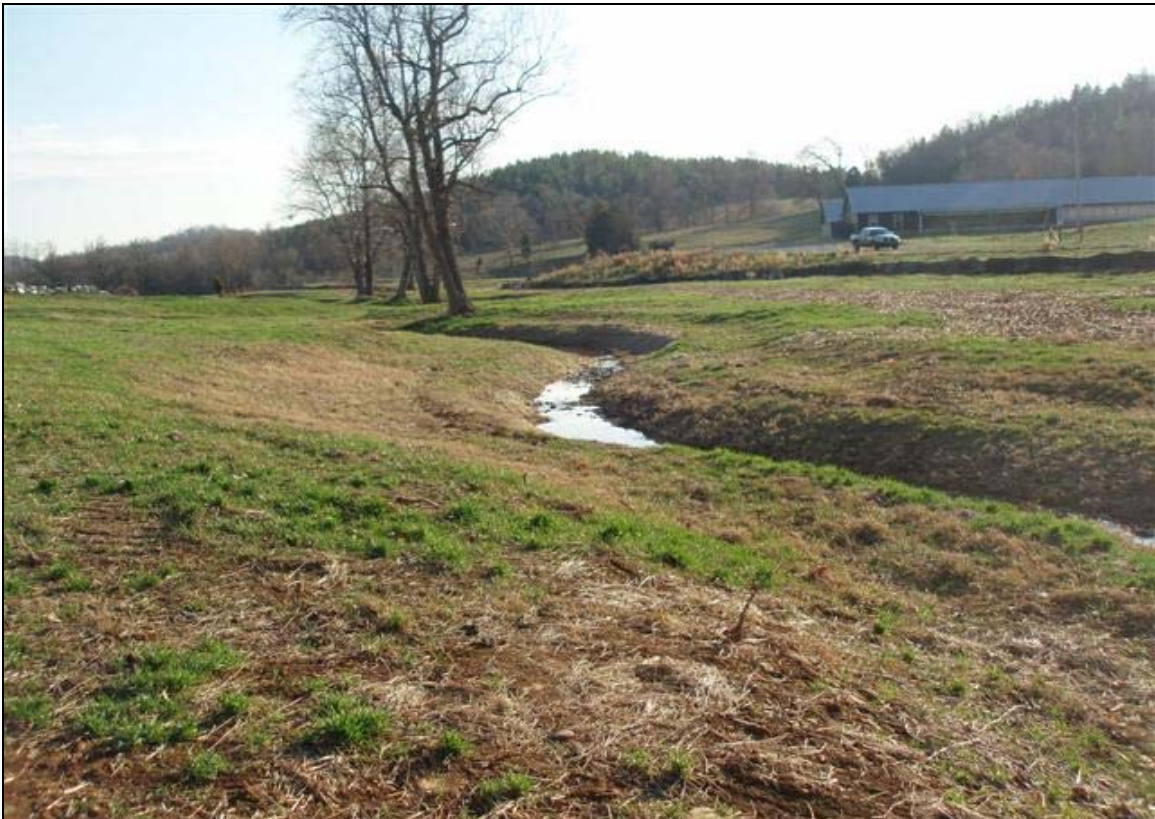
Photo Point 1b: View looking downstream near Station 11+50. 12/19/07 – As-Built

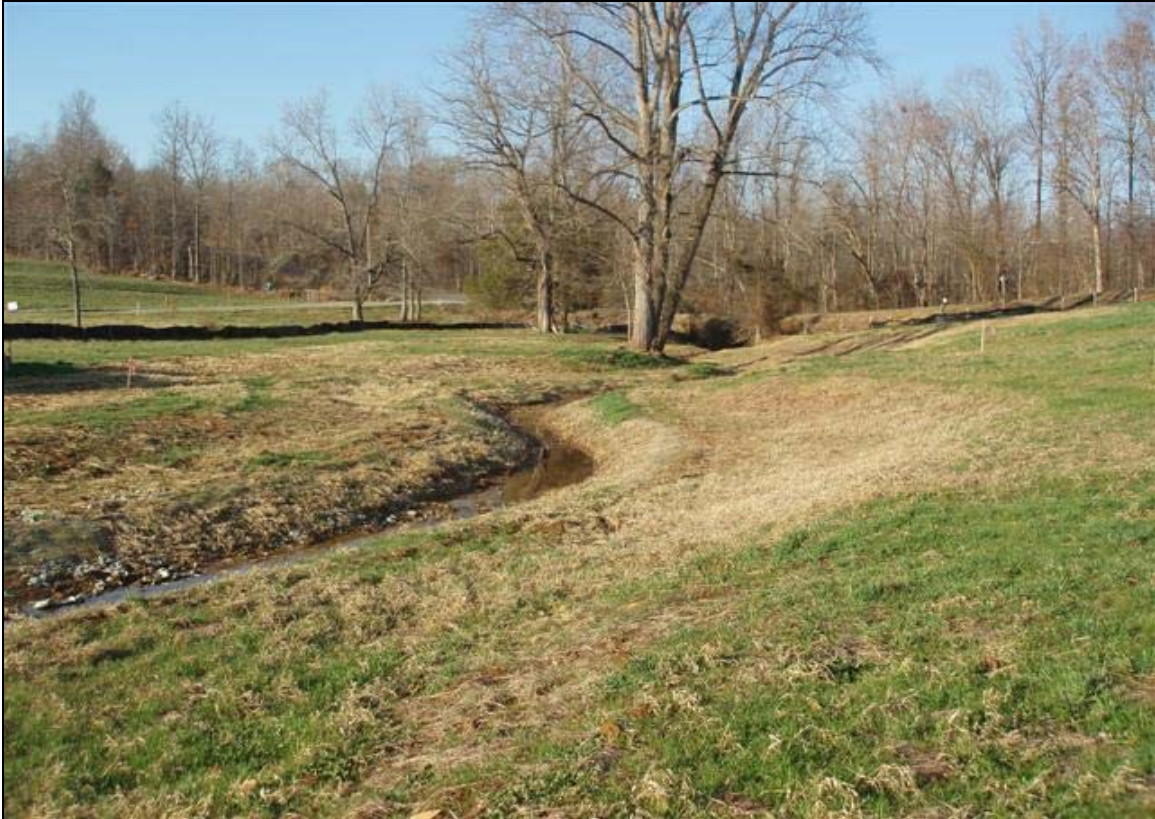
Photo Point 2a: View looking upstream taken near Station 13+10. 12/19/07 – As-Built

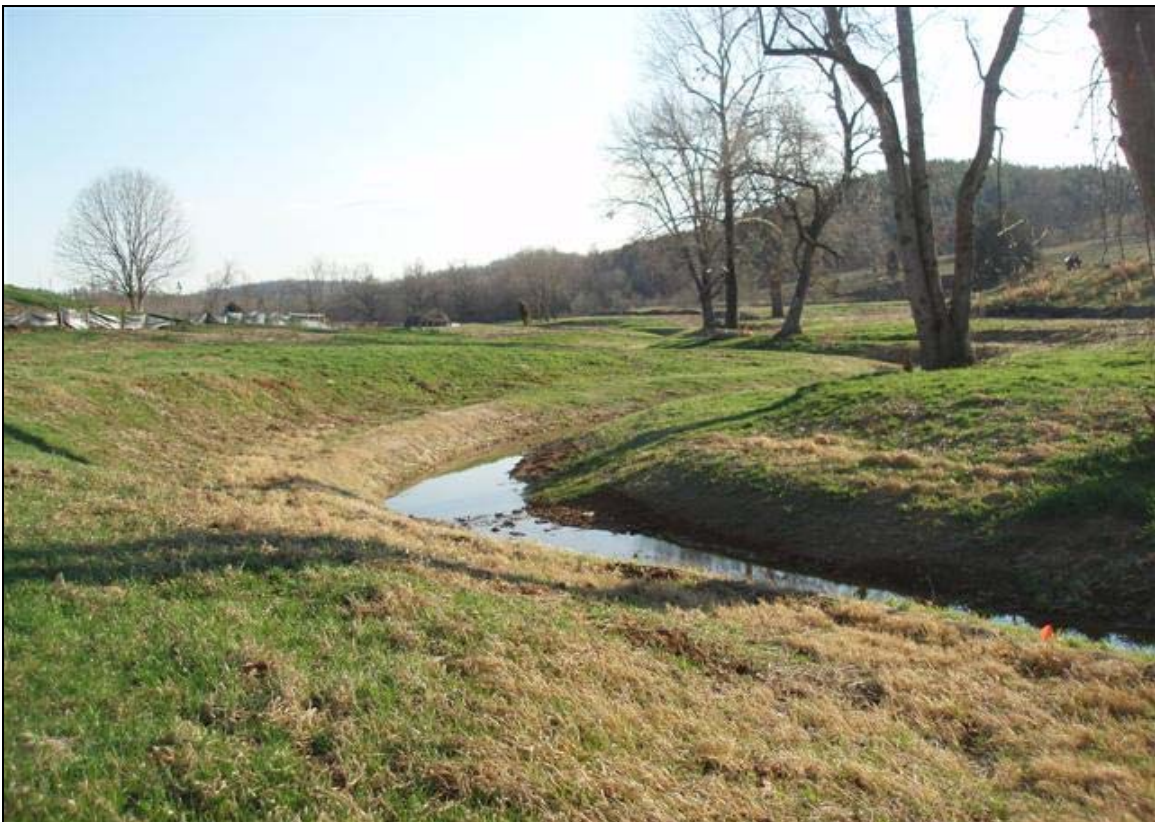
Photo Point 2b: View looking downstream taken near Station 13+10. 12/19/07 – As-Built

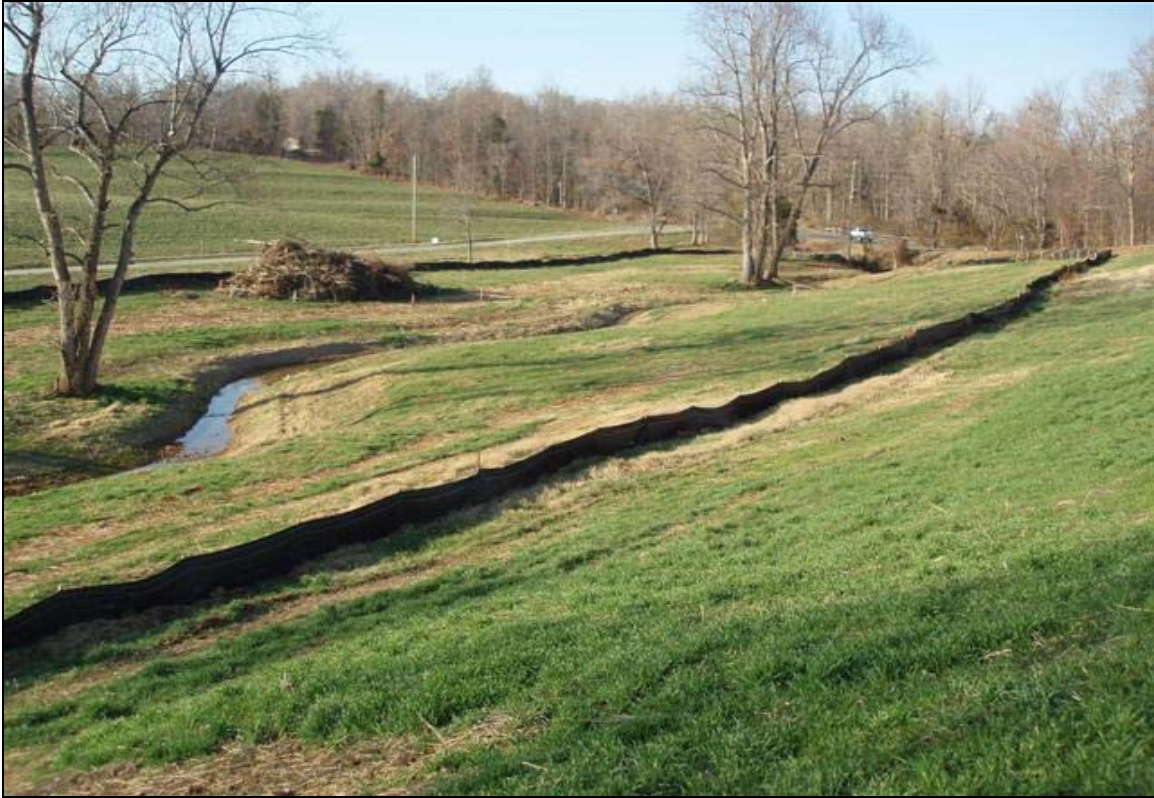
Photo Point 3a: View looking upstream from eastern side slope near Station 15+00. 12/19/07 – As-Built

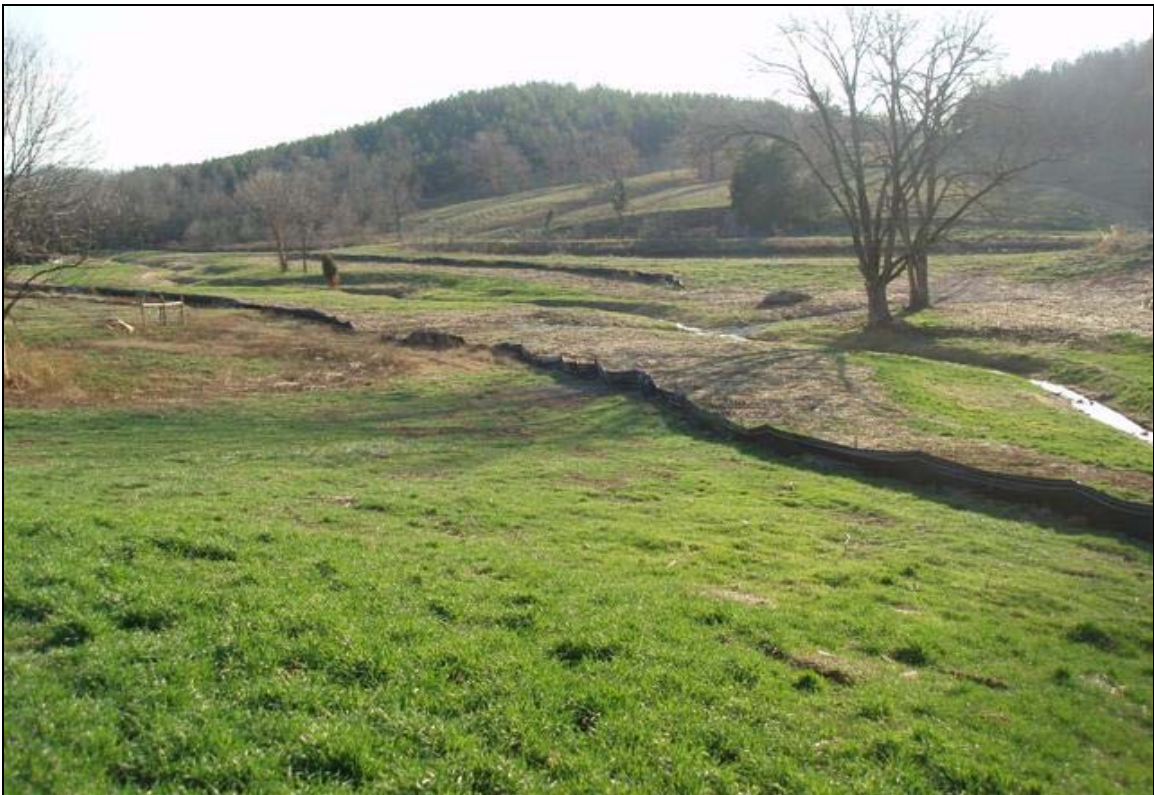
Photo Point 3b: View looking downstream from eastern side slope near Station 15+00. 12/19/07 – As-Built

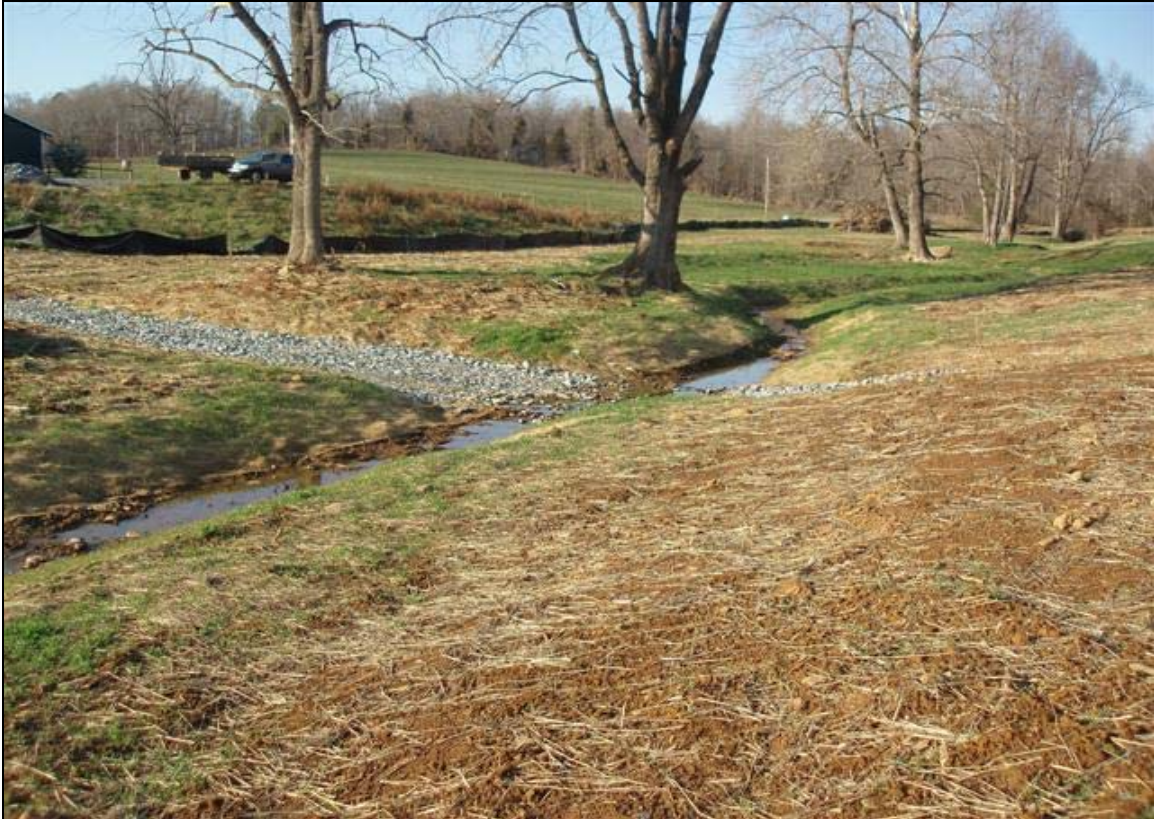
Photo Point 4a: View looking upstream near Station 18+00. 12/19/07 – As-Built

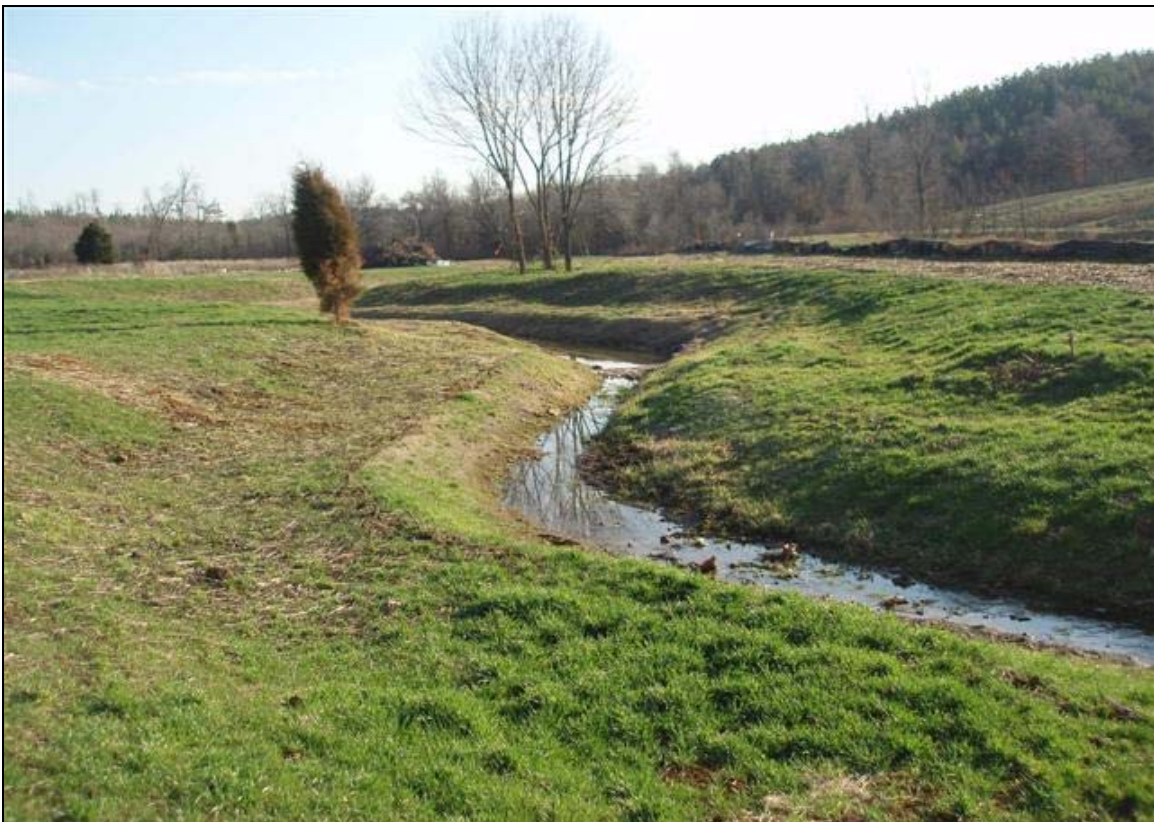
Photo Point 4b: View looking downstream near Station 18+00. 12/19/07 – As-Built

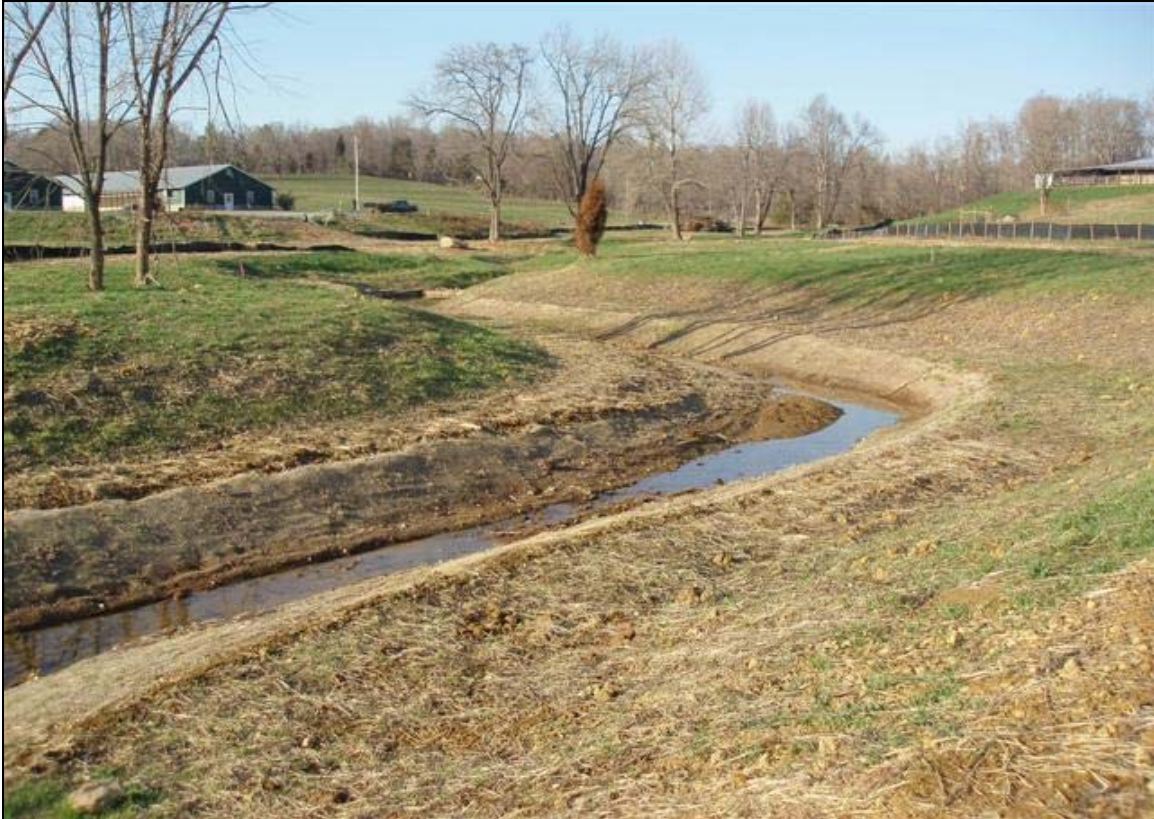
Photo Point 5a: View looking upstream near Station 21+00. 12/19/07 – As-Built

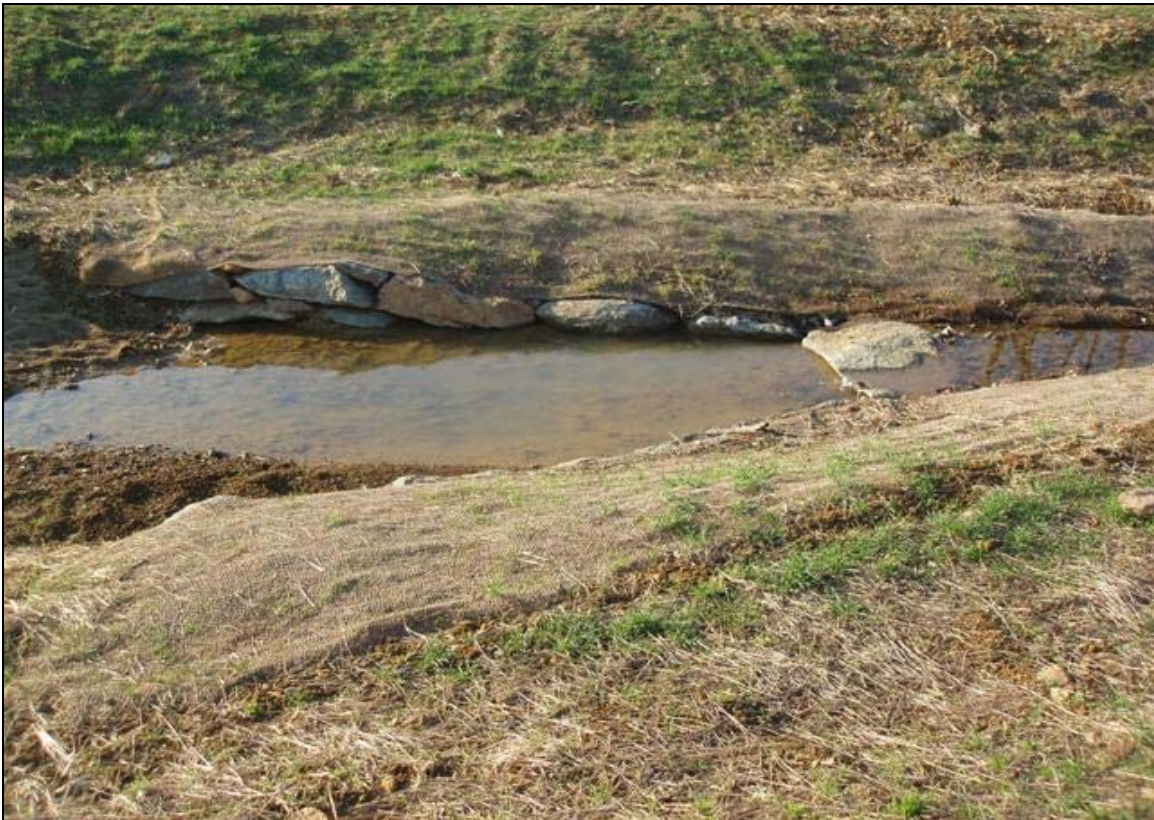
Photo Point 5b: View looking at cross vane near Station 21+00. 12/19/07 – As-Built

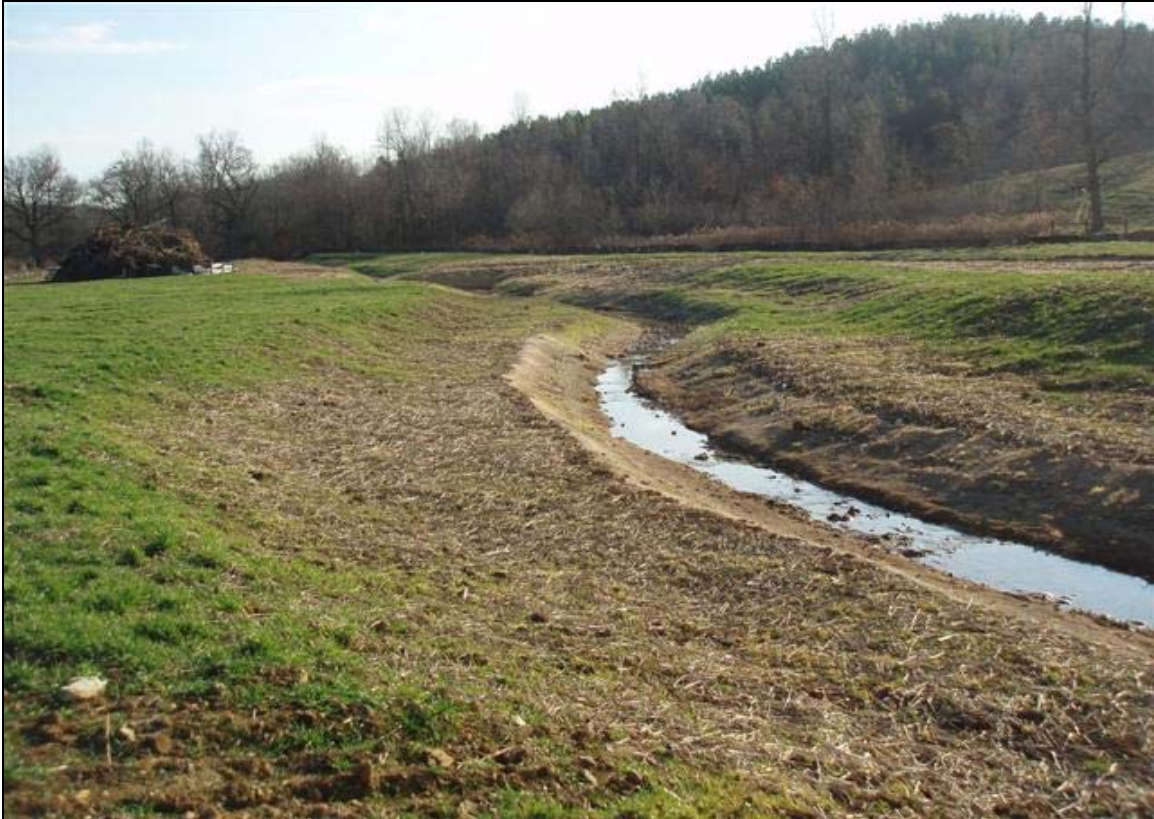
Photo Point 5c: View looking downstream near Station 21+00. 12/19/07 – As-Built

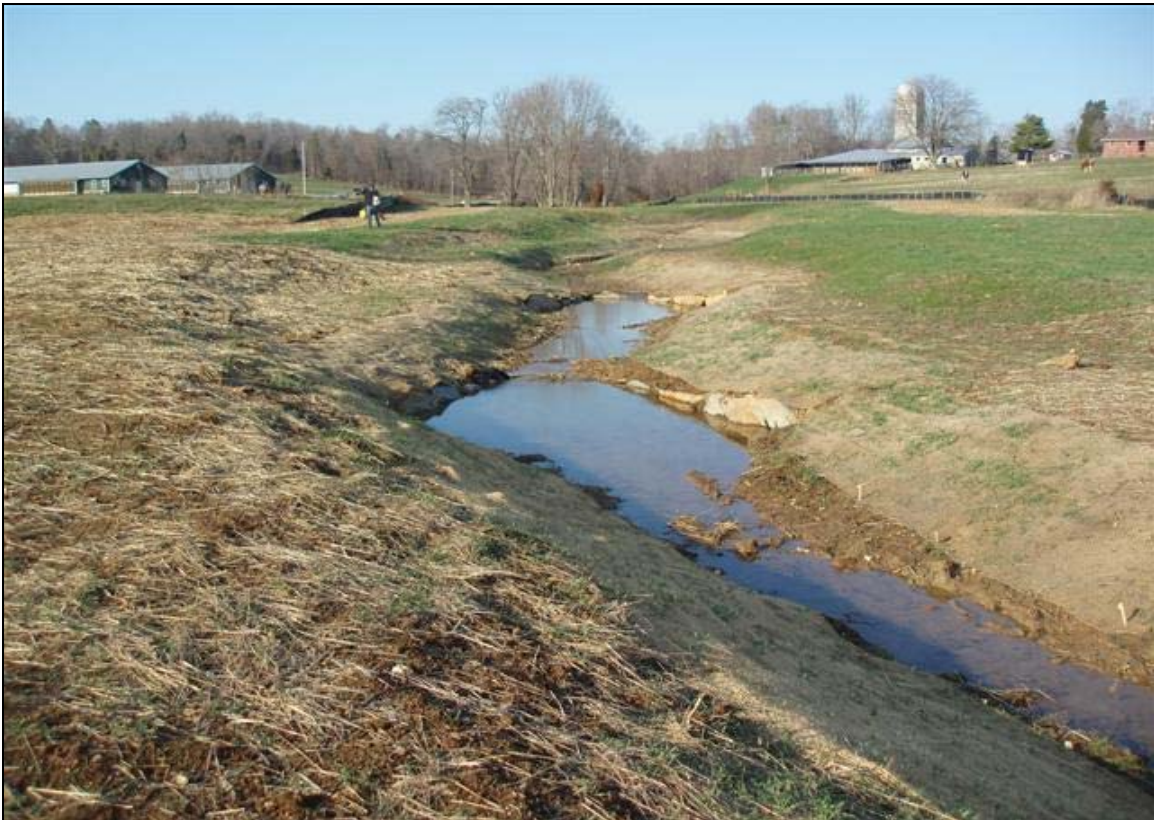
Photo Point 6a: View looking upstream near confluence. 12/19/07 – As-Built
