**Briles Stream Restoration
Mitigation Plan / As-Built Report
EEP Project # 47
2008**

June 2008

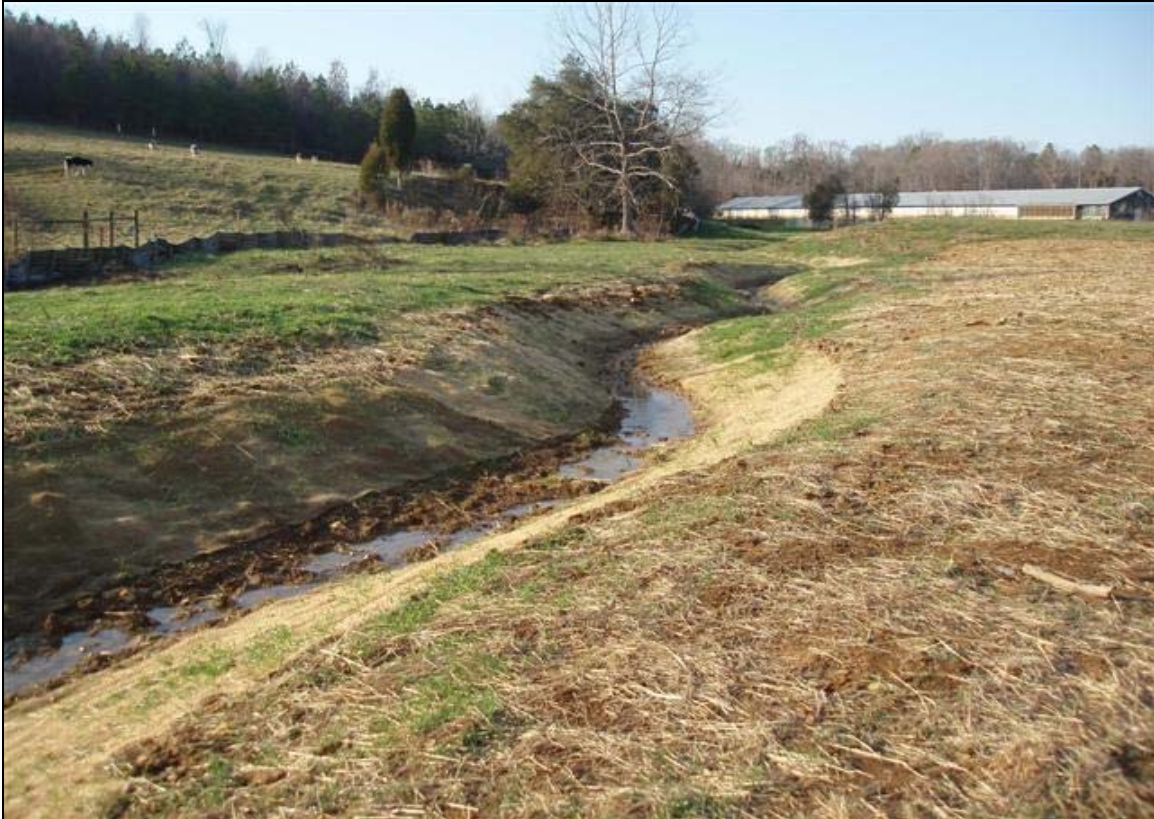
Photo Point 6b: View looking upstream the tributary near confluence. 12/19/07 – As-Built

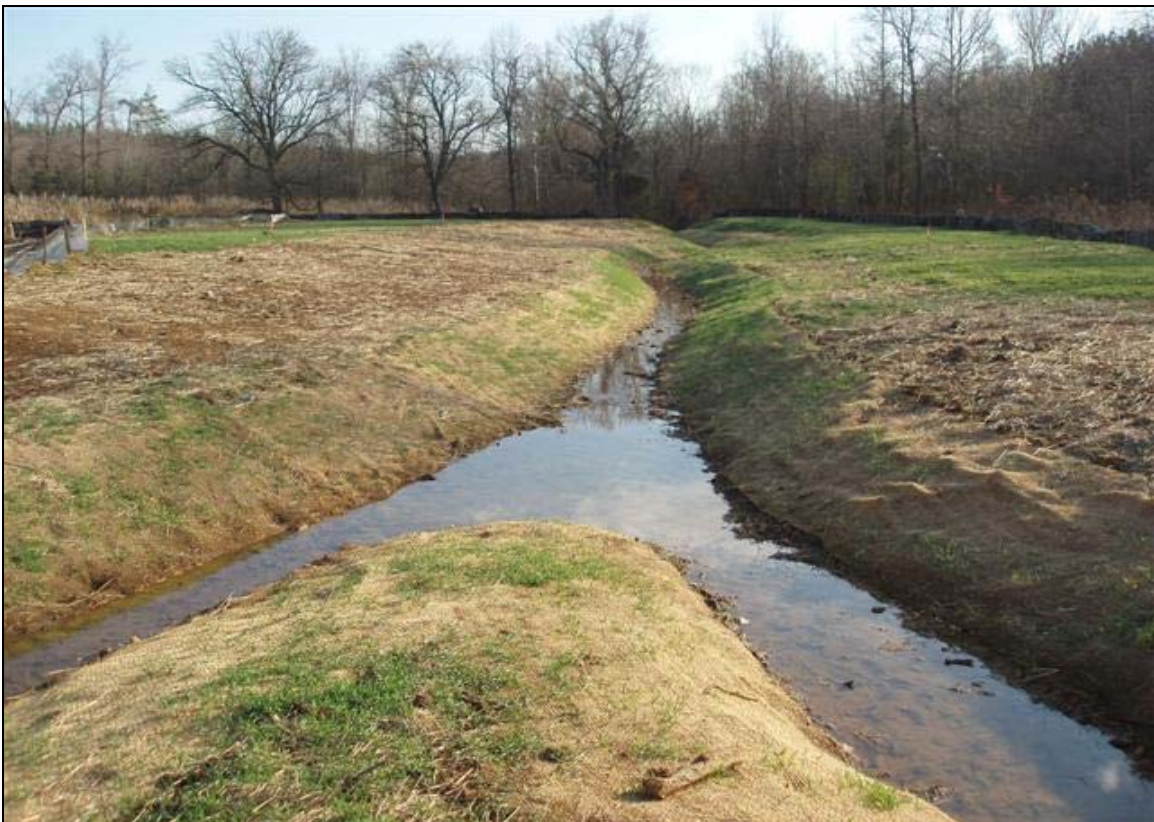
Photo Point 6c: View looking downstream at confluence. 12/19/07 – As-Built

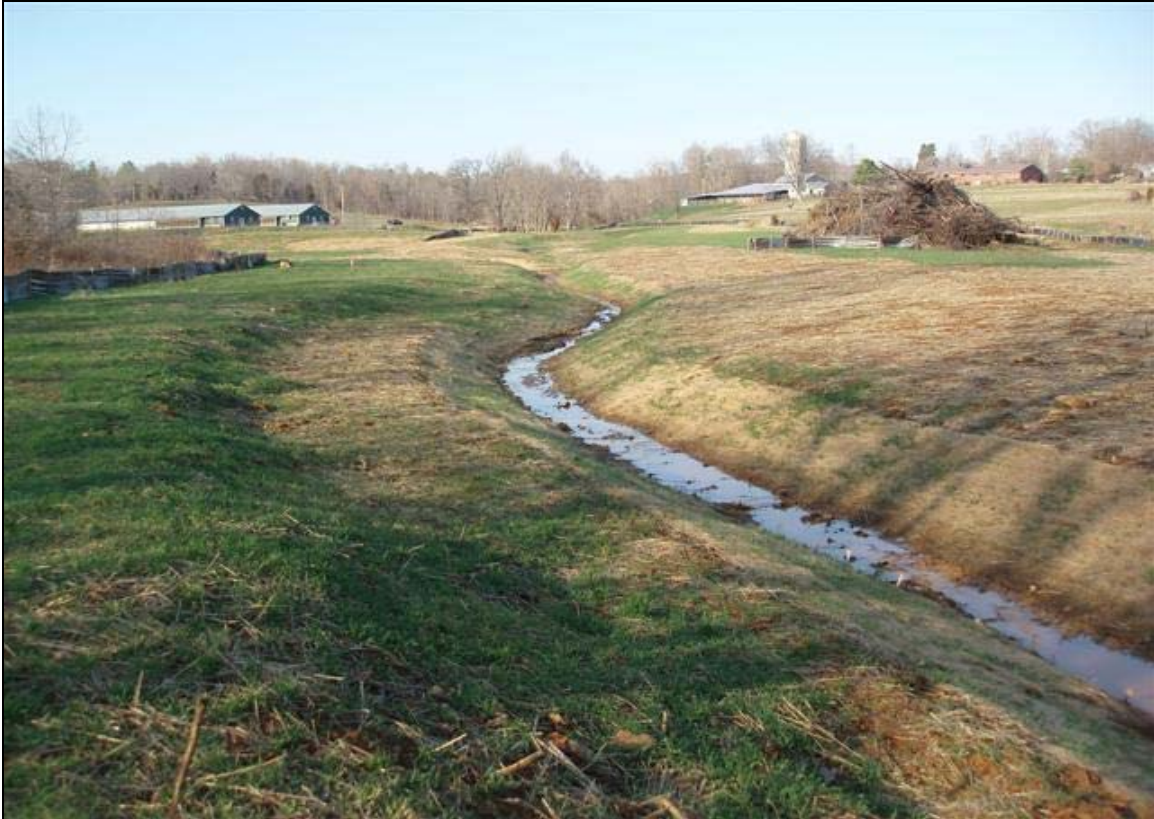
Photo Point 7a: View looking upstream near Station 27+25. 12/19/07 – As-Built

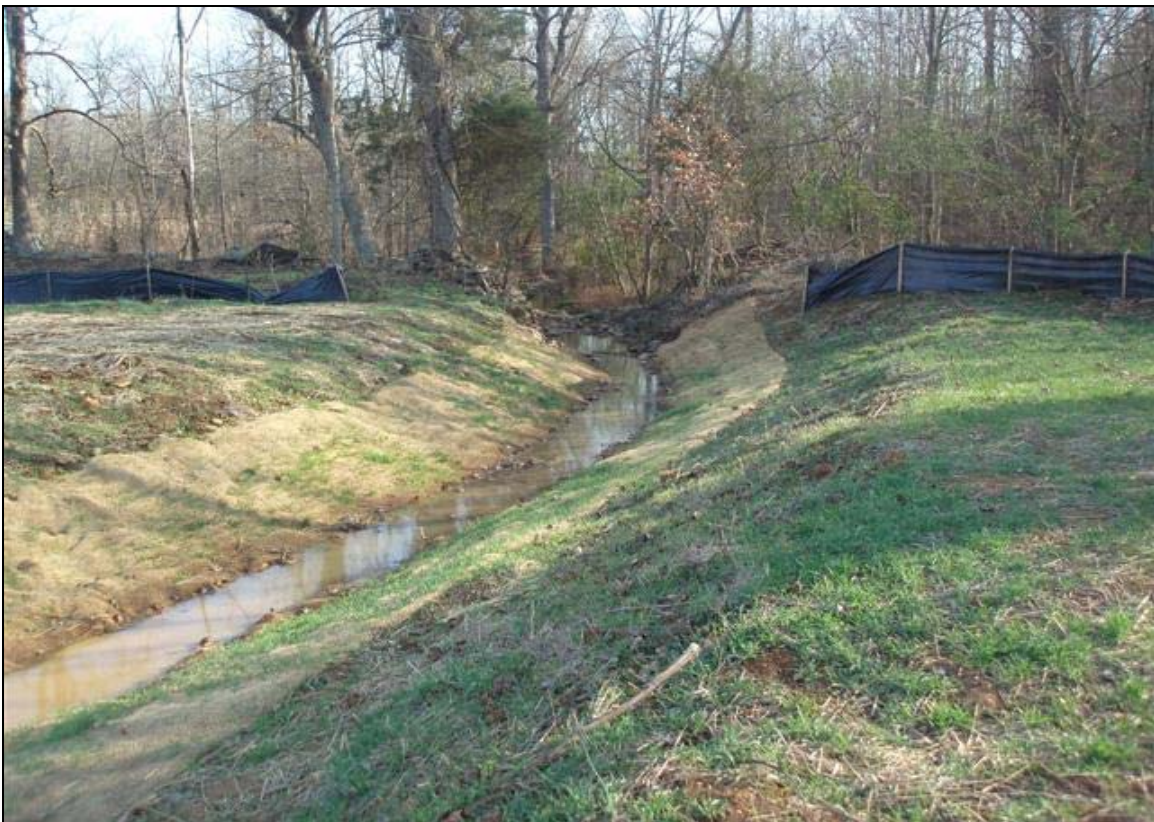
Photo Point 7b: View looking downstream towards end of project. 12/19/07 – As-Built

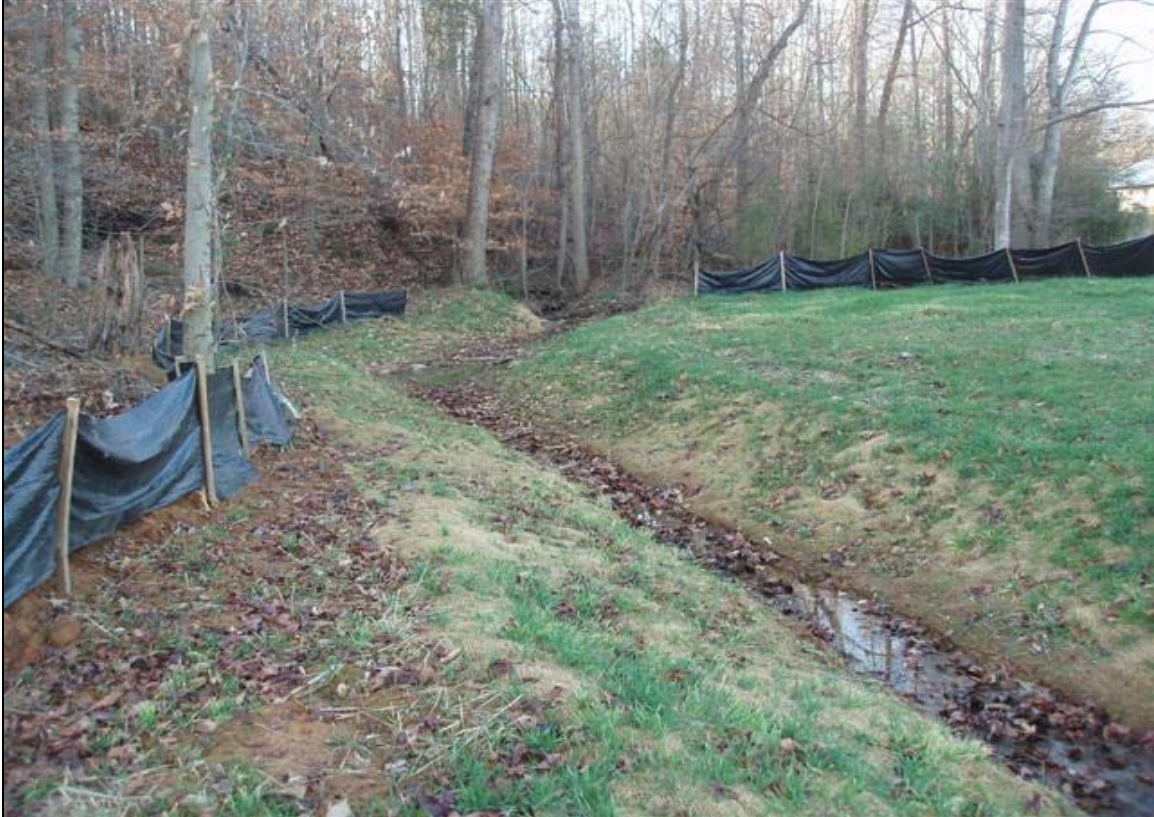
Photo Point 8a: View looking upstream towards beginning of tributary. 12/19/07 – As-Built

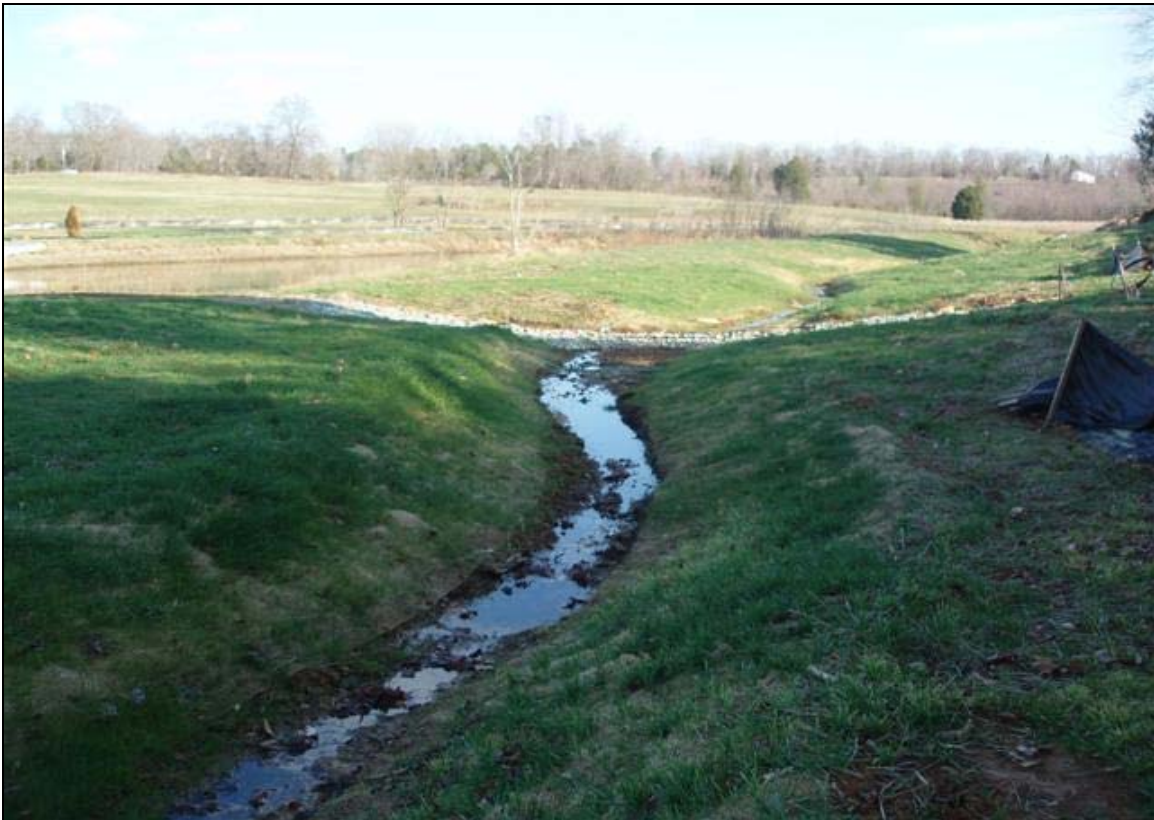
Photo Point 8b: View looking downstream on tributary near Station 51+00. 12/19/07 – As-Built

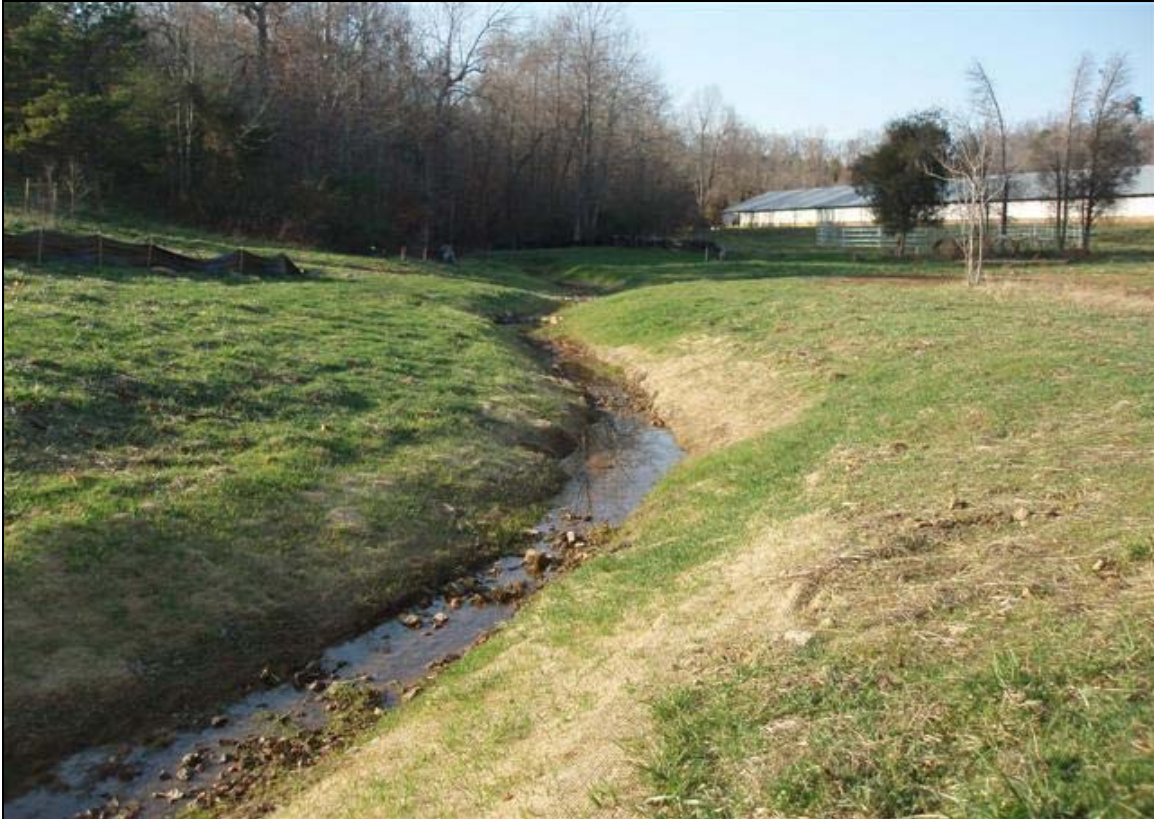
Photo Point 9a: View looking upstream on tributary near Station 53+15. 12/19/07 – As-Built

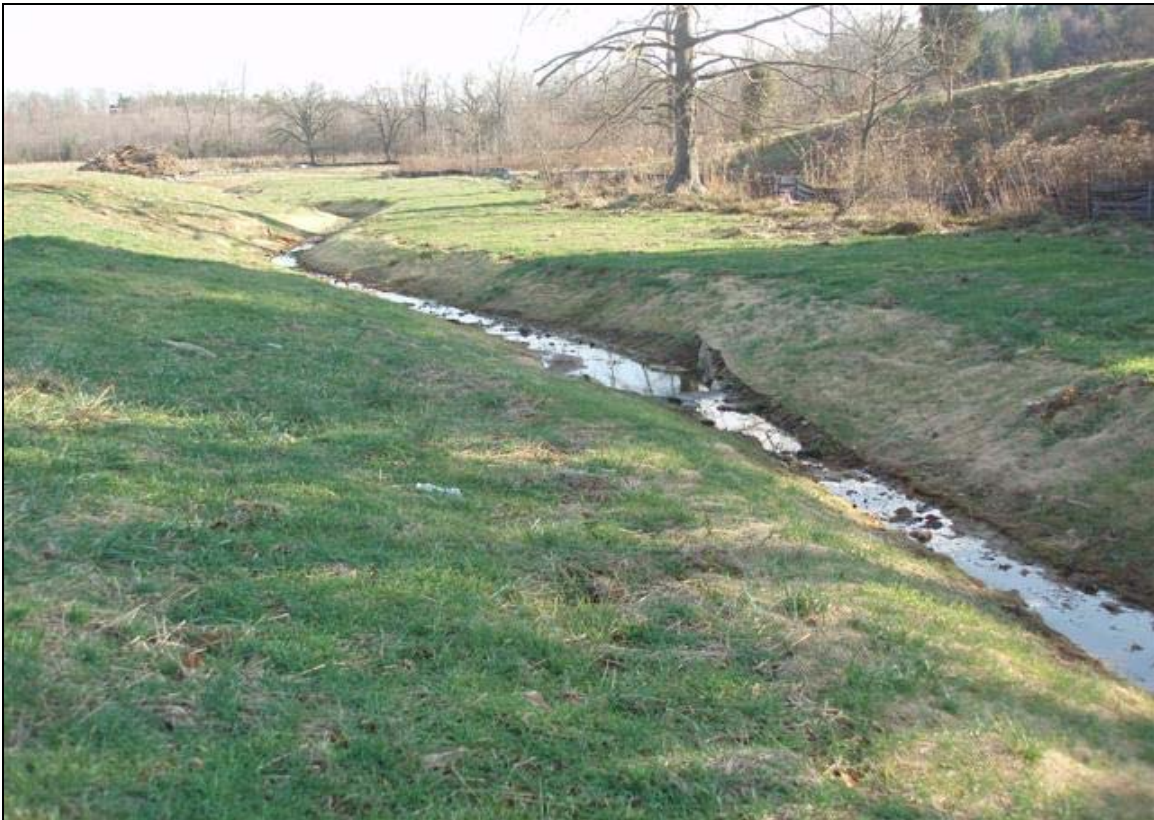
Photo Point 9b: View looking downstream on tributary near Station 53+15. 12/19/07 – As-Built

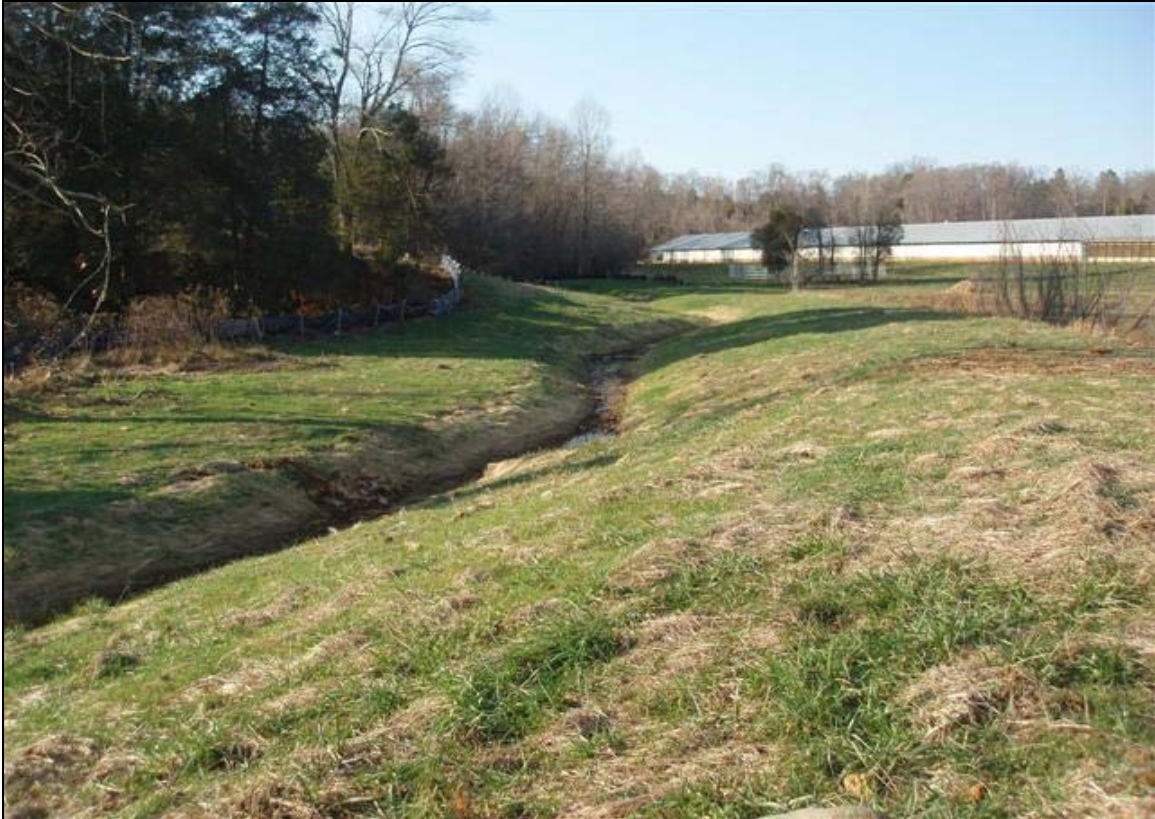
Photo Point 10a: View looking upstream on tributary near Station 55+25. 12/19/07 – As-Built

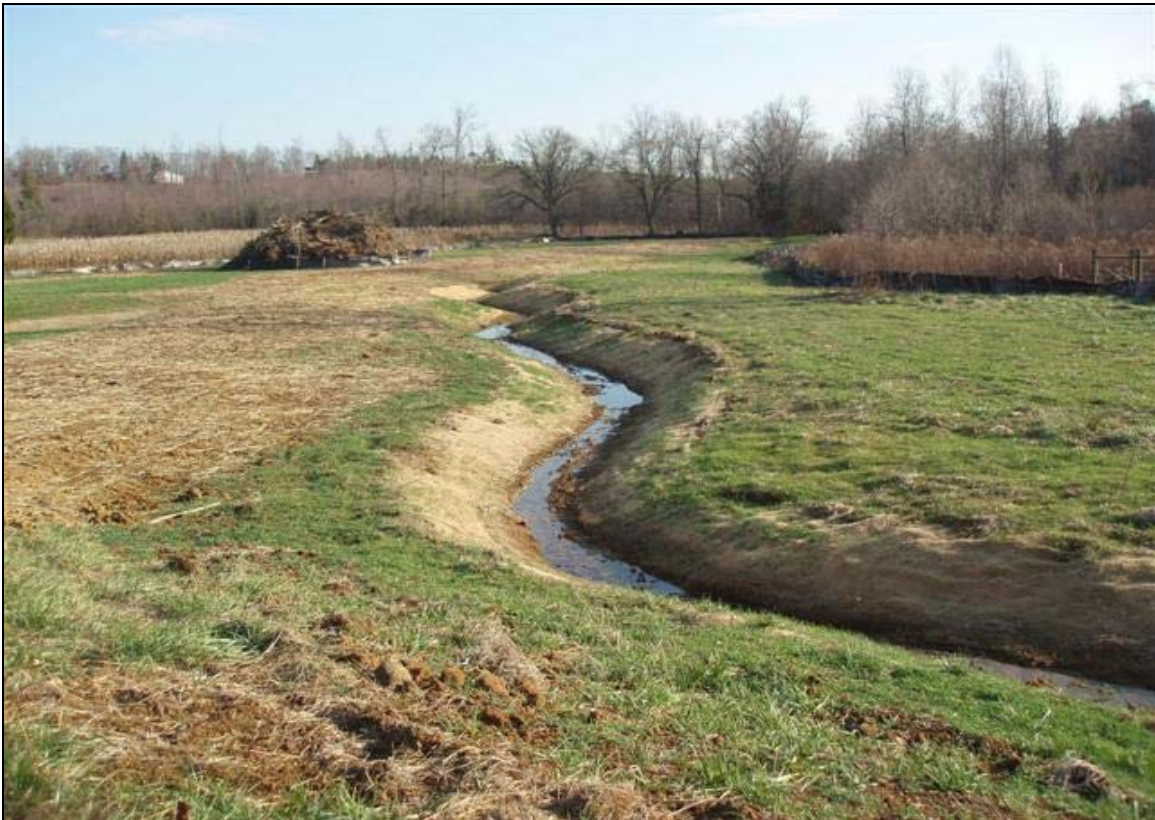
Photo Point 10b: View looking downstream on tributary near Station 55+25. 12/19/07 – As-Built
