# **Briles Stream Restoration Monitoring Report Year 1 of 5 (2009)**

**Randolph County, North Carolina**

**Project ID No. 047**

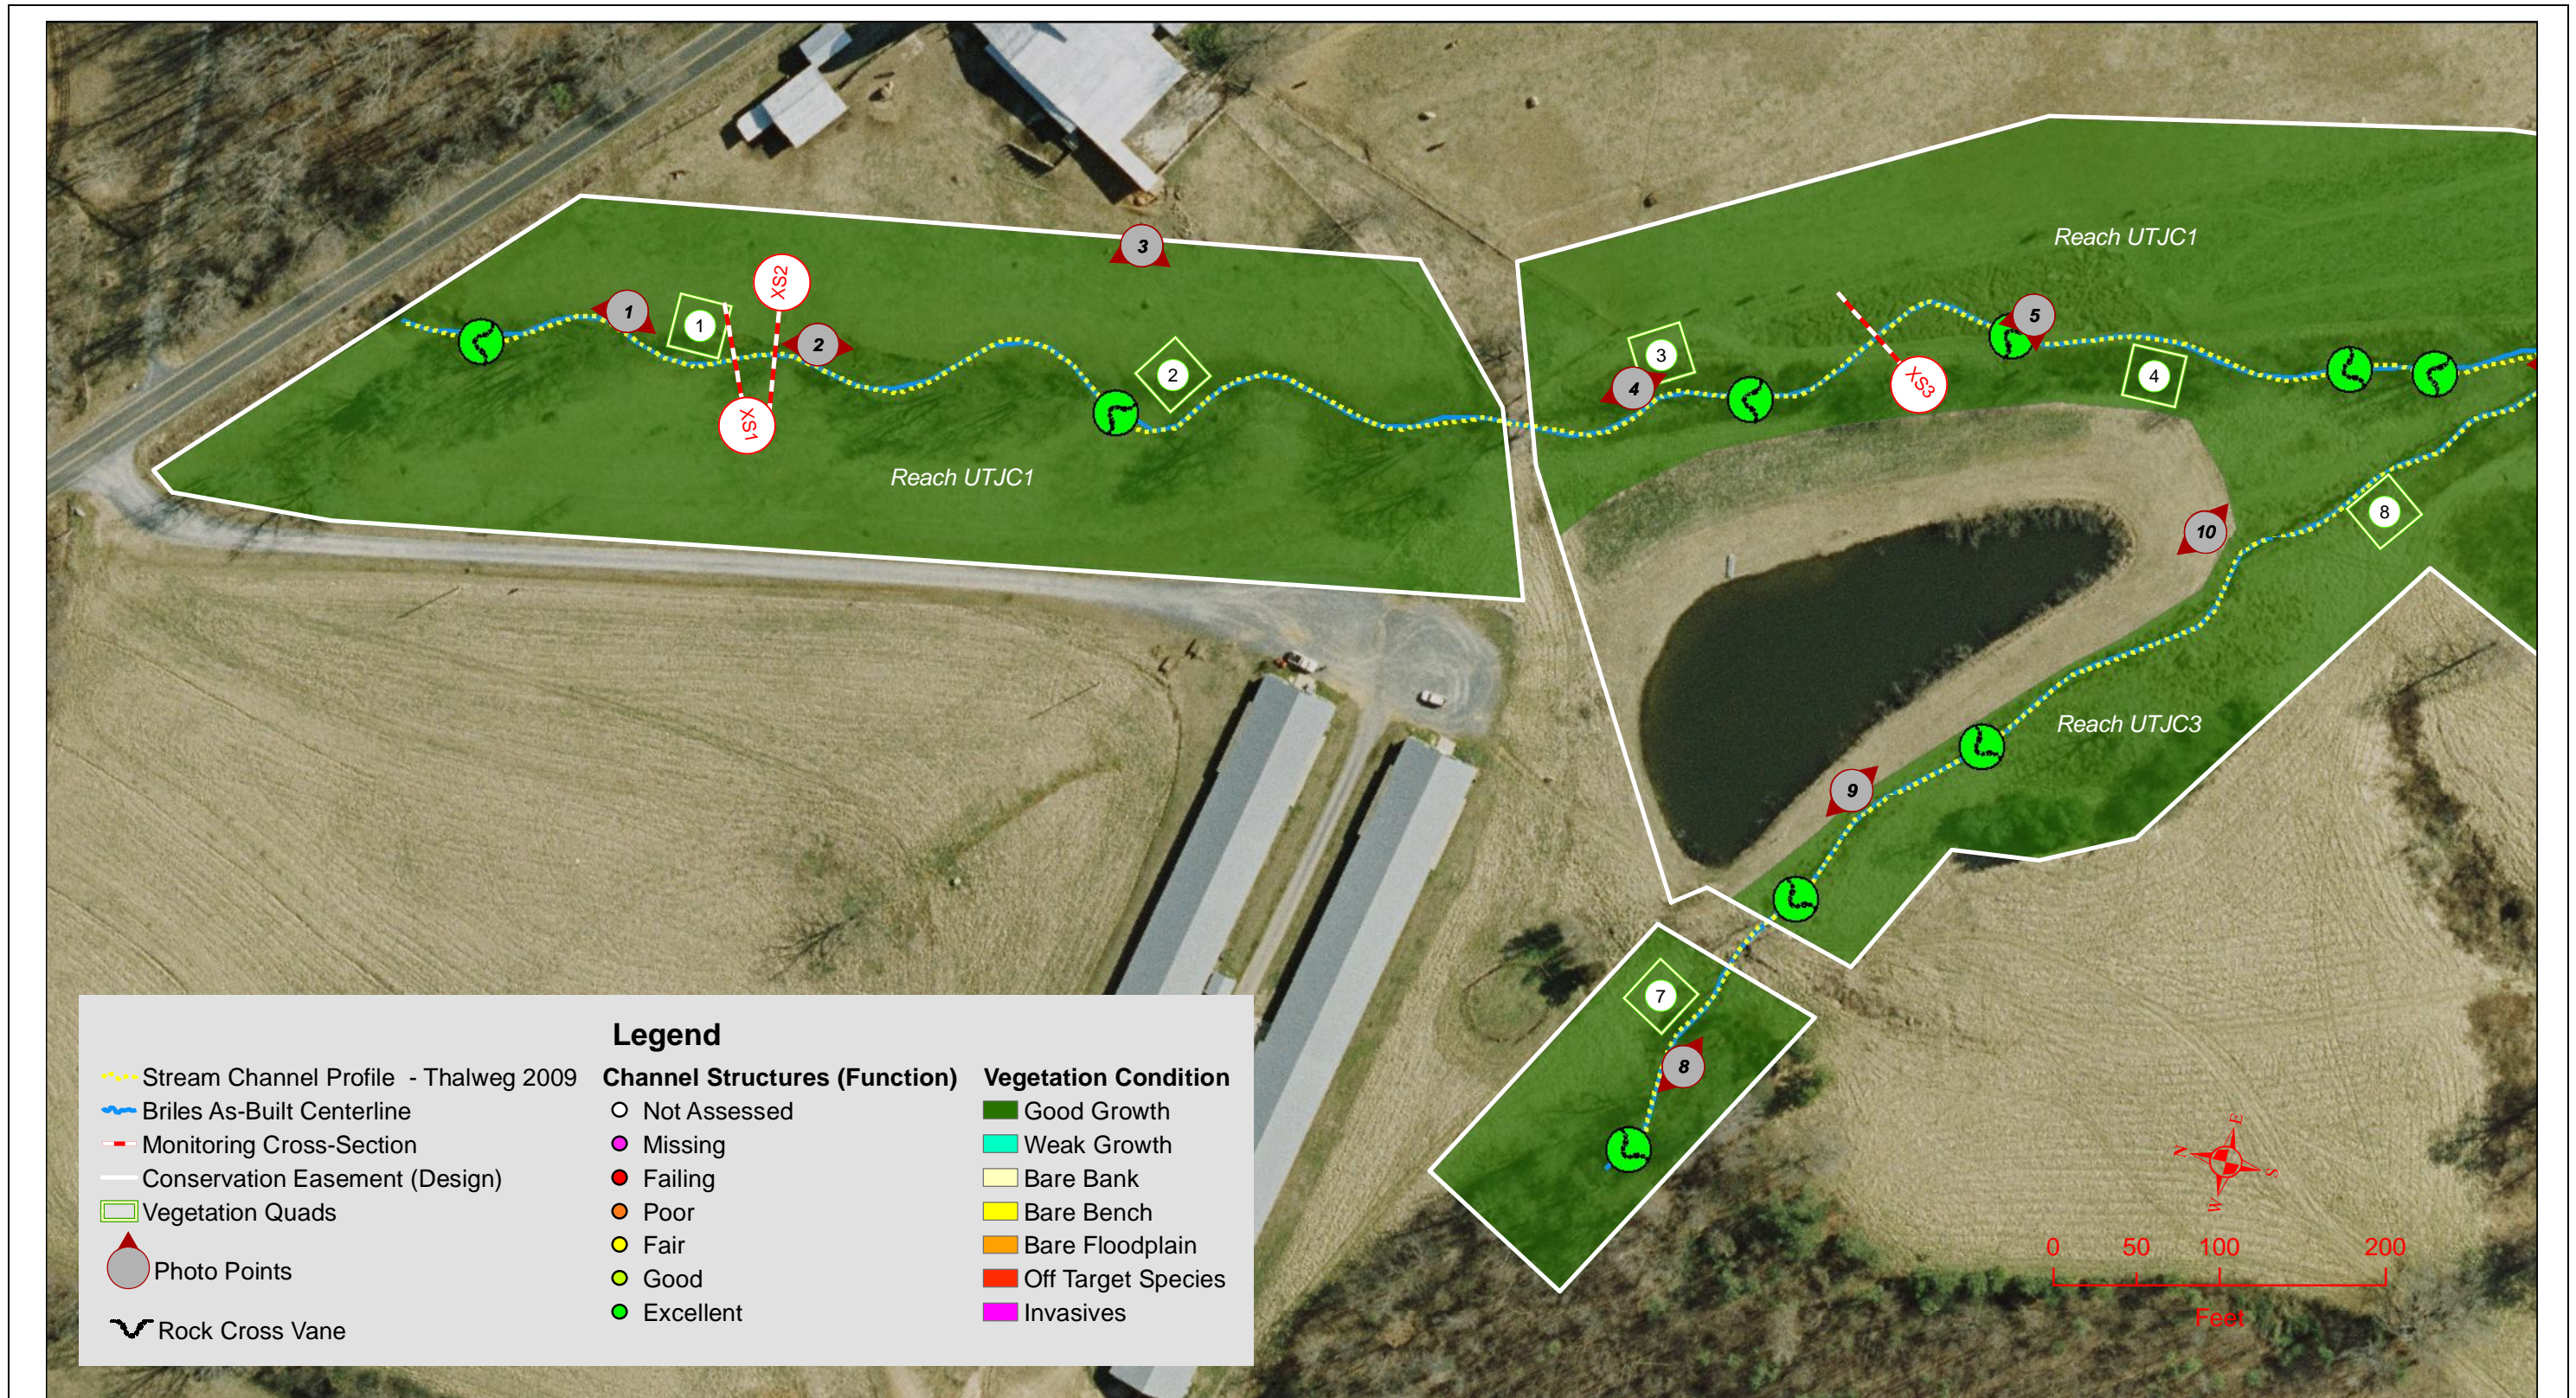
<b>Title</b>		Current Conditions Plan View Upper (2007 Aerial courtesy of NC One Map)		
<b>Prepared For:</b>	<b>Project</b>	Briles Stream Restoration Monitoring Year 1 – 2009 Randolph County, North Carolina		
	<b>Date</b>	4/30/10	<b>Project Number</b>	047
				<b>Figure</b>
				2

FIGURE 1	PROJECT SETTING
FIGURE 2	CURRENT CONDITIONS PLAN VIEW UPPER
FIGURE 3	CURRENT CONDITIONS PLAN VIEW LOWER

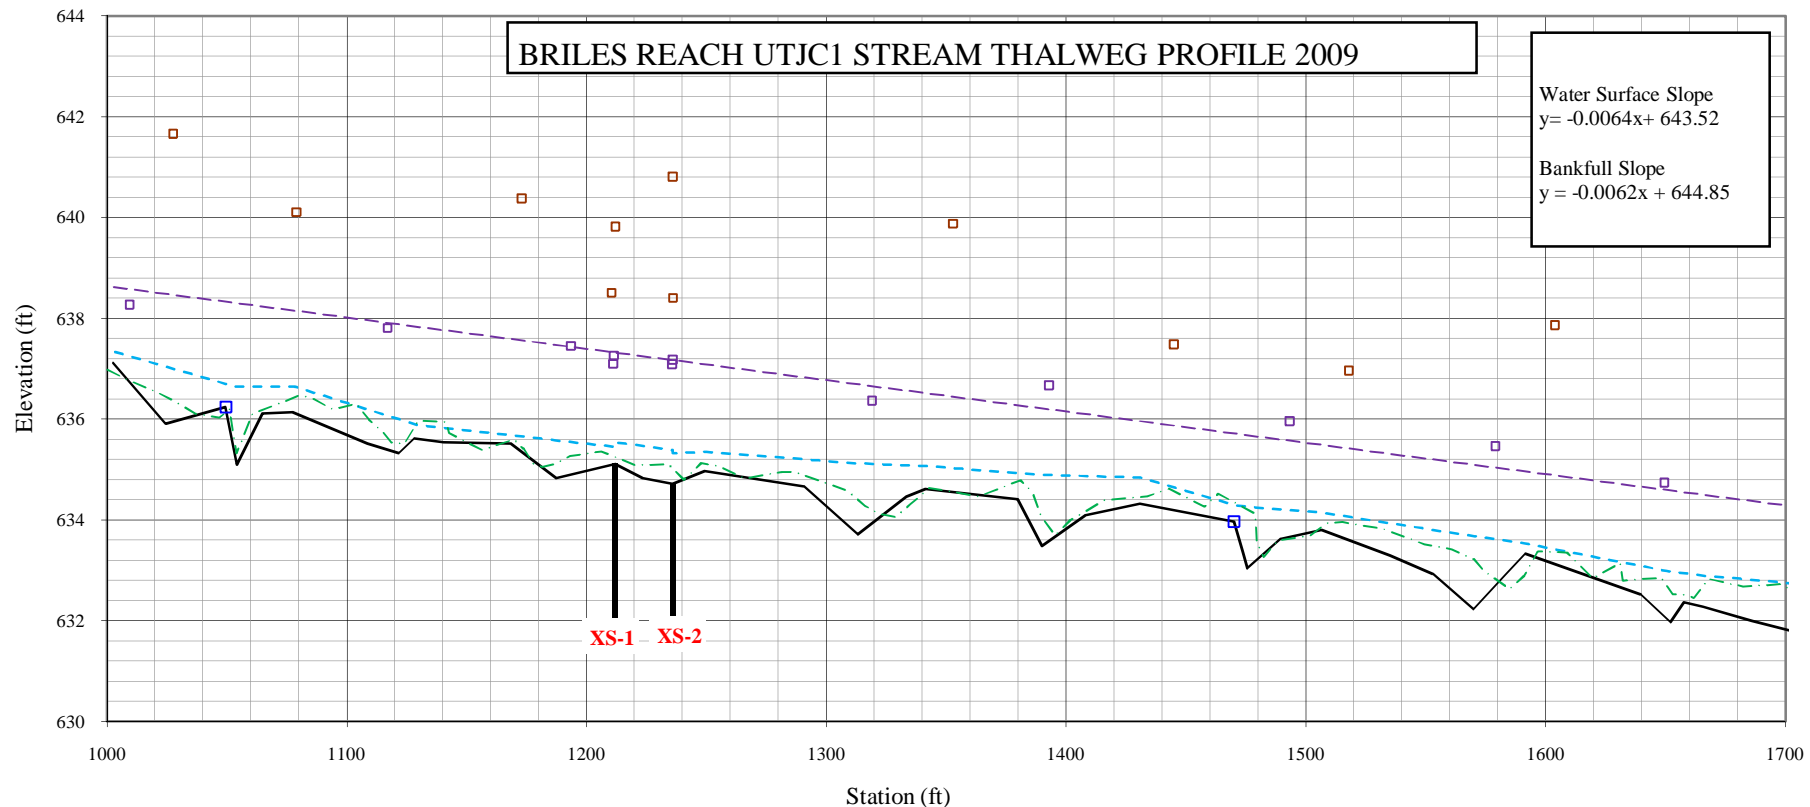
# BRILES REACH UTJC1 STREAM THALWEG PROFILE 2009

Water Surface Slope  
 $y = -0.0064x + 643.52$

Bankfull Slope  
 $y = -0.0062x + 644.85$

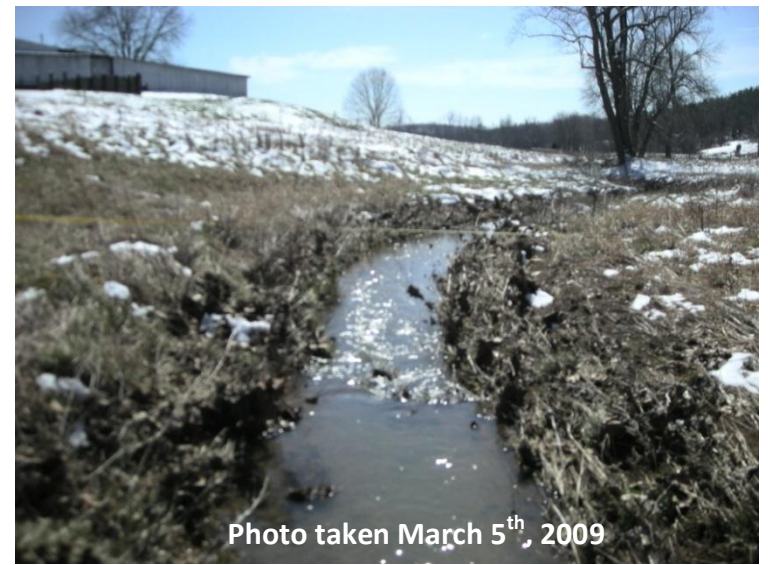
ID	YEAR	PHASE	FACET TYPE	Wbkf	Abkf	Dbkf
XS1	2007	AB	RIFFLE	13.4	15.9	1.2
XS1	2009	MY1	RIFFLE	14.6	16.0	1.1

ID	YEAR	PHASE	d50 (mm)	d84 (mm)
XS1	2007	AB	0.07	5.02
XS1	2009	MY1	11.73	31.00

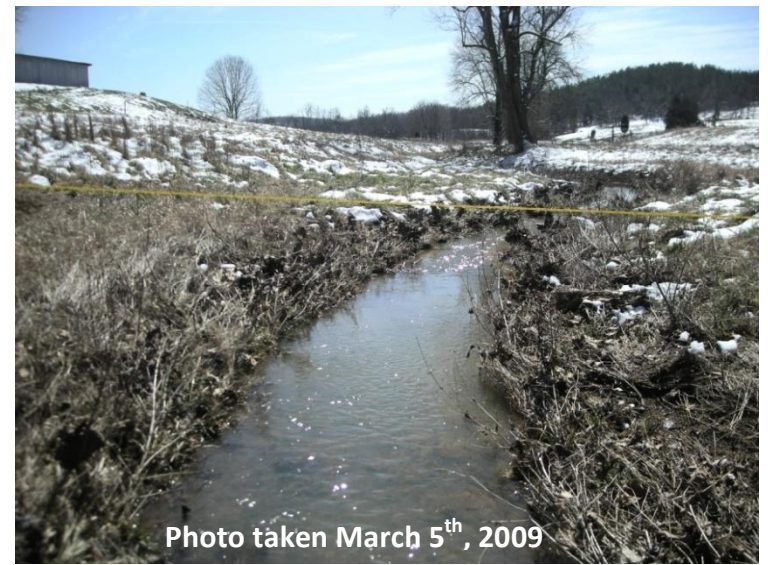
ID	YEAR	PHASE	FACET TYPE	Wbkf	Abkf	Dbkf
XS2	2007	AB	POOL	15.9	18.9	1.2
XS2	2009	MY1	POOL	17.6	22.5	1.3

ID	YEAR	PHASE	d50 (mm)	d84 (mm)
XS2	2007	AB	0.14	3.63
XS2	2009	MY1	28.15	62.7

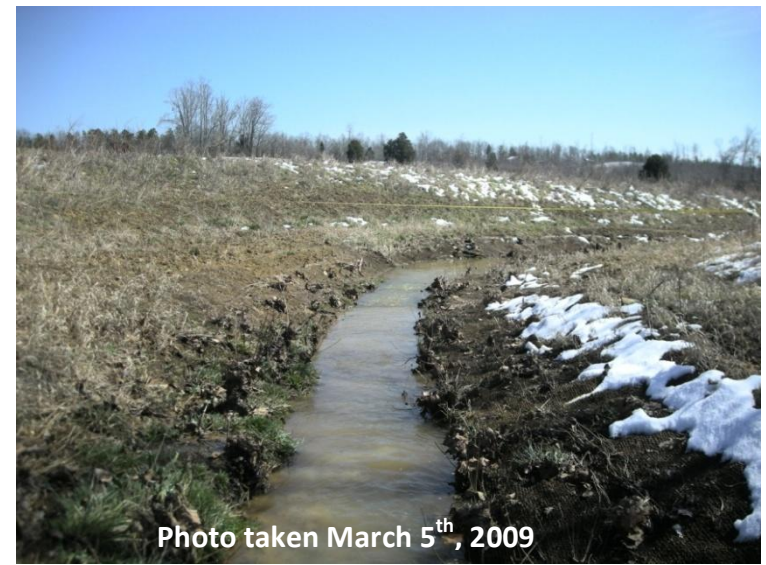
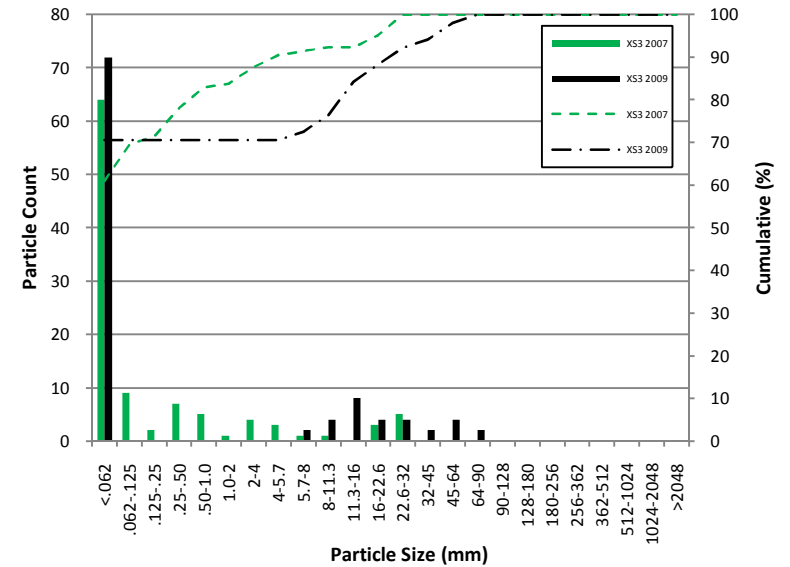
ID	YEAR	PHASE	FACET TYPE	Wbkf	Abkf	Dbkf
XS3	2007	AB	POOL	14.2	16.2	1.1
XS3	2009	MY1	POOL	14.1	17.9	1.3

ID	YEAR	PHASE	d50 (mm)	d84 (mm)
XS3	2007	AB	--	1.05
XS3	2009	MY1	--	11.17

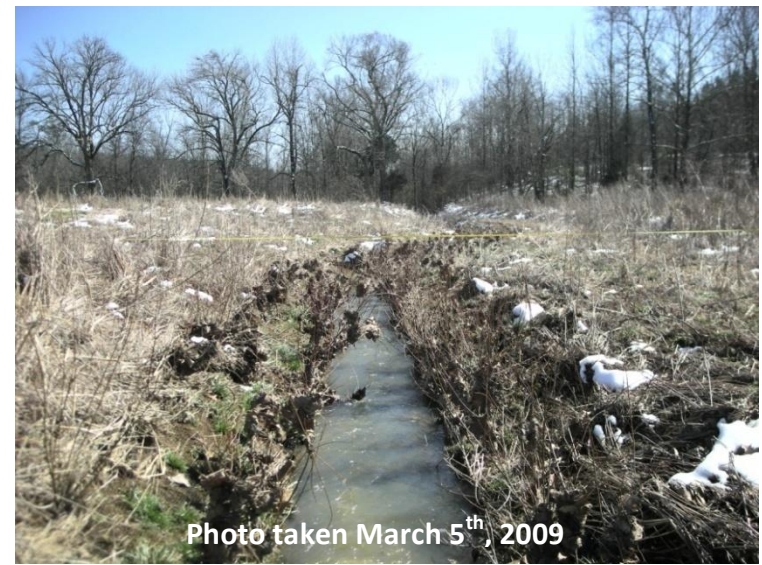
ID	YEAR	PHASE	FACET TYPE	Wbkf	Abkf	Dbkf
XS4	2007	AB	RIFFLE	15.8	19.8	1.3
XS4	2009	MY1	RIFFLE	15.0	20.2	1.4

ID	YEAR	PHASE	d50 (mm)	d84 (mm)
XS4	2007	AB	0.09	3.53
XS4	2009	MY1	12.71	42.24

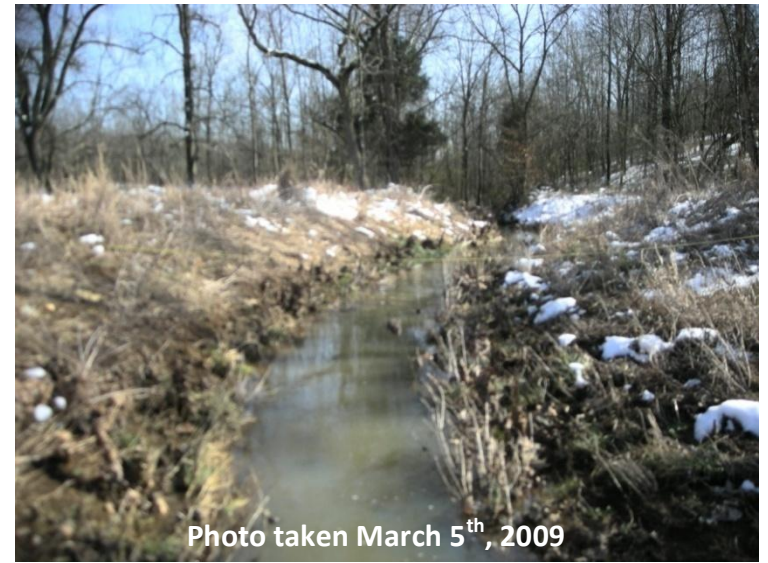
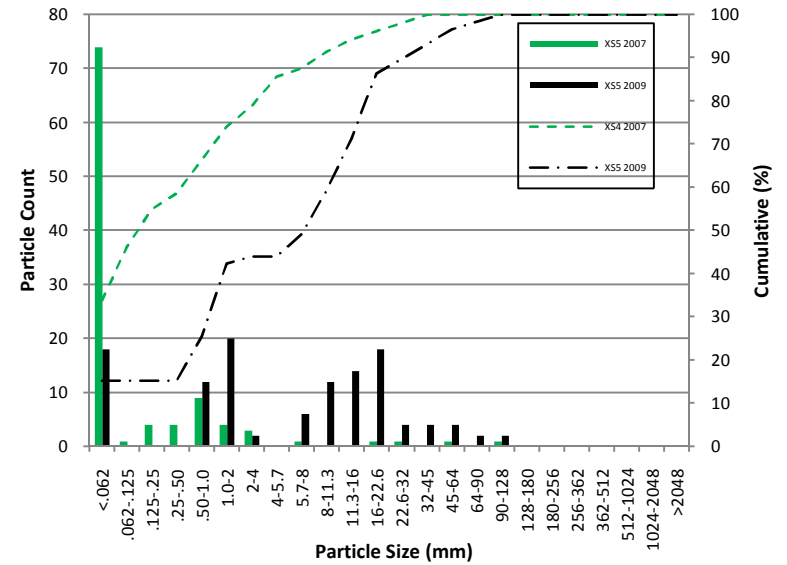
ID	YEAR	PHASE	FACET TYPE	Wbkf	Abkf	Dbkf
XS5	2007	AB	RIFFLE	14.0	21.4	1.5
XS5	2009	MY1	RIFFLE	12.7	18.2	1.4

ID	YEAR	PHASE	d50 (mm)	d84 (mm)
XS5	2007	AB	--	0.37
XS5	2009	MY1	5.89	15.25
