N.C. Wetlands Restoration Program
NCDENR DWQ

Brown Branch Final Stream Restoration Report

February 2002

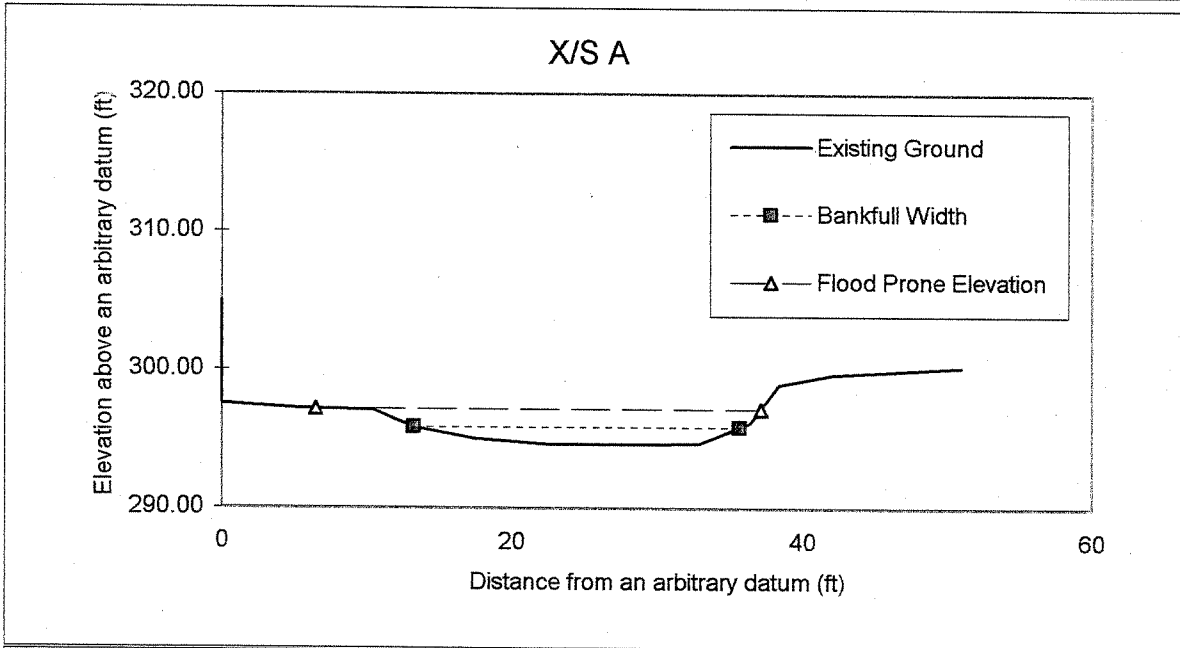
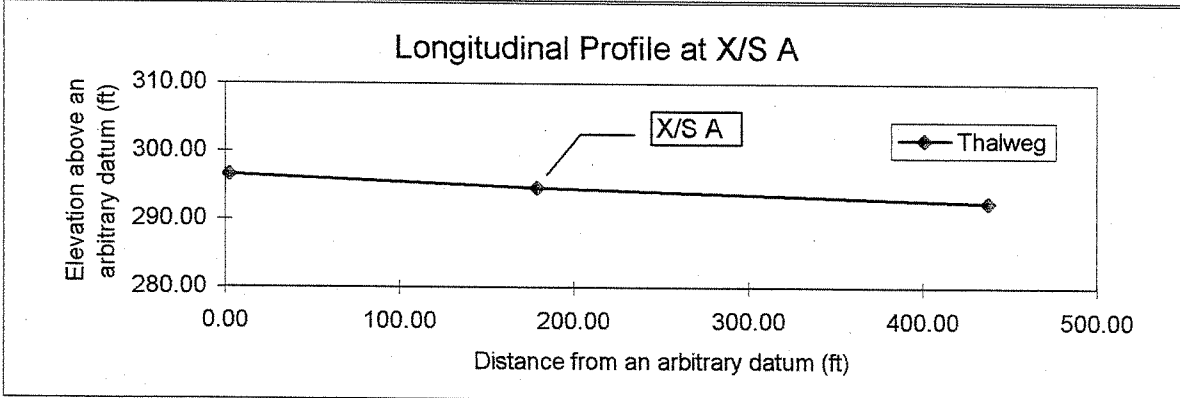
Rosgen Stream Type Classification	
Entrenchment	1.36
Width:Depth	23.09
Sinosity	~1
Slope	0.0091
D50	21 (mm)
Stream Type	F4

Flow Calculations	
Bankfull Width	22.50 (ft)
Bankfull Depth	0.97 (ft)
Area	21.93 (ft ²)
Manning's n	0.0300
Velocity	4.62 (ft/s)
Discharge	101.28 (cfs)
Shear Stress	0.55 (lb/ft ²)

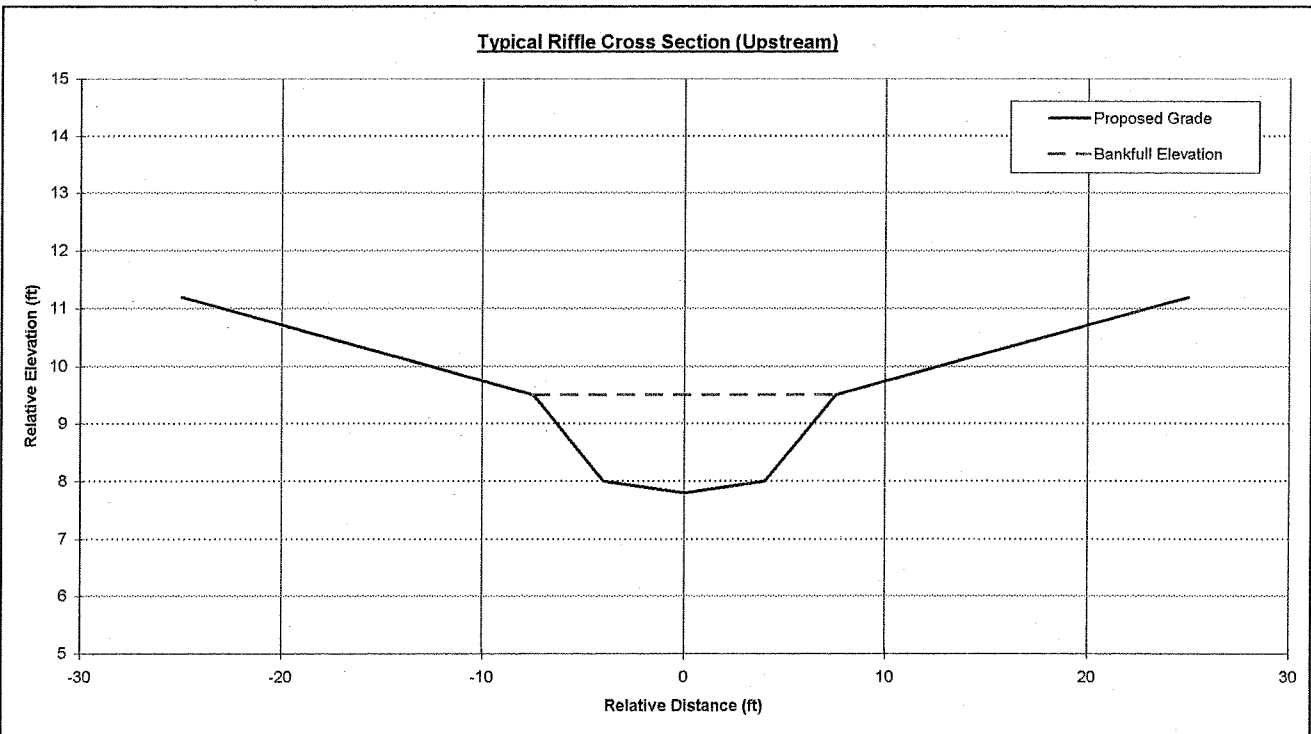
Typical Riffle Cross Section (Upstream)

Calculated Variables	Units
Bankfull Cross Section Area =	18.1 (ft ²)
Bankfull Wetted Perimeter =	15.6 (ft)
Bankfull Hydraulic Radius =	1.16 (ft)
Bankfull Discharge =	89 (cfs)
Floodprone Cross Section Area =	73.3 (ft ²)
Floodprone Wetted Perimeter =	51 (ft)
Floodprone Hydraulic Radius =	1.44 (ft)
Floodprone Discharge =	378 (cfs)
Bankfull Average Depth =	1.20 (ft)
Bankfull W/D Ratio =	12.5 (ft/ft)
Bankfull Entrenchment Ratio =	3.3 (ft/ft)
Bankfull Shear Stress =	0.79 (lb/ft ²)
D94 =	52 (mm)
Bankfull Max Depth =	1.70 (ft)

The following section explains the development of average cross-sectional dimensions used in the design. (Actual values depicted in the grading plan may differ slightly to create variability). All typical dimensions discussed below are shown together in Appendix D for both riffle and pool cross sections. These dimensions are also contrasted with existing conditions and reference reach values in Table 8.5.
