BROWN BRANCH STREAM RESTORATION

POST-CONSTRUCTION MITIGATION PLAN

Biohabitats, Inc.
15 West Aylesbury Road
Timonium, Maryland 21093

March 2003

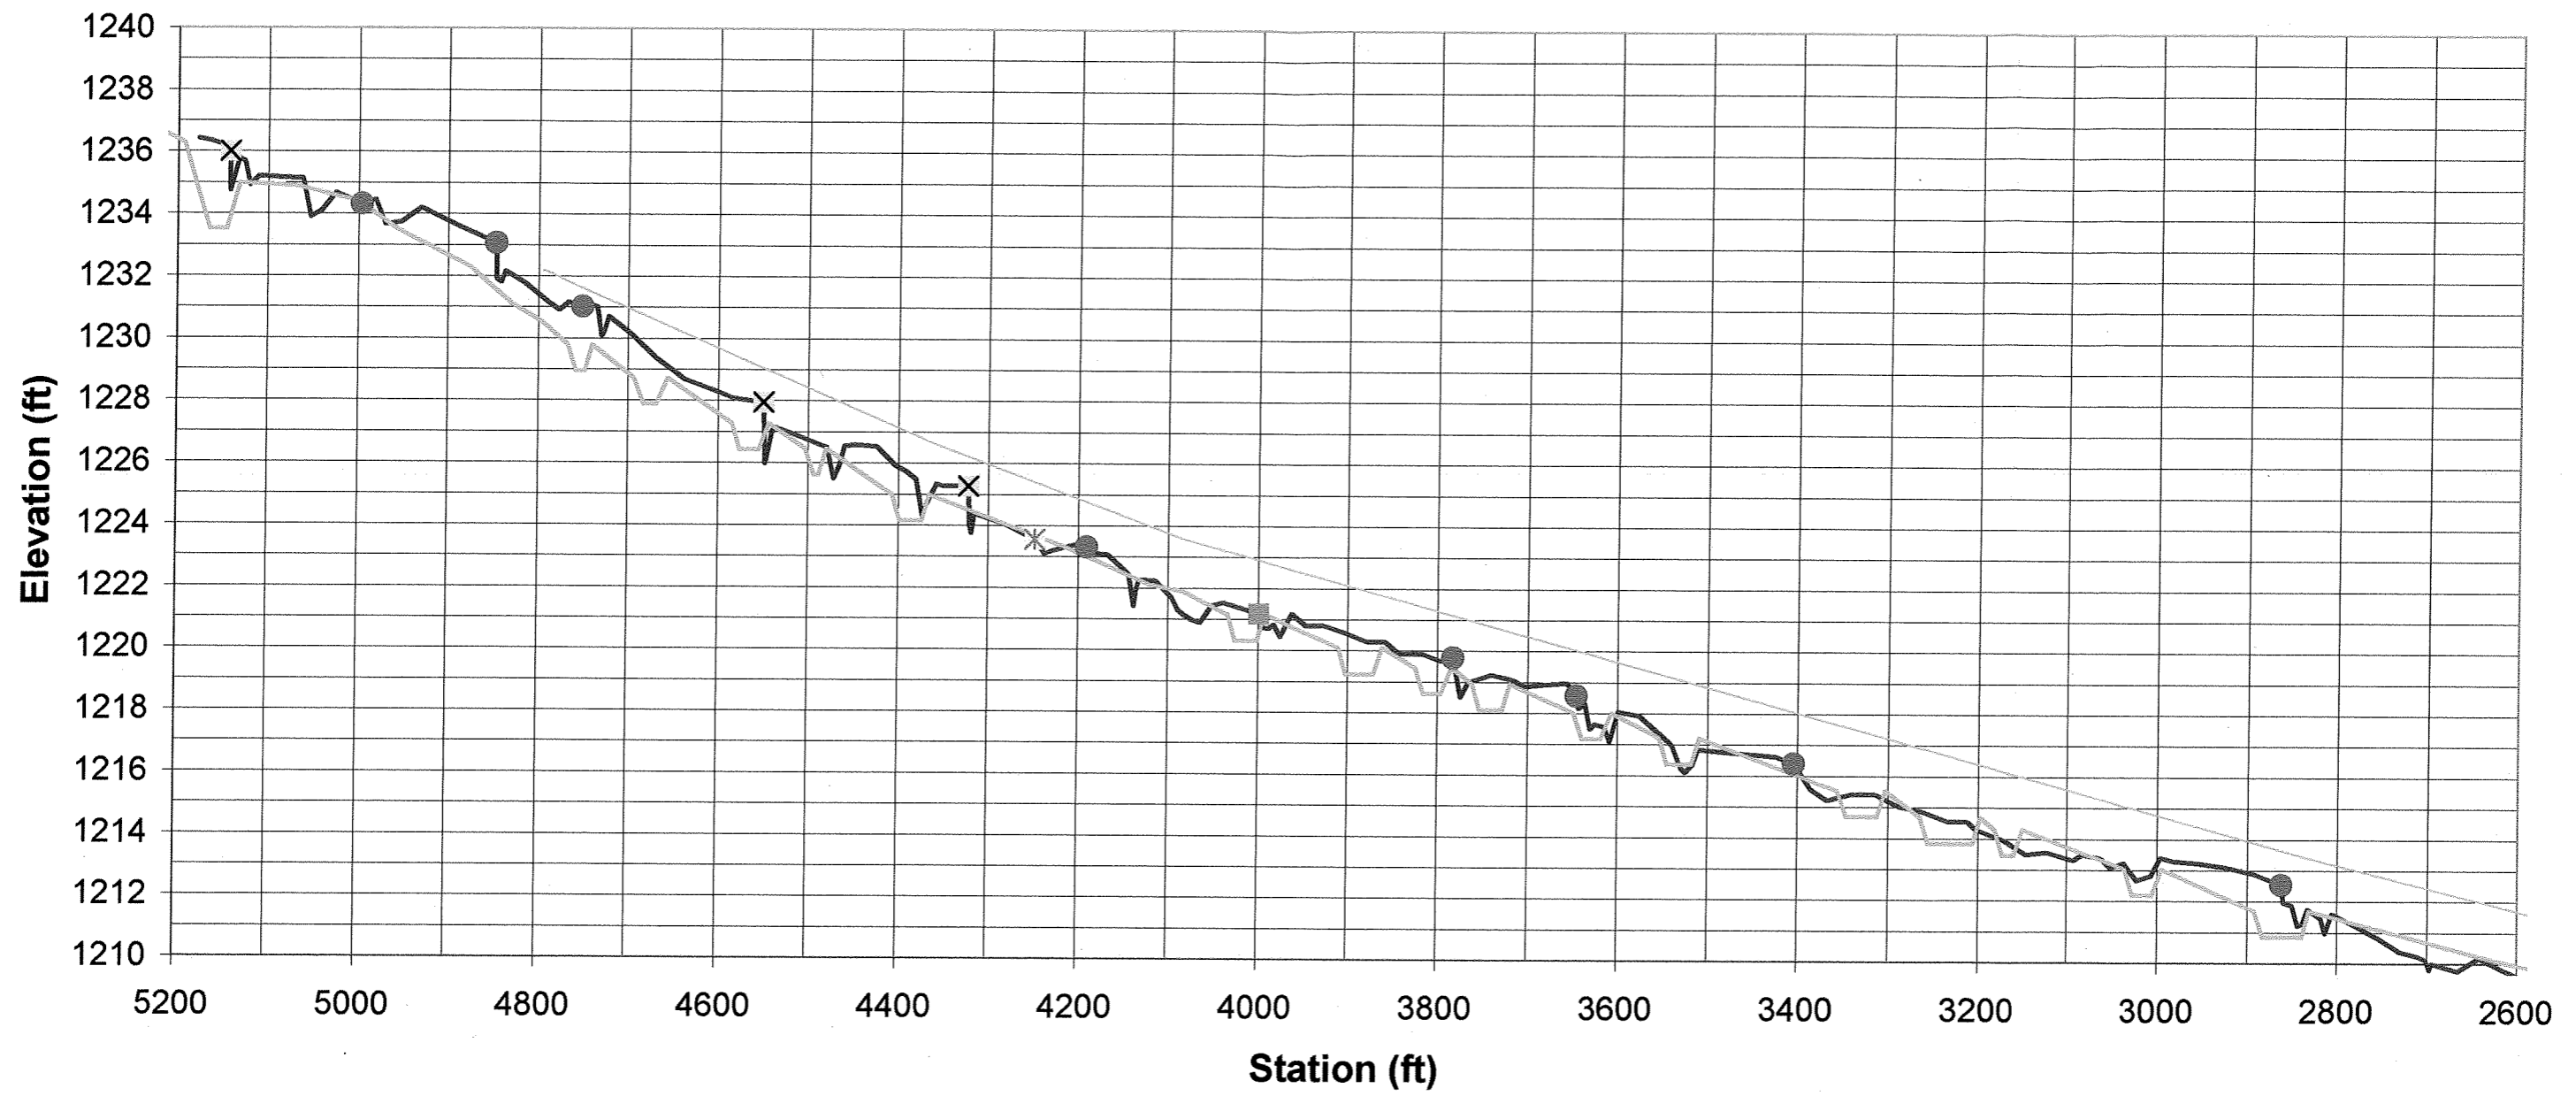
- As-Built Thalweg Profile
- - - Design Thalweg Profile
- Design Bankfull Slope
- Log Vane
- × Cross Vane
- Rock Vane
- △ Rock J Vane
- * Rootwad/Log J Vane

Longitudinal Profile
Upstream Portion of Brown Branch
 Baseline Monitoring Conditions
 Survey Date: January 15, 2003

One continuous profile was surveyed through the project reach along the thalweg to establish baseline streambed elevations. Features such as riffles and pools were noted in the survey. The elevation of flow deflection and grade control structures such as log vanes and rock cross vanes were also surveyed. The baseline longitudinal profile is shown in Appendix B. Stationing of features shown in the baseline profile (Appendix B) differs slightly from stationing shown in the as-built (Appendix A) due to minor differences in the field interpretation of thalweg.

To construct the baseline profile survey shown in Appendix B, measuring tapes were stretched end-to-end along the thalweg to record cumulative distance downstream. Because the thalweg will adjust slightly in planform from year to year, it should be expected that the total reach length will be somewhat different for each monitoring year. As a result, a point at a given distance on a profile graph may not represent the same location within Brown Branch. (The magnitude of the offset can, however, be evaluated by comparing the x-axis "distance" of a stationary in-stream structure (e.g., a cross vane) between years.)

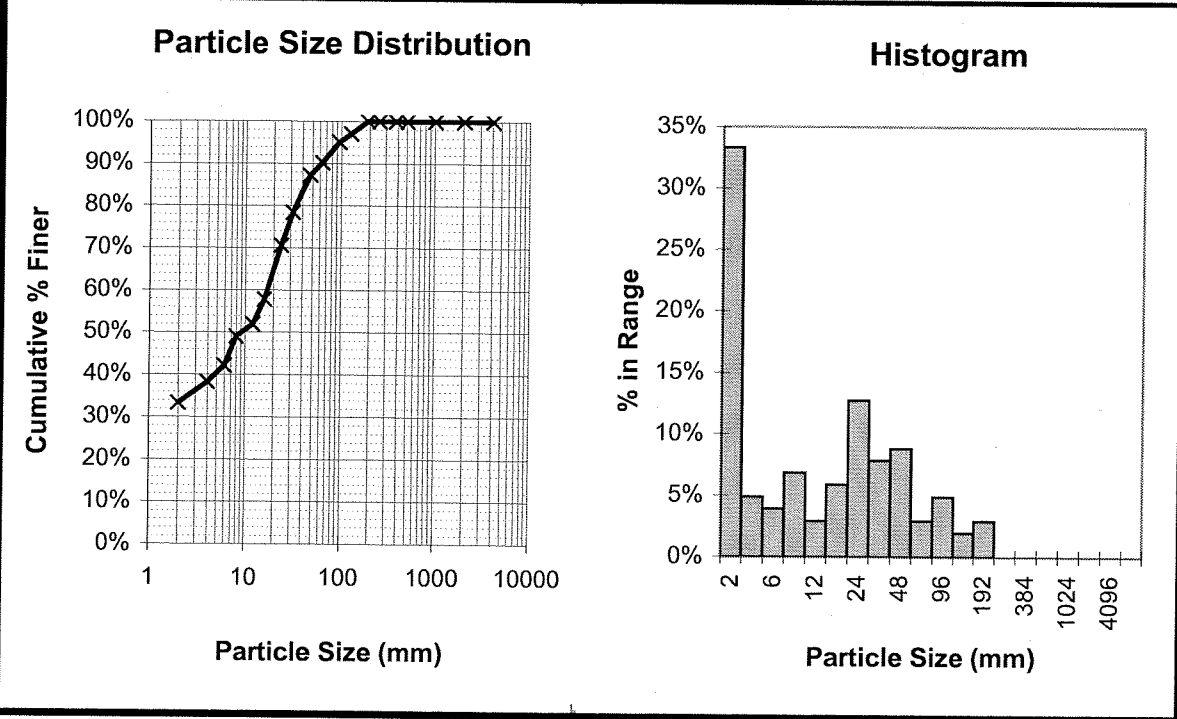
BASELINE CONDITIONS, PEBBLE COUNT B

Site Name: Brown Branch Biohabitats, Inc.
 Project No: 01015.01 Pebble Count Data Sheet
 Date: 1/16/2003 As-built STA 24+45-25+30, Pool 40%, Riffle 60%

$D_{50} = 9.3$ mm, $D_{75} = 28.5$ mm, $D_{84} = 42.1$ mm, $D_{90} = 62.9$ mm

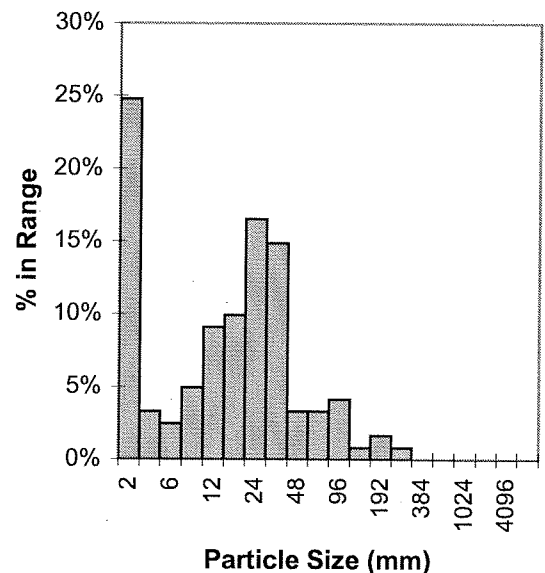
BASELINE CONDITIONS, PEBBLE COUNT C

Site Name:	Brown Branch	Biohabitats, Inc.
Project No:	01015.01	Pebble Count Data Sheet
Date:	1/16/2003	As-built STA 11+30-12+20, Pool 40%, Riffle 60%

D₅₀ = 14.2 mm, D₇₅ = 26.1 mm, D₈₄ = 31.0 mm, D₉₀ = 51.6 mm

Particle Size Distribution

Histogram

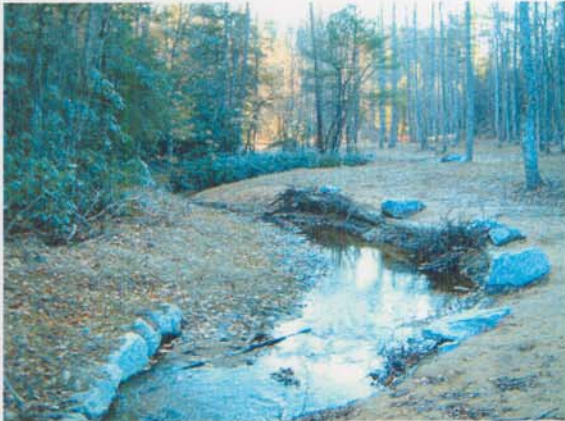
Photo Station #1. Looking downstream from as-built Station ~51+00.

To document the overall channel stability and development of the riparian zone with time, twenty-two (22) permanent photo stations were established along the length of the project reach. A color photograph was taken at each photo station to document baseline conditions. Each photo station location is marked in the field by a partially embedded 4-foot long rebar with a yellow cap. The locations of photo stations are depicted by numbered red dots in Appendix A. Photographs from each station are included in this report in the beginning of Appendix E.

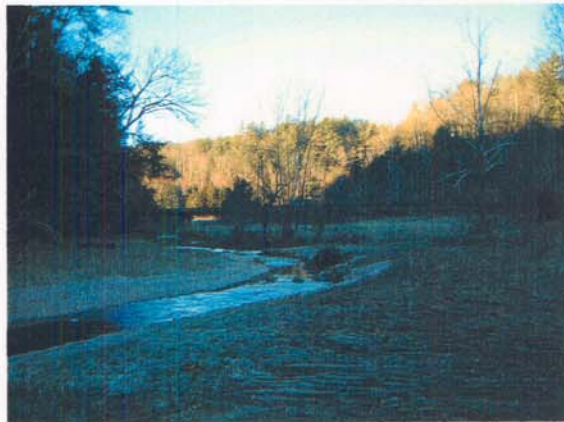
Photograph NM-1. Looking upstream at cross vane from as-built Station ~51+00.

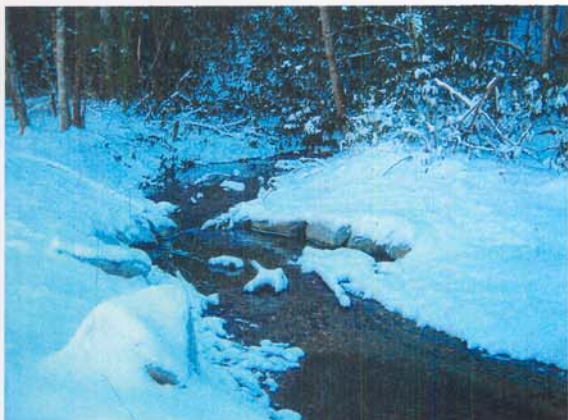
Photograph NM-2. Looking downstream at rootwads and log toe protection from as-built Station ~51+00.

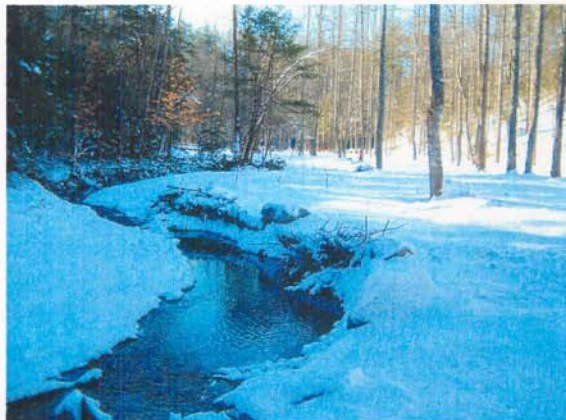
Photograph NM-3. Looking downstream at rootwads and log toe protection from as-built Station ~49+25.

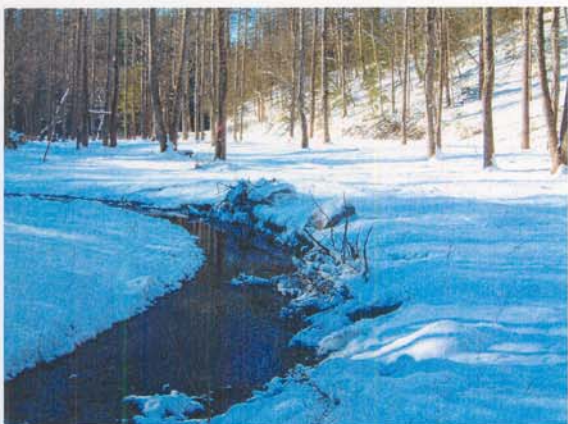
Photograph NM-4. Looking upstream at buried log vane from as-built Station ~49+25.

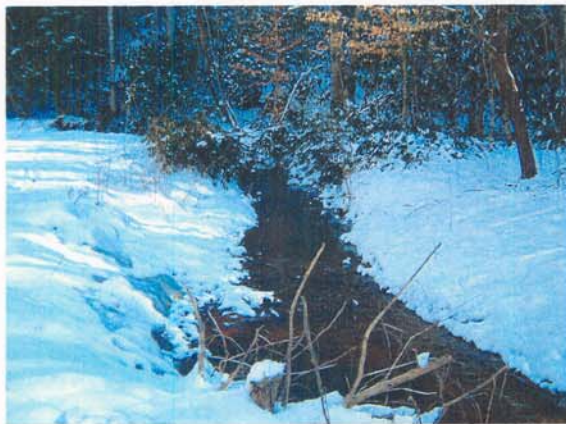
Photograph NM-5. Looking upstream at log vane from as-built Station ~48+25.

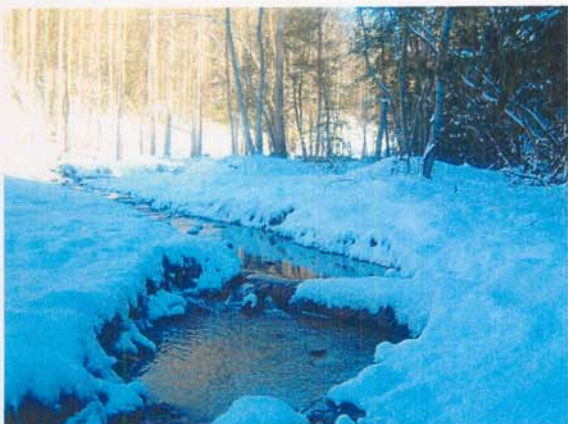
Photograph NM-6. Looking downstream at log vane from as-built Station ~47+25.

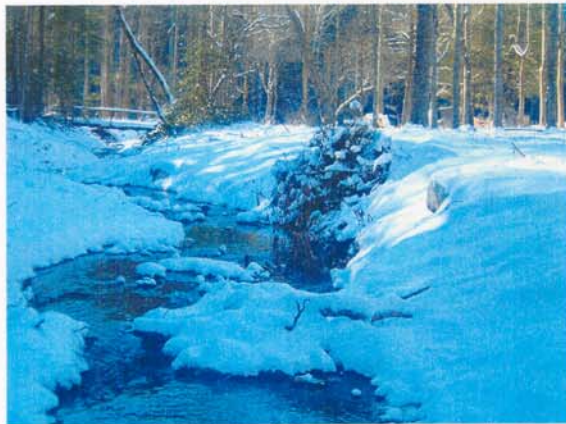
Photograph NM-7. Looking upstream at cross vane from as-built Station ~44+80.

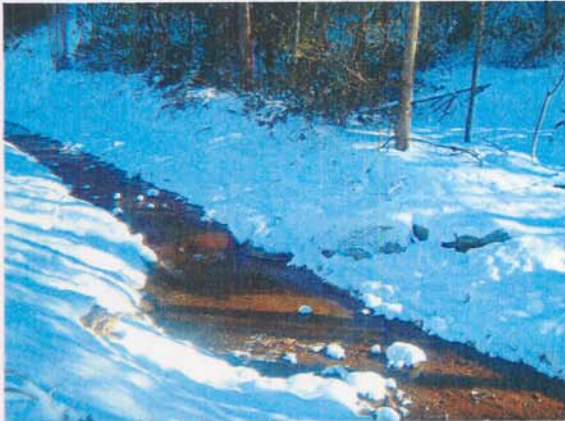
Photograph NM-8. Looking downstream at rootwad and rock toe protection from pedestrian bridge at as-built Station ~44+60.

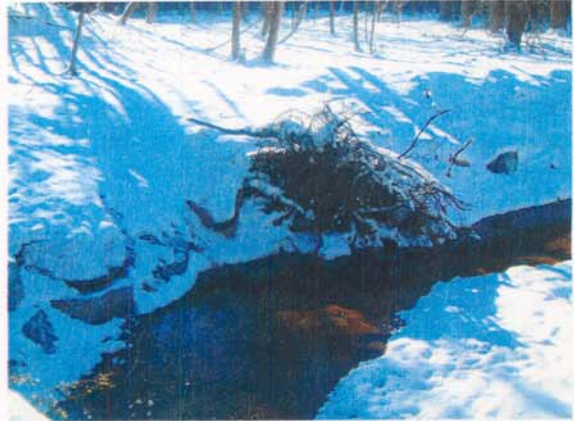
Photograph NM-9. Looking downstream at rootwads and rock toe protection from as-built Station ~43+80.

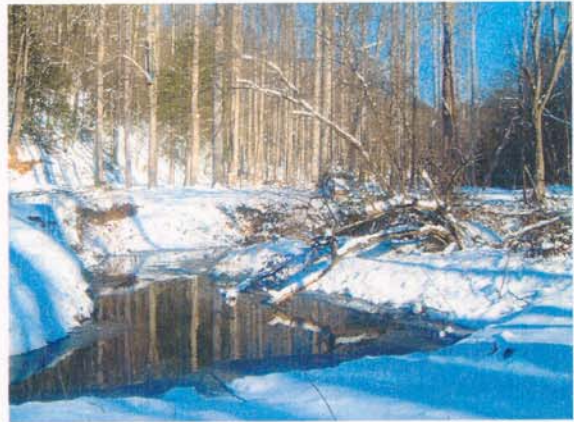
Photograph NM-11. Looking down outlet channel draining oxbow wetland into mainstem channel, at as-built Station ~43+40.

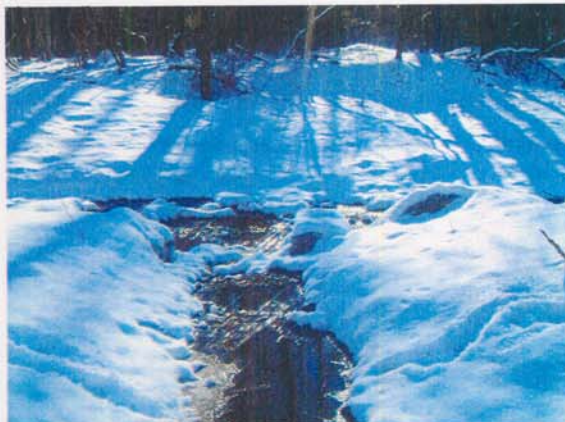
Photograph NM-12. Looking upstream at cross vane from as-built Station ~42+50.

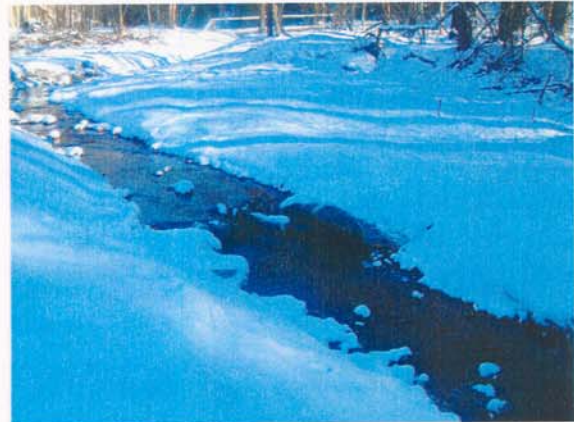
Photograph NM-13. Looking downstream at rootwad/log "J" vane from as-built Station ~42+25.

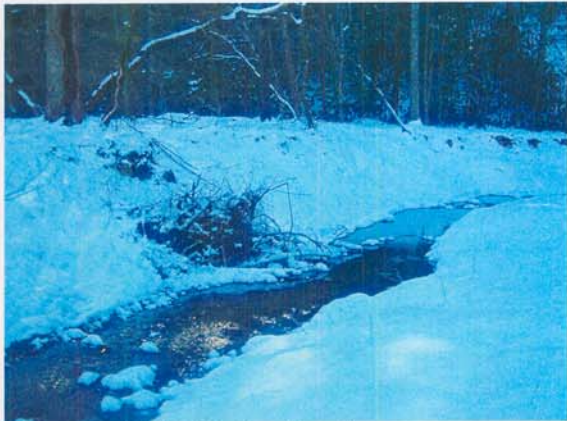
Photograph NM-14. Looking downstream at log vane at as-built Station ~41+50.

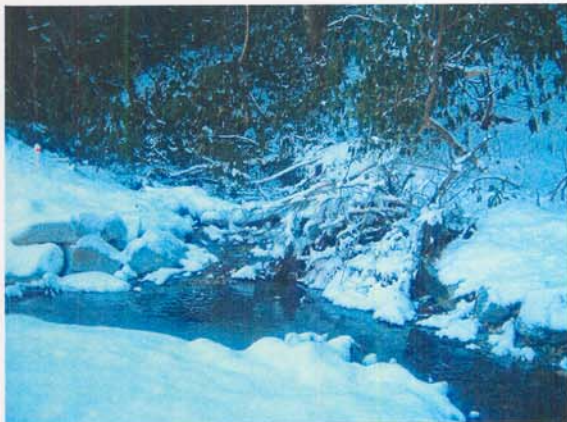
Photograph NM-16. Looking downstream at rock toe protection along opposite bank, view from as-built Station ~41+00.

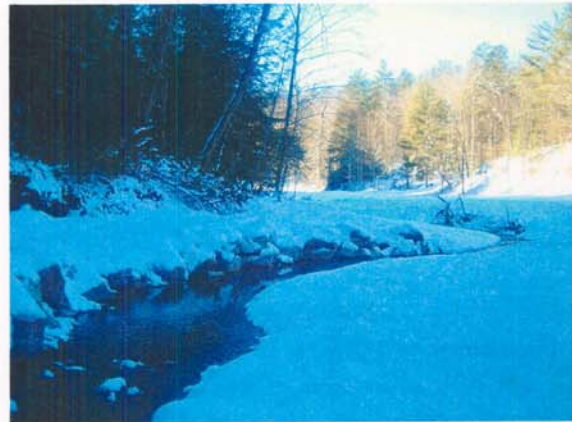
Photograph NM-17. Looking downstream at rock vane, rootwads, and log toe protection from as-built Station ~39+75.

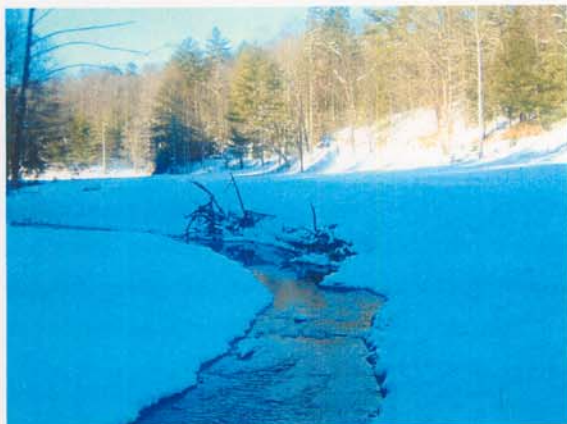
Photograph NM-18. Looking downstream at log vane and rootwads from as-built Station 37+75.

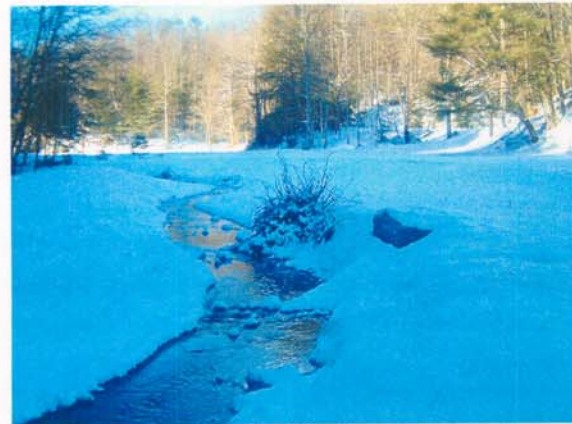
Photograph NM-19. Looking upstream at log vane from as-built Station ~37+50.

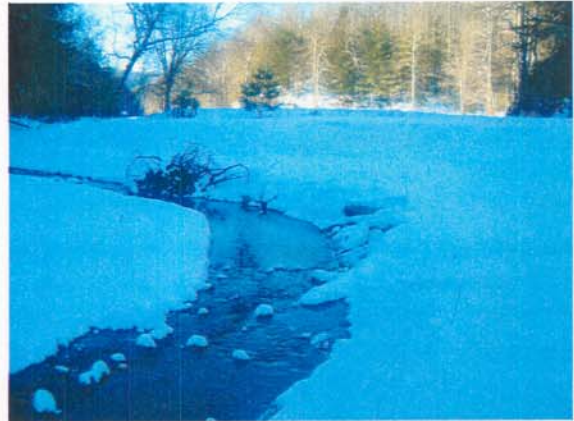
Photograph NM-20. Looking downstream at log vane, rootwad, and log toe protection from as-built Station ~36+25.

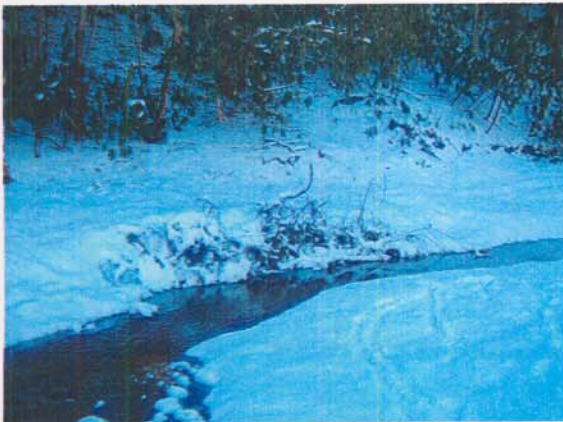
Photograph NM-21. Looking downstream at rootwads from as-built Station ~35+00.

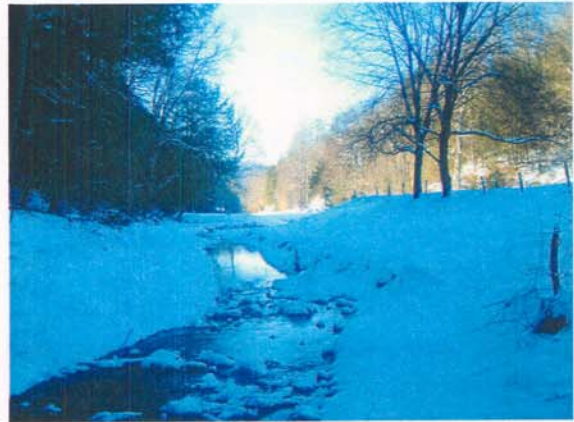
Photograph NM-22. Looking downstream at log vane and log toe protection from as-built Station ~34+00.

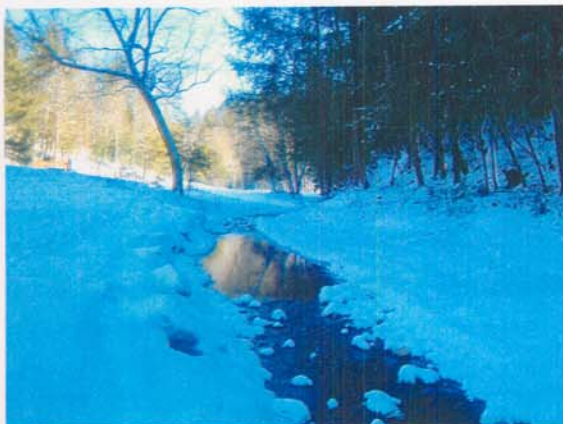
Photograph NM-23. Looking upstream at log toe protection from as-built Station ~32+50.

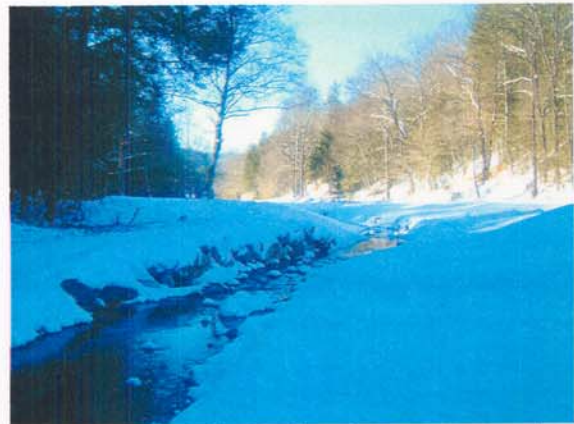
Photograph NM-24. Looking downstream at rock toe protection from as-built Station ~32+00.

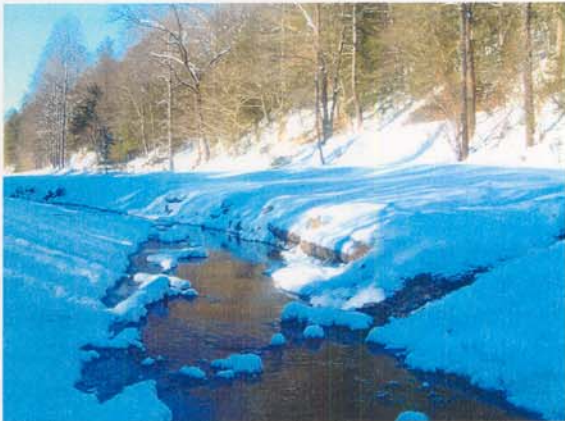
Photograph NM-25. Looking downstream at log toe protection from as-built Station ~31+00.

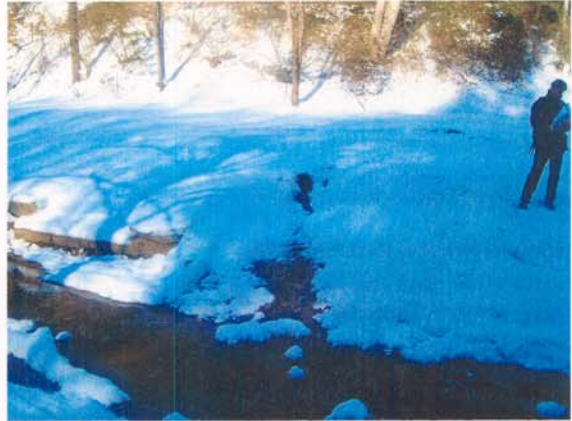
Photograph NM-26. Looking downstream at log toe protection from as-built Station ~30+85.

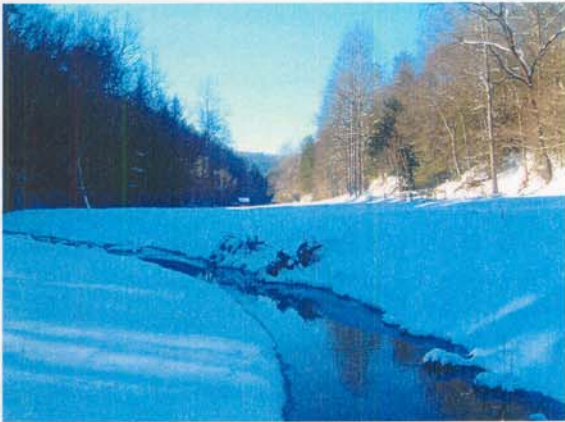
Photograph NM-27. Looking downstream at rootwad and log toe protection from as-built Station ~30+50.

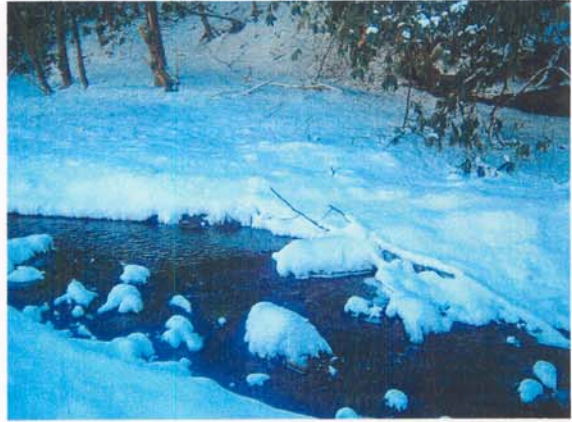
Photograph NM-28. Looking upstream at log vane from as-built Station ~28+10.

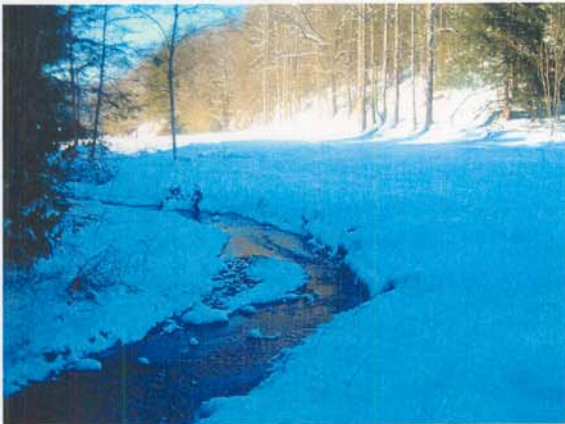
Photograph NM-29. Looking downstream at log toe protection and rootwad from as-built Station ~27+25.

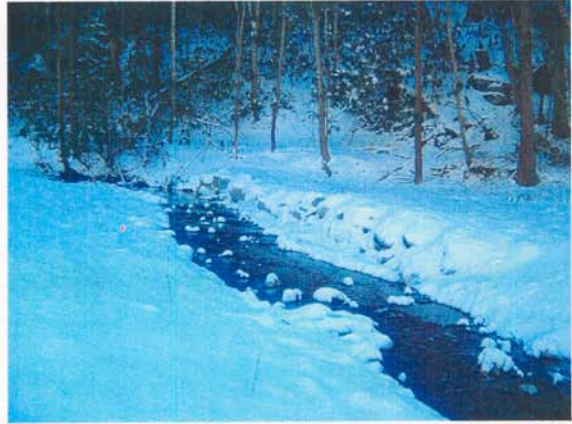
Photograph NM-30. Looking upstream at log vane and rock toe protection from as-built Station ~24+60.

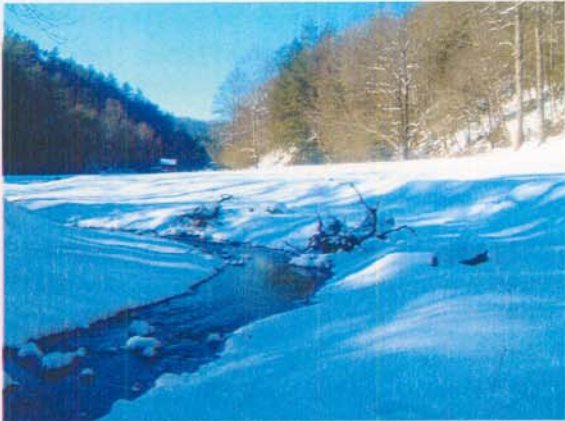
Photograph NM-31. Looking downstream at log vane and rootwads from as-built Station 24+60.

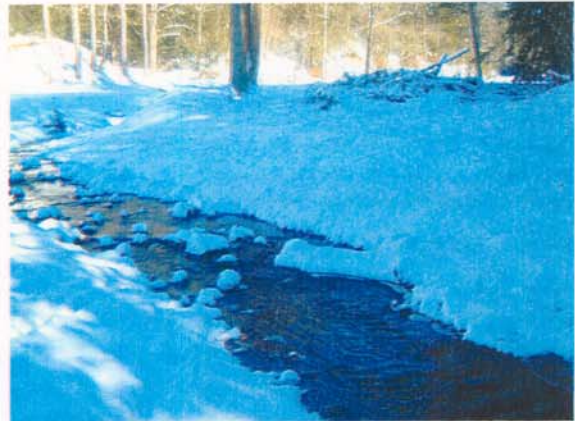
Photograph NM-32. Looking downstream at log vane from as-built Station ~23+30.

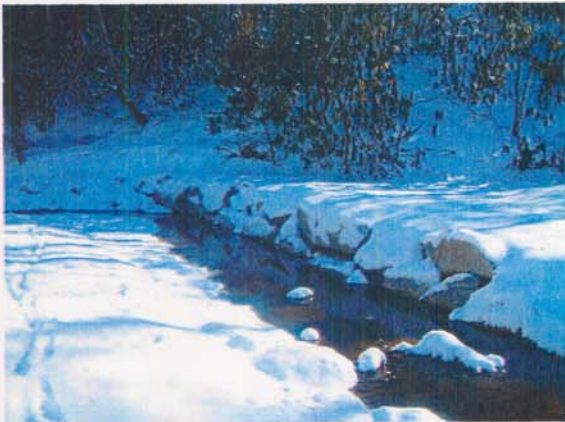
Photograph NM-33. Looking upstream at rock toe protection from as-built Station ~23+00.

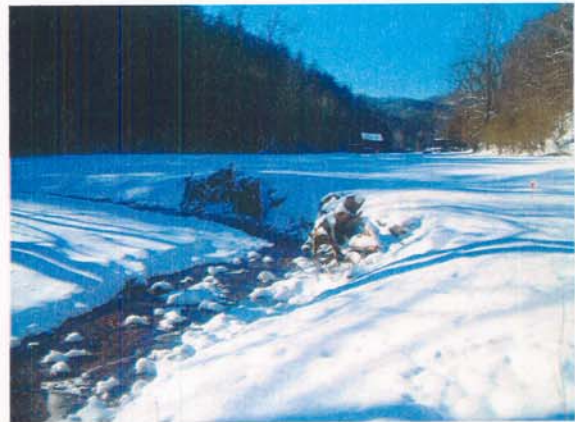
Photograph NM-34. Looking downstream at rootwad and rootwad/log "J" vane from as-built Station ~22+50.

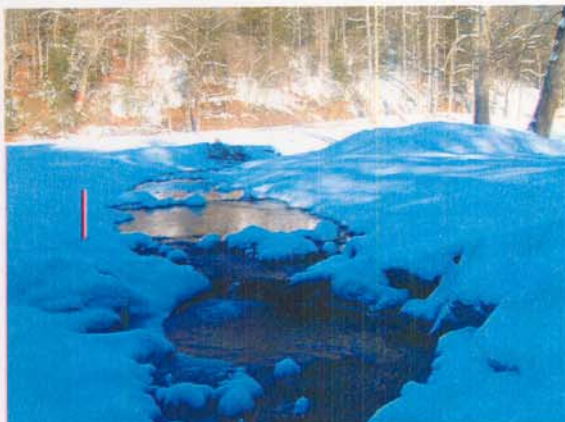
Photograph NM-35. Looking upstream at cross vane from as-built Station ~20+50.

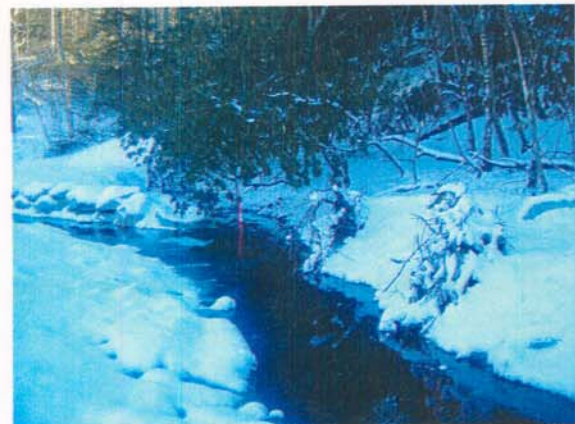
Photograph NM-36. Looking upstream at rootwads and rock toe protection from as-built Station ~20+00.

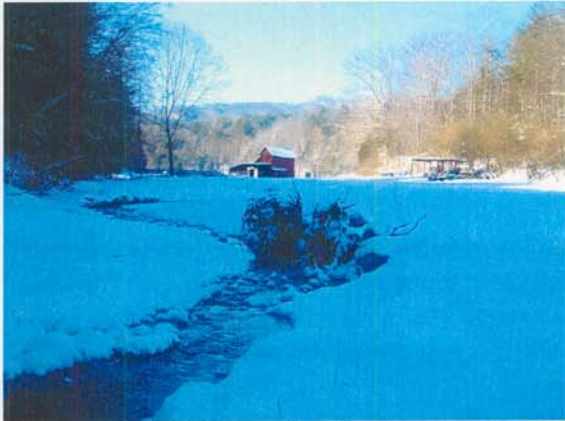
Photograph NM-37. Looking downstream at log toe protection and log vane from Station ~19+70.

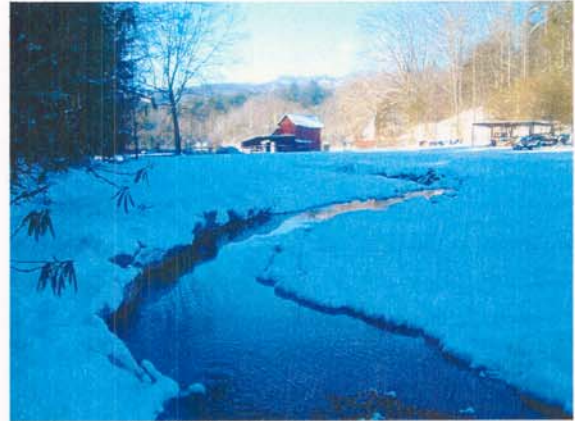
Photograph NM-38. Looking downstream at rock toe protection from as-built Station ~19+00.

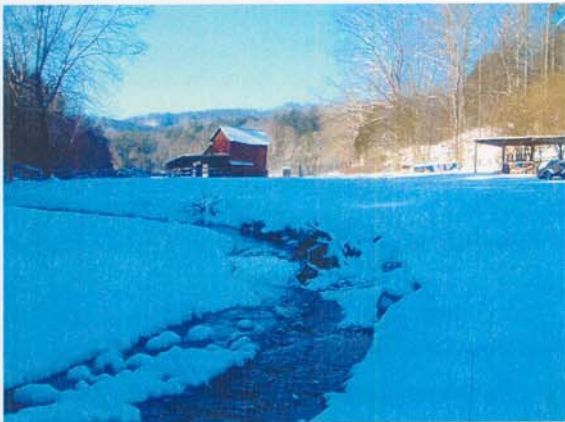
Photograph NM-39. Looking downstream at log vane and rootwad from as-built Station ~17+75.

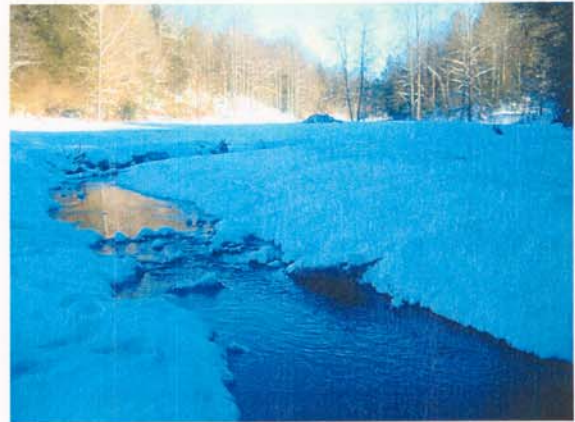
Photograph NM-40. Looking upstream at rock "J" vane from as-built Station ~16+00.

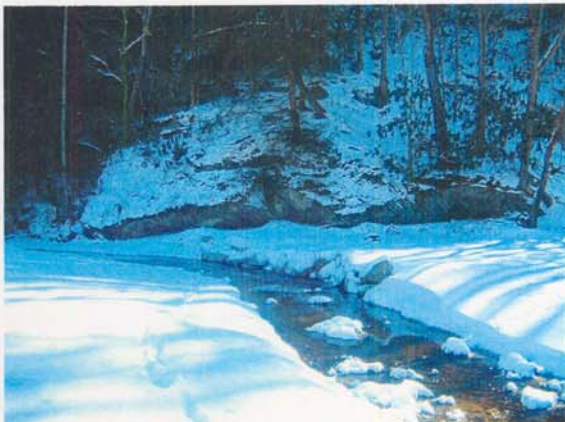
Photograph NM-41. Looking upstream at rock toe protection from as-built Station ~14+50.

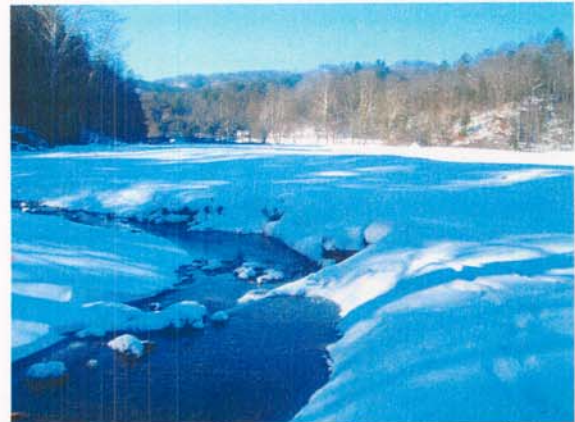
Photograph NM-42. Looking downstream at log vane from as-built Station ~14+25.

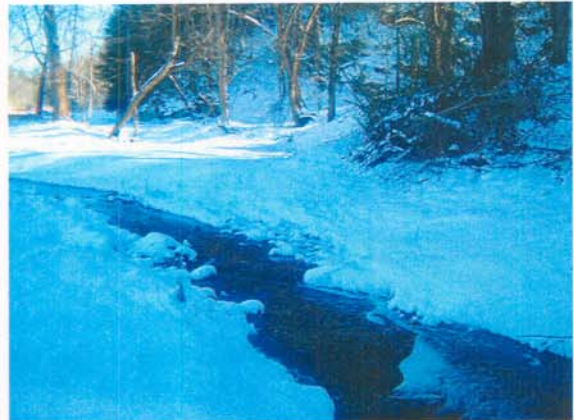
Photograph NM-44. Looking upstream at log vane from as-built Station ~12+75.

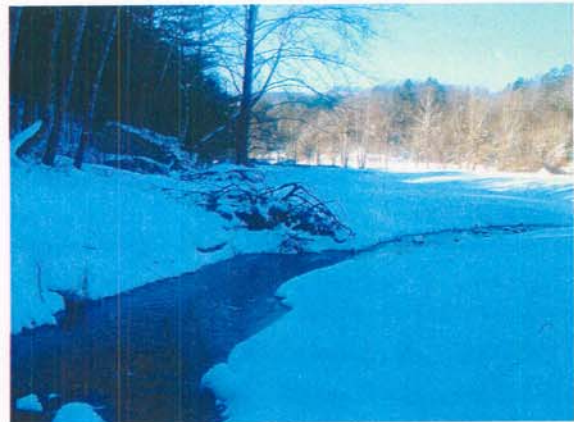
Photograph NM-46. Looking downstream at rootwads from as-built Station ~12+25.

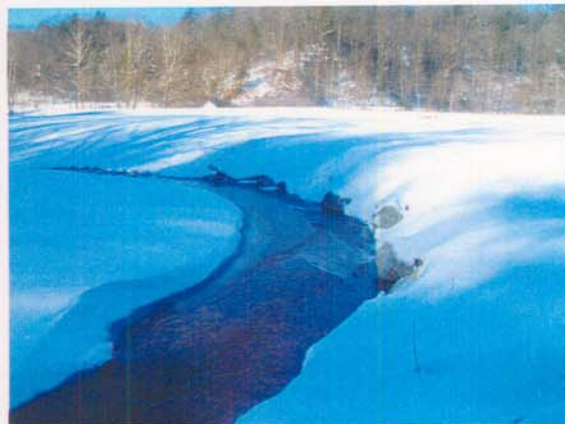
Photograph NM-47. Looking downstream at rock cross vane from as-built Station ~11+30.

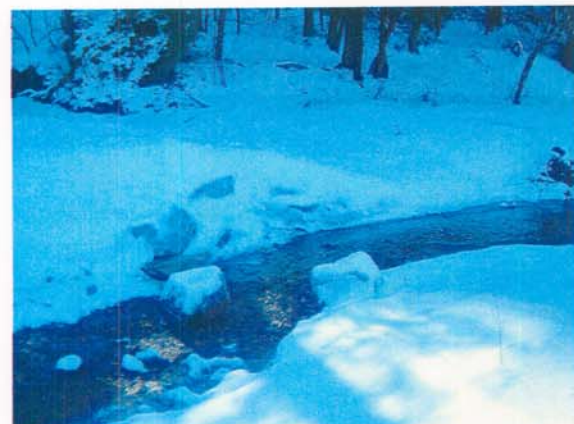
Photograph NM-48. Looking downstream at rock "J" vane from as-built Station ~10+25.

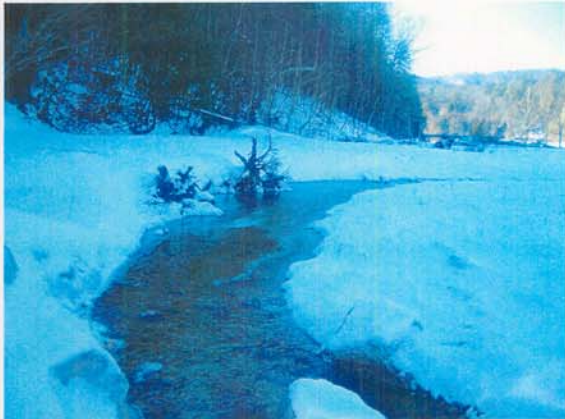
Photograph NM-49. Looking downstream at rootwads and rock vane from as-built Station ~10+00.

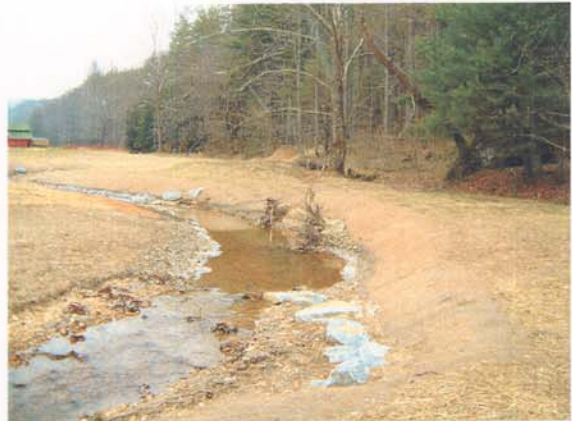
Photograph NM-50. Looking downstream at rock vane and rootwads from as-built Station ~9+50.

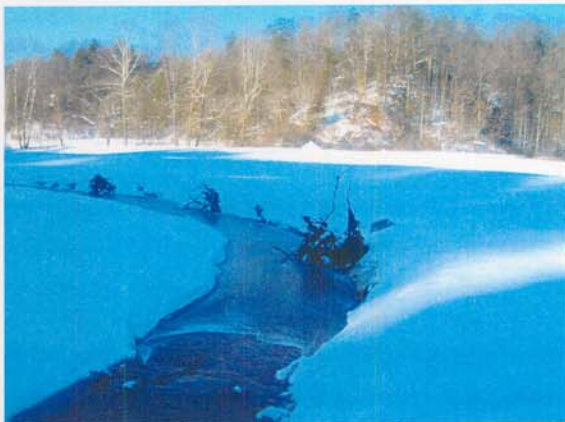
Photograph NM-51. Looking downstream at cross vane and rootwads from as-built Station ~9+00.

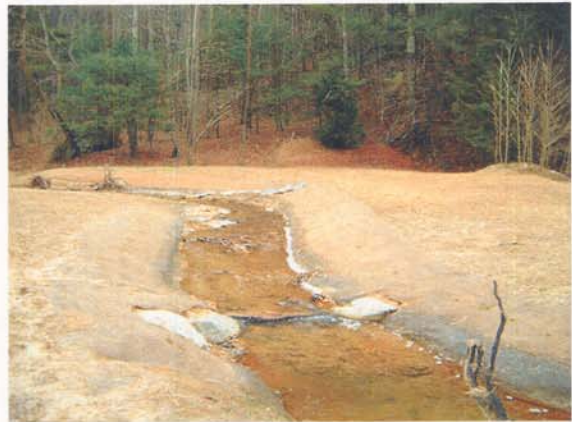
Photograph NM-52. Looking upstream at rock vane and rootwads from as-built Station ~8+75.

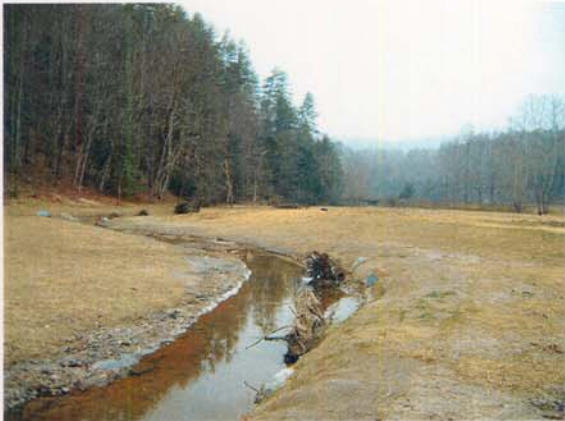
Photograph NM-55. Looking downstream at rootwads from as-built Station ~8+50.

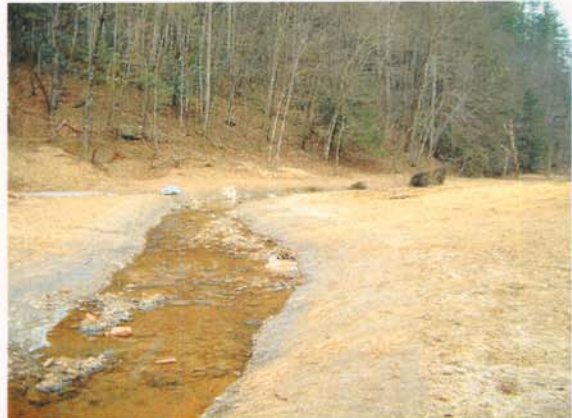
Photograph NM-56. Looking downstream along riffle from as-built Station ~8+00.

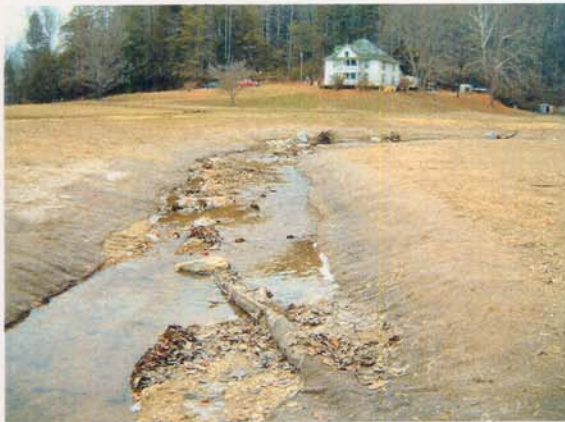
Photograph NM-57. Looking upstream at log vane from as-built Station ~7+00.

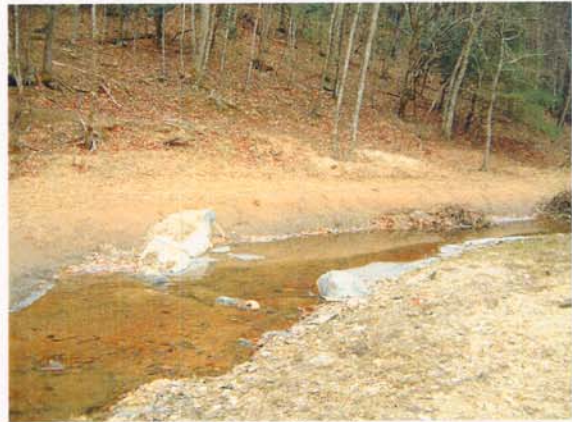
Photograph NM-58. Looking downstream at rock "J" vane from as-built Station ~6+80.

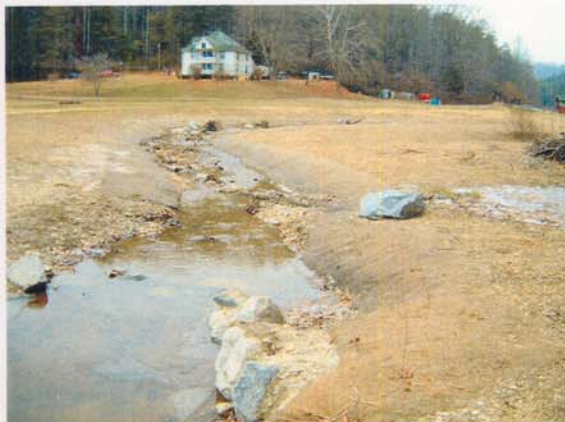
Photograph NM-59. Looking upstream at rock "J" vane from as-built Station ~6+80.

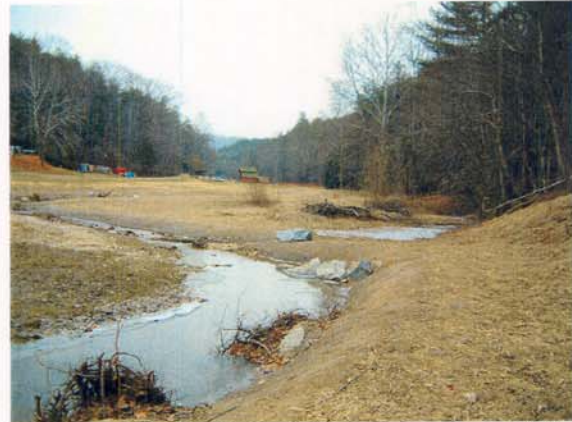
Photograph NM-60. Looking upstream at rock "J" vane and wetland from as-built Station ~ 6+50.

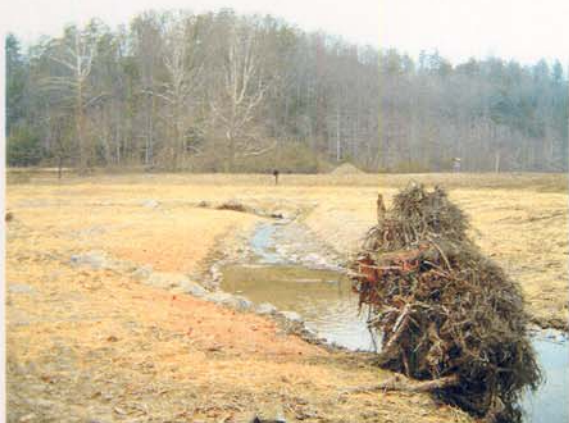
Photograph NM-61. Looking downstream at rootwads and rock toe protection from as-built Station ~6+50.

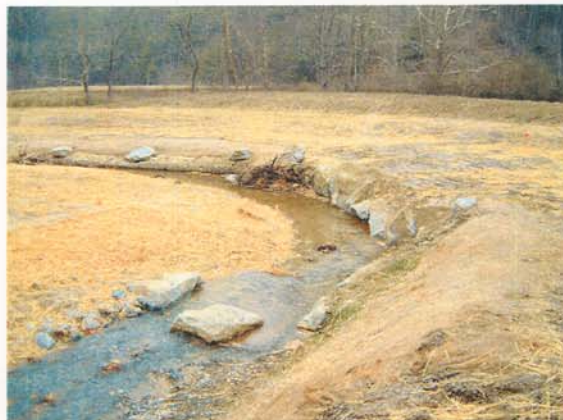
Photograph NM-62. Looking downstream at rock "J" vane, rock toe protection, and rootwad from as-built Station ~5+50.

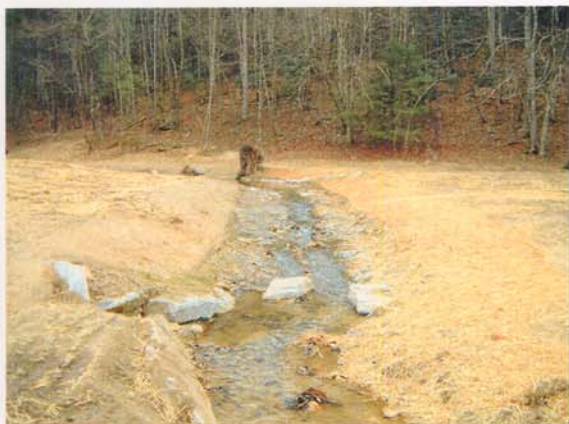
Photograph NM-63. Looking upstream at rock "J" vane from as-built Station ~5+25.

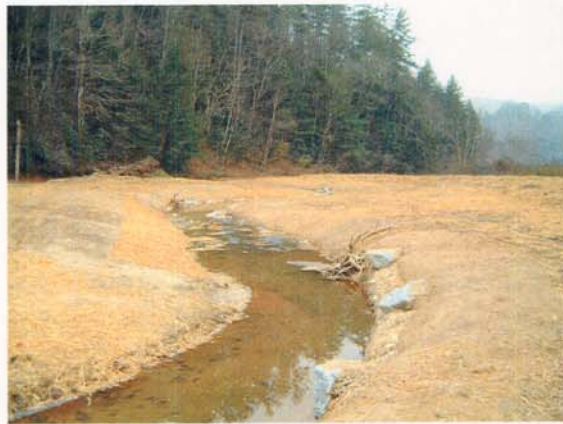
Photograph NM-64. Looking downstream at log toe protection and rootwad from as-built Station ~5+25.

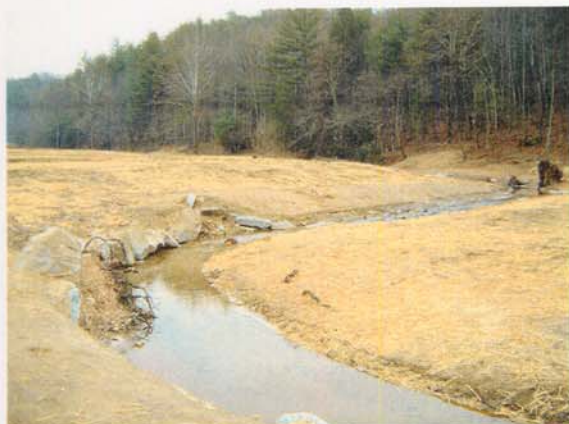
Photograph NM-65. Looking upstream at log toe protection, rootwad, and rock vane from as-built Station ~4+50.

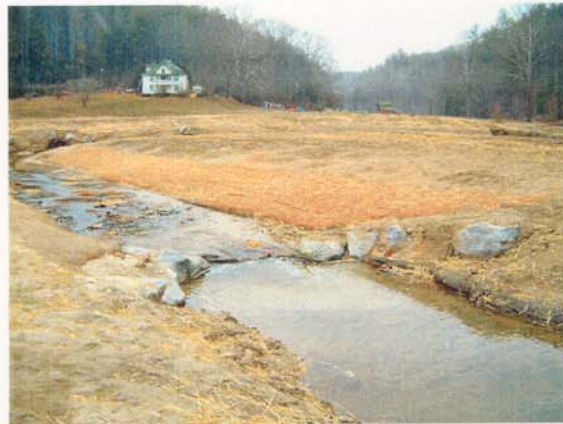
Photograph NM-66. Looking upstream at cross vane from as-built Station ~4+00.

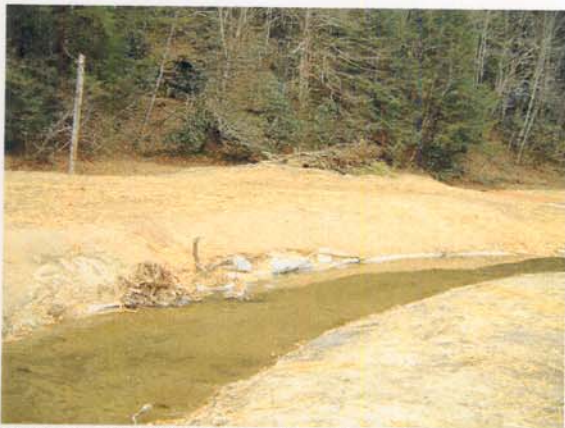
Photograph NM-67. Looking downstream at rootwad from as-built Station ~4+00.

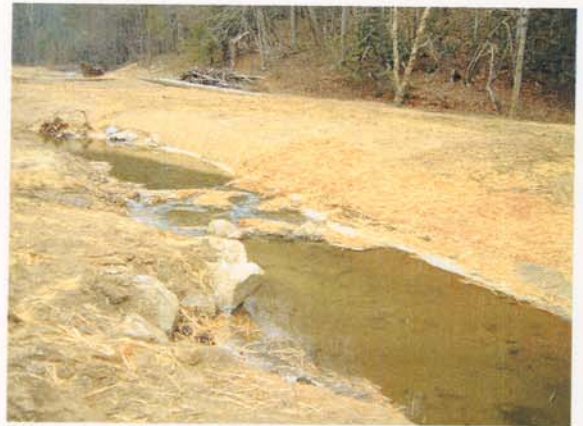
Photograph NM-68. Looking upstream at rock "J" vane from as-built Station ~3+25.

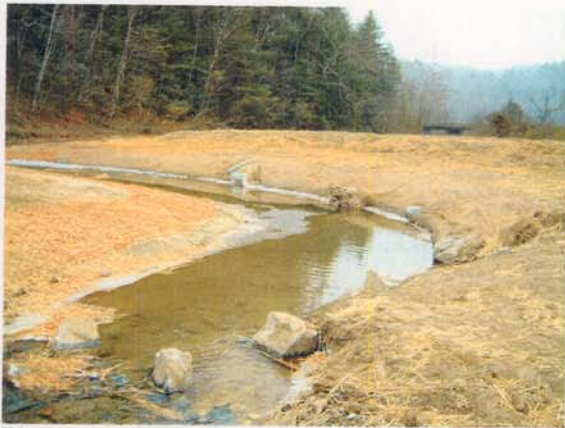
Photograph NM-69. Looking downstream at rock "J" vane from as-built Station ~3+25.

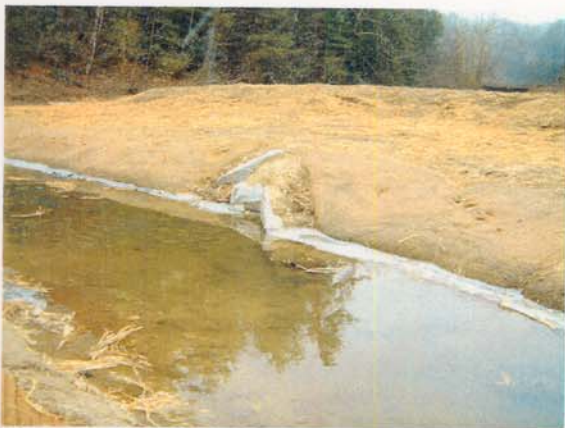
Photograph NM-71. Looking downstream at rock vane from as-built Station ~2+75.

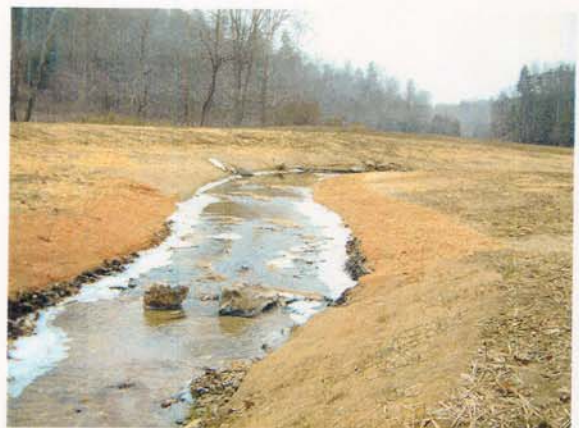
Photograph NM-72. Looking upstream at rock "J" vane from as-built Station ~2+00.

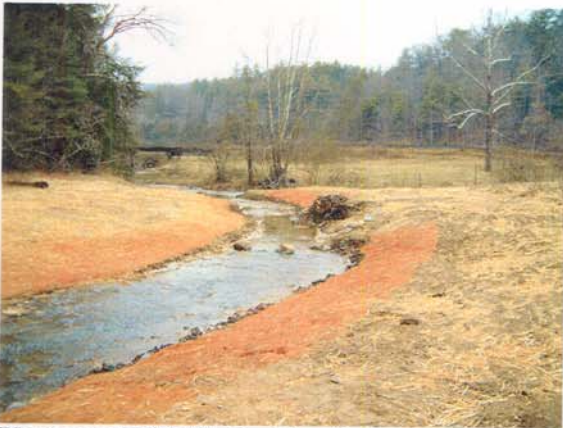
Photograph NM-73. Looking downstream at rock "J" vane and rootwad from as-built Station ~1+00.

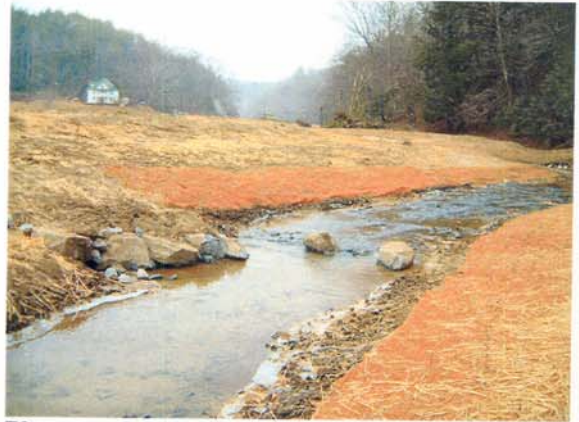
Photograph NM-74. Looking upstream at rock "J" vane from as-built Station ~0+85.

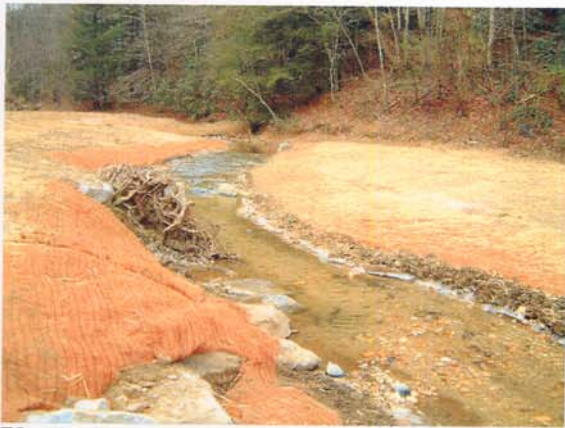
Photograph NM-75. Looking upstream at rock vane and rootwad from as-built Station ~0+65.
