FINAL
Baseline Monitoring Document and As-Built Baseline Report
Browns Summit Creek Restoration Project

Guilford County, North Carolina

DMS Project ID No. 96313, DEQ Contract No. 5792

Submission Date: November 2017

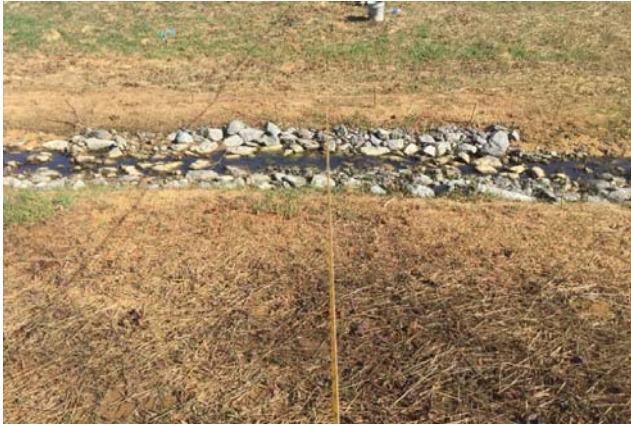
Looking at the Left Bank

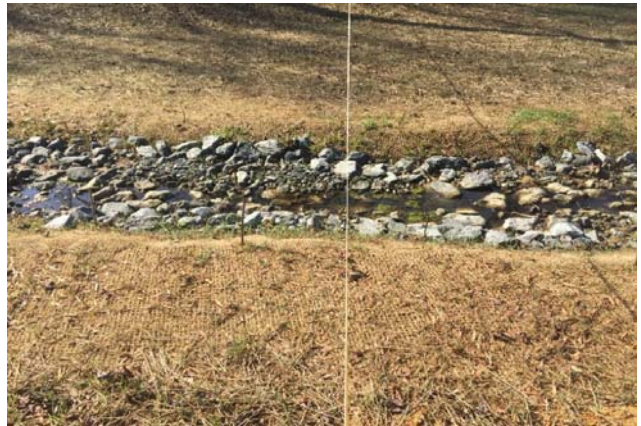
Looking at the Right Bank

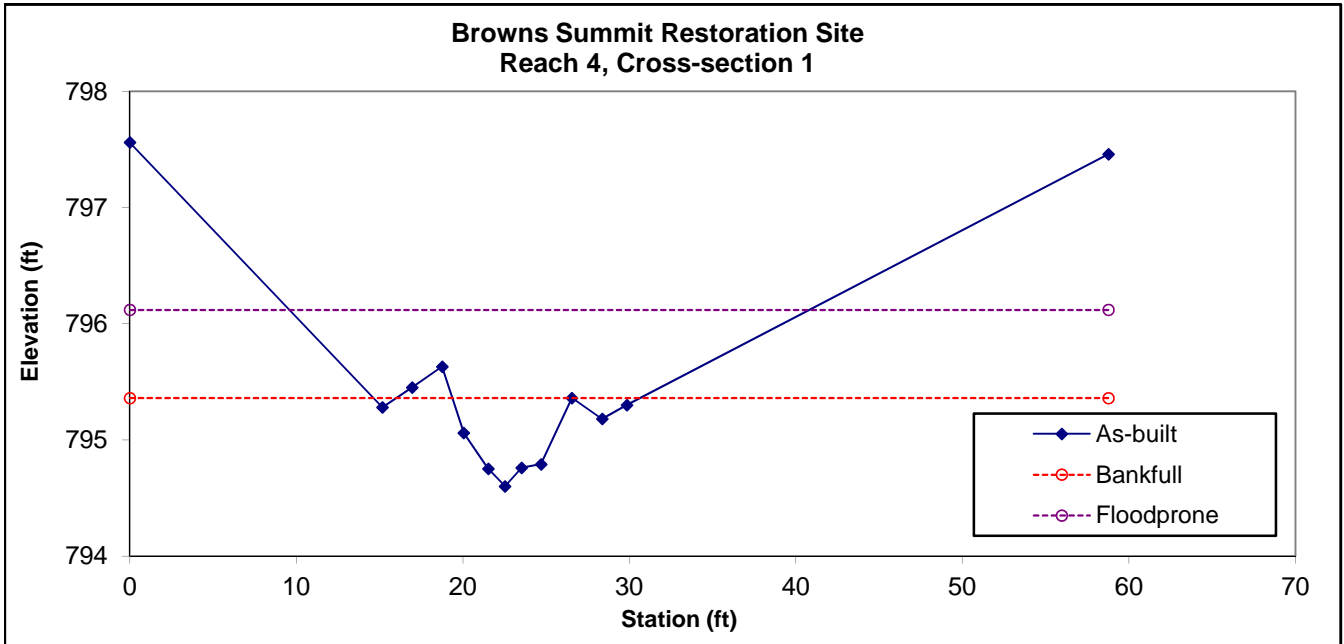
Permanent Cross-section 1
(As-built Data - Collected March 2017)

Feature	Stream Type	BKF Area	BKF Width	BKF Depth	Max BKF Depth	W/D	BH Ratio	ER	BKF Elev	TOB Elev
Riffle	C	3.3	7.2	0.5	0.8	15.4	1	4.4	795.36	795.36

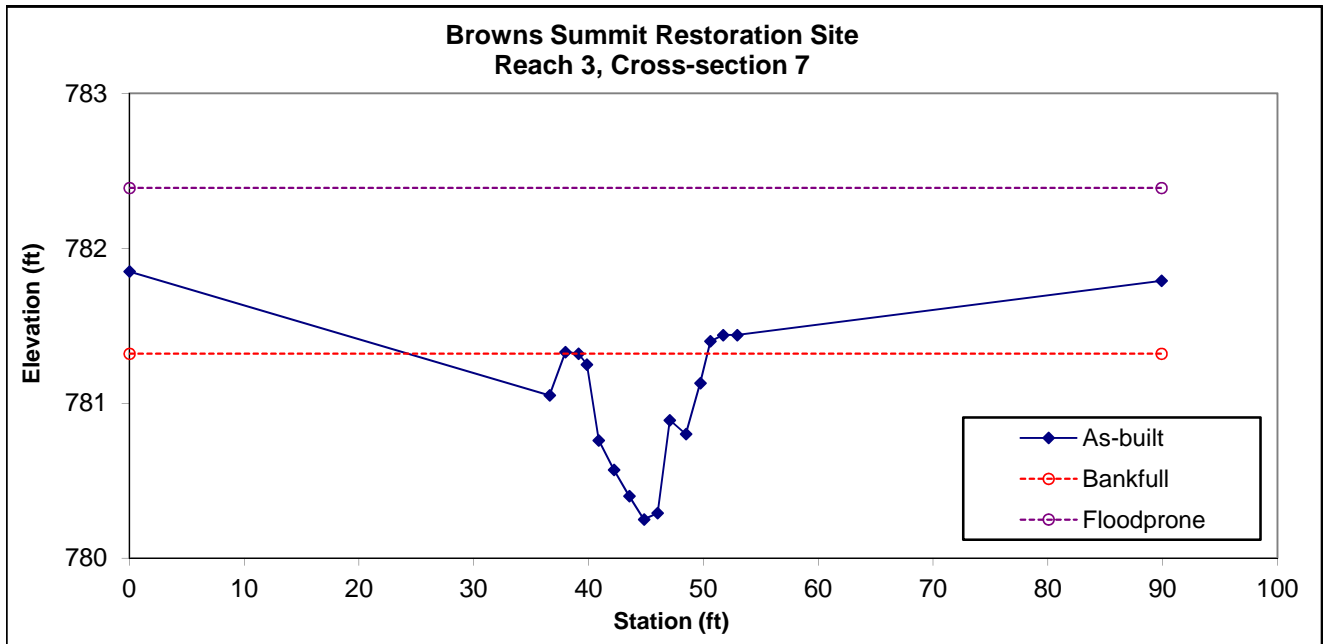
Permanent Cross-section 7
(As-built Data - Collected March 2017)

Feature	Stream Type	BKF Area	BKF Width	BKF Depth	Max BKF Depth	W/D	BH Ratio	ER	BKF Elev	TOB Elev
Riffle	C	6.8	11.2	0.6	1.1	18.6	1	8	781.32	781.32

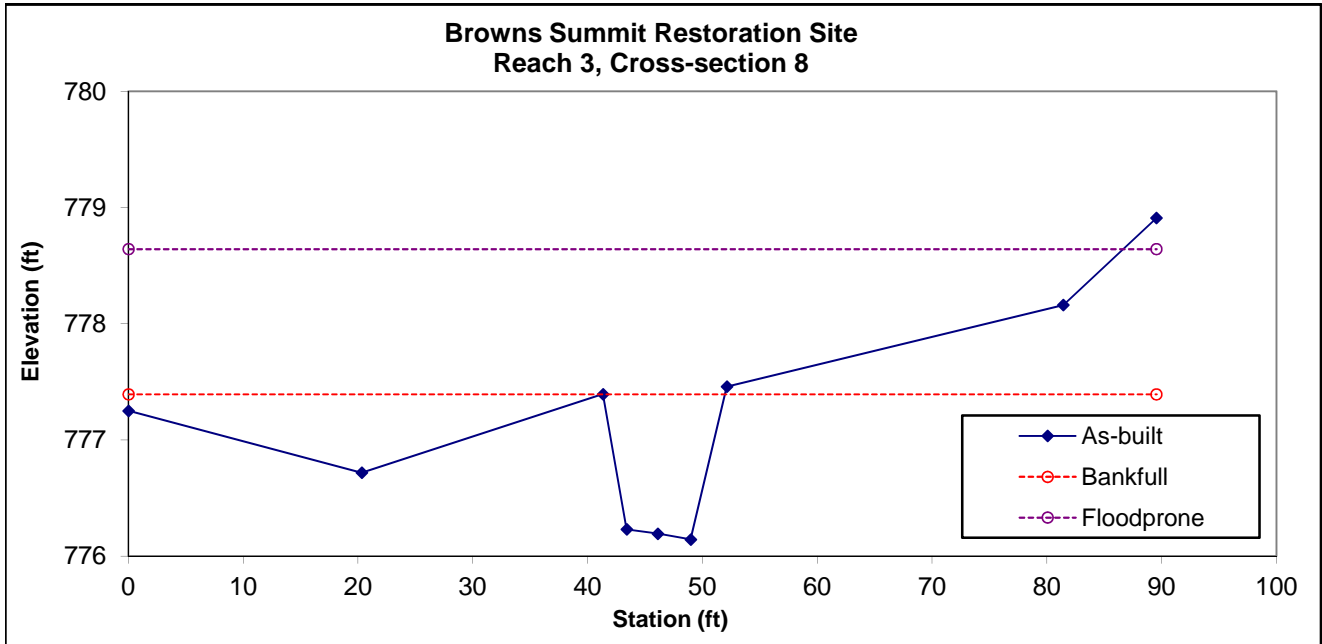
Permanent Cross-section 8
(As-built Data - Collected March 2017)

Feature	Stream Type	BKF Area	BKF Width	BKF Depth	Max BKF Depth	W/D	BH Ratio	ER	BKF Elev	TOB Elev
Riffle	E	9.8	10.6	0.9	1.3	11.5	1	8.2	777.39	777.39

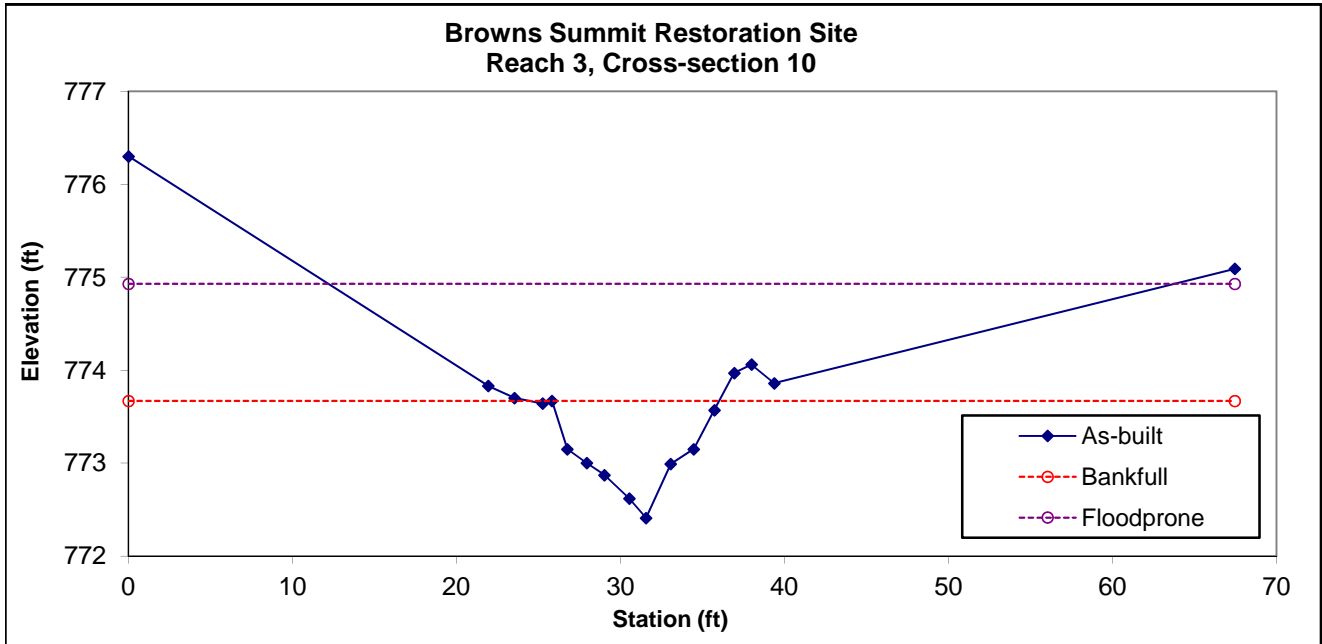
Permanent Cross-section 10
(As-built Data - Collected March 2017)

Feature	Stream Type	BKF Area	BKF Width	BKF Depth	Max BKF Depth	W/D	BH Ratio	ER	BKF Elev	TOB Elev
Riffle	C	7	11.6	0.6	1.3	19.2	1	4.4	773.67	773.67

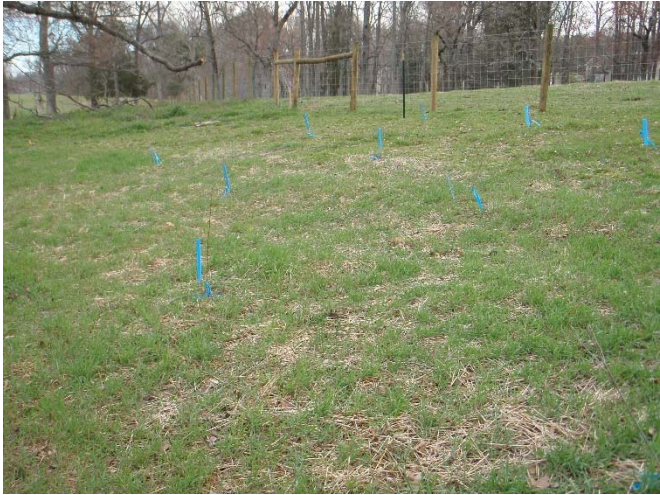
Vegetation Plot 1

Browns Summit Creek Restoration Project – Vegetation Plot Photo Stations

Photos take March 22, 2017

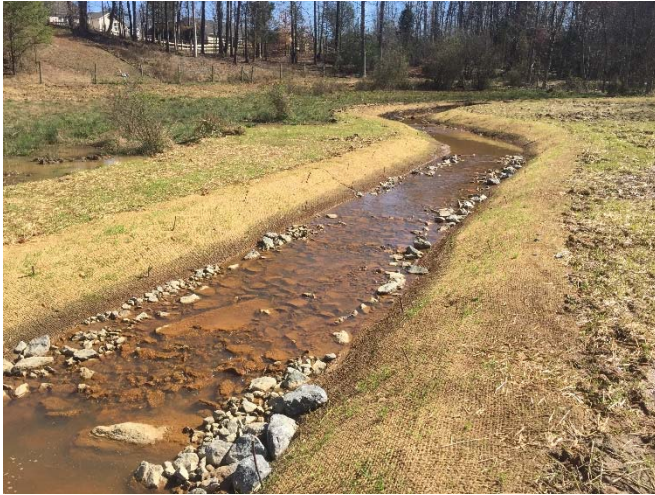
Photo Point 1 – Station 63+75, Reach 1

Browns Summit Creek Restoration Project – Longitudinal Stream Photo Stations
Photos take March 9, 2017 (All photos are viewing upstream)

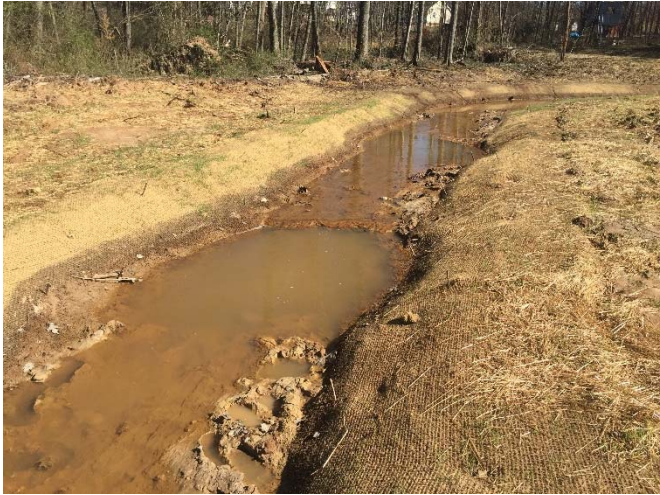
Photo Point 7 – Station 53+50, Reach 1

Browns Summit Creek Restoration Project – Longitudinal Stream Photo Stations
Photos take March 9, 2017 (All photos are viewing upstream)

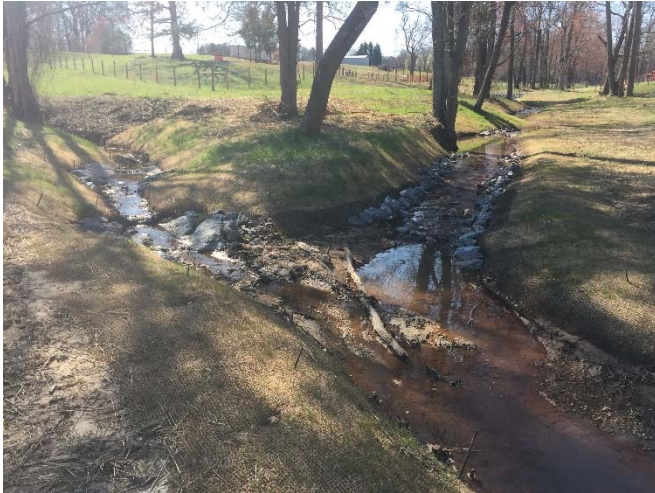
Photo Point 13 – Station 43+75, Reach 2/Reach T2

Browns Summit Creek Restoration Project – Longitudinal Stream Photo Stations
Photos take March 9, 2017 (All photos are viewing upstream)

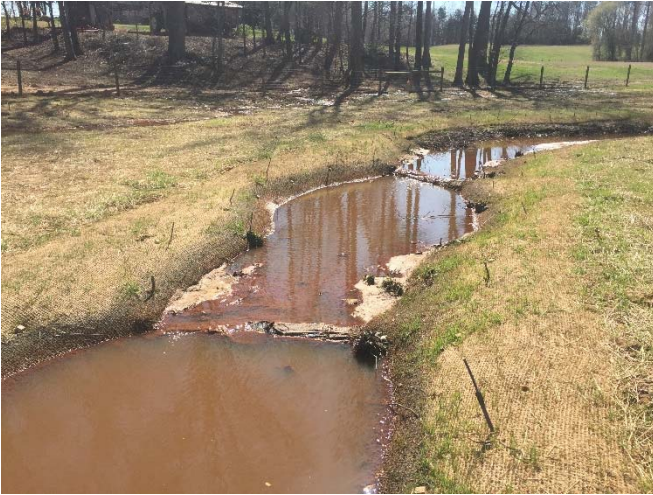
Photo Point 19 – Station 33+00, Reach 3

Browns Summit Creek Restoration Project – Longitudinal Stream Photo Stations
Photos take March 9, 2017 (All photos are viewing upstream)

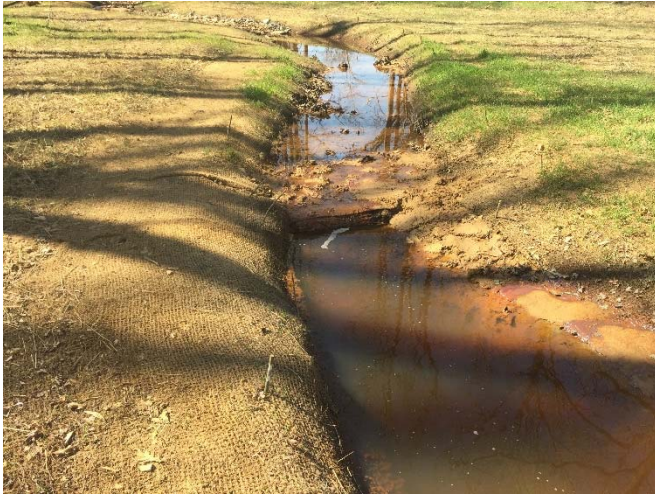
Photo Point 25 – Station 24+50, Reach 4

Browns Summit Creek Restoration Project – Longitudinal Stream Photo Stations
Photos take March 9, 2017 (All photos are viewing upstream)
