BYRDS CREEK MITIGATION SITE
Person County, NC
DENR Contract 003987
NCEEP Project Number 95020

Baseline Monitoring Document and As-Built Baseline Report
FINAL

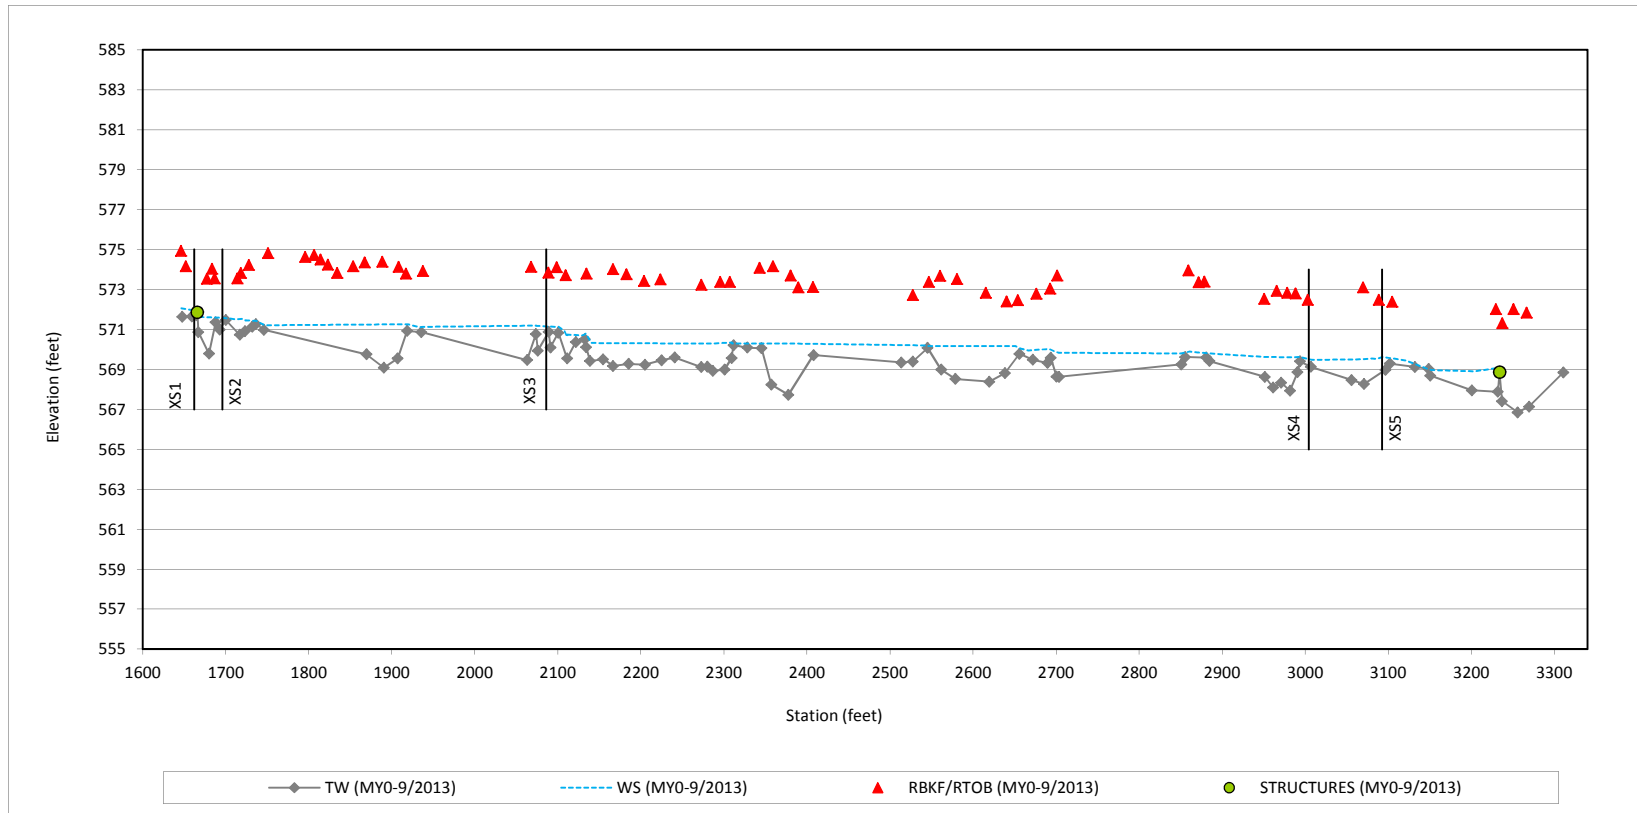
Longitudinal Profile Plots
Byrds Creek Mitigation Site (NCEP Project No. 95020)
BC2
Monitoring Year 0

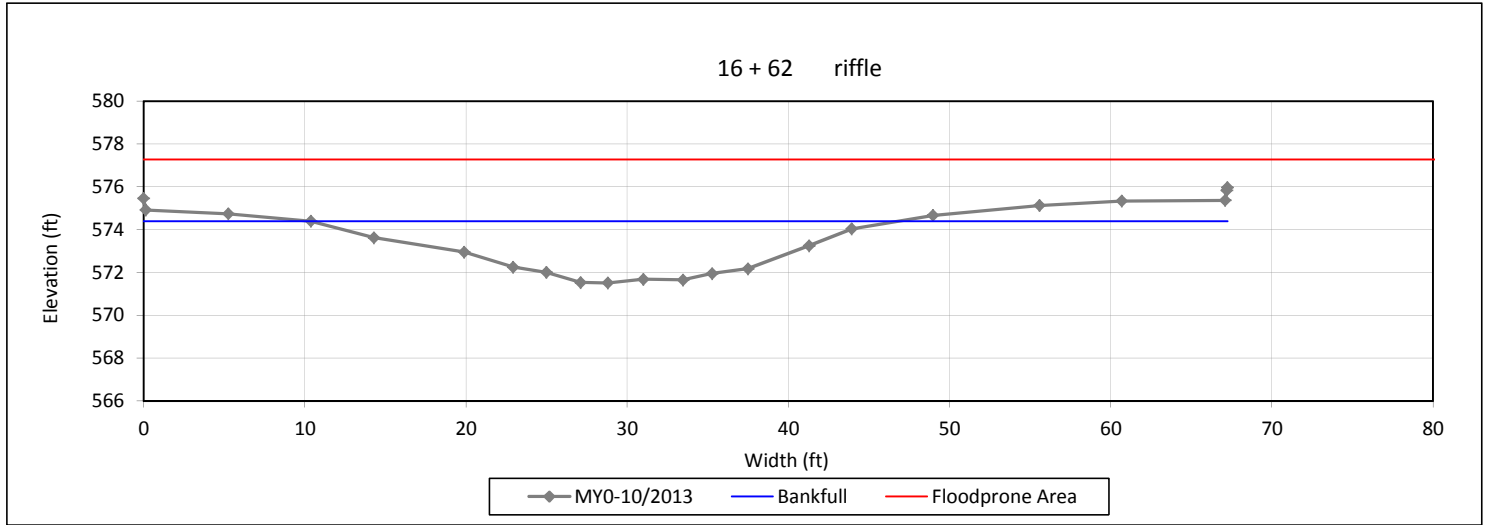
Cross Section 1-BC2

Cross-Section Plots
 Byrds Creek Mitigation Site
 EEP Project No. 95020
 Monitoring Year 0

The baseline (MY-0) dimension numbers closely match the design parameters with minor variations in all reaches. These variations are primarily due to constructed riffles in the riffle sections and brush toe in the pool sections. Installation of these structures results in irregularity of the surface which is reflected in the cross sections. Summary data and cross-section plots of each project reach can be found in Appendix 2.

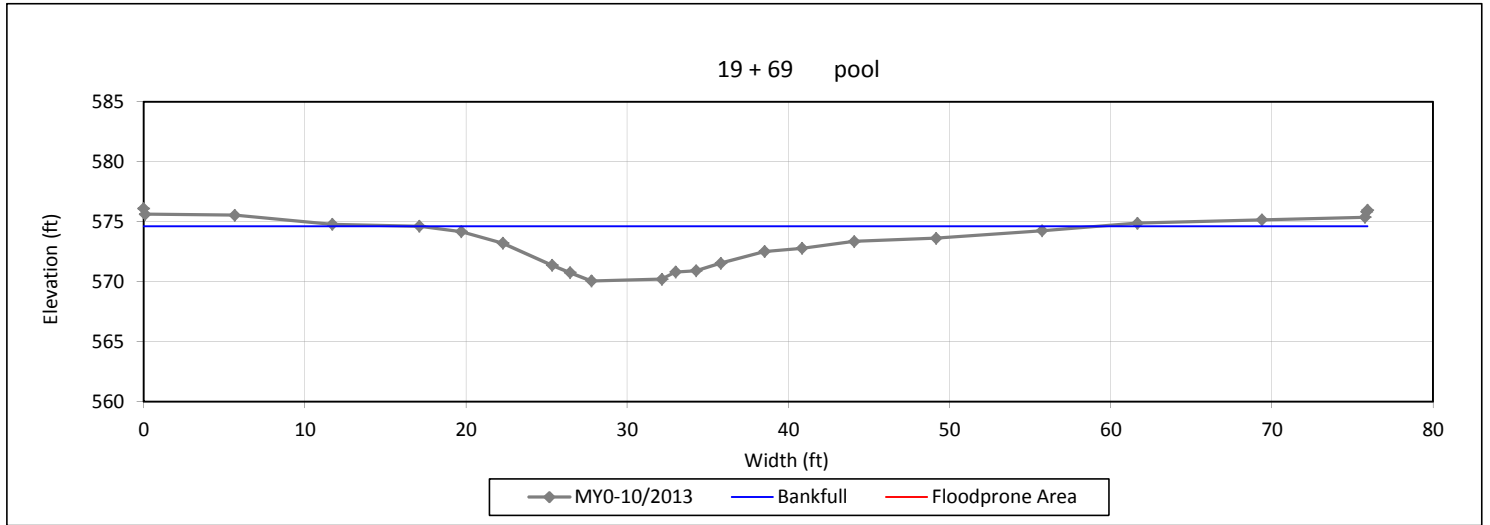
Cross Section 2-BC2

Cross-Section Plots
 Byrds Creek Mitigation Site
 EEP Project No. 95020
 Monitoring Year 0

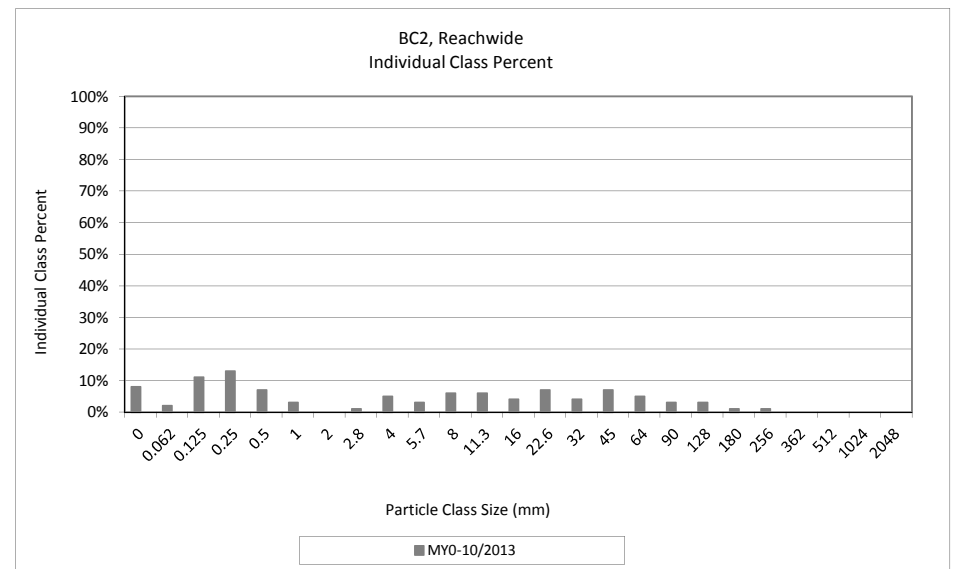
Particle Class		Diameter (mm)		Particle Count			BC2 Reach Summary	
		min	max	Riffle	Pool	Total	Class Percentage	Percent Cumulative
SILT/CLAY	Silt/Clay	0.000	0.062	5	3	8	8	8
SAND	Very fine	0.062	0.125		2	2	2	10
	Fine	0.125	0.250	5	6	11	11	21
	Medium	0.250	0.500		13	13	13	34
	Coarse	0.5	1.0	2	5	7	7	41
	Very Coarse	1.0	2.0	1	2	3	3	44
GRAVEL	Very Fine	2.0	2.8					44
	Very Fine	2.8	4.0		1	1	1	45
	Fine	4.0	5.7	4	1	5	5	50
	Fine	5.7	8.0	2	1	3	3	53
	Medium	8.0	11.3	4	2	6	6	59
	Medium	11.3	16.0	3	3	6	6	65
	Coarse	16.0	22.6	3	1	4	4	69
	Coarse	22.6	32	3	4	7	7	76
	Very Coarse	32	45	2	2	4	4	80
	Very Coarse	45	64	5	2	7	7	87
COBBLE	Small	64	90	4	1	5	5	92
	Small	90	128	3		3	3	95
	Large	128	180	3		3	3	98
	Large	180	256	1		1	1	99
BOULDER	Small	256	362		1	1	1	100
	Small	362	512					100
	Medium	512	1024					100
	Large/Very Large	1024	2048					100
BEDROCK	Bedrock	2048	>2048					100
Total				50	50	100	100	100

Reachwide Channel materials (mm)	
D ₁₆ =	0.2
D ₃₅ =	0.6
D ₅₀ =	5.6
D ₈₄ =	55.0
D ₉₅ =	128.0
D ₁₀₀ =	362.0

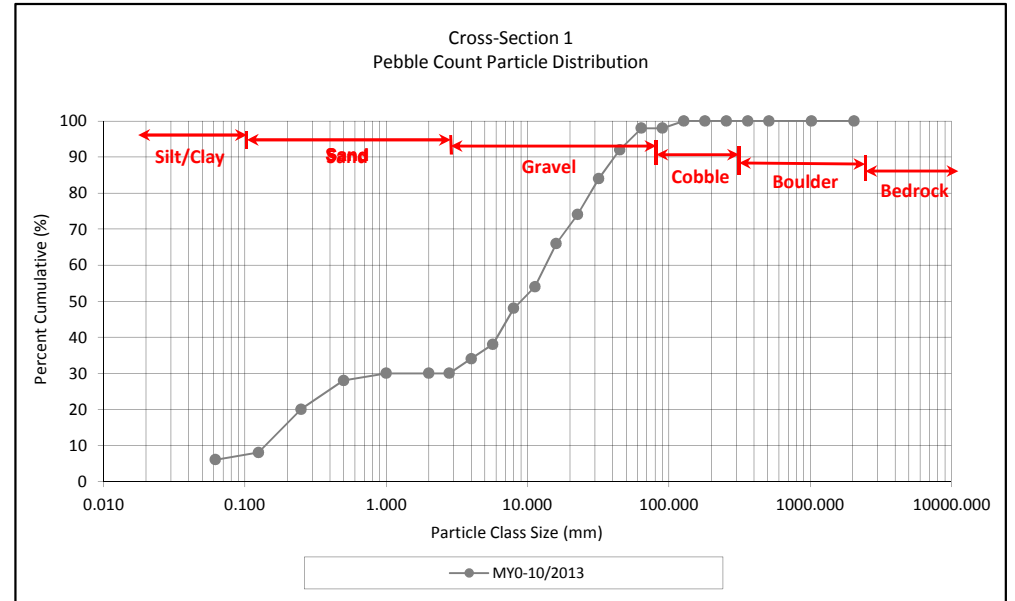
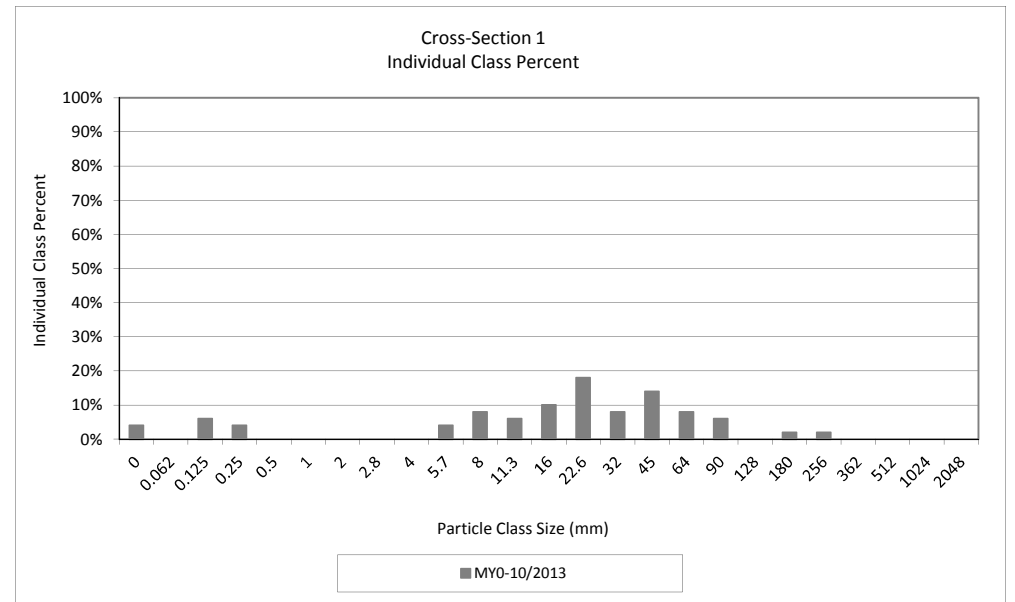
Reachwide and Cross-Section Substrate Plots
 Byrds Creek Mitigation Site (NCEEP Project No. 95020)
 BC2, Cross-Section 1
 Monitoring Year 0

Particle Class		Diameter (mm)		Particle Count	Cross-Section 1 Summary	
		min	max		Class Percentage	Percent Cumulative
SILT/CLAY	Silt/Clay	0.000	0.062	6	6	6
SAND	Very fine	0.062	0.125			6
	Fine	0.125	0.250	2	2	8
	Medium	0.250	0.500	12	12	20
	Coarse	0.5	1.0	8	8	28
	Very Coarse	1.0	2.0	2	2	30
GRAVEL	Very Fine	2.0	2.8			30
	Very Fine	2.8	4.0			30
	Fine	4.0	5.7	4	4	34
	Fine	5.7	8.0	4	4	38
	Medium	8.0	11.3	10	10	48
	Medium	11.3	16.0	6	6	54
	Coarse	16.0	22.6	12	12	66
	Coarse	22.6	32	8	8	74
	Very Coarse	32	45	10	10	84
	Very Coarse	45	64	8	8	92
COBBLE	Small	64	90	6	6	98
	Small	90	128			98
	Large	128	180	2	2	100
	Large	180	256			100
BOULDER	Small	256	362			100
	Small	362	512			100
	Medium	512	1024			100
	Large/Very Large	1024	2048			100
BEDROCK	Bedrock	2048	>2048			100
Total				100	100	100

Cross-Section 1 Channel materials (mm)	
D ₁₆ =	0.4
D ₃₅ =	6.1
D ₅₀ =	12.5
D ₈₄ =	45.0
D ₉₅ =	75.9
D ₁₀₀ =	180.0

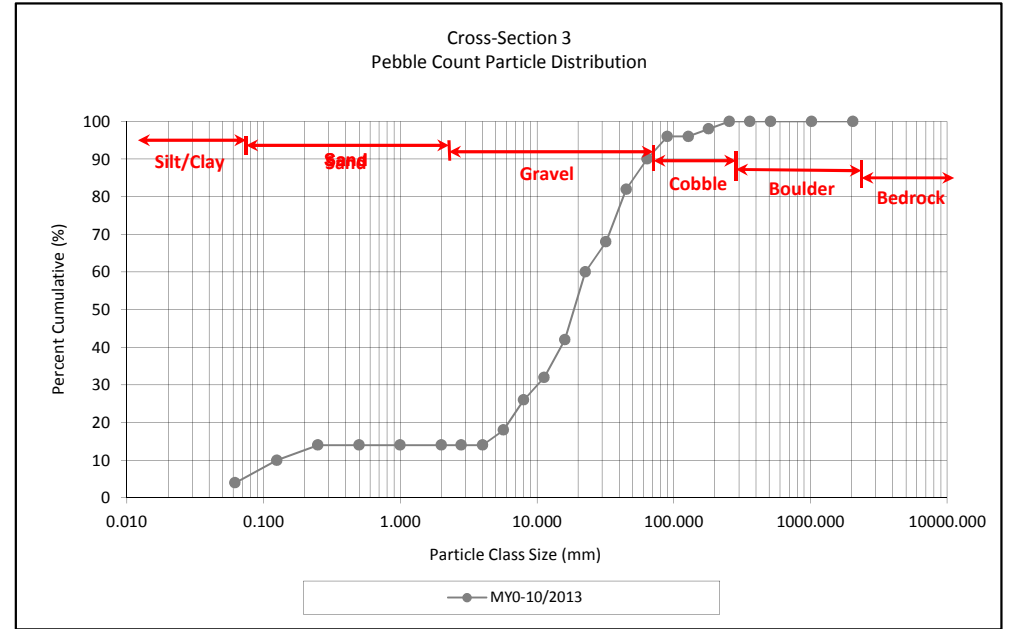
Reachwide and Cross-Section Substrate Plots
 Byrds Creek Mitigation Site (NCEEP Project No. 95020)
 BC2, Cross-Section 3
 Monitoring Year 0

Particle Class		Diameter (mm)		Particle Count	Cross-Section 3 Summary	
		min	max		Class Percentage	Percent Cumulative
SILT/CLAY	Silt/Clay	0.000	0.062	4	4	4
SAND	Very fine	0.062	0.125			4
	Fine	0.125	0.250	6	6	10
	Medium	0.250	0.500	4	4	14
	Coarse	0.5	1.0			14
	Very Coarse	1.0	2.0			14
GRAVEL	Very Fine	2.0	2.8			14
	Very Fine	2.8	4.0			14
	Fine	4.0	5.7			14
	Fine	5.7	8.0	4	4	18
	Medium	8.0	11.3	8	8	26
	Medium	11.3	16.0	6	6	32
	Coarse	16.0	22.6	10	10	42
	Coarse	22.6	32	18	18	60
	Very Coarse	32	45	8	8	68
	Very Coarse	45	64	14	14	82
COBBLE	Small	64	90	8	8	90
	Small	90	128	6	6	96
	Large	128	180			96
	Large	180	256	2	2	98
BOULDER	Small	256	362	2	2	100
	Small	362	512			100
	Medium	512	1024			100
	Large/Very Large	1024	2048			100
BEDROCK	Bedrock	2048	>2048			100
Total				100	100	100

Cross-Section 3 Channel materials (mm)	
D ₁₆ =	6.7
D ₃₅ =	17.7
D ₅₀ =	26.4
D ₈₄ =	69.7
D ₉₅ =	120.7
D ₁₀₀ =	362.0

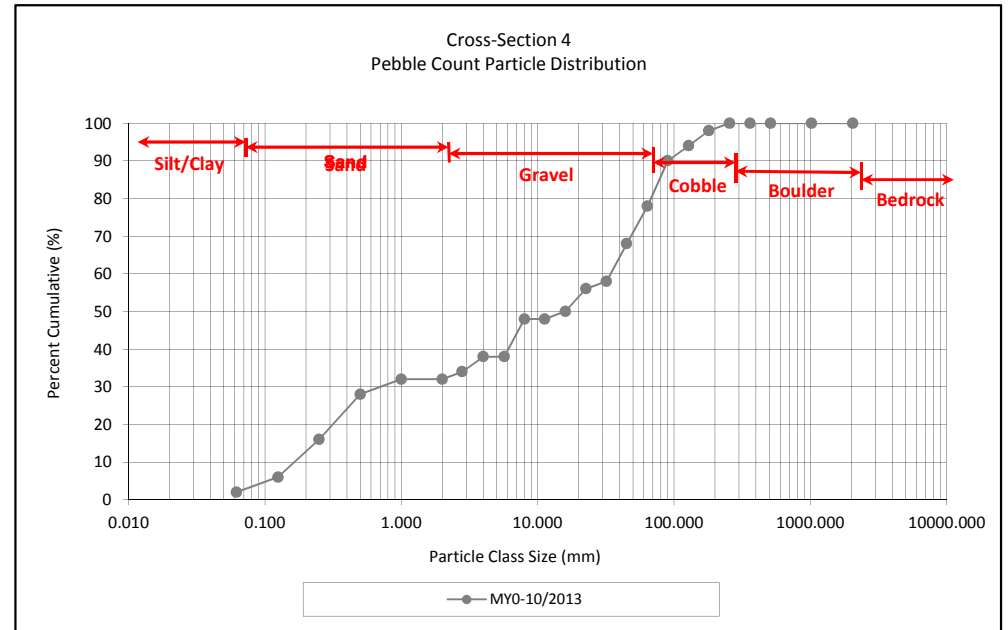
Reachwide and Cross-Section Substrate Plots
 Byrds Creek Mitigation Site (NCEP Project No. 95020)
 BC2, Cross-Section 4
 Monitoring Year 0

Particle Class		Diameter (mm)		Particle Count	Cross-Section 4 Summary	
		min	max		Class Percentage	Percent Cumulative
SILT/CLAY	Silt/Clay	0.000	0.062	2	2	2
SAND	Very fine	0.062	0.125			2
	Fine	0.125	0.250	4	4	6
	Medium	0.250	0.500	10	10	16
	Coarse	0.5	1.0	12	12	28
	Very Coarse	1.0	2.0	4	4	32
GRAVEL	Very Fine	2.0	2.8			32
	Very Fine	2.8	4.0	2	2	34
	Fine	4.0	5.7	4	4	38
	Fine	5.7	8.0			38
	Medium	8.0	11.3	10	10	48
	Medium	11.3	16.0			48
	Coarse	16.0	22.6	2	2	50
	Coarse	22.6	32	6	6	56
	Very Coarse	32	45	2	2	58
	Very Coarse	45	64	10	10	68
COBBLE	Small	64	90	10	10	78
	Small	90	128	12	12	90
	Large	128	180	4	4	94
	Large	180	256	4	4	98
BOULDER	Small	256	362	2	2	100
	Small	362	512			100
	Medium	512	1024			100
	Large/Very Large	1024	2048			100
BEDROCK	Bedrock	2048	>2048			100
Total				100	100	100

Cross-Section 4 Channel materials (mm)	
D ₁₆ =	0.5
D ₃₅ =	4.4
D ₅₀ =	22.6
D ₈₄ =	107.3
D ₉₅ =	196.6
D ₁₀₀ =	362.0

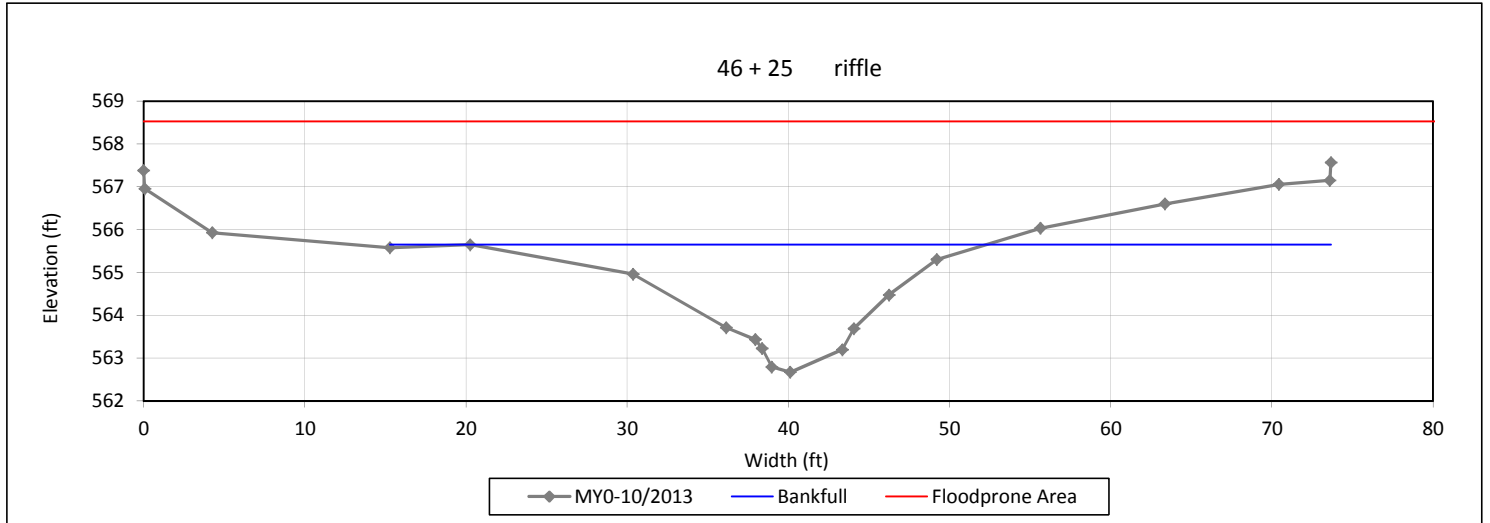
Cross Section 8-BC3

Cross-Section Plots
 Byrds Creek Mitigation Site
 EEP Project No. 95020
 Monitoring Year 0

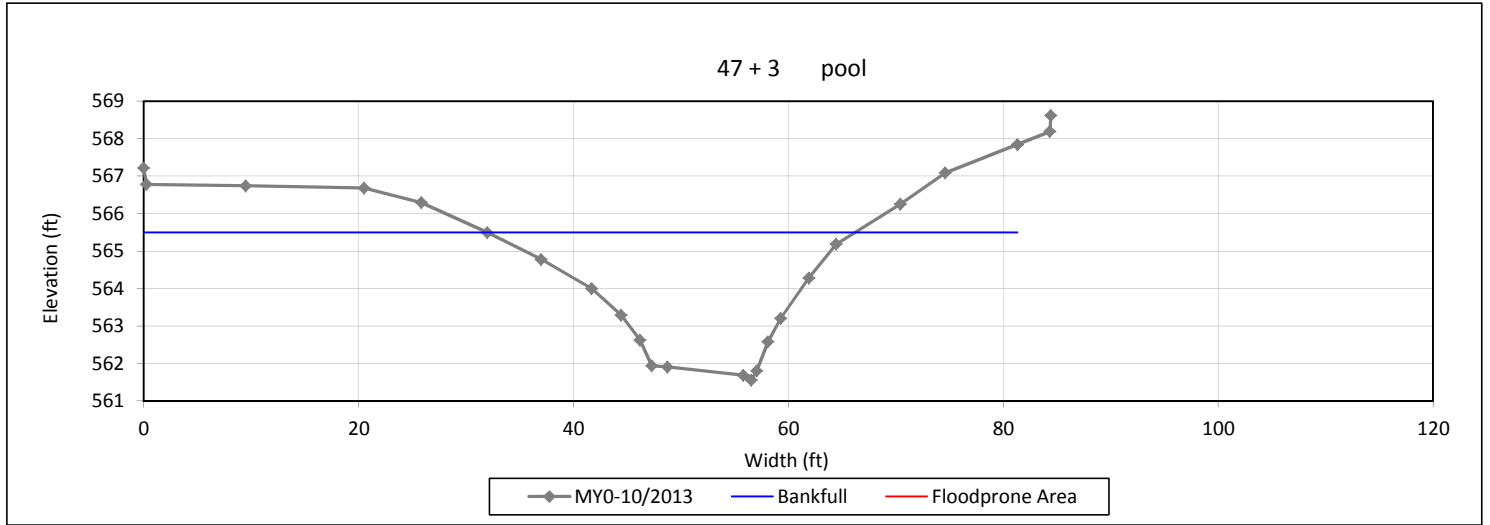
Cross Section 9-BC3

Bankfull Dimensions

69.6	x-section area (ft.sq.)
34.2	width (ft)
2.0	mean depth (ft)
3.9	max depth (ft)
35.6	wetted perimeter (ft)
2.0	hyd radi (ft)
16.8	width-depth ratio

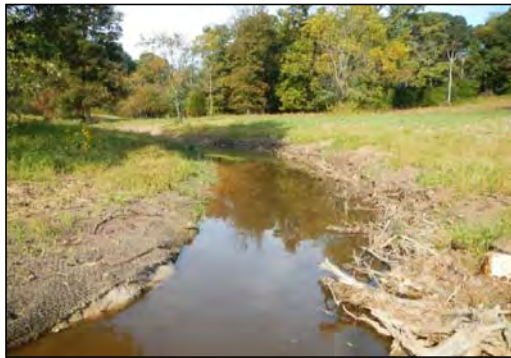
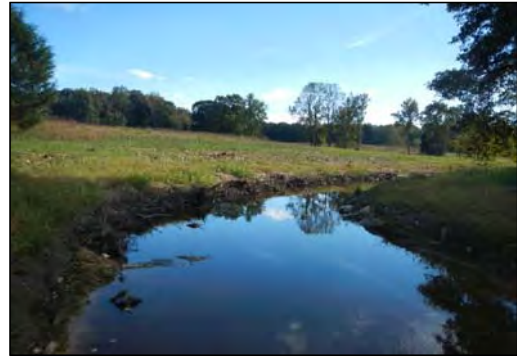
View Upstream (10/2013)

View Downstream (10/2013)

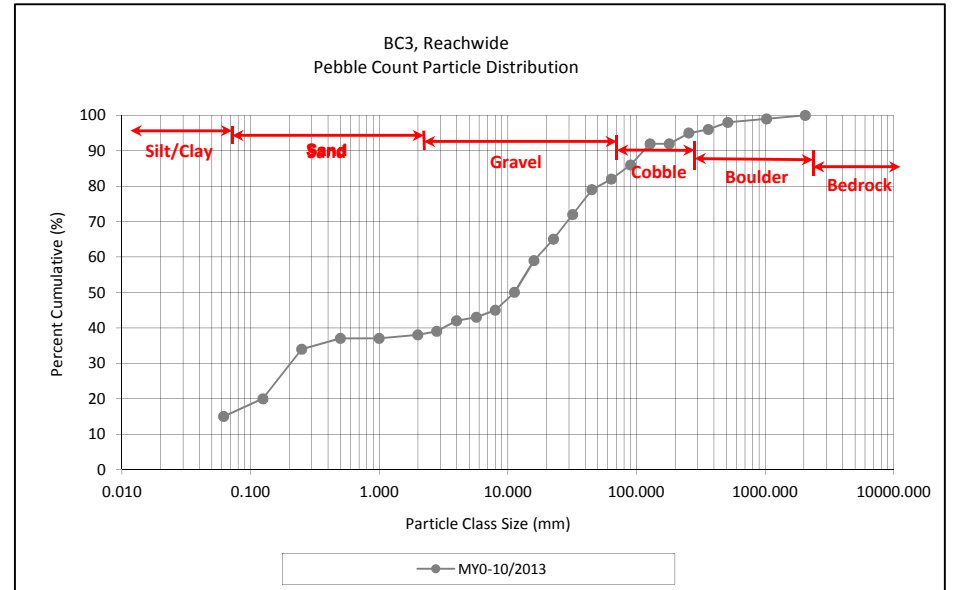
Particle Class		Diameter (mm)		Particle Count			BC3 Reach Summary	
		min	max	Riffle	Pool	Total	Class Percentage	Percent Cumulative
SILT/CLAY	Silt/Clay	0.000	0.062	2	13	15	15	15
SAND	Very fine	0.062	0.125					15
	Fine	0.125	0.250	1	4	5	5	20
	Medium	0.250	0.500	3	11	14	14	34
	Coarse	0.5	1.0		3	3	3	37
	Very Coarse	1.0	2.0					37
GRAVEL	Very Fine	2.0	2.8	1		1	1	38
	Very Fine	2.8	4.0	1		1	1	39
	Fine	4.0	5.7		3	3	3	42
	Fine	5.7	8.0		1	1	1	43
	Medium	8.0	11.3	1	1	2	2	45
	Medium	11.3	16.0	3	2	5	5	50
	Coarse	16.0	22.6	6	3	9	9	59
	Coarse	22.6	32	3	3	6	6	65
	Very Coarse	32	45	5	2	7	7	72
	Very Coarse	45	64	7		7	7	79
COBBLE	Small	64	90	3		3	3	82
	Small	90	128	3	1	4	4	86
	Large	128	180	6		6	6	92
	Large	180	256					92
BOULDER	Small	256	362	3		3	3	95
	Small	362	512		1	1	1	96
	Medium	512	1024	1	1	2	2	98
	Large/Very Large	1024	2048		1	1	1	99
BEDROCK	Bedrock	2048	>2048	1		1	1	100
Total				50	50	100	100	100

Reachwide	
Channel materials (mm)	
D ₁₆ =	0.1
D ₃₅ =	0.6
D ₅₀ =	16.0
D ₈₄ =	107.3
D ₉₅ =	362.0
D ₁₀₀ =	>2048

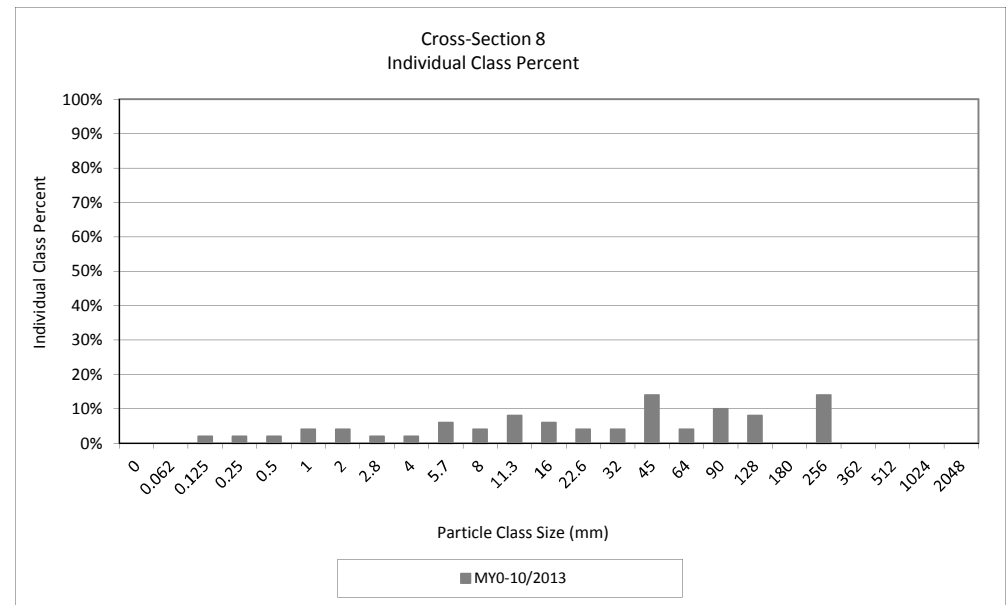
Reachwide and Cross-Section Substrate Plots
 Byrds Creek Mitigation Site (NCEEP Project No. 95020)
 BC3, Cross-Section 8
 Monitoring Year 0

Particle Class		Diameter (mm)		Particle Count	Cross-Section 8 Summary	
		min	max		Class Percentage	Percent Cumulative
SILT/CLAY	Silt/Clay	0.000	0.062			0
SAND	Very fine	0.062	0.125			0
	Fine	0.125	0.250	2	2	2
	Medium	0.250	0.500	2	2	4
	Coarse	0.5	1.0	2	2	6
	Very Coarse	1.0	2.0	4	4	10
GRAVEL	Very Fine	2.0	2.8	4	4	14
	Very Fine	2.8	4.0	2	2	16
	Fine	4.0	5.7	2	2	18
	Fine	5.7	8.0	6	6	24
	Medium	8.0	11.3	4	4	28
	Medium	11.3	16.0	8	8	36
	Coarse	16.0	22.6	6	6	42
	Coarse	22.6	32	4	4	46
	Very Coarse	32	45	4	4	50
	Very Coarse	45	64	14	14	64
COBBLE	Small	64	90	4	4	68
	Small	90	128	10	10	78
	Large	128	180	8	8	86
	Large	180	256			86
BOULDER	Small	256	362	14	14	100
	Small	362	512			100
	Medium	512	1024			100
	Large/Very Large	1024	2048			100
BEDROCK	Bedrock	2048	>2048			100
Total				100	100	100

Cross-Section 1	
Channel materials (mm)	
D ₁₆ =	4.0
D ₃₅ =	15.3
D ₅₀ =	45.0
D ₈₄ =	165.3
D ₉₅ =	319.9
D ₁₀₀ =	362.0

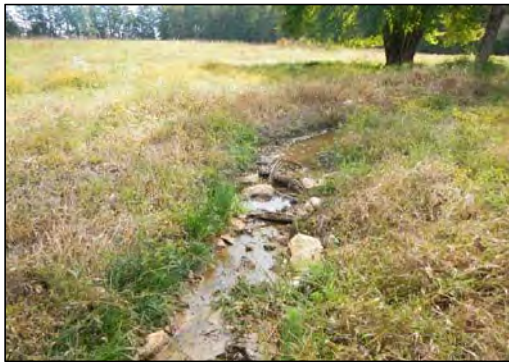
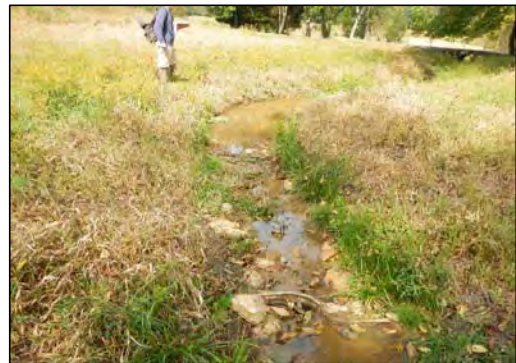
Cross Section 10- SB1

View Upstream (10/2013)

View Downstream (10/2013)

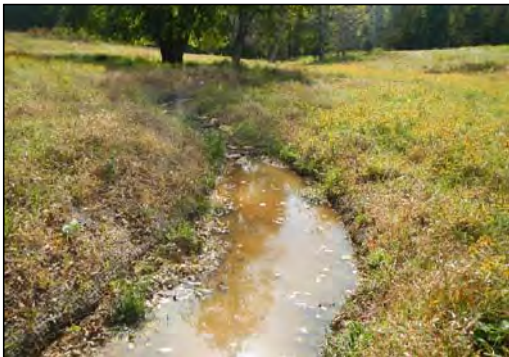
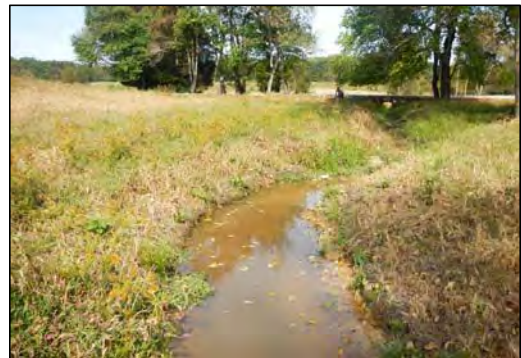
Cross Section 11- SB1

View Upstream (10/2013)

View Downstream (10/2013)

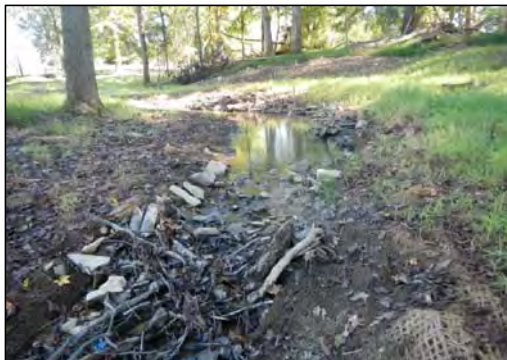
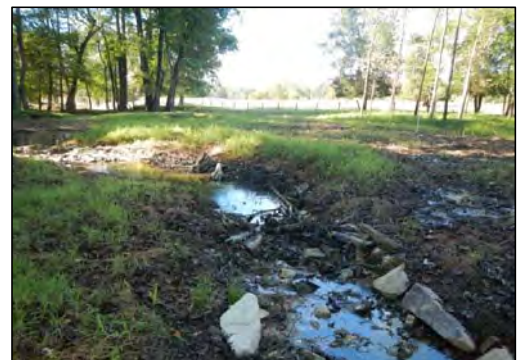
Cross Section 12 - SE1

View Upstream (10/2013)

View Downstream (10/2013)

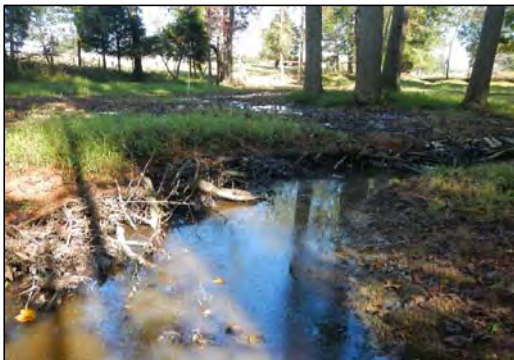
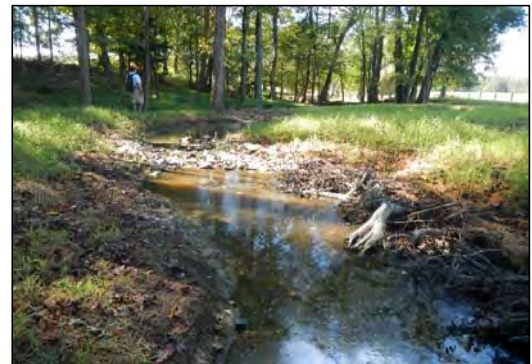
Cross Section 13 - SE1

View Upstream (10/2013)

View Downstream (10/2013)

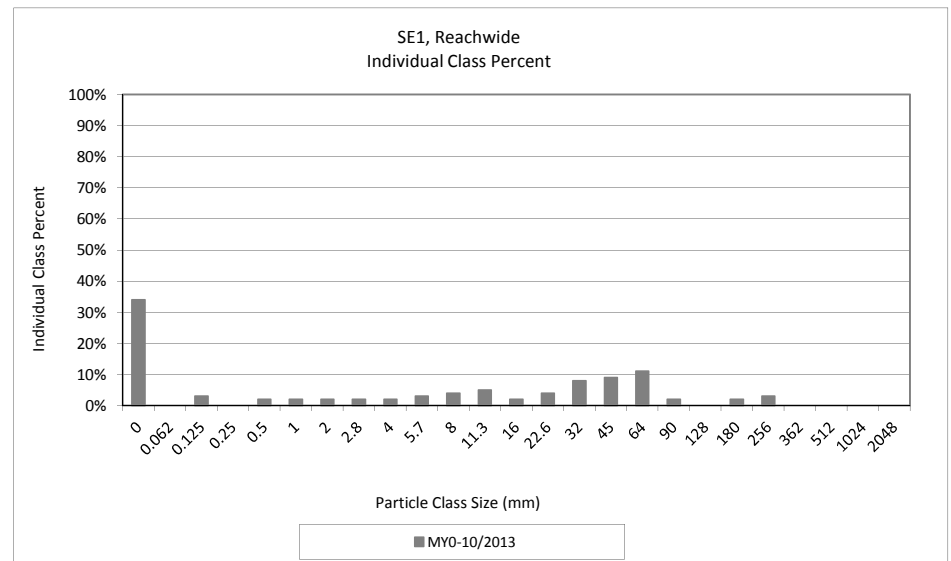
Particle Class		Diameter (mm)		Particle Count			SE1 Reach Summary	
		min	max	Riffle	Pool	Total	Class Percentage	Percent Cumulative
SILT/CLAY	Silt/Clay	0.000	0.062		34	34	34	34
SAND	Very fine	0.062	0.125					34
	Fine	0.125	0.250		3	3	3	37
	Medium	0.250	0.500					37
	Coarse	0.5	1.0		2	2	2	39
	Very Coarse	1.0	2.0		2	2	2	41
GRAVEL	Very Fine	2.0	2.8	1	1	2	2	43
	Very Fine	2.8	4.0	1	1	2	2	45
	Fine	4.0	5.7	1	1	2	2	47
	Fine	5.7	8.0		3	3	3	50
	Medium	8.0	11.3	4		4	4	54
	Medium	11.3	16.0	4	1	5	5	59
	Coarse	16.0	22.6	1	1	2	2	61
	Coarse	22.6	32	4		4	4	65
	Very Coarse	32	45	8		8	8	73
	Very Coarse	45	64	9		9	9	82
COBBLE	Small	64	90	10	1	11	11	93
	Small	90	128	2		2	2	95
	Large	128	180					95
	Large	180	256	2		2	2	97
BOULDER	Small	256	362	3		3	3	100
	Small	362	512					100
	Medium	512	1024					100
	Large/Very Large	1024	2048					100
BEDROCK	Bedrock	2048	>2048					100
Total				50	50	100	100	100

Reachwide Channel materials (mm)	
D ₁₆ =	silt/clay
D ₃₅ =	0.2
D ₅₀ =	8.0
D ₈₄ =	68.1
D ₉₅ =	180.0
D ₁₀₀ =	362.0

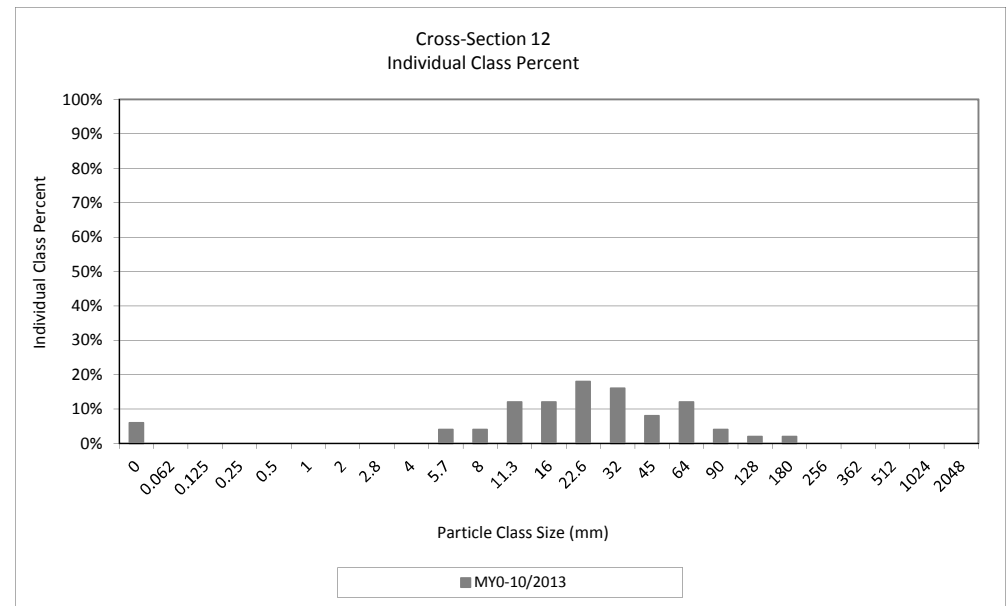
Reachwide and Cross-Section Substrate Plots
 Byrds Creek Mitigation Site (NCEEP Project No. 95020)
 SE1, Cross-Section 12
 Monitoring Year 0

Particle Class		Diameter (mm)		Particle Count	Cross-Section 12 Summary	
		min	max		Class Percentage	Percent Cumulative
SILT/CLAY	Silt/Clay	0.000	0.062	6	6	6
SAND	Very fine	0.062	0.125			6
	Fine	0.125	0.250			6
	Medium	0.250	0.500			6
	Coarse	0.5	1.0			6
	Very Coarse	1.0	2.0			6
GRAVEL	Very Fine	2.0	2.8			6
	Very Fine	2.8	4.0			6
	Fine	4.0	5.7			6
	Fine	5.7	8.0	4	4	10
	Medium	8.0	11.3	4	4	14
	Medium	11.3	16.0	12	12	26
	Coarse	16.0	22.6	12	12	38
	Coarse	22.6	32	18	18	56
	Very Coarse	32	45	16	16	72
Very Coarse	45	64	8	8	80	
COBBLE	Small	64	90	12	12	92
	Small	90	128	4	4	96
	Large	128	180	2	2	98
	Large	180	256	2	2	100
BOULDER	Small	256	362			100
	Small	362	512			100
BOULDER	Medium	512	1024			100
	Large/Very Large	1024	2048			100
BEDROCK	Bedrock	2048	>2048			100
Total				100	100	100

Cross-Section 12 Channel materials (mm)	
D ₁₆ =	11.7
D ₃₅ =	20.7
D ₅₀ =	28.5
D ₈₄ =	71.7
D ₉₅ =	117.2
D ₁₀₀ =	256.0

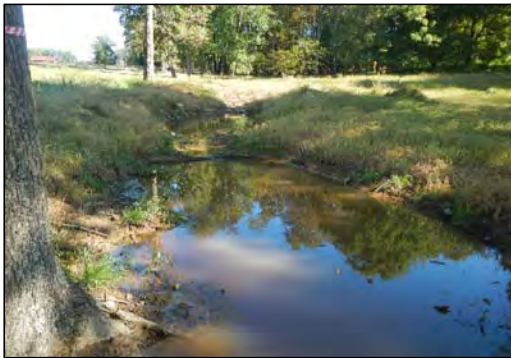
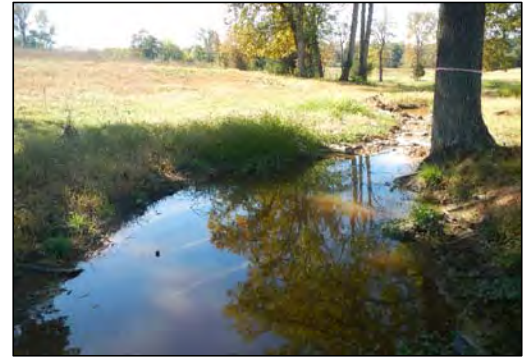
Cross Section 14 - SE2

View Upstream (10/2013)

View Downstream (10/2013)

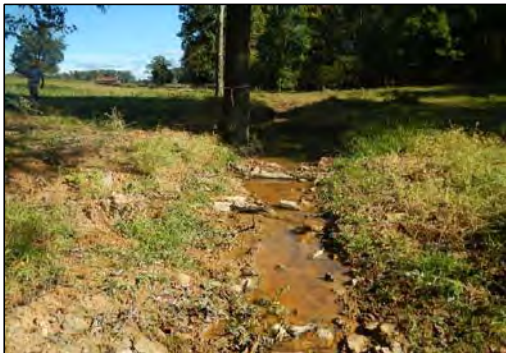
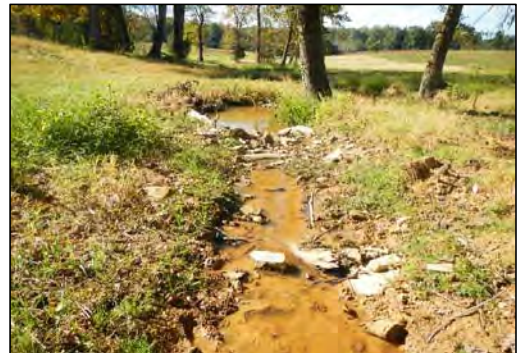
Cross Section 15 - SE2

View Upstream (10/2013)

View Downstream (10/2013)
