# MONITORING YEAR 4 of 5 ANNUAL REPORT

## BYRDS CREEK MITIGATION SITE

Person County, NC  
NCDEQ Contract 003987  
DMS Project Number 95020  
USACE Action ID Number 2012-00230  
NCDWR Project Number 2012-0102

Data Collection Period: January 2017 - October 2017  
Draft Submission Date: November 22, 2017  
Final Submission Date: January 3, 2018

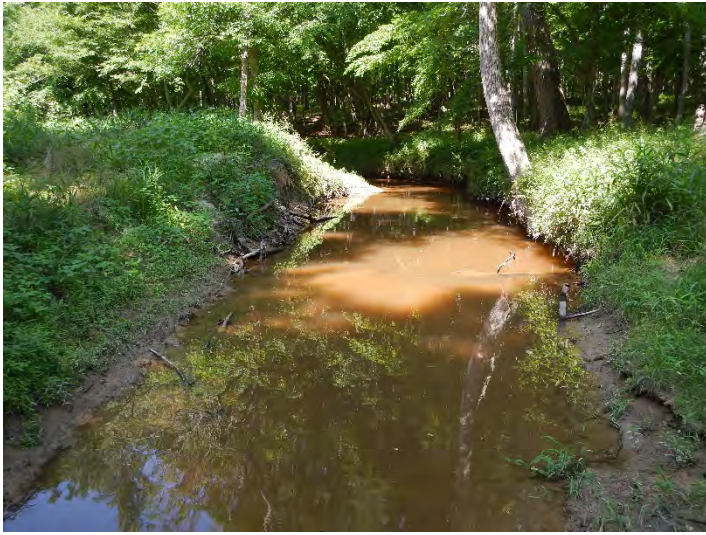
**PHOTO POINT 1** – looking upstream (05/18/2017)

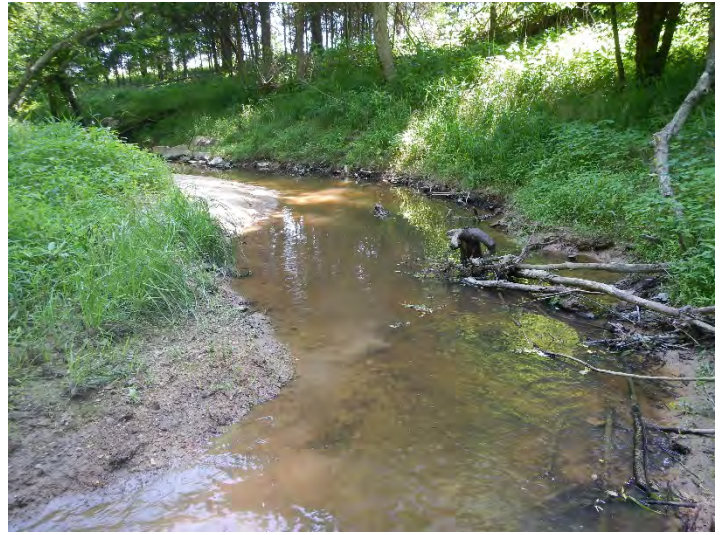
**PHOTO POINT 1** – looking downstream (05/18/2017)

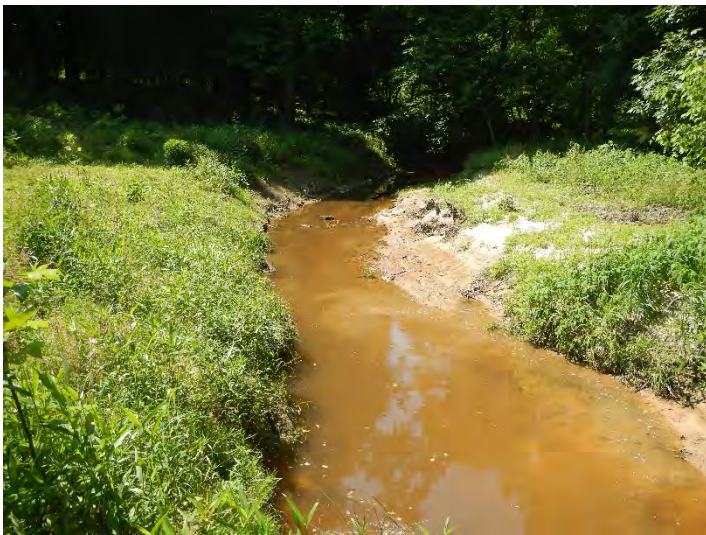
**PHOTO POINT 2** – looking upstream (05/18/2017)

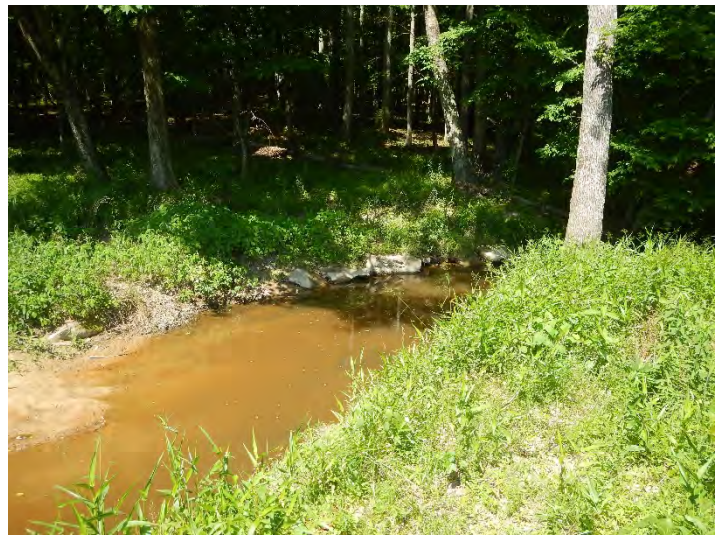
**PHOTO POINT 2** – looking downstream (05/18/2017)

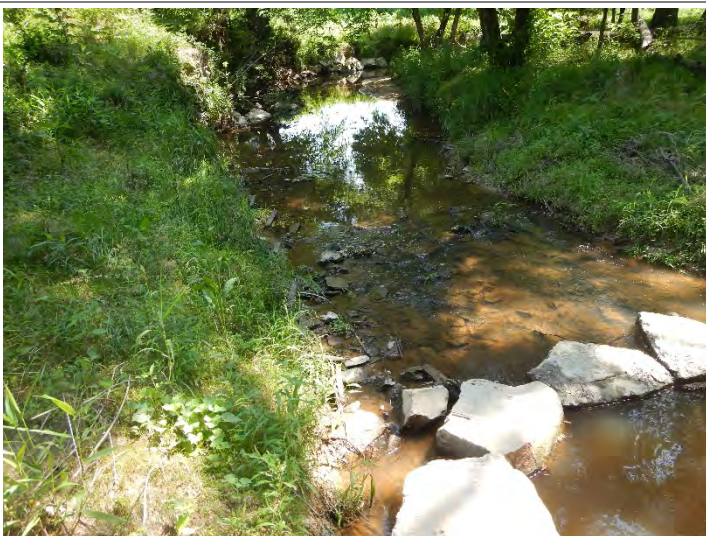
**PHOTO POINT 3** – looking upstream (05/18/2017)

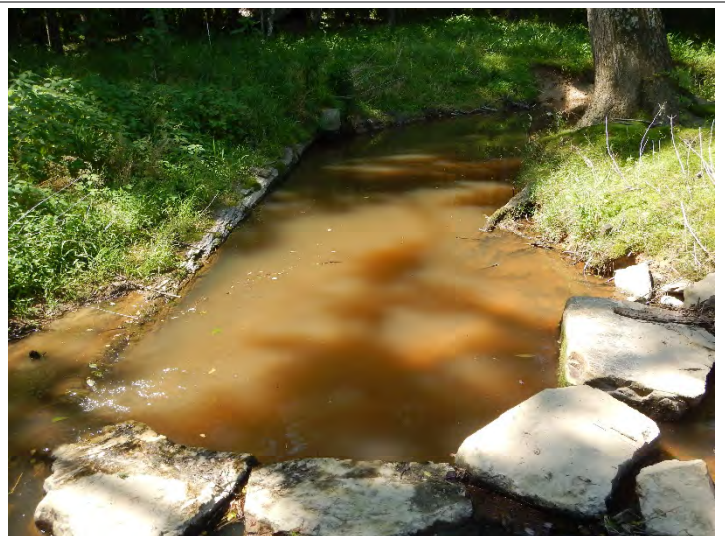
**PHOTO POINT 3** – looking downstream (05/18/2017)

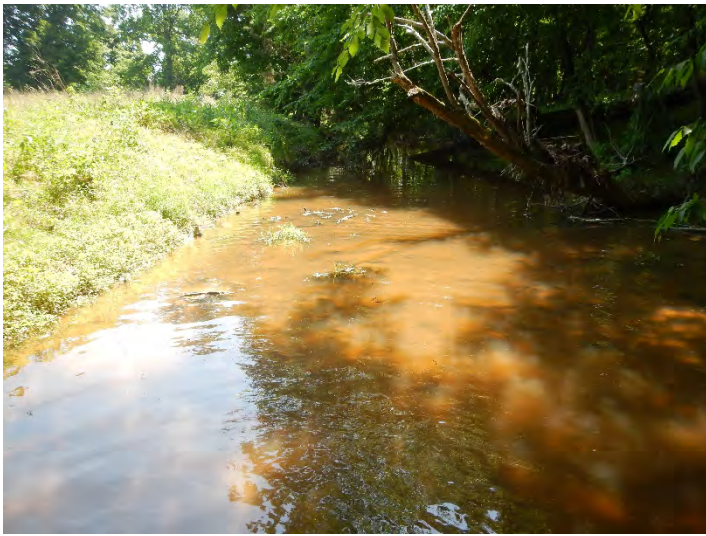
**PHOTO POINT 4 – looking upstream (05/18/2017)**

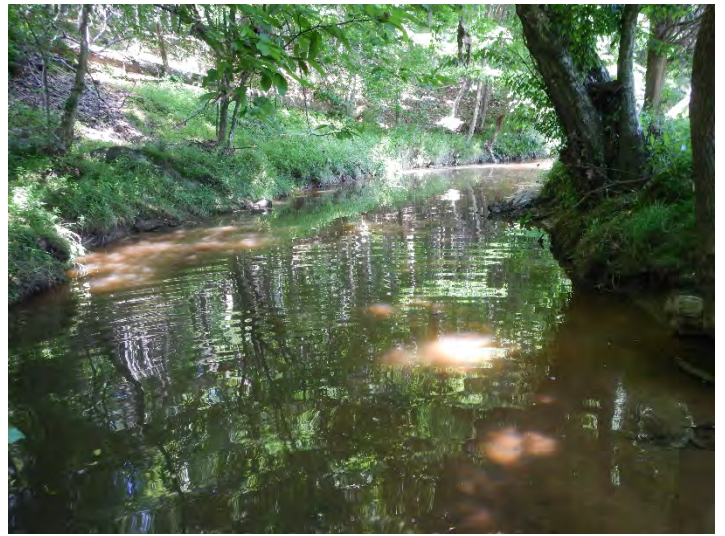
**PHOTO POINT 4 – looking downstream (05/18/2017)**

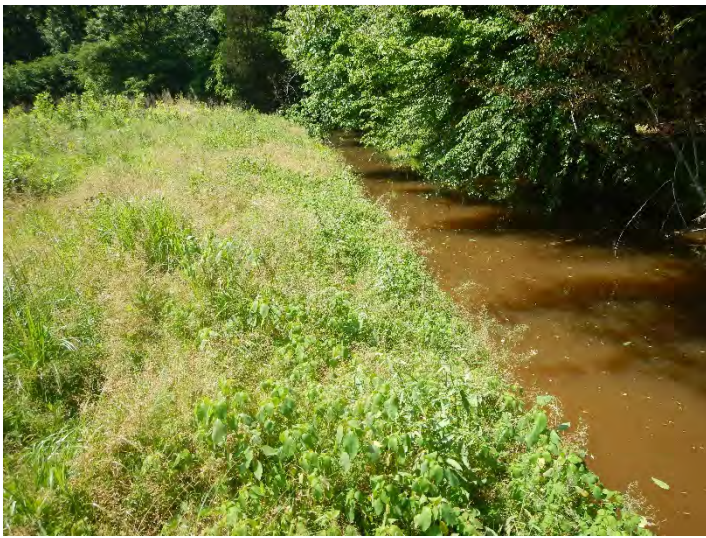
**PHOTO POINT 5 – looking upstream (05/18/2017)**

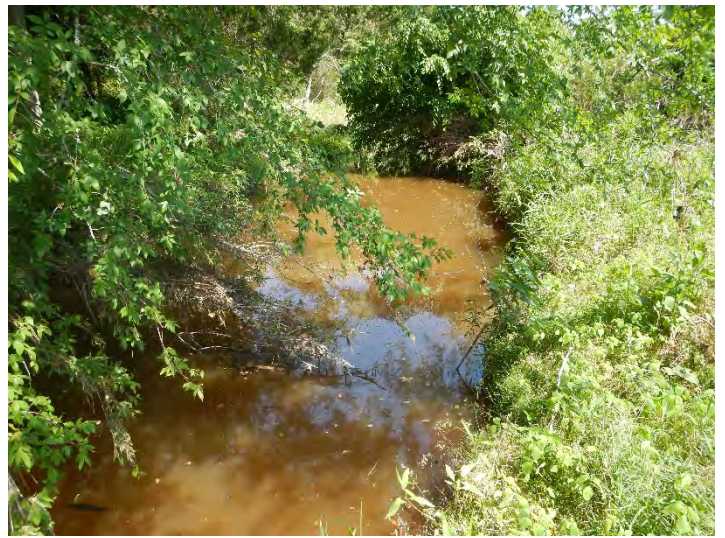
**PHOTO POINT 5 – looking downstream (05/18/2017)**

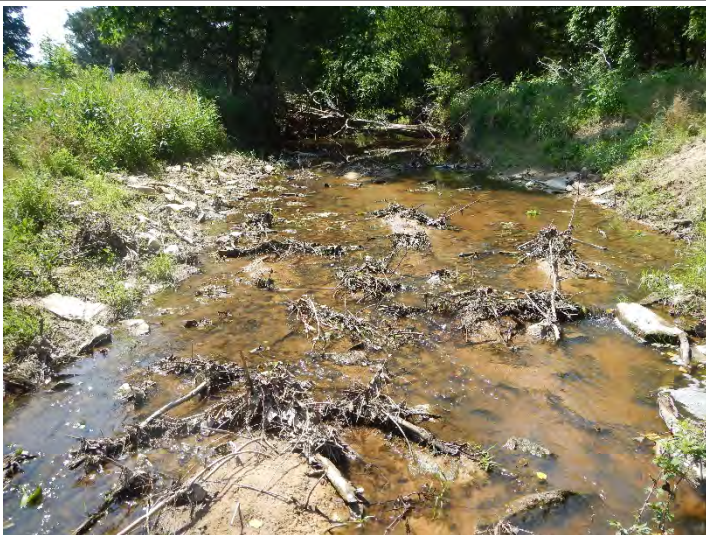
**PHOTO POINT 6 – looking upstream (05/18/2017)**

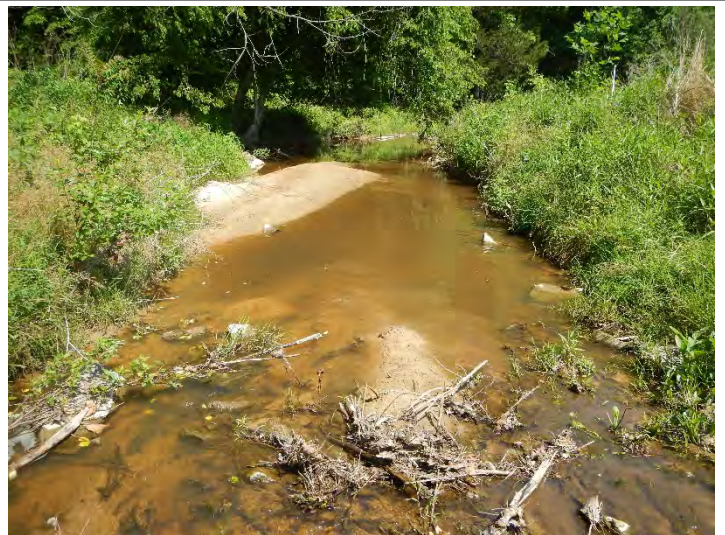
**PHOTO POINT 6 – looking downstream (05/18/2017)**

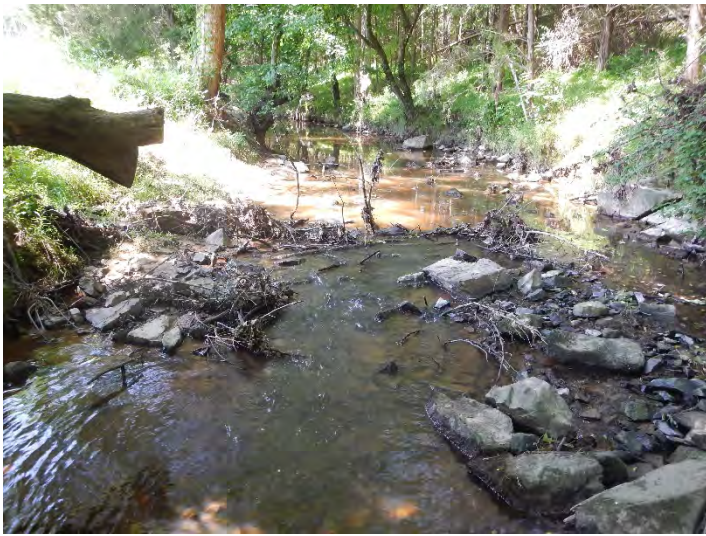
**PHOTO POINT 7** – looking upstream (05/18/2017)

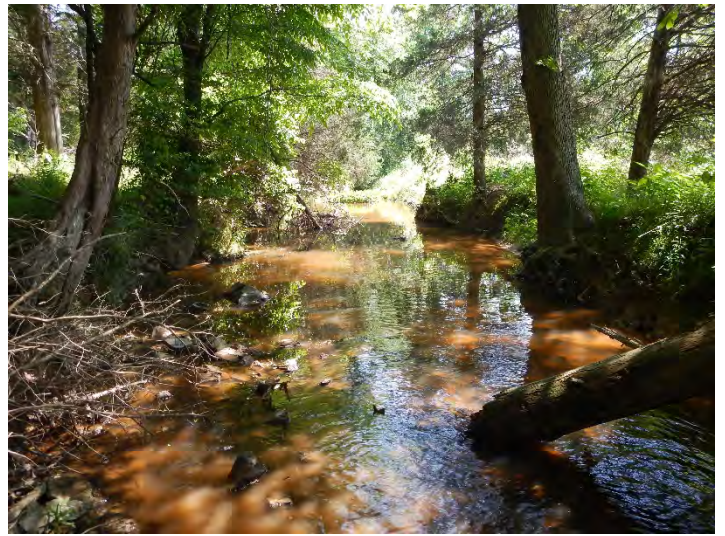
**PHOTO POINT 7** – looking downstream (05/18/2017)

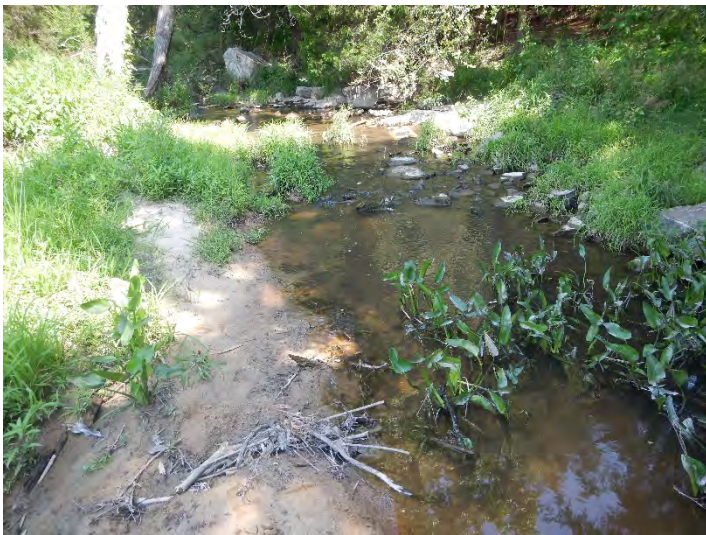
**PHOTO POINT 8** – looking upstream (05/18/2017)

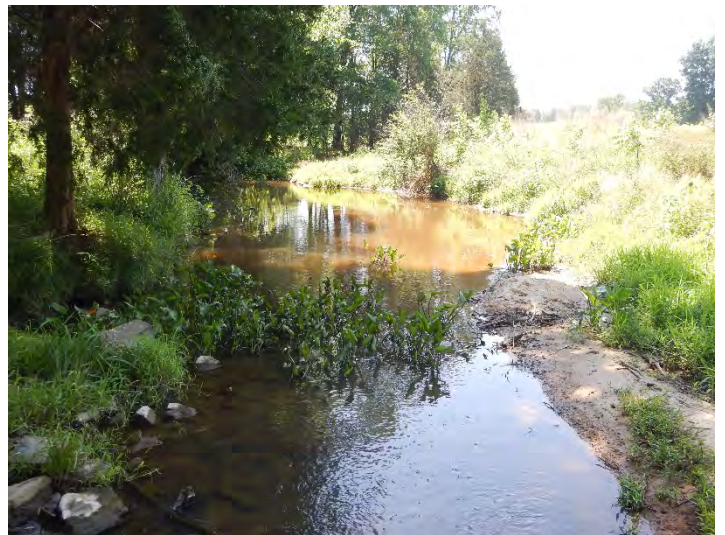
**PHOTO POINT 8** – looking downstream (05/18/2017)

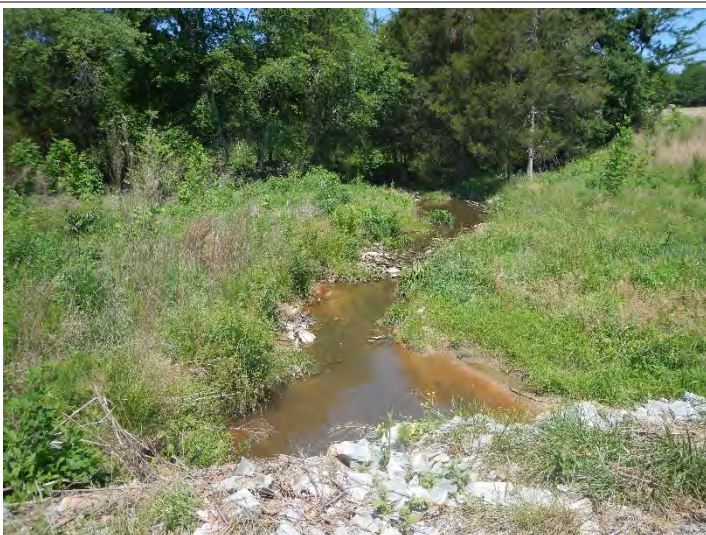
**PHOTO POINT 9** – looking upstream (05/18/2017)

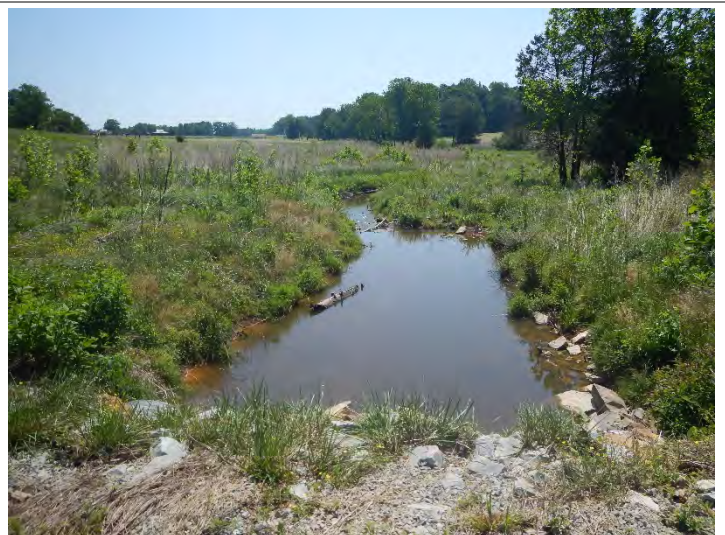
**PHOTO POINT 9** – looking downstream (05/18/2017)

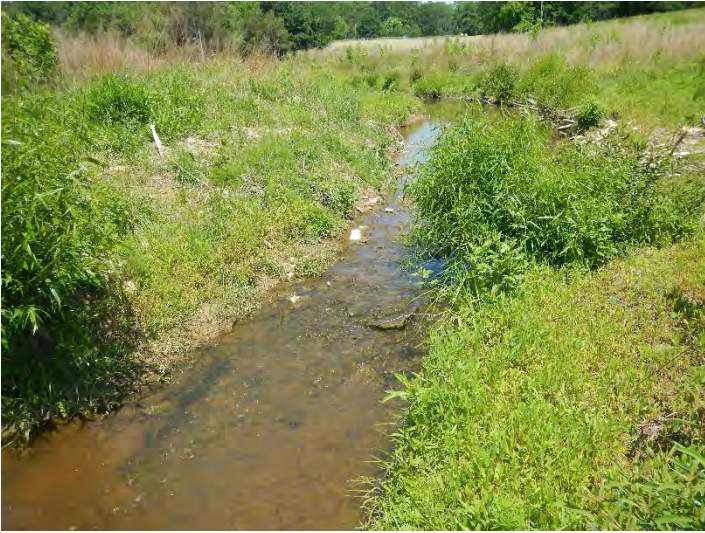
**PHOTO POINT 10** – looking upstream (05/18/2017)

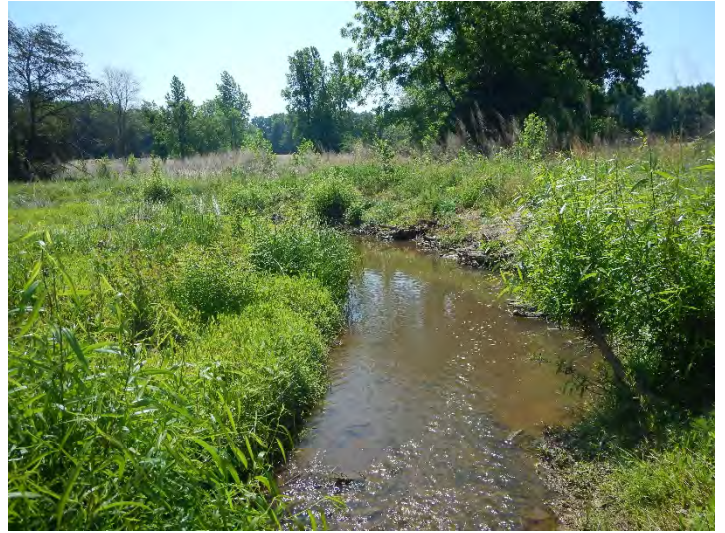
**PHOTO POINT 10** – looking downstream (05/18/2017)

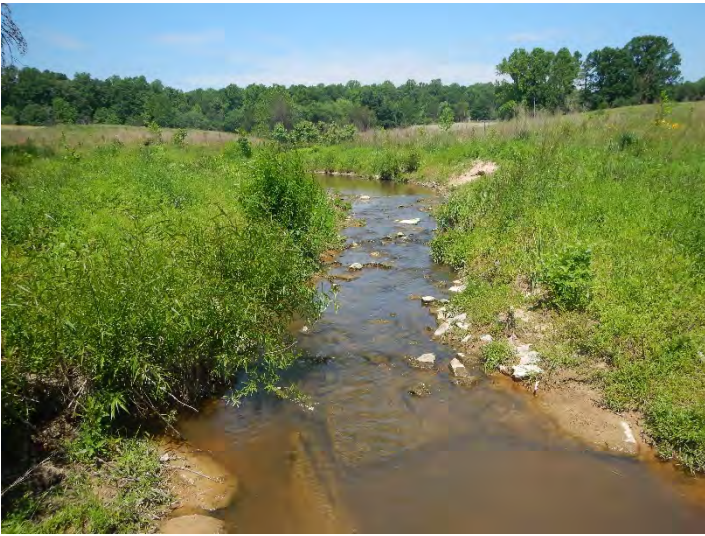
**PHOTO POINT 11** – looking upstream (05/18/2017)

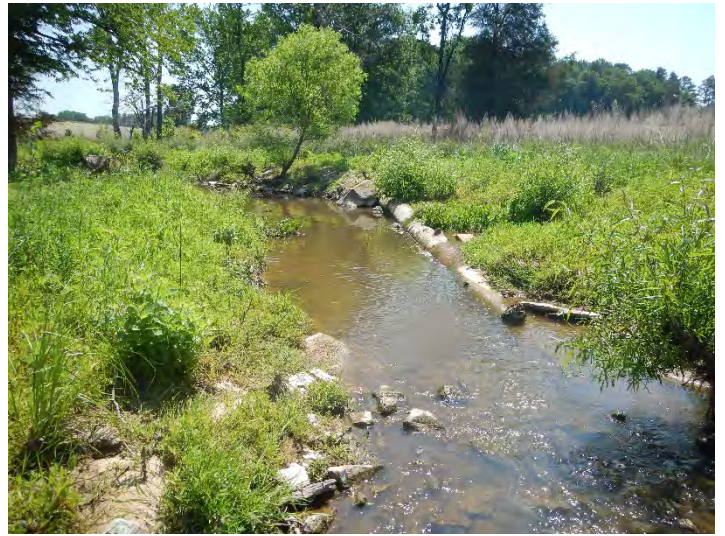
**PHOTO POINT 11** – looking downstream (05/18/2017)

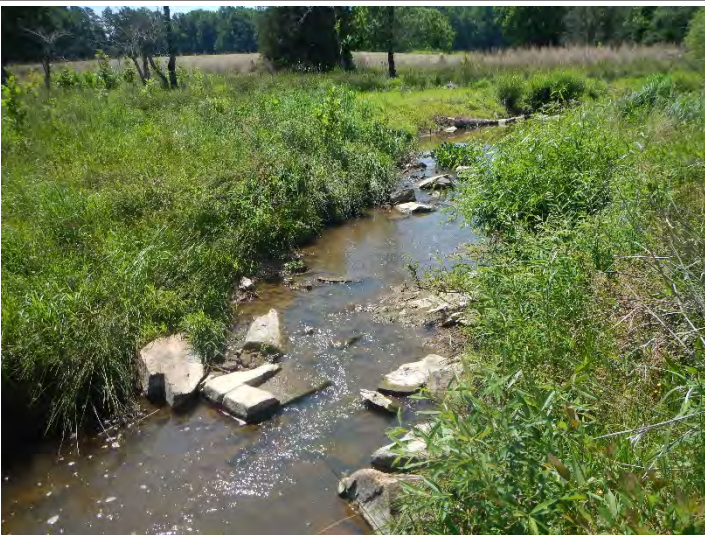
**PHOTO POINT 12** – looking upstream (05/18/2017)

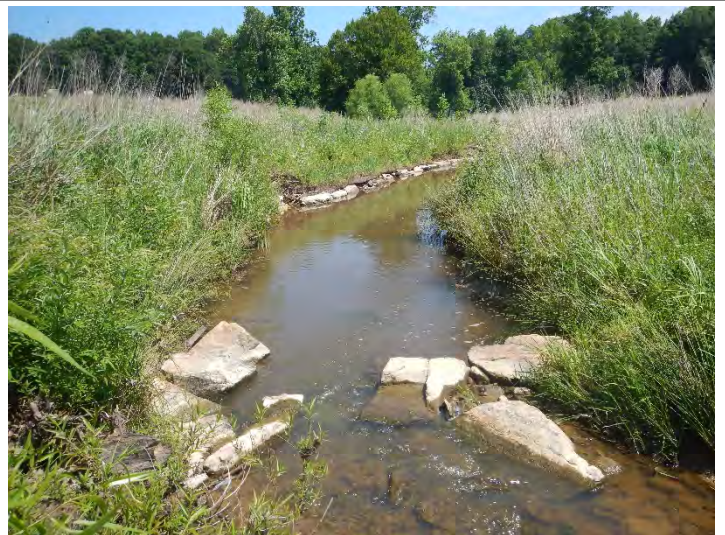
**PHOTO POINT 12** – looking downstream (05/18/2017)

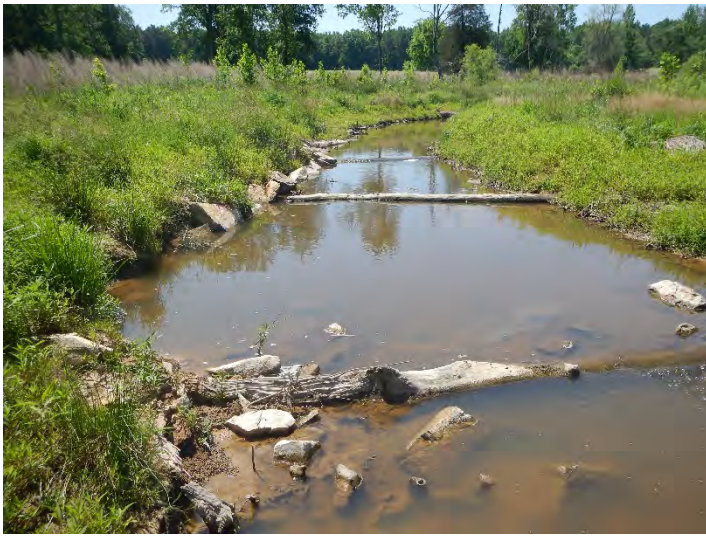
**PHOTO POINT 13** – looking upstream (05/18/2017)

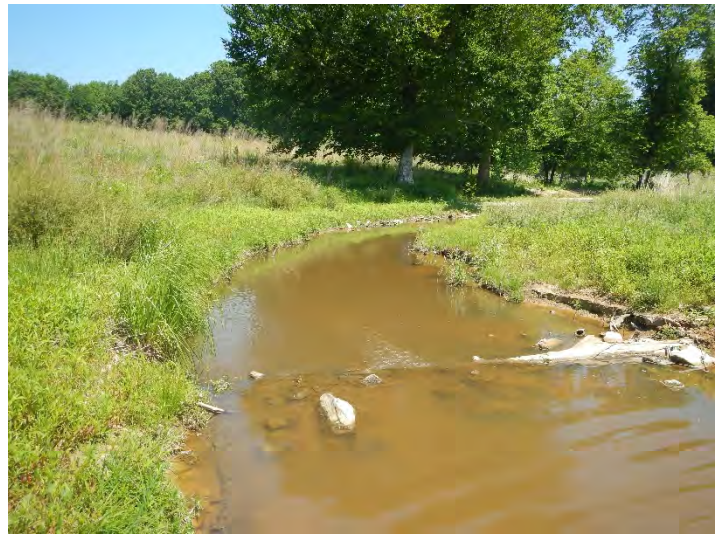
**PHOTO POINT 13** – looking downstream (05/18/2017)

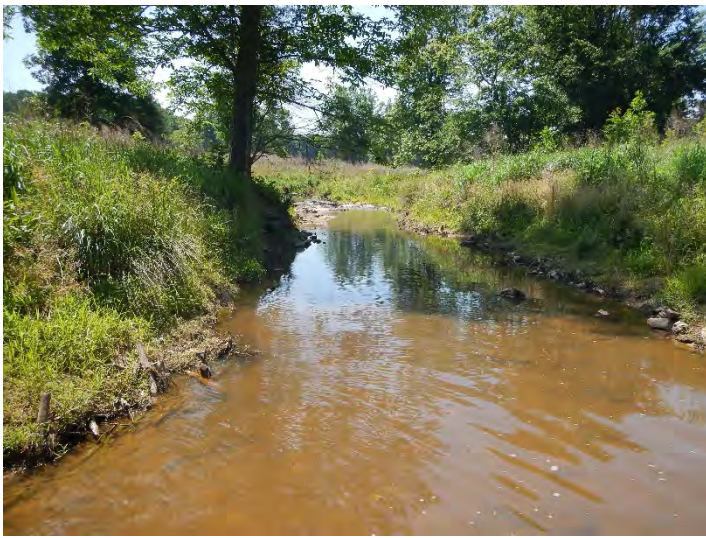
**PHOTO POINT 14** – looking upstream (05/18/2017)

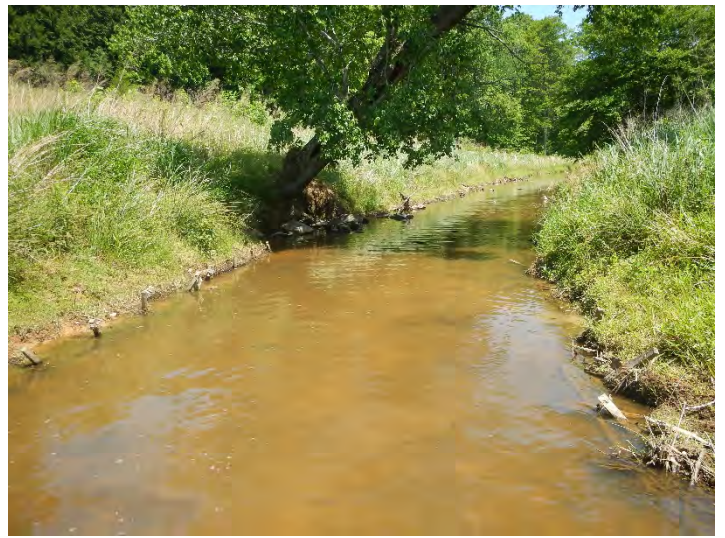
**PHOTO POINT 14** – looking downstream (05/18/2017)

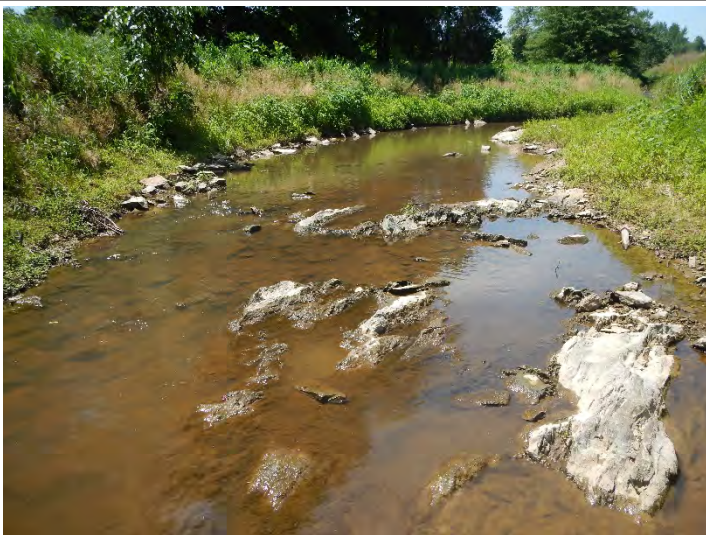
**PHOTO POINT 15** – looking upstream (05/18/2017)

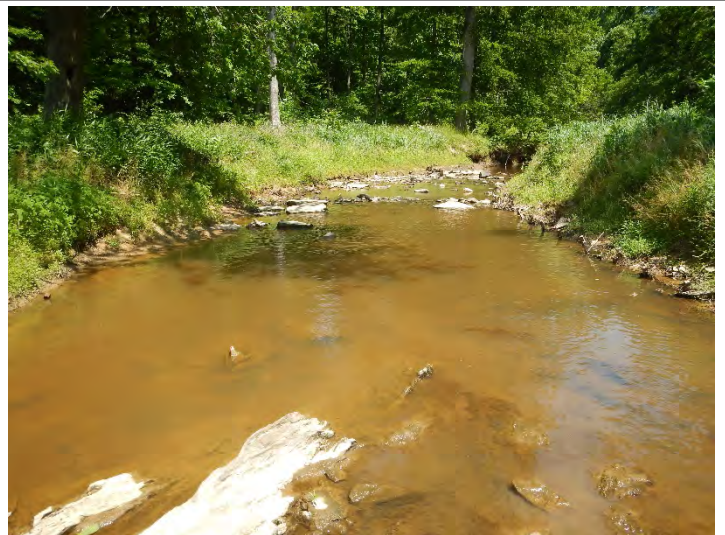
**PHOTO POINT 15** – looking downstream (05/18/2017)

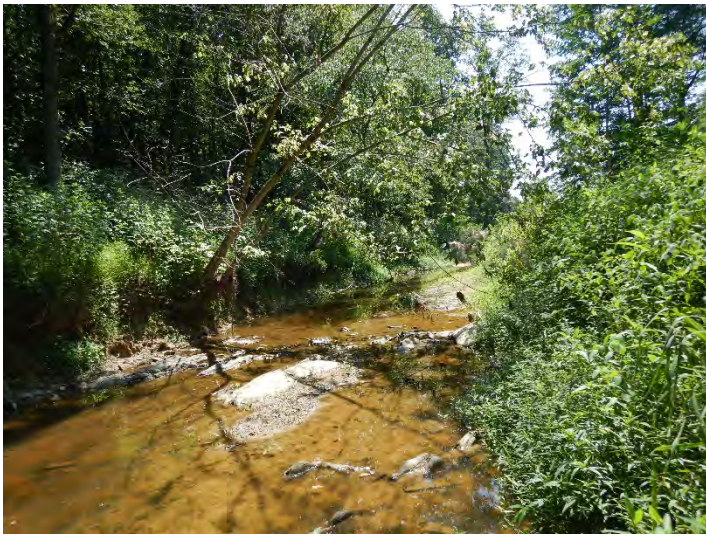
**PHOTO POINT 16** – looking upstream (08/21/2017)

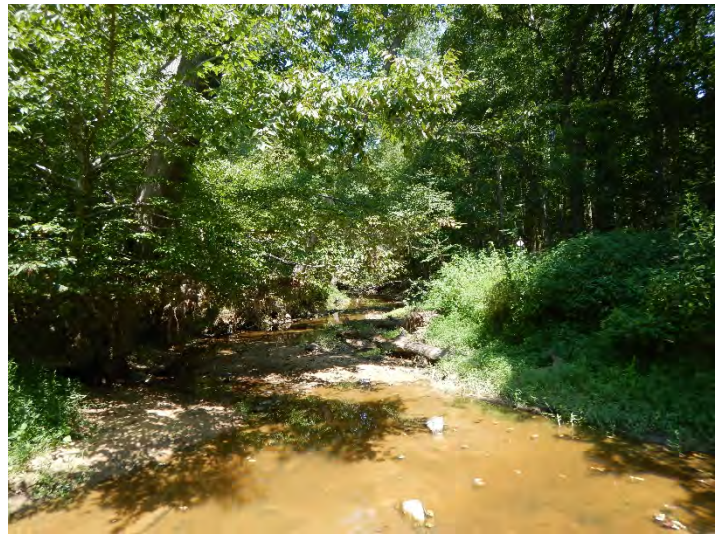
**PHOTO POINT 16** – looking downstream (08/21/2017)

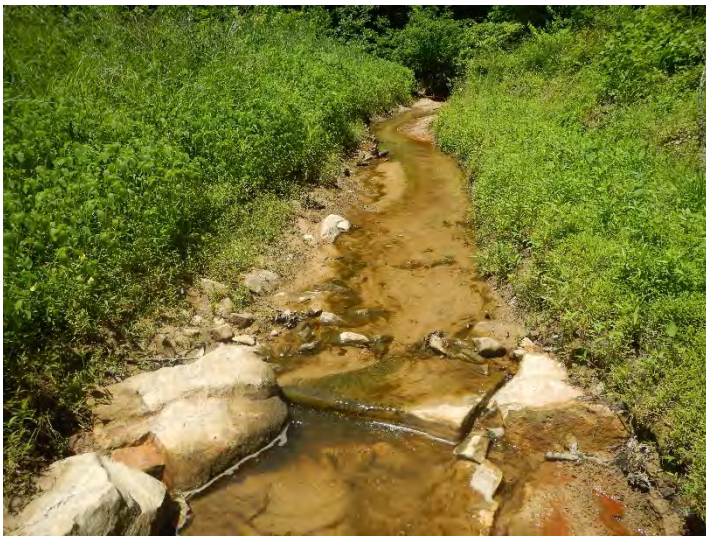
**PHOTO POINT 19** – looking upstream (05/18/2017)

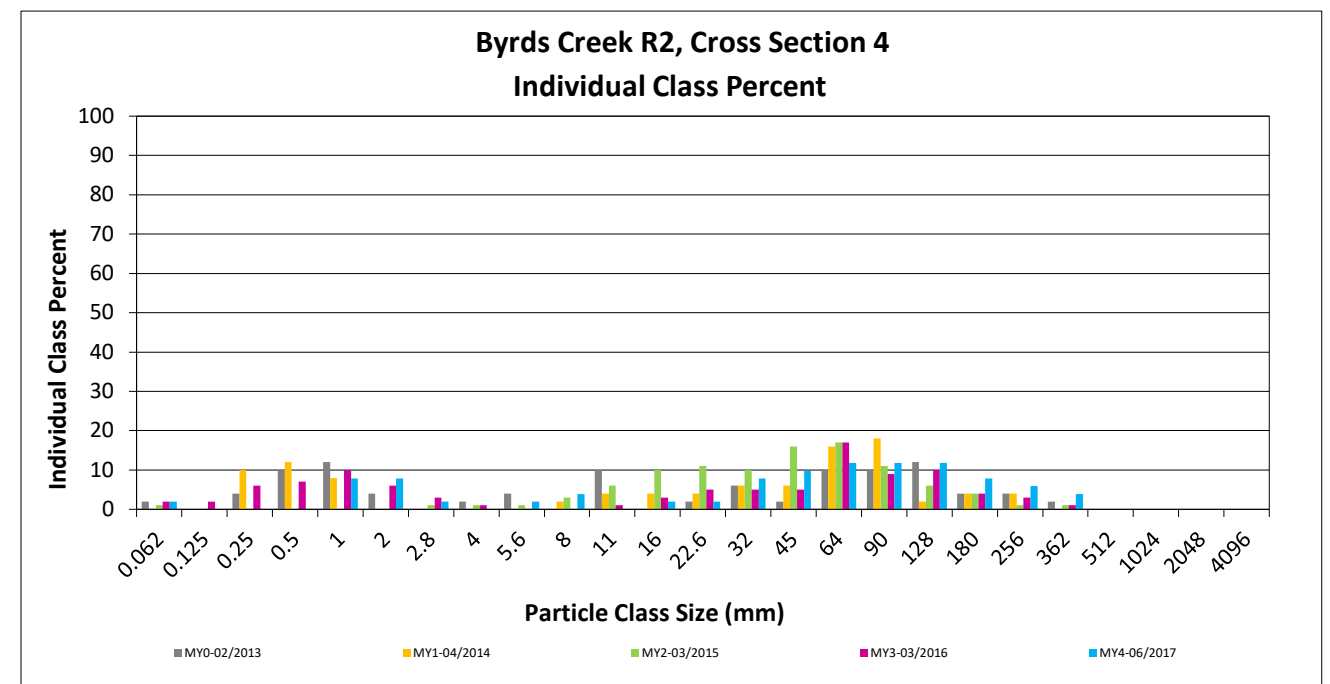
**Reachwide and Cross Section Pebble Count Plots**

Particle Class		Diameter (mm)		Riffle 100-Count	Summary	
		min	max		Class Percentage	Percent Cumulative
<b>SILT/CLAY</b>	Silt/Clay	0.000	0.062	2	2	2
<b>SAND</b>	Very fine	0.062	0.125			2
	Fine	0.125	0.250			2
	Medium	0.25	0.50			2
	Coarse	0.5	1.0	8	8	10
	Very Coarse	1.0	2.0	8	8	18
<b>GRAVEL</b>	Very Fine	2.0	2.8	2	2	20
	Very Fine	2.8	4.0			20
	Fine	4.0	5.6	2	2	22
	Fine	5.6	8.0	4	4	25
	Medium	8.0	11.0			25
	Medium	11.0	16.0	2	2	27
	Coarse	16.0	22.6	2	2	29
	Coarse	22.6	32	8	8	37
	Very Coarse	32	45	10	10	47
	Very Coarse	45	64	12	12	59
<b>COBBLE</b>	Small	64	90	12	12	71
	Small	90	128	12	12	82
	Large	128	180	8	8	90
	Large	180	256	6	6	96
<b>BOULDER</b>	Small	256	362	4	4	100
	Small	362	512			100
	Medium	512	1024			100
	Large/Very Large	1024	2048			100
<b>BEDROCK</b>	Bedrock	2048	>2048			100
<b>Total</b>				<b>102</b>	<b>100</b>	<b>100</b>

Cross Section 4 Channel materials (mm)	
D <sub>16</sub> =	1.73
D <sub>35</sub> =	28.96
D <sub>50</sub> =	49.1
D <sub>84</sub> =	137.5
D <sub>95</sub> =	240.0
D <sub>100</sub> =	362.0

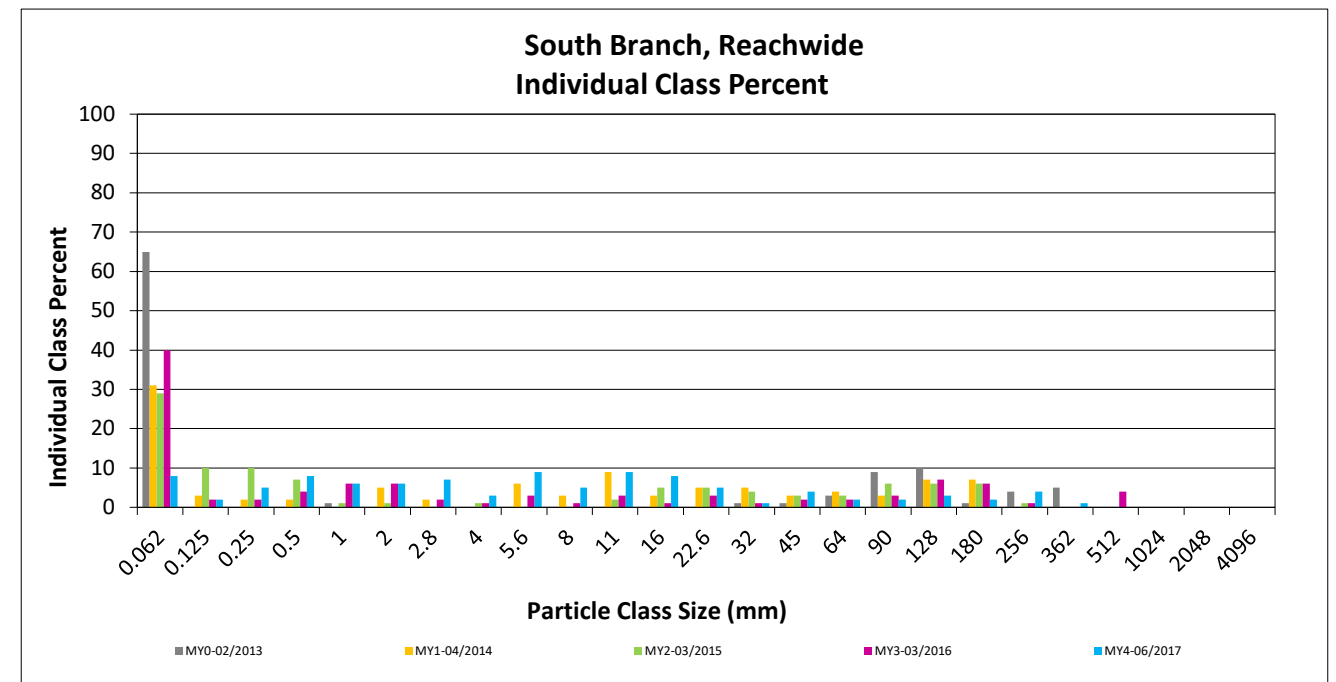
## Reachwide and Cross Section Pebble Count Plots

Particle Class		Diameter (mm)		Particle Count			Reach Summary	
		min	max	Riffle	Pool	Total	Class Percentage	Percent Cumulative
<b>SILT/CLAY</b>	Silt/Clay	0.000	0.062		8	8	8	8
<b>SAND</b>	Very fine	0.062	0.125		2	2	2	10
	Fine	0.125	0.250	1	4	5	5	15
	Medium	0.25	0.50	2	6	8	8	23
	Coarse	0.5	1.0	2	4	6	6	29
	Very Coarse	1.0	2.0	1	5	6	6	35
<b>GRAVEL</b>	Very Fine	2.0	2.8	2	5	7	7	42
	Very Fine	2.8	4.0	2	1	3	3	45
	Fine	4.0	5.6	7	2	9	9	54
	Fine	5.6	8.0	4	1	5	5	59
	Medium	8.0	11.0	6	3	9	9	68
	Medium	11.0	16.0	5	3	8	8	76
	Coarse	16.0	22.6	2	3	5	5	81
	Coarse	22.6	32	1		1	1	82
	Very Coarse	32	45	2	2	4	4	86
	Very Coarse	45	64	2		2	2	88
<b>COBBLE</b>	Small	64	90	2		2	2	90
	Small	90	128	2	1	3	3	93
	Large	128	180	2		2	2	95
	Large	180	256	4		4	4	99
<b>BOULDER</b>	Small	256	362	1		1	1	100
	Small	362	512					100
	Medium	512	1024					100
	Large/Very Large	1024	2048					100
<b>BEDROCK</b>	Bedrock	2048	>2048					100
<b>Total</b>				<b>50</b>	<b>50</b>	<b>100</b>	<b>100</b>	<b>100</b>

Reachwide Channel materials (mm)	
D <sub>16</sub> =	0.27
D <sub>35</sub> =	2.00
D <sub>50</sub> =	4.8
D <sub>84</sub> =	37.9
D <sub>95</sub> =	180.0
D <sub>100</sub> =	362.0

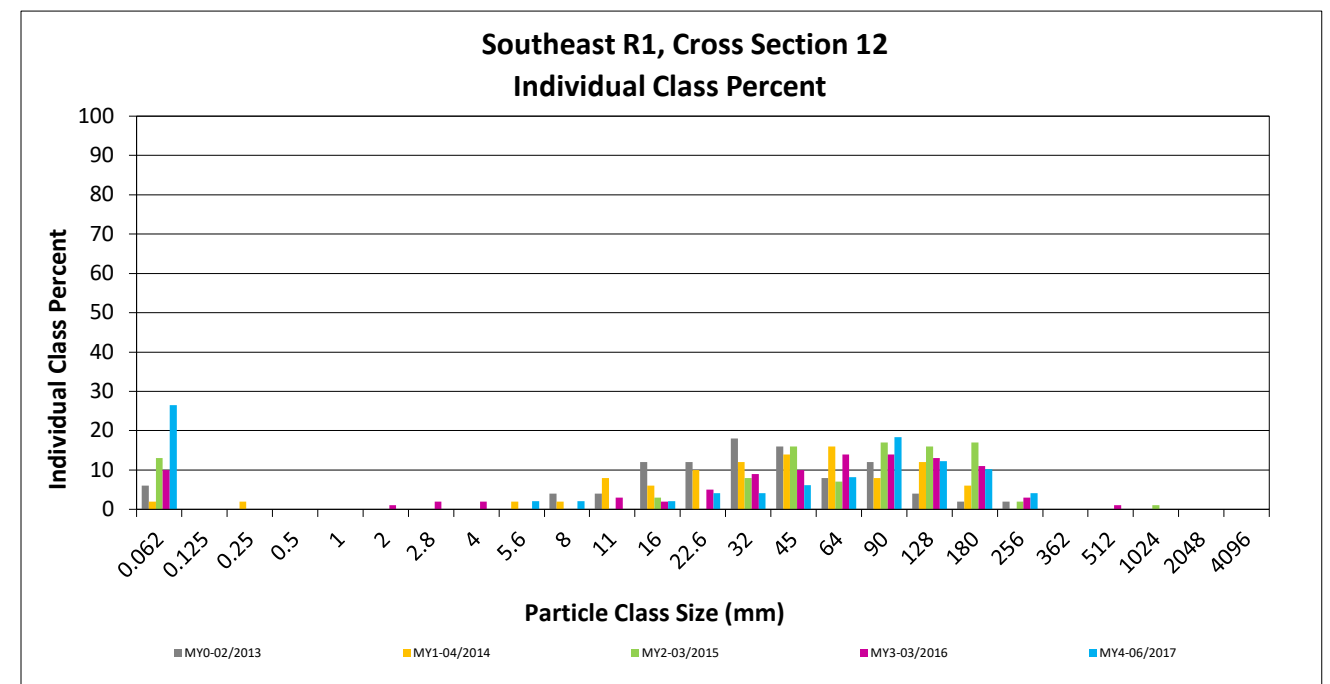
### Reachwide and Cross Section Pebble Count Plots

Particle Class		Diameter (mm)		Rifle 100-Count	Summary	
		min	max		Class Percentage	Percent Cumulative
<b>SILT/CLAY</b>	Silt/Clay	0.000	0.062	26	27	27
<b>SAND</b>	Very fine	0.062	0.125			27
	Fine	0.125	0.250			27
	Medium	0.25	0.50			27
	Coarse	0.5	1.0			27
	Very Coarse	1.0	2.0			27
<b>GRAVEL</b>	Very Fine	2.0	2.8			27
	Very Fine	2.8	4.0			27
	Fine	4.0	5.6	2	2	29
	Fine	5.6	8.0	2	2	31
	Medium	8.0	11.0			31
	Medium	11.0	16.0	2	2	33
	Coarse	16.0	22.6	4	4	37
	Coarse	22.6	32	4	4	41
	Very Coarse	32	45	6	6	47
	Very Coarse	45	64	8	8	55
<b>COBBLE</b>	Small	64	90	18	18	73
	Small	90	128	12	12	86
	Large	128	180	10	10	96
	Large	180	256	4	4	100
<b>BOULDER</b>	Small	256	362			100
	Small	362	512			100
	Medium	512	1024			100
	Large/Very Large	1024	2048			100
<b>BEDROCK</b>	Bedrock	2048	>2048			100
<b>Total</b>				<b>98</b>	<b>100</b>	<b>100</b>

Cross Section 12 Channel materials (mm)	
D <sub>16</sub> =	Silt/Clay
D <sub>35</sub> =	19.51
D <sub>50</sub> =	51.4
D <sub>84</sub> =	121.8
D <sub>95</sub> =	174.6
D <sub>100</sub> =	256.0
