Candiff Creek As-built Baseline Report - Final

Surry County, North Carolina

EEP Project Number 92767

Date Submitted: July 2012

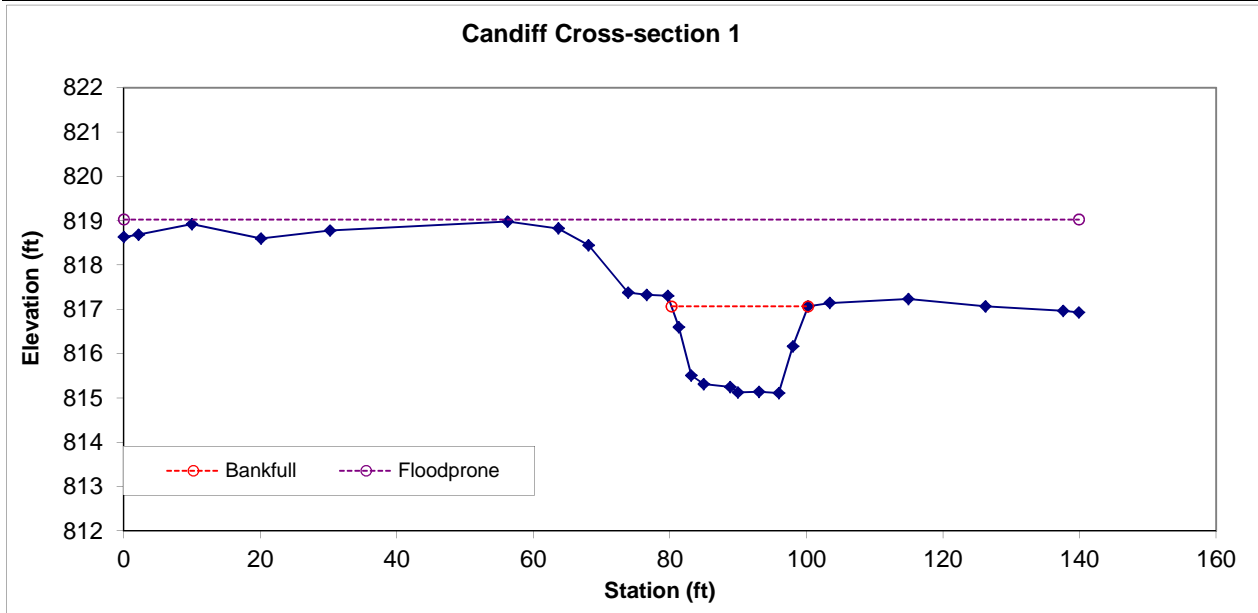
Permanent Cross-section 1
(As-Built Data - collected March 2012)

Feature	Stream Type	BKF Area	BKF Width	BKF Depth	Max BKF Depth	W/D	BH Ratio	ER	BKF Elev	TOB Elev
Riffle	C	29.8	20	1.49	1.96	13.44	1	7	817.07	817.07

For monitoring stream success criteria, 10 permanent cross-sections, and 1 crest gauge were installed. The permanent cross-sections will be used to monitor channel dimension and bank erosion over time. The crest gauge will be used to document the occurrence of bankfull events. In addition, a complete longitudinal survey was completed for the restored stream channels to provide a base-line for evaluating changes in bed conditions over time. The longitudinal profile included the elevations of all grade control structures. The permanent cross-section and longitudinal data are provided in Appendix B.

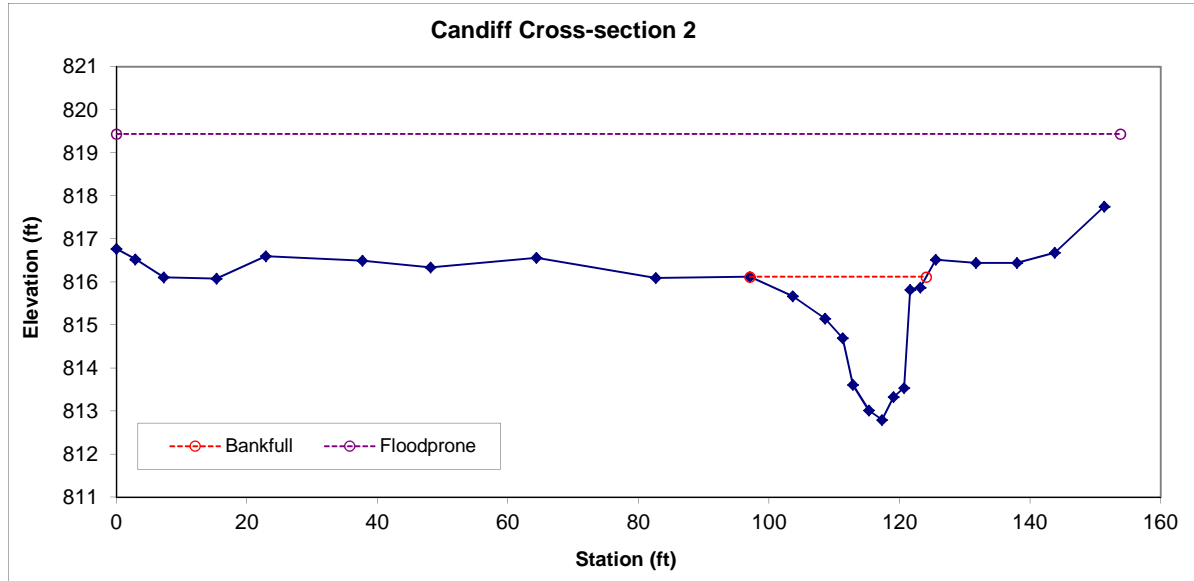
Permanent Cross-section 2
(As-Built Data - collected March 2012)

Feature	Stream Type	BKF Area	BKF Width	BKF Depth	Max BKF Depth	W/D	BH Ratio	ER	BKF Elev	TOB Elev
Pool		36.3	27.02	1.34	3.32	20.13	1	5.7	816.12	816.12

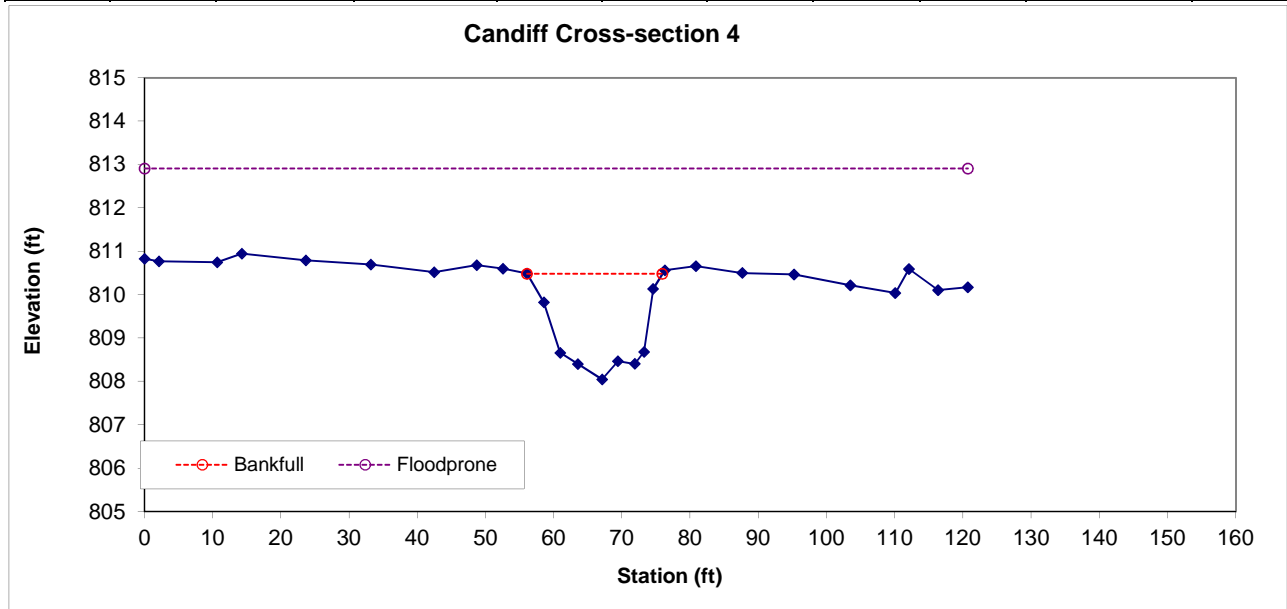
Permanent Cross-section 4
 (As-Built Data - collected March 2012)

Feature	Stream Type	BKF Area	BKF Width	BKF Depth	Max BKF Depth	W/D	BH Ratio	ER	BKF Elev	TOB Elev
Riffle	C	31.3	19.84	1.58	2.43	12.56	1	6.1	810.48	810.49
