# **BASELINE MONITORING DOCUMENT AND AS-BUILT BASELINE REPORT**

## **CANDY CREEK MITIGATION SITE**

Guilford County, NC  
NCDEQ Contract 5794  
DMS ID No. 96315

Data Collection Period: October 2016 – March 2017  
Final Submission Date: June 2, 2017

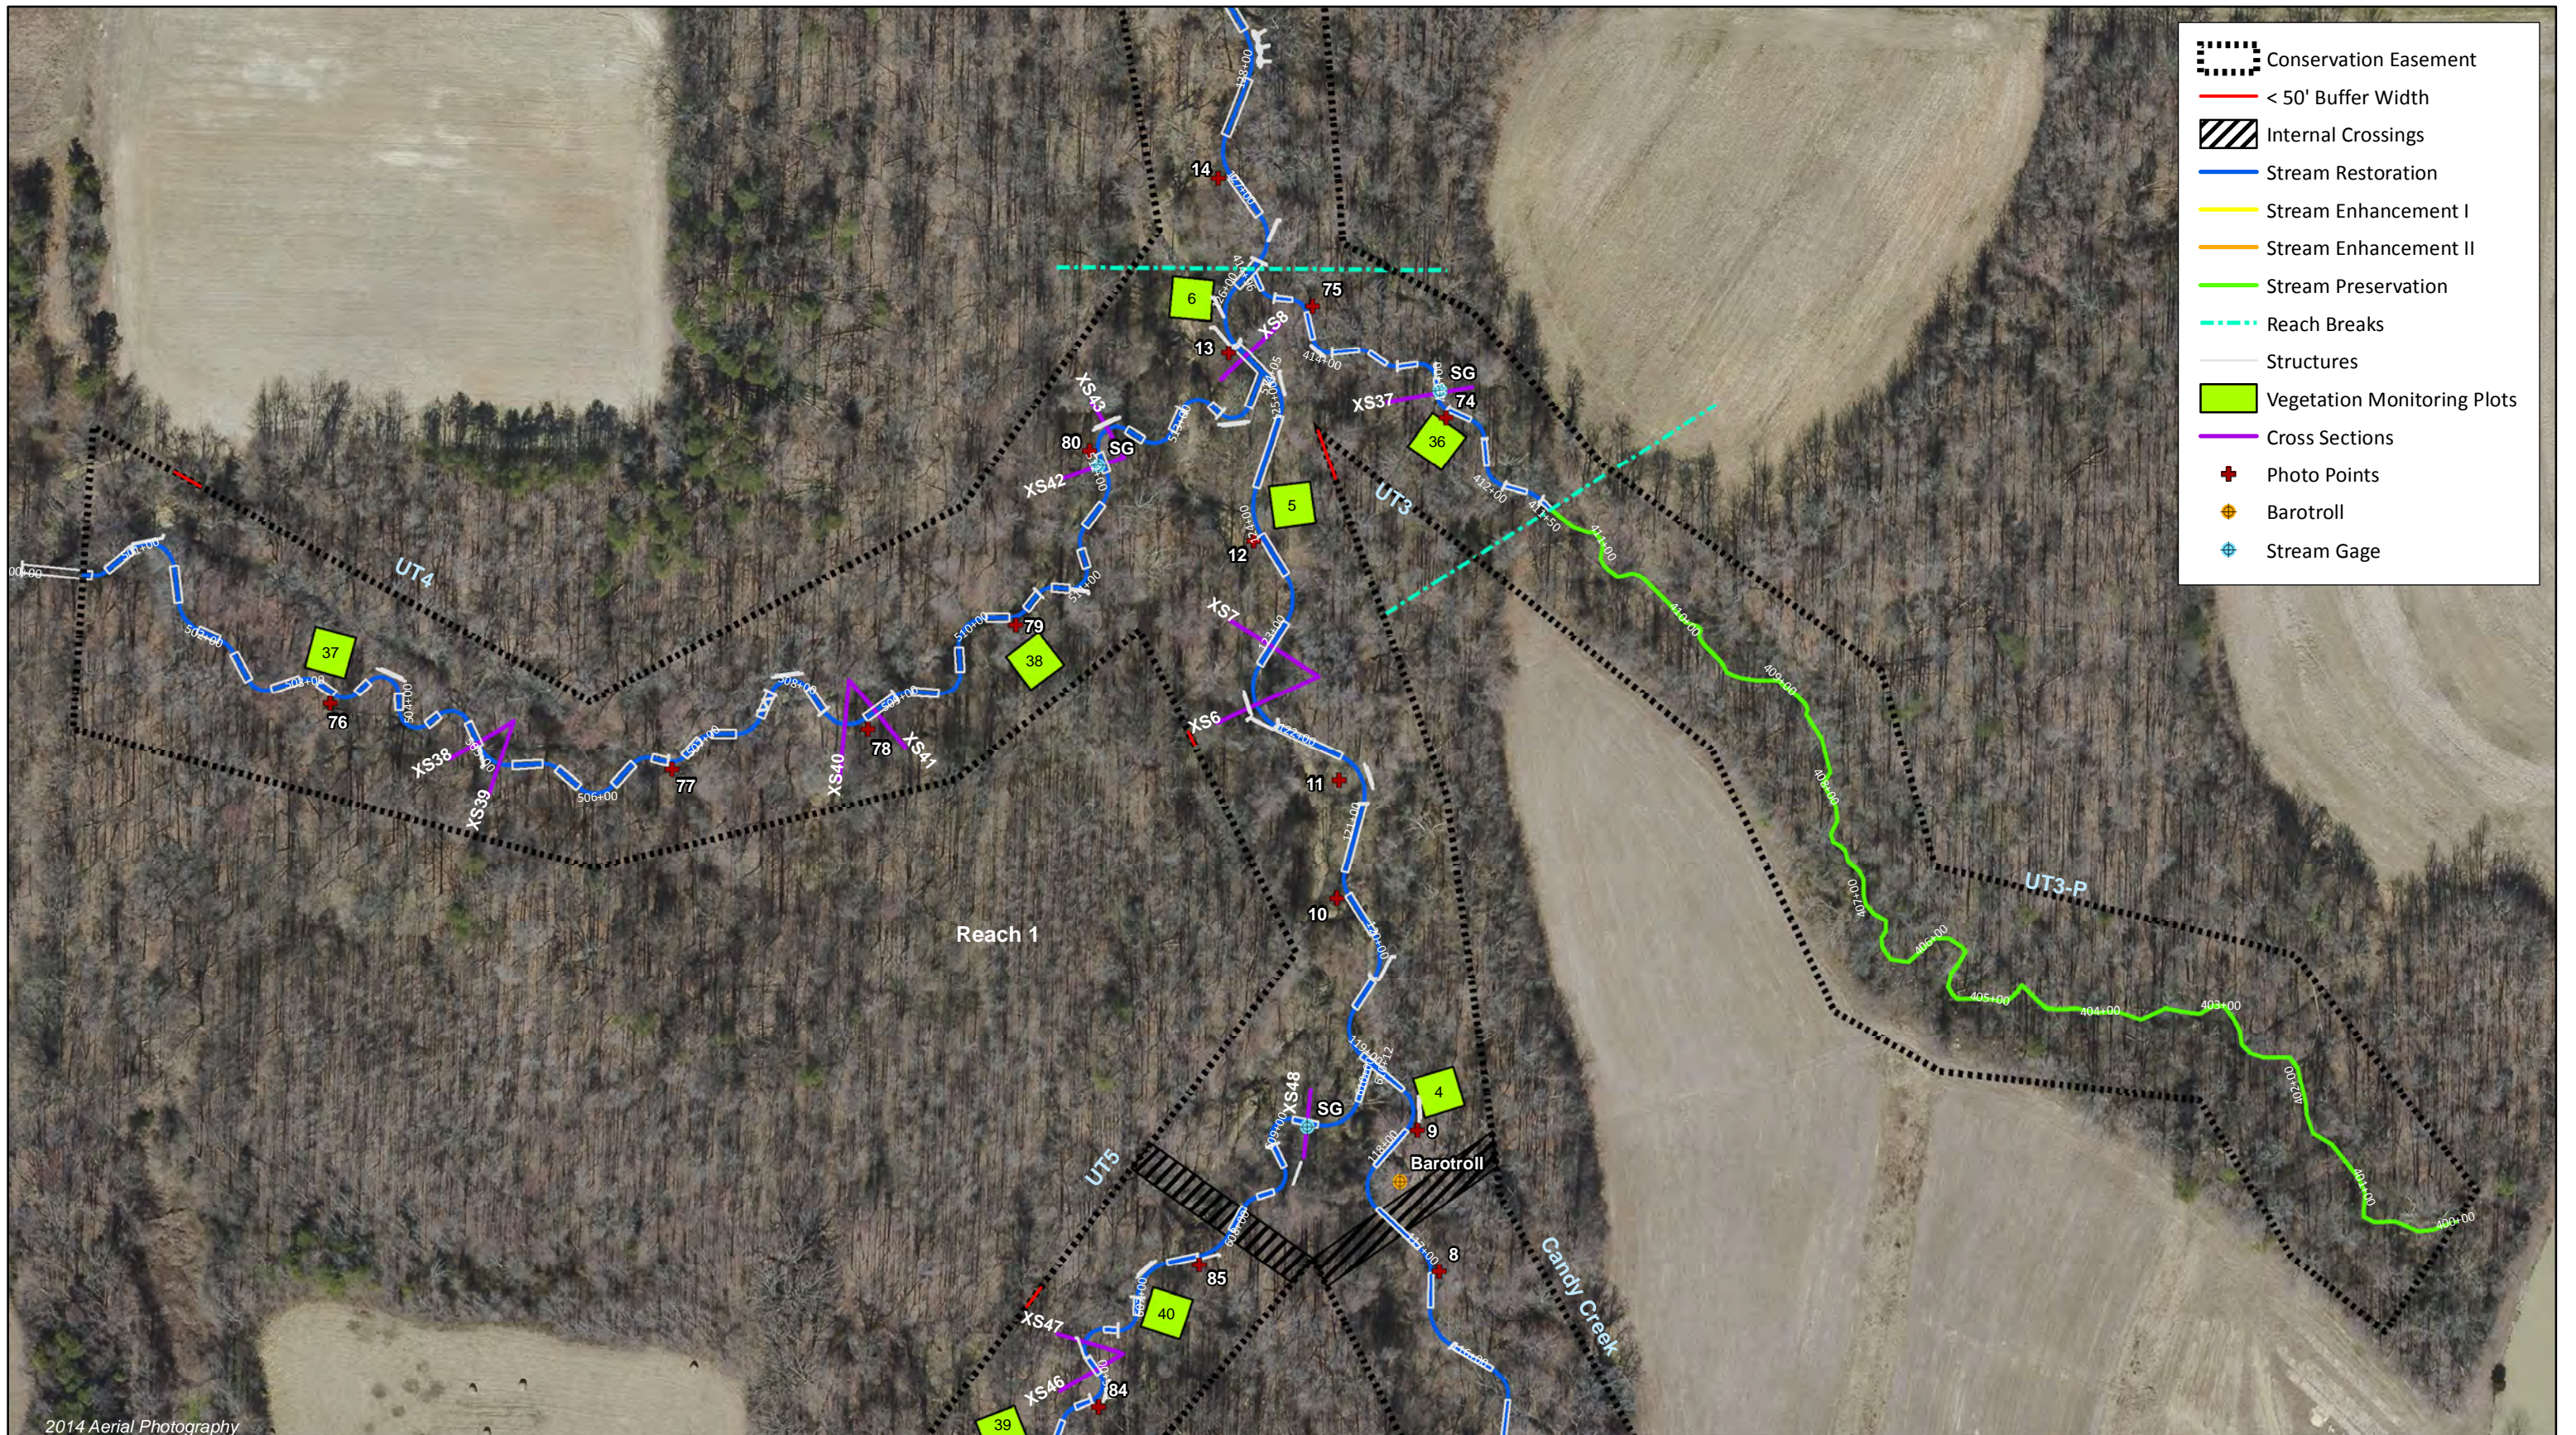
Figure 3.2 Monitoring Plan View  
 Candy Creek Mitigation Site  
 DMS Project No. 96315  
 Monitoring Year 0 - 2017  
 Guilford County, NC

- Conservation Easement
- < 50' Buffer Width
- Internal Crossings
- Stream Restoration
- Stream Enhancement I
- Stream Enhancement II
- Stream Preservation
- Reach Breaks
- Structures
- Vegetation Monitoring Plots
- Cross Sections
- Photo Points
- Barotroll
- Stream Gage

Geomorphic assessments follow guidelines outlined in the Stream Channel Reference Sites: An Illustrated Guide to Field Techniques (Harrelson et al., 1994), methodologies utilized in the Rosgen stream assessment and classification documents (Rosgen, 1994 and 1996), and in the Stream Restoration: A Natural Channel Design Handbook (Doll et al, 2003). Refer to Figures 3.0 – 3.7 in Appendix 1 for monitoring locations discussed below.

Planted woody vegetation will be monitored in accordance with the guidelines and procedures developed by the Carolina Vegetation Survey Level 2 Protocol (Lee et al., 2006) to monitor and assess the planted woody vegetation. A total of 37 standard 10 meter by 10 meter vegetation plots and three non-standard 5 meter by 20 meter plots were established within the project easement area. Refer to Figure 3.0 – 3.7 in Appendix 1 for the vegetation monitoring locations.

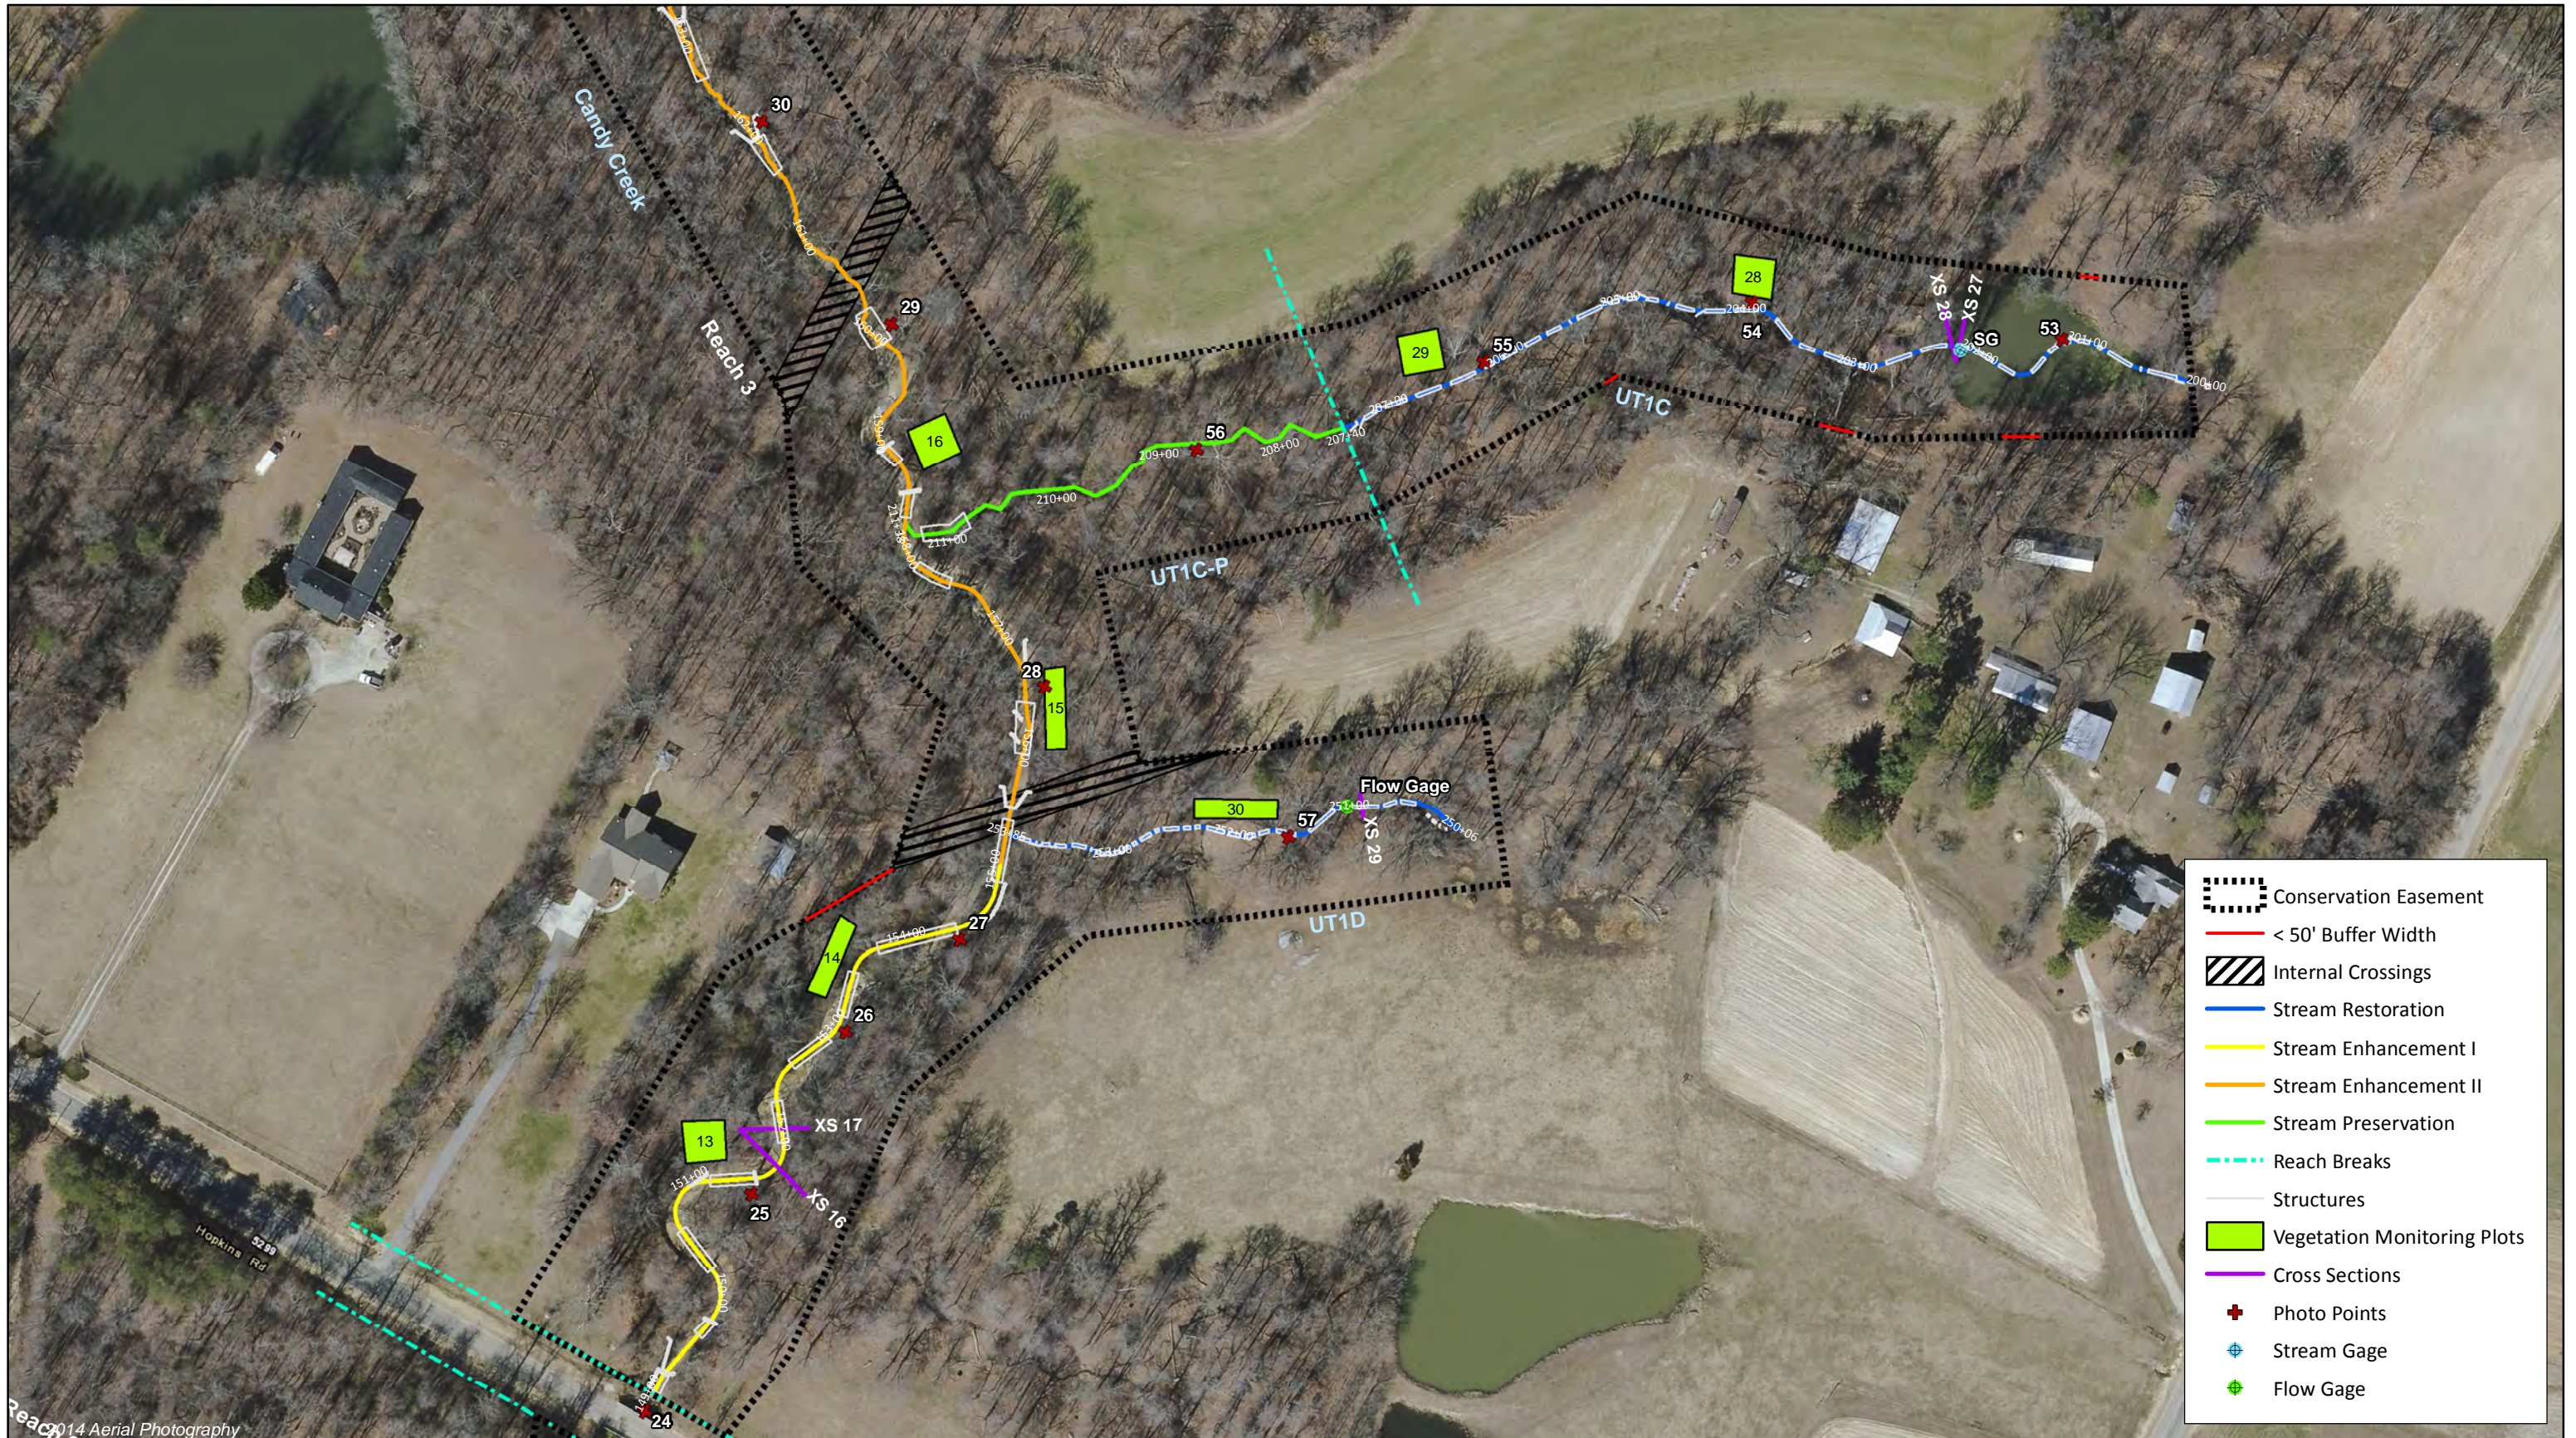
Figure 3.5 Monitoring Plan View  
 Candy Creek Mitigation Site  
 DMS Project No. 96315  
 Monitoring Year 0 - 2017  
 Guilford County, NC

- Conservation Easement
- < 50' Buffer Width
- Internal Crossings
- Stream Restoration
- Stream Enhancement I
- Stream Enhancement II
- Stream Preservation
- Reach Breaks
- Structures
- Vegetation Monitoring Plots
- Cross Sections
- Photo Points
- Stream Gage
- Flow Gage

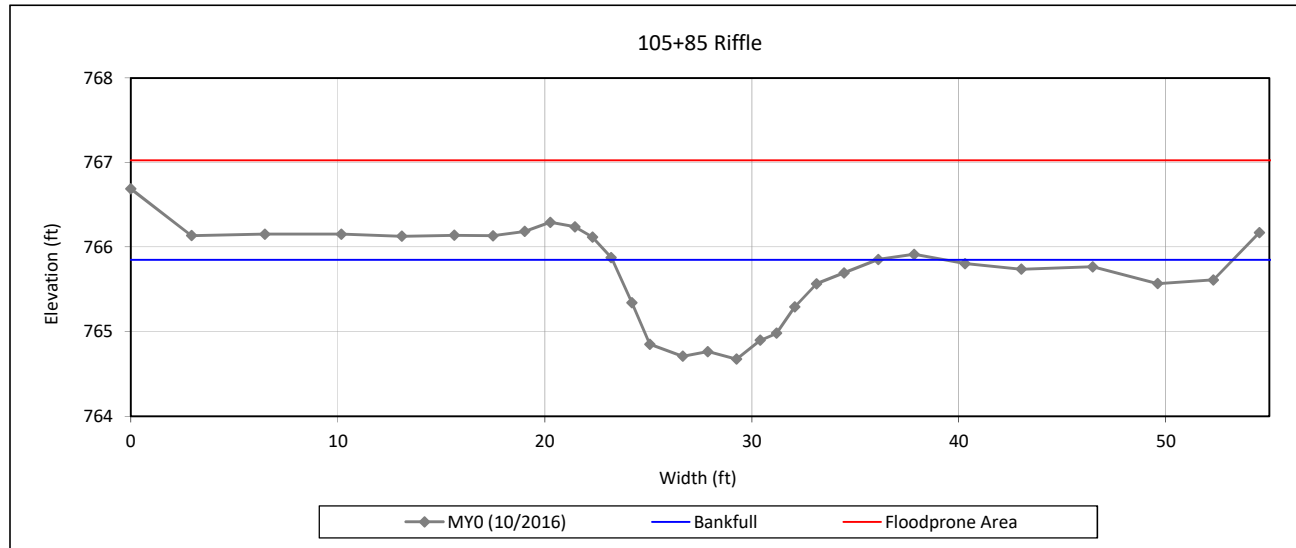
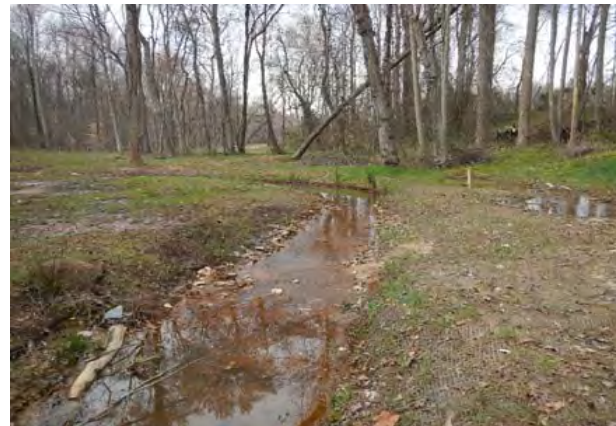
### Cross Section 1 - Candy Creek Reach 1

8.9	x-section area (ft.sq.)
12.8	width (ft)
0.7	mean depth (ft)
1.2	max depth (ft)
13.2	wetted perimeter (ft)
0.7	hydraulic radius (ft)
18.4	width-depth ratio
71.0	W flood prone area (ft)
5.5	entrenchment ratio
1.0	low bank height ratio

Survey Date: 10/2016

View Downstream

In order to monitor the channel dimension, 48 permanent cross sections were installed per DMS guidance along the stream restoration and enhancement I reaches. Each cross section is permanently marked with rebar installed in concrete and marked with PVC pipes. Cross section surveys include points measured at all breaks in slope, including top of bank, bankfull, edge of water, and thalweg. If bank erosion is observed within permanent cross sections during the monitoring period, an array of bank pins will be installed in the permanent cross section where erosion is occurring for reaches with bankfull widths large enough to warrant bank pin monitoring. Bank pins will be installed on the outside bend of the cross section in at least three locations (one in upper third of the pool, one at the permanent cross section, and one in the lower third of the pool). Bank pins will be monitored by measuring exposed rebar and maintaining pins flush to bank to capture bank erosion progression. Cross section and bank pin surveys (if applicable) will be conducted in monitoring years one (MY1), two (MY2), three (MY3), five (MY5), and seven (MY7). Photographs will be taken annually of the cross sections looking upstream and downstream.

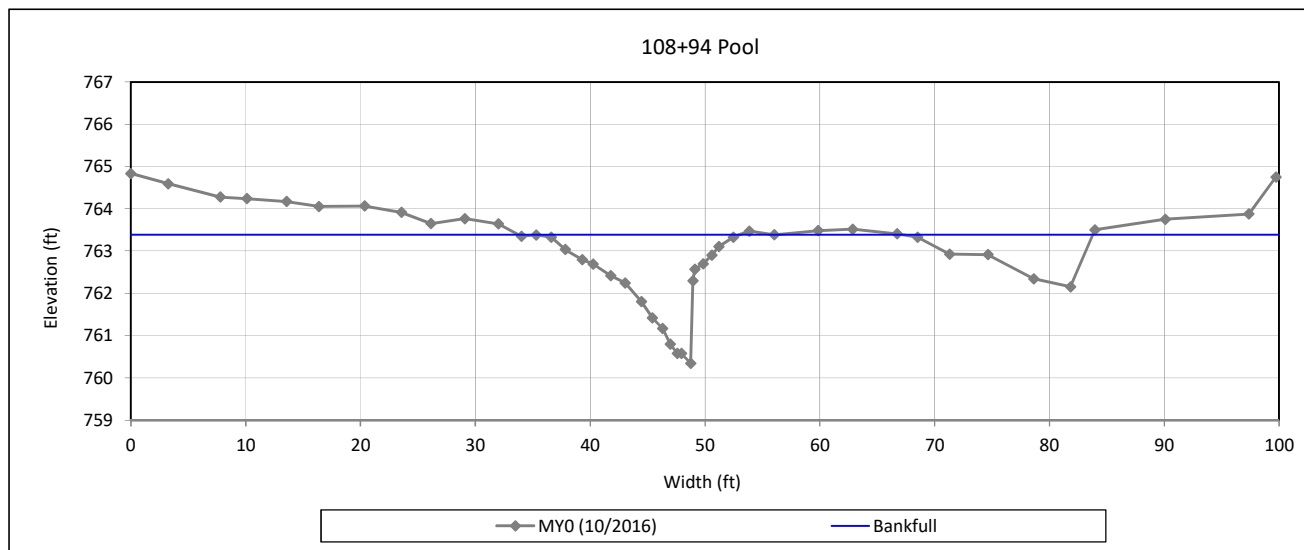
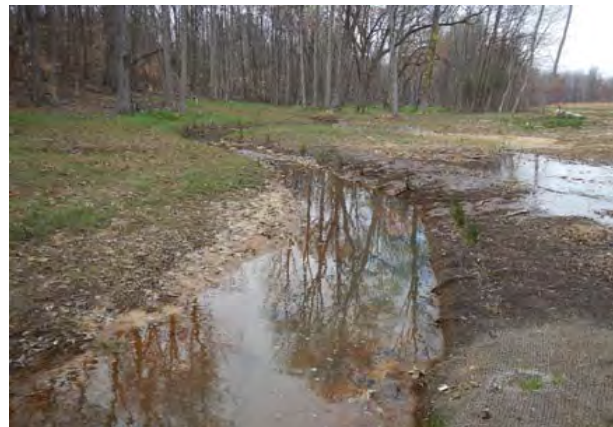
### Cross Section 2 - Candy Creek Reach 1

18.4	x-section area (ft.sq.)
18.7	width (ft)
1.0	mean depth (ft)
3.0	max depth (ft)
21.2	wetted perimeter (ft)
0.9	hydraulic radius (ft)
19.0	width-depth ratio

Survey Date: 10/2016  
Field Crew: Kee Mapping & Surveying

View Downstream

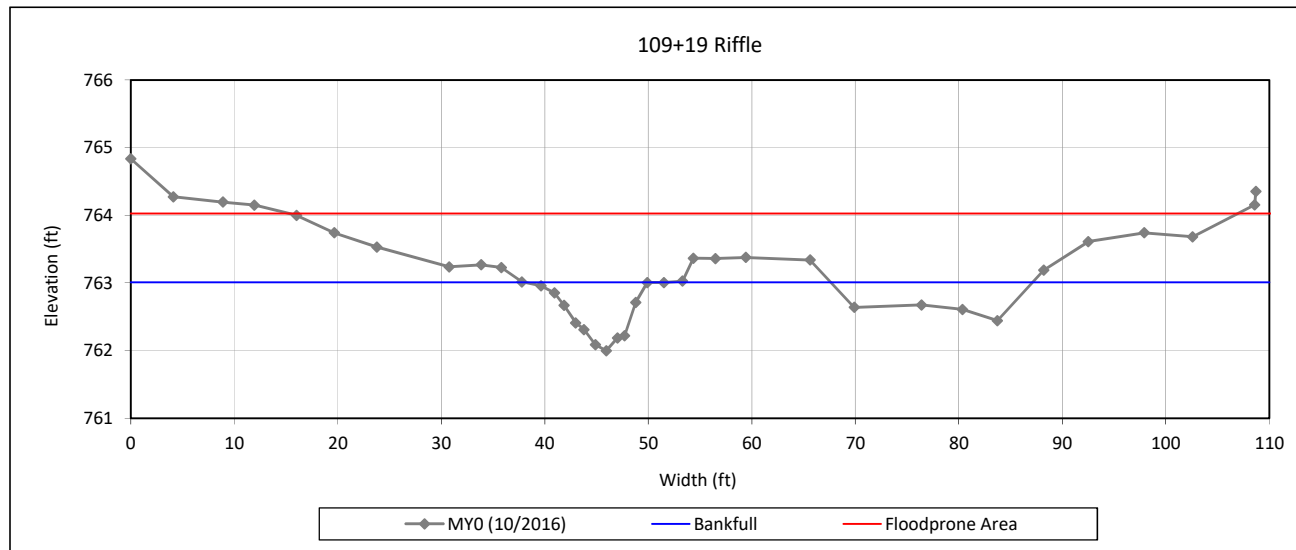
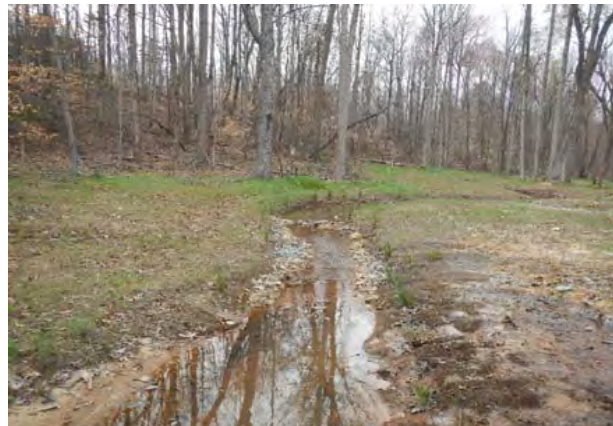
### Cross Section 3 - Candy Creek Reach 1

5.7	x-section area (ft.sq.)
12.0	width (ft)
0.5	mean depth (ft)
1.0	max depth (ft)
12.2	wetted perimeter (ft)
0.5	hydraulic radius (ft)
25.3	width-depth ratio
97.0	W flood prone area (ft)
8.1	entrenchment ratio
1.0	low bank height ratio

Survey Date: 10/2016

View Downstream

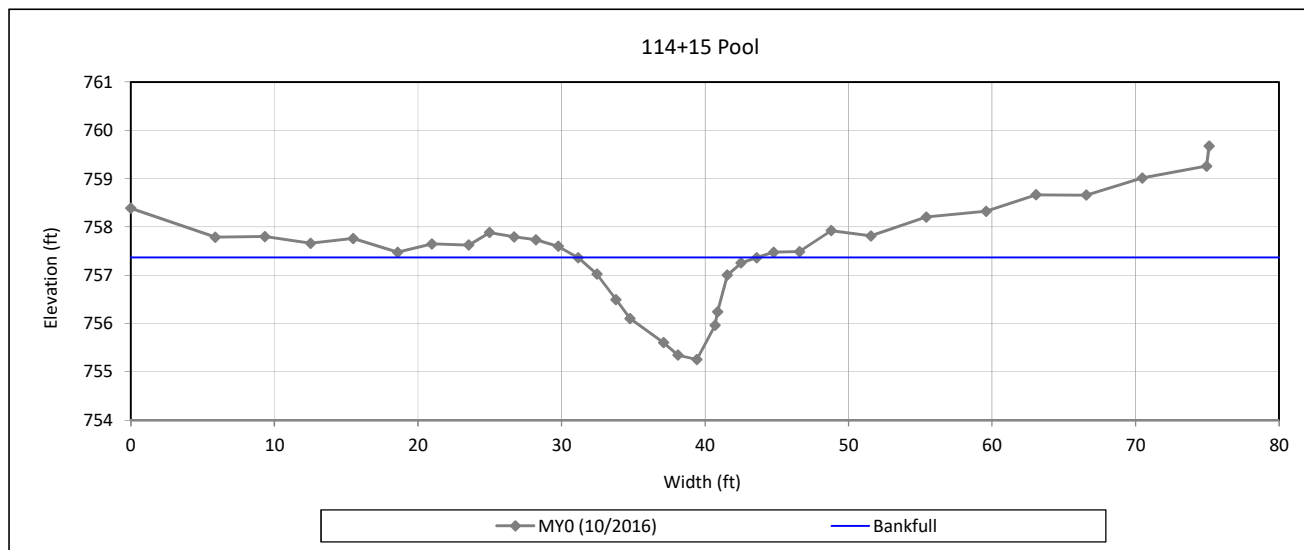
#### Cross Section 4 - Candy Creek Reach 1

13.5	x-section area (ft.sq.)
12.5	width (ft)
1.1	mean depth (ft)
2.1	max depth (ft)
13.6	wetted perimeter (ft)
1.0	hydraulic radius (ft)
11.6	width-depth ratio

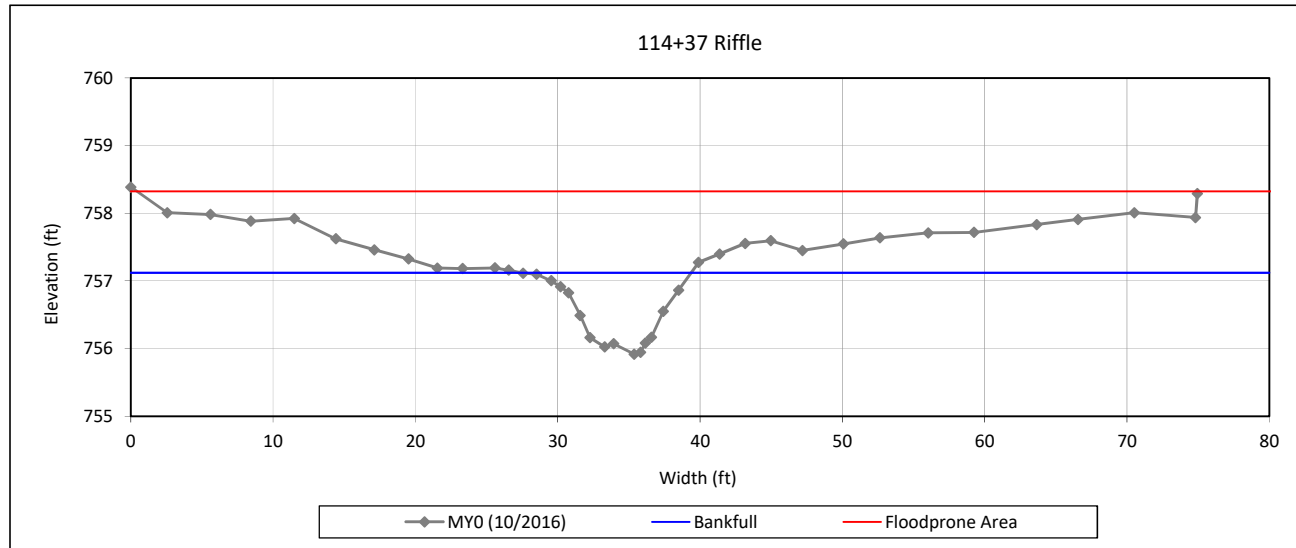
### Cross Section 5 - Candy Creek Reach 1

7.1	x-section area (ft.sq.)
11.9	width (ft)
0.6	mean depth (ft)
1.2	max depth (ft)
12.3	wetted perimeter (ft)
0.6	hydraulic radius (ft)
19.9	width-depth ratio
53.0	W flood prone area (ft)
4.4	entrenchment ratio
1.0	low bank height ratio

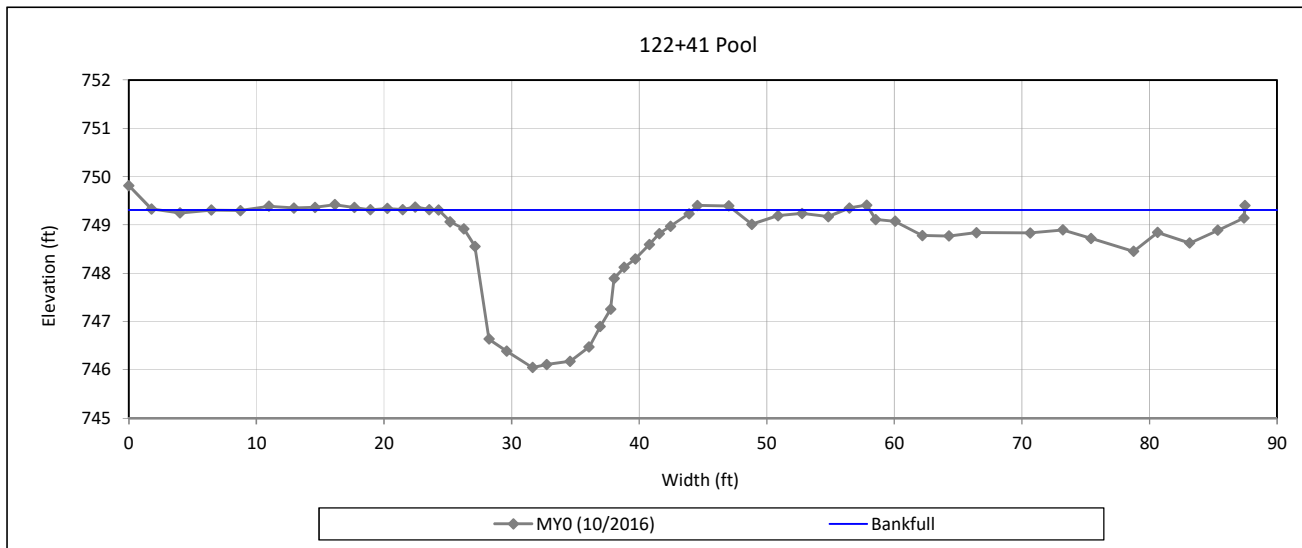
#### Cross Section 6 - Candy Creek Reach 1

35.5	x-section area (ft.sq.)
19.9	width (ft)
1.8	mean depth (ft)
3.3	max depth (ft)
22.0	wetted perimeter (ft)
1.6	hydraulic radius (ft)
11.2	width-depth ratio

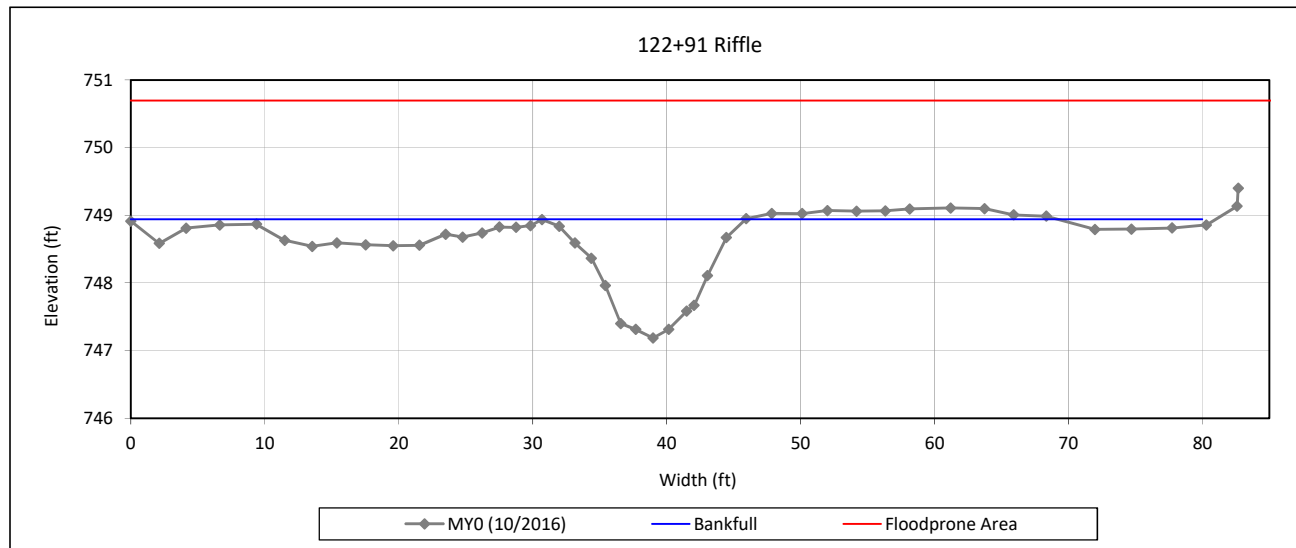
### Cross Section 7 - Candy Creek Reach 1

13.9	x-section area (ft.sq.)
16.1	width (ft)
0.9	mean depth (ft)
1.8	max depth (ft)
16.6	wetted perimeter (ft)
0.8	hydraulic radius (ft)
18.6	width-depth ratio
164.0	W flood prone area (ft)
10.2	entrenchment ratio
1.0	low bank height ratio

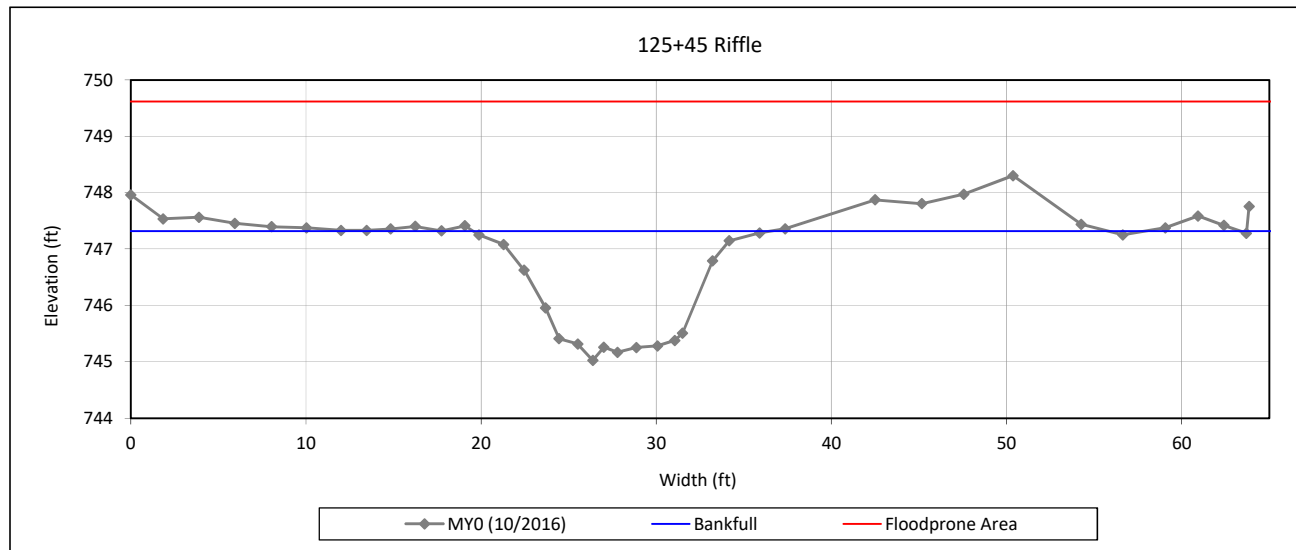
### Cross Section 8 - Candy Creek Reach 1

20.3	x-section area (ft.sq.)
17.0	width (ft)
1.2	mean depth (ft)
2.3	max depth (ft)
18.1	wetted perimeter (ft)
1.1	hydraulic radius (ft)
14.3	width-depth ratio
292.0	W flood prone area (ft)
17.1	entrenchment ratio
1.0	low bank height ratio

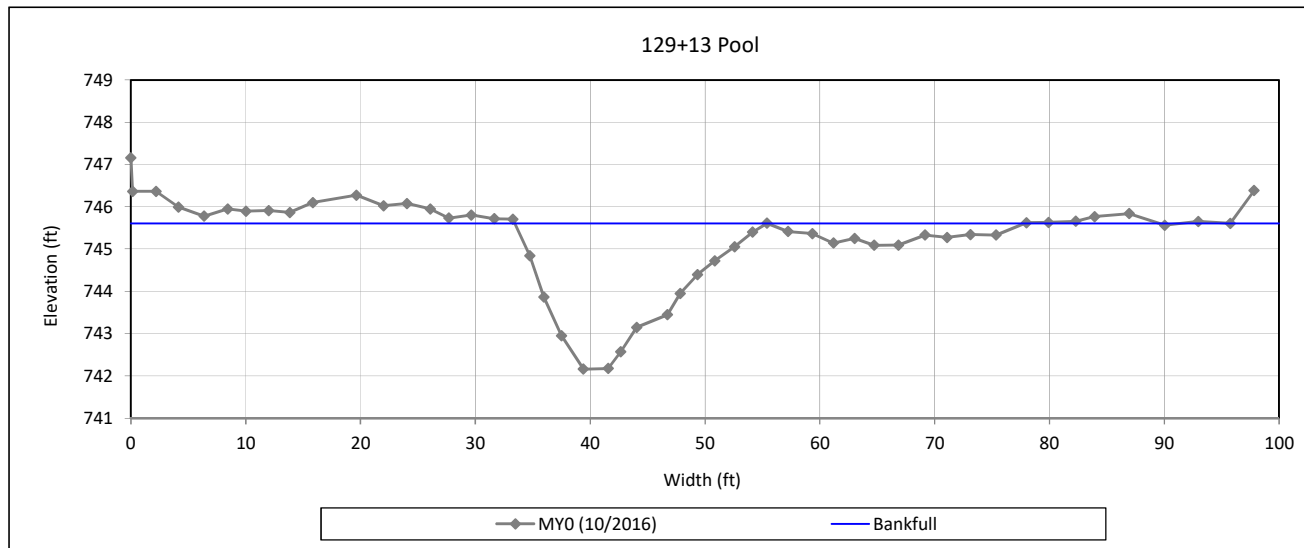
### Cross Section 9 - Candy Creek Reach 2

40.1	x-section area (ft.sq.)
22.0	width (ft)
1.8	mean depth (ft)
3.5	max depth (ft)
23.4	wetted perimeter (ft)
1.7	hydraulic radius (ft)
12.0	width-depth ratio

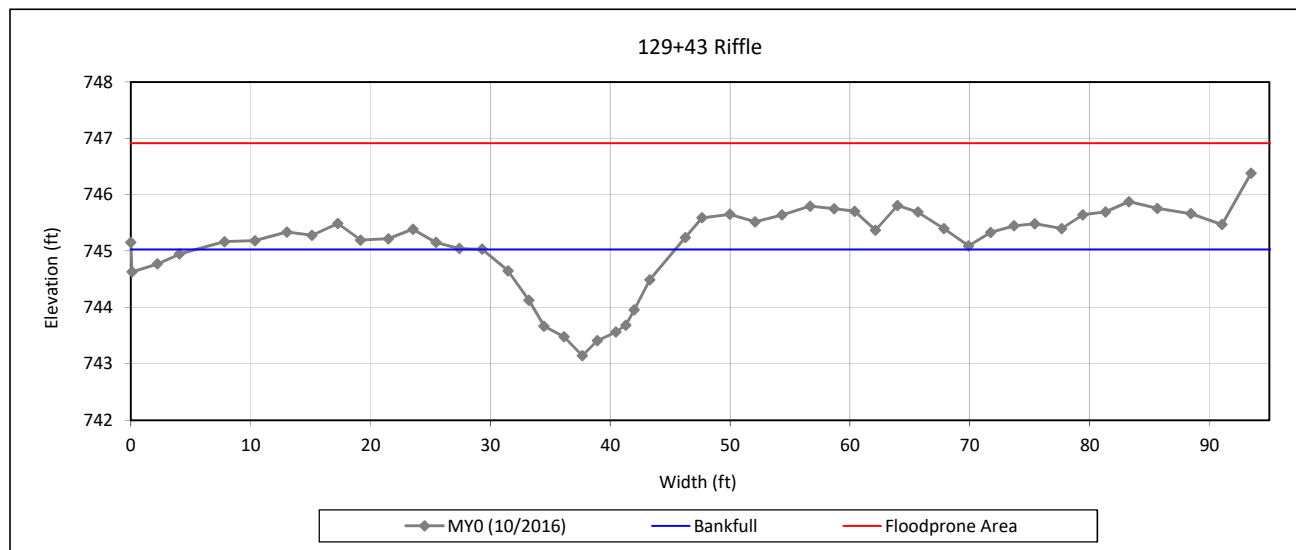
### Cross Section 10 - Candy Creek Reach 2

16.2	x-section area (ft.sq.)
16.1	width (ft)
1.0	mean depth (ft)
1.9	max depth (ft)
16.6	wetted perimeter (ft)
1.0	hydraulic radius (ft)
16.0	width-depth ratio
254.0	W flood prone area (ft)
15.8	entrenchment ratio
1.0	low bank height ratio

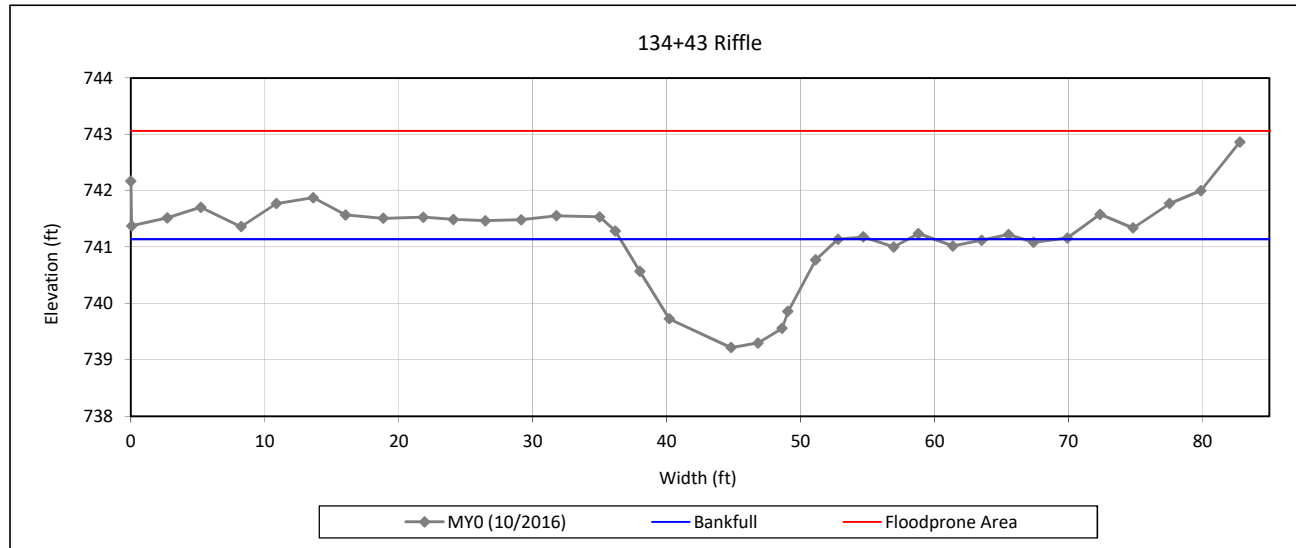
### Cross Section 11 - Candy Creek Reach 2

19.8	x-section area (ft.sq.)
16.3	width (ft)
1.2	mean depth (ft)
1.9	max depth (ft)
16.9	wetted perimeter (ft)
1.2	hydraulic radius (ft)
13.3	width-depth ratio
154.0	W flood prone area (ft)
9.5	entrenchment ratio
1.0	low bank height ratio

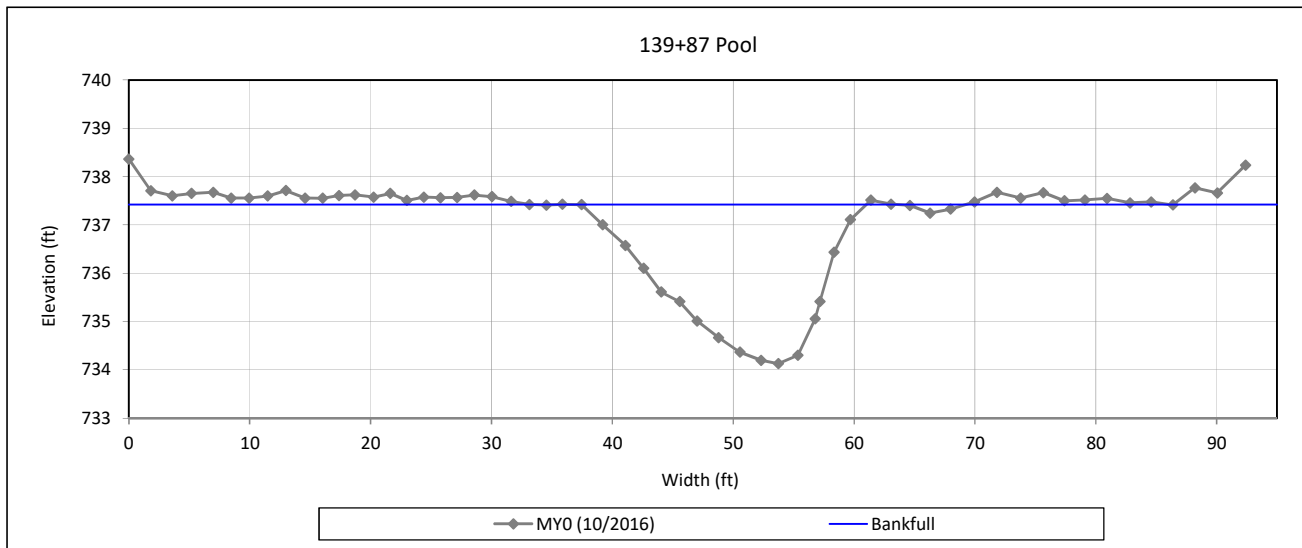
### Cross Section 12 - Candy Creek Reach 2

44.2	x-section area (ft.sq.)
23.6	width (ft)
1.9	mean depth (ft)
3.3	max depth (ft)
24.9	wetted perimeter (ft)
1.8	hydraulic radius (ft)
12.6	width-depth ratio

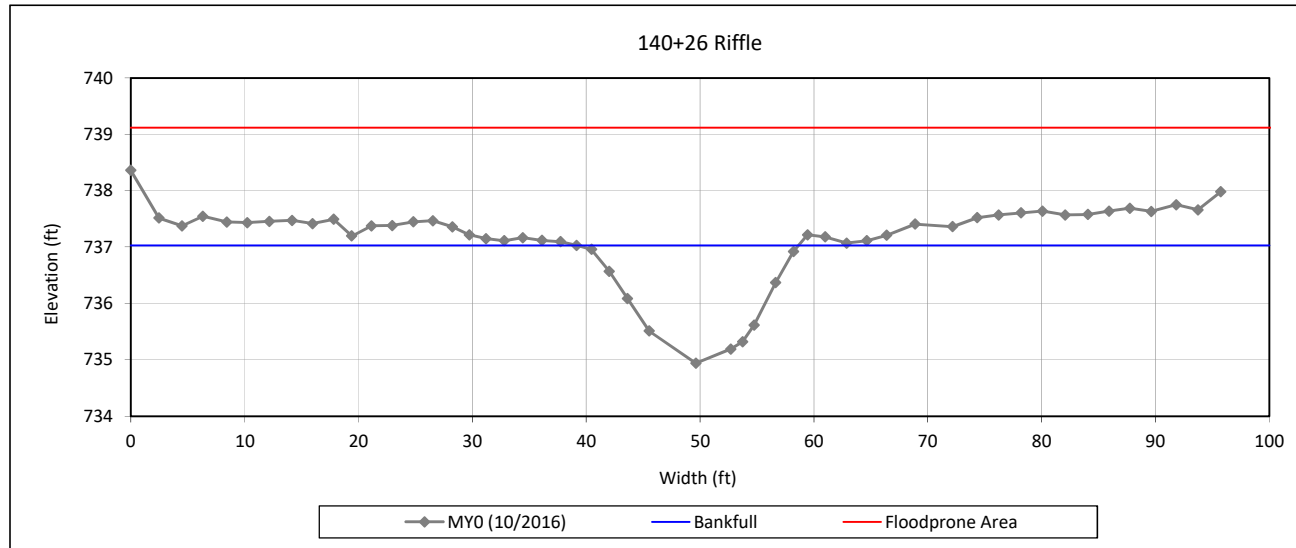
### Cross Section 13 - Candy Creek Reach 2

23.3	x-section area (ft.sq.)
19.5	width (ft)
1.2	mean depth (ft)
2.1	max depth (ft)
20.1	wetted perimeter (ft)
1.2	hydraulic radius (ft)
16.3	width-depth ratio
221.0	W flood prone area (ft)
11.3	entrenchment ratio
1.0	low bank height ratio

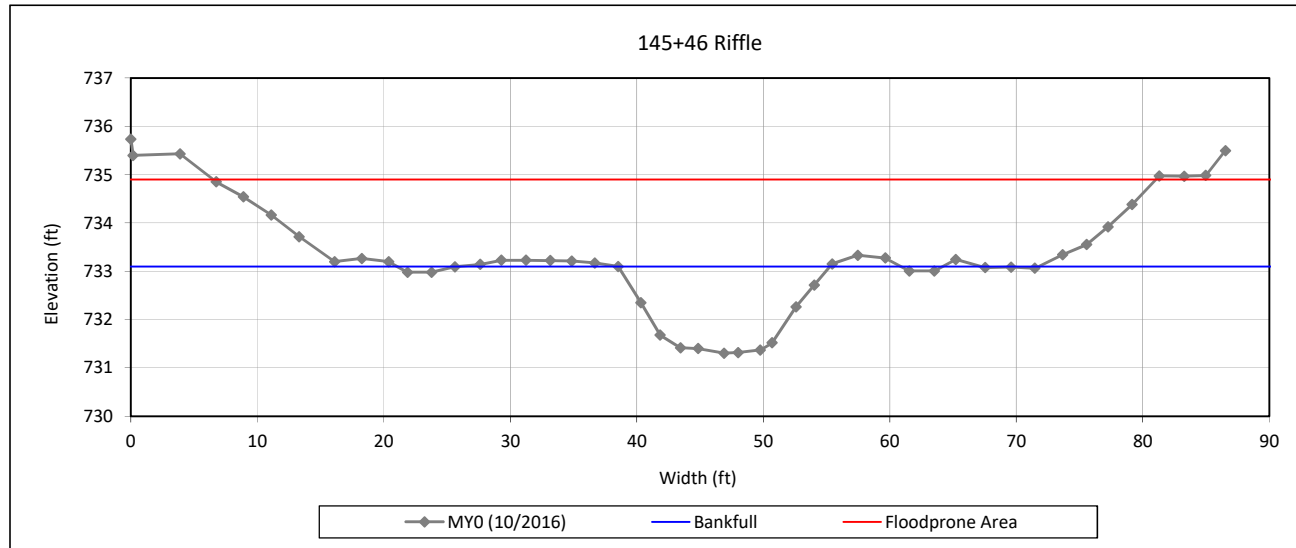
### Cross Section 14 - Candy Creek Reach 2

20.8	x-section area (ft.sq.)
16.7	width (ft)
1.2	mean depth (ft)
1.8	max depth (ft)
17.3	wetted perimeter (ft)
1.2	hydraulic radius (ft)
13.5	width-depth ratio
164.0	W flood prone area (ft)
9.8	entrenchment ratio
1.0	low bank height ratio

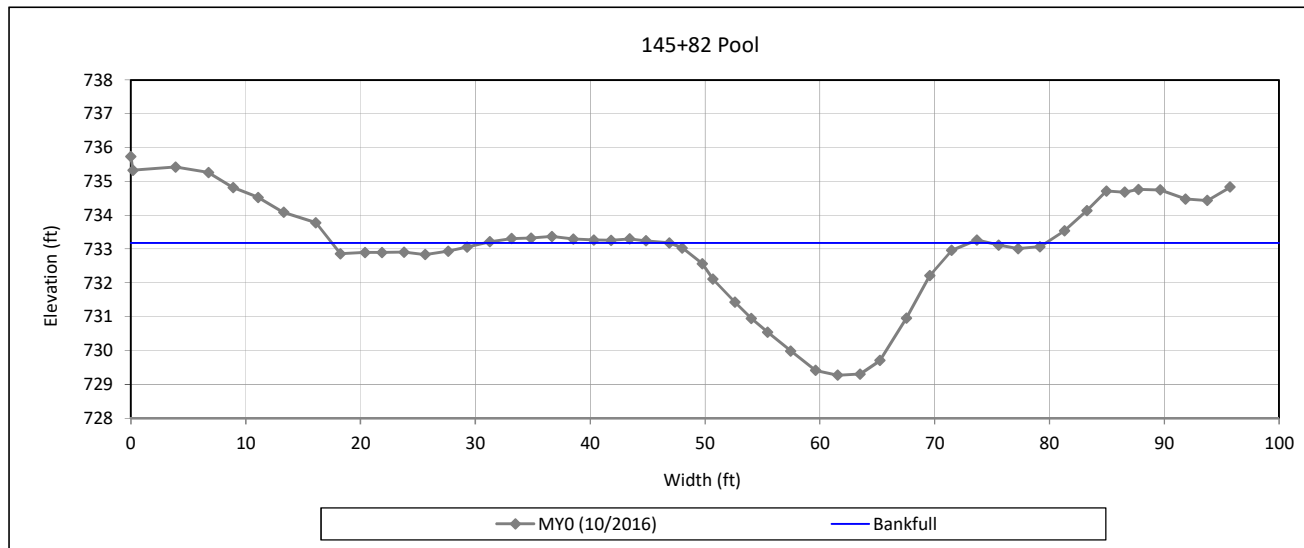
### Cross Section 15 - Candy Creek Reach 2

56.4	x-section area (ft.sq.)
26.1	width (ft)
2.2	mean depth (ft)
3.9	max depth (ft)
27.6	wetted perimeter (ft)
2.0	hydraulic radius (ft)
12.1	width-depth ratio

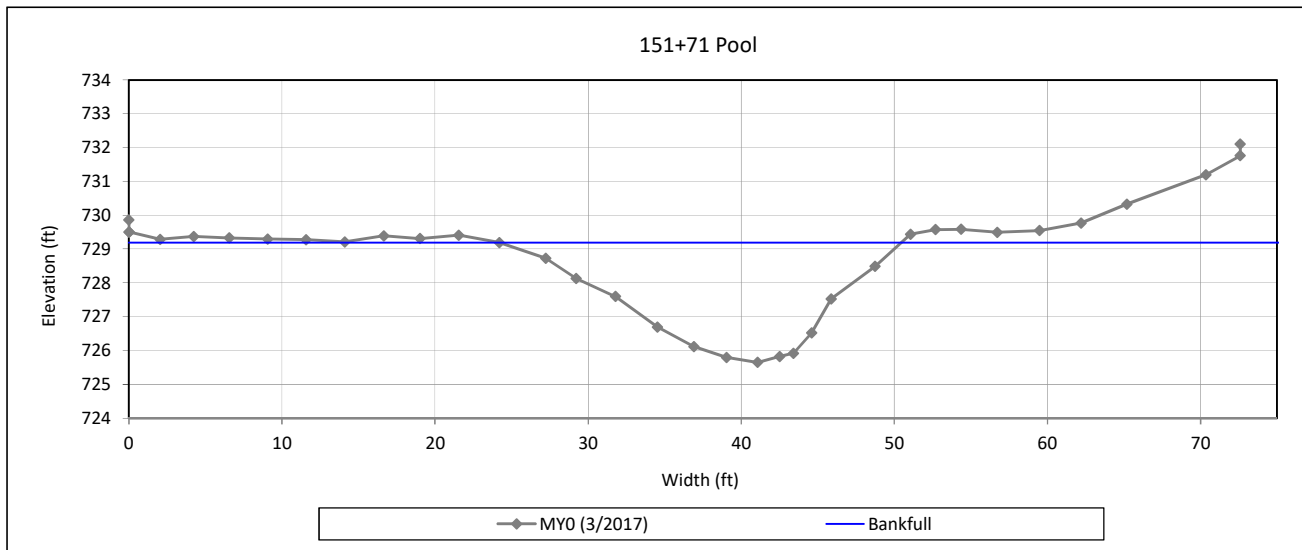
### Cross Section 16 - Candy Creek Reach 3

44.4	x-section area (ft.sq.)
18.7	width (ft)
2.4	mean depth (ft)
3.5	max depth (ft)
19.7	wetted perimeter (ft)
2.3	hydraulic radius (ft)
7.8	width-depth ratio

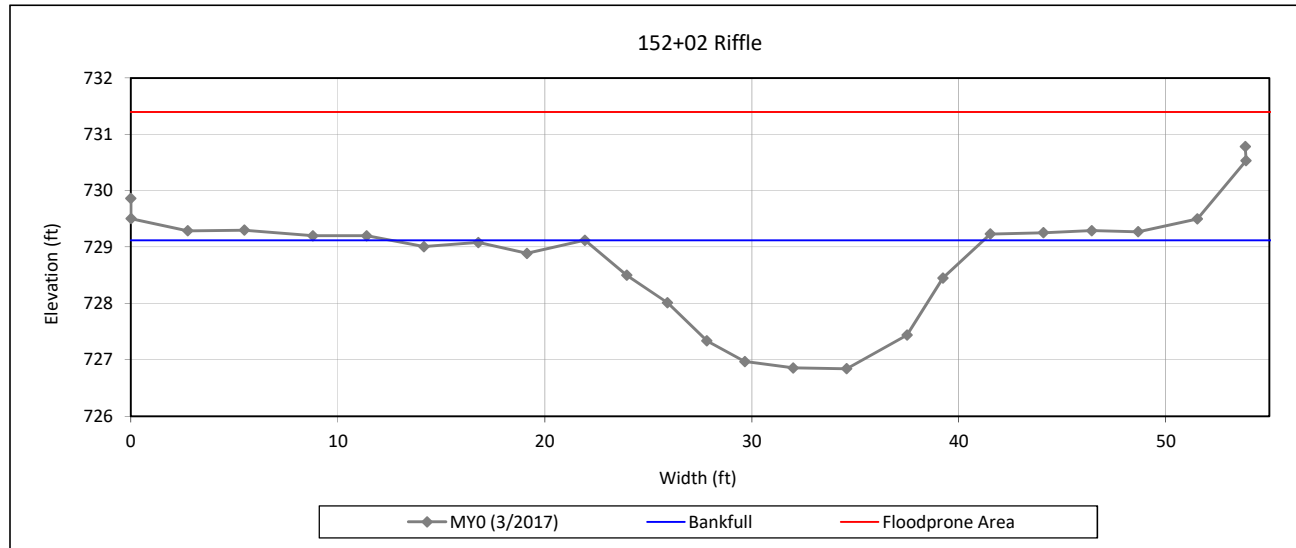
### Cross Section 17 - Candy Creek Reach 3

28.2	x-section area (ft.sq.)
19.2	width (ft)
1.5	mean depth (ft)
2.3	max depth (ft)
20.0	wetted perimeter (ft)
1.4	hydraulic radius (ft)
13.1	width-depth ratio
57.0	W flood prone area (ft)
3.0	entrenchment ratio
1.0	low bank height ratio

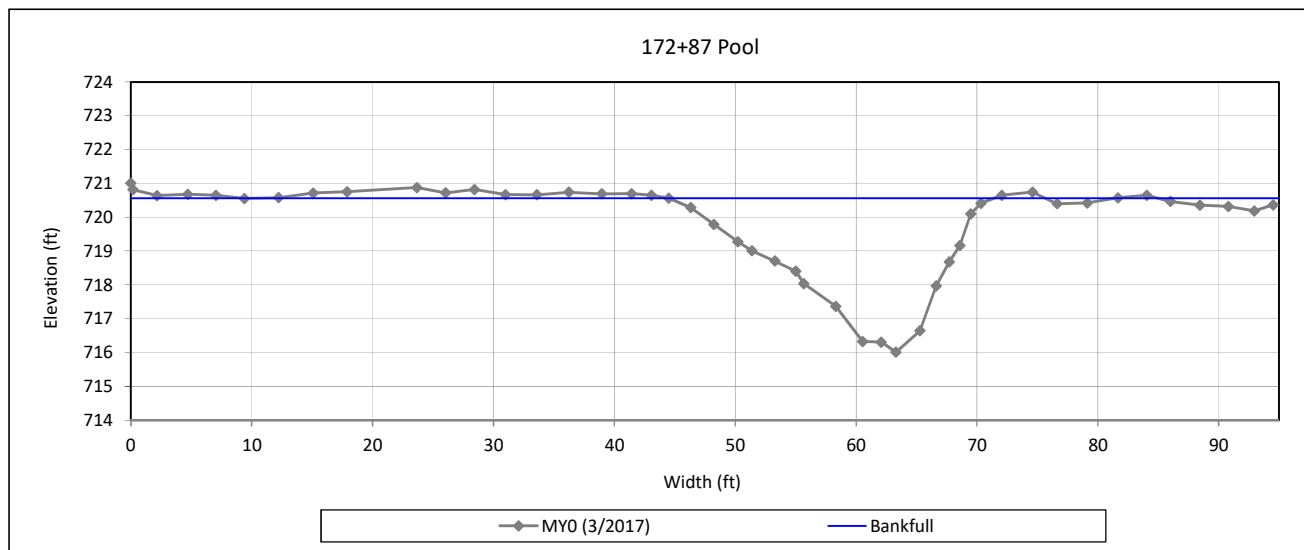
### Cross Section 18 - Candy Creek Reach 4

58.7	x-section area (ft.sq.)
26.9	width (ft)
2.2	mean depth (ft)
4.5	max depth (ft)
29.0	wetted perimeter (ft)
2.0	hydraulic radius (ft)
12.3	width-depth ratio
