# **BASELINE MONITORING DOCUMENT AND AS-BUILT BASELINE REPORT**

## **CANDY CREEK MITIGATION SITE**

Guilford County, NC  
NCDEQ Contract 5794  
DMS ID No. 96315

Data Collection Period: October 2016 – March 2017  
Final Submission Date: June 2, 2017

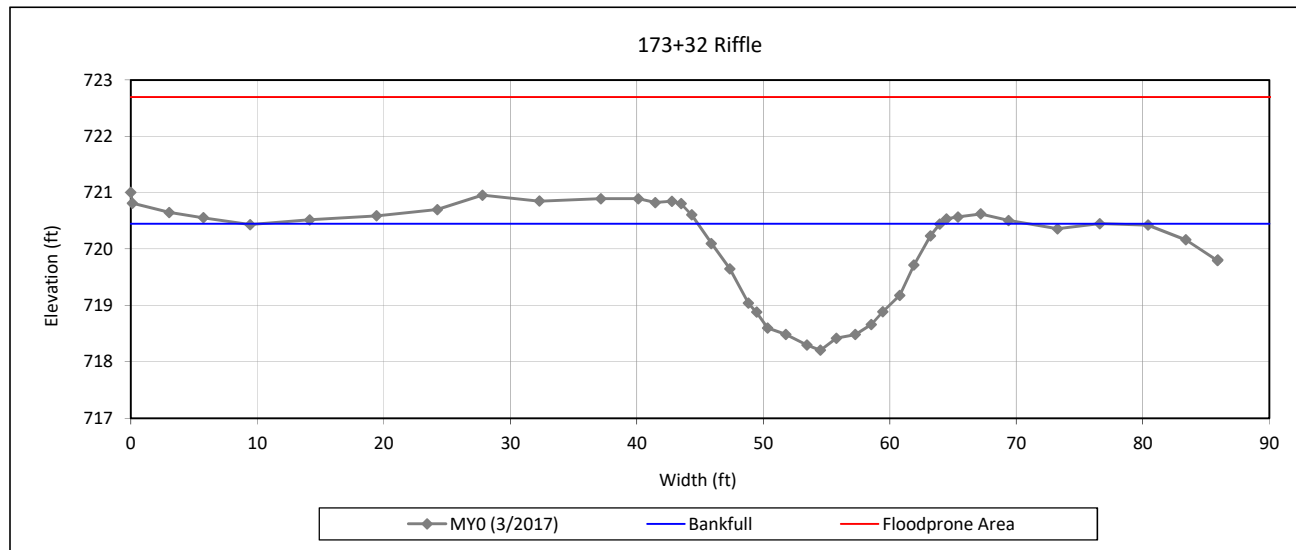
### Cross Section 19 - Candy Creek Reach 4

26.9	x-section area (ft.sq.)
19.1	width (ft)
1.4	mean depth (ft)
2.2	max depth (ft)
19.8	wetted perimeter (ft)
1.4	hydraulic radius (ft)
13.6	width-depth ratio
222.0	W flood prone area (ft)
11.6	entrenchment ratio
1.0	low bank height ratio

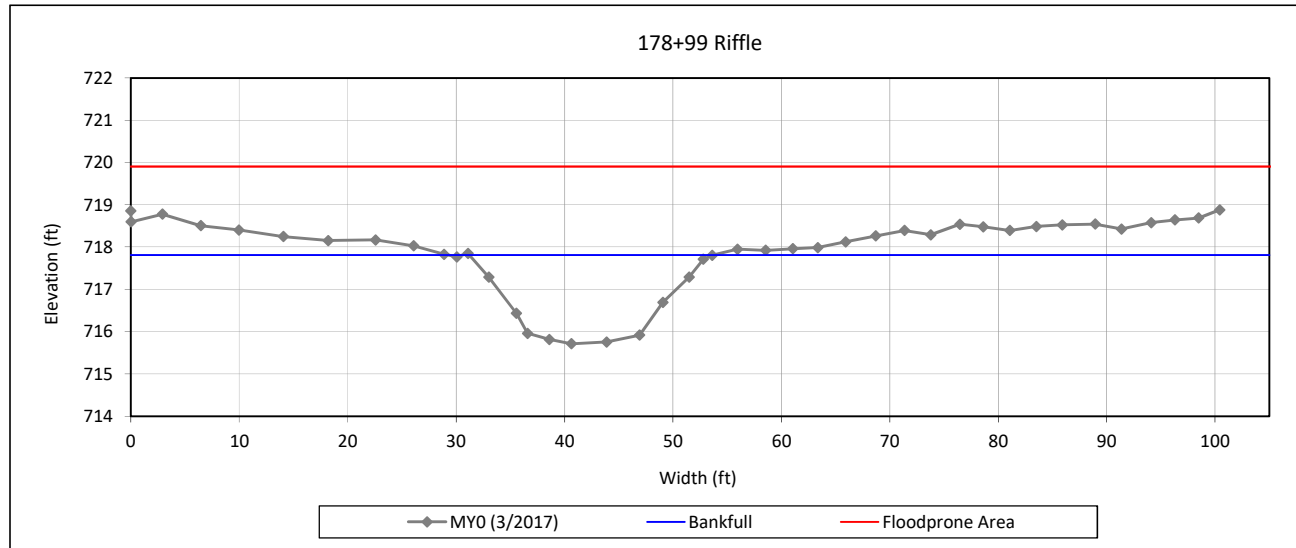
### Cross Section 20 - Candy Creek Reach 4

31.0	x-section area (ft.sq.)
22.4	width (ft)
1.4	mean depth (ft)
2.1	max depth (ft)
23.0	wetted perimeter (ft)
1.3	hydraulic radius (ft)
16.2	width-depth ratio
158.0	W flood prone area (ft)
7.1	entrenchment ratio
1.0	low bank height ratio

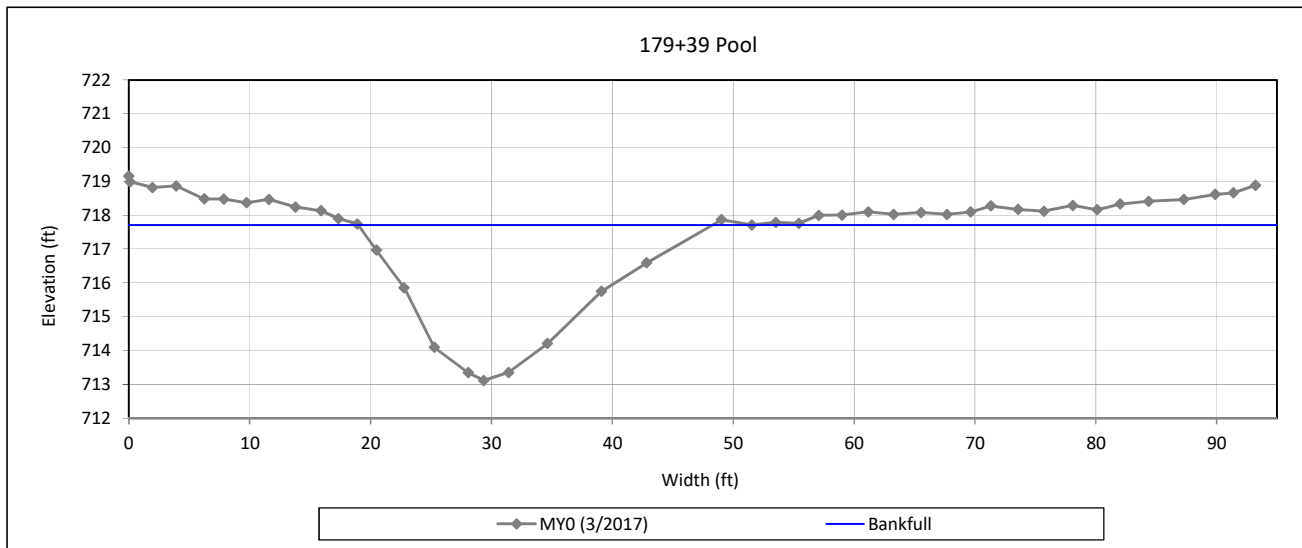
#### Cross Section 21 - Candy Creek Reach 4

70.1	x-section area (ft.sq.)
29.3	width (ft)
2.4	mean depth (ft)
4.6	max depth (ft)
31.0	wetted perimeter (ft)
2.3	hydraulic radius (ft)
12.2	width-depth ratio

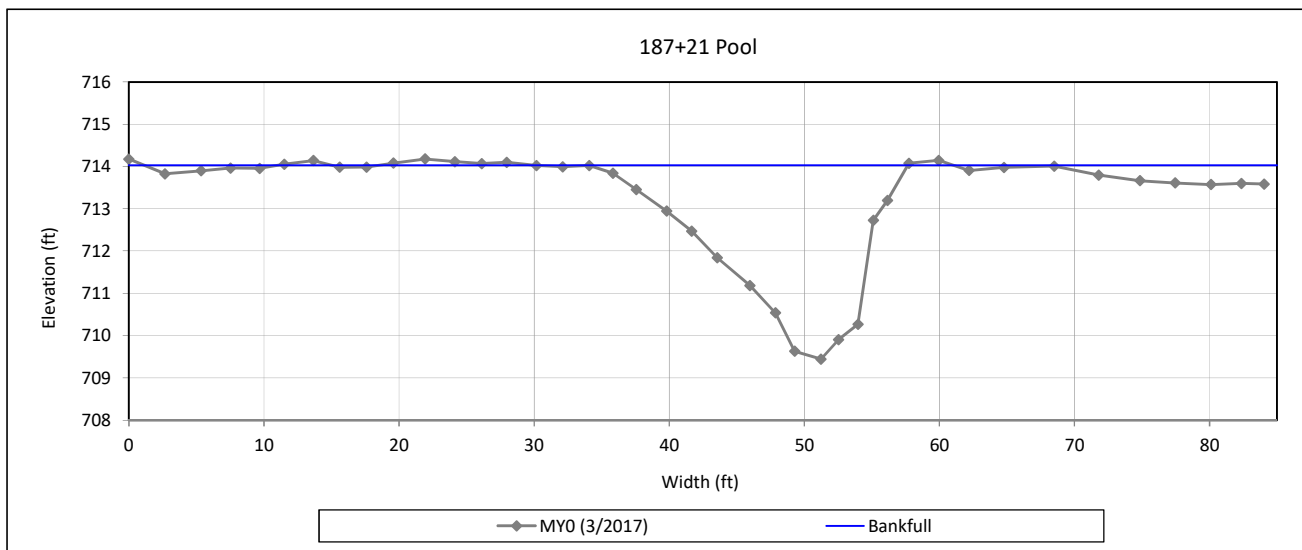
### Cross Section 22 - Candy Creek Reach 4

51.1	x-section area (ft.sq.)
23.6	width (ft)
2.2	mean depth (ft)
4.6	max depth (ft)
26.3	wetted perimeter (ft)
1.9	hydraulic radius (ft)
10.9	width-depth ratio

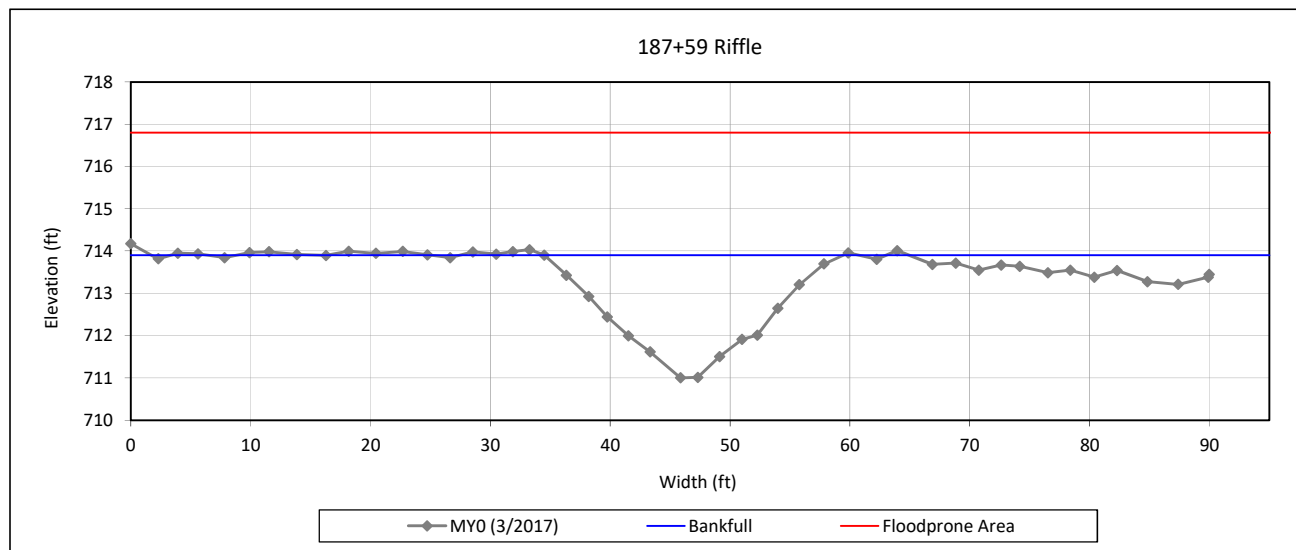
### Cross Section 23 - Candy Creek Reach 4

38.1	x-section area (ft.sq.)
24.9	width (ft)
1.5	mean depth (ft)
2.9	max depth (ft)
25.7	wetted perimeter (ft)
1.5	hydraulic radius (ft)
16.3	width-depth ratio
180.0	W flood prone area (ft)
7.2	entrenchment ratio
1.0	low bank height ratio

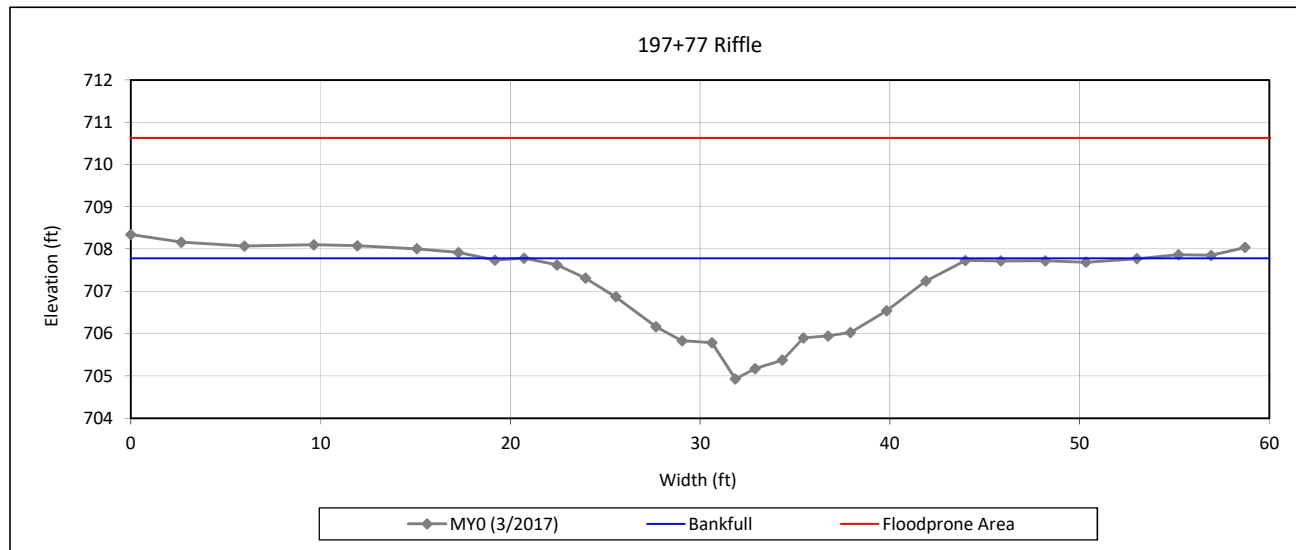
### Cross Section 24 - Candy Creek Reach 4

31.6	x-section area (ft.sq.)
23.2	width (ft)
1.4	mean depth (ft)
2.9	max depth (ft)
24.2	wetted perimeter (ft)
1.3	hydraulic radius (ft)
17.1	width-depth ratio
155.0	W flood prone area (ft)
6.7	entrenchment ratio
1.0	low bank height ratio

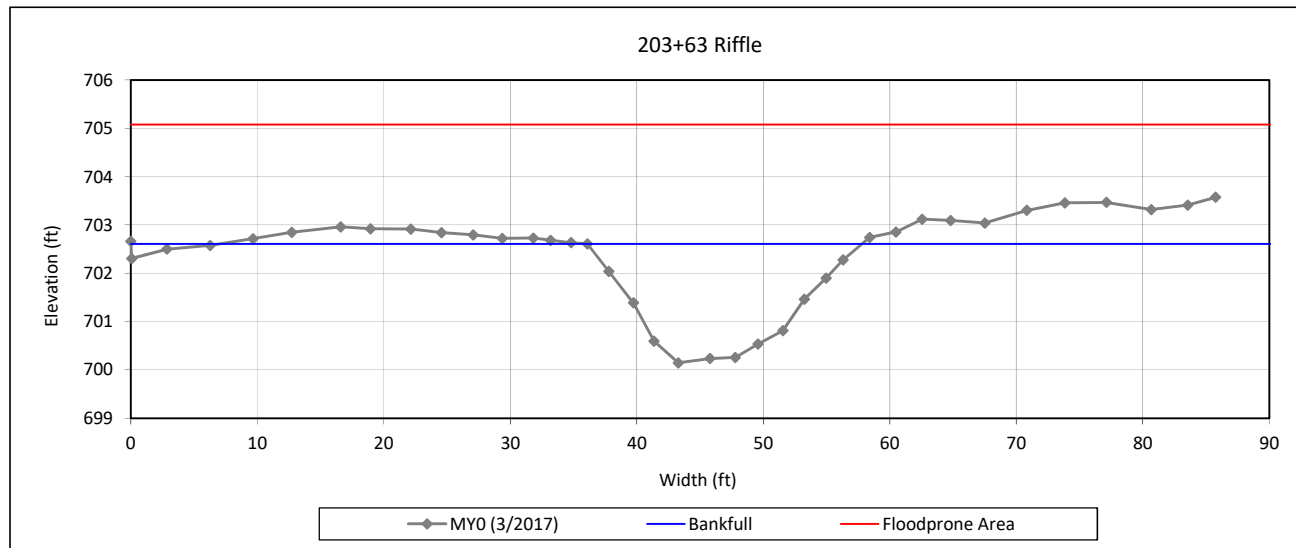
### Cross Section 25 - Candy Creek Reach 4

32.8	x-section area (ft.sq.)
21.7	width (ft)
1.5	mean depth (ft)
2.5	max depth (ft)
22.5	wetted perimeter (ft)
1.5	hydraulic radius (ft)
14.4	width-depth ratio
132.0	W flood prone area (ft)
6.1	entrenchment ratio
1.0	low bank height ratio

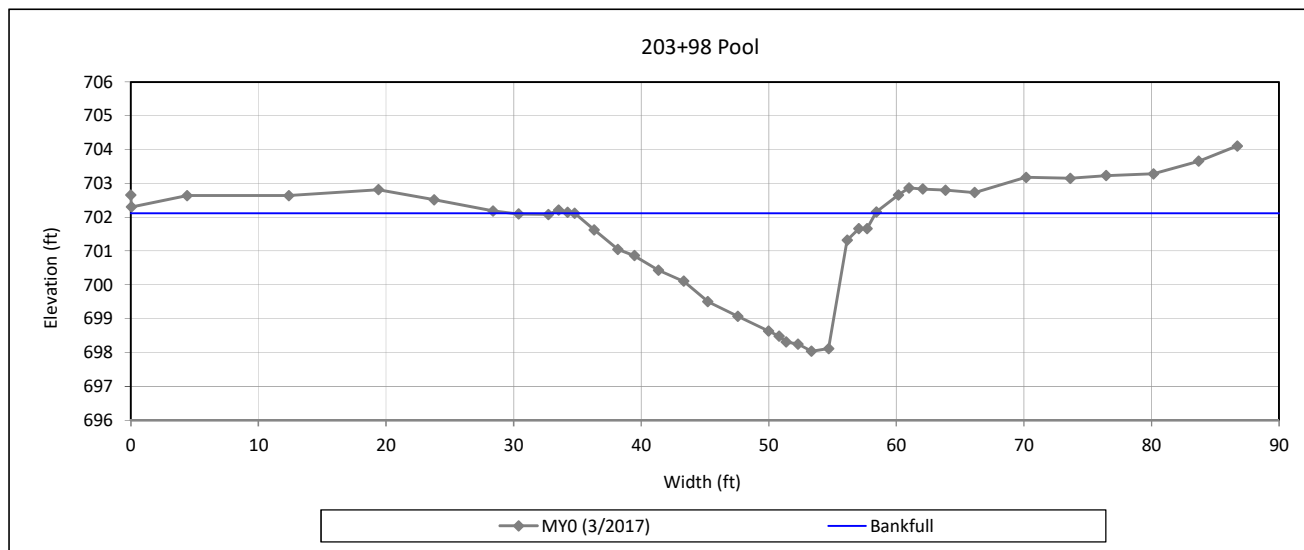
### Cross Section 26 - Candy Creek Reach 4

51.3	x-section area (ft.sq.)
23.6	width (ft)
2.2	mean depth (ft)
4.1	max depth (ft)
26.4	wetted perimeter (ft)
1.9	hydraulic radius (ft)
10.8	width-depth ratio

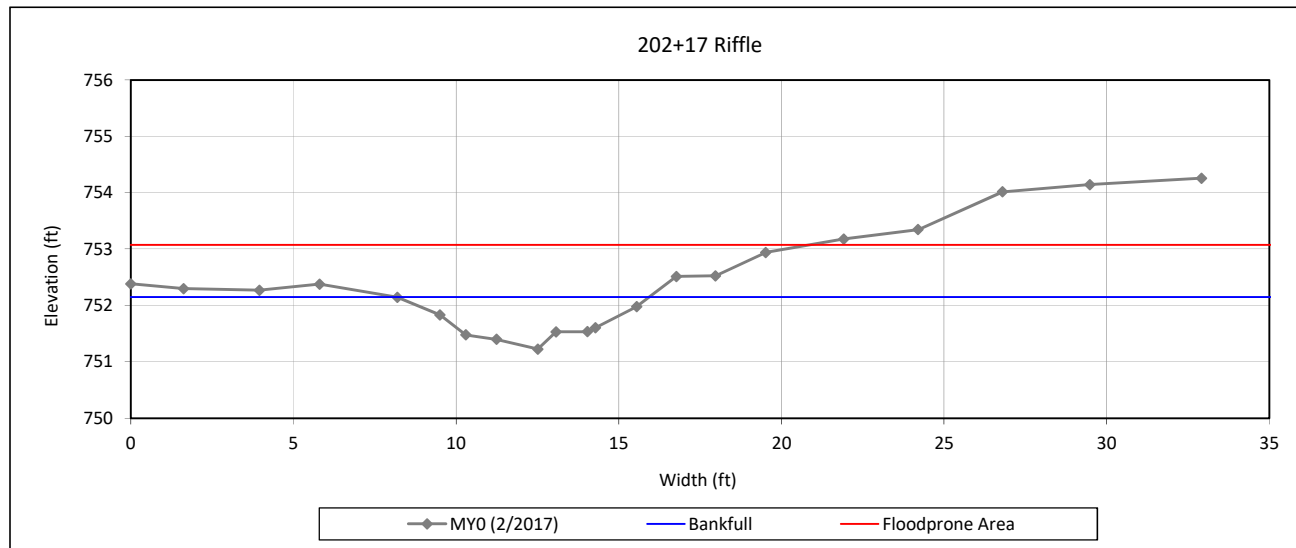
### Cross Section 27 - UT1C

4.0	x-section area (ft.sq.)
7.8	width (ft)
0.5	mean depth (ft)
0.9	max depth (ft)
8.1	wetted perimeter (ft)
0.5	hydraulic radius (ft)
15.0	width-depth ratio
28.0	W flood prone area (ft)
3.6	entrenchment ratio
1.0	low bank height ratio

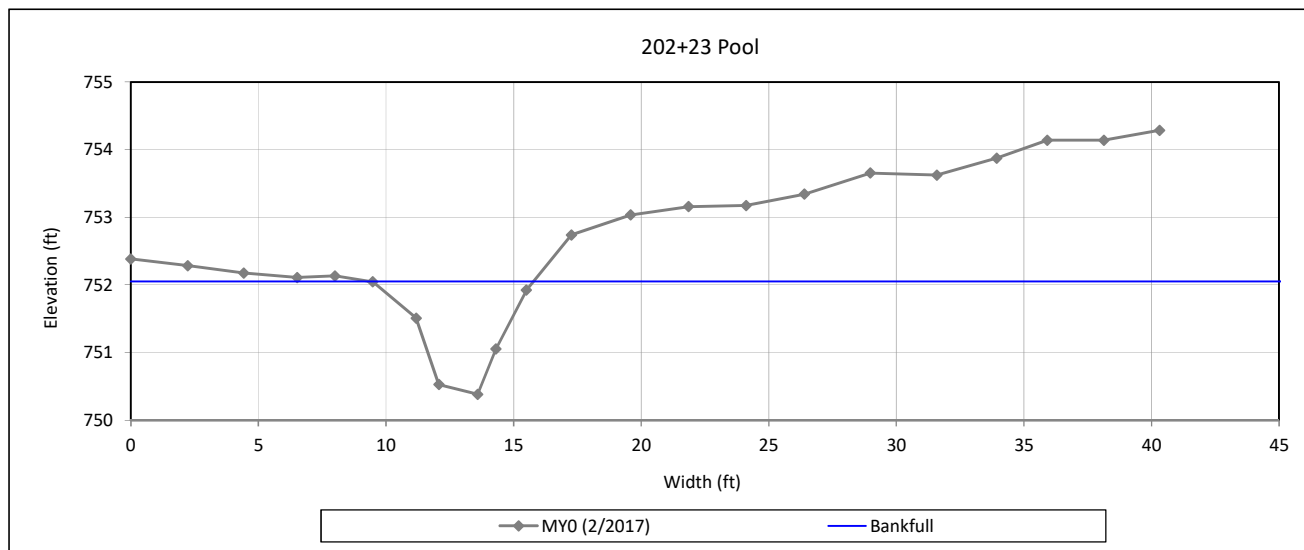
### Cross Section 28 - UT1C

5.4	x-section area (ft.sq.)
6.4	width (ft)
0.9	mean depth (ft)
1.7	max depth (ft)
7.5	wetted perimeter (ft)
0.7	hydraulic radius (ft)
7.5	width-depth ratio

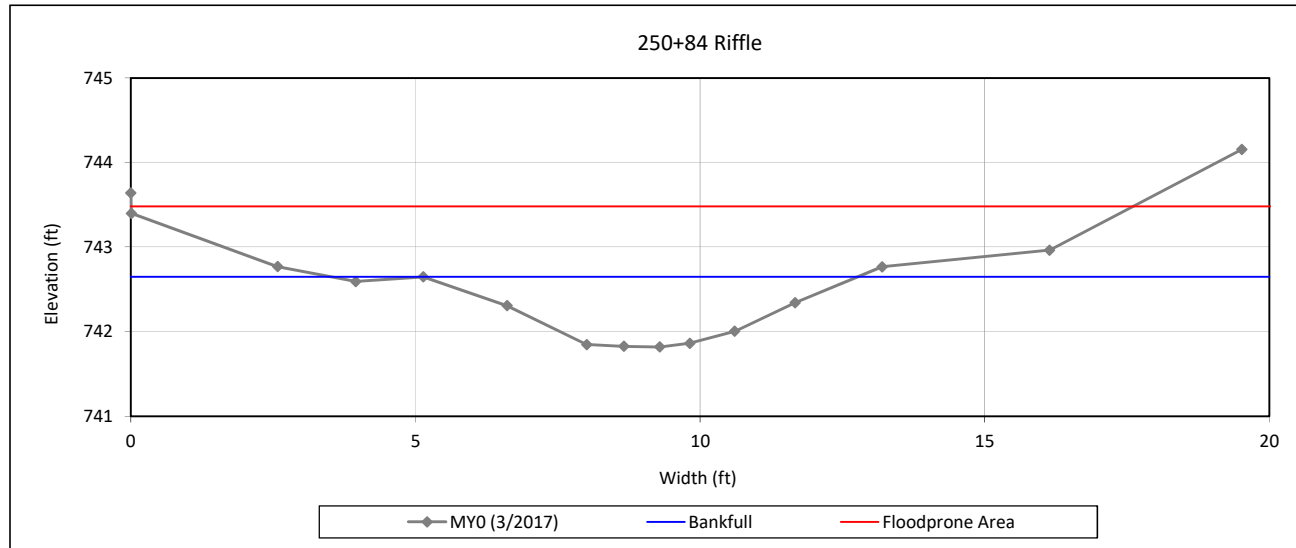
### Cross Section 29 - UT1D

3.8	x-section area (ft.sq.)
7.6	width (ft)
0.5	mean depth (ft)
0.8	max depth (ft)
7.9	wetted perimeter (ft)
0.5	hydraulic radius (ft)
15.4	width-depth ratio
15.0	W flood prone area (ft)
2.0	entrenchment ratio
1.0	low bank height ratio

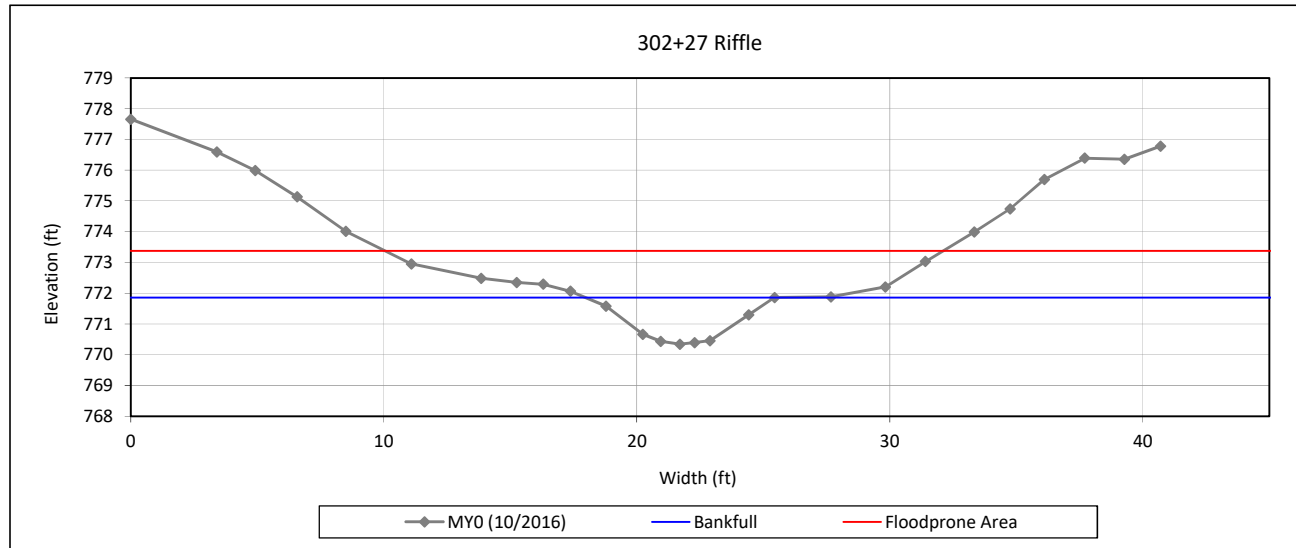
### Cross Section 30 - UT2 Reach 1

6.8	x-section area (ft.sq.)
7.5	width (ft)
0.9	mean depth (ft)
1.5	max depth (ft)
8.2	wetted perimeter (ft)
0.8	hydraulic radius (ft)
8.3	width-depth ratio
22.0	W flood prone area (ft)
2.9	entrenchment ratio
1.0	low bank height ratio

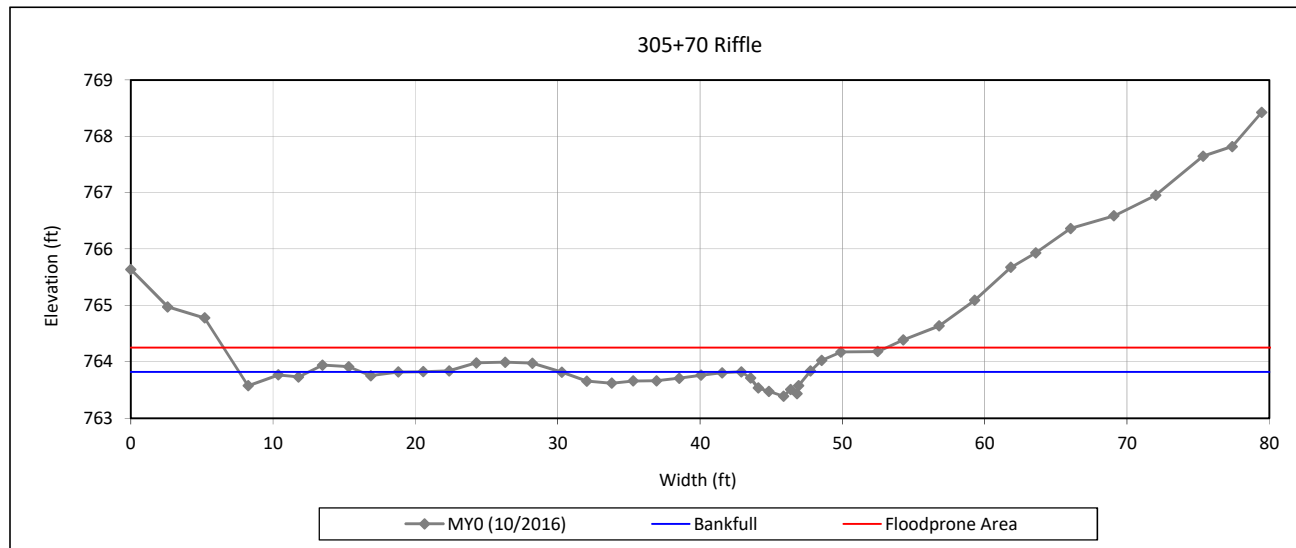
### Cross Section 31 - UT2 Reach 1

1.2	x-section area (ft.sq.)
4.8	width (ft)
0.3	mean depth (ft)
0.4	max depth (ft)
5.0	wetted perimeter (ft)
0.3	hydraulic radius (ft)
18.5	width-depth ratio
47.0	W flood prone area (ft)
9.8	entrenchment ratio
1.0	low bank height ratio

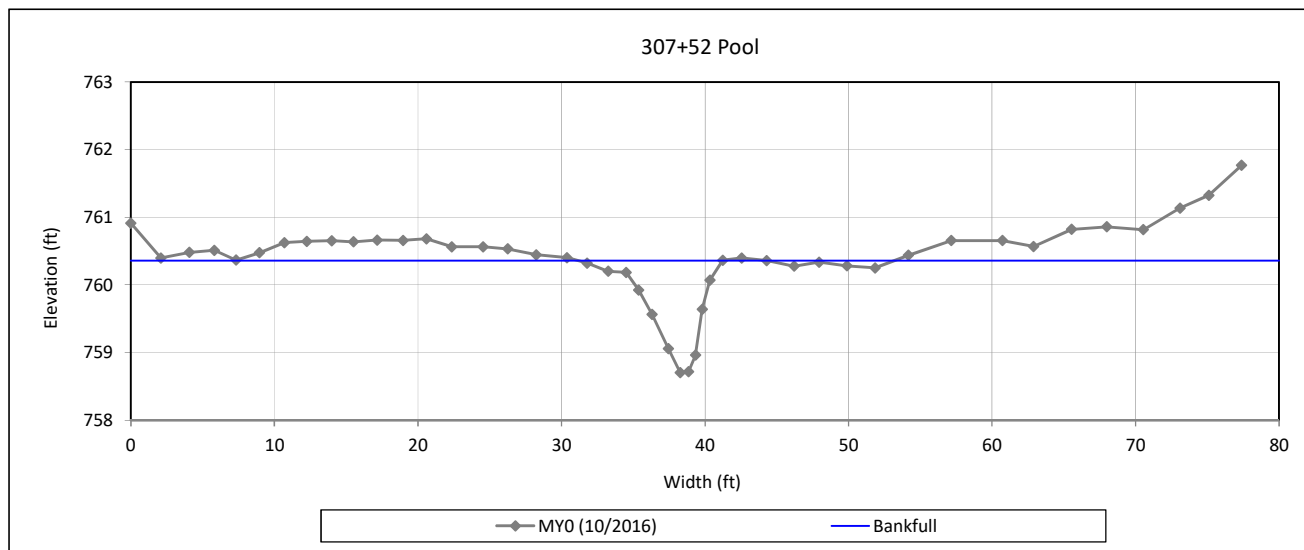
### Cross Section 32 - UT2 Reach 1

6.2	x-section area (ft.sq.)
10.1	width (ft)
0.6	mean depth (ft)
1.7	max depth (ft)
11.0	wetted perimeter (ft)
0.6	hydraulic radius (ft)
16.4	width-depth ratio

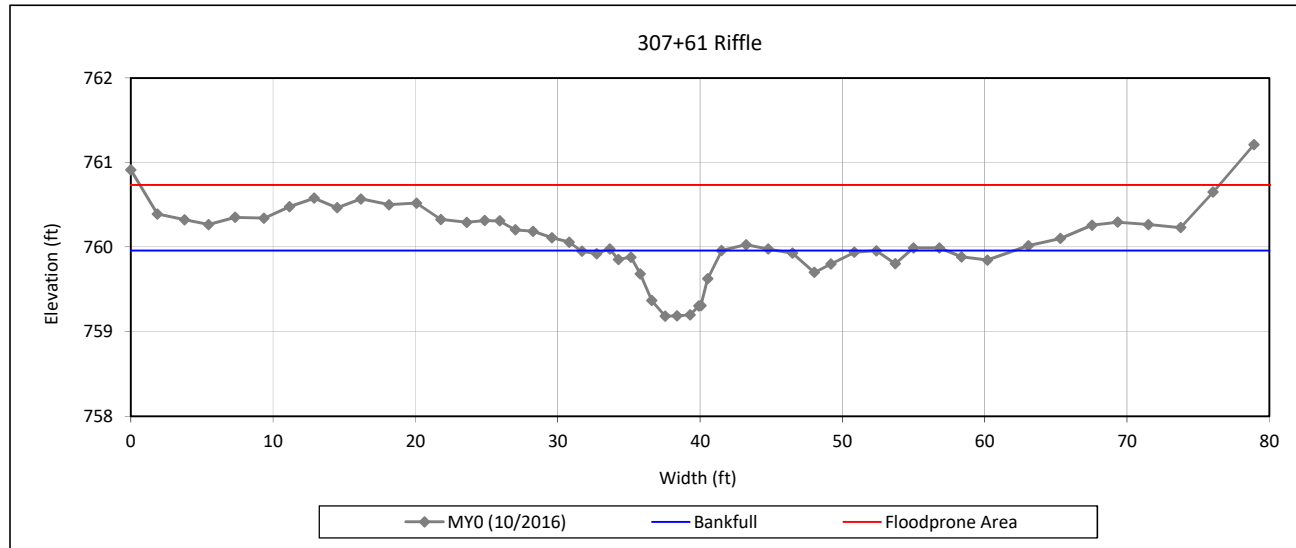
### Cross Section 33 - UT2 Reach 1

3.5	x-section area (ft.sq.)
7.8	width (ft)
0.5	mean depth (ft)
0.8	max depth (ft)
8.0	wetted perimeter (ft)
0.4	hydraulic radius (ft)
17.2	width-depth ratio
88.0	W flood prone area (ft)
11.3	entrenchment ratio
1.0	low bank height ratio

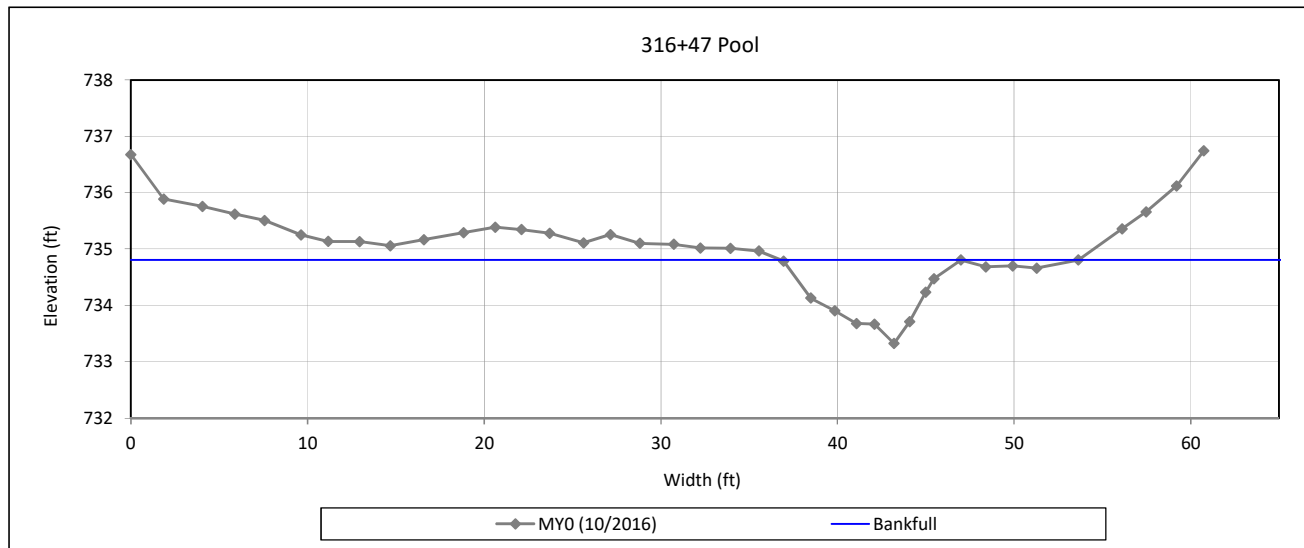
#### Cross Section 34 - UT2 Reach 2

7.9	x-section area (ft.sq.)
10.2	width (ft)
0.8	mean depth (ft)
1.5	max depth (ft)
10.8	wetted perimeter (ft)
0.7	hydraulic radius (ft)
13.3	width-depth ratio

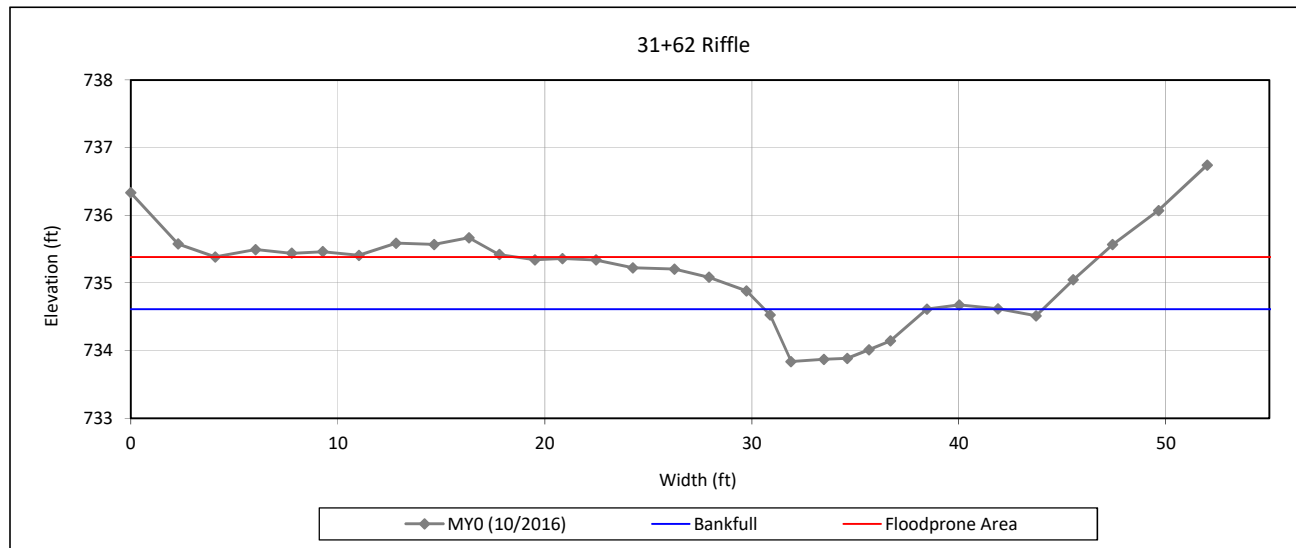
### Cross Section 35 - UT2 Reach 2

- 4.1 x-section area (ft.sq.)
- 7.8 width (ft)
- 0.5 mean depth (ft)
- 0.8 max depth (ft)
- 8.1 wetted perimeter (ft)
- 0.5 hydraulic radius (ft)
- 14.9 width-depth ratio
- 60.0 W flood prone area (ft)
- 7.7 entrenchment ratio
- 1.0 low bank height ratio

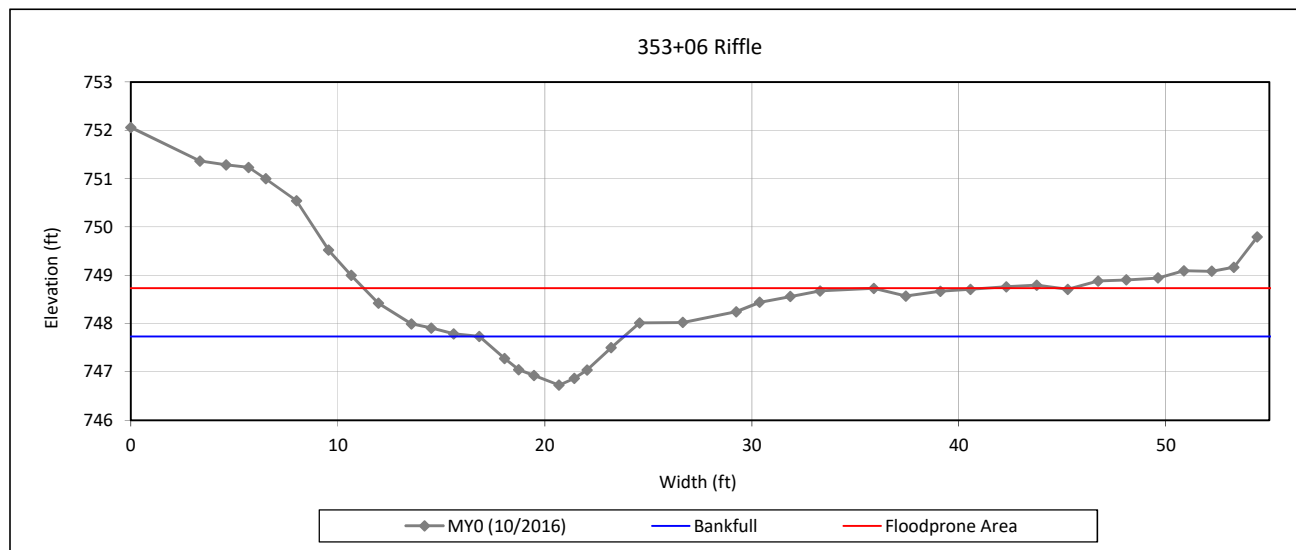
### Cross Section 36 - UT2A

4.1	x-section area (ft.sq.)
7.0	width (ft)
0.6	mean depth (ft)
1.0	max depth (ft)
7.3	wetted perimeter (ft)
0.6	hydraulic radius (ft)
11.9	width-depth ratio
31.0	W flood prone area (ft)
4.4	entrenchment ratio
1.0	low bank height ratio

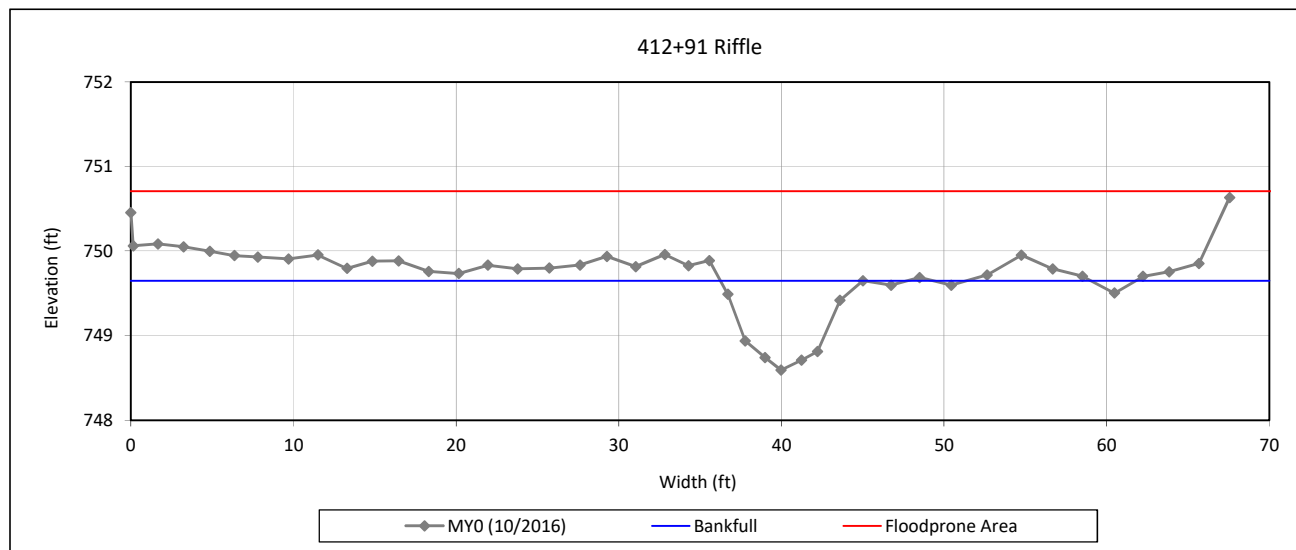
### Cross Section 37 - UT3

5.5	x-section area (ft.sq.)
8.8	width (ft)
0.6	mean depth (ft)
1.1	max depth (ft)
9.1	wetted perimeter (ft)
0.6	hydraulic radius (ft)
14.0	width-depth ratio
77.0	W flood prone area (ft)
8.8	entrenchment ratio
1.0	low bank height ratio

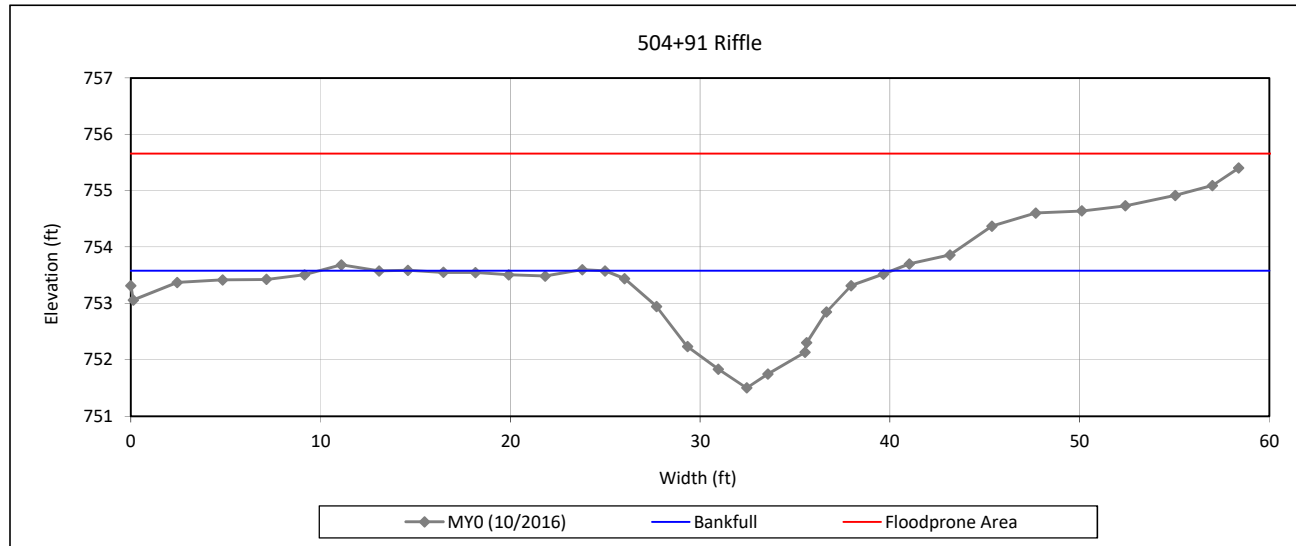
### Cross Section 38 - UT4

15.2	x-section area (ft.sq.)
15.1	width (ft)
1.0	mean depth (ft)
2.1	max depth (ft)
15.8	wetted perimeter (ft)
1.0	hydraulic radius (ft)
15.0	width-depth ratio
98.0	W flood prone area (ft)
6.5	entrenchment ratio
1.0	low bank height ratio

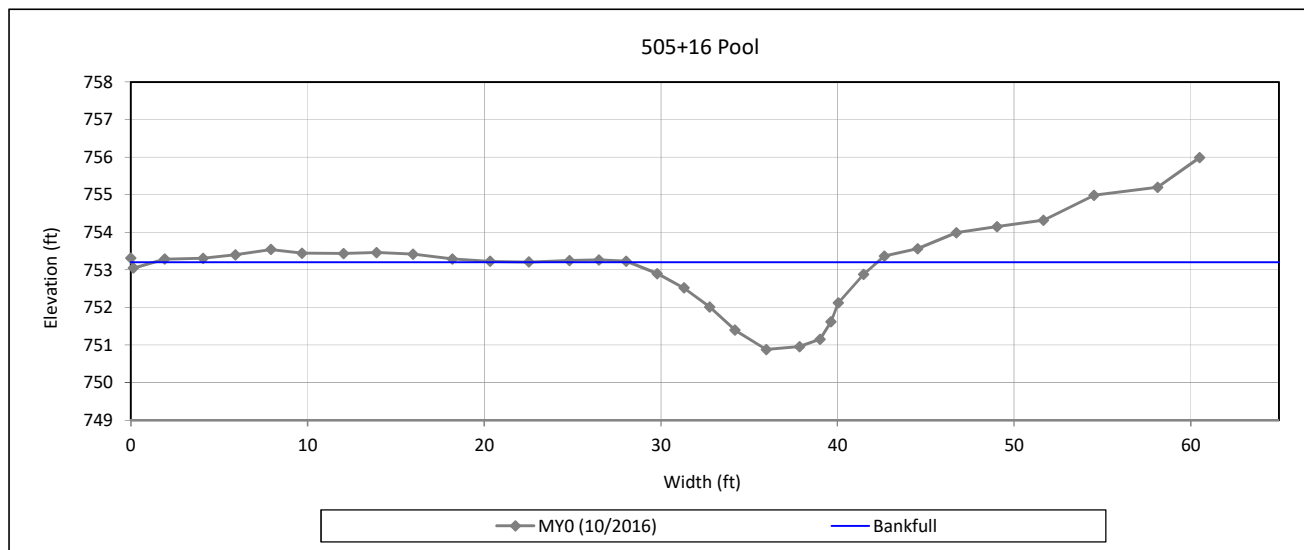
### Cross Section 39 - UT4

17.8	x-section area (ft.sq.)
14.1	width (ft)
1.3	mean depth (ft)
2.3	max depth (ft)
15.1	wetted perimeter (ft)
1.2	hydraulic radius (ft)
11.2	width-depth ratio

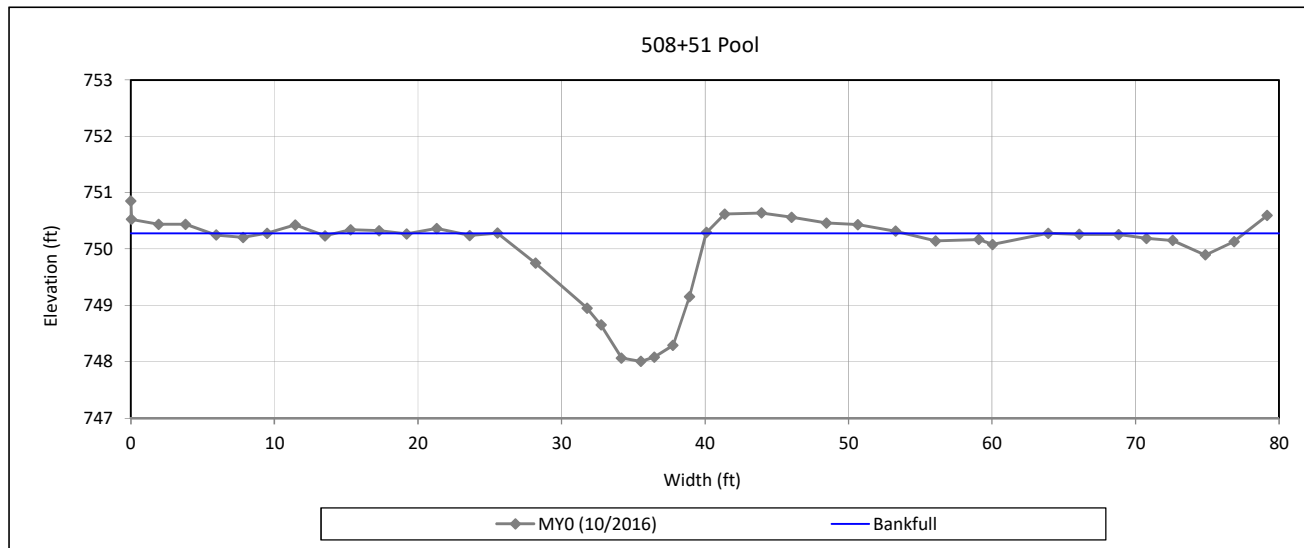
### Cross Section 40 - UT4

18.5	x-section area (ft.sq.)
14.5	width (ft)
1.3	mean depth (ft)
2.3	max depth (ft)
15.6	wetted perimeter (ft)
1.2	hydraulic radius (ft)
11.4	width-depth ratio

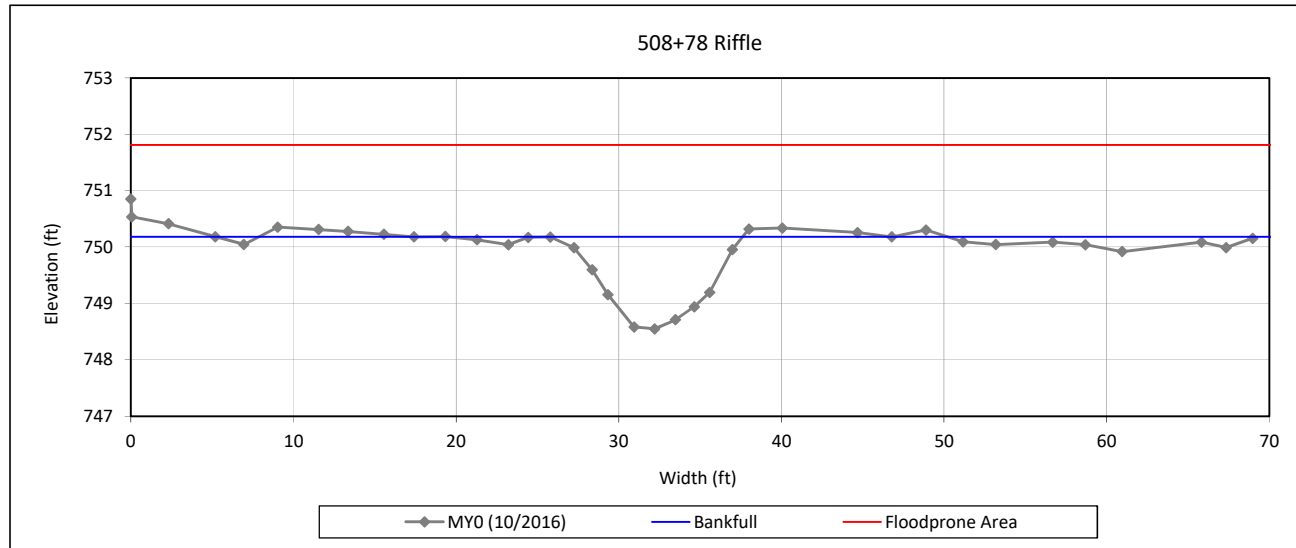
### Cross Section 41 - UT4

11.0	x-section area (ft.sq.)
11.8	width (ft)
0.9	mean depth (ft)
1.6	max depth (ft)
12.4	wetted perimeter (ft)
0.9	hydraulic radius (ft)
12.7	width-depth ratio
172.0	W flood prone area (ft)
14.6	entrenchment ratio
1.0	low bank height ratio

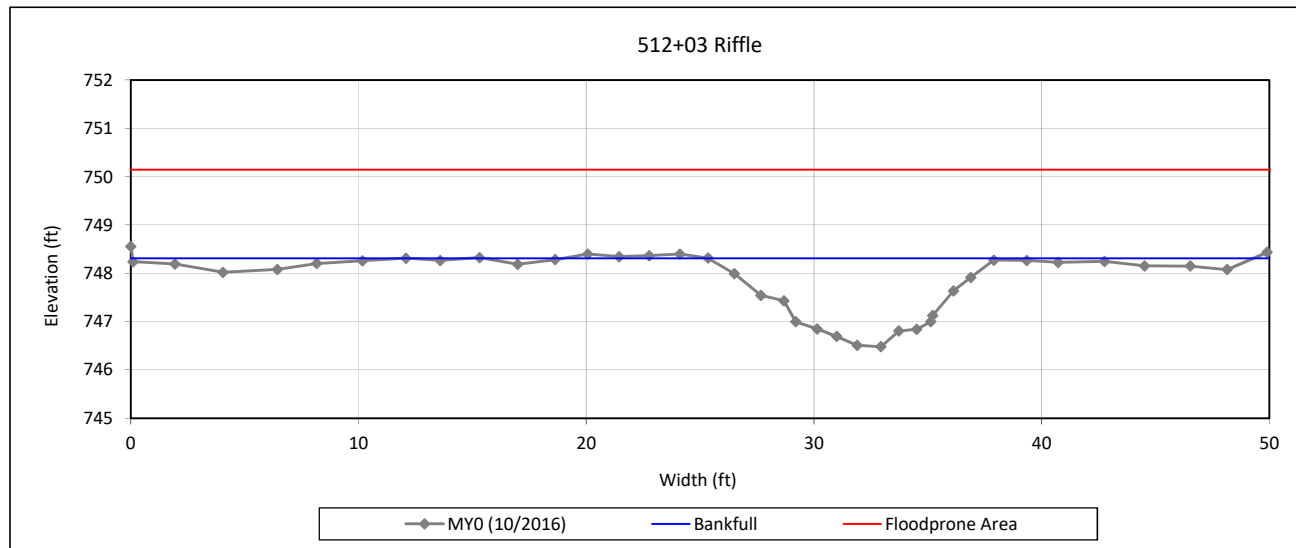
#### Cross Section 42 - UT4

13.0	x-section area (ft.sq.)
11.5	width (ft)
1.1	mean depth (ft)
1.8	max depth (ft)
12.2	wetted perimeter (ft)
1.1	hydraulic radius (ft)
10.2	width-depth ratio
288.0	W flood prone area (ft)
25.0	entrenchment ratio
1.0	low bank height ratio

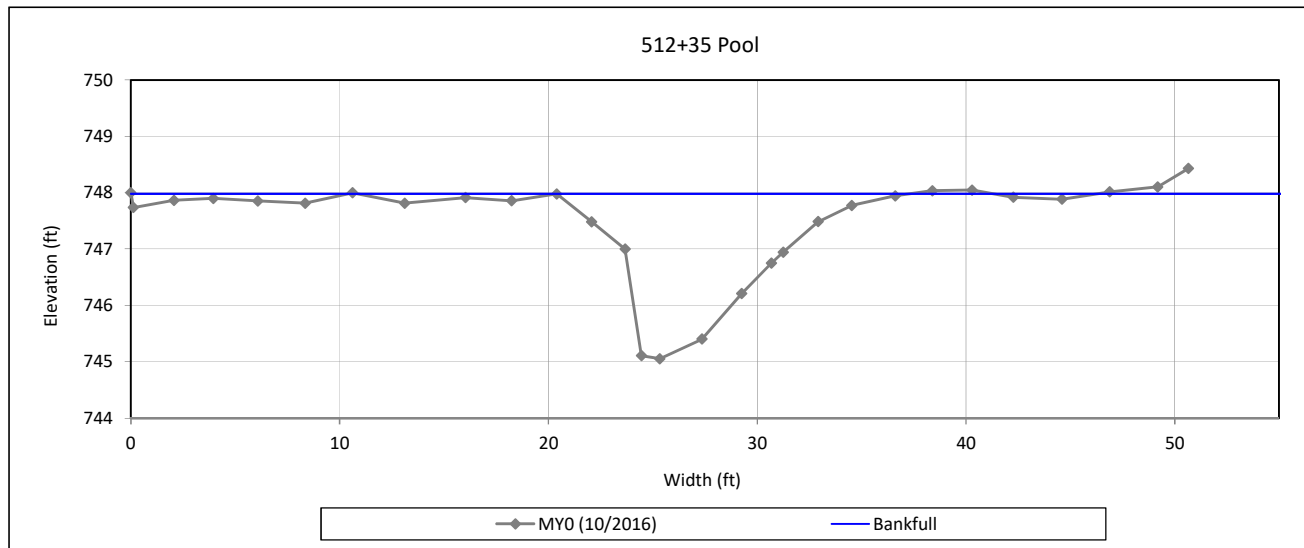
### Cross Section 43 - UT4

20.2	x-section area (ft.sq.)
16.9	width (ft)
1.2	mean depth (ft)
2.9	max depth (ft)
18.8	wetted perimeter (ft)
1.1	hydraulic radius (ft)
14.2	width-depth ratio

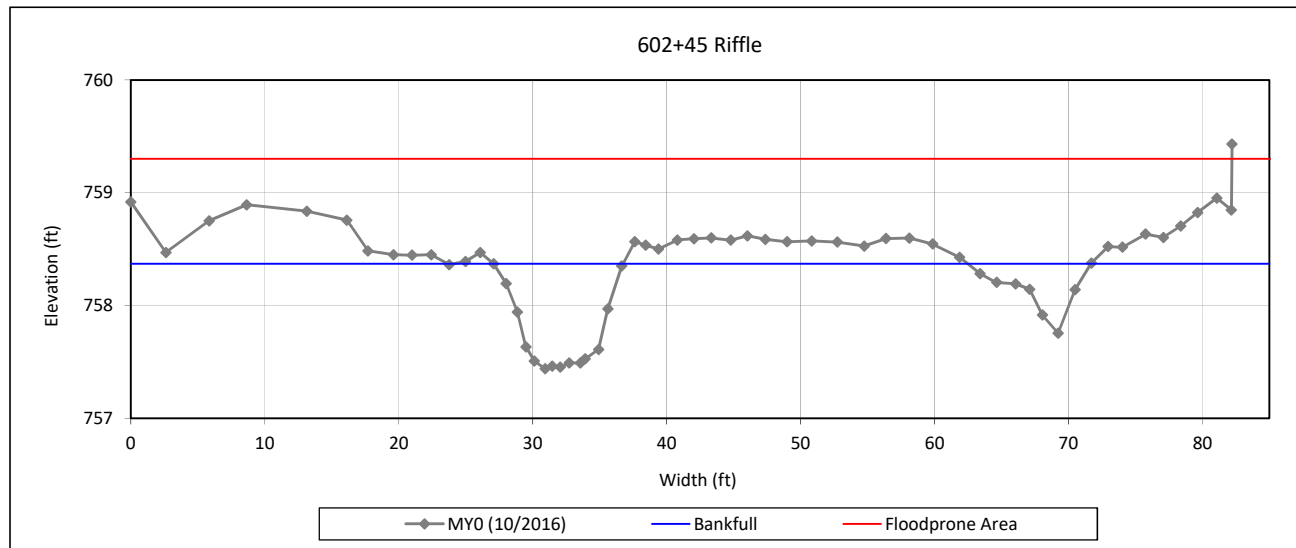
### Cross Section 44 - UT5

6.0	x-section area (ft.sq.)
9.7	width (ft)
0.6	mean depth (ft)
0.9	max depth (ft)
10.0	wetted perimeter (ft)
0.6	hydraulic radius (ft)
15.5	width-depth ratio
83.0	W flood prone area (ft)
8.6	entrenchment ratio
1.0	low bank height ratio

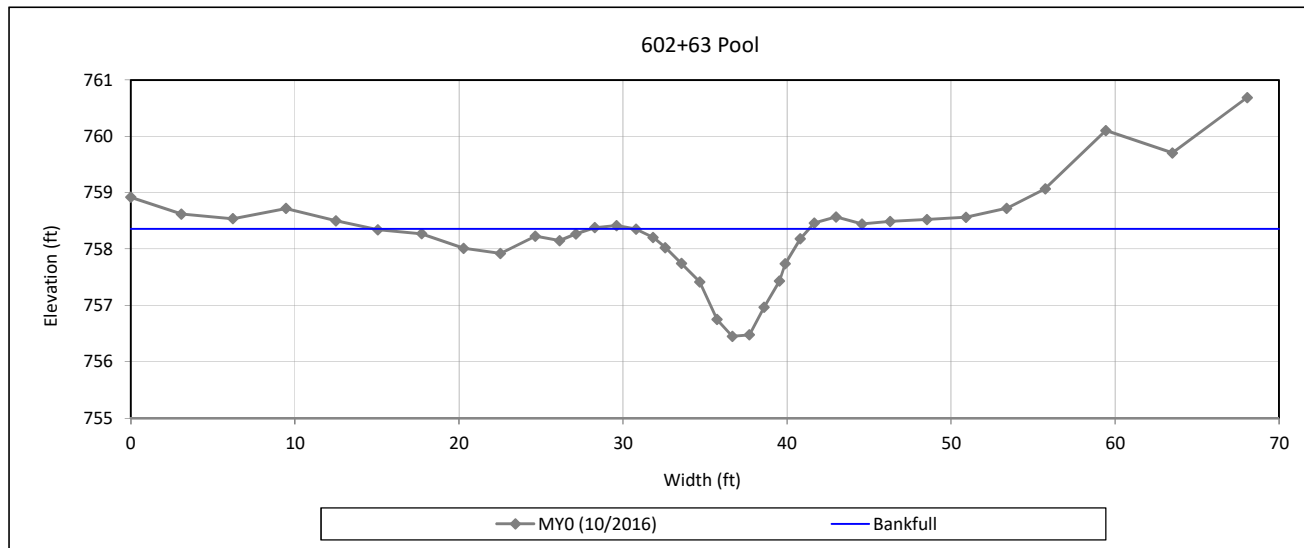
### Cross Section 45 - UT5

#### Bankfull Dimensions

9.8	x-section area (ft.sq.)
10.6	width (ft)
0.9	mean depth (ft)
1.9	max depth (ft)
11.4	wetted perimeter (ft)
0.9	hydraulic radius (ft)
11.4	width-depth ratio

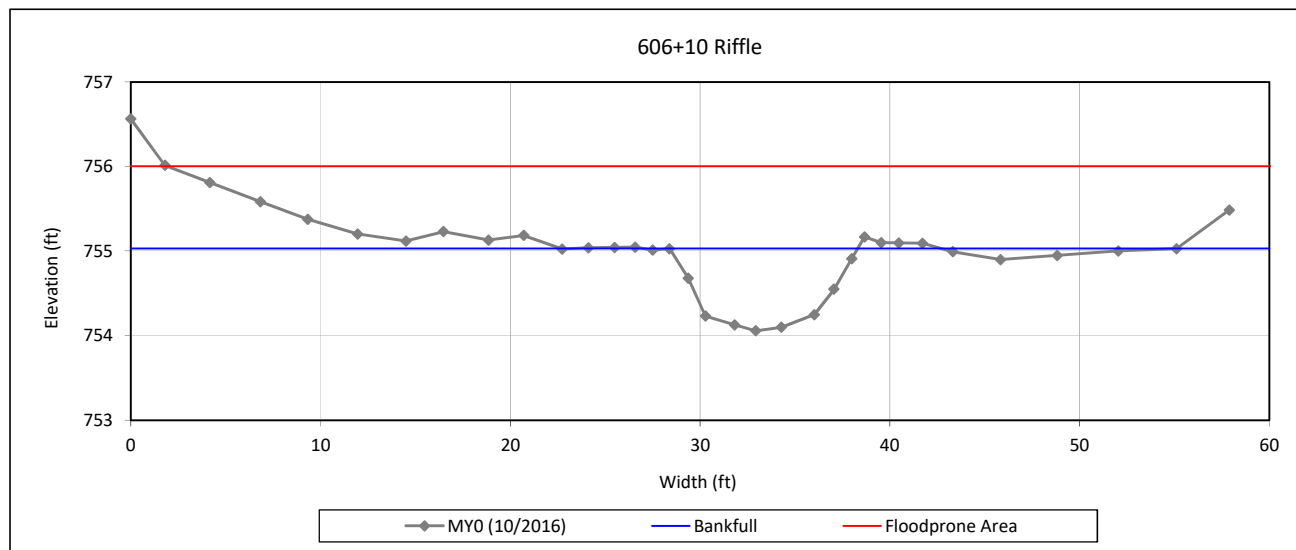
### Cross Section 46 - UT5

#### Bankfull Dimensions

6.8	x-section area (ft.sq.)
9.9	width (ft)
0.7	mean depth (ft)
1.0	max depth (ft)
10.2	wetted perimeter (ft)
0.7	hydraulic radius (ft)
14.5	width-depth ratio
84.0	W flood prone area (ft)
8.5	entrenchment ratio
1.0	low bank height ratio

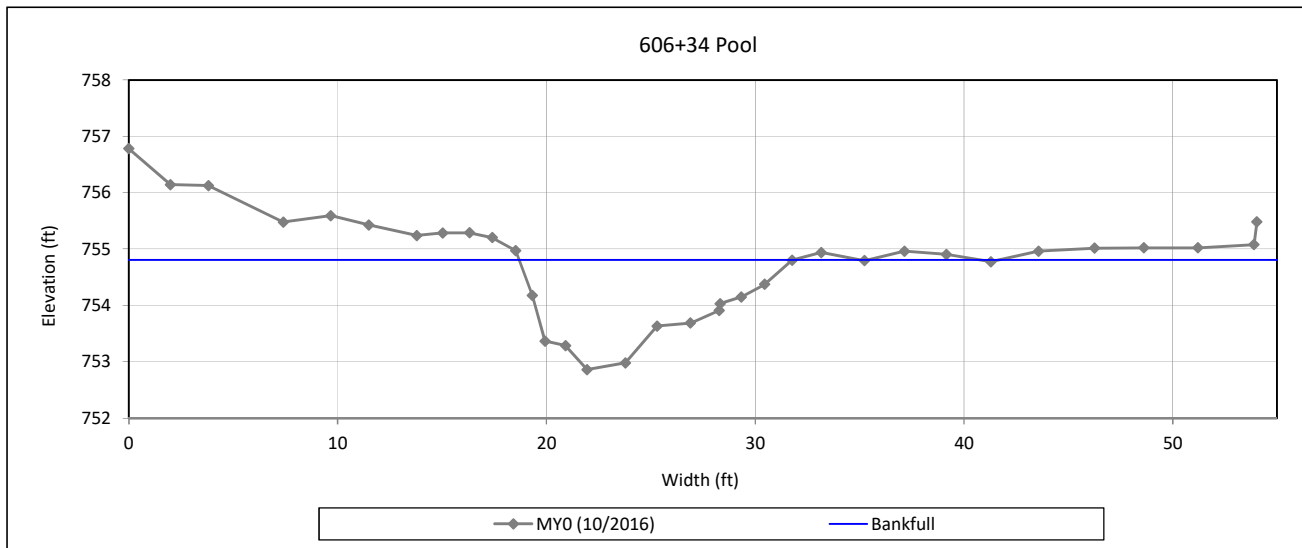
### Cross Section 47 - UT5

#### Bankfull Dimensions

14.7	x-section area (ft.sq.)
13.1	width (ft)
1.1	mean depth (ft)
1.9	max depth (ft)
14.2	wetted perimeter (ft)
1.0	hydraulic radius (ft)
11.6	width-depth ratio
