# **BASELINE MONITORING DOCUMENT AND AS-BUILT BASELINE REPORT**

## **CANDY CREEK MITIGATION SITE**

Guilford County, NC  
NCDEQ Contract 5794  
DMS ID No. 96315

Data Collection Period: October 2016 – March 2017  
Final Submission Date: June 2, 2017

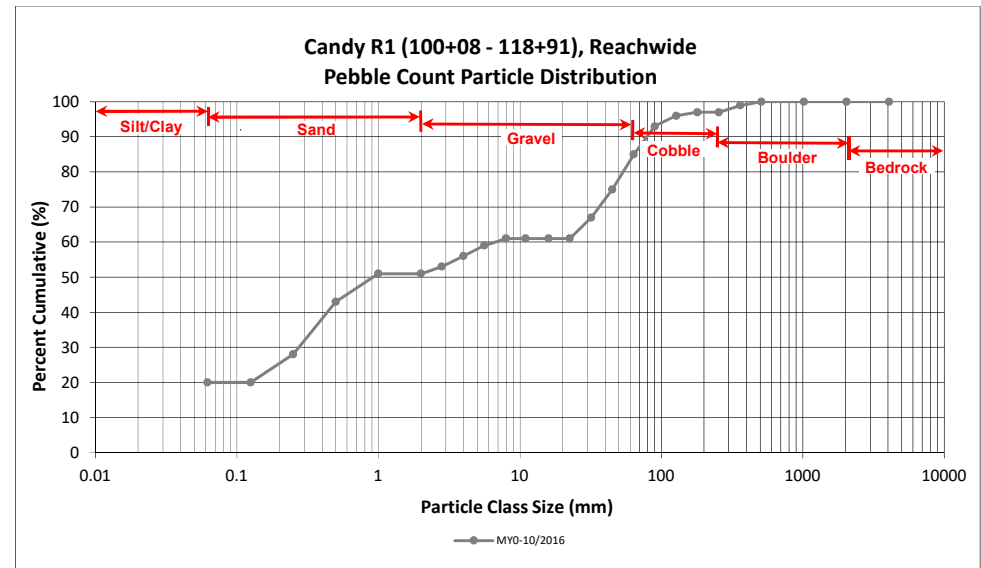
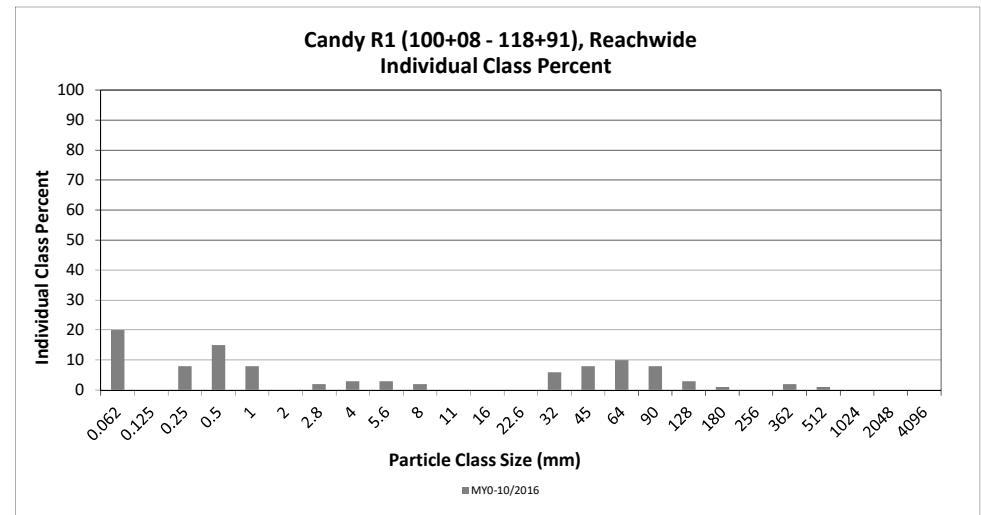
## Reachwide and Cross Section Pebble Count Plots

Particle Class		Diameter (mm)		Particle Count			Reach Summary	
		min	max	Riffle	Pool	Total	Class Percentage	Percent Cumulative
<b>SILT/CLAY</b>		Silt/Clay	0.000	0.062	3	17	20	20
<b>SAND</b>	Very fine	0.062	0.125				8	20
	Fine	0.125	0.250		8	8	8	28
	Medium	0.25	0.50	5	10	15	15	43
	Coarse	0.5	1.0		8	8	8	51
	Very Coarse	1.0	2.0					51
<b>GRAVEL</b>	Very Fine	2.0	2.8		2	2	2	53
	Very Fine	2.8	4.0	2	1	3	3	56
	Fine	4.0	5.6	2	1	3	3	59
	Fine	5.6	8.0	1	1	2	2	61
	Medium	8.0	11.0					61
	Medium	11.0	16.0					61
	Coarse	16.0	22.6					61
	Coarse	22.6	32	6		6	6	67
	Very Coarse	32	45	8		8	8	75
	Very Coarse	45	64	10		10	10	85
<b>COBBLE</b>	Small	64	90	8		8	8	93
	Small	90	128	3		3	3	96
	Large	128	180	1		1	1	97
	Large	180	256					97
<b>BOULDER</b>	Small	256	362		2	2	2	99
	Small	362	512	1		1	1	100
	Medium	512	1024					100
<b>BEDROCK</b>	Large/Very Large	1024	2048					100
	Bedrock	2048	>2048					100
<b>Total</b>				<b>50</b>	<b>50</b>	<b>100</b>	<b>100</b>	<b>100</b>

Reachwide	
Channel materials (mm)	
D <sub>16</sub> =	Silt/Clay
D <sub>35</sub> =	0.35
D <sub>50</sub> =	0.9
D <sub>84</sub> =	61.8
D <sub>95</sub> =	113.8
D <sub>100</sub> =	512.0

increase in substrate particle size (Table 7a-f). The substrate data for each constructed reach was compared to the design shear stress parameters from the mitigation plan to assess the potential for bed degradation. The shear stresses calculated for the constructed channels are within the allowable range, which indicates the channel is not at risk to trend toward channel degradation.

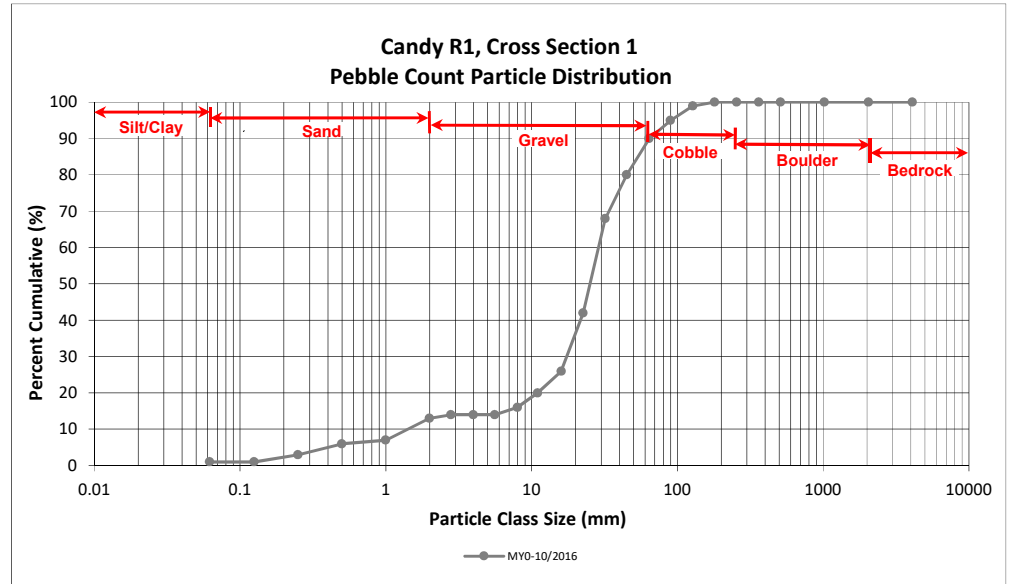
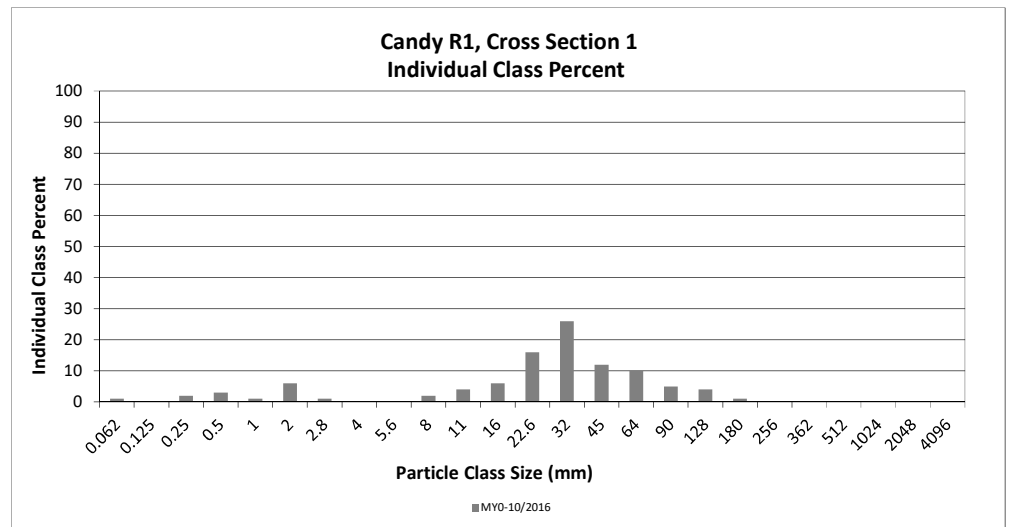
## Reachwide and Cross Section Pebble Count Plots

Particle Class		Diameter (mm)		Riffle 100-Count	Summary	
		min	max		Class Percentage	Percent Cumulative
<i>SILT/CLAY</i>	Silt/Clay	0.000	0.062	1	1	1
<i>SAND</i>	Very fine	0.062	0.125			1
	Fine	0.125	0.250	2	2	3
	Medium	0.25	0.50	3	3	6
	Coarse	0.5	1.0	1	1	7
	Very Coarse	1.0	2.0	6	6	13
<i>GRAVEL</i>	Very Fine	2.0	2.8	1	1	14
	Very Fine	2.8	4.0			14
	Fine	4.0	5.6			14
	Fine	5.6	8.0	2	2	16
	Medium	8.0	11.0	4	4	20
	Medium	11.0	16.0	6	6	26
	Coarse	16.0	22.6	16	16	42
	Coarse	22.6	32	26	26	68
	Very Coarse	32	45	12	12	80
	Very Coarse	45	64	10	10	90
<i>COBBLE</i>	Small	64	90	5	5	95
	Small	90	128	4	4	99
	Large	128	180	1	1	100
	Large	180	256			100
<i>BOULDER</i>	Small	256	362			100
	Small	362	512			100
	Medium	512	1024			100
	Large/Very Large	1024	2048			100
<i>BEDROCK</i>	Bedrock	2048	>2048			100
<b>Total</b>				<b>100</b>	<b>100</b>	<b>100</b>

Cross Section 1	
Channel materials (mm)	
D <sub>16</sub> =	8.00
D <sub>35</sub> =	19.43
D <sub>50</sub> =	25.2
D <sub>84</sub> =	51.8
D <sub>95</sub> =	90.0
D <sub>100</sub> =	180.0

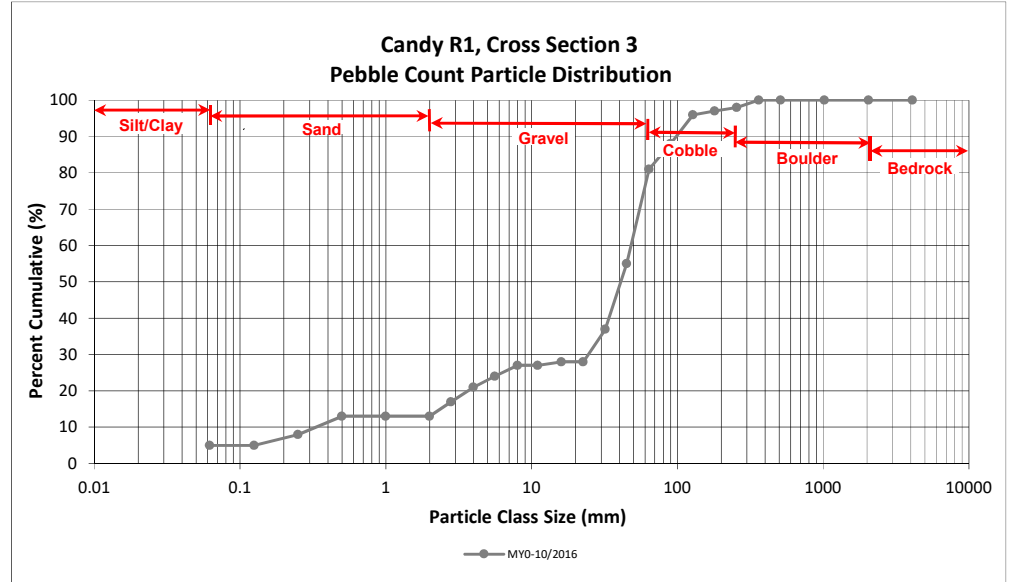
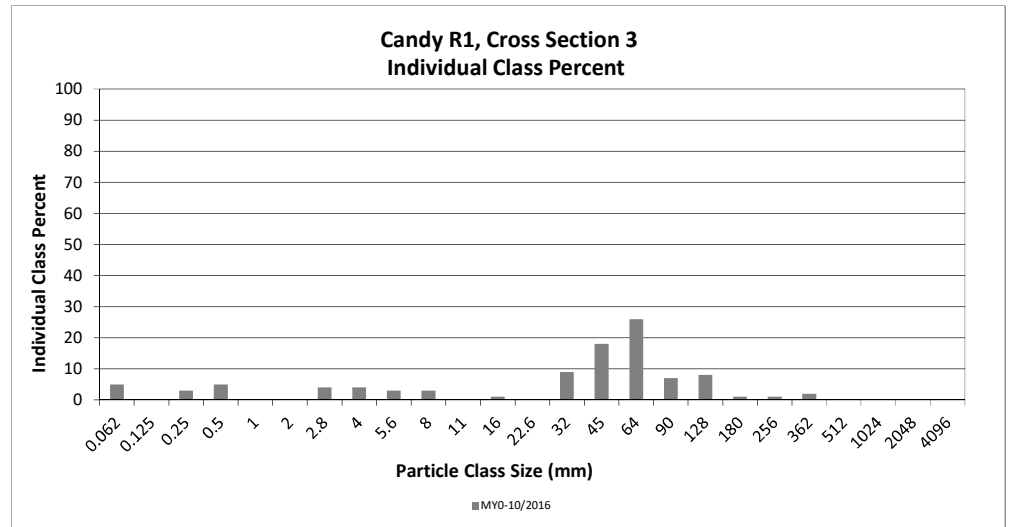
**Reachwide and Cross Section Pebble Count Plots**

Particle Class		Diameter (mm)		Riffle 100-Count	Summary	
		min	max		Class Percentage	Percent Cumulative
<i>SILT/CLAY</i>	Silt/Clay	0.000	0.062	5	5	5
<i>SAND</i>	Very fine	0.062	0.125			5
	Fine	0.125	0.250	3	3	8
	Medium	0.25	0.50	5	5	13
	Coarse	0.5	1.0			13
	Very Coarse	1.0	2.0			13
<i>GRAVEL</i>	Very Fine	2.0	2.8	4	4	17
	Very Fine	2.8	4.0	4	4	21
	Fine	4.0	5.6	3	3	24
	Fine	5.6	8.0	3	3	27
	Medium	8.0	11.0			27
	Medium	11.0	16.0	1	1	28
	Coarse	16.0	22.6			28
	Coarse	22.6	32	9	9	37
	Very Coarse	32	45	18	18	55
	Very Coarse	45	64	26	26	81
<i>COBBLE</i>	Small	64	90	7	7	88
	Small	90	128	8	8	96
	Large	128	180	1	1	97
	Large	180	256	1	1	98
<i>BOULDER</i>	Small	256	362	2	2	100
	Small	362	512			100
	Medium	512	1024			100
	Large/Very Large	1024	2048			100
<i>BEDROCK</i>	Bedrock	2048	>2048			100
<b>Total</b>				<b>100</b>	<b>100</b>	<b>100</b>

Cross Section 3	
Channel materials (mm)	
D <sub>16</sub> =	2.57
D <sub>35</sub> =	29.62
D <sub>50</sub> =	40.9
D <sub>84</sub> =	74.1
D <sub>95</sub> =	122.5
D <sub>100</sub> =	362.0

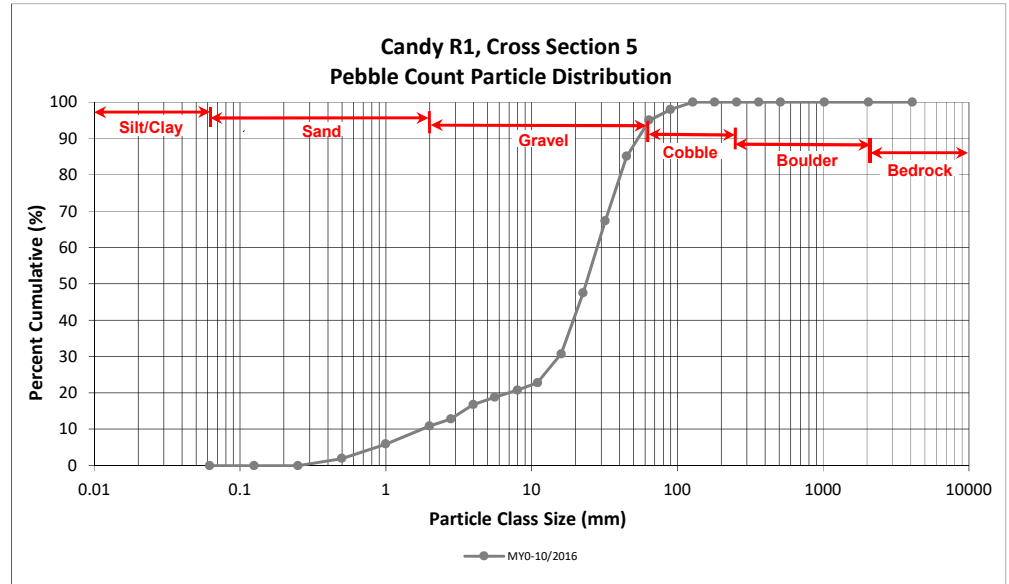
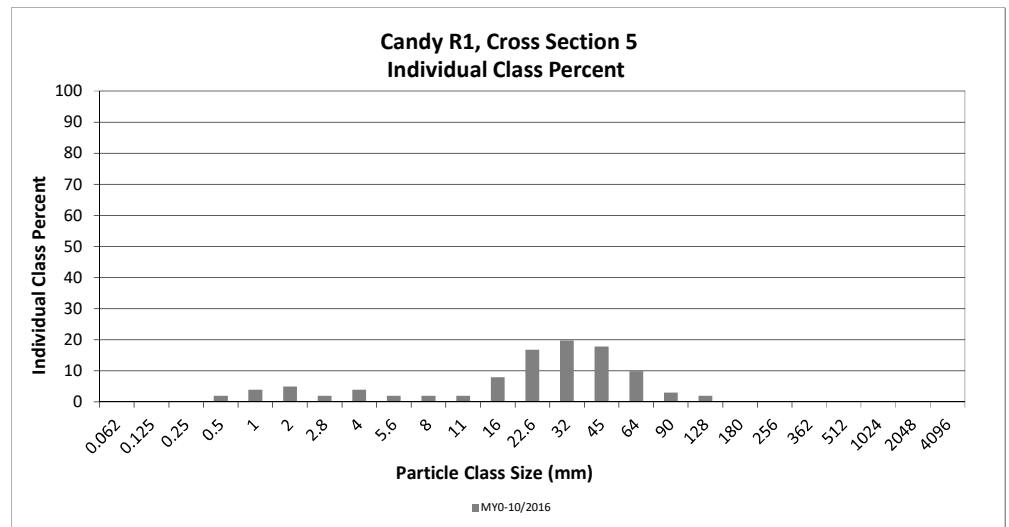
## Reachwide and Cross Section Pebble Count Plots

Particle Class		Diameter (mm)		Riffle 100-Count	Summary	
		min	max		Class Percentage	Percent Cumulative
<i>SILT/CLAY</i>	Silt/Clay	0.000	0.062			0
<i>SAND</i>	Very fine	0.062	0.125			0
	Fine	0.125	0.250			0
	Medium	0.25	0.50	2	2	2
	Coarse	0.5	1.0	4	4	6
	Very Coarse	1.0	2.0	5	5	11
<i>GRAVEL</i>	Very Fine	2.0	2.8	2	2	13
	Very Fine	2.8	4.0	4	4	17
	Fine	4.0	5.6	2	2	19
	Fine	5.6	8.0	2	2	21
	Medium	8.0	11.0	2	2	23
	Medium	11.0	16.0	8	8	31
	Coarse	16.0	22.6	17	17	48
	Coarse	22.6	32	20	20	67
	Very Coarse	32	45	18	18	85
	Very Coarse	45	64	10	10	95
<i>COBBLE</i>	Small	64	90	3	3	98
	Small	90	128	2	2	100
	Large	128	180			100
	Large	180	256			100
<i>BOULDER</i>	Small	256	362			100
	Small	362	512			100
	Medium	512	1024			100
	Large/Very Large	1024	2048			100
<i>BEDROCK</i>	Bedrock	2048	>2048			100
<b>Total</b>				<b>101</b>	<b>100</b>	<b>100</b>

Cross Section 5	
Channel materials (mm)	
D <sub>16</sub> =	3.71
D <sub>35</sub> =	17.48
D <sub>50</sub> =	23.6
D <sub>84</sub> =	44.0
D <sub>95</sub> =	63.9
D <sub>100</sub> =	128.0

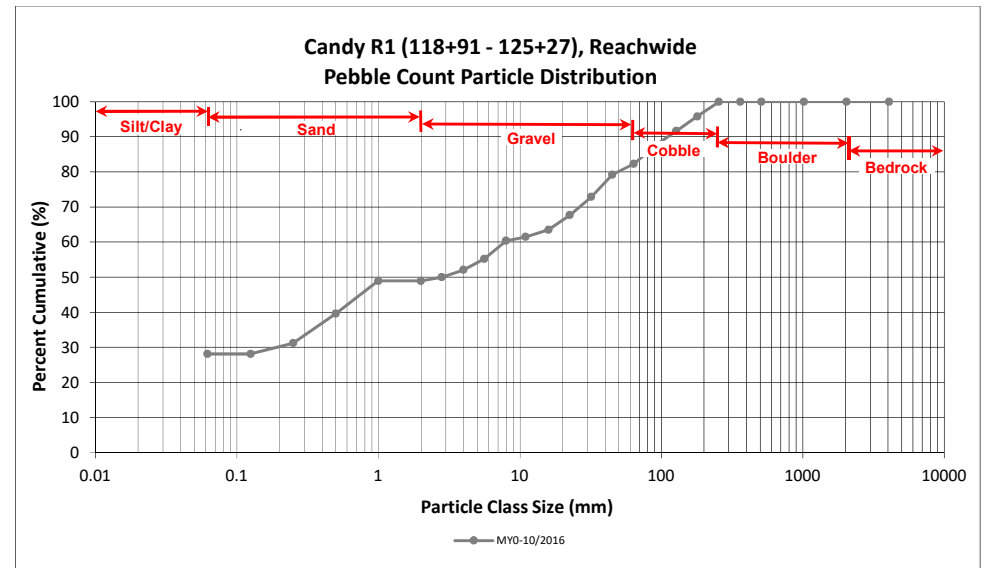
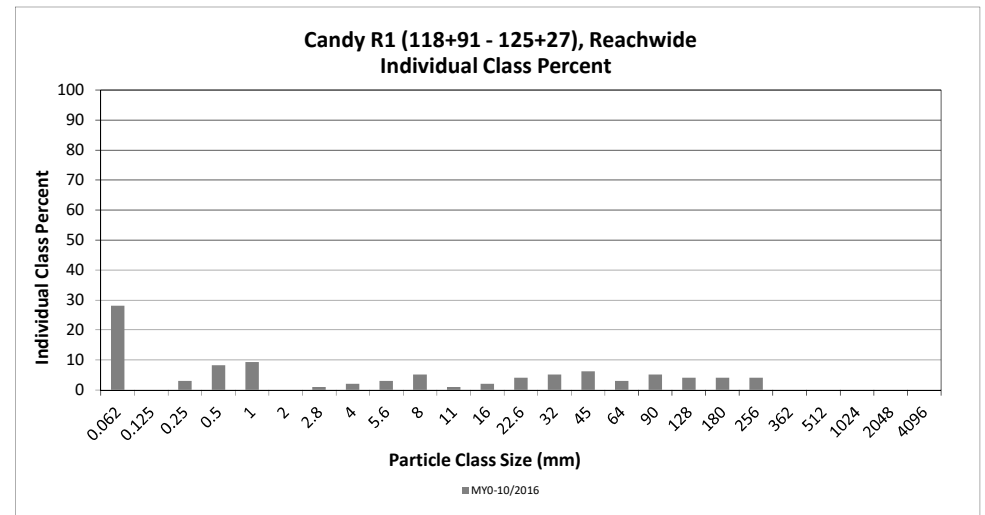
## Reachwide and Cross Section Pebble Count Plots

Bedrock	2048	>2048					100	100
<b>Total</b>				<b>50</b>	<b>46</b>	<b>96</b>	<b>100</b>	<b>100</b>	<b>100</b>

Reachwide	
Channel materials (mm)	
D <sub>16</sub> =	Silt/Clay
D <sub>35</sub> =	0.34
D <sub>50</sub> =	2.8
D <sub>84</sub> =	71.6
D <sub>95</sub> =	168.1
D <sub>100</sub> =	256.0

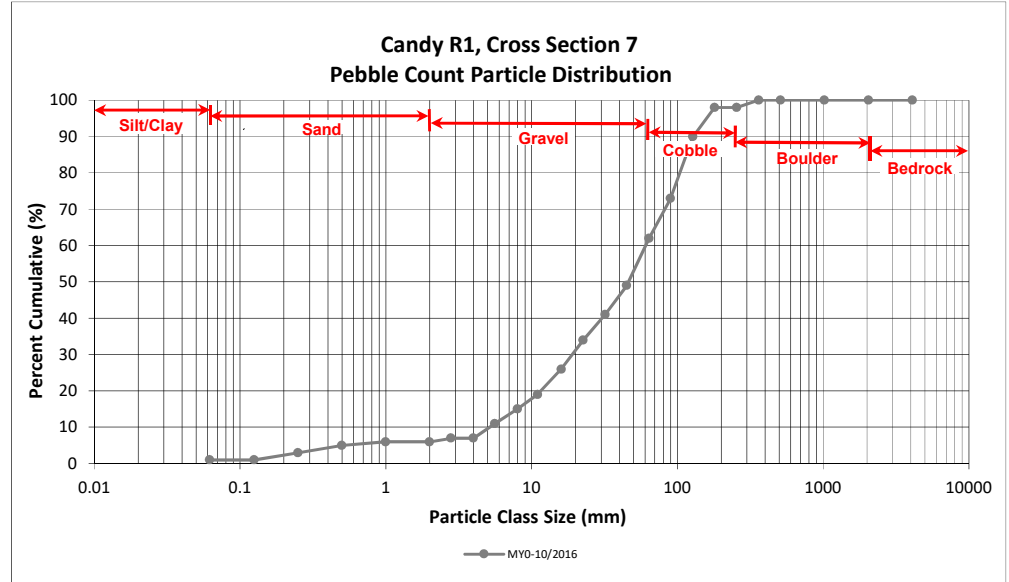
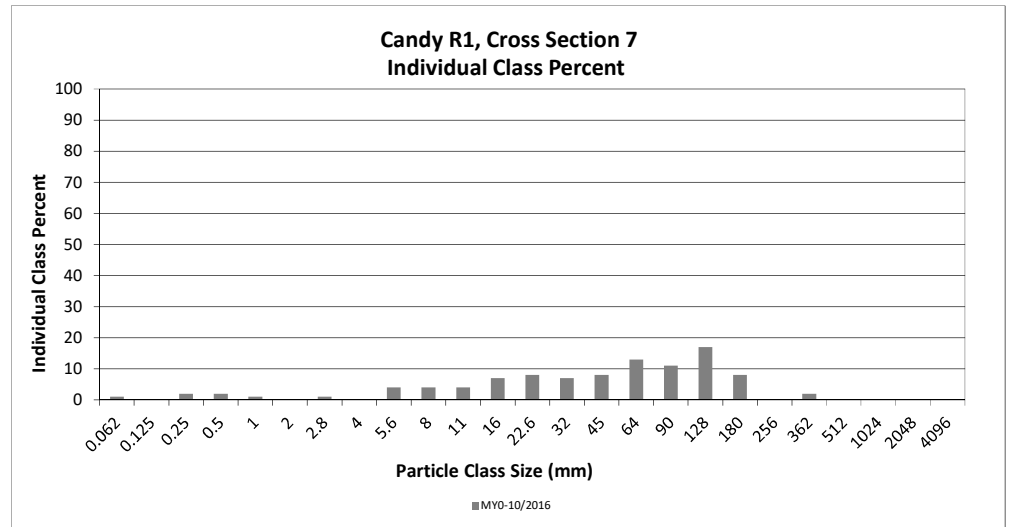
**Reachwide and Cross Section Pebble Count Plots**

Particle Class		Diameter (mm)		Riffle 100-Count	Summary	
		min	max		Class Percentage	Percent Cumulative
<i>SILT/CLAY</i>	Silt/Clay	0.000	0.062	1	1	1
<i>SAND</i>	Very fine	0.062	0.125			1
	Fine	0.125	0.250	2	2	3
	Medium	0.25	0.50	2	2	5
	Coarse	0.5	1.0	1	1	6
	Very Coarse	1.0	2.0			6
<i>GRAVEL</i>	Very Fine	2.0	2.8	1	1	7
	Very Fine	2.8	4.0			7
	Fine	4.0	5.6	4	4	11
	Fine	5.6	8.0	4	4	15
	Medium	8.0	11.0	4	4	19
	Medium	11.0	16.0	7	7	26
	Coarse	16.0	22.6	8	8	34
	Coarse	22.6	32	7	7	41
	Very Coarse	32	45	8	8	49
	Very Coarse	45	64	13	13	62
<i>COBBLE</i>	Small	64	90	11	11	73
	Small	90	128	17	17	90
	Large	128	180	8	8	98
	Large	180	256			98
<i>BOULDER</i>	Small	256	362	2	2	100
	Small	362	512			100
	Medium	512	1024			100
	Large/Very Large	1024	2048			100
<i>BEDROCK</i>	Bedrock	2048	>2048			100
<b>Total</b>				<b>100</b>	<b>100</b>	<b>100</b>

Cross Section 7	
Channel materials (mm)	
D <sub>16</sub> =	8.66
D <sub>35</sub> =	23.75
D <sub>50</sub> =	46.2
D <sub>84</sub> =	113.0
D <sub>95</sub> =	158.4
D <sub>100</sub> =	362.0

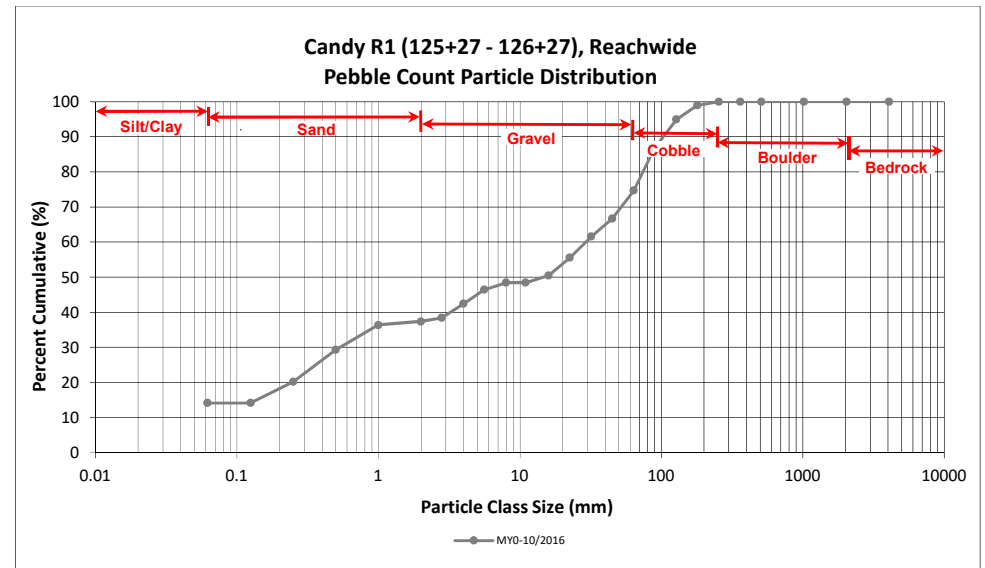
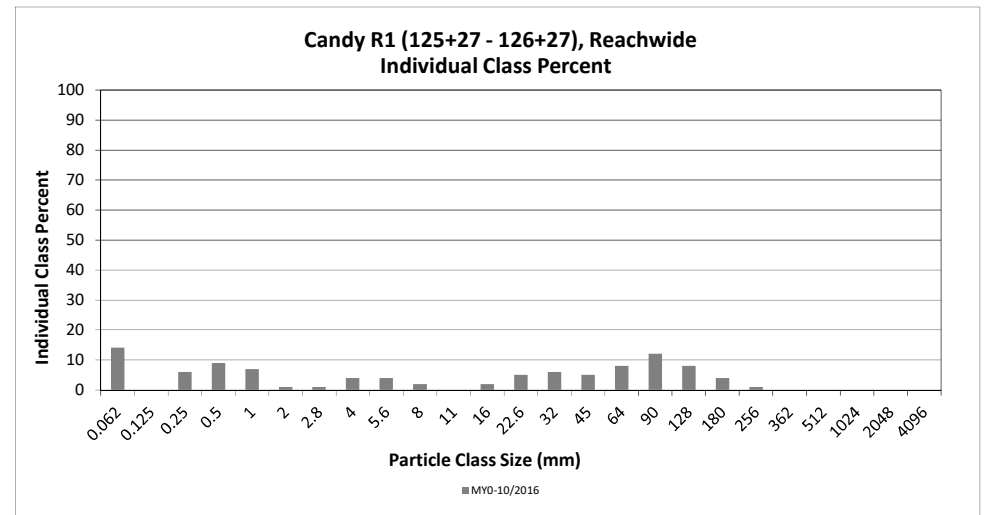
## Reachwide and Cross Section Pebble Count Plots

Particle Class		Diameter (mm)		Particle Count			Reach Summary	
		min	max	Riffle	Pool	Total	Class Percentage	Percent Cumulative
SILT/CLAY	Silt/Clay	0.000	0.062	4	10	14	14	14
	Very fine	0.062	0.125					14
SAND	Fine	0.125	0.250	2	4	6	6	20
	Medium	0.25	0.50	1	8	9	9	29
	Coarse	0.5	1.0	4	3	7	7	36
	Very Coarse	1.0	2.0		1	1	1	37
	Very Fine	2.0	2.8		1	1	1	38
GRAVEL	Very Fine	2.8	4.0		4	4	4	42
	Fine	4.0	5.6	2	2	4	4	46
	Fine	5.6	8.0	2		2	2	48
	Medium	8.0	11.0					48
	Medium	11.0	16.0	2		2	2	51
	Coarse	16.0	22.6	5		5	5	56
	Coarse	22.6	32	6		6	6	62
	Very Coarse	32	45	5		5	5	67
	Very Coarse	45	64	8		8	8	75
	Very Coarse	64	90	12		12	12	87
COBBLE	Small	90	128	8		8	8	95
	Large	128	180	4		4	4	99
	Large	180	256	1		1	1	100
BOULDER	Small	256	362					100
	Small	362	512					100
	Medium	512	1024					100
BEDROCK	Large/Very Large	1024	2048					100
	Bedrock	2048	>2048					100
<b>Total</b>				<b>66</b>	<b>33</b>	<b>99</b>	<b>100</b>	<b>100</b>

Reachwide	
Channel materials (mm)	
D <sub>16</sub> =	0.15
D <sub>35</sub> =	0.87
D <sub>50</sub> =	14.6
D <sub>84</sub> =	83.0
D <sub>95</sub> =	128.5
D <sub>100</sub> =	256.0

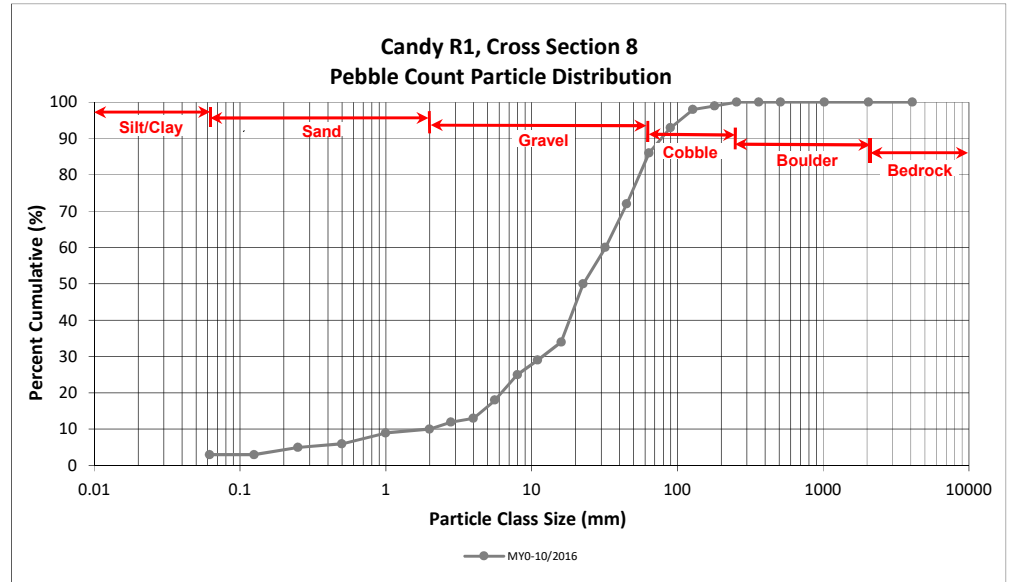
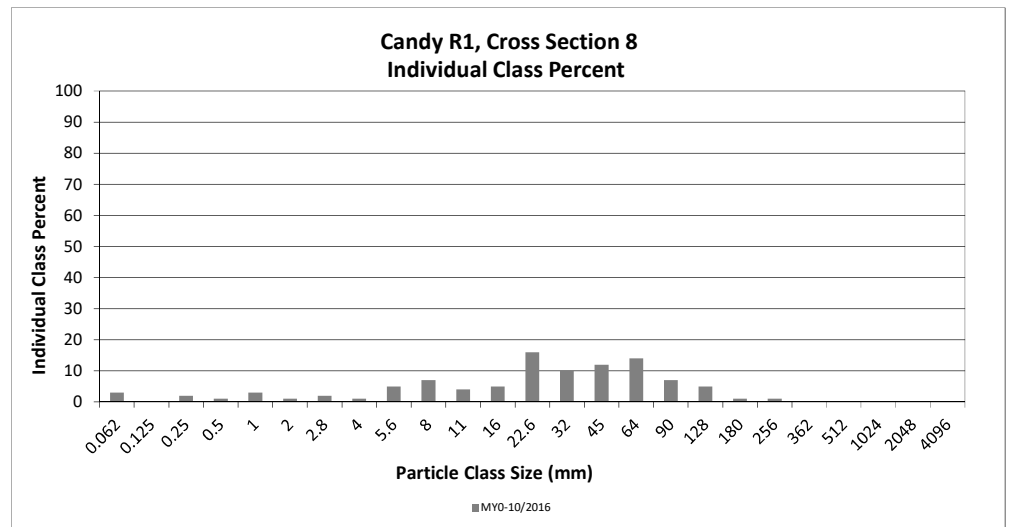
## Reachwide and Cross Section Pebble Count Plots

Particle Class		Diameter (mm)		Riffle 100-Count	Summary	
		min	max		Class Percentage	Percent Cumulative
<i>SILT/CLAY</i>	Silt/Clay	0.000	0.062	3	3	3
<i>SAND</i>	Very fine	0.062	0.125			3
	Fine	0.125	0.250	2	2	5
	Medium	0.25	0.50	1	1	6
	Coarse	0.5	1.0	3	3	9
	Very Coarse	1.0	2.0	1	1	10
<i>GRAVEL</i>	Very Fine	2.0	2.8	2	2	12
	Very Fine	2.8	4.0	1	1	13
	Fine	4.0	5.6	5	5	18
	Fine	5.6	8.0	7	7	25
	Medium	8.0	11.0	4	4	29
	Medium	11.0	16.0	5	5	34
	Coarse	16.0	22.6	16	16	50
	Coarse	22.6	32	10	10	60
	Very Coarse	32	45	12	12	72
	Very Coarse	45	64	14	14	86
<i>COBBLE</i>	Small	64	90	7	7	93
	Small	90	128	5	5	98
	Large	128	180	1	1	99
	Large	180	256	1	1	100
<i>BOULDER</i>	Small	256	362			100
	Small	362	512			100
	Medium	512	1024			100
	Large/Very Large	1024	2048			100
<i>BEDROCK</i>	Bedrock	2048	>2048			100
<b>Total</b>				<b>100</b>	<b>100</b>	<b>100</b>

Cross Section 8	
Channel materials (mm)	
D <sub>16</sub> =	4.89
D <sub>35</sub> =	16.35
D <sub>50</sub> =	22.6
D <sub>84</sub> =	60.9
D <sub>95</sub> =	103.6
D <sub>100</sub> =	256.0

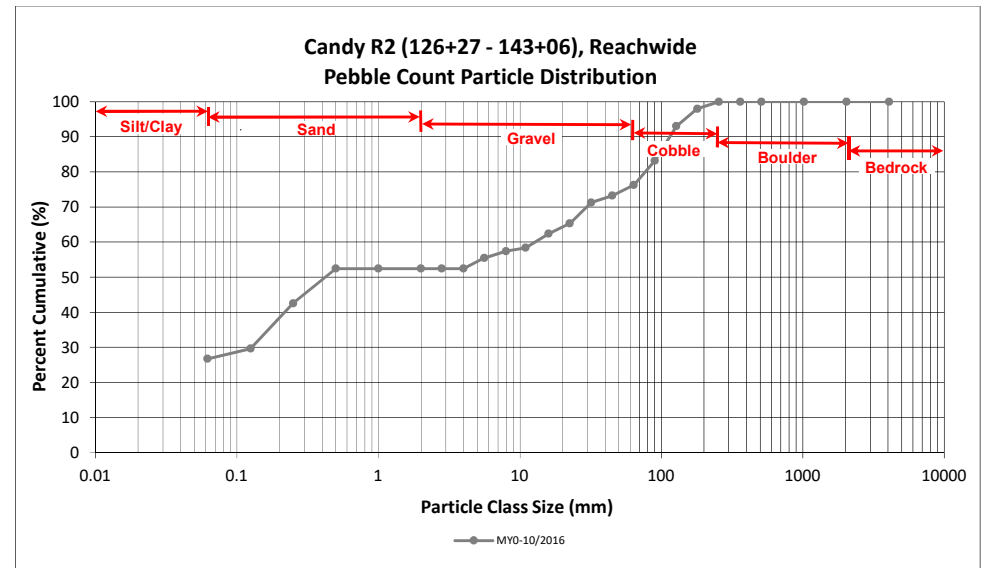
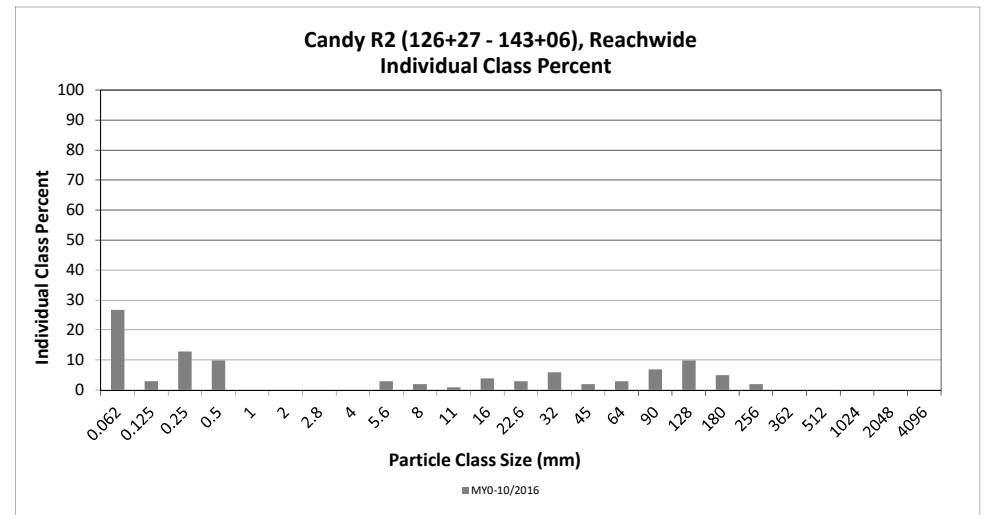
### Reachwide and Cross Section Pebble Count Plots

Particle Class		Diameter (mm)		Particle Count			Reach Summary	
		min	max	Riffle	Pool	Total	Class Percentage	Percent Cumulative
SILT/CLAY	Silt/Clay	0.000	0.062	2	25	27	27	27
	Very fine	0.062	0.125		3	3	3	30
SAND	Fine	0.125	0.250	1	12	13	13	43
	Medium	0.25	0.50	4	6	10	10	52
	Coarse	0.5	1.0					52
	Very Coarse	1.0	2.0					52
	Very Fine	2.0	2.8					52
GRAVEL	Very Fine	2.8	4.0					52
	Fine	4.0	5.6	1	2	3	3	55
	Fine	5.6	8.0	2		2	2	57
	Medium	8.0	11.0	1		1	1	58
	Medium	11.0	16.0	2	2	4	4	62
	Coarse	16.0	22.6	3		3	3	65
	Coarse	22.6	32	6		6	6	71
	Very Coarse	32	45	2		2	2	73
	Very Coarse	45	64	3		3	3	76
	Very Coarse	64	90	7		7	7	83
COBBLE	Small	90	128	10		10	10	93
	Large	128	180	5		5	5	98
	Large	180	256	2		2	2	100
BOULDER	Small	256	362					100
	Small	362	512					100
	Medium	512	1024					100
BEDROCK	Large/Very Large	1024	2048					100
	Bedrock	2048	>2048					100
<b>Total</b>				<b>51</b>	<b>50</b>	<b>101</b>	<b>100</b>	<b>100</b>

Reachwide	
Channel materials (mm)	
D <sub>16</sub> =	Silt/Clay
D <sub>35</sub> =	0.17
D <sub>50</sub> =	0.4
D <sub>84</sub> =	92.7
D <sub>95</sub> =	146.2
D <sub>100</sub> =	256.0

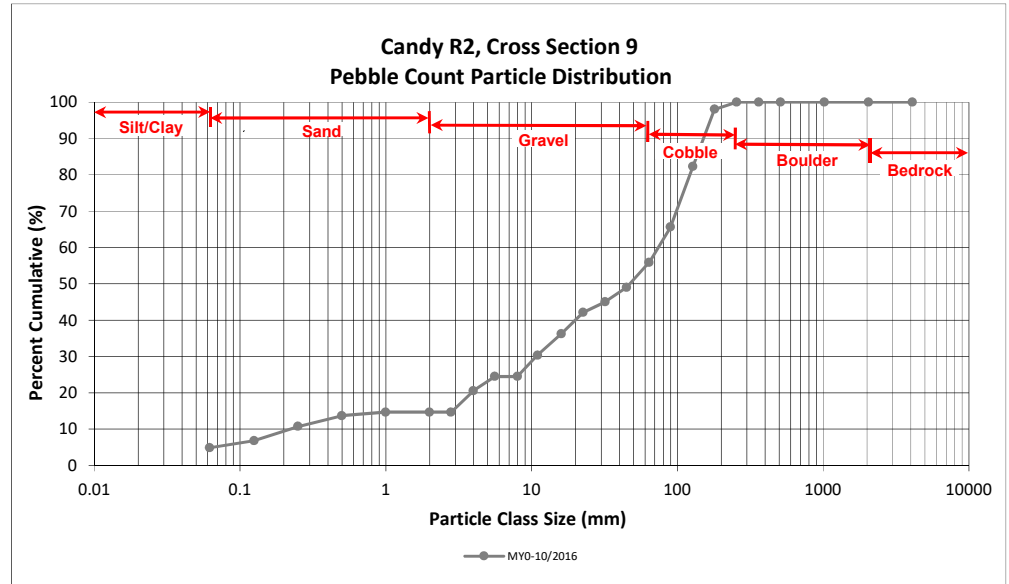
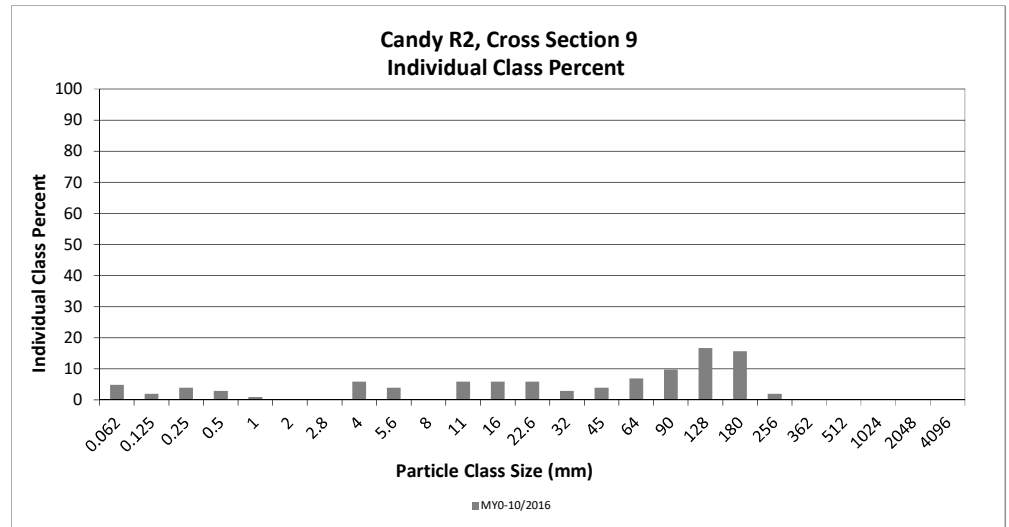
**Reachwide and Cross Section Pebble Count Plots**

Particle Class		Diameter (mm)		Riffle 100-Count	Summary	
		min	max		Class Percentage	Percent Cumulative
<i>SILT/CLAY</i>	Silt/Clay	0.000	0.062	5	5	5
<i>SAND</i>	Very fine	0.062	0.125	2	2	7
	Fine	0.125	0.250	4	4	11
	Medium	0.25	0.50	3	3	14
	Coarse	0.5	1.0	1	1	15
	Very Coarse	1.0	2.0			15
<i>GRAVEL</i>	Very Fine	2.0	2.8			15
	Very Fine	2.8	4.0	6	6	21
	Fine	4.0	5.6	4	4	25
	Fine	5.6	8.0			25
	Medium	8.0	11.0	6	6	30
	Medium	11.0	16.0	6	6	36
	Coarse	16.0	22.6	6	6	42
	Coarse	22.6	32	3	3	45
	Very Coarse	32	45	4	4	49
	Very Coarse	45	64	7	7	56
<i>COBBLE</i>	Small	64	90	10	10	66
	Small	90	128	17	17	82
	Large	128	180	16	16	98
	Large	180	256	2	2	100
<i>BOULDER</i>	Small	256	362			100
	Small	362	512			100
	Medium	512	1024			100
	Large/Very Large	1024	2048			100
<i>BEDROCK</i>	Bedrock	2048	>2048			100
<b>Total</b>				<b>102</b>	<b>100</b>	<b>100</b>

Cross Section 9	
Channel materials (mm)	
D <sub>16</sub> =	3.03
D <sub>35</sub> =	14.75
D <sub>50</sub> =	47.3
D <sub>84</sub> =	132.7
D <sub>95</sub> =	168.5
D <sub>100</sub> =	256.0

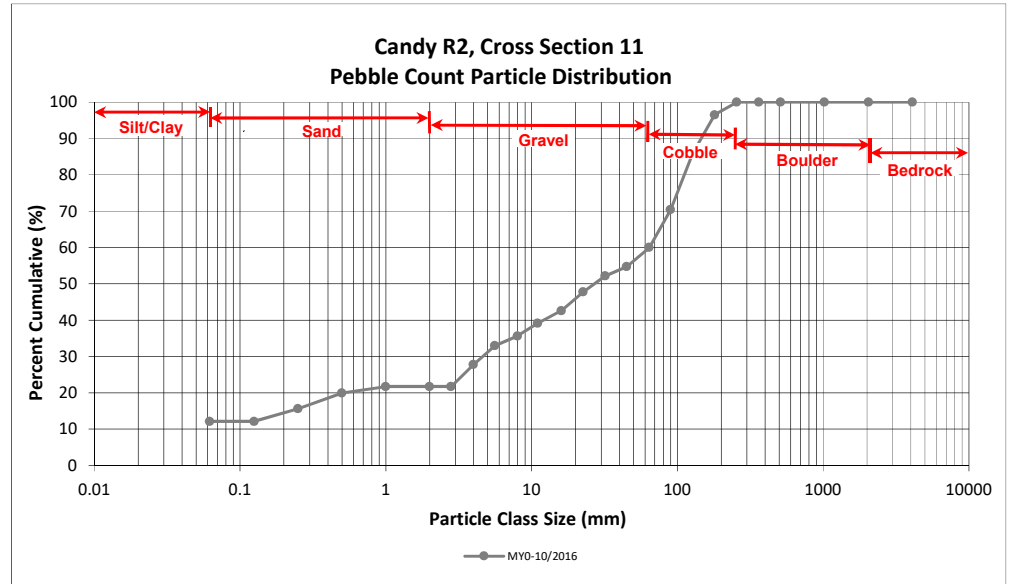
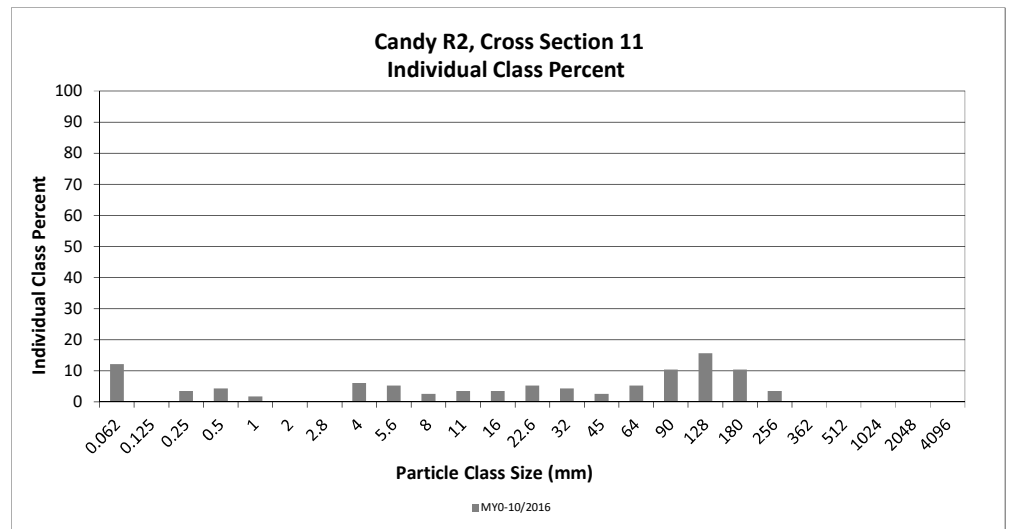
**Reachwide and Cross Section Pebble Count Plots**

Particle Class		Diameter (mm)		Riffle 100-Count	Summary	
		min	max		Class Percentage	Percent Cumulative
<i>SILT/CLAY</i>	Silt/Clay	0.000	0.062	14	12	12
<i>SAND</i>	Very fine	0.062	0.125			12
	Fine	0.125	0.250	4	3	16
	Medium	0.25	0.50	5	4	20
	Coarse	0.5	1.0	2	2	22
	Very Coarse	1.0	2.0			22
<i>GRAVEL</i>	Very Fine	2.0	2.8			22
	Very Fine	2.8	4.0	7	6	28
	Fine	4.0	5.6	6	5	33
	Fine	5.6	8.0	3	3	36
	Medium	8.0	11.0	4	3	39
	Medium	11.0	16.0	4	3	43
	Coarse	16.0	22.6	6	5	48
	Coarse	22.6	32	5	4	52
	Very Coarse	32	45	3	3	55
	Very Coarse	45	64	6	5	60
<i>COBBLE</i>	Small	64	90	12	10	70
	Small	90	128	18	16	86
	Large	128	180	12	10	97
	Large	180	256	4	3	100
<i>BOULDER</i>	Small	256	362			100
	Small	362	512			100
	Medium	512	1024			100
<i>BEDROCK</i>	Large/Very Large	1024	2048			100
	Bedrock	2048	>2048			100
<b>Total</b>				<b>115</b>	<b>100</b>	<b>100</b>

Cross Section 11 Channel materials (mm)	
D <sub>16</sub> =	0.26
D <sub>35</sub> =	7.32
D <sub>50</sub> =	26.9
D <sub>84</sub> =	122.1
D <sub>95</sub> =	171.3
D <sub>100</sub> =	256.0

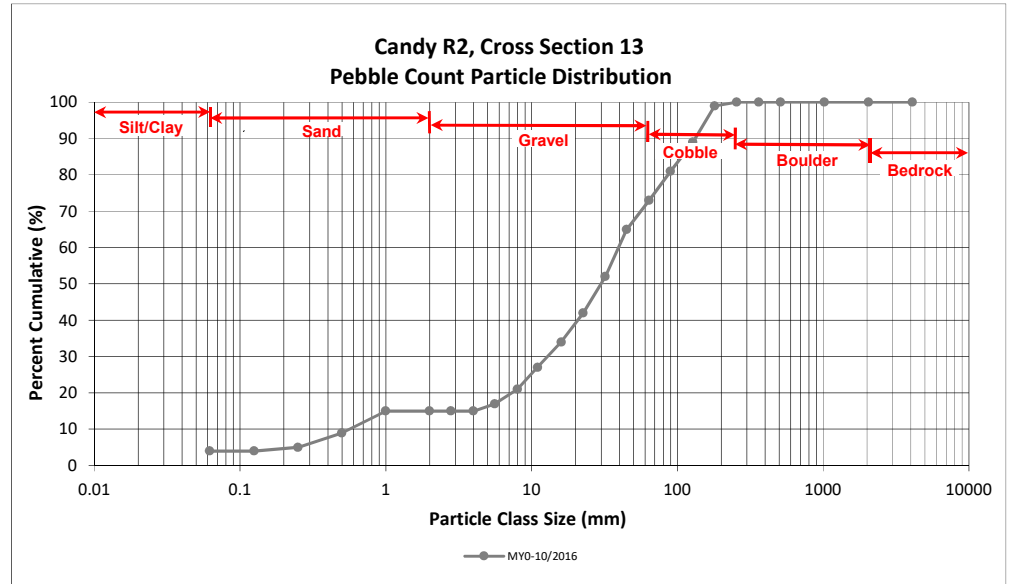
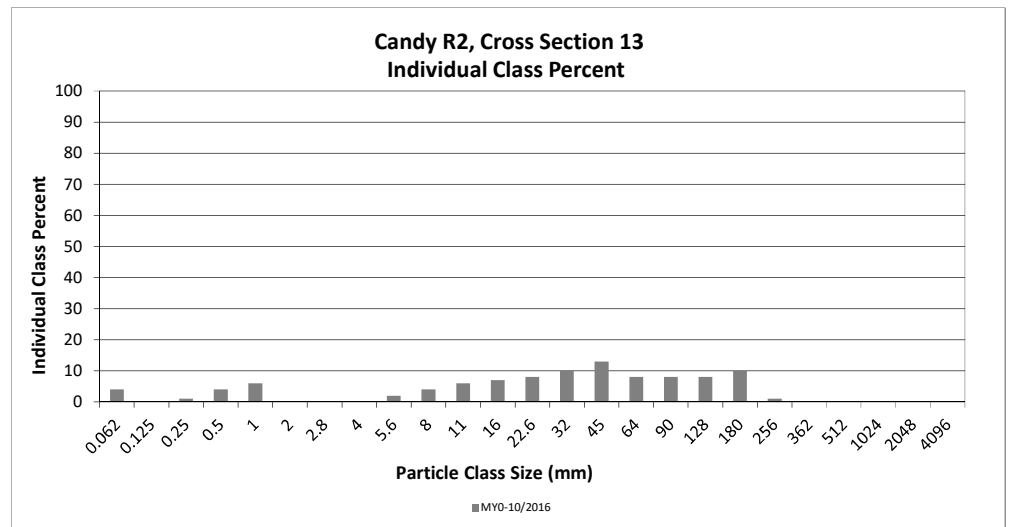
### Reachwide and Cross Section Pebble Count Plots

Particle Class		Diameter (mm)		Riffle 100-Count	Summary	
		min	max		Class Percentage	Percent Cumulative
<i>SILT/CLAY</i>	Silt/Clay	0.000	0.062	4	4	4
<i>SAND</i>	Very fine	0.062	0.125			4
	Fine	0.125	0.250	1	1	5
	Medium	0.25	0.50	4	4	9
	Coarse	0.5	1.0	6	6	15
	Very Coarse	1.0	2.0			15
<i>GRAVEL</i>	Very Fine	2.0	2.8			15
	Very Fine	2.8	4.0			15
	Fine	4.0	5.6	2	2	17
	Fine	5.6	8.0	4	4	21
	Medium	8.0	11.0	6	6	27
	Medium	11.0	16.0	7	7	34
	Coarse	16.0	22.6	8	8	42
	Coarse	22.6	32	10	10	52
	Very Coarse	32	45	13	13	65
	Very Coarse	45	64	8	8	73
<i>COBBLE</i>	Small	64	90	8	8	81
	Small	90	128	8	8	89
	Large	128	180	10	10	99
	Large	180	256	1	1	100
<i>BOULDER</i>	Small	256	362			100
	Small	362	512			100
	Medium	512	1024			100
	Large/Very Large	1024	2048			100
<i>BEDROCK</i>	Bedrock	2048	>2048			100
<b>Total</b>				<b>100</b>	<b>100</b>	<b>100</b>

Cross Section 13 Channel materials (mm)	
D <sub>16</sub> =	4.73
D <sub>35</sub> =	16.71
D <sub>50</sub> =	29.8
D <sub>84</sub> =	102.7
D <sub>95</sub> =	157.1
D <sub>100</sub> =	256.0

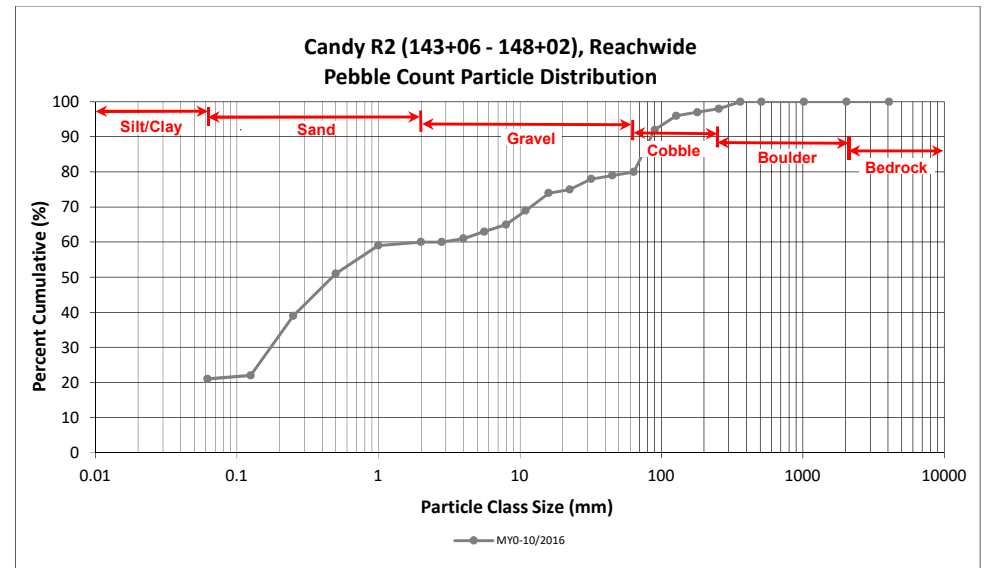
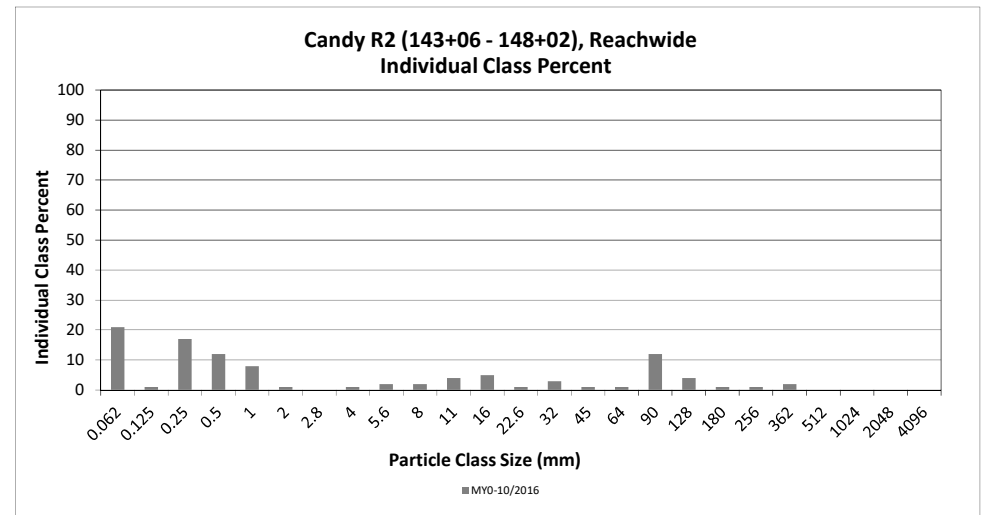
## Reachwide and Cross Section Pebble Count Plots

Particle Class		Diameter (mm)		Particle Count			Reach Summary	
		min	max	Riffle	Pool	Total	Class Percentage	Percent Cumulative
<b>SILT/CLAY</b>		Silt/Clay	0.000	0.062	4	17	21	21
<b>SAND</b>	Very fine	0.062	0.125	1	1	1	1	22
	Fine	0.125	0.250	4	13	17	17	39
	Medium	0.25	0.50	3	9	12	12	51
	Coarse	0.5	1.0	2	6	8	8	59
	Very Coarse	1.0	2.0	1	1	1	1	60
<b>GRAVEL</b>	Very Fine	2.0	2.8					60
	Very Fine	2.8	4.0		1	1	1	61
	Fine	4.0	5.6	1	1	2	2	63
	Fine	5.6	8.0	2		2	2	65
	Medium	8.0	11.0	3	1	4	4	69
	Medium	11.0	16.0	4	1	5	5	74
	Coarse	16.0	22.6	1		1	1	75
	Coarse	22.6	32	2	1	3	3	78
	Very Coarse	32	45	1		1	1	79
	Very Coarse	45	64	1		1	1	80
<b>COBBLE</b>	Small	64	90	12		12	12	92
	Small	90	128	4		4	4	96
	Large	128	180	1		1	1	97
	Large	180	256	1		1	1	98
<b>BOULDER</b>	Small	256	362	2		2	2	100
	Small	362	512					100
	Medium	512	1024					100
<b>BEDROCK</b>	Large/Very Large	1024	2048					100
	Bedrock	2048	>2048					100
<b>Total</b>				<b>50</b>	<b>50</b>	<b>100</b>	<b>100</b>	<b>100</b>

Reachwide	
Channel materials (mm)	
D <sub>16</sub> =	Silt/Clay
D <sub>35</sub> =	0.21
D <sub>50</sub> =	0.5
D <sub>84</sub> =	71.7
D <sub>95</sub> =	117.2
D <sub>100</sub> =	362.0

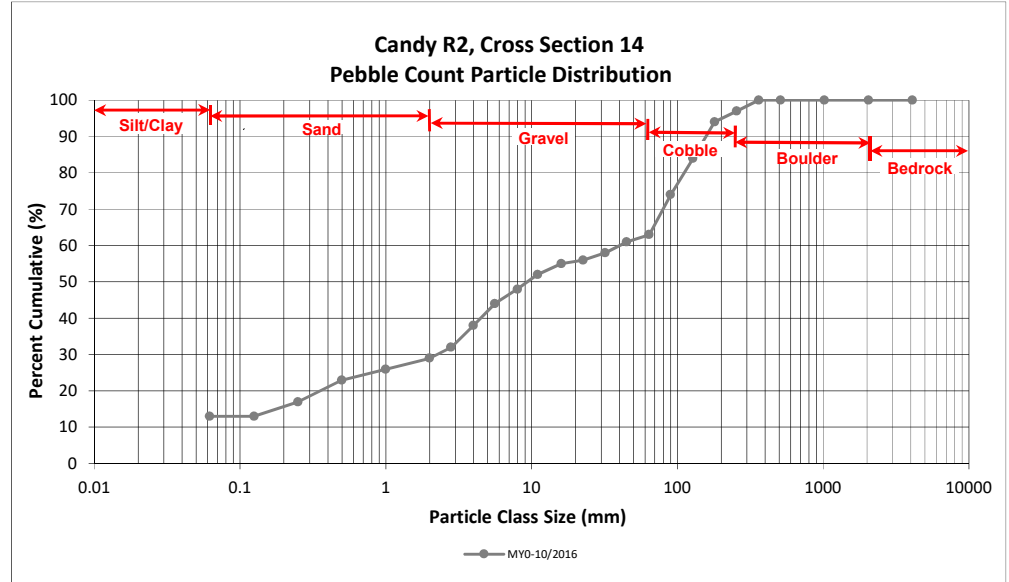
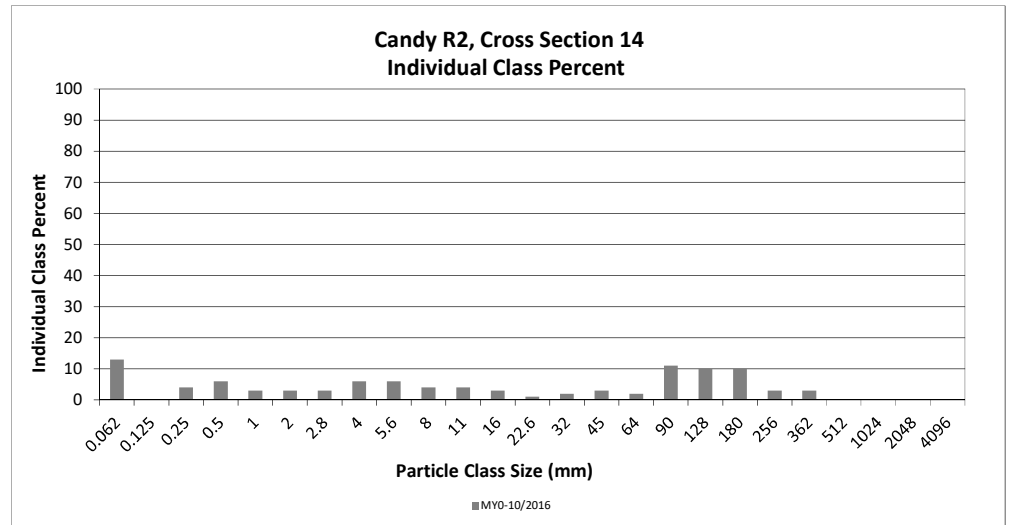
### Reachwide and Cross Section Pebble Count Plots

Particle Class		Diameter (mm)		Riffle 100-Count	Summary	
		min	max		Class Percentage	Percent Cumulative
<i>SILT/CLAY</i>	Silt/Clay	0.000	0.062	13	13	13
<i>SAND</i>	Very fine	0.062	0.125			13
	Fine	0.125	0.250	4	4	17
	Medium	0.25	0.50	6	6	23
	Coarse	0.5	1.0	3	3	26
	Very Coarse	1.0	2.0	3	3	29
<i>GRAVEL</i>	Very Fine	2.0	2.8	3	3	32
	Very Fine	2.8	4.0	6	6	38
	Fine	4.0	5.6	6	6	44
	Fine	5.6	8.0	4	4	48
	Medium	8.0	11.0	4	4	52
	Medium	11.0	16.0	3	3	55
	Coarse	16.0	22.6	1	1	56
	Coarse	22.6	32	2	2	58
	Very Coarse	32	45	3	3	61
	Very Coarse	45	64	2	2	63
<i>COBBLE</i>	Small	64	90	11	11	74
	Small	90	128	10	10	84
	Large	128	180	10	10	94
	Large	180	256	3	3	97
<i>BOULDER</i>	Small	256	362	3	3	100
	Small	362	512			100
	Medium	512	1024			100
	Large/Very Large	1024	2048			100
<i>BEDROCK</i>	Bedrock	2048	>2048			100
<b>Total</b>				<b>100</b>	<b>100</b>	<b>100</b>

Cross Section 14 Channel materials (mm)	
D <sub>16</sub> =	0.21
D <sub>35</sub> =	3.35
D <sub>50</sub> =	9.4
D <sub>84</sub> =	128.0
D <sub>95</sub> =	202.4
D <sub>100</sub> =	362.0

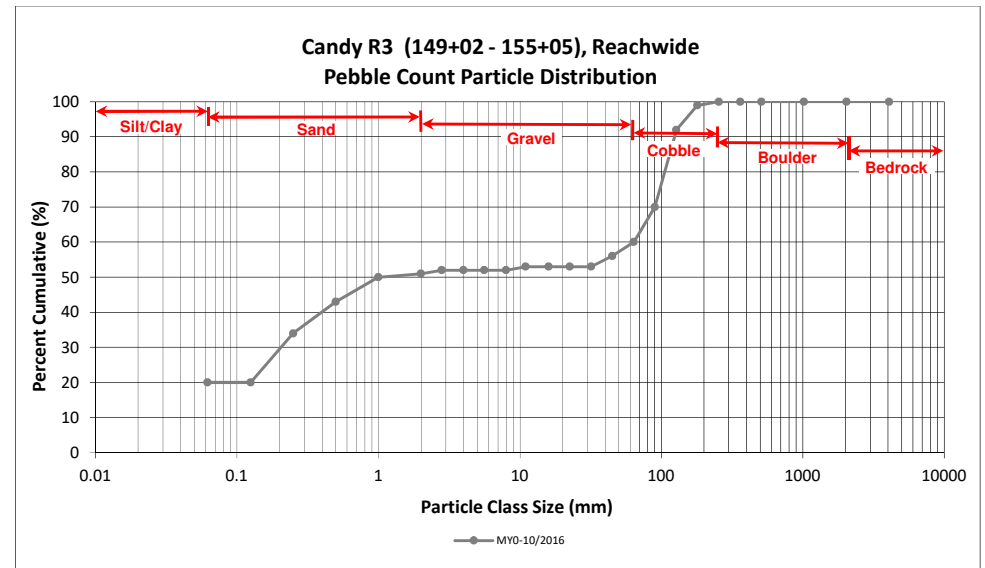
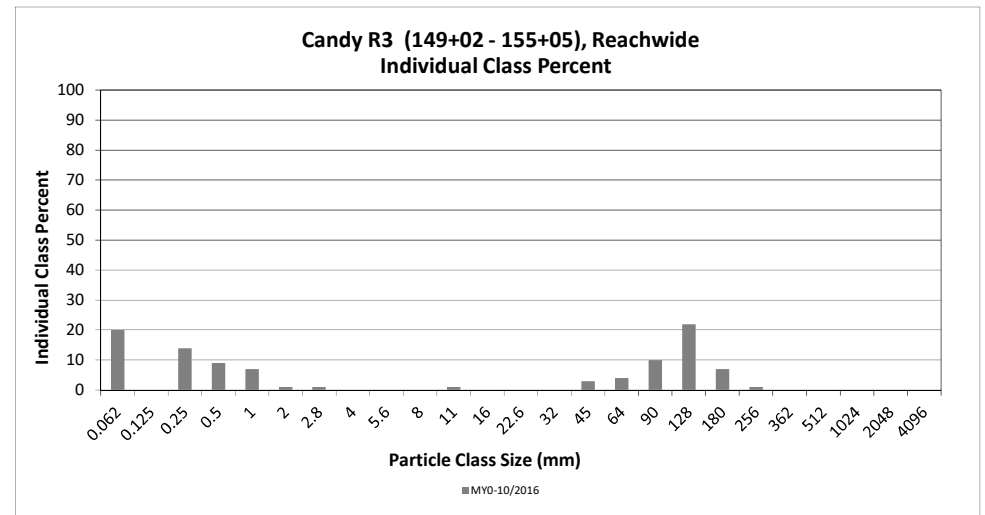
## Reachwide and Cross Section Pebble Count Plots

Particle Class		Diameter (mm)		Particle Count			Reach Summary	
		min	max	Riffle	Pool	Total	Class Percentage	Percent Cumulative
<b>SILT/CLAY</b>		Silt/Clay	0.000	0.062		20	20	20
<b>SAND</b>	Very fine	0.062	0.125					20
	Fine	0.125	0.250	2	12	14	14	34
	Medium	0.25	0.50		9	9	9	43
	Coarse	0.5	1.0	2	5	7	7	50
	Very Coarse	1.0	2.0		1	1	1	51
<b>GRAVEL</b>	Very Fine	2.0	2.8		1	1	1	52
	Very Fine	2.8	4.0					52
	Fine	4.0	5.6					52
	Fine	5.6	8.0					52
	Medium	8.0	11.0		1	1	1	53
	Medium	11.0	16.0					53
	Coarse	16.0	22.6					53
	Coarse	22.6	32					53
	Very Coarse	32	45	2	1	3	3	56
	Very Coarse	45	64	4		4	4	60
<b>COBBLE</b>	Small	64	90	10		10	10	70
	Small	90	128	22		22	22	92
	Large	128	180	7		7	7	99
<b>BOULDER</b>	Large	180	256	1		1	1	100
	Small	256	362					100
	Small	362	512					100
	Medium	512	1024					100
<b>BEDROCK</b>	Large/Very Large	1024	2048					100
	Bedrock	2048	>2048					100
<b>Total</b>				<b>50</b>	<b>50</b>	<b>100</b>	<b>100</b>	<b>100</b>

Reachwide	
Channel materials (mm)	
D <sub>16</sub> =	Silt/Clay
D <sub>35</sub> =	0.27
D <sub>50</sub> =	1.0
D <sub>84</sub> =	112.6
D <sub>95</sub> =	148.1
D <sub>100</sub> =	256.0

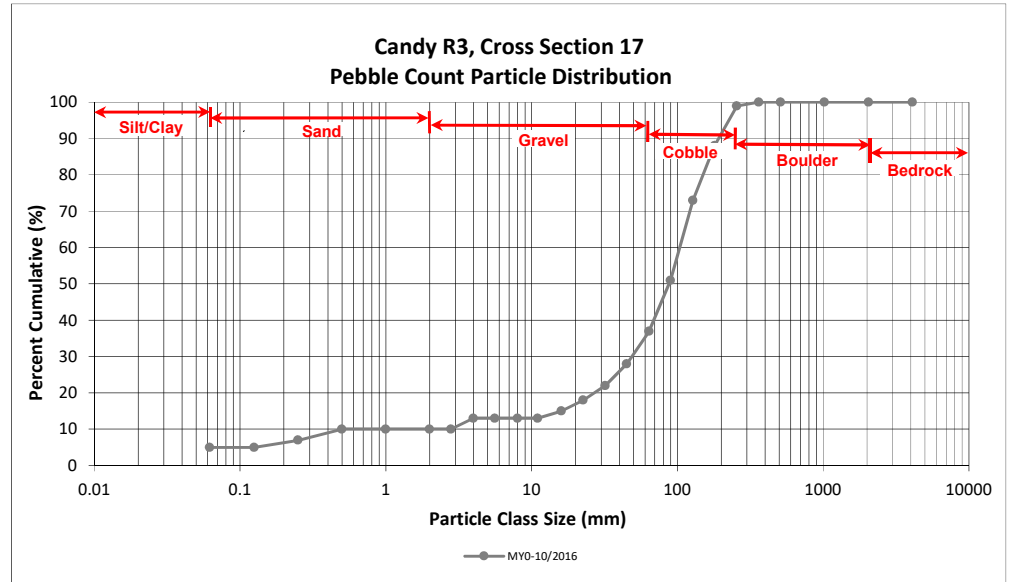
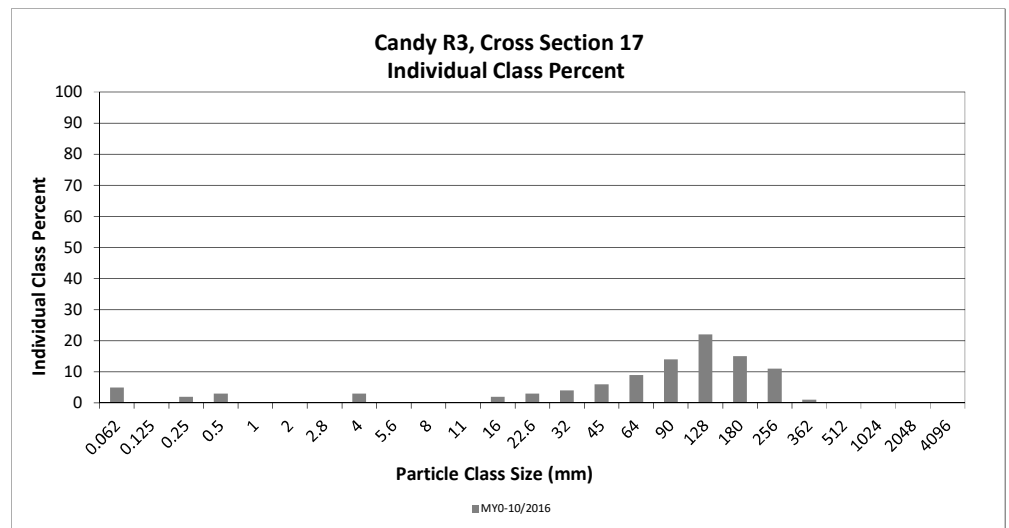
Cross Section 17 Channel materials (mm)	
D <sub>16</sub> =	17.95
D <sub>35</sub> =	59.18
D <sub>50</sub> =	87.8
D <sub>84</sub> =	164.4
D <sub>95</sub> =	225.2
D <sub>100</sub> =	362.0
