# **BASELINE MONITORING DOCUMENT AND AS-BUILT BASELINE REPORT**

## **CANDY CREEK MITIGATION SITE**

Guilford County, NC  
NCDEQ Contract 5794  
DMS ID No. 96315

Data Collection Period: October 2016 – March 2017  
Final Submission Date: June 2, 2017

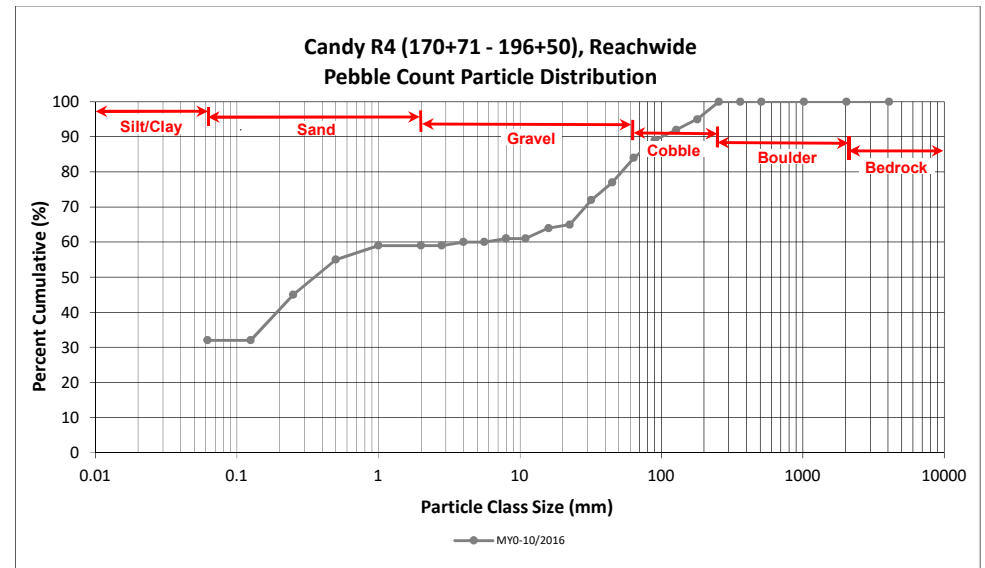
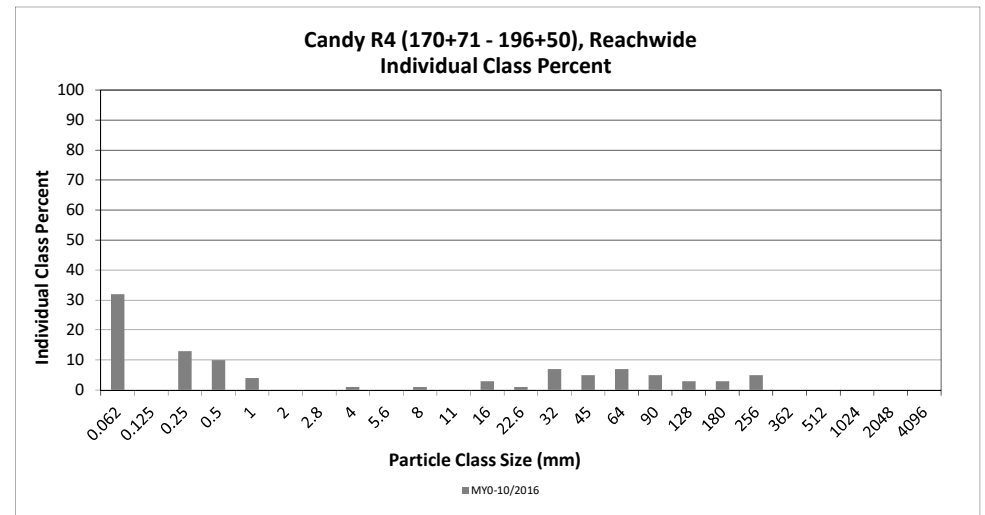
Reachwide	
Channel materials (mm)	
D <sub>16</sub> =	Silt/Clay
D <sub>35</sub> =	0.15
D <sub>50</sub> =	0.4
D <sub>84</sub> =	64.0
D <sub>95</sub> =	180.0
D <sub>100</sub> =	256.0

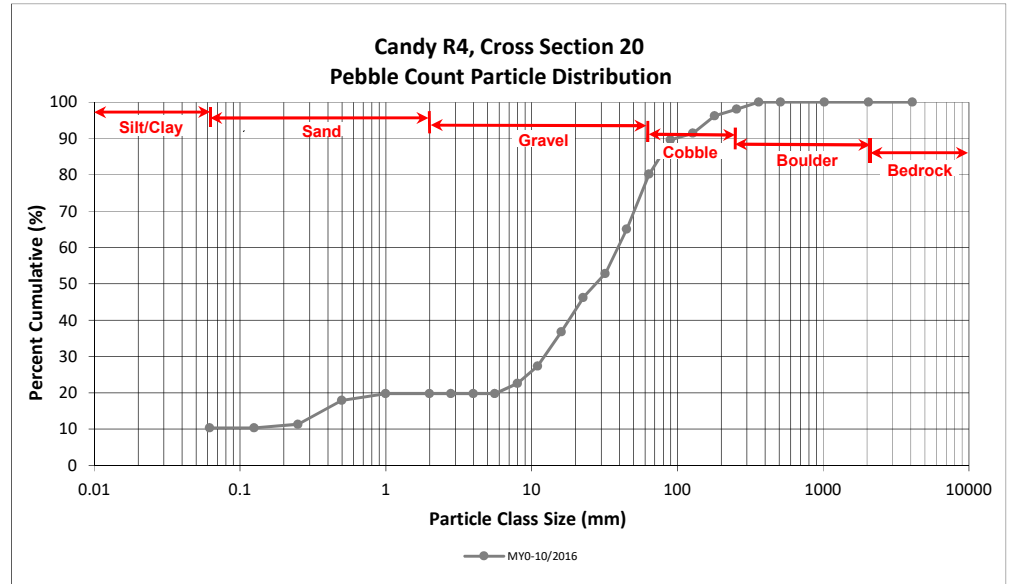
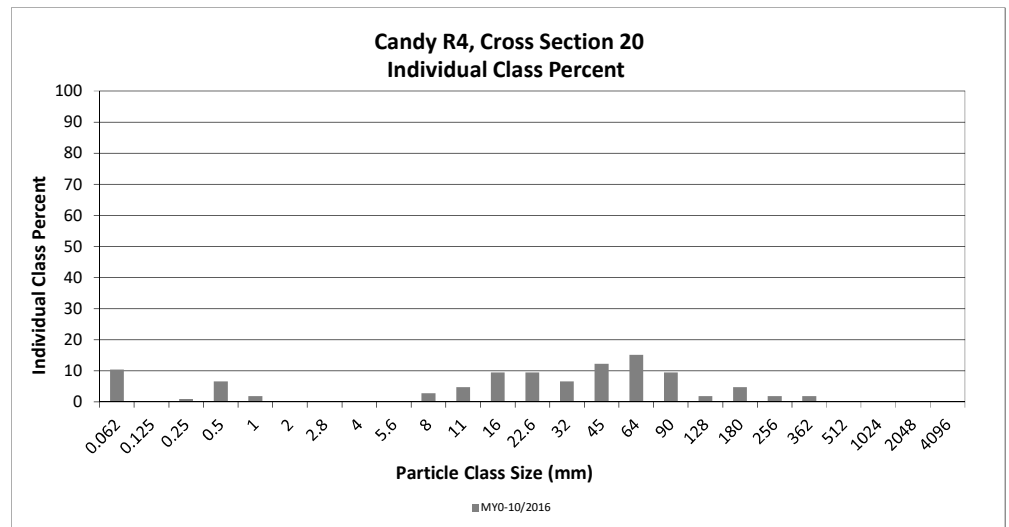
Cross Section 20	
Channel materials (mm)	
D <sub>16</sub> =	0.41
D <sub>35</sub> =	14.90
D <sub>50</sub> =	27.6
D <sub>84</sub> =	73.5
D <sub>95</sub> =	164.7
D <sub>100</sub> =	362.0

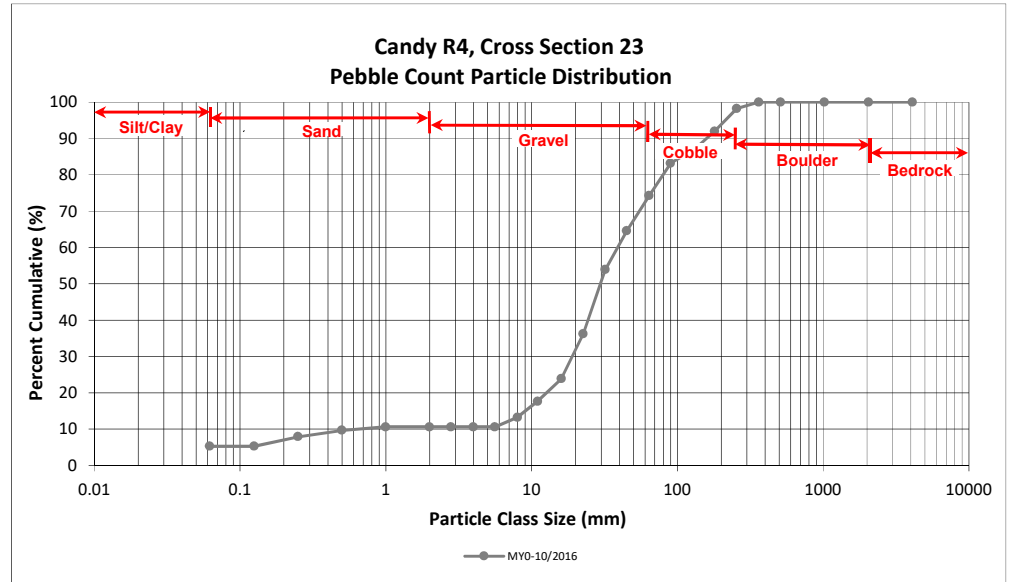
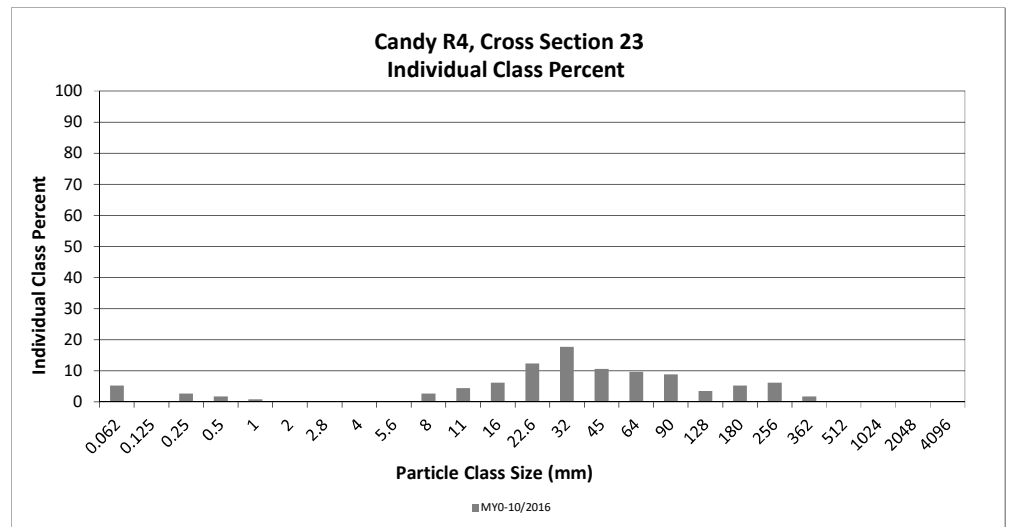
Cross Section 23 Channel materials (mm)	
D <sub>16</sub> =	9.73
D <sub>35</sub> =	21.81
D <sub>50</sub> =	29.6
D <sub>84</sub> =	97.6
D <sub>95</sub> =	213.0
D <sub>100</sub> =	362.0

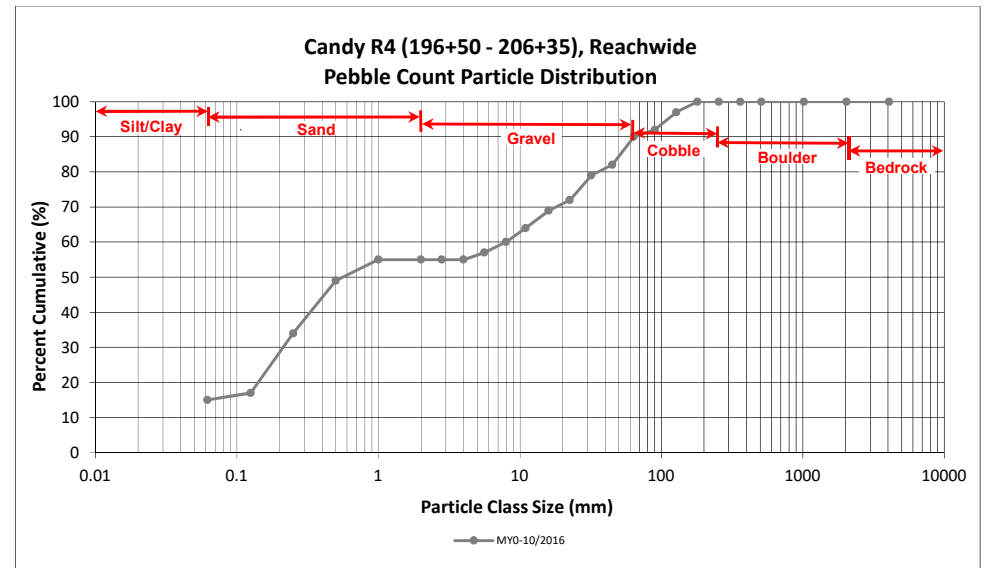
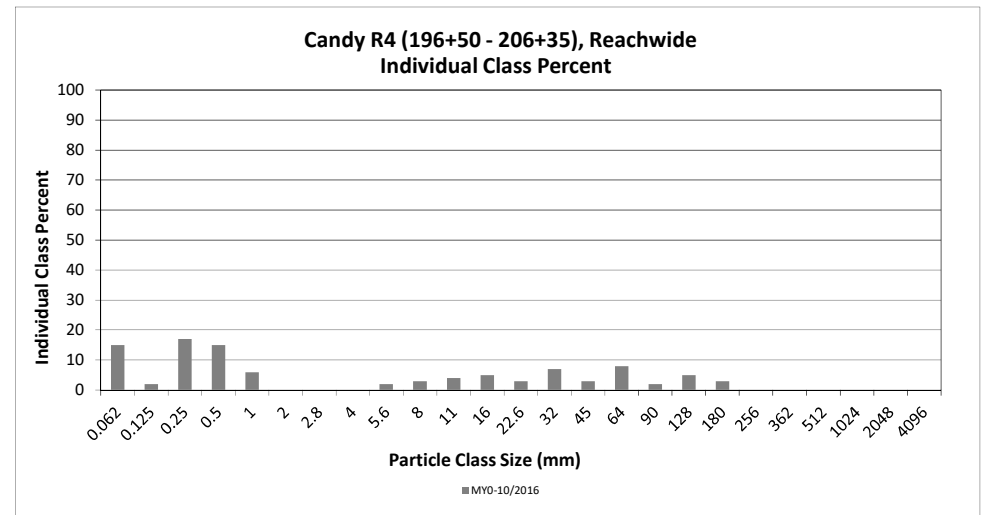
Reachwide	
Channel materials (mm)	
D <sub>16</sub> =	0.09
D <sub>35</sub> =	0.26
D <sub>50</sub> =	0.6
D <sub>84</sub> =	49.1
D <sub>95</sub> =	111.2
D <sub>100</sub> =	180.0

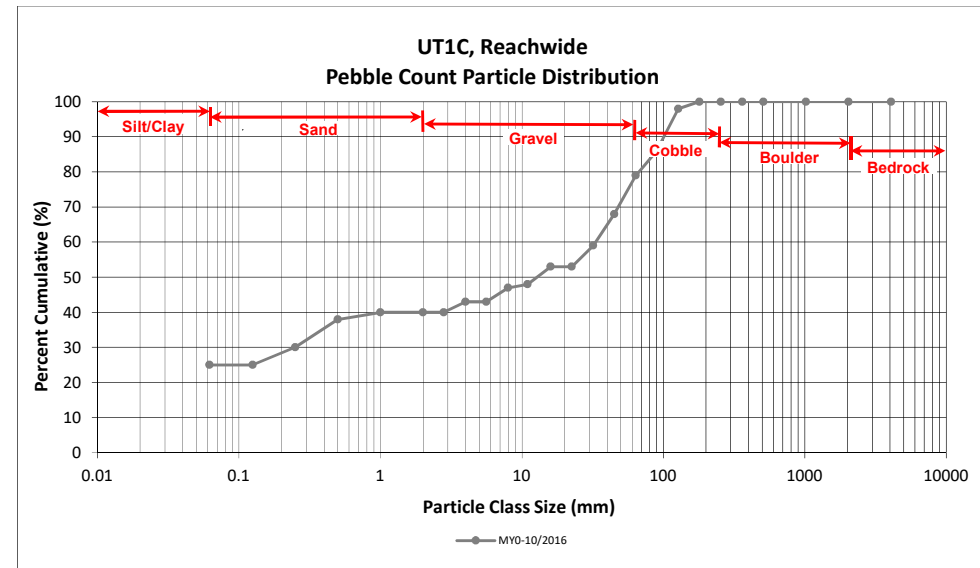
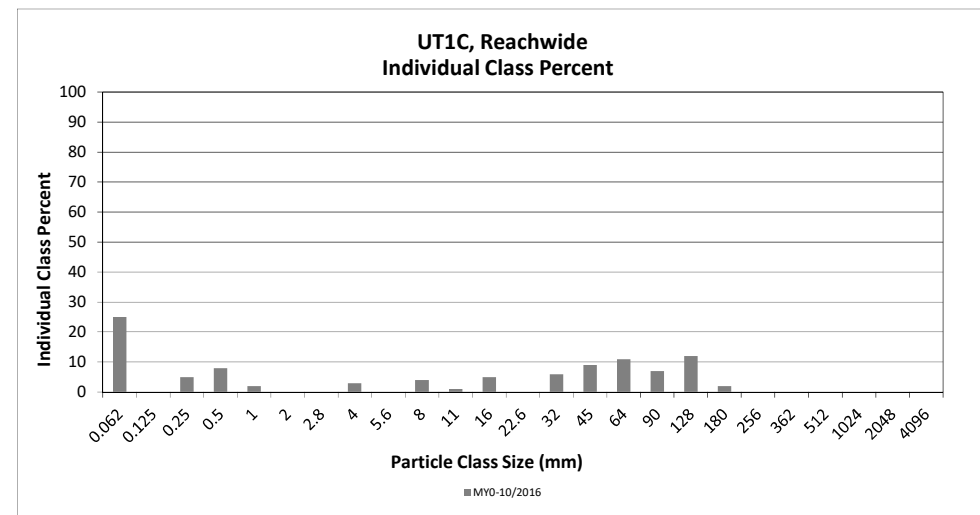
Reachwide	
Channel materials (mm)	
D <sub>16</sub> =	Silt/Clay
D <sub>35</sub> =	0.39
D <sub>50</sub> =	12.8
D <sub>84</sub> =	81.6
D <sub>95</sub> =	117.2
D <sub>100</sub> =	180.0

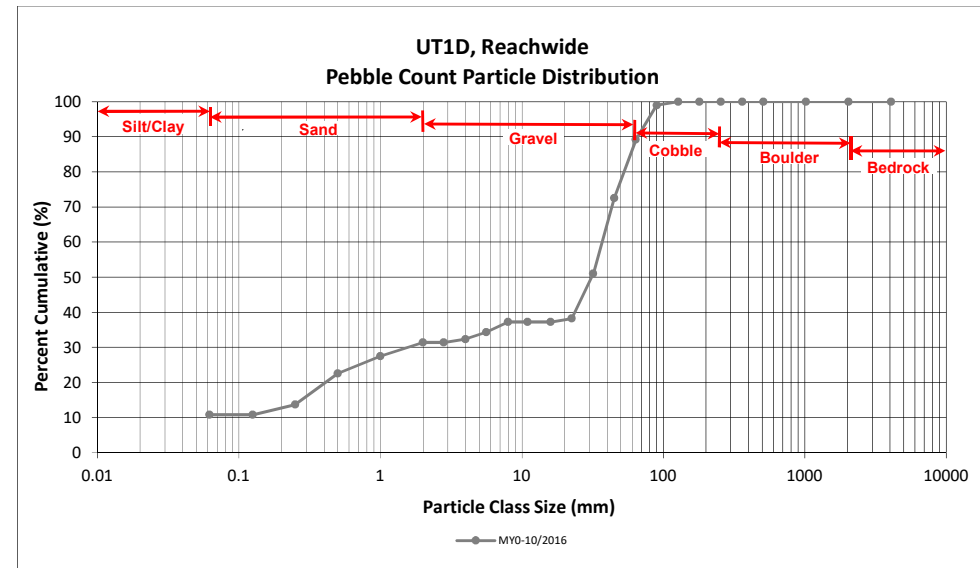
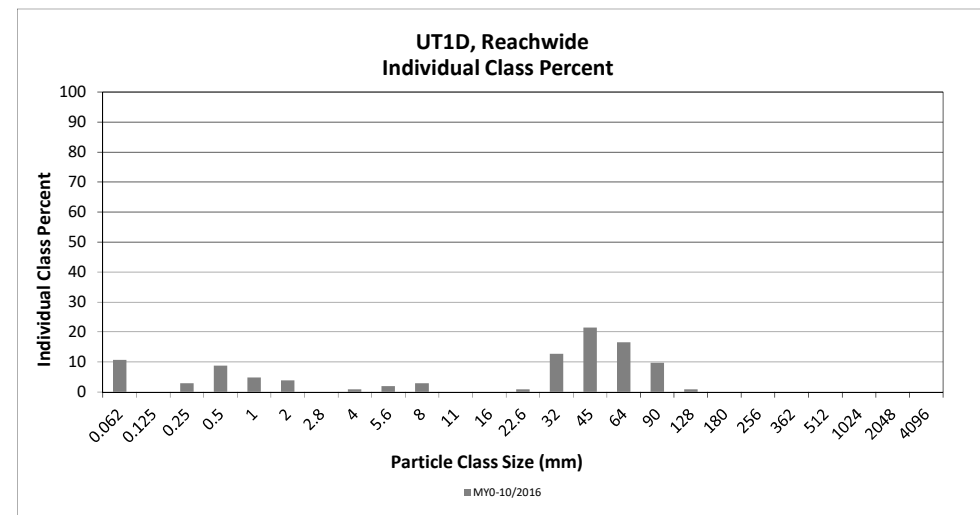
Reachwide	
Channel materials (mm)	
D <sub>16</sub> =	0.30
D <sub>35</sub> =	6.09
D <sub>50</sub> =	31.2
D <sub>84</sub> =	57.3
D <sub>95</sub> =	78.3
D <sub>100</sub> =	128.0

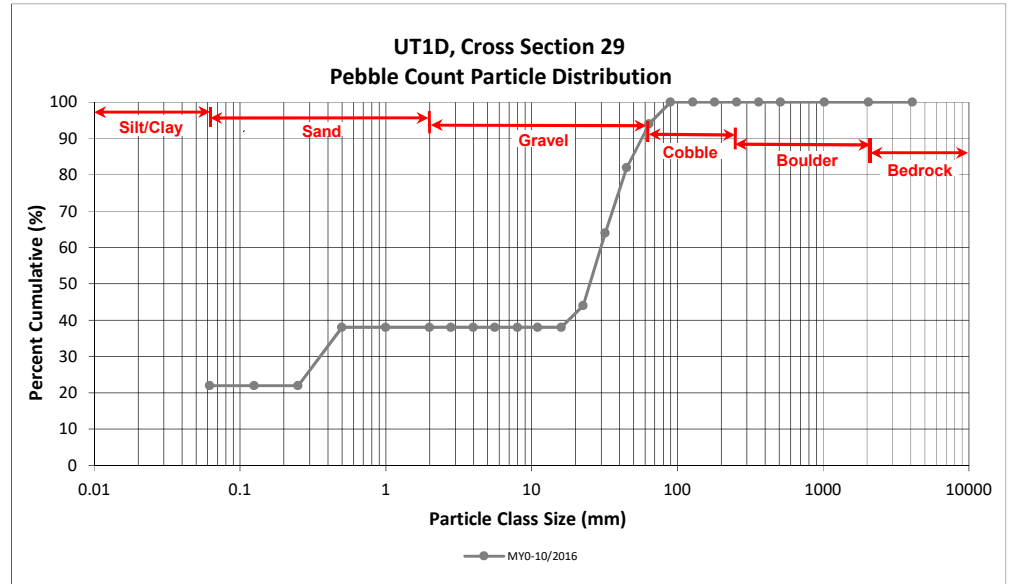
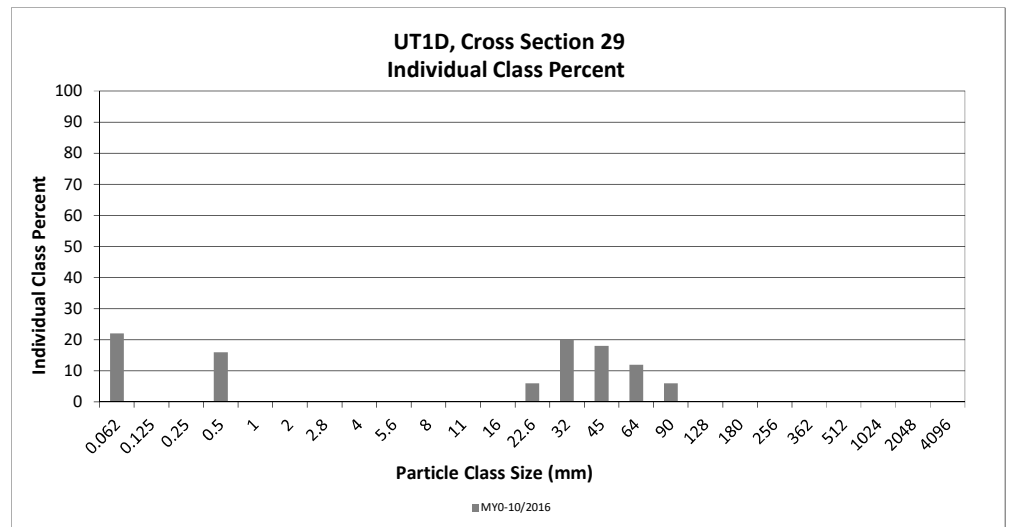
Cross Section 29	
Channel materials (mm)	
D <sub>16</sub> =	Silt/Clay
D <sub>35</sub> =	0.44
D <sub>50</sub> =	25.1
D <sub>84</sub> =	47.7
D <sub>95</sub> =	67.7
D <sub>100</sub> =	90.0

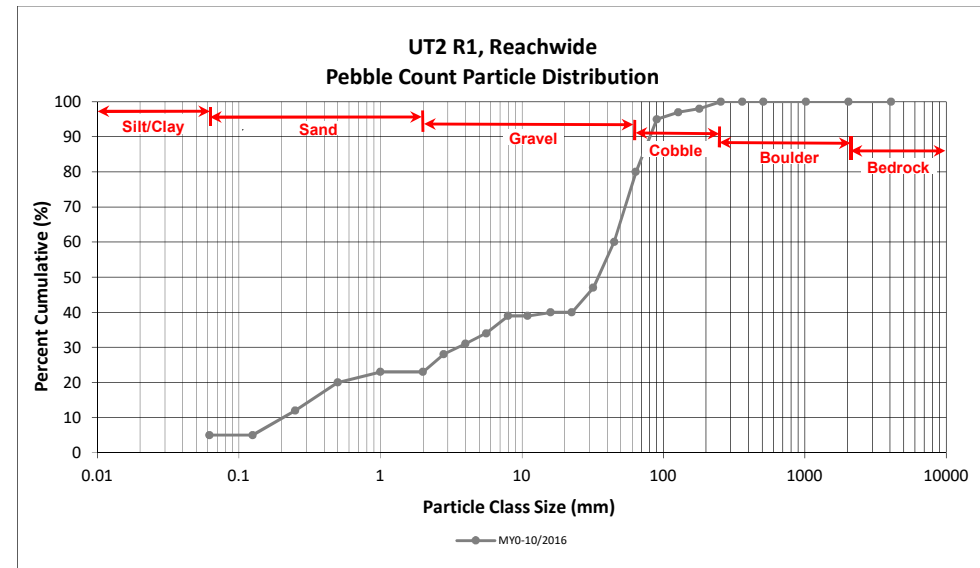
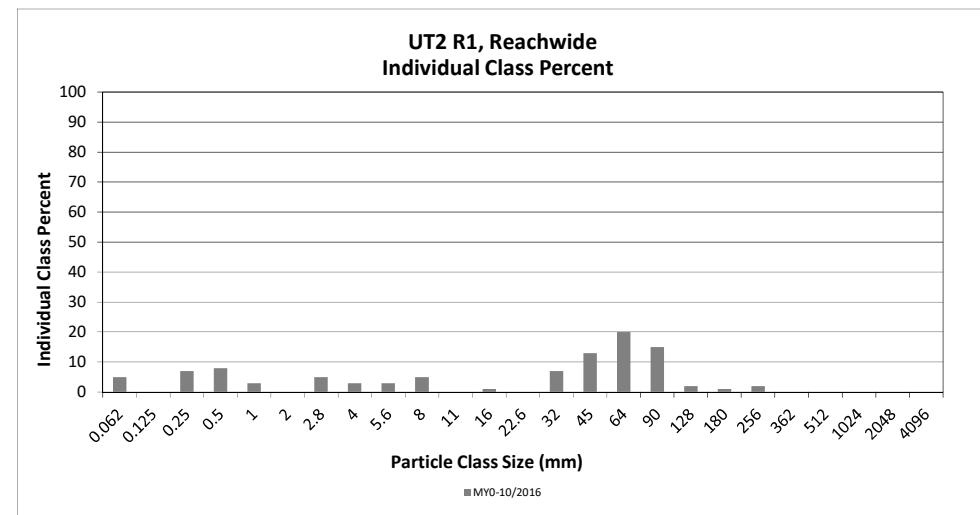
Reachwide	
Channel materials (mm)	
D <sub>16</sub> =	0.35
D <sub>35</sub> =	6.01
D <sub>50</sub> =	34.6
D <sub>84</sub> =	70.1
D <sub>95</sub> =	90.0
D <sub>100</sub> =	256.0

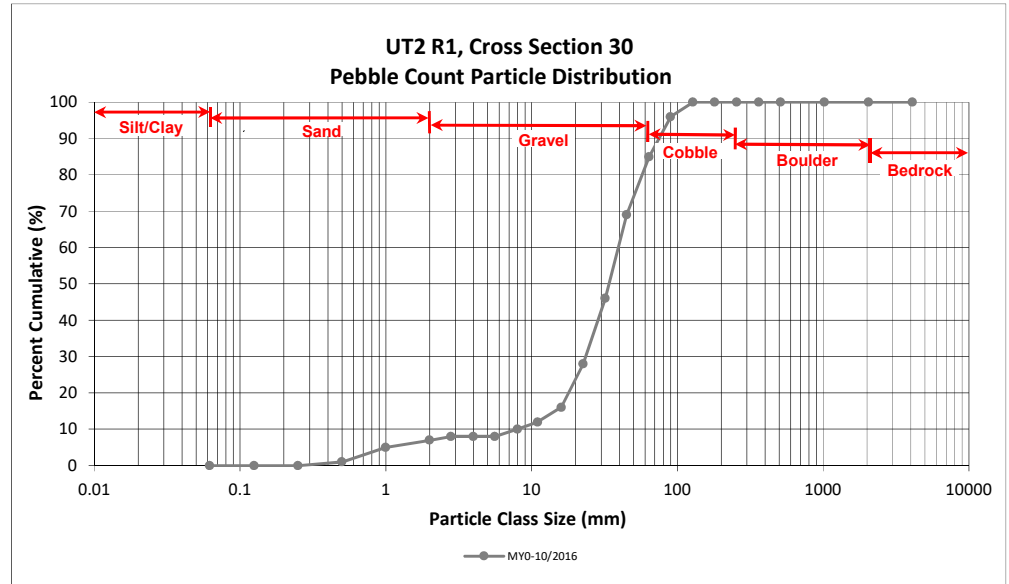
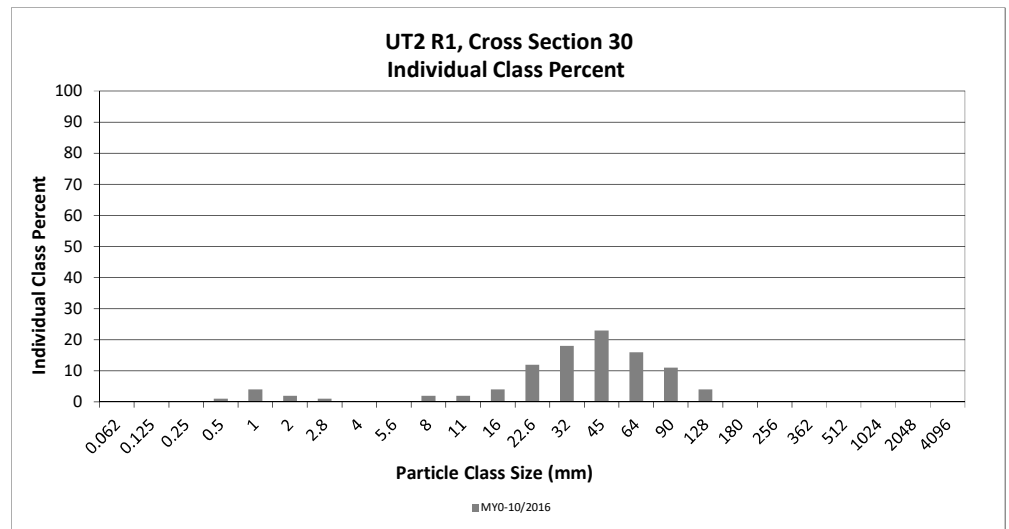
Cross Section 30 Channel materials (mm)	
D <sub>16</sub> =	16.00
D <sub>35</sub> =	25.87
D <sub>50</sub> =	34.0
D <sub>84</sub> =	62.6
D <sub>95</sub> =	87.3
D <sub>100</sub> =	128.0

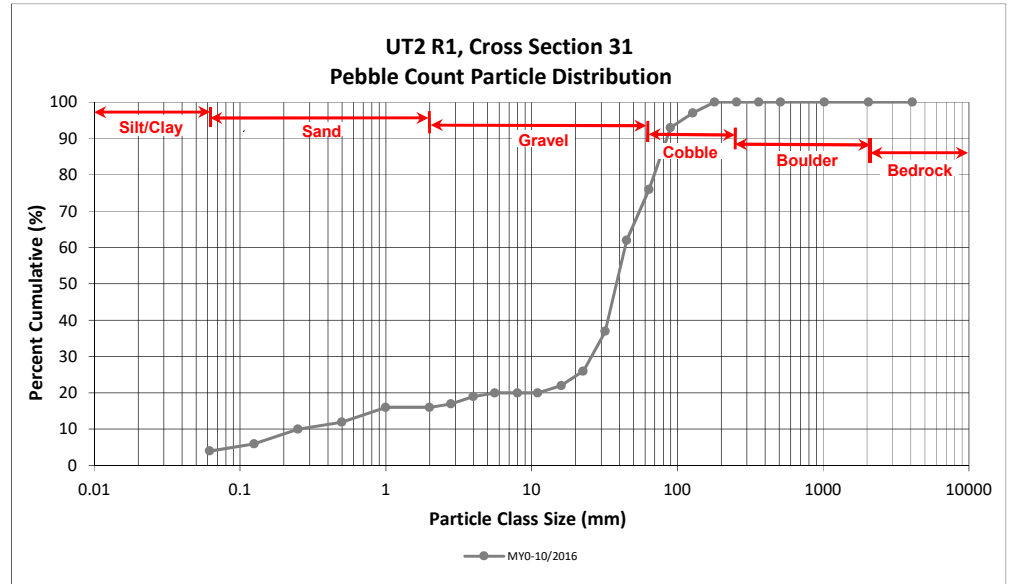
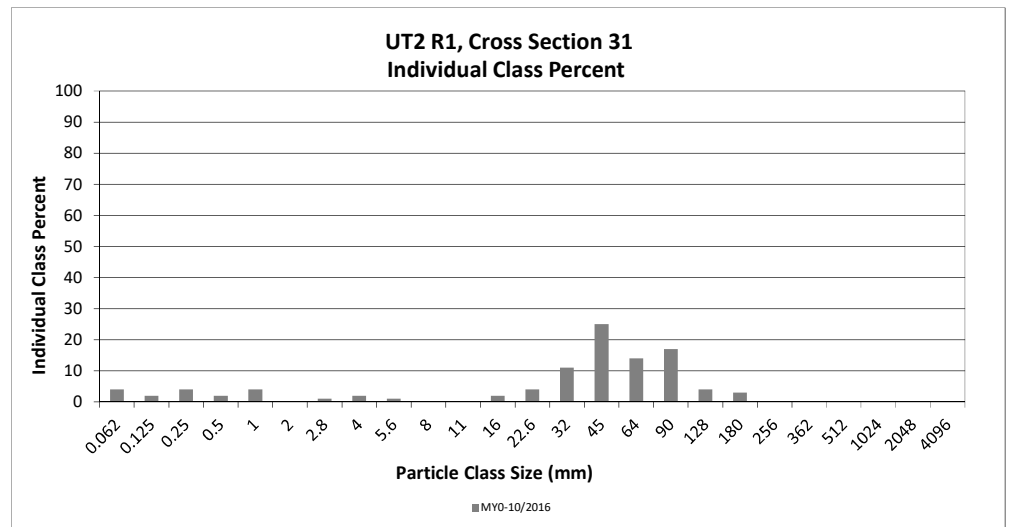
Cross Section 31 Channel materials (mm)	
D <sub>16</sub> =	1.00
D <sub>35</sub> =	30.04
D <sub>50</sub> =	38.2
D <sub>84</sub> =	75.1
D <sub>95</sub> =	107.3
D <sub>100</sub> =	180.0

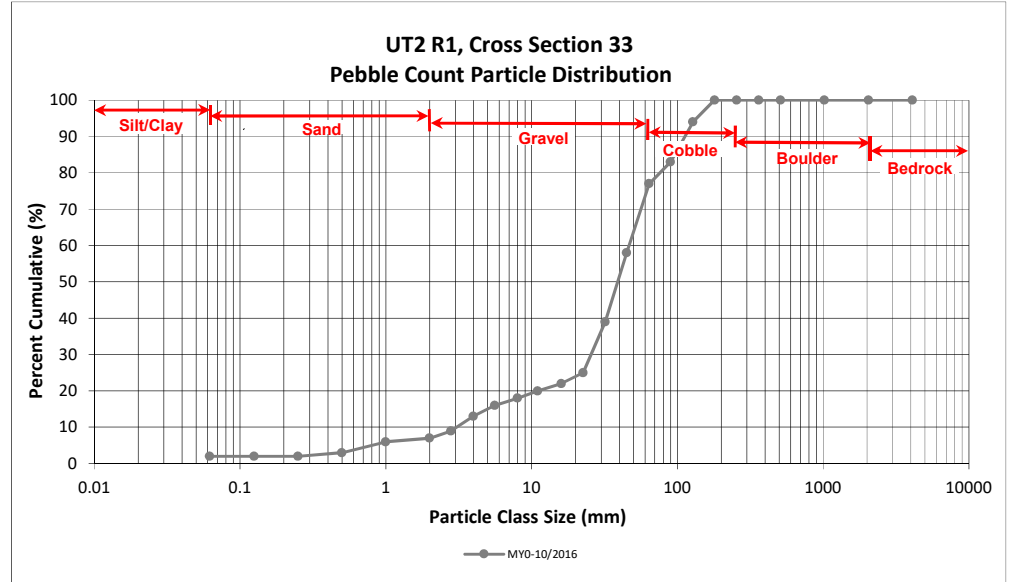
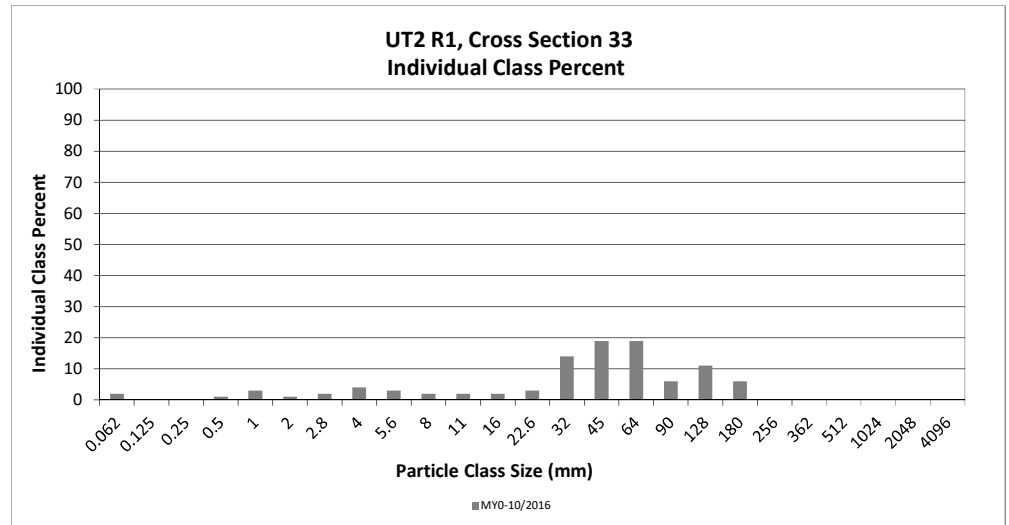
Cross Section 33 Channel materials (mm)	
D <sub>16</sub> =	5.60
D <sub>35</sub> =	28.97
D <sub>50</sub> =	39.0
D <sub>84</sub> =	92.9
D <sub>95</sub> =	135.5
D <sub>100</sub> =	180.0

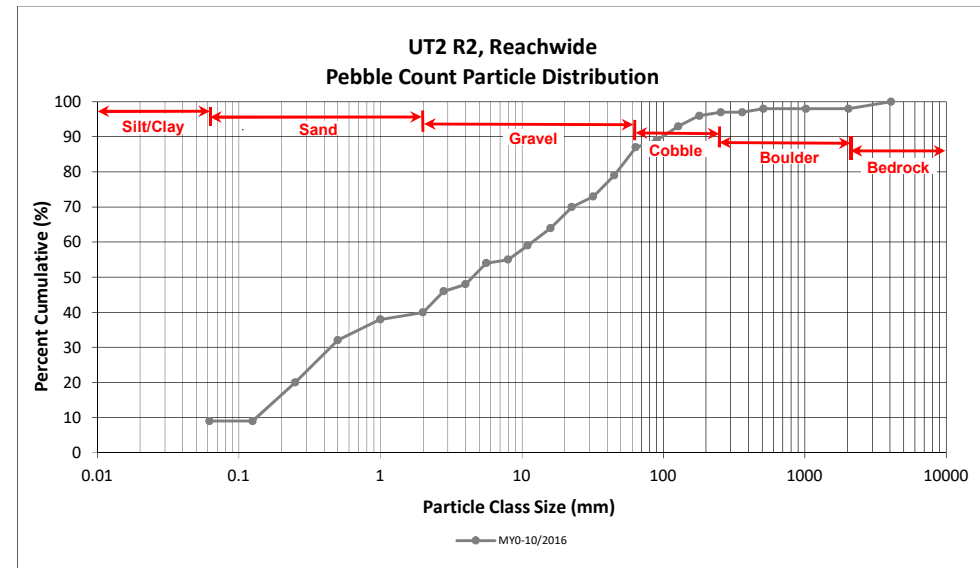
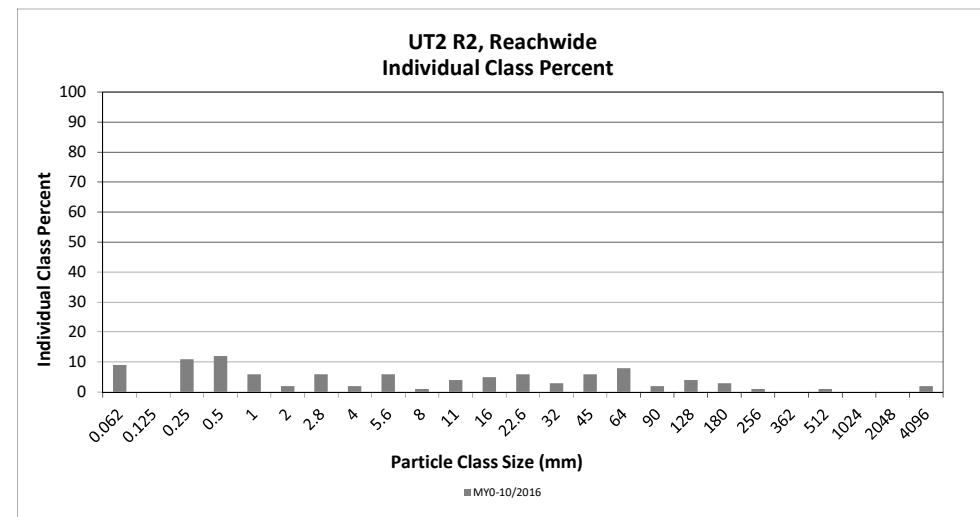
Reachwide	
Channel materials (mm)	
D <sub>16</sub> =	0.19
D <sub>35</sub> =	0.71
D <sub>50</sub> =	4.5
D <sub>84</sub> =	56.1
D <sub>95</sub> =	160.7
D <sub>100</sub> =	>2048

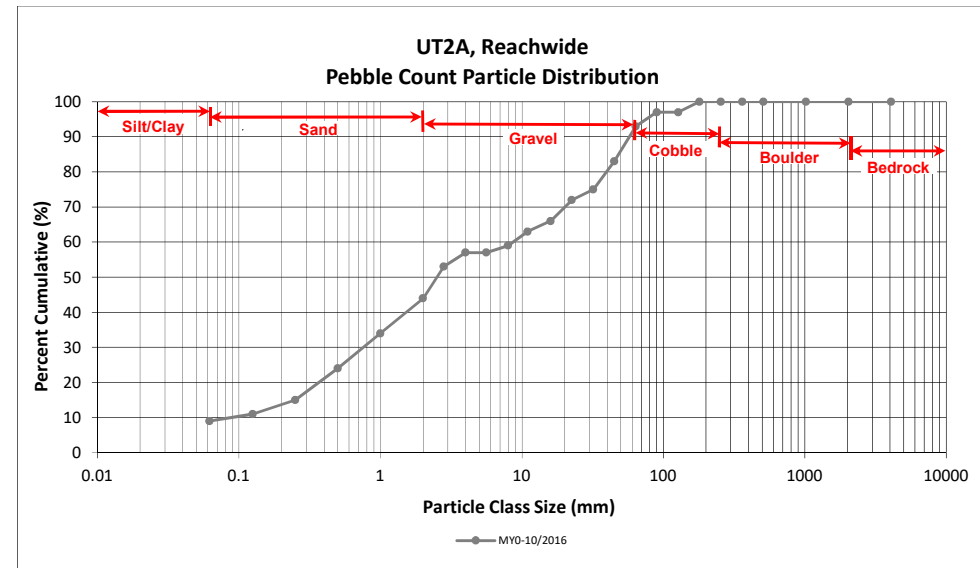
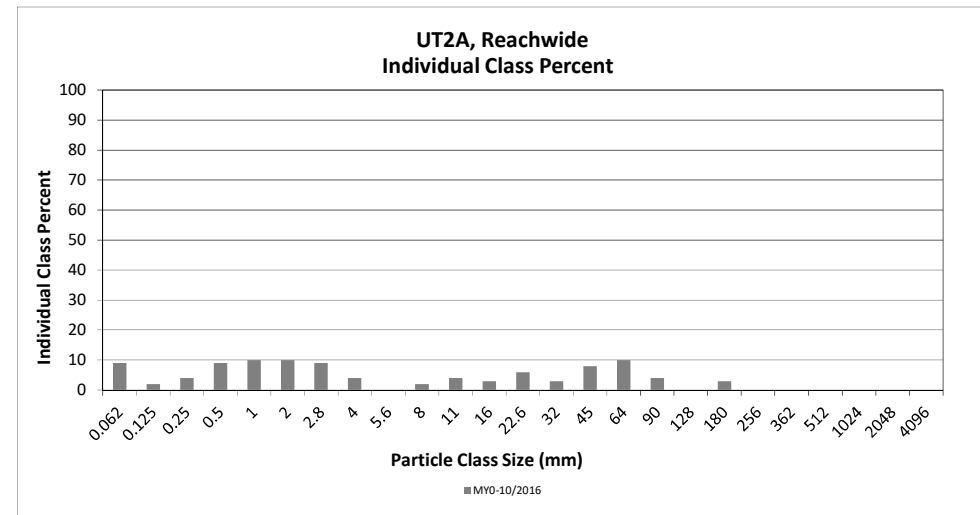
Reachwide	
Channel materials (mm)	
D <sub>16</sub> =	0.27
D <sub>35</sub> =	1.07
D <sub>50</sub> =	2.5
D <sub>84</sub> =	46.6
D <sub>95</sub> =	75.9
D <sub>100</sub> =	180.0

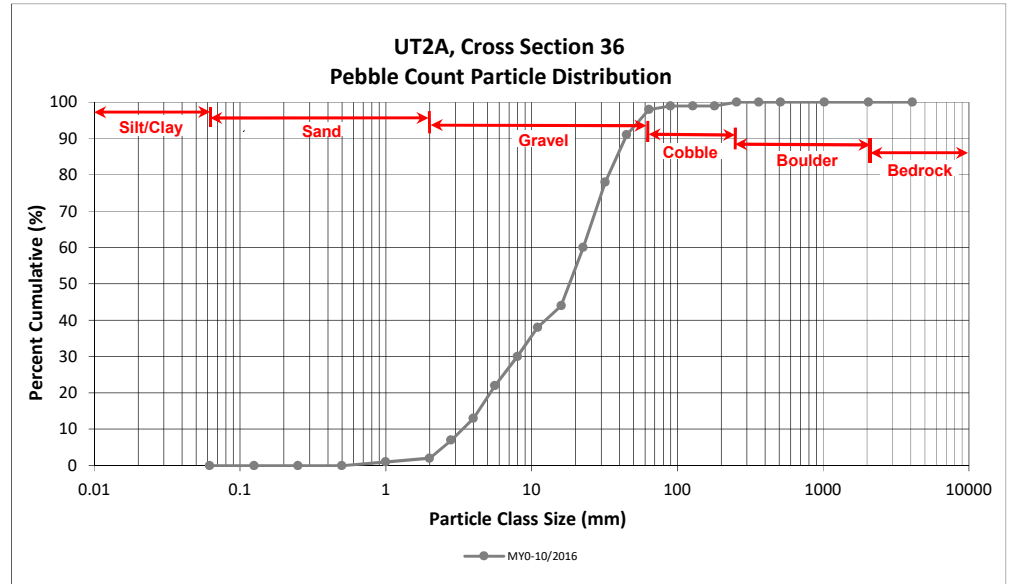
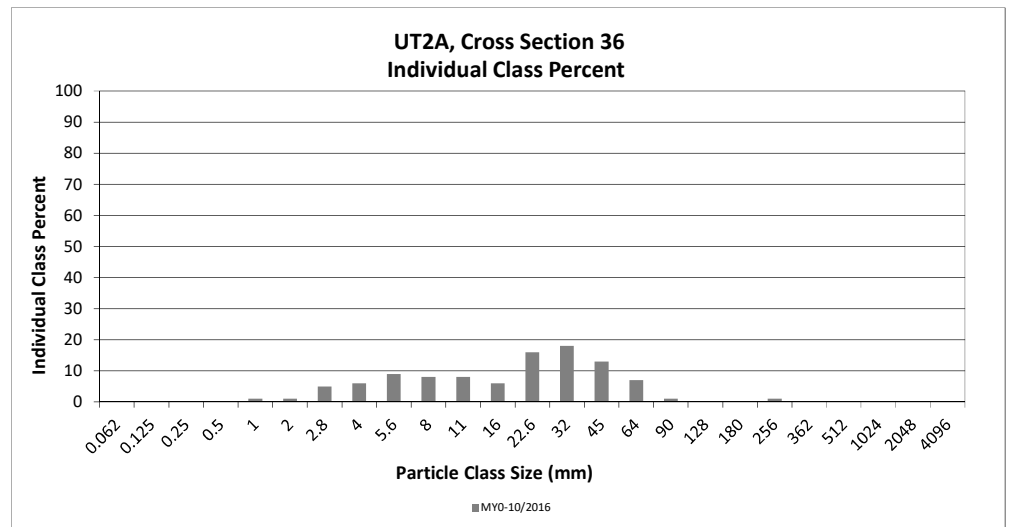
Cross Section 36 Channel materials (mm)	
D <sub>16</sub> =	4.47
D <sub>35</sub> =	9.76
D <sub>50</sub> =	18.2
D <sub>84</sub> =	37.5
D <sub>95</sub> =	55.0
D <sub>100</sub> =	256.0

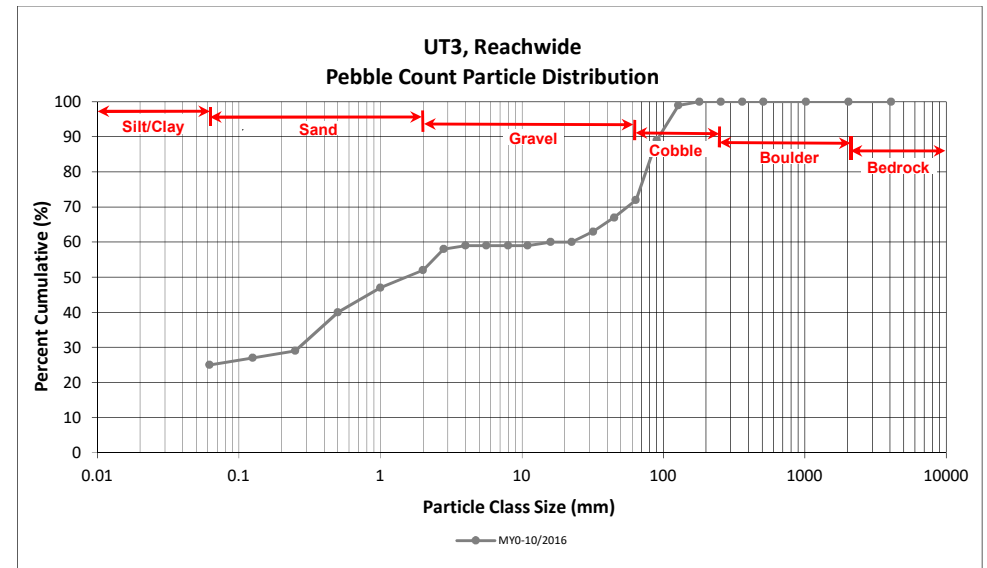
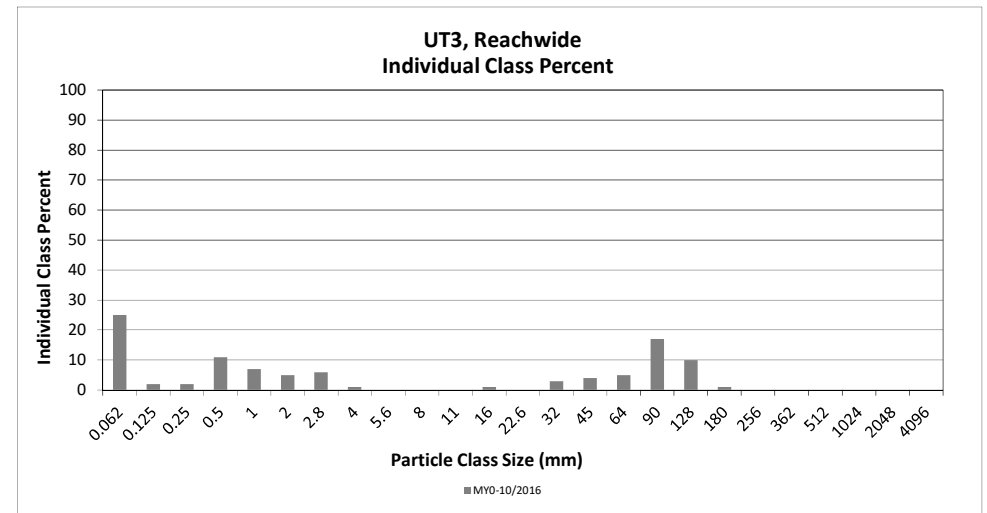
Particle Class		Diameter (mm)		Particle Count			Reach Summary	
		min	max	Riffle	Pool	Total	Class Percentage	Percent Cumulative
<b>SILT/CLAY</b>		Silt/Clay	0.000	0.062	2	23	25	25
<b>SAND</b>	Very fine	0.062	0.125	2		2	2	27
	Fine	0.125	0.250	1	1	2	2	29
	Medium	0.25	0.50	1	10	11	11	40
	Coarse	0.5	1.0	1	6	7	7	47
	Very Coarse	1.0	2.0	1	4	5	5	52
<b>GRAVEL</b>	Very Fine	2.0	2.8	1	5	6	6	58
	Very Fine	2.8	4.0		1	1	1	59
	Fine	4.0	5.6					59
	Fine	5.6	8.0					59
	Medium	8.0	11.0					59
	Medium	11.0	16.0	1		1	1	60
	Coarse	16.0	22.6					60
	Coarse	22.6	32	3		3	3	63
	Very Coarse	32	45	4		4	4	67
	Very Coarse	45	64	5		5	5	72
<b>COBBLE</b>	Small	64	90	17		17	17	89
	Small	90	128	10		10	10	99
	Large	128	180	1		1	1	100
<b>BOULDER</b>	Large	180	256					100
	Small	256	362					100
	Small	362	512					100
	Medium	512	1024					100
<b>BEDROCK</b>	Large/Very Large	1024	2048					100
	Bedrock	2048	>2048					100
<b>Total</b>				<b>50</b>	<b>50</b>	<b>100</b>	<b>100</b>	<b>100</b>

Reachwide	
Channel materials (mm)	
D <sub>16</sub> =	Silt/Clay
D <sub>35</sub> =	0.36
D <sub>50</sub> =	1.5
D <sub>84</sub> =	81.4
D <sub>95</sub> =	111.2
D <sub>100</sub> =	180.0

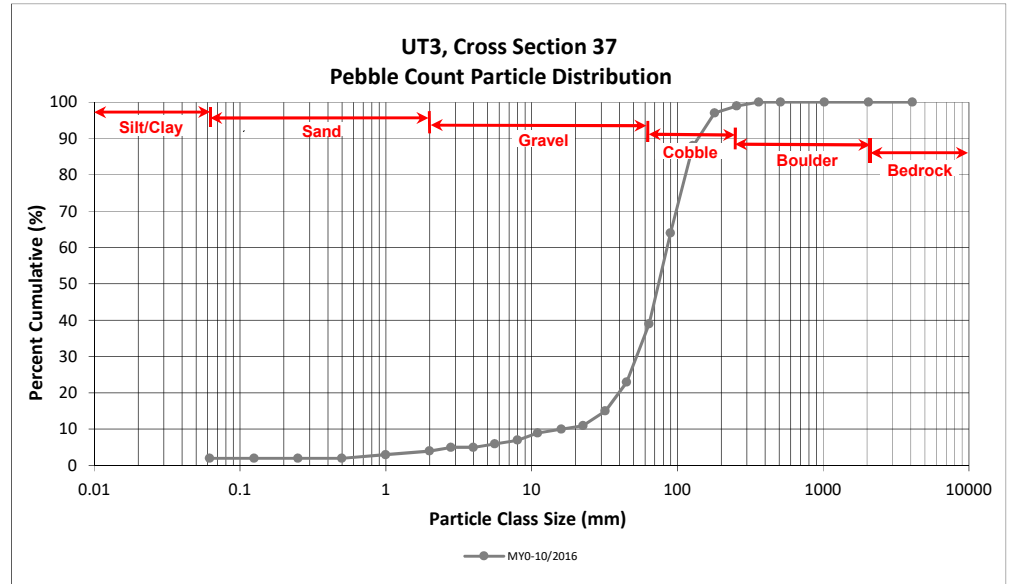
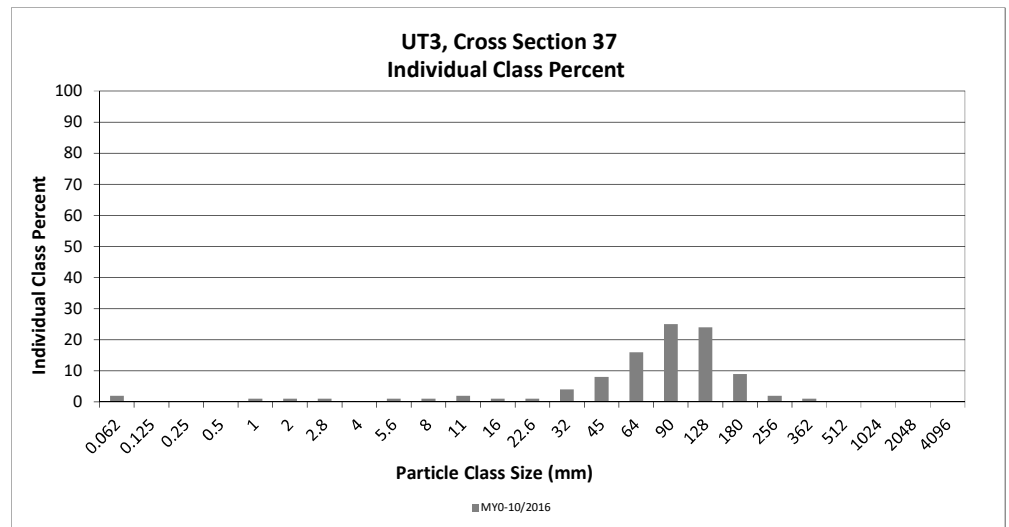
Particle Class		Diameter (mm)		Riffle 100-Count	Summary	
		min	max		Class Percentage	Percent Cumulative
<i>SILT/CLAY</i>	Silt/Clay	0.000	0.062	2	2	2
<i>SAND</i>	Very fine	0.062	0.125			2
	Fine	0.125	0.250			2
	Medium	0.25	0.50			2
	Coarse	0.5	1.0	1	1	3
	Very Coarse	1.0	2.0	1	1	4
<i>GRAVEL</i>	Very Fine	2.0	2.8	1	1	5
	Very Fine	2.8	4.0			5
	Fine	4.0	5.6	1	1	6
	Fine	5.6	8.0	1	1	7
	Medium	8.0	11.0	2	2	9
	Medium	11.0	16.0	1	1	10
	Coarse	16.0	22.6	1	1	11
	Coarse	22.6	32	4	4	15
	Very Coarse	32	45	8	8	23
	Very Coarse	45	64	16	16	39
<i>COBBLE</i>	Small	64	90	25	25	64
	Small	90	128	24	24	88
	Large	128	180	9	9	97
	Large	180	256	2	2	99
<i>BOULDER</i>	Small	256	362	1	1	100
	Small	362	512			100
	Medium	512	1024			100
	Large/Very Large	1024	2048			100
<i>BEDROCK</i>	Bedrock	2048	>2048			100
<b>Total</b>				<b>100</b>	<b>100</b>	<b>100</b>

Cross Section 37 Channel materials (mm)	
D <sub>16</sub> =	33.39
D <sub>35</sub> =	58.61
D <sub>50</sub> =	74.4
D <sub>84</sub> =	120.7
D <sub>95</sub> =	166.9
D <sub>100</sub> =	362.0

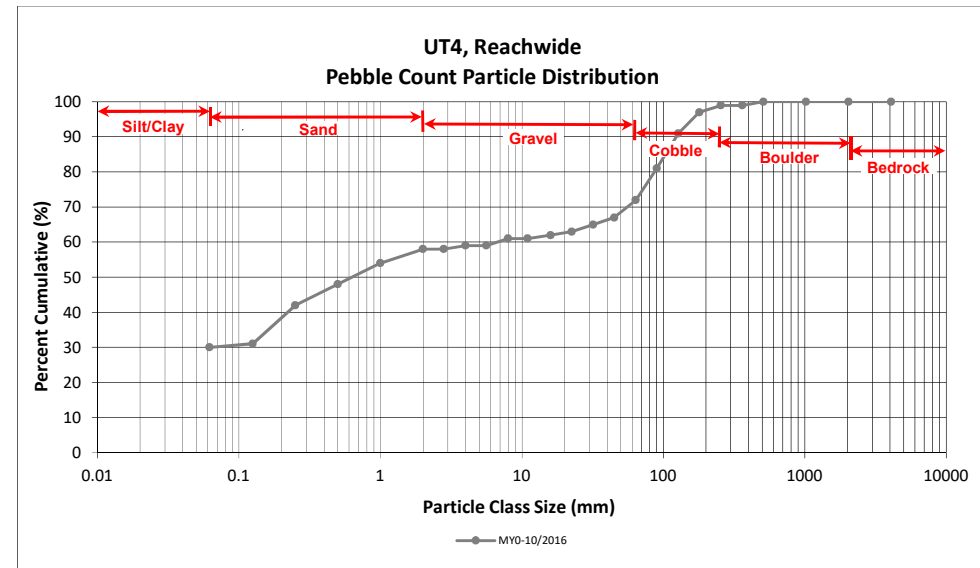
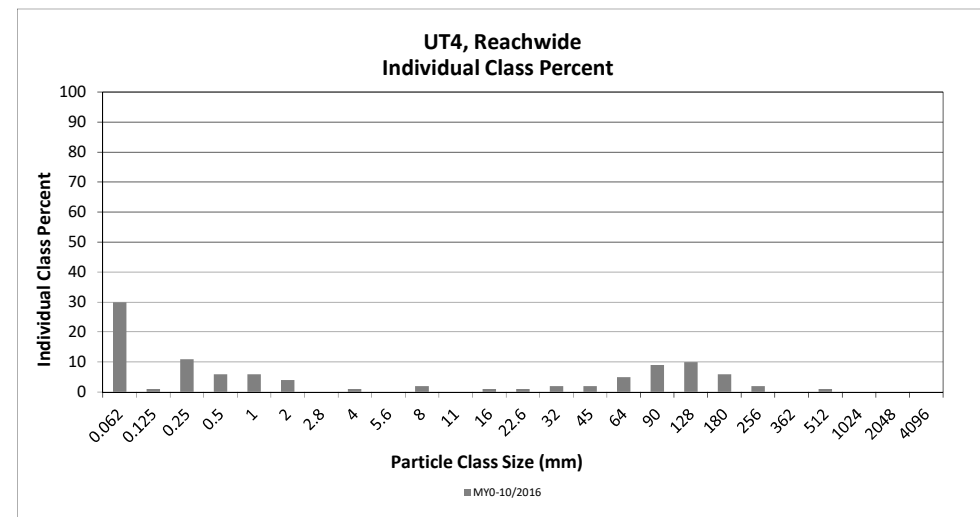
Particle Class		Diameter (mm)		Particle Count			Reach Summary	
		min	max	Riffle	Pool	Total	Class Percentage	Percent Cumulative
<b>SILT/CLAY</b>		Silt/Clay	0.000	0.062	0	30	30	30
<b>SAND</b>	Very fine	0.062	0.125	0	1	1	1	31
	Fine	0.125	0.250	5	6	11	11	42
	Medium	0.25	0.50	2	4	6	6	48
	Coarse	0.5	1.0	2	4	6	6	54
	Very Coarse	1.0	2.0	0	4	4	4	58
<b>GRAVEL</b>	Very Fine	2.0	2.8	0				58
	Very Fine	2.8	4.0	1		1	1	59
	Fine	4.0	5.6	0				59
	Fine	5.6	8.0	1	1	2	2	61
	Medium	8.0	11.0	0				61
	Medium	11.0	16.0	1		1	1	62
	Coarse	16.0	22.6	1		1	1	63
	Coarse	22.6	32	2		2	2	65
	Very Coarse	32	45	2		2	2	67
	Very Coarse	45	64	5		5	5	72
<b>COBBLE</b>	Small	64	90	9		9	9	81
	Small	90	128	10		10	10	91
	Large	128	180	6		6	6	97
	Large	180	256	2		2	2	99
<b>BOULDER</b>	Small	256	362	0				99
	Small	362	512	1		1	1	100
	Medium	512	1024					100
<b>BEDROCK</b>	Large/Very Large	1024	2048					100
	Bedrock	2048	>2048					100
<b>Total</b>				<b>50</b>	<b>50</b>	<b>100</b>	<b>100</b>	<b>100</b>

Reachwide	
Channel materials (mm)	
D <sub>16</sub> =	Silt/Clay
D <sub>35</sub> =	0.16
D <sub>50</sub> =	0.6
D <sub>84</sub> =	100.0
D <sub>95</sub> =	160.7
D <sub>100</sub> =	512.0

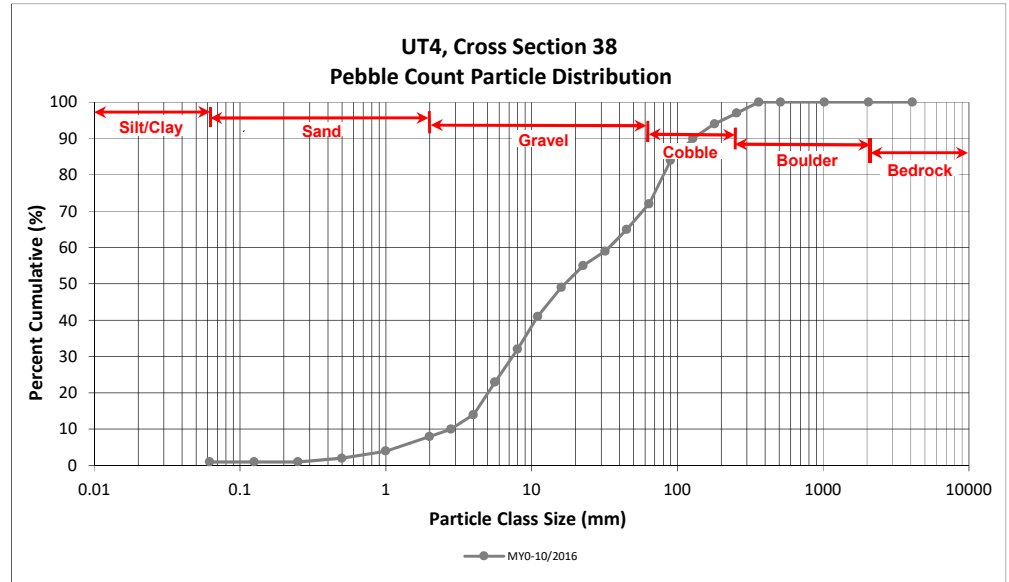
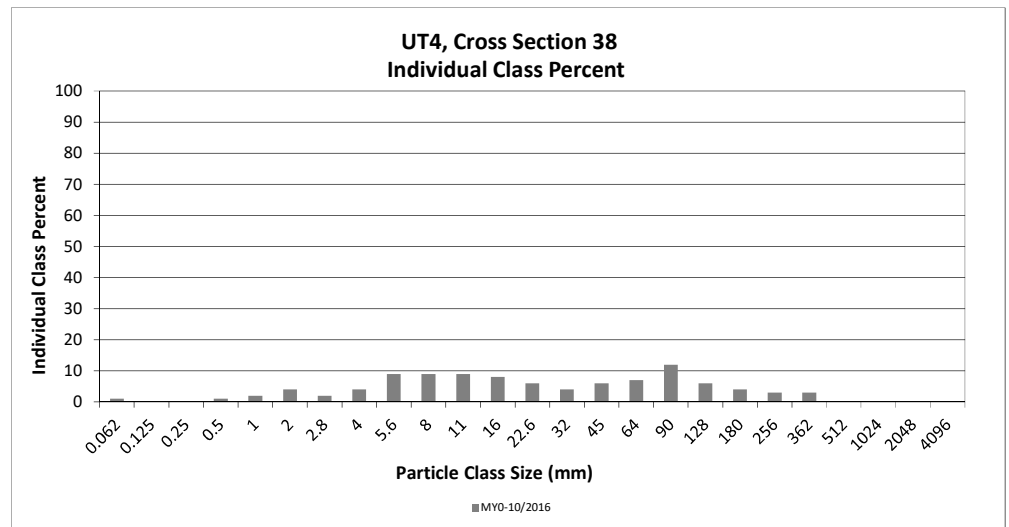
Particle Class		Diameter (mm)		Riffle 100-Count	Summary	
		min	max		Class Percentage	Percent Cumulative
<i>SILT/CLAY</i>	Silt/Clay	0.000	0.062	1	1	1
<i>SAND</i>	Very fine	0.062	0.125	0	0	1
	Fine	0.125	0.250	0	0	1
	Medium	0.25	0.50	1	1	2
	Coarse	0.5	1.0	2	2	4
	Very Coarse	1.0	2.0	4	4	8
<i>GRAVEL</i>	Very Fine	2.0	2.8	2	2	10
	Very Fine	2.8	4.0	4	4	14
	Fine	4.0	5.6	9	9	23
	Fine	5.6	8.0	9	9	32
	Medium	8.0	11.0	9	9	41
	Medium	11.0	16.0	8	8	49
	Coarse	16.0	22.6	6	6	55
	Coarse	22.6	32	4	4	59
	Very Coarse	32	45	6	6	65
	Very Coarse	45	64	7	7	72
<i>COBBLE</i>	Small	64	90	12	12	84
	Small	90	128	6	6	90
	Large	128	180	4	4	94
	Large	180	256	3	3	97
<i>BOULDER</i>	Small	256	362	3	3	100
	Small	362	512			100
	Medium	512	1024			100
	Large/Very Large	1024	2048			100
<i>BEDROCK</i>	Bedrock	2048	>2048			100
<b>Total</b>				<b>100</b>	<b>100</b>	<b>100</b>

Cross Section 38 Channel materials (mm)	
D <sub>16</sub> =	4.31
D <sub>35</sub> =	8.90
D <sub>50</sub> =	16.9
D <sub>84</sub> =	90.0
D <sub>95</sub> =	202.4
D <sub>100</sub> =	362.0

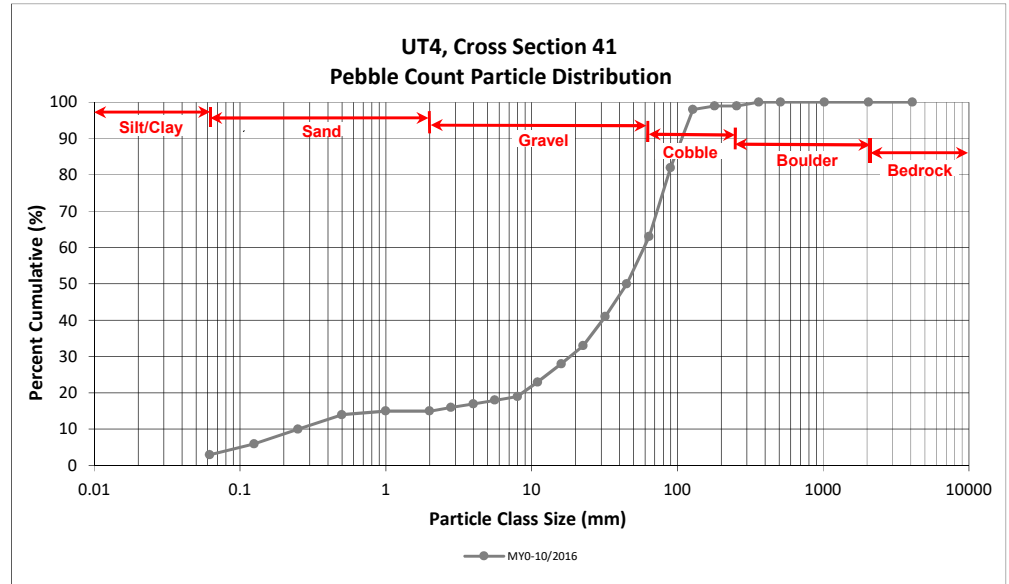
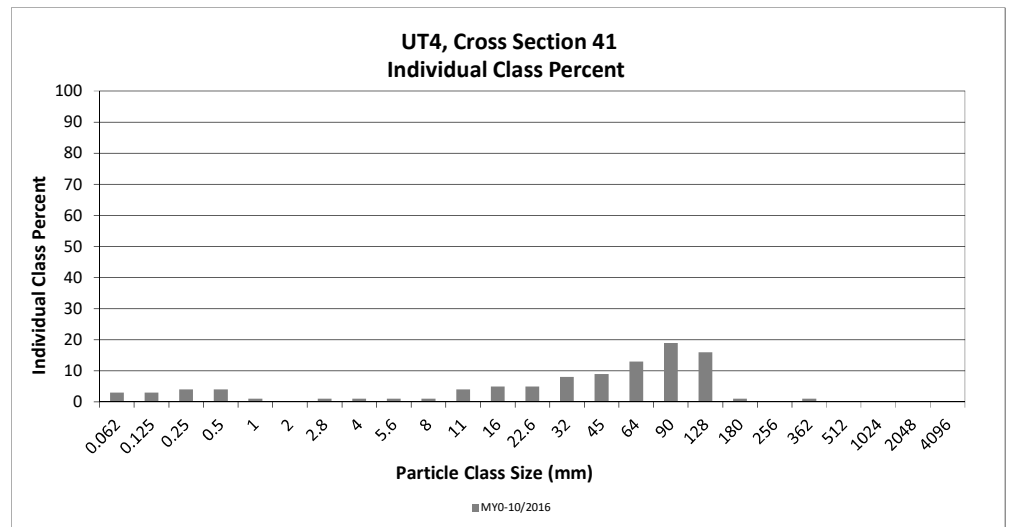
Particle Class		Diameter (mm)		Riffle 100-Count	Summary	
		min	max		Class Percentage	Percent Cumulative
<i>SILT/CLAY</i>	Silt/Clay	0.000	0.062	3	3	3
<i>SAND</i>	Very fine	0.062	0.125	3	3	6
	Fine	0.125	0.250	4	4	10
	Medium	0.25	0.50	4	4	14
	Coarse	0.5	1.0	1	1	15
	Very Coarse	1.0	2.0	0	0	15
<i>GRAVEL</i>	Very Fine	2.0	2.8	1	1	16
	Very Fine	2.8	4.0	1	1	17
	Fine	4.0	5.6	1	1	18
	Fine	5.6	8.0	1	1	19
	Medium	8.0	11.0	4	4	23
	Medium	11.0	16.0	5	5	28
	Coarse	16.0	22.6	5	5	33
	Coarse	22.6	32	8	8	41
	Very Coarse	32	45	9	9	50
	Very Coarse	45	64	13	13	63
<i>COBBLE</i>	Small	64	90	19	19	82
	Small	90	128	16	16	98
	Large	128	180	1	1	99
	Large	180	256	0	0	99
<i>BOULDER</i>	Small	256	362	1	1	100
	Small	362	512			100
	Medium	512	1024			100
	Large/Very Large	1024	2048			100
<i>BEDROCK</i>	Bedrock	2048	>2048			100
<b>Total</b>				<b>100</b>	<b>100</b>	<b>100</b>

Cross Section 41 Channel materials (mm)	
D <sub>16</sub> =	2.80
D <sub>35</sub> =	24.65
D <sub>50</sub> =	45.0
D <sub>84</sub> =	94.1
D <sub>95</sub> =	119.8
D <sub>100</sub> =	362.0
