# **BASELINE MONITORING DOCUMENT AND AS-BUILT BASELINE REPORT**

## **CANDY CREEK MITIGATION SITE**

Guilford County, NC  
NCDEQ Contract 5794  
DMS ID No. 96315

Data Collection Period: October 2016 – March 2017  
Final Submission Date: June 2, 2017

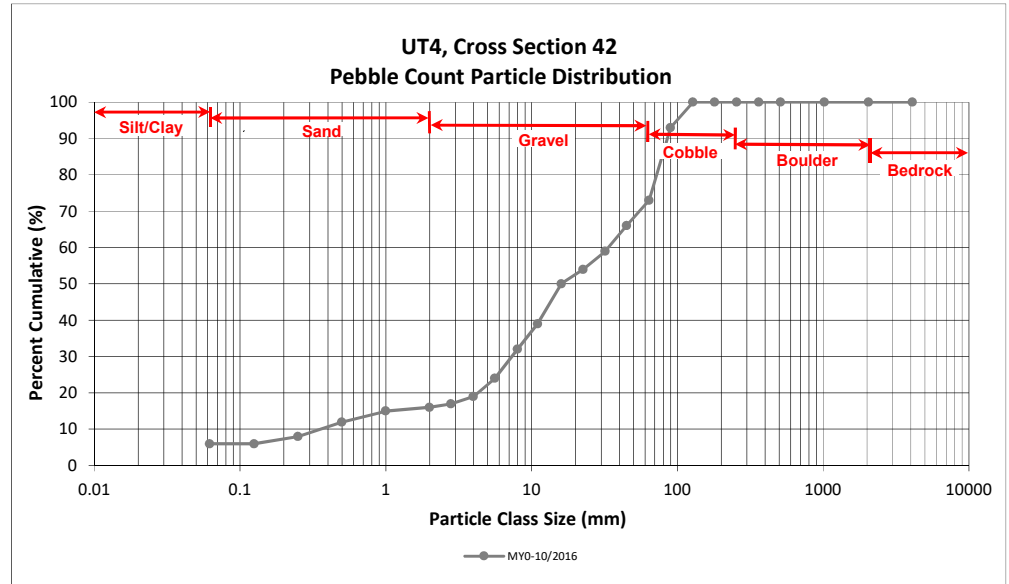
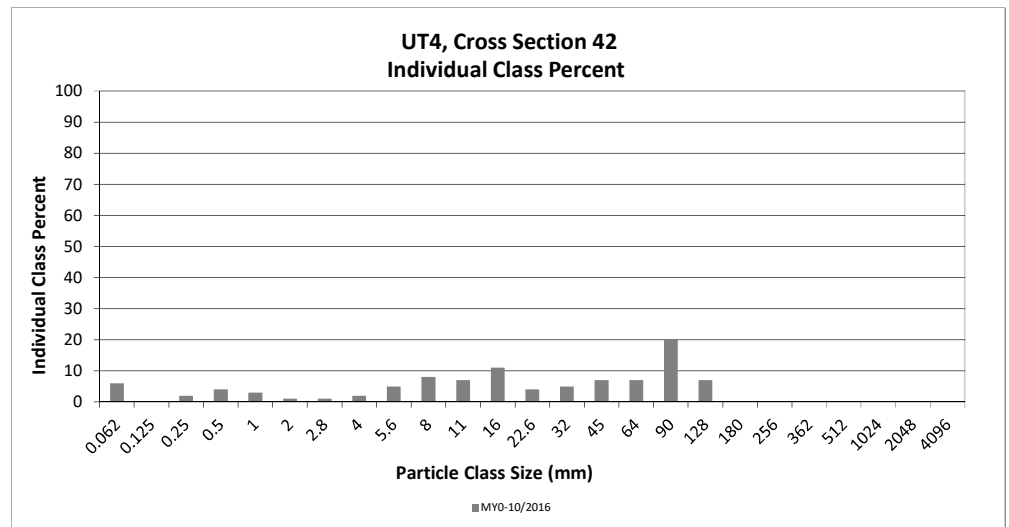
Particle Class		Diameter (mm)		Riffle 100-Count	Summary	
		min	max		Class Percentage	Percent Cumulative
<i>SILT/CLAY</i>	Silt/Clay	0.000	0.062	6	6	6
<i>SAND</i>	Very fine	0.062	0.125	0	0	6
	Fine	0.125	0.250	2	2	8
	Medium	0.25	0.50	4	4	12
	Coarse	0.5	1.0	3	3	15
	Very Coarse	1.0	2.0	1	1	16
<i>GRAVEL</i>	Very Fine	2.0	2.8	1	1	17
	Very Fine	2.8	4.0	2	2	19
	Fine	4.0	5.6	5	5	24
	Fine	5.6	8.0	8	8	32
	Medium	8.0	11.0	7	7	39
	Medium	11.0	16.0	11	11	50
	Coarse	16.0	22.6	4	4	54
	Coarse	22.6	32	5	5	59
	Very Coarse	32	45	7	7	66
	Very Coarse	45	64	7	7	73
<i>COBBLE</i>	Small	64	90	20	20	93
	Small	90	128	7	7	100
	Large	128	180			100
	Large	180	256			100
<i>BOULDER</i>	Small	256	362			100
	Small	362	512			100
	Medium	512	1024			100
	Large/Very Large	1024	2048			100
<i>BEDROCK</i>	Bedrock	2048	>2048			100
<b>Total</b>				<b>100</b>	<b>100</b>	<b>100</b>

Cross Section 43	
Channel materials (mm)	
D <sub>16</sub> =	2.00
D <sub>35</sub> =	9.17
D <sub>50</sub> =	16.0
D <sub>84</sub> =	77.2
D <sub>95</sub> =	99.5
D <sub>100</sub> =	128.0

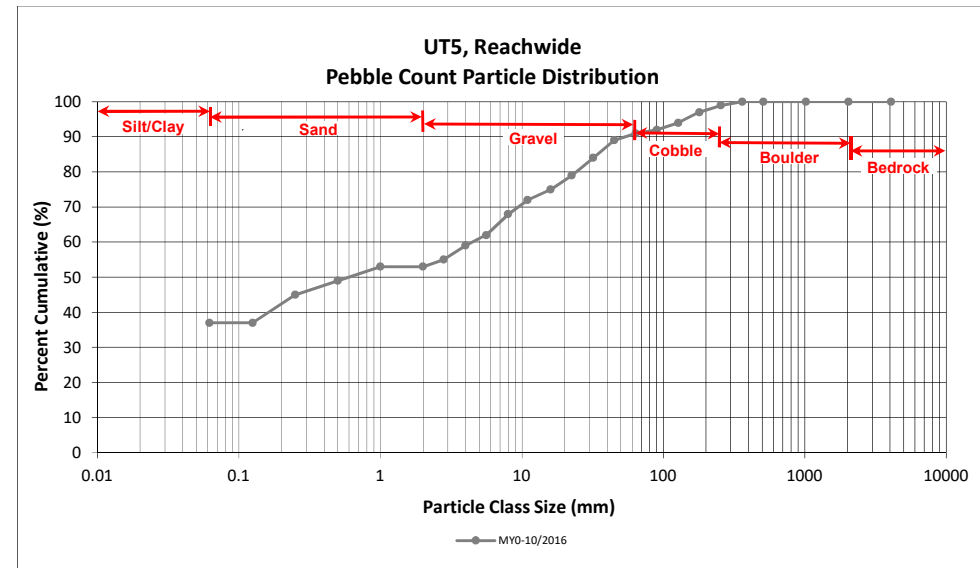
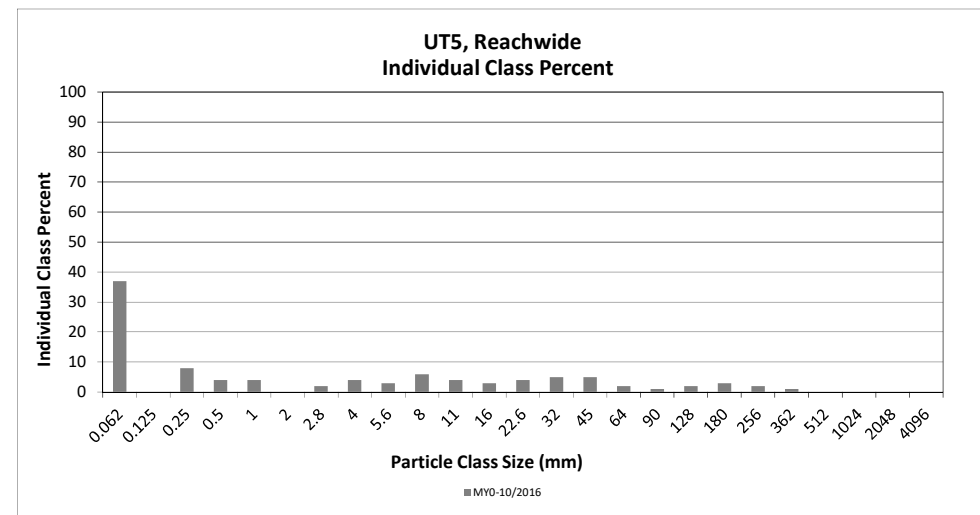
Particle Class		Diameter (mm)		Particle Count			Reach Summary	
		min	max	Riffle	Pool	Total	Class Percentage	Percent Cumulative
<b>SILT/CLAY</b>	Silt/Clay	0.000	0.062	3	34	37	37	37
	Very fine	0.062	0.125	0	0			37
<b>SAND</b>	Fine	0.125	0.250	2	6	8	8	45
	Medium	0.25	0.50	3	1	4	4	49
	Coarse	0.5	1.0	1	3	4	4	53
	Very Coarse	1.0	2.0	0	0			53
	Very Fine	2.0	2.8	1	1	2	2	55
<b>GRAVEL</b>	Very Fine	2.8	4.0	3	1	4	4	59
	Fine	4.0	5.6	3	0	3	3	62
	Fine	5.6	8.0	3	3	6	6	68
	Medium	8.0	11.0	3	1	4	4	72
	Medium	11.0	16.0	3		3	3	75
	Coarse	16.0	22.6	4		4	4	79
	Coarse	22.6	32	5		5	5	84
	Very Coarse	32	45	5		5	5	89
	Very Coarse	45	64	2		2	2	91
	Very Coarse	64	90	1		1	1	92
<b>COBBLE</b>	Small	90	128	2		2	2	94
	Large	128	180	3		3	3	97
<b>BOULDER</b>	Large	180	256	2		2	2	99
	Small	256	362	1		1	1	100
<b>BOULDER</b>	Small	362	512					100
	Medium	512	1024					100
	Large/Very Large	1024	2048					100
<b>BEDROCK</b>	Bedrock	2048	>2048					100
<b>Total</b>				<b>50</b>	<b>50</b>	<b>100</b>	<b>100</b>	<b>100</b>

Reachwide	
Channel materials (mm)	
D <sub>16</sub> =	Silt/Clay
D <sub>35</sub> =	Silt/Clay
D <sub>50</sub> =	0.6
D <sub>84</sub> =	32.0
D <sub>95</sub> =	143.4
D <sub>100</sub> =	362.0

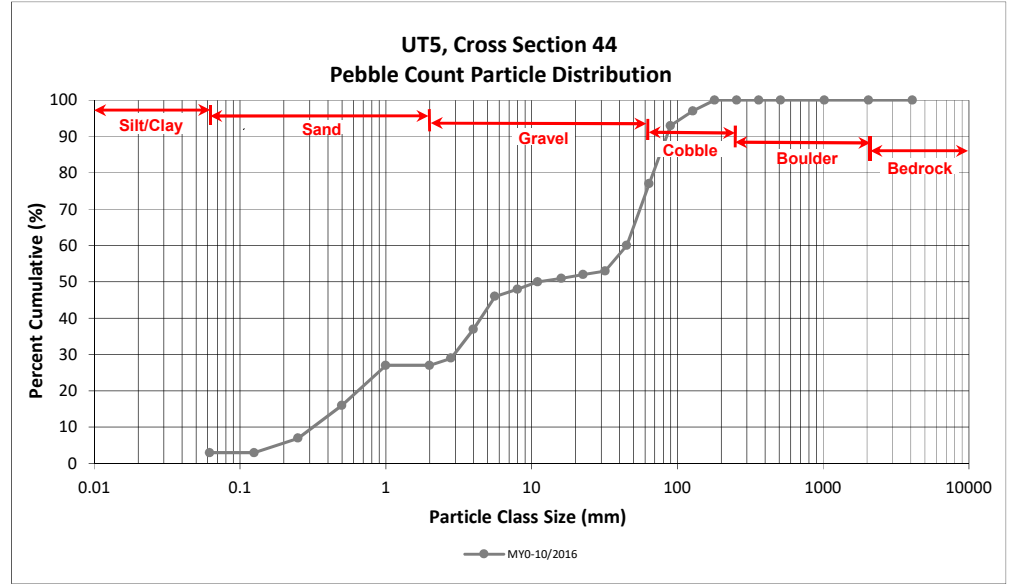
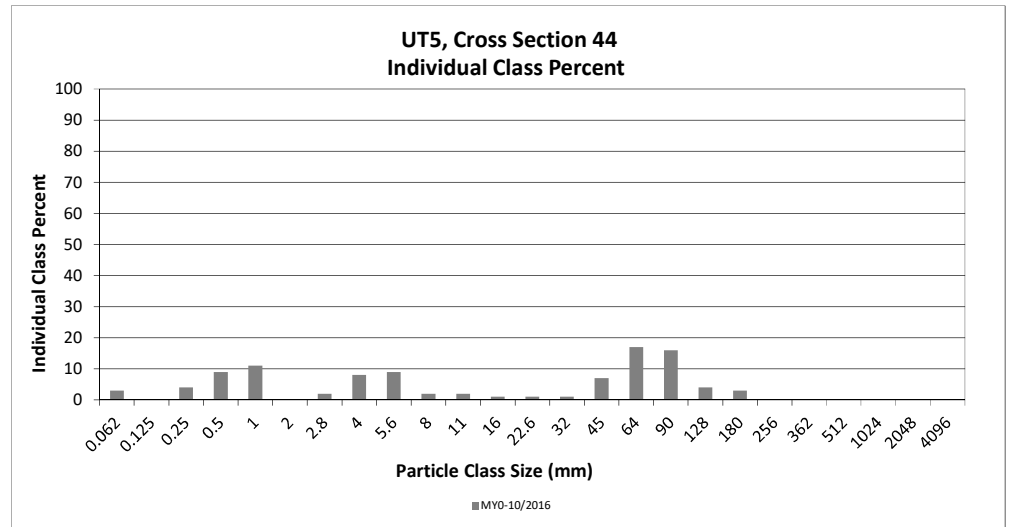
Particle Class		Diameter (mm)		Riffle 100-Count	Summary	
		min	max		Class Percentage	Percent Cumulative
<i>SILT/CLAY</i>	Silt/Clay	0.000	0.062	3	3	3
<i>SAND</i>	Very fine	0.062	0.125	0	0	3
	Fine	0.125	0.250	4	4	7
	Medium	0.25	0.50	9	9	16
	Coarse	0.5	1.0	11	11	27
	Very Coarse	1.0	2.0	0	0	27
<i>GRAVEL</i>	Very Fine	2.0	2.8	2	2	29
	Very Fine	2.8	4.0	8	8	37
	Fine	4.0	5.6	9	9	46
	Fine	5.6	8.0	2	2	48
	Medium	8.0	11.0	2	2	50
	Medium	11.0	16.0	1	1	51
	Coarse	16.0	22.6	1	1	52
	Coarse	22.6	32	1	1	53
	Very Coarse	32	45	7	7	60
	Very Coarse	45	64	17	17	77
<i>COBBLE</i>	Small	64	90	16	16	93
	Small	90	128	4	4	97
	Large	128	180	3	3	100
	Large	180	256			100
<i>BOULDER</i>	Small	256	362			100
	Small	362	512			100
	Medium	512	1024			100
	Large/Very Large	1024	2048			100
<i>BEDROCK</i>	Bedrock	2048	>2048			100
<b>Total</b>				<b>100</b>	<b>100</b>	<b>100</b>

Cross Section 45	
Channel materials (mm)	
D <sub>16</sub> =	0.50
D <sub>35</sub> =	3.66
D <sub>50</sub> =	11.0
D <sub>84</sub> =	74.3
D <sub>95</sub> =	107.3
D <sub>100</sub> =	180.0

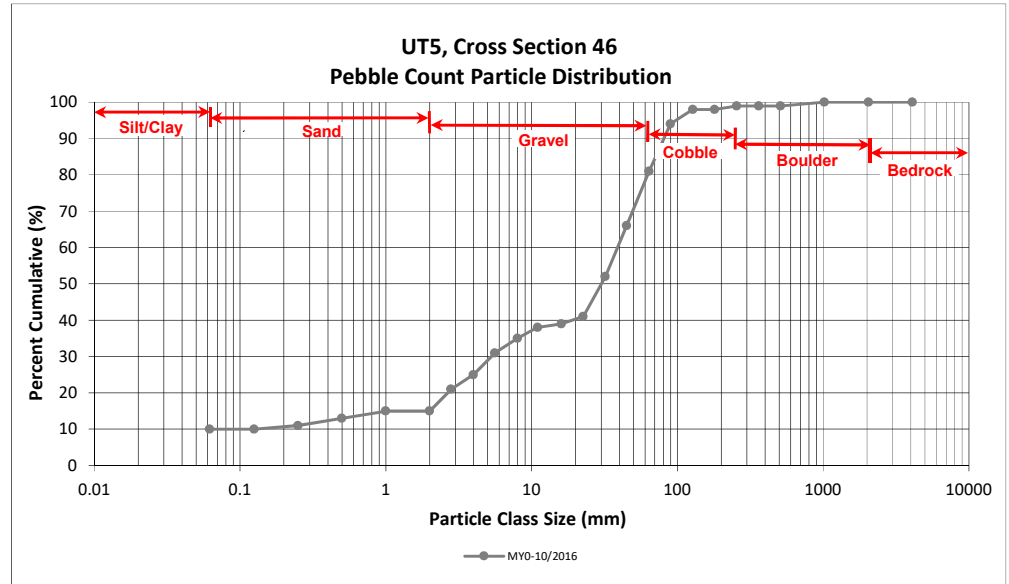
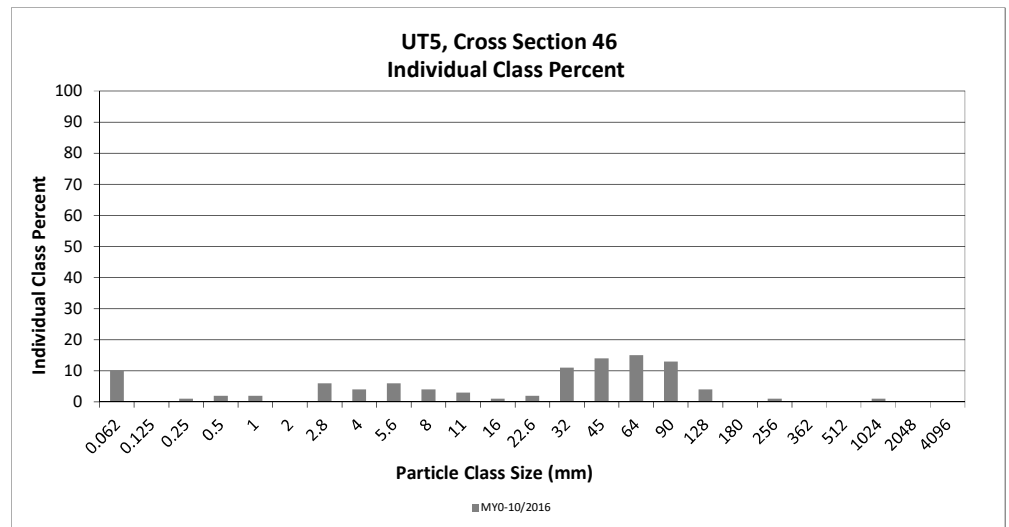
Particle Class		Diameter (mm)		Riffle 100-Count	Summary	
		min	max		Class Percentage	Percent Cumulative
<i>SILT/CLAY</i>	Silt/Clay	0.000	0.062	10	10	10
<i>SAND</i>	Very fine	0.062	0.125	0	0	10
	Fine	0.125	0.250	1	1	11
	Medium	0.25	0.50	2	2	13
	Coarse	0.5	1.0	2	2	15
	Very Coarse	1.0	2.0	0	0	15
<i>GRAVEL</i>	Very Fine	2.0	2.8	6	6	21
	Very Fine	2.8	4.0	4	4	25
	Fine	4.0	5.6	6	6	31
	Fine	5.6	8.0	4	4	35
	Medium	8.0	11.0	3	3	38
	Medium	11.0	16.0	1	1	39
	Coarse	16.0	22.6	2	2	41
	Coarse	22.6	32	11	11	52
	Very Coarse	32	45	14	14	66
	Very Coarse	45	64	15	15	81
<i>COBBLE</i>	Small	64	90	13	13	94
	Small	90	128	4	4	98
	Large	128	180	0	0	98
	Large	180	256	1	1	99
<i>BOULDER</i>	Small	256	362			99
	Small	362	512			99
	Medium	512	1024	1	1	100
	Large/Very Large	1024	2048			100
<i>BEDROCK</i>	Bedrock	2048	>2048			100
<b>Total</b>				<b>100</b>	<b>100</b>	<b>100</b>

Cross Section 46	
Channel materials (mm)	
D <sub>16</sub> =	2.12
D <sub>35</sub> =	8.00
D <sub>50</sub> =	30.0
D <sub>84</sub> =	69.2
D <sub>95</sub> =	98.3
D <sub>100</sub> =	1024.0

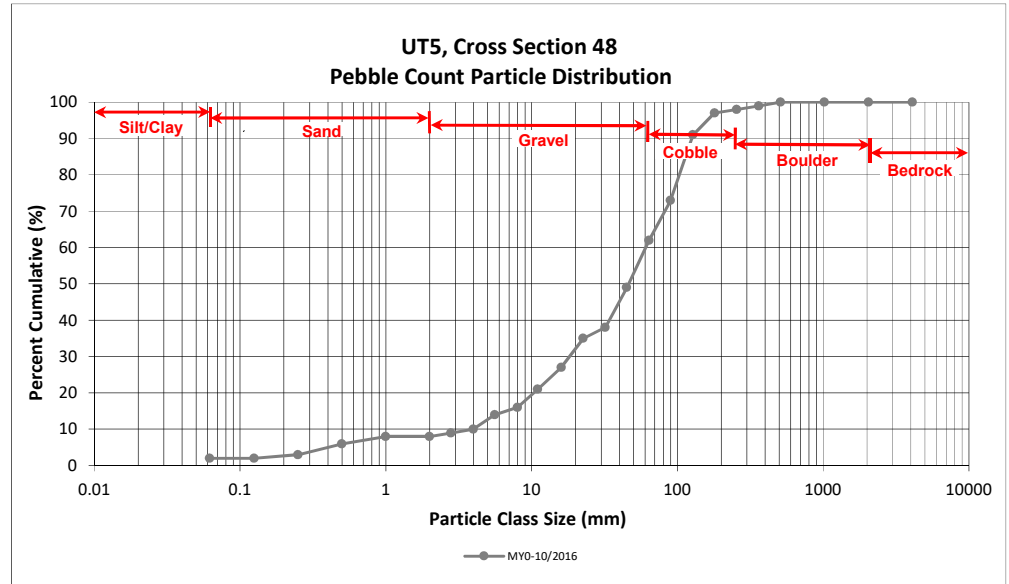
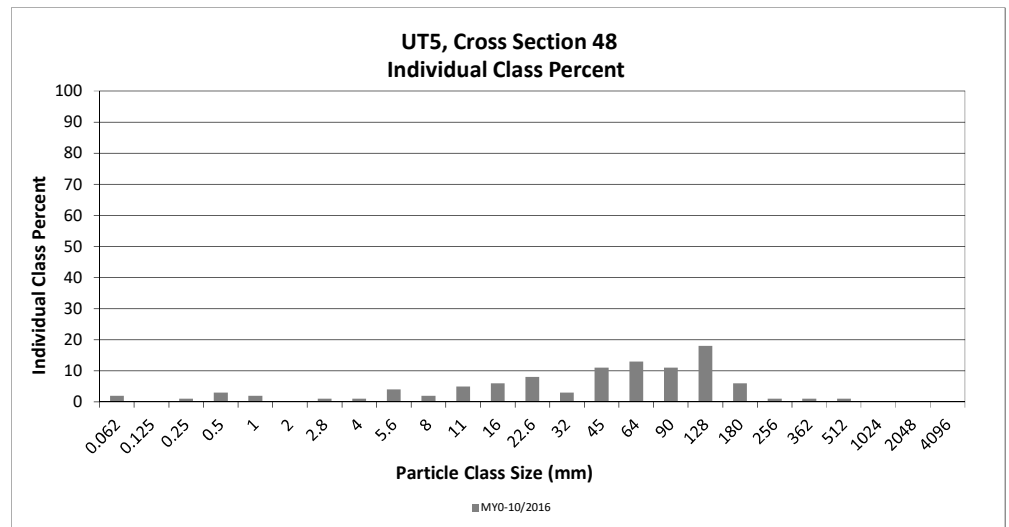
Particle Class		Diameter (mm)		Riffle 100-Count	Summary	
		min	max		Class Percentage	Percent Cumulative
<i>SILT/CLAY</i>	Silt/Clay	0.000	0.062	2	2	2
<i>SAND</i>	Very fine	0.062	0.125	0	0	2
	Fine	0.125	0.250	1	1	3
	Medium	0.25	0.50	3	3	6
	Coarse	0.5	1.0	2	2	8
	Very Coarse	1.0	2.0	0	0	8
<i>GRAVEL</i>	Very Fine	2.0	2.8	1	1	9
	Very Fine	2.8	4.0	1	1	10
	Fine	4.0	5.6	4	4	14
	Fine	5.6	8.0	2	2	16
	Medium	8.0	11.0	5	5	21
	Medium	11.0	16.0	6	6	27
	Coarse	16.0	22.6	8	8	35
	Coarse	22.6	32	3	3	38
	Very Coarse	32	45	11	11	49
	Very Coarse	45	64	13	13	62
<i>COBBLE</i>	Small	64	90	11	11	73
	Small	90	128	18	18	91
	Large	128	180	6	6	97
	Large	180	256	1	1	98
<i>BOULDER</i>	Small	256	362	1	1	99
	Small	362	512	1	1	100
	Medium	512	1024			100
	Large/Very Large	1024	2048			100
<i>BEDROCK</i>	Bedrock	2048	>2048			100
<b>Total</b>				<b>100</b>	<b>100</b>	<b>100</b>

Cross Section 48	
Channel materials (mm)	
D <sub>16</sub> =	8.00
D <sub>35</sub> =	22.60
D <sub>50</sub> =	46.2
D <sub>84</sub> =	111.6
D <sub>95</sub> =	160.7
D <sub>100</sub> =	512.0

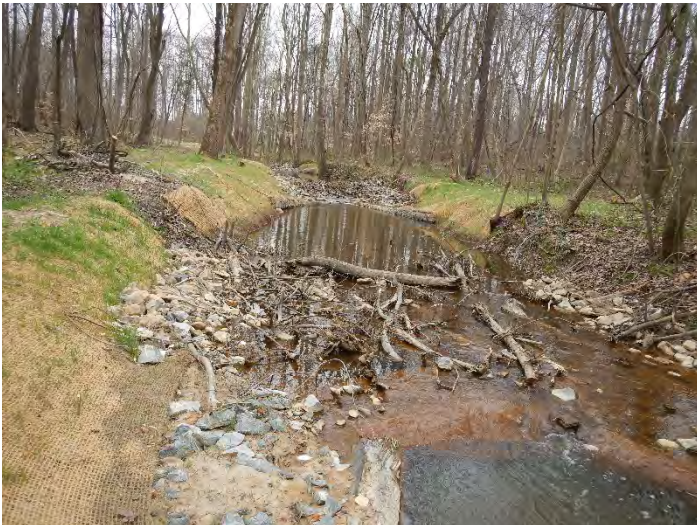
**Photo Point 31 – looking upstream (03/07/2017)**

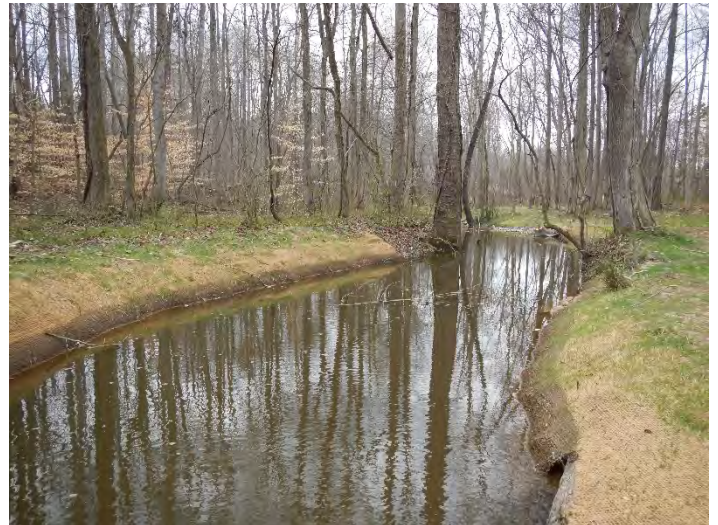
**Photo Point 31 – looking downstream (03/07/2017)**

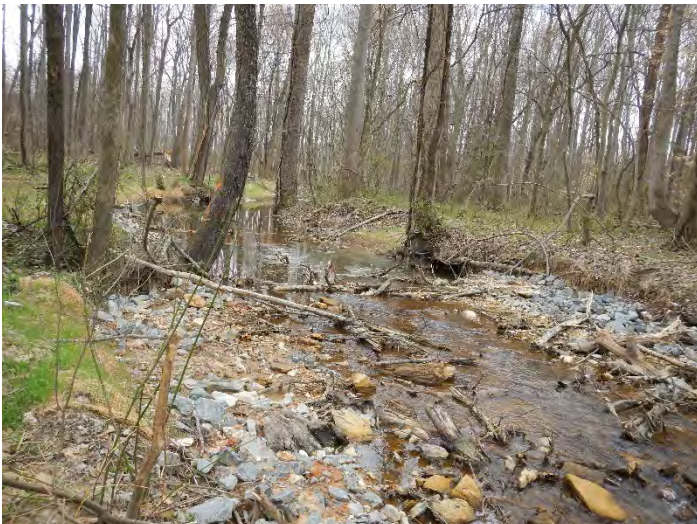
**Photo Point 32 – looking upstream (03/07/2017)**

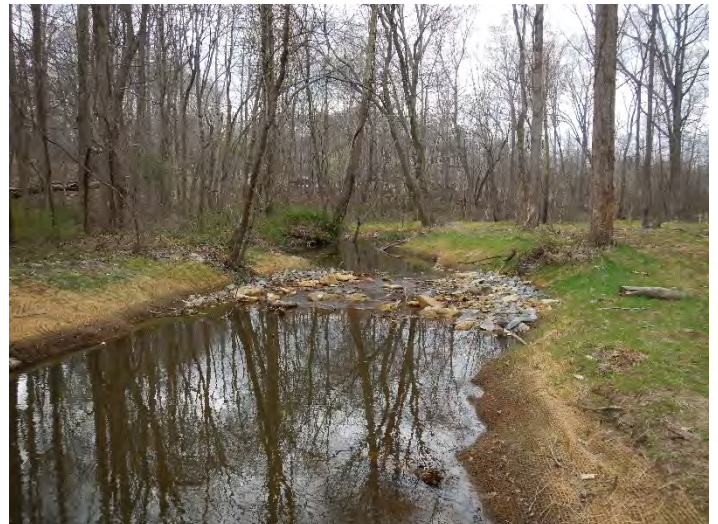
**Photo Point 32 – looking downstream (03/07/2017)**

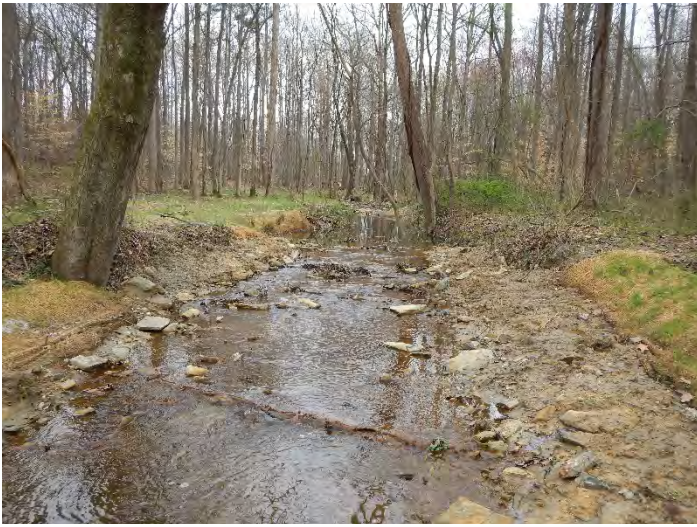
**Photo Point 33** – looking upstream (03/07/2017)

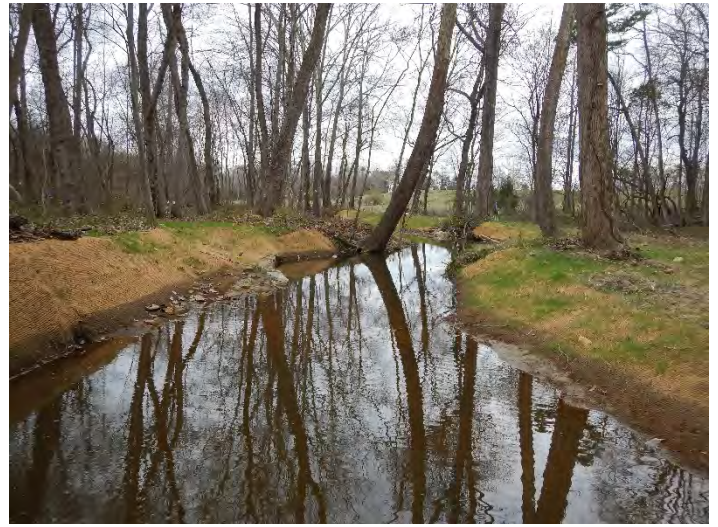
**Photo Point 33** – looking downstream (03/07/2017)

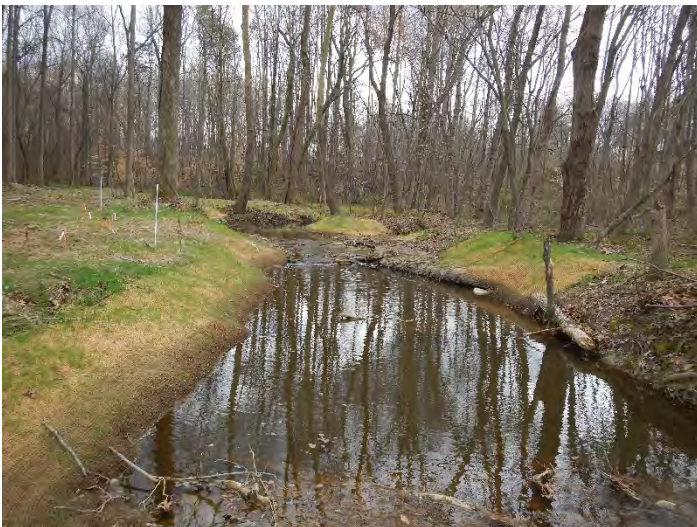
**Photo Point 34** – looking upstream (03/07/2017)

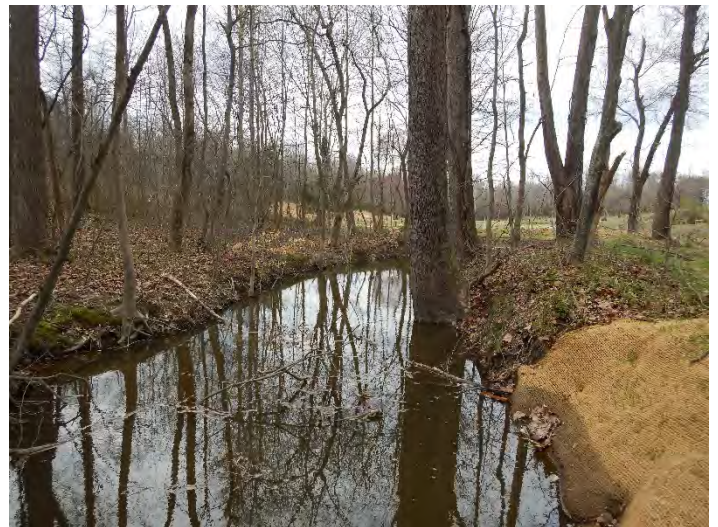
**Photo Point 34** – looking downstream (03/07/2017)

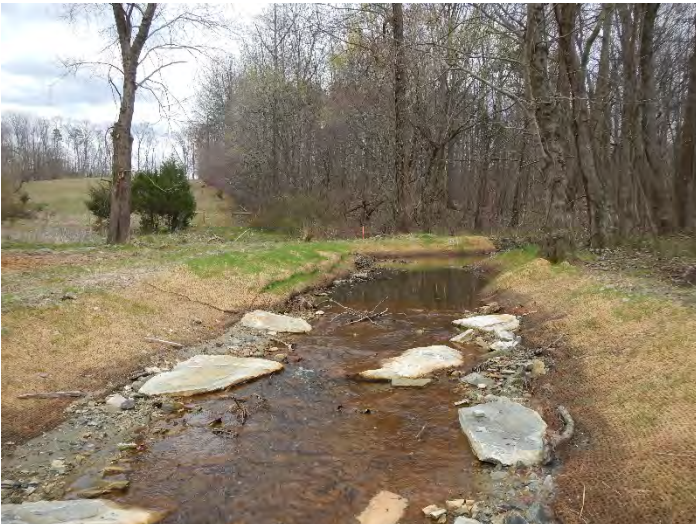
**Photo Point 35** – looking upstream (03/07/2017)

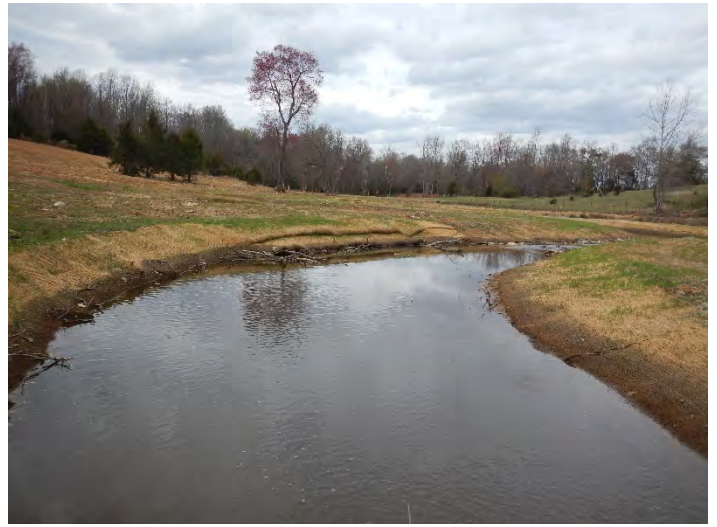
**Photo Point 35** – looking downstream (03/07/2017)

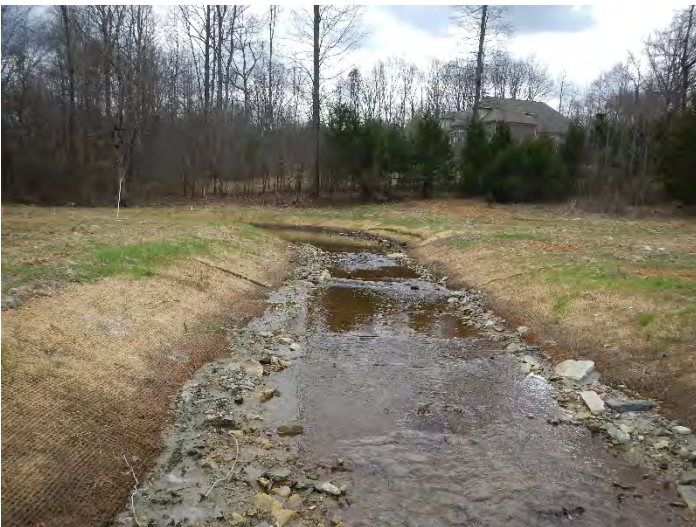
**Photo Point 36** – looking upstream (03/07/2017)

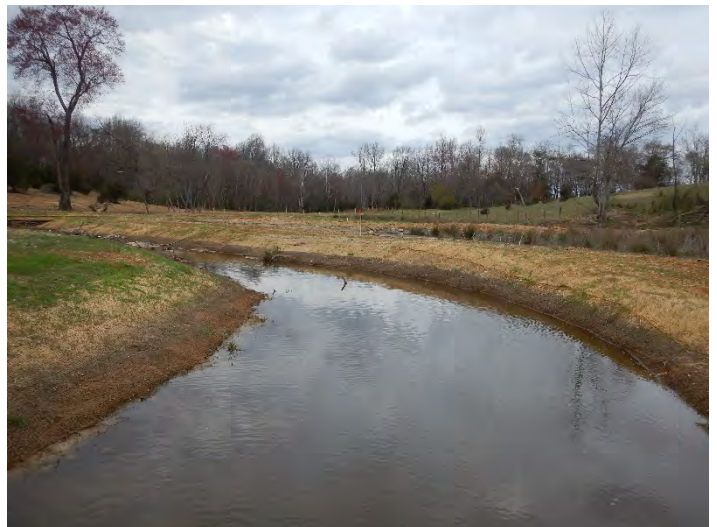
**Photo Point 36** – looking downstream (03/07/2017)

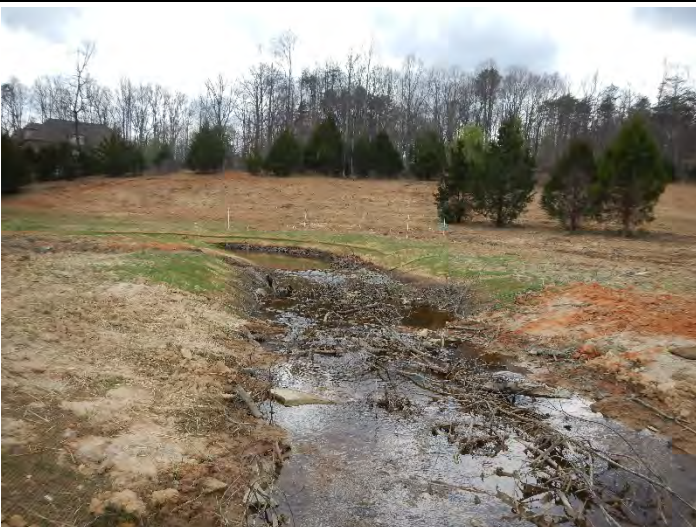
**Photo Point 37** – looking upstream (03/07/2017)

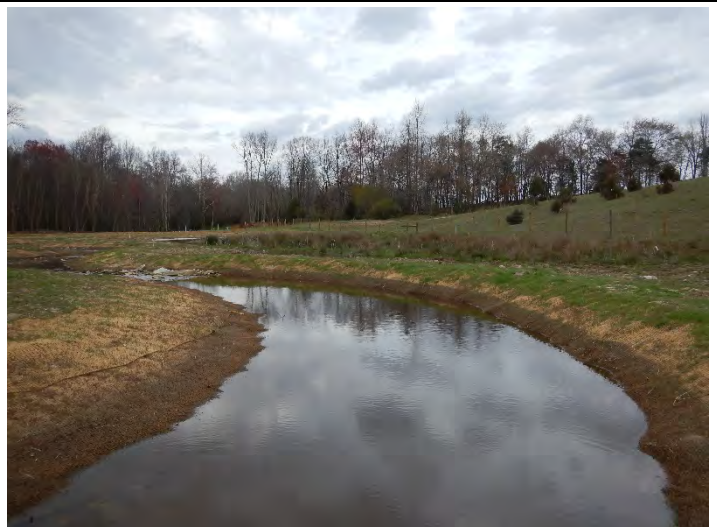
**Photo Point 37** – looking downstream (03/07/2017)

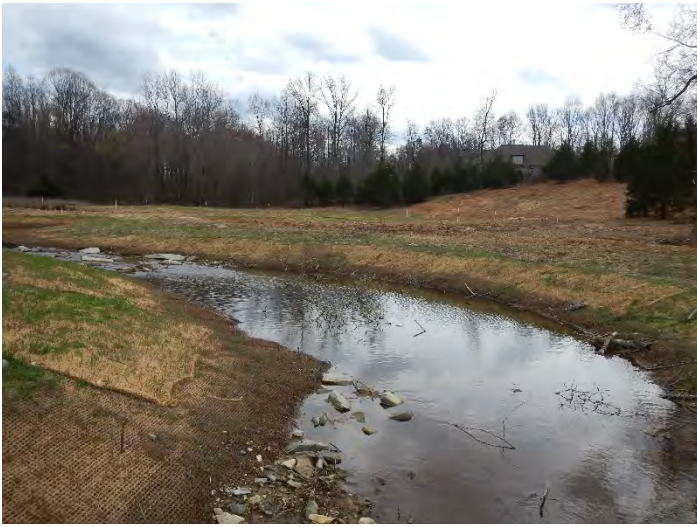
**Photo Point 38** – looking upstream (03/07/2017)

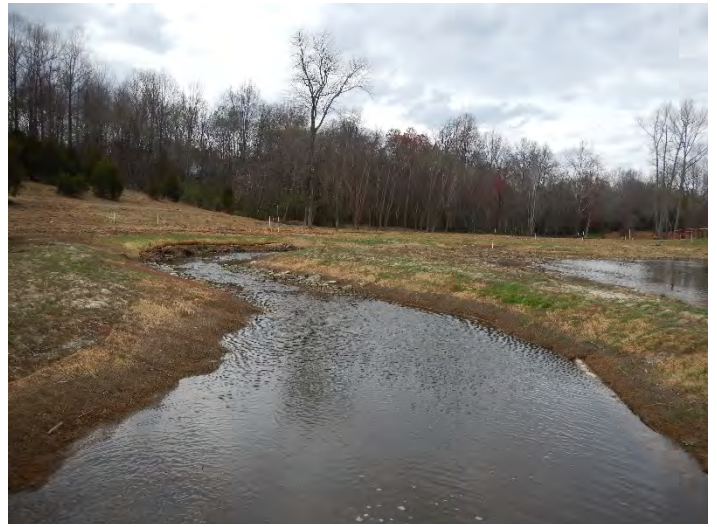
**Photo Point 38** – looking downstream (03/07/2017)

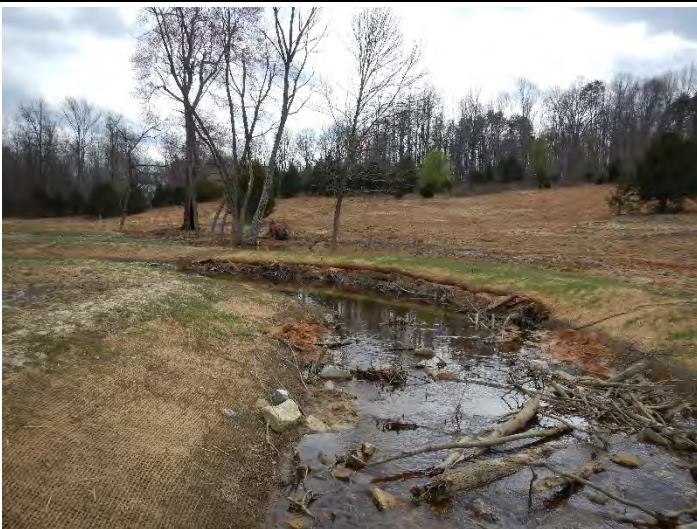
**Photo Point 39** – looking upstream (03/07/2017)

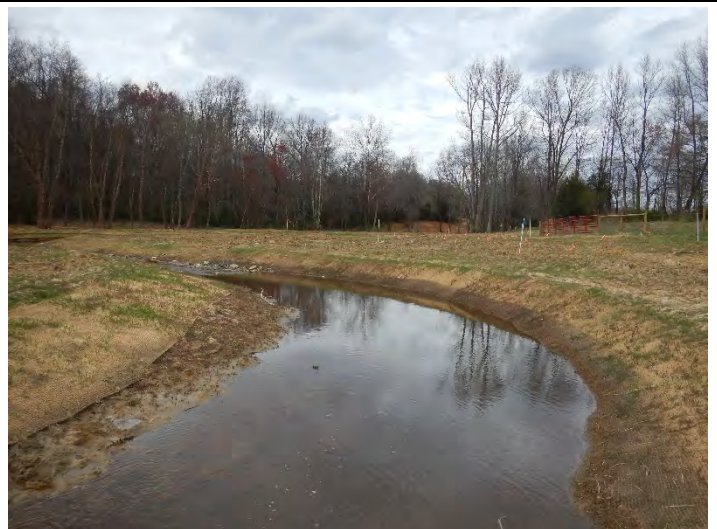
**Photo Point 39** – looking downstream (03/07/2017)

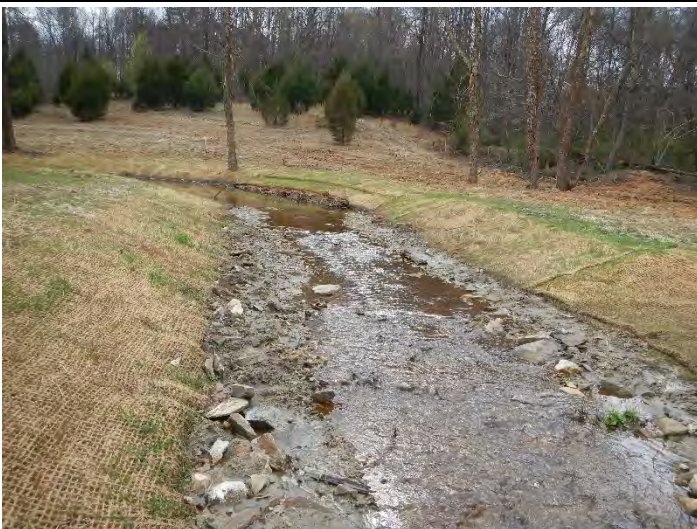
**Photo Point 40** – looking upstream (03/07/2017)

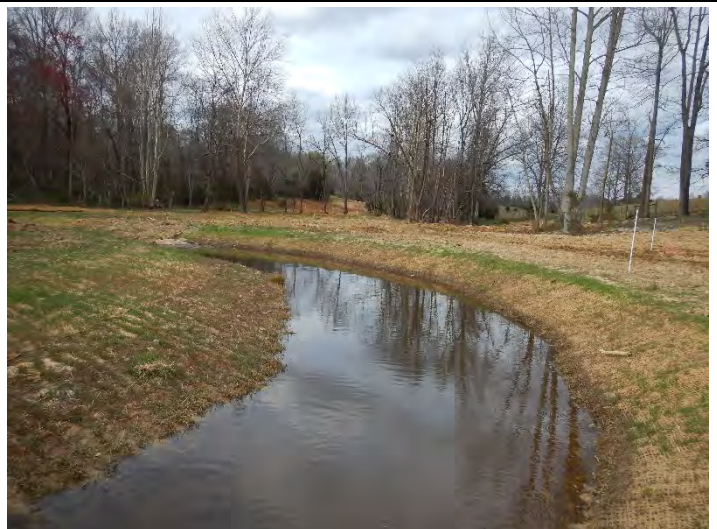
**Photo Point 40** – looking downstream (03/07/2017)

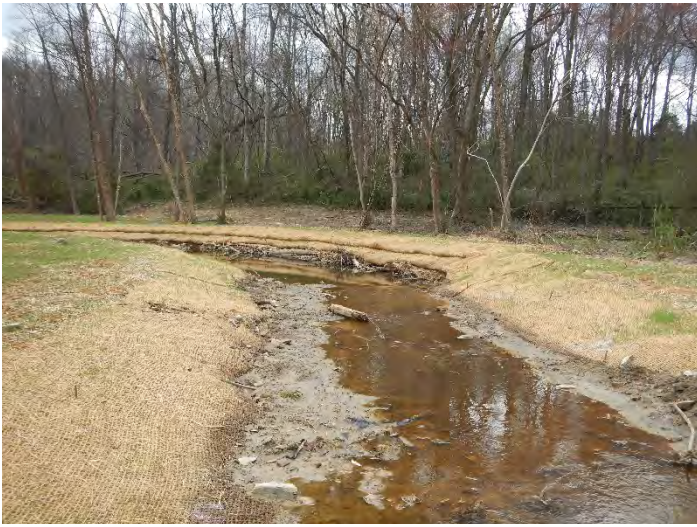
**Photo Point 41** – looking upstream (03/07/2017)

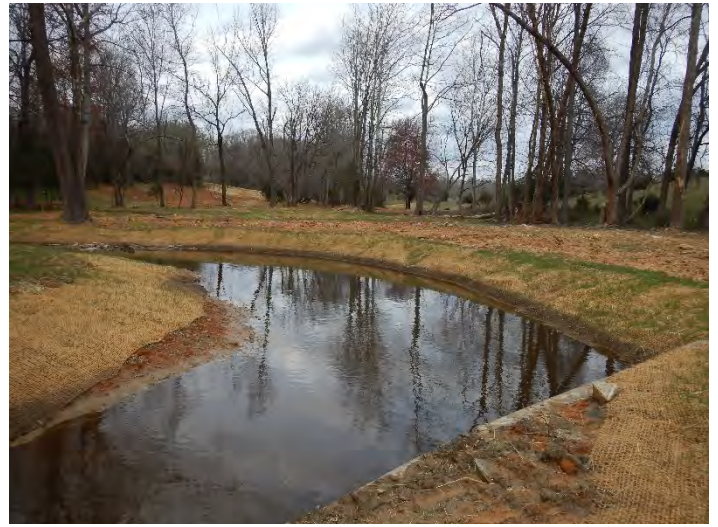
**Photo Point 41** – looking downstream (03/07/2017)

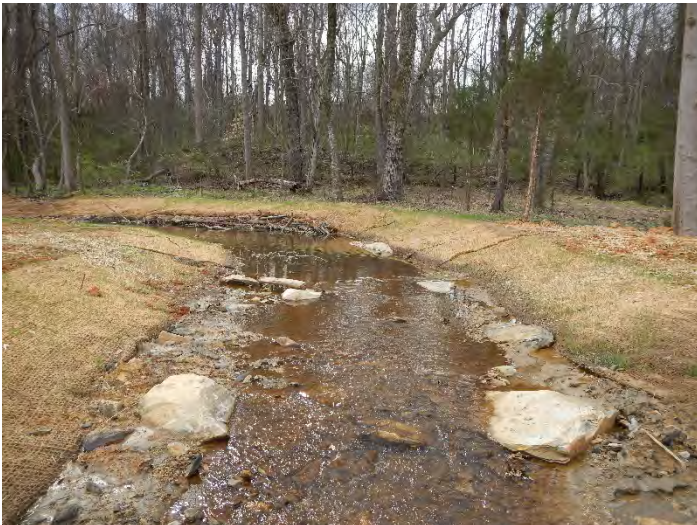
**Photo Point 42** – looking upstream (03/07/2017)

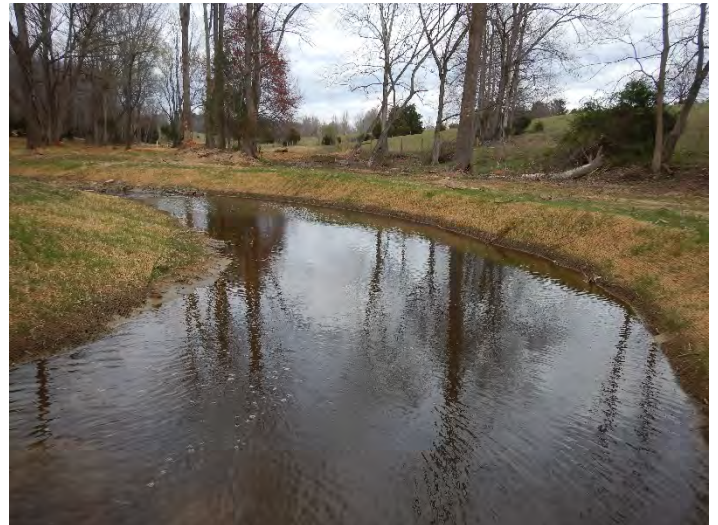
**Photo Point 42** – looking downstream (03/07/2017)

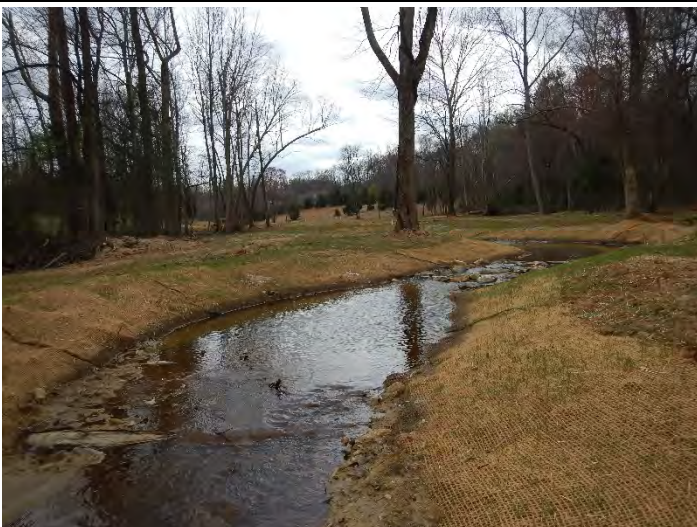
**Photo Point 43** – looking upstream (03/07/2017)

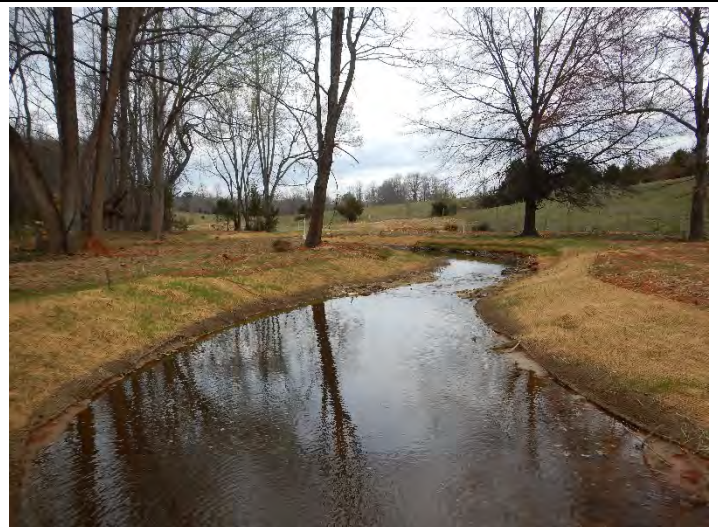
**Photo Point 43** – looking downstream (03/07/2017)

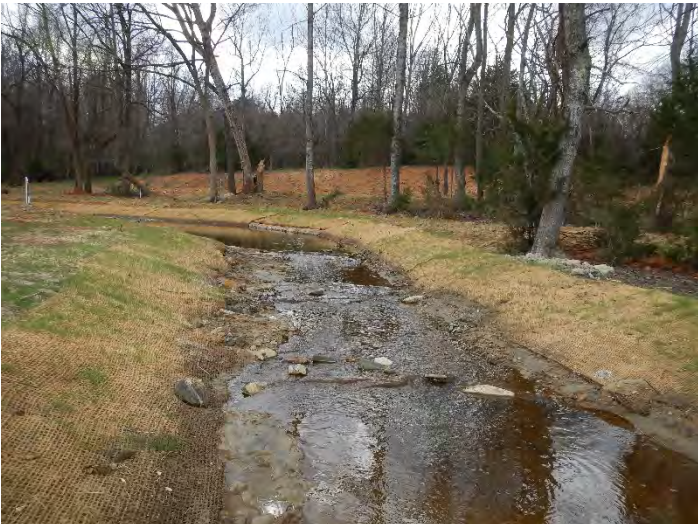
**Photo Point 44** – looking upstream (03/07/2017)

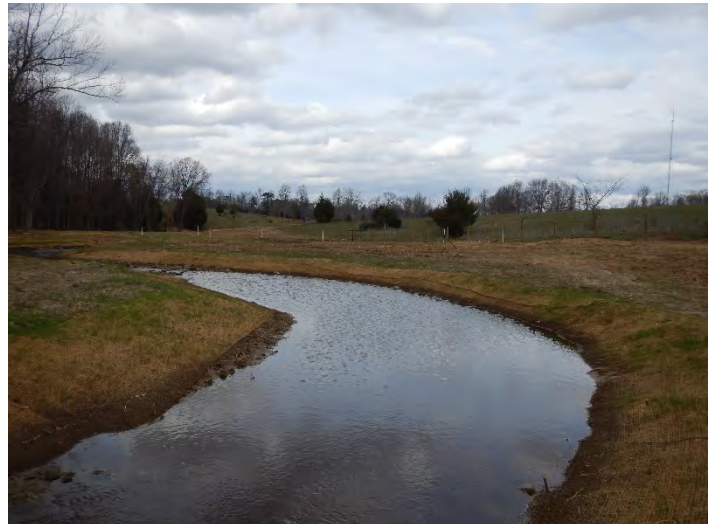
**Photo Point 44** – looking downstream (03/07/2017)

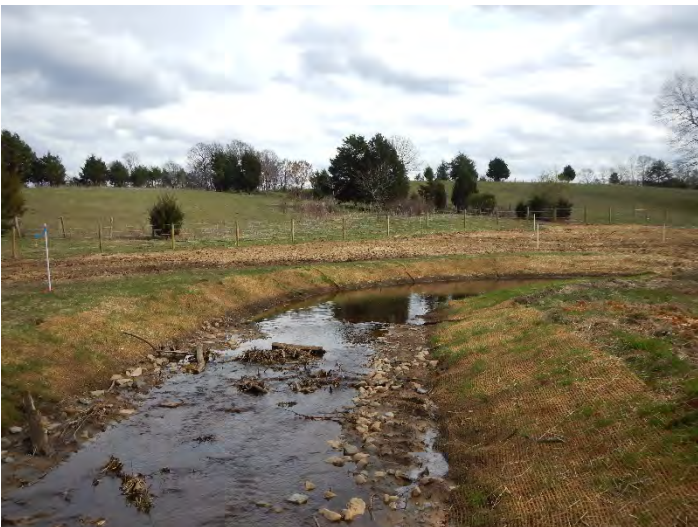
**Photo Point 45** – looking upstream (03/07/2017)

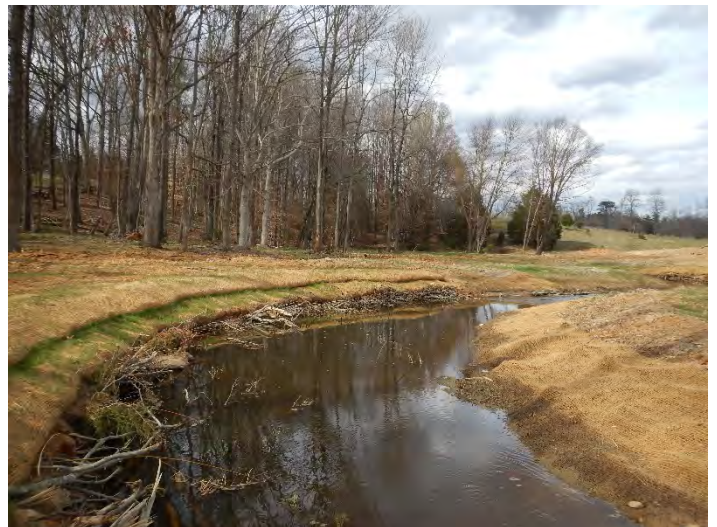
**Photo Point 45** – looking downstream (03/07/2017)

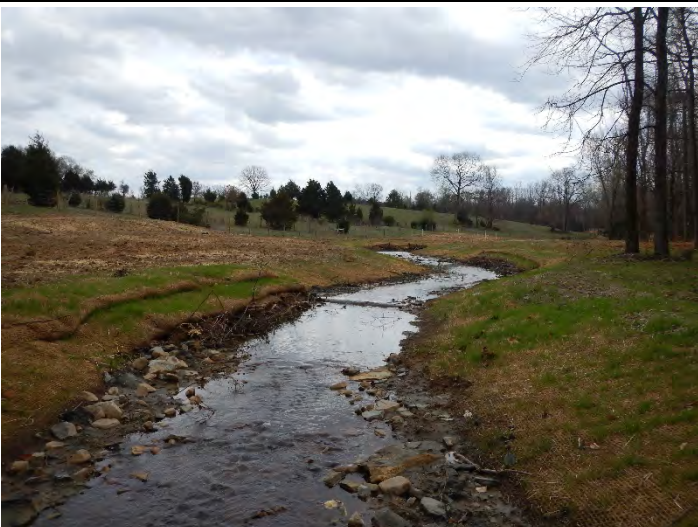
**Photo Point 46** – looking upstream (03/07/2017)

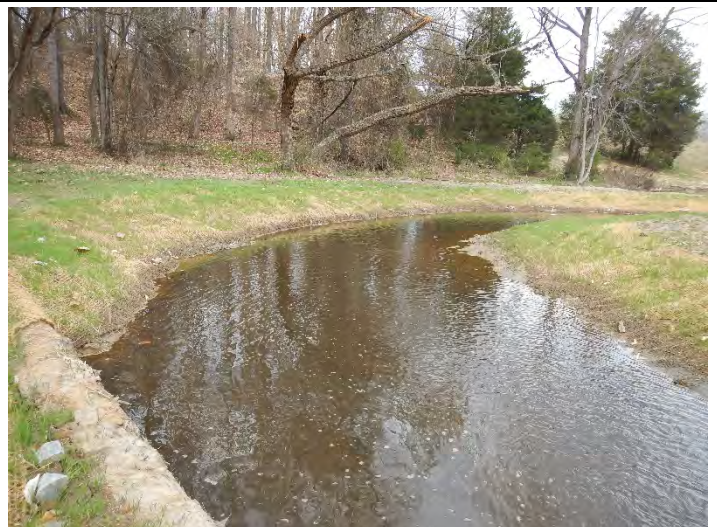
**Photo Point 46** – looking downstream (03/07/2017)

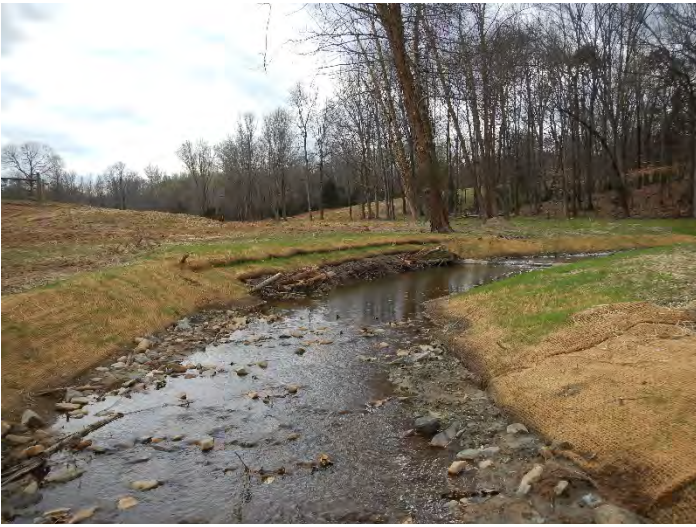
**Photo Point 47 – looking upstream (03/07/2017)**

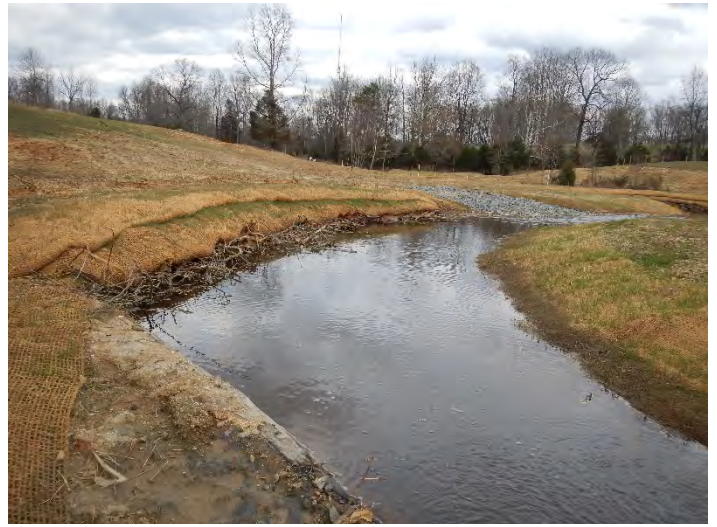
**Photo Point 47 – looking downstream (03/07/2017)**

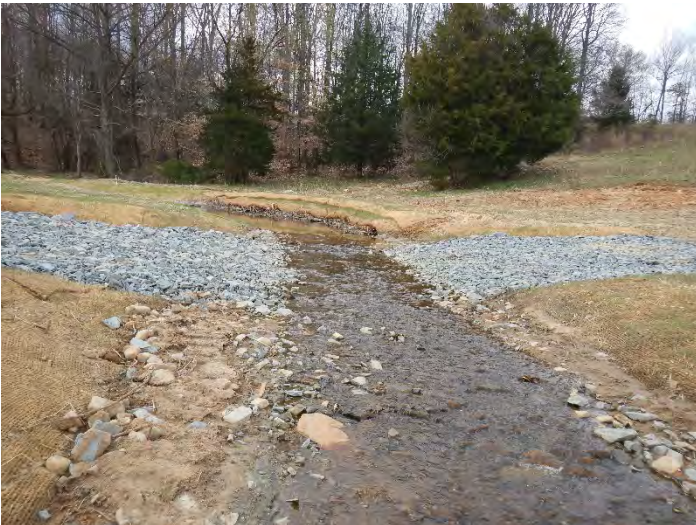
**Photo Point 48 – looking upstream (03/07/2017)**

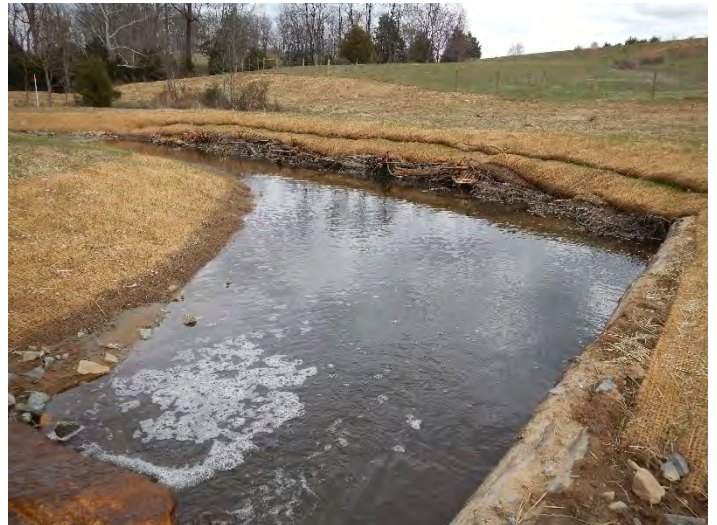
**Photo Point 48 – looking downstream (03/07/2017)**

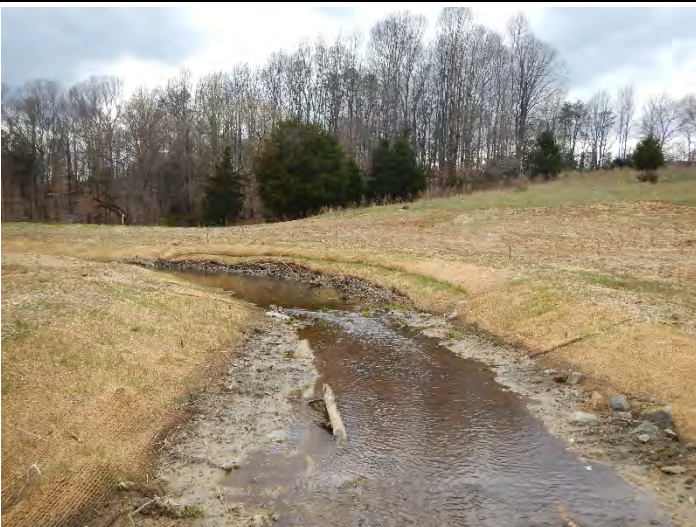
**Photo Point 49 – looking upstream (03/07/2017)**

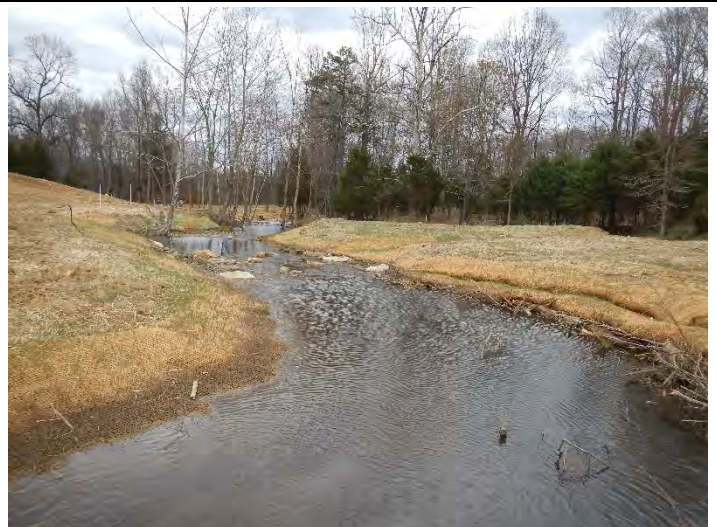
**Photo Point 49 – looking downstream (03/07/2017)**

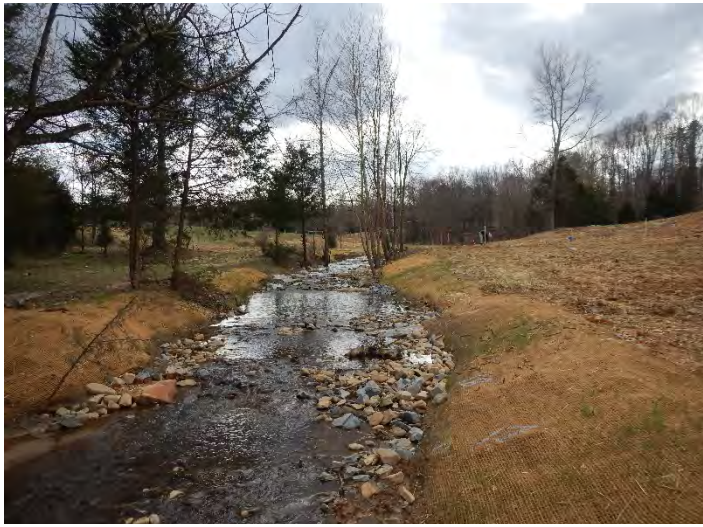
**Photo Point 50 – looking upstream (03/07/2017)**

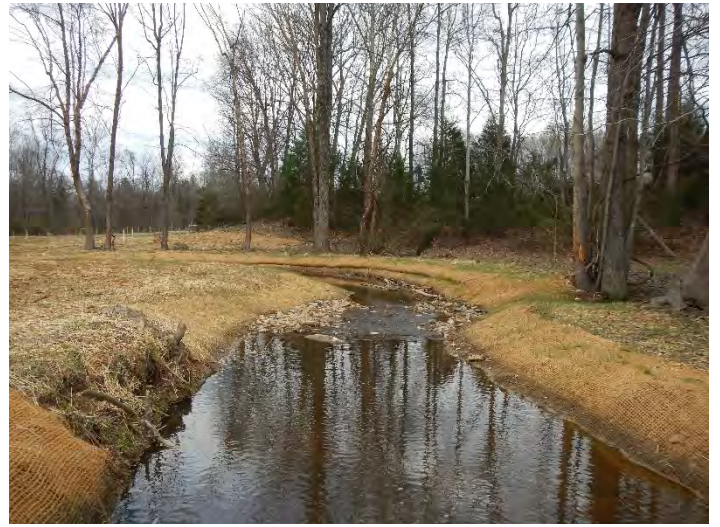
**Photo Point 50 – looking downstream (03/07/2017)**
