# **BASELINE MONITORING DOCUMENT AND AS-BUILT BASELINE REPORT**

## **CANDY CREEK MITIGATION SITE**

Guilford County, NC  
NCDEQ Contract 5794  
DMS ID No. 96315

Data Collection Period: October 2016 – March 2017  
Final Submission Date: June 2, 2017

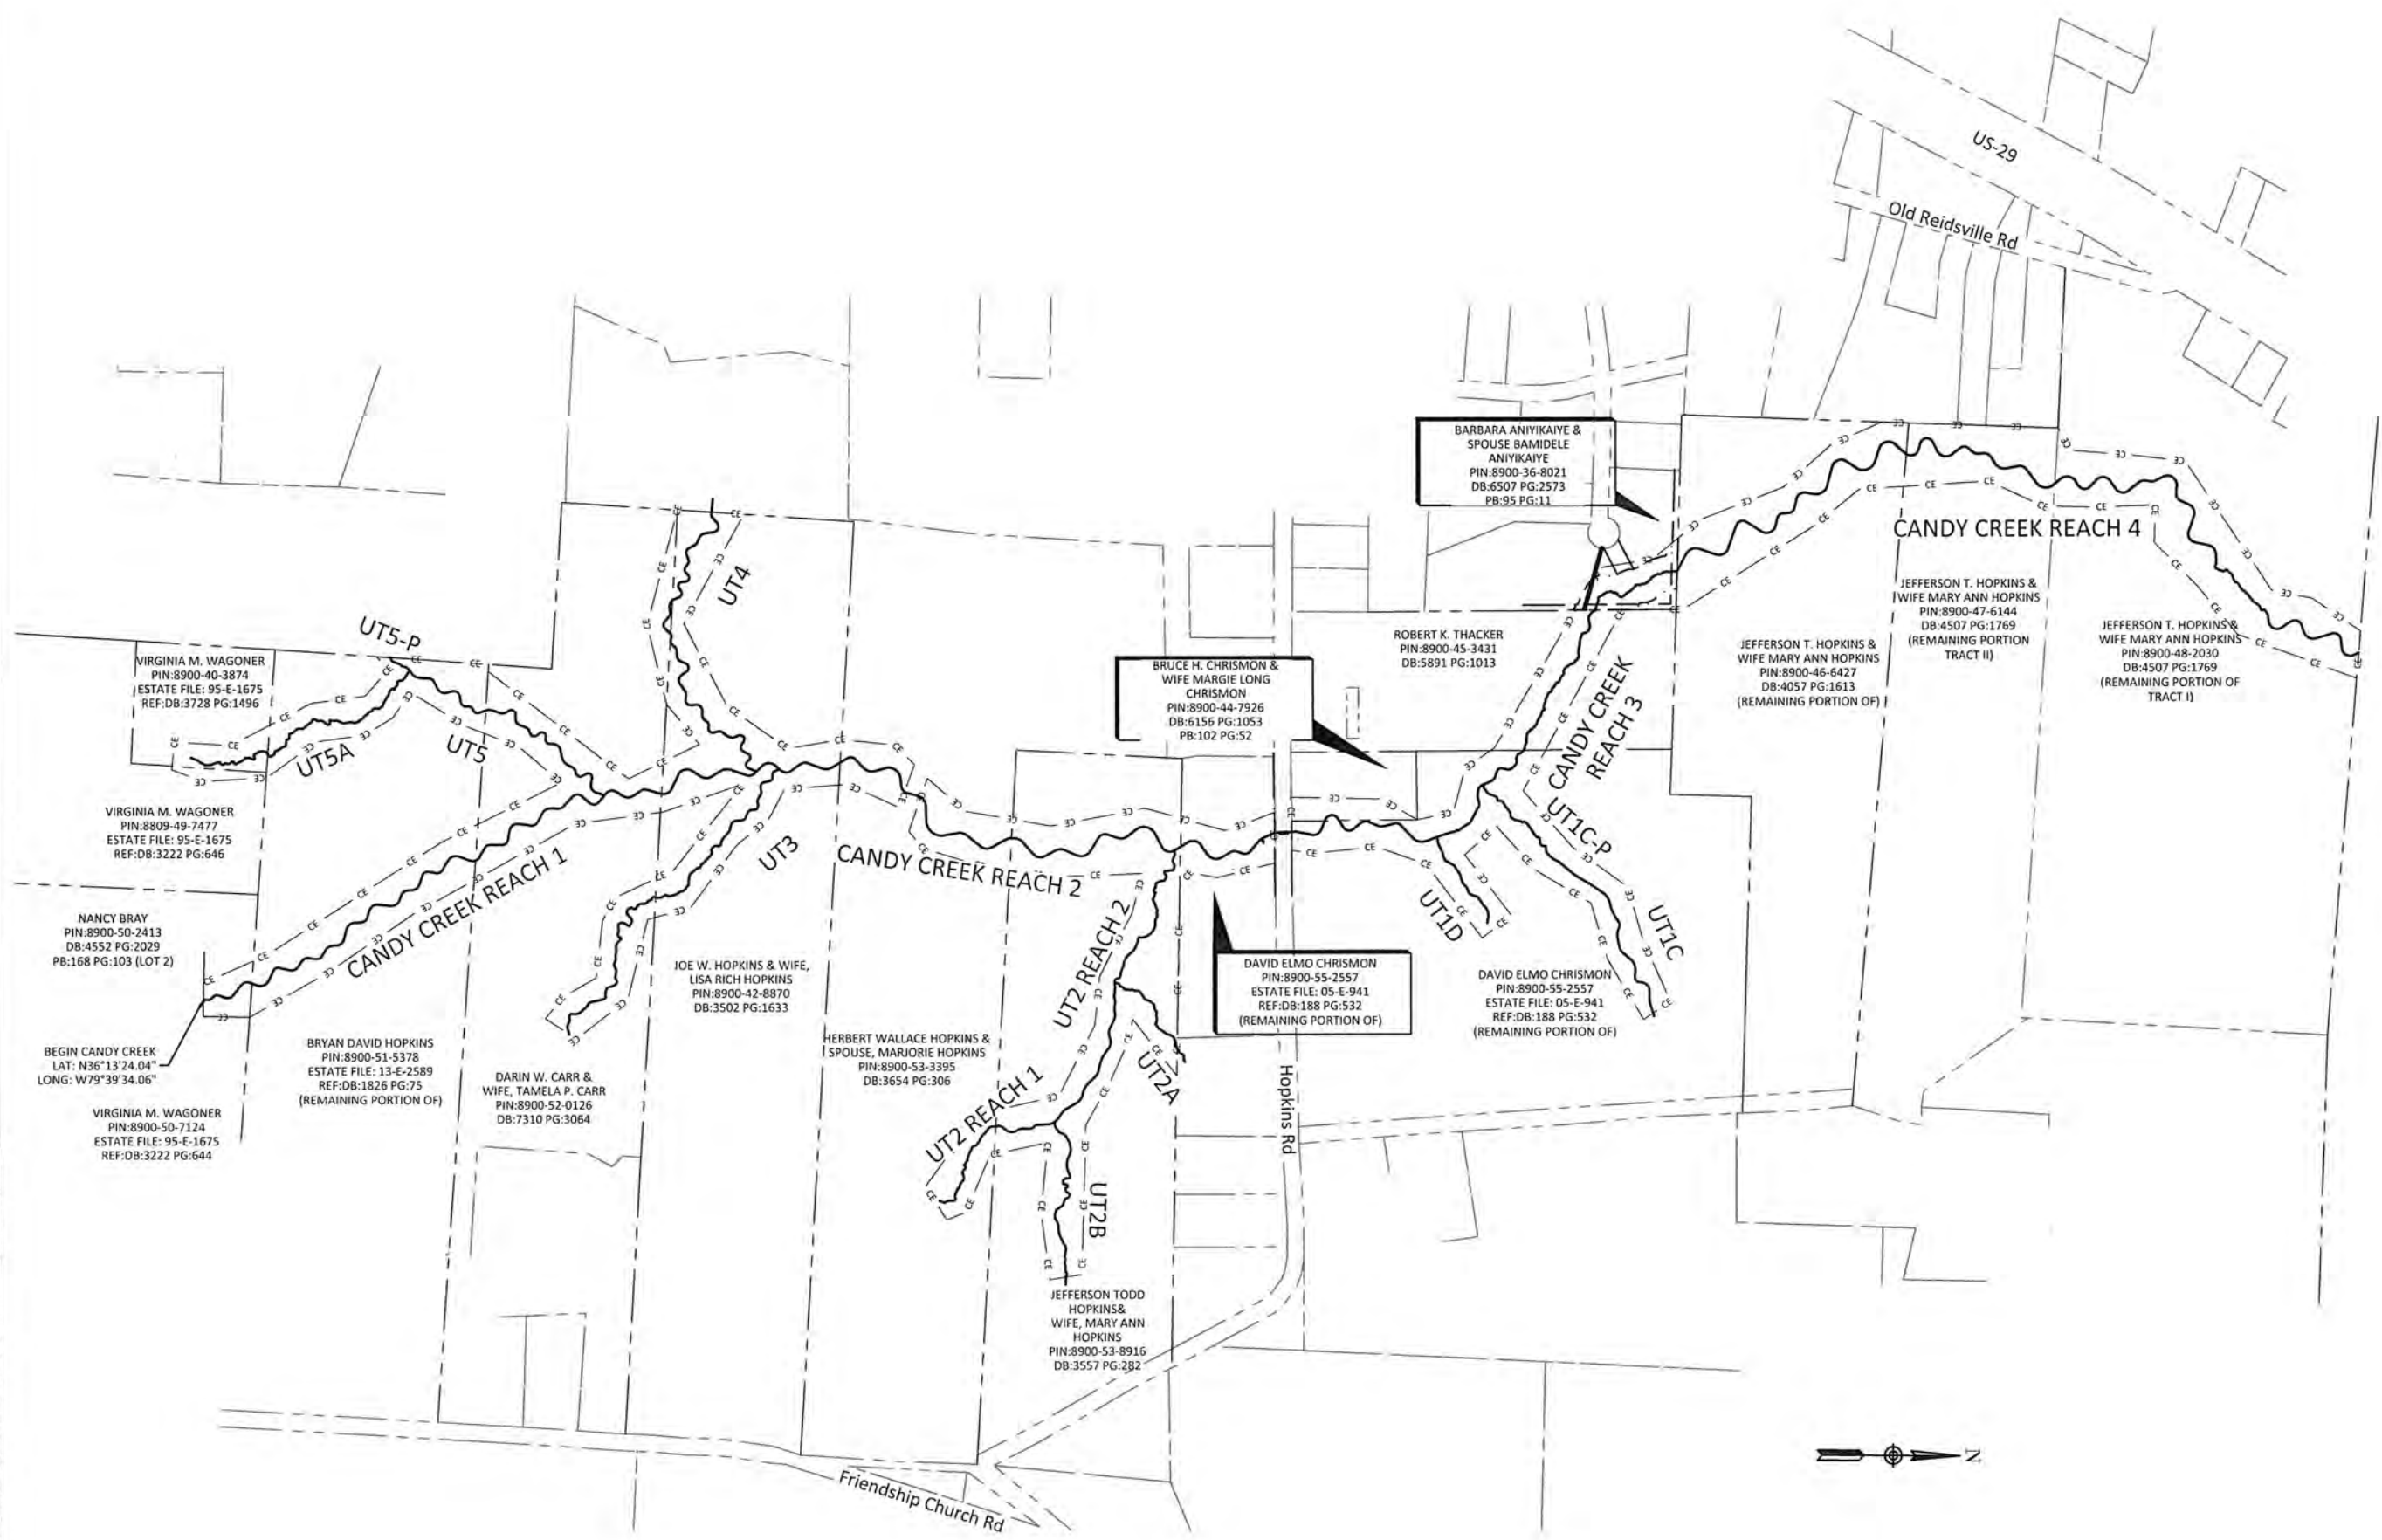
1.0

Candy Creek Mitigation Site-Record Drawings  
 Guilford County, North Carolina  
 Project Overview

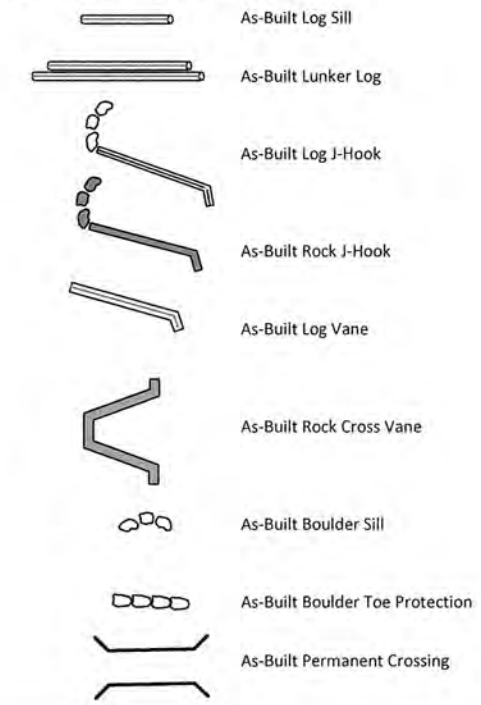
### As-Built Structures

AS-BUILT DRAWINGS:  
Deviations from the design will be shown in red.

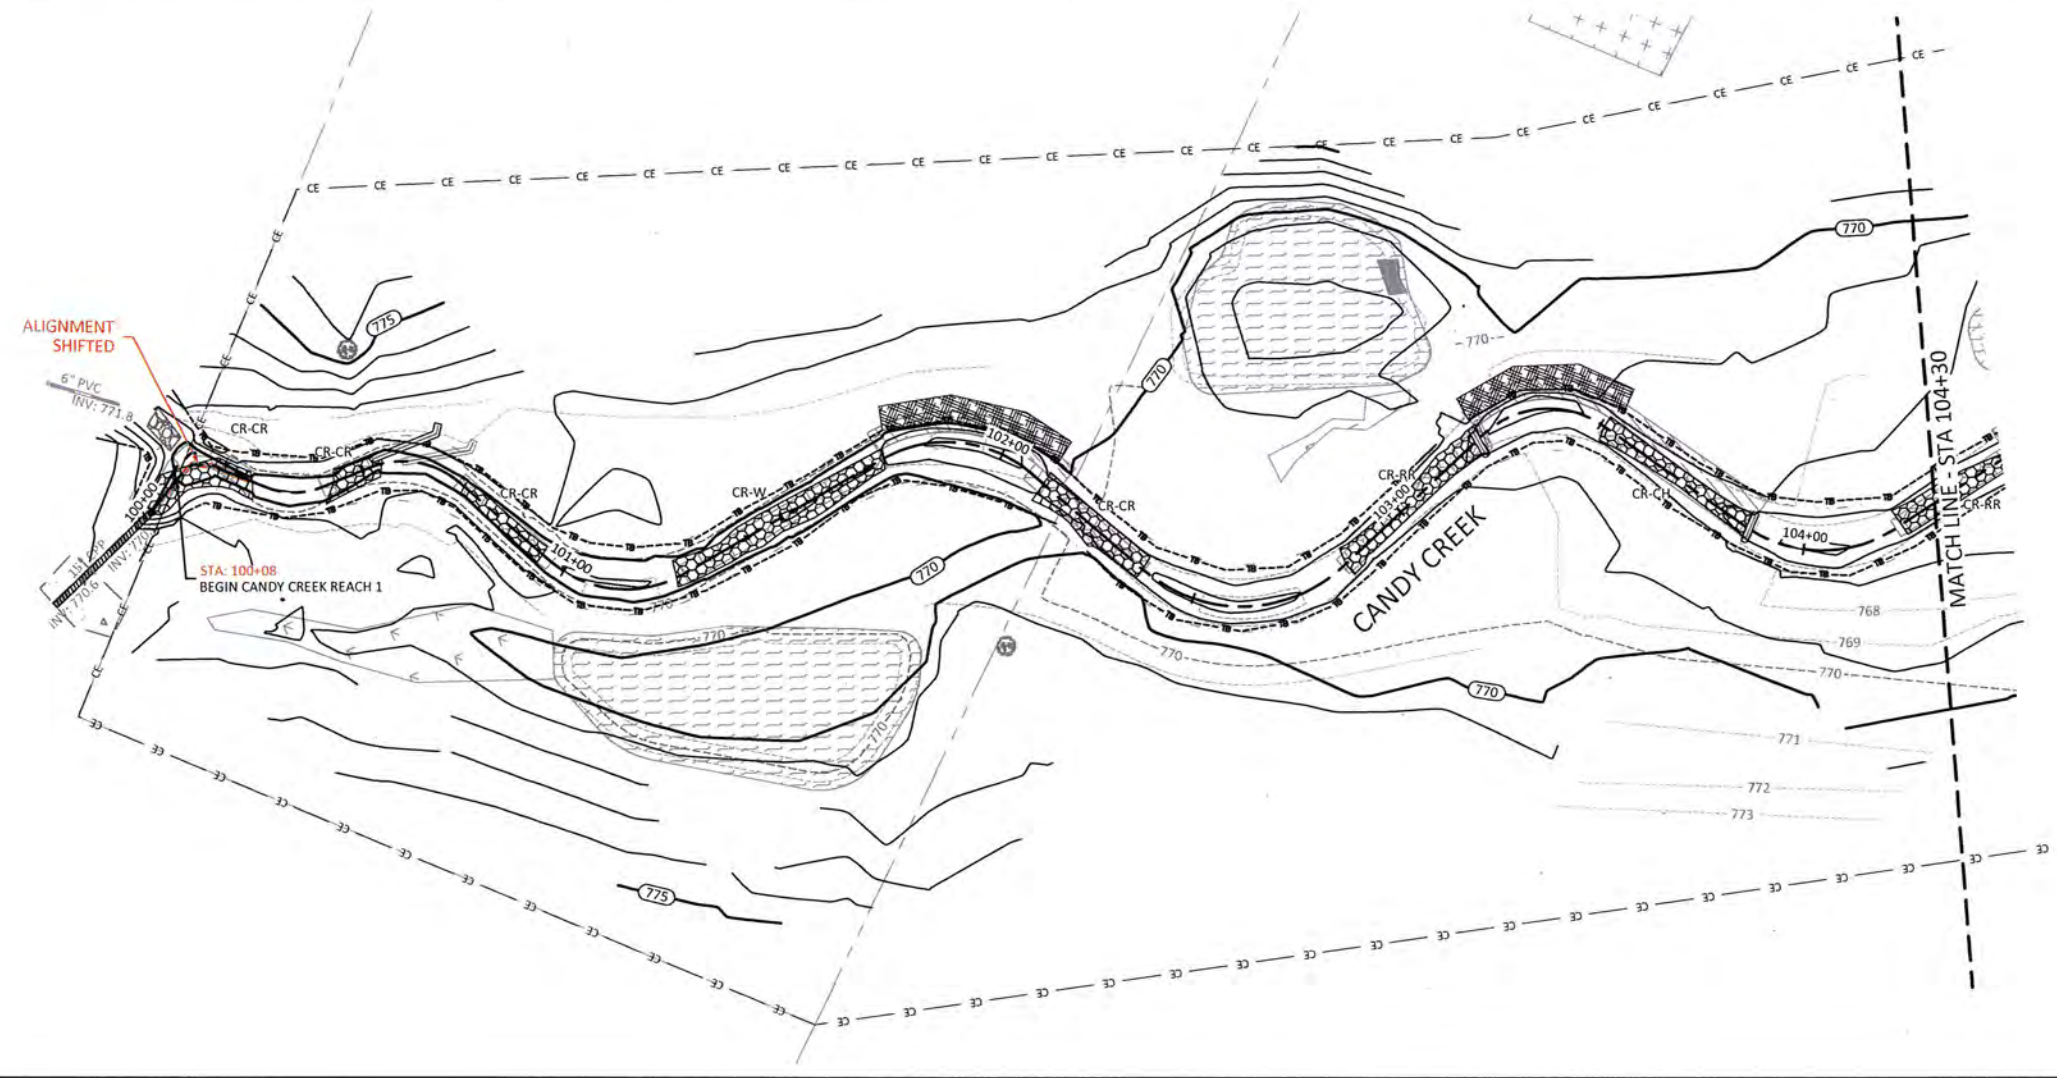
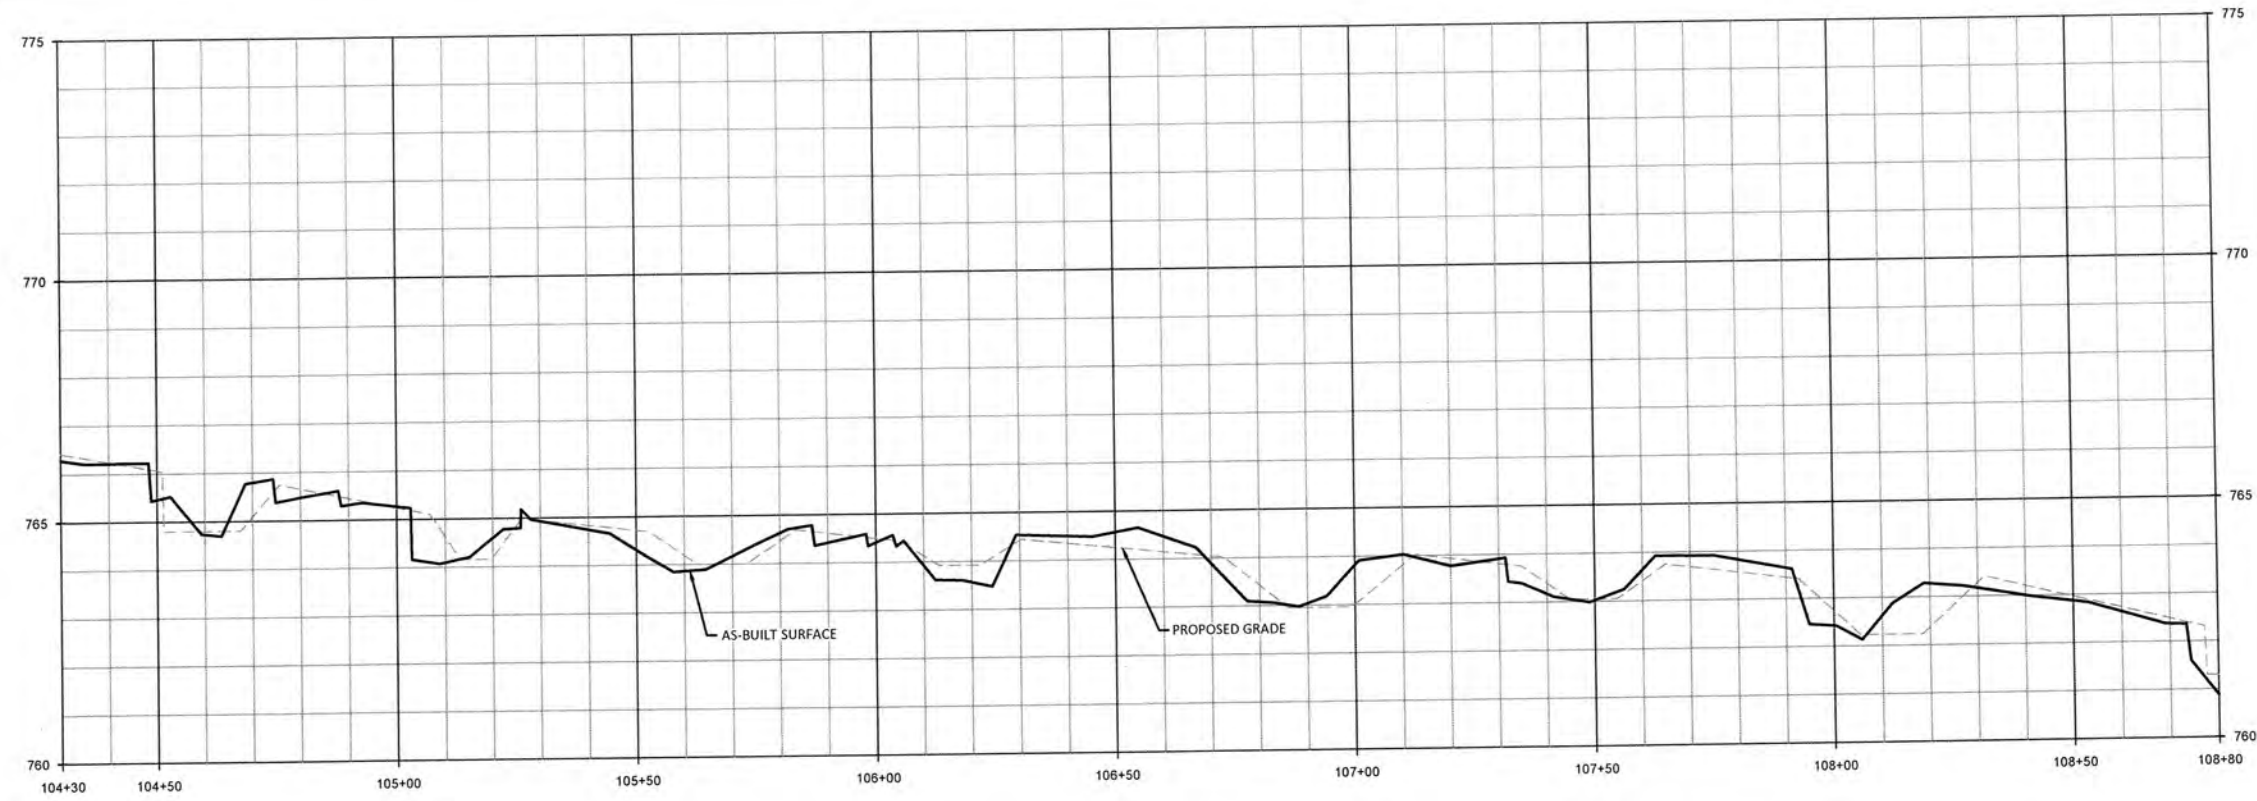
Candy Creek Mitigation Site-Record Drawings  
Guilford County, North Carolina  
Candy Creek Reach 1  
Stream Plan and Profile

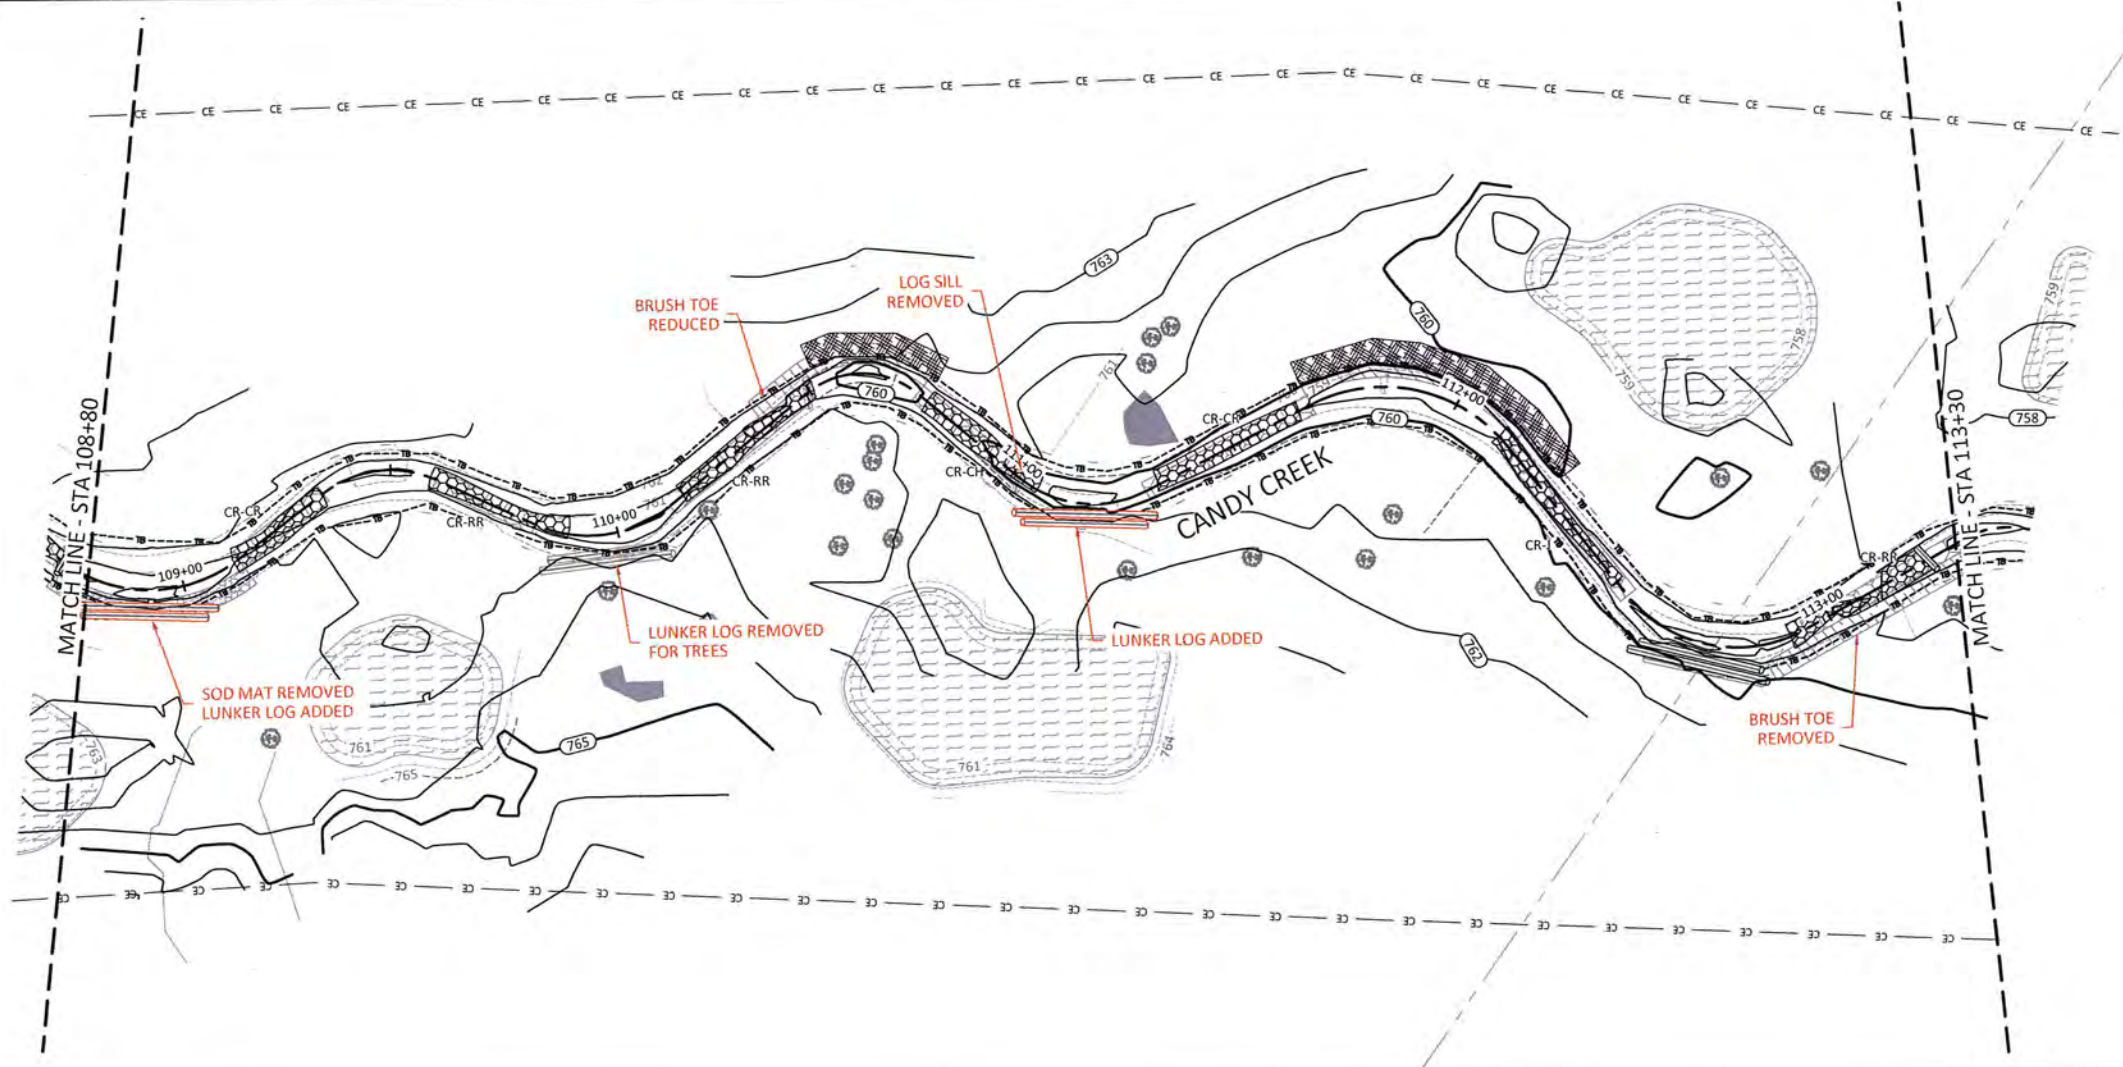
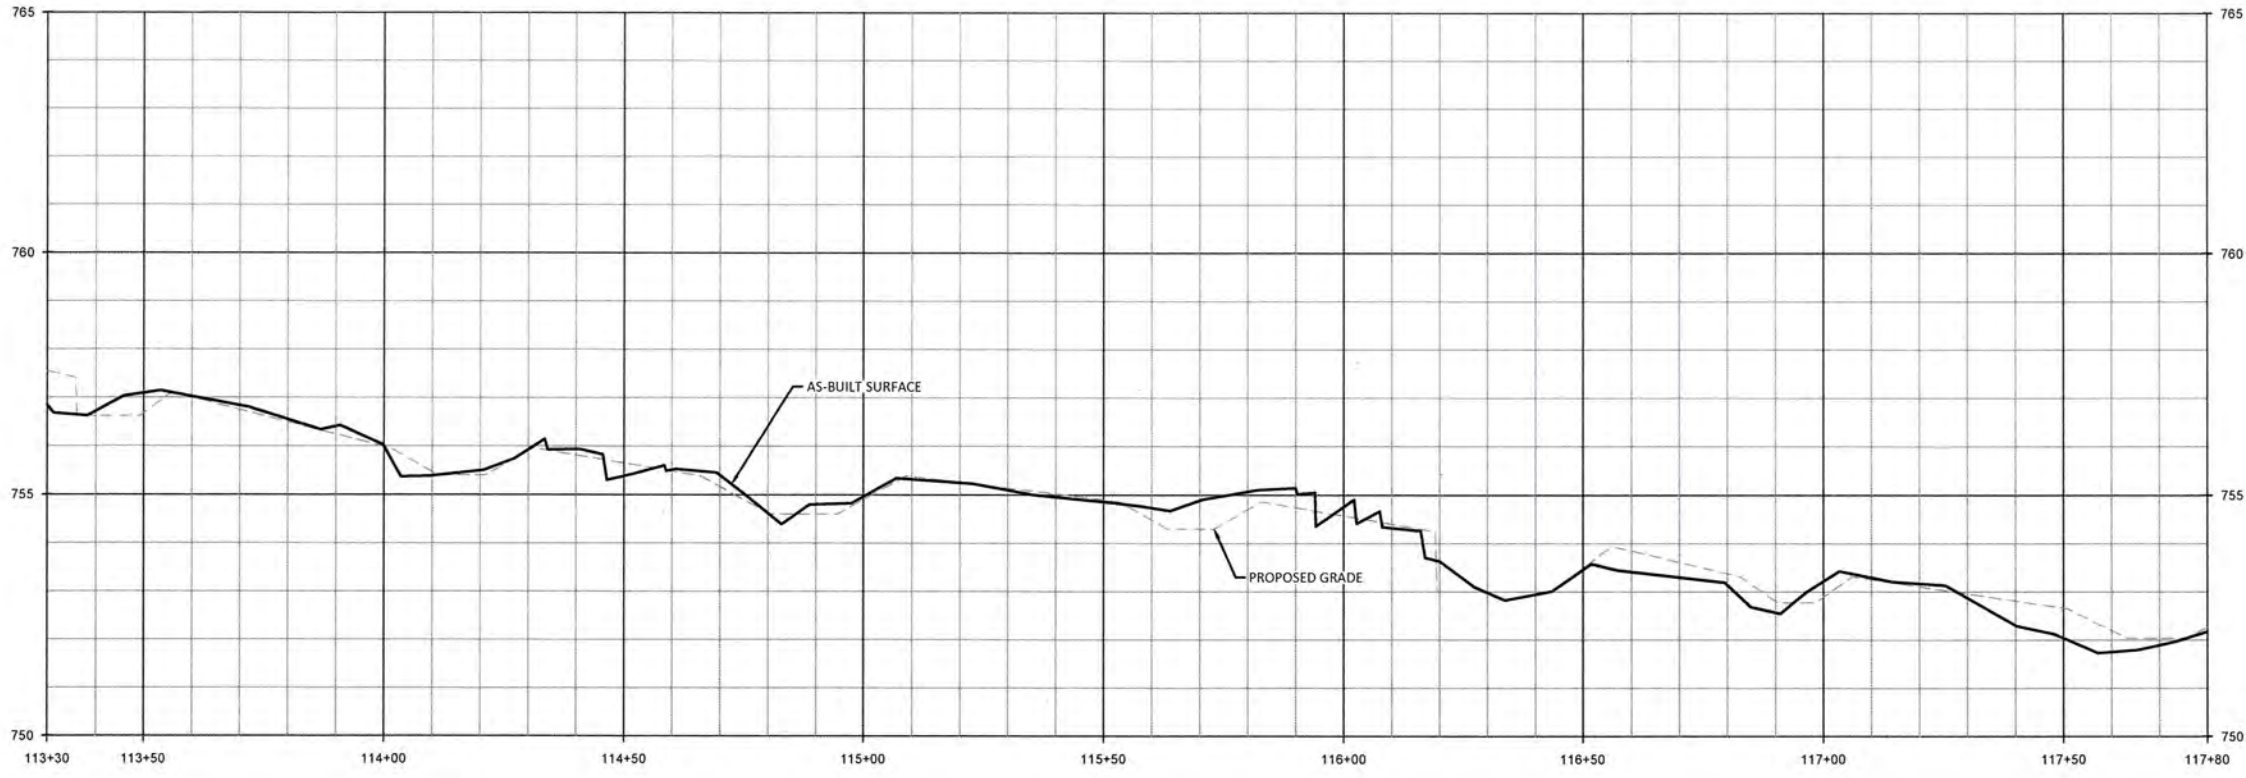
**2.1.3**  
 Sheet

Candy Creek Mitigation Site-Record Drawings  
 Guilford County, North Carolina  
 Candy Creek Reach 1  
 Stream Plan and Profile

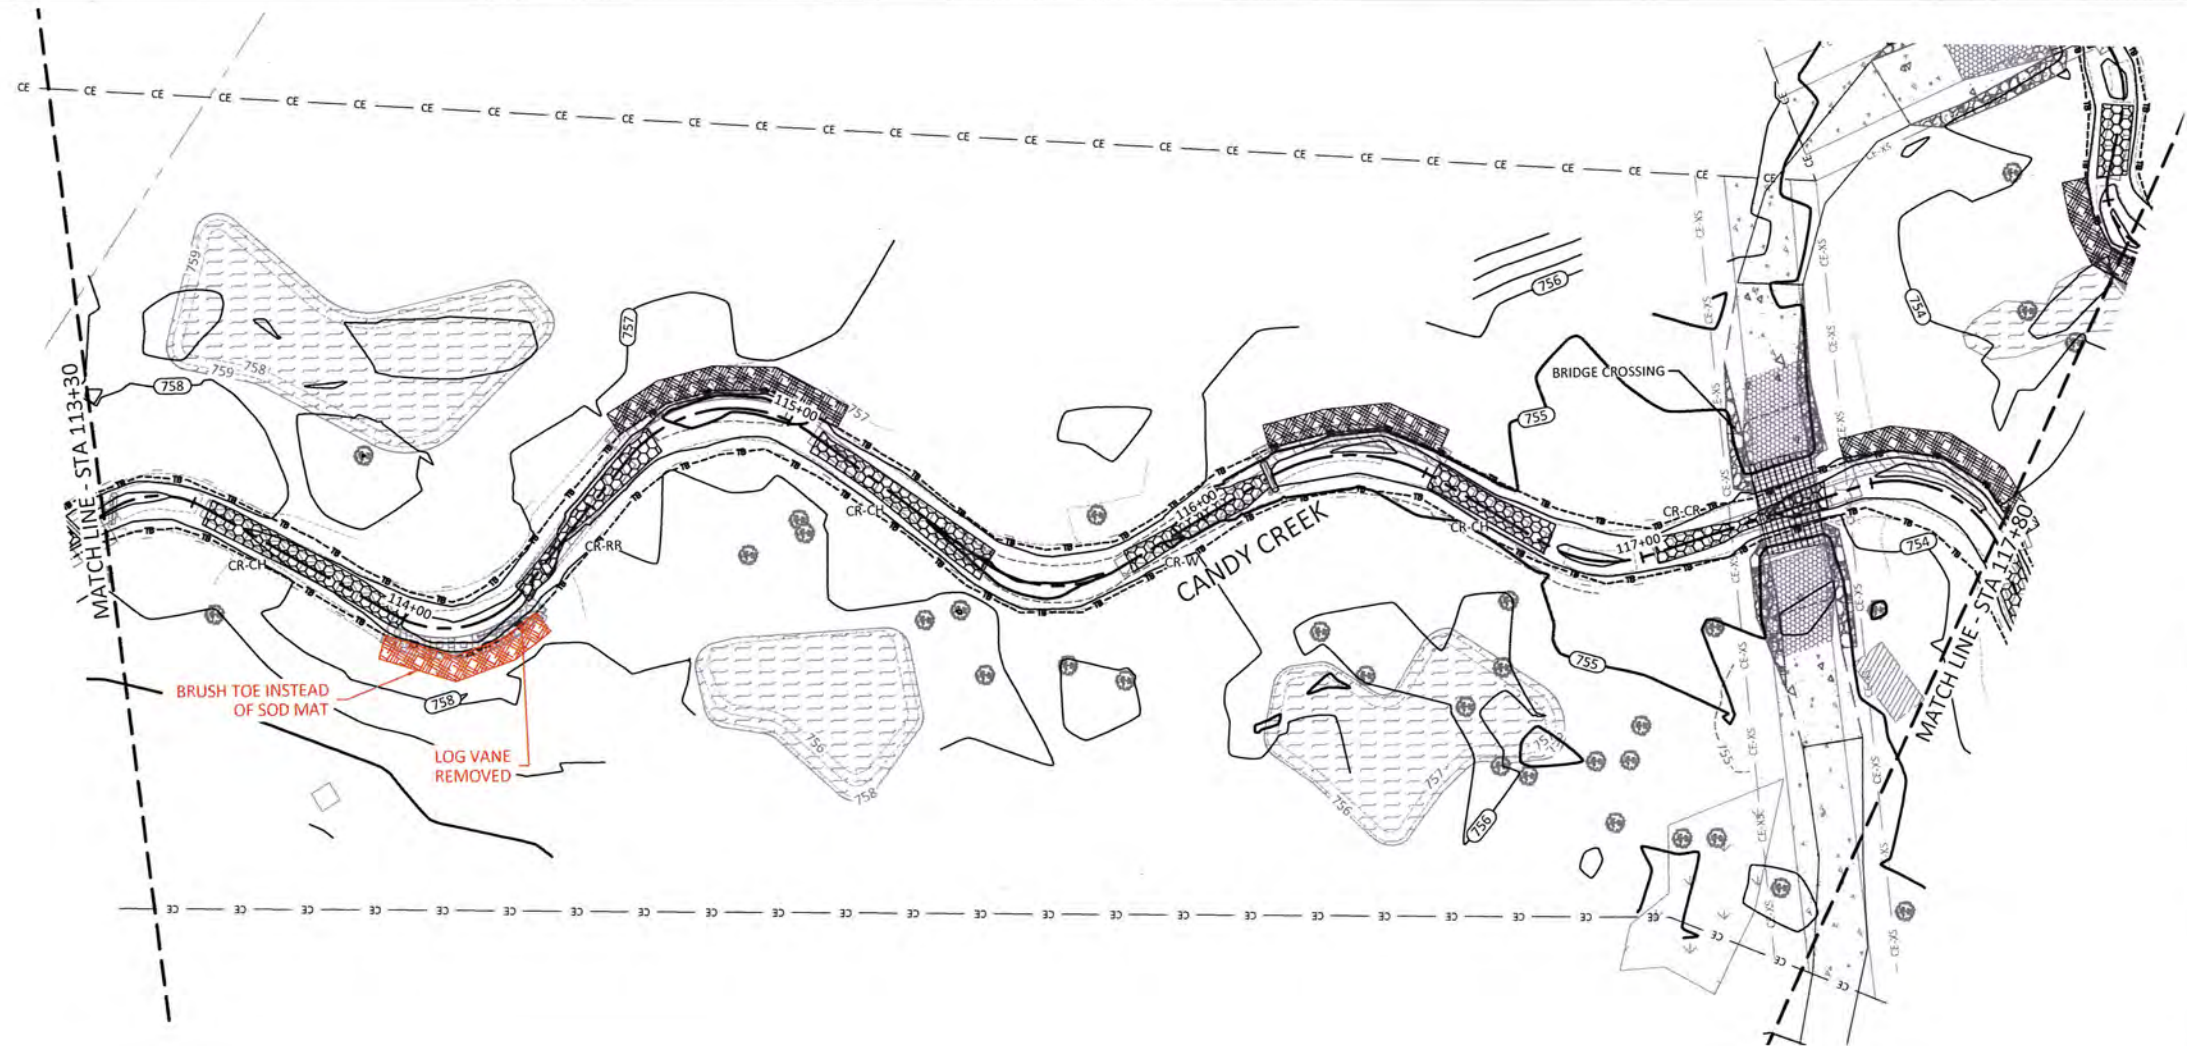
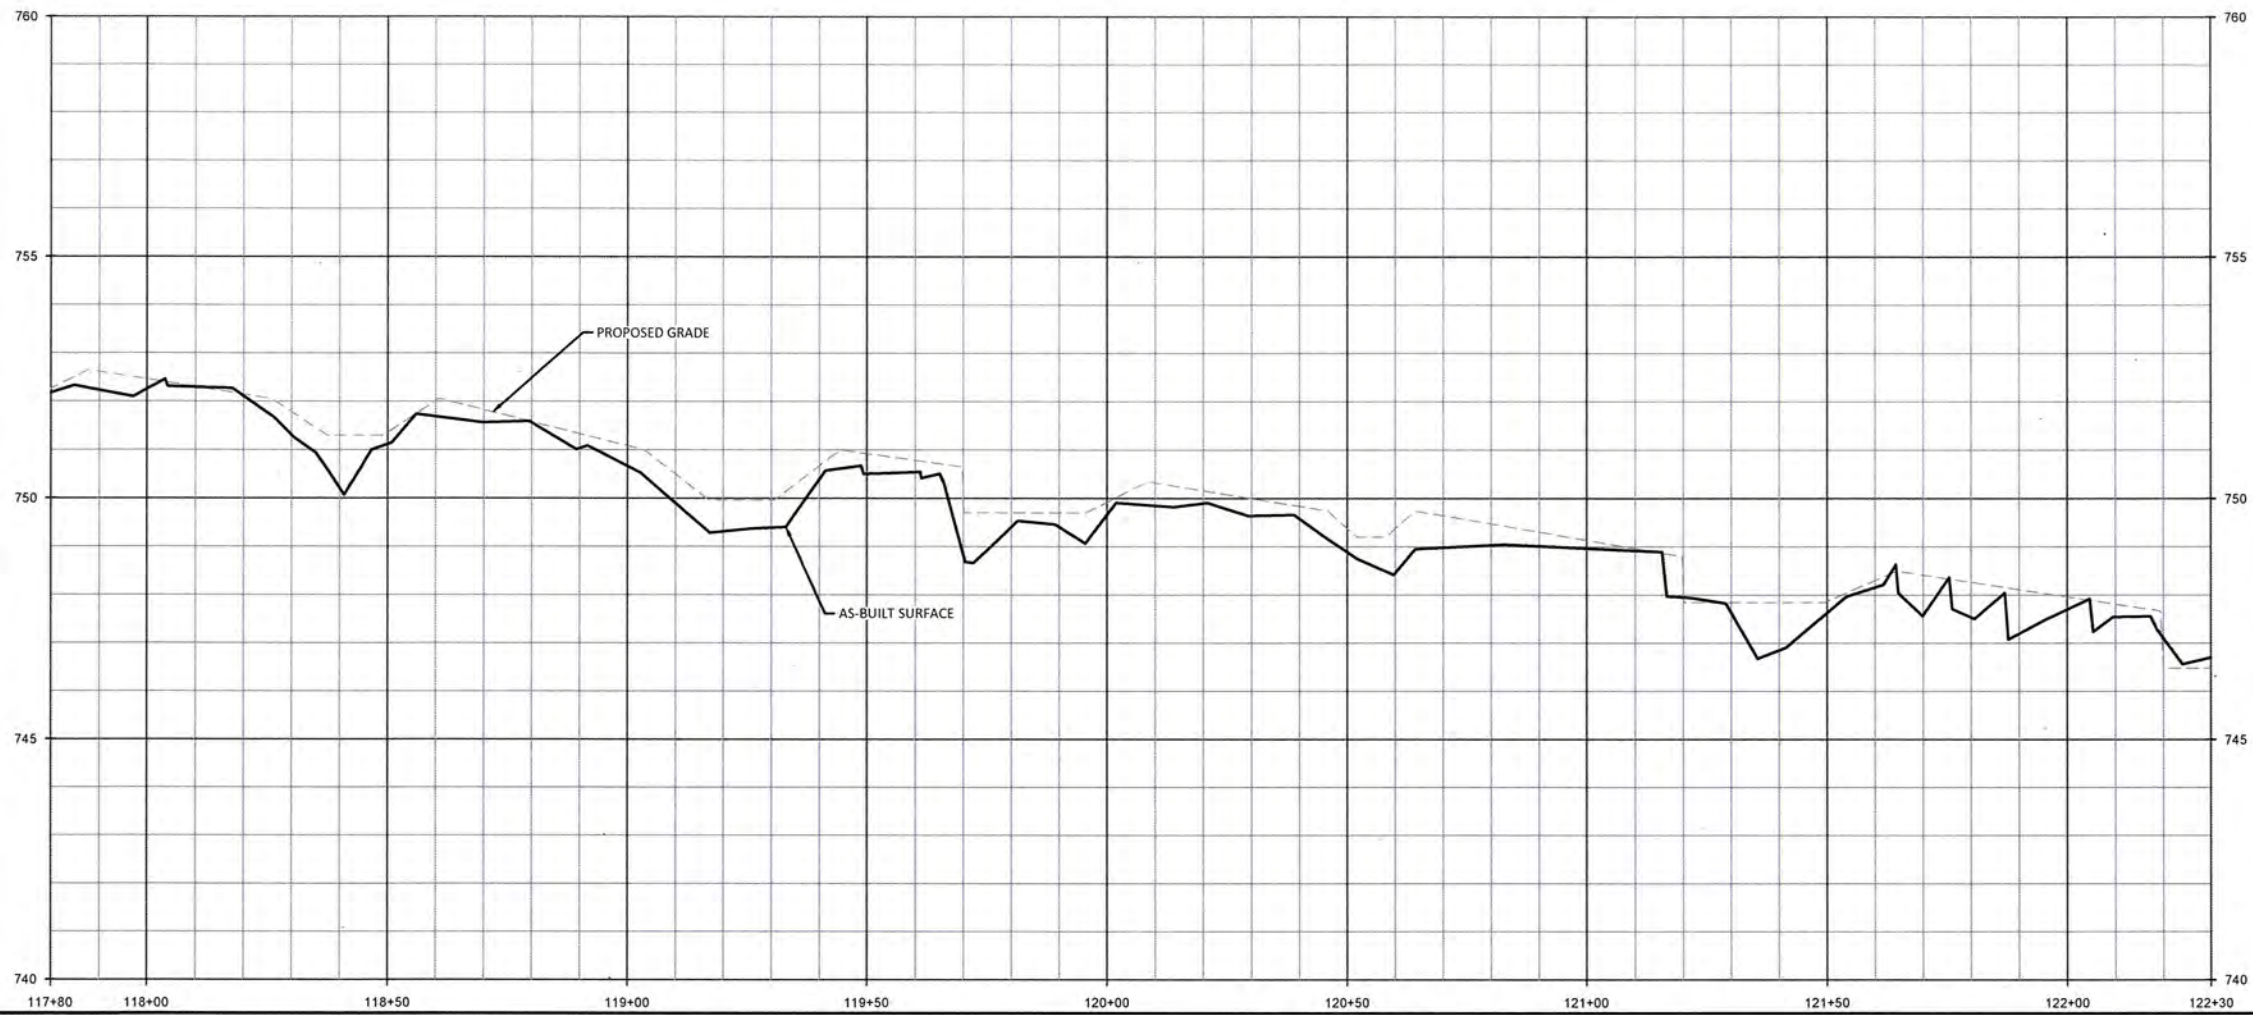
Candy Creek Mitigation Site-Record Drawings  
 Guilford County, North Carolina

Candy Creek Reach 1  
 Stream Plan and Profile

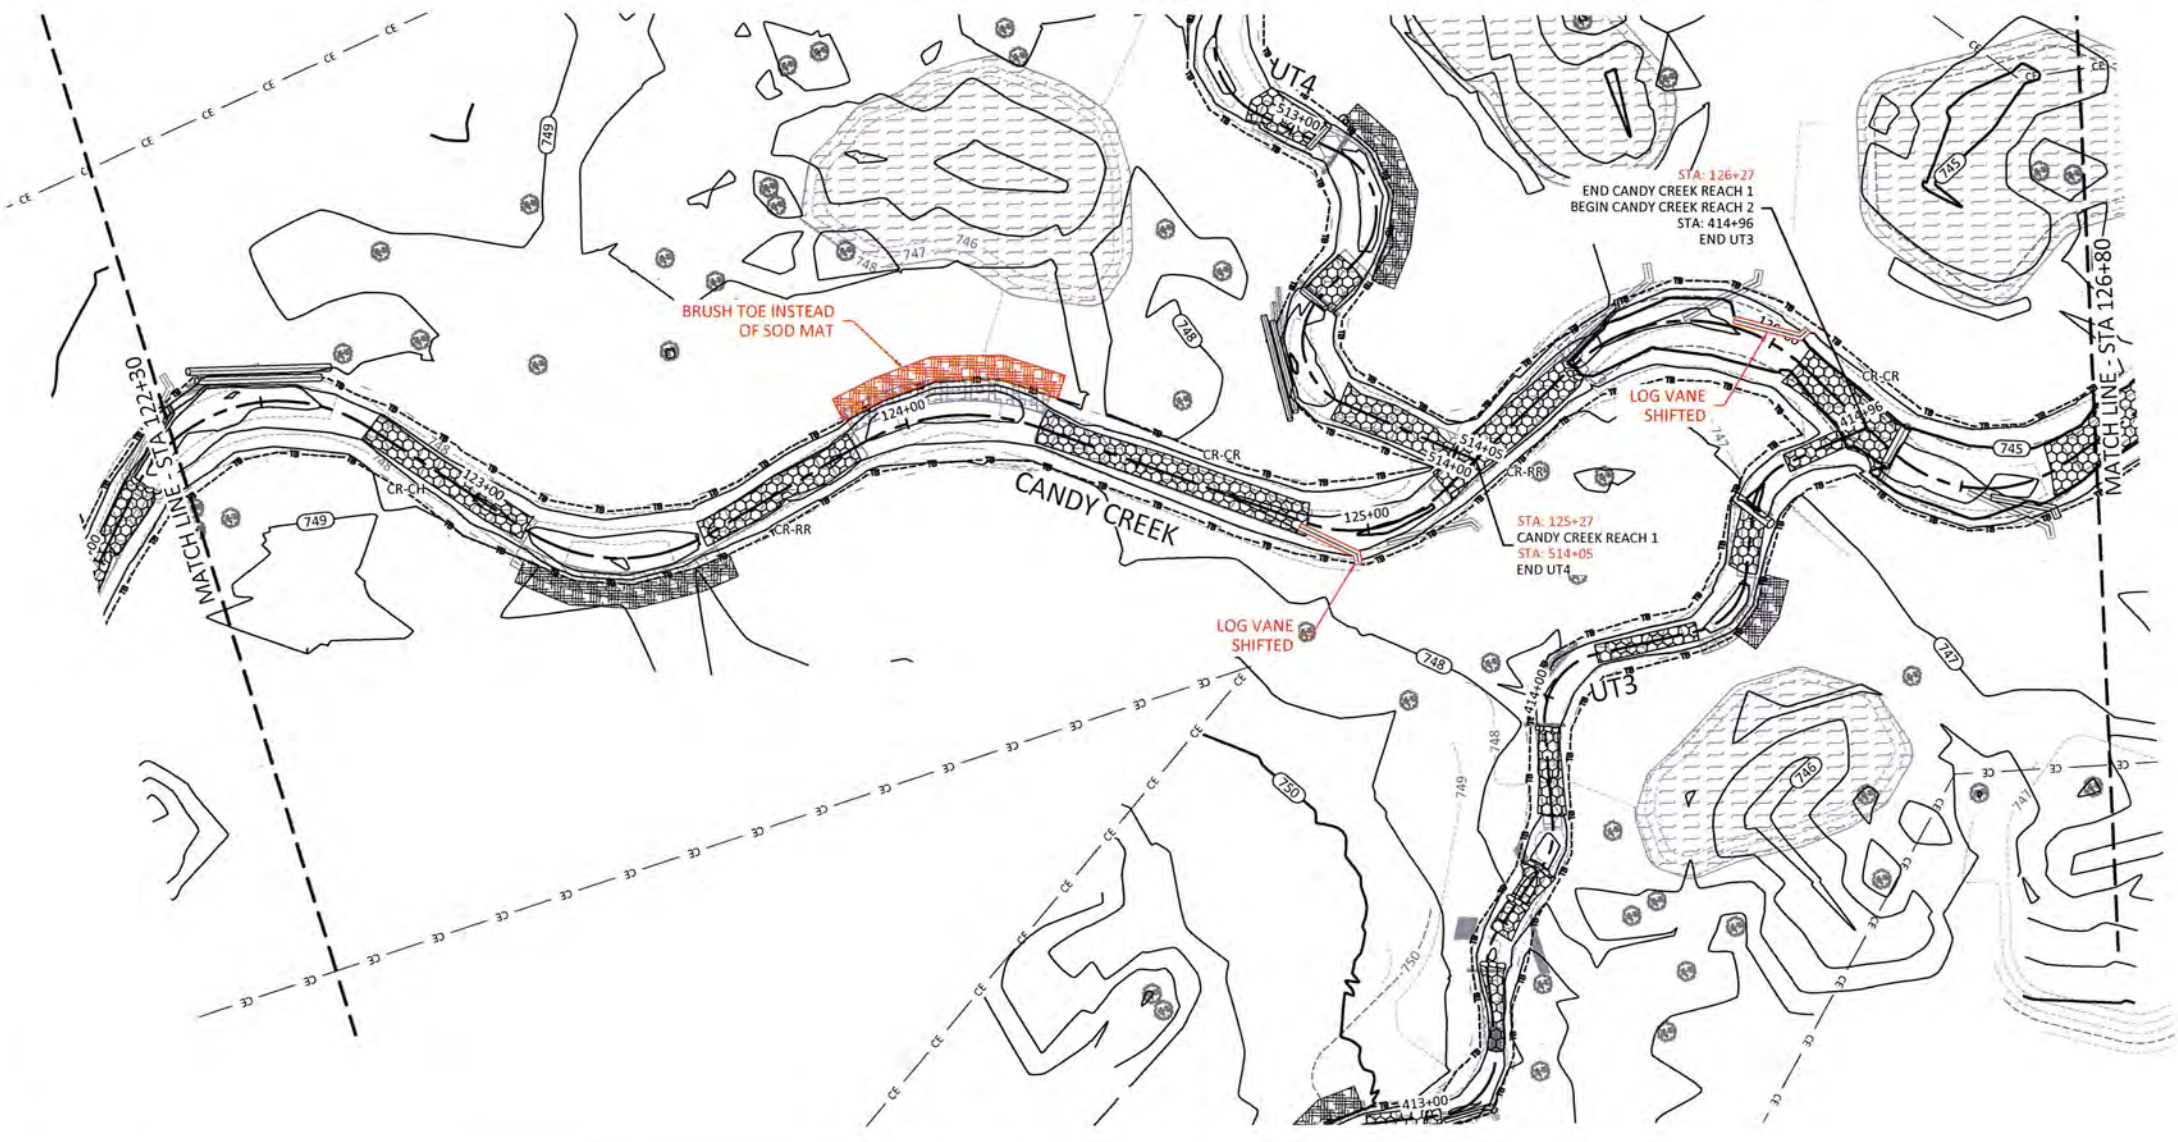
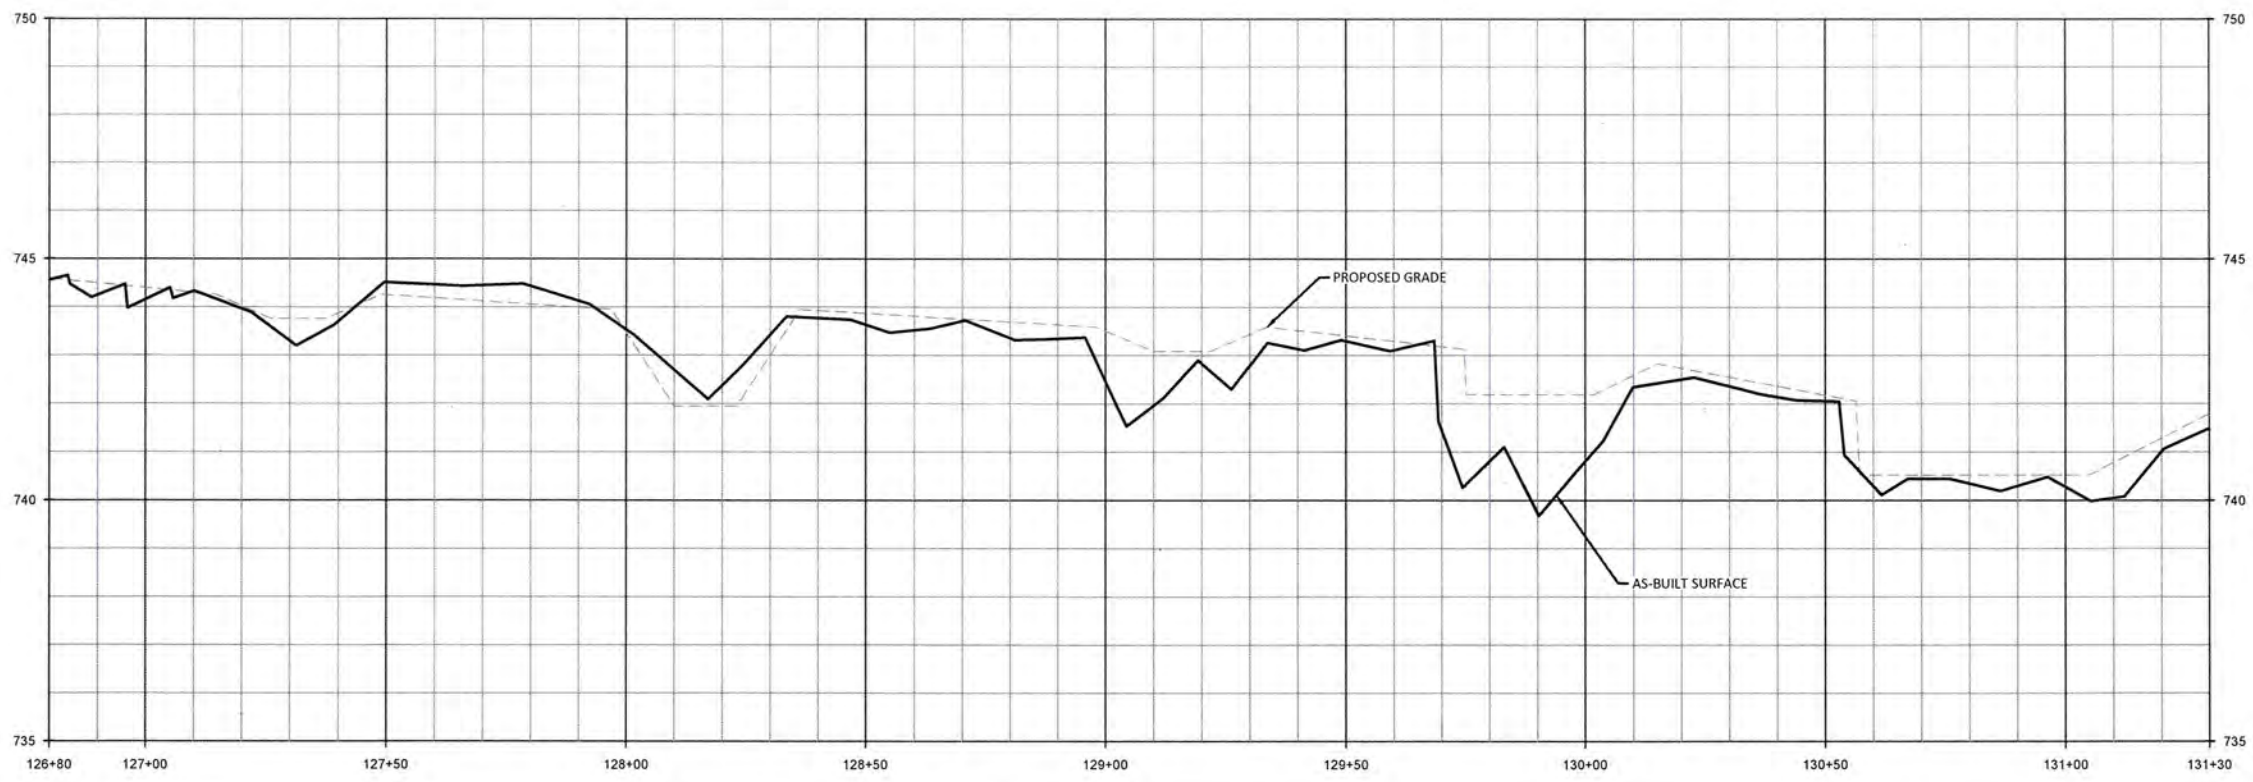
Candy Creek Mitigation Site-Record Drawings  
 Guilford County, North Carolina

Candy Creek Reach 1 & 2  
 Stream Plan and Profile
