# **BASELINE MONITORING DOCUMENT AND AS-BUILT BASELINE REPORT**

## **CANDY CREEK MITIGATION SITE**

Guilford County, NC  
NCDEQ Contract 5794  
DMS ID No. 96315

Data Collection Period: October 2016 – March 2017  
Final Submission Date: June 2, 2017

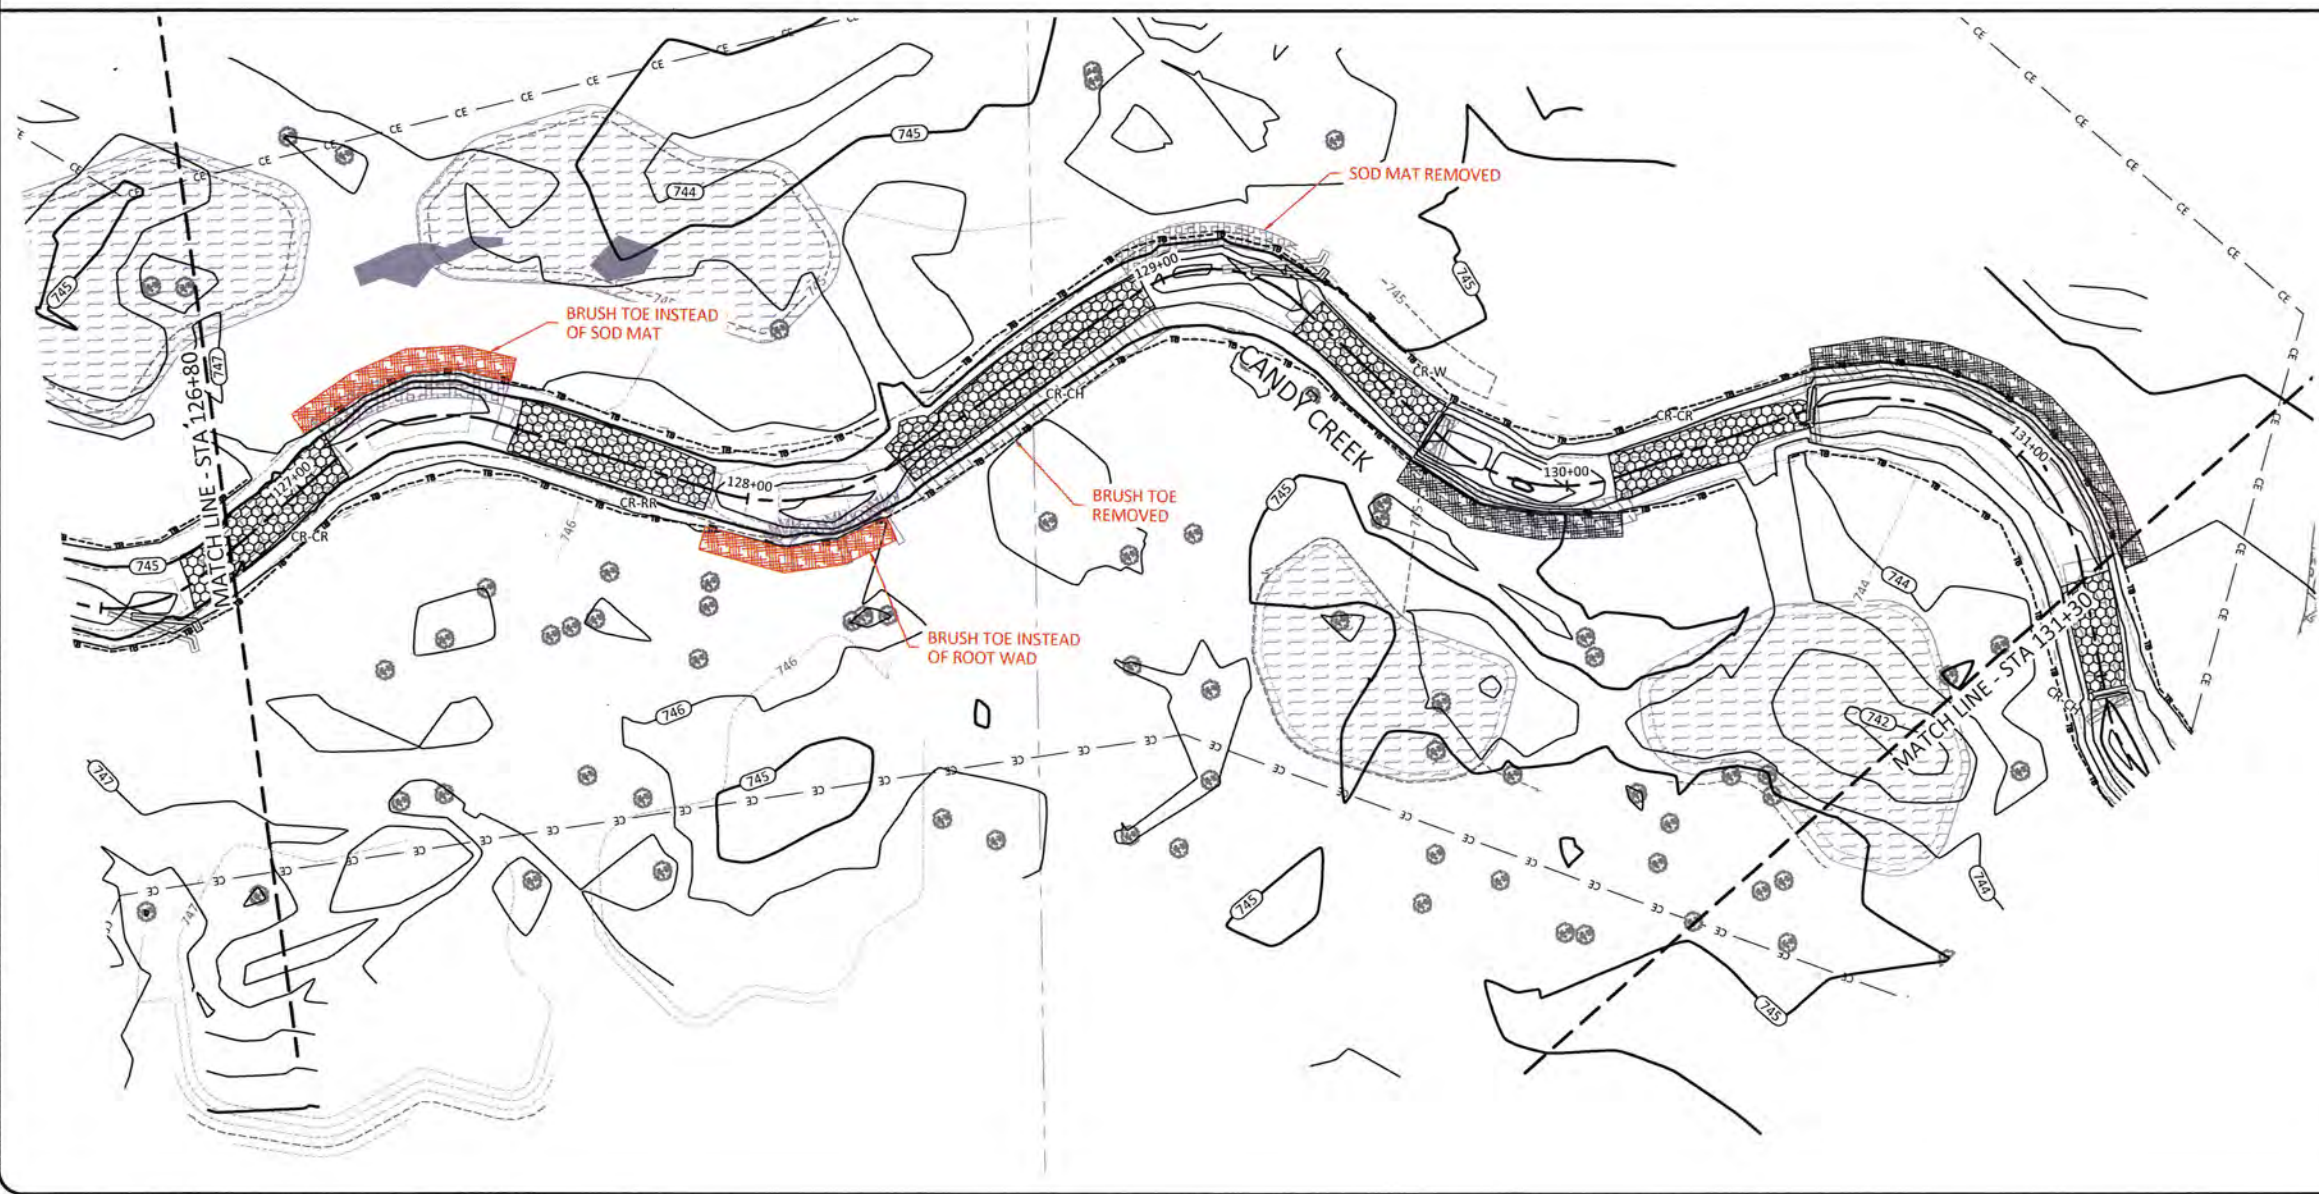
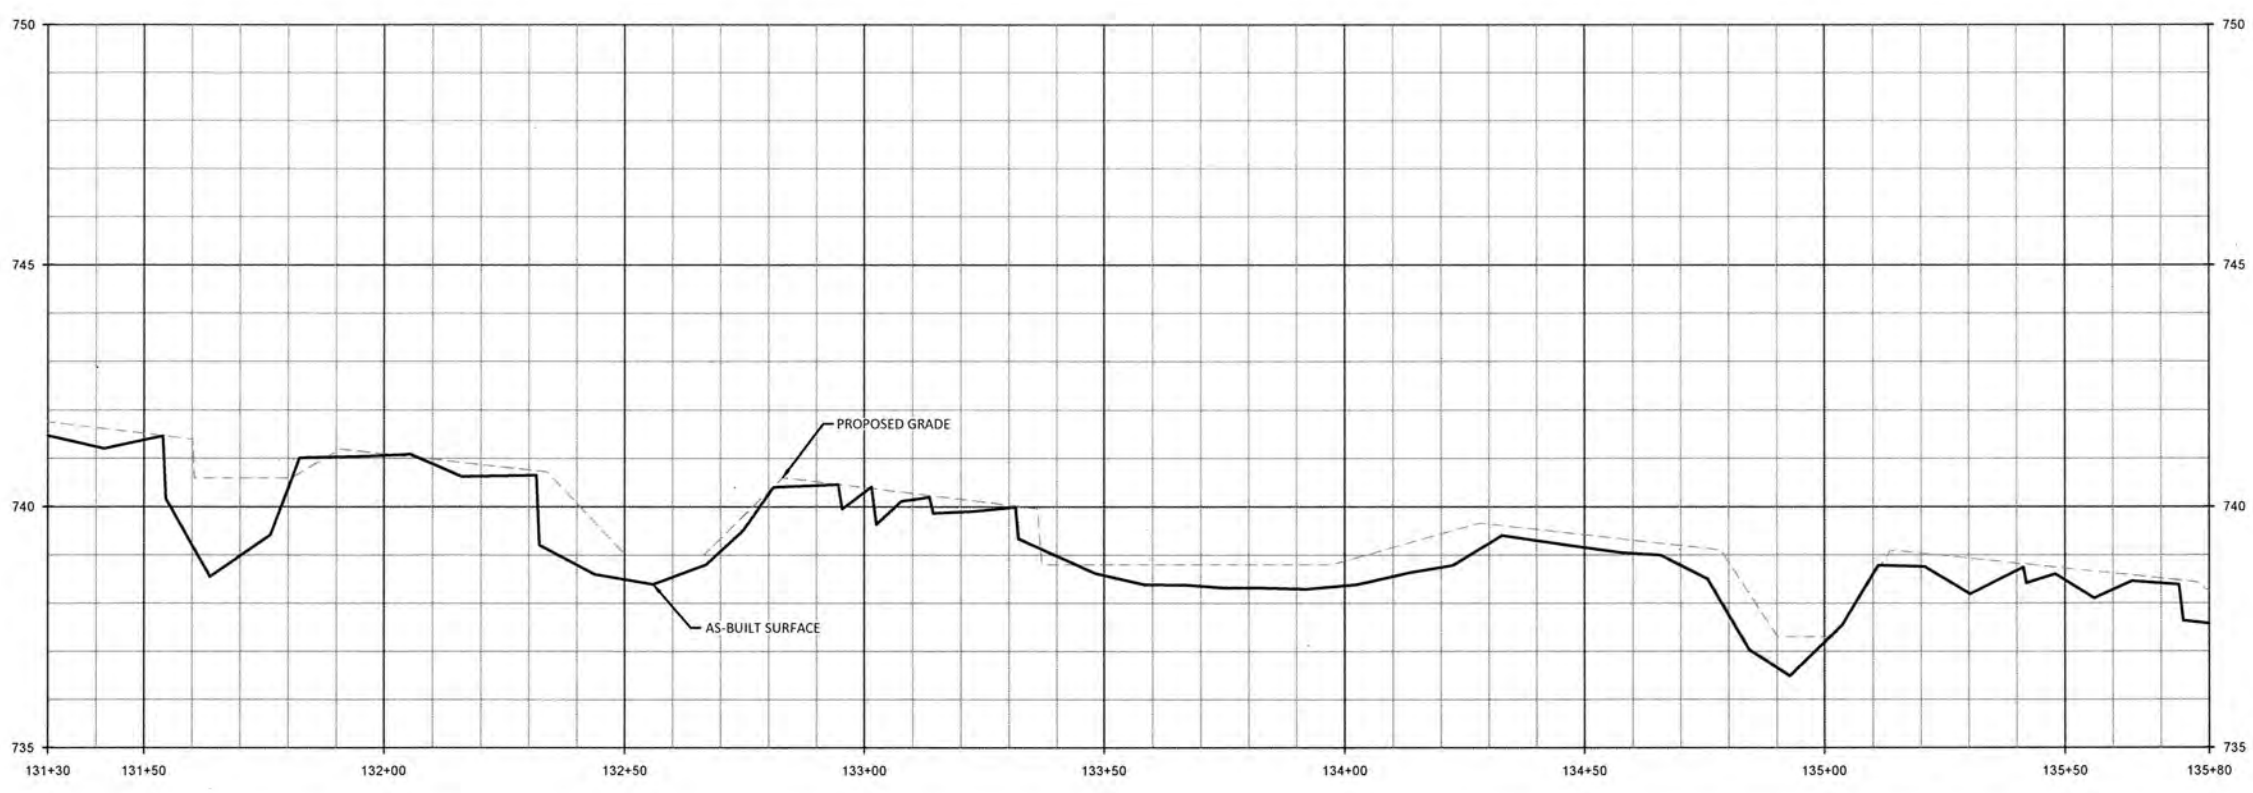
Candy Creek Mitigation Site-Record Drawings  
 Guilford County, North Carolina

Candy Creek Reach 2  
 Stream Plan and Profile

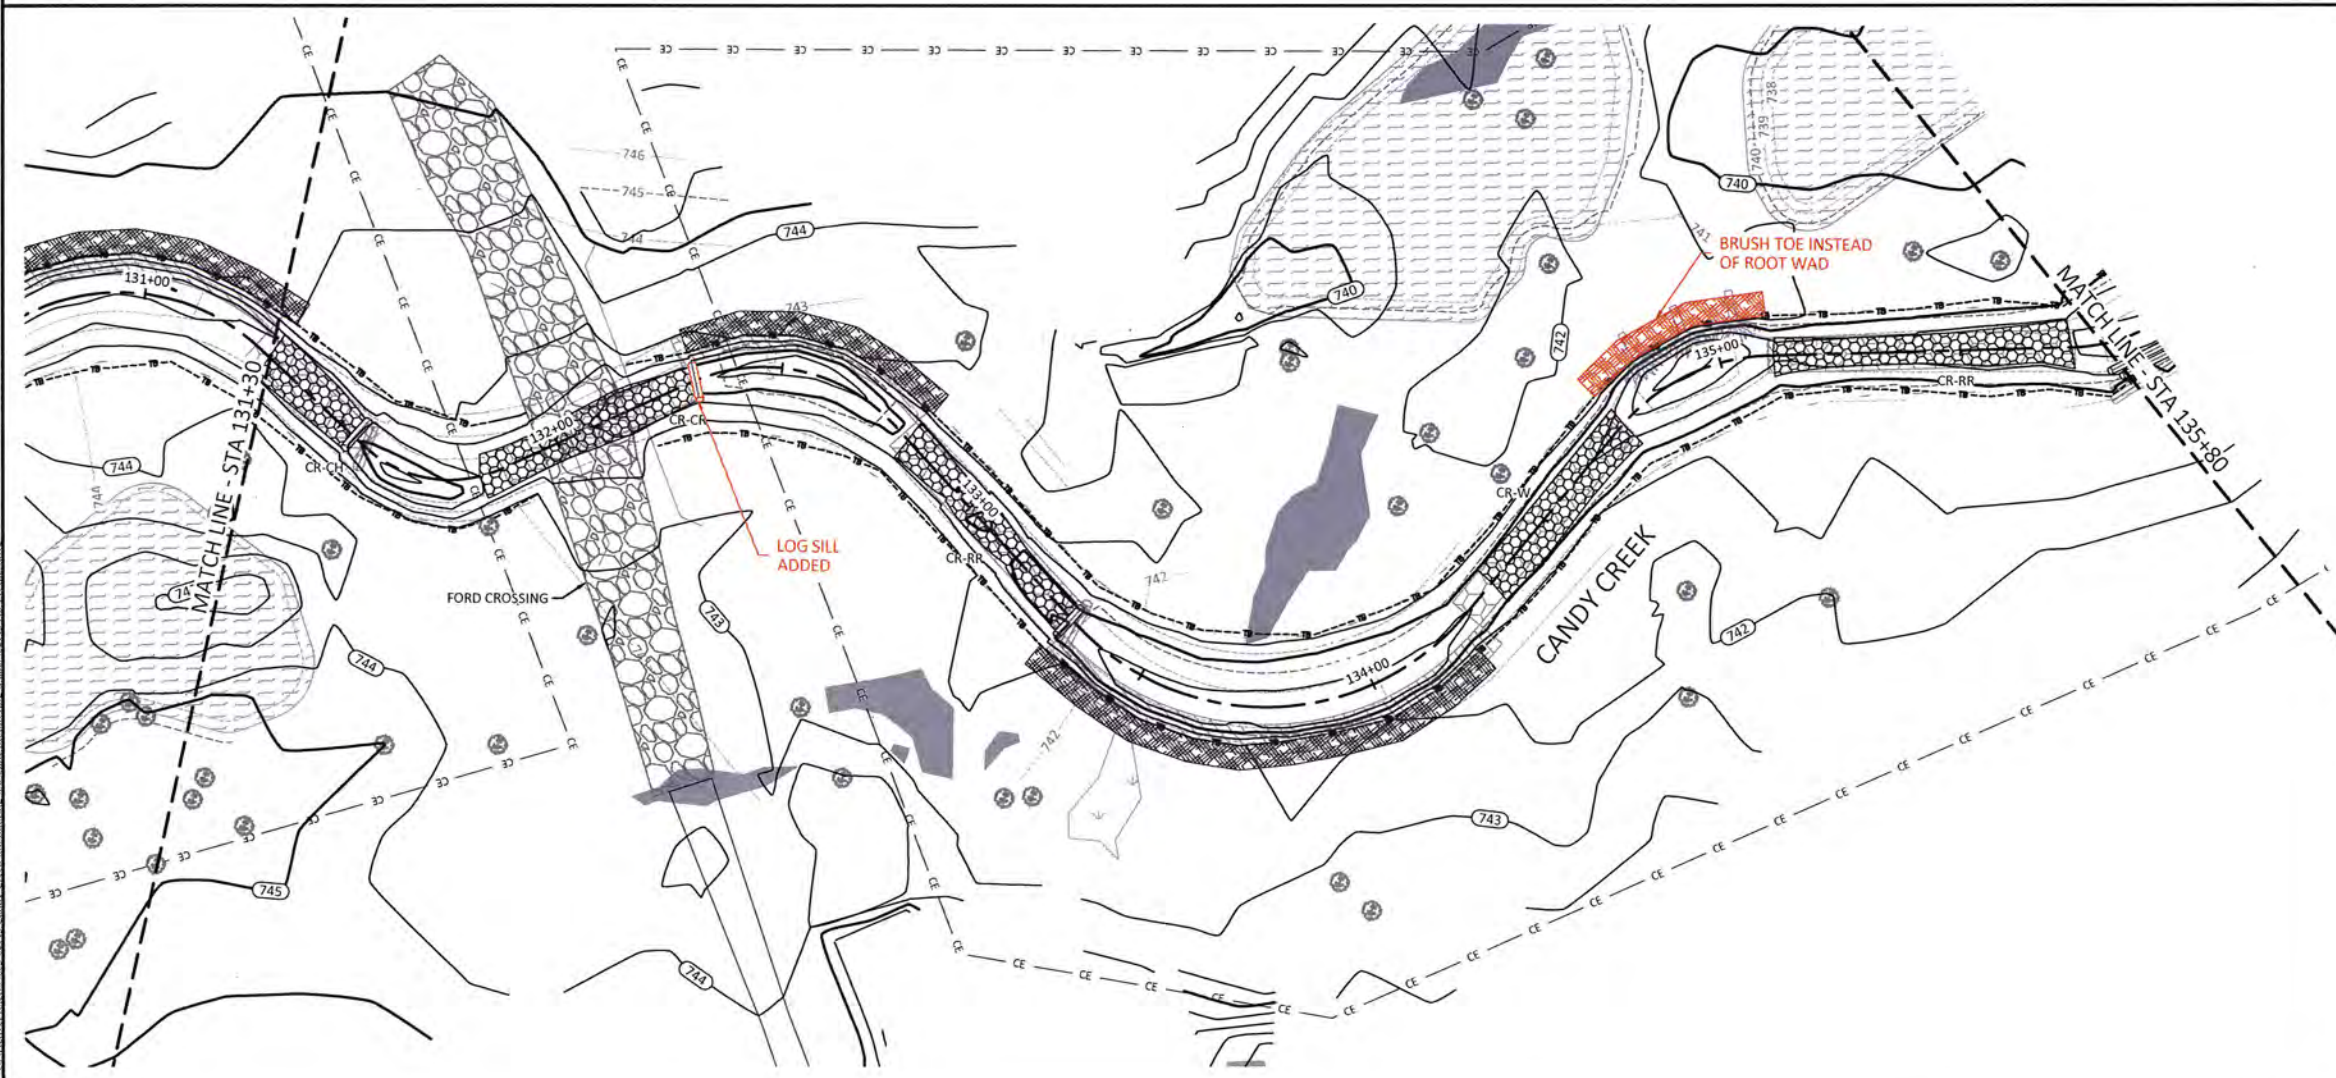
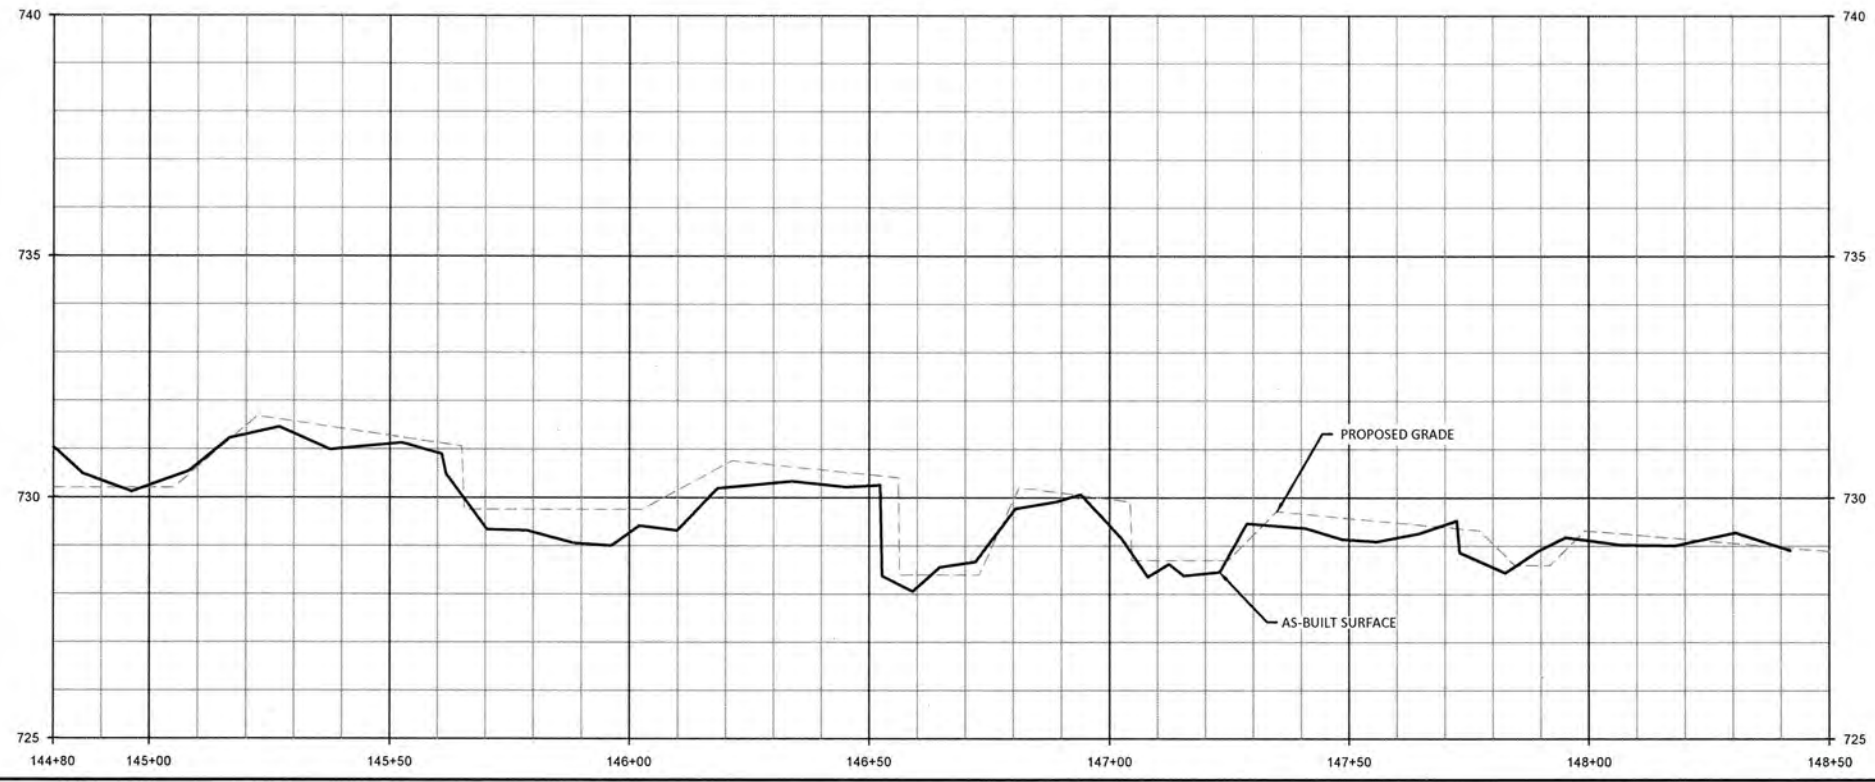
Candy Creek Mitigation Site-Record Drawings  
Guilford County, North Carolina

Candy Creek Reach 2  
Stream Plan and Profile

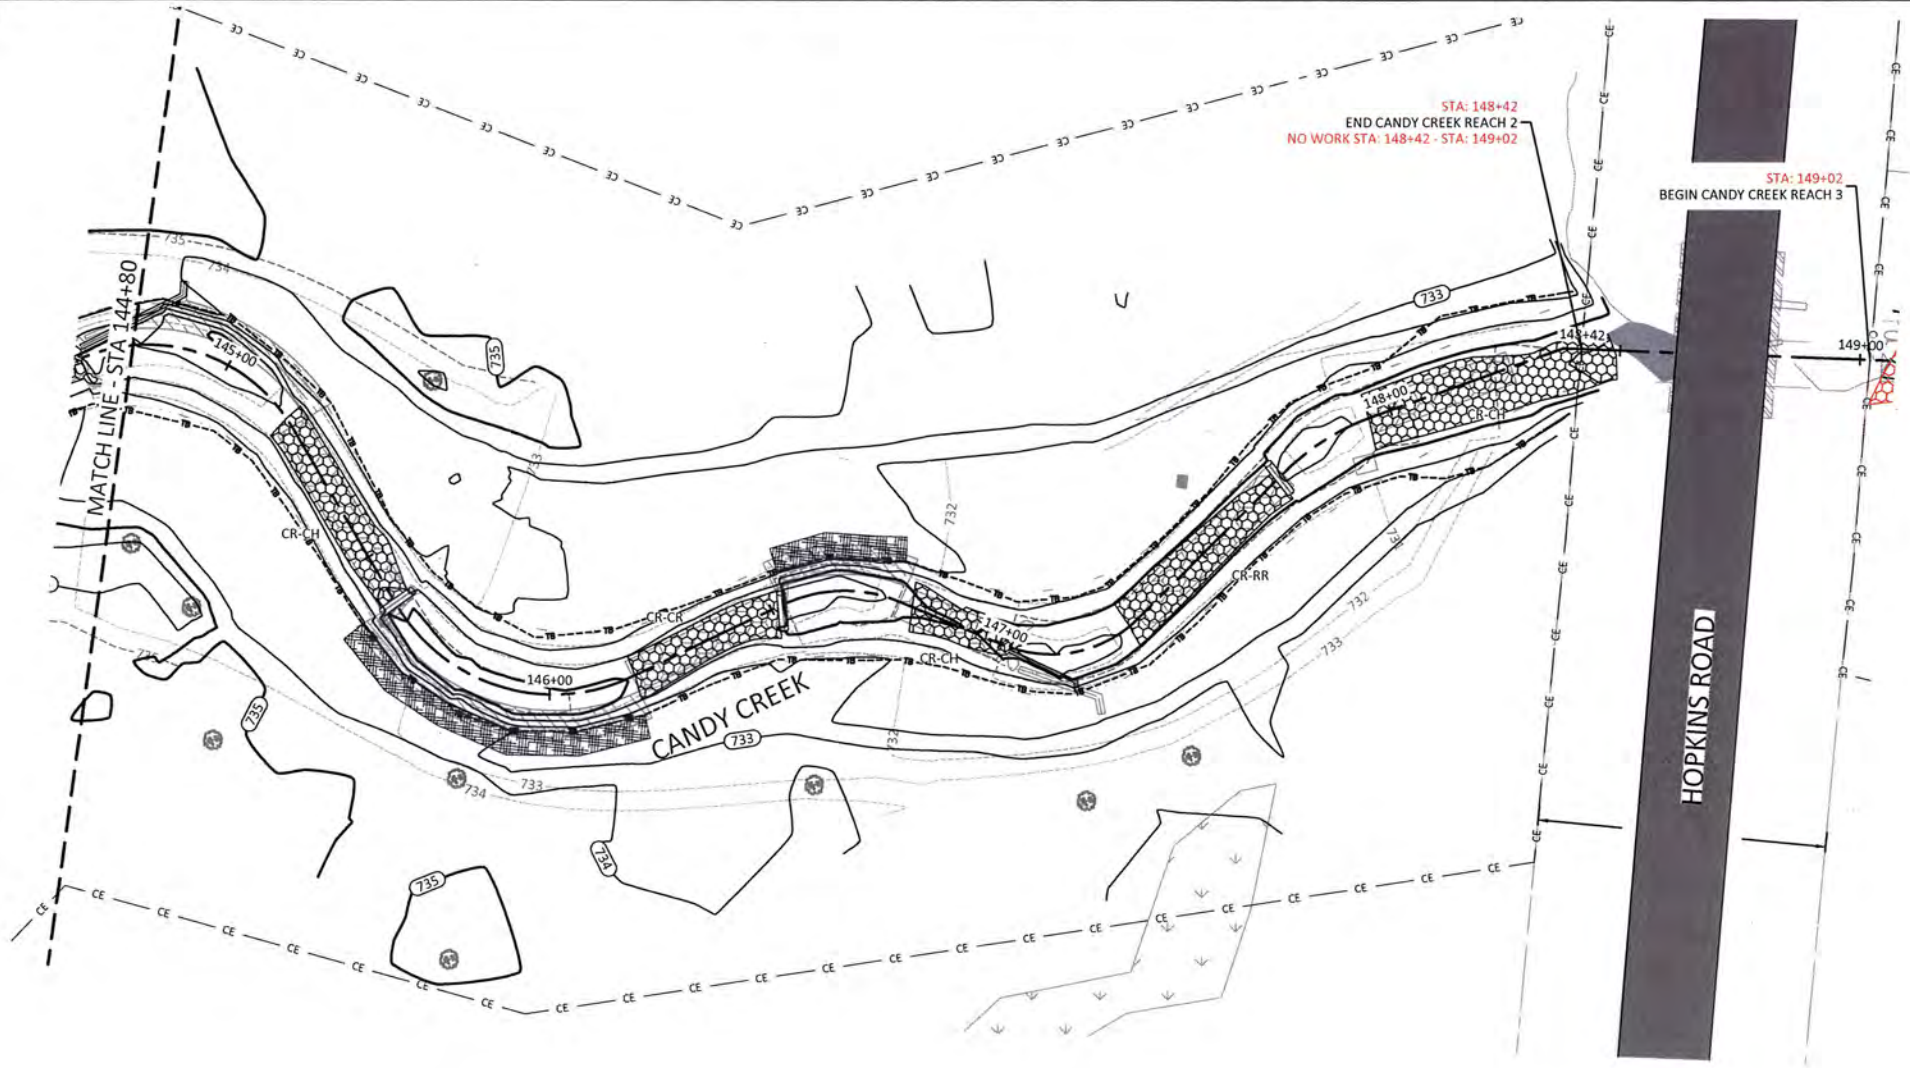
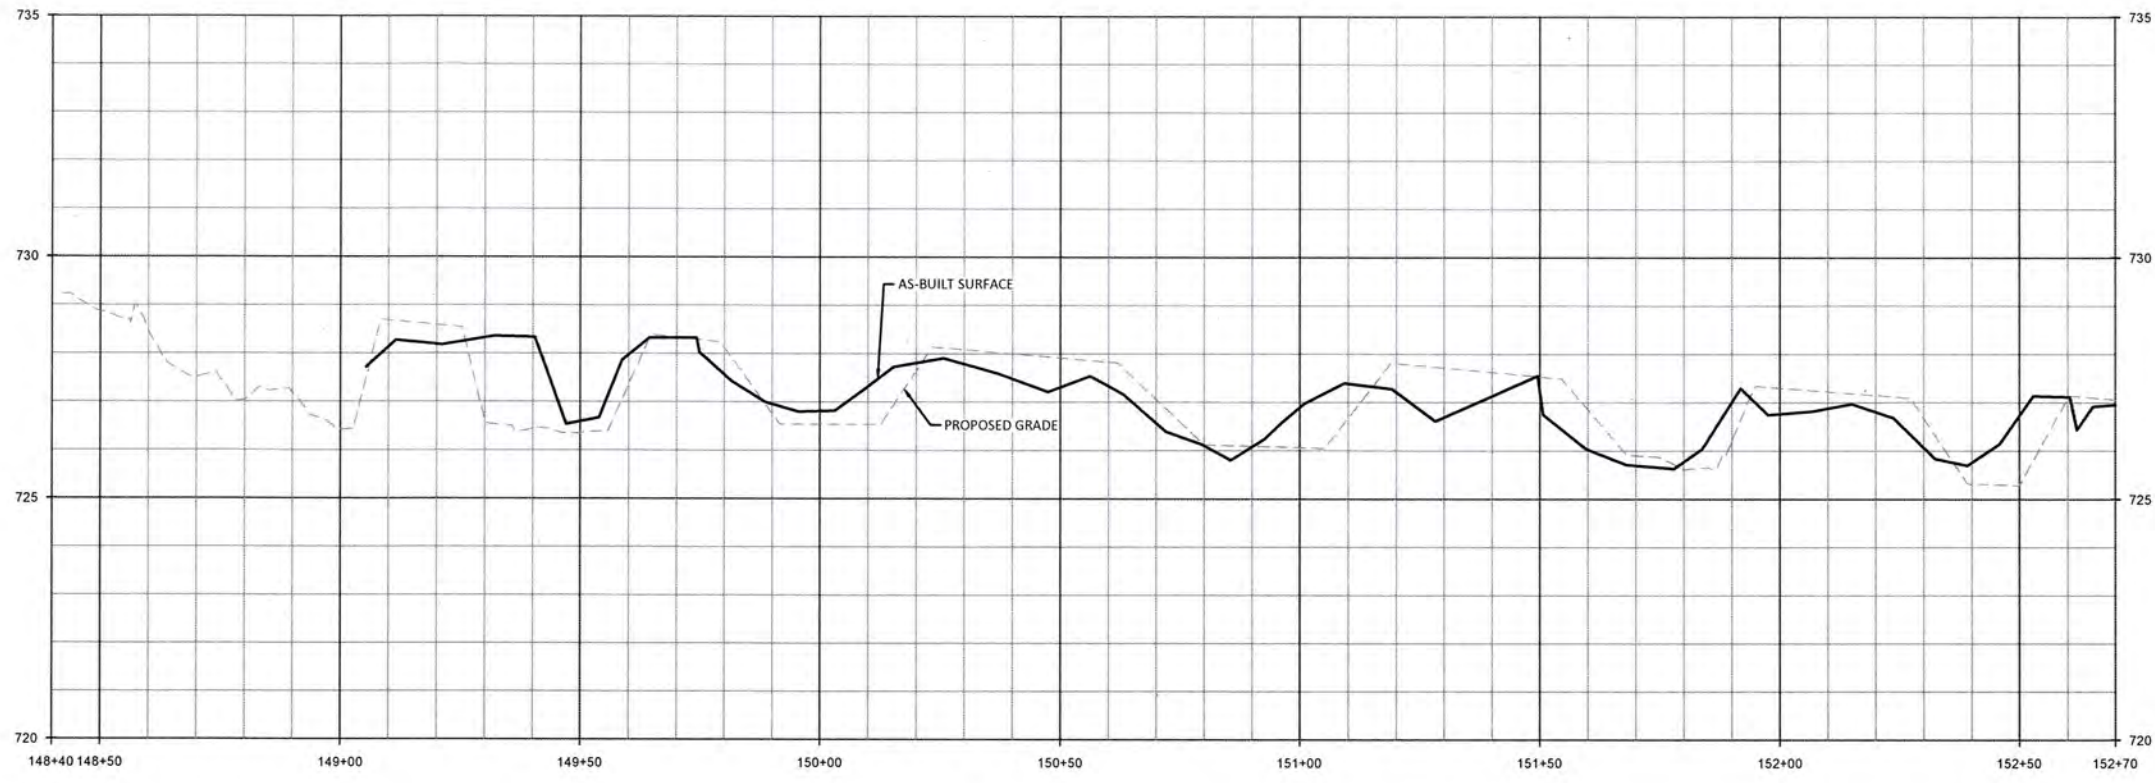
Candy Creek Mitigation Site-Record Drawings  
 Guilford County, North Carolina  
 Candy Creek Reach 2 & Reach 3  
 Stream Plan and Profile

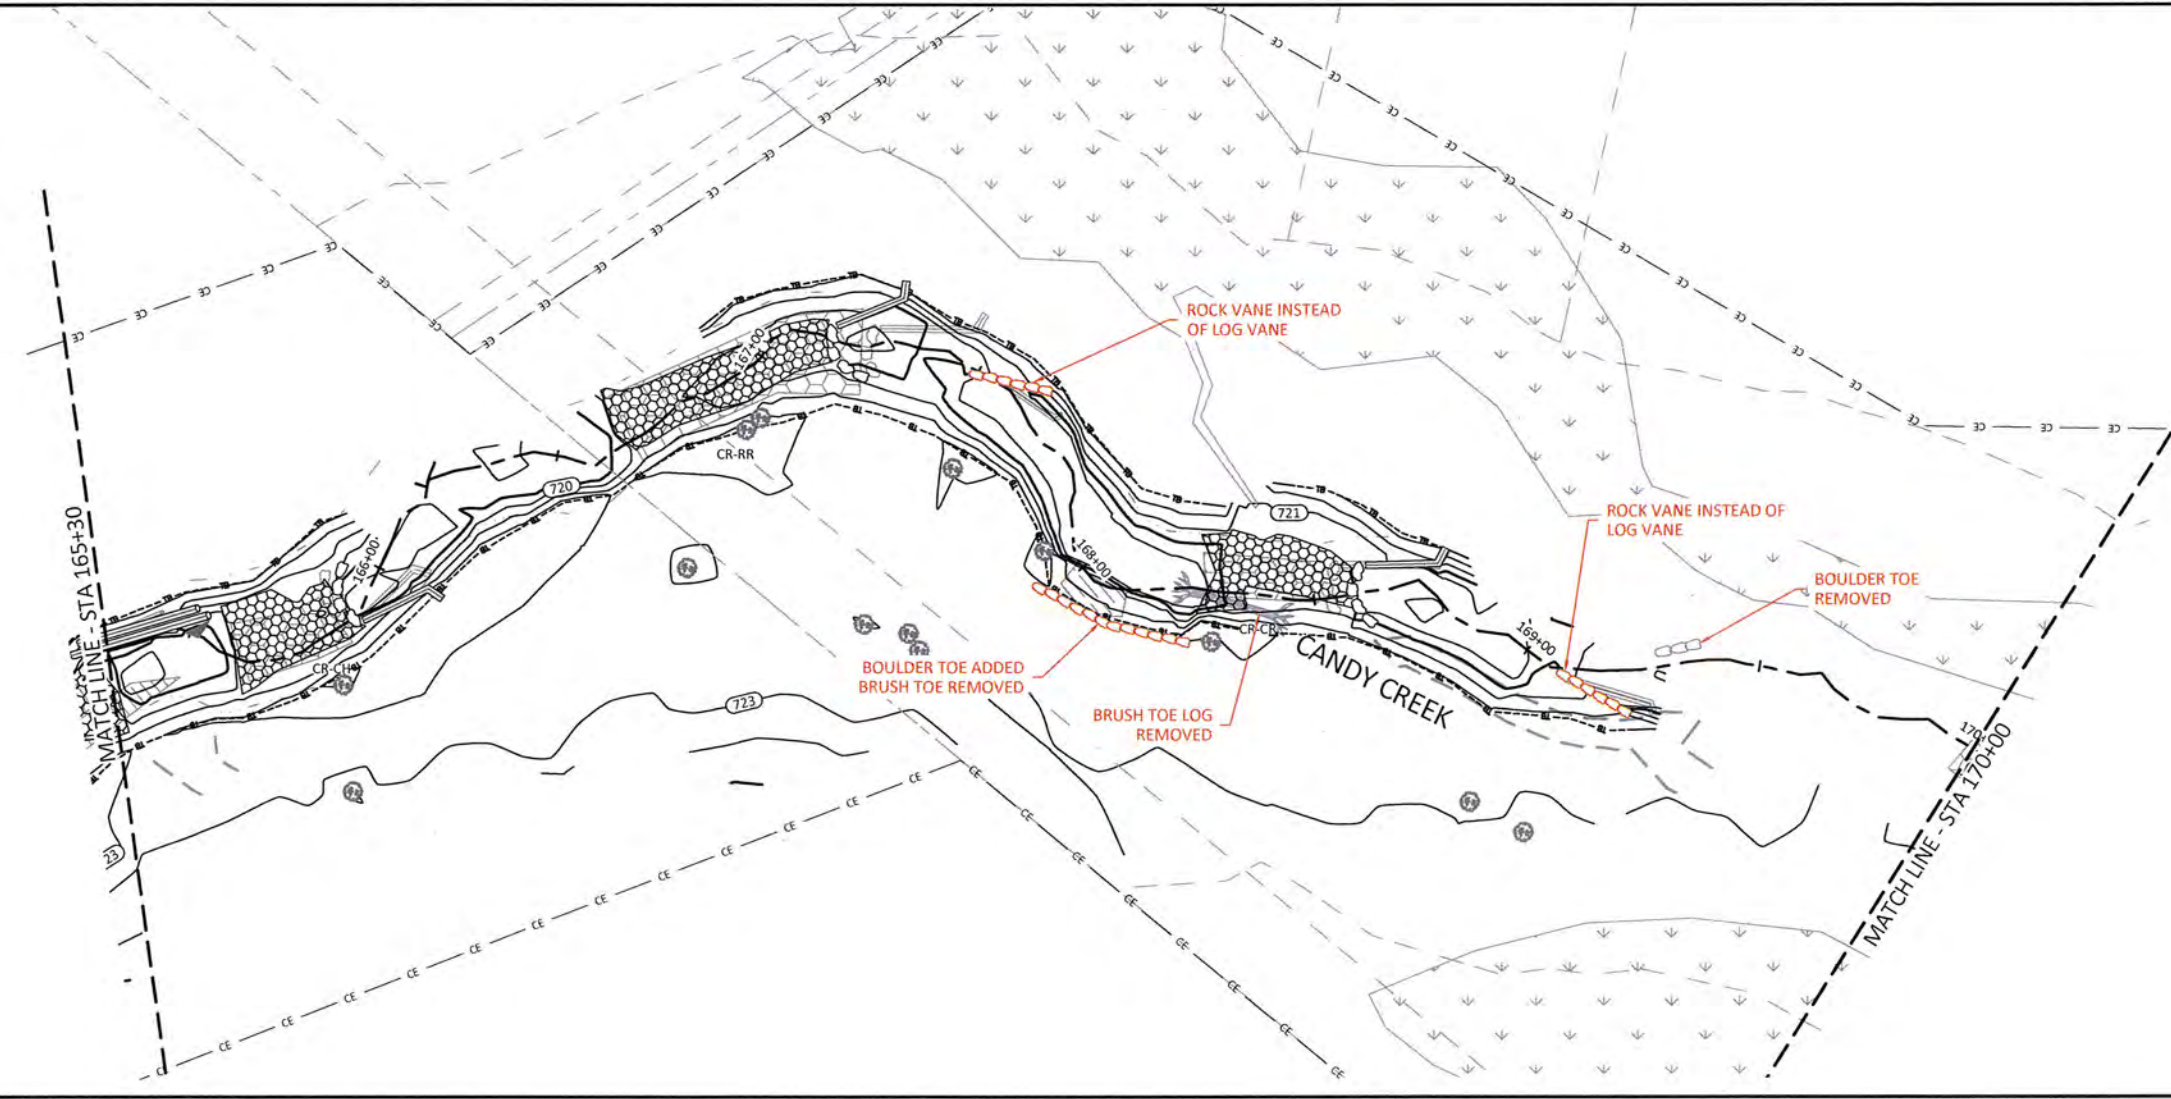
Candy Creek Mitigation Site-Record Drawings  
Guilford County, North Carolina

Candy Creek Reach 3  
Stream Plan and Profile

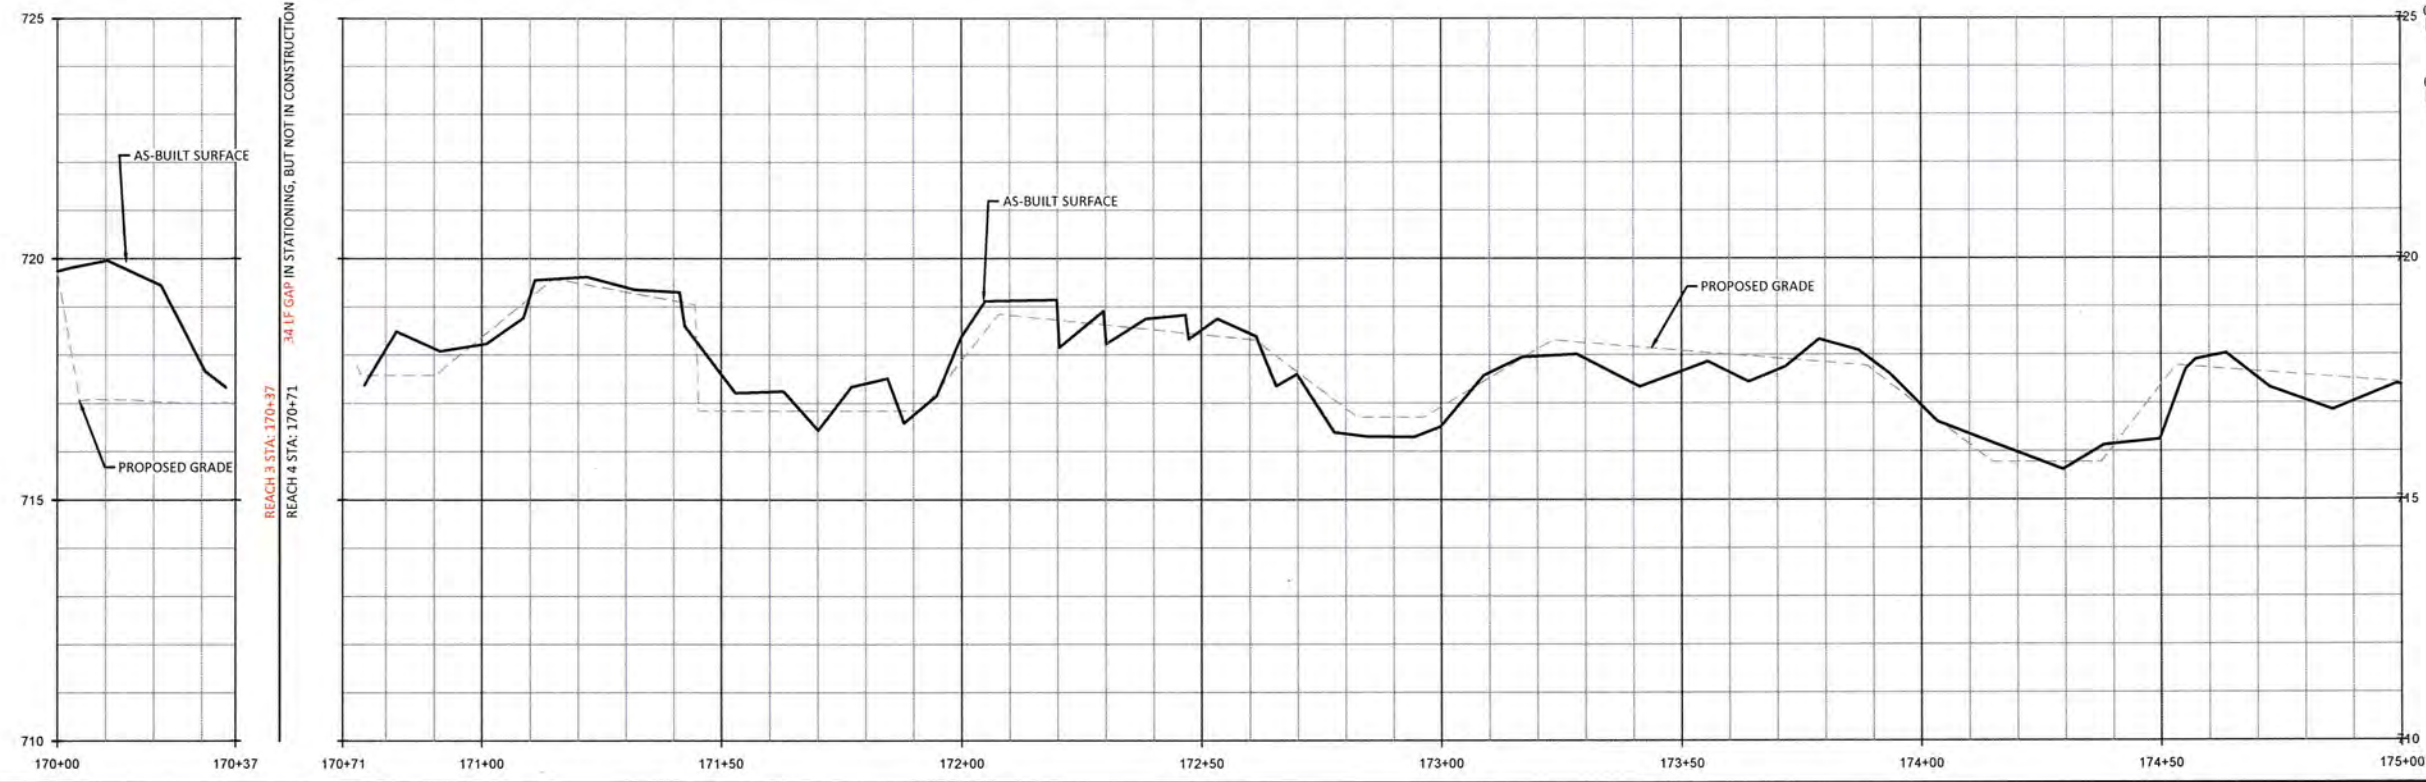
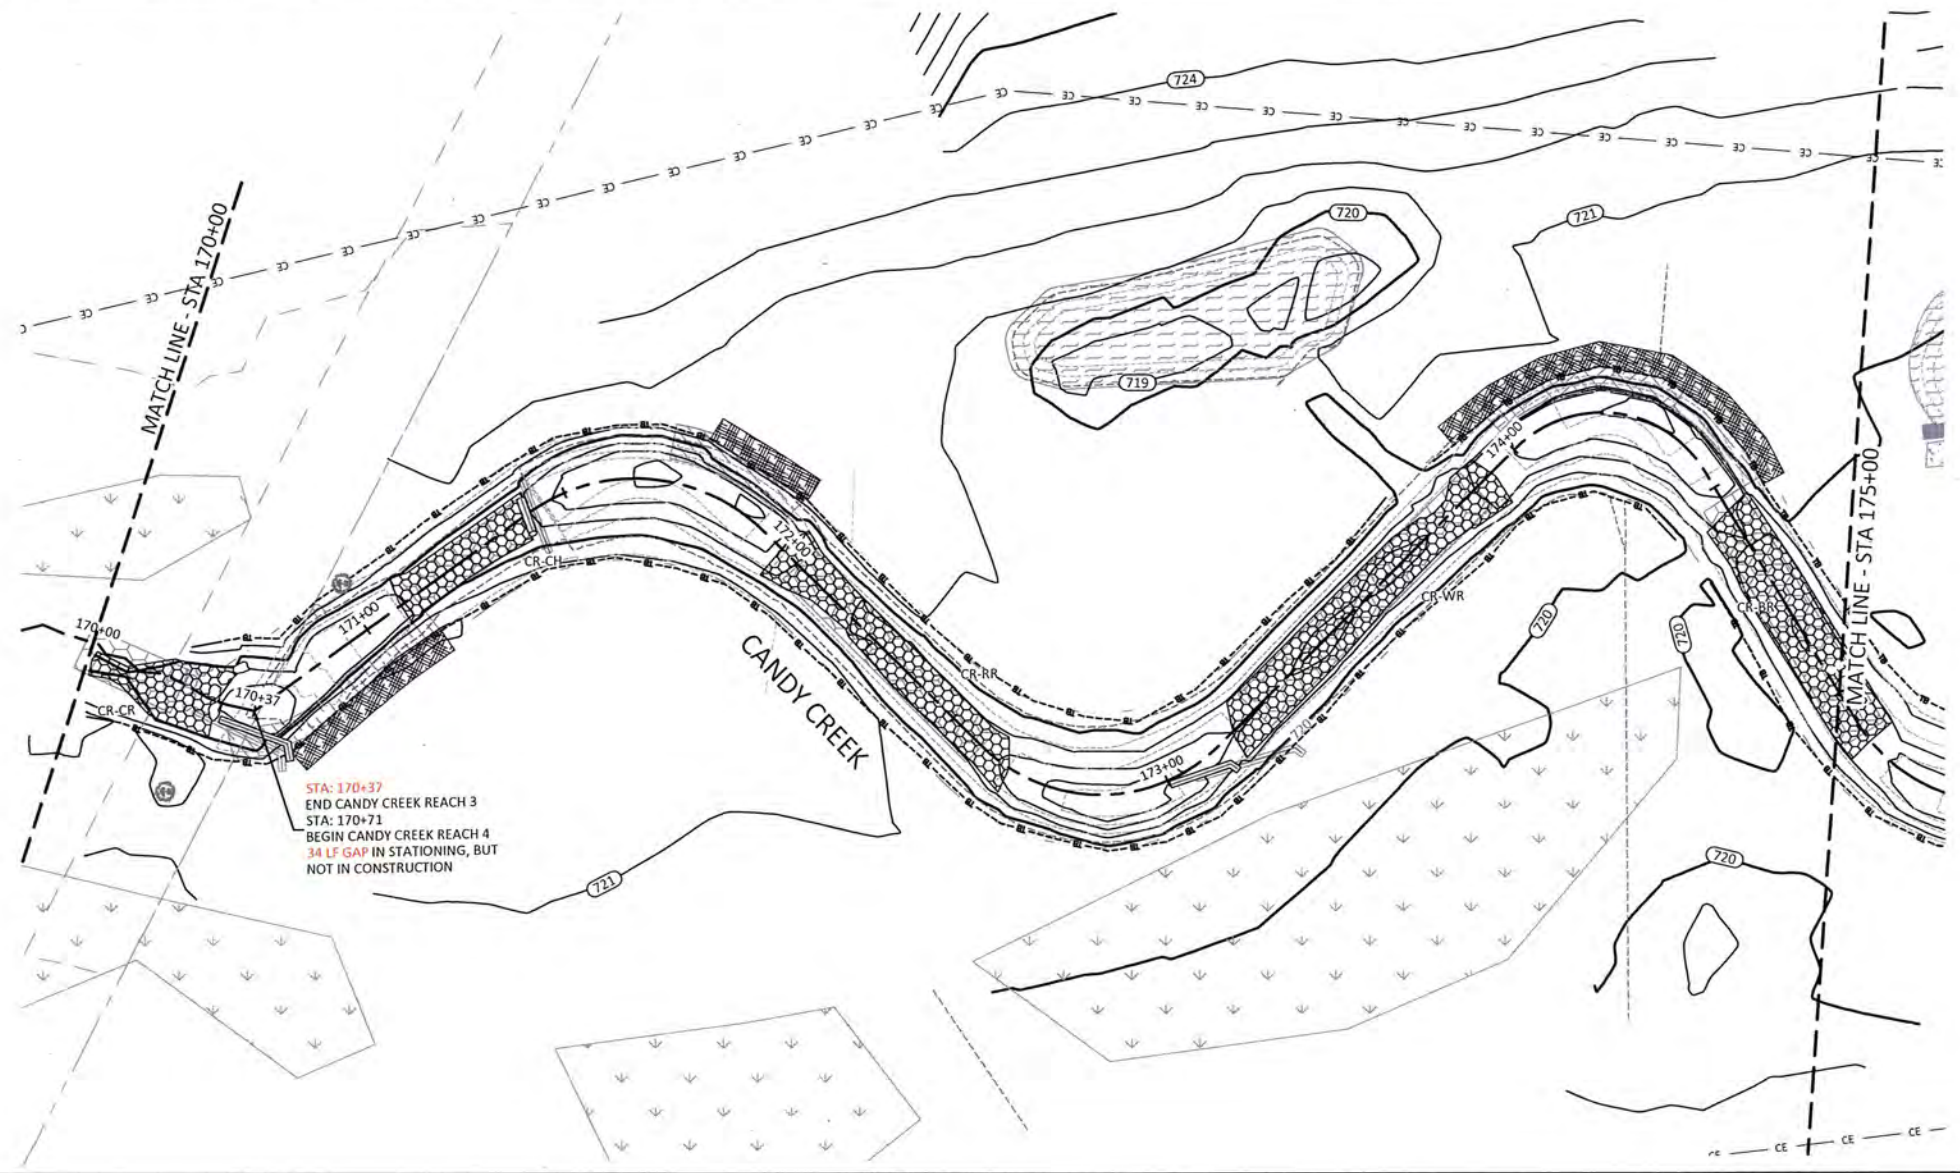
Date:	May 30, 2017
Job Number:	005-02145
Project Engineer:	ASE
Drawn By:	SID
Checked By:	IL
<b>2.1.16</b>	
Sheet

STA: 170+37  
END CANDY CREEK REACH 3  
STA: 170+71  
BEGIN CANDY CREEK REACH 4  
34 LF GAP IN STATIONING, BUT  
NOT IN CONSTRUCTION

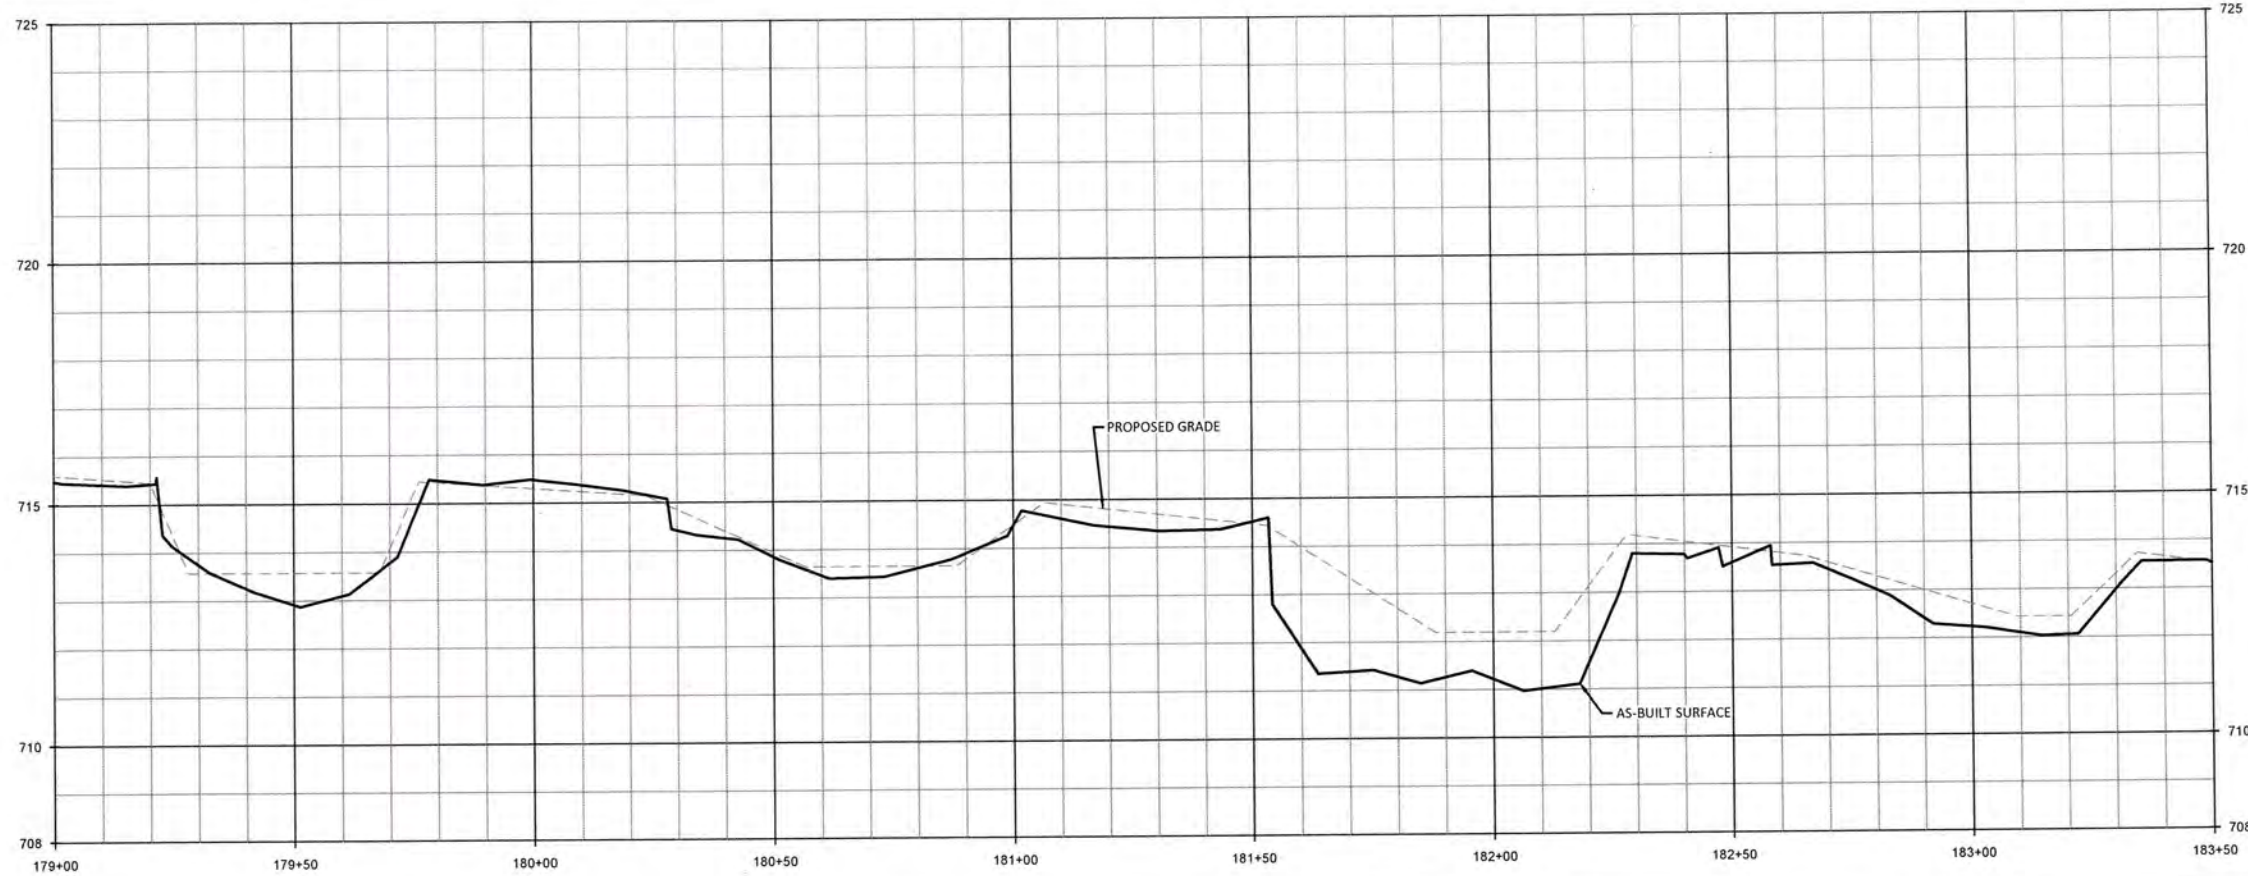
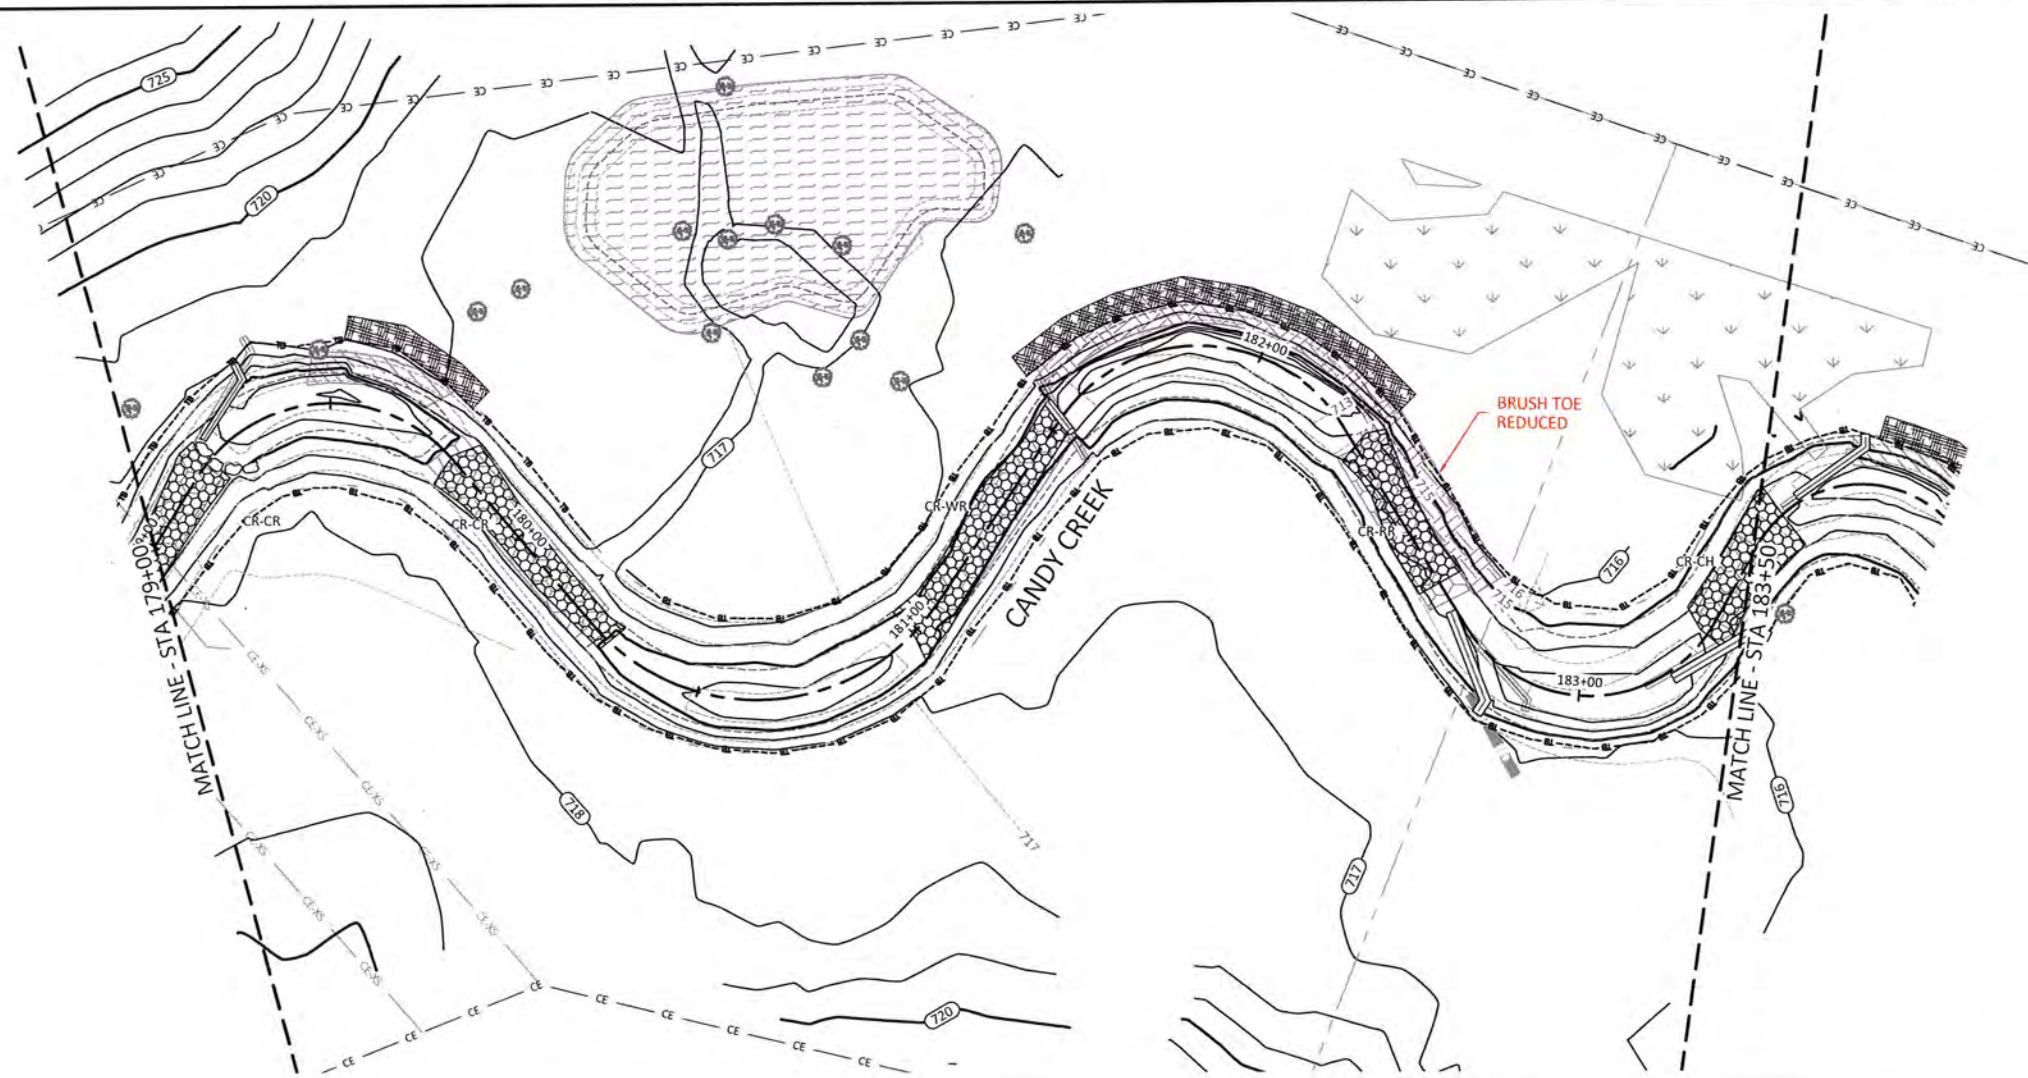
Date: May 30, 2017  
Job Number: 005-02145  
Project Engineer: ASE  
Drawn By: SID  
Checked By: JL  
**2.1.17**  
Sheet

Candy Creek Reach 4  
 Stream Plan and Profile
