# **BASELINE MONITORING DOCUMENT AND AS-BUILT BASELINE REPORT**

## **CANDY CREEK MITIGATION SITE**

Guilford County, NC  
NCDEQ Contract 5794  
DMS ID No. 96315

Data Collection Period: October 2016 – March 2017  
Final Submission Date: June 2, 2017

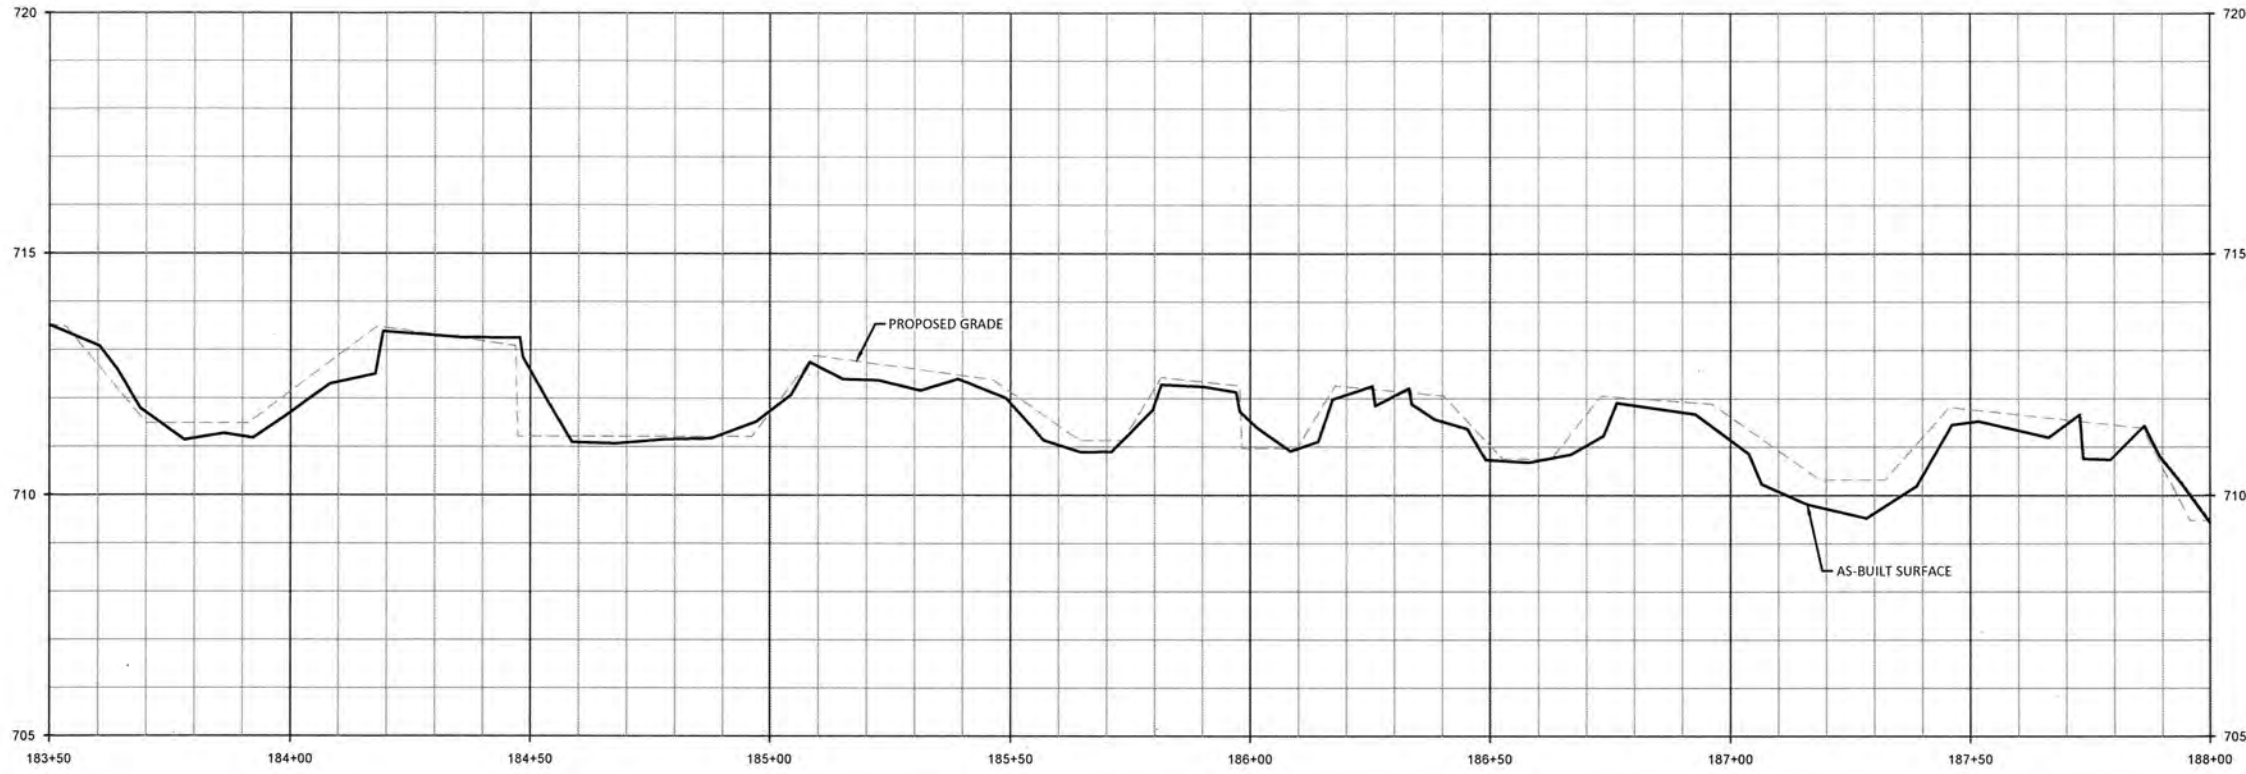
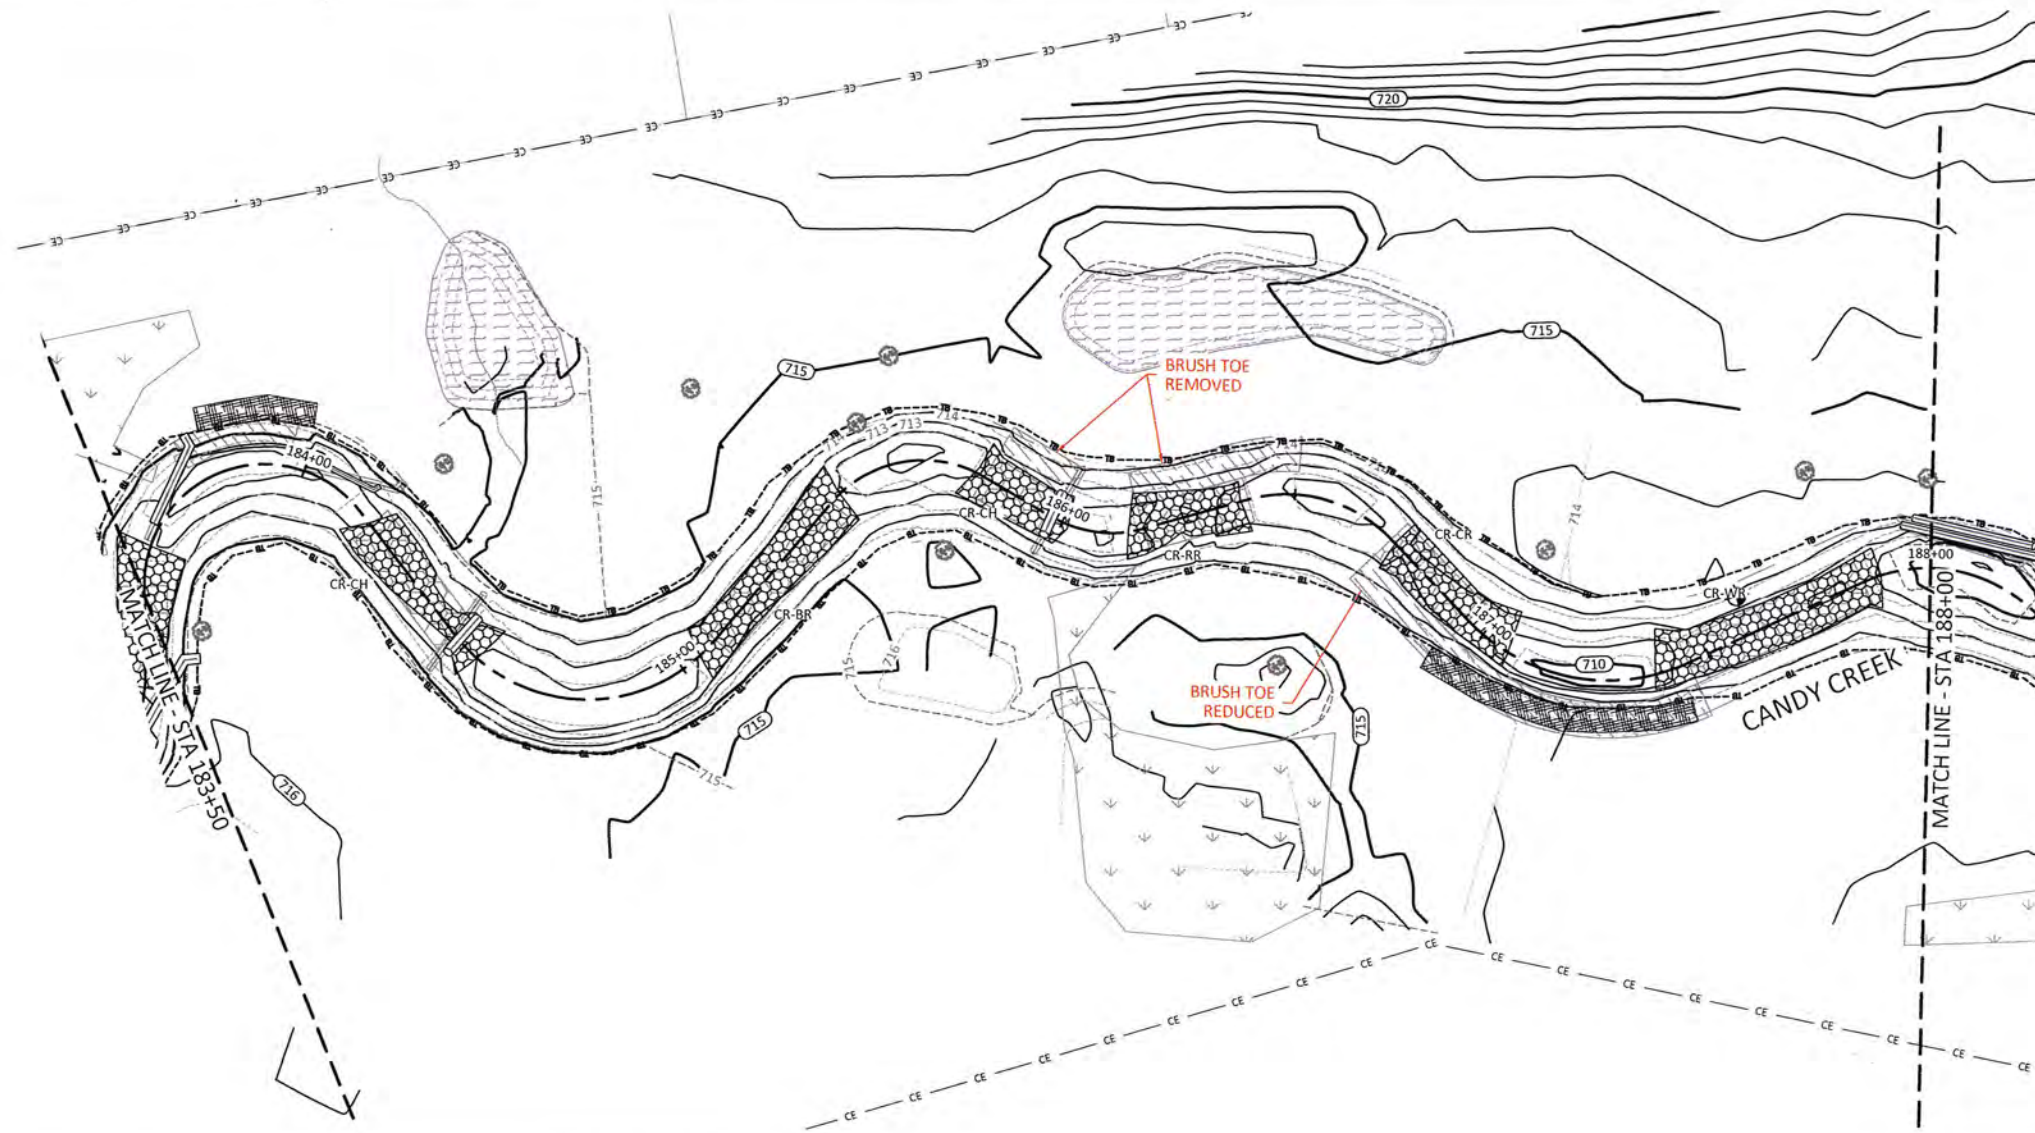
Candy Creek Mitigation Site-Record Drawings  
 Guilford County, North Carolina  
 Candy Creek Reach 4  
 Stream Plan and Profile

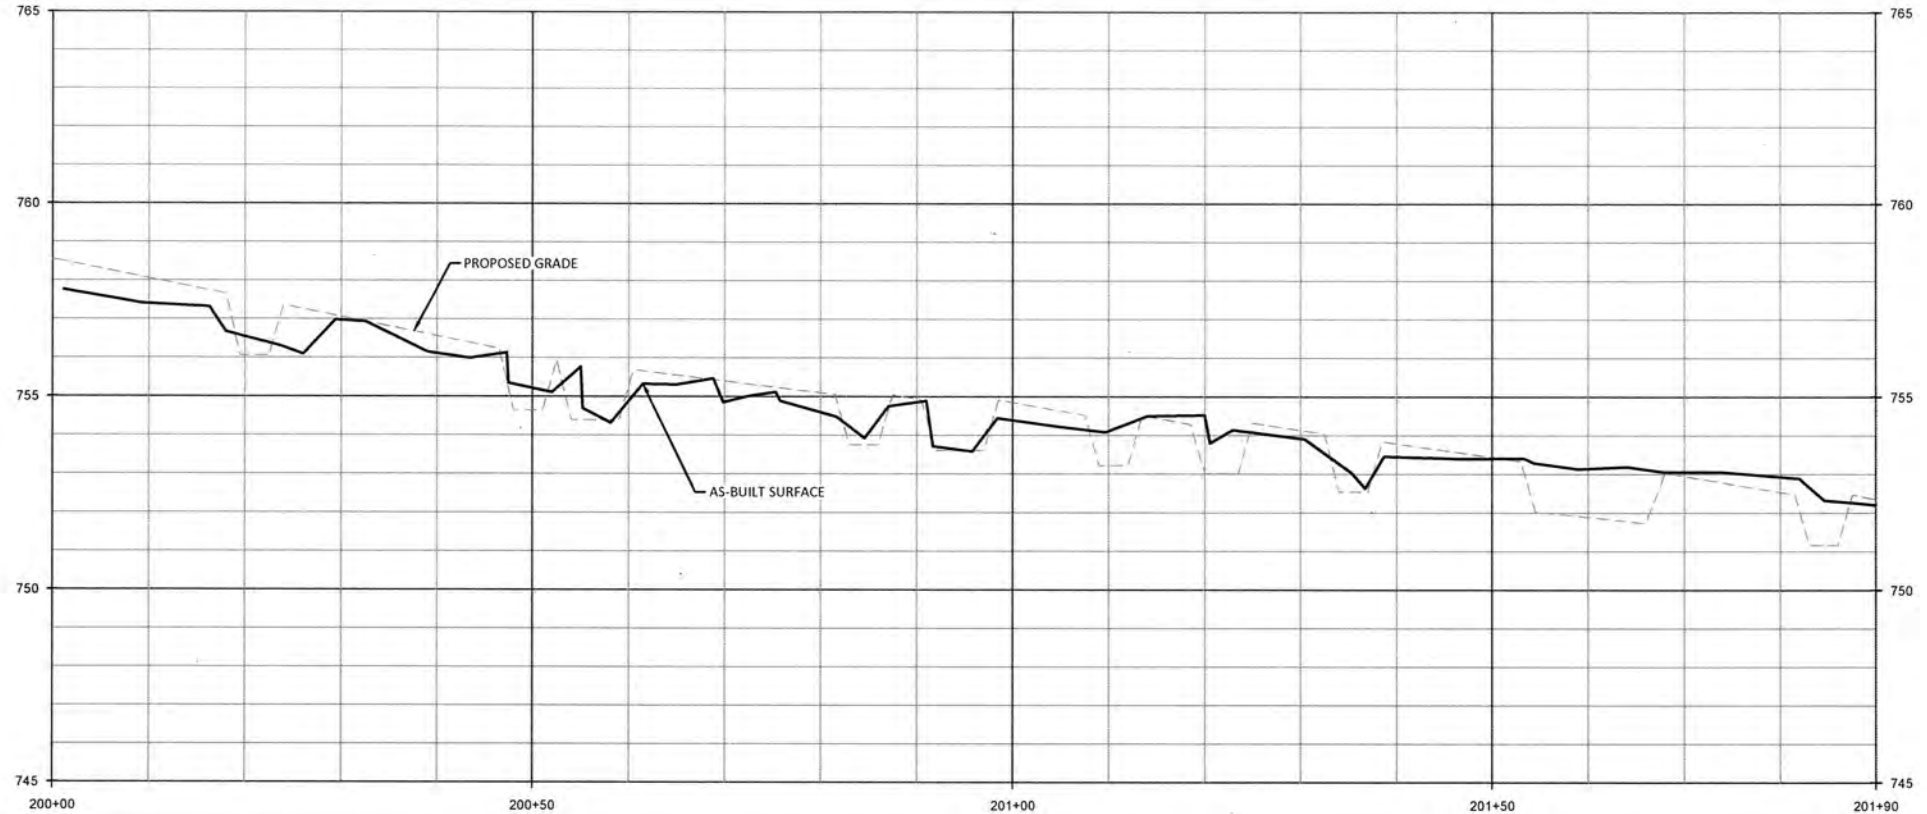
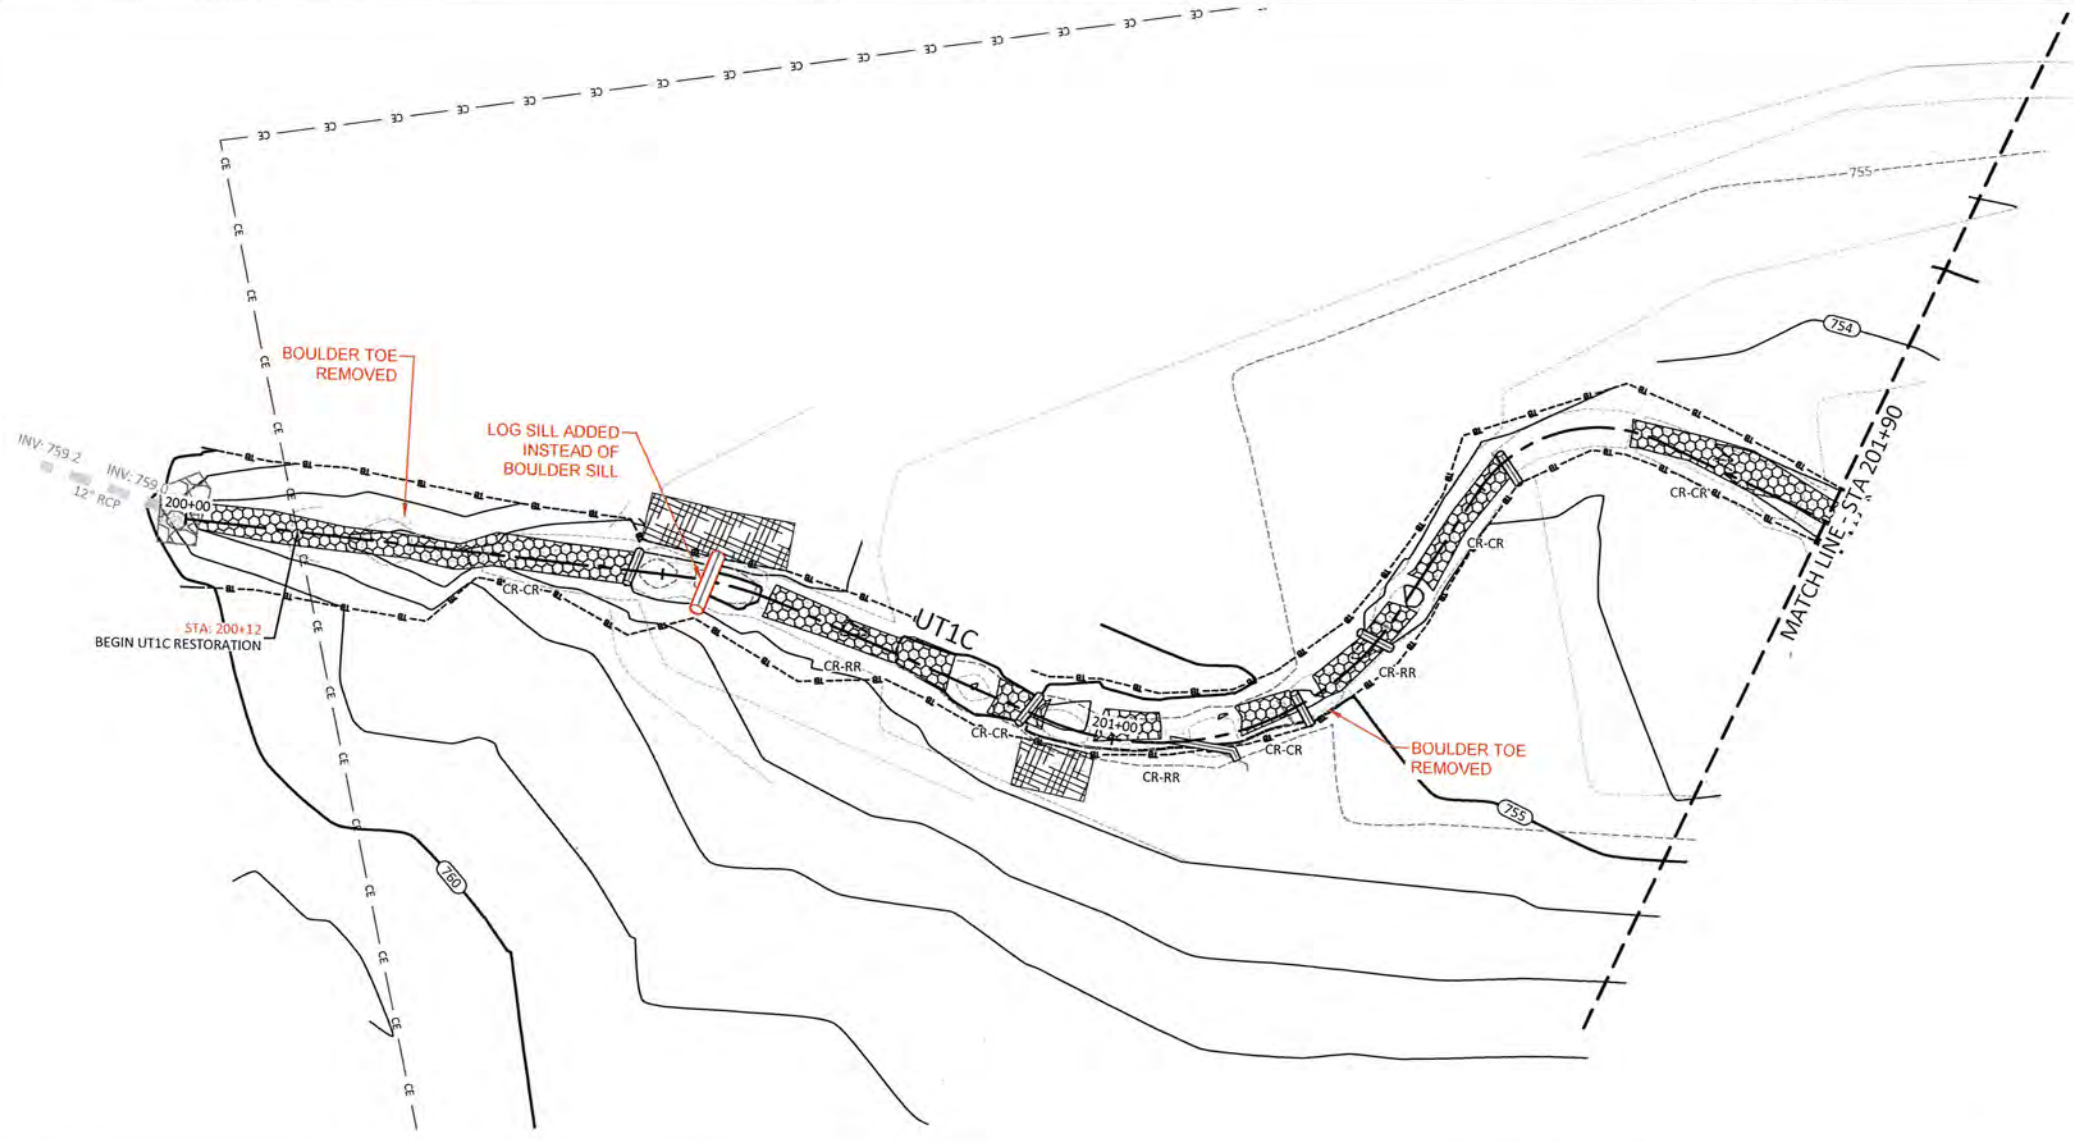
UT1C  
 Stream Plan and Profile

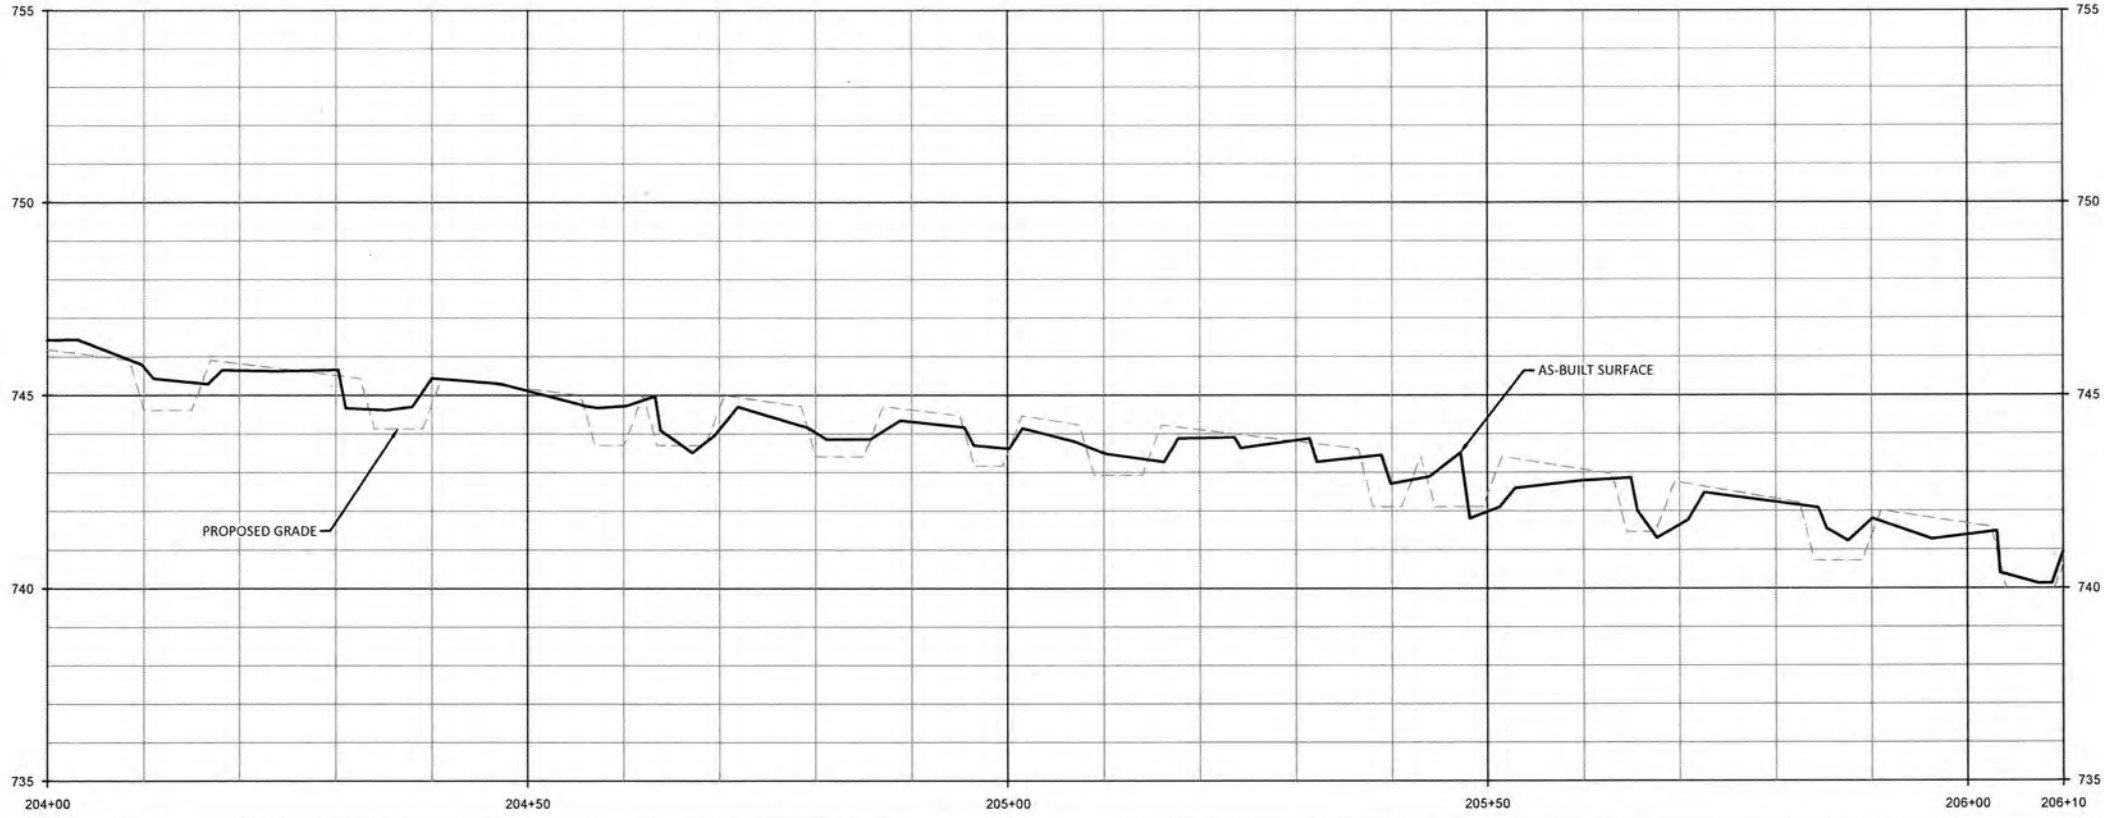
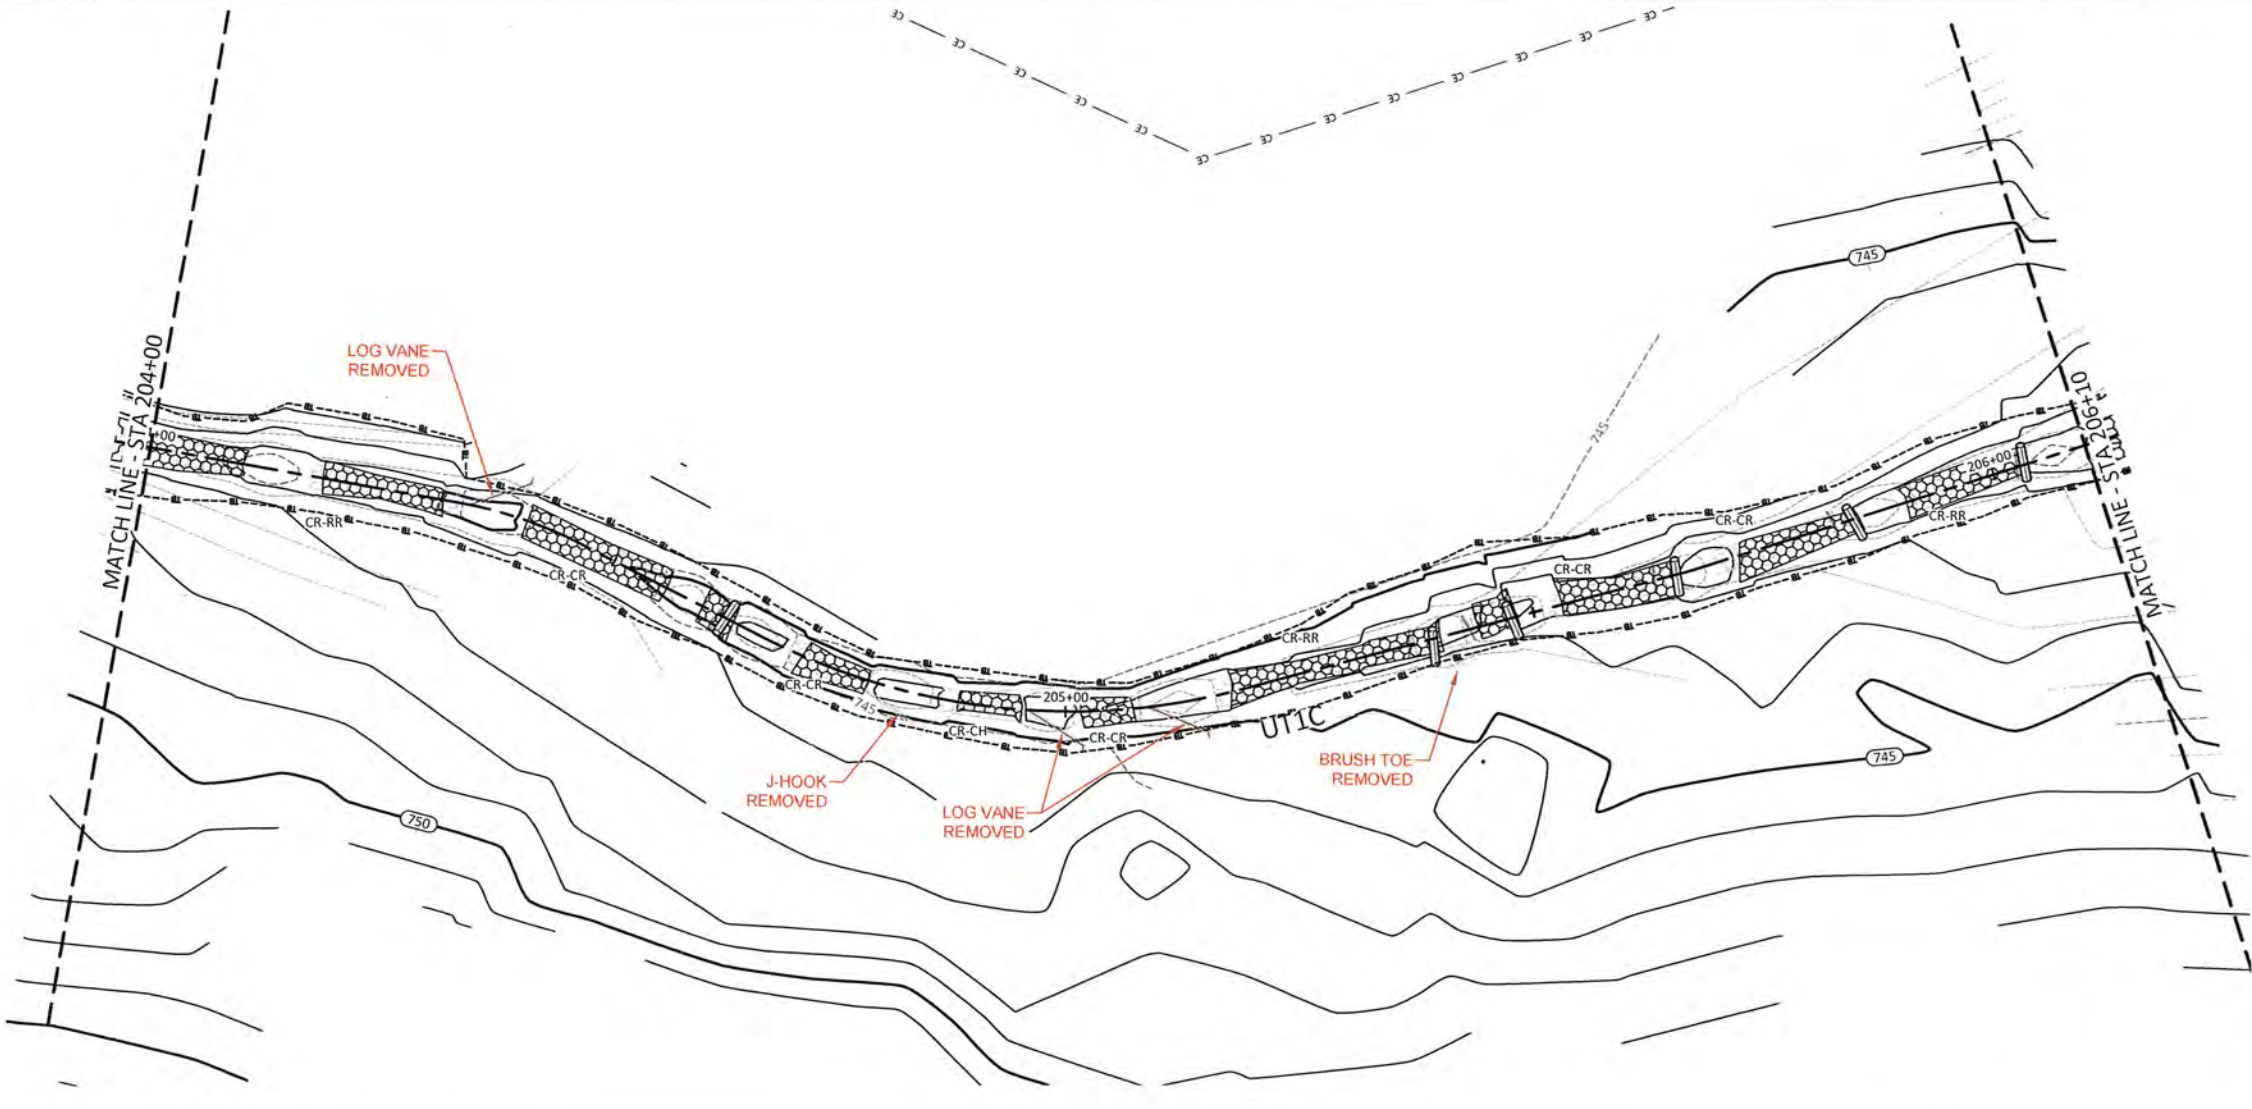
UT1C  
Stream Plan and Profile

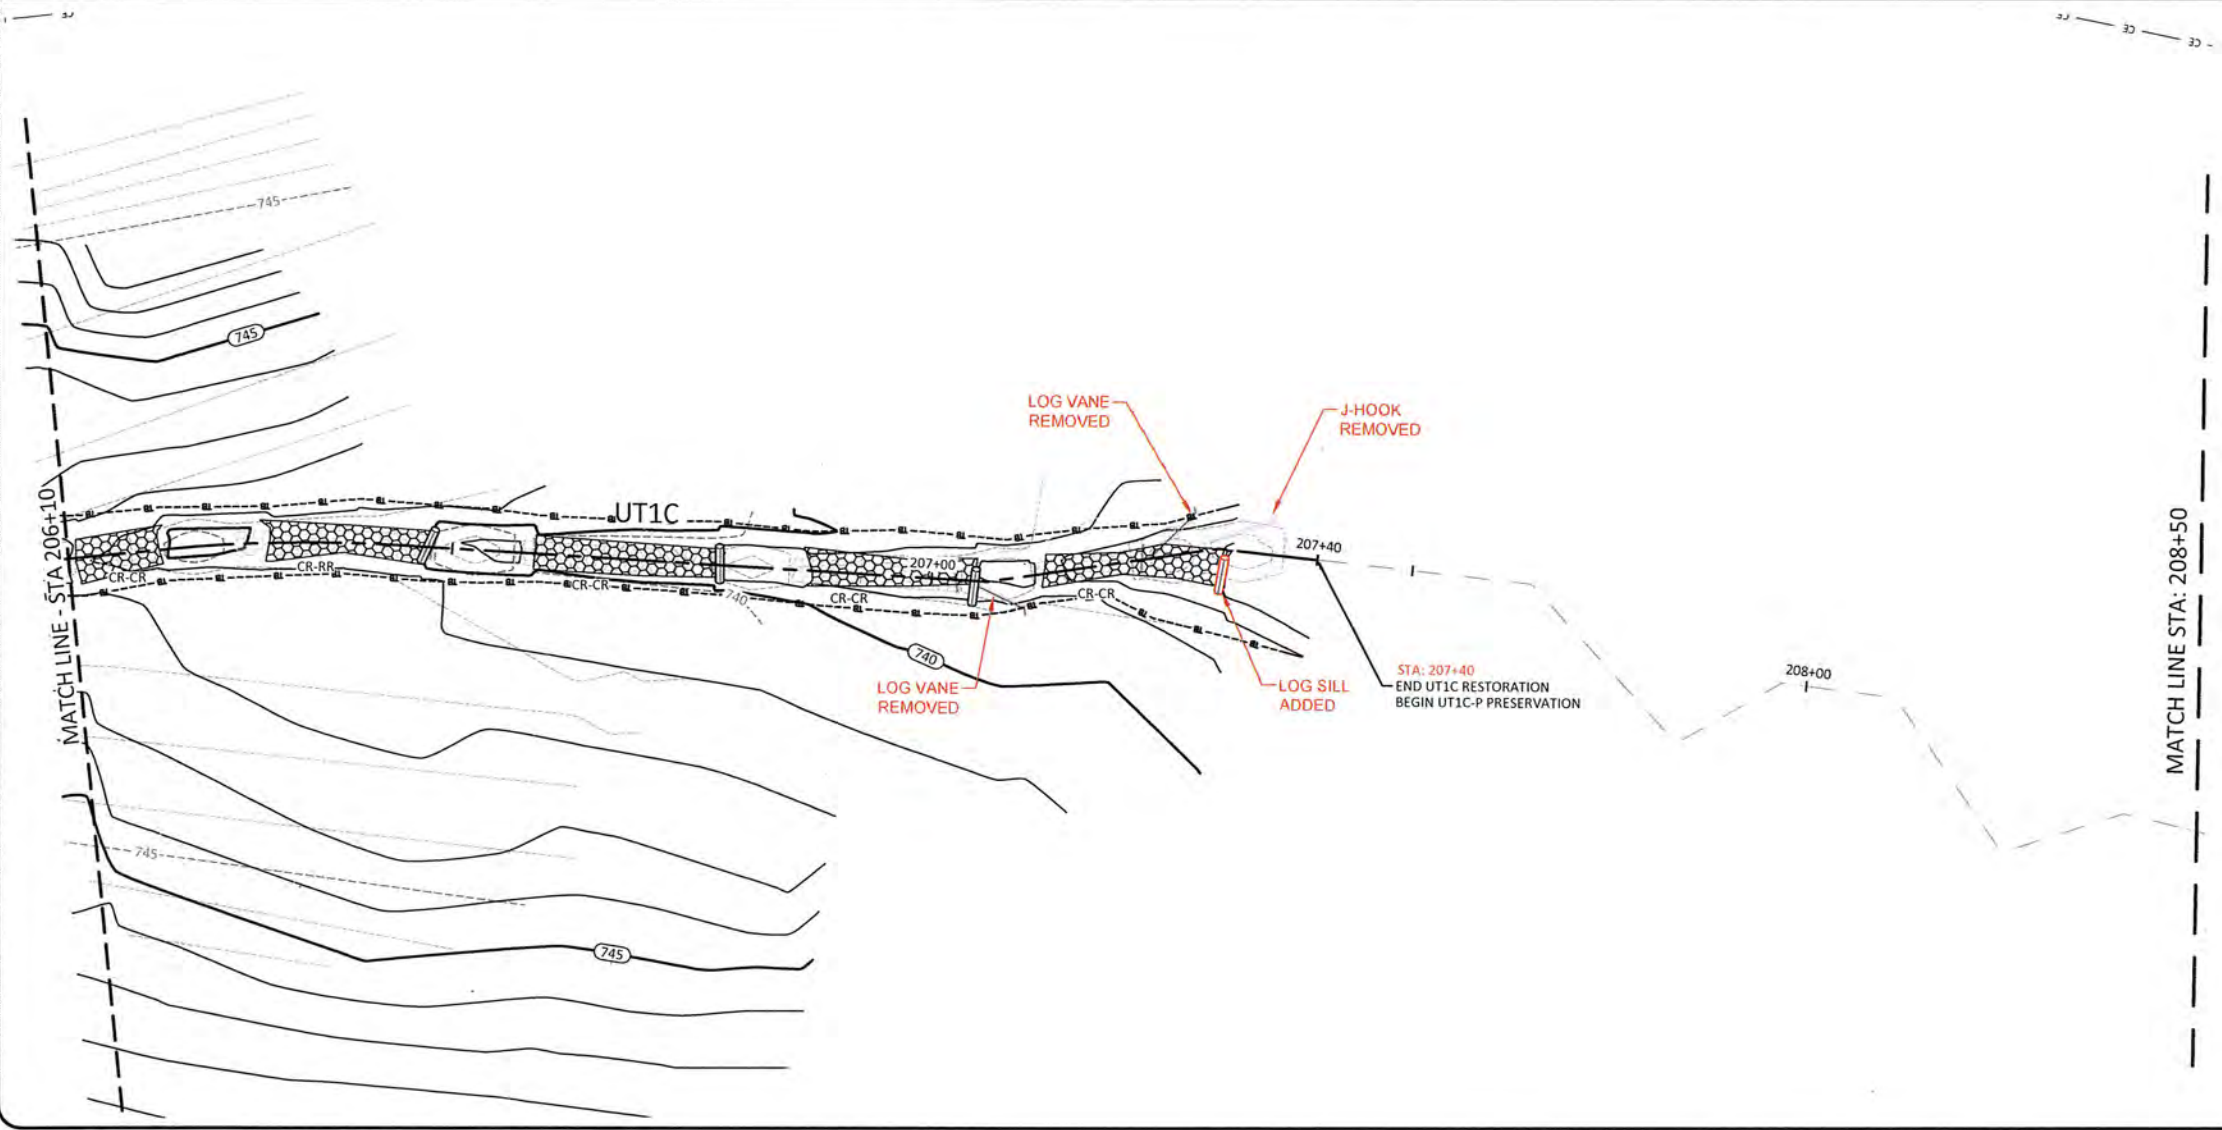
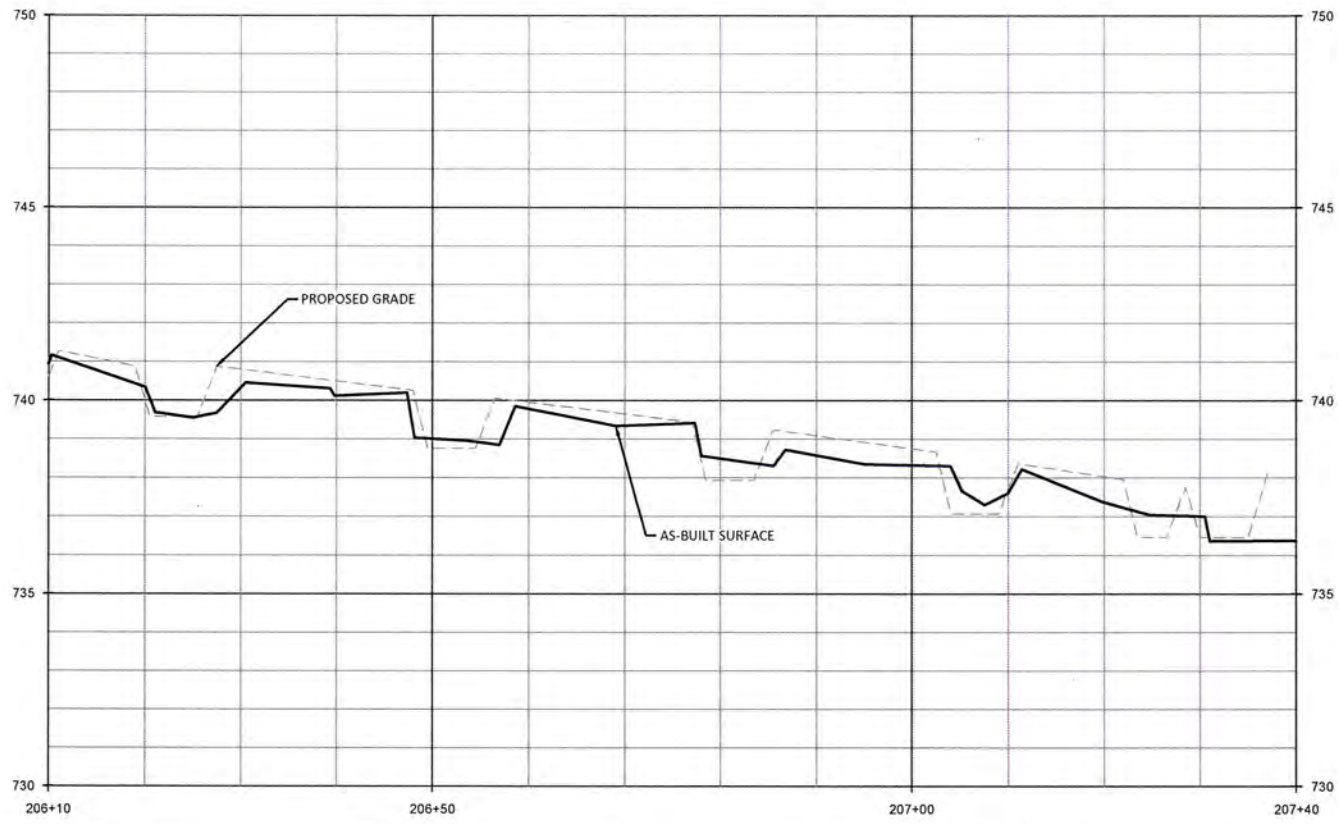
UT1C  
Stream Plan and Profile

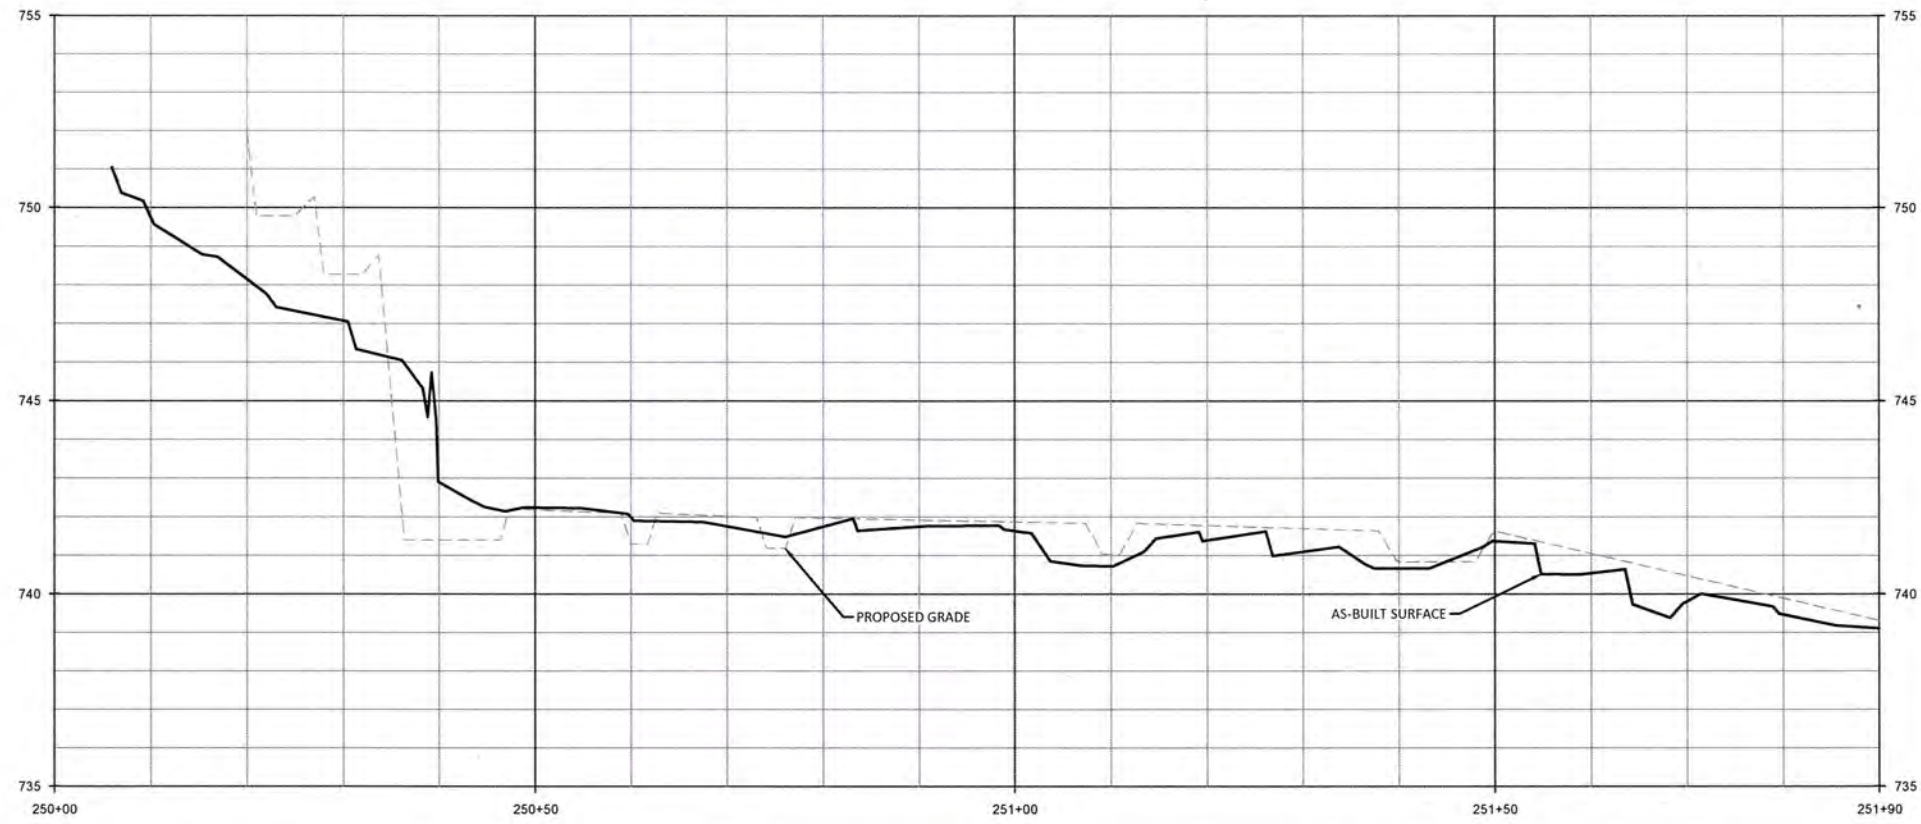
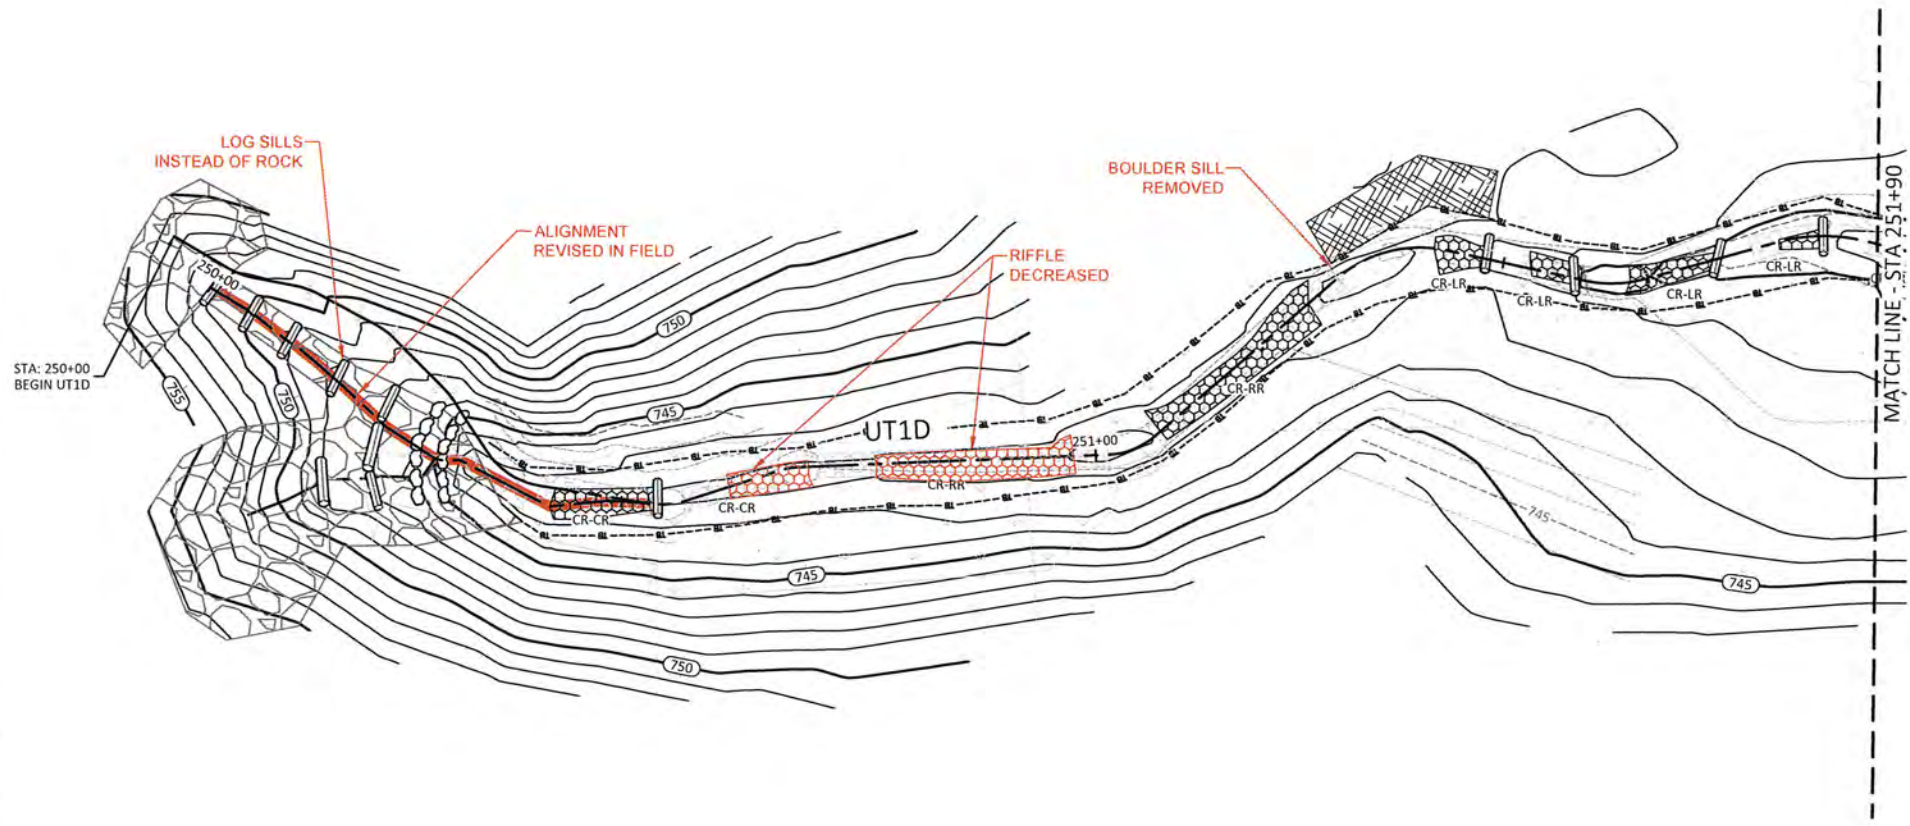
\*NOTE: STEP POOL SECTIONS WILL VARY IN SIZE. COORDINATE WITH ENGINEER IN FIELD.

UT1D  
Stream Plan and Profile

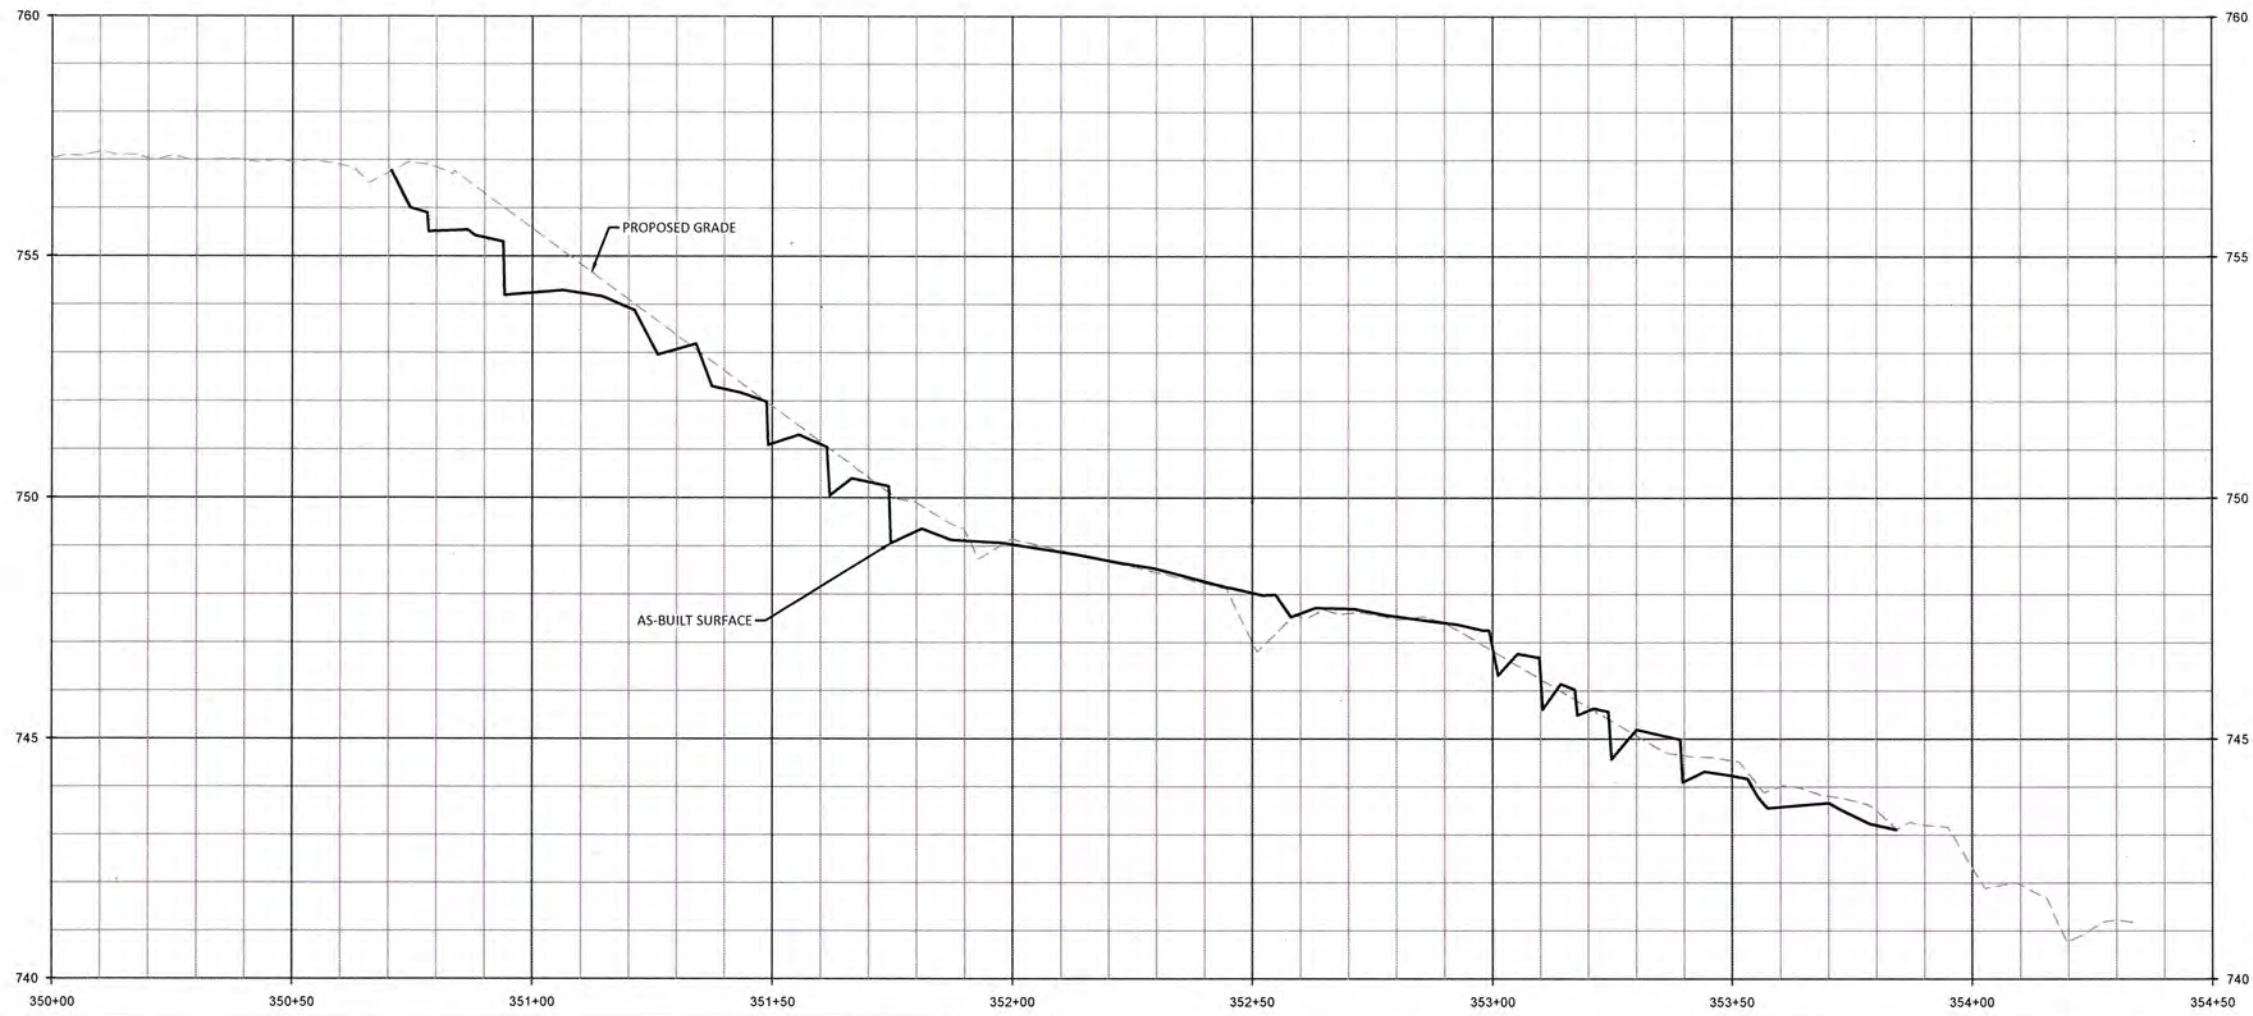
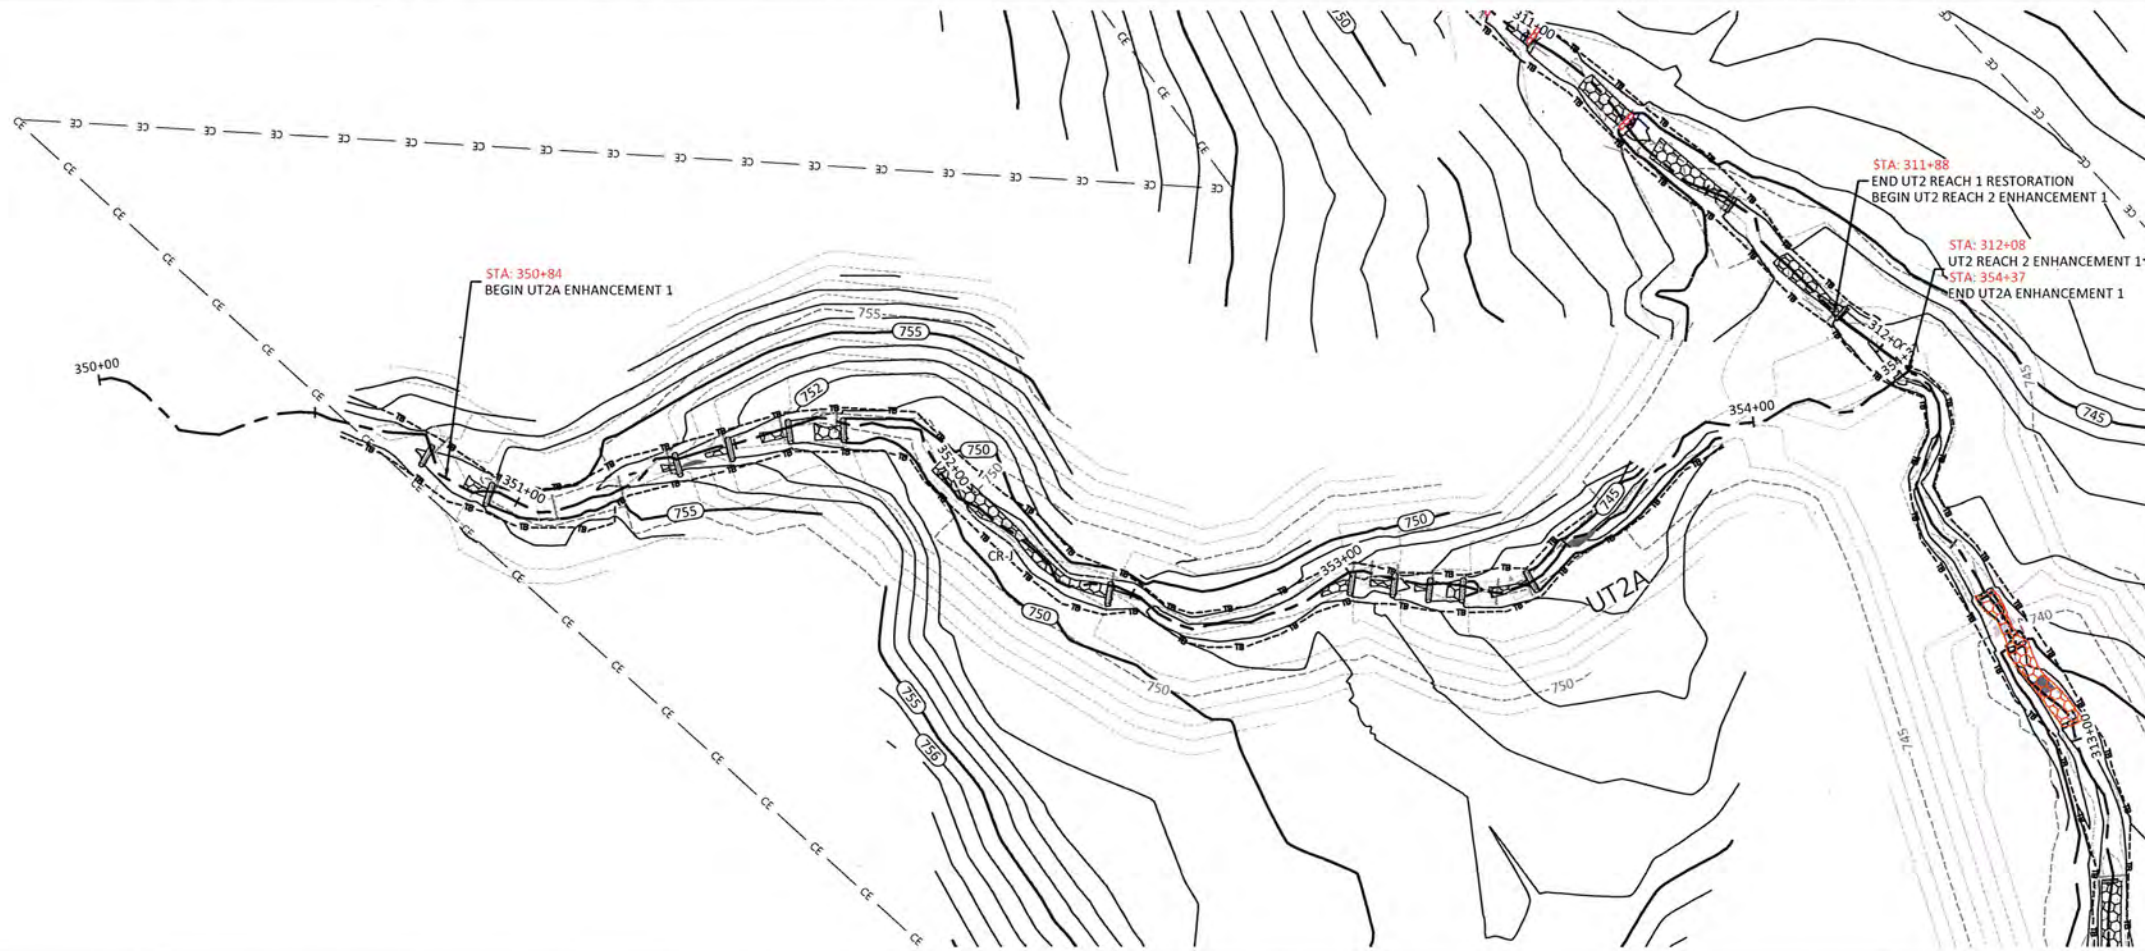
UT2A  
 Stream Plan and Profile
