# **BASELINE MONITORING DOCUMENT AND AS-BUILT BASELINE REPORT**

## **CANDY CREEK MITIGATION SITE**

Guilford County, NC  
NCDEQ Contract 5794  
DMS ID No. 96315

Data Collection Period: October 2016 – March 2017  
Final Submission Date: June 2, 2017

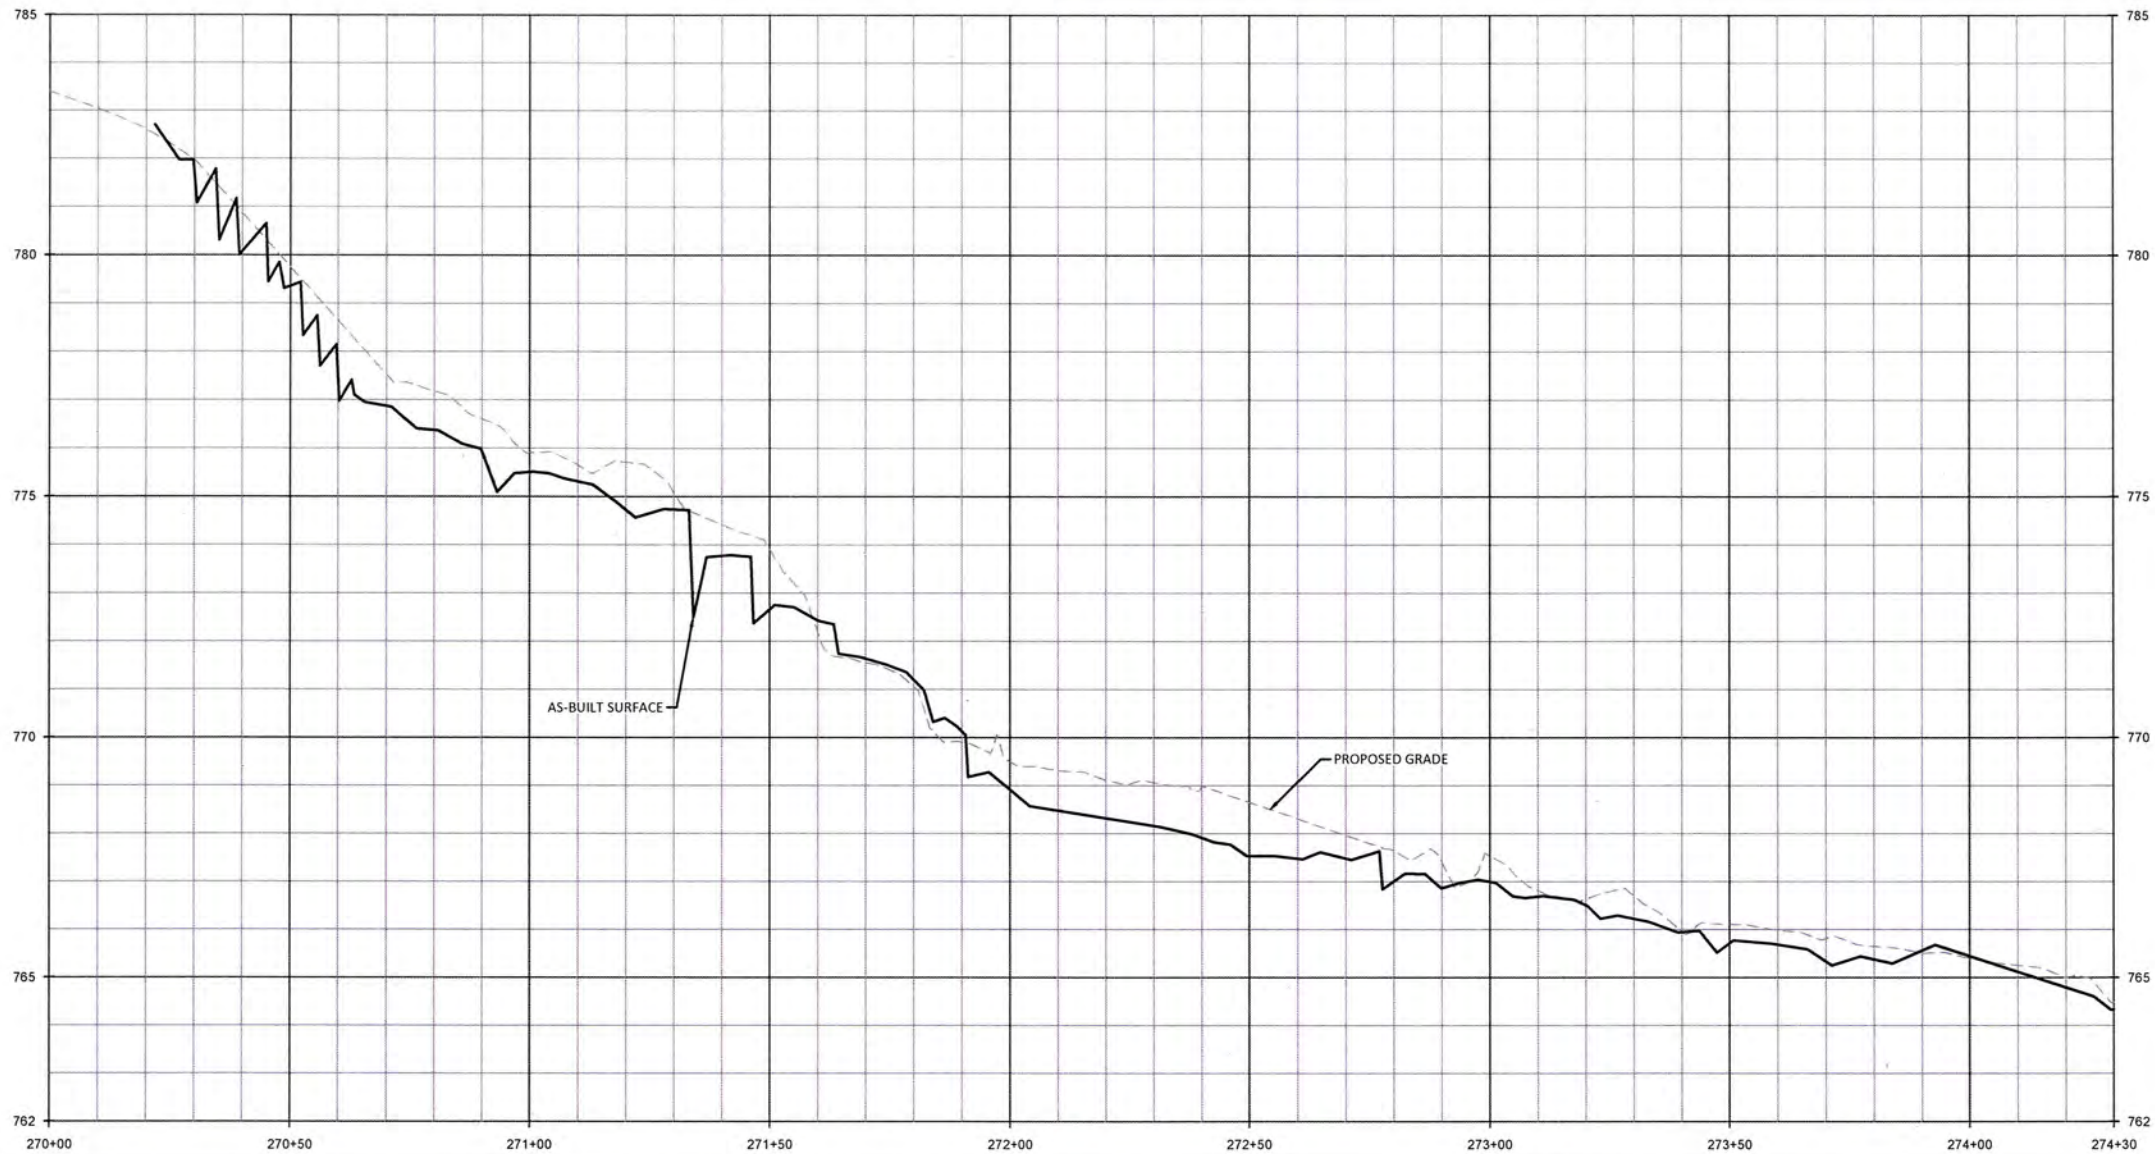
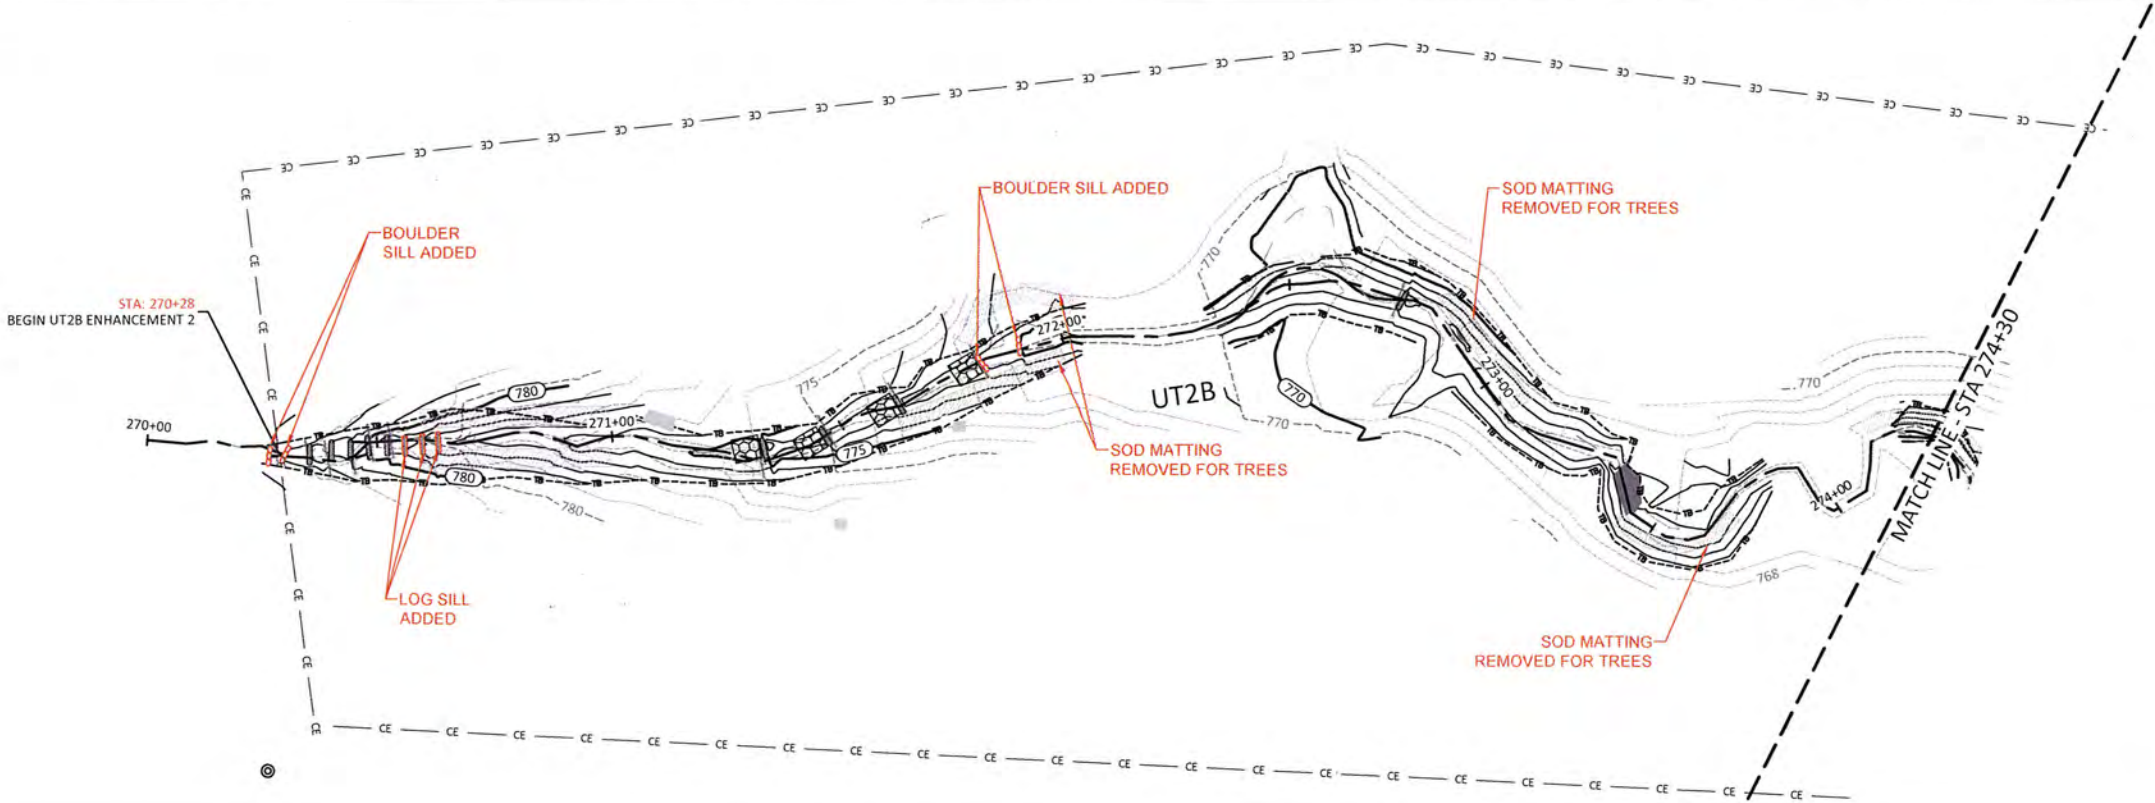
UT2B  
 Stream Plan and Profile

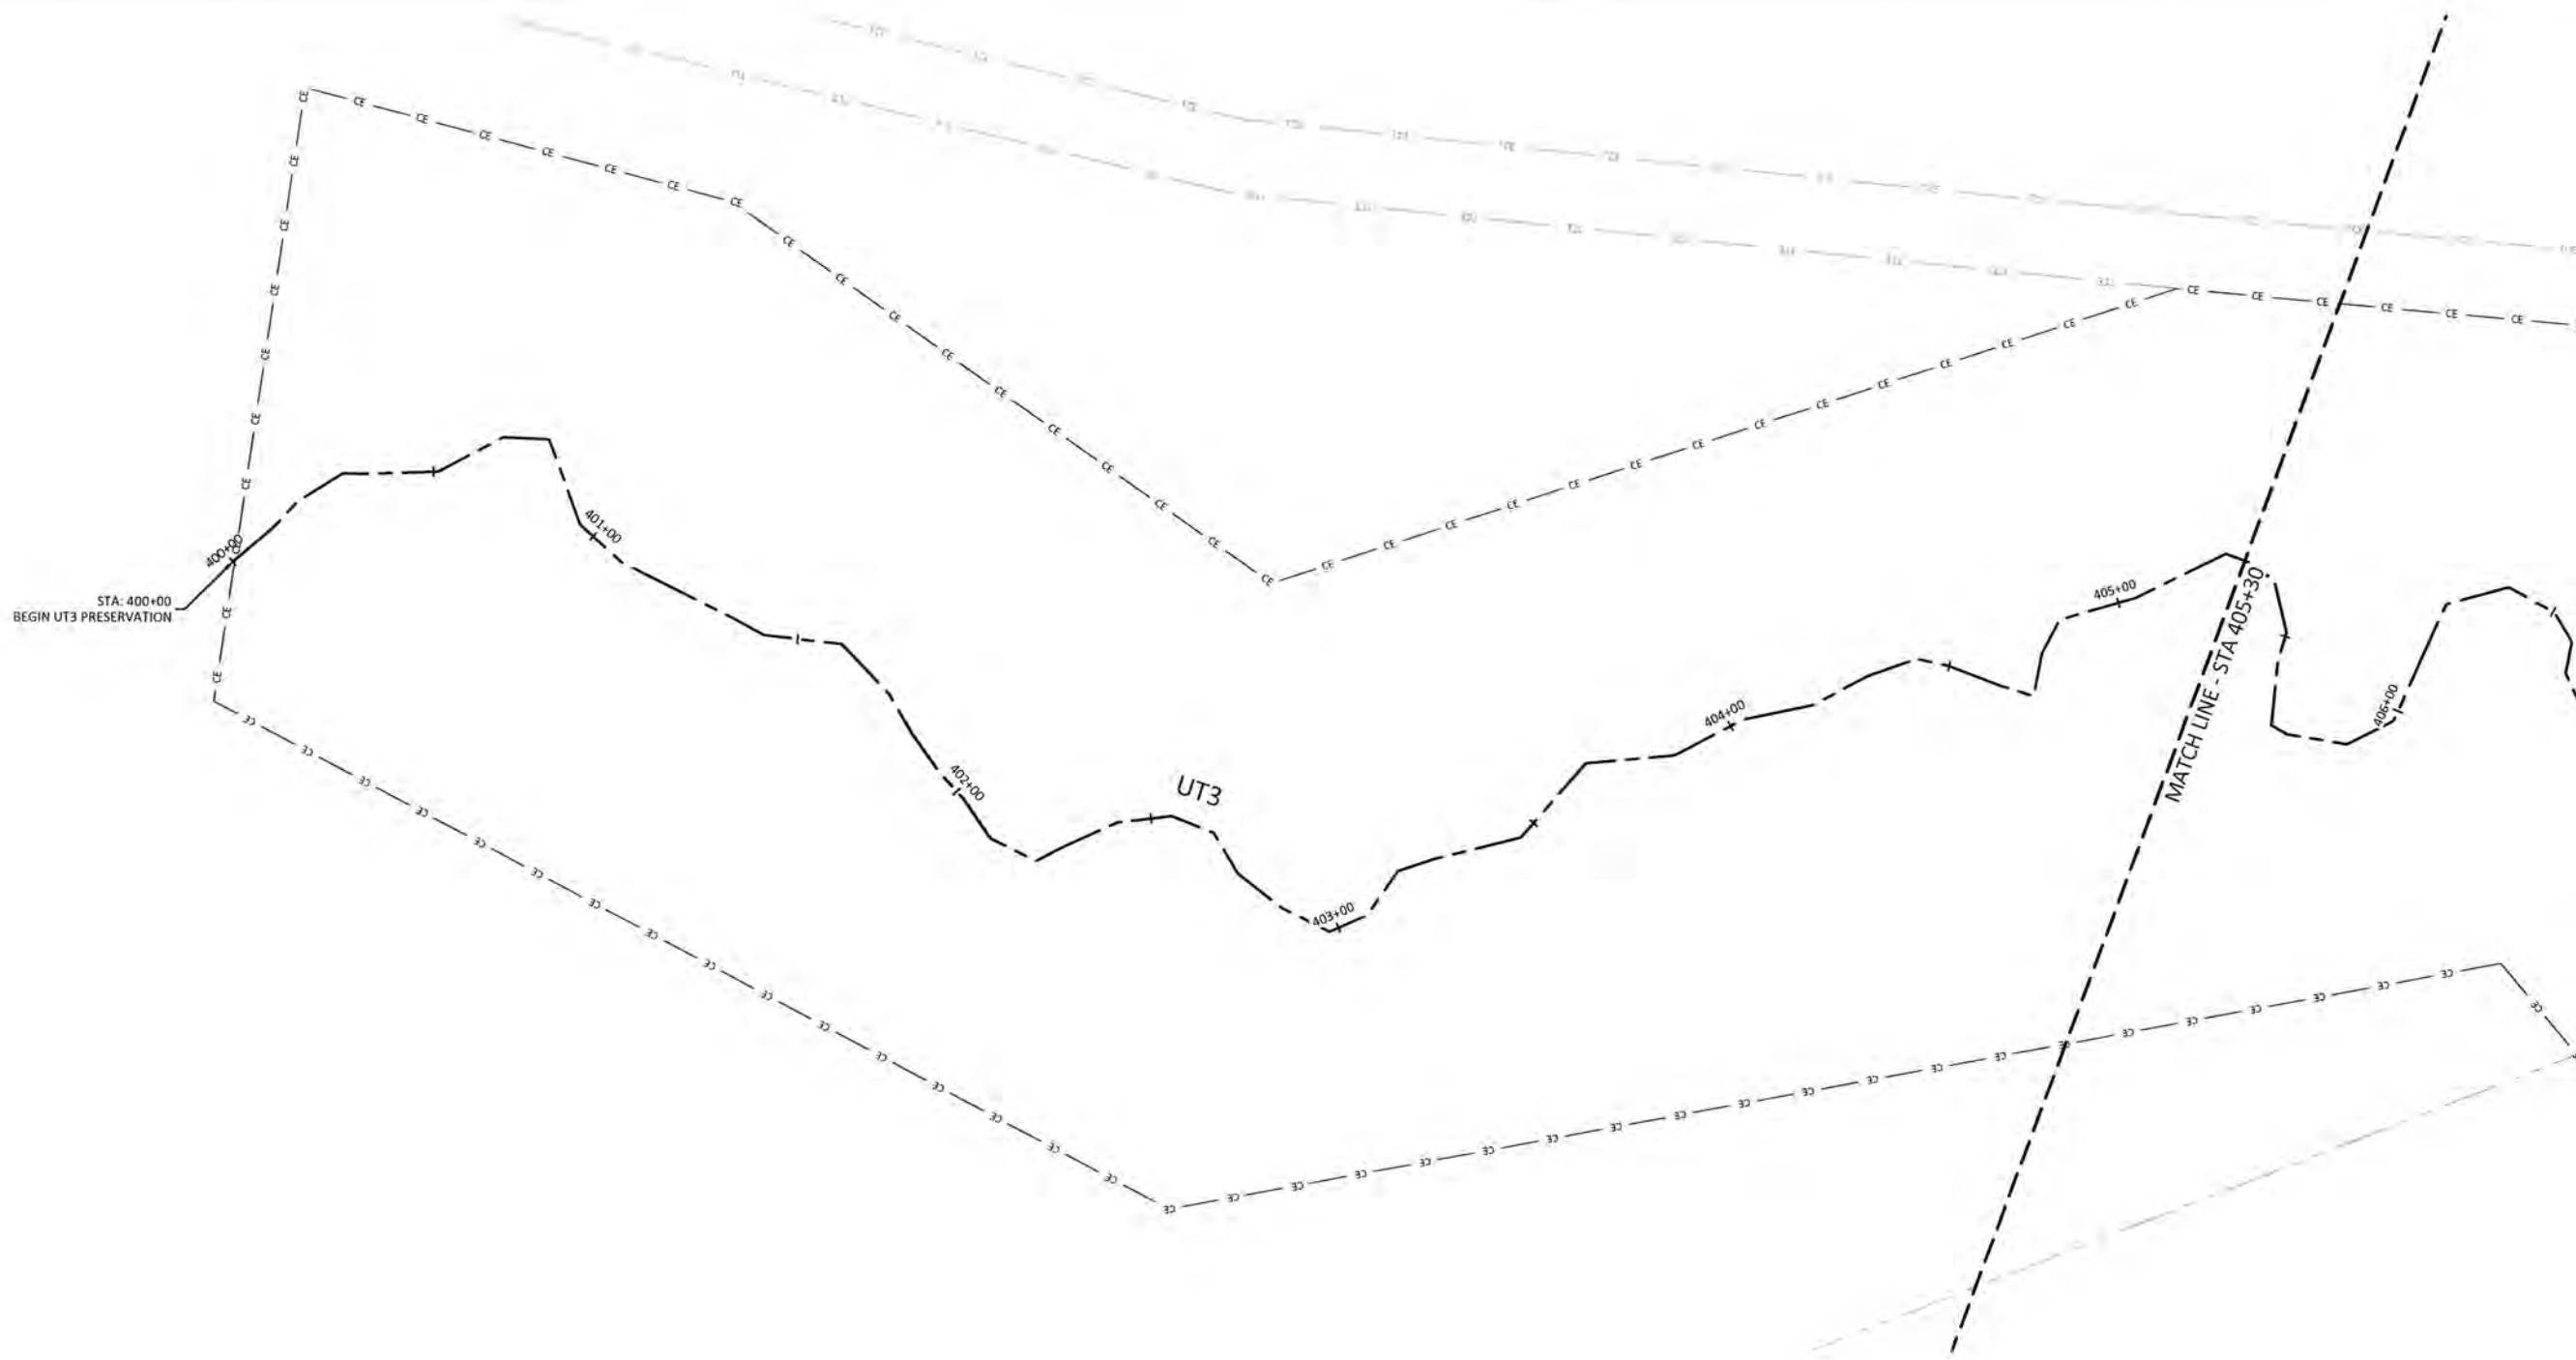
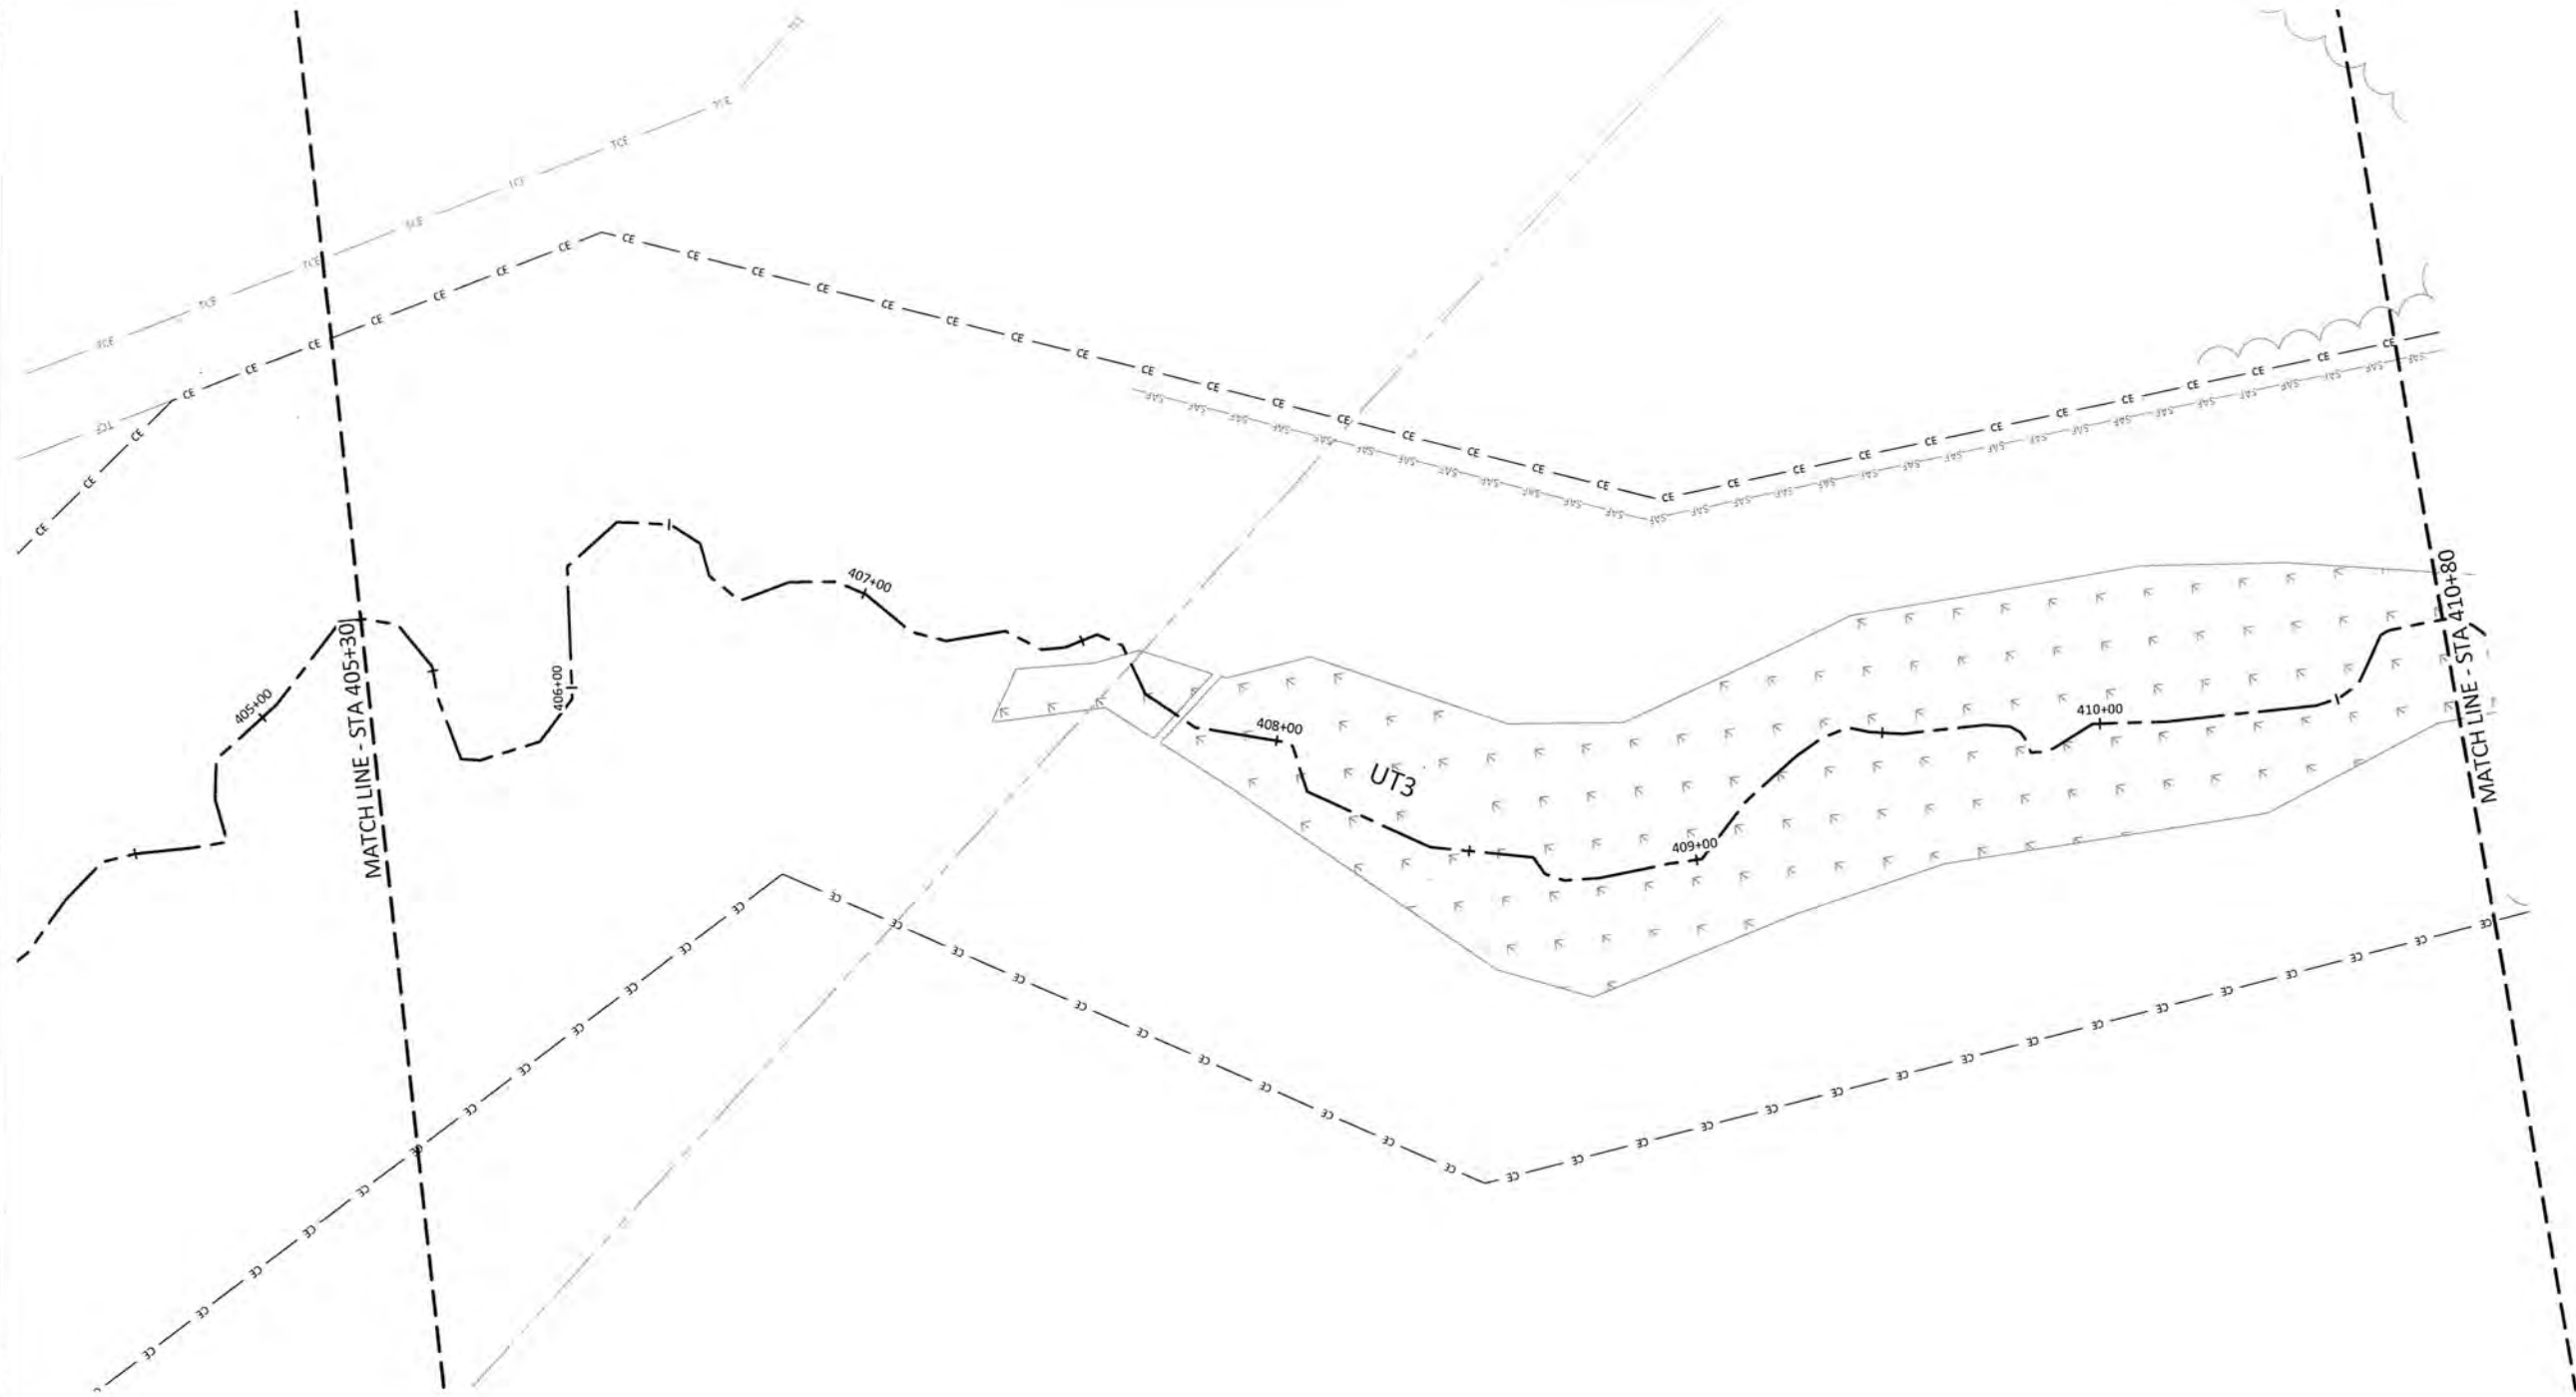
UT3  
 Stream Plan and Profile

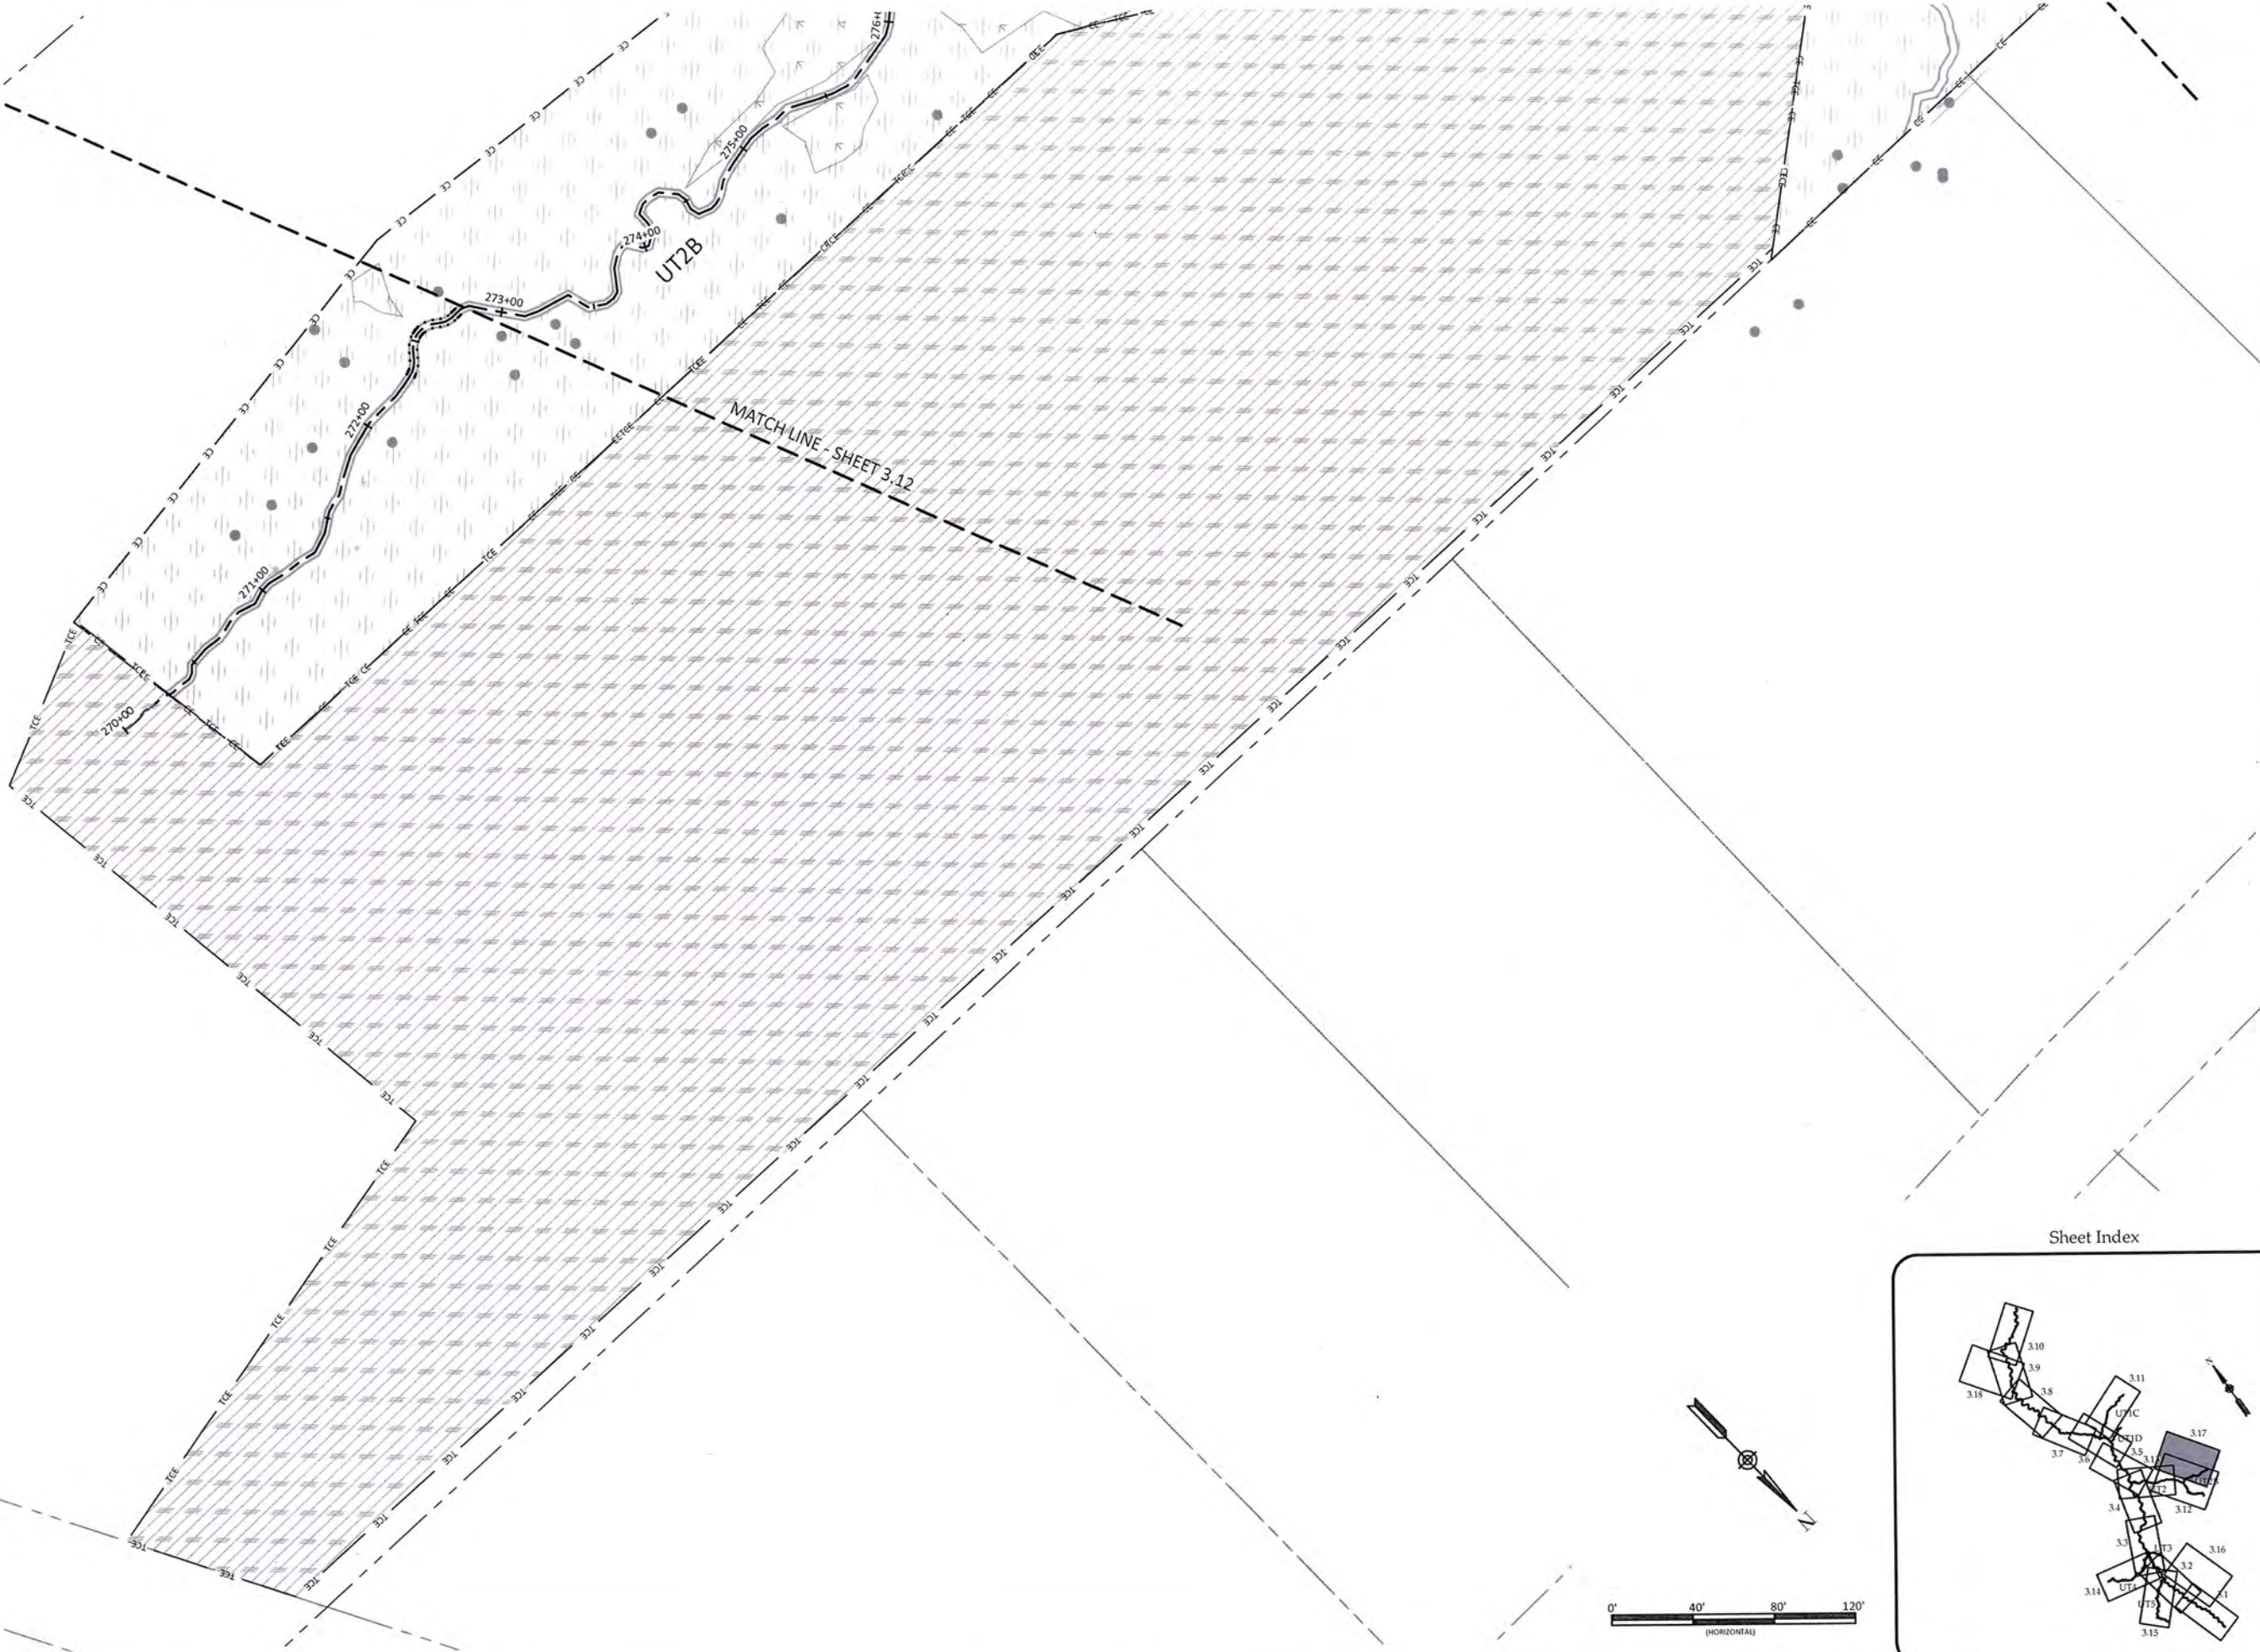
TCE  
Planting Plan
