# MONITORING YEAR 3 ANNUAL REPORT

## **CANDY CREEK MITIGATION SITE**

Guilford County, NC

NCDMS Project Number 96315

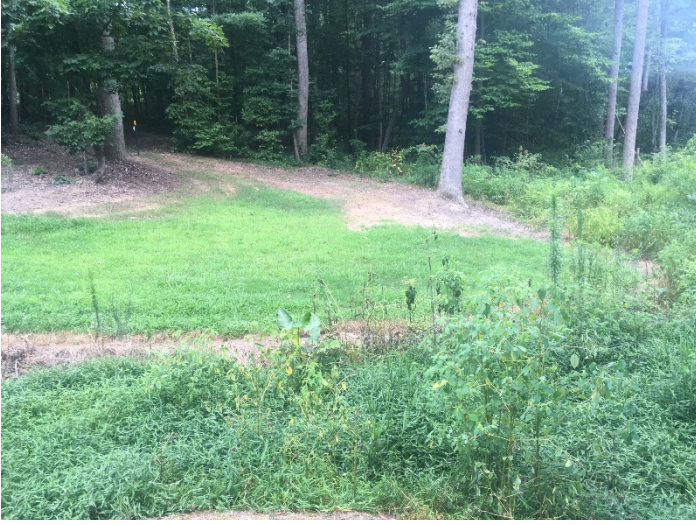
**Candy Creek Reach 1 Mowing Encroachment** – looking upstream  
*(07/15/2019)*

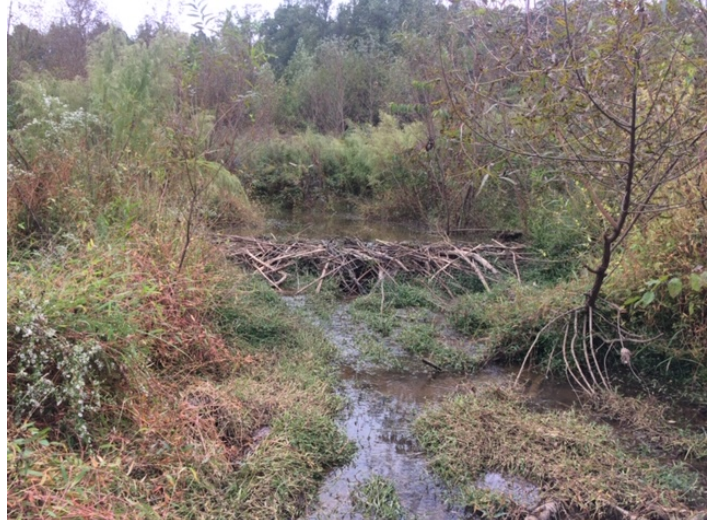
**Candy Creek Reach 4 Beaver Dam** – looking upstream  
*(10/08/2019)*

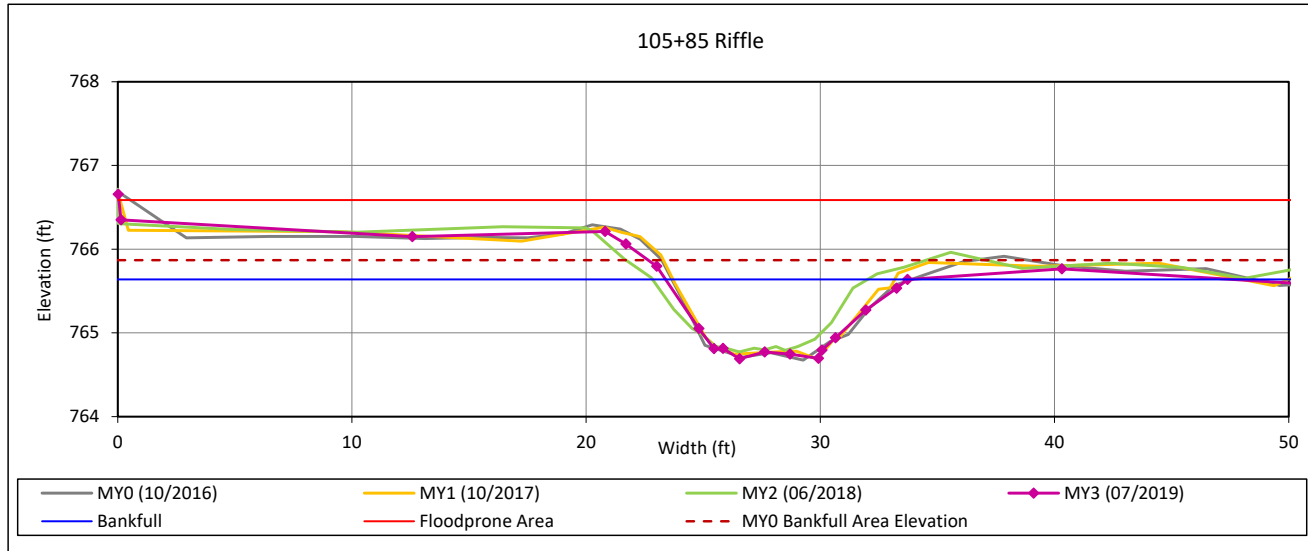
#### Cross-Section 1 - Candy Creek Reach 1

6.5	x-section area (ft.sq.)
10.3	width (ft)
0.6	mean depth (ft)
0.9	max depth (ft)
10.6	wetted perimeter (ft)
0.6	hydraulic radius (ft)
16.5	width-depth ratio
54.5	W flood prone area (ft)
5.3	entrenchment ratio
0.8	low bank height ratio

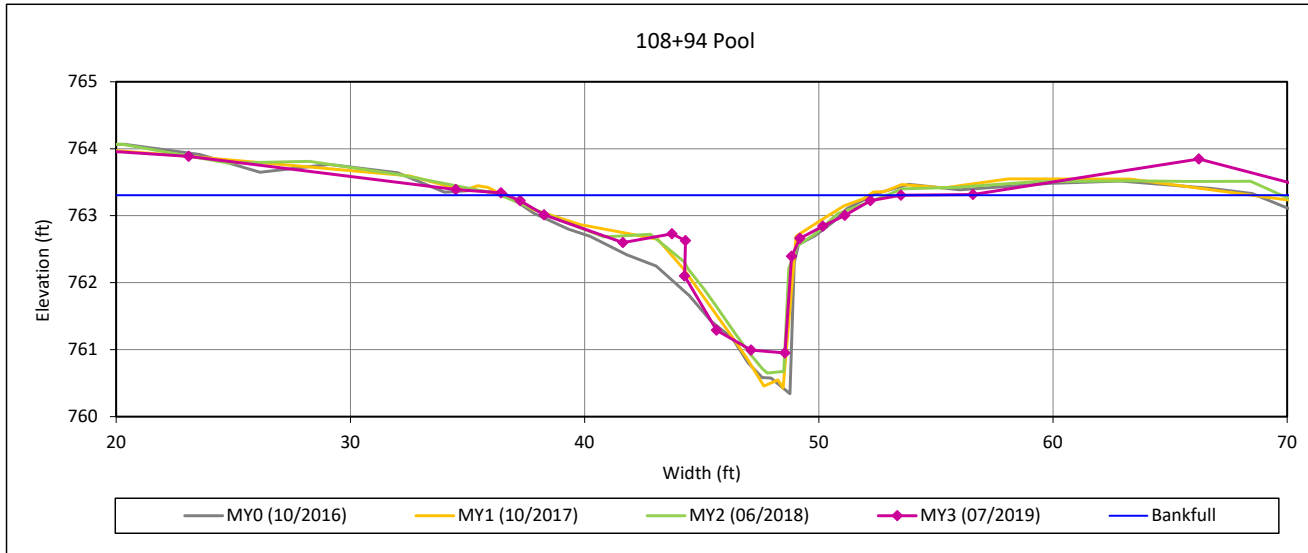
#### Cross-Section 2 - Candy Creek Reach 1

14.2	x-section area (ft.sq.)
16.8	width (ft)
0.8	mean depth (ft)
2.4	max depth (ft)
19.1	wetted perimeter (ft)
0.7	hydraulic radius (ft)
19.9	width-depth ratio

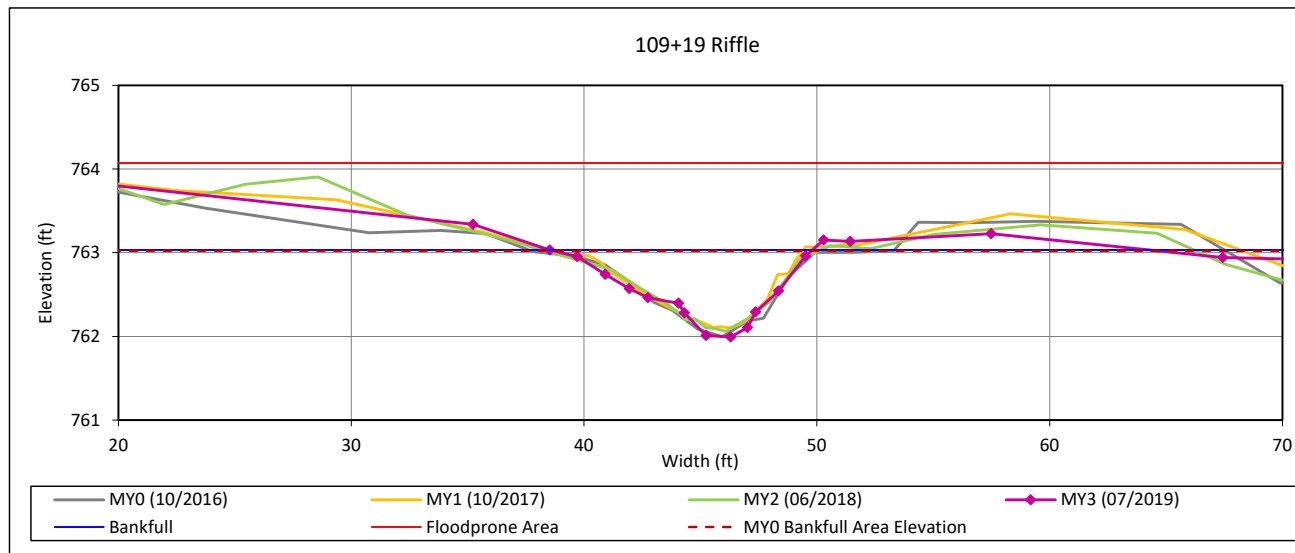
#### Cross-Section 3 - Candy Creek Reach 1

5.9	x-section area (ft.sq.)
11.3	width (ft)
0.5	mean depth (ft)
1.0	max depth (ft)
11.6	wetted perimeter (ft)
0.5	hydraulic radius (ft)
21.6	width-depth ratio
96.2	W flood prone area (ft)
8.5	entrenchment ratio
1.0	low bank height ratio

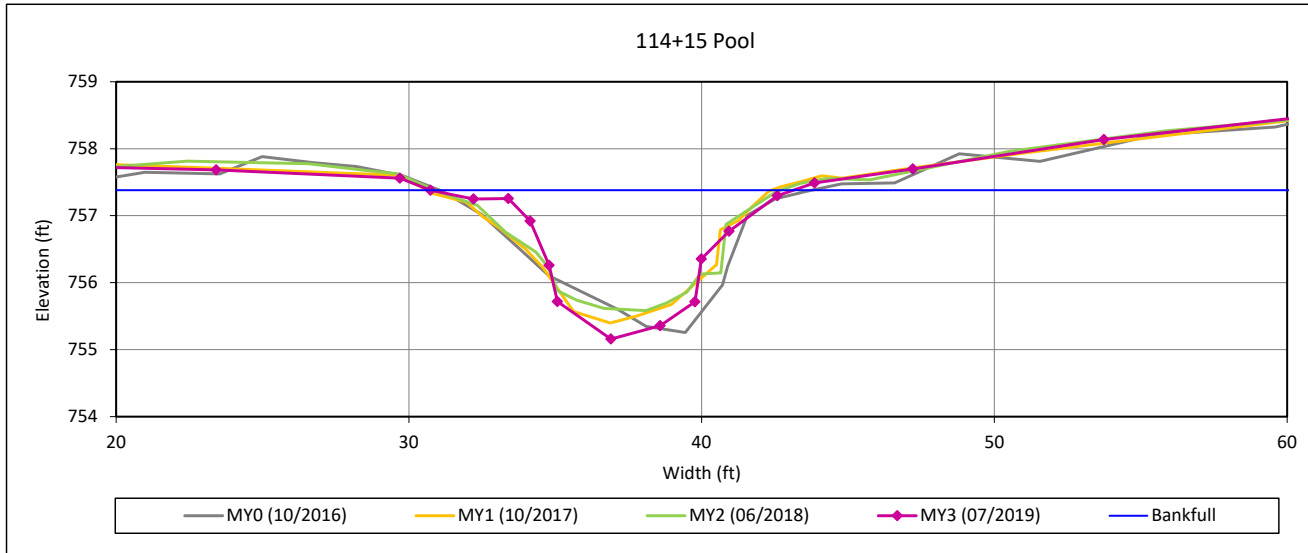
#### Cross Section 4 - Candy Creek Reach 1

12.3	x-section area (ft.sq.)
11.8	width (ft)
1.0	mean depth (ft)
2.2	max depth (ft)
13.3	wetted perimeter (ft)
0.9	hydraulic radius (ft)
11.4	width-depth ratio

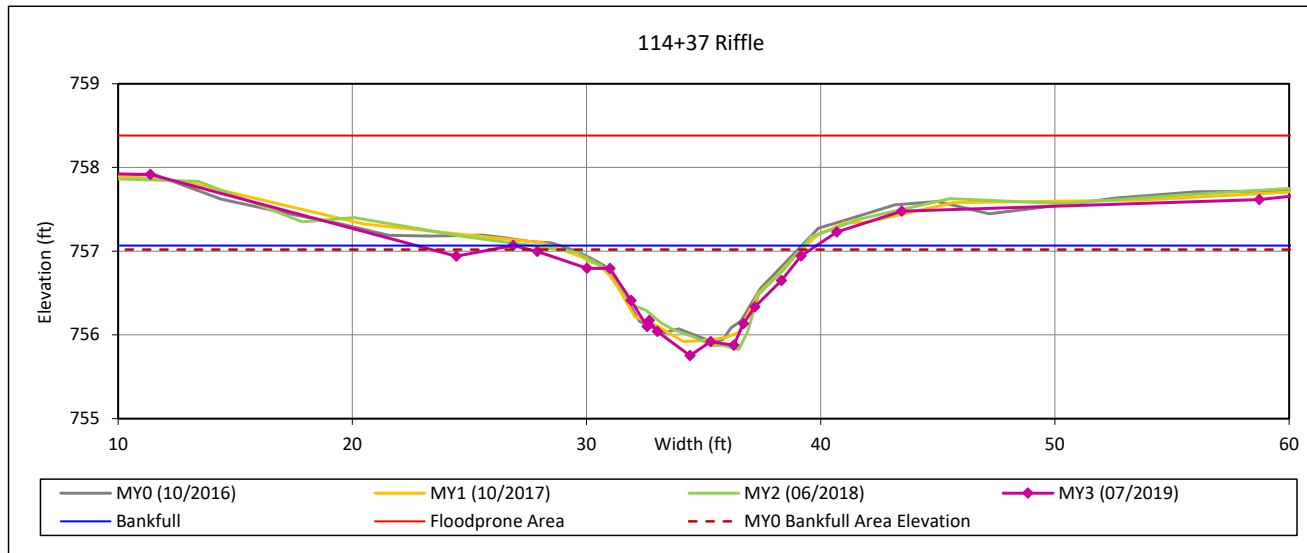
#### Cross-Section 5 - Candy Creek Reach 1

7.7	x-section area (ft.sq.)
13.0	width (ft)
0.6	mean depth (ft)
1.3	max depth (ft)
13.4	wetted perimeter (ft)
0.6	hydraulic radius (ft)
21.8	width-depth ratio
74.8	W flood prone area (ft)
5.8	entrenchment ratio
1.0	low bank height ratio

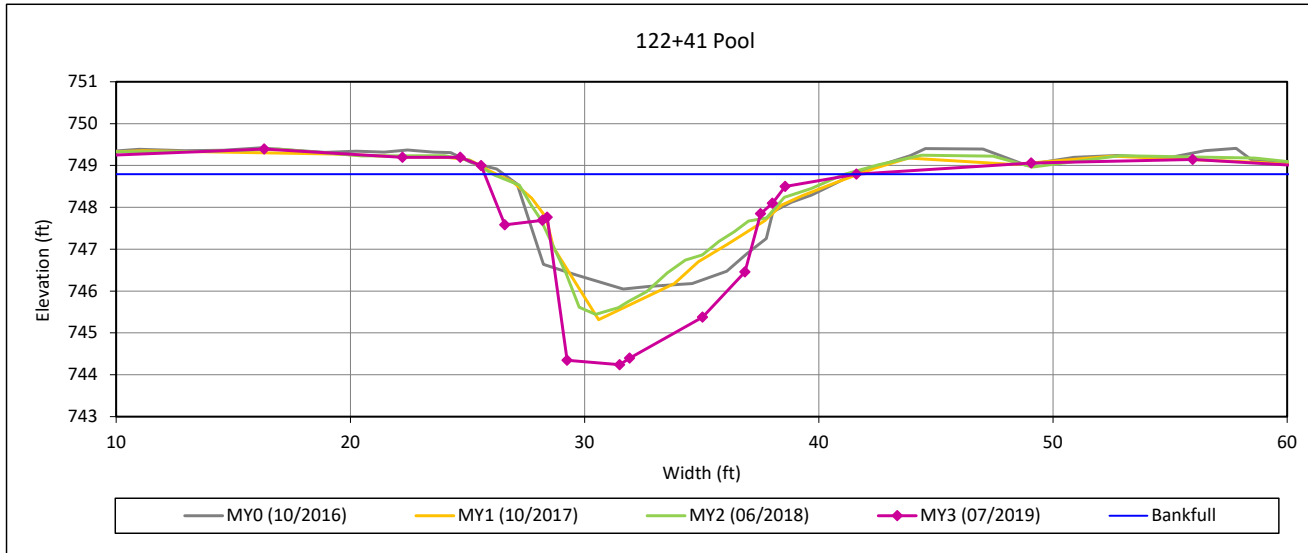
#### Cross-Section 6 - Candy Creek Reach 1

36.5	x-section area (ft.sq.)
15.9	width (ft)
2.3	mean depth (ft)
4.6	max depth (ft)
20.7	wetted perimeter (ft)
1.8	hydraulic radius (ft)
6.9	width-depth ratio

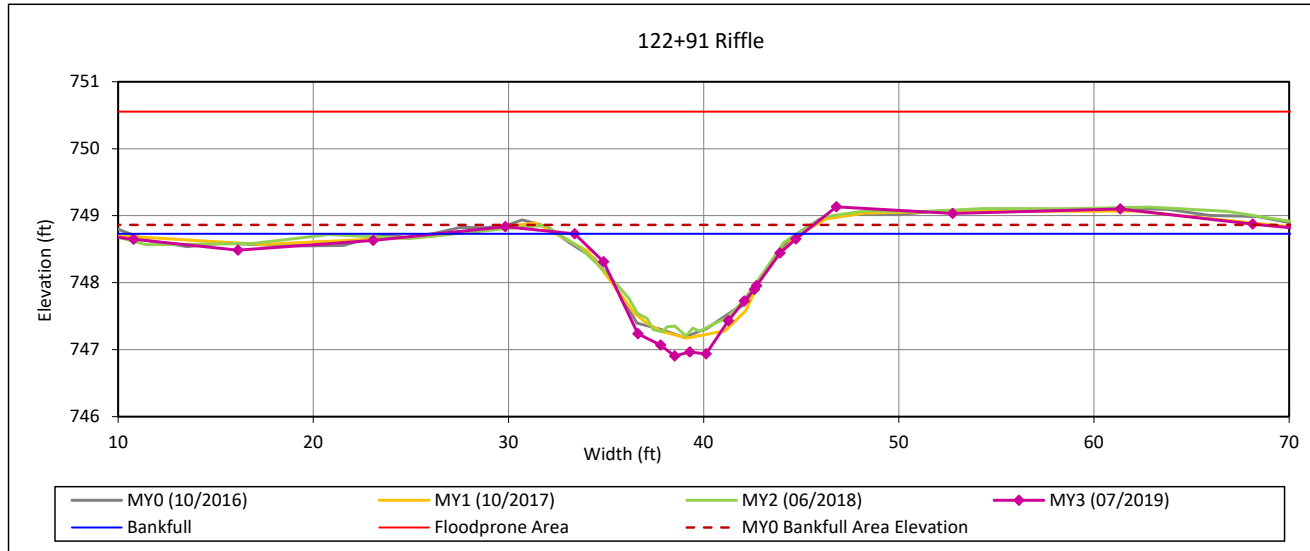
#### Cross-Section 7 - Candy Creek Reach 1

12.0	x-section area (ft.sq.)
11.7	width (ft)
1.0	mean depth (ft)
1.8	max depth (ft)
12.4	wetted perimeter (ft)
1.0	hydraulic radius (ft)
11.3	width-depth ratio
82.7	W flood prone area (ft)
7.1	entrenchment ratio
1.0	low bank height ratio

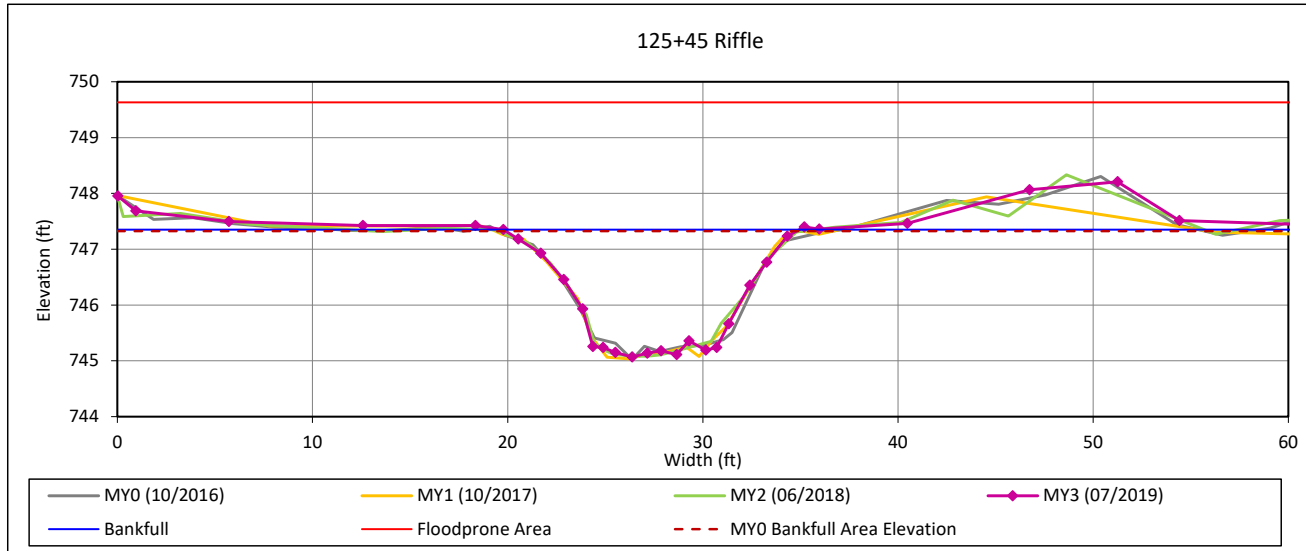
#### Cross-Section 8 - Candy Creek Reach 1

20.7	x-section area (ft.sq.)
15.2	width (ft)
1.4	mean depth (ft)
2.3	max depth (ft)
16.4	wetted perimeter (ft)
1.3	hydraulic radius (ft)
11.1	width-depth ratio
63.8	W flood prone area (ft)
4.2	entrenchment ratio
1.0	low bank height ratio

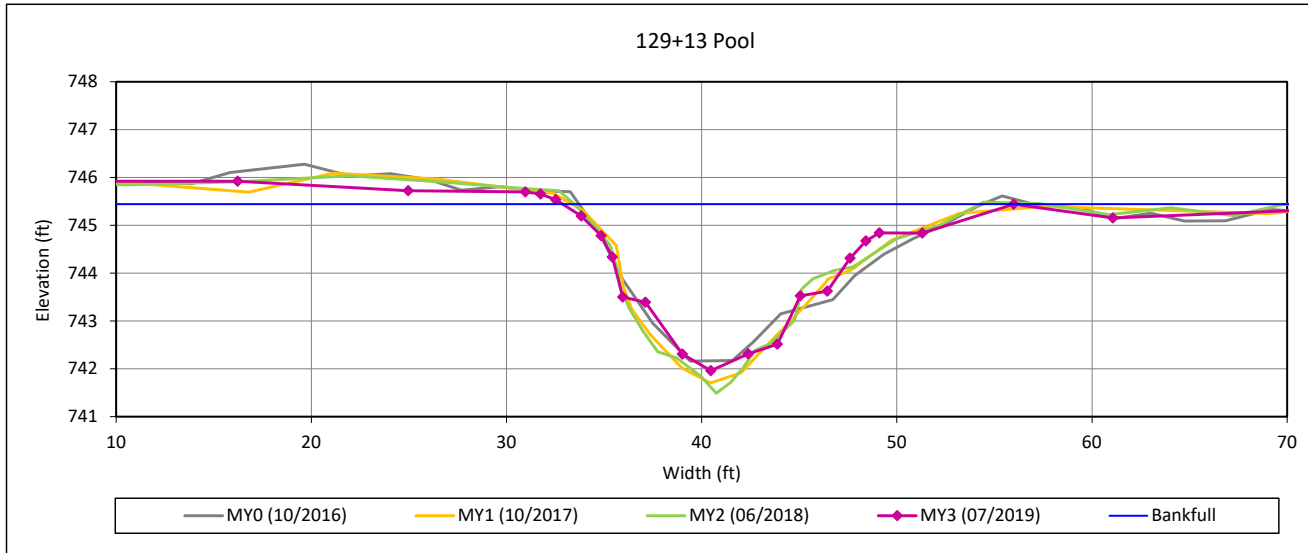
#### Cross-Section 9 - Candy Creek Reach 2

36.0	x-section area (ft.sq.)
23.1	width (ft)
1.6	mean depth (ft)
3.5	max depth (ft)
24.9	wetted perimeter (ft)
1.4	hydraulic radius (ft)
14.9	width-depth ratio

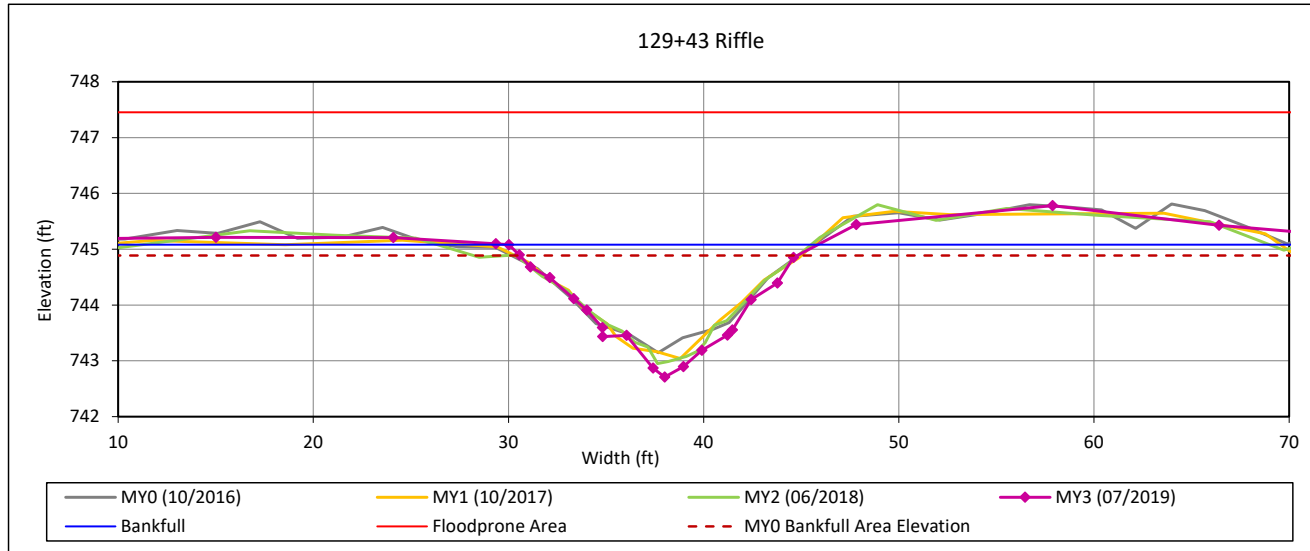
#### Cross-Section 10 - Candy Creek Reach 2

#### Bankfull Dimensions

19.1	x-section area (ft.sq.)
15.8	width (ft)
1.2	mean depth (ft)
2.4	max depth (ft)
16.8	wetted perimeter (ft)
1.1	hydraulic radius (ft)
13.1	width-depth ratio
93.4	W flood prone area (ft)
5.9	entrenchment ratio
1.1	low bank height ratio

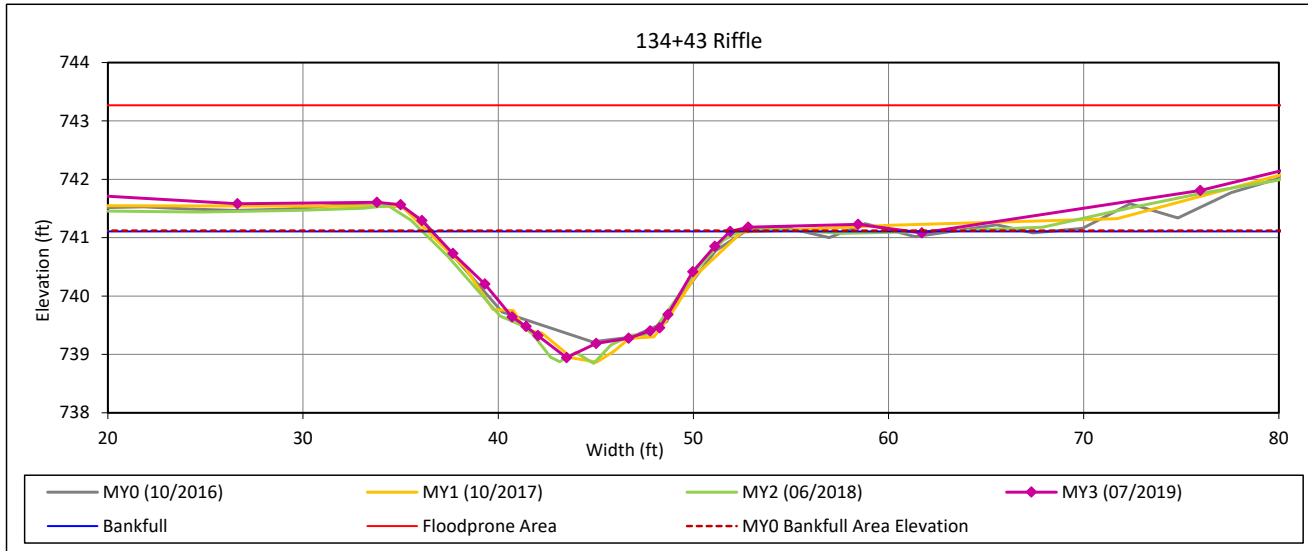
#### Cross-Section 11 - Candy Creek Reach 2

#### Bankfull Dimensions

19.6	x-section area (ft.sq.)
15.3	width (ft)
1.3	mean depth (ft)
2.2	max depth (ft)
16.0	wetted perimeter (ft)
1.2	hydraulic radius (ft)
11.9	width-depth ratio
82.8	W flood prone area (ft)
5.4	entrenchment ratio
1.0	low bank height ratio

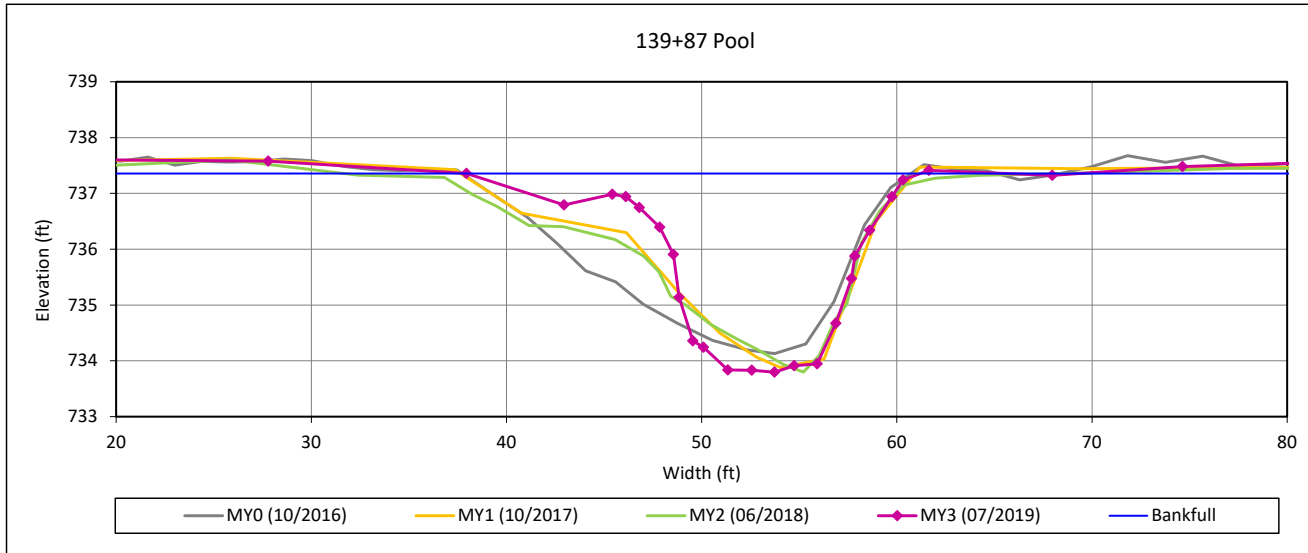
#### Cross-Section 12 - Candy Creek Reach 2

#### Bankfull Dimensions

36.1	x-section area (ft.sq.)
23.2	width (ft)
1.6	mean depth (ft)
3.6	max depth (ft)
25.7	wetted perimeter (ft)
1.4	hydraulic radius (ft)
15.0	width-depth ratio

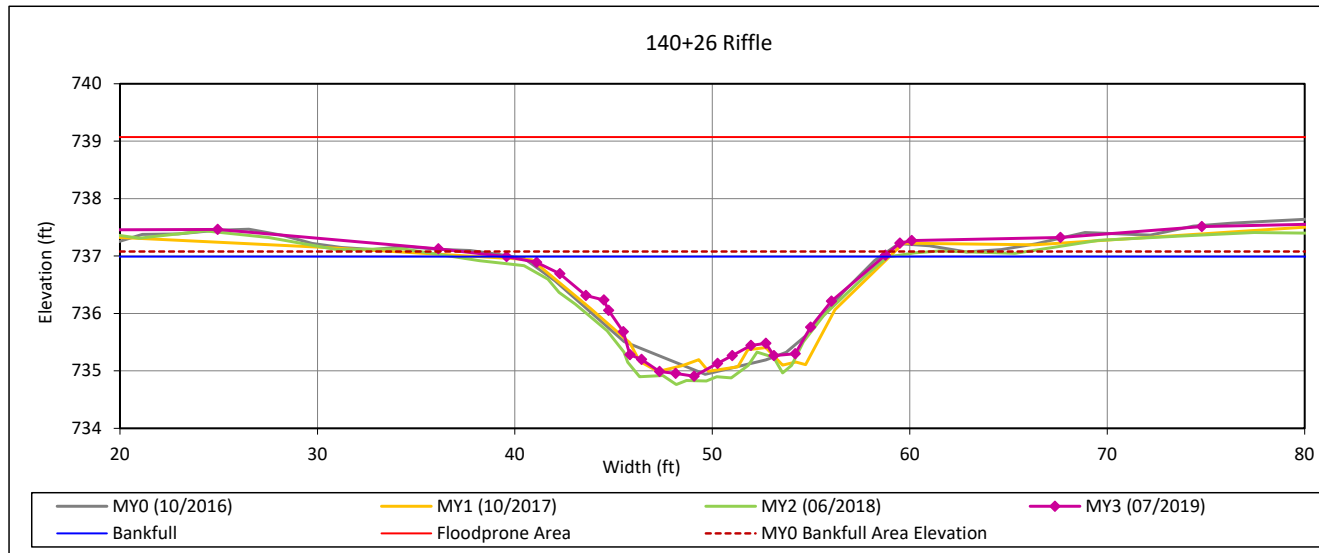
#### Cross-Section 13 - Candy Creek Reach 2

#### Bankfull Dimensions

21.6	x-section area (ft.sq.)
19.1	width (ft)
1.1	mean depth (ft)
2.1	max depth (ft)
20.0	wetted perimeter (ft)
1.1	hydraulic radius (ft)
16.9	width-depth ratio
95.8	W flood prone area (ft)
5.0	entrenchment ratio
1.0	low bank height ratio

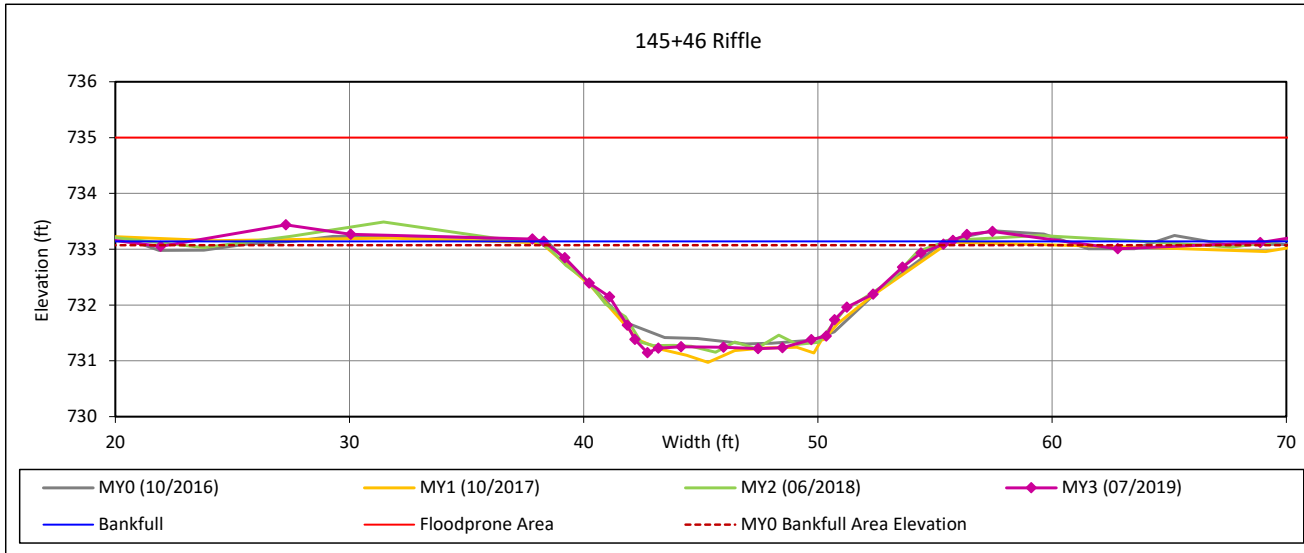
**Cross-Section 14 - Candy Creek Reach 2**

Bankfull Dimensions

22.0	x-section area (ft.sq.)
17.4	width (ft)
1.3	mean depth (ft)
2.0	max depth (ft)
18.2	wetted perimeter (ft)
1.2	hydraulic radius (ft)
13.7	width-depth ratio
86.5	W flood prone area (ft)
5.0	entrenchment ratio
1.0	low bank height ratio

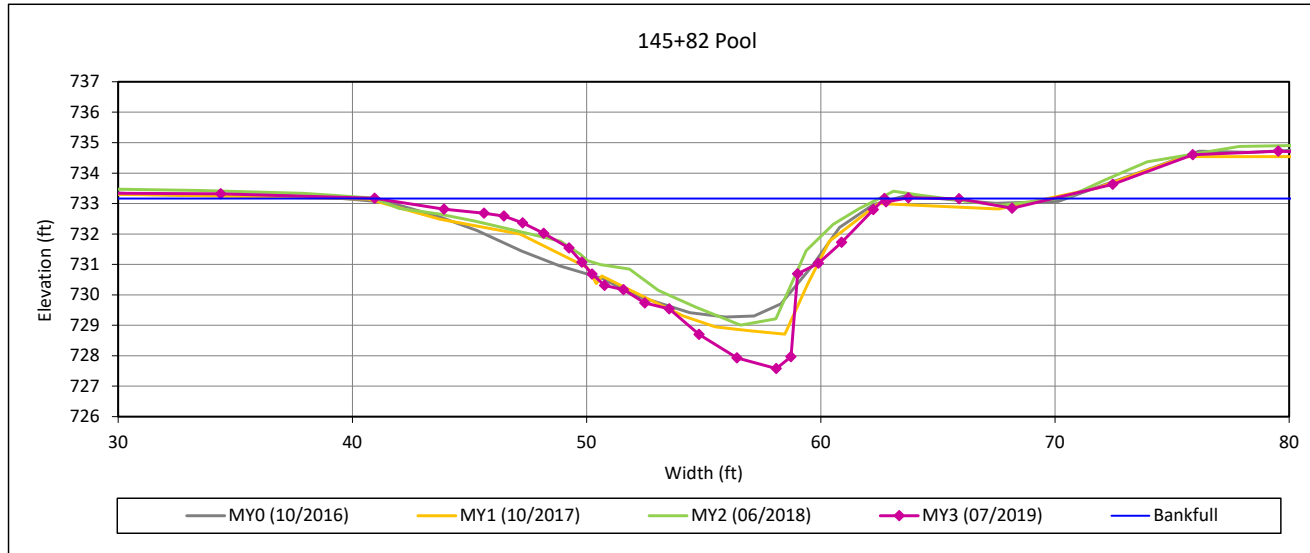
#### Cross-Section 15 - Candy Creek Reach 2

#### Bankfull Dimensions

48.6	x-section area (ft.sq.)
21.7	width (ft)
2.2	mean depth (ft)
5.6	max depth (ft)
26.3	wetted perimeter (ft)
1.9	hydraulic radius (ft)
9.7	width-depth ratio

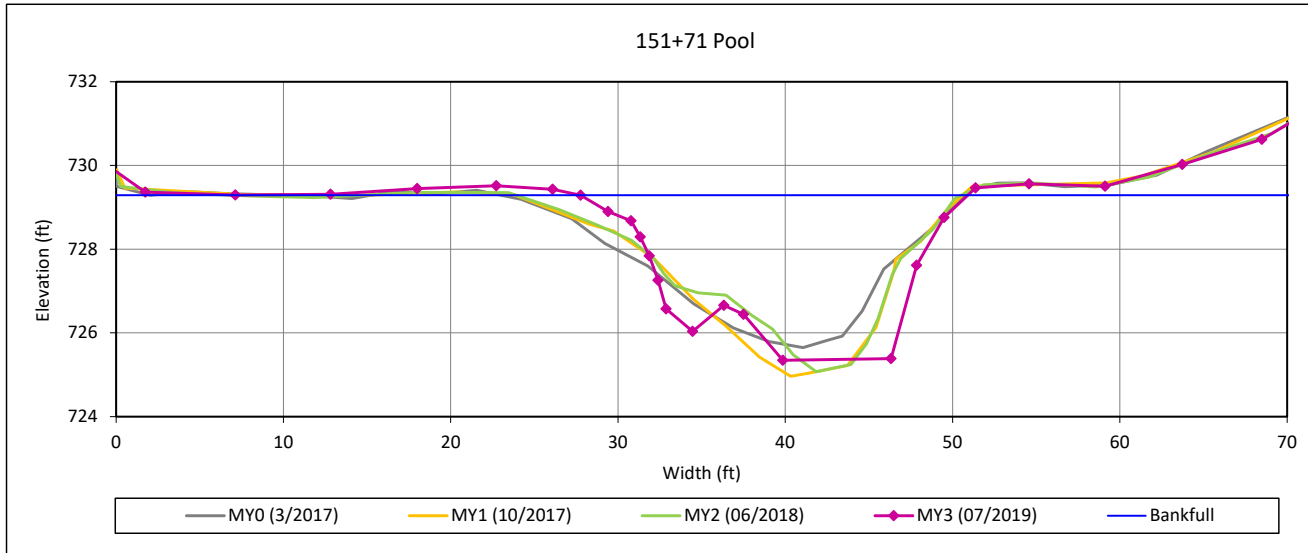
### Cross-Section 16 - Candy Creek Reach 3

#### Bankfull Dimensions

57.4	x-section area (ft.sq.)
23.1	width (ft)
2.5	mean depth (ft)
3.9	max depth (ft)
26.2	wetted perimeter (ft)
2.2	hydraulic radius (ft)
9.3	width-depth ratio

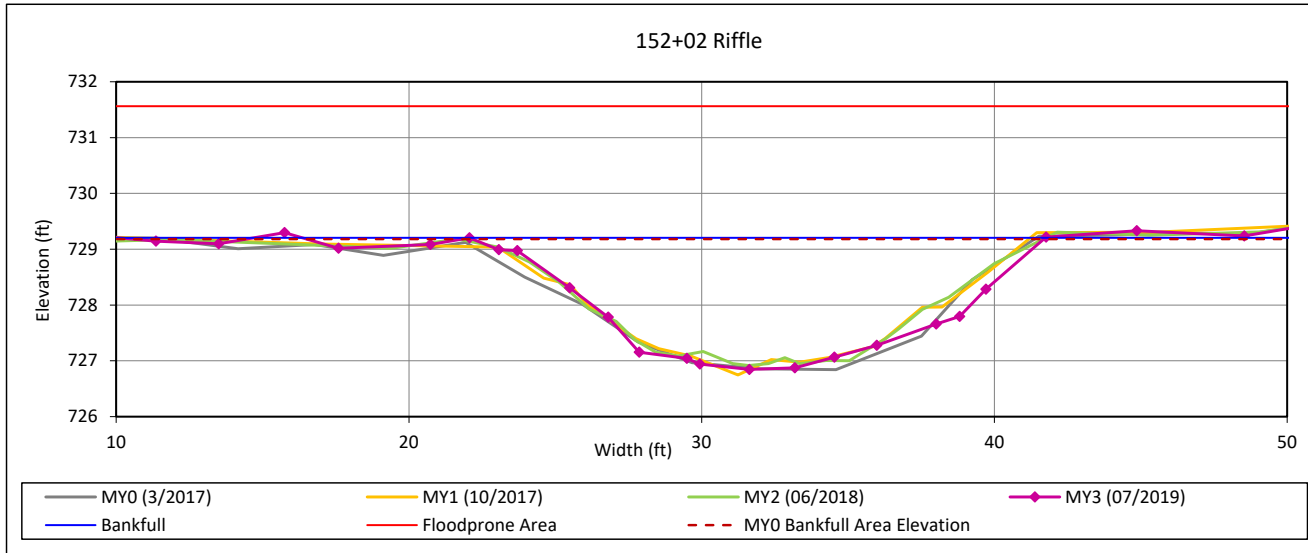
### Cross-Section 17 - Candy Creek Reach 3

#### Bankfull Dimensions

29.2	x-section area (ft.sq.)
19.7	width (ft)
1.5	mean depth (ft)
2.4	max depth (ft)
20.5	wetted perimeter (ft)
1.4	hydraulic radius (ft)
13.2	width-depth ratio
53.7	W flood prone area (ft)
2.7	entrenchment ratio
1.0	low bank height ratio

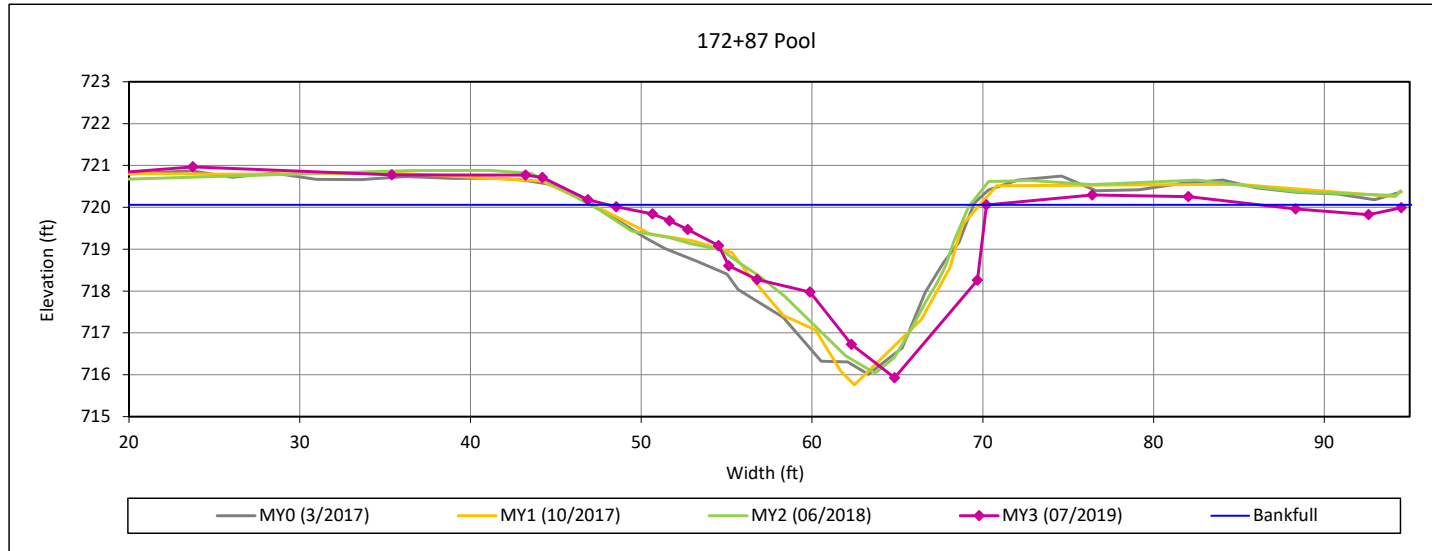
#### Cross-Section 18 - Candy Creek Reach 4

#### Bankfull Dimensions

42.8	x-section area (ft.sq.)
22.2	width (ft)
1.9	mean depth (ft)
4.1	max depth (ft)
24.8	wetted perimeter (ft)
1.7	hydraulic radius (ft)
11.5	width-depth ratio

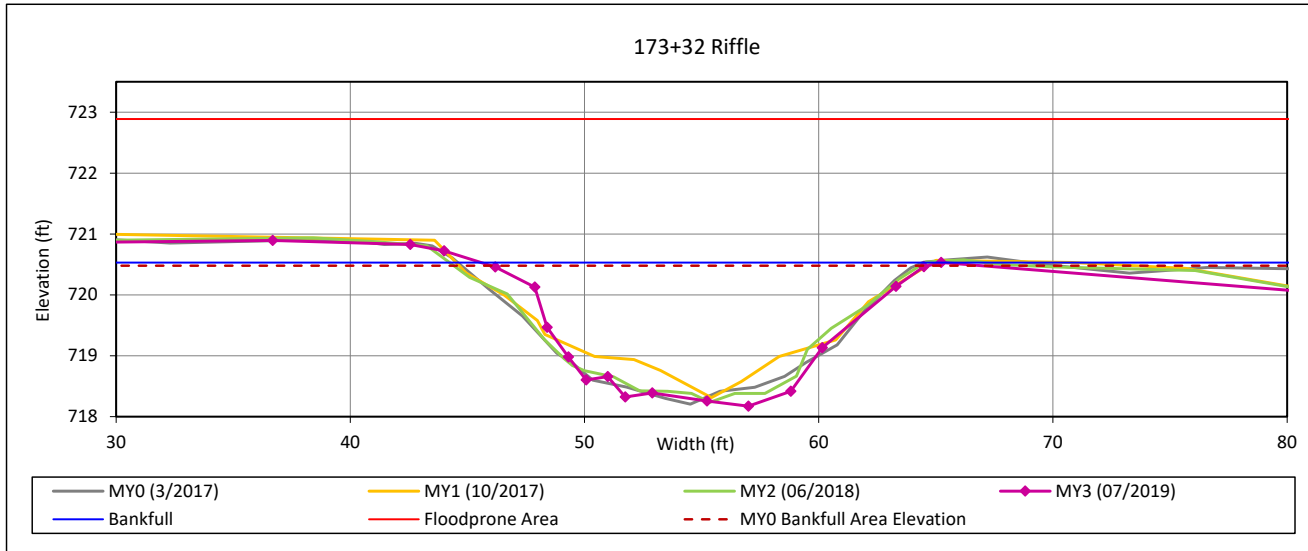
### Cross-Section 19 - Candy Creek Reach 4

#### Bankfull Dimensions

27.9	x-section area (ft.sq.)
19.6	width (ft)
1.4	mean depth (ft)
2.4	max depth (ft)
20.7	wetted perimeter (ft)
1.3	hydraulic radius (ft)
13.8	width-depth ratio
85.9	W flood prone area (ft)
4.4	entrenchment ratio
1.0	low bank height ratio

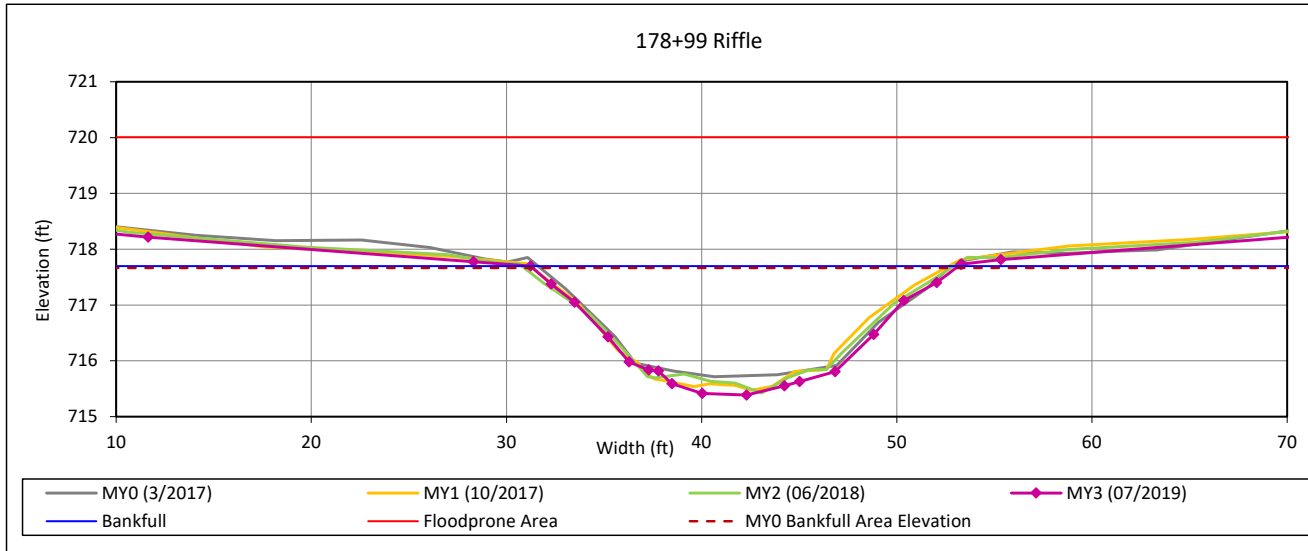
#### Cross-Section 20 - Candy Creek Reach 4

#### Bankfull Dimensions

31.7	x-section area (ft.sq.)
21.9	width (ft)
1.4	mean depth (ft)
2.3	max depth (ft)
22.6	wetted perimeter (ft)
1.4	hydraulic radius (ft)
15.2	width-depth ratio
100.4	W flood prone area (ft)
4.6	entrenchment ratio
1.0	low bank height ratio

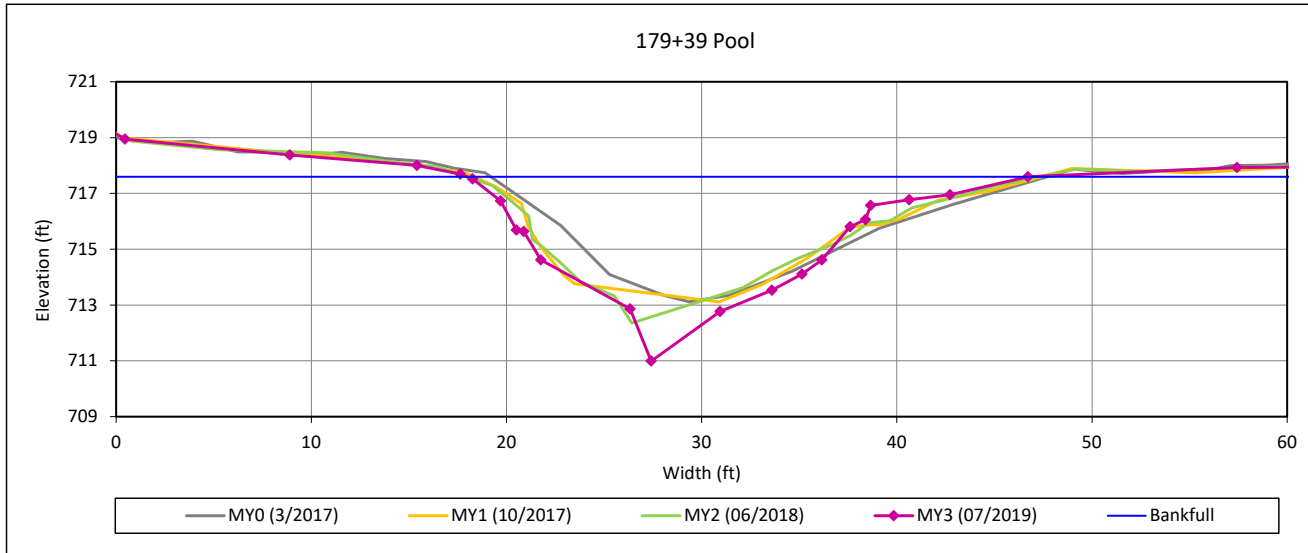
#### Cross-Section 21 - Candy Creek Reach 4

#### Bankfull Dimensions

79.3	x-section area (ft.sq.)
28.7	width (ft)
2.8	mean depth (ft)
6.6	max depth (ft)
32.9	wetted perimeter (ft)
2.4	hydraulic radius (ft)
10.4	width-depth ratio

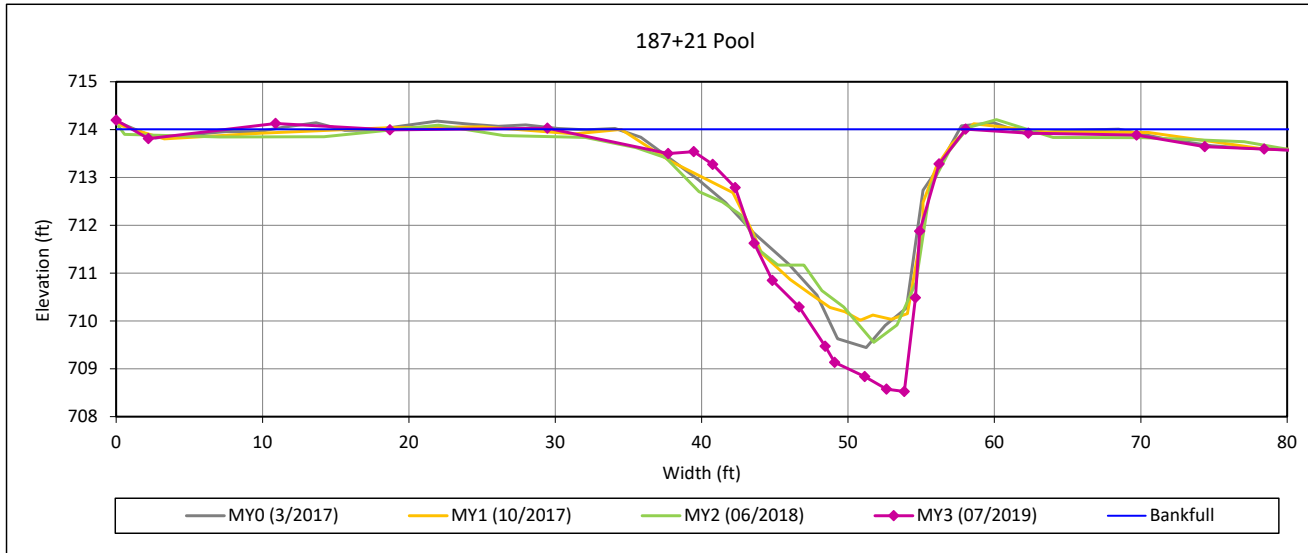
#### Cross-Section 22 - Candy Creek Reach 4

#### Bankfull Dimensions

59.2	x-section area (ft.sq.)
28.3	width (ft)
2.1	mean depth (ft)
5.5	max depth (ft)
32.7	wetted perimeter (ft)
1.8	hydraulic radius (ft)
13.5	width-depth ratio

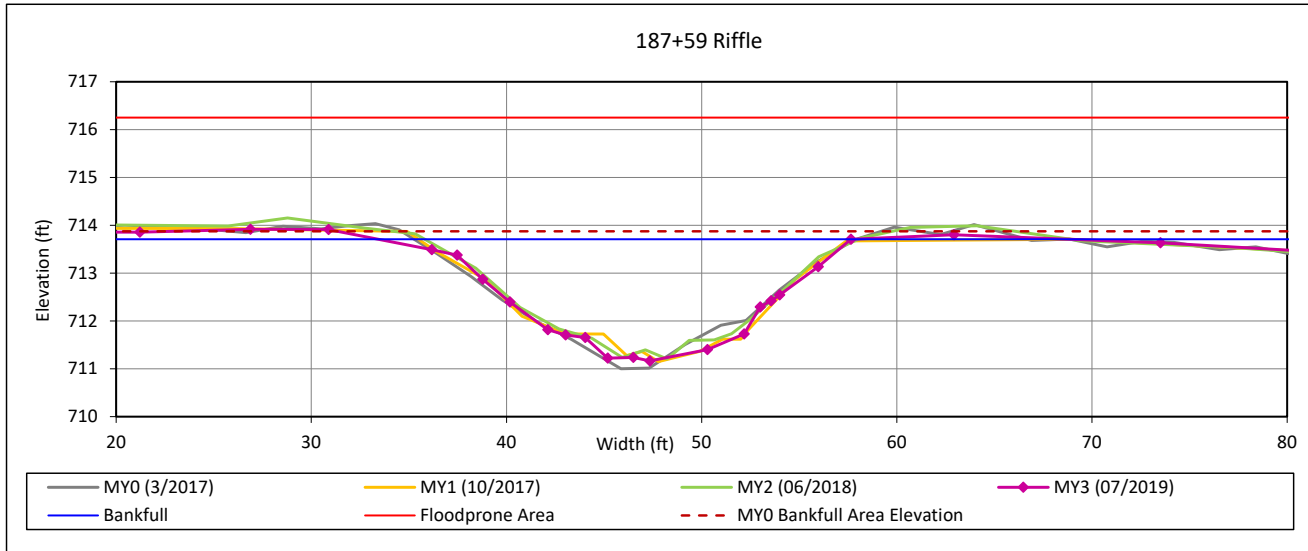
#### Cross-Section 23 - Candy Creek Reach 4

#### Bankfull Dimensions

33.9	x-section area (ft.sq.)
24.2	width (ft)
1.4	mean depth (ft)
2.5	max depth (ft)
25.0	wetted perimeter (ft)
1.4	hydraulic radius (ft)
17.3	width-depth ratio
90.0	W flood prone area (ft)
3.7	entrenchment ratio
0.9	low bank height ratio

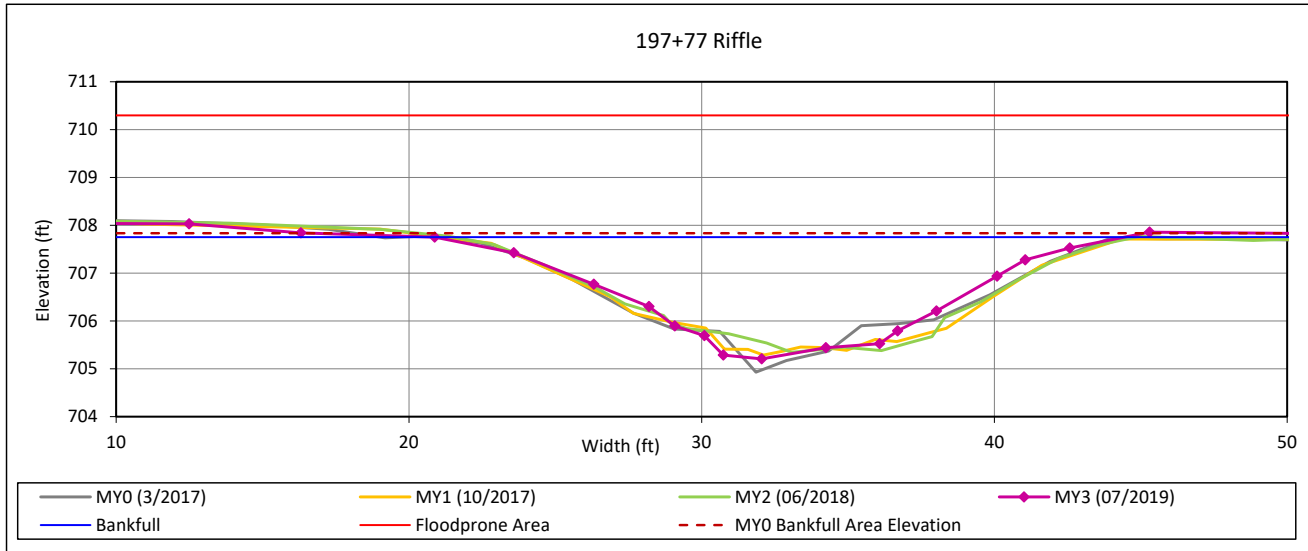
#### Cross-Section 24 - Candy Creek Reach 4

#### Bankfull Dimensions

29.6	x-section area (ft.sq.)
23.6	width (ft)
1.3	mean depth (ft)
2.5	max depth (ft)
24.3	wetted perimeter (ft)
1.2	hydraulic radius (ft)
18.8	width-depth ratio
58.8	W flood prone area (ft)
2.5	entrenchment ratio
1.0	low bank height ratio

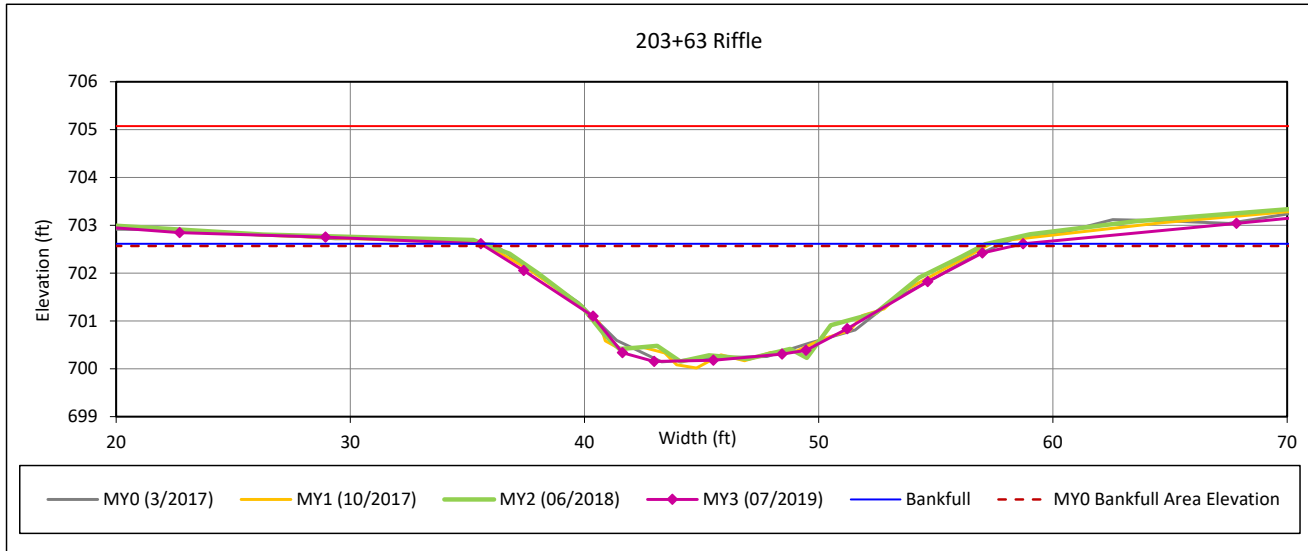
#### Cross-Section 25 - Candy Creek Reach 4

#### Bankfull Dimensions

33.9	x-section area (ft.sq.)
23.2	width (ft)
1.5	mean depth (ft)
2.5	max depth (ft)
23.9	wetted perimeter (ft)
1.4	hydraulic radius (ft)
15.8	width-depth ratio
85.8	W flood prone area (ft)
3.7	entrenchment ratio
1.0	low bank height ratio

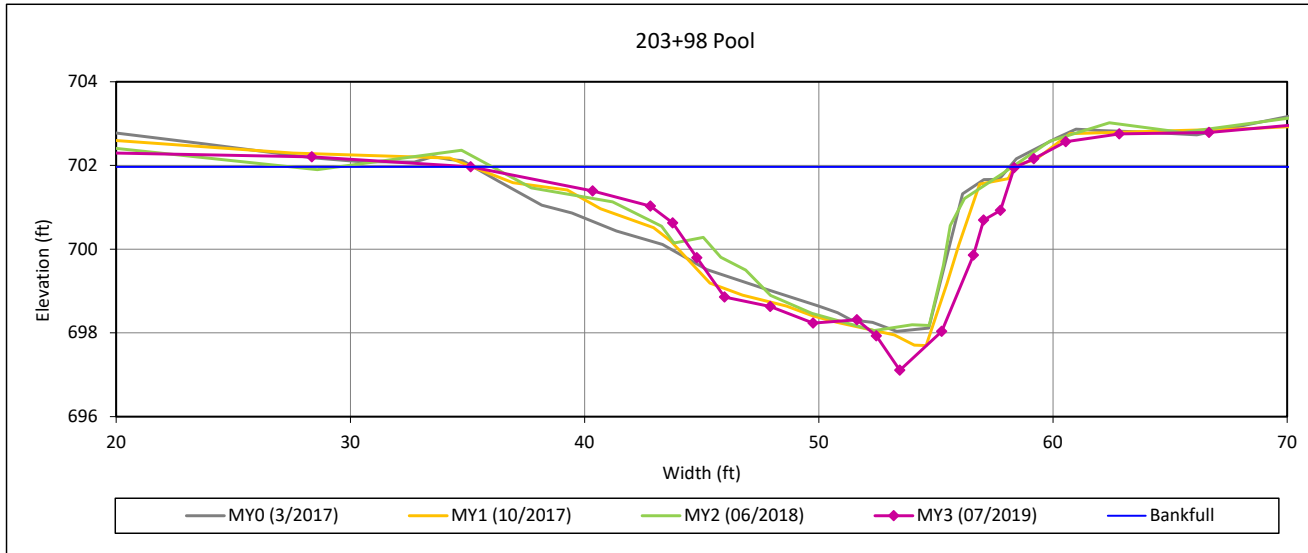
#### Cross-Section 26 - Candy Creek Reach 4

#### Bankfull Dimensions

50.5	x-section area (ft.sq.)
23.3	width (ft)
2.2	mean depth (ft)
4.9	max depth (ft)
26.8	wetted perimeter (ft)
1.9	hydraulic radius (ft)
10.7	width-depth ratio

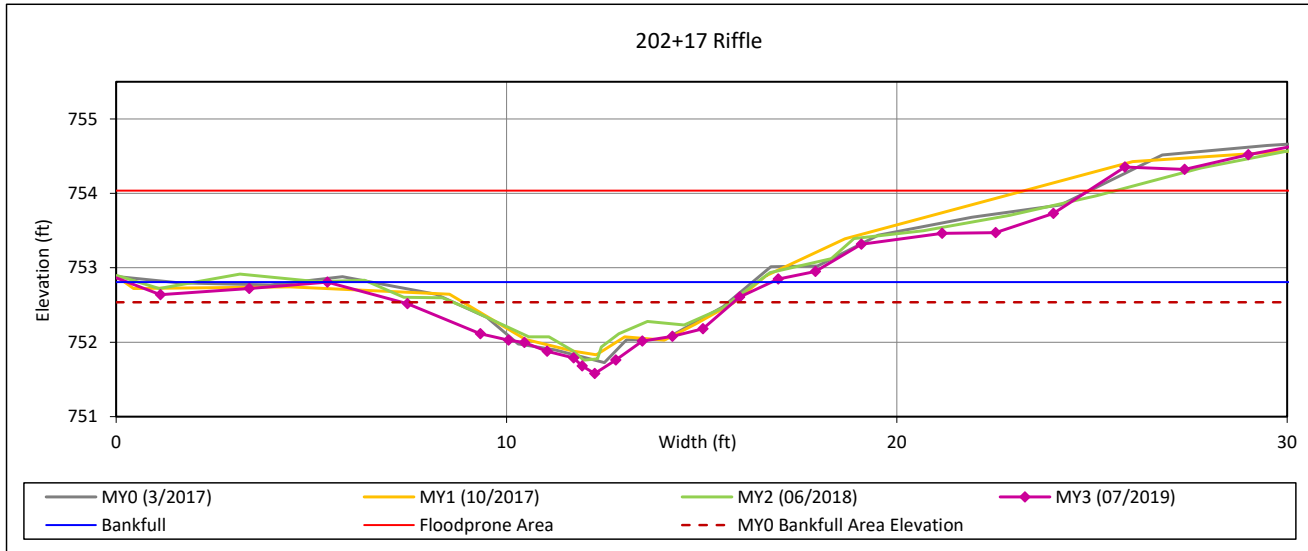
#### Cross-Section 27 - UT1C

#### Bankfull Dimensions

6.7	x-section area (ft.sq.)
11.4	width (ft)
0.6	mean depth (ft)
1.2	max depth (ft)
11.7	wetted perimeter (ft)
0.6	hydraulic radius (ft)
19.4	width-depth ratio
24.9	W flood prone area (ft)
2.2	entrenchment ratio
1.3	low bank height ratio

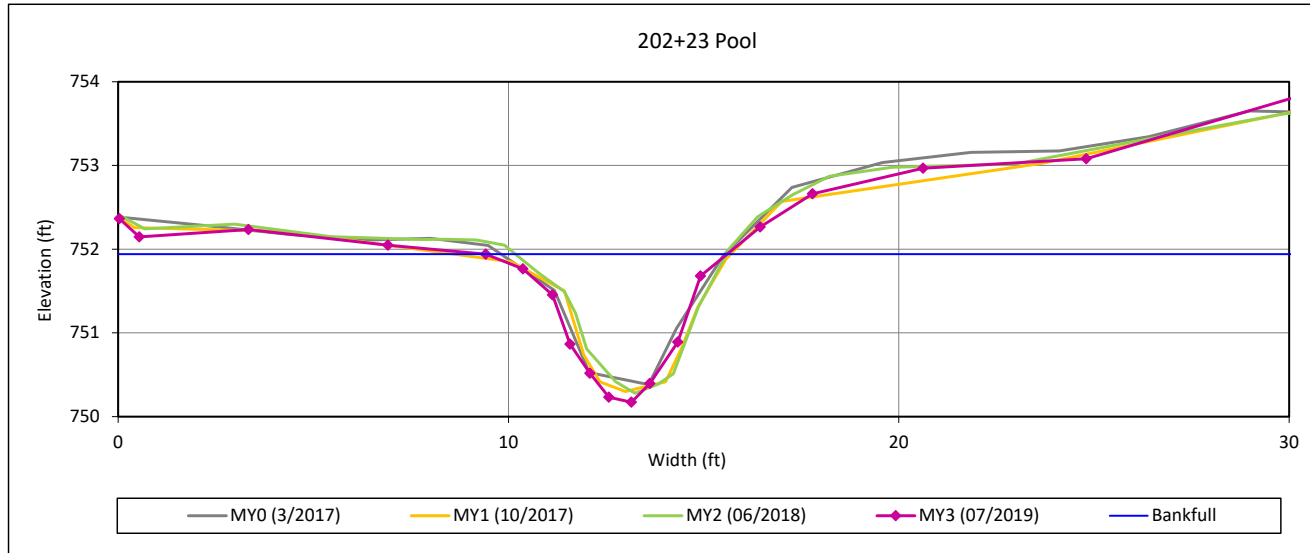
### Cross-Section 28 - UT1C

#### Bankfull Dimensions

5.3	x-section area (ft.sq.)
6.2	width (ft)
0.9	mean depth (ft)
1.8	max depth (ft)
7.4	wetted perimeter (ft)
0.7	hydraulic radius (ft)
7.3	width-depth ratio
