# MONITORING YEAR 3 ANNUAL REPORT

## **CANDY CREEK MITIGATION SITE**

Guilford County, NC

NCDMS Project Number 96315

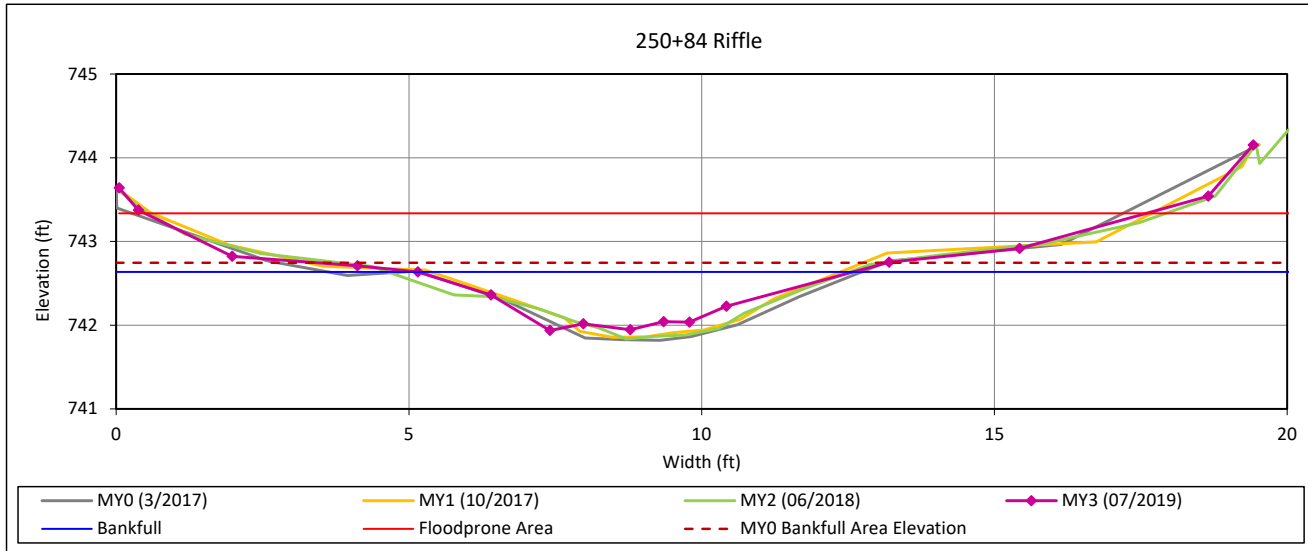
#### Cross-Section 29 - UT1D

#### Bankfull Dimensions

3.0	x-section area (ft.sq.)
7.4	width (ft)
0.4	mean depth (ft)
0.7	max depth (ft)
7.6	wetted perimeter (ft)
0.4	hydraulic radius (ft)
18.7	width-depth ratio
17.1	W flood prone area (ft)
2.3	entrenchment ratio
0.9	low bank height ratio

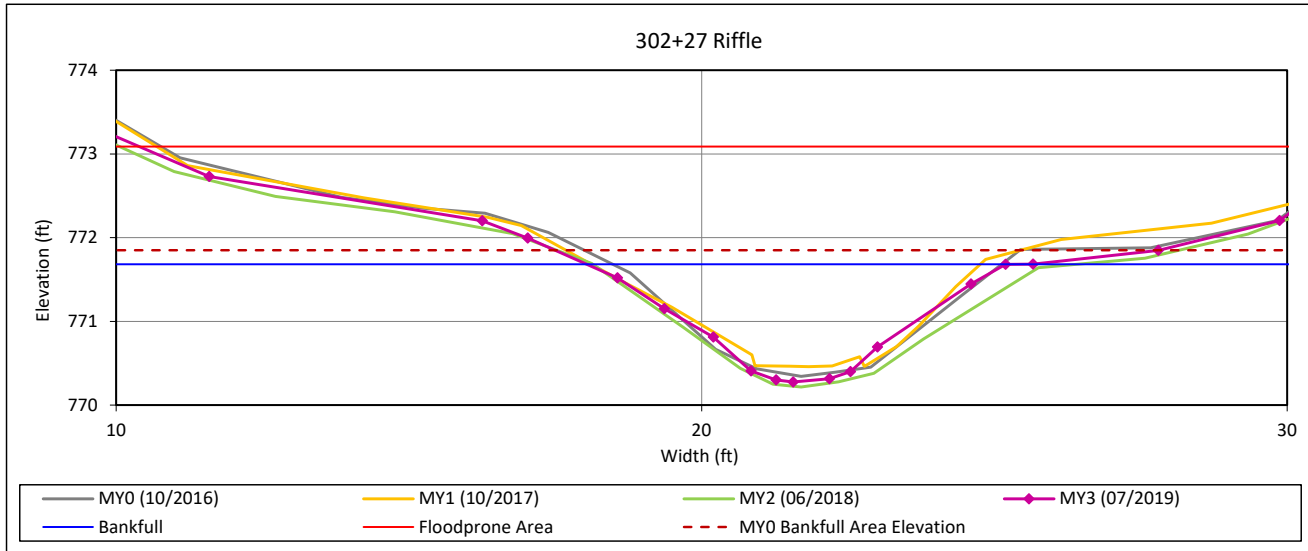
#### Cross-Section 30 - UT2 Reach 1

#### Bankfull Dimensions

5.5	x-section area (ft.sq.)
7.2	width (ft)
0.8	mean depth (ft)
1.4	max depth (ft)
7.8	wetted perimeter (ft)
0.7	hydraulic radius (ft)
9.3	width-depth ratio
21.2	W flood prone area (ft)
3.0	entrenchment ratio
0.9	low bank height ratio

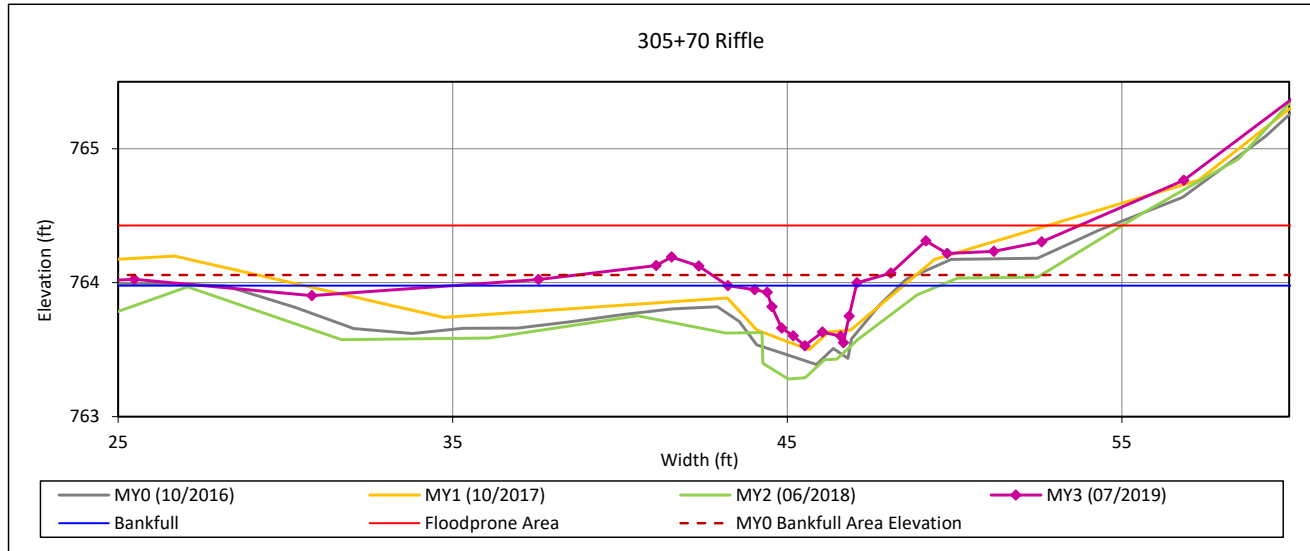
#### Cross-Section 31 - UT2 Reach 1

#### Bankfull Dimensions

0.9	x-section area (ft.sq.)
3.8	width (ft)
0.2	mean depth (ft)
0.4	max depth (ft)
4.1	wetted perimeter (ft)
0.2	hydraulic radius (ft)
16.5	width-depth ratio
48.1	W flood prone area (ft)
12.5	entrenchment ratio
0.9	low bank height ratio

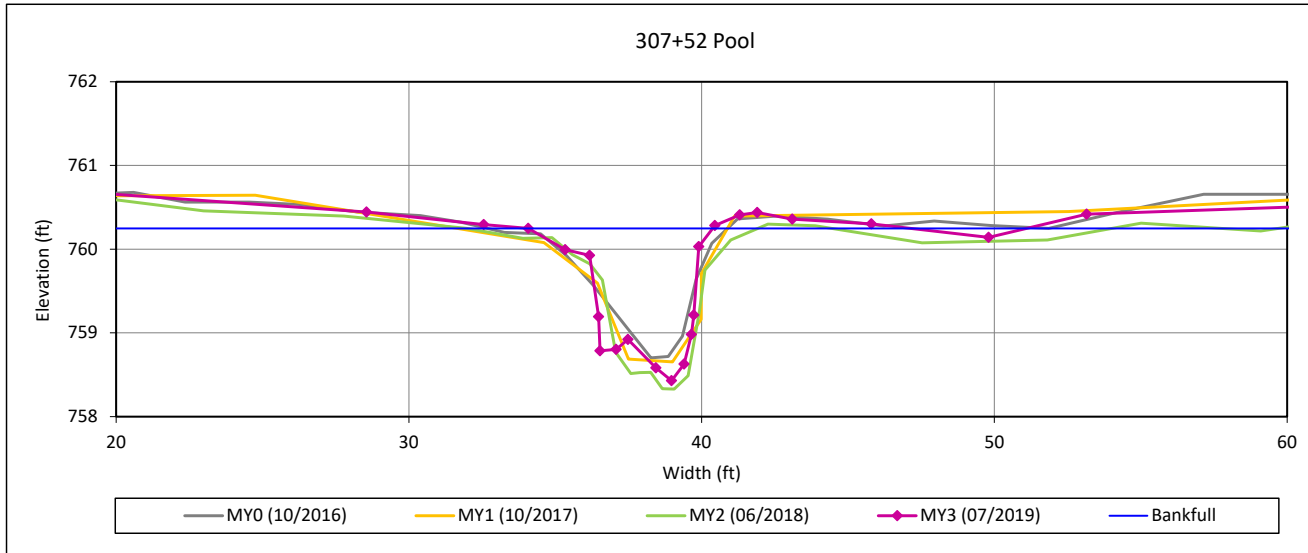
#### Cross-Section 32 - UT2 Reach 1

#### Bankfull Dimensions

5.7	x-section area (ft.sq.)
6.3	width (ft)
0.9	mean depth (ft)
1.8	max depth (ft)
8.4	wetted perimeter (ft)
0.7	hydraulic radius (ft)
6.9	width-depth ratio

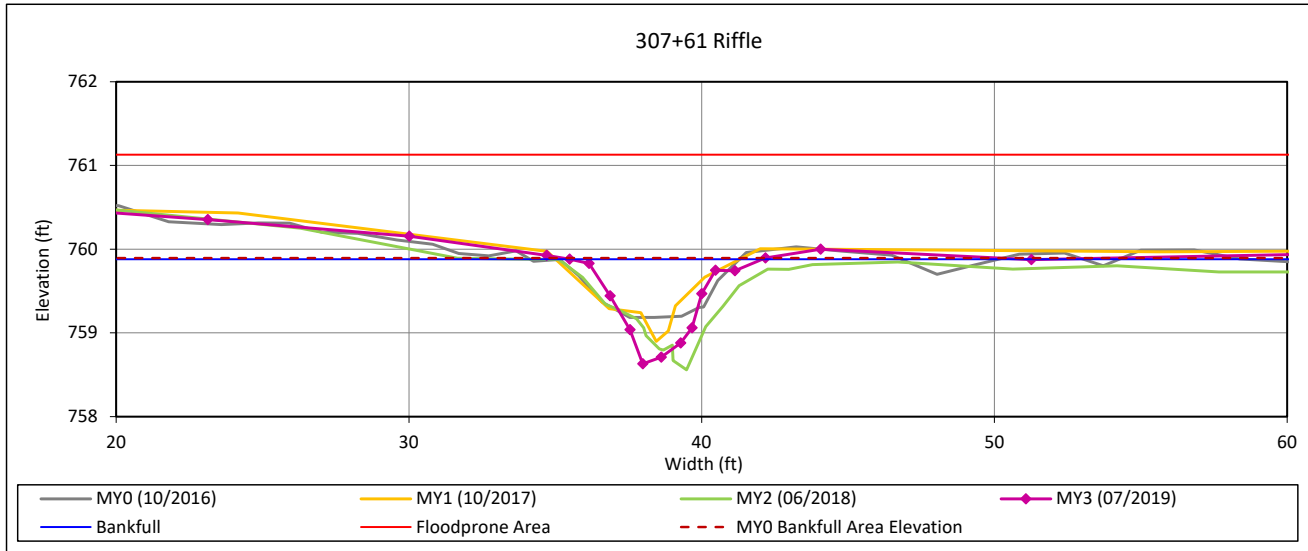
#### Cross-Section 33 - UT2 Reach 1

#### Bankfull Dimensions

3.4	x-section area (ft.sq.)
6.6	width (ft)
0.5	mean depth (ft)
1.2	max depth (ft)
7.3	wetted perimeter (ft)
0.5	hydraulic radius (ft)
12.8	width-depth ratio
78.1	W flood prone area (ft)
11.8	entrenchment ratio
1.0	low bank height ratio

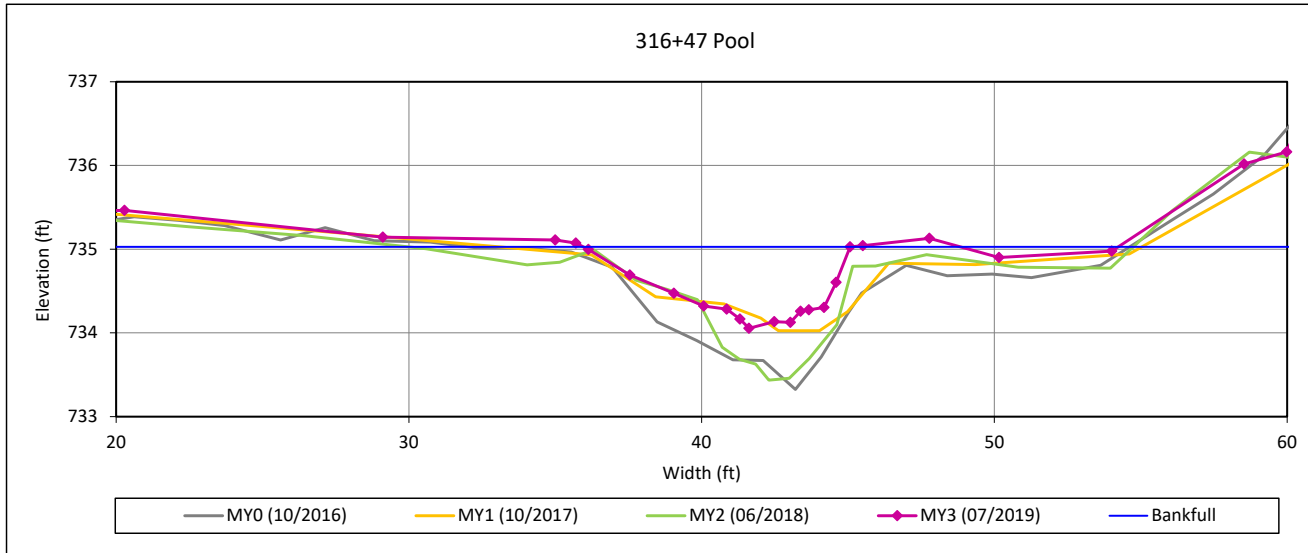
#### Cross-Section 34 - UT2 Reach 2

#### Bankfull Dimensions

5.3	x-section area (ft.sq.)
9.1	width (ft)
0.6	mean depth (ft)
1.0	max depth (ft)
9.5	wetted perimeter (ft)
0.6	hydraulic radius (ft)
15.6	width-depth ratio

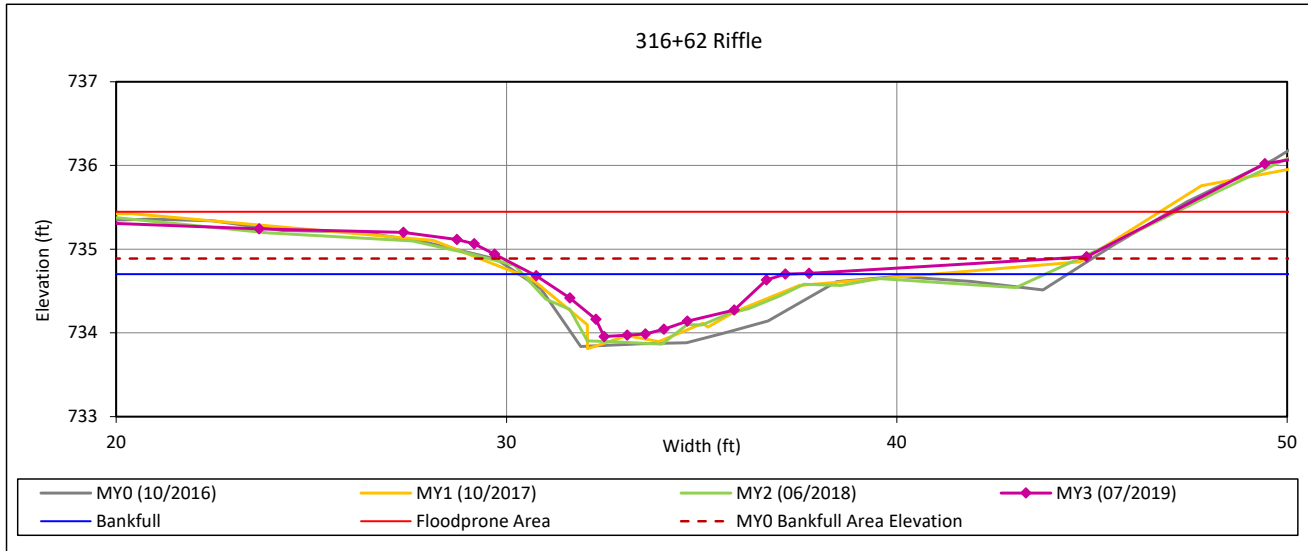
#### Cross-Section 35 - UT2 Reach 2

#### Bankfull Dimensions

2.8	x-section area (ft.sq.)
6.5	width (ft)
0.4	mean depth (ft)
0.7	max depth (ft)
6.7	wetted perimeter (ft)
0.4	hydraulic radius (ft)
14.8	width-depth ratio
37.9	W flood prone area (ft)
5.9	entrenchment ratio
0.8	low bank height ratio

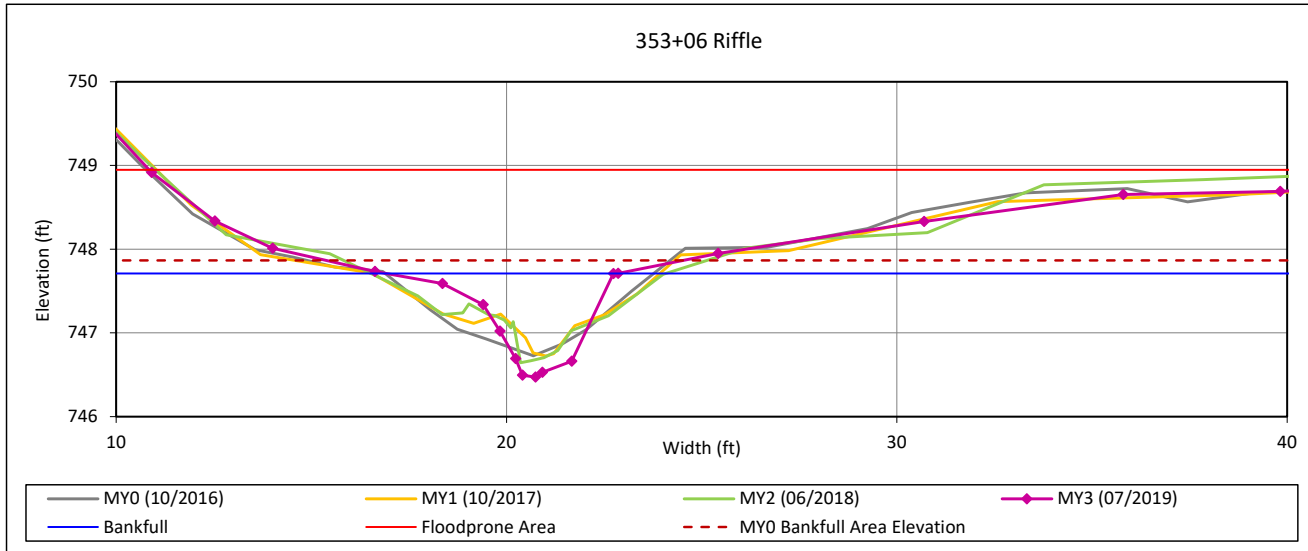
#### Cross-Section 36 - UT2A

#### Bankfull Dimensions

3.1	x-section area (ft.sq.)
5.9	width (ft)
0.5	mean depth (ft)
1.2	max depth (ft)
6.7	wetted perimeter (ft)
0.5	hydraulic radius (ft)
11.2	width-depth ratio
38.2	W flood prone area (ft)
6.4	entrenchment ratio
0.9	low bank height ratio

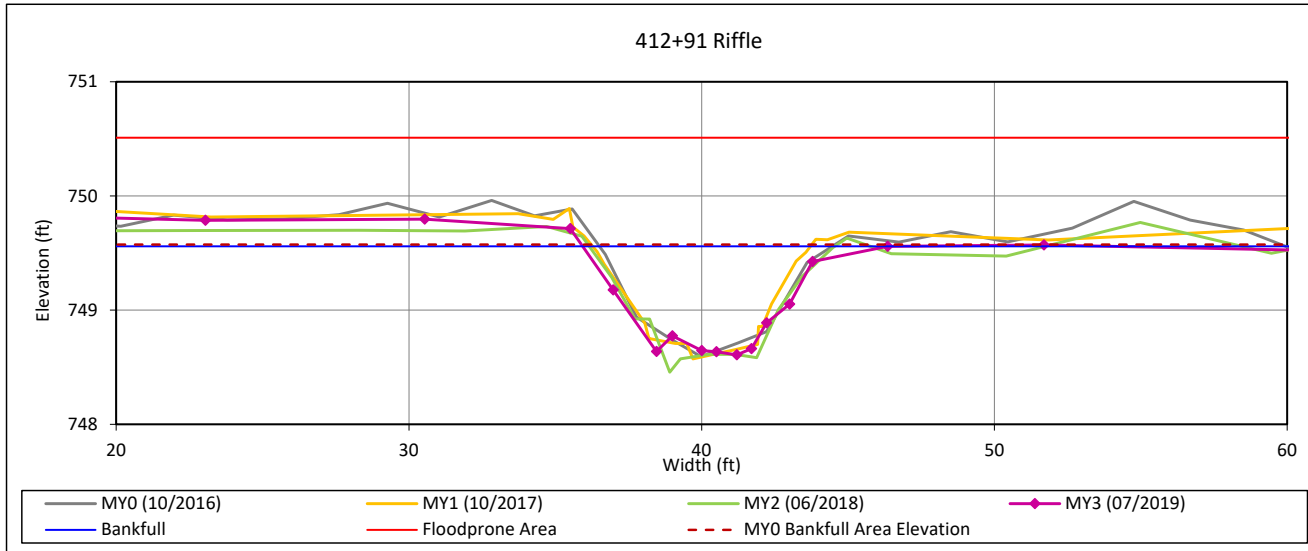
### Cross-Section 37 - UT3

#### Bankfull Dimensions

5.3	x-section area (ft.sq.)
10.4	width (ft)
0.5	mean depth (ft)
1.0	max depth (ft)
10.8	wetted perimeter (ft)
0.5	hydraulic radius (ft)
20.3	width-depth ratio
67.3	W flood prone area (ft)
6.5	entrenchment ratio
1.0	low bank height ratio

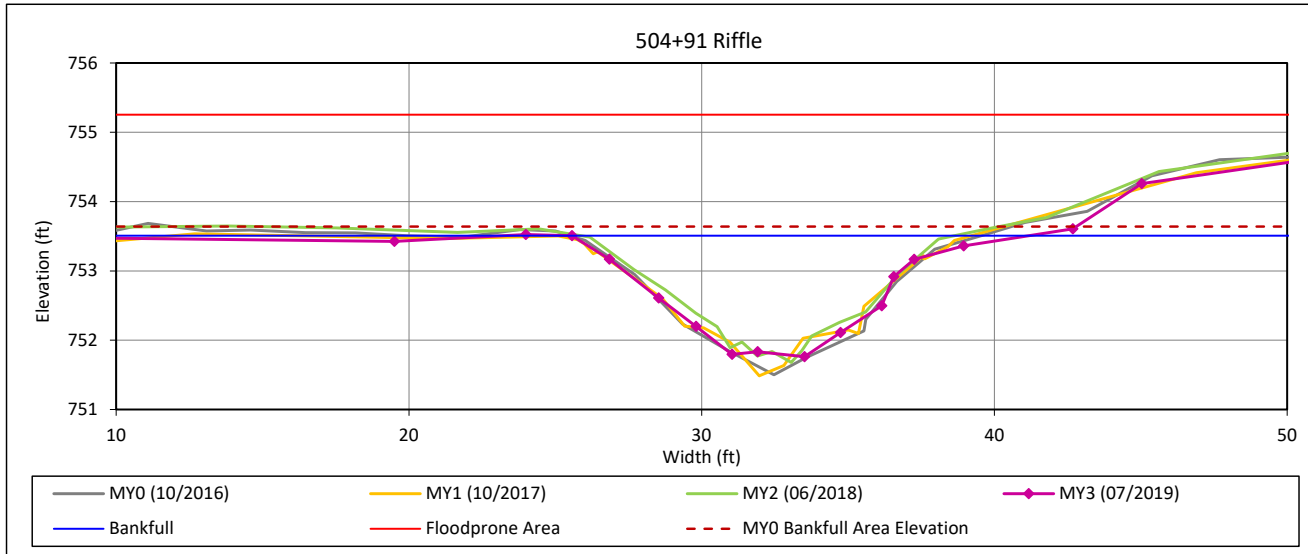
**Cross-Section 38 - UT4**

**Bankfull Dimensions**

13.6	x-section area (ft.sq.)
15.6	width (ft)
0.9	mean depth (ft)
1.7	max depth (ft)
16.2	wetted perimeter (ft)
0.8	hydraulic radius (ft)
17.9	width-depth ratio
58.0	W flood prone area (ft)
3.7	entrenchment ratio
0.9	low bank height ratio

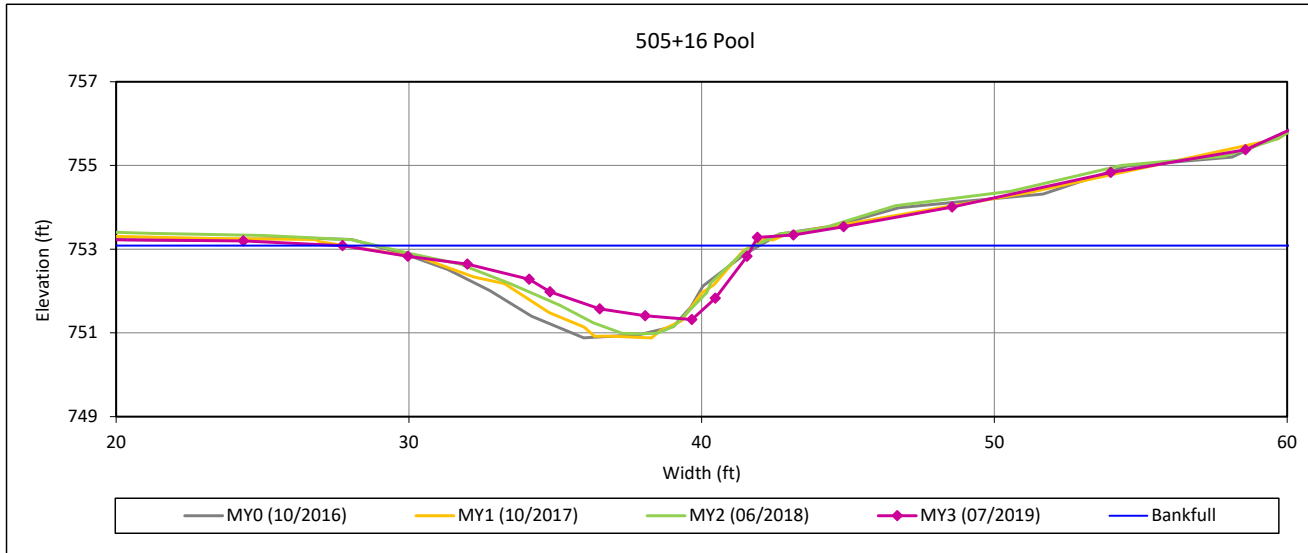
#### Cross-Section 39 - UT4

#### Bankfull Dimensions

12.5	x-section area (ft.sq.)
14.0	width (ft)
0.9	mean depth (ft)
1.8	max depth (ft)
14.9	wetted perimeter (ft)
0.8	hydraulic radius (ft)
15.7	width-depth ratio

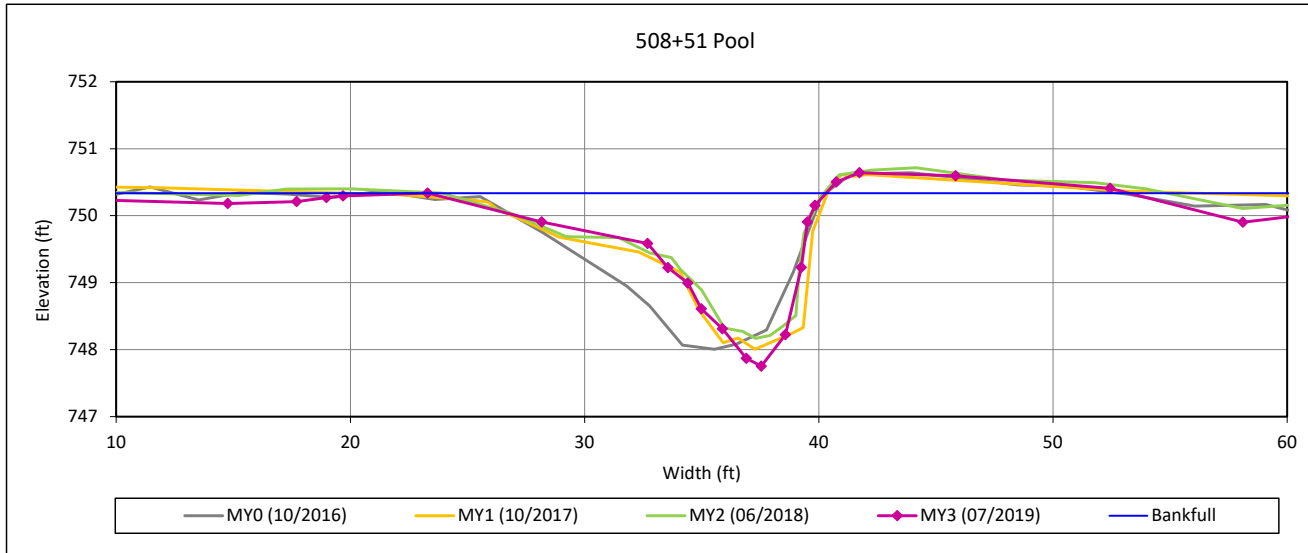
#### Cross-Section 40 - UT4

#### Bankfull Dimensions

15.9	x-section area (ft.sq.)
17.0	width (ft)
0.9	mean depth (ft)
2.6	max depth (ft)
18.6	wetted perimeter (ft)
0.9	hydraulic radius (ft)
18.2	width-depth ratio

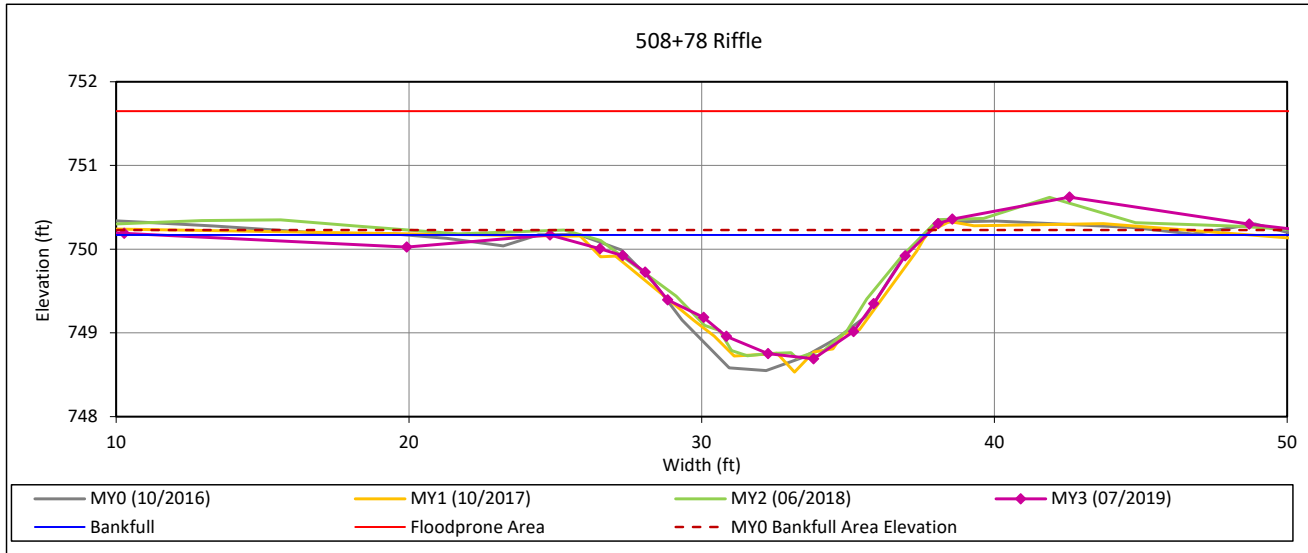
**Cross-Section 41 - UT4**

**Bankfull Dimensions**

10.2	x-section area (ft.sq.)
12.9	width (ft)
0.8	mean depth (ft)
1.5	max depth (ft)
13.3	wetted perimeter (ft)
0.8	hydraulic radius (ft)
16.1	width-depth ratio
69.1	W flood prone area (ft)
5.4	entrenchment ratio
1.0	low bank height ratio

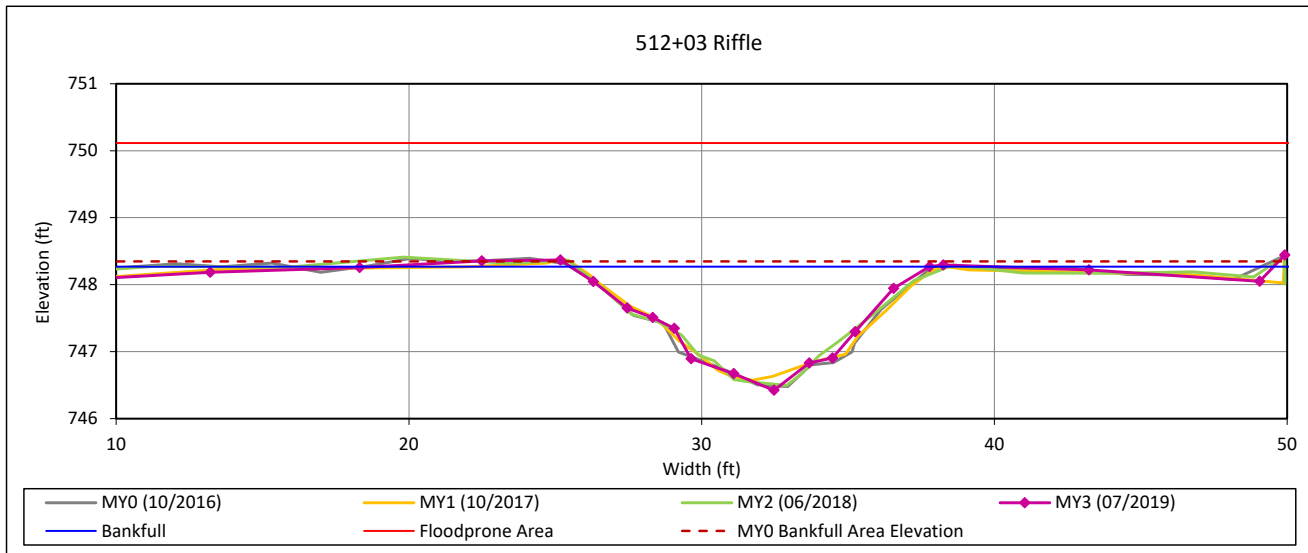
#### Cross-Section 42 - UT4

#### Bankfull Dimensions

12.0	x-section area (ft.sq.)
12.3	width (ft)
1.0	mean depth (ft)
1.8	max depth (ft)
12.9	wetted perimeter (ft)
0.9	hydraulic radius (ft)
12.5	width-depth ratio
49.9	W flood prone area (ft)
4.1	entrenchment ratio
1.0	low bank height ratio

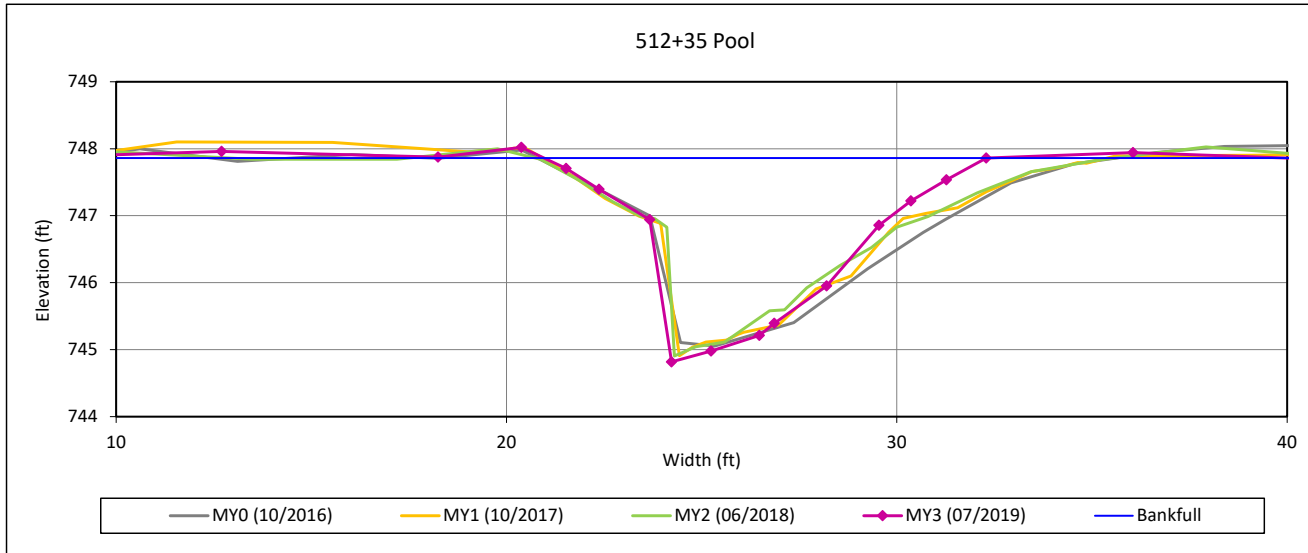
#### Cross-Section 43 - UT4

#### Bankfull Dimensions

15.9	x-section area (ft.sq.)
11.3	width (ft)
1.4	mean depth (ft)
3.0	max depth (ft)
13.8	wetted perimeter (ft)
1.2	hydraulic radius (ft)
8.1	width-depth ratio

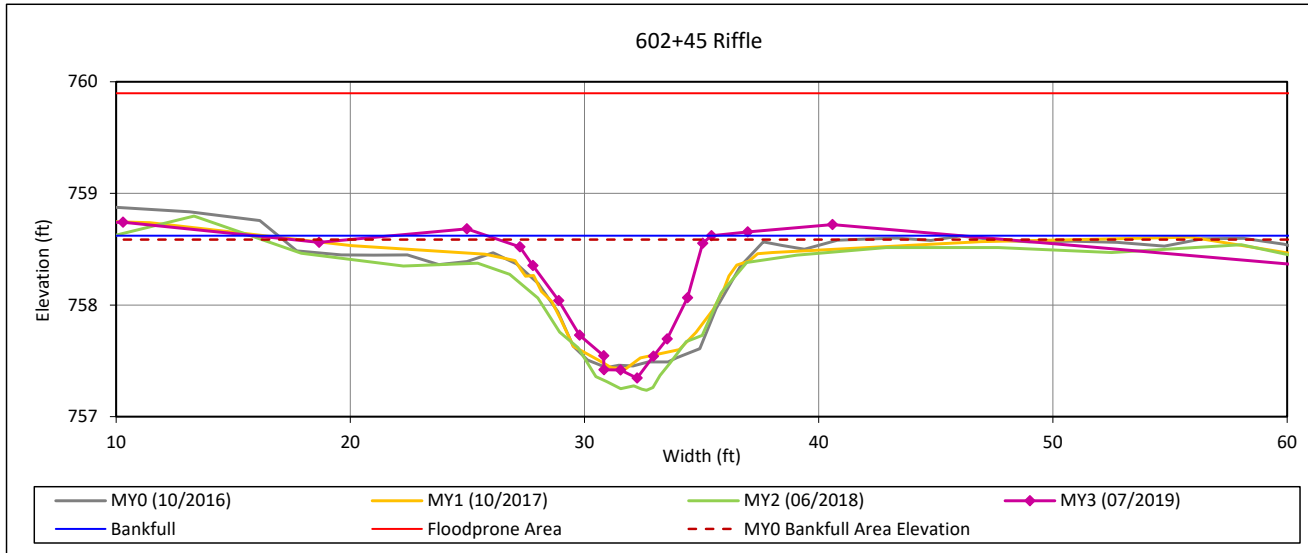
#### Cross-Section 44 - UT5

#### Bankfull Dimensions

6.3	x-section area (ft.sq.)
9.6	width (ft)
0.7	mean depth (ft)
1.3	max depth (ft)
10.1	wetted perimeter (ft)
0.6	hydraulic radius (ft)
14.5	width-depth ratio
82.3	W flood prone area (ft)
8.6	entrenchment ratio
1.0	low bank height ratio

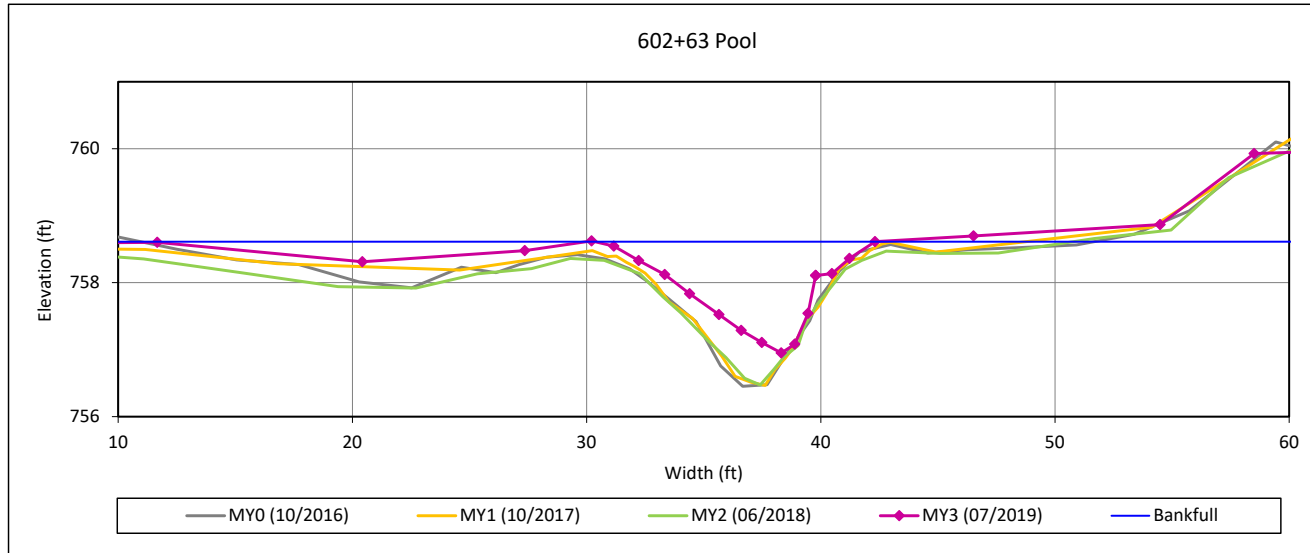
#### Cross-Section 45 - UT5

#### Bankfull Dimensions

8.9	x-section area (ft.sq.)
12.0	width (ft)
0.7	mean depth (ft)
1.7	max depth (ft)
12.7	wetted perimeter (ft)
0.7	hydraulic radius (ft)
16.2	width-depth ratio

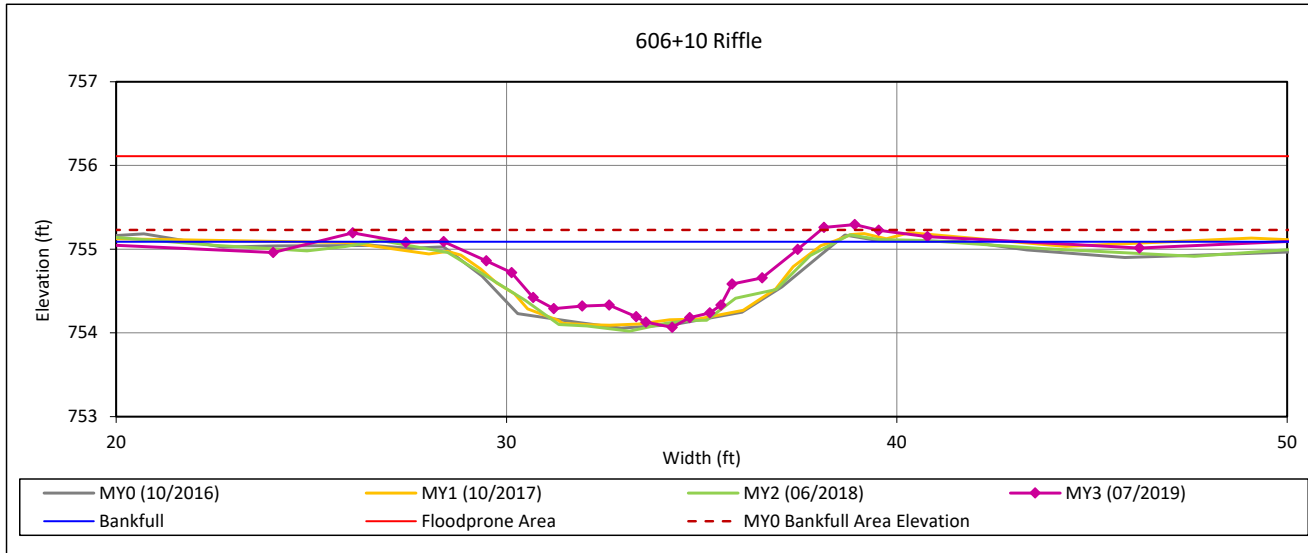
**Cross-Section 46 - UT5**

**Bankfull Dimensions**

5.5	x-section area (ft.sq.)
9.3	width (ft)
0.6	mean depth (ft)
1.0	max depth (ft)
9.7	wetted perimeter (ft)
0.6	hydraulic radius (ft)
15.8	width-depth ratio
56.0	W flood prone area (ft)
6.0	entrenchment ratio
0.9	low bank height ratio

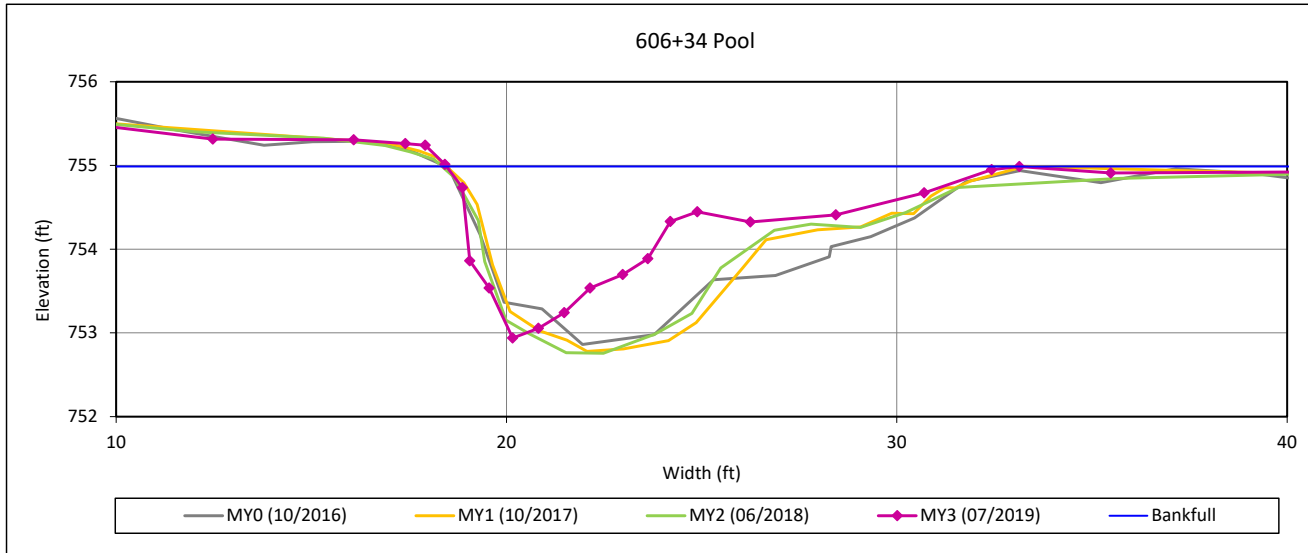
#### Cross-Section 47 - UT5

#### Bankfull Dimensions

11.8	x-section area (ft.sq.)
14.7	width (ft)
0.8	mean depth (ft)
2.0	max depth (ft)
16.1	wetted perimeter (ft)
0.7	hydraulic radius (ft)
18.3	width-depth ratio

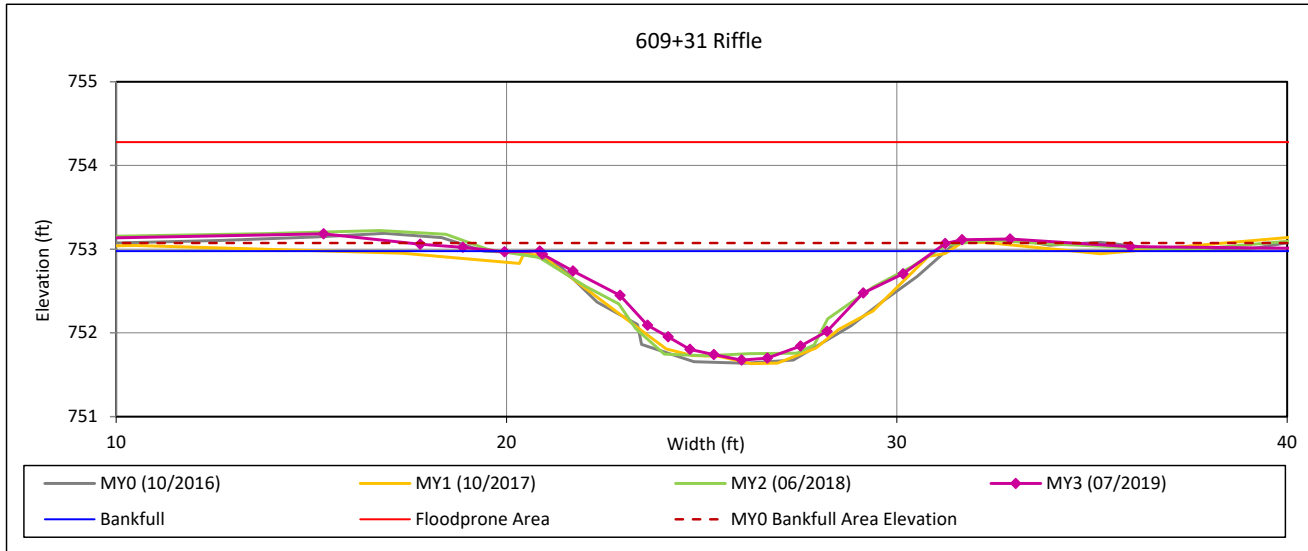
#### Cross-Section 48 - UT5

#### Bankfull Dimensions

7.6	x-section area (ft.sq.)
10.1	width (ft)
0.8	mean depth (ft)
1.3	max depth (ft)
10.5	wetted perimeter (ft)
0.7	hydraulic radius (ft)
13.5	width-depth ratio
53.8	W flood prone area (ft)
5.3	entrenchment ratio
1.0	low bank height ratio

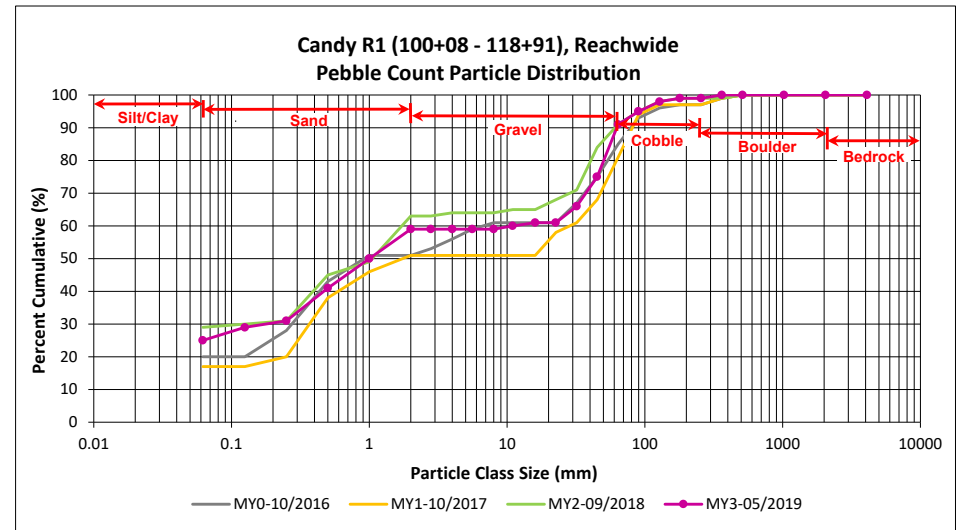
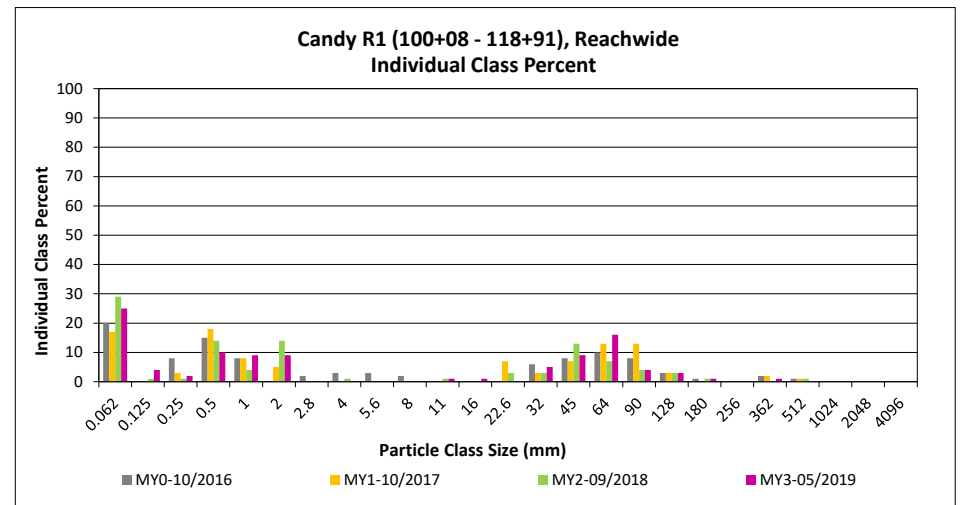
**Reachwide and Cross-Section Pebble Count Plots**

Particle Class		Diameter (mm)		Particle Count			Reach Summary		
		min	max	Riffle	Pool	Total	Class Percentage	Percent Cumulative	
<b>SILT/CLAY</b>		Silt/Clay	0.000	0.062	3	22	25	25	25
<b>SAND</b>	Very fine	0.062	0.125		4	4	4	29	
	Fine	0.125	0.250		2	2	2	31	
	Medium	0.25	0.50	1	9	10	10	41	
	Coarse	0.5	1.0	2	7	9	9	50	
	Very Coarse	1.0	2.0	6	3	9	9	59	
<b>GRAVEL</b>	Very Fine	2.0	2.8					59	
	Very Fine	2.8	4.0					59	
	Fine	4.0	5.6					59	
	Fine	5.6	8.0					59	
	Medium	8.0	11.0		1	1	1	60	
	Medium	11.0	16.0	1		1	1	61	
	Coarse	16.0	22.6					61	
	Coarse	22.6	32	4	1	5	5	66	
	Very Coarse	32	45	9		9	9	75	
	Very Coarse	45	64	16		16	16	91	
<b>COBBLE</b>	Small	64	90	4		4	4	95	
	Small	90	128	3		3	3	98	
	Large	128	180	1		1	1	99	
	Large	180	256					99	
<b>BOULDER</b>	Small	256	362		1	1	1	100	
	Small	362	512					100	
	Medium	512	1024					100	
	Large/Very Large	1024	2048					100	
<b>BEDROCK</b>	Bedrock	2048	>2048					100	
<b>Total</b>				<b>50</b>	<b>50</b>	<b>100</b>	<b>100</b>	<b>100</b>

Reachwide Channel materials (mm)	
D <sub>16</sub> =	Silt/Clay
D <sub>35</sub> =	0.3
D <sub>50</sub> =	1.0
D <sub>84</sub> =	54.9
D <sub>95</sub> =	90.0
D <sub>100</sub> =	362.0

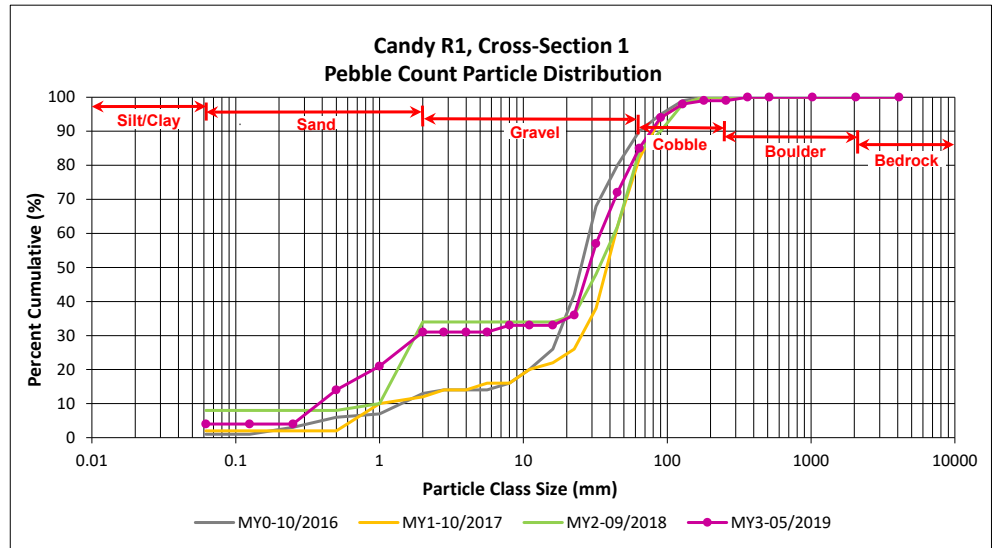
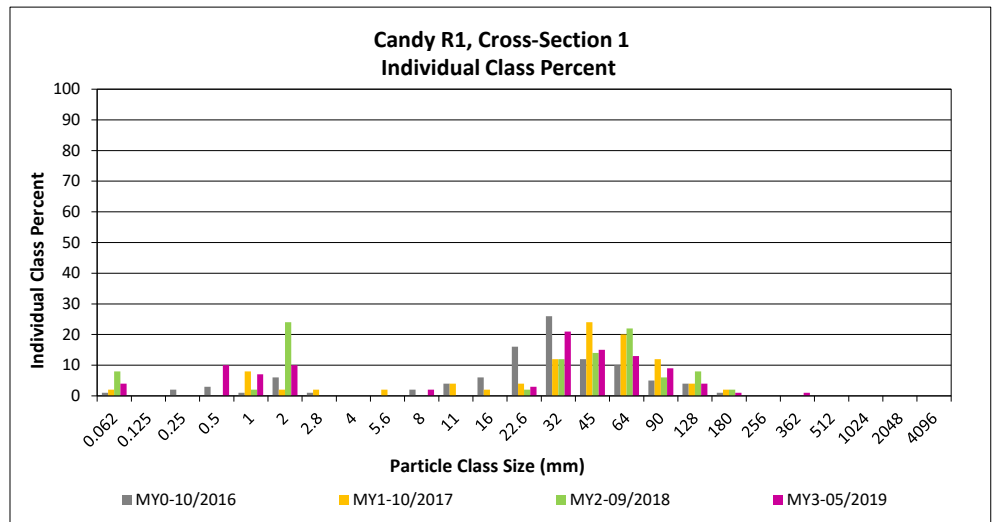
**Reachwide and Cross-Section Pebble Count Plots**

Particle Class		Diameter (mm)		Riffle 100-Count	Summary	
		min	max		Class Percentage	Percent Cumulative
<b>SILT/CLAY</b>	Silt/Clay	0.062	0.062	4	4	4
<b>SAND</b>	Very fine	0.062	0.125			4
	Fine	0.125	0.250			4
	Medium	0.25	0.50	10	10	14
	Coarse	0.5	1.0	7	7	21
	Very Coarse	1.0	2.0	10	10	31
<b>GRAVEL</b>	Very Fine	2.0	2.8			31
	Very Fine	2.8	4.0			31
	Fine	4.0	5.6			31
	Fine	5.6	8.0	2	2	33
	Medium	8.0	11.0			33
	Medium	11.0	16.0			33
	Coarse	16.0	22.6	3	3	36
	Coarse	22.6	32	21	21	57
	Very Coarse	32	45	15	15	72
	Very Coarse	45	64	13	13	85
<b>COBBLE</b>	Small	64	90	9	9	94
	Small	90	128	4	4	98
	Large	128	180	1	1	99
	Large	180	256			99
<b>BOULDER</b>	Small	256	362	1	1	100
	Small	362	512			100
	Medium	512	1024			100
<b>BEDROCK</b>	Large/Very Large	1024	2048			100
	Bedrock	2048	>2048			100
<b>Total</b>				<b>100</b>	<b>100</b>	<b>100</b>

Cross-Section 1	
Channel materials (mm)	
D <sub>16</sub> =	0.6
D <sub>35</sub> =	20.1
D <sub>50</sub> =	28.5
D <sub>84</sub> =	62.3
D <sub>95</sub> =	98.3
D <sub>100</sub> =	362.0

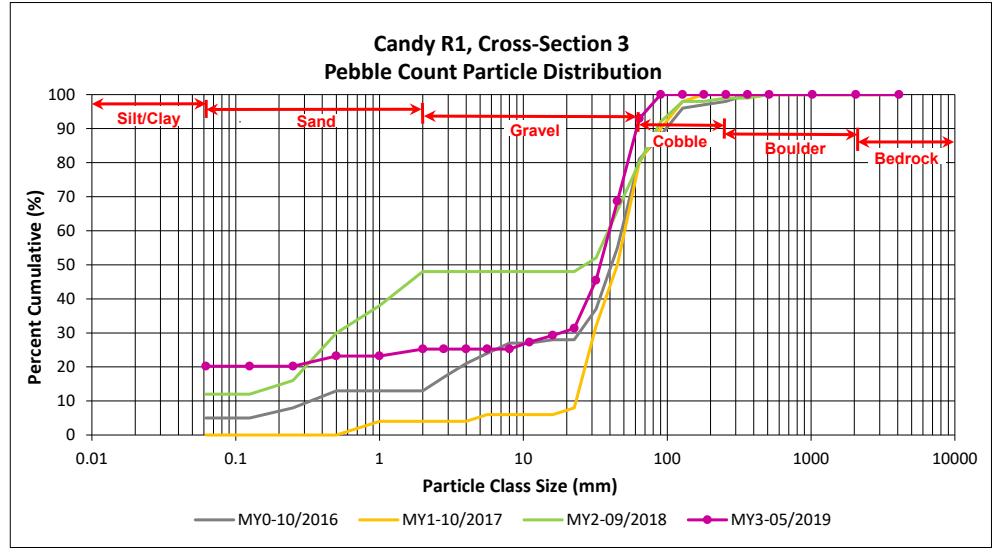
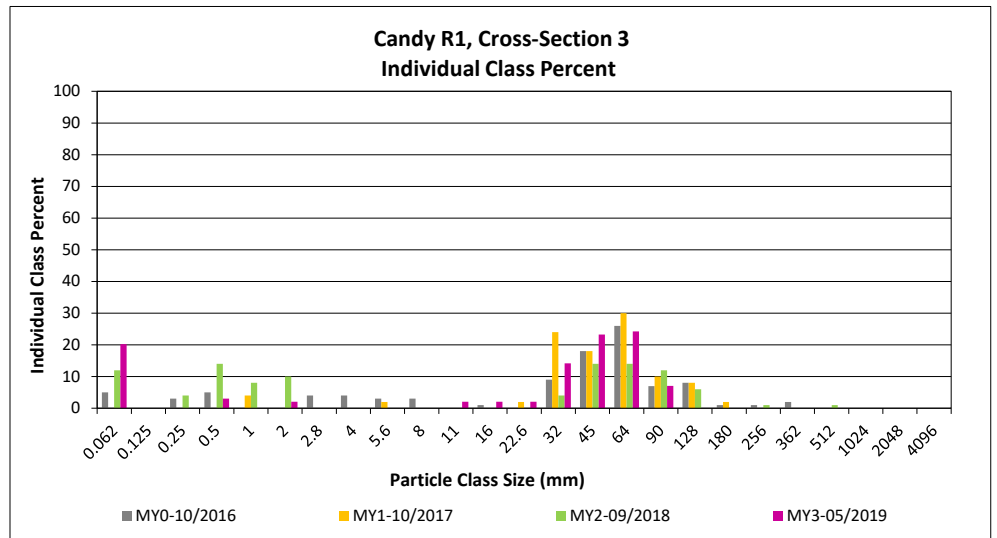
**Reachwide and Cross-Section Pebble Count Plots**

Particle Class		Diameter (mm)		Riffle 100-Count	Summary	
		min	max		Class Percentage	Percent Cumulative
<b>SILT/CLAY</b>	Silt/Clay	0.000	0.062	20	20	20
<b>SAND</b>	Very fine	0.062	0.125			20
	Fine	0.125	0.250			20
	Medium	0.25	0.50	3	3	23
	Coarse	0.5	1.0			23
	Very Coarse	1.0	2.0	2	2	25
<b>GRAVEL</b>	Very Fine	2.0	2.8			25
	Very Fine	2.8	4.0			25
	Fine	4.0	5.6			25
	Fine	5.6	8.0			25
	Medium	8.0	11.0	2	2	27
	Medium	11.0	16.0	2	2	29
	Coarse	16.0	22.6	2	2	31
	Coarse	22.6	32	14	14	45
	Very Coarse	32	45	23	23	69
	Very Coarse	45	64	24	24	93
<b>COBBLE</b>	Small	64	90	7	7	100
	Small	90	128			100
	Large	128	180			100
	Large	180	256			100
<b>BOULDER</b>	Small	256	362			100
	Small	362	512			100
	Medium	512	1024			100
	Large/Very Large	1024	2048			100
<b>BEDROCK</b>	Bedrock	2048	>2048			100
<b>Total</b>				<b>99</b>	<b>100</b>	<b>100</b>

Cross-Section 3	
Channel materials (mm)	
D <sub>16</sub> =	Silt/Clay
D <sub>35</sub> =	24.7
D <sub>50</sub> =	34.2
D <sub>84</sub> =	56.2
D <sub>95</sub> =	70.7
D <sub>100</sub> =	90.0

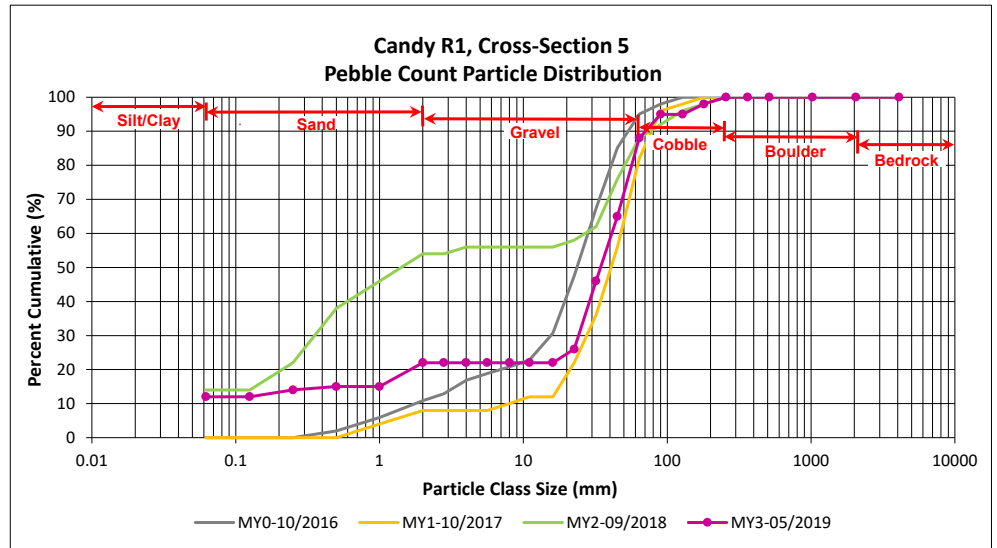
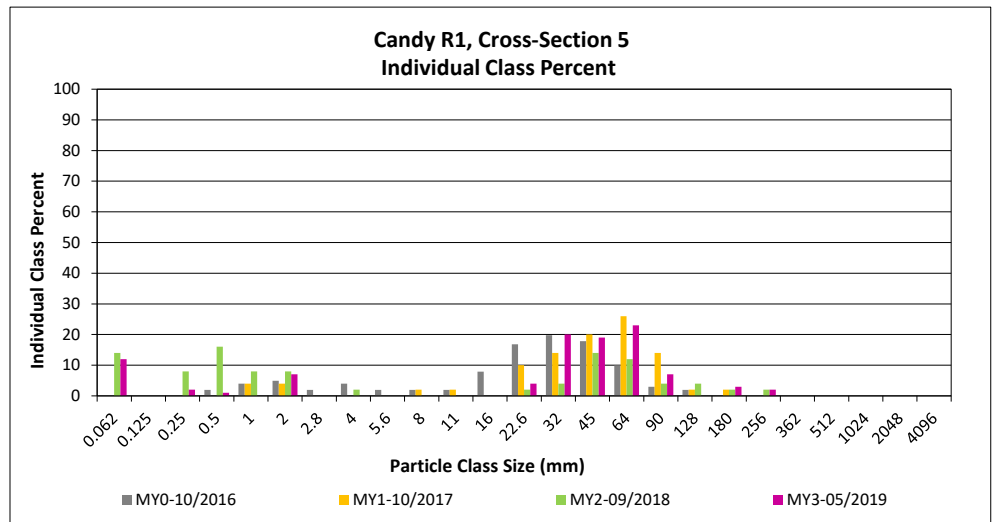
### Reachwide and Cross-Section Pebble Count Plots

Particle Class		Diameter (mm)		Riffle 100-Count	Summary	
		min	max		Class Percentage	Percent Cumulative
<b>SILT/CLAY</b>	Silt/Clay	0.000	0.062	12	12	12
<b>SAND</b>	Very fine	0.062	0.125			12
	Fine	0.125	0.250	2	2	14
	Medium	0.25	0.50	1	1	15
	Coarse	0.5	1.0			15
	Very Coarse	1.0	2.0	7	7	22
<b>GRAVEL</b>	Very Fine	2.0	2.8			22
	Very Fine	2.8	4.0			22
	Fine	4.0	5.6			22
	Fine	5.6	8.0			22
	Medium	8.0	11.0			22
	Medium	11.0	16.0			22
	Coarse	16.0	22.6	4	4	26
	Coarse	22.6	32	20	20	46
	Very Coarse	32	45	19	19	65
	Very Coarse	45	64	23	23	88
<b>COBBLE</b>	Small	64	90	7	7	95
	Small	90	128			95
	Large	128	180	3	3	98
	Large	180	256	2	2	100
<b>BOULDER</b>	Small	256	362			100
	Small	362	512			100
	Medium	512	1024			100
<b>BEDROCK</b>	Large/Very Large	1024	2048			100
	Bedrock	2048	>2048			100
<b>Total</b>				<b>100</b>	<b>100</b>	<b>100</b>

Cross-Section 5 Channel materials (mm)	
D <sub>16</sub> =	1.1
D <sub>35</sub> =	26.4
D <sub>50</sub> =	34.4
D <sub>84</sub> =	60.2
D <sub>95</sub> =	90.0
D <sub>100</sub> =	256.0

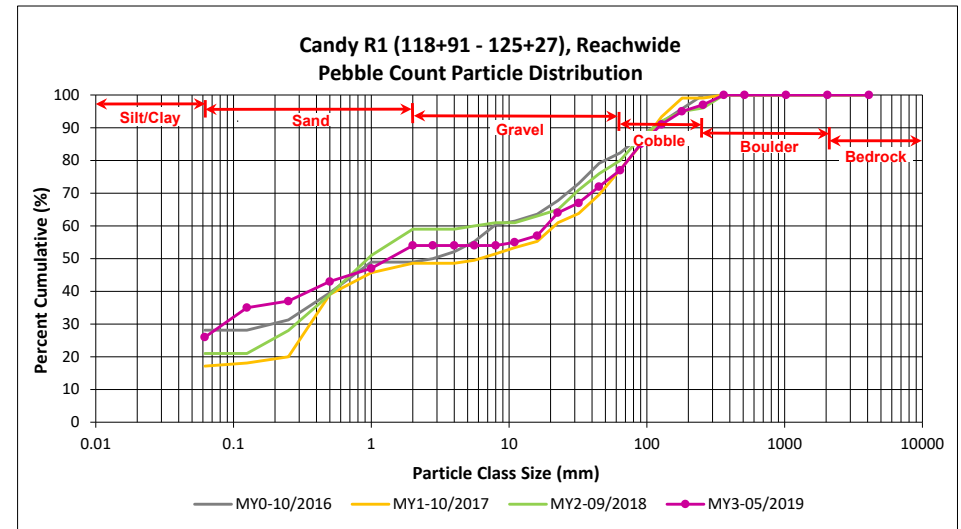
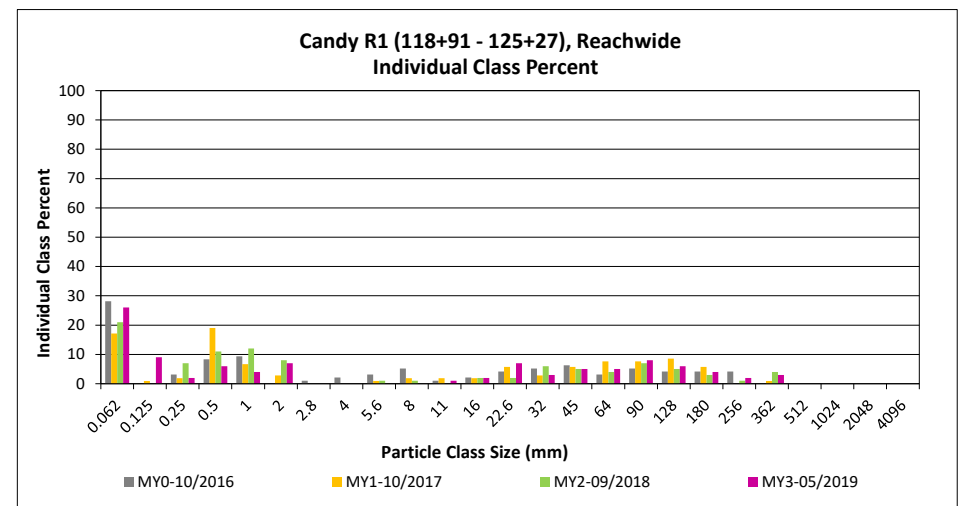
**Reachwide and Cross-Section Pebble Count Plots**

Particle Class		Diameter (mm)		Particle Count			Reach Summary		
		min	max	Riffle	Pool	Total	Class Percentage	Percent Cumulative	
<b>SILT/CLAY</b>		Silt/Clay	0.000	0.062	2	24	26	26	26
<b>SAND</b>	Very fine	0.062	0.125		9	9	9	35	
	Fine	0.125	0.250		2	2	2	37	
	Medium	0.25	0.50		6	6	6	43	
	Coarse	0.5	1.0		4	4	4	47	
	Very Coarse	1.0	2.0	3	4	7	7	54	
<b>GRAVEL</b>	Very Fine	2.0	2.8					54	
	Very Fine	2.8	4.0					54	
	Fine	4.0	5.6					54	
	Fine	5.6	8.0					54	
	Medium	8.0	11.0	1		1	1	55	
	Medium	11.0	16.0	2		2	2	57	
	Coarse	16.0	22.6	7		7	7	64	
	Coarse	22.6	32	3		3	3	67	
	Very Coarse	32	45	5		5	5	72	
	Very Coarse	45	64	5		5	5	77	
<b>COBBLE</b>	Small	64	90	8		8	8	85	
	Small	90	128	6		6	6	91	
	Large	128	180	4		4	4	95	
	Large	180	256	2		2	2	97	
<b>BOULDER</b>	Small	256	362	2	1	3	3	100	
	Small	362	512					100	
	Medium	512	1024					100	
	Large/Very Large	1024	2048					100	
<b>BEDROCK</b>	Bedrock	2048	>2048					100	
<b>Total</b>				<b>50</b>	<b>50</b>	<b>100</b>	<b>100</b>	<b>100</b>

Reachwide Channel materials (mm)	
D <sub>16</sub> =	Silt/Clay
D <sub>35</sub> =	0.1
D <sub>50</sub> =	1.3
D <sub>84</sub> =	86.2
D <sub>95</sub> =	180.0
D <sub>100</sub> =	362.0
