# MONITORING YEAR 3 ANNUAL REPORT

## **CANDY CREEK MITIGATION SITE**

Guilford County, NC

NCDMS Project Number 96315

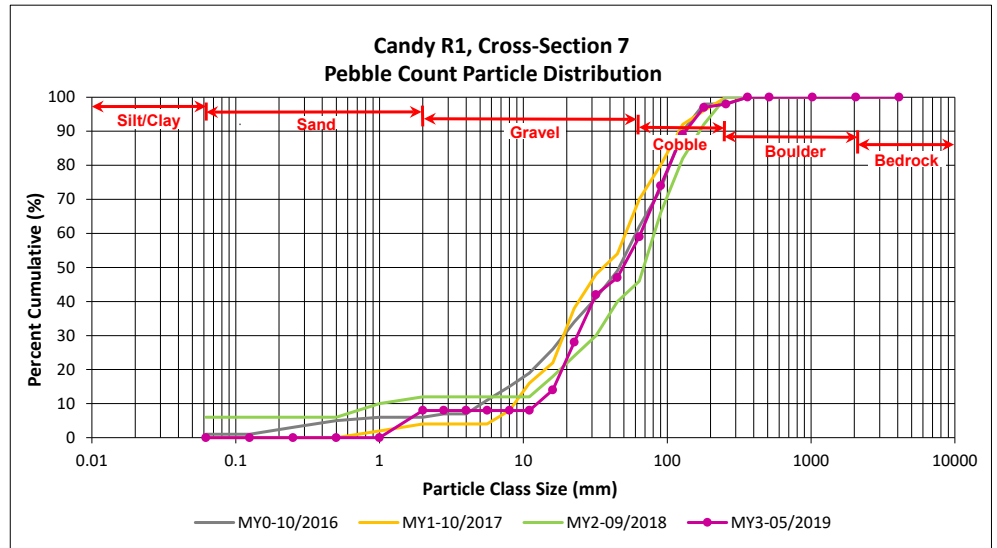
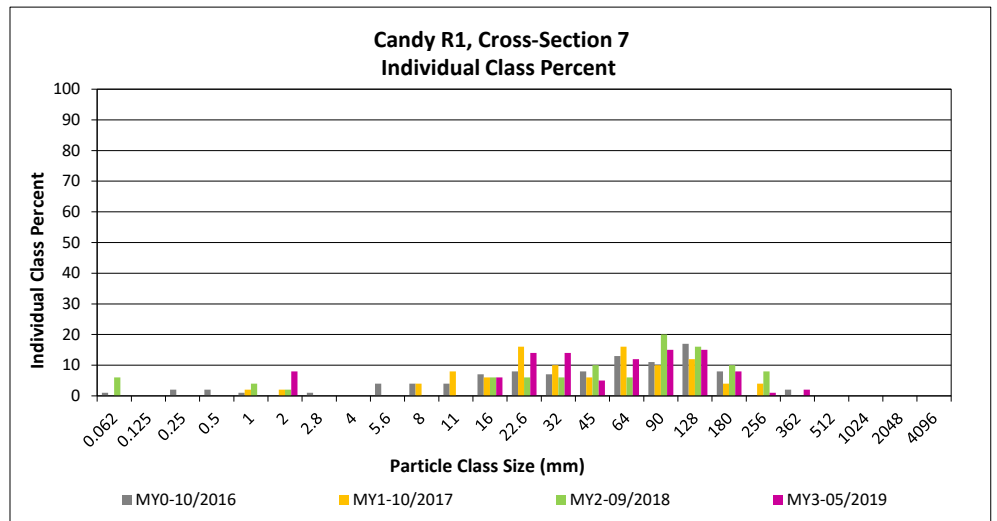
**Reachwide and Cross-Section Pebble Count Plots**

Particle Class		Diameter (mm)		Riffle 100-Count	Summary	
		min	max		Class Percentage	Percent Cumulative
<b>SILT/CLAY</b>	Silt/Clay	0.000	0.062			0
<b>SAND</b>	Very fine	0.062	0.125			0
	Fine	0.125	0.250			0
	Medium	0.25	0.50			0
	Coarse	0.5	1.0			0
	Very Coarse	1.0	2.0	8	8	8
<b>GRAVEL</b>	Very Fine	2.0	2.8			8
	Very Fine	2.8	4.0			8
	Fine	4.0	5.6			8
	Fine	5.6	8.0			8
	Medium	8.0	11.0			8
	Medium	11.0	16.0	6	6	14
	Coarse	16.0	22.6	14	14	28
	Coarse	22.6	32	14	14	42
	Very Coarse	32	45	5	5	47
	Very Coarse	45	64	12	12	59
<b>COBBLE</b>	Small	64	90	15	15	74
	Small	90	128	15	15	89
	Large	128	180	8	8	97
	Large	180	256	1	1	98
<b>BOULDER</b>	Small	256	362	2	2	100
	Small	362	512			100
	Medium	512	1024			100
<b>BEDROCK</b>	Large/Very Large	1024	2048			100
	Bedrock	2048	>2048			100
<b>Total</b>				<b>100</b>	<b>100</b>	<b>100</b>

Cross-Section 7 Channel materials (mm)	
D <sub>16</sub> =	16.8
D <sub>35</sub> =	26.9
D <sub>50</sub> =	49.1
D <sub>84</sub> =	113.8
D <sub>95</sub> =	165.3
D <sub>100</sub> =	362.0

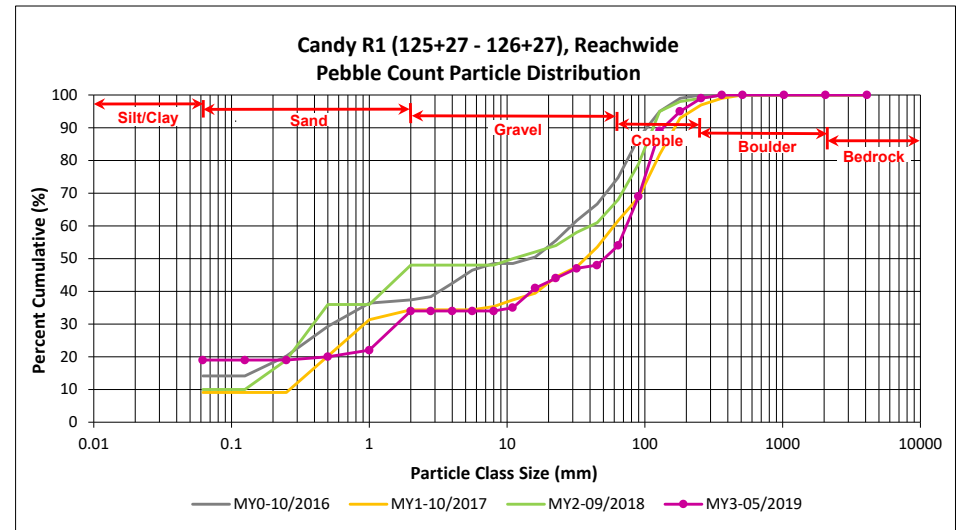
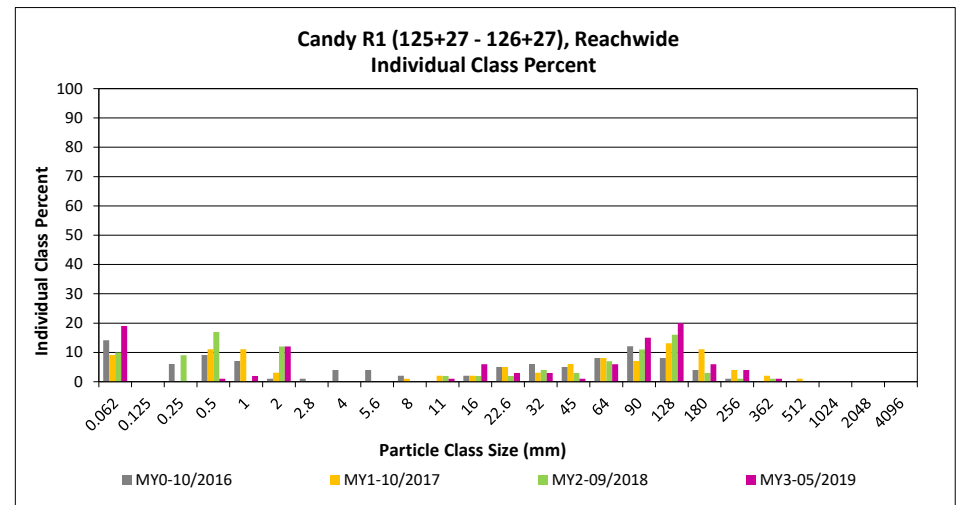
**Reachwide and Cross-Section Pebble Count Plots**

Particle Class		Diameter (mm)		Particle Count			Reach Summary	
		min	max	Riffle	Pool	Total	Class Percentage	Percent Cumulative
<b>SILT/CLAY</b>		Silt/Clay	0.000	0.062	3	16	19	19
<b>SAND</b>	Very fine	0.062	0.125					19
	Fine	0.125	0.250					19
	Medium	0.25	0.50	1		1	1	20
	Coarse	0.5	1.0		2	2	2	22
	Very Coarse	1.0	2.0		12	12	12	34
<b>GRAVEL</b>	Very Fine	2.0	2.8					34
	Very Fine	2.8	4.0					34
	Fine	4.0	5.6					34
	Fine	5.6	8.0					34
	Medium	8.0	11.0		1	1	1	35
	Medium	11.0	16.0	3	3	6	6	41
	Coarse	16.0	22.6	2	1	3	3	44
	Coarse	22.6	32	3		3	3	47
	Very Coarse	32	45	1		1	1	48
	Very Coarse	45	64	6		6	6	54
<b>COBBLE</b>	Small	64	90	15		15	15	69
	Small	90	128	20		20	20	89
	Large	128	180	6		6	6	95
	Large	180	256	4		4	4	99
<b>BOULDER</b>	Small	256	362	1		1	1	100
	Small	362	512					100
	Medium	512	1024					100
	Large/Very Large	1024	2048					100
<b>BEDROCK</b>	Bedrock	2048	>2048					100
<b>Total</b>				<b>65</b>	<b>35</b>	<b>100</b>	<b>100</b>	<b>100</b>

Reachwide Channel materials (mm)	
D <sub>16</sub> =	Silt/Clay
D <sub>35</sub> =	11.0
D <sub>50</sub> =	50.6
D <sub>84</sub> =	117.2
D <sub>95</sub> =	180.0
D <sub>100</sub> =	362.0

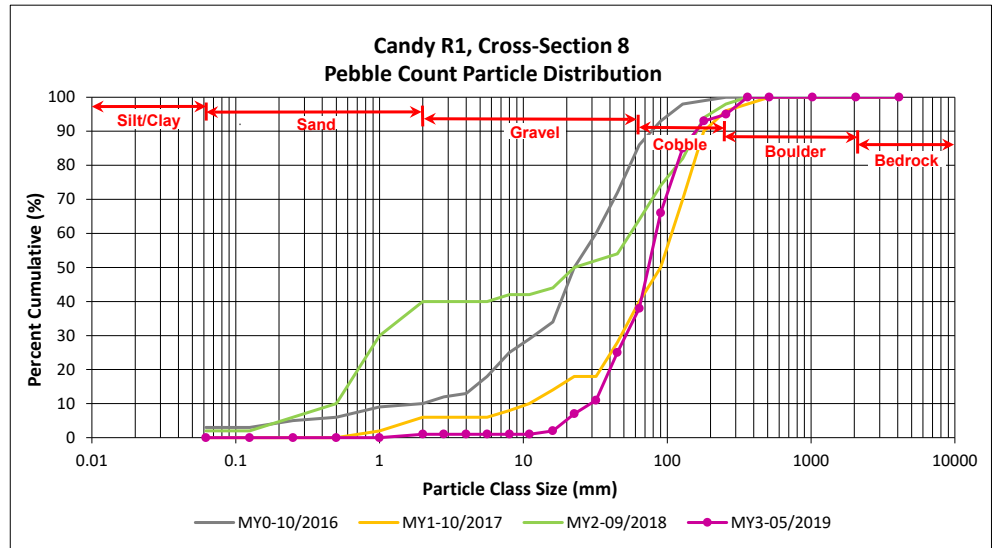
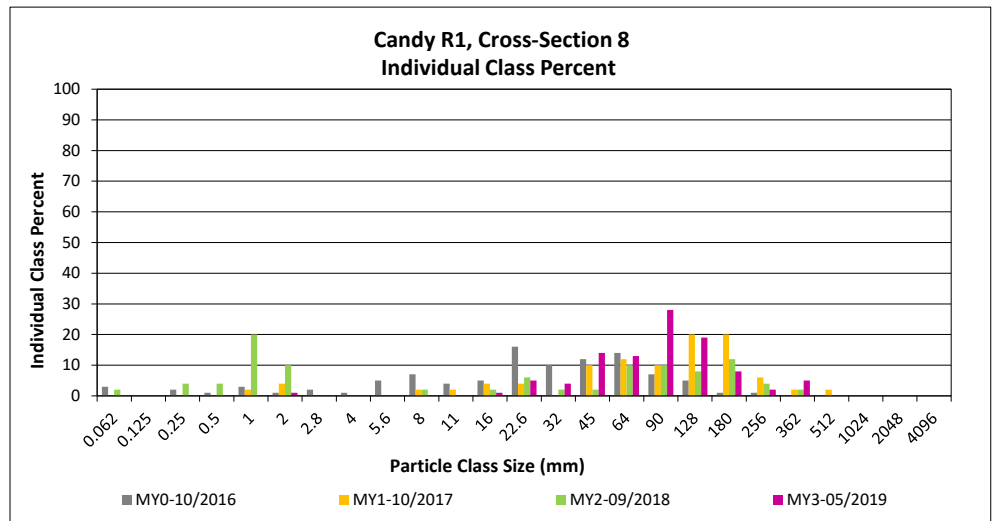
**Reachwide and Cross-Section Pebble Count Plots**

Particle Class		Diameter (mm)		Riffle 100-Count	Summary	
		min	max		Class Percentage	Percent Cumulative
<b>SILT/CLAY</b>		Silt/Clay				0
<b>SAND</b>	Very fine	0.062	0.125			0
	Fine	0.125	0.250			0
	Medium	0.25	0.50			0
	Coarse	0.5	1.0			0
	Very Coarse	1.0	2.0	1	1	1
<b>GRAVEL</b>	Very Fine	2.0	2.8			1
	Very Fine	2.8	4.0			1
	Fine	4.0	5.6			1
	Fine	5.6	8.0			1
	Medium	8.0	11.0			1
	Medium	11.0	16.0	1	1	2
	Coarse	16.0	22.6	5	5	7
	Coarse	22.6	32	4	4	11
	Very Coarse	32	45	14	14	25
	Very Coarse	45	64	13	13	38
<b>COBBLE</b>	Small	64	90	28	28	66
	Small	90	128	19	19	85
	Large	128	180	8	8	93
	Large	180	256	2	2	95
<b>BOULDER</b>	Small	256	362	5	5	100
	Small	362	512			100
	Medium	512	1024			100
<b>BEDROCK</b>	Large/Very Large	1024	2048			100
	Bedrock	2048	>2048			100
<b>Total</b>				<b>100</b>	<b>100</b>	<b>100</b>

Cross-Section 8	
Channel materials (mm)	
D <sub>16</sub> =	36.1
D <sub>35</sub> =	59.0
D <sub>50</sub> =	74.1
D <sub>84</sub> =	125.6
D <sub>95</sub> =	256.0
D <sub>100</sub> =	362.0

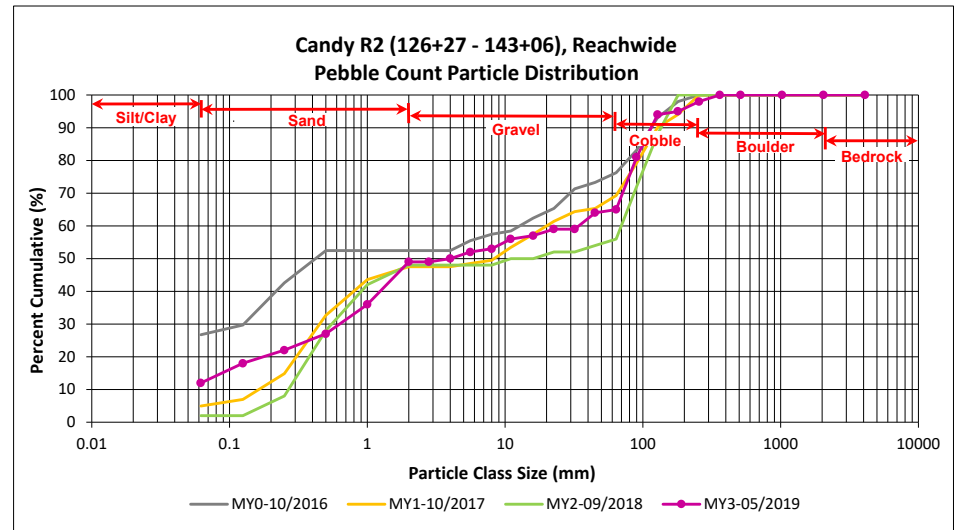
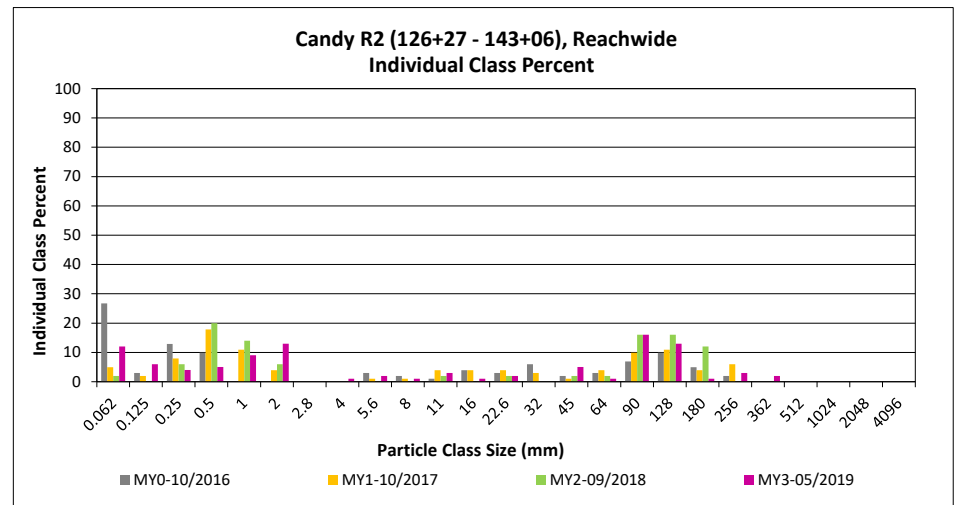
**Reachwide and Cross-Section Pebble Count Plots**

Reachwide Channel materials (mm)	
D <sub>16</sub> =	0.1
D <sub>35</sub> =	0.9
D <sub>50</sub> =	4.0
D <sub>84</sub> =	97.6
D <sub>95</sub> =	180.0
D <sub>100</sub> =	362.0

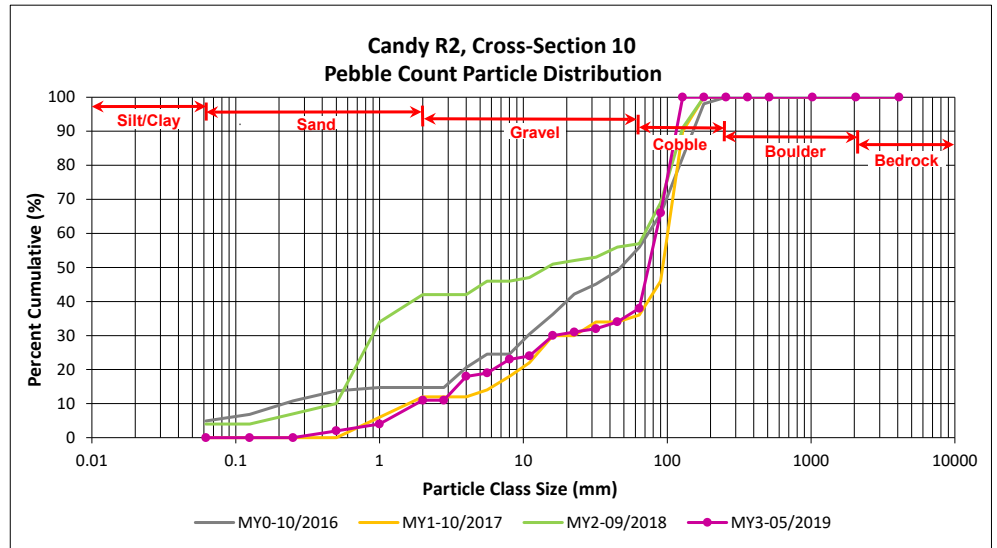
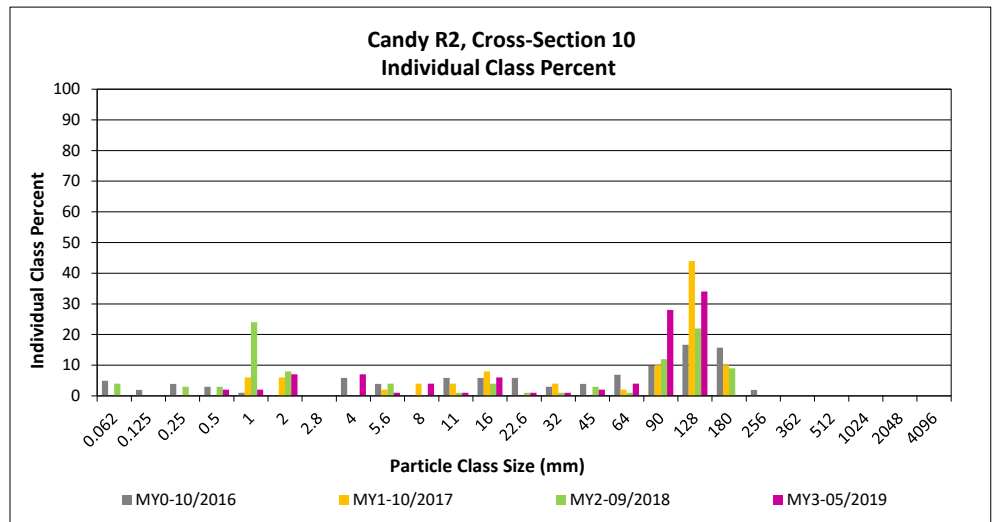
**Reachwide and Cross-Section Pebble Count Plots**

Particle Class		Diameter (mm)		Riffle 100-Count	Summary	
		min	max		Class Percentage	Percent Cumulative
<b>SILT/CLAY</b>	Silt/Clay	0.062	0.062			0
<b>SAND</b>	Very fine	0.062	0.125			0
	Fine	0.125	0.250			0
	Medium	0.25	0.50	2	2	2
	Coarse	0.5	1.0	2	2	4
	Very Coarse	1.0	2.0	7	7	11
<b>GRAVEL</b>	Very Fine	2.0	2.8			11
	Very Fine	2.8	4.0	7	7	18
	Fine	4.0	5.6	1	1	19
	Fine	5.6	8.0	4	4	23
	Medium	8.0	11.0	1	1	24
	Medium	11.0	16.0	6	6	30
	Coarse	16.0	22.6	1	1	31
	Coarse	22.6	32	1	1	32
	Very Coarse	32	45	2	2	34
	Very Coarse	45	64	4	4	38
<b>COBBLE</b>	Small	64	90	28	28	66
	Small	90	128	34	34	100
	Large	128	180			100
	Large	180	256			100
<b>BOULDER</b>	Small	256	362			100
	Small	362	512			100
	Medium	512	1024			100
<b>BEDROCK</b>	Large/Very Large	1024	2048			100
	Bedrock	2048	>2048			100
<b>Total</b>				<b>100</b>	<b>100</b>	<b>100</b>

Cross-Section 10 Channel materials (mm)	
D <sub>16</sub> =	3.6
D <sub>35</sub> =	49.1
D <sub>50</sub> =	74.1
D <sub>84</sub> =	108.4
D <sub>95</sub> =	121.5
D <sub>100</sub> =	128.0

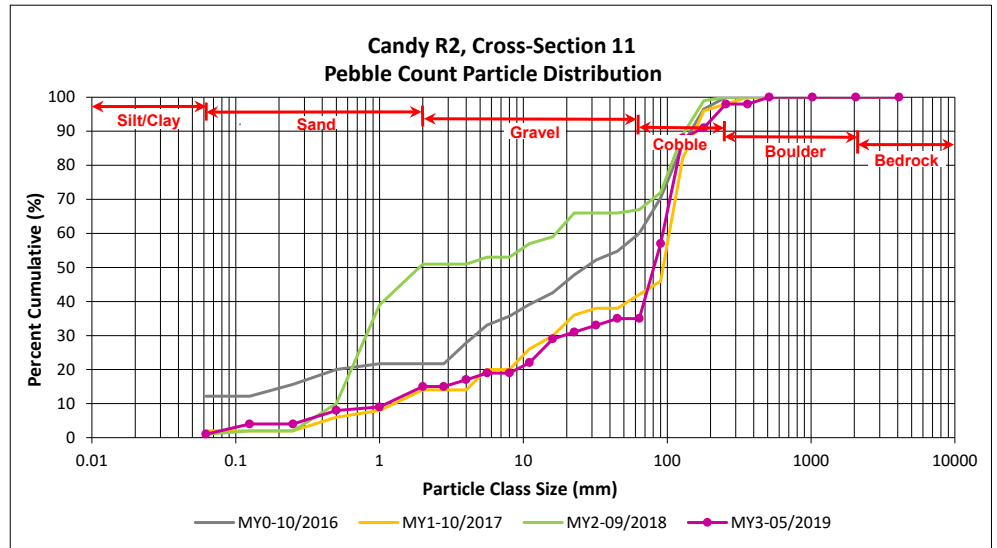
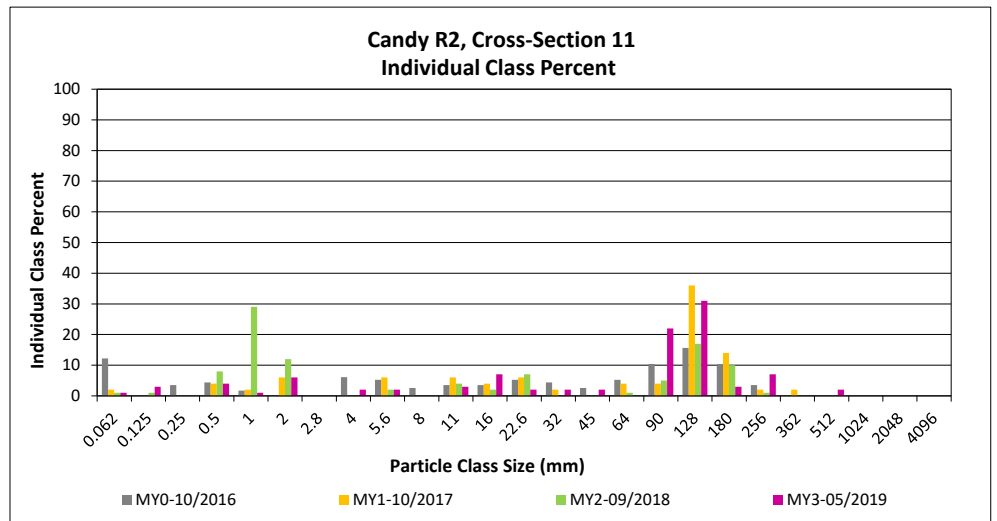
**Reachwide and Cross-Section Pebble Count Plots**

Particle Class		Diameter (mm)		Riffle 100-Count	Summary	
		min	max		Class Percentage	Percent Cumulative
<b>SILT/CLAY</b>	Silt/Clay	0.062	0.062	1	1	1
<b>SAND</b>	Very fine	0.062	0.125	3	3	4
	Fine	0.125	0.250			4
	Medium	0.25	0.50	4	4	8
	Coarse	0.5	1.0	1	1	9
	Very Coarse	1.0	2.0	6	6	15
<b>GRAVEL</b>	Very Fine	2.0	2.8			15
	Very Fine	2.8	4.0	2	2	17
	Fine	4.0	5.6	2	2	19
	Fine	5.6	8.0			19
	Medium	8.0	11.0	3	3	22
	Medium	11.0	16.0	7	7	29
	Coarse	16.0	22.6	2	2	31
	Coarse	22.6	32	2	2	33
	Very Coarse	32	45	2	2	35
	Very Coarse	45	64			35
<b>COBBLE</b>	Small	64	90	22	22	57
	Small	90	128	31	31	88
	Large	128	180	3	3	91
	Large	180	256	7	7	98
<b>BOULDER</b>	Small	256	362			98
	Small	362	512	2	2	100
	Medium	512	1024			100
<b>BEDROCK</b>	Large/Very Large	1024	2048			100
	Bedrock	2048	>2048			100
<b>Total</b>				<b>100</b>	<b>100</b>	<b>100</b>

Cross-Section 11 Channel materials (mm)	
D <sub>16</sub> =	3.3
D <sub>35</sub> =	45.0
D <sub>50</sub> =	80.7
D <sub>84</sub> =	122.3
D <sub>95</sub> =	220.1
D <sub>100</sub> =	512.0

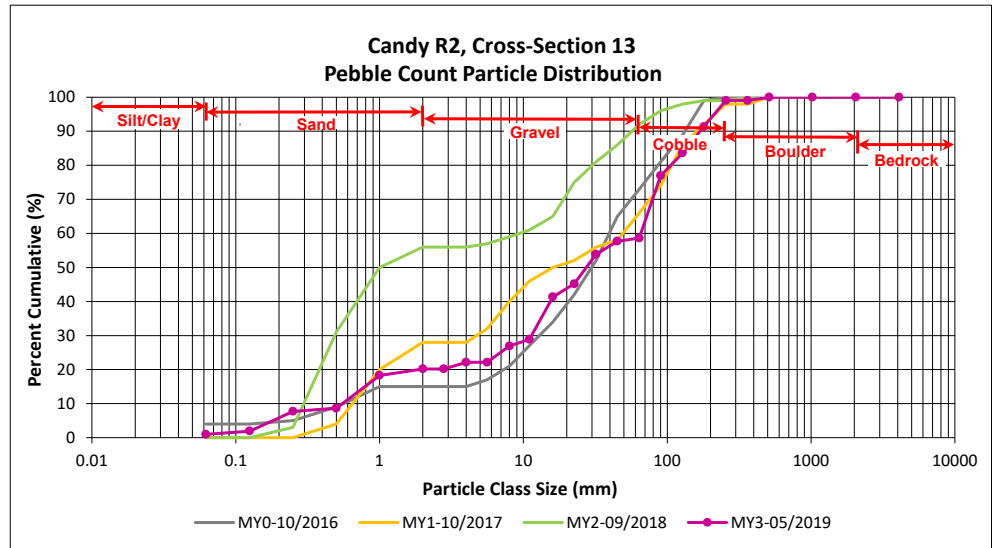
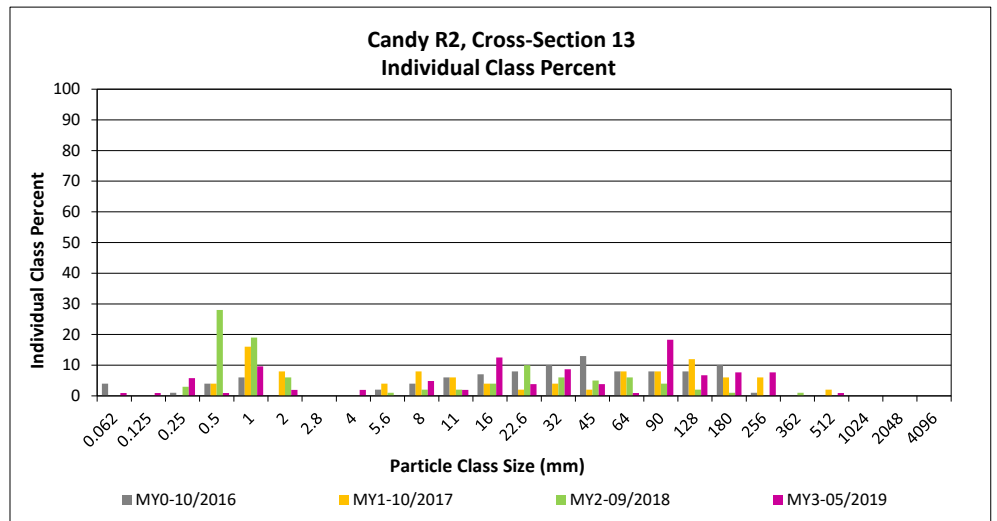
**Reachwide and Cross-Section Pebble Count Plots**

Particle Class		Diameter (mm)		Riffle 100-Count	Summary	
		min	max		Class Percentage	Percent Cumulative
<b>SILT/CLAY</b>	Silt/Clay	0.000	0.062	1	1	1
<b>SAND</b>	Very fine	0.062	0.125	1	1	2
	Fine	0.125	0.250	6	6	8
	Medium	0.25	0.50	1	1	9
	Coarse	0.5	1.0	10	10	18
	Very Coarse	1.0	2.0	2	2	20
<b>GRAVEL</b>	Very Fine	2.0	2.8			20
	Very Fine	2.8	4.0	2	2	22
	Fine	4.0	5.6			22
	Fine	5.6	8.0	5	5	27
	Medium	8.0	11.0	2	2	29
	Medium	11.0	16.0	13	13	41
	Coarse	16.0	22.6	4	4	45
	Coarse	22.6	32	9	9	54
	Very Coarse	32	45	4	4	58
	Very Coarse	45	64	1	1	59
<b>COBBLE</b>	Small	64	90	19	18	77
	Small	90	128	7	7	84
	Large	128	180	8	8	91
	Large	180	256	8	8	99
<b>BOULDER</b>	Small	256	362			99
	Small	362	512	1	1	100
	Medium	512	1024			100
<b>BEDROCK</b>	Large/Very Large	1024	2048			100
	Bedrock	2048	>2048			100
<b>Total</b>				<b>104</b>	<b>100</b>	<b>100</b>

Cross-Section 13 Channel materials (mm)	
D <sub>16</sub> =	0.8
D <sub>35</sub> =	13.2
D <sub>50</sub> =	27.4
D <sub>84</sub> =	130.0
D <sub>95</sub> =	212.8
D <sub>100</sub> =	512.0

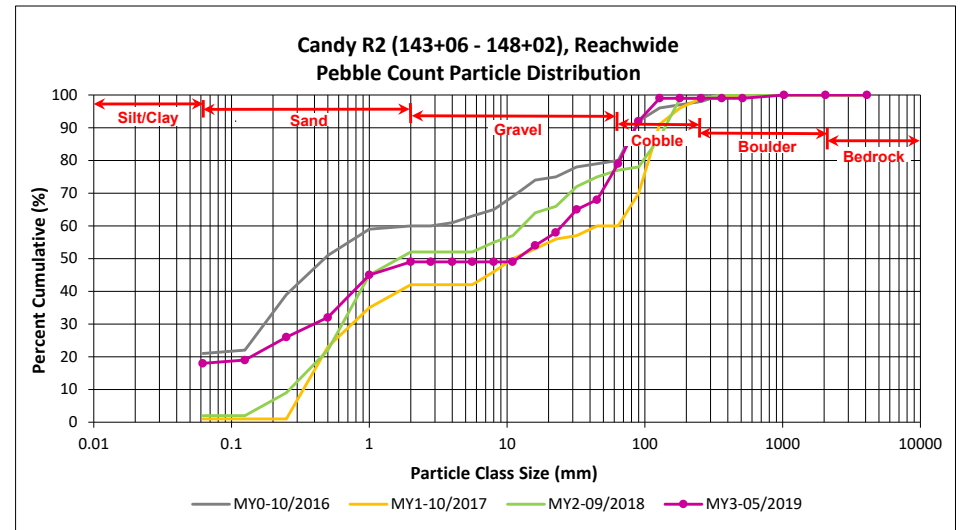
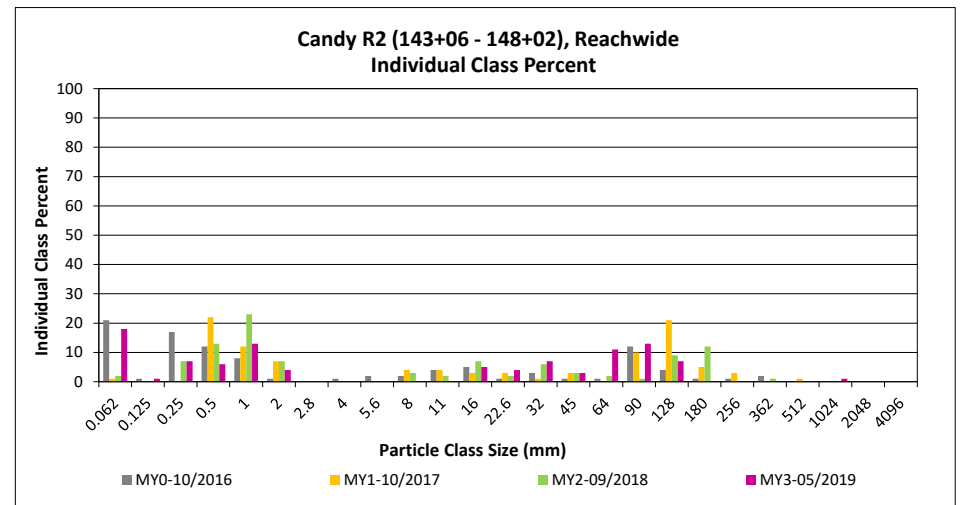
**Reachwide and Cross-Section Pebble Count Plots**

Particle Class		Diameter (mm)		Particle Count			Reach Summary		
		min	max	Riffle	Pool	Total	Class Percentage	Percent Cumulative	
<b>SILT/CLAY</b>		Silt/Clay	0.000	0.062		18	18	18	18
<b>SAND</b>	Very fine	0.062	0.125	1		1	1	19	
	Fine	0.125	0.250	1	6	7	7	26	
	Medium	0.25	0.50	1	5	6	6	32	
	Coarse	0.5	1.0	1	12	13	13	45	
	Very Coarse	1.0	2.0		4	4	4	49	
<b>GRAVEL</b>	Very Fine	2.0	2.8					49	
	Very Fine	2.8	4.0					49	
	Fine	4.0	5.6					49	
	Fine	5.6	8.0					49	
	Medium	8.0	11.0					49	
	Medium	11.0	16.0	3	2	5	5	54	
	Coarse	16.0	22.6	4		4	4	58	
	Coarse	22.6	32	4	3	7	7	65	
	Very Coarse	32	45	3		3	3	68	
	Very Coarse	45	64	11		11	11	79	
<b>COBBLE</b>	Small	64	90	13		13	13	92	
	Small	90	128	7		7	7	99	
	Large	128	180					99	
	Large	180	256					99	
<b>BOULDER</b>	Small	256	362					99	
	Small	362	512					99	
	Medium	512	1024	1		1	1	100	
<b>BEDROCK</b>	Large/Very Large	1024	2048					100	
	Bedrock	2048	>2048					100	
<b>Total</b>				<b>50</b>	<b>50</b>	<b>100</b>	<b>100</b>	<b>100</b>

Reachwide Channel materials (mm)	
D <sub>16</sub> =	Silt/Clay
D <sub>35</sub> =	0.6
D <sub>50</sub> =	11.9
D <sub>84</sub> =	73.0
D <sub>95</sub> =	104.7
D <sub>100</sub> =	1024.0

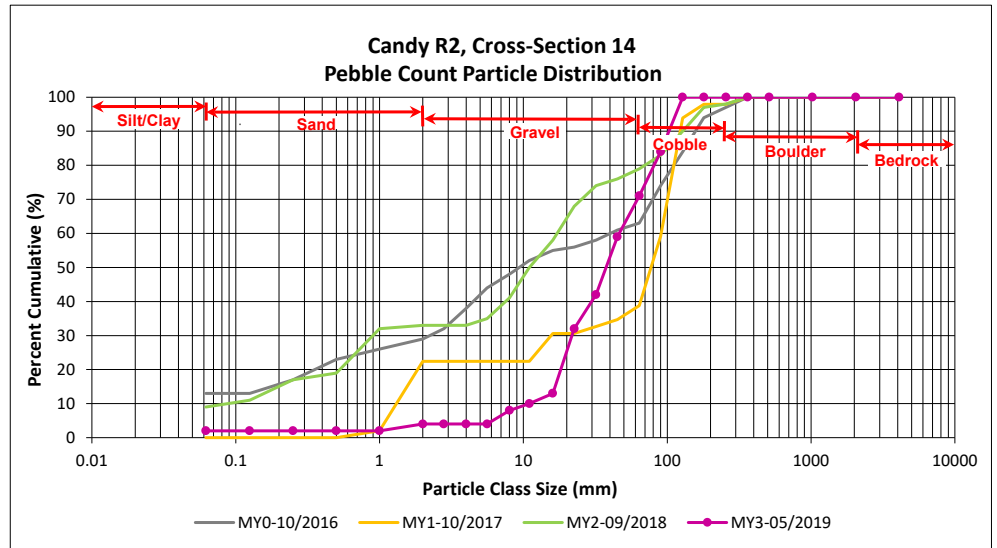
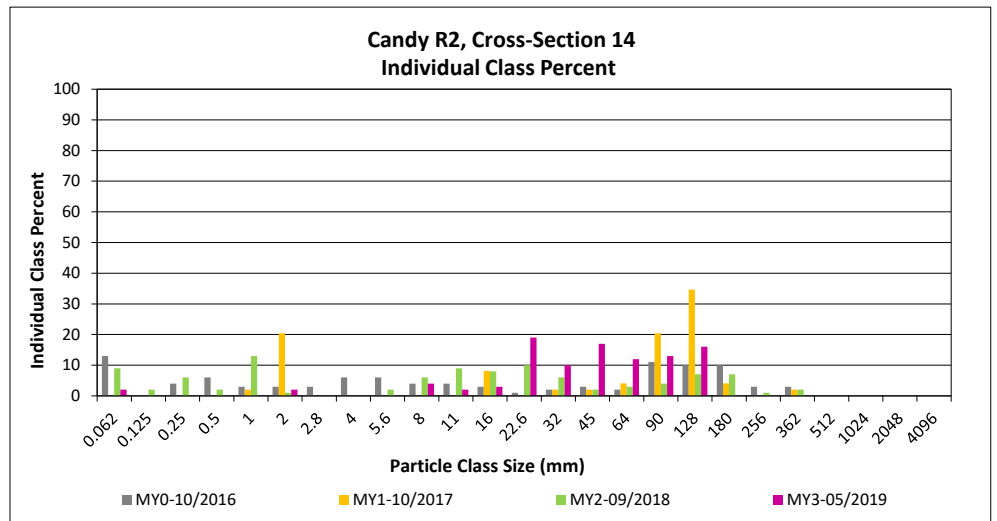
**Reachwide and Cross-Section Pebble Count Plots**

Particle Class		Diameter (mm)		Riffle 100-Count	Summary	
		min	max		Class Percentage	Percent Cumulative
<b>SILT/CLAY</b>	Silt/Clay	0.000	0.062	2	2	2
<b>SAND</b>	Very fine	0.062	0.125			2
	Fine	0.125	0.250			2
	Medium	0.25	0.50			2
	Coarse	0.5	1.0			2
	Very Coarse	1.0	2.0	2	2	4
<b>GRAVEL</b>	Very Fine	2.0	2.8			4
	Very Fine	2.8	4.0			4
	Fine	4.0	5.6			4
	Fine	5.6	8.0	4	4	8
	Medium	8.0	11.0	2	2	10
	Medium	11.0	16.0	3	3	13
	Coarse	16.0	22.6	19	19	32
	Coarse	22.6	32	10	10	42
	Very Coarse	32	45	17	17	59
	Very Coarse	45	64	12	12	71
<b>COBBLE</b>	Small	64	90	13	13	84
	Small	90	128	16	16	100
	Large	128	180			100
	Large	180	256			100
<b>BOULDER</b>	Small	256	362			100
	Small	362	512			100
	Medium	512	1024			100
<b>BEDROCK</b>	Large/Very Large	1024	2048			100
	Bedrock	2048	>2048			100
<b>Total</b>				<b>100</b>	<b>100</b>	<b>100</b>

Cross-Section 14 Channel materials (mm)	
D <sub>16</sub> =	16.9
D <sub>35</sub> =	25.1
D <sub>50</sub> =	37.6
D <sub>84</sub> =	90.0
D <sub>95</sub> =	114.7
D <sub>100</sub> =	128.0

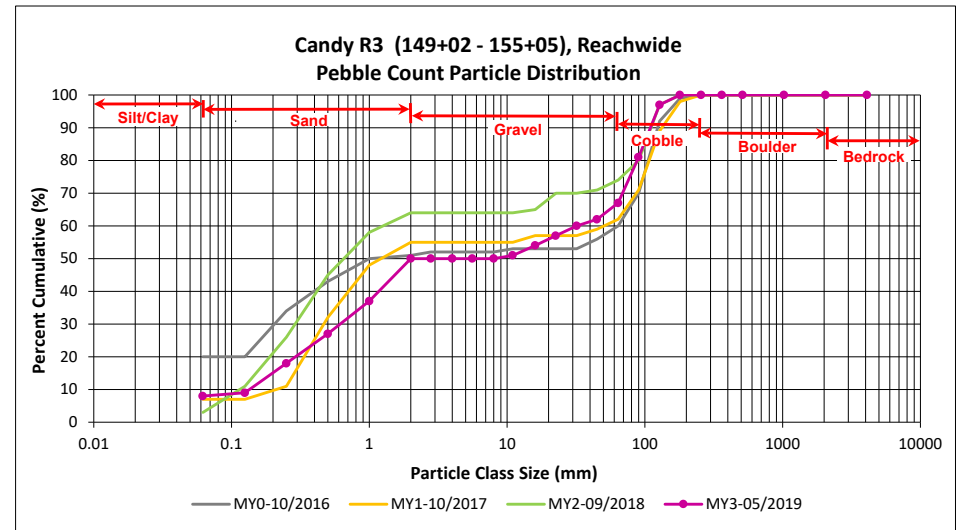
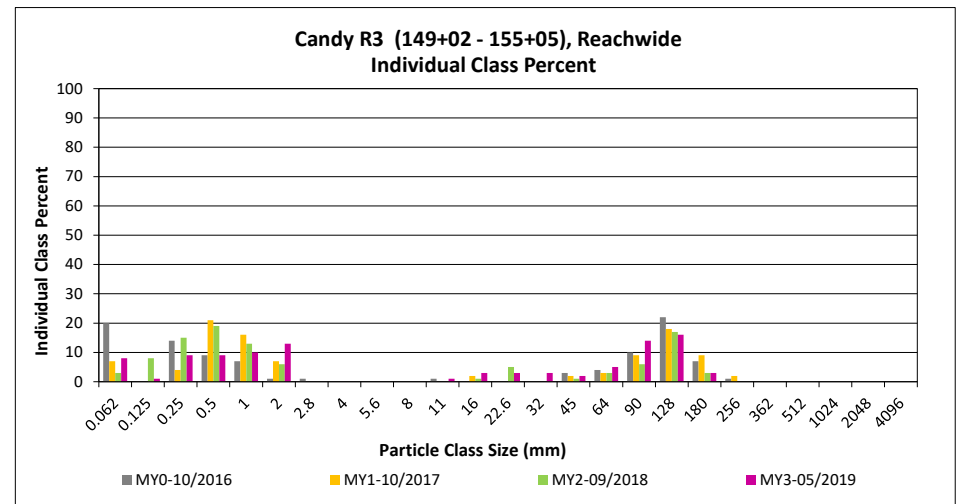
**Reachwide and Cross-Section Pebble Count Plots**

Particle Class		Diameter (mm)		Particle Count			Reach Summary		
		min	max	Riffle	Pool	Total	Class Percentage	Percent Cumulative	
<b>SILT/CLAY</b>		Silt/Clay	0.000	0.062		8	8	8	8
<b>SAND</b>	Very fine	0.062	0.125		1	1	1	9	
	Fine	0.125	0.250		9	9	9	18	
	Medium	0.25	0.50		9	9	9	27	
	Coarse	0.5	1.0		10	10	10	37	
	Very Coarse	1.0	2.0	4	9	13	13	50	
<b>GRAVEL</b>	Very Fine	2.0	2.8					50	
	Very Fine	2.8	4.0					50	
	Fine	4.0	5.6					50	
	Fine	5.6	8.0					50	
	Medium	8.0	11.0	1		1	1	51	
	Medium	11.0	16.0	2	1	3	3	54	
	Coarse	16.0	22.6	2	1	3	3	57	
	Coarse	22.6	32	1	2	3	3	60	
	Very Coarse	32	45	2		2	2	62	
	Very Coarse	45	64	5		5	5	67	
<b>COBBLE</b>	Small	64	90	14		14	14	81	
	Small	90	128	16		16	16	97	
	Large	128	180	3		3	3	100	
	Large	180	256					100	
<b>BOULDER</b>	Small	256	362					100	
	Small	362	512					100	
	Medium	512	1024					100	
	Large/Very Large	1024	2048					100	
<b>BEDROCK</b>	Bedrock	2048	>2048					100	
<b>Total</b>				<b>50</b>	<b>50</b>	<b>100</b>	<b>100</b>	<b>100</b>

Reachwide Channel materials (mm)	
D <sub>16</sub> =	0.2
D <sub>35</sub> =	0.9
D <sub>50</sub> =	2.0
D <sub>84</sub> =	96.1
D <sub>95</sub> =	122.5
D <sub>100</sub> =	180.0

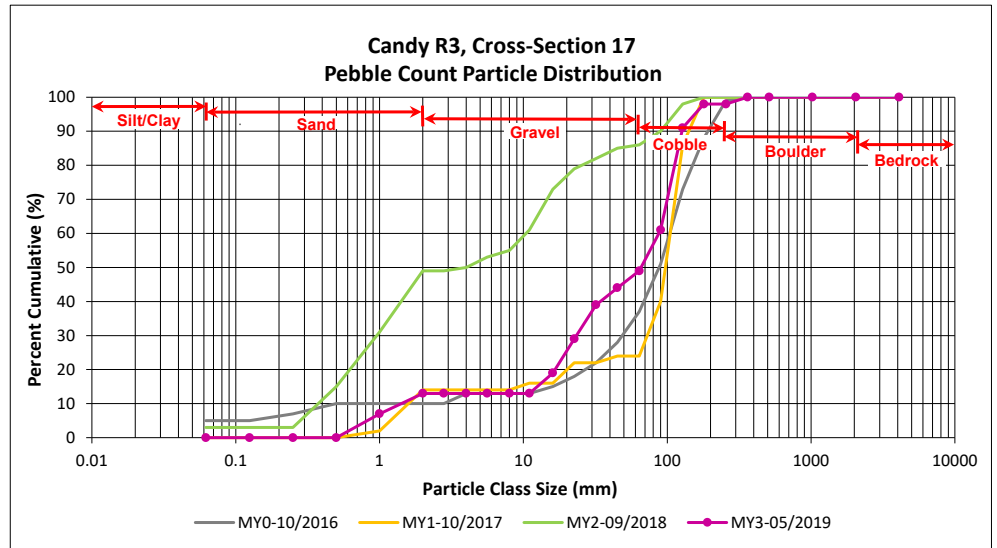
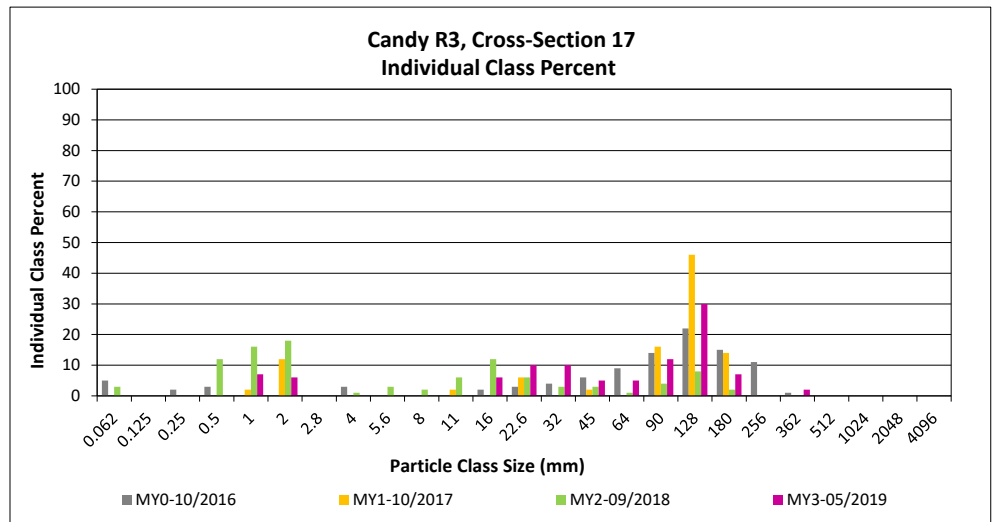
**Reachwide and Cross-Section Pebble Count Plots**

Particle Class		Diameter (mm)		Riffle 100-Count	Summary	
		min	max		Class Percentage	Percent Cumulative
<b>SILT/CLAY</b>	Silt/Clay	0.000	0.062			0
<b>SAND</b>	Very fine	0.062	0.125			0
	Fine	0.125	0.250			0
	Medium	0.25	0.50			0
	Coarse	0.5	1.0	7	7	7
	Very Coarse	1.0	2.0	6	6	13
<b>GRAVEL</b>	Very Fine	2.0	2.8			13
	Very Fine	2.8	4.0			13
	Fine	4.0	5.6			13
	Fine	5.6	8.0			13
	Medium	8.0	11.0			13
	Medium	11.0	16.0	6	6	19
	Coarse	16.0	22.6	10	10	29
	Coarse	22.6	32	10	10	39
	Very Coarse	32	45	5	5	44
	Very Coarse	45	64	5	5	49
<b>COBBLE</b>	Small	64	90	12	12	61
	Small	90	128	30	30	91
	Large	128	180	7	7	98
	Large	180	256			98
<b>BOULDER</b>	Small	256	362	2	2	100
	Small	362	512			100
	Medium	512	1024			100
<b>BEDROCK</b>	Large/Very Large	1024	2048			100
	Bedrock	2048	>2048			100
<b>Total</b>				<b>100</b>	<b>100</b>	<b>100</b>

Cross-Section 17 Channel materials (mm)	
D <sub>16</sub> =	13.3
D <sub>35</sub> =	27.8
D <sub>50</sub> =	65.8
D <sub>84</sub> =	117.9
D <sub>95</sub> =	155.5
D <sub>100</sub> =	362.0

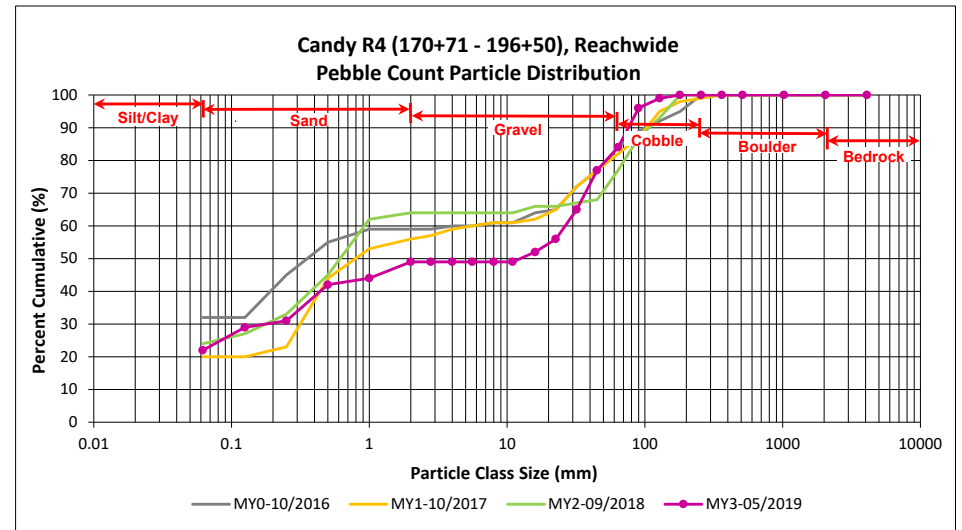
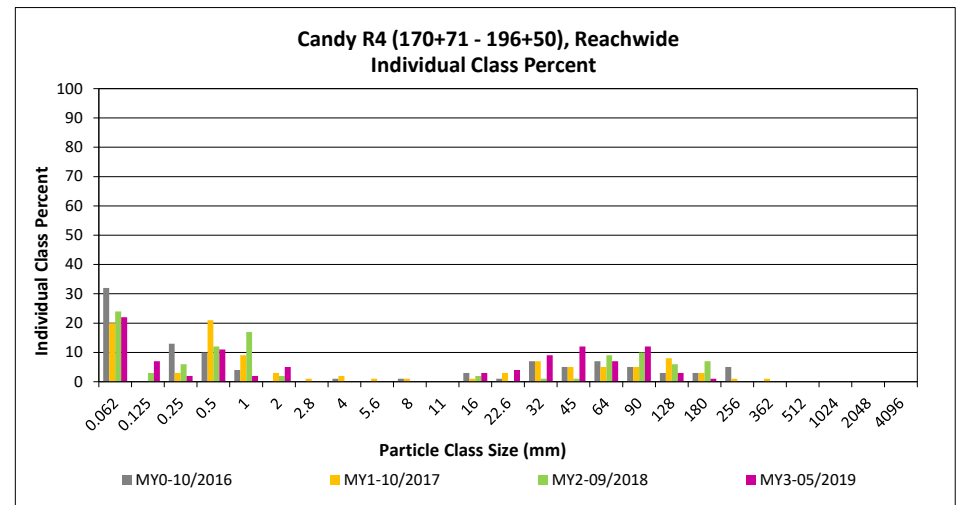
**Reachwide and Cross-Section Pebble Count Plots**

Particle Class		Diameter (mm)		Particle Count			Reach Summary		
		min	max	Riffle	Pool	Total	Class Percentage	Percent Cumulative	
<b>SILT/CLAY</b>		Silt/Clay	0.000	0.062		22	22	22	22
<b>SAND</b>	Very fine	0.062	0.125		7	7	7	29	
	Fine	0.125	0.250	1	1	2	2	31	
	Medium	0.25	0.50	1	10	11	11	42	
	Coarse	0.5	1.0		2	2	2	44	
	Very Coarse	1.0	2.0		5	5	5	49	
<b>GRAVEL</b>	Very Fine	2.0	2.8					49	
	Very Fine	2.8	4.0					49	
	Fine	4.0	5.6					49	
	Fine	5.6	8.0					49	
	Medium	8.0	11.0					49	
	Medium	11.0	16.0	3		3	3	52	
	Coarse	16.0	22.6	4		4	4	56	
	Coarse	22.6	32	6	3	9	9	65	
	Very Coarse	32	45	12		12	12	77	
	Very Coarse	45	64	7		7	7	84	
<b>COBBLE</b>	Small	64	90	12		12	12	96	
	Small	90	128	3		3	3	99	
	Large	128	180	1		1	1	100	
	Large	180	256					100	
<b>BOULDER</b>	Small	256	362					100	
	Small	362	512					100	
	Medium	512	1024					100	
	Large/Very Large	1024	2048					100	
<b>BEDROCK</b>	Bedrock	2048	>2048					100	
<b>Total</b>				<b>50</b>	<b>50</b>	<b>100</b>	<b>100</b>	<b>100</b>

Reachwide Channel materials (mm)	
D <sub>16</sub> =	Silt/Clay
D <sub>35</sub> =	0.3
D <sub>50</sub> =	12.5
D <sub>84</sub> =	64.0
D <sub>95</sub> =	87.5
D <sub>100</sub> =	180.0

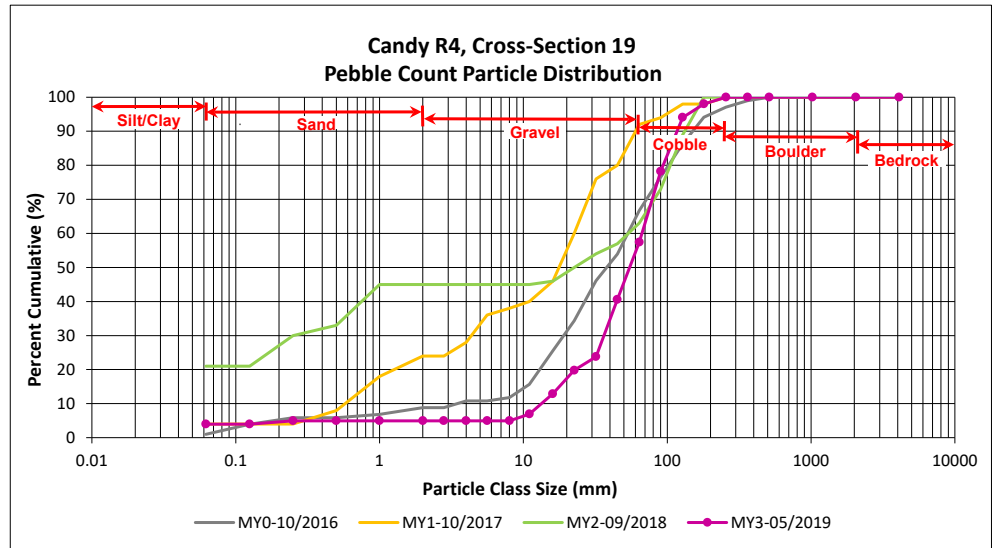
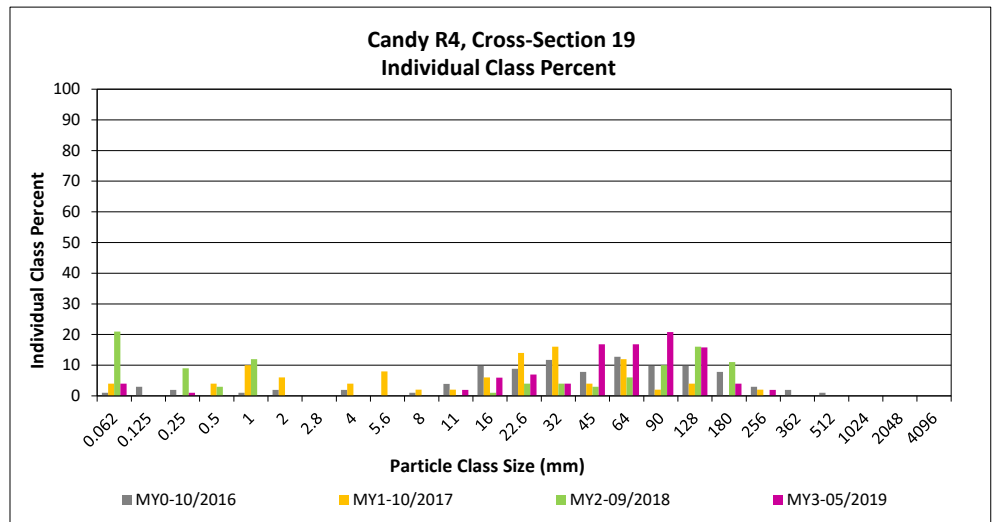
**Reachwide and Cross-Section Pebble Count Plots**

Particle Class		Diameter (mm)		Riffle 100-Count	Summary	
		min	max		Class Percentage	Percent Cumulative
<b>SILT/CLAY</b>	Silt/Clay	0.062	0.062	4	4	4
<b>SAND</b>	Very fine	0.062	0.125			4
	Fine	0.125	0.250	1	1	5
	Medium	0.25	0.50			5
	Coarse	0.5	1.0			5
	Very Coarse	1.0	2.0			5
<b>GRAVEL</b>	Very Fine	2.0	2.8			5
	Very Fine	2.8	4.0			5
	Fine	4.0	5.6			5
	Fine	5.6	8.0			5
	Medium	8.0	11.0	2	2	7
	Medium	11.0	16.0	6	6	13
	Coarse	16.0	22.6	7	7	20
	Coarse	22.6	32	4	4	24
	Very Coarse	32	45	17	17	41
	Very Coarse	45	64	17	17	57
<b>COBBLE</b>	Small	64	90	21	21	78
	Small	90	128	16	16	94
	Large	128	180	4	4	98
	Large	180	256	2	2	100
<b>BOULDER</b>	Small	256	362			100
	Small	362	512			100
	Medium	512	1024			100
<b>BEDROCK</b>	Large/Very Large	1024	2048			100
	Bedrock	2048	>2048			100
<b>Total</b>				<b>101</b>	<b>100</b>	<b>100</b>

Cross-Section 19 Channel materials (mm)	
D <sub>16</sub> =	18.7
D <sub>35</sub> =	40.2
D <sub>50</sub> =	54.8
D <sub>84</sub> =	102.3
D <sub>95</sub> =	138.8
D <sub>100</sub> =	256.0

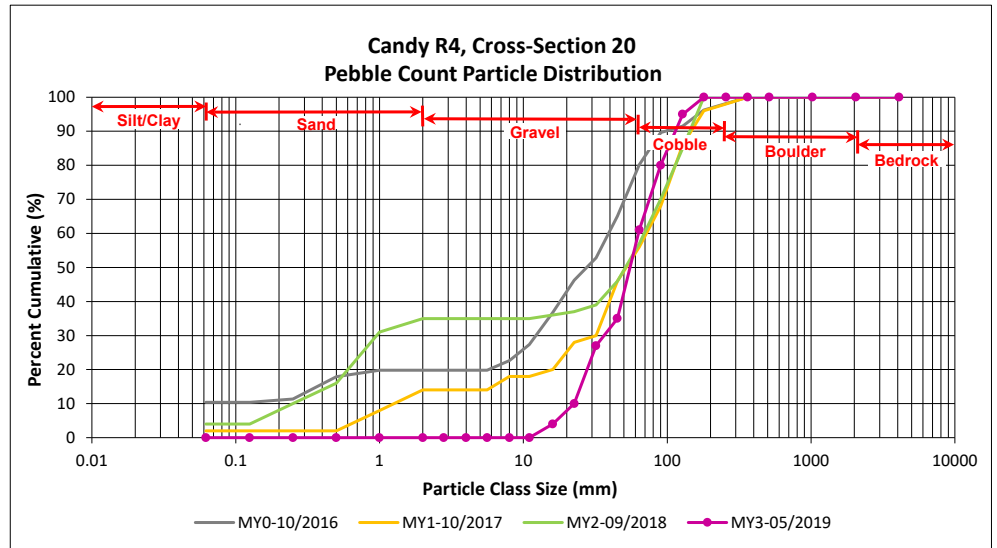
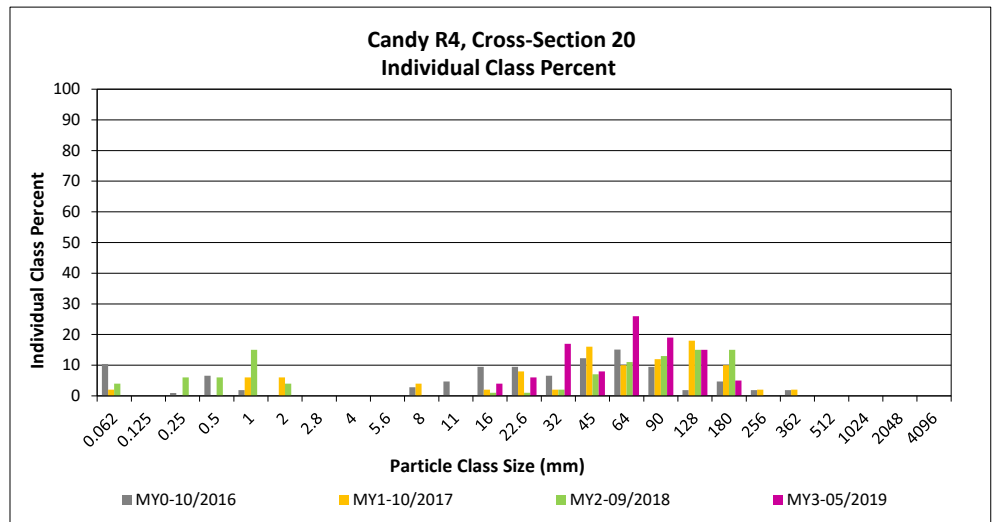
**Reachwide and Cross-Section Pebble Count Plots**

Particle Class		Diameter (mm)		Riffle 100-Count	Summary	
		min	max		Class Percentage	Percent Cumulative
<b>SILT/CLAY</b>	Silt/Clay	0.062	0.062			0
<b>SAND</b>	Very fine	0.062	0.125			0
	Fine	0.125	0.250			0
	Medium	0.25	0.50			0
	Coarse	0.5	1.0			0
	Very Coarse	1.0	2.0			0
<b>GRAVEL</b>	Very Fine	2.0	2.8			0
	Very Fine	2.8	4.0			0
	Fine	4.0	5.6			0
	Fine	5.6	8.0			0
	Medium	8.0	11.0			0
	Medium	11.0	16.0	4	4	4
	Coarse	16.0	22.6	6	6	10
	Coarse	22.6	32	17	17	27
	Very Coarse	32	45	8	8	35
	Very Coarse	45	64	26	26	61
<b>COBBLE</b>	Small	64	90	19	19	80
	Small	90	128	15	15	95
	Large	128	180	5	5	100
	Large	180	256			100
<b>BOULDER</b>	Small	256	362			100
	Small	362	512			100
	Medium	512	1024			100
<b>BEDROCK</b>	Large/Very Large	1024	2048			100
	Bedrock	2048	>2048			100
<b>Total</b>				<b>100</b>	<b>100</b>	<b>100</b>

Cross-Section 20 Channel materials (mm)	
D <sub>16</sub> =	25.6
D <sub>35</sub> =	45.0
D <sub>50</sub> =	55.1
D <sub>84</sub> =	98.9
D <sub>95</sub> =	128.0
D <sub>100</sub> =	180.0

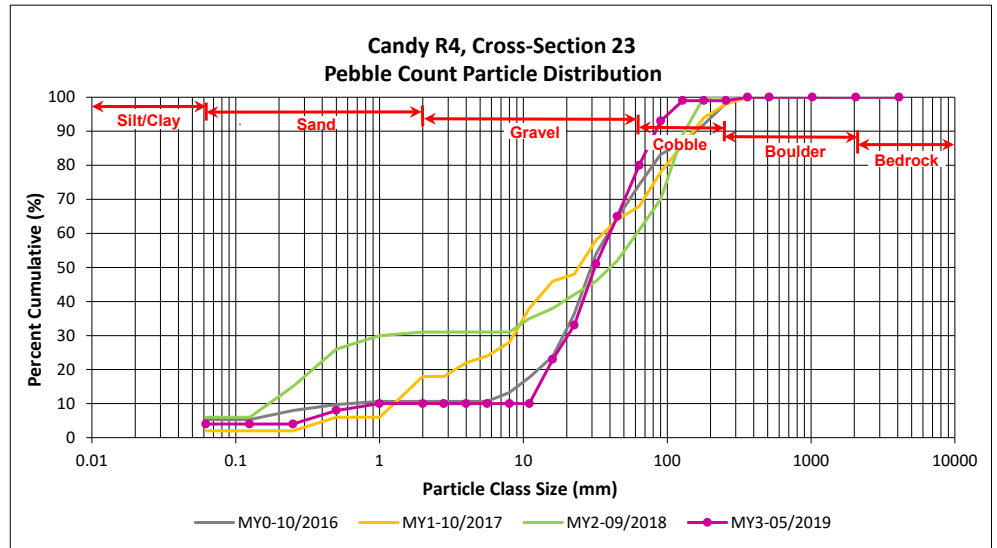
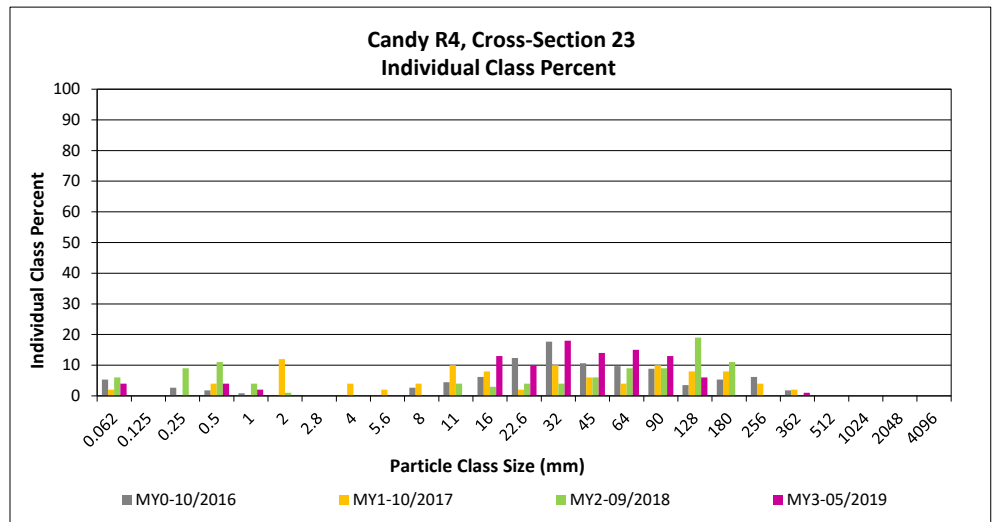
**Reachwide and Cross-Section Pebble Count Plots**

Cross-Section 23 Channel materials (mm)	
D <sub>16</sub> =	13.1
D <sub>35</sub> =	23.5
D <sub>50</sub> =	31.4
D <sub>84</sub> =	71.1
D <sub>95</sub> =	101.2
D <sub>100</sub> =	362.0

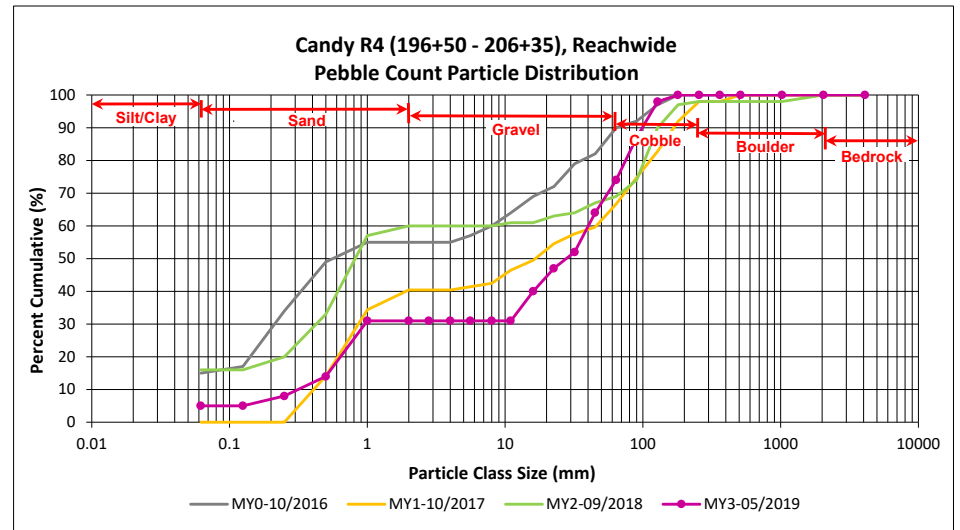
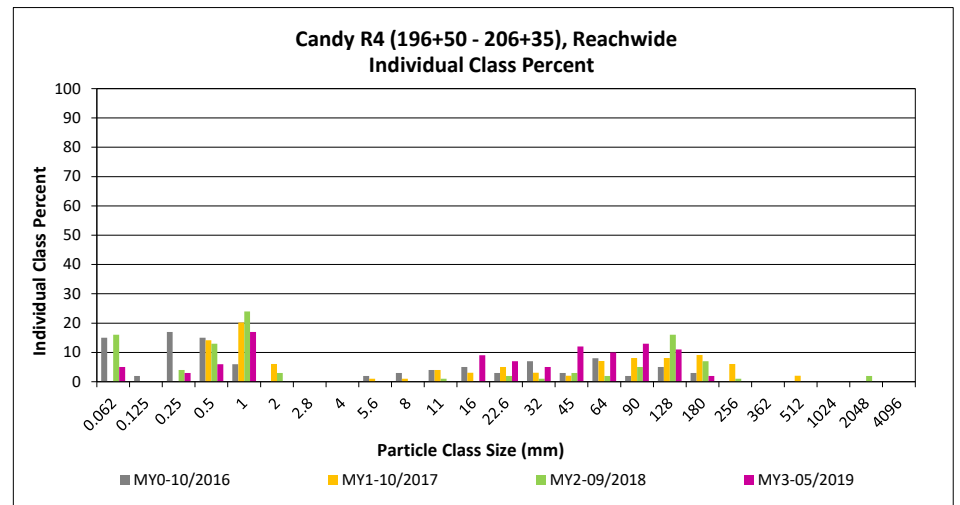
**Reachwide and Cross-Section Pebble Count Plots**

Reachwide Channel materials (mm)	
D <sub>16</sub> =	0.5
D <sub>35</sub> =	13.0
D <sub>50</sub> =	27.8
D <sub>84</sub> =	83.2
D <sub>95</sub> =	116.3
D <sub>100</sub> =	180.0

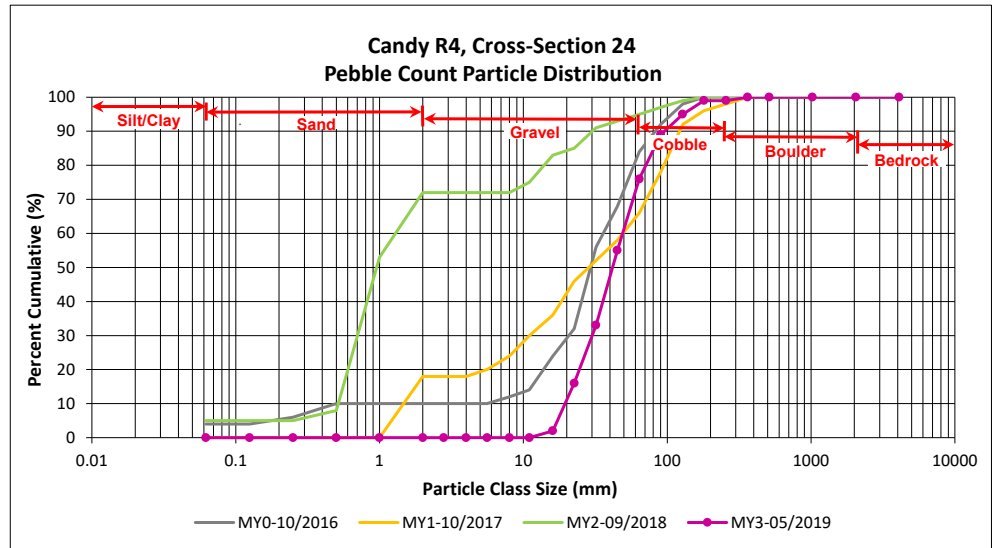
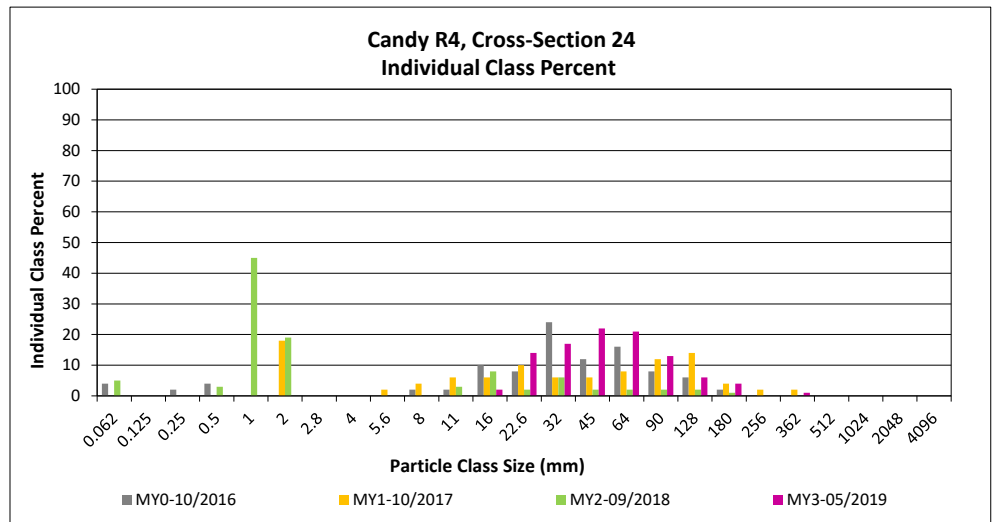
**Reachwide and Cross-Section Pebble Count Plots**

Cross-Section 24 Channel materials (mm)	
D <sub>16</sub> =	22.6
D <sub>35</sub> =	33.0
D <sub>50</sub> =	41.6
D <sub>84</sub> =	78.9
D <sub>95</sub> =	128.0
D <sub>100</sub> =	362.0
