# MONITORING YEAR 3 ANNUAL REPORT

## **CANDY CREEK MITIGATION SITE**

Guilford County, NC

NCDMS Project Number 96315

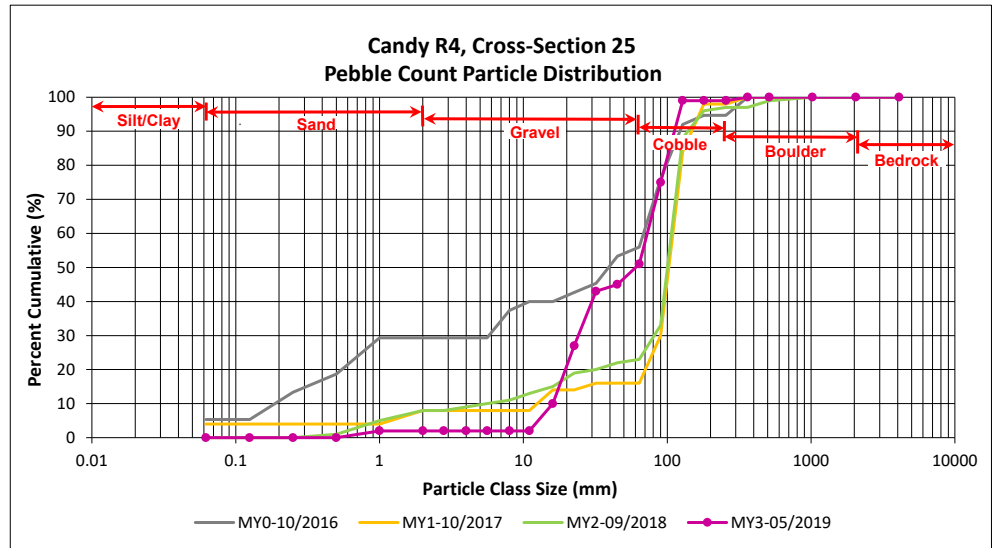
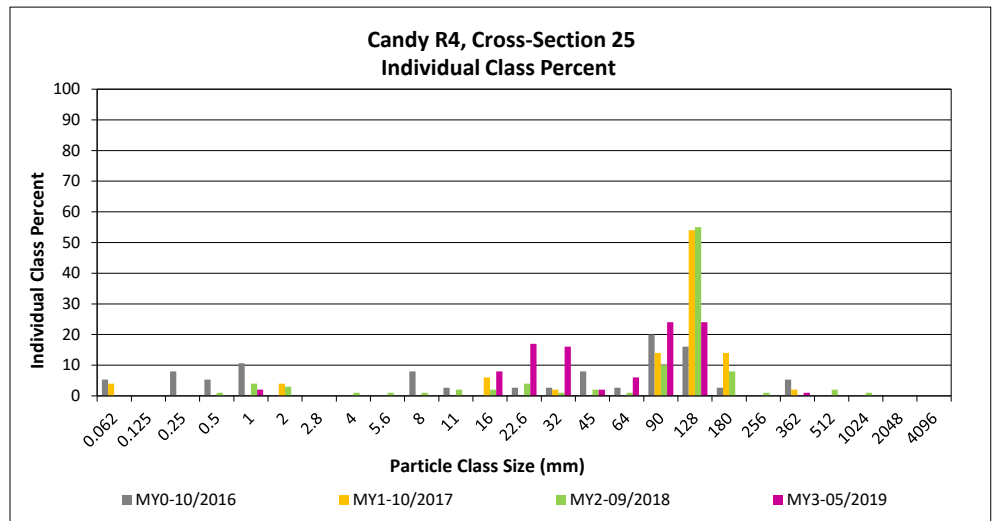
### Reachwide and Cross-Section Pebble Count Plots

Cross-Section 25 Channel materials (mm)	
D <sub>16</sub> =	18.1
D <sub>35</sub> =	26.9
D <sub>50</sub> =	60.4
D <sub>84</sub> =	102.7
D <sub>95</sub> =	120.7
D <sub>100</sub> =	362.0

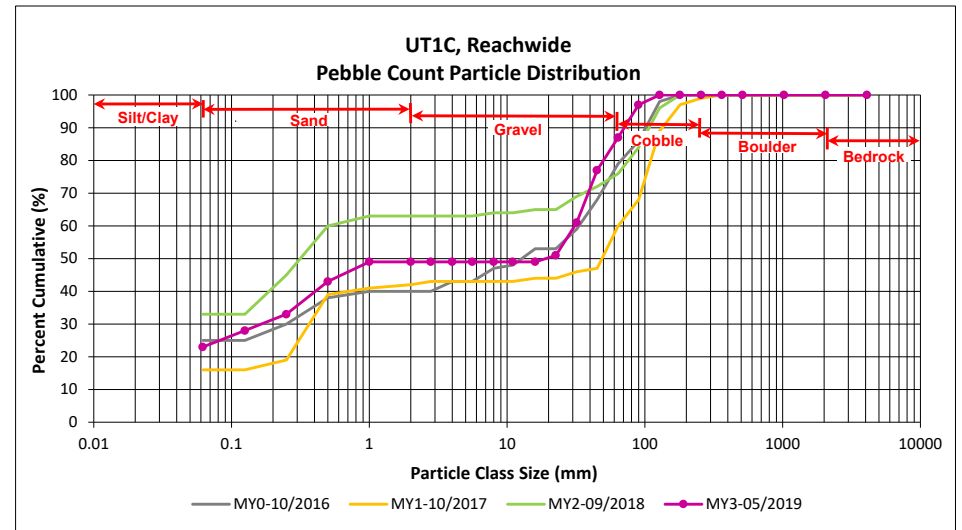
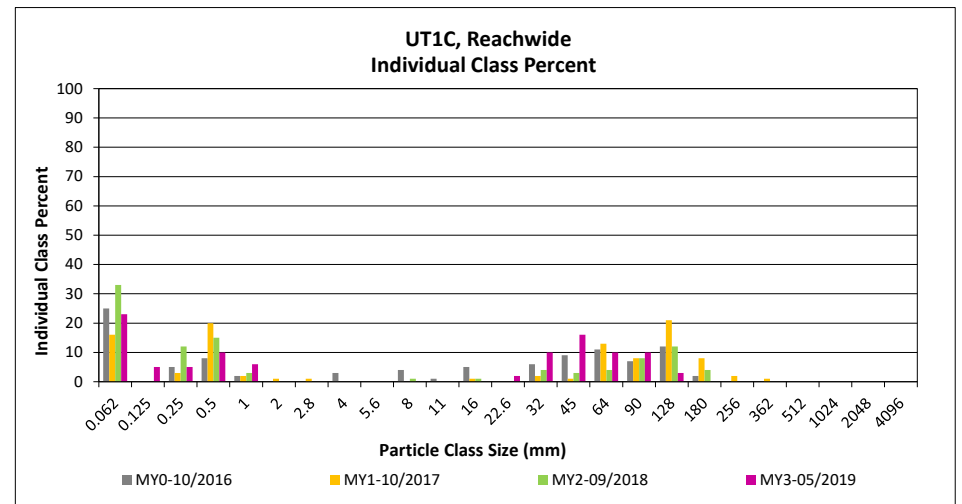
**Reachwide and Cross-Section Pebble Count Plots**

Reachwide Channel materials (mm)	
D <sub>16</sub> =	Silt/Clay
D <sub>35</sub> =	0.3
D <sub>50</sub> =	19.0
D <sub>84</sub> =	57.6
D <sub>95</sub> =	84.1
D <sub>100</sub> =	128.0

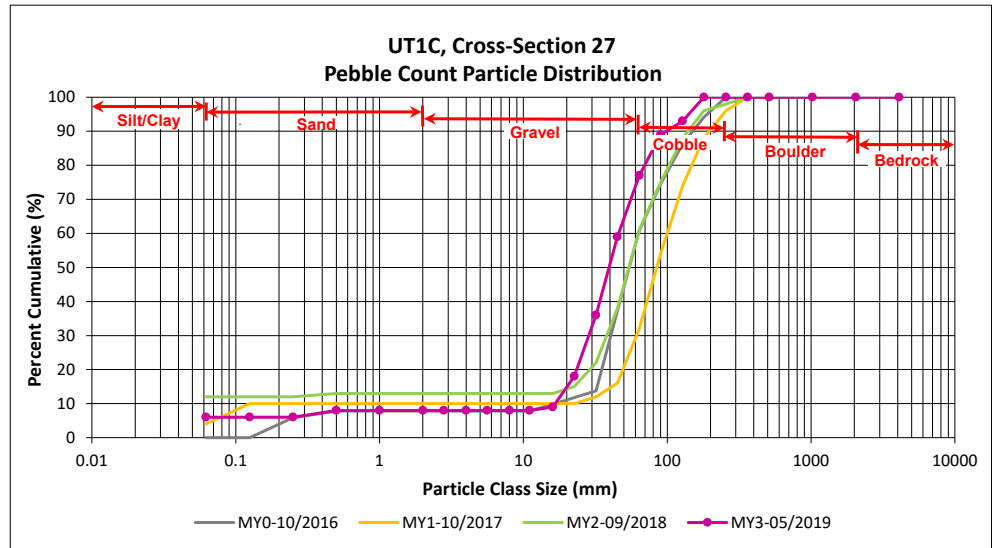
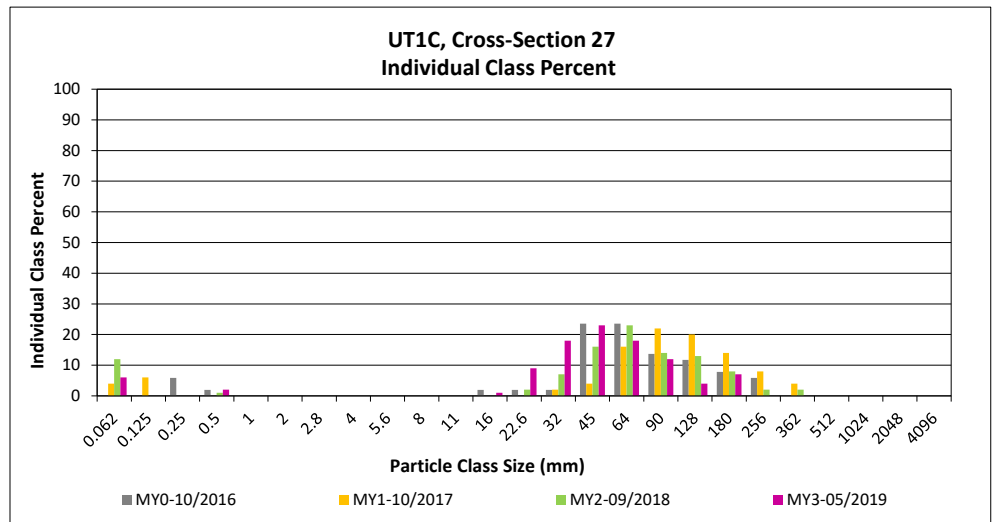
**Reachwide and Cross-Section Pebble Count Plots**

Cross-Section 27 Channel materials (mm)	
D <sub>16</sub> =	20.9
D <sub>35</sub> =	31.4
D <sub>50</sub> =	39.4
D <sub>84</sub> =	78.1
D <sub>95</sub> =	141.1
D <sub>100</sub> =	180.0

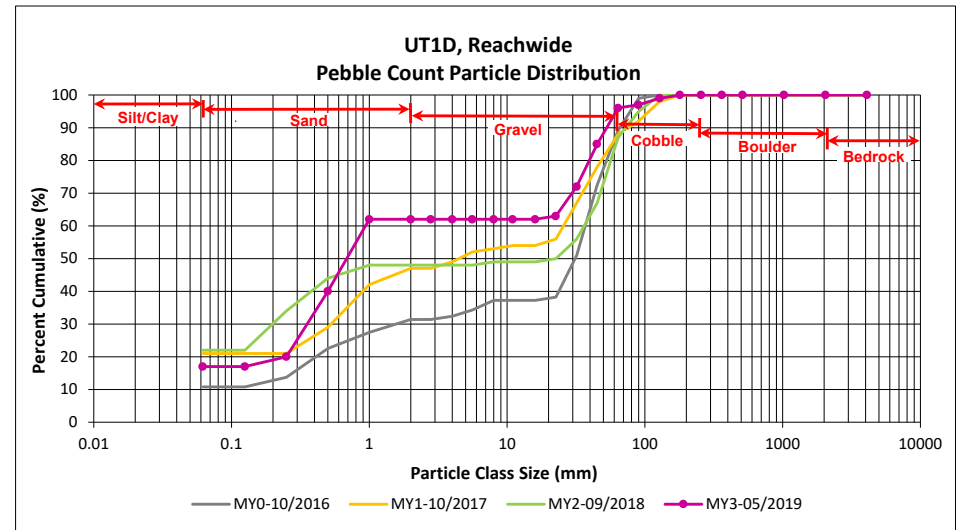
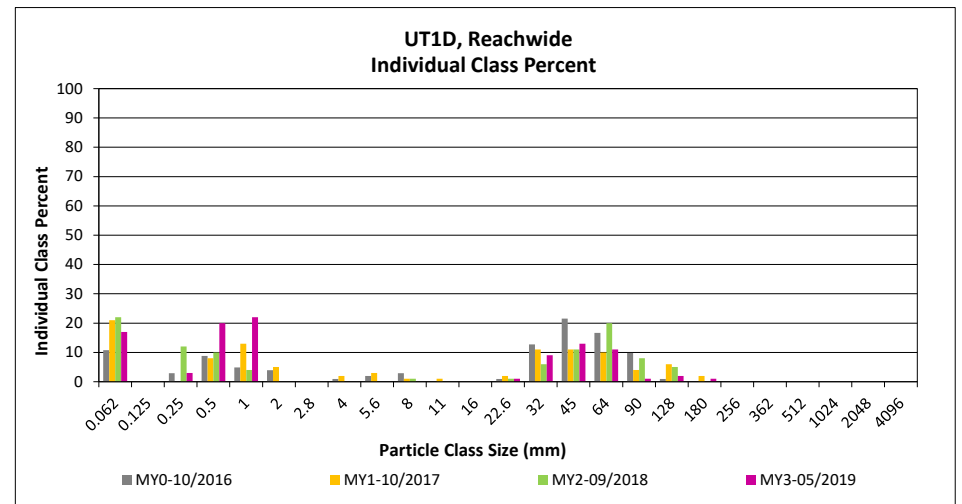
**Reachwide and Cross-Section Pebble Count Plots**

Reachwide Channel materials (mm)	
D <sub>16</sub> =	Silt/Clay
D <sub>35</sub> =	0.4
D <sub>50</sub> =	0.7
D <sub>84</sub> =	43.8
D <sub>95</sub> =	62.0
D <sub>100</sub> =	180.0

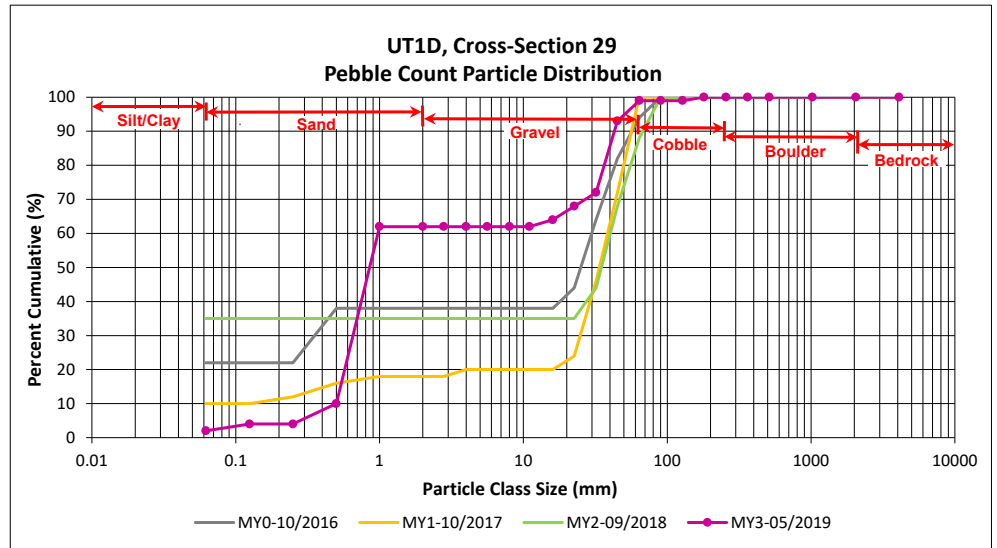
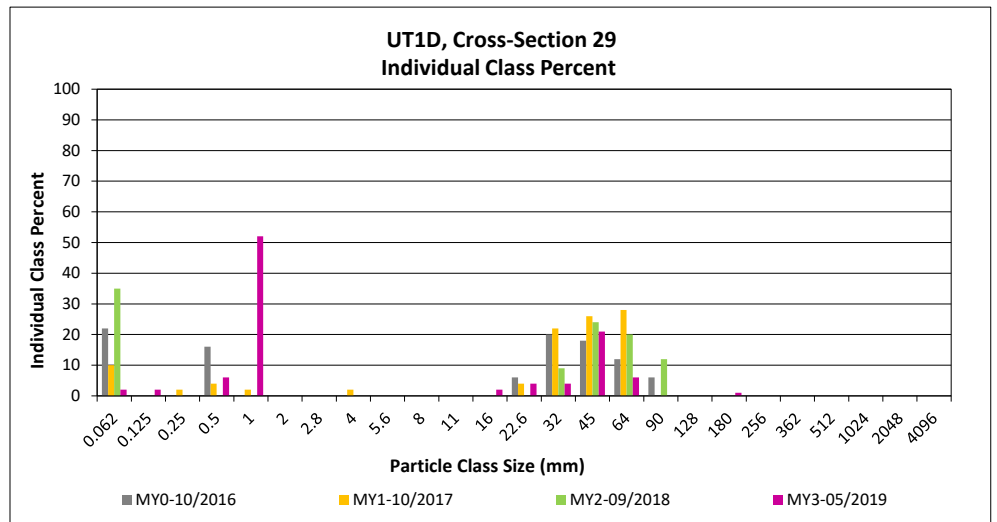
### Reachwide and Cross-Section Pebble Count Plots

Cross-Section 29 Channel materials (mm)	
D <sub>16</sub> =	0.5
D <sub>35</sub> =	0.7
D <sub>50</sub> =	0.9
D <sub>84</sub> =	38.9
D <sub>95</sub> =	50.6
D <sub>100</sub> =	180.0

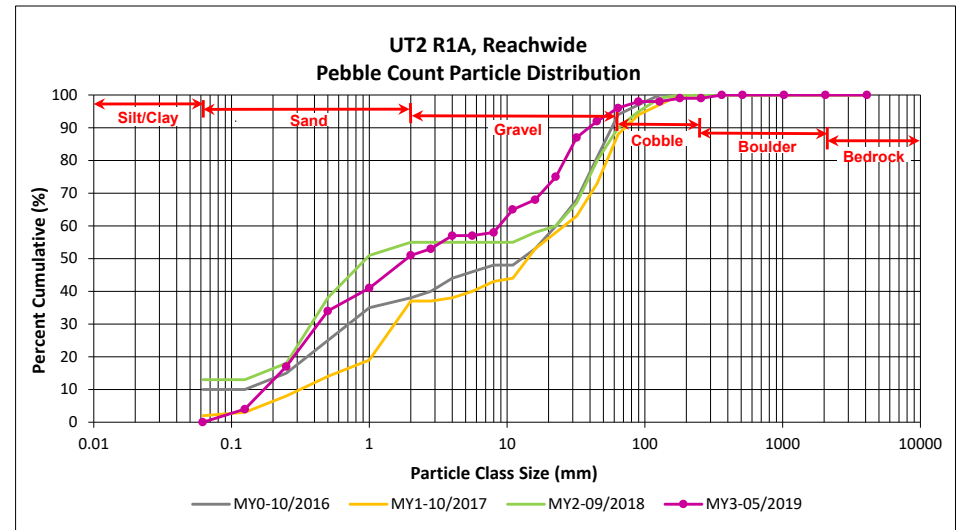
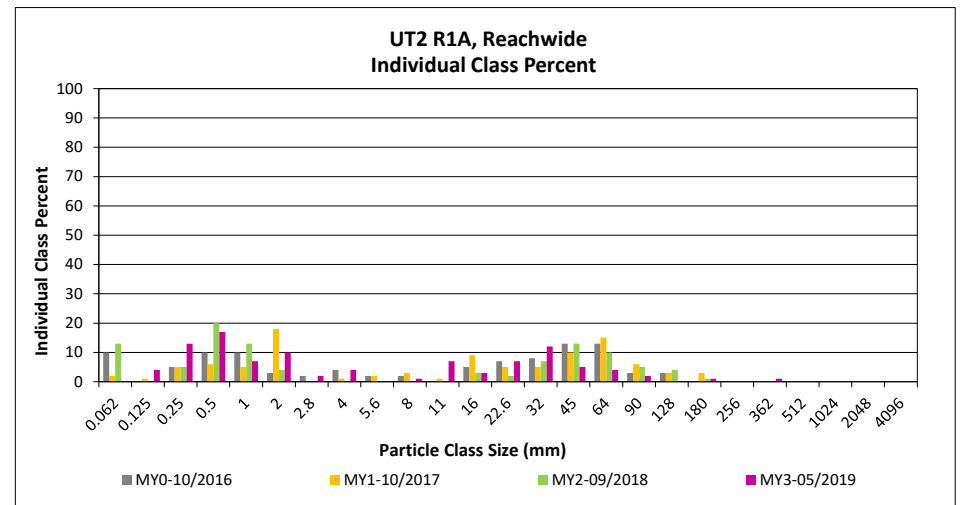
**Reachwide and Cross-Section Pebble Count Plots**

Reachwide	
Channel materials (mm)	
D <sub>16</sub> =	0.2
D <sub>35</sub> =	0.6
D <sub>50</sub> =	1.9
D <sub>84</sub> =	29.3
D <sub>95</sub> =	58.6
D <sub>100</sub> =	362.0

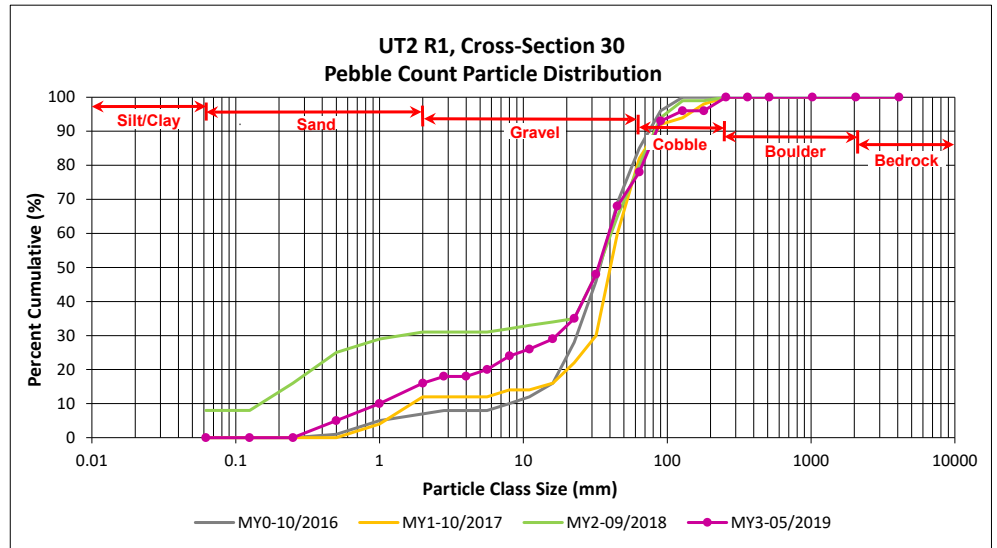
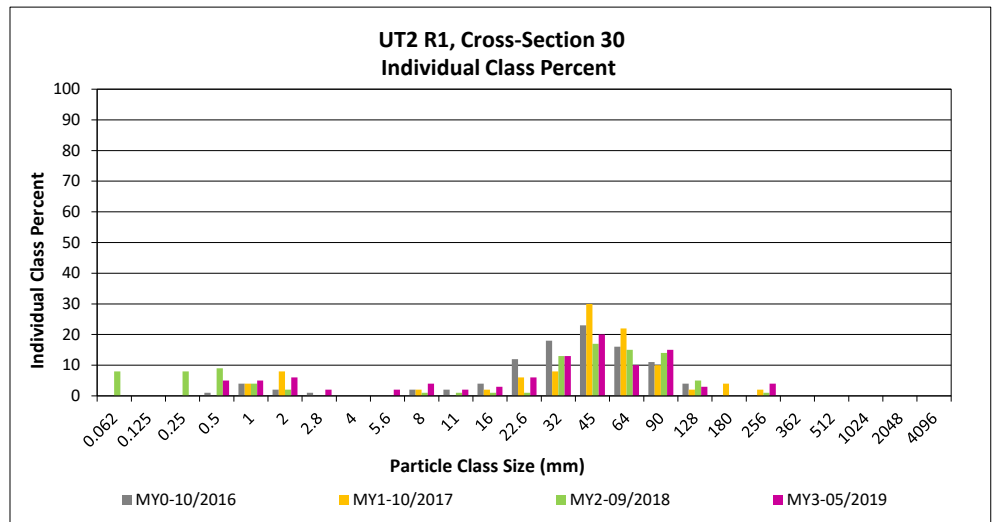
**Reachwide and Cross-Section Pebble Count Plots**

Cross-Section 30 Channel materials (mm)	
D <sub>16</sub> =	2.0
D <sub>35</sub> =	22.6
D <sub>50</sub> =	33.1
D <sub>84</sub> =	73.4
D <sub>95</sub> =	113.8
D <sub>100</sub> =	256.0

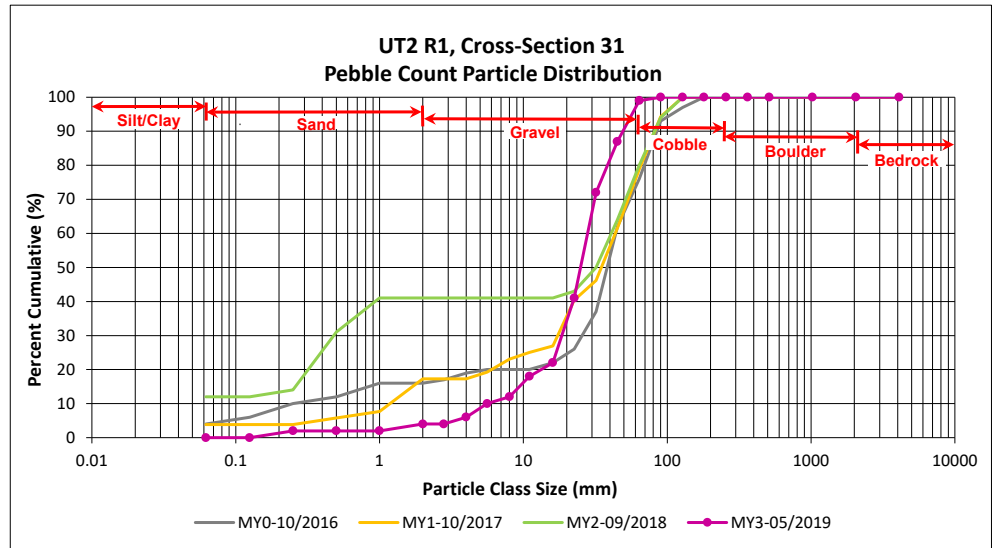
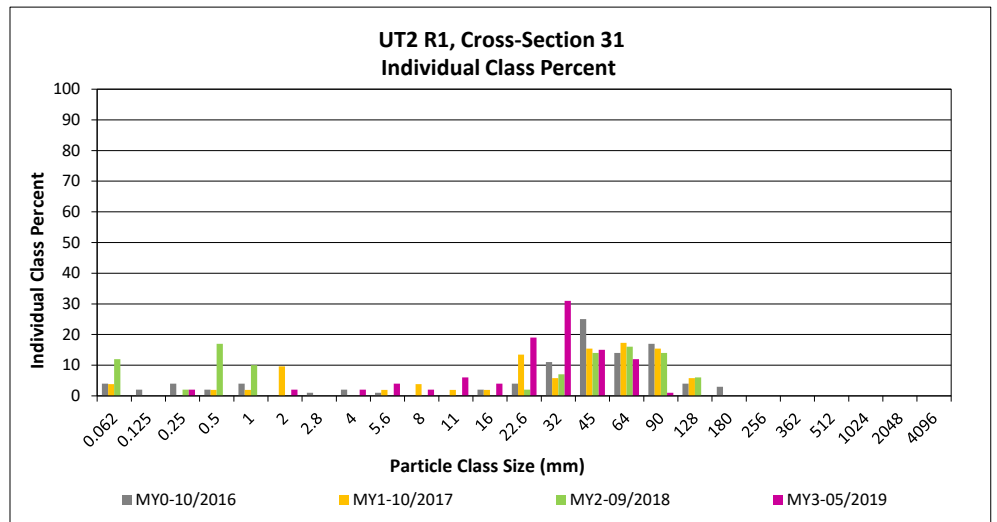
**Reachwide and Cross-Section Pebble Count Plots**

Cross-Section 31 Channel materials (mm)	
D <sub>16</sub> =	9.9
D <sub>35</sub> =	20.3
D <sub>50</sub> =	25.0
D <sub>84</sub> =	42.0
D <sub>95</sub> =	56.9
D <sub>100</sub> =	90.0

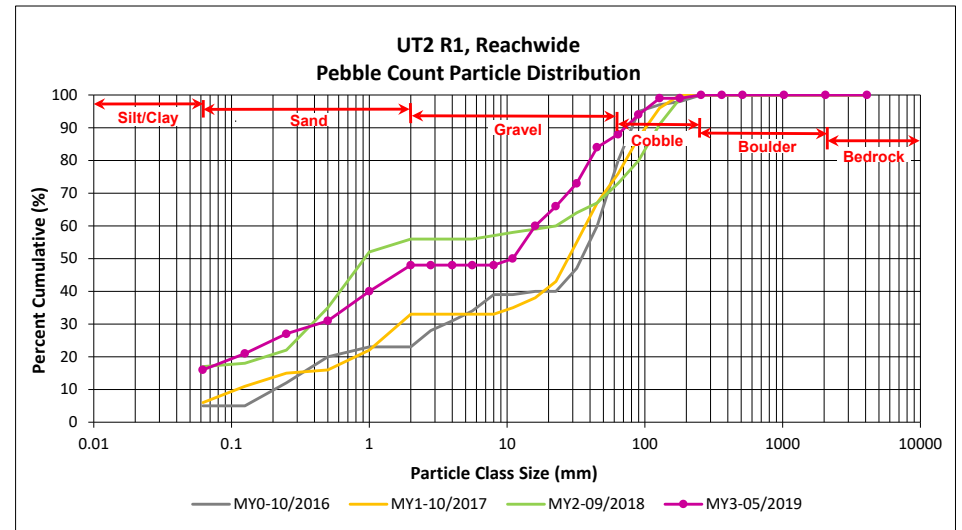
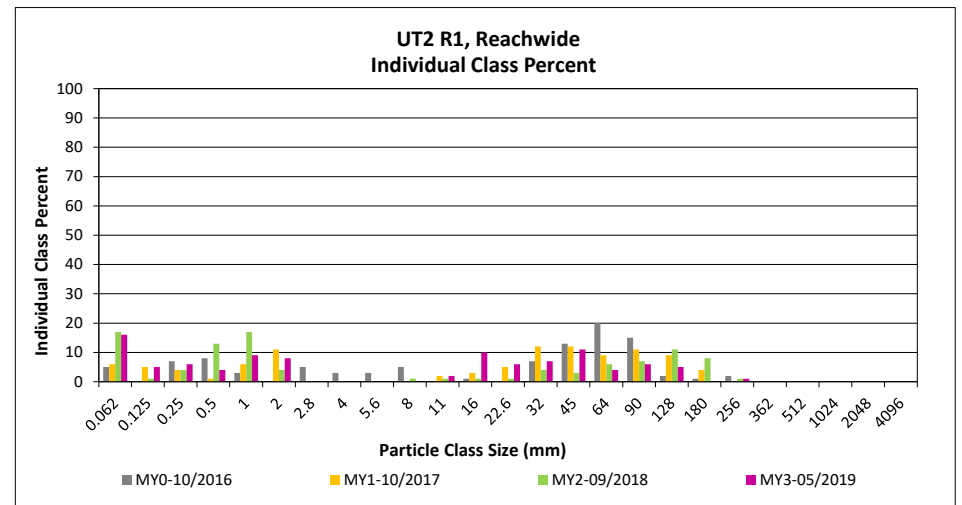
**Reachwide and Cross-Section Pebble Count Plots**

Reachwide Channel materials (mm)	
D <sub>16</sub> =	Silt/Clay
D <sub>35</sub> =	0.7
D <sub>50</sub> =	11.0
D <sub>84</sub> =	45.0
D <sub>95</sub> =	96.6
D <sub>100</sub> =	256.0

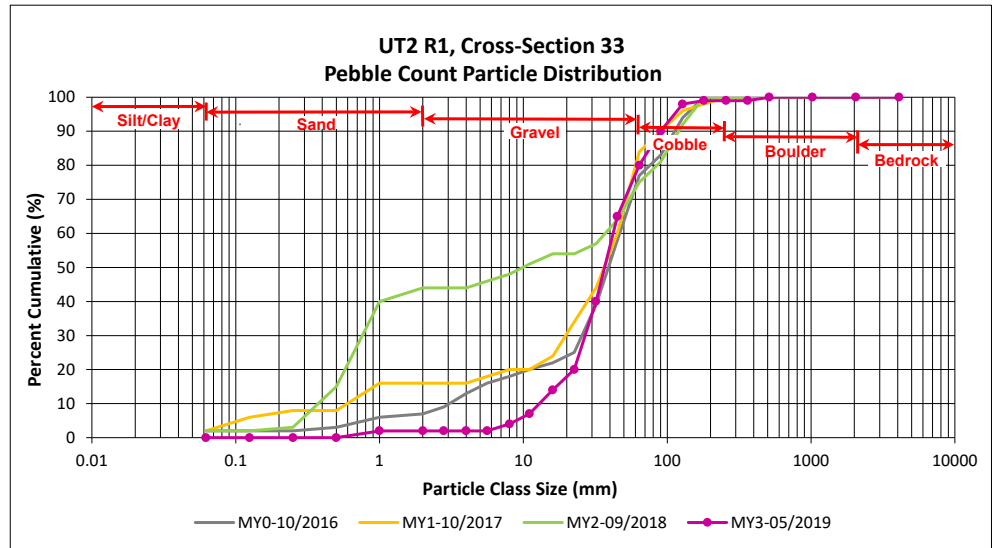
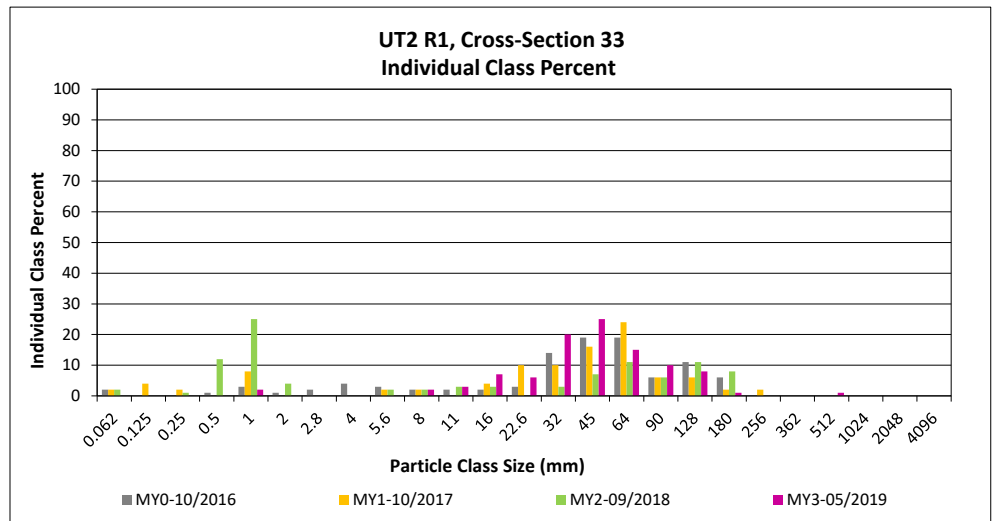
### Reachwide and Cross-Section Pebble Count Plots

Cross-Section 33 Channel materials (mm)	
D <sub>16</sub> =	18.0
D <sub>35</sub> =	29.3
D <sub>50</sub> =	36.7
D <sub>84</sub> =	73.4
D <sub>95</sub> =	112.2
D <sub>100</sub> =	512.0

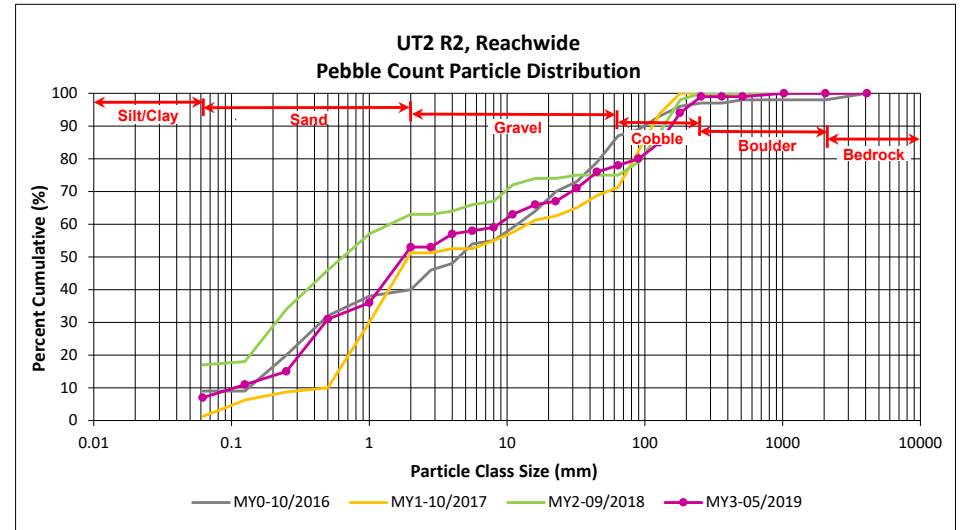
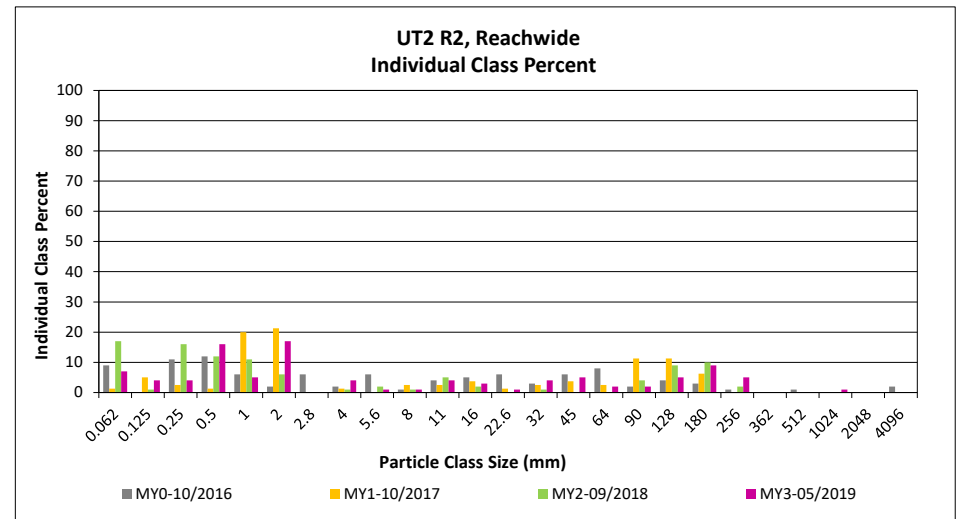
**Reachwide and Cross-Section Pebble Count Plots**

Reachwide Channel materials (mm)	
D <sub>16</sub> =	0.3
D <sub>35</sub> =	0.9
D <sub>50</sub> =	1.8
D <sub>84</sub> =	119.3
D <sub>95</sub> =	193.1
D <sub>100</sub> =	1024.0

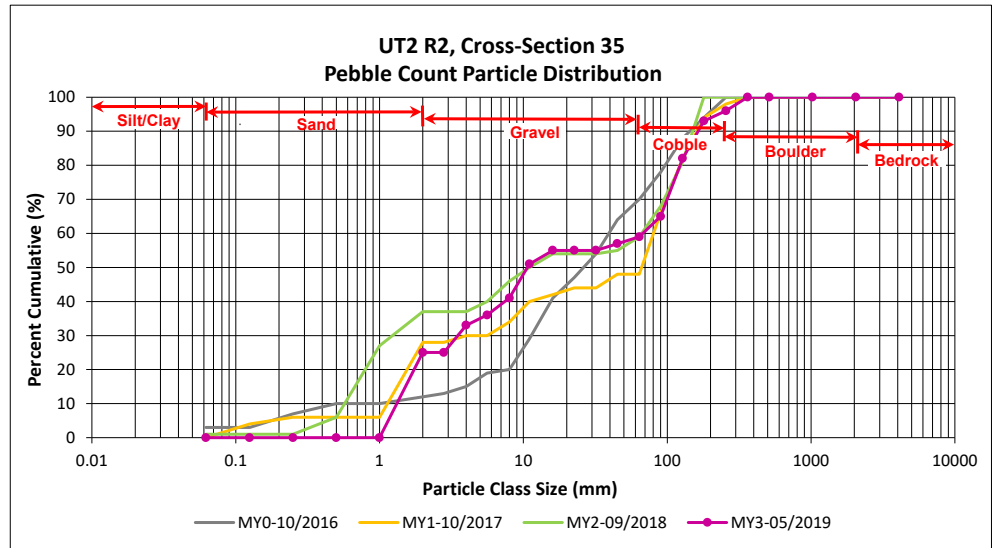
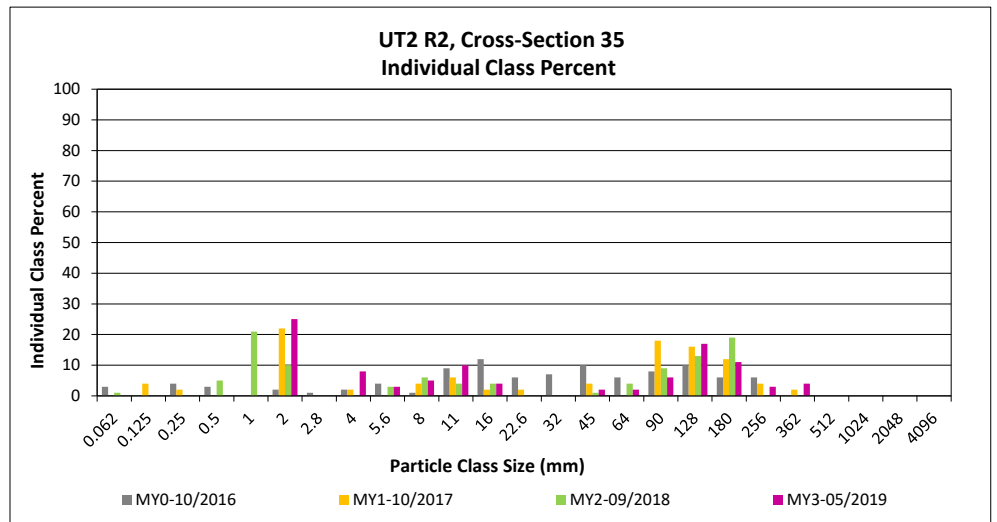
**Reachwide and Cross-Section Pebble Count Plots**

Cross-Section 35 Channel materials (mm)	
D <sub>16</sub> =	1.6
D <sub>35</sub> =	5.0
D <sub>50</sub> =	10.7
D <sub>84</sub> =	136.2
D <sub>95</sub> =	227.6
D <sub>100</sub> =	362.0

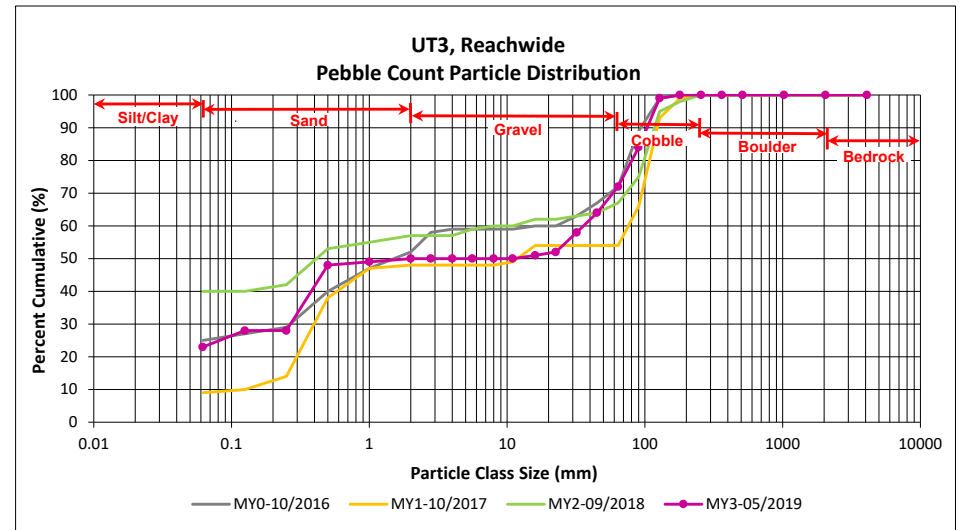
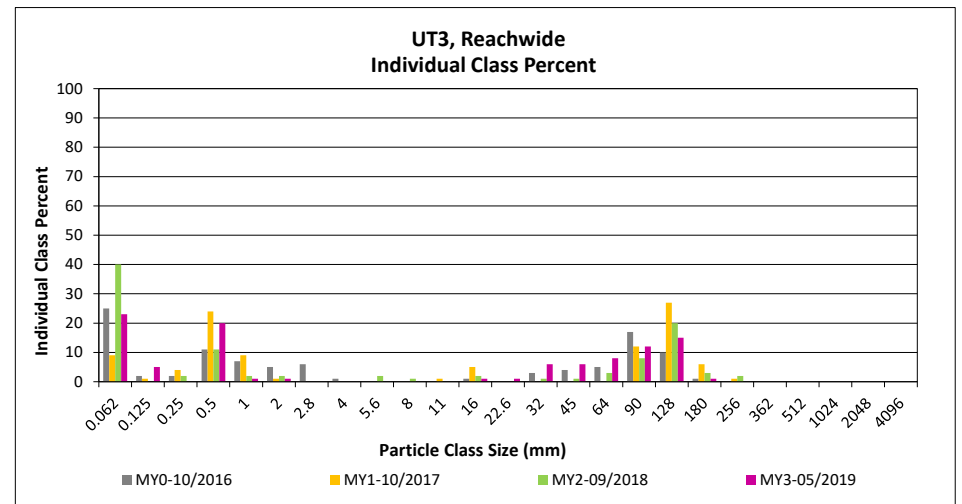
**Reachwide and Cross-Section Pebble Count Plots**

Reachwide Channel materials (mm)	
D <sub>16</sub> =	Silt/Clay
D <sub>35</sub> =	0.3
D <sub>50</sub> =	2.0
D <sub>84</sub> =	90.0
D <sub>95</sub> =	116.5
D <sub>100</sub> =	180.0

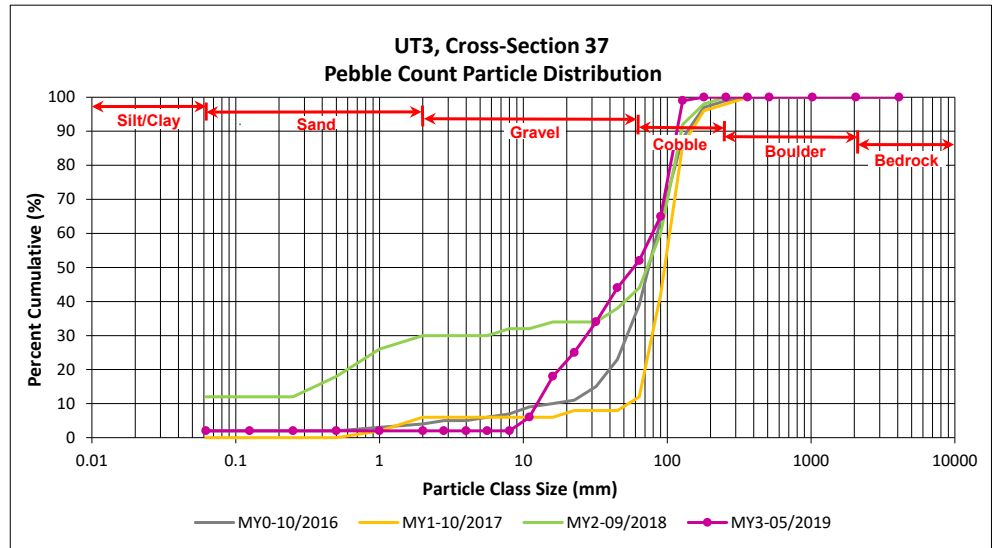
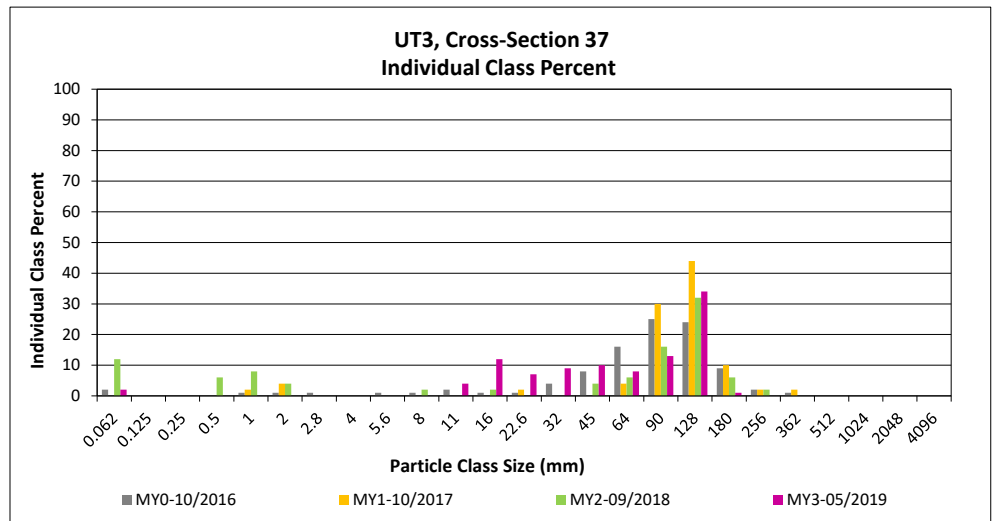
### Reachwide and Cross-Section Pebble Count Plots

Cross-Section 37	
Channel materials (mm)	
D <sub>16</sub> =	15.0
D <sub>35</sub> =	33.1
D <sub>50</sub> =	58.6
D <sub>84</sub> =	109.6
D <sub>95</sub> =	122.8
D <sub>100</sub> =	180.0

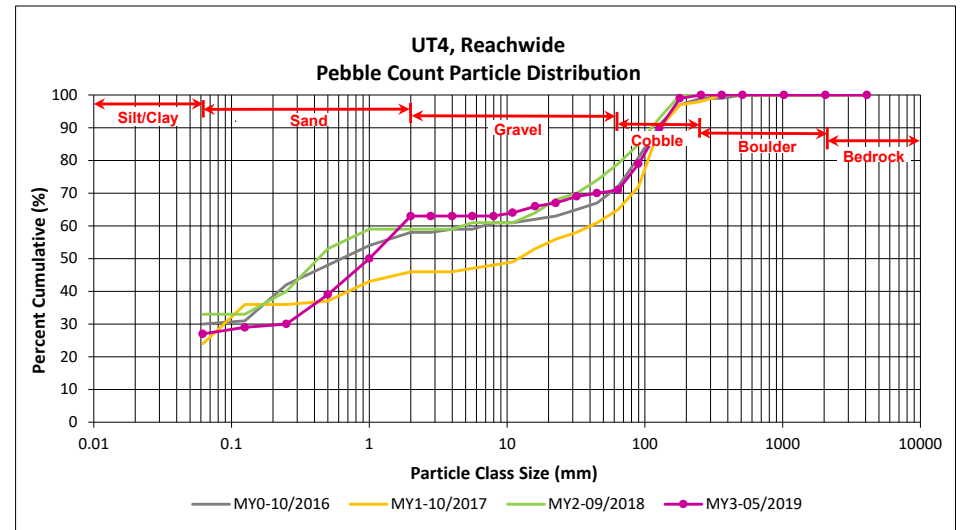
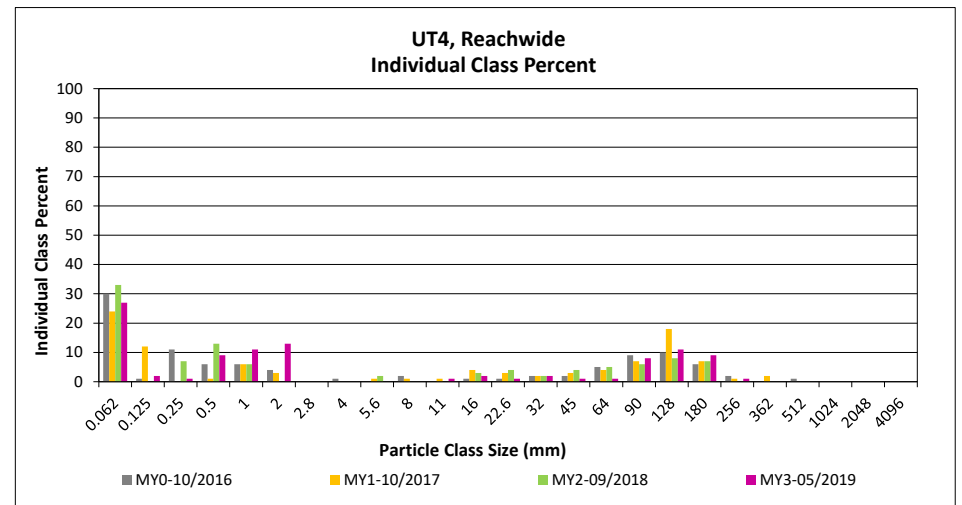
**Reachwide and Cross-Section Pebble Count Plots**

Reachwide Channel materials (mm)	
D <sub>16</sub> =	Silt/Clay
D <sub>35</sub> =	0.4
D <sub>50</sub> =	1.0
D <sub>84</sub> =	105.6
D <sub>95</sub> =	154.7
D <sub>100</sub> =	256.0

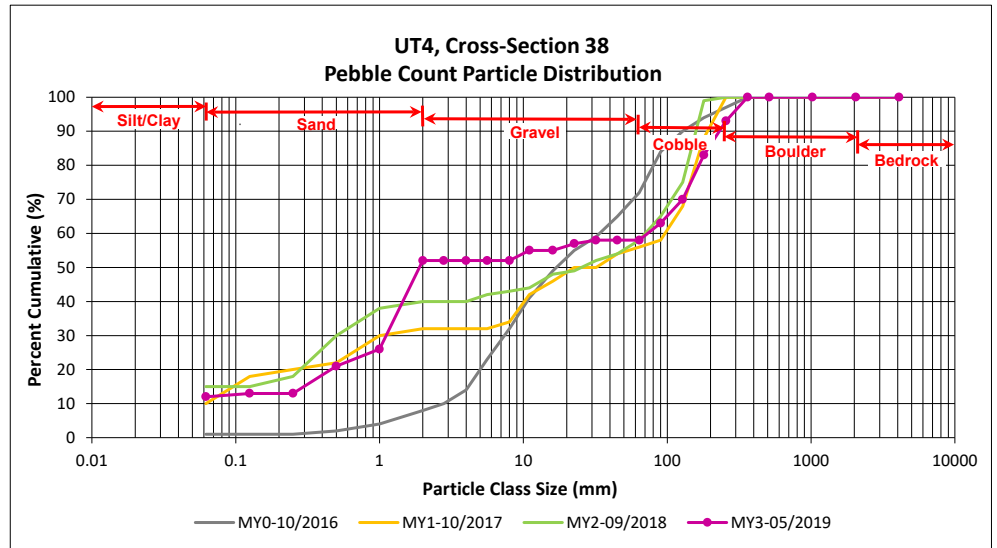
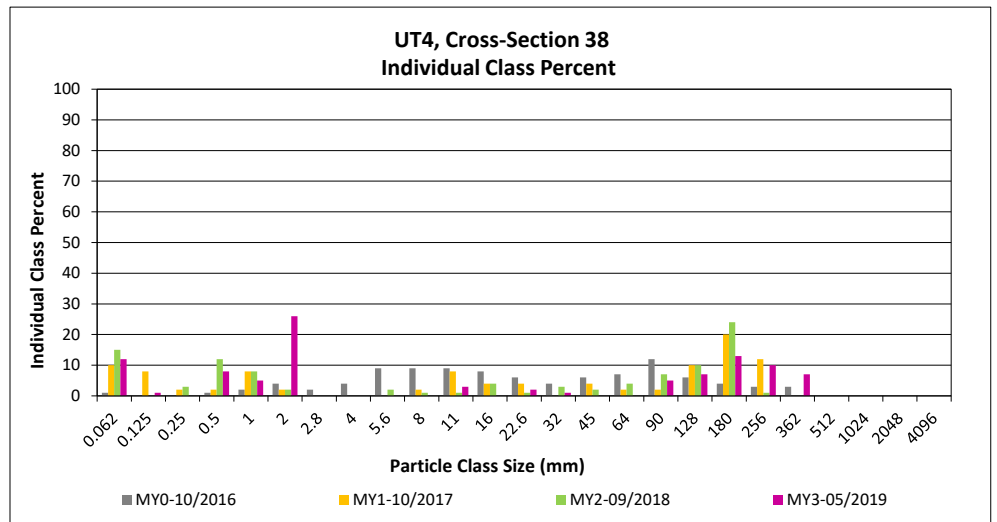
**Reachwide and Cross-Section Pebble Count Plots**

Cross-Section 38	
Channel materials (mm)	
D <sub>16</sub> =	0.3
D <sub>35</sub> =	1.3
D <sub>50</sub> =	1.9
D <sub>84</sub> =	186.5
D <sub>95</sub> =	282.6
D <sub>100</sub> =	362.0

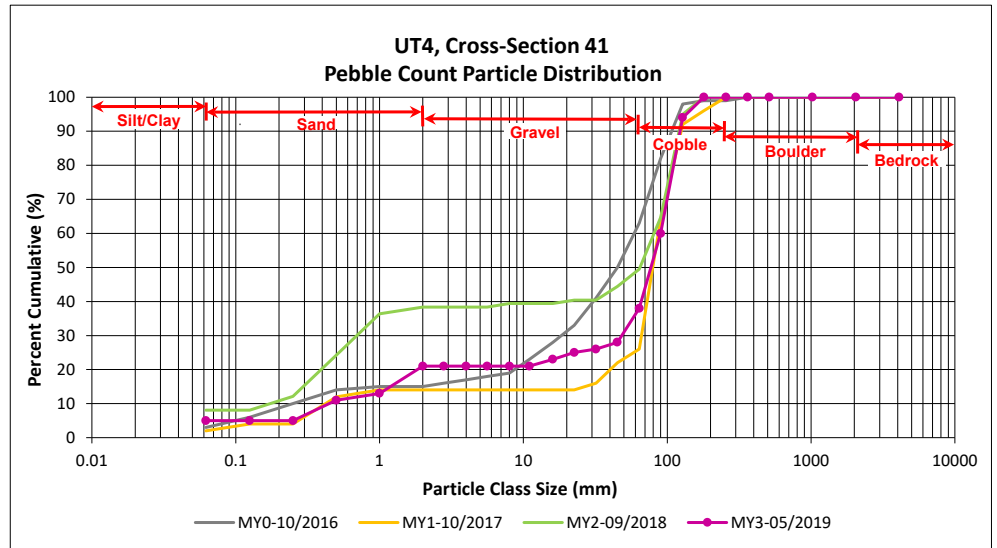
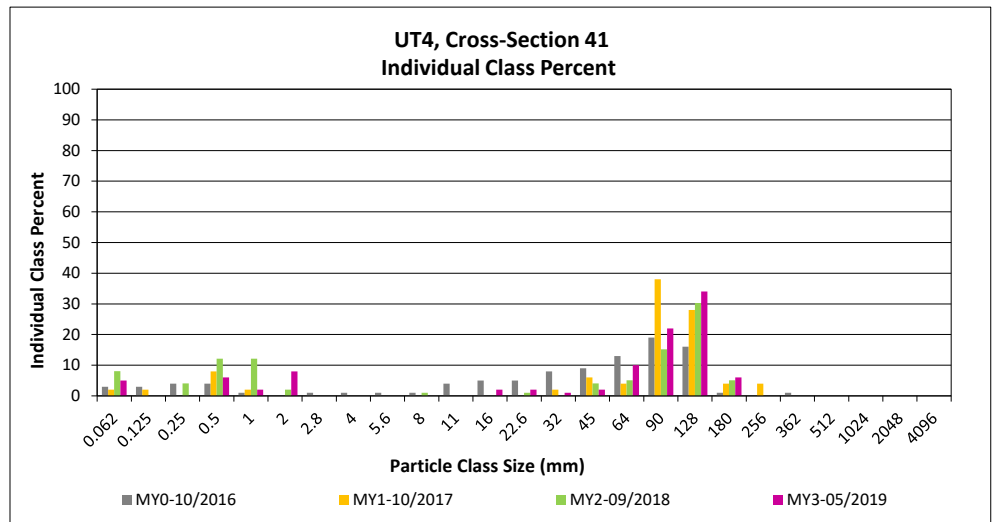
**Reachwide and Cross-Section Pebble Count Plots**

Cross-Section 41 Channel materials (mm)	
D <sub>16</sub> =	1.3
D <sub>35</sub> =	57.6
D <sub>50</sub> =	77.1
D <sub>84</sub> =	115.4
D <sub>95</sub> =	135.5
D <sub>100</sub> =	180.0

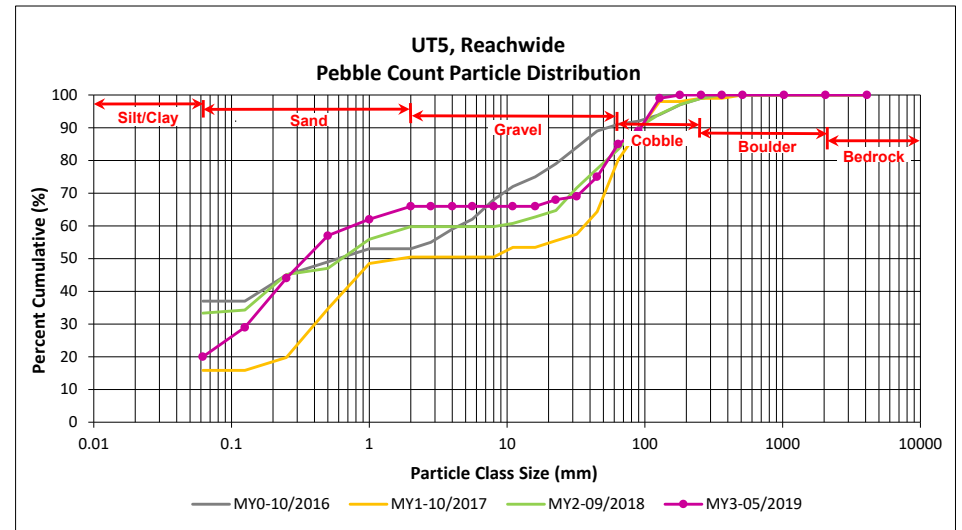
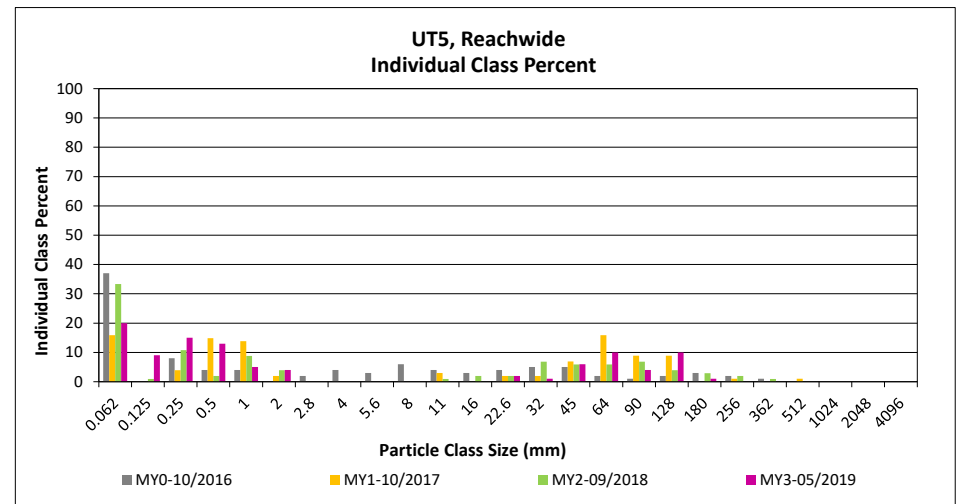
**Reachwide and Cross-Section Pebble Count Plots**

Reachwide Channel materials (mm)	
D <sub>16</sub> =	Silt/Clay
D <sub>35</sub> =	0.2
D <sub>50</sub> =	0.3
D <sub>84</sub> =	61.8
D <sub>95</sub> =	111.2
D <sub>100</sub> =	180.0

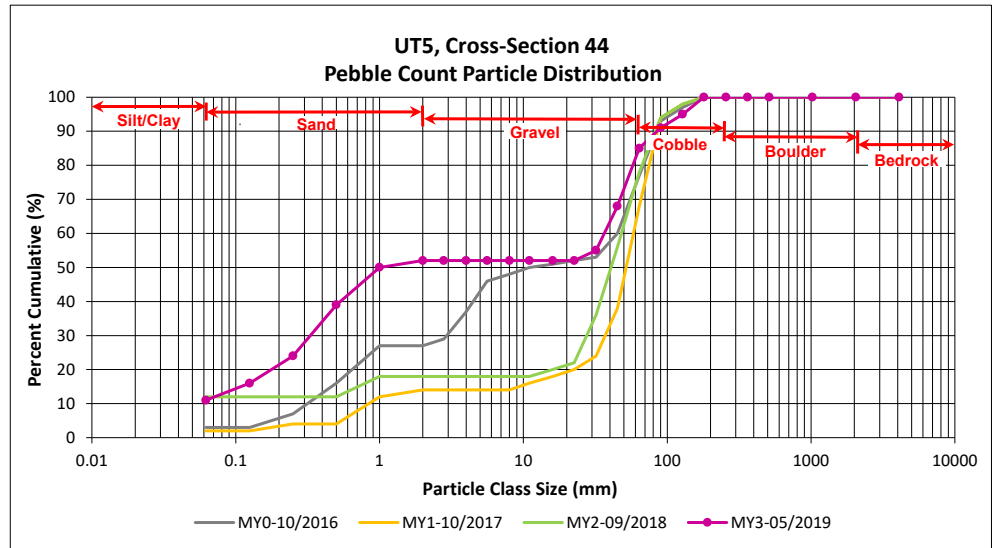
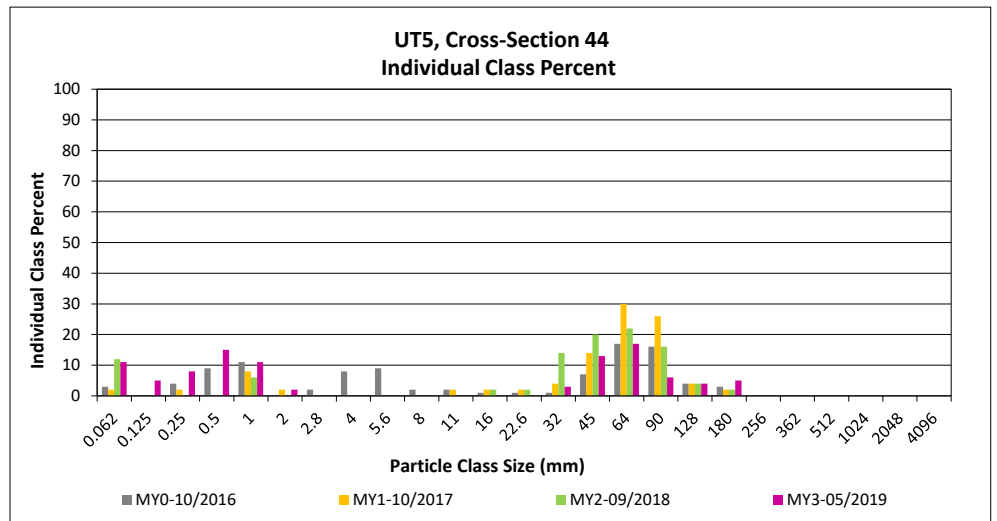
**Reachwide and Cross-Section Pebble Count Plots**

Cross-Section 44	
Channel materials (mm)	
D <sub>16</sub> =	0.1
D <sub>35</sub> =	0.4
D <sub>50</sub> =	1.0
D <sub>84</sub> =	62.7
D <sub>95</sub> =	128.0
D <sub>100</sub> =	180.0

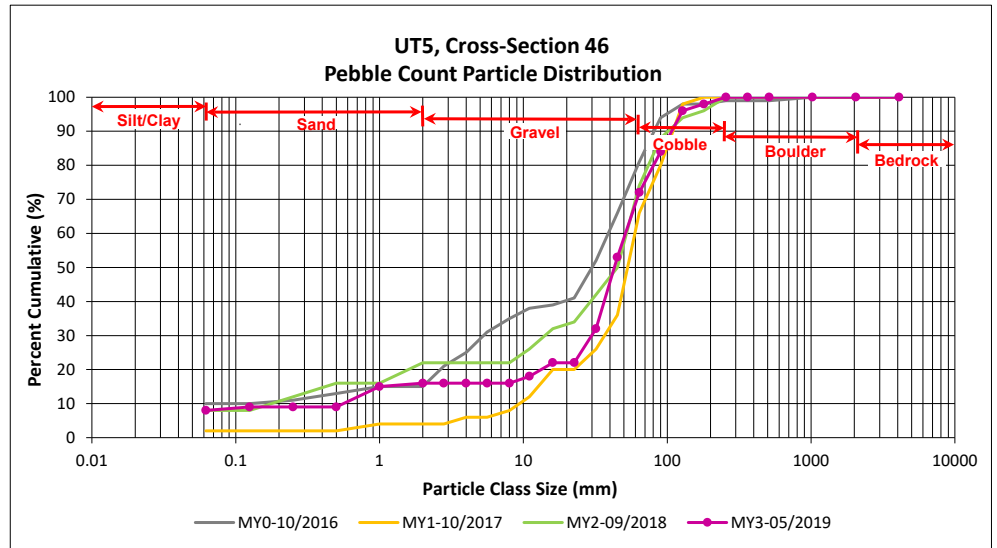
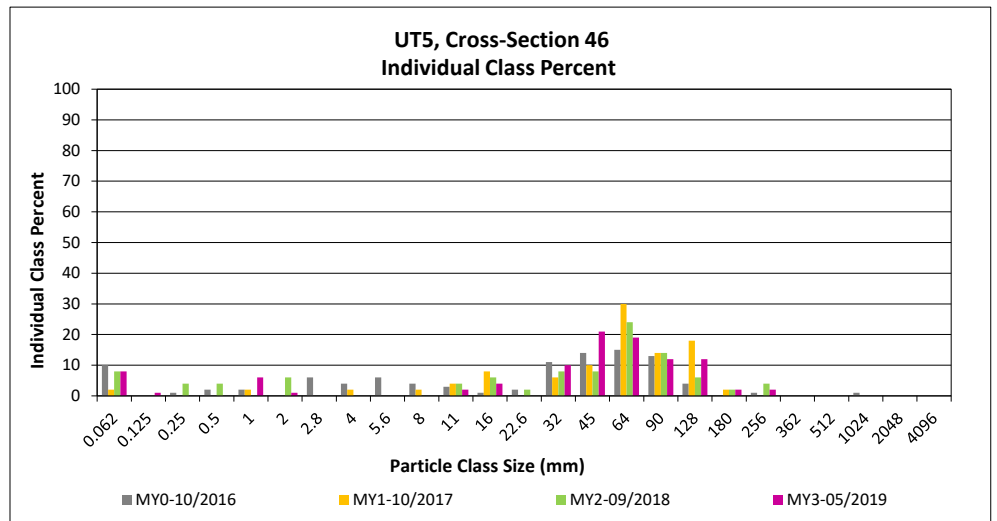
**Reachwide and Cross-Section Pebble Count Plots**

Cross-Section 46 Channel materials (mm)	
D <sub>16</sub> =	2.0
D <sub>35</sub> =	33.6
D <sub>50</sub> =	42.9
D <sub>84</sub> =	90.0
D <sub>95</sub> =	124.3
D <sub>100</sub> =	256.0

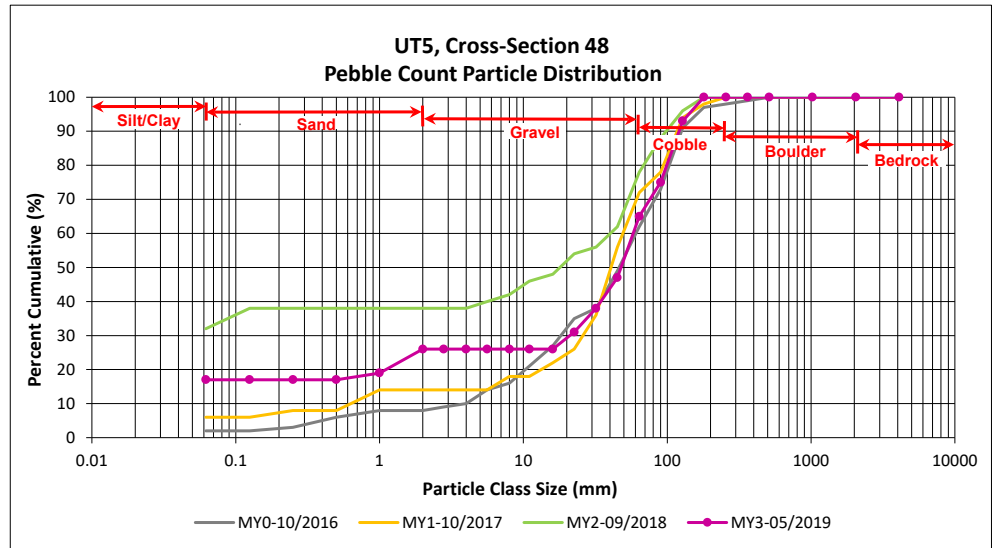
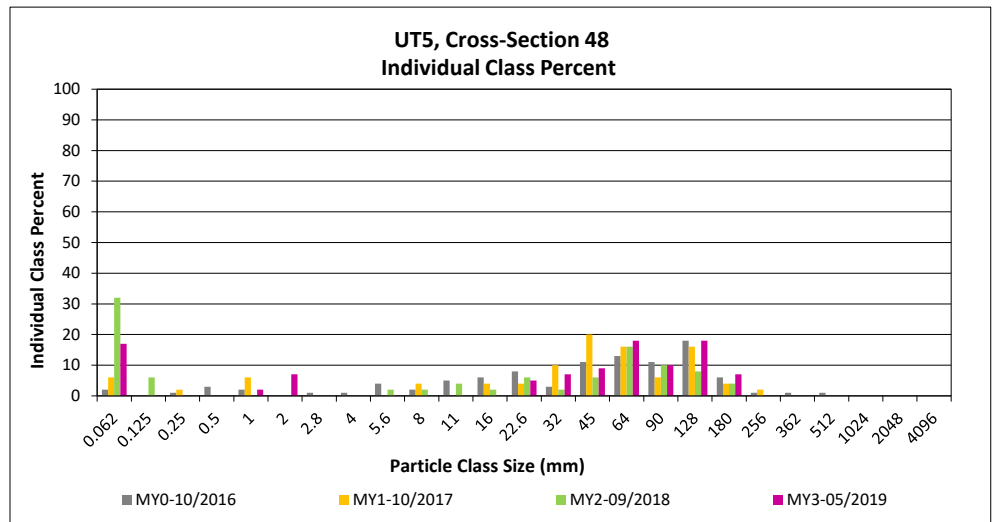
### Reachwide and Cross-Section Pebble Count Plots

Cross-Section 48	
Channel materials (mm)	
D <sub>16</sub> =	Silt/Clay
D <sub>35</sub> =	27.6
D <sub>50</sub> =	47.7
D <sub>84</sub> =	107.3
D <sub>95</sub> =	141.1
D <sub>100</sub> =	180.0
