# MONITORING YEAR 3 ANNUAL REPORT

## **CANDY CREEK MITIGATION SITE**

Guilford County, NC

NCDMS Project Number 96315

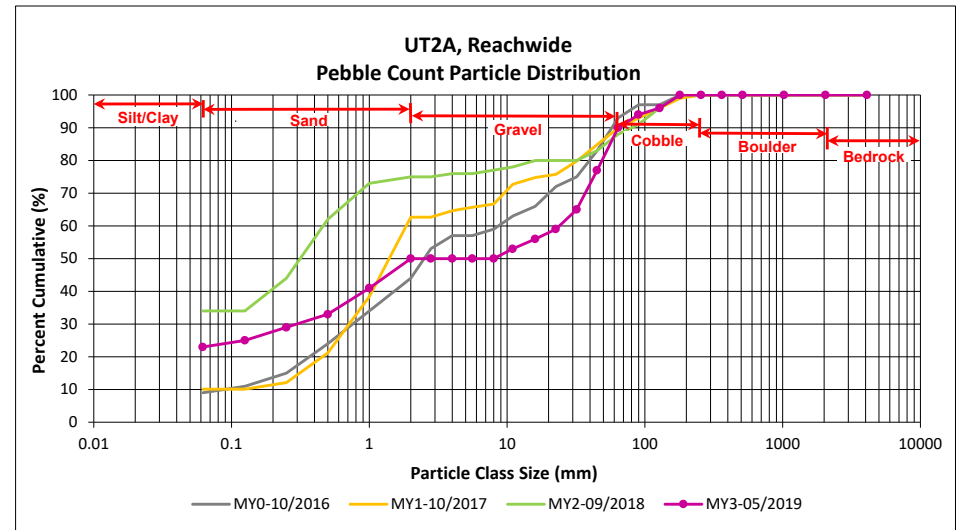
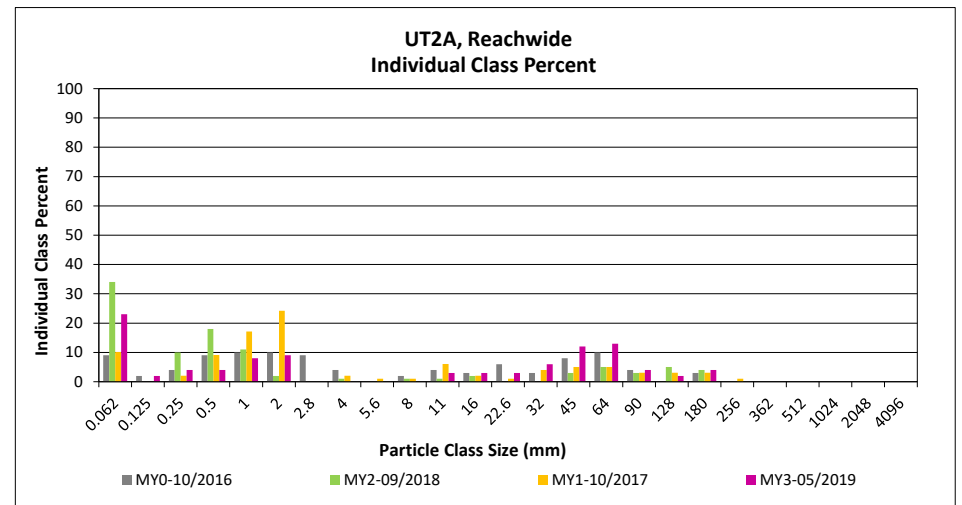
**Reachwide and Cross-Section Pebble Count Plots**

Reachwide Channel materials (mm)	
D <sub>16</sub> =	Silt/Clay
D <sub>35</sub> =	0.6
D <sub>50</sub> =	2.0
D <sub>84</sub> =	54.4
D <sub>95</sub> =	107.3
D <sub>100</sub> =	180.0

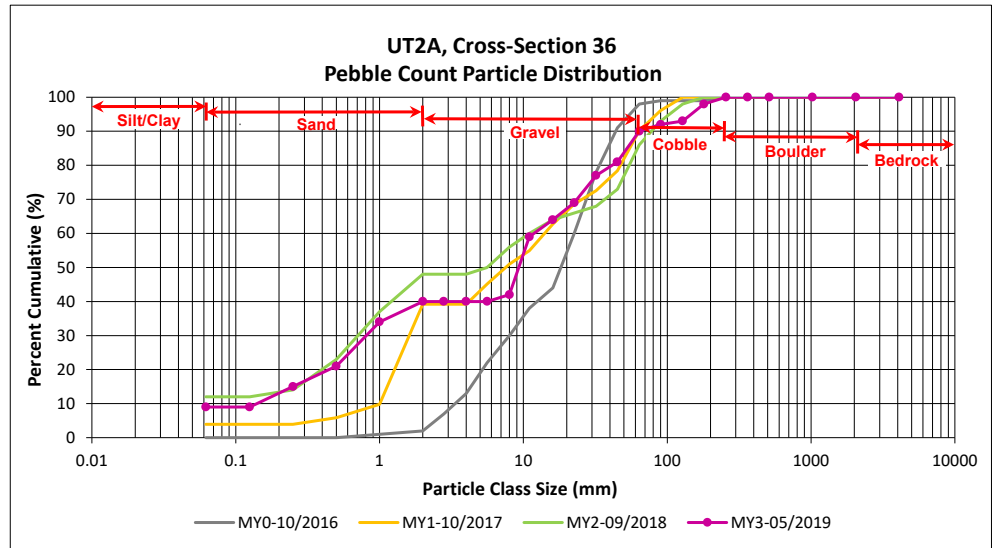
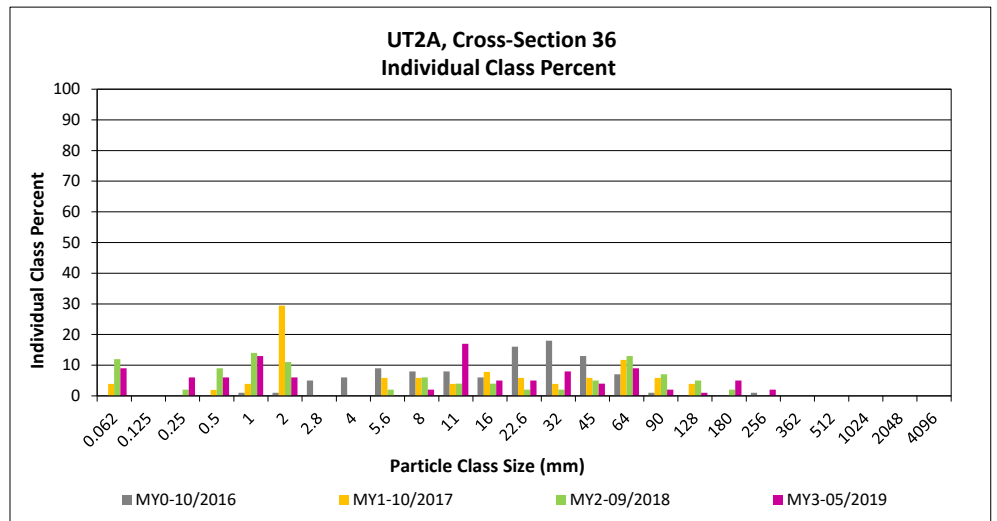
Cross-Section 36 Channel materials (mm)	
D <sub>16</sub> =	0.3
D <sub>35</sub> =	1.1
D <sub>50</sub> =	9.3
D <sub>84</sub> =	50.6
D <sub>95</sub> =	146.7
D <sub>100</sub> =	256.0
