# Cane Creek Tributary Stream Restoration Site Monitoring Report MY02 Basin 03010104 / Contract # D06002

**January 2011**

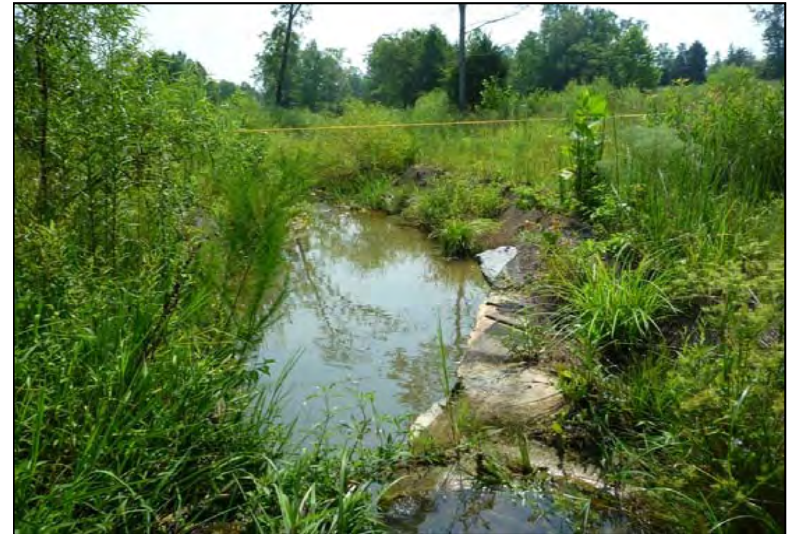
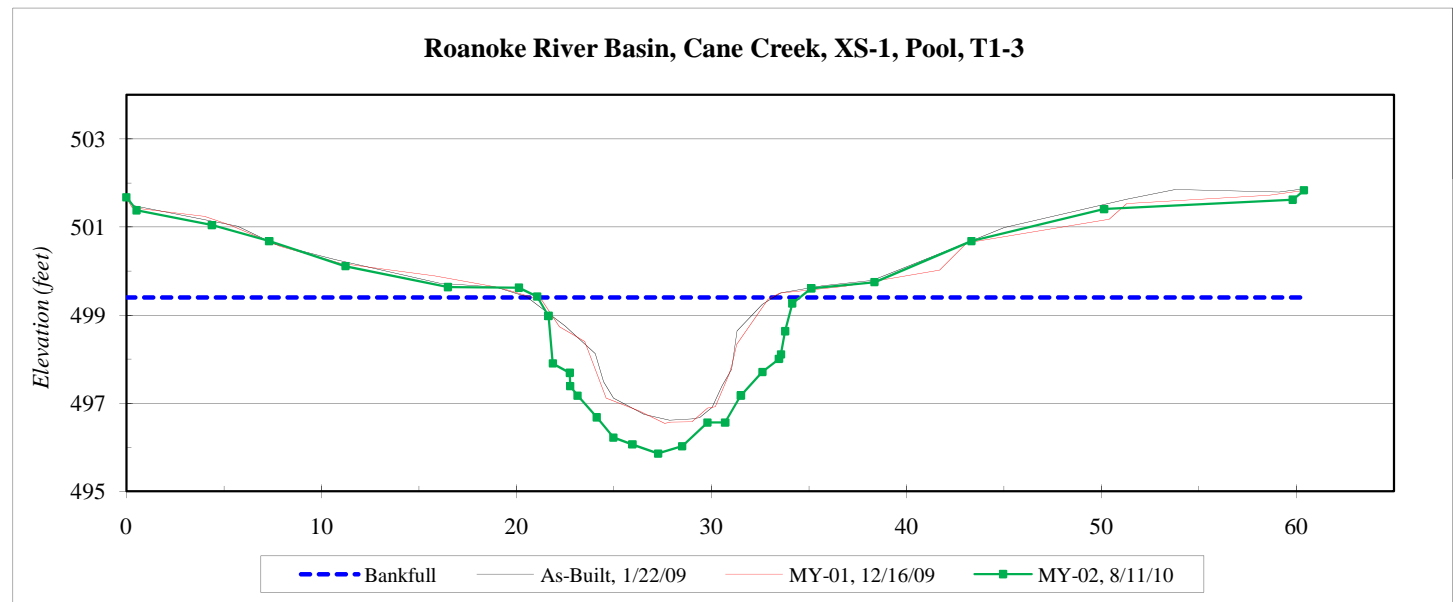
Station	Elevation
0.0	501.68
0.5	501.38
4.4	501.04
7.3	500.68
11.2	500.11
16.5	499.64
20.1	499.62
21.1	499.42
21.6	498.98
21.9	497.90
22.7	497.69
22.8	497.39
23.1	497.17
24.1	496.68
25.0	496.22
25.9	496.07
27.3	495.86
28.5	496.02
29.8	496.56
30.7	496.56
31.5	497.18
32.6	497.71
33.5	498.00
33.6	498.11
33.8	498.64
34.2	499.27
35.1	499.61
38.4	499.75
43.3	500.68
50.1	501.41
59.8	501.62
60.4	501.83

SUMMARY DATA	
<b>Bankfull Elevation:</b>	499.4
<b>Bankfull Cross-Sectional Area:</b>	32.2
<b>Bankfull Width:</b>	13.4
<b>Flood Prone Area Elevation:</b>	-
<b>Flood Prone Width:</b>	-
<b>Max Depth at Bankfull:</b>	3.5
<b>Mean Depth at Bankfull:</b>	2.4
<b>W / D Ratio:</b>	-
<b>Entrenchment Ratio:</b>	-
<b>Bank Height Ratio:</b>	-

<b>Stream Type</b>	C/B4
--------------------	------

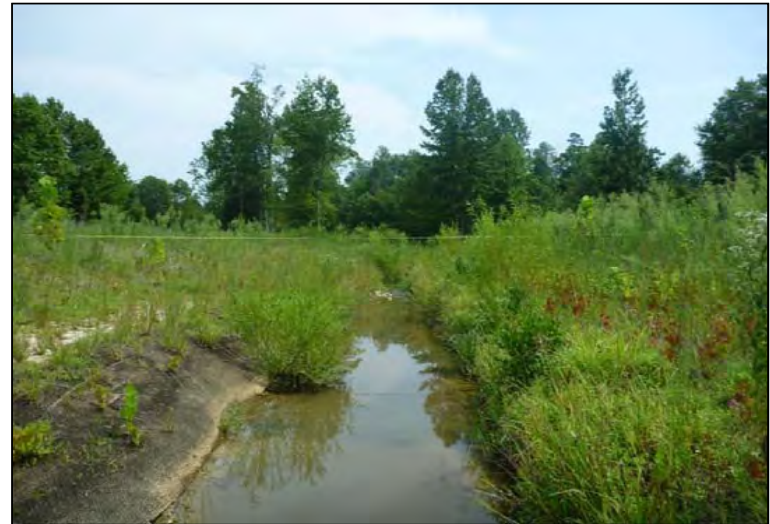
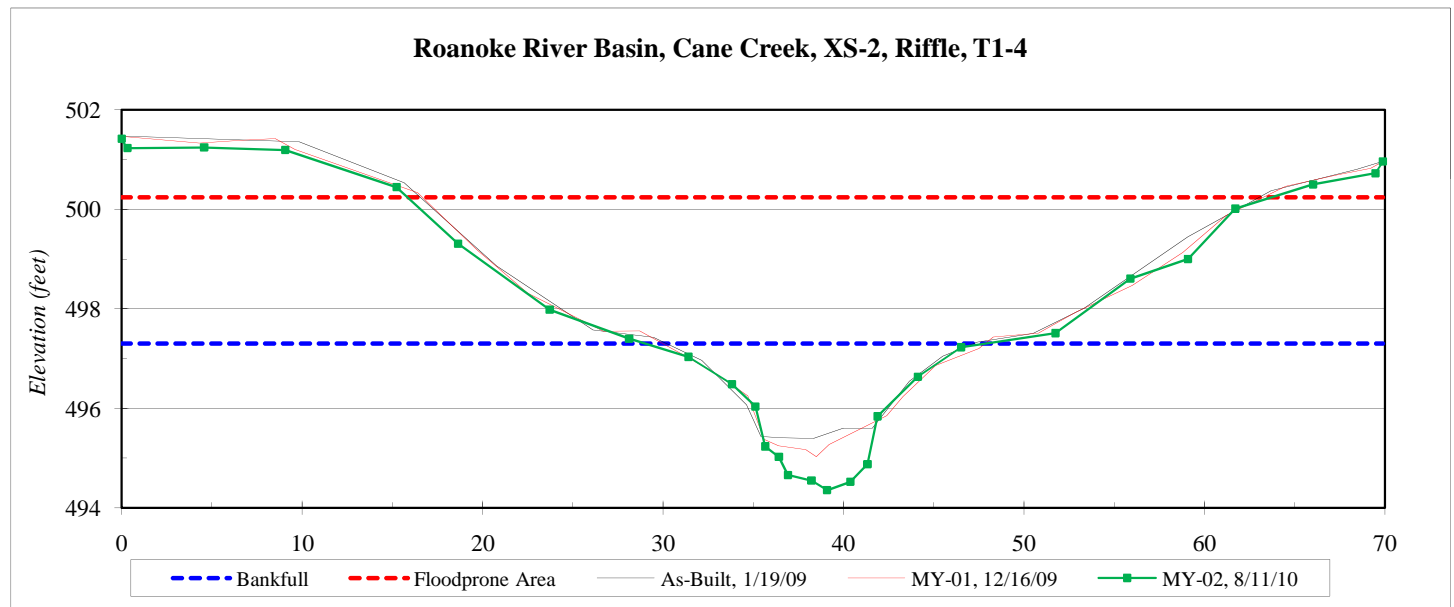
<b>River Basin:</b>	Roanoke
<b>Watershed:</b>	Cane Creek
<b>XS ID</b>	XS-2, Riffle, T1-4
<b>Drainage Area (sq mi):</b>	0.62
<b>Date:</b>	8/11/2010
<b>Field Crew:</b>	A. French, A. Helms

Station	Elevation
0.0	501.42
0.3	501.23
4.6	501.25
9.1	501.19
15.2	500.45
18.6	499.31
23.7	497.98
28.1	497.40
31.4	497.04
33.8	496.49
35.1	496.04
35.7	495.23
36.4	495.02
36.9	494.66
38.2	494.55
39.1	494.35
40.4	494.52
41.3	494.88
41.9	495.84
44.1	496.63
46.5	497.23
51.7	497.51
55.9	498.61
59.1	499.00
61.7	500.01
66.0	500.50
69.5	500.73
69.9	500.96

SUMMARY DATA	
<b>Bankfull Elevation:</b>	497.3
<b>Bankfull Cross-Sectional Area:</b>	23.3
<b>Bankfull Width:</b>	18.8
<b>Flood Prone Area Elevation:</b>	500.2
<b>Flood Prone Width:</b>	42
<b>Max Depth at Bankfull:</b>	2.9
<b>Mean Depth at Bankfull:</b>	1.2
<b>W / D Ratio:</b>	15.2
<b>Entrenchment Ratio:</b>	2.2
<b>Bank Height Ratio:</b>	1.0

<b>Stream Type</b>	C/B4
--------------------	------

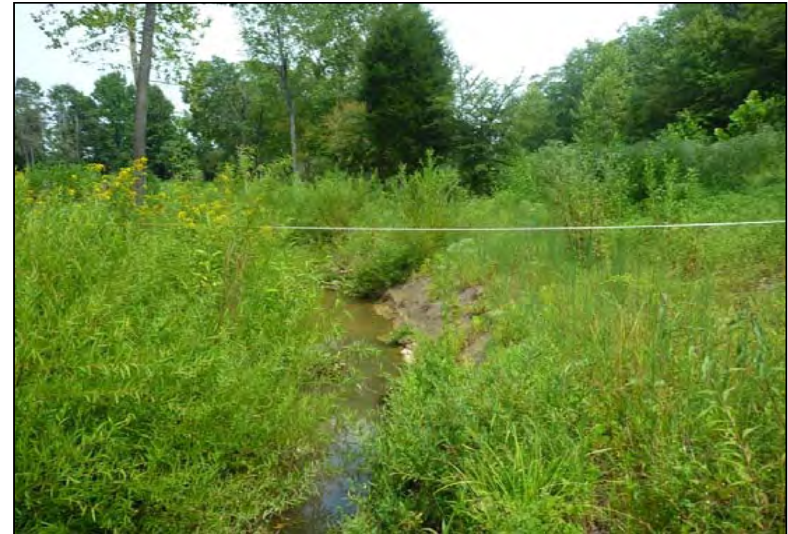
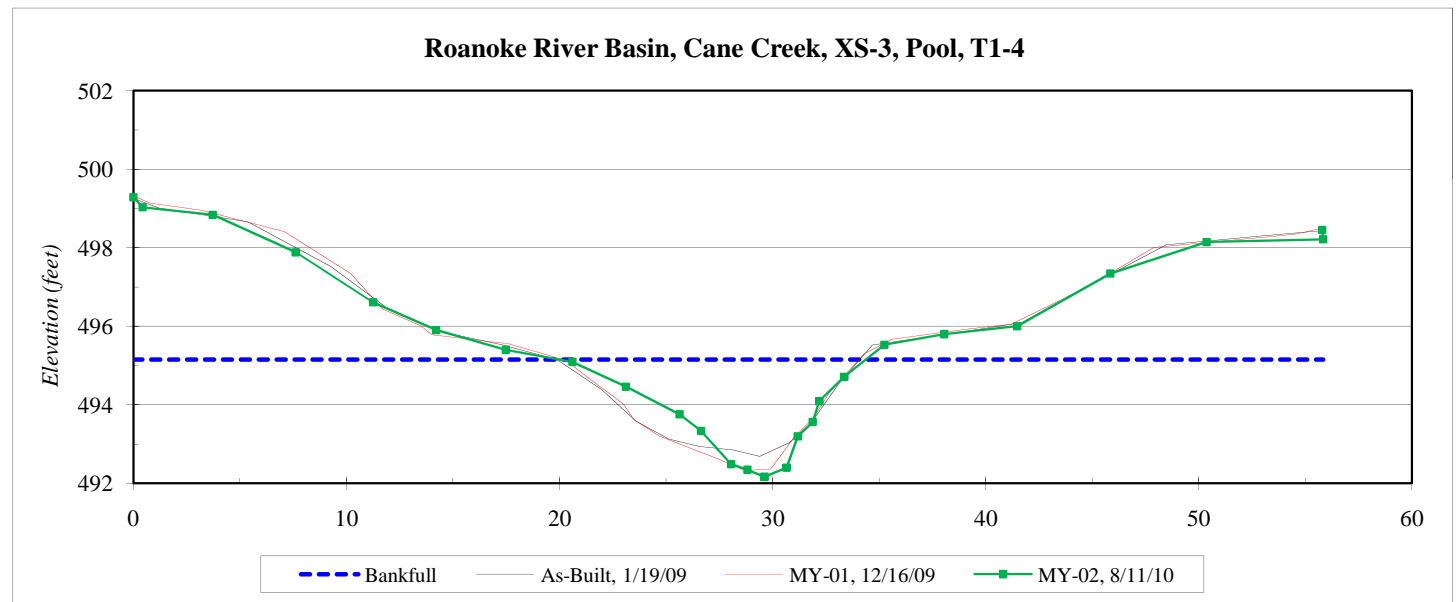
<b>River Basin:</b>	Roanoke
<b>Watershed:</b>	Cane Creek
<b>XS ID</b>	XS-3, Pool, T1-4
<b>Drainage Area (sq mi):</b>	0.62
<b>Date:</b>	8/11/2010
<b>Field Crew:</b>	A. French, A. Helms

Station	Elevation
0.0	499.28
0.4	499.03
3.7	498.84
7.6	497.88
11.3	496.61
14.2	495.90
17.5	495.40
20.6	495.09
23.1	494.46
25.6	493.76
26.6	493.34
28.1	492.49
28.8	492.34
29.6	492.16
30.7	492.40
31.2	493.20
31.9	493.56
32.2	494.09
33.4	494.71
35.2	495.53
38.1	495.80
41.5	496.00
45.8	497.34
50.4	498.14
55.8	498.22
55.8	498.45

SUMMARY DATA	
<b>Bankfull Elevation:</b>	495.2
<b>Bankfull Cross-Sectional Area:</b>	19.7
<b>Bankfull Width:</b>	14.4
<b>Flood Prone Area Elevation:</b>	-
<b>Flood Prone Width:</b>	-
<b>Max Depth at Bankfull:</b>	3.0
<b>Mean Depth at Bankfull:</b>	1.4
<b>W / D Ratio:</b>	-
<b>Entrenchment Ratio:</b>	-
<b>Bank Height Ratio:</b>	-

<b>Stream Type</b>	C/B4
--------------------	------

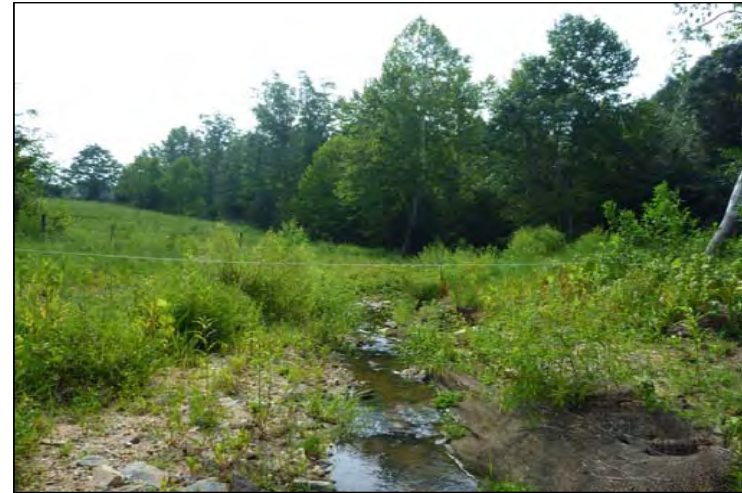
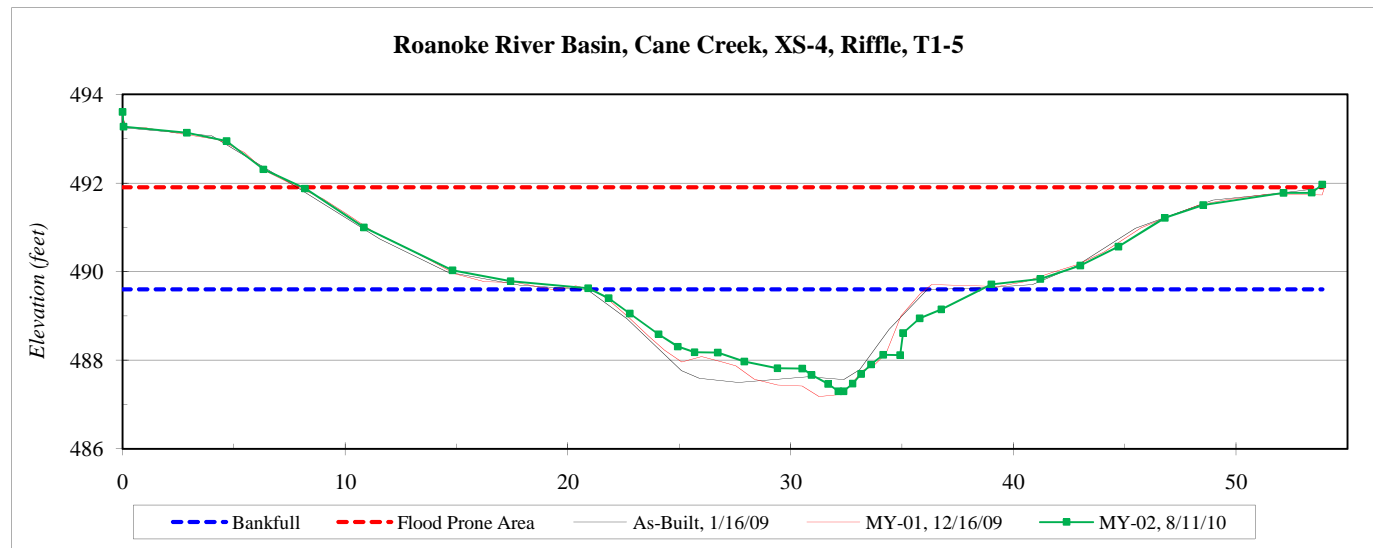
<b>River Basin:</b>	Roanoke
<b>Watershed:</b>	Cane Creek
<b>XS ID</b>	XS-4, Riffle, T1-5
<b>Drainage Area (sq mi):</b>	0.70
<b>Date:</b>	8/11/2010
<b>Field Crew:</b>	A. French, A. Helms

Stream Type C/B4

Station	Elevation
0.0	493.61
0.05	493.27
2.9	493.14
4.7	492.95
6.3	492.31
8.2	491.88
10.8	490.99
14.8	490.03
17.4	489.79
20.9	489.63
21.8	489.40
22.8	489.06
24.1	488.59
24.9	488.31
25.7	488.18
26.7	488.17
27.9	487.97
29.4	487.82
30.5	487.81
30.9	487.66
31.7	487.46
32.1	487.30
32.4	487.30
32.8	487.47
33.2	487.69
33.6	487.90
34.2	488.12
34.9	488.12
35.0	488.62
35.8	488.94
36.8	489.15
39.0	489.71
41.2	489.83
43.0	490.14
44.7	490.57
46.8	491.22
48.5	491.50
52.1	491.78
53.4	491.78
53.9	491.97

SUMMARY DATA	
<b>Bankfull Elevation:</b>	489.6
<b>Bankfull Cross-Sectional Area:</b>	21.2
<b>Bankfull Width:</b>	17.5
<b>Flood Prone Area Elevation:</b>	491.9
<b>Flood Prone Width:</b>	37
<b>Max Depth at Bankfull:</b>	2.3
<b>Mean Depth at Bankfull:</b>	1.2
<b>W / D Ratio:</b>	14.4
<b>Entrenchment Ratio:</b>	2.1
<b>Bank Height Ratio:</b>	1.0

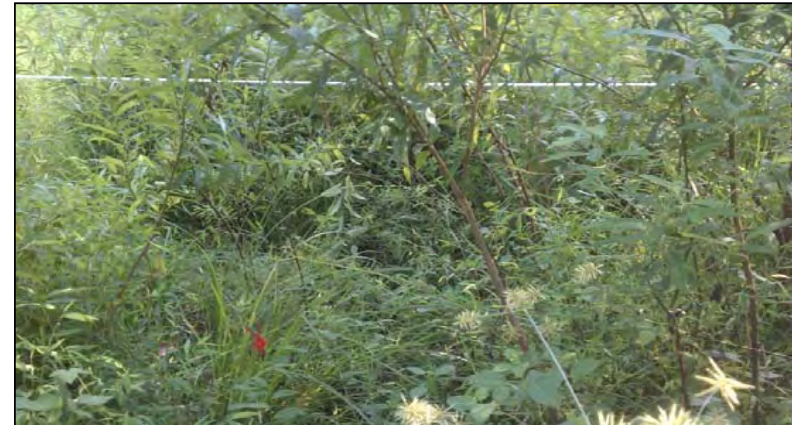
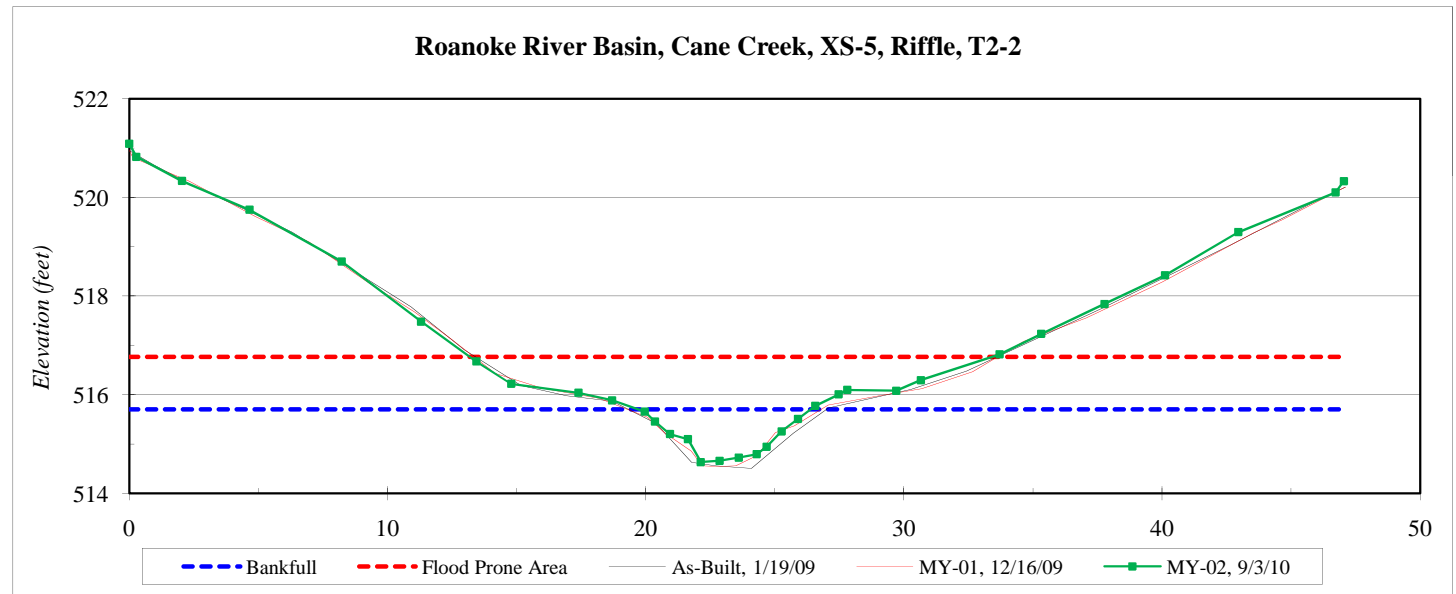
<b>River Basin:</b>	Roanoke
<b>Watershed:</b>	Cane Creek
<b>XS ID</b>	XS-5, Riffle, T2-2
<b>Drainage Area (sq mi):</b>	0.11
<b>Date:</b>	9/3/2010
<b>Field Crew:</b>	A. French, M. Koss

Station	Elevation
0.0	521.08
0.3	520.82
2.0	520.33
4.7	519.75
8.2	518.70
11.3	517.48
13.4	516.67
14.8	516.22
17.4	516.04
18.7	515.89
20.0	515.66
20.4	515.45
20.9	515.20
21.6	515.10
22.1	514.63
22.9	514.66
23.6	514.72
24.3	514.79
24.7	514.95
25.3	515.26
25.9	515.51
26.6	515.77
27.5	516.01
27.8	516.10
29.7	516.08
30.7	516.30
33.7	516.81
35.3	517.23
37.8	517.84
40.1	518.42
43.0	519.29
46.7	520.10
47.0	520.33

SUMMARY DATA	
<b>Bankfull Elevation:</b>	515.7
<b>Bankfull Cross-Sectional Area:</b>	4.2
<b>Bankfull Width:</b>	6.7
<b>Flood Prone Area Elevation:</b>	516.8
<b>Flood Prone Width:</b>	21
<b>Max Depth at Bankfull:</b>	1.1
<b>Mean Depth at Bankfull:</b>	0.6
<b>W / D Ratio:</b>	10.7
<b>Entrenchment Ratio:</b>	3.1
<b>Bank Height Ratio:</b>	1.0

<b>Stream Type</b>	C/E4
--------------------	------

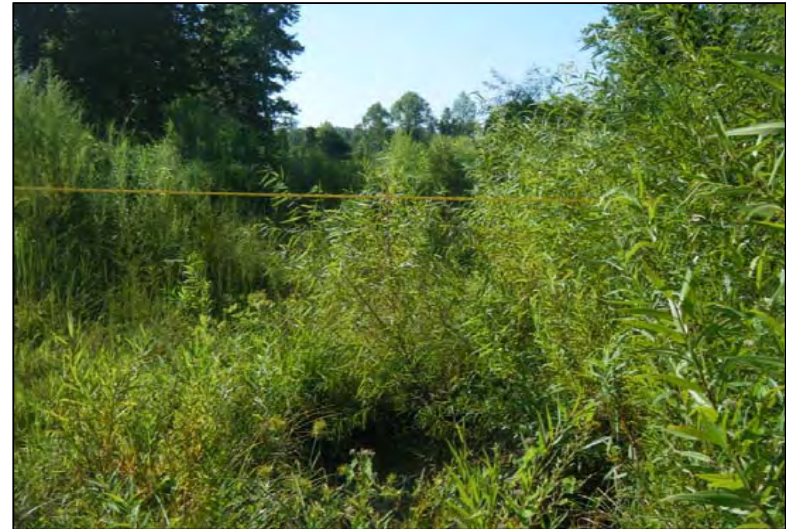
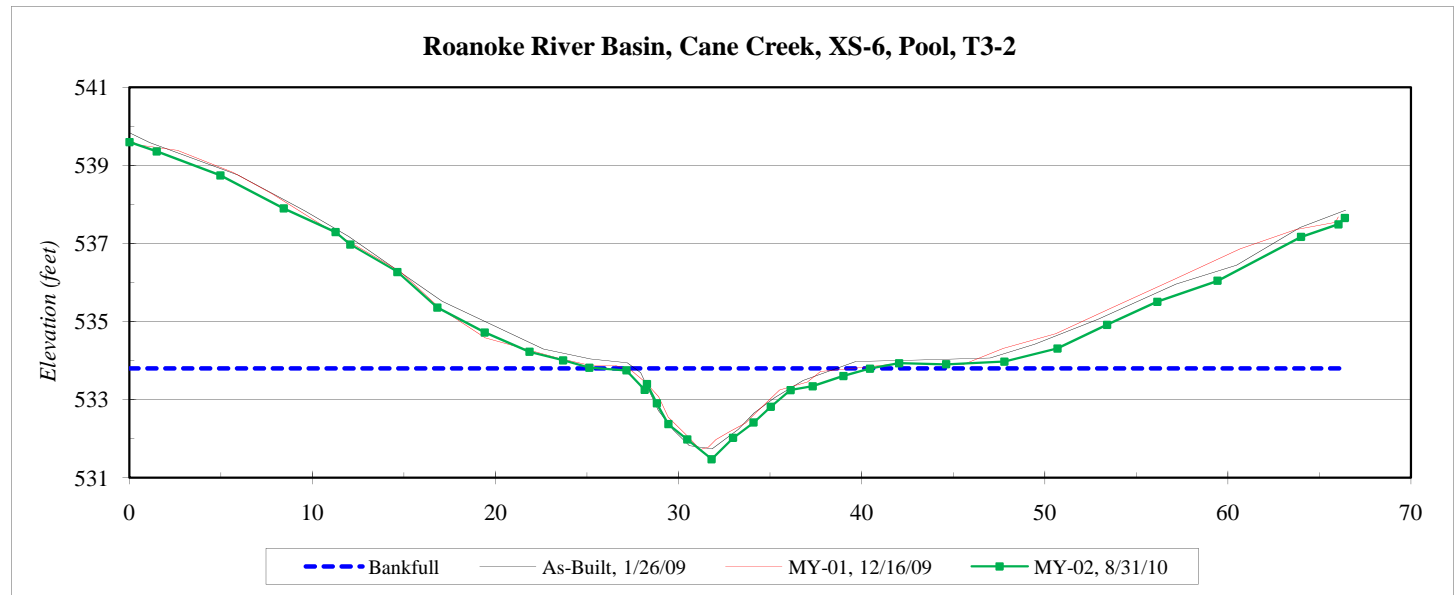
<b>River Basin:</b>	Roanoke
<b>Watershed:</b>	Cane Creek
<b>XS ID</b>	XS-6, Pool, T3-2
<b>Drainage Area (sq mi):</b>	0.08
<b>Date:</b>	8/31/2010
<b>Field Crew:</b>	A. French, M. Koss

Stream Type B4

Station	Elevation
0.0	539.60
1.5	539.36
5.0	538.74
8.4	537.89
11.3	537.29
12.1	536.97
14.6	536.27
16.8	535.36
19.4	534.72
21.9	534.22
23.7	534.01
25.1	533.82
27.1	533.75
28.2	533.25
28.3	533.40
28.8	532.91
29.4	532.37
30.5	531.98
31.8	531.47
33.0	532.02
34.1	532.41
35.0	532.81
36.1	533.24
37.3	533.34
39.0	533.61
40.4	533.79
42.0	533.93
44.6	533.90
47.8	533.97
50.7	534.31
53.4	534.91
56.1	535.50
59.4	536.04
64.0	537.16
66.0	537.49
66.4	537.65

SUMMARY DATA	
<b>Bankfull Elevation:</b>	533.8
<b>Bankfull Cross-Sectional Area:</b>	13.3
<b>Bankfull Width:</b>	13.5
<b>Flood Prone Area Elevation:</b>	-
<b>Flood Prone Width:</b>	-
<b>Max Depth at Bankfull:</b>	2.3
<b>Mean Depth at Bankfull:</b>	1.0
<b>W / D Ratio:</b>	-
<b>Entrenchment Ratio:</b>	-
<b>Bank Height Ratio:</b>	-

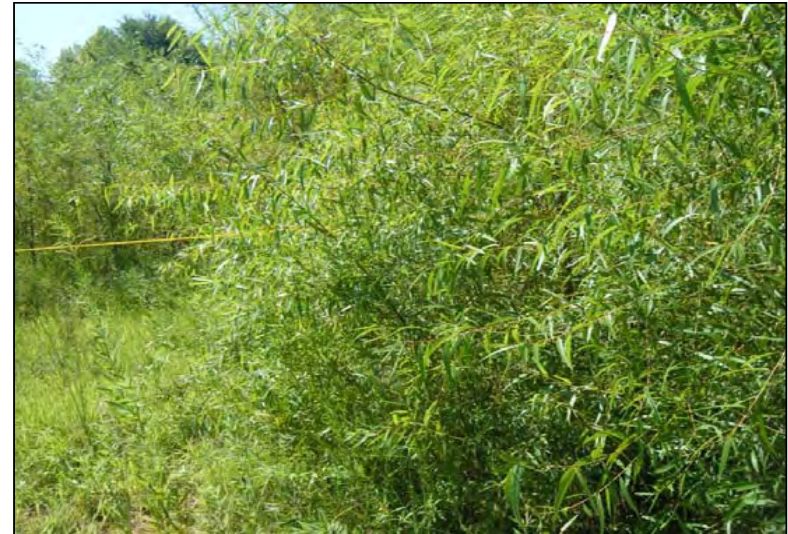
<b>River Basin:</b>	Roanoke
<b>Watershed:</b>	Cane Creek
<b>XS ID</b>	XS-7, Riffle, T3-2
<b>Drainage Area (sq mi):</b>	0.08
<b>Date:</b>	8/31/2010
<b>Field Crew:</b>	A. French, M. Koss

Station	Elevation
5.0	534.33
5.6	534.01
7.8	533.50
11.5	533.02
14.9	532.35
18.9	531.64
23.5	530.91
26.5	530.56
29.2	530.44
30.0	530.37
31.3	529.99
32.1	529.80
32.3	529.66
33.0	529.58
33.7	529.75
34.2	529.68
35.5	529.84
36.2	529.92
37.1	530.27
37.5	530.30
39.0	530.59
42.2	530.79
44.0	531.54
47.0	532.22
51.1	533.05
54.8	533.68
60.1	534.54
64.6	535.18
65.9	535.35
66.0	535.53

SUMMARY DATA	
<b>Bankfull Elevation:</b>	530.5
<b>Bankfull Cross-Sectional Area:</b>	4.7
<b>Bankfull Width:</b>	9.4
<b>Flood Prone Area Elevation:</b>	531.4
<b>Flood Prone Width:</b>	22
<b>Max Depth at Bankfull:</b>	0.9
<b>Mean Depth at Bankfull:</b>	0.5
<b>W / D Ratio:</b>	18.8
<b>Entrenchment Ratio:</b>	2.3
<b>Bank Height Ratio:</b>	1.0

<b>Stream Type</b>	B4
--------------------	----

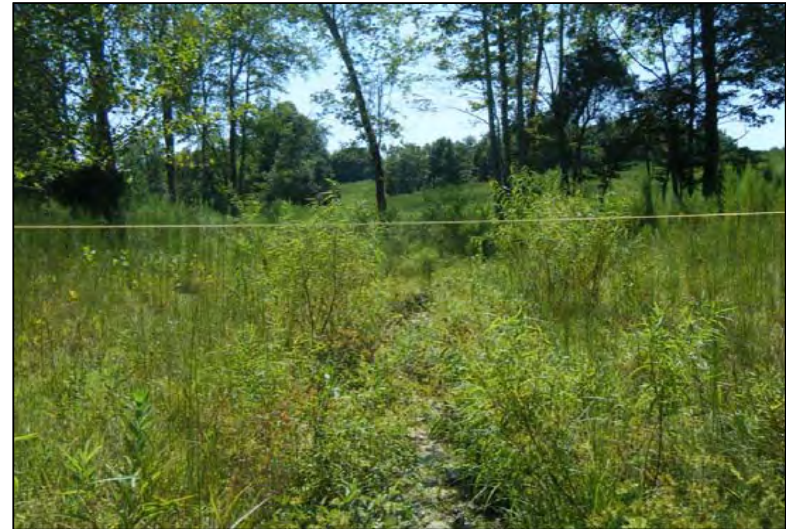
<b>River Basin:</b>	Roanoke
<b>Watershed:</b>	Cane Creek
<b>XS ID</b>	XS-8, Riffle, T3-2
<b>Drainage Area (sq mi):</b>	0.08
<b>Date:</b>	8/31/2010
<b>Field Crew:</b>	A. French, M. Koss

Station	Elevation
0.0	513.24
0.1	513.06
5.4	512.51
6.1	512.31
14.0	509.39
16.1	508.65
18.1	508.28
20.6	508.23
22.8	507.97
22.7	507.96
23.4	507.77
24.9	507.56
26.0	507.45
26.6	507.25
27.6	507.22
28.6	507.37
29.0	507.58
29.7	507.88
30.2	508.12
31.9	508.29
34.9	508.44
38.7	509.02
43.0	509.85
46.4	510.55
51.4	511.70
56.3	512.44
56.7	512.74

SUMMARY DATA	
<b>Bankfull Elevation:</b>	508.2
<b>Bankfull Cross-Sectional Area:</b>	4.7
<b>Bankfull Width:</b>	9.3
<b>Flood Prone Area Elevation:</b>	509.2
<b>Flood Prone Width:</b>	26
<b>Max Depth at Bankfull:</b>	1.0
<b>Mean Depth at Bankfull:</b>	0.5
<b>W / D Ratio:</b>	18.4
<b>Entrenchment Ratio:</b>	2.8
<b>Bank Height Ratio:</b>	1.0

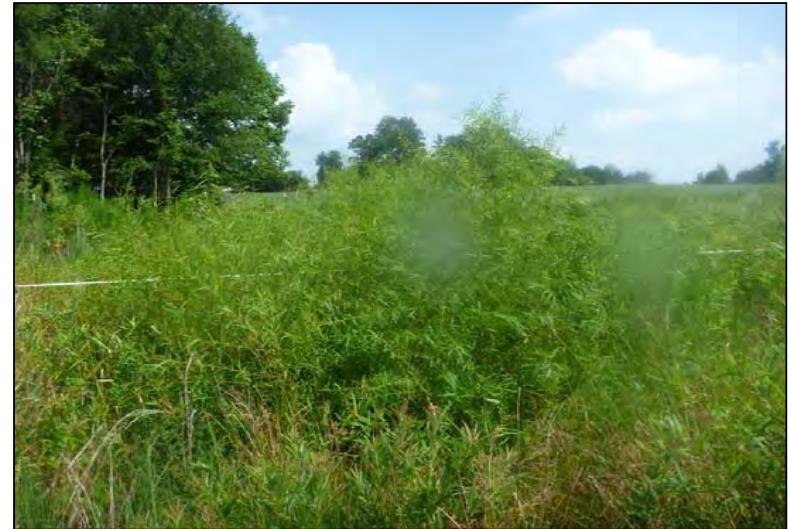
<b>River Basin:</b>	Roanoke
<b>Watershed:</b>	Cane Creek
<b>XS ID</b>	XS-9, Riffle, T4-1
<b>Drainage Area (sq mi):</b>	0.10
<b>Date:</b>	8/13/2010
<b>Field Crew:</b>	A. French, A. Helms

Station	Elevation
0.0	539.72
0.6	539.52
5.5	539.26
8.6	538.96
11.9	538.07
15.5	537.24
18.3	536.52
21.6	536.30
23.3	535.91
24.4	535.62
25.1	535.39
25.4	535.25
26.2	535.13
26.7	535.16
27.2	535.37
27.6	535.76
27.7	535.85
28.6	536.20
30.7	536.42
33.7	536.37
37.7	537.19
41.6	537.95
44.0	538.20
45.7	538.26
46.2	538.44

SUMMARY DATA	
<b>Bankfull Elevation:</b>	536.4
<b>Bankfull Cross-Sectional Area:</b>	5.3
<b>Bankfull Width:</b>	10.4
<b>Flood Prone Area Elevation:</b>	537.7
<b>Flood Prone Width:</b>	25
<b>Max Depth at Bankfull:</b>	1.3
<b>Mean Depth at Bankfull:</b>	0.5
<b>W / D Ratio:</b>	20.4
<b>Entrenchment Ratio:</b>	2.4
<b>Bank Height Ratio:</b>	1.0

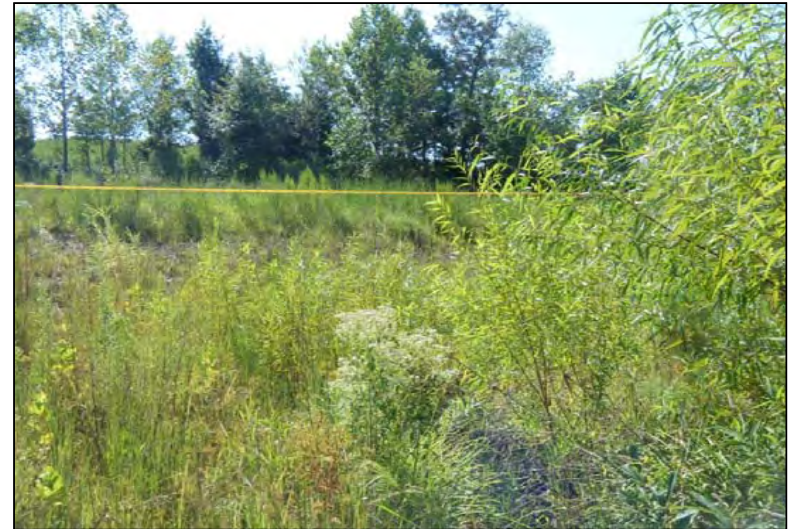
<b>River Basin:</b>	Roanoke
<b>Watershed:</b>	Cane Creek
<b>XS ID</b>	XS-10, Riffle, T4-2
<b>Drainage Area (sq mi):</b>	0.10
<b>Date:</b>	8/30/2010
<b>Field Crew:</b>	A. French, M. Koss

Station	Elevation
0.0	528.89
0.9	528.50
3.7	528.16
6.9	527.63
10.9	526.64
14.8	525.28
18.3	523.94
21.0	522.83
24.6	522.01
27.7	521.77
29.1	521.80
30.2	521.40
31.1	521.02
31.5	520.90
32.4	520.95
33.2	520.89
33.7	520.85
34.4	521.01
35.5	521.15
36.7	521.49
37.8	521.66
40.3	521.65
42.5	521.73
44.0	522.47
46.3	523.33
48.5	524.10
51.8	525.25
55.2	526.18
59.8	526.63
60.1	526.86

SUMMARY DATA	
<b>Bankfull Elevation:</b>	521.7
<b>Bankfull Cross-Sectional Area:</b>	4.1
<b>Bankfull Width:</b>	8.3
<b>Flood Prone Area Elevation:</b>	522.5
<b>Flood Prone Width:</b>	21
<b>Max Depth at Bankfull:</b>	0.8
<b>Mean Depth at Bankfull:</b>	0.5
<b>W / D Ratio:</b>	16.8
<b>Entrenchment Ratio:</b>	2.6
<b>Bank Height Ratio:</b>	1.0

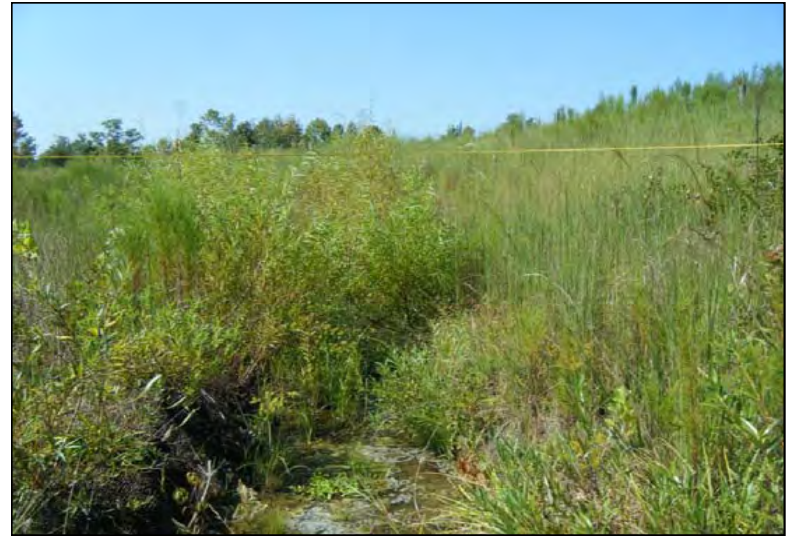
<b>River Basin:</b>	Roanoke
<b>Watershed:</b>	Cane Creek
<b>XS ID</b>	XS-11, Riffle, T4-2
<b>Drainage Area (sq mi):</b>	0.10
<b>Date:</b>	8/30/2010
<b>Field Crew:</b>	A. French, M. Koss

Station	Elevation
0.0	519.02
0.7	518.70
2.8	518.55
4.6	518.29
6.7	517.87
8.9	517.02
11.0	516.24
13.5	515.40
16.5	514.56
19.1	514.19
20.8	514.19
21.9	513.77
22.4	513.53
23.0	512.88
24.1	512.58
25.4	512.57
26.3	512.66
27.2	512.69
27.5	513.00
27.9	513.63
28.9	514.12
32.1	514.51
35.8	514.96
39.5	516.23
44.5	517.81
50.0	518.87
53.2	519.41
53.3	519.56

SUMMARY DATA	
<b>Bankfull Elevation:</b>	514.2
<b>Bankfull Cross-Sectional Area:</b>	6.4
<b>Bankfull Width:</b>	6.8
<b>Flood Prone Area Elevation:</b>	515.8
<b>Flood Prone Width:</b>	22
<b>Max Depth at Bankfull:</b>	1.6
<b>Mean Depth at Bankfull:</b>	0.9
<b>W / D Ratio:</b>	7.2
<b>Entrenchment Ratio:</b>	3.2
<b>Bank Height Ratio:</b>	1.0

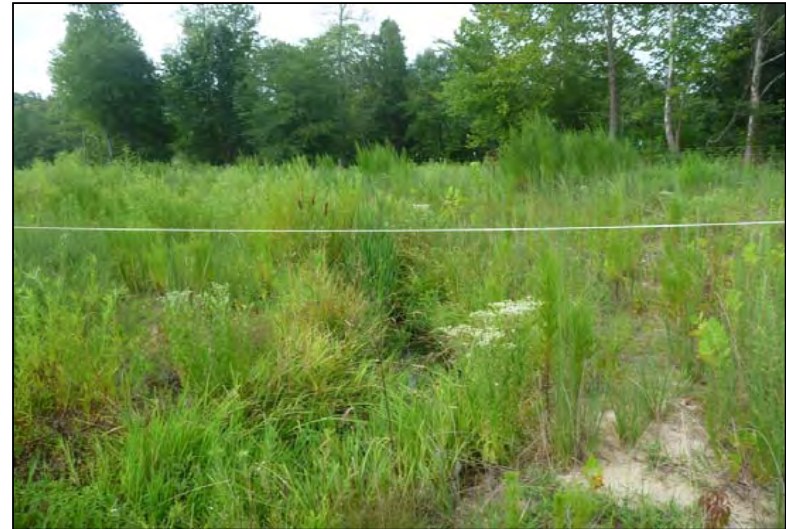
Roanoke River Basin, Cane Creek, XS-12, Pool, T4-2

<b>River Basin:</b>	Roanoke
<b>Watershed:</b>	Cane Creek
<b>XS ID</b>	XS-12, Pool, T4-2
<b>Drainage Area (sq mi):</b>	0.10
<b>Date:</b>	8/13/2010
<b>Field Crew:</b>	A. French, A. Helms

Station	Elevation
0.0	508.03
0.2	507.72
3.5	507.31
7.6	506.74
12.0	505.97
16.0	504.75
21.7	503.75
27.1	503.34
31.0	503.11
33.1	502.56
34.6	502.13
35.1	501.74
35.4	501.35
36.0	500.85
36.6	500.65
37.4	500.42
38.1	500.26
39.1	500.72
39.6	501.72
40.7	502.56
41.7	503.04
44.8	503.05
47.4	503.60
52.1	504.87
56.3	506.01
59.7	506.17
60.0	506.37

SUMMARY DATA	
<b>Bankfull Elevation:</b>	503.0
<b>Bankfull Cross-Sectional Area:</b>	13.6
<b>Bankfull Width:</b>	10.5
<b>Flood Prone Area Elevation:</b>	-
<b>Flood Prone Width:</b>	-
<b>Max Depth at Bankfull:</b>	2.8
<b>Mean Depth at Bankfull:</b>	1.3
<b>W / D Ratio:</b>	-
<b>Entrenchment Ratio:</b>	-
<b>Bank Height Ratio:</b>	-

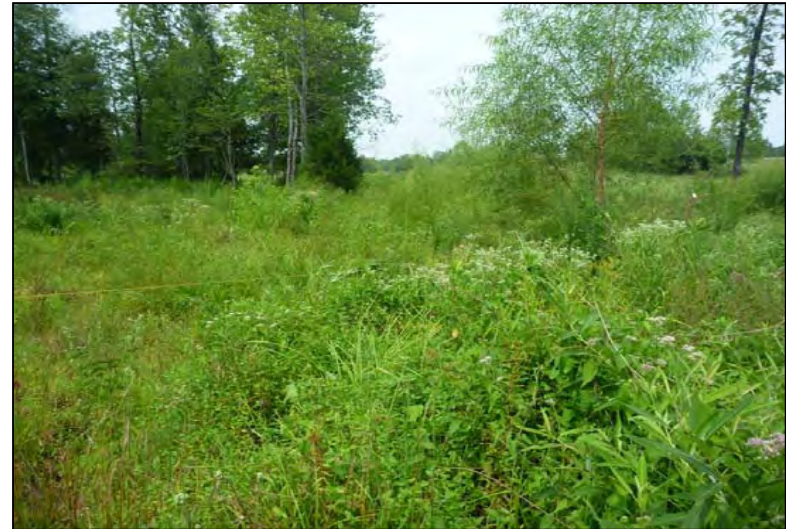
<b>River Basin:</b>	Roanoke
<b>Watershed:</b>	Cane Creek
<b>XS ID</b>	XS-13, Riffle, T5-2
<b>Drainage Area (sq mi):</b>	0.02
<b>Date:</b>	8/11/2010
<b>Field Crew:</b>	A. French, A. Helms

Station	Elevation
0.0	502.80
0.1	502.47
4.3	502.55
8.6	502.27
11.9	501.95
15.1	501.54
18.7	501.09
22.1	500.83
24.7	500.58
25.5	500.00
26.1	499.92
26.6	500.01
27.1	500.24
27.8	500.37
28.9	500.81
31.9	500.83
35.2	501.06
38.7	501.53
43.1	501.74
48.6	501.63
48.9	501.88

SUMMARY DATA	
<b>Bankfull Elevation:</b>	500.8
<b>Bankfull Cross-Sectional Area:</b>	2.6
<b>Bankfull Width:</b>	6.9
<b>Flood Prone Area Elevation:</b>	501.7
<b>Flood Prone Width:</b>	23
<b>Max Depth at Bankfull:</b>	0.9
<b>Mean Depth at Bankfull:</b>	0.4
<b>W / D Ratio:</b>	18.3
<b>Entrenchment Ratio:</b>	3.3
<b>Bank Height Ratio:</b>	1.0

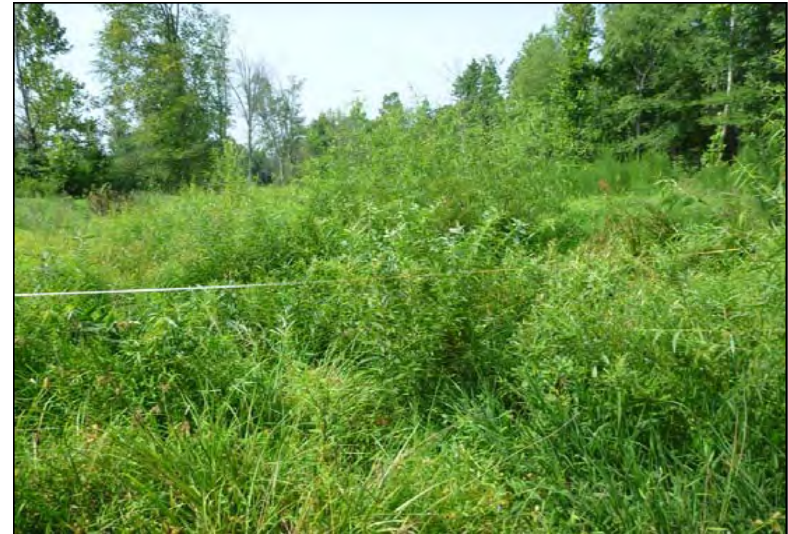
<b>River Basin:</b>	Roanoke
<b>Watershed:</b>	Cane Creek
<b>XS ID</b>	XS-14, Riffle, T6
<b>Drainage Area (sq mi):</b>	0.07
<b>Date:</b>	8/9/2010
<b>Field Crew:</b>	A. French, A. Helms

Station	Elevation
0.0	522.39
4.0	521.82
10.5	521.06
14.3	520.38
17.3	519.81
19.6	519.27
22.0	518.88
24.3	518.30
26.5	517.87
28.0	517.56
28.5	517.42
28.7	516.75
29.2	516.34
30.1	516.19
30.6	516.45
31.0	516.64
31.3	517.18
32.2	517.43
32.8	517.79
34.2	518.21
37.3	518.42
40.8	518.81
44.5	519.16
48.9	519.34
54.0	519.76
60.7	520.64
64.0	520.95
64.4	521.26

SUMMARY DATA	
<b>Bankfull Elevation:</b>	518.0
<b>Bankfull Cross-Sectional Area:</b>	5.9
<b>Bankfull Width:</b>	7.7
<b>Flood Prone Area Elevation:</b>	519.8
<b>Flood Prone Width:</b>	26
<b>Max Depth at Bankfull:</b>	1.8
<b>Mean Depth at Bankfull:</b>	0.8
<b>W / D Ratio:</b>	10.0
<b>Entrenchment Ratio:</b>	3.4
<b>Bank Height Ratio:</b>	1.0

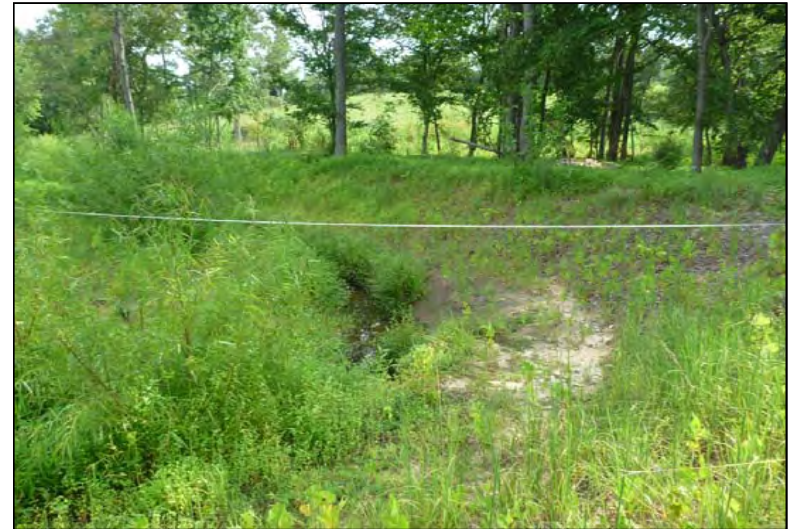
<b>River Basin:</b>	Roanoke
<b>Watershed:</b>	Cane Creek
<b>XS ID</b>	XS-15, Pool, T6
<b>Drainage Area (sq mi):</b>	0.07
<b>Date:</b>	8/9/2010
<b>Field Crew:</b>	A. French, A. Helms

Station	Elevation
0.0	497.12
0.4	496.58
4.0	496.47
8.0	496.32
11.6	495.84
15.9	495.30
19.4	494.82
23.8	494.26
26.6	493.13
30.1	492.71
33.3	492.53
35.7	492.01
36.5	491.30
37.4	491.02
38.1	490.88
38.4	491.13
39.2	492.19
40.5	492.76
42.0	492.79
44.7	493.45
47.7	494.56
51.5	496.31
55.4	497.75
57.6	497.73
57.6	497.95

SUMMARY DATA	
<b>Bankfull Elevation:</b>	492.3
<b>Bankfull Cross-Sectional Area:</b>	3.6
<b>Bankfull Width:</b>	5.0
<b>Flood Prone Area Elevation:</b>	-
<b>Flood Prone Width:</b>	-
<b>Max Depth at Bankfull:</b>	1.4
<b>Mean Depth at Bankfull:</b>	0.7
<b>W / D Ratio:</b>	-
<b>Entrenchment Ratio:</b>	-
<b>Bank Height Ratio:</b>	-

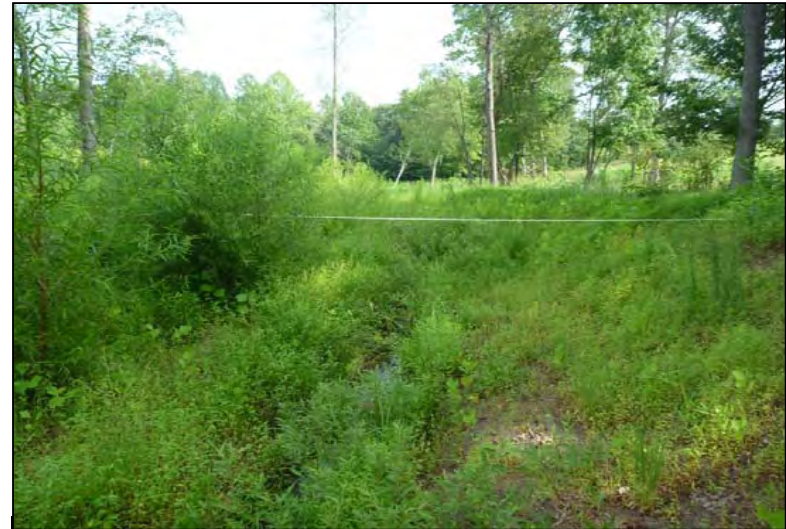
Roanoke River Basin, Cane Creek, XS-16, Riffle, T6

<b>River Basin:</b>	Roanoke
<b>Watershed:</b>	Cane Creek
<b>XS ID</b>	XS-16, Riffle, T6
<b>Drainage Area (sq mi):</b>	0.07
<b>Date:</b>	8/9/2010
<b>Field Crew:</b>	A. French, A. Helms

Station	Elevation
0.0	497.11
0.2	496.65
5.3	496.26
10.5	495.59
14.8	494.87
17.8	493.62
21.1	492.73
25.2	492.27
26.9	491.71
27.9	491.33
28.7	491.06
29.9	491.05
31.2	491.75
32.7	492.44
35.0	492.70
38.0	493.83
42.2	495.80
46.6	495.83
47.5	495.89

SUMMARY DATA	
<b>Bankfull Elevation:</b>	492.3
<b>Bankfull Cross-Sectional Area:</b>	5.2
<b>Bankfull Width:</b>	7.4
<b>Flood Prone Area Elevation:</b>	493.5
<b>Flood Prone Width:</b>	18
<b>Max Depth at Bankfull:</b>	1.2
<b>Mean Depth at Bankfull:</b>	0.7
<b>W / D Ratio:</b>	10.5
<b>Entrenchment Ratio:</b>	2.4
<b>Bank Height Ratio:</b>	1.0

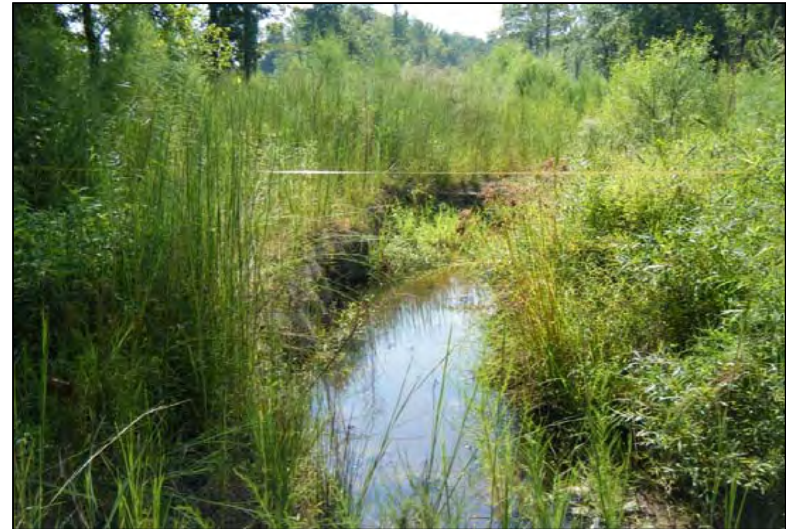
**Roanoke River Basin, Cane Creek, XS-17, Pool, T7-3**

<b>River Basin:</b>	Roanoke
<b>Watershed:</b>	Cane Creek
<b>XS ID</b>	XS-17, Pool, T7-3
<b>Drainage Area (sq mi):</b>	0.18
<b>Date:</b>	9/2/2010
<b>Field Crew:</b>	A. French, M. Koss

Station	Elevation
0.0	522.69
0.7	522.47
5.4	522.28
9.8	522.11
13.4	521.41
15.7	520.99
17.5	520.27
18.6	519.94
19.6	519.57
21.1	519.43
22.4	518.76
23.0	518.65
23.6	517.79
23.7	516.60
24.4	516.42
25.4	516.50
27.0	516.57
28.1	517.12
28.8	517.21
29.2	517.28
30.2	517.91
31.4	518.48
32.9	518.78
35.5	519.09
38.4	519.48
42.0	520.22
45.4	520.99
49.9	521.71
56.5	522.04
60.7	522.40
60.9	522.59

SUMMARY DATA	
<b>Bankfull Elevation:</b>	518.8
<b>Bankfull Cross-Sectional Area:</b>	13.3
<b>Bankfull Width:</b>	9.8
<b>Flood Prone Area Elevation:</b>	-
<b>Flood Prone Width:</b>	-
<b>Max Depth at Bankfull:</b>	2.3
<b>Mean Depth at Bankfull:</b>	1.4
<b>W / D Ratio:</b>	-
<b>Entrenchment Ratio:</b>	-
<b>Bank Height Ratio:</b>	-

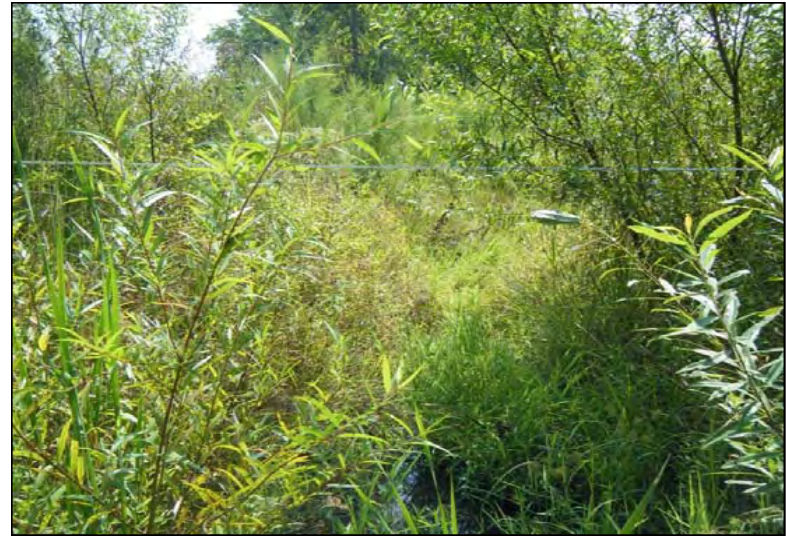
<b>River Basin:</b>	Roanoke
<b>Watershed:</b>	Cane Creek
<b>XS ID</b>	XS-18, Riffle, T7-3
<b>Drainage Area (sq mi):</b>	0.18
<b>Date:</b>	9/2/2010
<b>Field Crew:</b>	A. French, M. Koss

Station	Elevation
0.0	518.77
0.7	518.49
5.7	518.39
9.9	517.95
12.2	517.85
13.5	517.82
16.8	516.23
18.5	515.47
21.1	515.23
21.8	514.66
21.8	514.66
23.1	513.90
23.6	513.82
24.1	513.60
24.5	513.64
24.9	513.66
25.6	513.76
26.7	513.93
27.1	514.45
28.3	514.75
29.7	515.17
31.9	515.47
34.2	516.19
36.6	516.99
40.3	517.74
45.4	518.01
48.4	518.16
48.5	518.31

SUMMARY DATA	
<b>Bankfull Elevation:</b>	515.1
<b>Bankfull Cross-Sectional Area:</b>	7.2
<b>Bankfull Width:</b>	8.2
<b>Flood Prone Area Elevation:</b>	516.7
<b>Flood Prone Width:</b>	19
<b>Max Depth at Bankfull:</b>	1.5
<b>Mean Depth at Bankfull:</b>	0.9
<b>W / D Ratio:</b>	9.3
<b>Entrenchment Ratio:</b>	2.3
<b>Bank Height Ratio:</b>	1.0

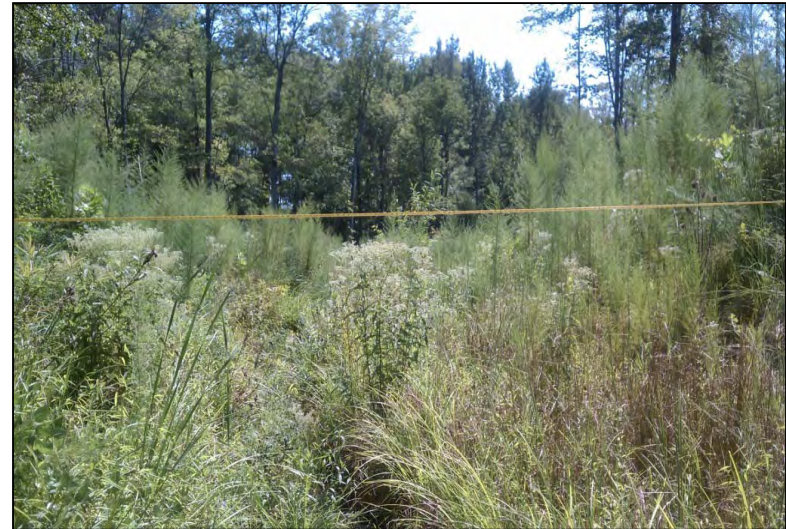
<b>River Basin:</b>	Roanoke
<b>Watershed:</b>	Cane Creek
<b>XS ID</b>	XS-19, Riffle, T7-3
<b>Drainage Area (sq mi):</b>	0.18
<b>Date:</b>	9/3/2010
<b>Field Crew:</b>	A. French, M. Koss

Station	Elevation
0.0	512.51
0.5	512.26
6.2	512.02
12.8	511.94
18.2	511.68
19.2	511.47
20.4	510.72
22.7	509.54
25.2	508.26
25.7	507.99
27.7	507.83
28.5	507.58
29.7	507.21
30.4	506.94
31.1	506.93
32.2	506.97
33.4	506.93
34.4	506.97
35.4	507.49
36.3	507.71
37.0	508.01
38.4	508.27
39.9	508.73
42.6	509.80
44.5	511.12
46.2	512.04
49.5	512.38
53.9	512.54
60.6	512.39
60.8	512.65

SUMMARY DATA	
<b>Bankfull Elevation:</b>	507.8
<b>Bankfull Cross-Sectional Area:</b>	5.2
<b>Bankfull Width:</b>	8.7
<b>Flood Prone Area Elevation:</b>	508.7
<b>Flood Prone Width:</b>	15
<b>Max Depth at Bankfull:</b>	0.9
<b>Mean Depth at Bankfull:</b>	0.6
<b>W / D Ratio:</b>	14.6
<b>Entrenchment Ratio:</b>	1.7
<b>Bank Height Ratio:</b>	1.0

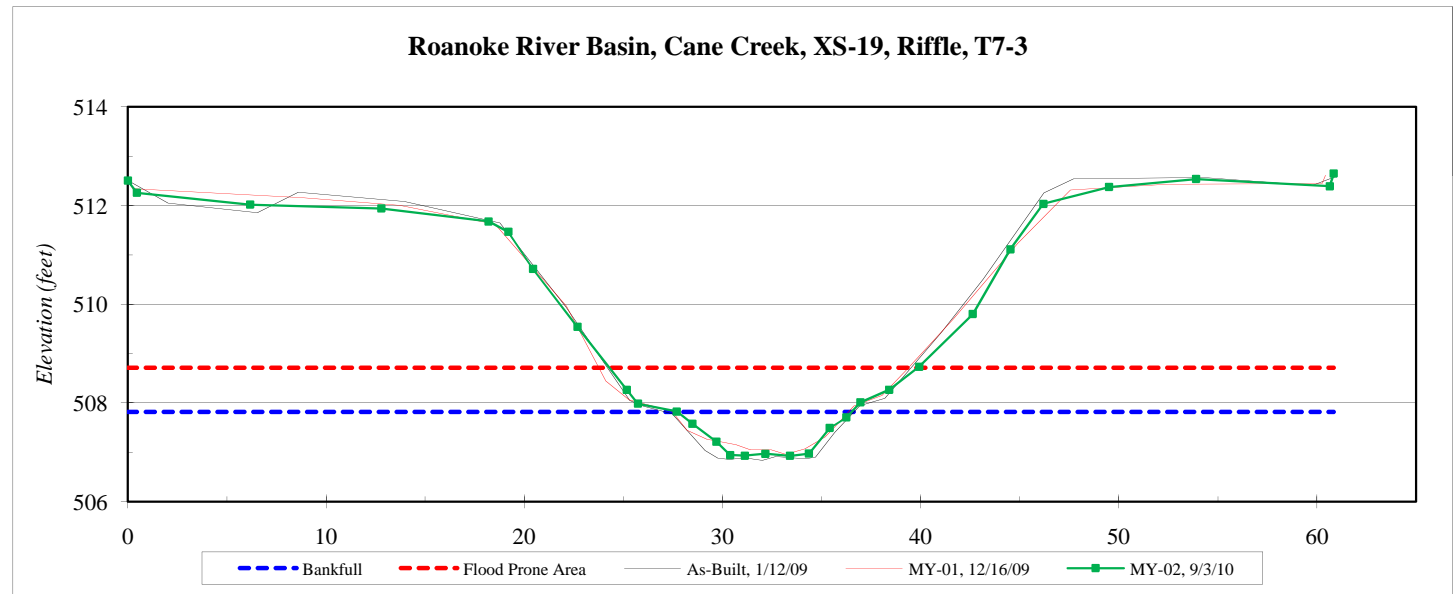
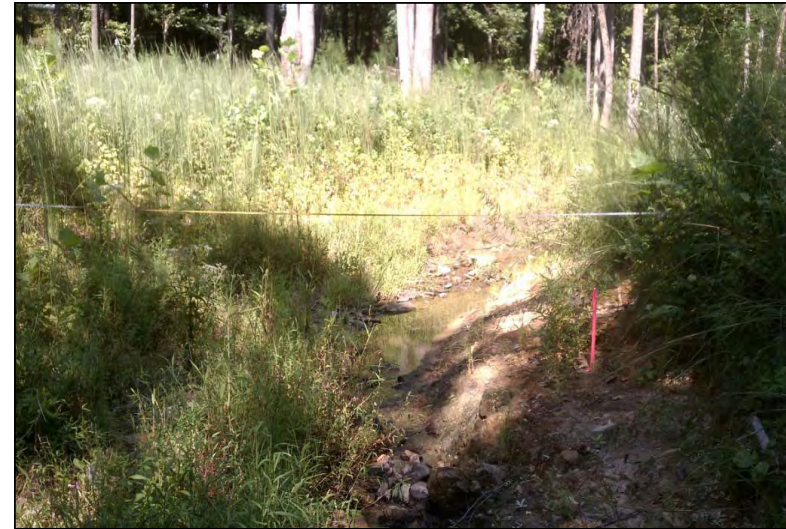
<b>River Basin:</b>	Roanoke
<b>Watershed:</b>	Cane Creek
<b>XS ID</b>	XS-20, Riffle, T7-5
<b>Drainage Area (sq mi):</b>	0.26
<b>Date:</b>	9/3/2010
<b>Field Crew:</b>	A. French, M. Koss

Station	Elevation
0.0	478.60
0.2	478.32
8.0	478.08
14.9	477.60
19.6	477.55
21.9	477.05
23.9	476.91
24.6	476.69
26.6	476.12
27.6	475.64
28.9	475.08
30.6	474.15
31.7	473.92
33.8	473.98
35.1	473.60
36.3	472.88
38.5	472.85
40.4	472.74
42.0	472.66
42.6	472.28
43.1	472.22
43.5	472.11
44.1	472.10
44.5	472.20
45.1	472.41
45.7	472.91
46.0	473.24
47.3	473.58
48.2	473.78
49.3	473.99
50.6	475.03
51.6	475.83
53.3	476.09
56.6	476.04
58.5	476.07
58.7	476.19

SUMMARY DATA	
<b>Bankfull Elevation:</b>	473.6
<b>Bankfull Cross-Sectional Area:</b>	8.9
<b>Bankfull Width:</b>	11.8
<b>Flood Prone Area Elevation:</b>	475.1
<b>Flood Prone Width:</b>	20.5
<b>Max Depth at Bankfull:</b>	1.5
<b>Mean Depth at Bankfull:</b>	0.8
<b>W / D Ratio:</b>	15.6
<b>Entrenchment Ratio:</b>	1.7
<b>Bank Height Ratio:</b>	1.0

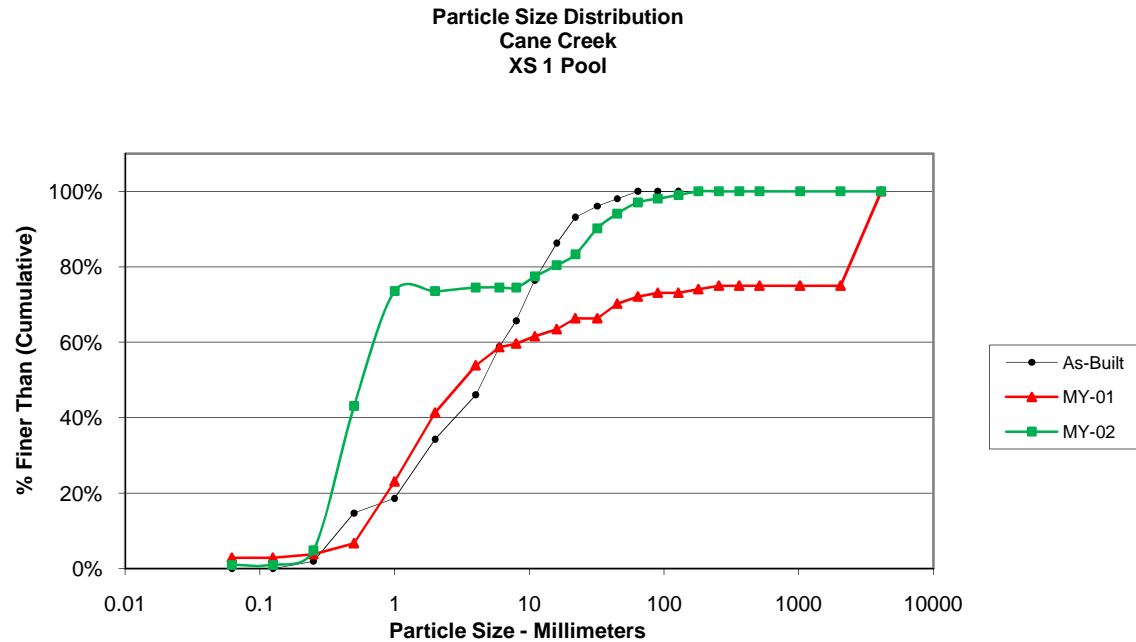
Cross-Section 1 Pool - MY02, Trib 1			
Particle	Millimeter		Count
Silt/Clay	< 0.062	S/C	1
Very Fine	.062 - .125	S	
Fine	.125 - .25	A	4
Medium	.25 - .50	N	39
Coarse	.50 - 1	D	31
Very Coarse	1 - 2	S	
Very Fine	2 - 4		1
Fine	4 - 5.7	G	
Fine	5.7 - 8	R	
Medium	8 - 11.3	A	3
Medium	11.3 - 16	V	3
Coarse	16 - 22.6	E	3
Coarse	22.6 - 32	L	7
Very Coarse	32 - 45	S	4
Very Coarse	45 - 64		3
Small	64 - 90	C	1
Small	90 - 128	O	1
Large	128 - 180	B	1
Large	180 - 256	L	
Small	256 - 362	B	
Small	362 - 512	L	
Medium	512 - 1024	D	
Lrg- Very Lrg	1024 - 2048	R	
Bedrock	>2048	BDRK	
		<b>Total</b>	102
Note:

Size (mm)	
D16	0.63
D35	1.1
D50	1.7
D65	3
D84	15
D95	55

Size Distribution	
mean	3.1
dispersion	5.8
skewness	0.22

Type	
silt/clay	3%
sand	38%
gravel	31%
cobble	3%
boulder	0%
bedrock	26%
hardpan	0%
wood/det	0%
artificial	0%

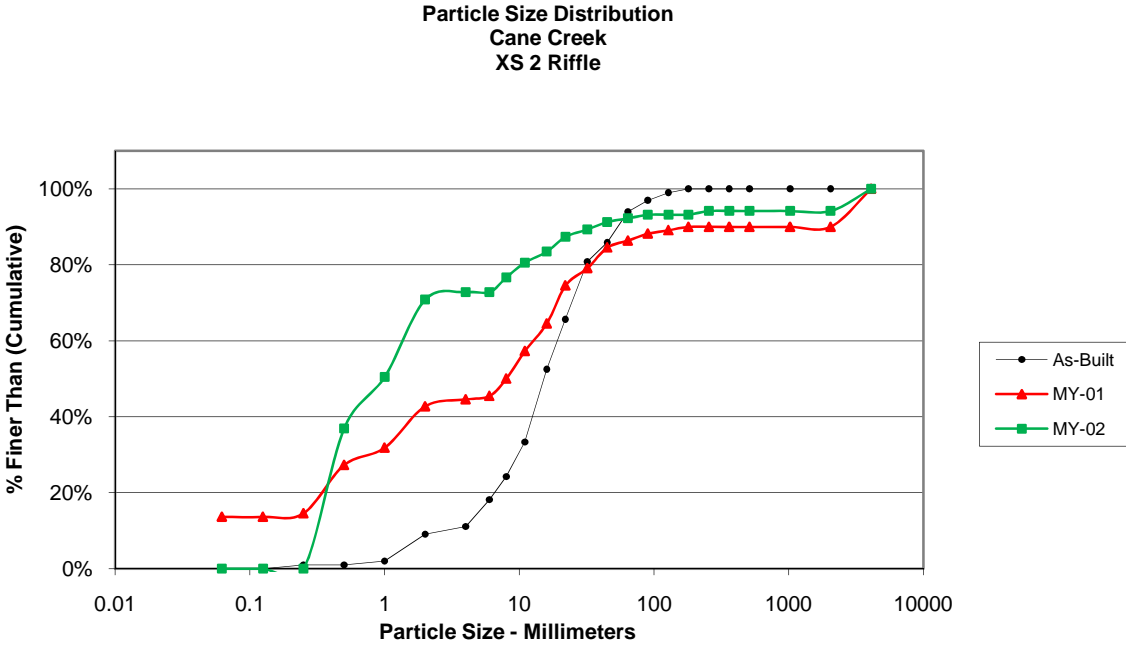
Cross-Section 2 Riffle - MY02, Trib 1			
Particle	Millimeter		Count
Silt/Clay	< 0.062	S/C	
Very Fine	.062 - .125	S	
Fine	.125 - .25	A	
Medium	.25 - .50	N	38
Coarse	.50 - 1	D	14
Very Coarse	1 - 2	S	21
Very Fine	2 - 4		2
Fine	4 - 5.7	G	
Fine	5.7 - 8	R	4
Medium	8 - 11.3	A	4
Medium	11.3 - 16	V	3
Coarse	16 - 22.6	E	4
Coarse	22.6 - 32	L	2
Very Coarse	32 - 45	S	2
Very Coarse	45 - 64		1
Small	64 - 90	C	1
Small	90 - 128	O	
Large	128 - 180	B	
Large	180 - 256	L	
Small	256 - 362	B	
Small	362 - 512	L	
Medium	512 - 1024	D	
Lrg- Very Lrg	1024 - 2048	R	
Bedrock	>2048	BDRK	6
		<b>Total</b>	<b>102</b>
Note:

Size (mm)	
D16	0.27
D35	1.2
D50	8
D65	16
D84	43
D95	2900

Size Distribution	
mean	3.4
dispersion	17.5
skewness	-0.25

Type	
silt/clay	14%
sand	29%
gravel	44%
cobble	4%
boulder	0%
bedrock	10%
hardpan	0%
wood/det	0%
artificial	0%

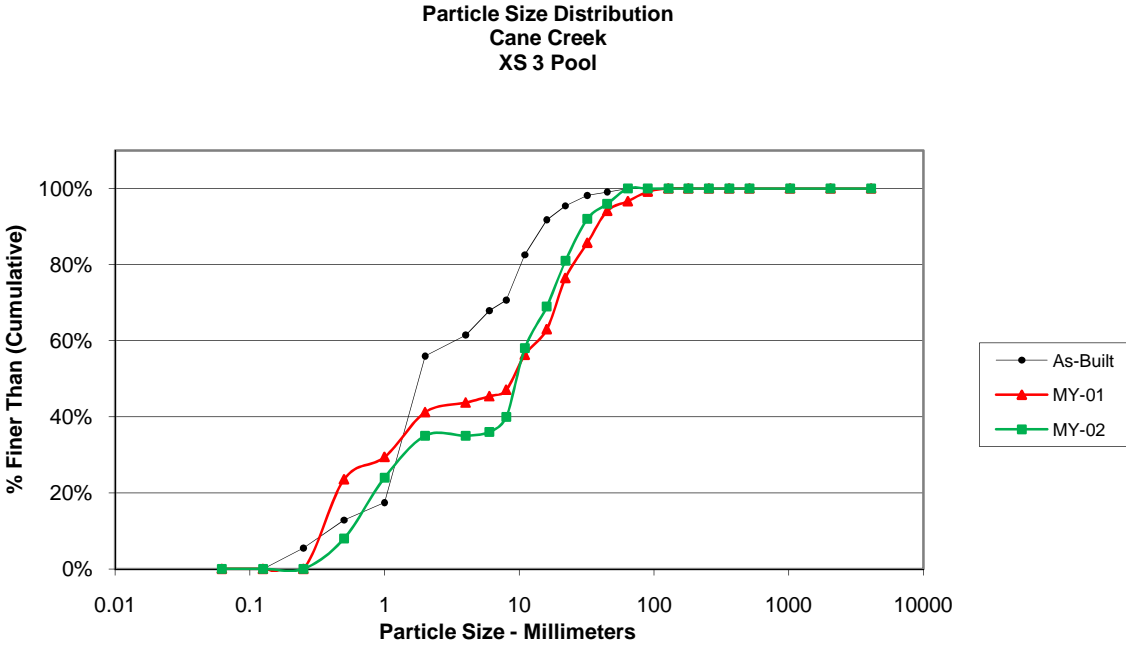
Cross-Section 3 Pool - MY02, Trib 1			
Particle	Millimeter		Count
Silt/Clay	< 0.062	S/C	
Very Fine	.062 - .125	S	
Fine	.125 - .25	A	
Medium	.25 - .50	N	8
Coarse	.50 - 1	D	16
Very Coarse	1 - 2	S	11
Very Fine	2 - 4		
Fine	4 - 5.7	G	1
Fine	5.7 - 8	R	4
Medium	8 - 11.3	A	18
Medium	11.3 - 16	V	11
Coarse	16 - 22.6	E	12
Coarse	22.6 - 32	L	11
Very Coarse	32 - 45	S	4
Very Coarse	45 - 64		4
Small	64 - 90	C	
Small	90 - 128	O	
Large	128 - 180	B	
Large	180 - 256	L	
Small	256 - 362	B	
Small	362 - 512	L	
Medium	512 - 1024	D	
Lrg- Very Lrg	1024 - 2048	R	
Bedrock	>2048	BDRK	
		<b>Total</b>	100

Size (mm)	
D16	0.4
D35	1.4
D50	8.9
D65	17
D84	30
D95	51

Size Distribution	
mean	3.5
dispersion	12.8
skewness	-0.30

Type	
silt/clay	0%
sand	41%
gravel	55%
cobble	3%
boulder	0%
bedrock	0%
hardpan	0%
wood/det	0%
artificial	0%
