# Cane Creek Tributary Stream Restoration Site Monitoring Report MY02 Basin 03010104 / Contract # D06002

**January 2011**

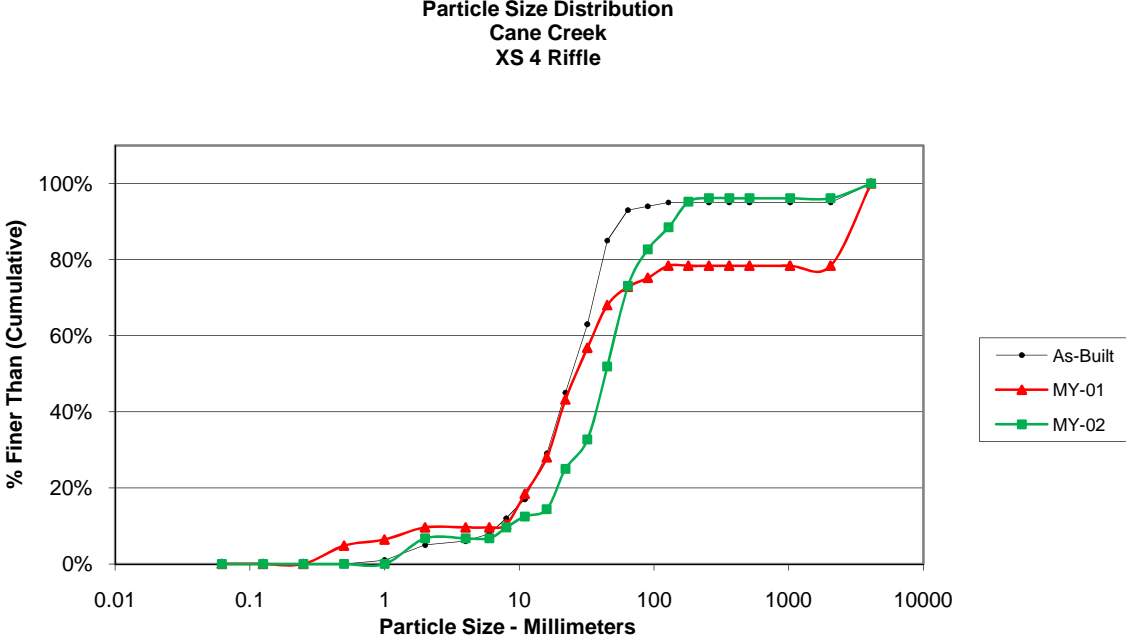
**Cross-Section 4 Riffle - MY02, Trib 1**

Particle	Millimeter		Count
Silt/Clay	< 0.062	S/C	
Very Fine	.062 - .125	S	
Fine	.125 - .25	A	
Medium	.25 - .50	N	
Coarse	.50 - 1	D	
Very Coarse	1 - 2	S	7
Very Fine	2 - 4		
Fine	4 - 5.7	G	
Fine	5.7 - 8	R	3
Medium	8 - 11.3	A	3
Medium	11.3 - 16	V	2
Coarse	16 - 22.6	E	11
Coarse	22.6 - 32	L	8
Very Coarse	32 - 45	S	20
Very Coarse	45 - 64		22
Small	64 - 90	C	10
Small	90 - 128	O	6
Large	128 - 180	B	7
Large	180 - 256	L	1
Small	256 - 362	B	
Small	362 - 512	L	
Medium	512 - 1024	D	
Lrg- Very Lrg	1024 - 2048	R	
Bedrock	>2048	BDRK	4
		<b>Total</b>	104

Size (mm)	
D16	10
D35	19
D50	27
D65	41
D84	2500
D95	3500

Size Distribution	
mean	158.1
dispersion	47.6
skewness	0.50

Type	
silt/clay	0%
sand	10%
gravel	63%
cobble	6%
boulder	0%
bedrock	22%
hardpan	0%
wood/det	0%
artificial	0%

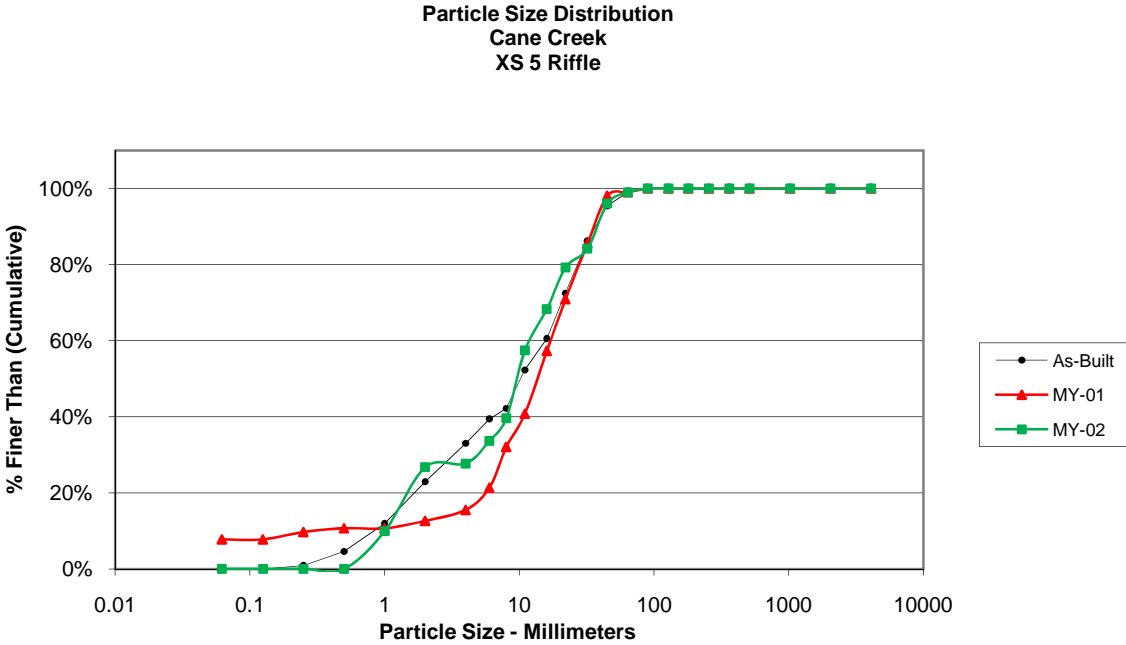
Cross-Section 5 Riffle - MY02, Trib 2			
Particle	Millimeter		Count
Silt/Clay	< 0.062	S/C	
Very Fine	.062 - .125	S	
Fine	.125 - .25	A	
Medium	.25 - .50	N	
Coarse	.50 - 1	D	10
Very Coarse	1 - 2	S	17
Very Fine	2 - 4		1
Fine	4 - 5.7	G	6
Fine	5.7 - 8	R	6
Medium	8 - 11.3	A	18
Medium	11.3 - 16	V	11
Coarse	16 - 22.6	E	11
Coarse	22.6 - 32	L	5
Very Coarse	32 - 45	S	12
Very Coarse	45 - 64		3
Small	64 - 90	C	1
Small	90 - 128	O	
Large	128 - 180	B	
Large	180 - 256	L	
Small	256 - 362	B	
Small	362 - 512	L	
Medium	512 - 1024	D	
Lrg- Very Lrg	1024 - 2048	R	
Bedrock	>2048	BDRK	
		<b>Total</b>	101
Note:

Size (mm)	
D16	4.1
D35	8.9
D50	14
D65	19
D84	31
D95	41

Size Distribution	
mean	11.3
dispersion	2.8
skewness	-0.10

Type	
silt/clay	8%
sand	5%
gravel	86%
cobble	1%
boulder	0%
bedrock	0%
hardpan	0%
wood/det	0%
artificial	0%

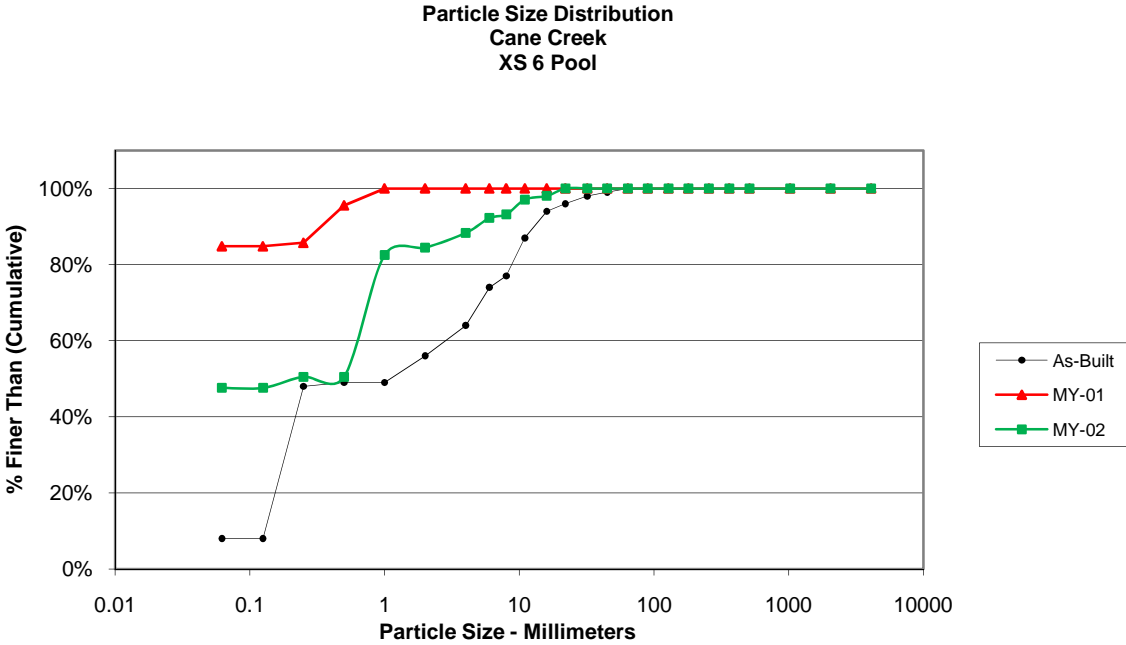
**Cross-Section 6 Pool - MY02, Trib 3**

Particle	Millimeter		Count
Silt/Clay	< 0.062	S/C	49
Very Fine	.062 - .125	S	
Fine	.125 - .25	A	3
Medium	.25 - .50	N	
Coarse	.50 - 1	D	33
Very Coarse	1 - 2	S	2
Very Fine	2 - 4		4
Fine	4 - 5.7	G	4
Fine	5.7 - 8	R	1
Medium	8 - 11.3	A	4
Medium	11.3 - 16	V	1
Coarse	16 - 22.6	E	2
Coarse	22.6 - 32	L	
Very Coarse	32 - 45	S	
Very Coarse	45 - 64		
Small	64 - 90	C	
Small	90 - 128	O	
Large	128 - 180	B	
Large	180 - 256	L	
Small	256 - 362	B	
Small	362 - 512	L	
Medium	512 - 1024	D	
Lrg- Very Lrg	1024 - 2048	R	
Bedrock	>2048	BDRK	
		<b>Total</b>	103

Size (mm)	
D16	0.062
D35	0.062
D50	0.062
D65	0.062
D84	0.062
D95	0.48

Size Distribution	
mean	0.1
dispersion	1.0
skewness	---

Type	
silt/clay	85%
sand	15%
gravel	0%
cobble	0%
boulder	0%
bedrock	0%
hardpan	0%
wood/det	0%
artificial	0%

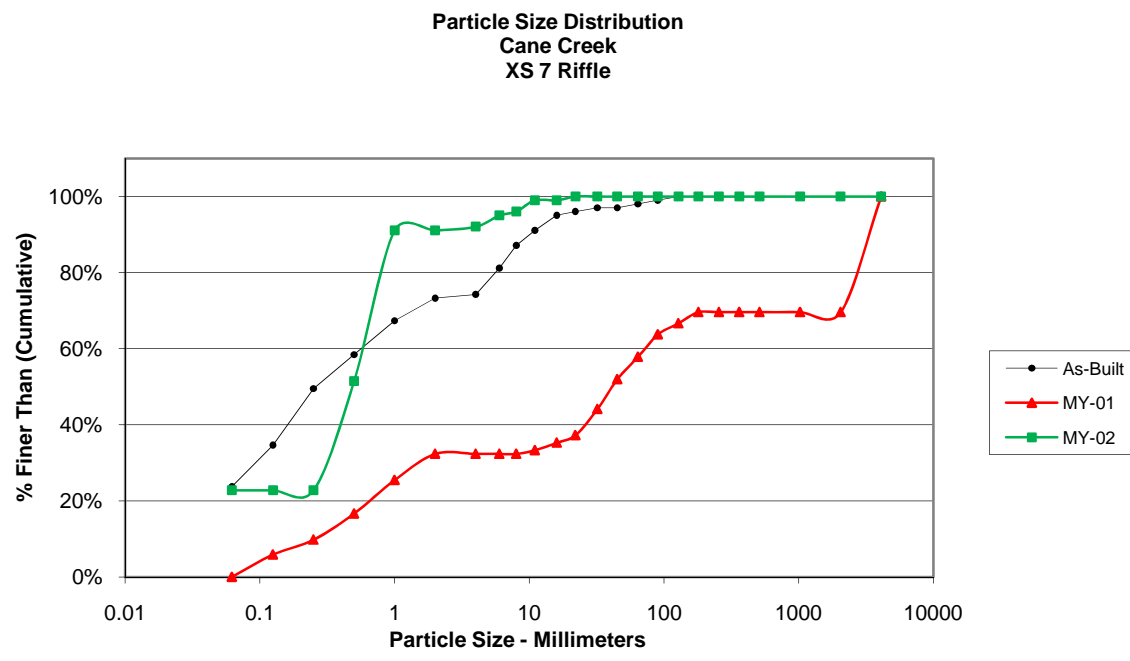
Cross-Section 7 Riffle - MY02, Trib 3			
Particle	Millimeter		Count
Silt/Clay	< 0.062	S/C	23
Very Fine	.062 - .125	S	
Fine	.125 - .25	A	
Medium	.25 - .50	N	29
Coarse	.50 - 1	D	40
Very Coarse	1 - 2	S	
Very Fine	2 - 4		1
Fine	4 - 5.7	G	3
Fine	5.7 - 8	R	1
Medium	8 - 11.3	A	3
Medium	11.3 - 16	V	
Coarse	16 - 22.6	E	1
Coarse	22.6 - 32	L	
Very Coarse	32 - 45	S	
Very Coarse	45 - 64		
Small	64 - 90	C	
Small	90 - 128	O	
Large	128 - 180	B	
Large	180 - 256	L	
Small	256 - 362	B	
Small	362 - 512	L	
Medium	512 - 1024	D	
Lrg- Very Lrg	1024 - 2048	R	
Bedrock	>2048	BDRK	
		<b>Total</b>	101
Note:

Size (mm)	
D16	0.42
D35	0.76
D50	1.3
D65	23
D84	41
D95	61

Size Distribution	
mean	4.1
dispersion	17.3
skewness	0.36

Type	
silt/clay	8%
sand	49%
gravel	40%
cobble	4%
boulder	0%
bedrock	0%
hardpan	0%
wood/det	0%
artificial	0%

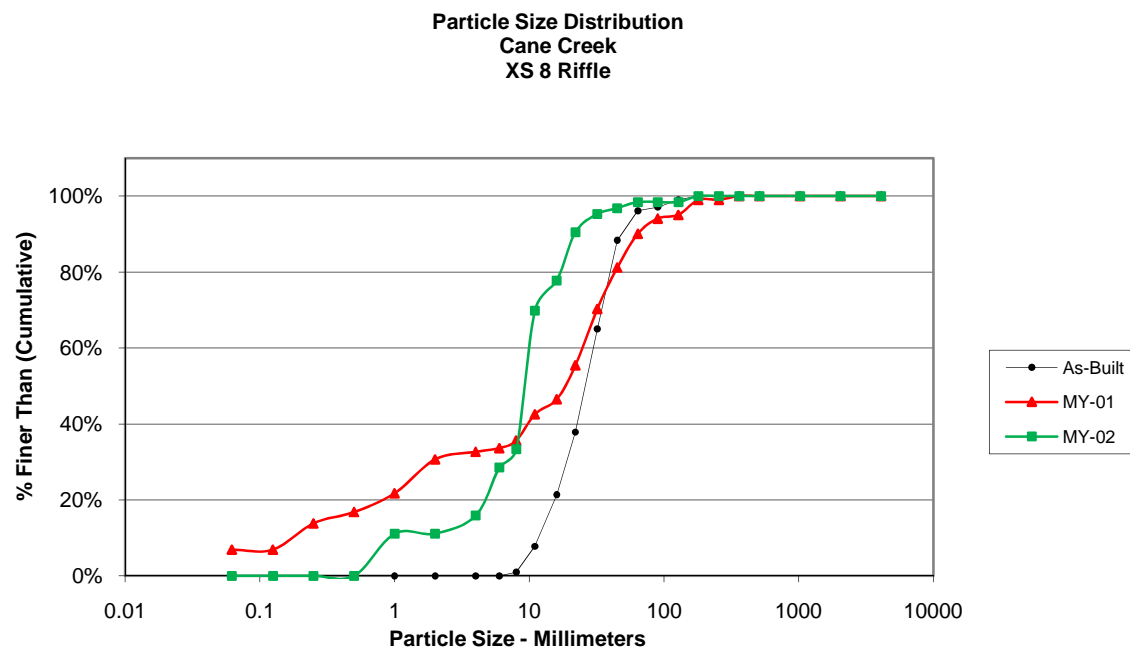
Cross-Section 8 Riffle - MY02, Trib 3			
Particle	Millimeter		Count
Silt/Clay	< 0.062	S/C	
Very Fine	.062 - .125	S	
Fine	.125 - .25	A	
Medium	.25 - .50	N	
Coarse	.50 - 1	D	7
Very Coarse	1 - 2	S	
Very Fine	2 - 4		3
Fine	4 - 5.7	G	8
Fine	5.7 - 8	R	3
Medium	8 - 11.3	A	23
Medium	11.3 - 16	V	5
Coarse	16 - 22.6	E	8
Coarse	22.6 - 32	L	3
Very Coarse	32 - 45	S	1
Very Coarse	45 - 64		1
Small	64 - 90	C	
Small	90 - 128	O	
Large	128 - 180	B	1
Large	180 - 256	L	
Small	256 - 362	B	
Small	362 - 512	L	
Medium	512 - 1024	D	
Lrg- Very Lrg	1024 - 2048	R	
Bedrock	>2048	BDRK	37
		<b>Total</b>	<b>100</b>
Note:

Size (mm)	
D16	0.41
D35	7.3
D50	18
D65	28
D84	50
D95	130

Size Distribution	
mean	4.5
dispersion	23.3
skewness	-0.41

Type	
silt/clay	7%
sand	24%
gravel	59%
cobble	9%
boulder	0%
bedrock	1%
hardpan	0%
wood/det	0%
artificial	0%

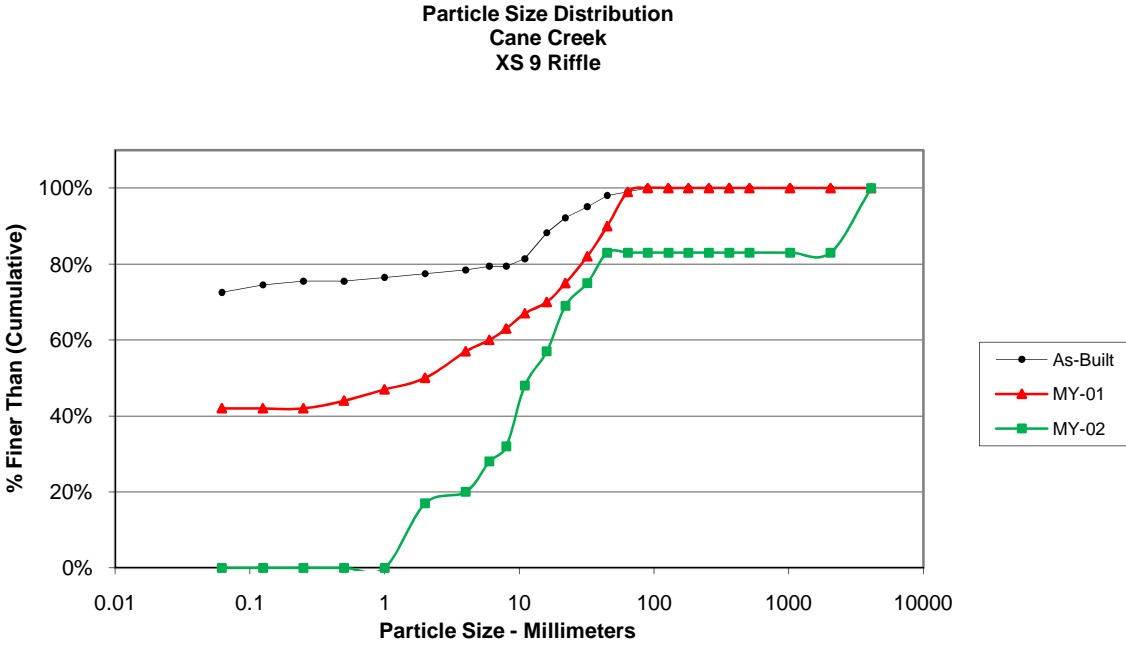
**Cross-Section 9 Riffle - MY02, Trib 4**

Particle	Millimeter		Count
Silt/Clay	< 0.062	S/C	
Very Fine	.062 - .125	S	
Fine	.125 - .25	A	
Medium	.25 - .50	N	
Coarse	.50 - 1	D	
Very Coarse	1 - 2	S	17
Very Fine	2 - 4		3
Fine	4 - 5.7	G	8
Fine	5.7 - 8	R	4
Medium	8 - 11.3	A	16
Medium	11.3 - 16	V	9
Coarse	16 - 22.6	E	12
Coarse	22.6 - 32	L	6
Very Coarse	32 - 45	S	8
Very Coarse	45 - 64		
Small	64 - 90	C	
Small	90 - 128	O	
Large	128 - 180	B	
Large	180 - 256	L	
Small	256 - 362	B	
Small	362 - 512	L	
Medium	512 - 1024	D	
Lrg- Very Lrg	1024 - 2048	R	
Bedrock	>2048	BDRK	17
		<b>Total</b>	<b>100</b>

Size (mm)	
D16	0.86
D35	4.4
D50	7.1
D65	9.9
D84	17
D95	26

Size Distribution	
mean	3.8
dispersion	5.3
skewness	-0.24

Type	
silt/clay	0%
sand	20%
gravel	63%
cobble	0%
boulder	0%
bedrock	17%
hardpan	0%
wood/det	0%
artificial	0%

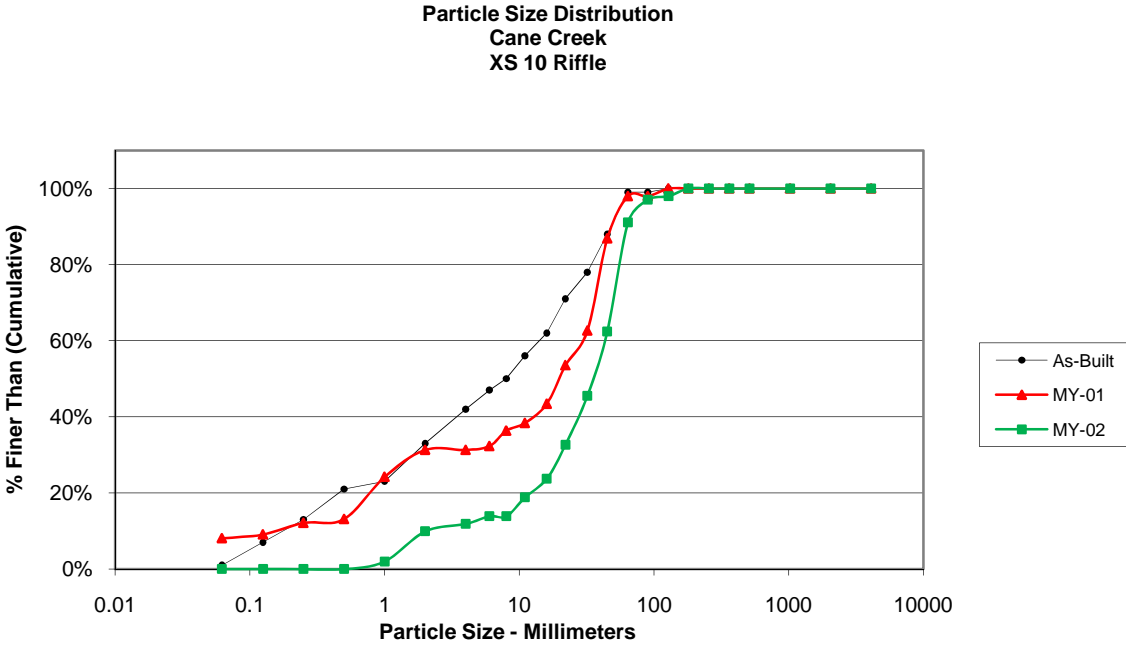
Cross-Section 10 Riffle - MY02, Trib 4			
Particle	Millimeter		Count
Silt/Clay	< 0.062	S/C	
Very Fine	.062 - .125	S	
Fine	.125 - .25	A	
Medium	.25 - .50	N	
Coarse	.50 - 1	D	2
Very Coarse	1 - 2	S	8
Very Fine	2 - 4		2
Fine	4 - 5.7	G	2
Fine	5.7 - 8	R	
Medium	8 - 11.3	A	5
Medium	11.3 - 16	V	5
Coarse	16 - 22.6	E	9
Coarse	22.6 - 32	L	13
Very Coarse	32 - 45	S	17
Very Coarse	45 - 64		29
Small	64 - 90	C	6
Small	90 - 128	O	1
Large	128 - 180	B	2
Large	180 - 256	L	
Small	256 - 362	B	
Small	362 - 512	L	
Medium	512 - 1024	D	
Lrg- Very Lrg	1024 - 2048	R	
Bedrock	>2048	BDRK	
		<b>Total</b>	101

Size (mm)	
D16	9.2
D35	24
D50	35
D65	46
D84	59
D95	80

Size Distribution	
mean	23.3
dispersion	2.7
skewness	-0.20

Type	
silt/clay	8%
sand	23%
gravel	67%
cobble	2%
boulder	0%
bedrock	0%
hardpan	0%
wood/det	0%
artificial	0%

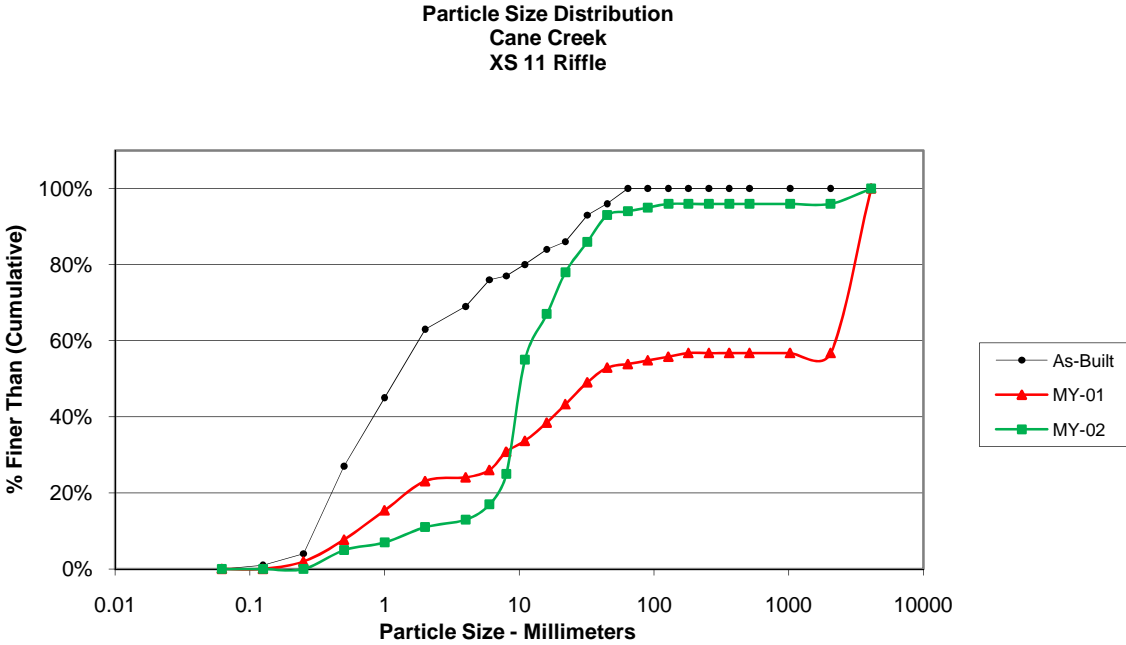
Cross-Section 11 Riffle - MY02, Trib 4			
Particle	Millimeter		Count
Silt/Clay	< 0.062	S/C	
Very Fine	.062 - .125	S	
Fine	.125 - .25	A	
Medium	.25 - .50	N	5
Coarse	.50 - 1	D	2
Very Coarse	1 - 2	S	4
Very Fine	2 - 4		2
Fine	4 - 5.7	G	4
Fine	5.7 - 8	R	8
Medium	8 - 11.3	A	30
Medium	11.3 - 16	V	12
Coarse	16 - 22.6	E	11
Coarse	22.6 - 32	L	8
Very Coarse	32 - 45	S	7
Very Coarse	45 - 64		1
Small	64 - 90	C	1
Small	90 - 128	O	1
Large	128 - 180	B	
Large	180 - 256	L	
Small	256 - 362	B	
Small	362 - 512	L	
Medium	512 - 1024	D	
Lrg- Very Lrg	1024 - 2048	R	
Bedrock	>2048	BDRK	4
		<b>Total</b>	100

Size (mm)	
D16	5.1
D35	8.8
D50	10
D65	14
D84	25
D95	41

Size Distribution	
mean	11.3
dispersion	2.2
skewness	0.06

Type	
silt/clay	0%
sand	11%
gravel	83%
cobble	2%
boulder	0%
bedrock	4%
hardpan	0%
wood/det	0%
artificial	0%

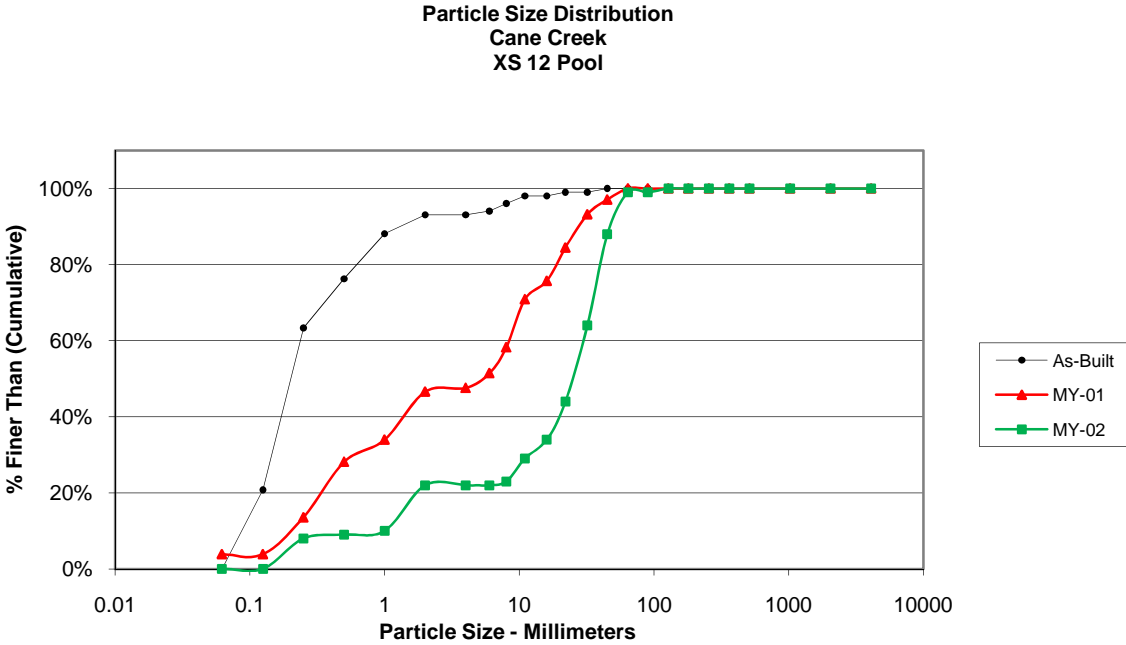
Cross-Section 12 Pool - MY02, Trib 4			
Particle	Millimeter		Count
Silt/Clay	< 0.062	S/C	
Very Fine	.062 - .125	S	
Fine	.125 - .25	A	8
Medium	.25 - .50	N	1
Coarse	.50 - 1	D	1
Very Coarse	1 - 2	S	12
Very Fine	2 - 4		
Fine	4 - 5.7	G	
Fine	5.7 - 8	R	1
Medium	8 - 11.3	A	6
Medium	11.3 - 16	V	5
Coarse	16 - 22.6	E	10
Coarse	22.6 - 32	L	20
Very Coarse	32 - 45	S	24
Very Coarse	45 - 64		11
Small	64 - 90	C	
Small	90 - 128	O	1
Large	128 - 180	B	
Large	180 - 256	L	
Small	256 - 362	B	
Small	362 - 512	L	
Medium	512 - 1024	D	
Lrg- Very Lrg	1024 - 2048	R	
Bedrock	>2048	BDRK	
		<b>Total</b>	100

Size (mm)	
D16	1.4
D35	17
D50	25
D65	32
D84	43
D95	56

Size Distribution	
mean	7.8
dispersion	9.8
skewness	-0.42

Type	
silt/clay	0%
sand	22%
gravel	77%
cobble	1%
boulder	0%
bedrock	0%
hardpan	0%
wood/det	0%
artificial	0%

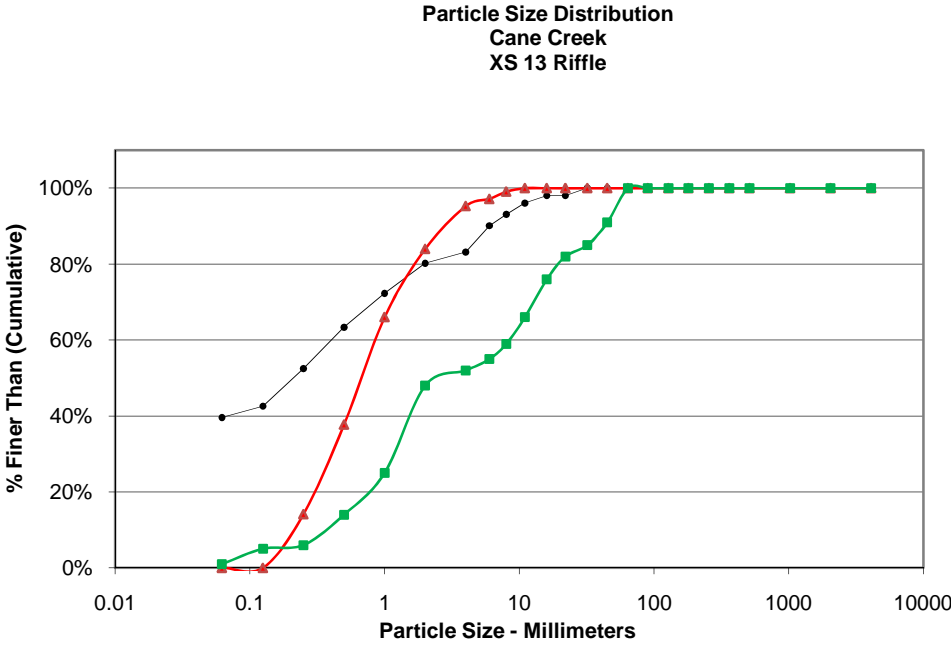
Cross-Section 13 Riffle - MY02, Trib 5			
Particle	Millimeter		Count
Silt/Clay	< 0.062	S/C	1
Very Fine	.062 - .125	S	4
Fine	.125 - .25	A	1
Medium	.25 - .50	N	8
Coarse	.50 - 1	D	11
Very Coarse	1 - 2	S	23
Very Fine	2 - 4		4
Fine	4 - 5.7	G	3
Fine	5.7 - 8	R	4
Medium	8 - 11.3	A	7
Medium	11.3 - 16	V	10
Coarse	16 - 22.6	E	6
Coarse	22.6 - 32	L	3
Very Coarse	32 - 45	S	6
Very Coarse	45 - 64		9
Small	64 - 90	C	
Small	90 - 128	O	
Large	128 - 180	B	
Large	180 - 256	L	
Small	256 - 362	B	
Small	362 - 512	L	
Medium	512 - 1024	D	
Lrg- Very Lrg	1024 - 2048	R	
Bedrock	>2048	BDRK	
		<b>Total</b>	100

Size (mm)	
D16	0.57
D35	1.4
D50	2.8
D65	11
D84	28
D95	53

Size Distribution	
mean	4.0
dispersion	7.5
skewness	0.12

Type	
silt/clay	1%
sand	47%
gravel	52%
cobble	0%
boulder	0%
bedrock	0%
hardpan	0%
wood/det	0%
artificial	0%

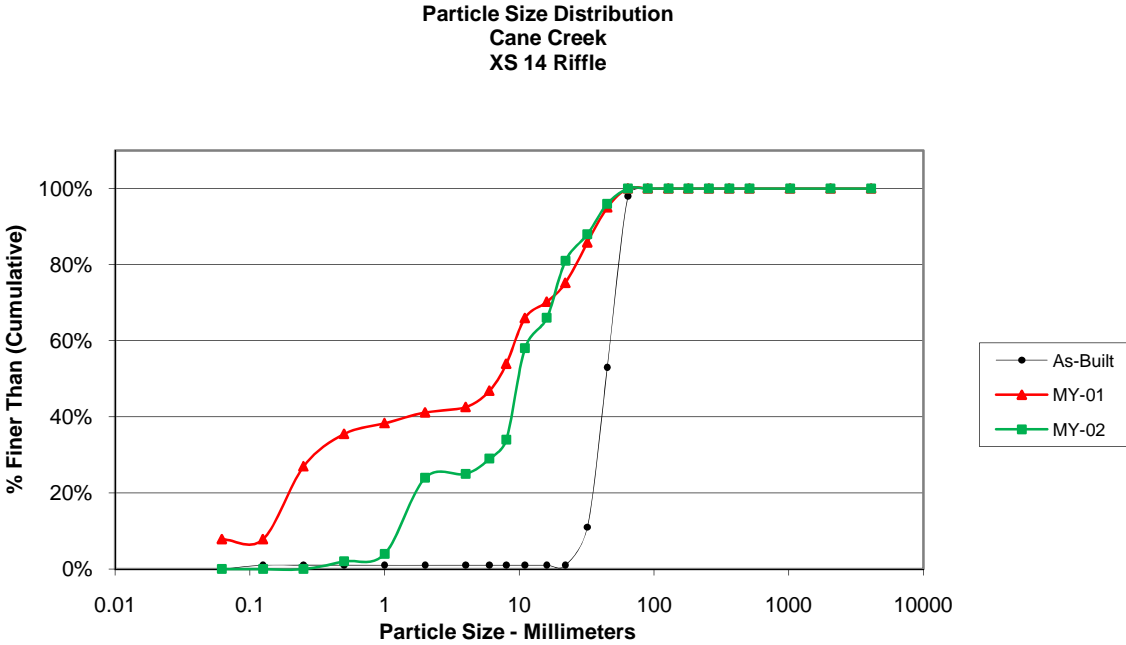
Cross-Section 14 Riffle - MY02, Trib 6			
Particle	Millimeter		Count
Silt/Clay	< 0.062	S/C	
Very Fine	.062 - .125	S	
Fine	.125 - .25	A	
Medium	.25 - .50	N	2
Coarse	.50 - 1	D	2
Very Coarse	1 - 2	S	20
Very Fine	2 - 4		1
Fine	4 - 5.7	G	4
Fine	5.7 - 8	R	5
Medium	8 - 11.3	A	24
Medium	11.3 - 16	V	8
Coarse	16 - 22.6	E	15
Coarse	22.6 - 32	L	7
Very Coarse	32 - 45	S	8
Very Coarse	45 - 64		4
Small	64 - 90	C	
Small	90 - 128	O	
Large	128 - 180	B	
Large	180 - 256	L	
Small	256 - 362	B	
Small	362 - 512	L	
Medium	512 - 1024	D	
Lrg- Very Lrg	1024 - 2048	R	
Bedrock	>2048	BDRK	
		<b>Total</b>	100

Size (mm)	
D16	1.5
D35	8.1
D50	9.9
D65	15
D84	26
D95	43

Size Distribution	
mean	6.2
dispersion	4.6
skewness	-0.18

Type	
silt/clay	0%
sand	24%
gravel	76%
cobble	0%
boulder	0%
bedrock	0%
hardpan	0%
wood/det	0%
artificial	0%

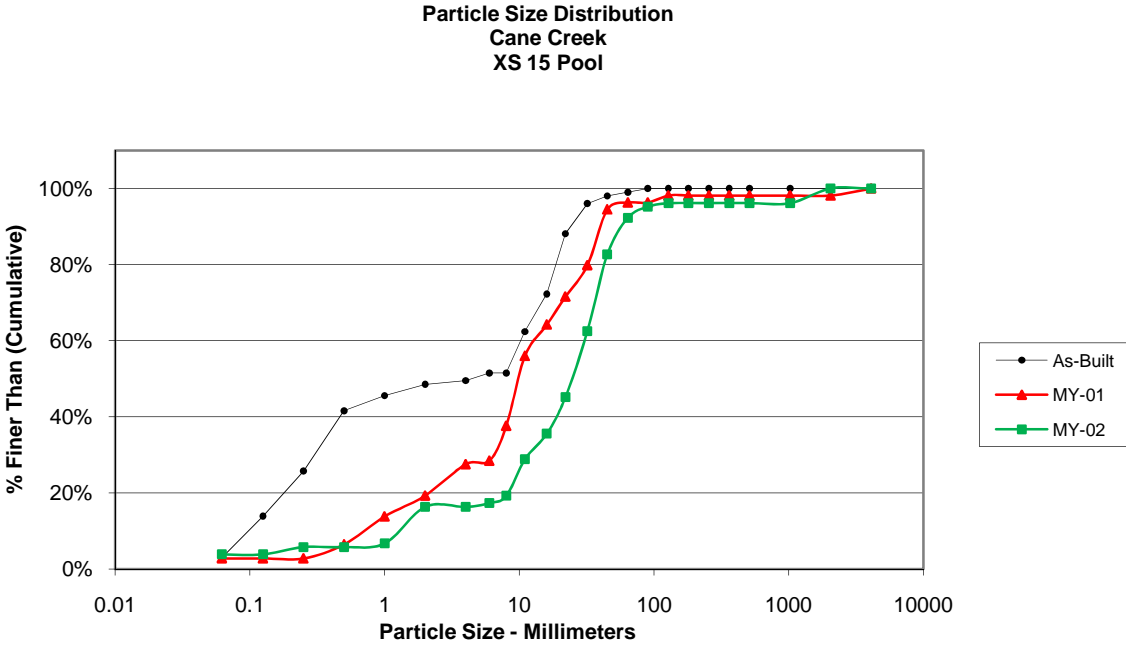
**Cross-Section 15 Pool - MY02, Trib 6**

Particle	Millimeter		Count
Silt/Clay	< 0.062	S/C	4
Very Fine	.062 - .125	S	
Fine	.125 - .25	A	2
Medium	.25 - .50	N	
Coarse	.50 - 1	D	1
Very Coarse	1 - 2	S	10
Very Fine	2 - 4		
Fine	4 - 5.7	G	1
Fine	5.7 - 8	R	2
Medium	8 - 11.3	A	10
Medium	11.3 - 16	V	7
Coarse	16 - 22.6	E	10
Coarse	22.6 - 32	L	18
Very Coarse	32 - 45	S	21
Very Coarse	45 - 64		10
Small	64 - 90	C	3
Small	90 - 128	O	1
Large	128 - 180	B	
Large	180 - 256	L	
Small	256 - 362	B	
Small	362 - 512	L	
Medium	512 - 1024	D	
Lrg- Very Lrg	1024 - 2048	R	4
Bedrock	>2048	BDRK	
		<b>Total</b>	104

Size (mm)	
D16	1.9
D35	14
D50	23
D65	32
D84	44
D95	62

Size Distribution	
mean	9.1
dispersion	7.0
skewness	-0.34

Type	
silt/clay	4%
sand	13%
gravel	76%
cobble	4%
boulder	4%
bedrock	0%
hardpan	0%
wood/det	0%
artificial	0%

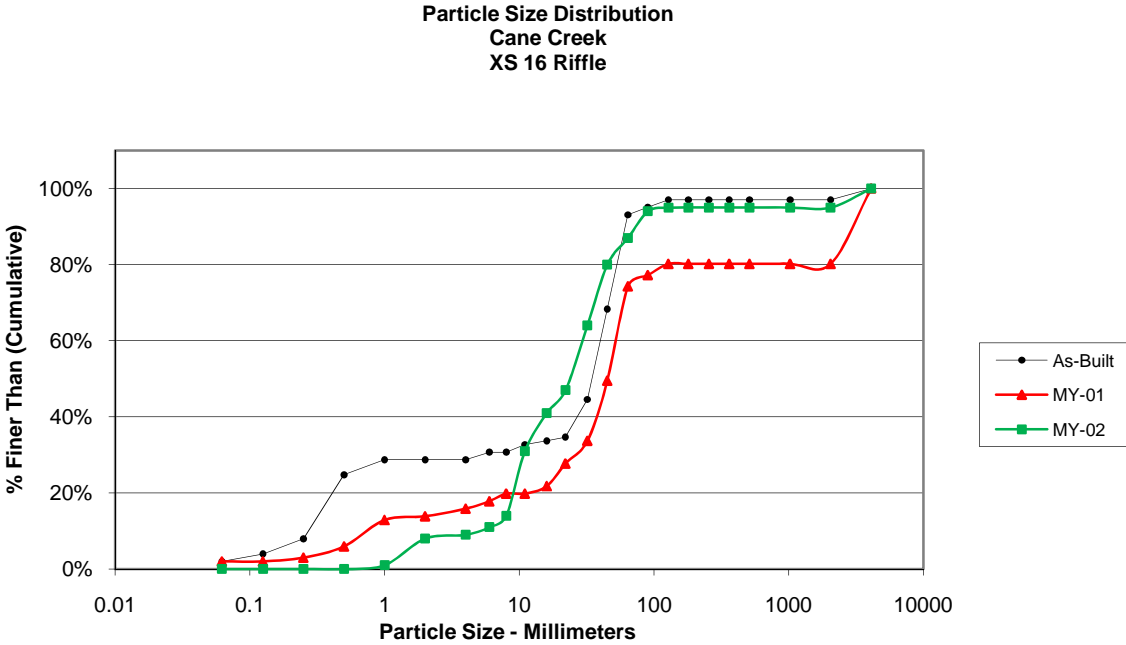
Cross-Section 16 Riffle - MY02, Trib 6			
Particle	Millimeter		Count
Silt/Clay	< 0.062	S/C	
Very Fine	.062 - .125	S	
Fine	.125 - .25	A	
Medium	.25 - .50	N	
Coarse	.50 - 1	D	1
Very Coarse	1 - 2	S	7
Very Fine	2 - 4		1
Fine	4 - 5.7	G	2
Fine	5.7 - 8	R	3
Medium	8 - 11.3	A	17
Medium	11.3 - 16	V	10
Coarse	16 - 22.6	E	6
Coarse	22.6 - 32	L	17
Very Coarse	32 - 45	S	16
Very Coarse	45 - 64		7
Small	64 - 90	C	7
Small	90 - 128	O	1
Large	128 - 180	B	
Large	180 - 256	L	
Small	256 - 362	B	
Small	362 - 512	L	
Medium	512 - 1024	D	
Lrg- Very Lrg	1024 - 2048	R	
Bedrock	>2048	BDRK	5
		<b>Total</b>	<b>100</b>

Size (mm)	
D16	8.2
D35	12
D50	22
D65	30
D84	45
D95	75

Size Distribution	
mean	19.2
dispersion	2.4
skewness	-0.07

Type	
silt/clay	0%
sand	8%
gravel	79%
cobble	8%
boulder	0%
bedrock	5%
hardpan	0%
wood/det	0%
artificial	0%

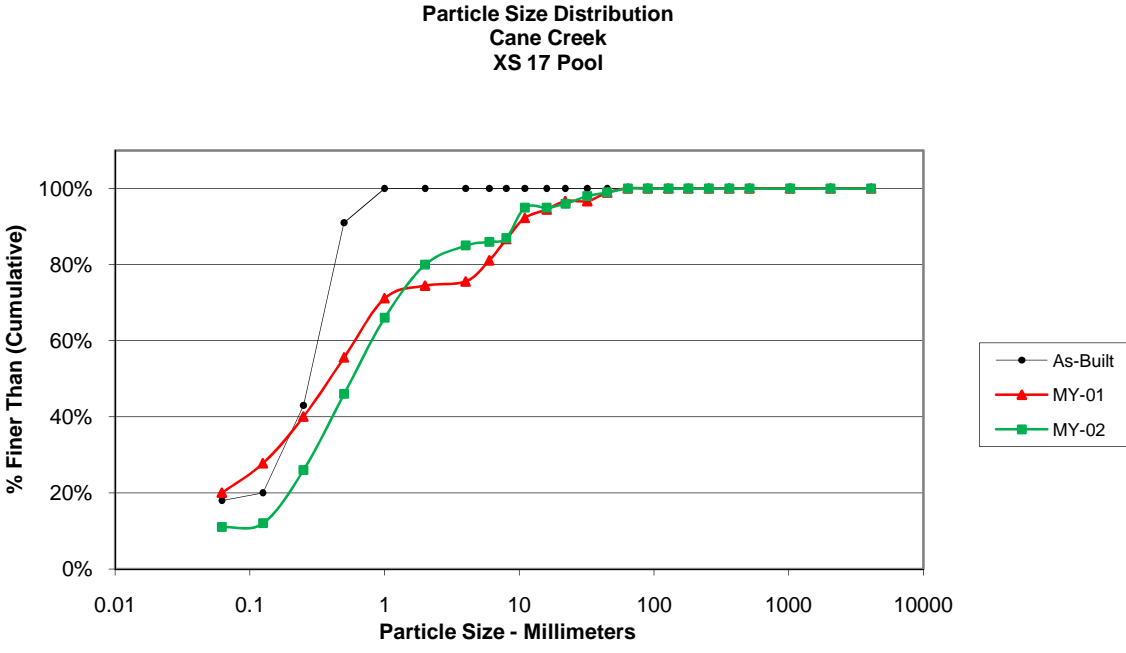
**Cross-Section 17 Pool - MY02, Trib 7**

Particle	Millimeter		Count
Silt/Clay	< 0.062	S/C	11
Very Fine	.062 - .125	S	1
Fine	.125 - .25	A	14
Medium	.25 - .50	N	20
Coarse	.50 - 1	D	20
Very Coarse	1 - 2	S	14
Very Fine	2 - 4		5
Fine	4 - 5.7	G	1
Fine	5.7 - 8	R	1
Medium	8 - 11.3	A	8
Medium	11.3 - 16	V	
Coarse	16 - 22.6	E	1
Coarse	22.6 - 32	L	2
Very Coarse	32 - 45	S	1
Very Coarse	45 - 64		1
Small	64 - 90	C	
Small	90 - 128	O	
Large	128 - 180	B	
Large	180 - 256	L	
Small	256 - 362	B	
Small	362 - 512	L	
Medium	512 - 1024	D	
Lrg- Very Lrg	1024 - 2048	R	
Bedrock	>2048	BDRK	
		<b>Total</b>	100

Size (mm)	
D16	0.15
D35	0.34
D50	0.57
D65	0.97
D84	3.5
D95	0

Size Distribution	
mean	0.7
dispersion	12.1
skewness	0.16

Type	
silt/clay	11%
sand	69%
gravel	20%
cobble	0%
boulder	0%
bedrock	0%
hardpan	0%
wood/det	0%
artificial	0%

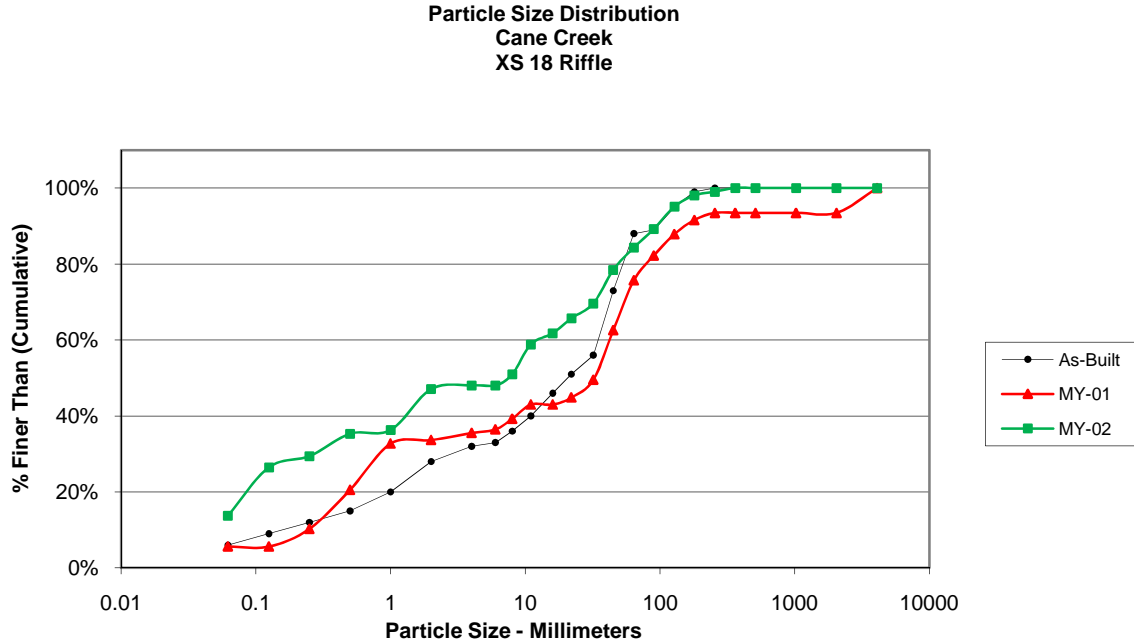
Cross-Section 18 Riffle - MY02, Trib 7			
Particle	Millimeter		Count
Silt/Clay	< 0.062	S/C	14
Very Fine	.062 - .125	S	13
Fine	.125 - .25	A	3
Medium	.25 - .50	N	6
Coarse	.50 - 1	D	1
Very Coarse	1 - 2	S	11
Very Fine	2 - 4		1
Fine	4 - 5.7	G	
Fine	5.7 - 8	R	3
Medium	8 - 11.3	A	8
Medium	11.3 - 16	V	3
Coarse	16 - 22.6	E	4
Coarse	22.6 - 32	L	4
Very Coarse	32 - 45	S	9
Very Coarse	45 - 64		6
Small	64 - 90	C	5
Small	90 - 128	O	6
Large	128 - 180	B	3
Large	180 - 256	L	1
Small	256 - 362	B	1
Small	362 - 512	L	
Medium	512 - 1024	D	
Lrg- Very Lrg	1024 - 2048	R	
Bedrock	>2048	BDRK	
		<b>Total</b>	102
Note:

Size (mm)	
D16	0.07
D35	0.48
D50	7.3
D65	21
D84	63
D95	130

Size Distribution	
mean	2.1
dispersion	56.5
skewness	-0.31

Type	
silt/clay	14%
sand	33%
gravel	37%
cobble	15%
boulder	1%
bedrock	0%
hardpan	0%
wood/det	0%
artificial	0%

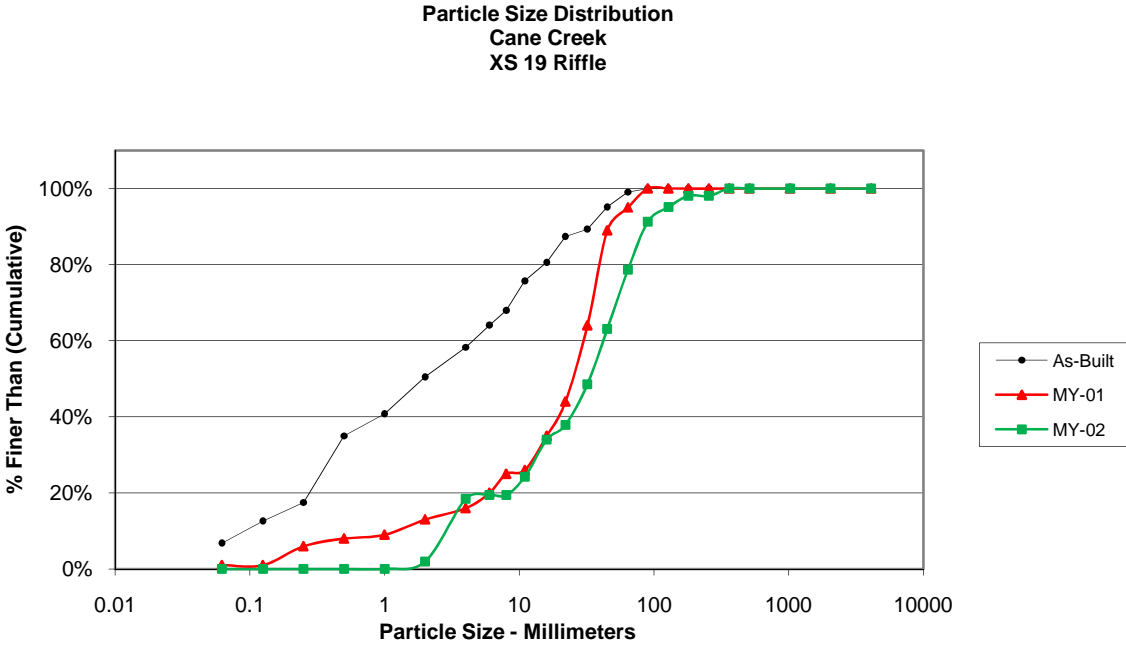
Cross-Section 19 Riffle - MY02, Trib 7			
Particle	Millimeter		Count
Silt/Clay	< 0.062	S/C	
Very Fine	.062 - .125	S	
Fine	.125 - .25	A	
Medium	.25 - .50	N	
Coarse	.50 - 1	D	
Very Coarse	1 - 2	S	2
Very Fine	2 - 4		17
Fine	4 - 5.7	G	1
Fine	5.7 - 8	R	
Medium	8 - 11.3	A	5
Medium	11.3 - 16	V	10
Coarse	16 - 22.6	E	4
Coarse	22.6 - 32	L	11
Very Coarse	32 - 45	S	15
Very Coarse	45 - 64		16
Small	64 - 90	C	13
Small	90 - 128	O	4
Large	128 - 180	B	3
Large	180 - 256	L	
Small	256 - 362	B	2
Small	362 - 512	L	
Medium	512 - 1024	D	
Lrg- Very Lrg	1024 - 2048	R	
Bedrock	>2048	BDRK	
		<b>Total</b>	103

Size (mm)	
D16	3.6
D35	17
D50	33
D65	47
D84	74
D95	130

Size Distribution	
mean	16.3
dispersion	5.7
skewness	-0.27

Type	
silt/clay	0%
sand	2%
gravel	77%
cobble	19%
boulder	2%
bedrock	0%
hardpan	0%
wood/det	0%
artificial	0%

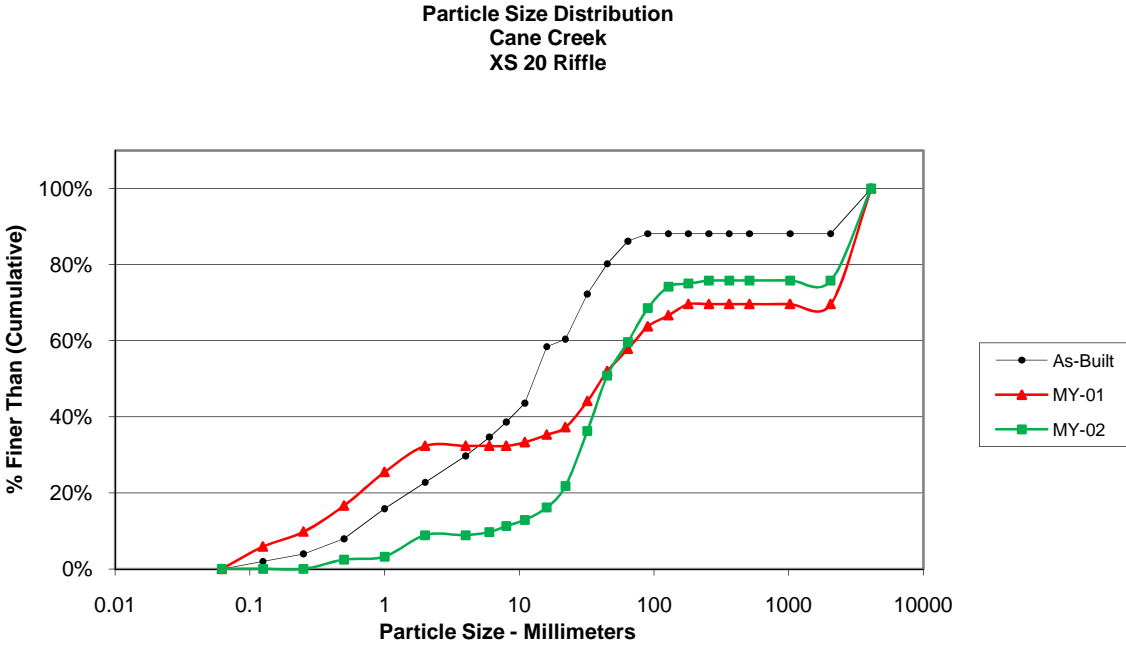
Cross-Section 20 Riffle - MY02, Trib 7			
Particle	Millimeter		Count
Silt/Clay	< 0.062	S/C	
Very Fine	.062 - .125	S	
Fine	.125 - .25	A	
Medium	.25 - .50	N	3
Coarse	.50 - 1	D	1
Very Coarse	1 - 2	S	7
Very Fine	2 - 4		
Fine	4 - 5.7	G	1
Fine	5.7 - 8	R	2
Medium	8 - 11.3	A	2
Medium	11.3 - 16	V	4
Coarse	16 - 22.6	E	7
Coarse	22.6 - 32	L	18
Very Coarse	32 - 45	S	18
Very Coarse	45 - 64		11
Small	64 - 90	C	11
Small	90 - 128	O	7
Large	128 - 180	B	1
Large	180 - 256	L	1
Small	256 - 362	B	
Small	362 - 512	L	
Medium	512 - 1024	D	
Lrg- Very Lrg	1024 - 2048	R	
Bedrock	>2048	BDRK	10
		<b>Total</b>	<b>104</b>

Size (mm)	
D16	9.4
D35	25
D50	33
D65	43
D84	75
D95	110

Size Distribution	
mean	26.6
dispersion	2.9
skewness	-0.10

Type	
silt/clay	0%
sand	11%
gravel	61%
cobble	19%
boulder	0%
bedrock	10%
hardpan	0%
wood/det	0%
artificial	0%

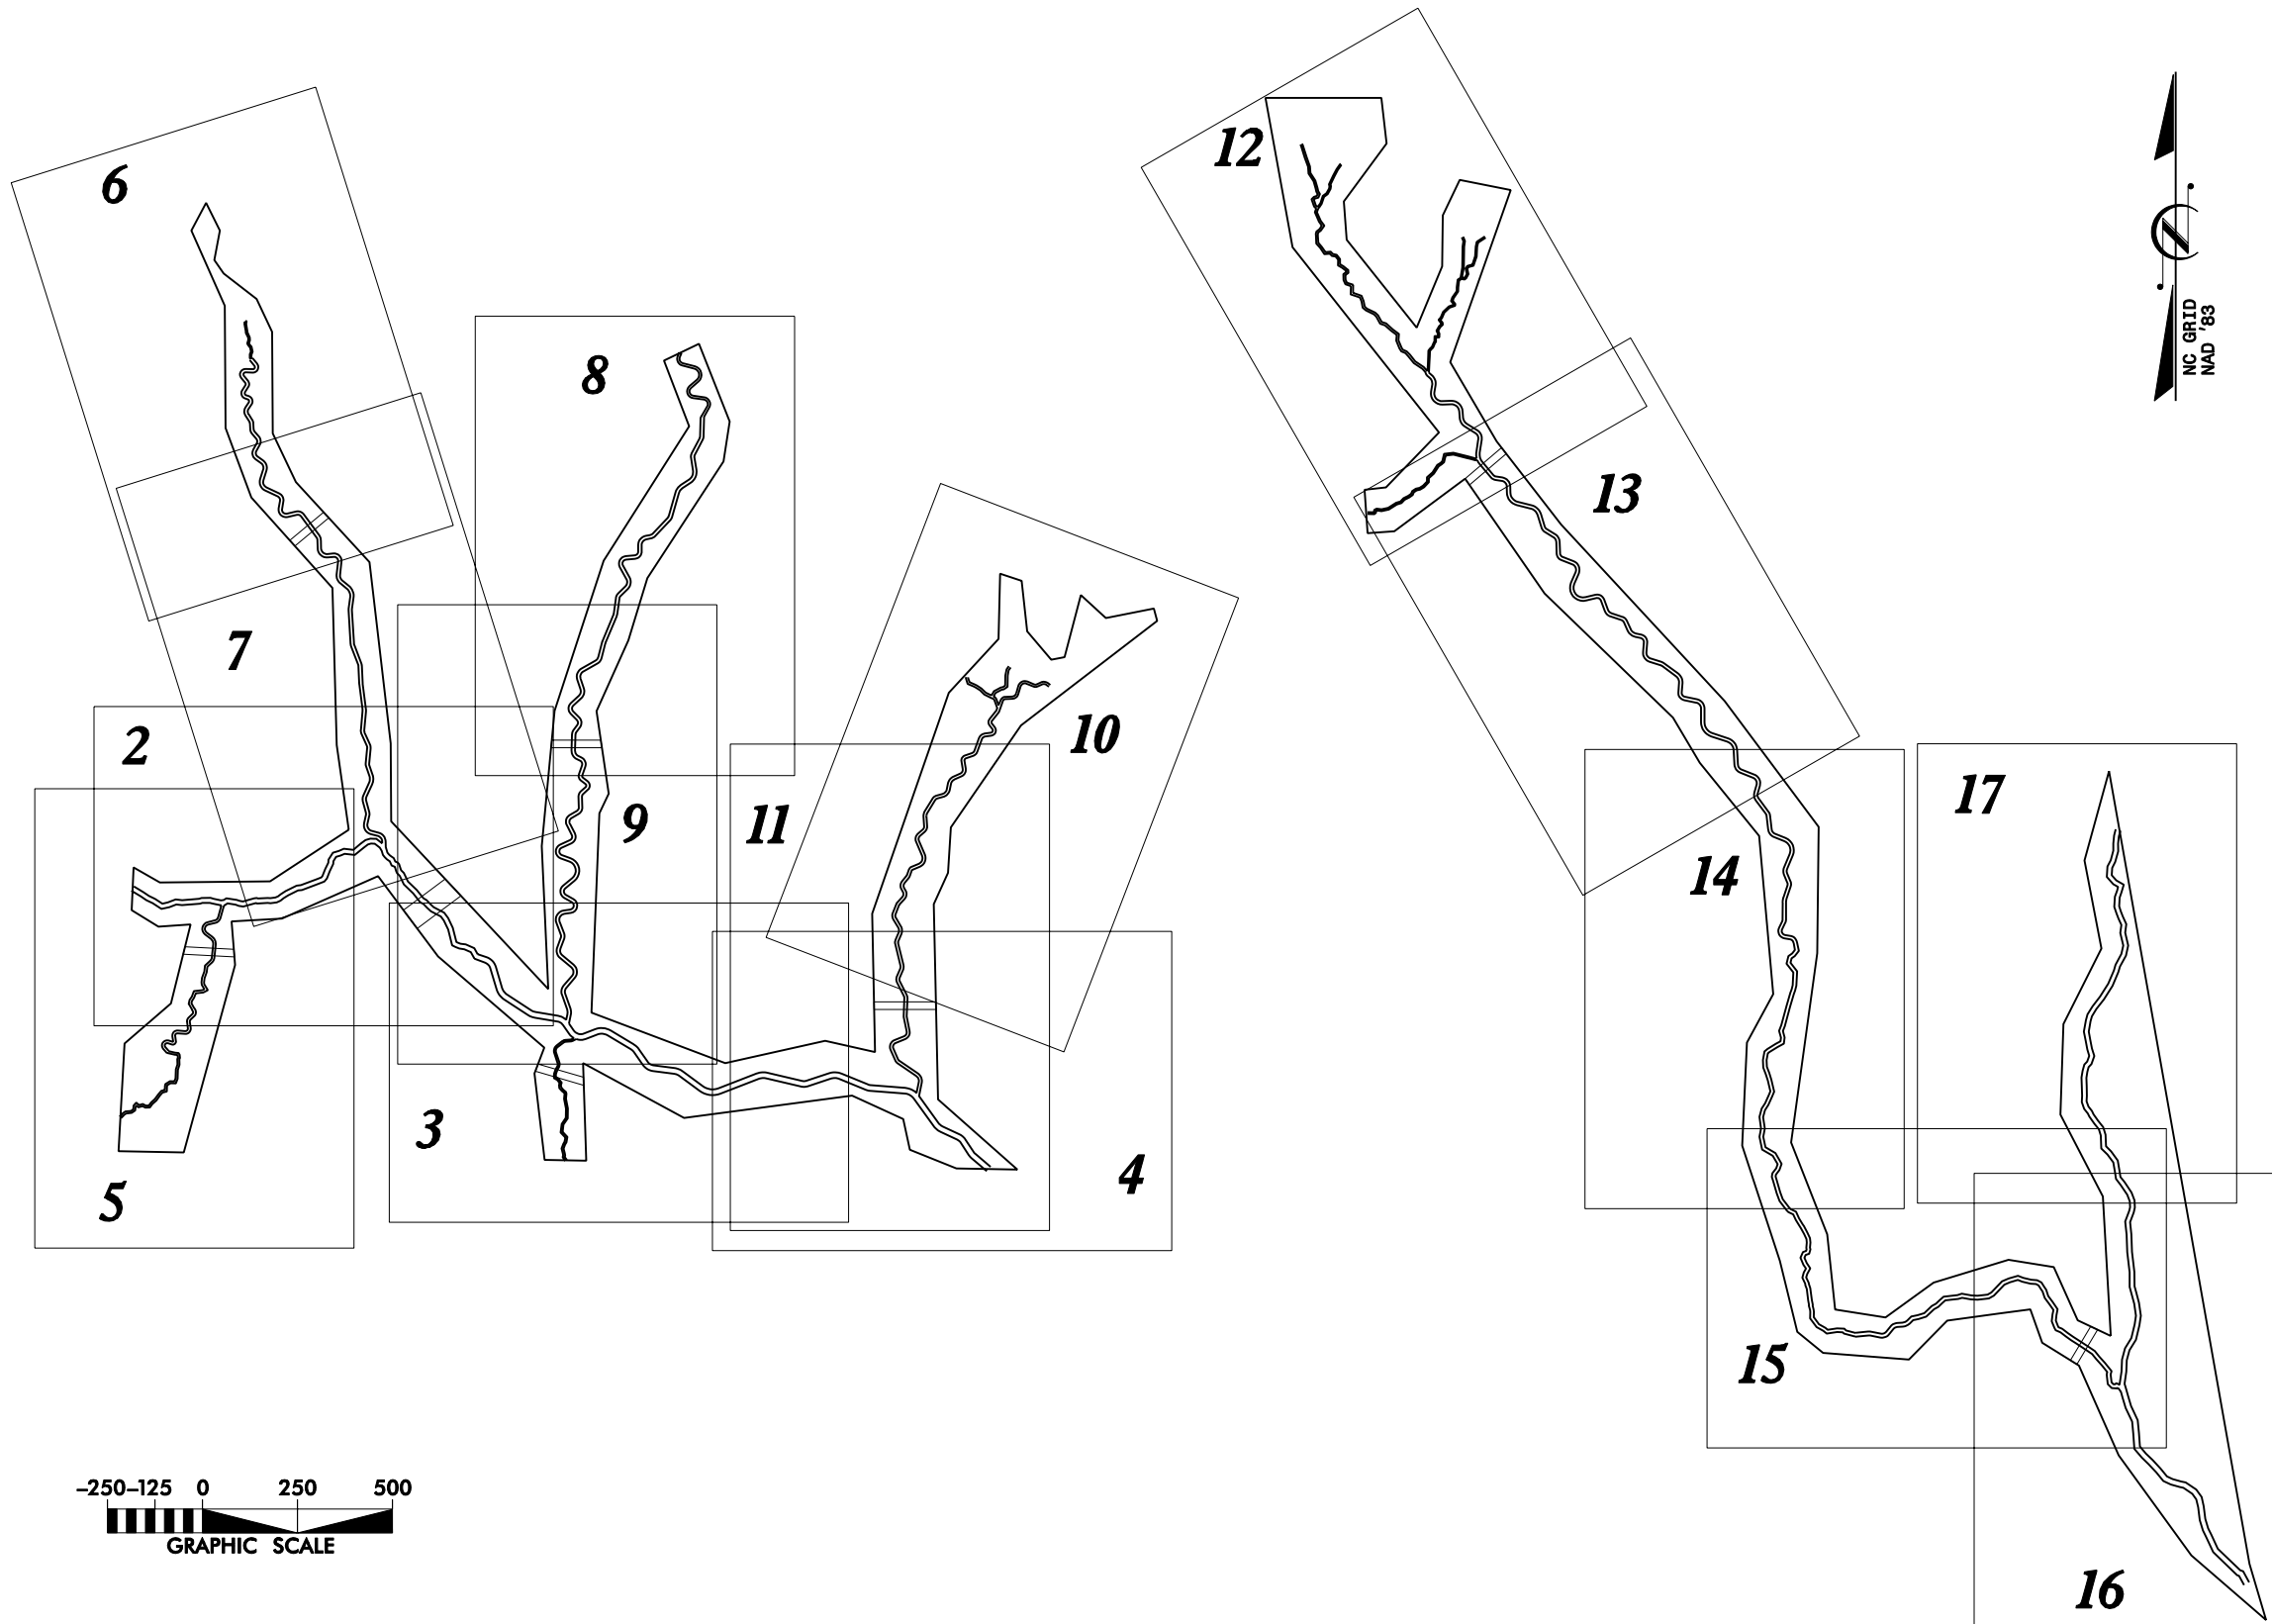
DATE: JAN 2011  
 SCALE: 1"=500'  
**CURRENT  
 CONDITION  
 PLAN VIEW**  
 SHEET 1 OF 17

## **Current Condition Plan View**
