# Cane Creek Tributary Stream Restoration Site Monitoring Report MY02 Basin 03010104 / Contract # D06002

**January 2011**

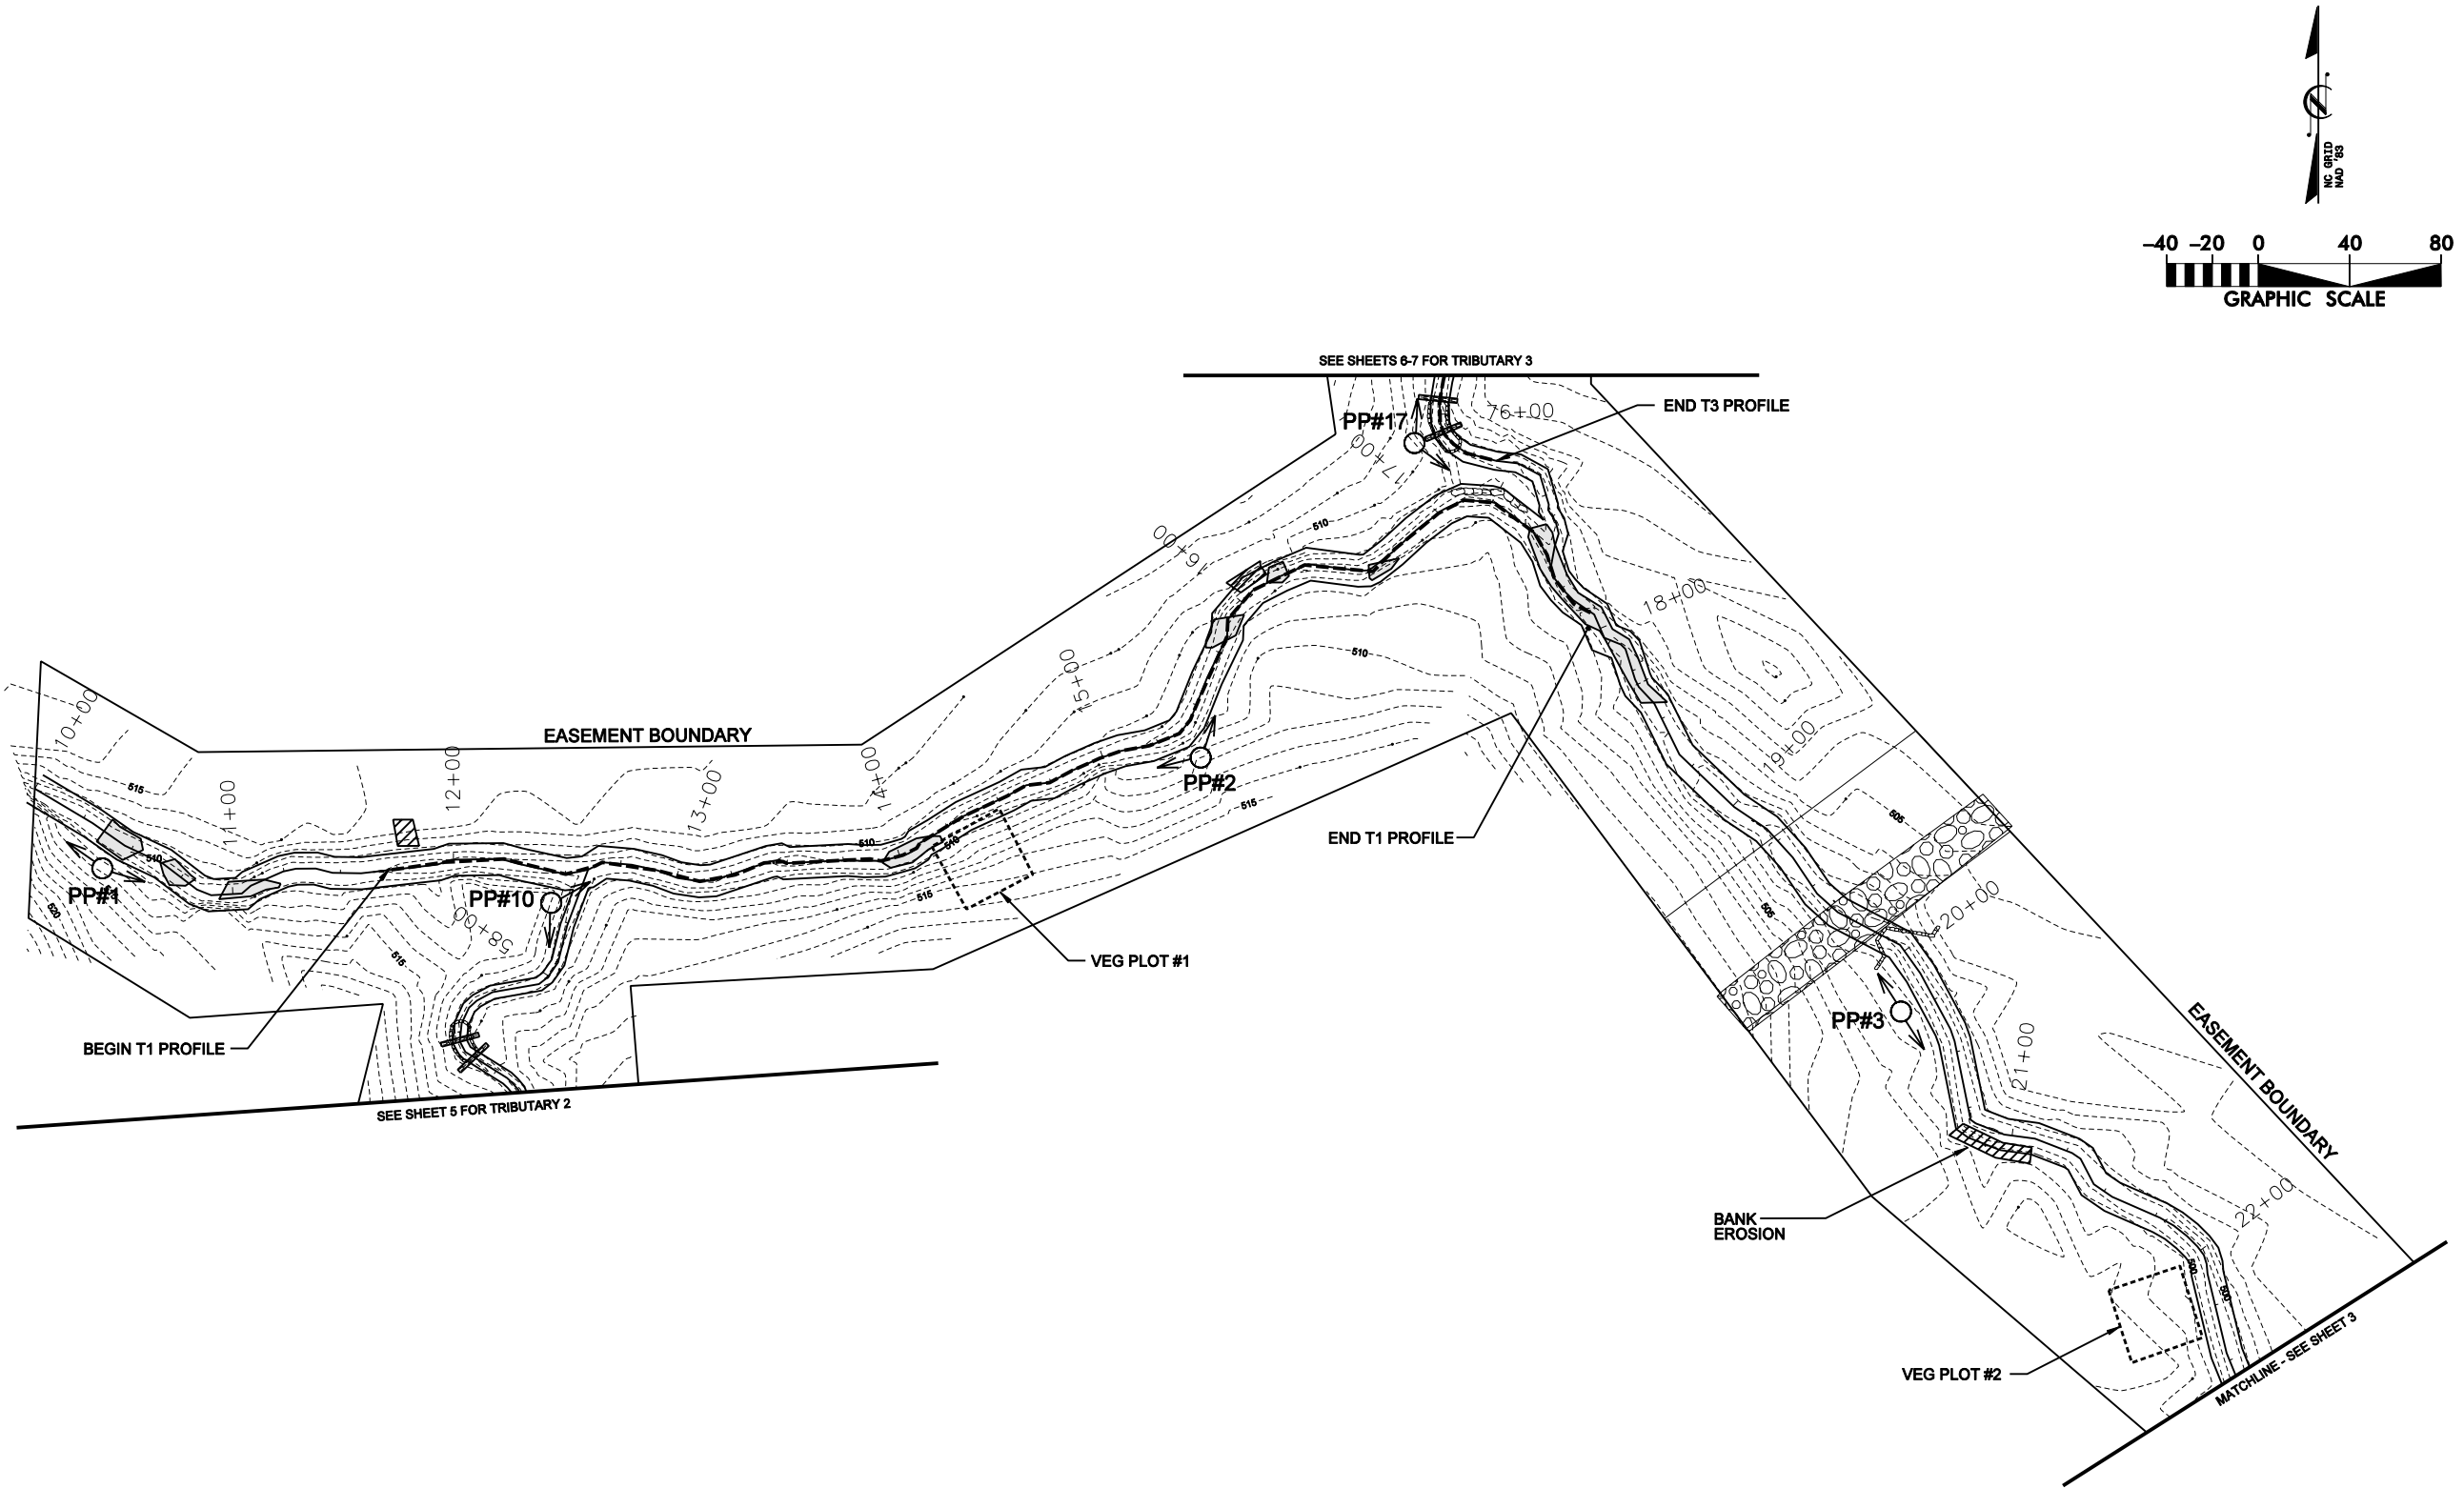
DATE: JAN 2011  
 SCALE: 1"=500'  
**CURRENT  
 CONDITION  
 PLAN VIEW**  
 SHEET 1 OF 17

**CANE CREEK  
 STREAM RESTORATION PROJECT**  
 SEMORA, PERSON COUNTY, NORTH CAROLINA

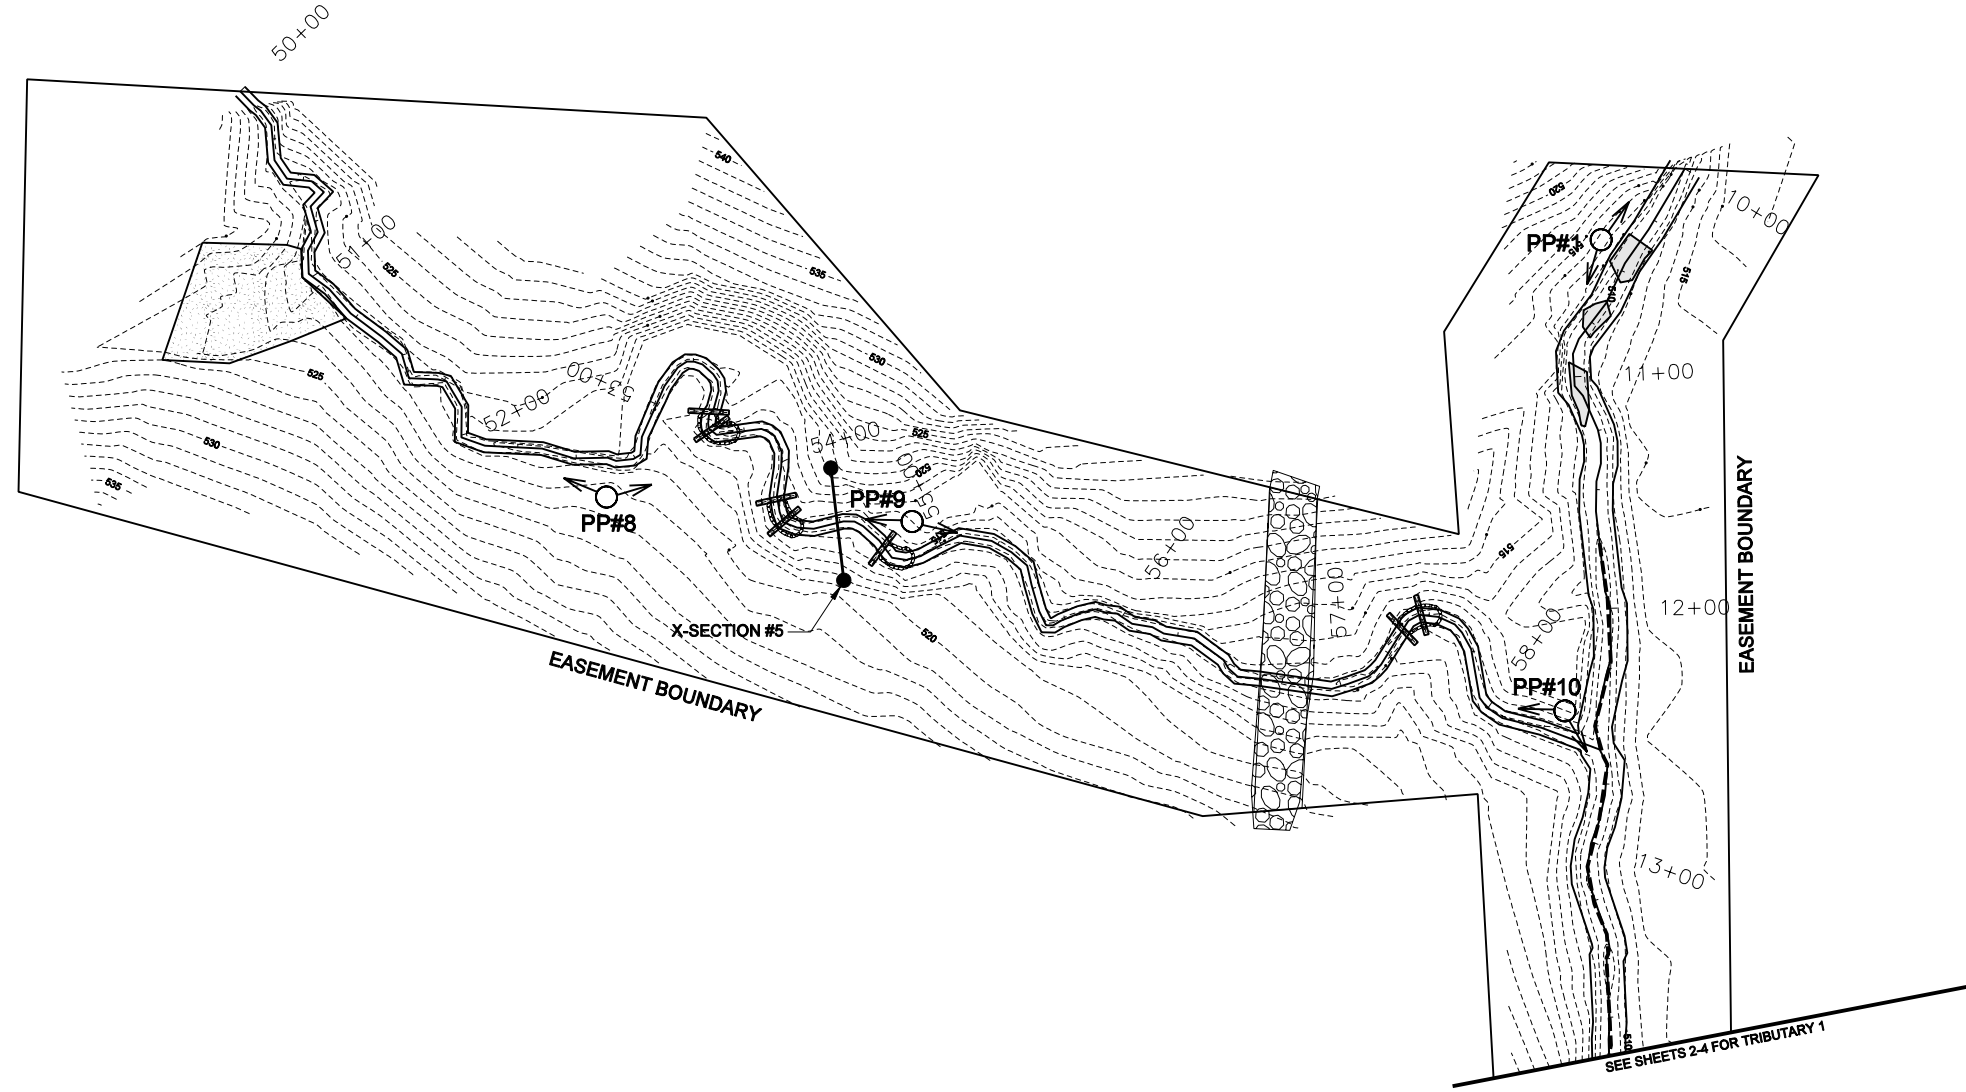
DATE: JAN 2011  
 SCALE: 1"=80'  
**CURRENT  
 CONDITION  
 PLAN VIEW**  
 SHEET 4 OF 17

**CANE CREEK  
 STREAM RESTORATION PROJECT**  
 SEMORA, PERSON COUNTY, NORTH CAROLINA  
 T1-4, T1-5: STATION 31+26 TO STATION 37+67

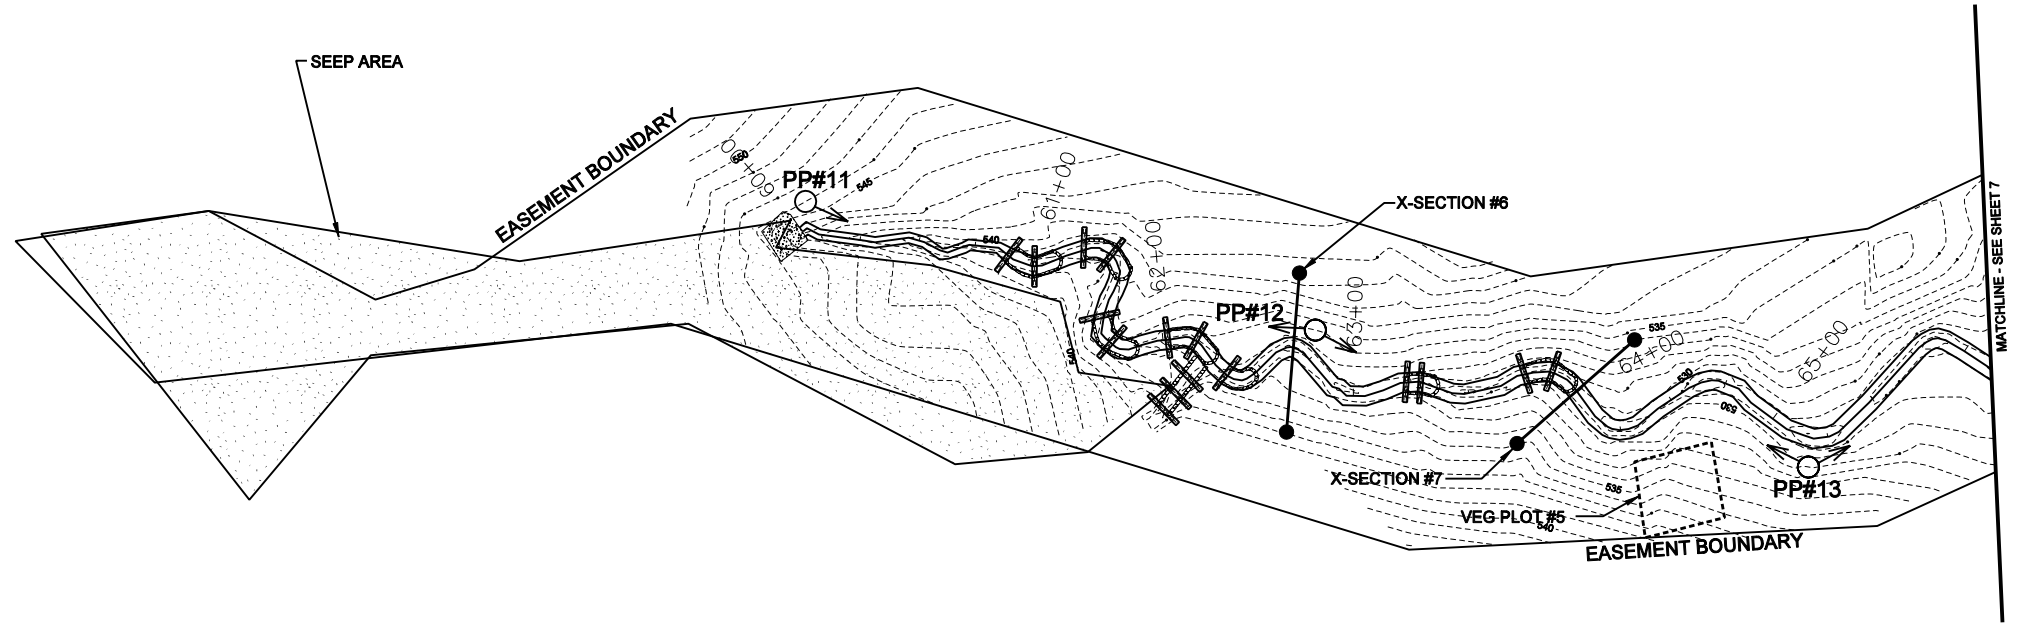
DATE: JAN 2011  
 SCALE: 1"=80'  
 CURRENT  
 CONDITION  
 PLAN VIEW  
 SHEET 5 OF 17

**CANE CREEK  
 STREAM RESTORATION PROJECT**  
 SEMORA, PERSON COUNTY, NORTH CAROLINA  
 T2-1, T2-2, T2-3, T2-4: STATION 50+00 TO STATION 58+50

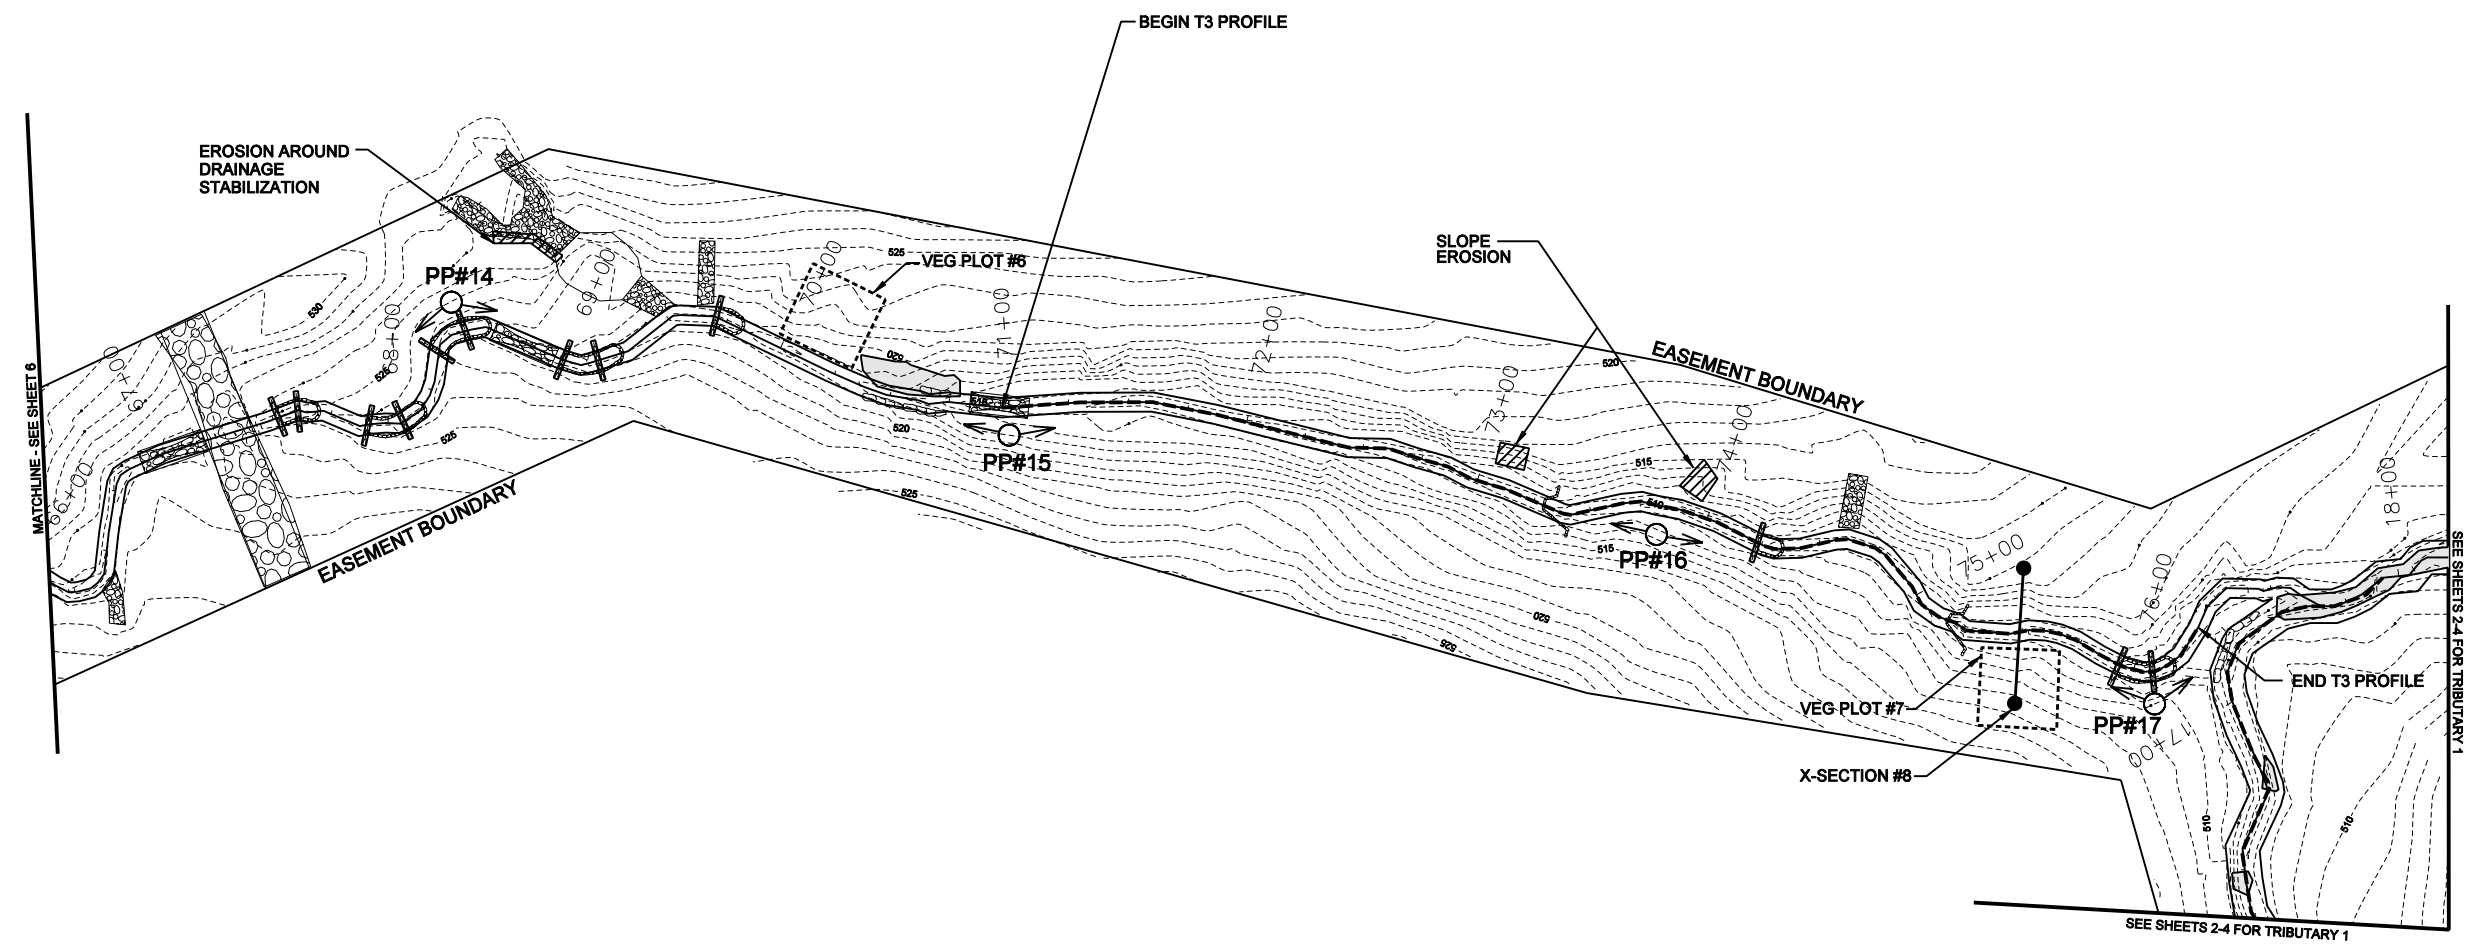
DATE: JAN 2011  
 SCALE: 1"=80'  
**CURRENT  
 CONDITIONS  
 PLAN VIEW**  
 SHEET 6 OF 17

**CANE CREEK  
 STREAM RESTORATION PROJECT**  
 SEMORA, PERSON COUNTY, NORTH CAROLINA  
 T3-1, T3-2: STATION 60+00 TO STATION 66+13

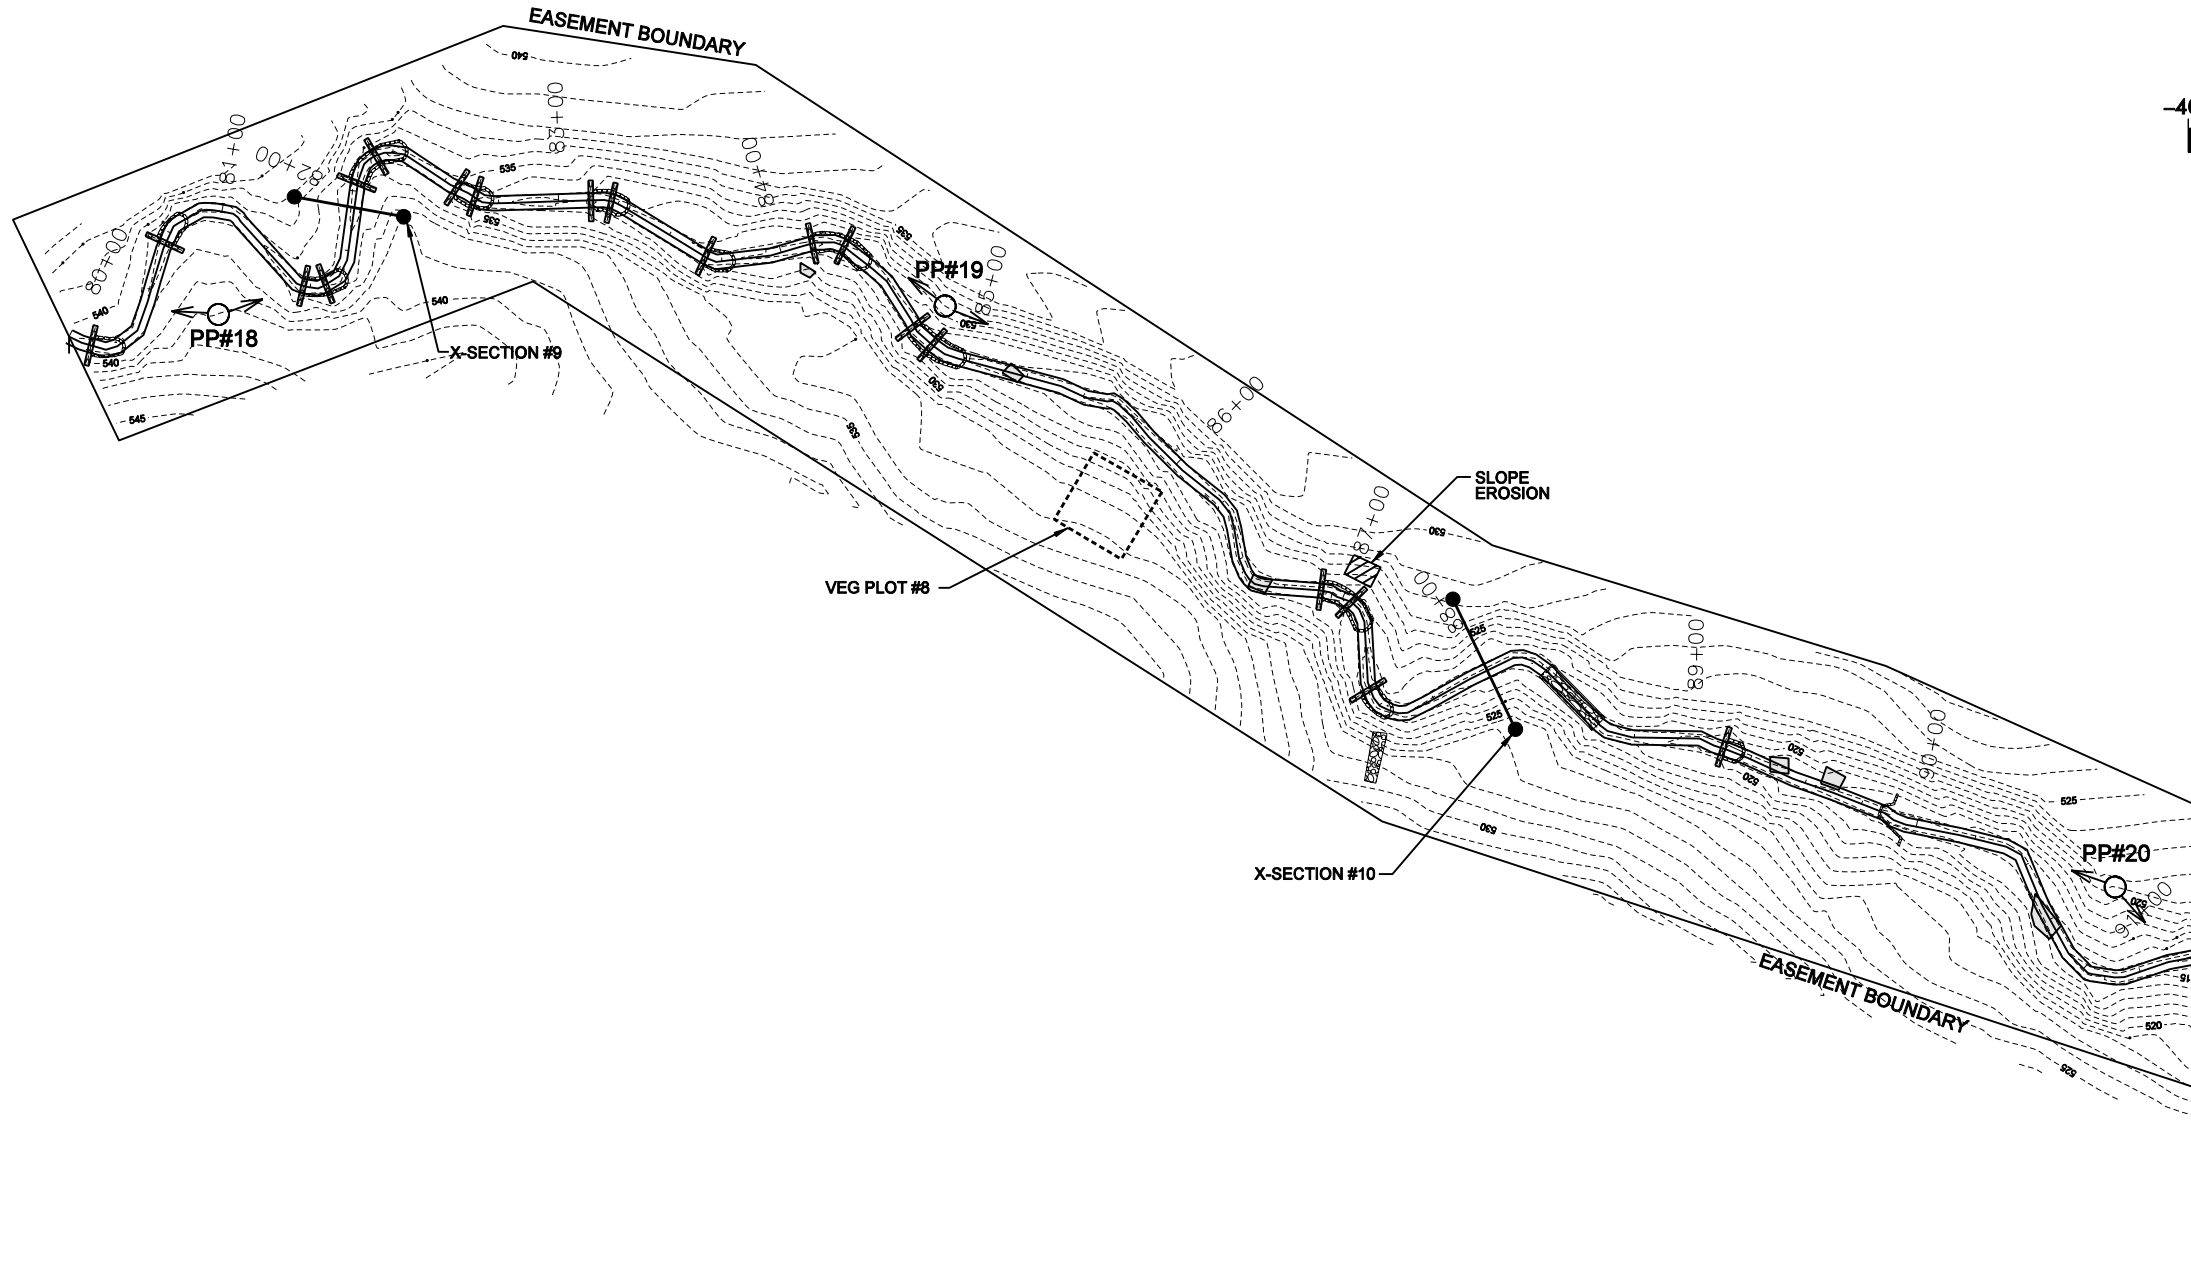
DATE: JAN 2011  
 SCALE: 1"=80'  
 CURRENT  
 CONDITION  
 PLAN VIEW  
 SHEET 7 OF 17

**CANE CREEK  
 STREAM RESTORATION PROJECT**  
 SEMORA, PERSON COUNTY, NORTH CAROLINA  
 T3-2: STATION 66+13 TO STATION 76+98

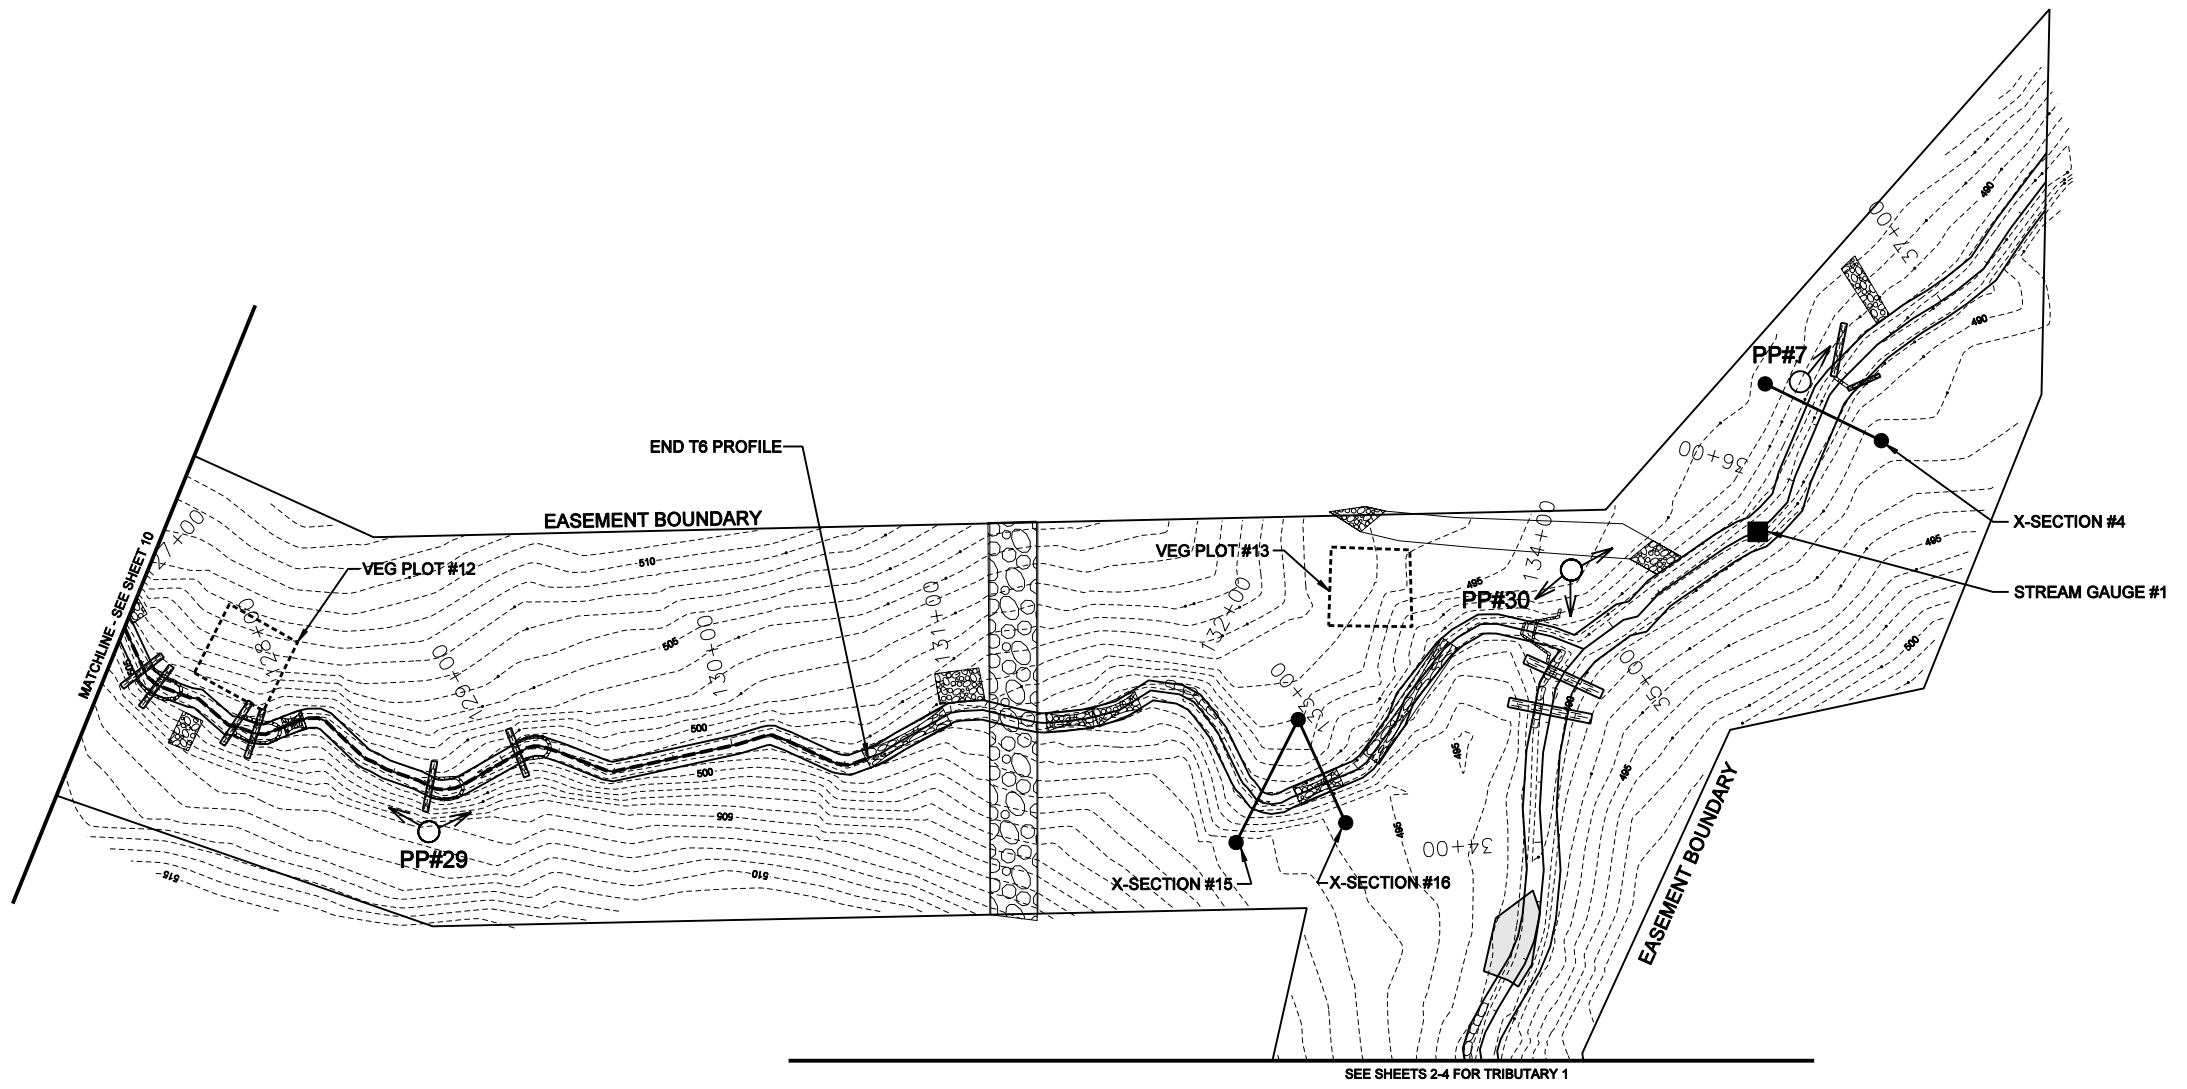
DATE: JAN 2011  
SCALE: 1"=80'  
**CURRENT  
CONDITION  
PLAN VIEW**  
SHEET 10 OF 17

**CANE CREEK  
STREAM RESTORATION PROJECT**  
SEMORA, PERSON COUNTY, NORTH CAROLINA  
T6A, T6B, T6B-1, T6C-1, T6C-2, T6C-3, T6AB, T6C, T6: STA 300+00  
TO 300+80, STA 310+00 TO 310+82, STA 240+00 TO 241+21,  
STA 248+38 TO 251+04, AND STA 117+02 TO 127+10

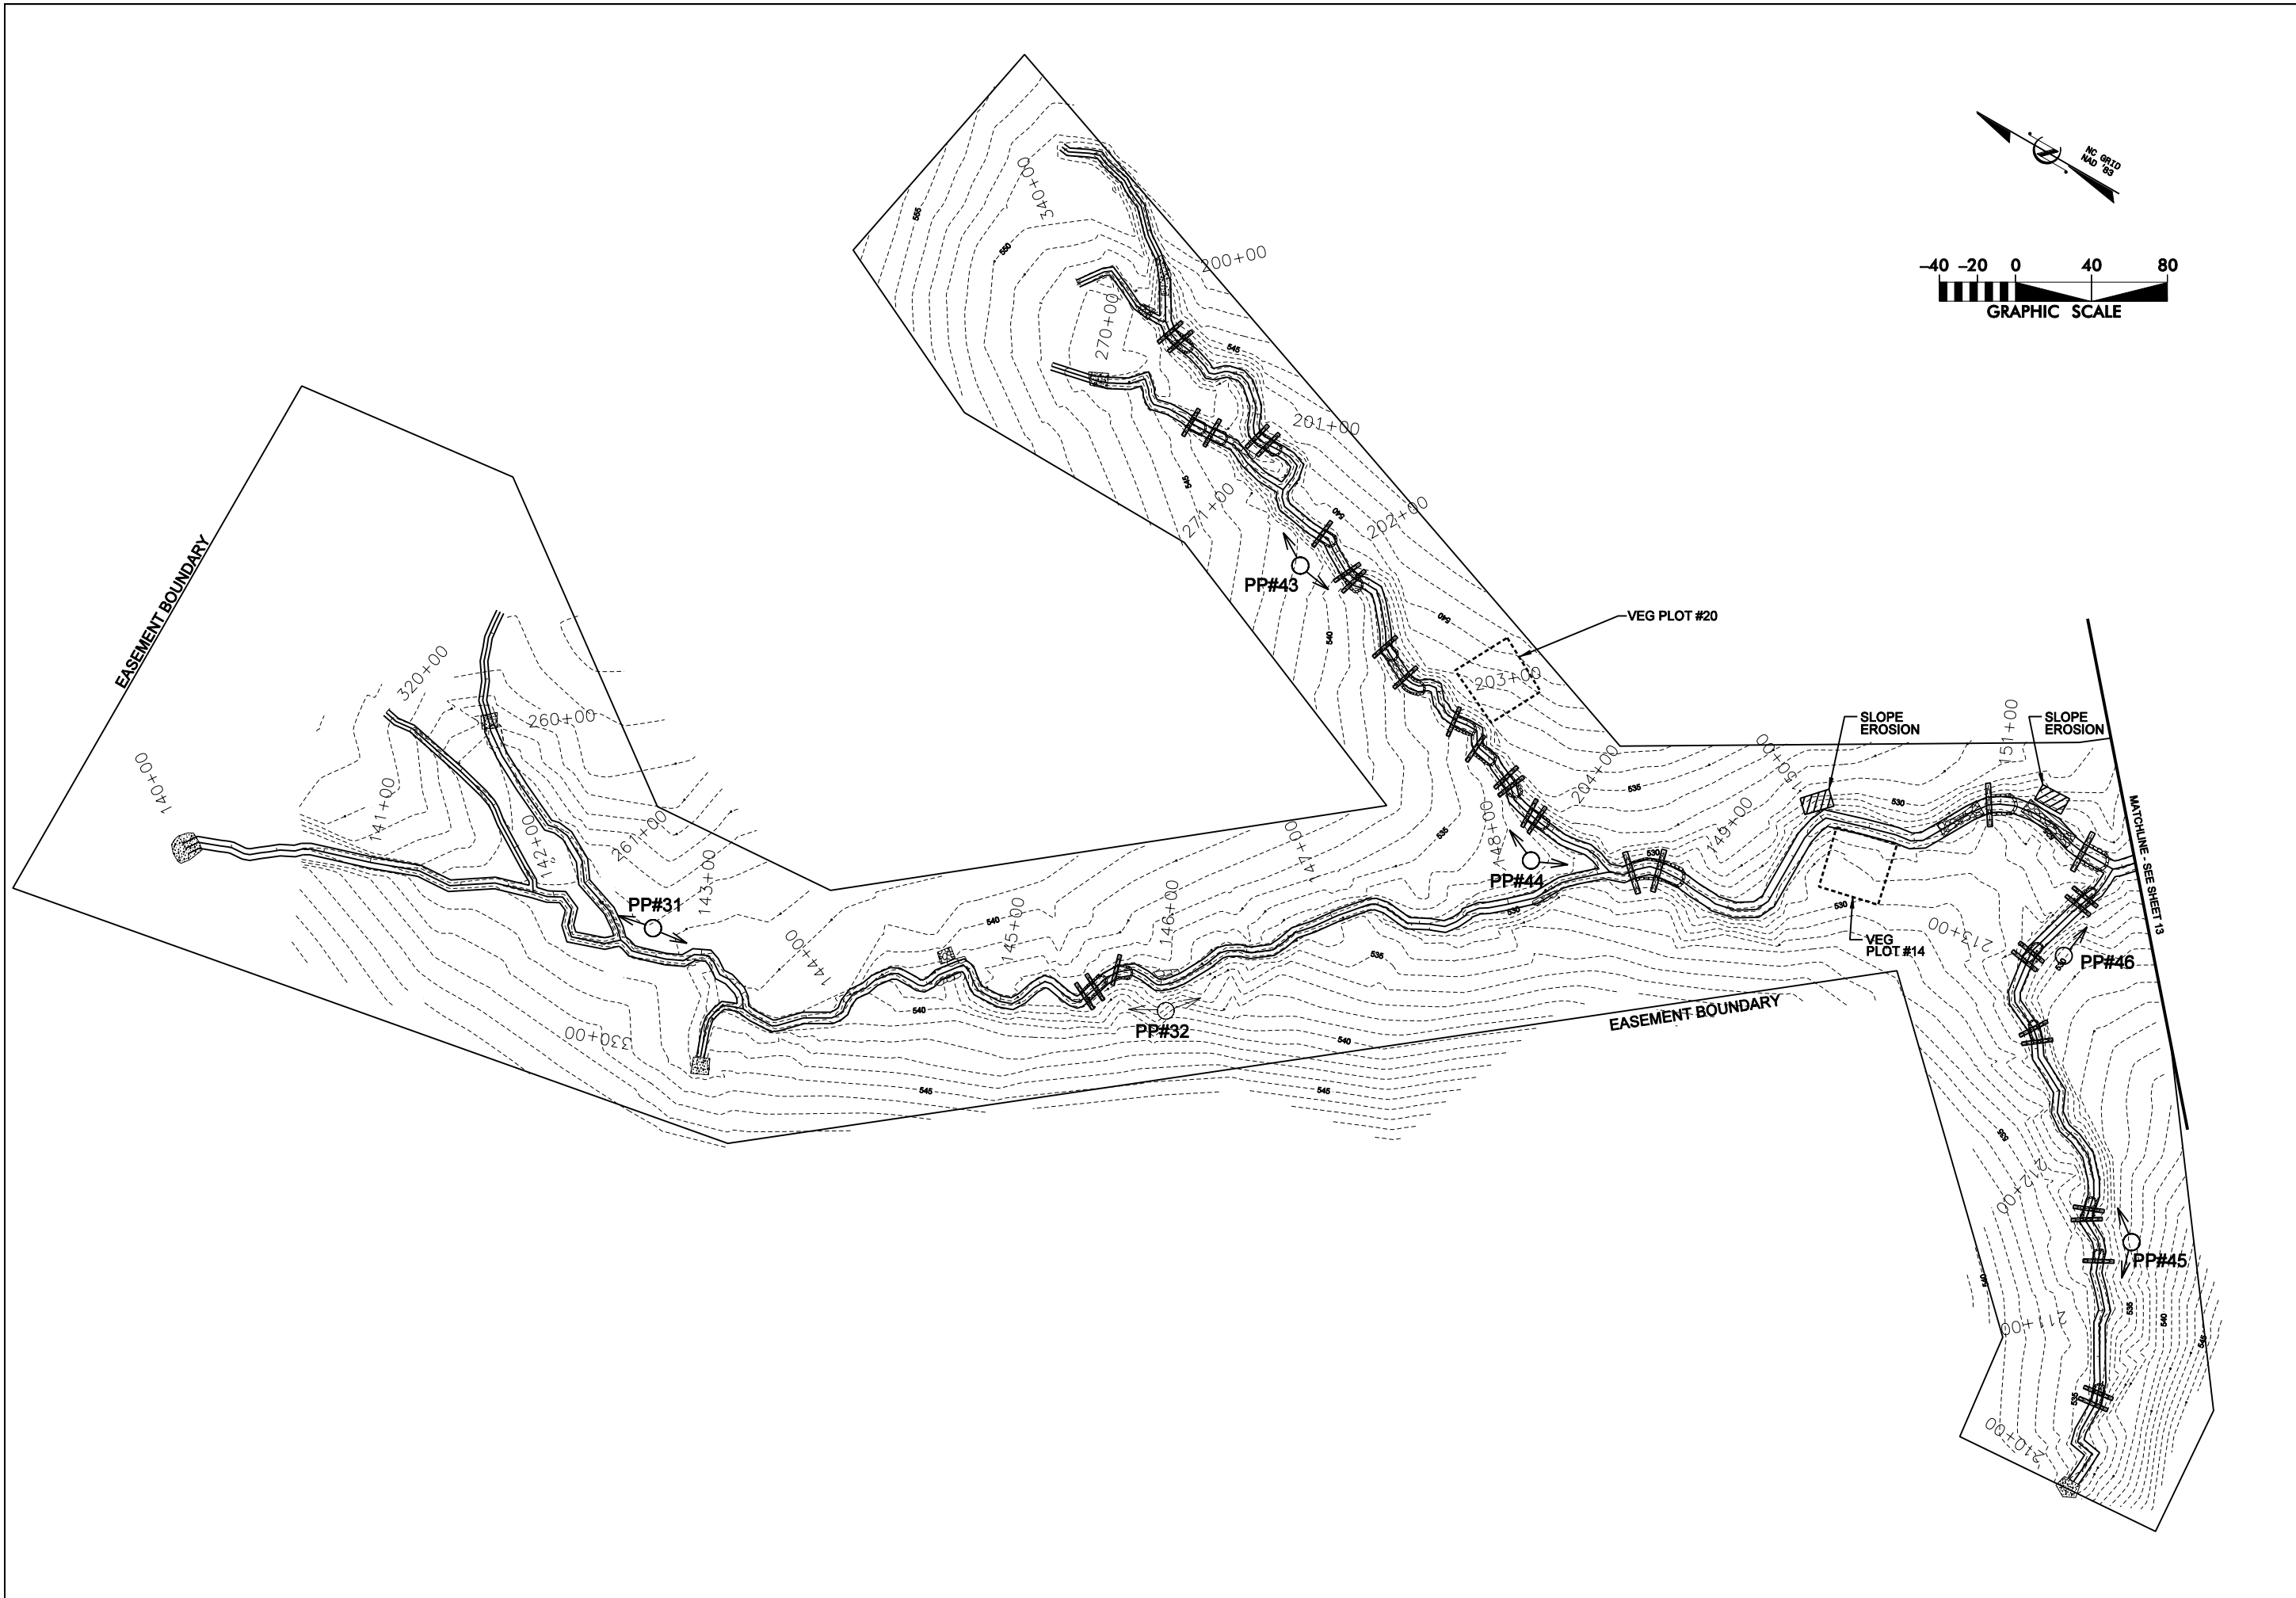
DATE: JAN 2011  
SCALE: 1"=80'  
**CURRENT  
CONDITION  
PLAN VIEW**  
SHEET 11 OF 17

**CANE CREEK  
STREAM RESTORATION PROJECT**  
SEMORA, PERSON COUNTY, NORTH CAROLINA  
T6: STATION 127+10 TO STATION 134+25

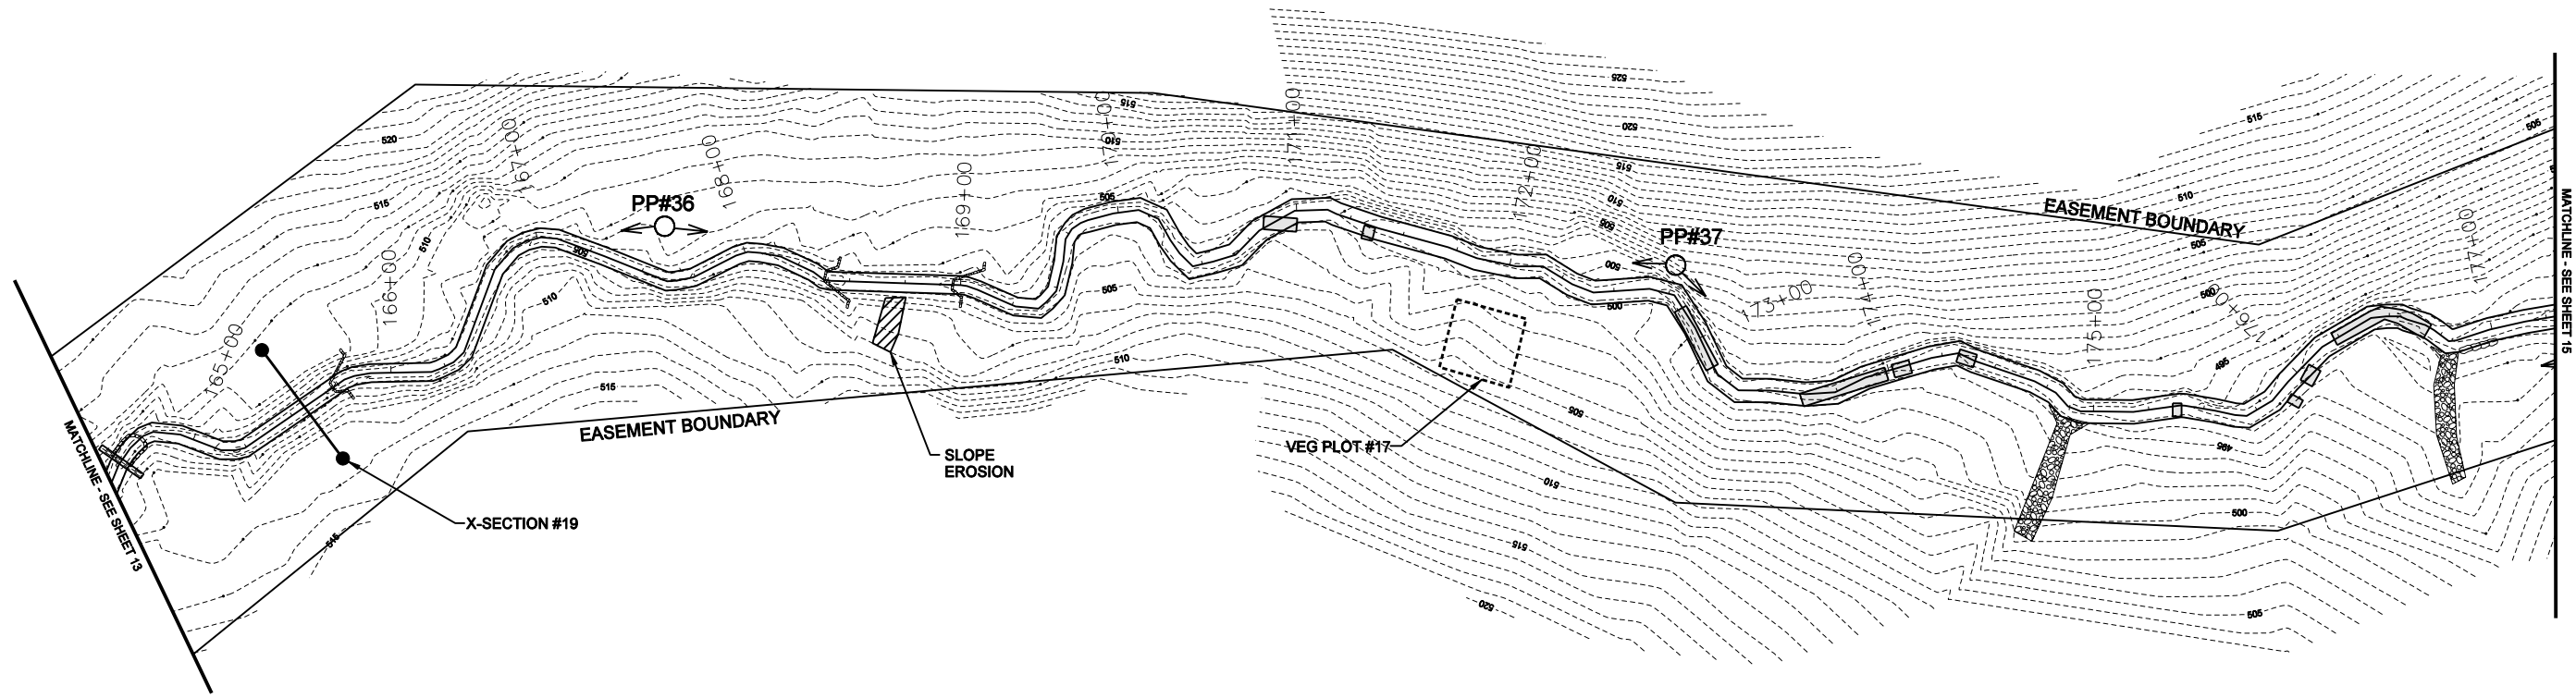
DATE: JAN 2011  
 SCALE: 1"=80'  
**CURRENT  
 CONDITION  
 PLAN VIEW**  
 SHEET 13 OF 17

**CANE CREEK  
 STREAM RESTORATION PROJECT**  
 SEMORA, PERSON COUNTY, NORTH CAROLINA  
 T7-3: STATION 151+57 TO STATION 164+50
