# Cane Creek Tributary Stream Restoration Site Monitoring Report MY02 Basin 03010104 / Contract # D06002

**January 2011**

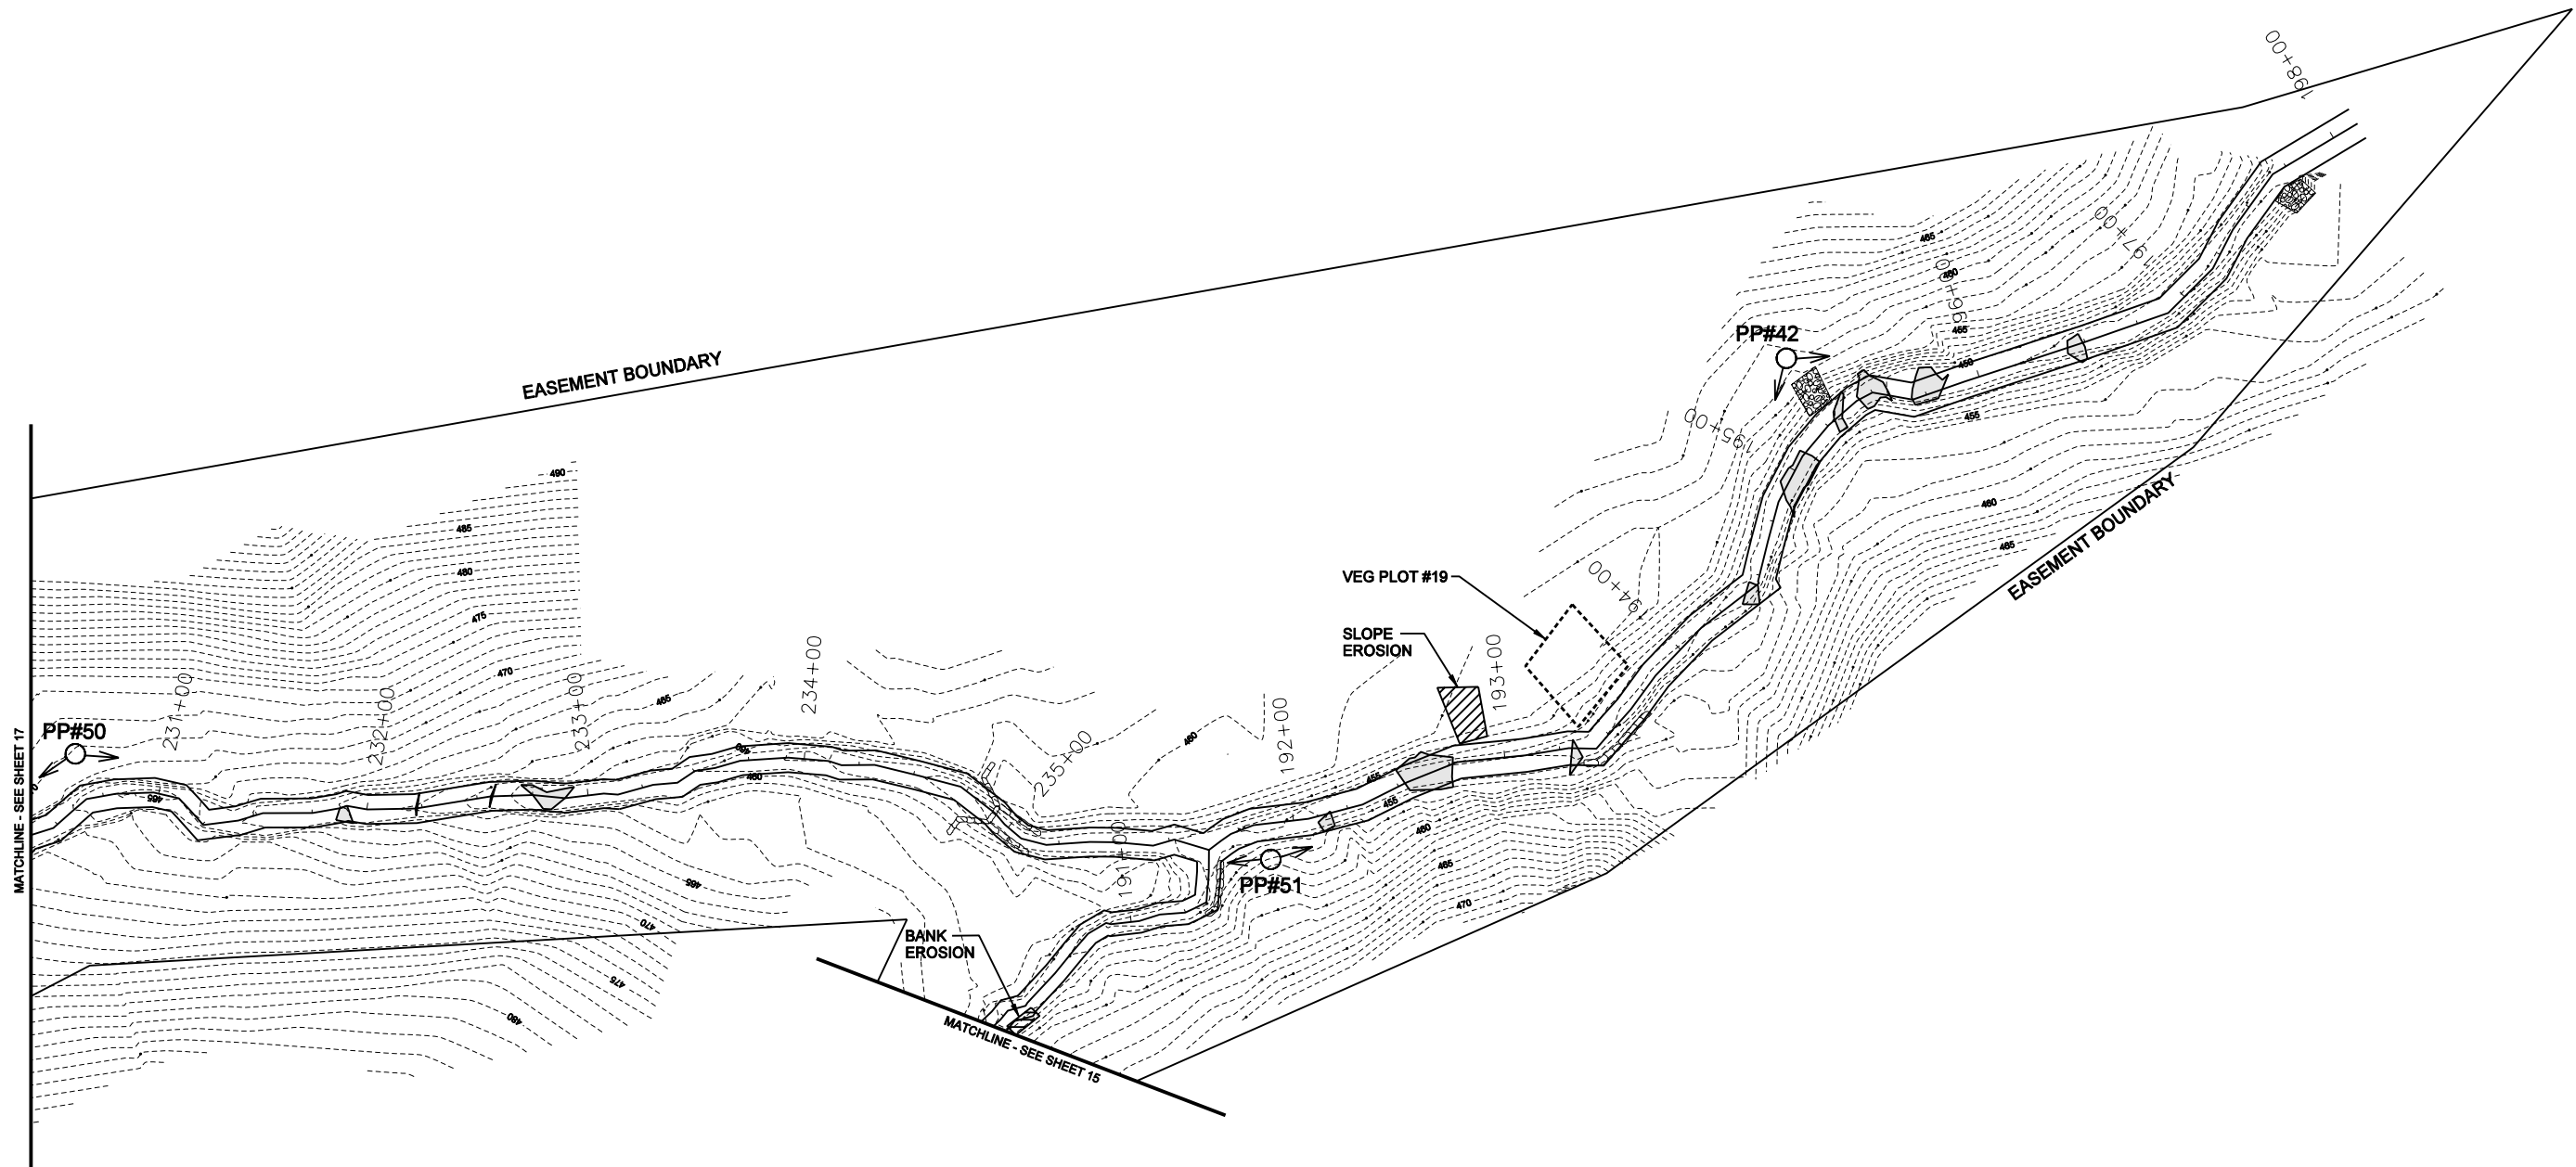
DATE: JAN 2011  
 SCALE: 1"=80'  
**CURRENT  
 CONDITION  
 PLAN VIEW**  
 SHEET 16 OF 17

**CANE CREEK  
 STREAM RESTORATION PROJECT**  
 SEMORA, PERSON COUNTY, NORTH CAROLINA  
 T7-4, T7-5, T7-6: STATION 177+29 TO STATION 190+18
